Building and Timber Pest Inspection Report

Inspection Date: Mon, 23 Mar 2026

Property Address: 16 Wattle St, Killara NSW 2071, Australia

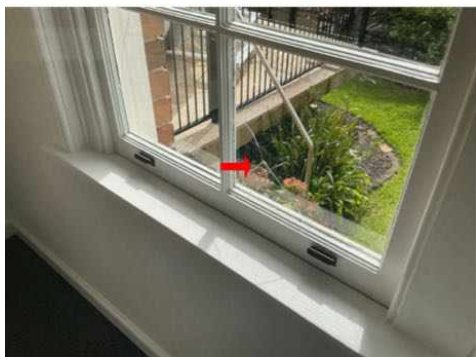
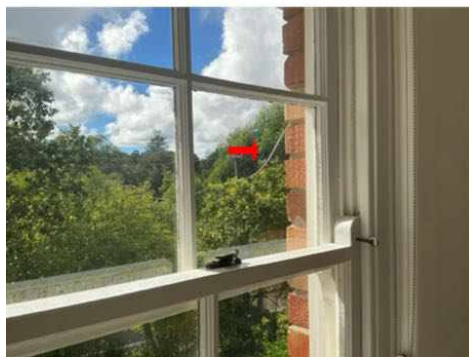
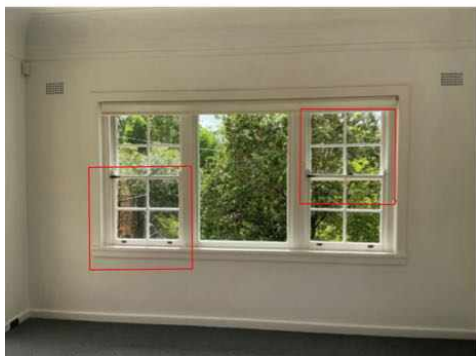
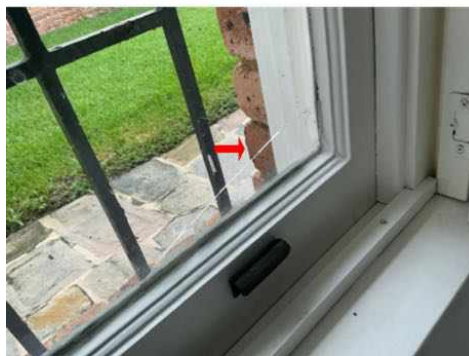
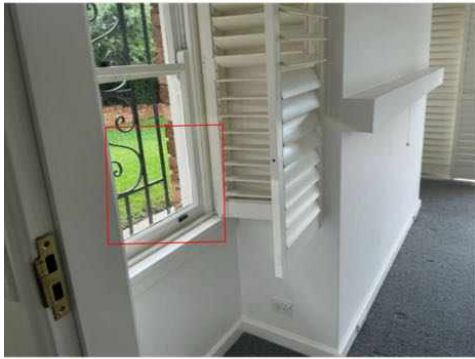
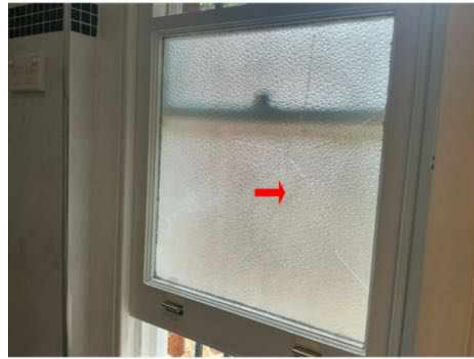
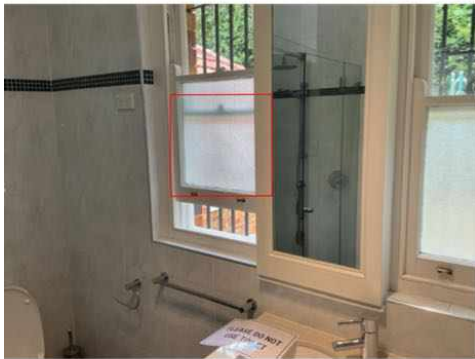
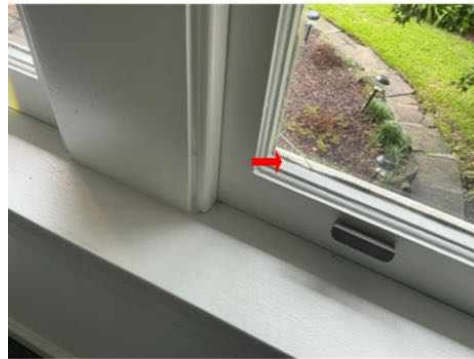
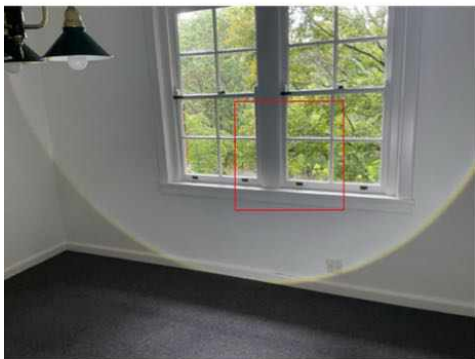
Building: Main Building
Location: All Areas
Finding: Window/s - Cracked
Information: At the time of the inspection, cracks were identified in the glazing in this area of the property.

Cracking in glazing is generally the result of impact damage, and is likely to develop further when left unmanaged. The likelihood of this window pane further cracking and shattering is increased exponentially, providing a safety hazard in the area. The cracked window also impairs the weather tightness of the building, creating potential for minor water leaks.

A qualified glazier is required to repair the window as soon as possible. Depending on the extent of the cracking, replacement of the window may be required. Please be advised that any persons coming into contact with the cracked window should do so with due caution to avoid any personal injury that may ensue.

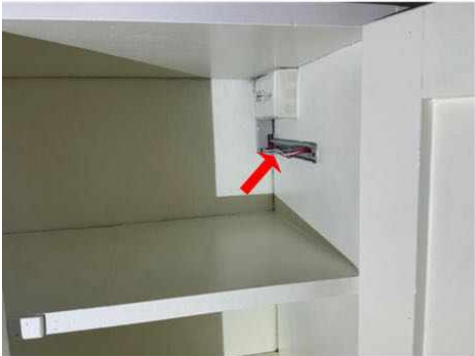
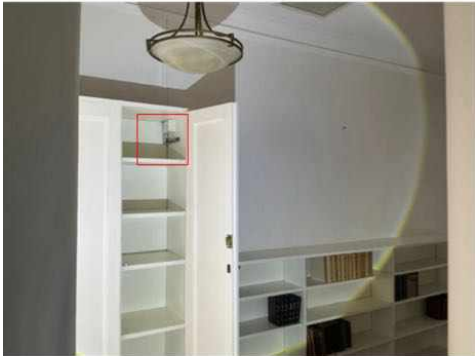
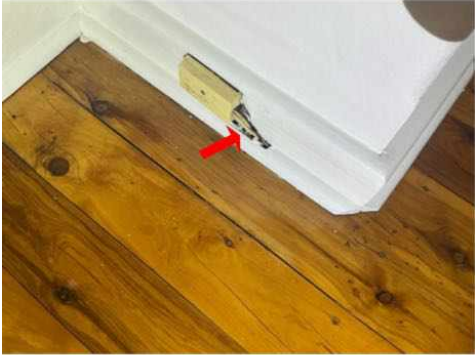
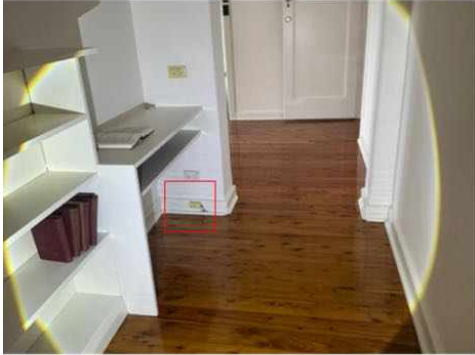
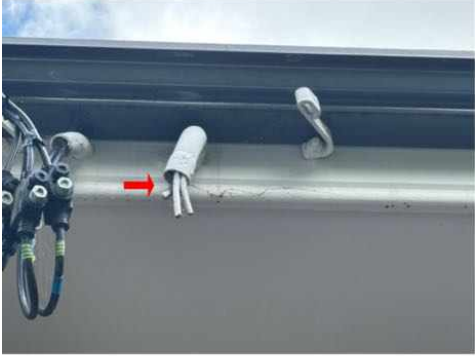
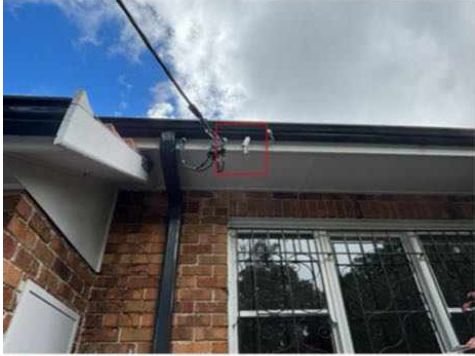
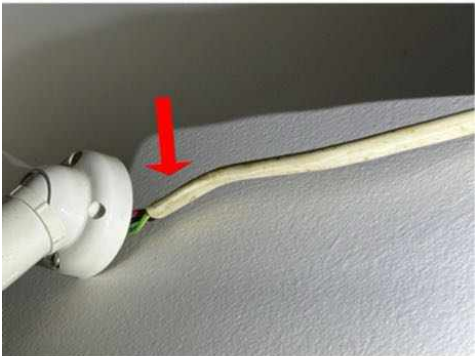
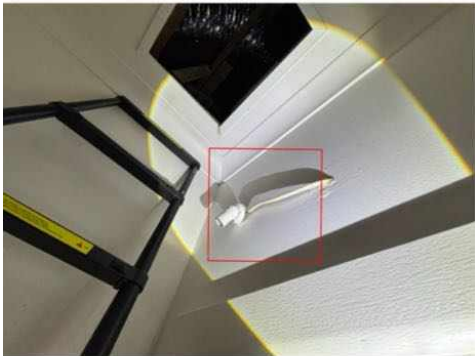
Finding 1.02

Building:	Main Building
Location:	Exterior Front, Hallway, Bedroom 3
Finding:	Exposed Wiring
Information:	At the time of inspection, wiring was observed to be exposed and not properly concealed. Exposed wiring presents a safety hazard, as it may be susceptible to damage, accidental contact, and potential electrical risks.

It is recommended that all wiring, whether electrical or communication/cable wiring, be properly enclosed and secured to ensure safety and compliance with acceptable standards. Where the wiring is electrical in nature, a licensed electrician should be engaged to assess and rectify the installation. For non-electrical wiring, a suitably

qualified handyman may be engaged to neatly conceal and secure the wiring in a professional manner.

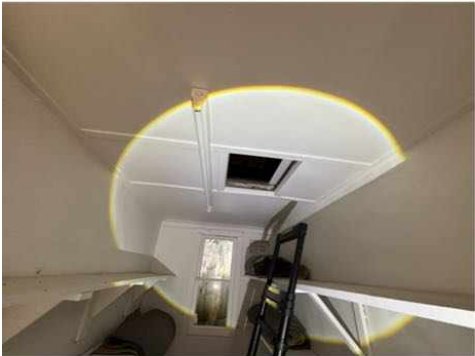
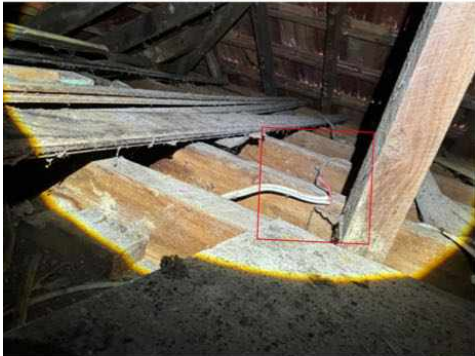
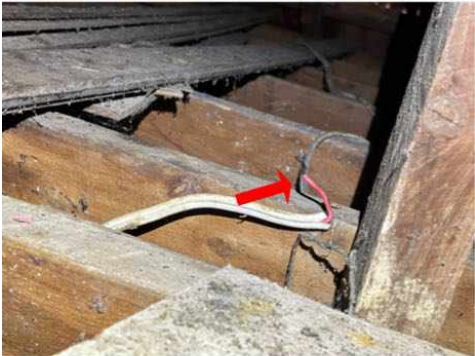
Finding 1.03

Finding: Electrical Wires - Exposed

Information: During the inspection, exposed electrical wires were noted. This condition poses a significant safety hazard, as it increases the risk of electrical shock, short circuits, and potential fire. It is imperative that a qualified electrician addresses this issue immediately by properly insulating the exposed wires and ensuring all electrical connections comply with safety standards. Prompt action will mitigate the risks associated with exposed wiring and maintain the safety and integrity of the property's electrical system.

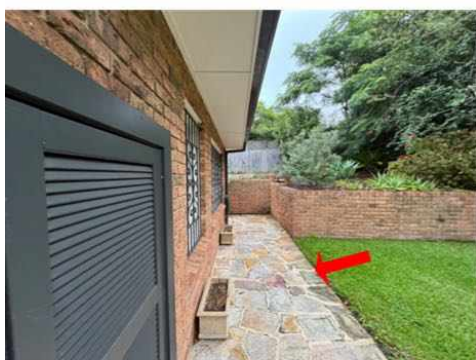
Building: Main Building
Location: Yard - Back
Finding: Inadequate Site Drainage - Exterior Areas
Information: At the time of inspection, inadequate site drainage was observed around the perimeter of the building, which can lead to water pooling and insufficient runoff management.

This condition may result in moisture being absorbed by the foundation or lower walls, potentially leading to rising damp, cracks in brickwork, erosion of the soil around the building, or structural issues over time. Water pooling can also create ideal conditions for mould growth, contribute to the deterioration of exterior materials, and act as conducive conditions for termite activity, as termites are attracted to areas with elevated and persistent moisture levels.

It is recommended that proper site drainage be installed, such as redirecting water flow away from the building or incorporating drainage systems, to prevent further damage and ensure the long-term stability of the structure.

To address the inadequate site drainage, a qualified landscaper or drainage specialist should be engaged to design and install appropriate drainage solutions, such as grading the ground away from the building or installing French drains, surface drains, or downspout extensions. If more complex issues are present, such as damage to the foundation or moisture entering the walls, a structural engineer may need to assess the situation, and a builder may be required for repairs.

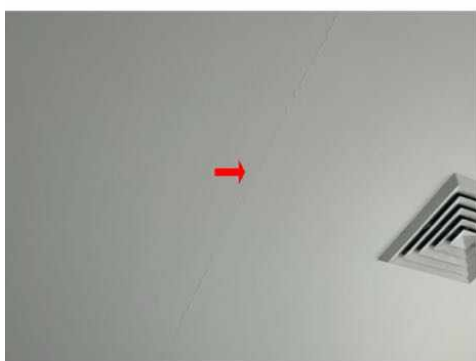
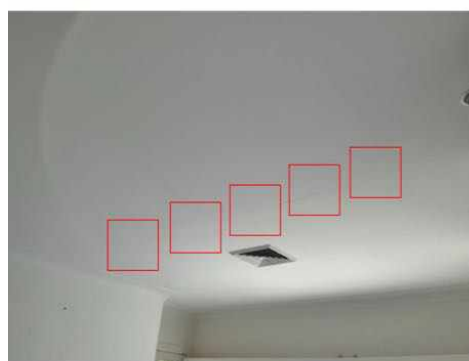
Finding 3.02

Building:	Main Building
Location:	Bedroom 1
Finding:	Cracking - Damage Category 1 - Fine (up to 1mm)
Information:	Although fine cracks are quite noticeable, they are often only considered to be an appearance defect, and usually do not indicate any structural damage. Generally, the cause of a fine crack is indicative of a separation between building materials and finishes (e.g. paint, plaster, etc.) along joins.

Cracking of this nature can generally be repaired with minor sanding, filling and/or repainting. Such works should be performed by a qualified painter or a general handyman.

Monitoring of all cracking should be conducted frequently. Always contact a building inspector should cracks widen, lengthen, or become more numerous.

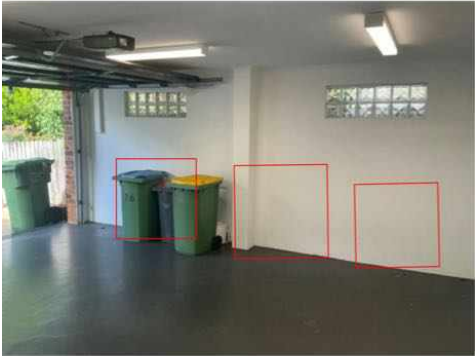
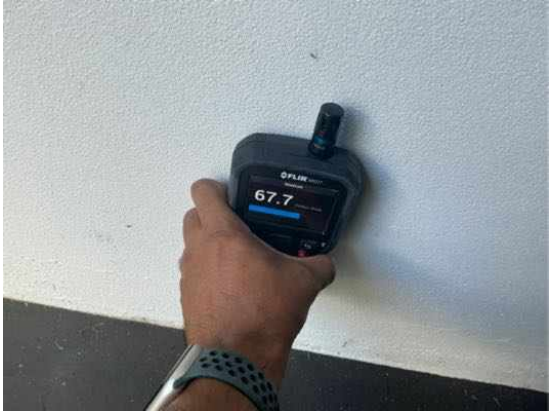
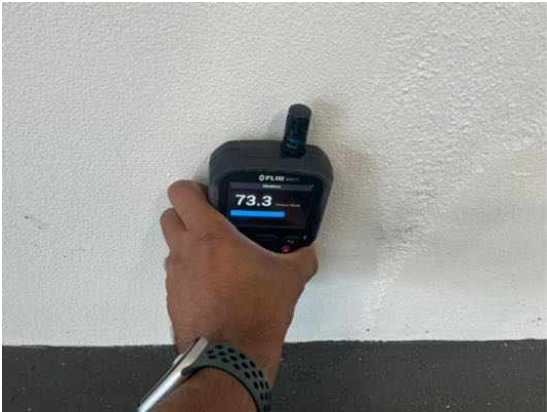
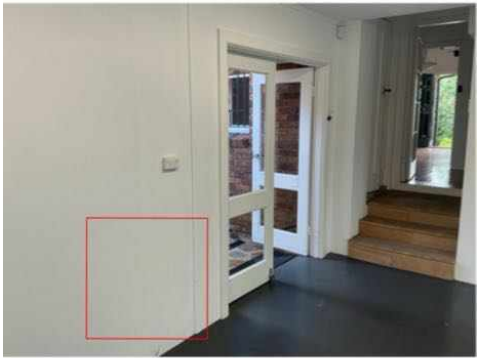
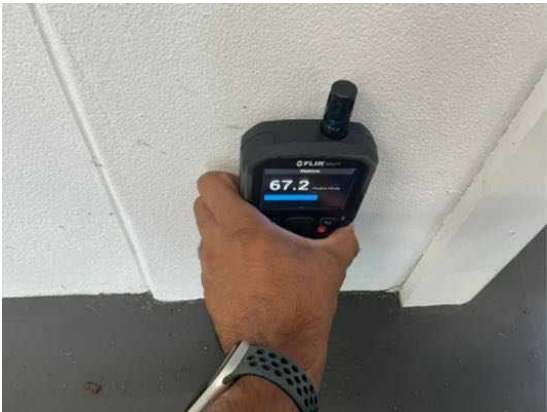
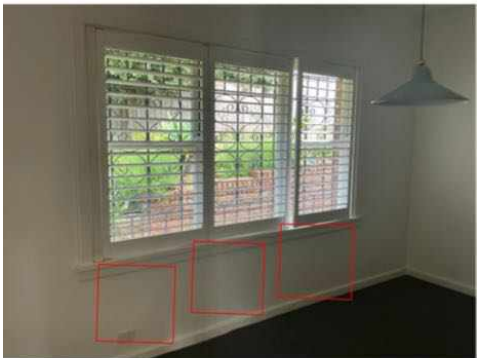
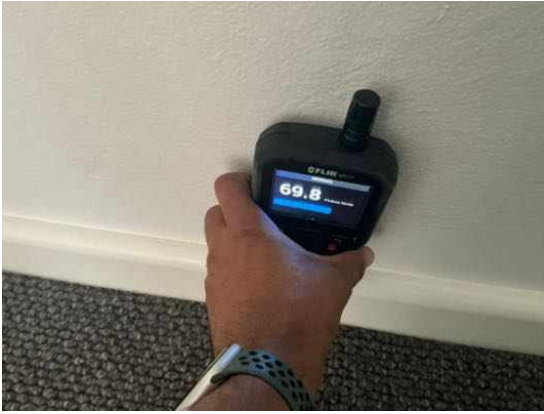
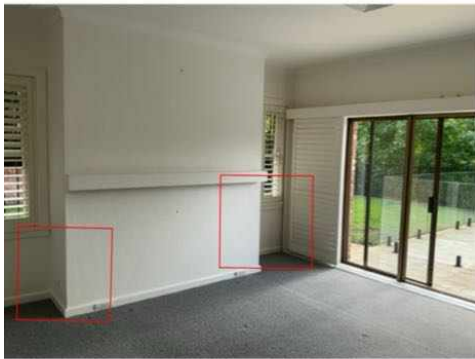
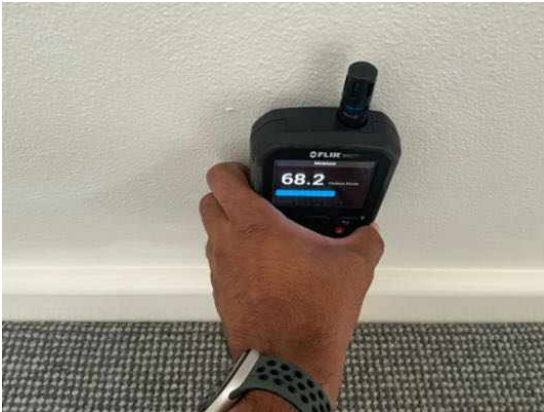
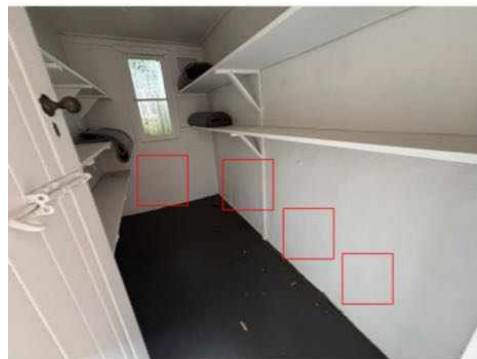
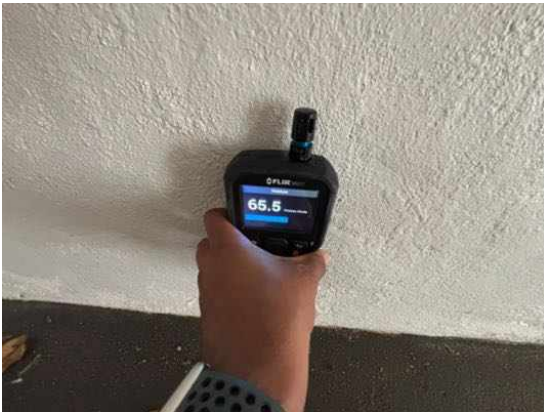
Finding 3.03

Building:	Main Building
Location:	Bedroom 1, Bedroom 2, Storage, Garage
Finding:	Damp - Rising
Information:	At the time of inspection, rising damp was identified within the property. This condition results from the upward movement of moisture through porous building materials, such as bricks, sandstone, or mortar, via capillary action. A damp-proof course (DPC), an impermeable barrier installed at the base of walls above ground level during construction, is typically used to prevent rising damp. However, the absence, deterioration, or bridging of the DPC can compromise its effectiveness, specially in older buildings, leading to moisture ingress. Inadequate site drainage, which allows water to accumulate around the foundation, is a common contributing factor to this issue.

If left unaddressed, rising damp can pose significant health risks due to mould growth and cause extensive damage to building elements, including wall finishes such as paint and plasterwork. The current condition should be monitored over a 12-month period to assess its progression.

It is strongly recommended that the client engage a qualified damp-proofing specialist for remedial actions. Additionally, consulting a qualified plumber or drainage specialist to assess and improve site drainage is advised to mitigate further risks. Monitoring the condition for 12 months is essential to evaluate its status and prevent potential recurrence or further damage.

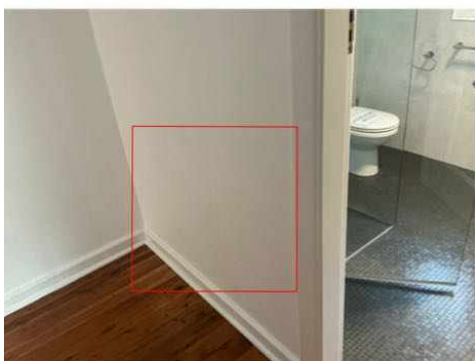
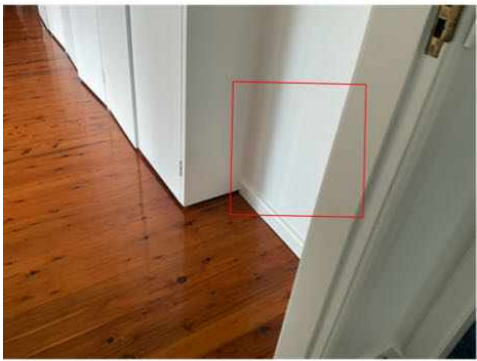
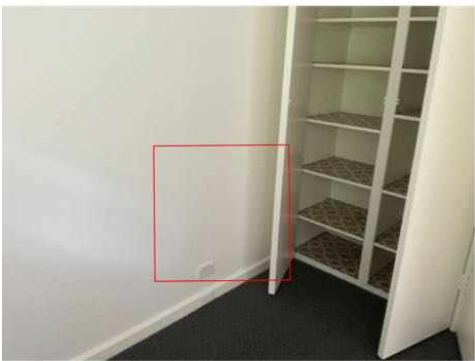
Finding 3.04

Building:	Main Building
Location:	Ensuite - Master, Bathroom
Finding:	Shower Damp - Adjacent Bathroom (Monitoring)
Information:	At the time of inspection, elevated moisture levels were detected on the wall adjacent to the shower area. While no visible water damage or deterioration was noted, the presence of moisture suggests possible seepage or condensation associated with regular shower use.

At this stage, no immediate action is required. However, the area should be monitored over the next 12 months for any signs of deterioration such as staining, bubbling paint, or mould growth. It should be noted that moisture ingress of this nature does not generally resolve without intervention, and at some point remedial works are likely to be required. Should conditions worsen, the client is advised to engage services of a licensed plumber or waterproofing specialist to rectify the issue of moisture before this minor defect turns into major defect.

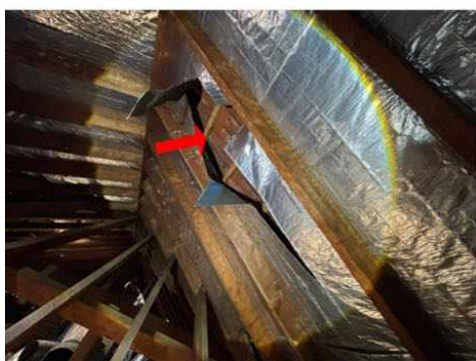
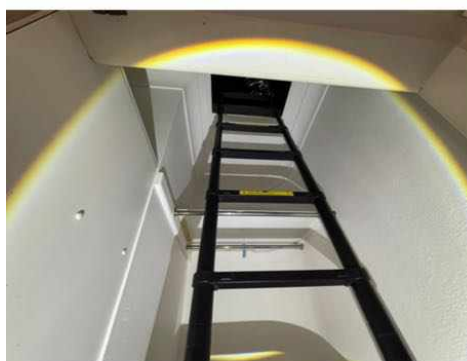
Finding 3.19

Building: Main Building
Location: Roof Void

Finding: Sarking - Damaged
 Information: Sarking, a laminated aluminium foil applied to the interior of the roof covering, assists in insulating the property and acting as a vapour-barrier to the roof void and, subsequently, to the household.

Where sarking is damaged, both insulation and moisture protection of the property are inhibited. This creates a loss of energy and thus negatively impacts the energy efficiency of the property, allowing potential for moisture ingress from condensation or leaking roof tiles.

It is important to repair any holes or damaged sections of sarking to ensure that the building material is fully functional. A registered roofer should be consulted to provide further advice on this defect and to perform rectification works at client discretion.

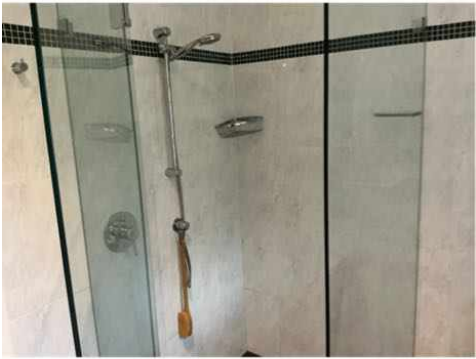
Finding 3.20

Building: Main Building
 Location: All Bathrooms
 Finding: Excessive Moisture - Shower Damp
 Information: At the time of inspection, excessive moisture was noted within the shower area, which is a common issue in wet areas due to the continual exposure to water. This condition is typically caused by moisture seeping through grout lines and settling behind tiles, resulting in localised high-moisture zones. Provided there is no evidence of water staining or elevated moisture readings on the opposite side of the wall, this is considered a minor defect.

However, persistently damp conditions may act as conducive conditions for termite activity, as termites are strongly attracted to moisture-rich environments. It is recommended that the client ensures regular use of the exhaust fan and maintains adequate ventilation after shower use to promote drying and reduce long-term moisture build-up, thereby also reducing the risk of attracting termites.

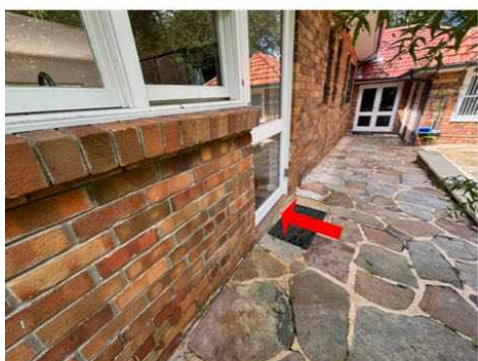
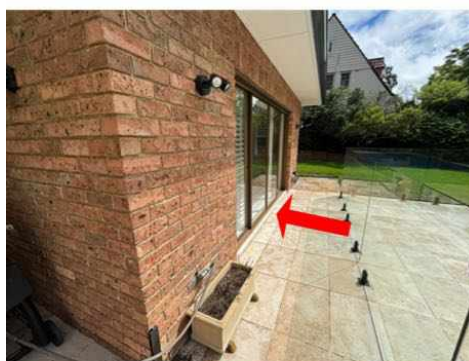
Finding 6.02

Building: Main Building
 Location: All Areas
 Finding: Bridging or Breaching of Termite Barriers - Adjacent Internal Flooring
 Information: Bridging is the spanning of a termite barrier or inspection zone so that subterranean termites are provided with passage over or around that barrier.

It is important for internal flooring to be raised above adjacent external ground levels. Where external ground levels are above or same level as internal flooring, water pooling and subsequent internal flooding is likely to occur which may attract termite activity to the internal area.

It is highly advised that a landscaper or relevant tradesperson be appointed to lower external grounds that are raised above or same as adjacent internal flooring. Alternatively if external grounds and internal flooring is level installation of a raised door sill may be appropriate in preventing any water pooling in the area. If the client wishes not to make any changes, then a qualified pest controller is recommended for termite treatment around the perimeter of the house and subfloor (if any) as soon as possible.

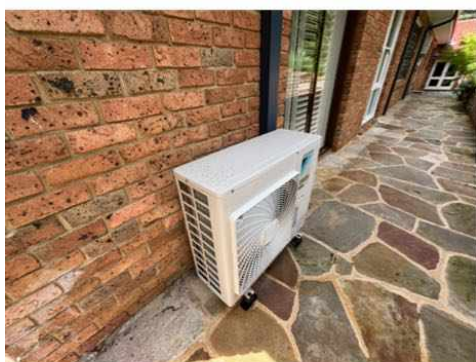
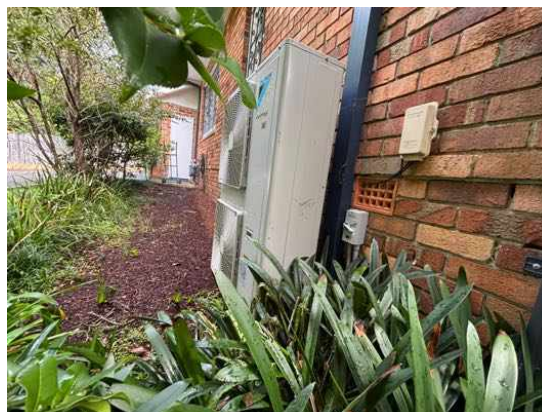
Finding 6.03

Building: Main Building
 Location: All Areas
 Finding: Bridging Appliances - Attachment to Buildings
 Information: Bridging occurs when items against a building provide a concealed entry point for termites into the building or by passing around a termite management system.

Where any part of an attachment to a building is not isolated and is not provided with a clear gap of not less than 25mm from the building, bridging occurs. Attachments to buildings such as hot water services, downpipes, verandahs, decks, steps, fences, service conduits and the like provide the opportunity for concealed entry.

Building attachments of this nature need to be frequently inspected for termite activity by a qualified inspector.

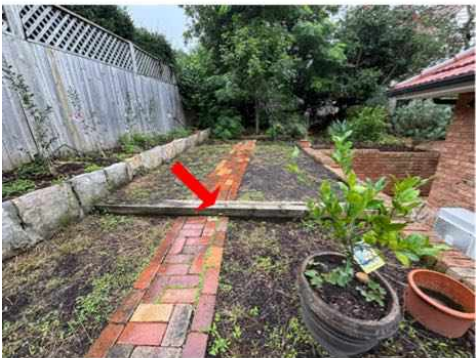
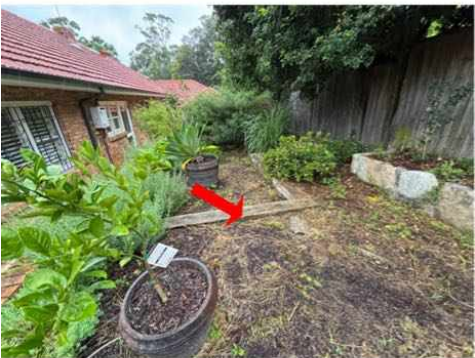
Finding 6.04

Building: Yard
 Location: All Areas
 Finding: Building Materials in Direct Ground Contact - Conducive to Termites
 Information: Timber elements that are in direct contact with the ground and exposed to moisture or damp conditions are highly conducive to termite activity. This susceptibility arises

because timber, when in contact with soil and dampness, creates an environment that is particularly attractive to termites, encouraging infestation and potential structural compromise. Whether the timber is used as a part of the building's construction or incorporated into fencing, its presence near or on the ground can become a pathway for termites to access and damage the property.

When exposed to excessive moisture, timber begins to deteriorate, developing conditions such as wood decay and rot. These compromised areas of timber are even more appealing to termites, as they are easier to infest and consume. This is especially true for untreated or non-durable timber, which lacks the protective treatments that can deter or withstand termite attacks. Termites can use these weakened, moisture-laden elements as a bridge into other parts of the structure, creating an entry point for potential infestations that can spread and cause extensive damage if left unchecked.

For any timber in direct contact with the external ground, special attention is required. The combination of moisture, untreated wood, and direct ground contact not only accelerates the decay process but also provides subterranean termites with a straightforward means of ingress into the structure. This entry can lead to termites moving undetected into other vulnerable areas, resulting in potentially significant structural issues and costly repairs.

To mitigate the risk of termite activity, it is imperative that any such materials or timber elements be appropriately treated or removed as soon as possible. Timbers that are necessary for use should be made durable through appropriate treatments and maintained to ensure they do not create conditions conducive to termites. Additionally, the client is advised to schedule regular termite treatments to maintain an effective barrier against infestations and ensure ongoing protection.

The client is strongly advised to assess the property for any timber elements that may be in direct contact with the ground and ensure prompt action is taken to remove or treat them effectively. Regular inspections, proactive maintenance, and consistent termite treatment are essential steps in minimising the risk of termite attack and protecting the structural integrity of the property. Taking these preventive measures is crucial for maintaining a termite-free environment and avoiding potentially costly damage and future repairs.

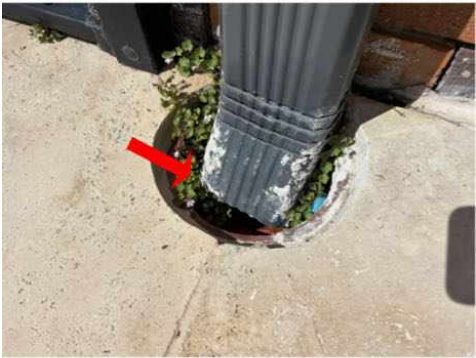
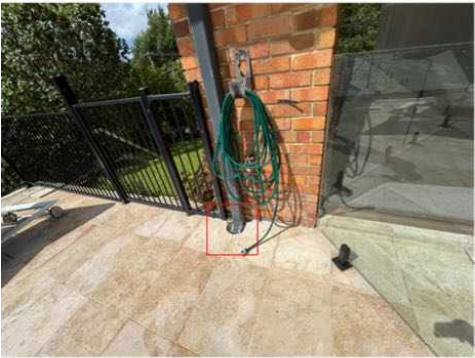
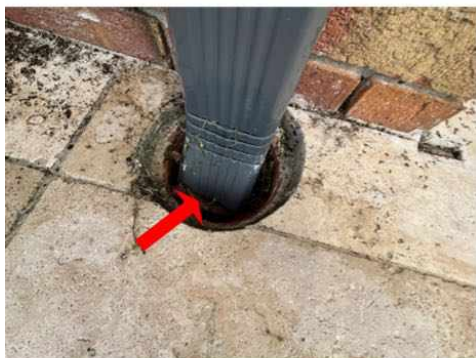
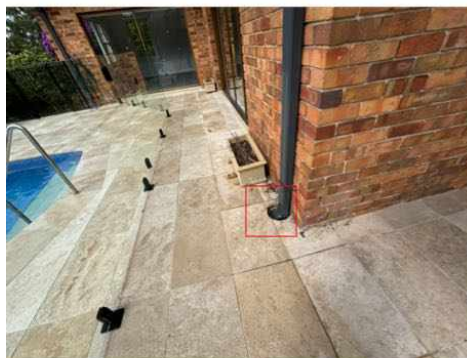
Finding 6.05

Building: Main Building
Location: Exterior walls - rear
Finding: Stormwater Drain - Not Connected (Roof Plumbing)
Information: The inspection revealed that the roof plumbing system is not adequately connected to the site's stormwater drainage, reducing its functional efficiency. This disconnection can lead to water pooling around the base of the property, increasing the risk of rust and corrosion to building elements, structural damage, and attracting termites due to the persistent dampness.

Improper drainage can also contribute to mould and mildew growth, affecting indoor air quality and health, and may lead to ground movement, causing cracks in walls and other structural issues.

It is strongly recommended that a licensed roof plumber be engaged to assess the system and ensure appropriate connections to stormwater outlets are installed to effectively redirect water away from the structure.

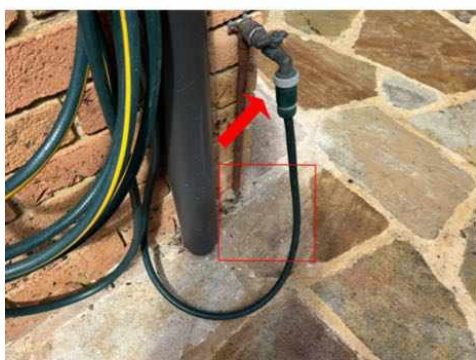
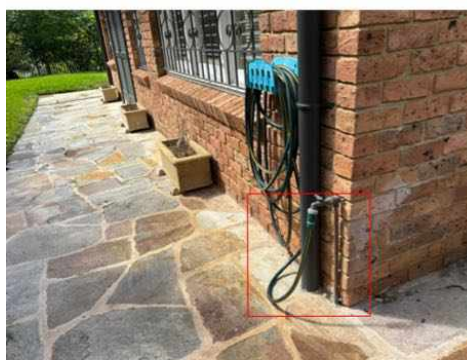
Finding 6.06

Building:	Main Building
Location:	Exterior walls - rear
Finding:	No Stormwater Drain - Under Exterior Tap
Information:	The inspection identified that the exterior tap is not connected to a stormwater drainage system, allowing water to pool around the base. This can lead to moisture-related issues such as deterioration of nearby building materials, mould growth, and increased risk of termite activity—each of which may compromise the property's structural integrity and create health or safety concerns.

To prevent these risks, it is strongly recommended that a licensed plumber be engaged to assess the area and install appropriate drainage, such as a stormwater connection or splash block, to redirect water away from the property. Ongoing maintenance and monitoring of external water sources are also advised to ensure long-term protection.

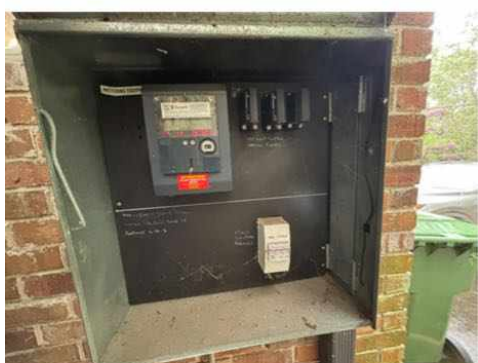
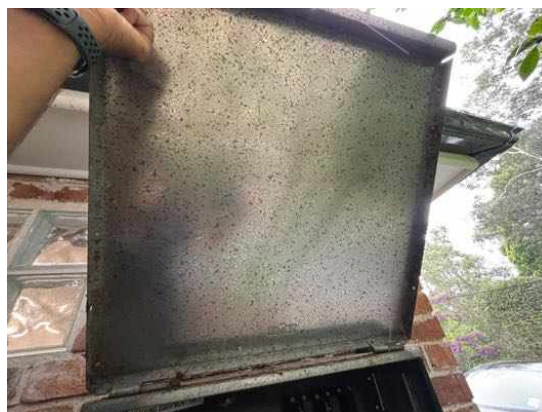
Finding 6.07

Building:	Main Building
Location:	Meter Box
Finding:	Termite Management System - No Evidence of Installation
Information:	The application of a post-construction chemical termite barrier is strongly

recommended for all properties, especially if there has been any history of live termite activity on-site. These barriers are highly effective in protecting timber building elements throughout the property by preventing termite attacks. It is also advisable to install a durable notice within the switchboard unit, indicating the presence of any termite barriers for future reference.

During the inspection, there was no indication that a termite management system had been installed, nor was there any evidence to suggest that preventative measures had previously been undertaken. The client is encouraged to seek further advice from a licensed pest controller regarding the costs and procedures involved in the application of a termite barrier. Prioritizing this step in the short term is strongly advised to ensure long-term protection.

Additionally, the client may want to consult with the vendor to determine whether regular Timber Pest inspections, as per AS4349.3 or AS 3660.2, have been conducted in the past. This will provide further insights into any past termite management practices and help inform the appropriate course of action.

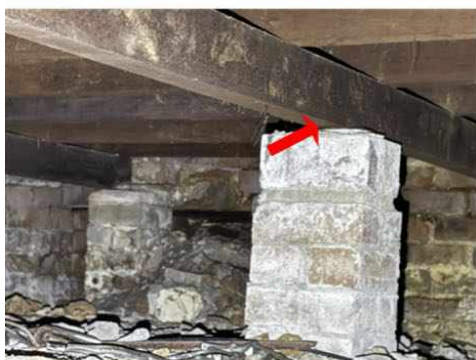
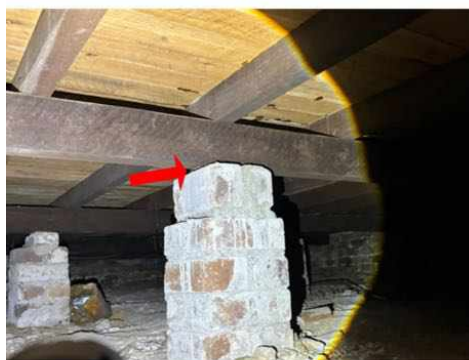
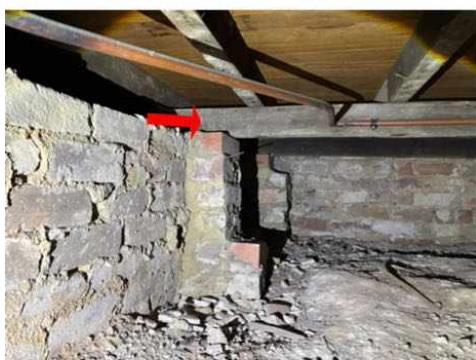
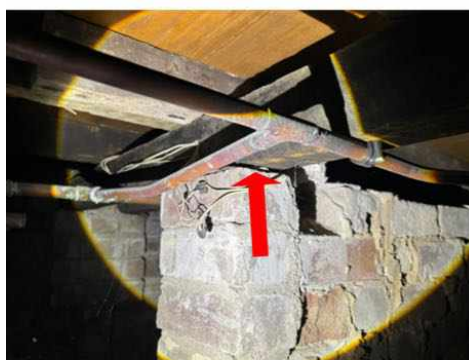
Finding 6.08

Building:	Main Building
Location:	All Areas
Finding:	Ant Cap - Displaced, Damaged & Missing
Information:	The ant cap in the subfloor has been displaced, creating conducive conditions for termite activity. Ant caps are critical in preventing termites from gaining undetected access to the wooden structures of a building. Their displacement compromises the integrity of the termite barrier system, allowing termites to potentially bypass detection and enter the building. This can lead to severe structural damage if not addressed promptly. Immediate rectification of the ant cap's position is essential to restore the termite barrier and protect the property from potential termite infestation and associated damage.

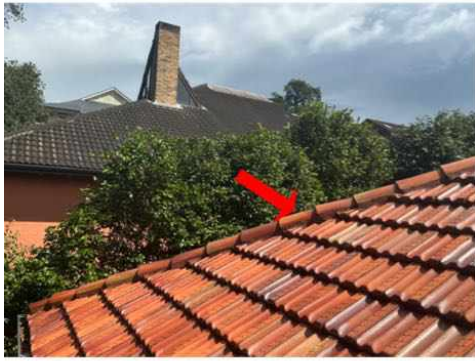
Finding 6.09

Building:	Main Building
Location:	Garage
Finding:	Overhanging Trees/Branches/Roots
Information:	Overhanging trees and exposed roots were noted near the property, which pose potential risks to the structure and surrounding areas.

The overhanging branches can cause damage to the roof, gutters, or walls, particularly during storms or high winds. Additionally, the roots may pose a threat to the foundation by causing ground movement, leading to cracks or uneven settling over time. The accumulation of leaves and debris in gutters and drainage systems can also lead to blockages, contributing to water overflow and potential water damage.

It is recommended that a qualified arborist be engaged to prune back the overhanging branches and assess any potential risks posed by the tree roots to prevent further damage to the property. It is advised to get this fixed as soon as possible. Regular maintenance should be carried out to ensure the trees are managed effectively and the property remains safe.

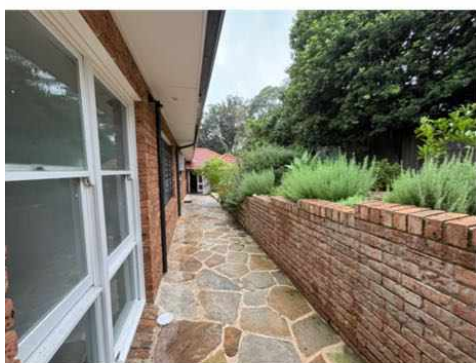
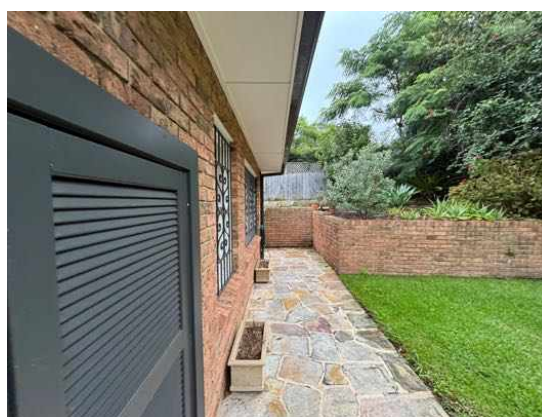
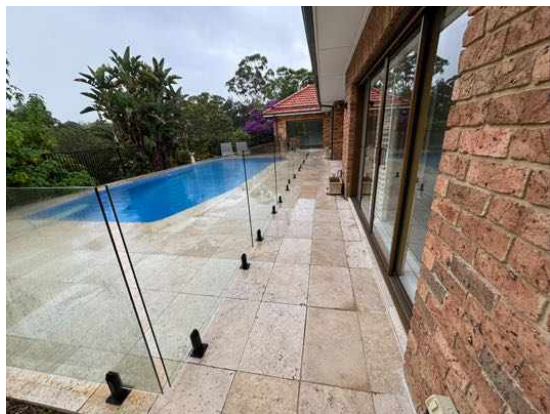
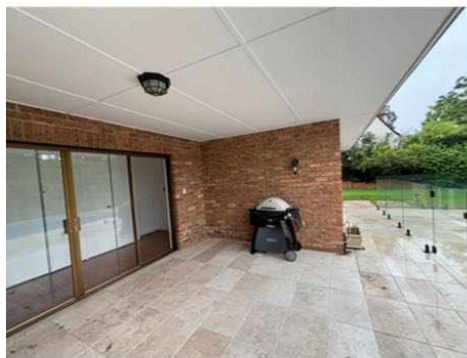
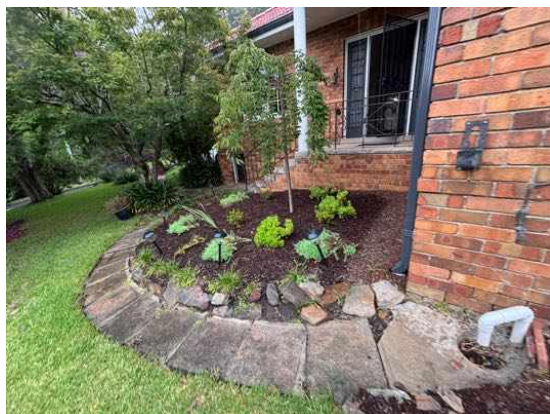
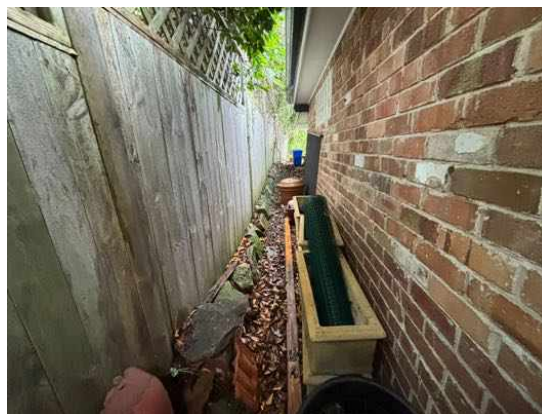
Building: Main Building
Location: All External Areas
Finding: Obstructions and Limitations - External Areas
Information: The attached photographs provide a visual representation of the obstructions and limitations that impeded a full inspection of the external areas of the property at the time of assessment. These obstructions, which may include vegetation, stored items, debris, or other physical barriers, can obscure potential defects and prevent a thorough evaluation of the property's condition. Obstructions of this nature can conceal a wide range of issues, such as structural damage, water ingress, pest infestations, or deteriorating building materials, which may not be visible during the initial inspection.

It is essential that these obstructions be cleared to allow for a comprehensive inspection of the external areas. Removing these barriers will enable a more accurate assessment of the property's condition and allow any hidden defects to be identified and addressed promptly. Failure to do so could result in undetected issues worsening over time, potentially leading to more costly repairs in the future.

Therefore, it is strongly recommended that the obstructions be removed and a re-inspection be scheduled once the affected areas are made fully accessible. This will ensure a complete evaluation of the property's exterior and provide the client with a clear understanding of any potential issues that may have been concealed during the initial inspection.

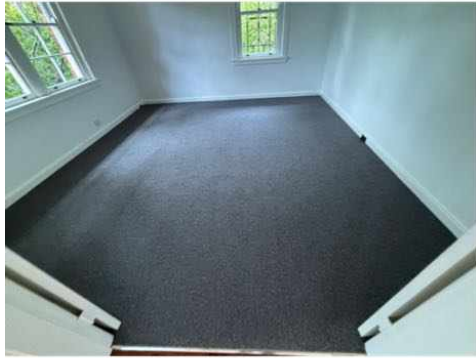
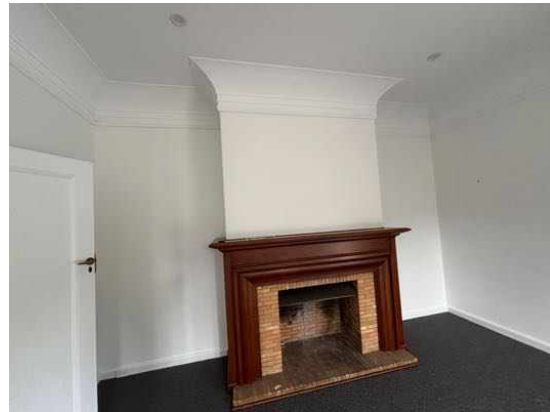
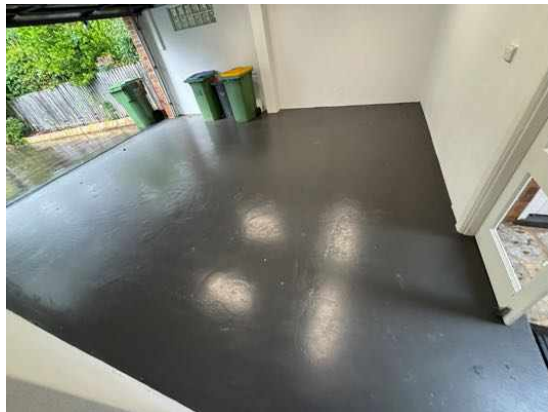
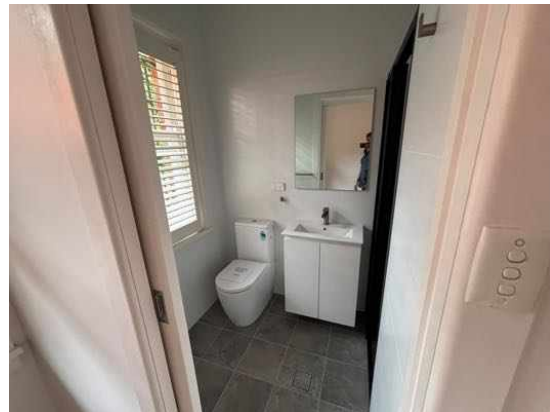
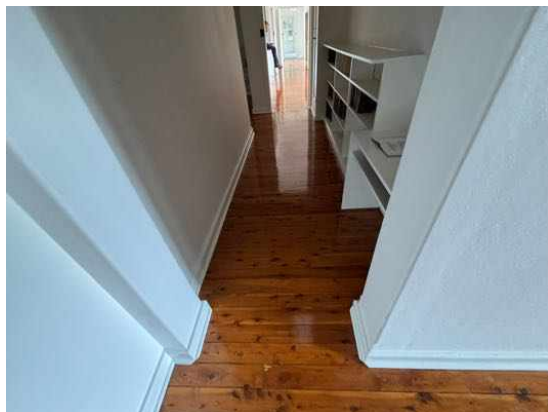
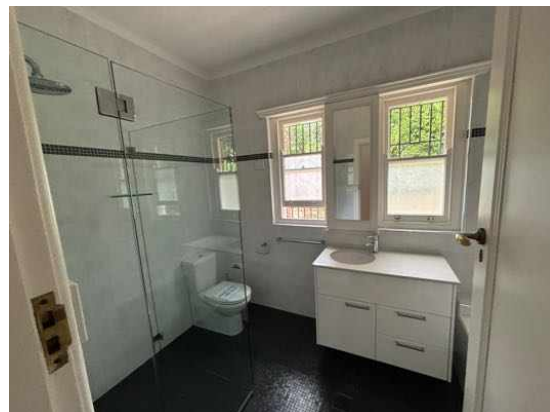
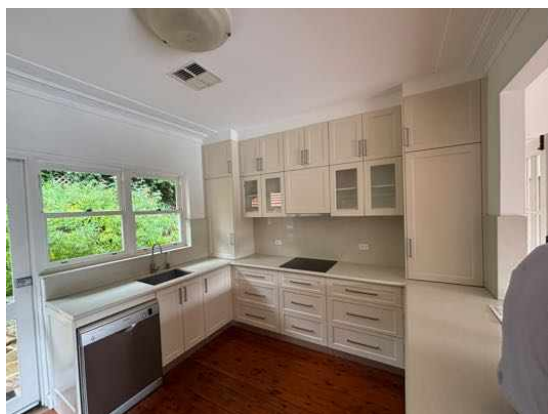
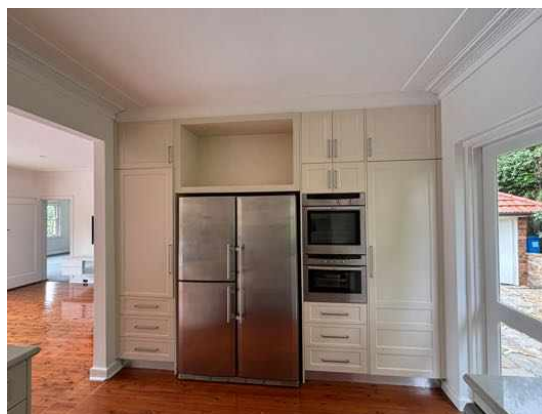
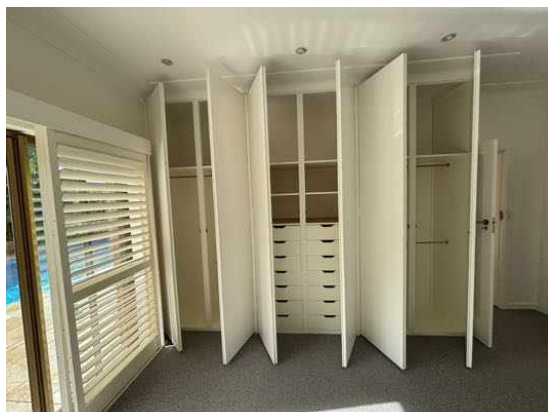
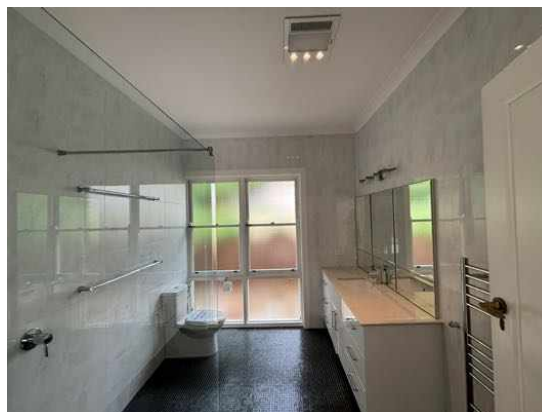
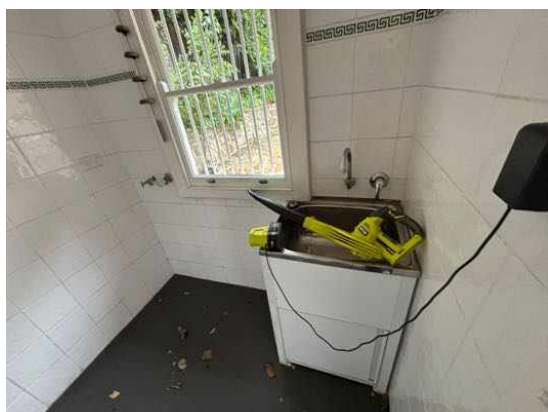
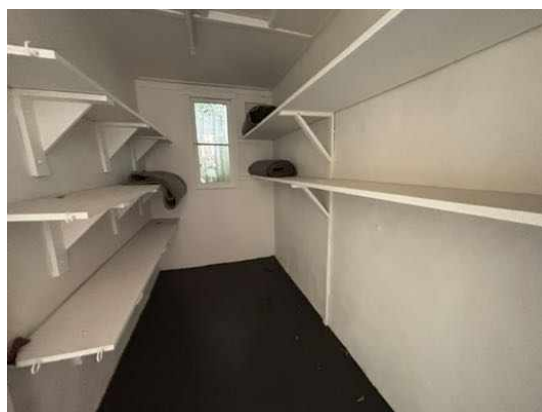
Information: The accompanying photographs provide clear evidence of the obstructions and limitations that restricted a comprehensive inspection of the internal areas of the property at the time of assessment. These obstructions, which may include furniture, personal belongings, stored items, or structural elements such as wall coverings and built-ins, significantly hindered the ability to thoroughly evaluate these areas. It is important to note that such obstructions can potentially conceal a wide array of defects, ranging from hidden structural damage, water leaks, pest infestations, or electrical issues, to deteriorating materials that may not be visible during the initial inspection.

The presence of these impediments means that critical areas of the property were not accessible, and therefore, any underlying defects that may affect the integrity and safety of the property could remain undetected. These hidden defects, if left unaddressed, could worsen over time and may result in costly repairs or pose potential safety hazards to the occupants.

It is highly recommended that all obstructions be cleared to facilitate a complete and thorough inspection of the internal areas. Once the obstructions have been removed and full access is available, a re-inspection should be carried out to ensure that any

previously concealed issues can be properly identified and rectified. This follow-up inspection will provide a more accurate assessment of the property's internal condition and help the client make informed decisions about any necessary repairs or maintenance.
