Building and Timber Pest Inspection Report

Inspection Date: Mon, 23 Mar 2026

Property Address: 16 Wattle St, Killara NSW 2071, Australia

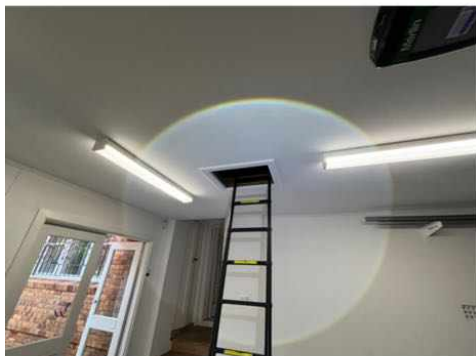
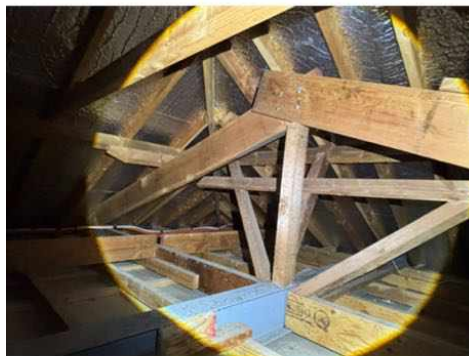
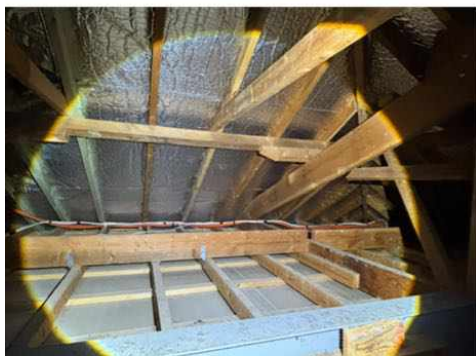
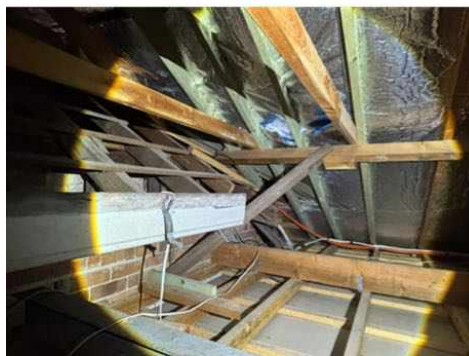
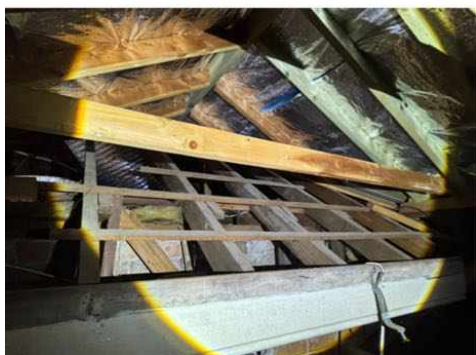
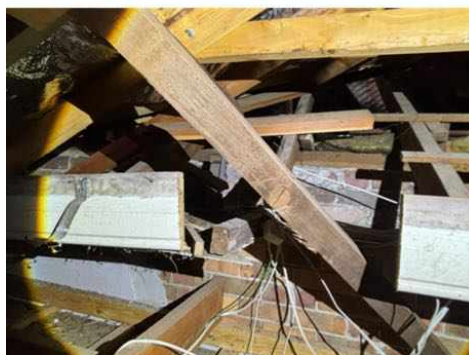
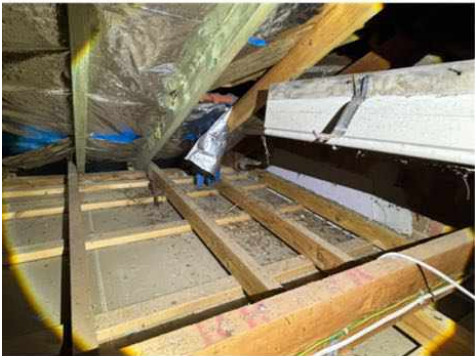
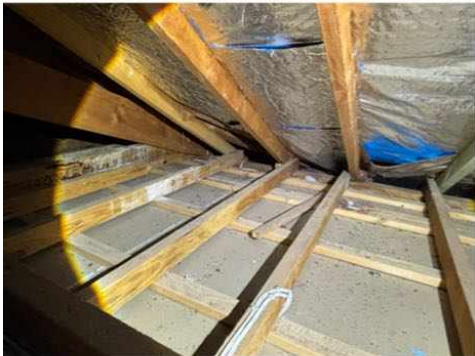
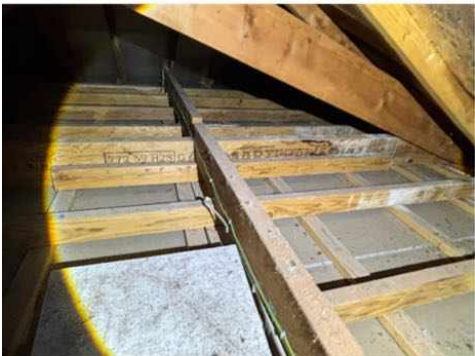
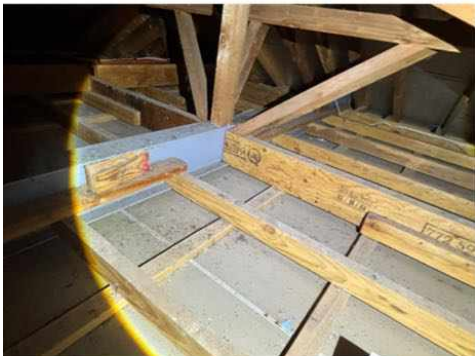
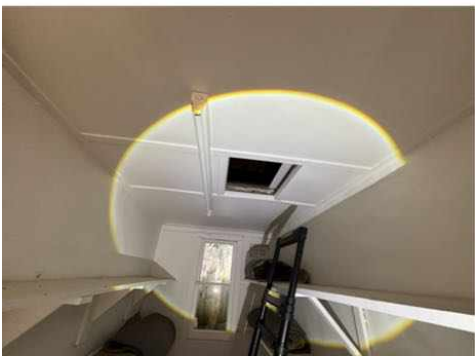
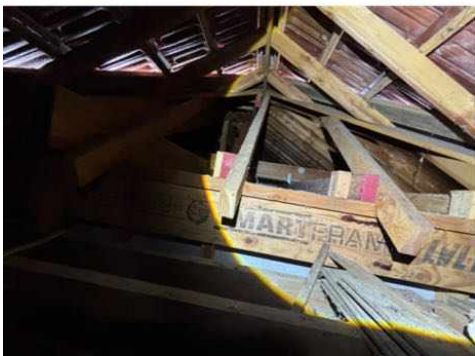
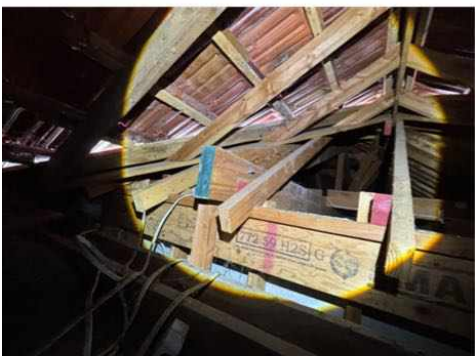
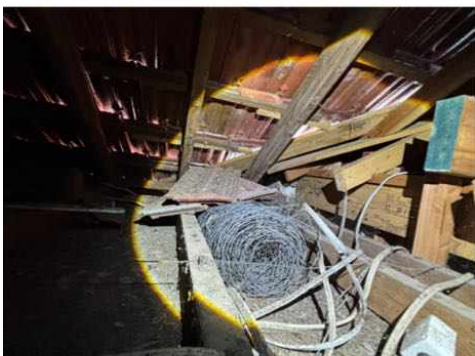
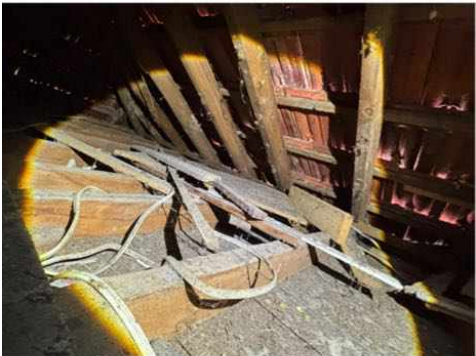
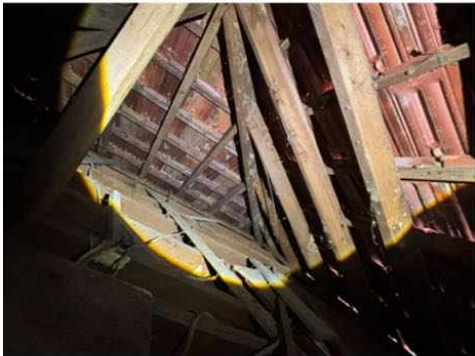
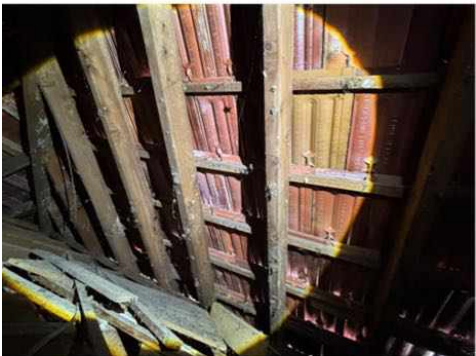
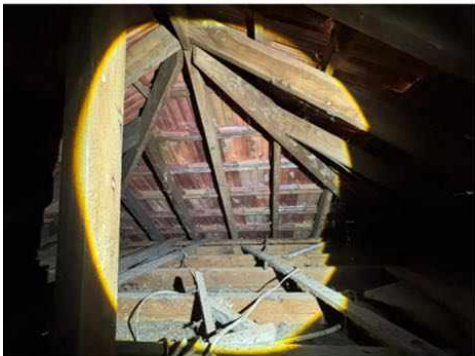
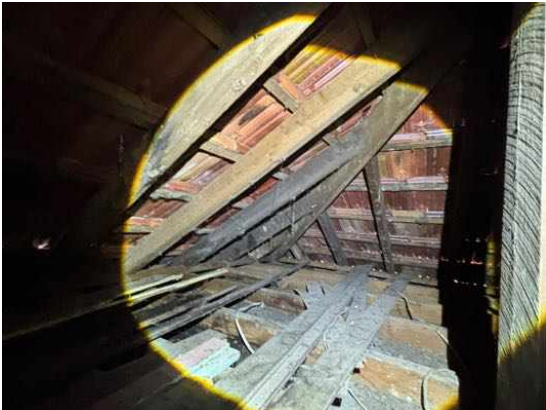
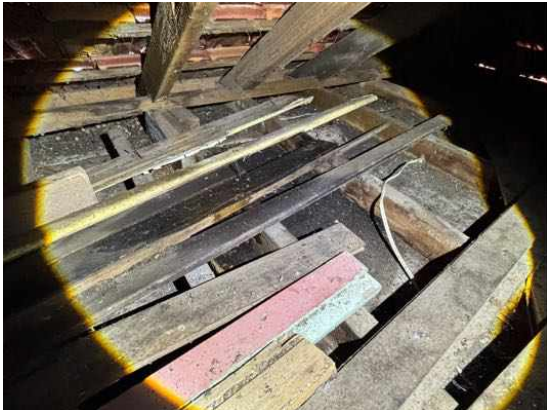
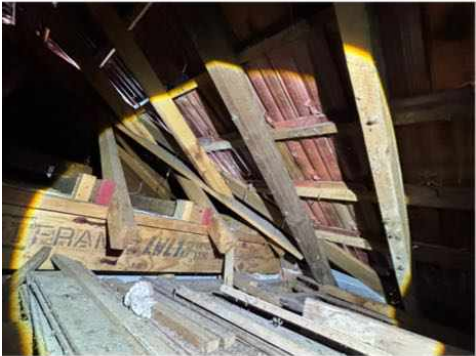
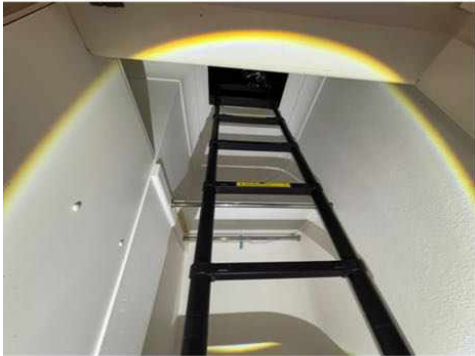
Building: Main Building
 Location: Roof Void
 Finding: Obstructions, Limitations, and General Roof Space Condition
 Information: The photographs provided document both the general condition and the obstructions and limitations that were present in the roof cavity of the main building at the time of inspection. These obstructions—such as insulation materials, stored items, structural elements, or electrical wiring—restricted safe and adequate access to key areas within the roof space. As a result, a comprehensive inspection of all components could not be completed.

Obstructions of this nature may conceal a variety of potential defects, including

damaged framing, compromised insulation, evidence of moisture ingress, pest activity, or electrical hazards. While no major issues were observed in the visible areas, the presence of these limitations means that some defects may remain undetected.

It is recommended that these barriers be removed or repositioned to facilitate full and safe access to the roof space. Once clear, a follow-up inspection should be conducted to allow for a thorough assessment of all concealed areas. This will help ensure that the condition of the roof cavity is accurately evaluated and any hidden issues are appropriately identified and addressed.

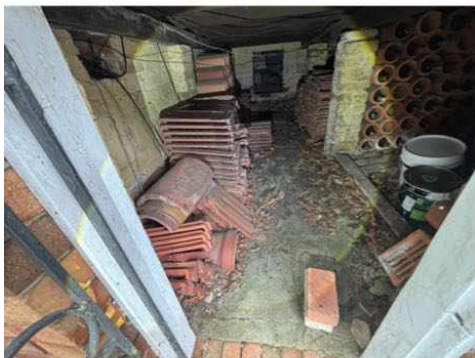
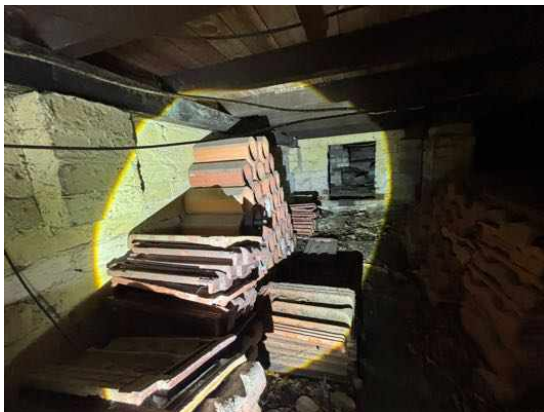
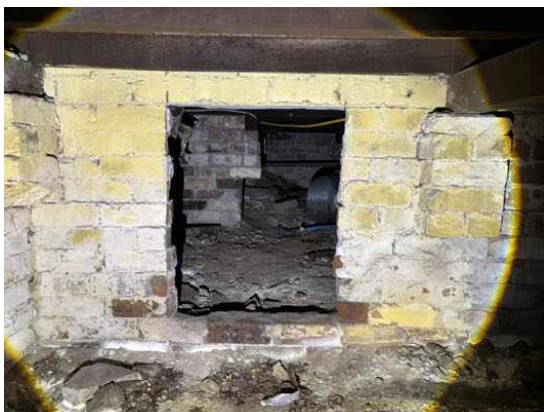
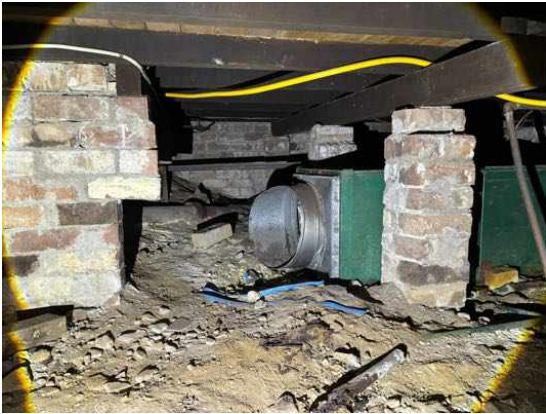
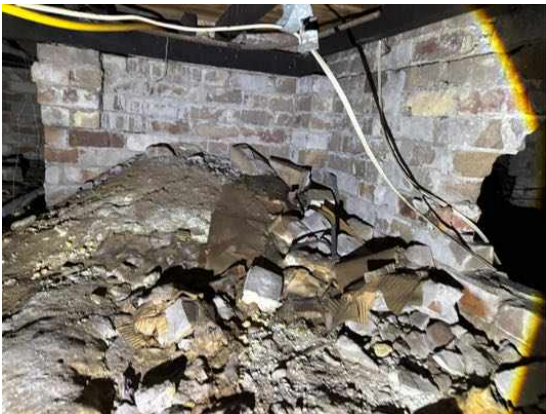
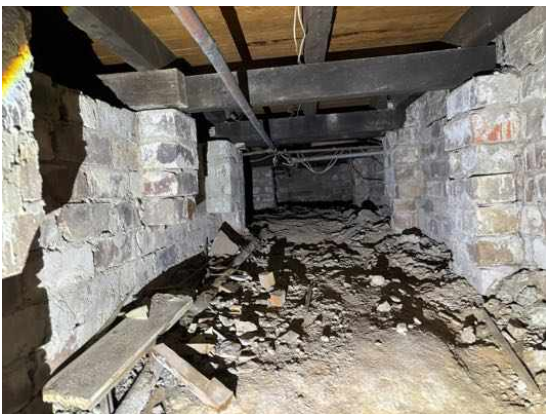
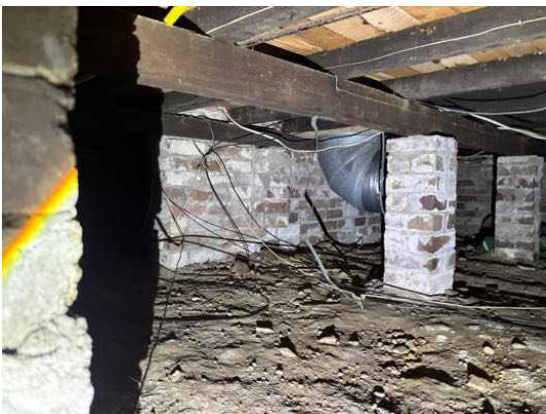
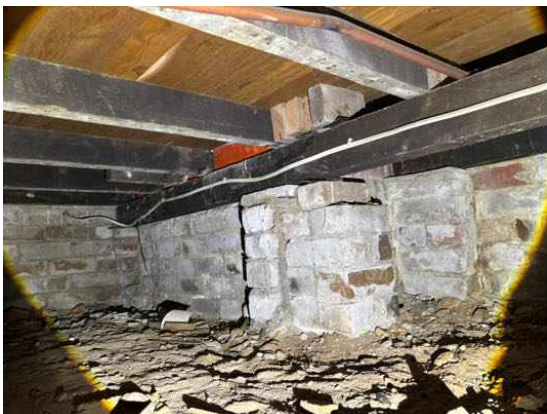
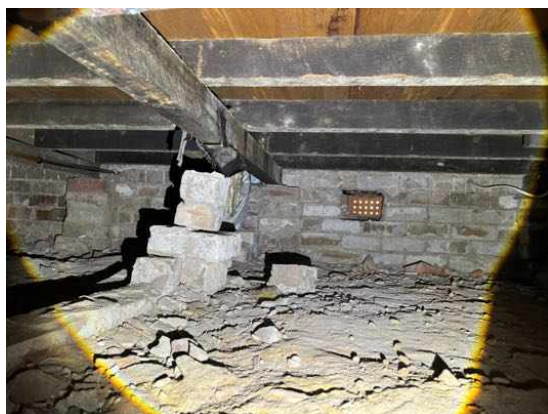
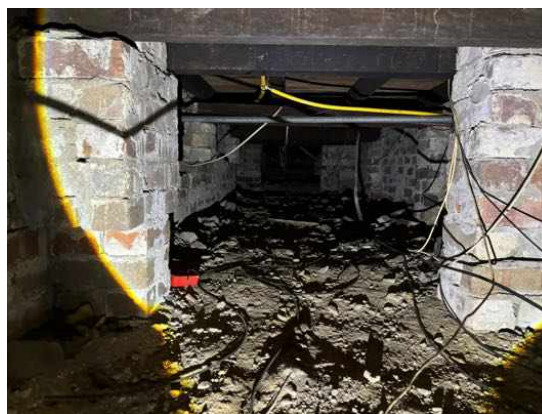
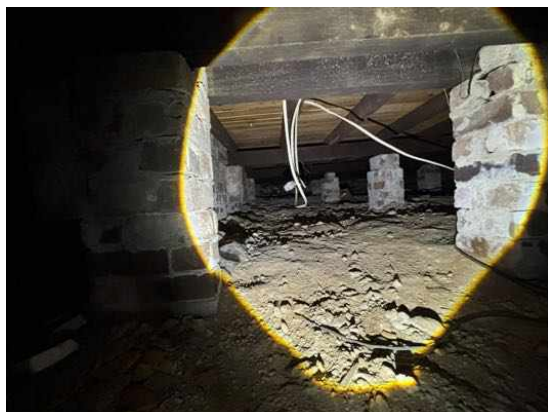
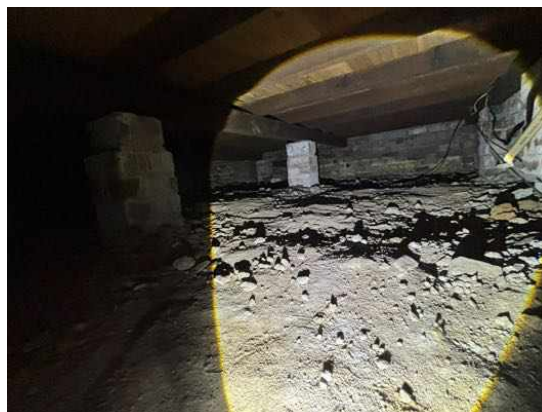
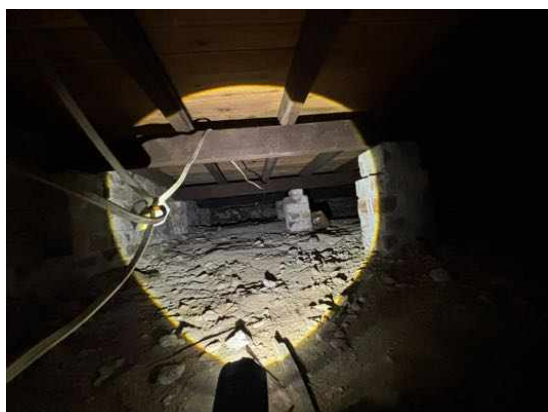
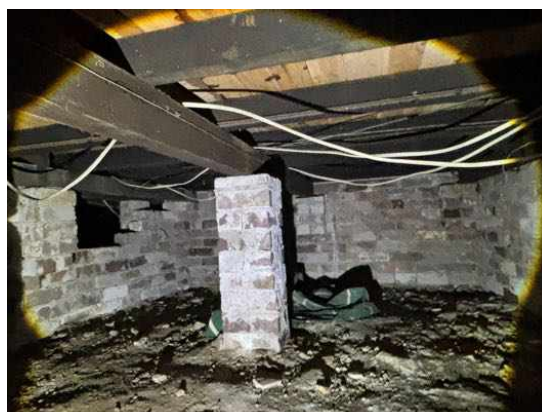
Building: Main Building
 Location: Subfloor
 Finding: Obstructions, Limitations, and General Subfloor Condition
 Information: The attached photographs illustrate the obstructions and access limitations that restricted a full inspection of the subfloor area of the main property at the time of assessment. Items such as stored materials, construction debris, low-hanging services, and insulation impeded movement and visibility within key sections of the subfloor. In addition, the limited crawl height further restricted safe access to inspect critical structural components.

important elements such as floor joists, bearers, stumps, drainage, subfloor ventilation, and signs of moisture or pest activity. These obstructions may also conceal defects such as timber decay, water ingress, termite damage, inadequate support, or ventilation issues that are not immediately visible during a limited inspection.

While no major concerns were identified in the accessible areas, a full and unobstructed inspection is necessary to properly assess the overall condition of the subfloor. It is recommended that obstructions be removed and access improved where possible. Once adequate clearance is provided, a re-inspection should be arranged to ensure that any concealed defects can be identified and addressed accordingly. This will assist in providing a more comprehensive understanding of the subfloor's condition and reduce the risk of unforeseen issues.

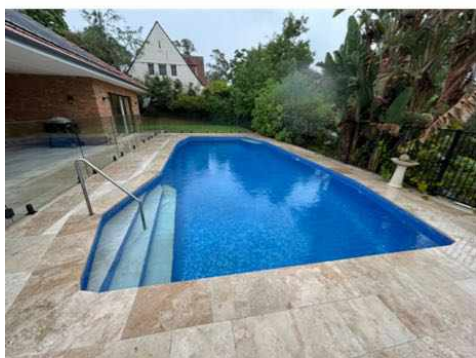
Building: Main Building
 Location: Pool Area
 Finding: FYI - Pool Area
 Information: This inspection explicitly excludes any assessment of the pool, spa, associated pool equipment, and the surrounding areas. As a standard building inspection does not encompass these elements, it is crucial for the client to understand that no evaluation has been conducted regarding the condition, functionality, or safety compliance of the pool or its associated systems. This includes, but is not limited to, pumps, filters, heating equipment, and structural integrity of the pool or spa surrounds.

To gain a comprehensive understanding of the condition and compliance of these components, it is highly recommended that the client engages a specialist pool inspector. A pool inspection will evaluate the structural condition of the pool, ensure the functionality of all associated equipment, and assess whether the pool and its surroundings meet current safety regulations. In particular, pool safety requirements, including fencing and access controls, are subject to stringent regulatory standards, which must be verified separately by a qualified pool inspector.

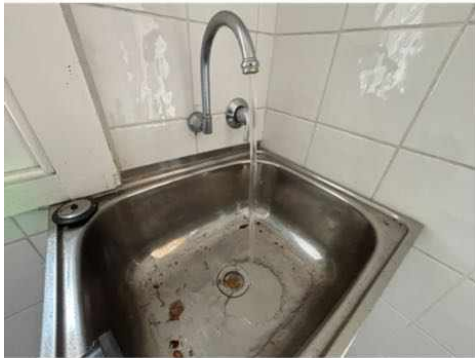
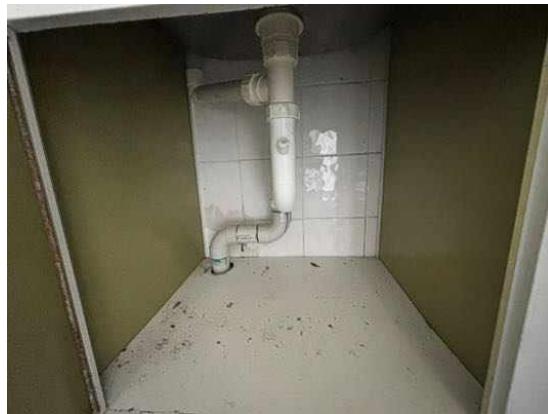
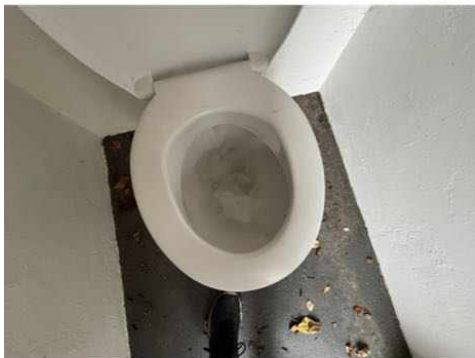
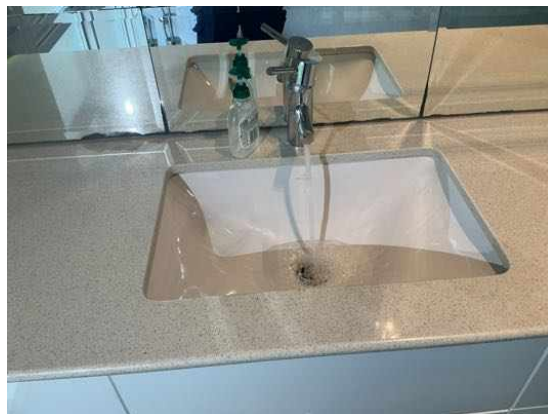
Building: Main Building
 Location: All Areas
 Finding: FYI - Taps, Drainage & Toilets Tested and Cabinetry Obstructions
 Information: During the inspection, all accessible taps, drainage systems, and toilets were tested for water flow and drainage efficiency, and checked for any visible signs of leakage. At the time of the inspection, no issues were noted in these areas. Unless highlighted in a separate defect statement, no immediate remedial work appears necessary.

It is important to note that while a visual inspection of cupboards and cabinetry beneath sinks and vanities was undertaken, stored personal items and fixtures presented obstructions that limited full visibility of the internal areas. As per standard inspection practices, inspectors are not permitted to move or disturb personal belongings during the inspection process. Therefore, only visible and accessible sections were inspected, and concealed water damage or plumbing defects may not have been detected.

Given this, a re-inspection is recommended after all obstructions have been cleared to allow for a comprehensive assessment of these areas. Regular maintenance and monitoring of plumbing and drainage systems is also advised to ensure ongoing functionality and early detection of potential issues.

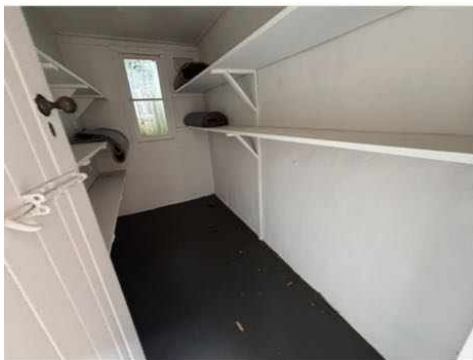
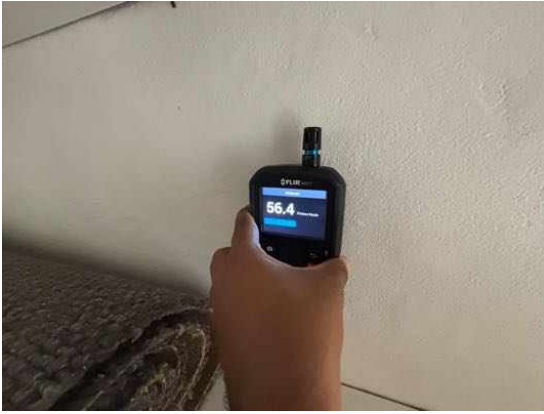
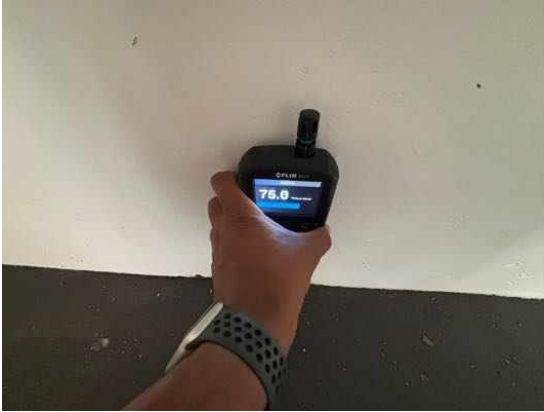
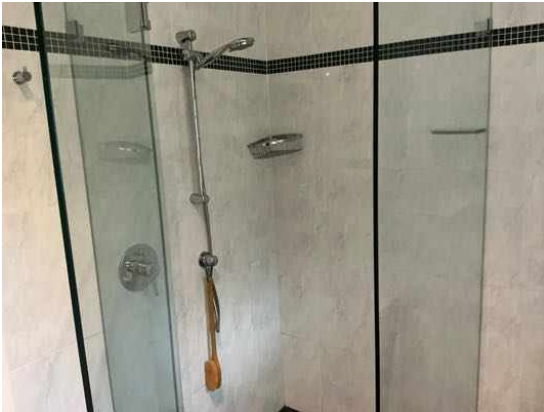
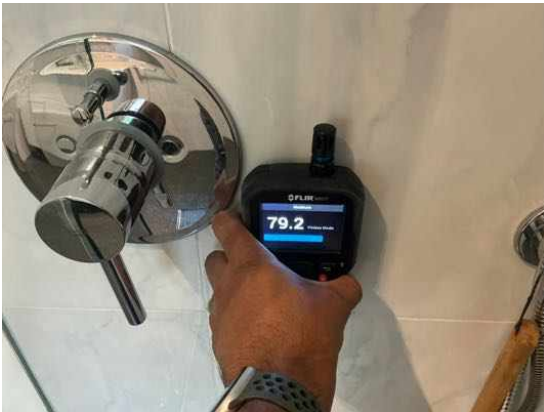
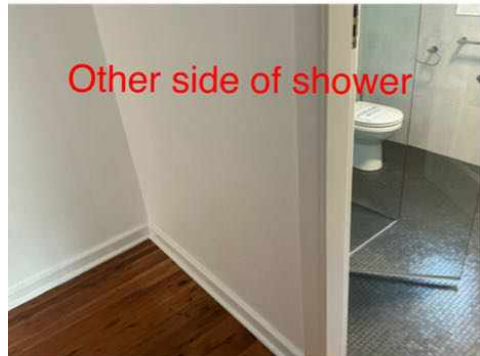
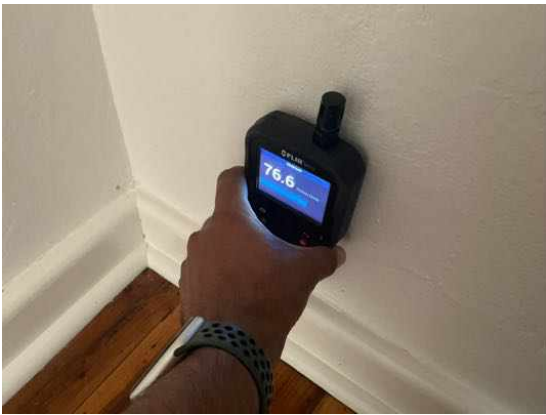
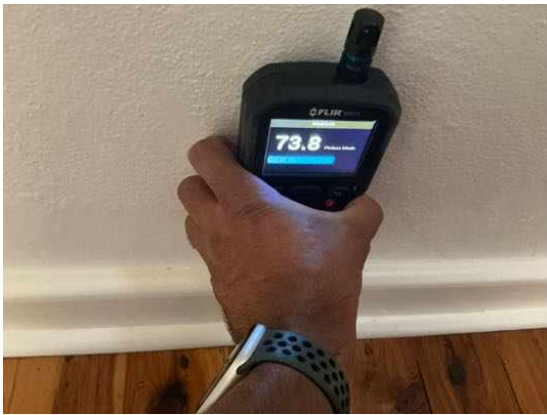
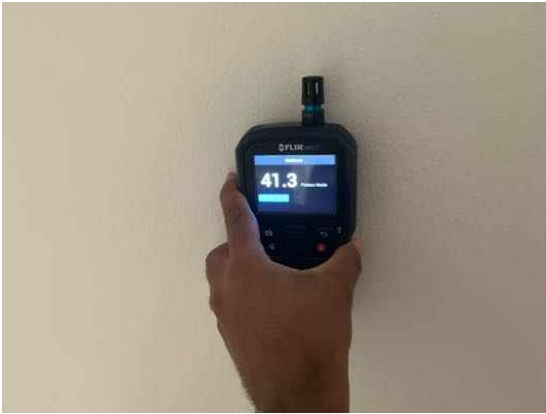
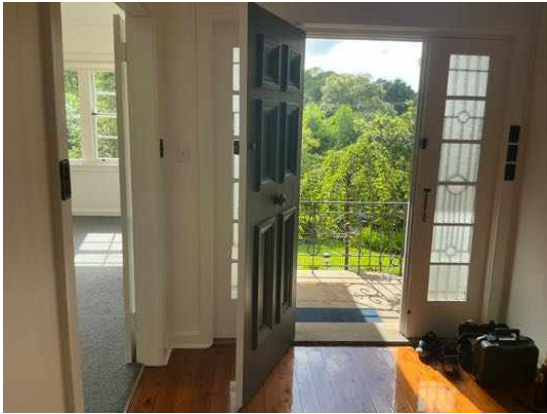
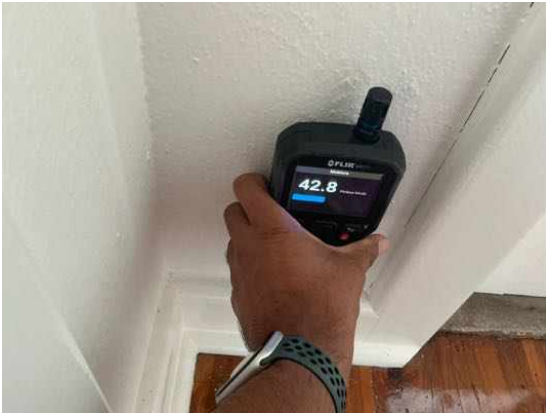
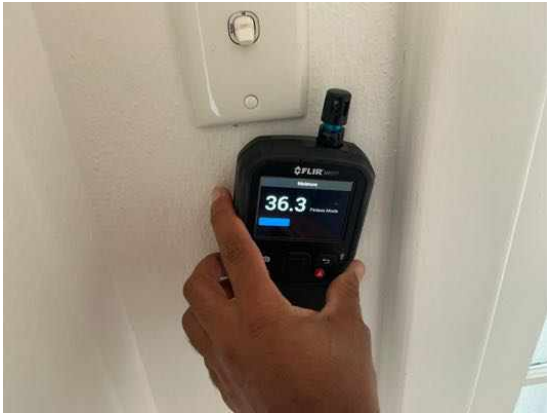
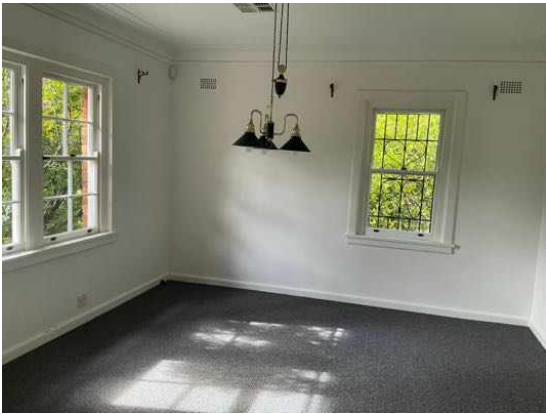
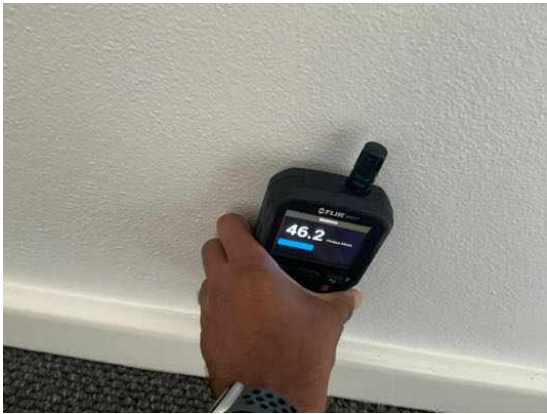
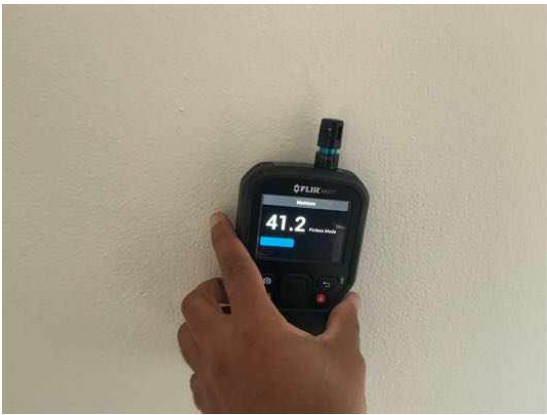
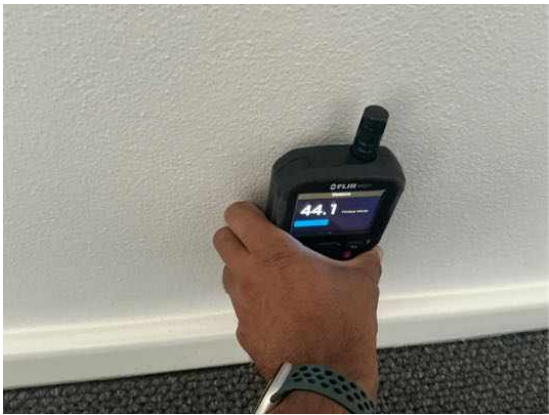
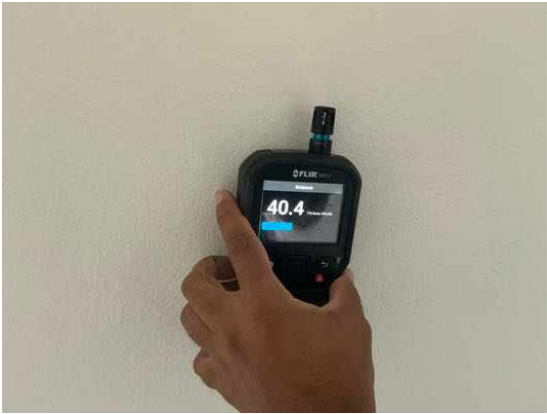
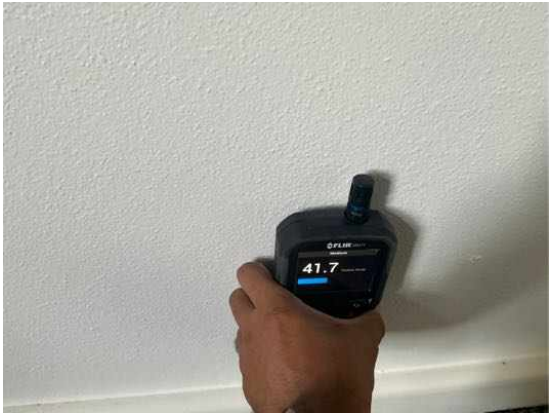
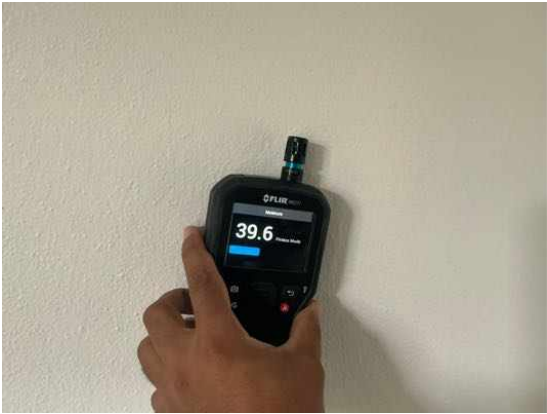
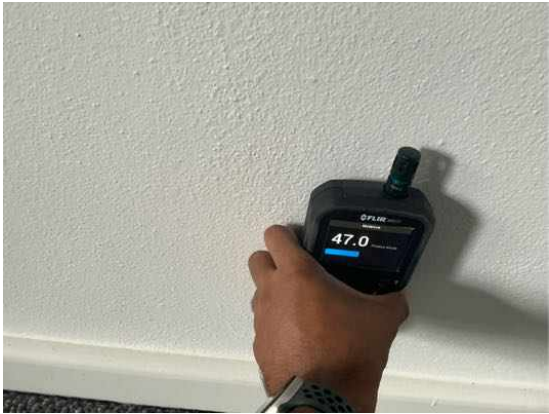
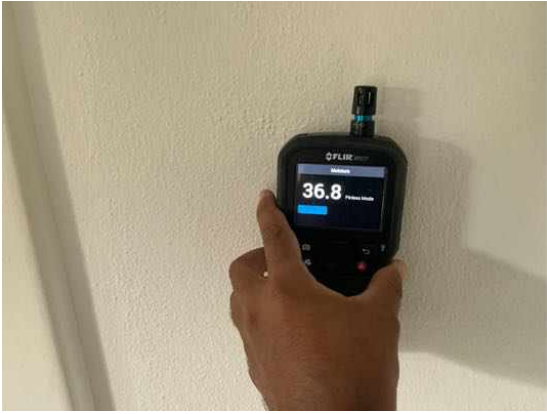
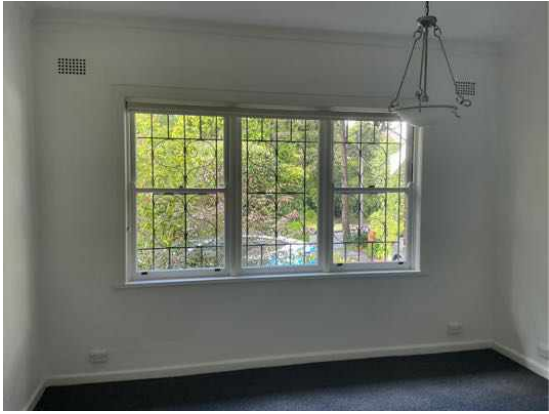
Building: Main Building
Location: All Areas
Finding: Additional Photos - Moisture Meter Readings
Information: Additional moisture meter reading photos have been provided for the property to offer further clarity on areas tested during the inspection. These photos are intended to give a visual reference for the specific locations where moisture levels were measured. These readings were taken at the time of the inspection to assess any potential moisture-related issues within the property. Any defects related to moisture that were identified during the inspection have been separately mentioned in the defect statements within the report.

It is important for the client to understand that moisture levels can fluctuate over time due to various factors, including changes in weather, humidity, and environmental conditions. While the readings reflect the property's moisture levels during the inspection, they may not represent future conditions, and increased moisture could lead to issues such as dampness, mould growth, or deterioration of building materials if left unmonitored.

For further clarification or additional information regarding the moisture readings, the client is encouraged to contact the building inspector directly. Regular monitoring of moisture-prone areas is recommended to ensure any emerging concerns are addressed promptly, particularly during wetter seasons or in high-humidity conditions.

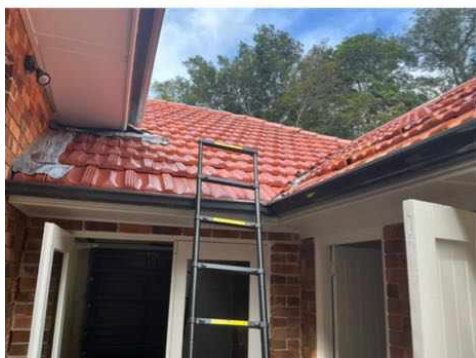
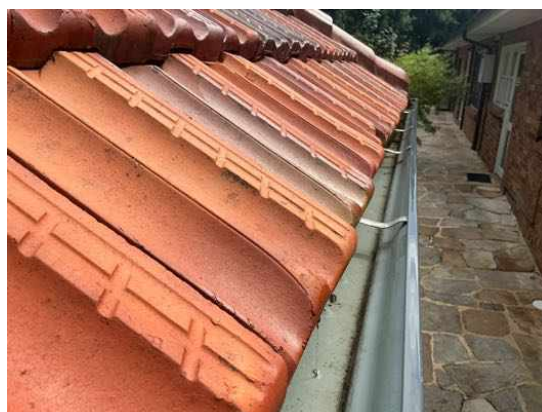
Information: As part of the information provided, please note that the attached roof photos represent the condition of the roof at the time of inspection. These photos are for visual reference only and do not constitute a detailed roofing assessment. Any defects or issues identified with the roof are mentioned separately in the defect statements. It is strongly recommended that the client engage a qualified roofer to conduct a thorough inspection of the roof, ensuring that any potential issues, such as leaks, structural integrity, or wear and tear, are properly identified and addressed.

Additionally, the condition of the roof may change over time due to weather, natural wear, or other unforeseen factors. Regular maintenance and inspections by a licensed professional are advised to ensure the roof remains in good condition and to avoid costly repairs in the future. The information provided in these photos should be considered a snapshot of the roof's condition during the time of inspection and not a guarantee of its future performance.

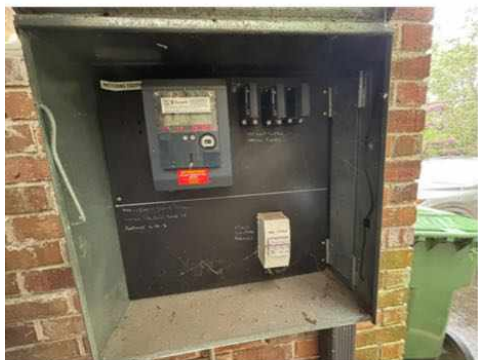
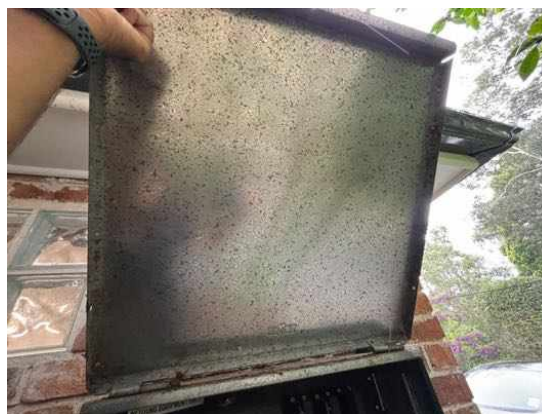
Building:	Main Building
Location:	Meter Box
Finding:	Termite Management Recommendation – No Evidence of Chemical Installation
Information:	At the time of inspection, there was no visible evidence of a chemical termite management system installed around the property. Chemical barriers are a key component of termite protection and are particularly important in preventing concealed termite entry into timber elements of the structure.

In accordance with standard requirements, a durable notice should be located within the electrical switchboard to detail any termite protection systems applied, including chemical treatments. No such notice was observed during the inspection.

It is recommended that the client engage a licensed pest controller to assess the suitability of installing a chemical barrier, and to provide advice on associated costs and procedures. This should be considered a short-term priority, particularly if the property has any history of termite activity or is located in a high-risk area.

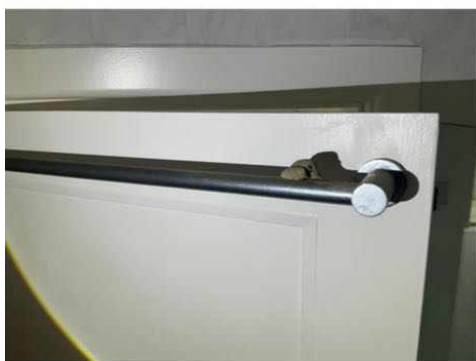
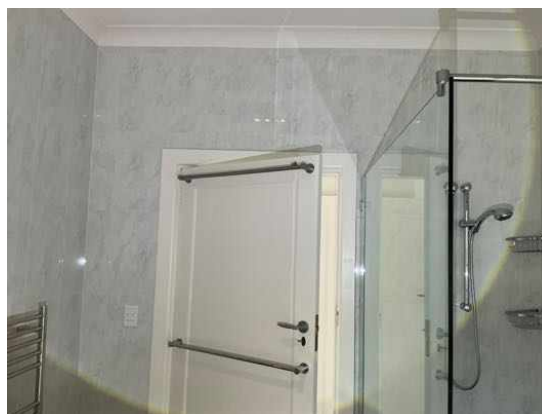
Building:	Main Building
Location:	Bedroom 1 en-suite
Finding:	Mud Nests
Information:	At the time of inspection, mud nests were observed in sheltered areas, likely created by insects such as mud daubers or mason wasps. These solitary wasps typically construct nests out of mud on protected surfaces, including crawl spaces, sheds, garages, and similar areas. Generally non-aggressive, these wasps may react defensively if their nests are disturbed. The presence of multiple nests could indicate a recurring issue with mud daubers, and regular inspections are recommended to

monitor any new activity. Inactive nests can be carefully removed by scraping them off the surface, but caution and protective equipment, such as gloves, should be used if there is ongoing wasp activity. For significant infestations, consulting a pest control professional may be advisable. To prevent future nesting, it is recommended to seal any openings or cracks in the crawl space and consider applying insect repellent in these areas if necessary.

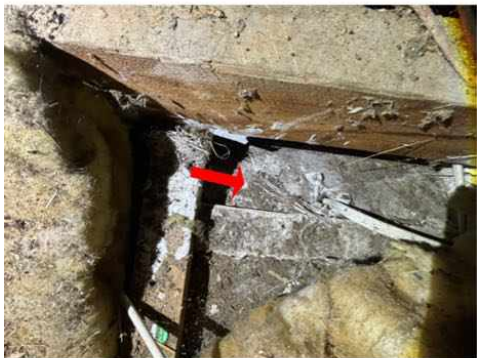
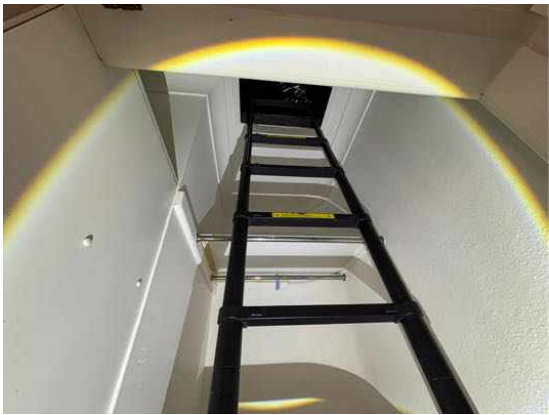
Building:	Main Building
Location:	Roof Void
Finding:	Asbestos - Suspected ACM Identified on Site
Information:	Reporting on Asbestos is outside the Scope of this Report. This suspected defect is highlighted as a caution only. We suspect, based on our experience in the building industry, that there is a higher risk of the identified building element containing asbestos.

As Asbestos Reporting is outside the scope of this report, we advise that you consider a separate Asbestos Inspection and Condition Audit, which can include the taking of samples for definitive confirmation of the presence of Asbestos.

In the interim, the client is advised to act with caution, especially when considering any damage to building materials general wear and tear renovations extensions demolition and general maintenance activities due to the suspected presence of Asbestos.
