# Building and Timber Pest Inspection Report

Inspection Date: Thu, 19 Mar 2026

Property Address: 1/36 - 38 Eighth St, Gawler South SA 5118,  
Australia

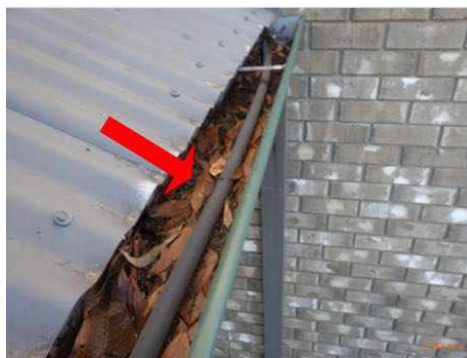
Blocked gutters are likely to lead to high levels of moisture in the affected areas. Such moisture will not only cause rust and decay of the associated building materials, but can also provide conditions that are conducive to termite and timber pest activity. Blockages in gutters should therefore be removed immediately to ensure dry conditions are maintained.

Consult a Licensed Plumber for further specific advice on remedial works that may be required. In the interim, it is highly advised that blocked gutters be removed by the homeowner or a general handyperson as a matter of urgency.

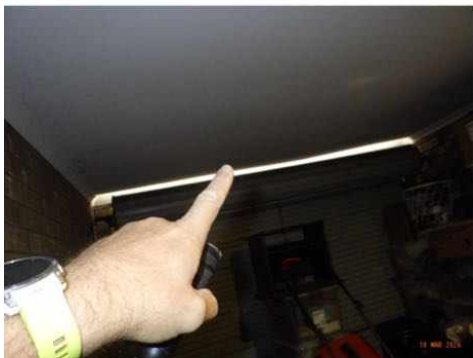
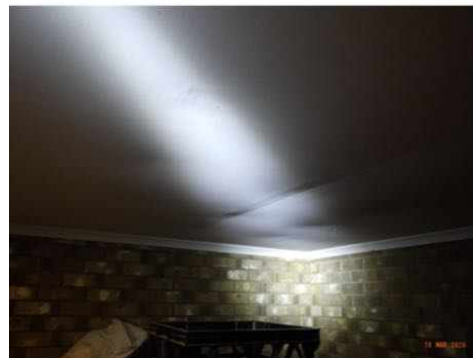
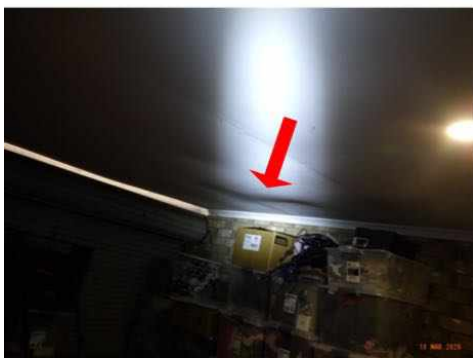
### Finding 3.02

Building:	Building 1
Location:	Garage
Finding:	Ceiling - Garage
Information:	A very common defect found in garages is that the ceiling can sag over time, due to their lack of insulation and or their susceptibility to moisture. Condensation builds up in the roof and rests on the plasterboard softening it somewhat which makes it more likely to sag and release from its fixing points. Moisture evaporating from cars can also contribute to this issue.

Therefore we recommend that you insulate your garage and also apply a good coat of washable paint to the ceiling of the garage to prevent any moisture entering the plasterboard and creating issues in the future. A licensed building insulation installer and licensed painting contractor could be appointed to carry out these works at the discretion of the client.

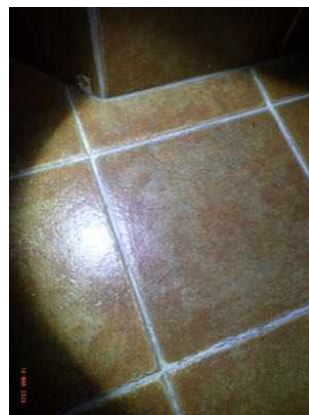
### Finding 3.03

Building:	Building 1
Location:	All Areas
Finding:	Minor defects present
Information:	Minor defects were evident throughout the dwelling at the time of inspection, which are consistent with normal wear and tear and considered appropriate for a property of this age.

These defects are typical of ongoing material ageing, settlement, and general use over time, and include, but are not limited to:

- Minor deteriorated exterior paint

- Window winder to lounge not smooth operation
- Laundry door rubbing on the frame.
- 1 drummy tile to bathroom

While these defects are not considered structurally significant at present, they should be addressed as part of routine and ongoing property maintenance to prevent further deterioration. Repairs and maintenance works should be carried out by appropriately licensed and qualified tradespeople to ensure the continued serviceability and longevity of the dwelling.

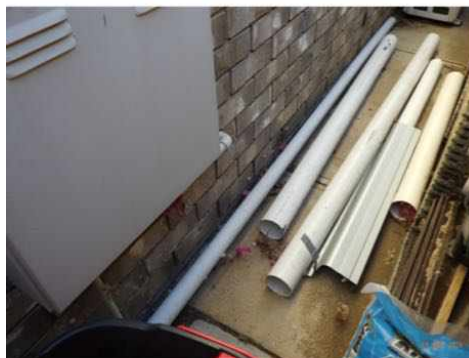
If the slab edge is not properly exposed there is a high risk of concealed termite attack which your inspector will likely not be able to see. Sometimes, in order to determine the type of slab, a suitably qualified person such as an architect or builder may be required to consult construction plans.

Where the slab edge cannot be properly inspected, it is highly recommended that termite or timber pest inspections be carried out every 6-12 months to aid protection of the property against infestation and termite treatment advice is followed closely.

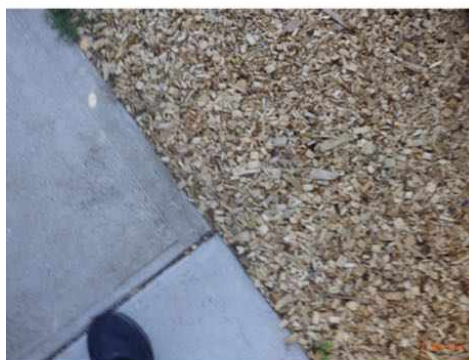
### Finding 6.02

Building:	Building 1
Location:	Yard - Back
Finding:	Untreated or non-durable timbers in a hazardous environment
Information:	To reduce the risk of timber pest attack it is essential that timber used in a hazardous environment (e.g. in direct contact with the ground or frequently exposed to damp conditions) is of sufficient durability and/or is adequately preservative treated. Additionally any timber lying around or timber stumps should be removed.

Untreated timbers in direct contact with the ground are likely to develop severe wood rot and/or fungal decay if left unattended creating attraction for subterranean termites to infest the timbers from surrounding areas.

If untreated or non-durable timbers are found to be in a hazardous environment it is highly advised that replacement of these building elements be performed as soon as possible to aid the protection of the property against termite / timber pest attack. Failing this close monitoring is recommended in an attempt to identify termite infestation at an early stage.

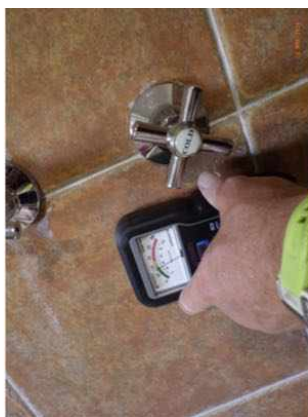
Building: Building 1  
 Location: Bathroom  
 Finding: Bath - Leaking  
 Information: At the time of inspection, the bath tap showed evidence of leaking during operation.

Although common, water leaks can be detrimental to surrounding building elements. Rust, corrosion, decay and water damage are all potential outcomes of a water leak that is left unattended, which are then likely to develop into more serious defects and may necessitate major repair works.

Additionally, water leaks may significantly increase the termite risk to the dwelling.

It is highly advised that water leak be addressed by a licensed plumber as soon as possible to prevent any damage.

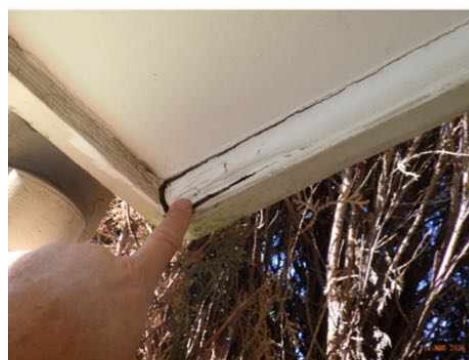
## Finding 7.01

Building:	Building 1
Location:	All External Areas
Finding:	Fascias - Wood rot
Information:	Wood rot was found to be affecting fascias and barges throughout the roof, evidenced by the presence of deterioration on the surface in some areas. Wood rot, also known as Fungal Decay, occurs when timbers and other cellulose building materials are exposed to damp conditions on an ongoing basis.

It is likely that this wood rot has developed as a result of faults in the roof plumbing, creating excessive moisture in this areas.

Frequent exposure to rain and other weather conditions also make fascias and barges susceptible to accelerated deterioration.

Early intervention and regular maintenance will prolong the useful life of these building elements. Prior to any works being performed, the cause of the moisture that has created the visible wood rot should be identified and addressed in a suitable manner.

It is advised that a roof plumber be appointed to inspect all roof plumbing and subsequently identify the cause of the wood rot. Replacement of affected fascias and barges may then be a necessary step in protecting surrounding building elements from such deterioration.

A qualified plumber may be appointed to assess the cause of excessive moisture and to provide advice on any remedial works as required. A qualified carpenter or may also be required to replace affected building materials.

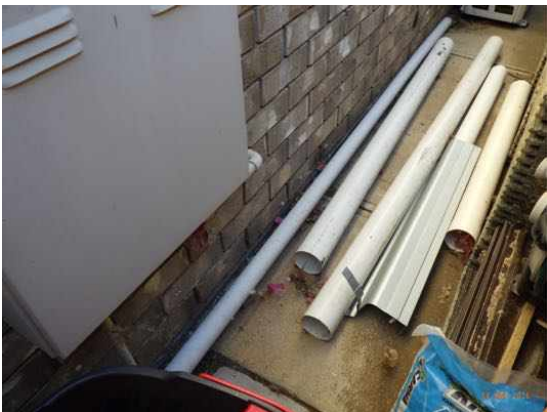
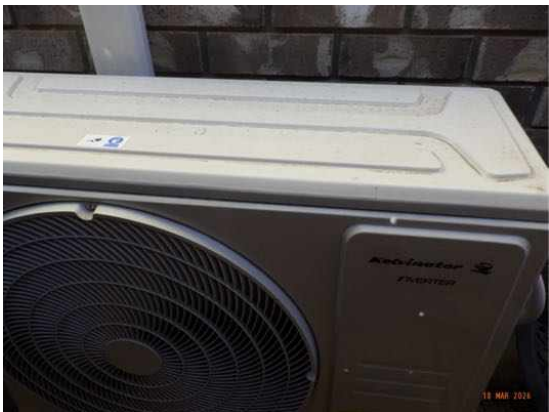
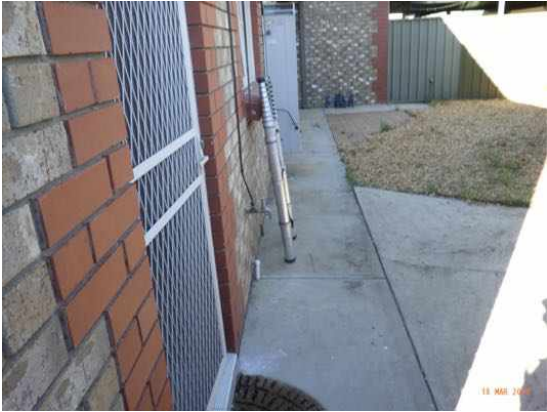
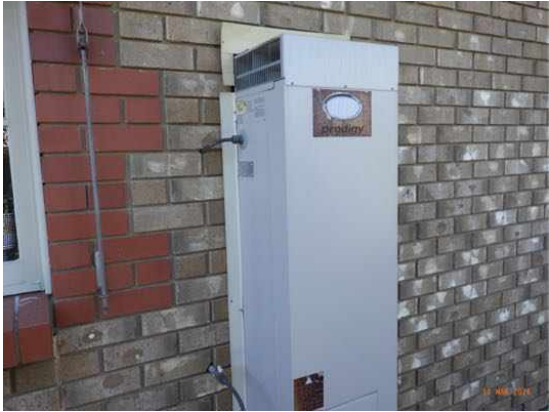
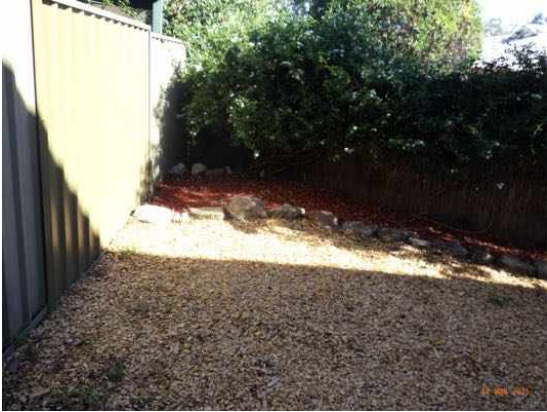
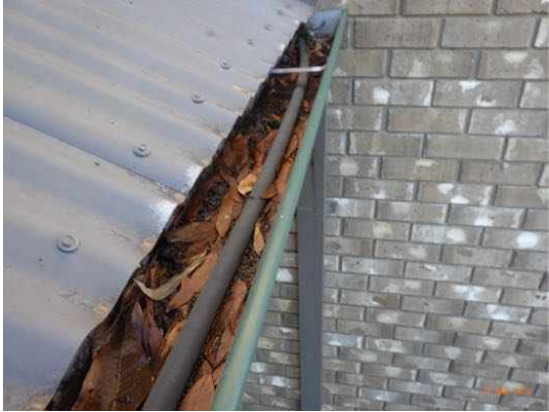
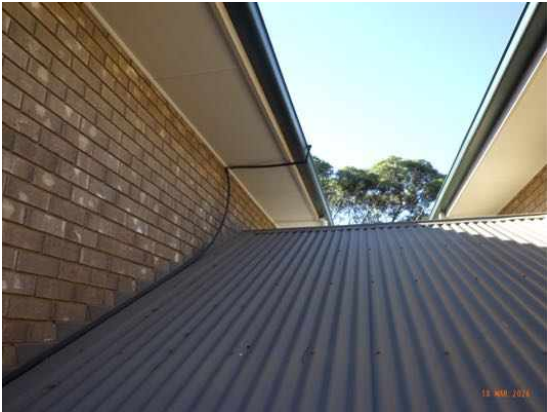
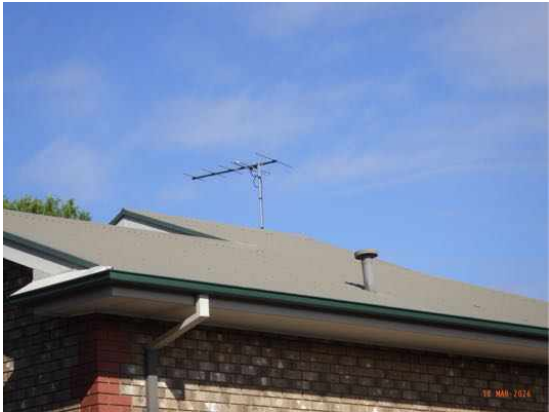
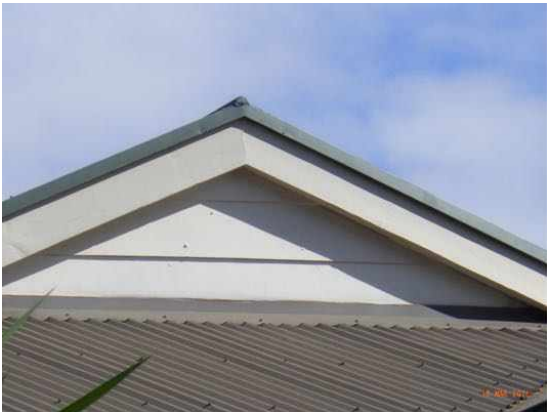
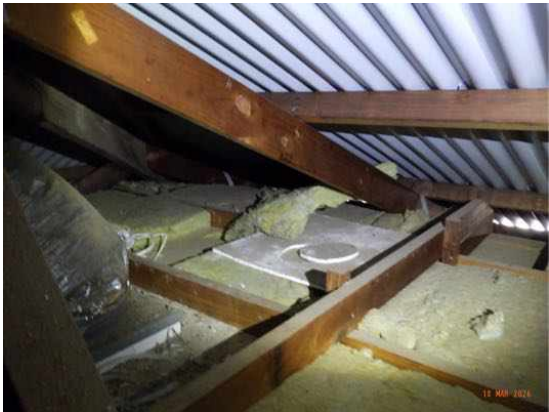
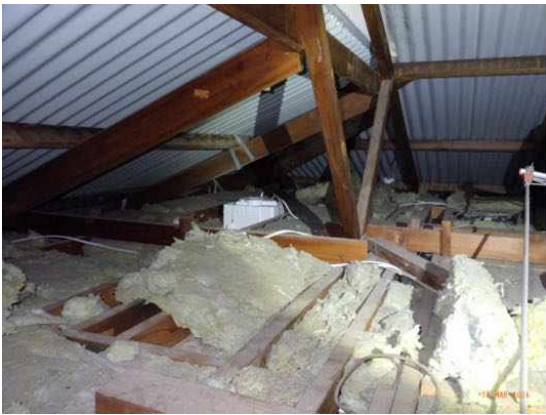
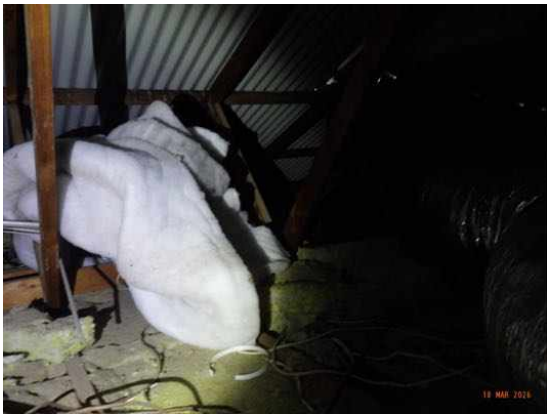
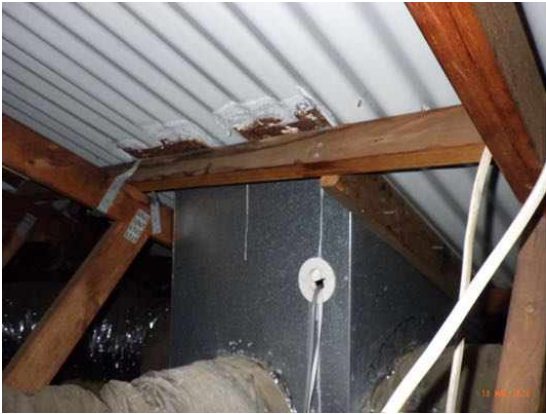
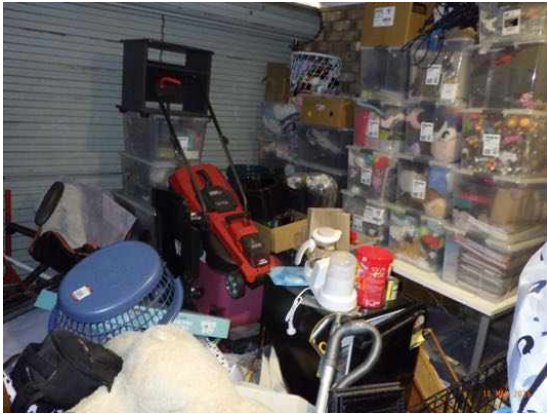
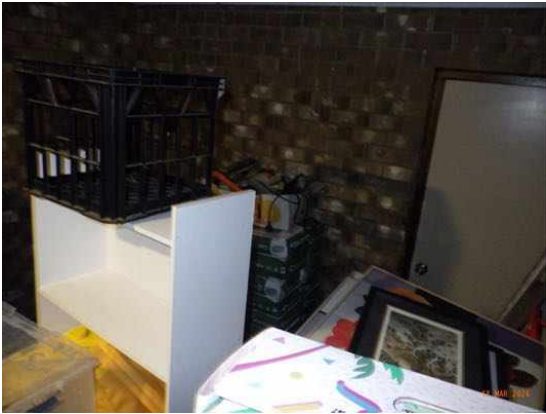
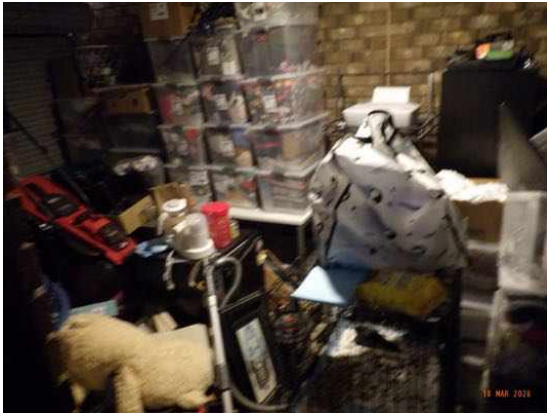
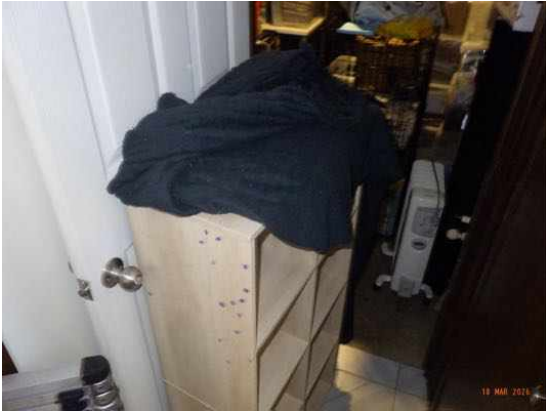
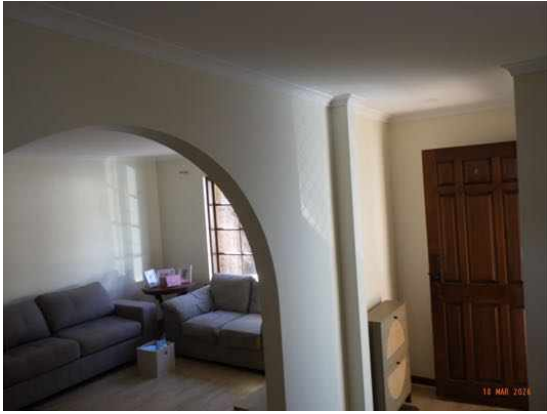
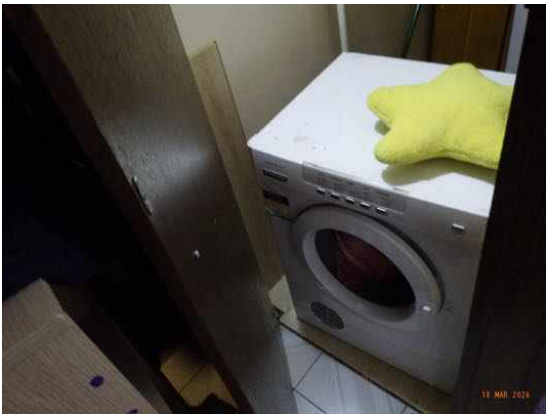
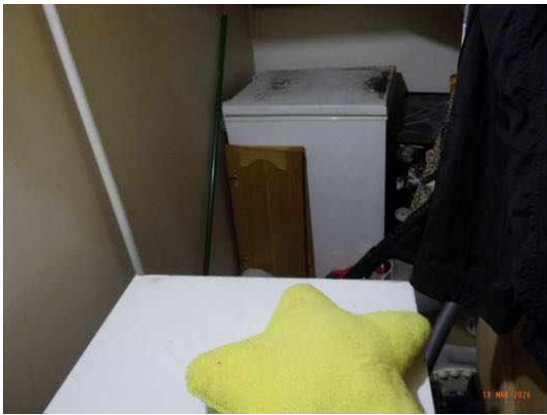
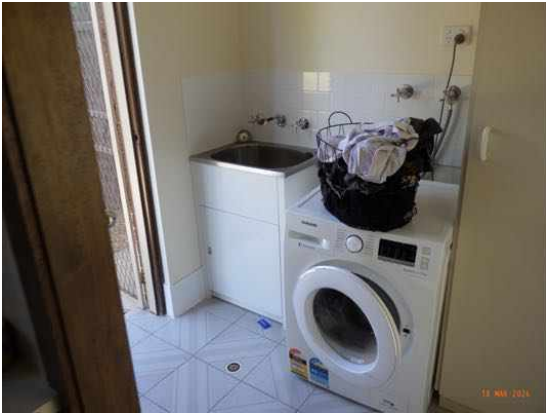
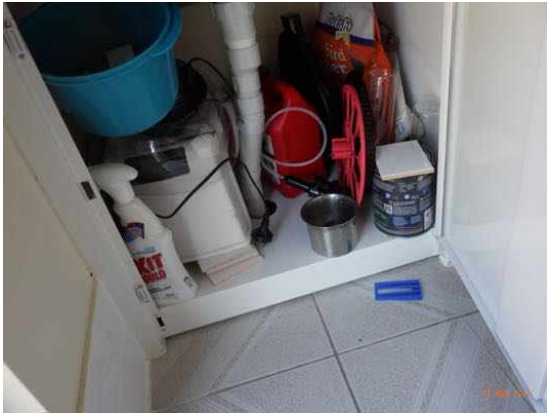
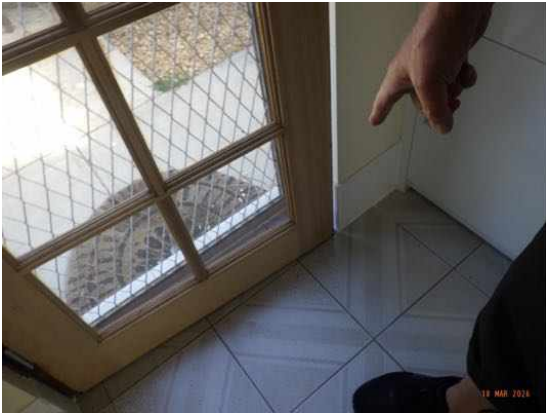
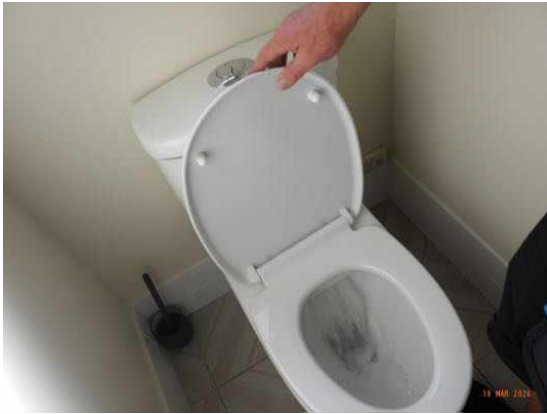
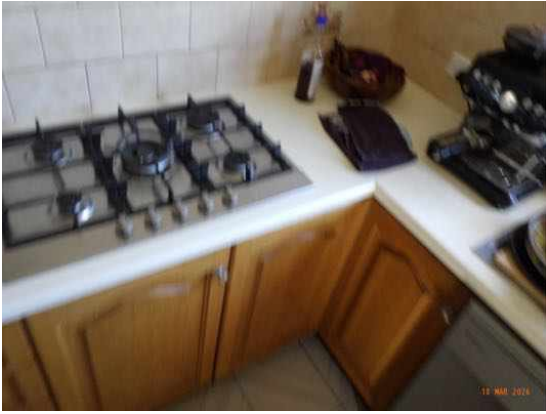
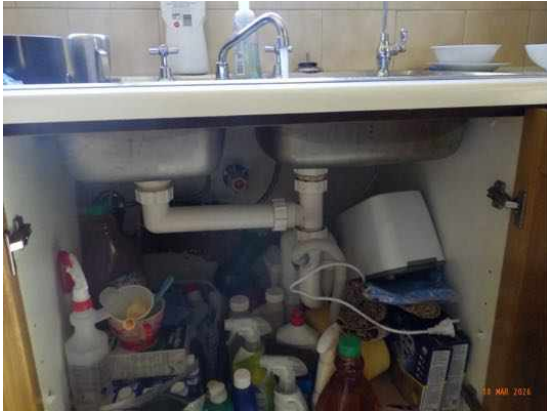
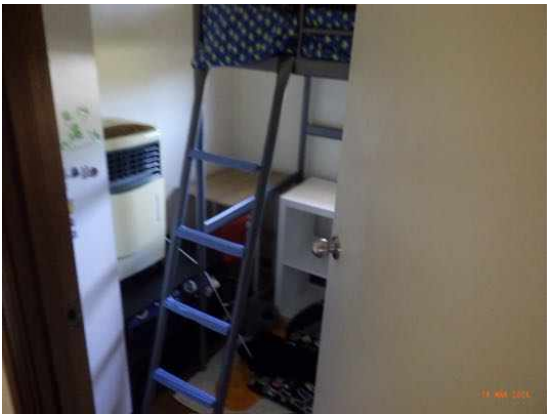
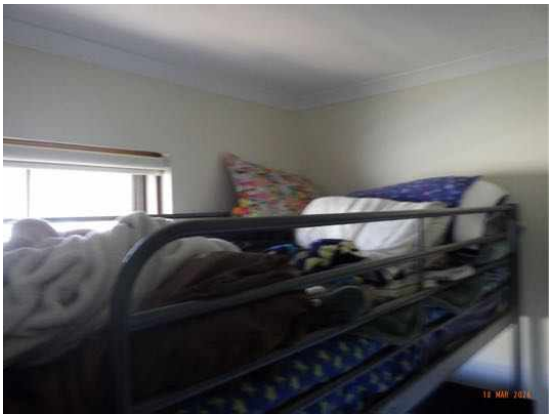
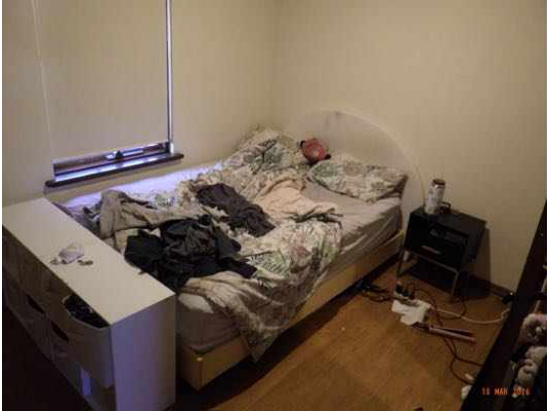
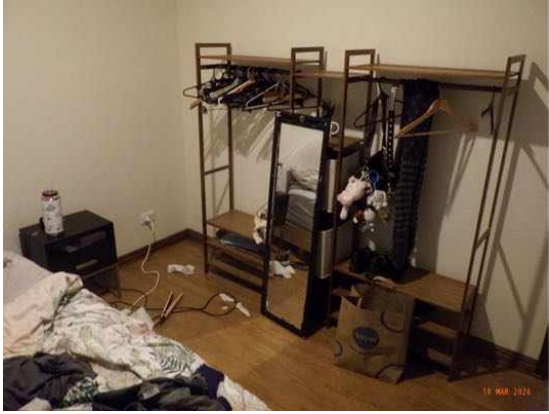
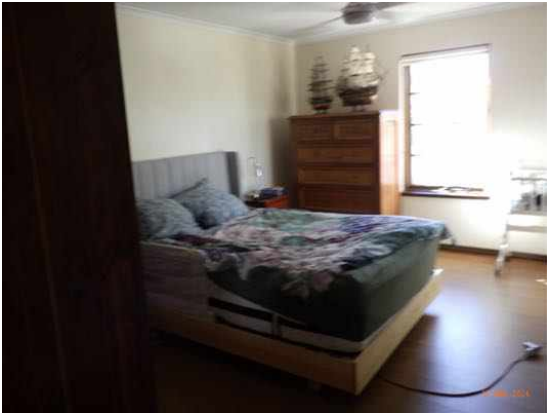
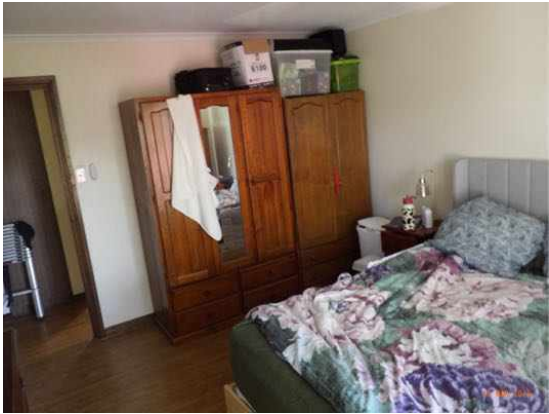
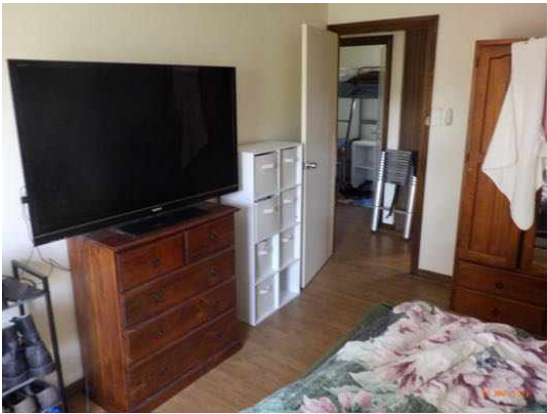
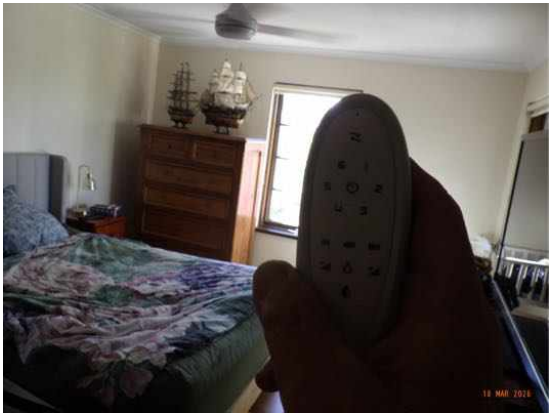
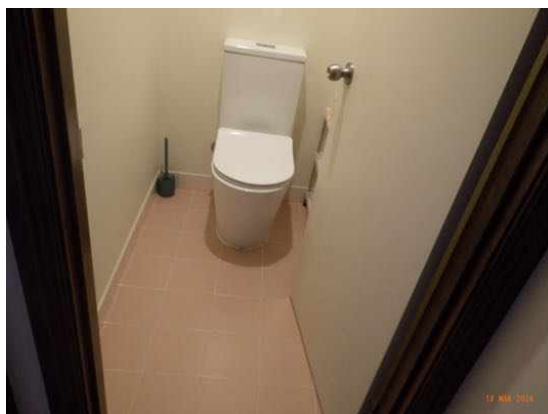
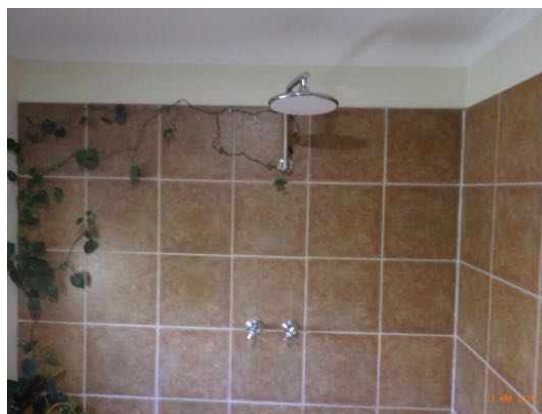
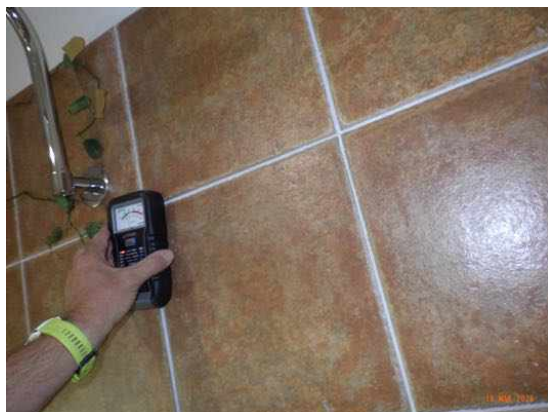
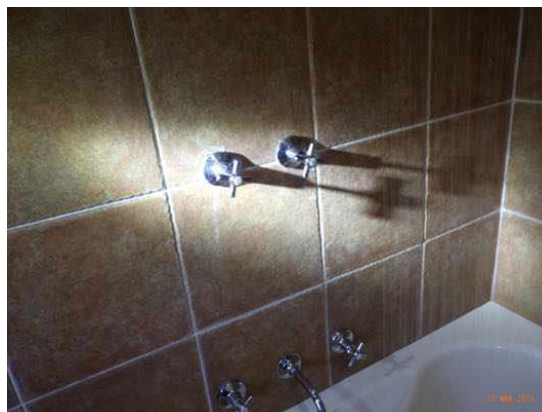
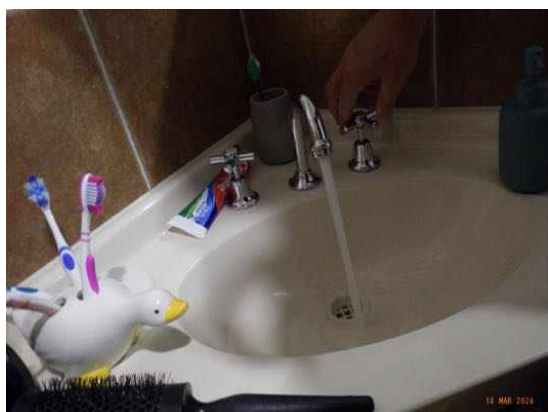
Building: Building 1  
 Location: All Areas  
 Finding: Additional Photos - Obstructions and Limitations  
 Information:

These photographs are an indication of the obstructions and limitations which impeded full inspection of the property at the time of inspection. These obstructions can hide an array of defects and should be removed to allow full inspection to be carried out.

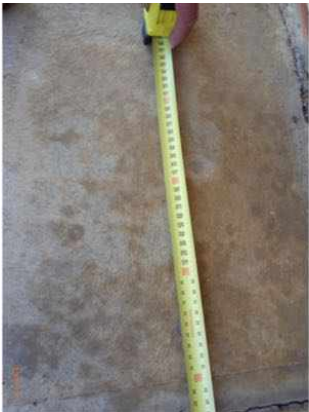
Building:	Building 1
Location:	All Areas
Finding:	Evidence of a chemical treated zone barrier was identified - drill and inject
Information:	During inspection of the property, it was noted that works to install a chemical treated zone barrier had previously been completed. A chemical treated zone barrier is likely to ensure effective protection against termites.

We strongly recommend annual inspections of the barrier and surrounding areas as there are several factors that can lead to deterioration of the barrier and decrease its effectiveness.

Where a Termite Management System has been identified, the client should identify to the type of barrier, date of installation, warranty conditions and any documentation provided by a builder or past owner. Consult the company who installed the barrier to confirm whether the system is still under warranty.
