# Building and Timber Pest Inspection Report

Inspection Date: Wed, 18 Mar 2026

Property Address: 2/20 Ewos Parade, Cronulla NSW 2230,  
Australia

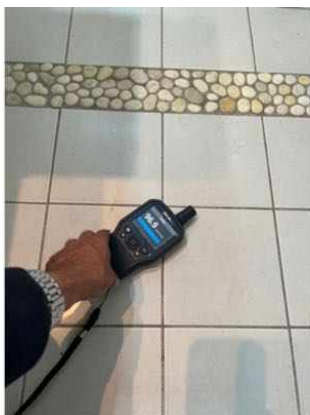
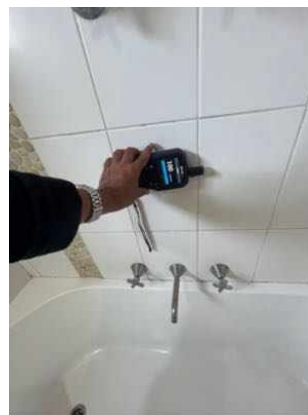
Building:	Main Building
Location:	Bathroom
Finding:	Elevated Moisture Bathroom & Back of shower (Possible waterproofing)
Information:	Elevated moisture levels were detected to tiled surfaces in bathroom/shower areas. This may be due to porous or missing grout, cracked tiles or recent use, however the possibility of waterproofing membrane failure or plumbing leaks cannot be excluded.

Persistent moisture ingress can lead to concealed damage, including timber rot and mould growth. Further investigation by a licensed plumber and/or waterproofing contractor is recommended as soon as possible. The back of shower area also showed elevated moisture with visible deterioration evident at the time of inspection.

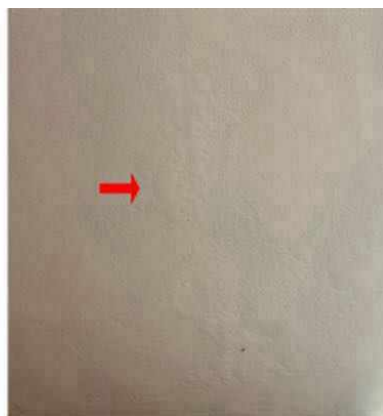
### Finding 2.02

Building:	Main Building
Location:	Balcony
Finding:	Painted surface - Bubbling - Balcony Soffit (Possible waterproofing)
Information:	Sections of paint in this area was found to have bubbled and deteriorated. Paint bubbling is generally an indication of excessive moisture in the area, that is currently hidden by the painted surface.

The presence of excessive moisture can have major implications on associated building elements if left unattended. While only seemingly minor at this stage, the damage cannot be determined due to the paint obstructing any further inspection of the damage.

It is highly advised that the affected paint be cleaned to allow a further, more invasive inspection by a licensed plumber. Failure to act on this defect may necessitate major works in the future.

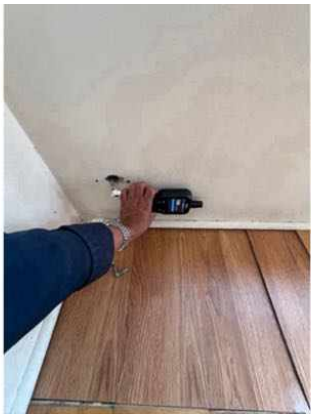
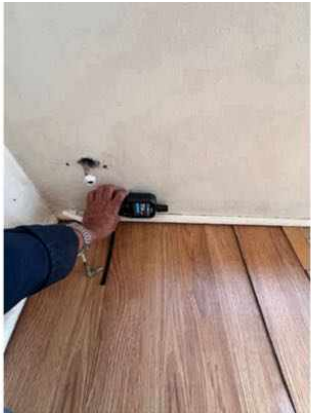
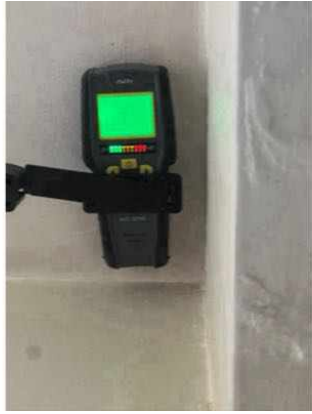
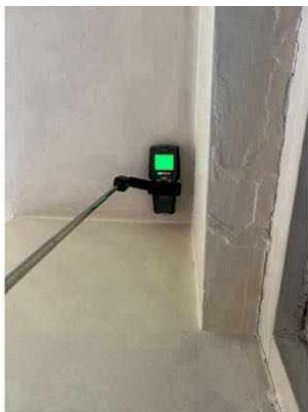
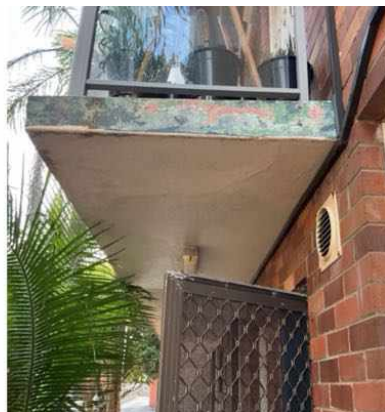
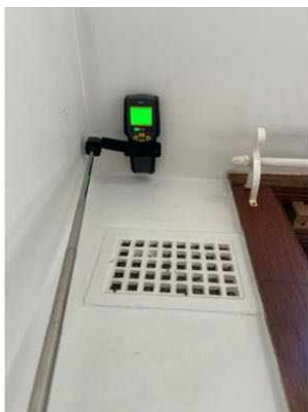
### Finding 3.01

Building:	Main Building
Location:	All Internal Areas - Rear wall lounge , bedrooms , front entrance and bedroom front ceiling
Finding:	Elevated Moisture – Further Investigation Recommended - Multiple areas (possible moisture ingress from external pathways and balcony)
Information:	Elevated moisture readings were detected in several locations, with some areas also showing signs of dampness while others did not present visible surface issues, although no significant structural damage was evident at the time of inspection, dampness can contribute to deterioration if left unaddressed. Inspector was not able to inspect the external wall due to space constraints. A further investigation by a licensed plumber or waterproofing specialist is recommended to confirm the source and ensure no concealed issues are developing.

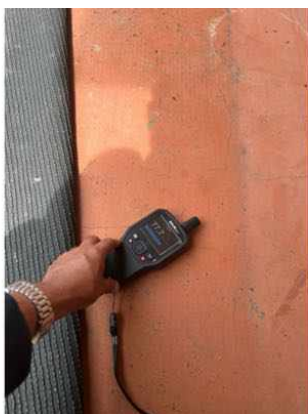
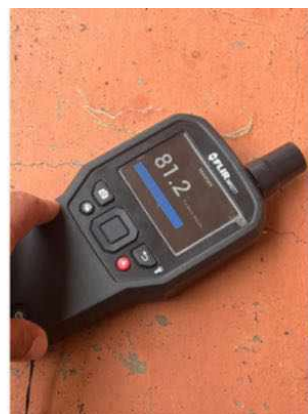
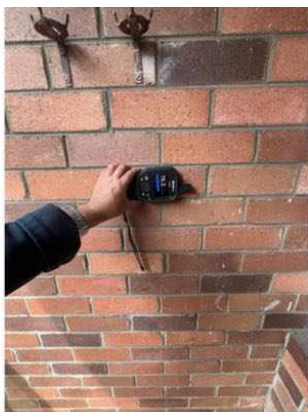
### Finding 3.02

Building:	Main Building
Location:	Balcony
Finding:	Balcony Elevated Moisture - Strata
Information:	Elevated moisture was recorded at the base of the balcony wall and flooring. While no significant internal damage was visible at the time of inspection, balconies in multi-unit dwellings are high-risk areas for waterproofing failure, which can lead to leaks into adjoining units and significant rectification costs. Further investigation by a licensed waterproofing contractor is strongly recommended.

Depending on the strata plan, this area may form part of the common property, in which case remedial responsibility may rest with the owners corporation (strata). Purchasers should seek clarification from the strata manager and legal adviser prior to purchase.

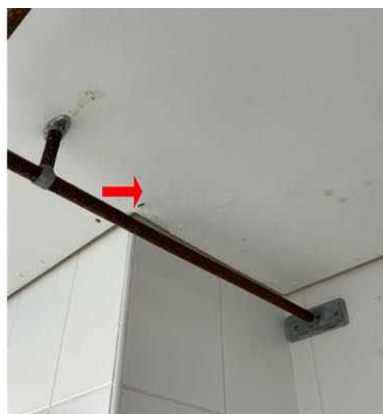
### Finding 3.03

Building:	Main Building
Location:	Bathroom
Finding:	Ceiling - Water damaged
Information:	Water damage to the ceiling lining is generally an indication of excessive moisture being present in the roof void, usually via a leak to the roof covering.

Where water damage is evident to the ceiling, the primary requirement is to identify and rectify the source of the leak. A roofing plumber should be appointed as soon as possible to identify the leak and perform rectification works as necessary, ensuring the water damage is restricted.

Once the leak is repaired, consultation with relevant tradespeople, including plasterers and painters, is advised. Rectification works may include replacement of ceiling lining or minor repainting, depending on the extent of the damage.

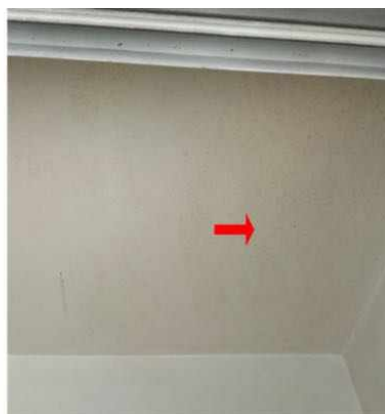
### Finding 3.04

Finding: Water staining

Information: Water staining was evident in this area at the time of inspection. Water staining indicates that surfaces have been exposed to excessive moisture over time. The minerals and other elements in the water lead to staining, which may graduate to corrosion and deterioration if left unmanaged.

While mostly an appearance defect, water staining can be indicative of more serious defects, which may be currently concealed by other building elements.

Where water staining is active, a licensed plumber must be consulted to identify the cause of the staining and to provide advice on any reparation works that may be required. Replacement of any broken or damaged structures is advised.

Conversely, where water staining is old and inactive, affected building materials may be repaired or replaced at client discretion. A qualified carpenter or registered builder may be appointed to perform these works.

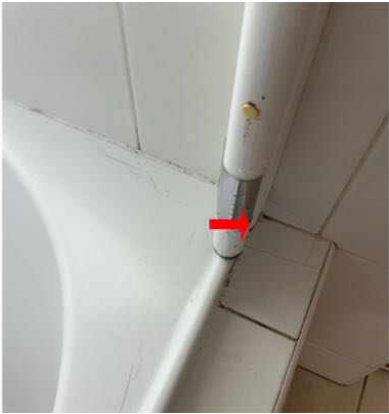
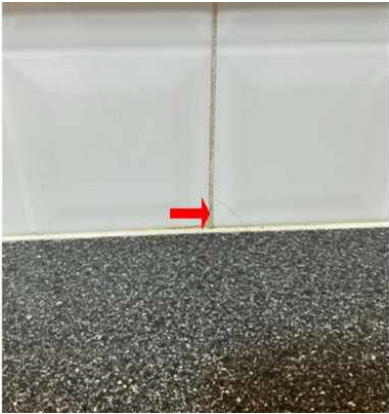
### Finding 3.05

Building:	Main Building
Location:	Bathroom, Kitchen
Finding:	Tiles - Cracked or damaged
Information:	Cracking was evident to the tiling in this area at the time of inspection. While the cracking appears to be minor, this area is frequently exposed to water, allowing potential for water penetration into adjoining sections of walls or flooring.

If left unmanaged, water penetration to these areas may lead to subsequent water damage, which is likely necessitate repair work to affected building elements.

A tiling contractor should be appointed to ensure that no further water damage occurs. The re-application of silicone and grouting throughout remaining tile work is also advised, to further protect the area against water penetration.

Where water penetration has led to water damage, appointment of a relevant tradesperson may be required to repair damaged building elements.

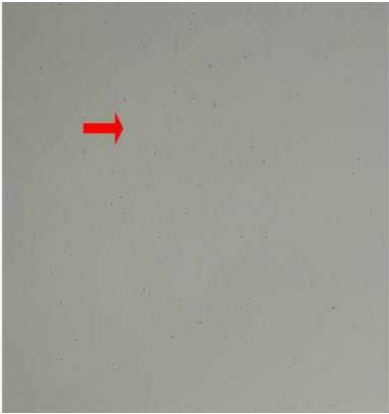
Building: Main Building  
Location: Bedroom  
Finding: Dark Spots - Ceiling  
Information: Very minor spotting was identified at the time of inspection, the pattern is consistent with airborne dust accumulation and/or minor environmental staining or possible insect droppings. No visible evidence of moisture ingress or structural defect was observed at the time of inspection.

Cleaning and repainting may be undertaken for cosmetic improvement. Regular cleaning and maintenance of air-conditioning filters and ventilation is recommended.

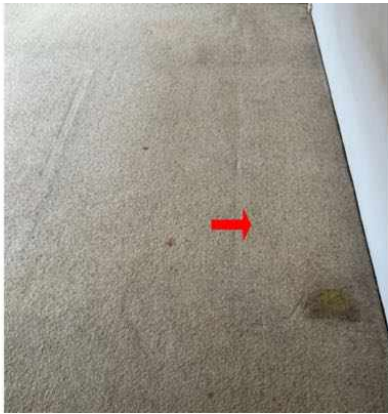
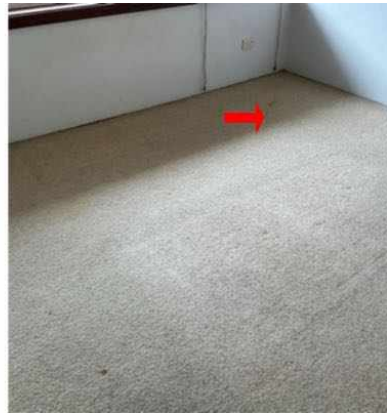
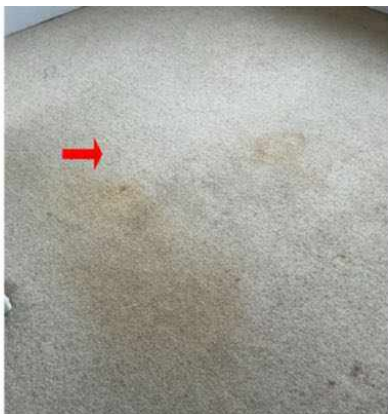
### Finding 3.09

Building: Main Building  
Location: All Internal Areas  
Finding: Building element - Damaged - Carpet deteriorated , rusted light fitting  
Information: Breakage occurs generally when the building materials have either aged and decayed, or as a result of damage (accidental or deliberate).

Repair and/or replacement of broken elements is advised to ensure that additional secondary defects do not arise as a consequence. Such works are necessary, as all building elements play a key role in the operation and function of the overall structure and its performance.

A relevant tradesperson should be appointed to repair or replace the affected building element prior to any subsequent damage being caused.

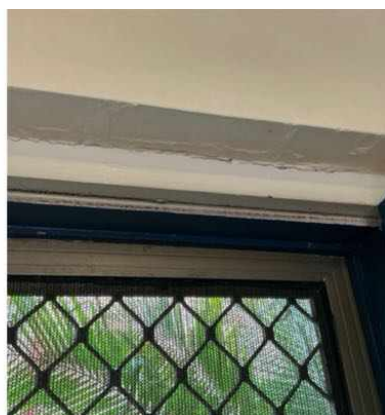
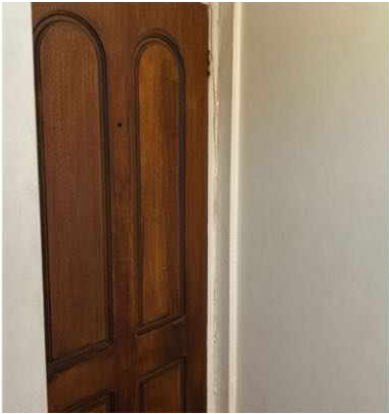
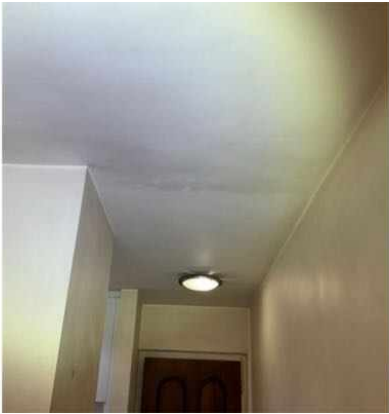
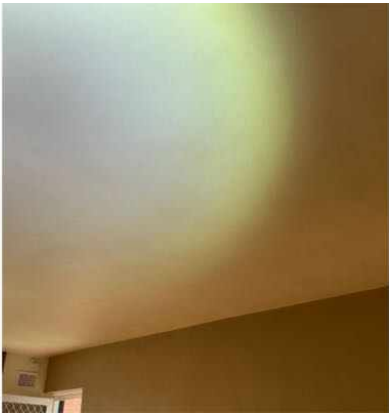
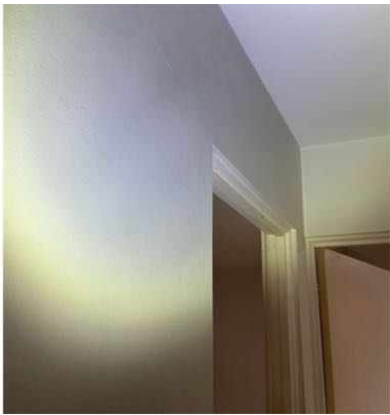
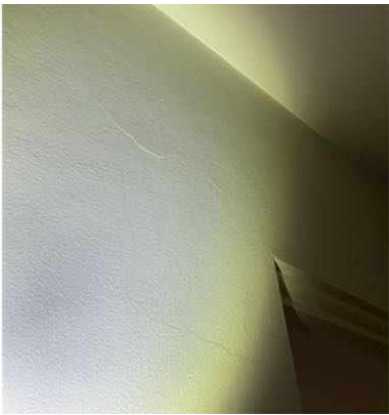
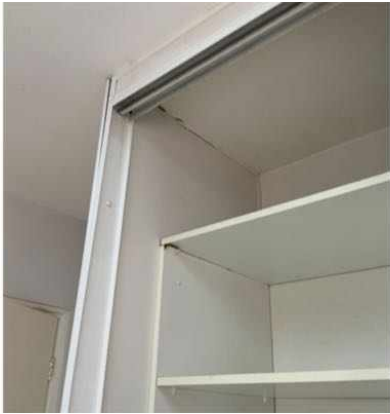
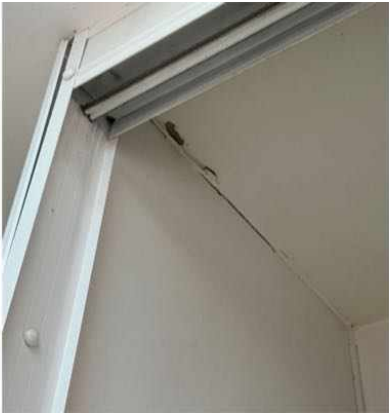
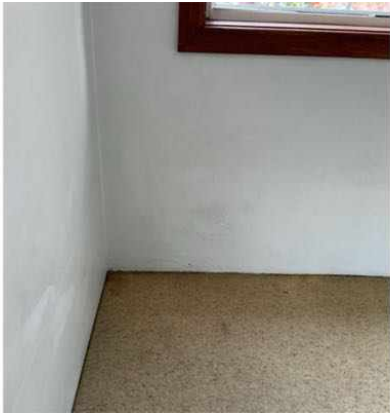
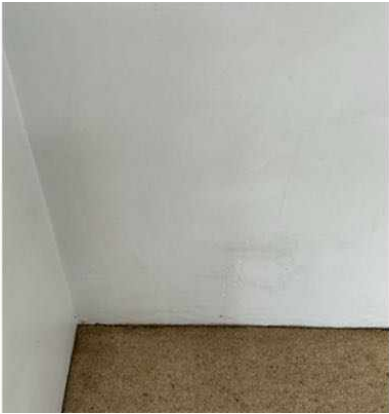
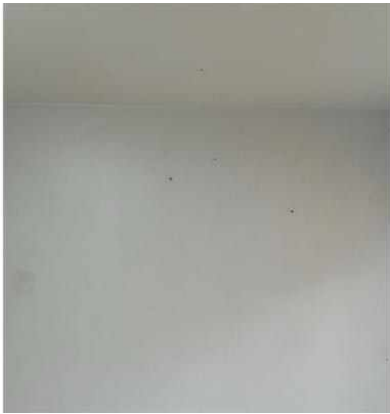
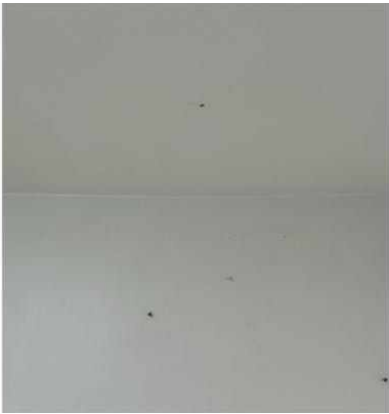
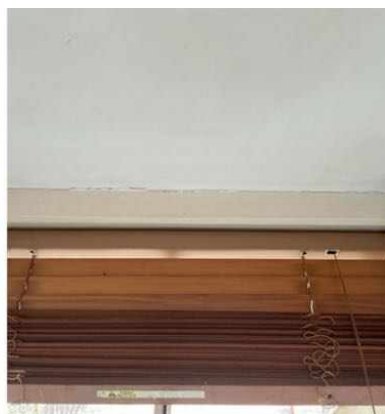
### Finding 3.10

Building:	Main Building
Location:	All Internal Areas
Finding:	Paint finish and hairline cracking
Information:	The paint finish in this area was identified as being incomplete at the time of inspection including some hairline minor cracking.

Whilst incomplete or missing paint and minor cracking and imperfections in finish is generally an appearance defect, it can also lead to the development of secondary building defects over time. Incomplete areas of paint finish expose the area to moisture, potentially accelerating the deterioration of underlying building materials.

Incomplete paint finishes should be sanded back, filled, leveled and painted, as applicable. Where inadequate or missing paint protection has led to the deterioration of the associated building element, repair and/or replacement of this building element may be required.

A painting contractor should be appointed as soon as possible to perform necessary works to aid the appearance of the affected area and to ensure the area is protected against further deterioration. Alternatively, the homeowner following manufacturer instructions may perform these works.

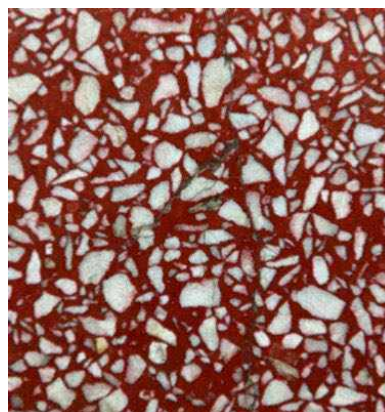
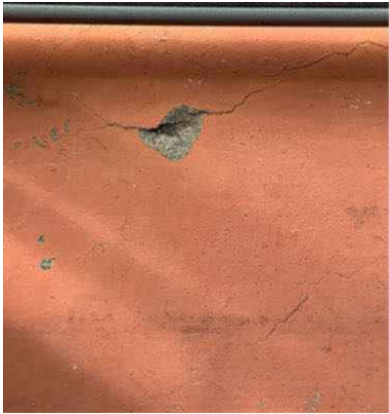
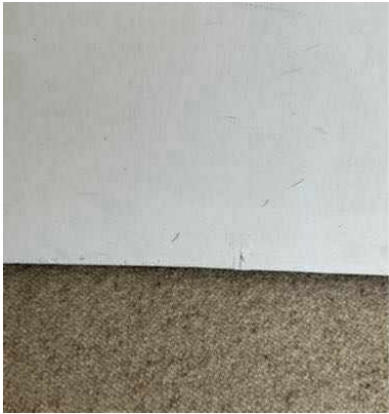
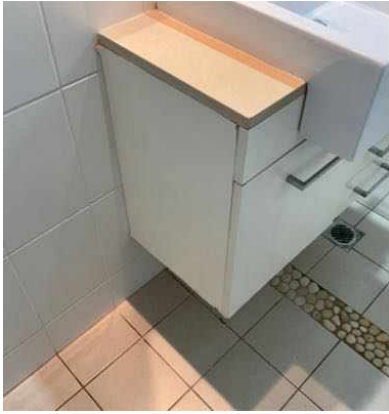
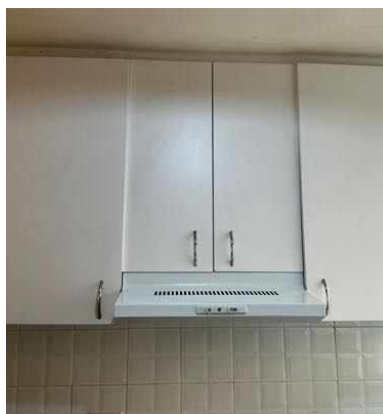
### Finding 3.11

Building:	Main Building
Location:	All Internal Areas
Finding:	Building element - Damaged - cracking in concrete paving , brickwork damaged and cracking , chipped concrete balcony , bedroom door chipped , mirror desilvering , vanity water damaged , kitchen cupboard misaligned
Information:	Breakage occurs generally when the building materials have either aged and decayed, or as a result of damage (accidental or deliberate).

Repair and/or replacement of broken elements is advised to ensure that additional secondary defects do not arise as a consequence. Such works are necessary, as all building elements play a key role in the operation and function of the overall structure and its performance.

A relevant tradesperson should be appointed to repair or replace the affected building element prior to any subsequent damage being caused.

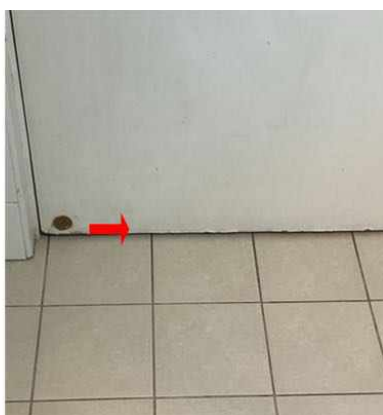
### Finding 3.12

Building:	Main Building
Location:	Bathroom
Finding:	Delamination of timbers
Information:	Localised delamination and surface deterioration were observed to sections of laminated joinery panels. This condition commonly occurs where moisture exposure or wear causes separation of laminate finishes from the underlying substrate. The defect is generally cosmetic in nature but may worsen over time if moisture exposure continues. Repair or replacement of affected joinery components may be considered as part of routine maintenance.

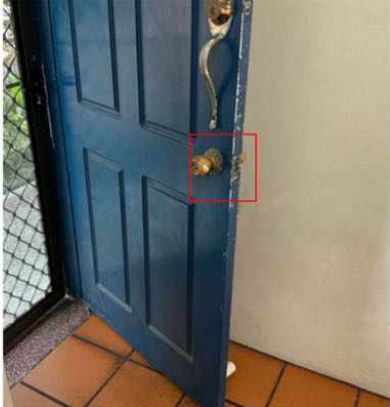
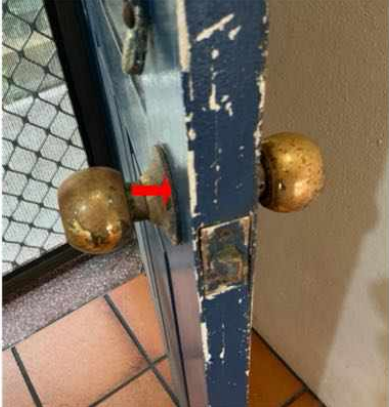
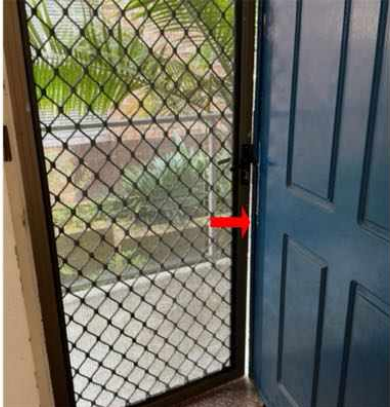
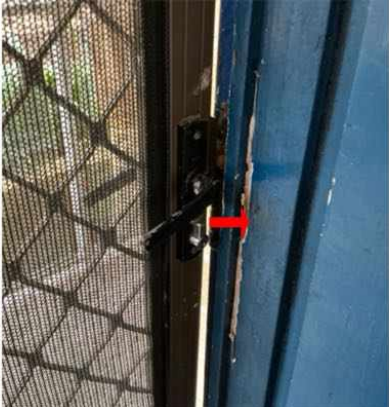
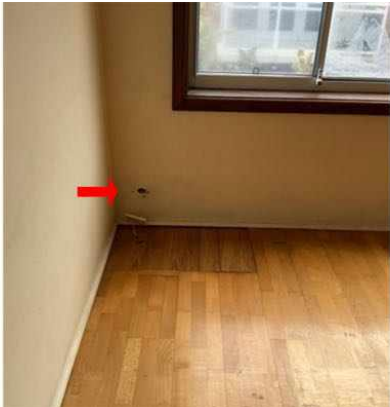
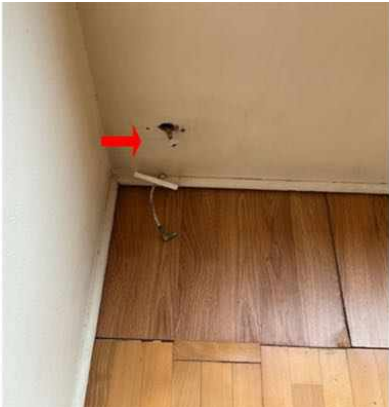
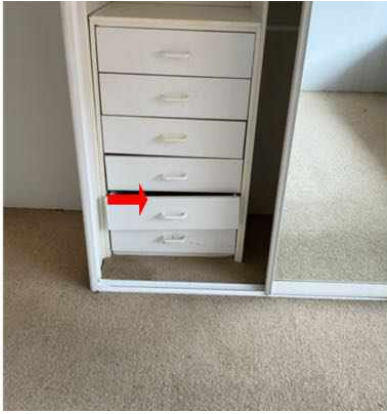
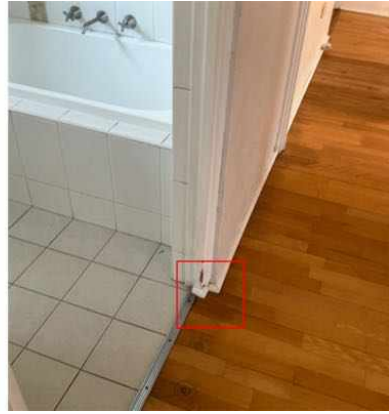
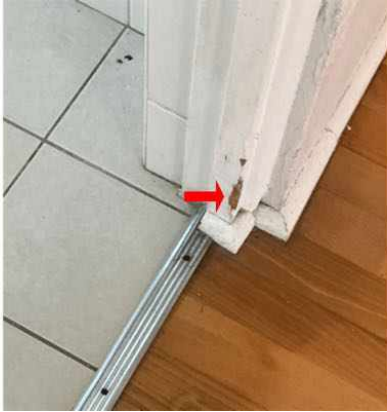
### Finding 3.13

Building:	Main Building
Location:	All Internal Areas
Finding:	Building element - Damaged - Door handle loose front , door binding , Tv cable fixing loose , BIR drawer misalignment, door jamb damaged bathroom
Information:	Breakage occurs generally when the building materials have either aged and decayed, or as a result of damage (accidental or deliberate).

Repair and/or replacement of broken elements is advised to ensure that additional secondary defects do not arise as a consequence. Such works are necessary, as all

A relevant tradesperson should be appointed to repair or replace the affected building element prior to any subsequent damage being caused.

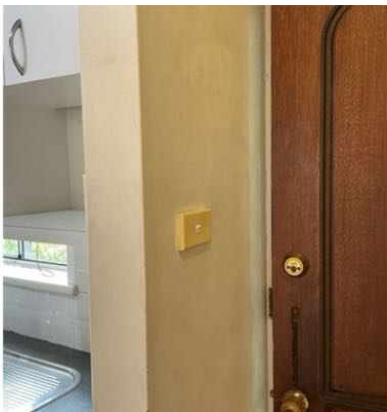
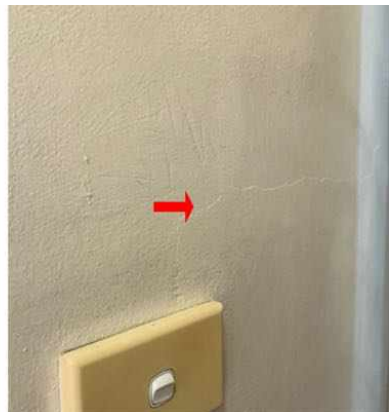
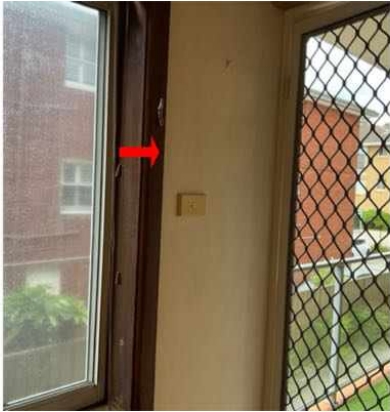
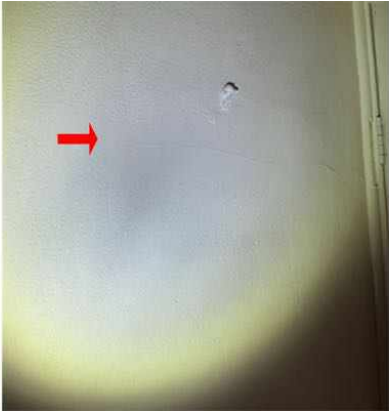
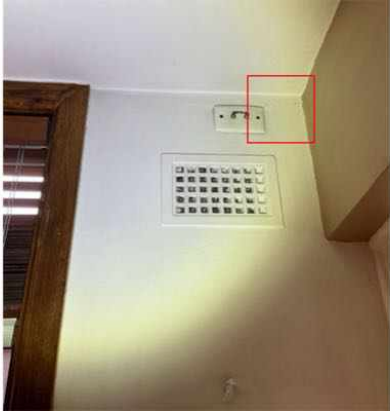
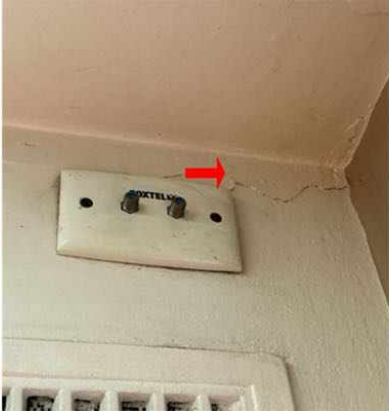
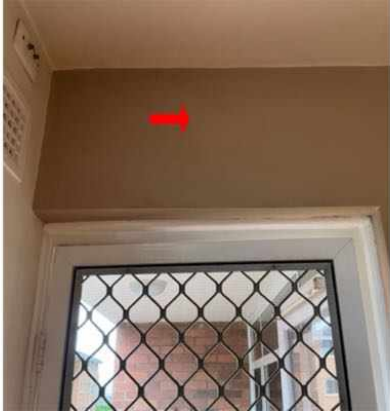
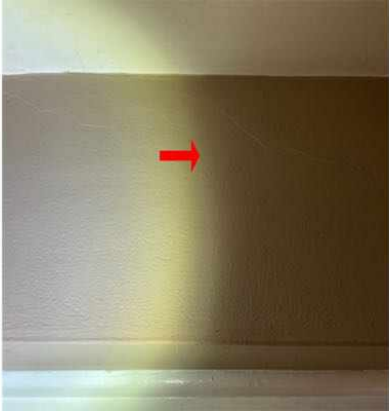
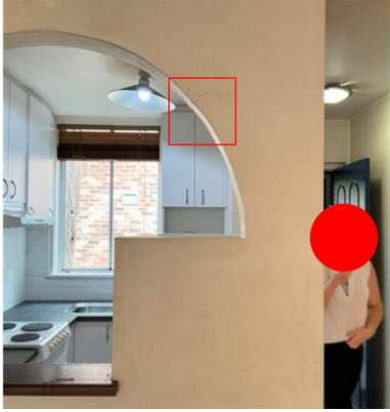
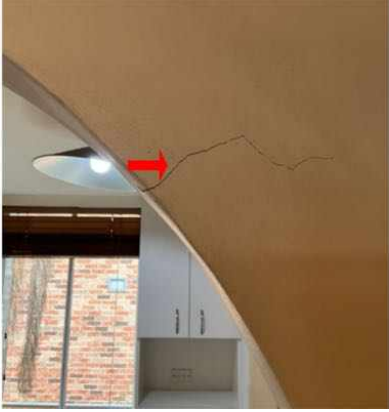
### Finding 3.14

Building:	Main Building
Location:	All Internal Areas
Finding:	Cracks to internal render - Category 1 to some areas
Information:	It has been observed that cracking to internal rendered surfaces has occurred. The degree of damage falls within Category 1, described as fine cracks that do not need repair and which are less than 1.0mm in width limit.

Damage of this category is not considered a defect for rectification. Always contact your building inspector should cracks widen, lengthen, or become more numerous.

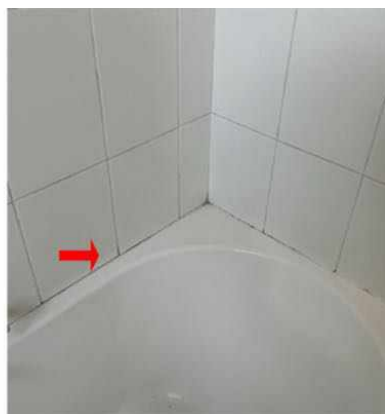
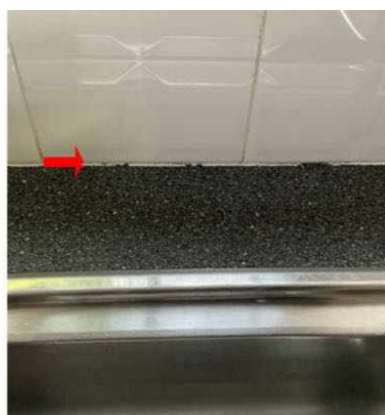
### Finding 3.15

Building:	Main Building
Location:	All Internal Areas
Finding:	Sealant and grouting - Missing or degraded to some areas
Information:	It was noted on inspection that sealant or grout is degraded. There is also evidence of poor workmanship and excessive use of sealant. Silicone should never be used as a first line of defence against waterproofing. Further inspection by a licensed waterproofing contractor is highly recommended.

There appears to be excessive mould to the sealant and grout which will likely require scraping out and replacement.

Flexible and mould resistant materials should be applied to affected areas to prevent any subsequent water damage that is likely to occur. Regular maintenance and replacement of damage or missing or damaged sealant and grout is highly recommended to the wet areas, as this is a regular wear and tear defect. Sealant and grouting in areas that come into regular contact with water should be maintained for the long term care of your property.

A sealant specialist or tiling contractor should be appointed to complete these works as soon as possible

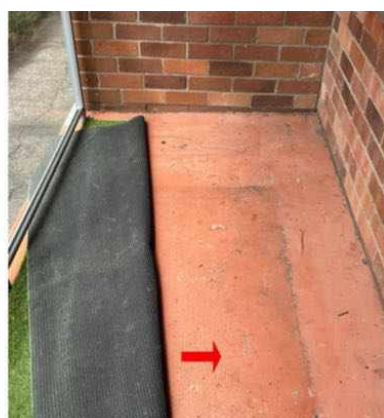
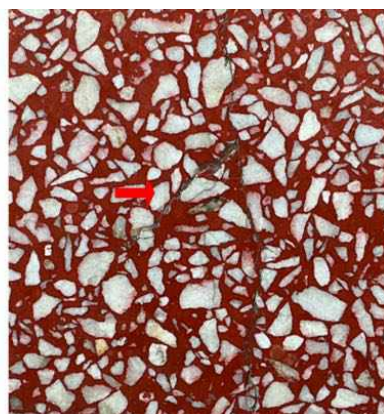
### Finding 3.16

Building:	Main Building
Location:	Balcony
Finding:	Cracking - External Concrete Paving Damage Category 0 - Hairline (less than 1mm) to some areas
Information:	Hairline cracks were identified in external concrete paving. Hairline cracks are very minor in nature and generally are only ever an appearance defect. To be classified as a Category 0 or hairline crack, the crack width would be less than 0.3mm. While such

cracking may be noticeable in some cases, it is common and does not indicate any structural damage.

Generally the cause of a hairline crack in existing concrete paving such as driveways and pathways is indicative of the expansion and contraction of the concrete. Such causes are generally due to environmental factors, such as moisture levels, weather conditions, root systems of nearby trees or the soil types on which they are laid.

Hairline cracks may also be due to poor original installation of the concrete. Factors such as poor compaction of the sub surface and/or inadequate reinforcing of the slab may create cracking and other secondary defects.

Monitoring of all cracking should be conducted frequently. Always contact a building inspector should cracks widen, lengthen, or become more numerous.

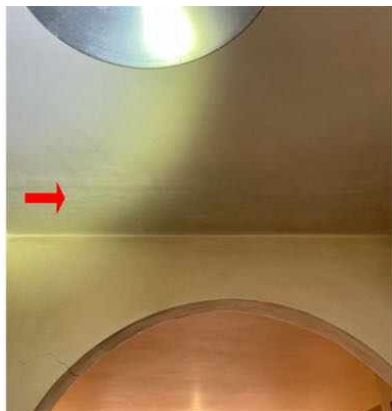
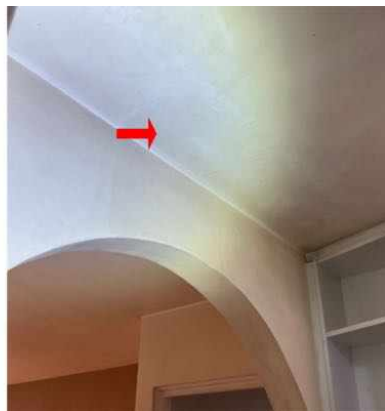
### Finding 3.17

Building:	Main Building
Location:	Kitchen
Finding:	Incomplete or substandard works - poor workmanship repairs to ceiling
Information:	The works to this area appear to be incomplete or have been completed to a substandard level.

development of building defects and may impede on the safety and integrity of the overall structure.

It is highly recommended that the relevant trades be appointed to complete these works and ensure the safety of the area and the longevity of all associated building elements.

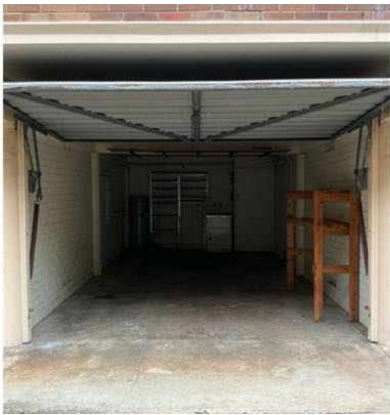
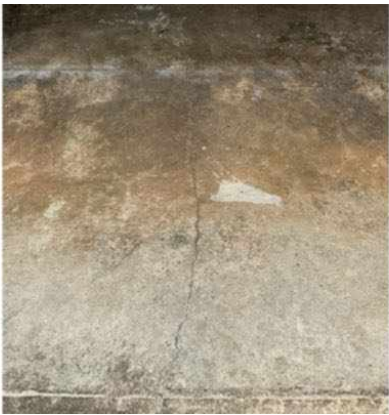
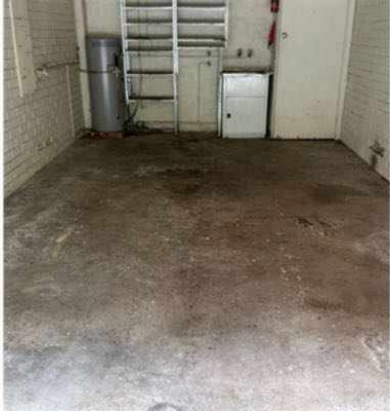
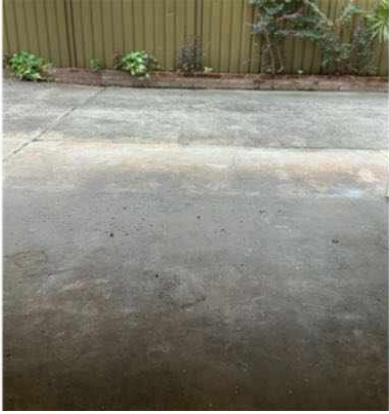
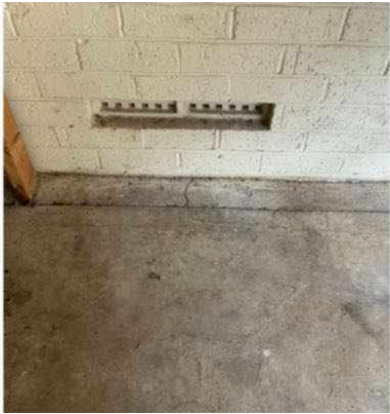
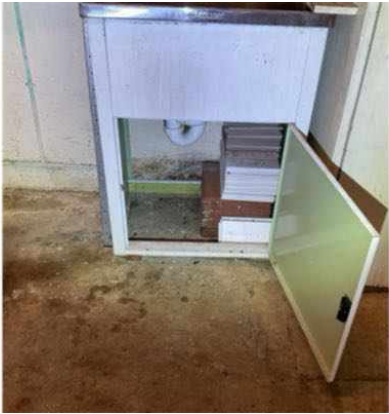
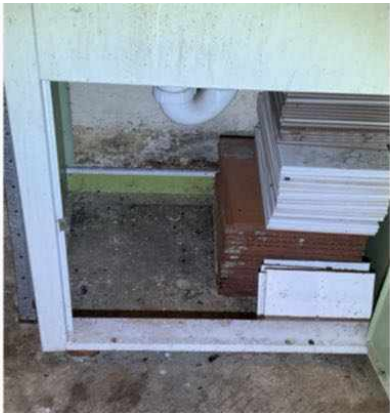
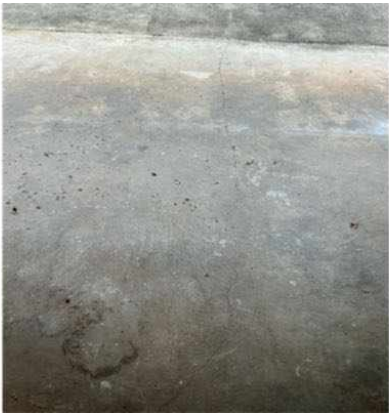
#### Noted Item

Building: Main Building  
Location: All External Areas  
Finding: Additional Photos - Obstructions and Limitations  
Information: These photographs are an indication of the obstructions and limitations which impeded full inspection of the property at the time of inspection. These obstructions can hide an array of defects and should be removed to allow full inspection to be carried out. A re-inspection is recommended once the areas are made accessible.

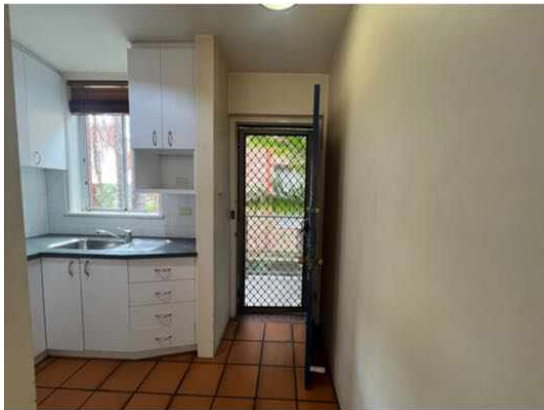
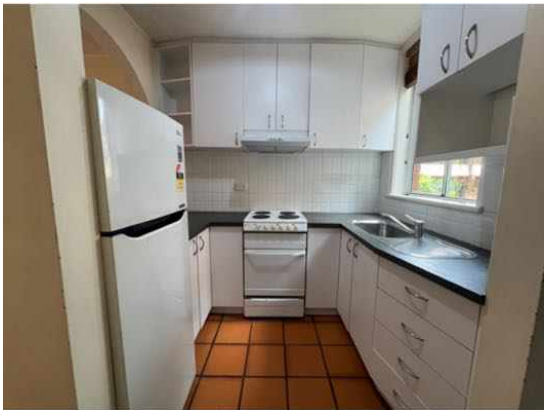
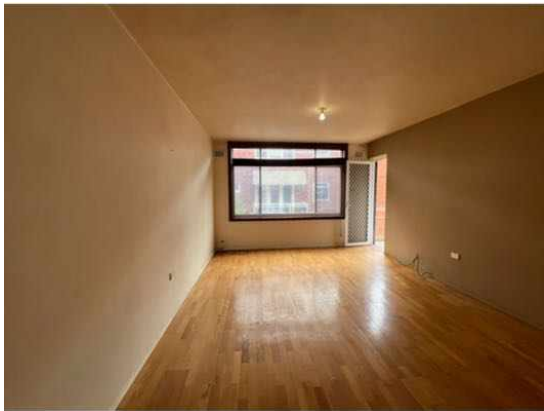
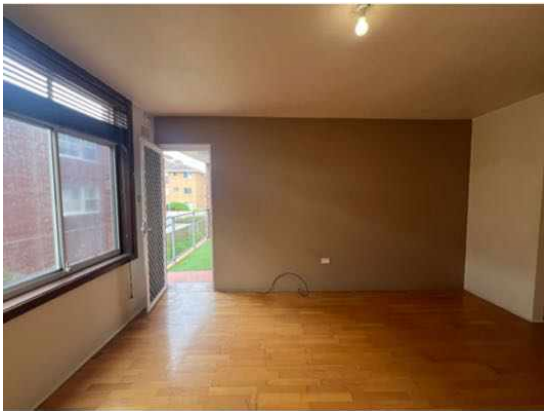
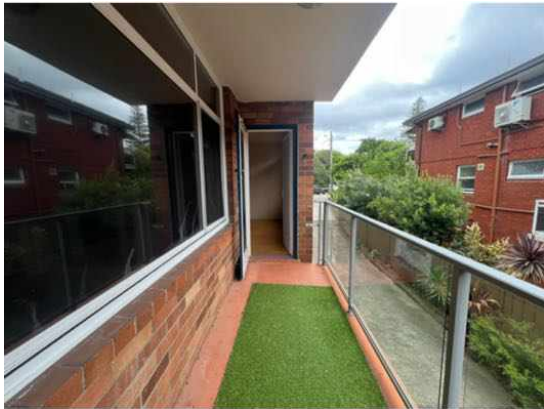
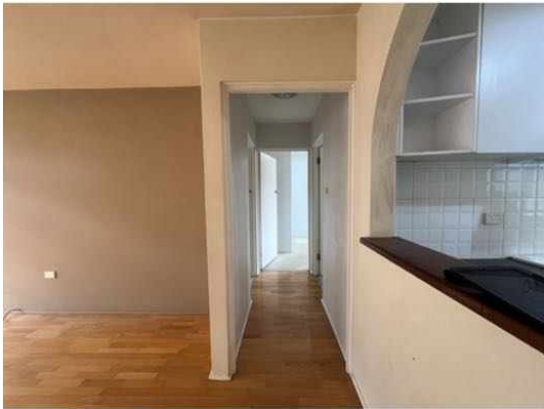
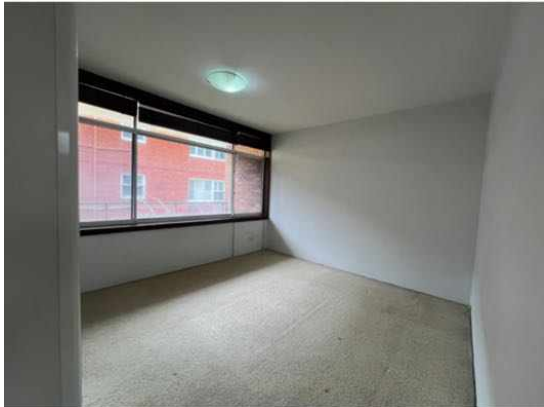
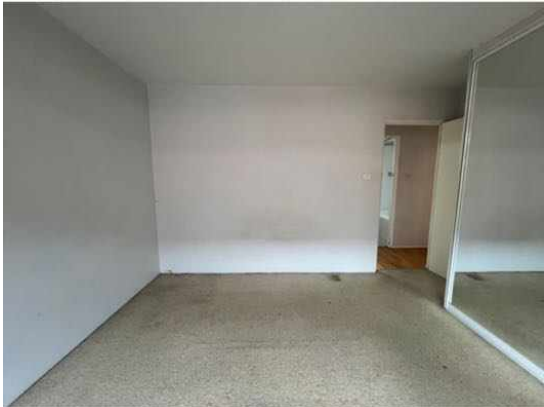
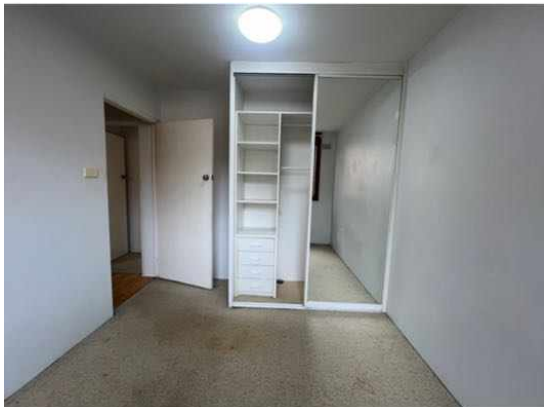
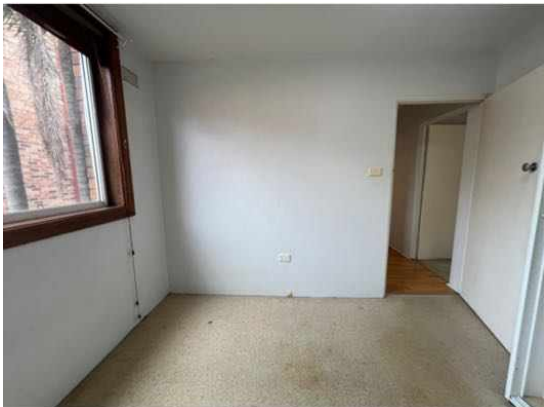
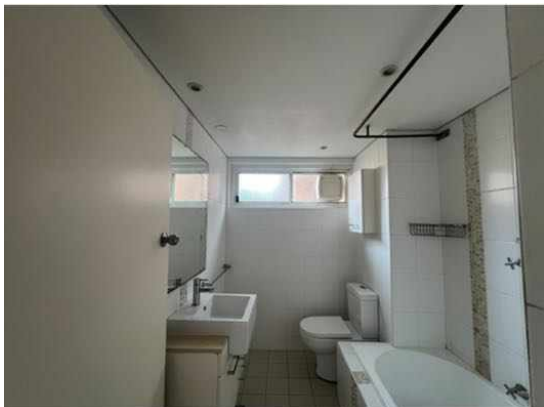
Building: Main Building  
Location: All Internal Areas  
Finding: Additional Photos - Obstructions and Limitations  
Information: These photographs are an indication of the obstructions and limitations which impeded full inspection of the property at the time of inspection. These obstructions can hide an array of defects and should be removed to allow full inspection to be carried out. A re-inspection is recommended once the areas are made accessible.
