# Building and Timber Pest Inspection Report

Inspection Date: Tue, 10 Mar 2026

Property Address: 4/4 Truman St, South Kingsville VIC 3015,  
Australia

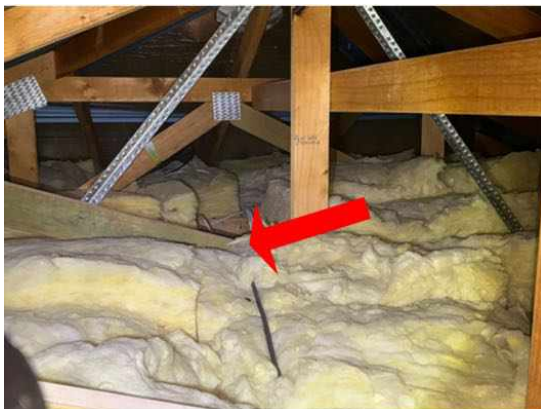
Building: Main Building  
Location: All Internal Areas  
Finding: Insulation - Covering downlights  
Information: Sections of insulation in the roof void have been poorly installed or moved from their original position and are covering down light fittings. While the down lights have been fitted with appropriate protective covers, the presence of this insulation creates a potential fire hazard.

Any insulation within the vicinity of down light fixtures should be moved and re-applied to more appropriate sections of the roof void, thus ensuring the area is fire-safe. An insulation contractor should be appointed as soon as possible to perform any necessary works as required.

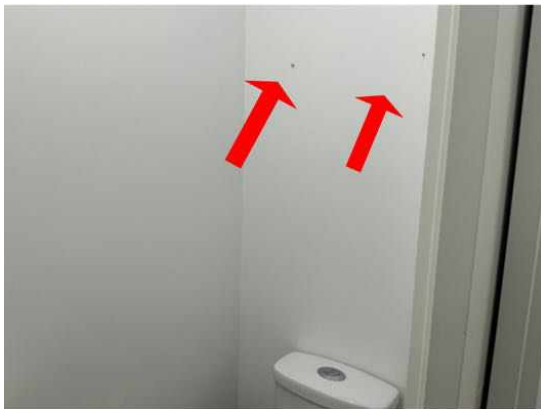
| Information: | It was observed at the time of the inspection that there were several minor holes in the plaster walls. It is suspected that the holes are present as a result of building elements being fixed to the walls and removed. |

Although this is an aesthetic defect it can detract from the overall appearance of the building.

A qualified painter should be engaged to review at owners discretion

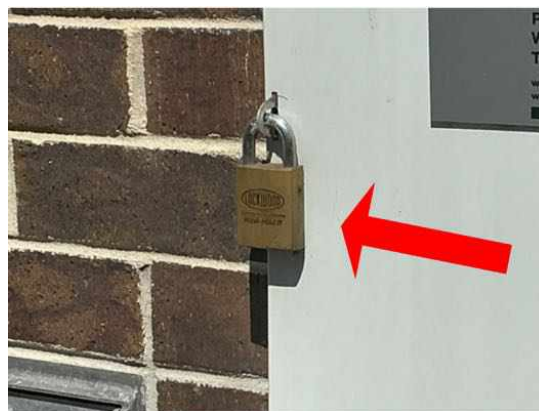
system has been installed, with no evidence to suggest preventative works taking place.

The client may consider gaining further advice from a pest controller as to the costs and procedures involved with this application. It is recommended that obtaining such advice be a short-term priority.

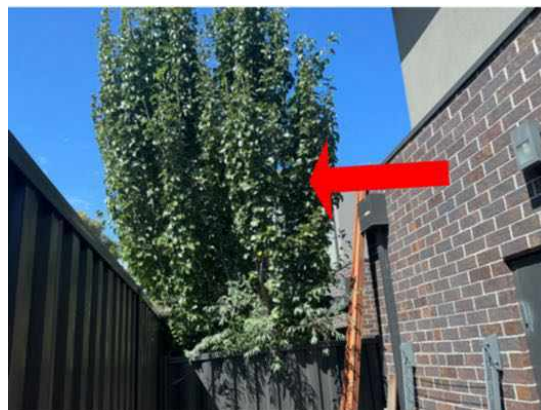
## Finding 6.02

| Information: | It was observed that there were several large trees next to or nearby the building. |

The trees have the potential to provide conducive conditions for termite infestation

It is recommended that periodic 12 monthly inspections by a registered pest control contractor be undertaken and further reinstatement of outdated termite barriers as soon as possible.

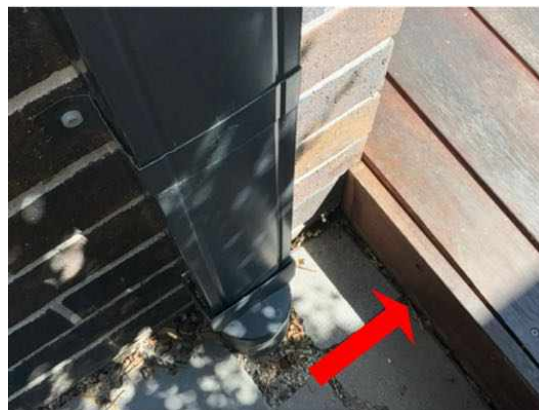
### Finding 6.03

Untreated timbers in direct contact with the ground are likely to develop severe wood rot and/or fungal decay if left unattended creating attraction for subterranean termites to infest the timbers from surrounding areas.

If untreated or non-durable timbers are found to be in a hazardous environment it is highly advised that replacement of these building elements be performed as soon as possible to aid the protection of the property against termite / timber pest attack.

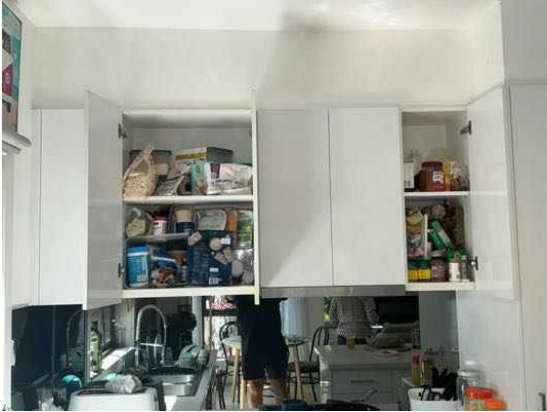
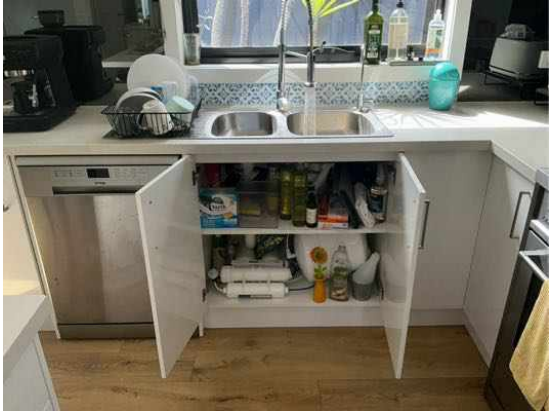
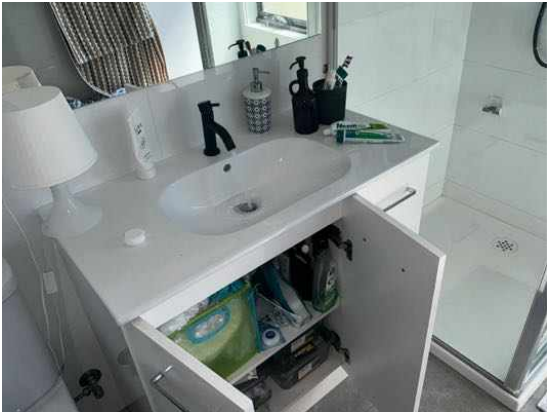
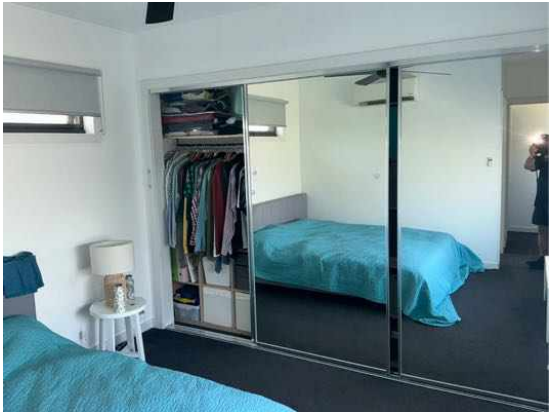
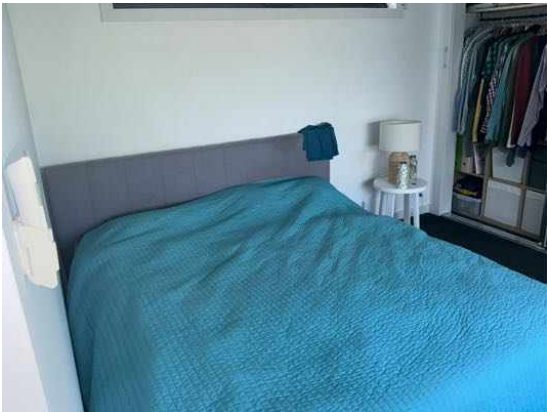
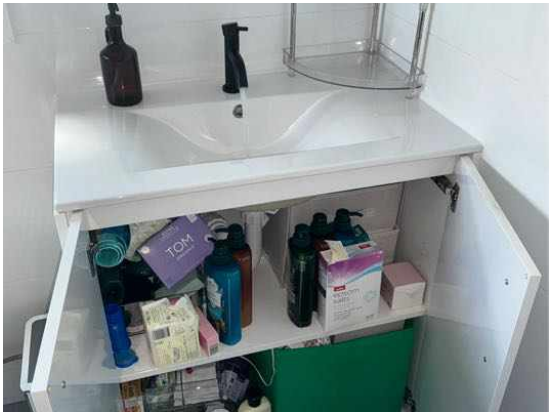
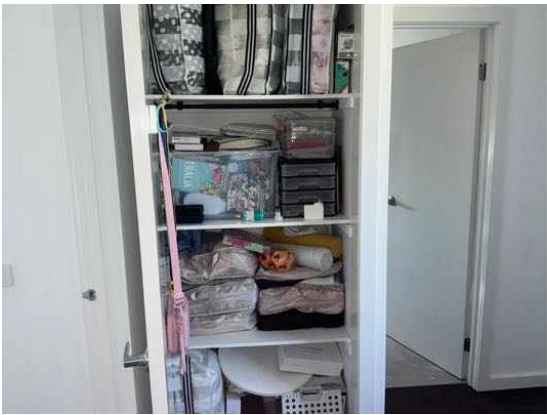
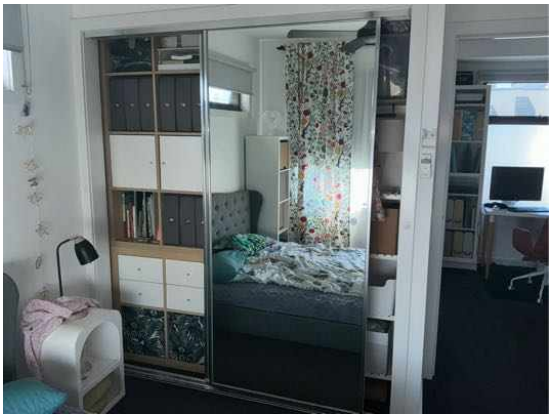
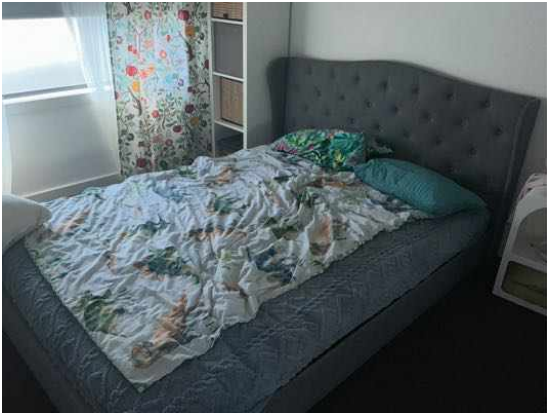
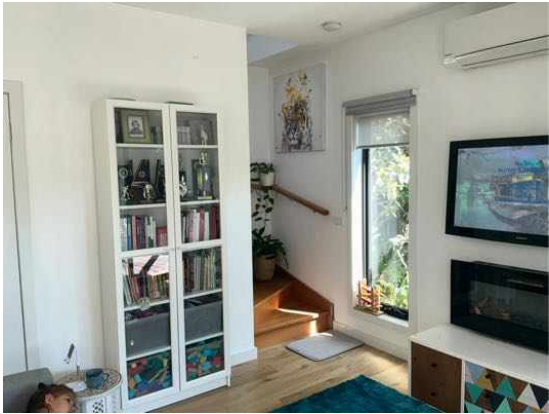
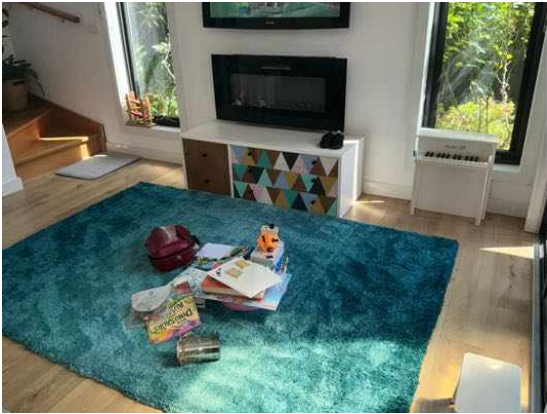
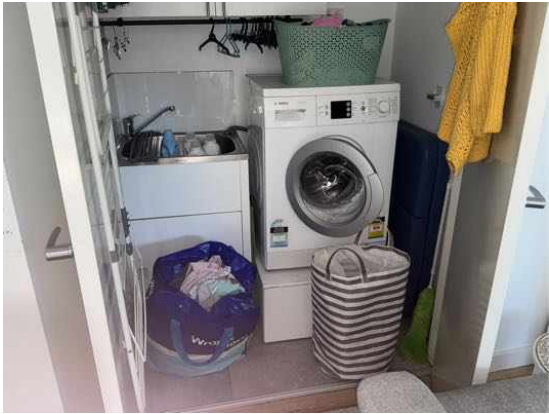
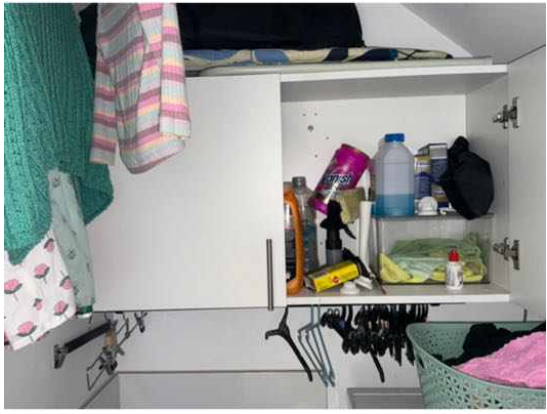
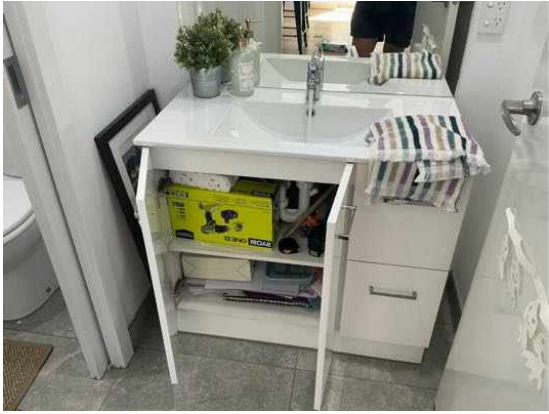
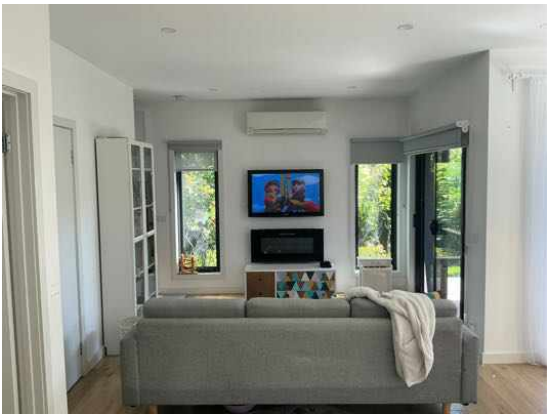
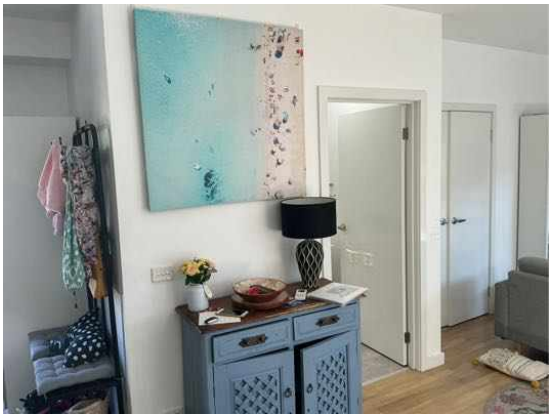
Building: Main Building  
Location: All Areas  
Finding: Additional Photos - Obstructions and Limitations  
Information: These photographs are an indication of the obstructions and limitations which impeded full inspection of the property at the time of inspection. These obstructions can hide an array of defects and should be removed to allow full inspection to be carried out. A re-inspection is recommended once the areas are made accessible.
