# Building and Timber Pest Inspection Report

Inspection Date: Fri, 23 Jan 2026

Property Address: 1219 Mulgoa Road, Mulgoa NSW 2745

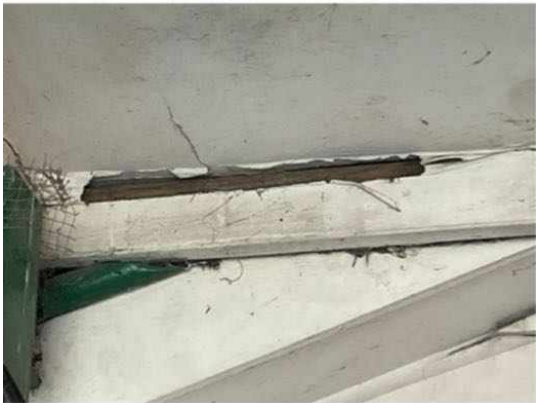
Building:	Carport
Location:	Carport
Finding:	Major Defect – Roof Rafters (Fungal Decay / Wood Rot) – Carport
Information:	Observation:

During the inspection, evidence of wood rot (fungal decay) was identified in several roof rafters within the carport structure. This type of decay typically develops when timber or other cellulose-based materials are exposed to persistent moisture, creating an environment conducive to fungal growth and progressive structural deterioration. In this instance, the timber decay is likely associated with leaks in the roof covering and defective or damaged flashings.

Temporary repairs were noted, including blocking attached to the lower ends of several affected rafters adjacent to the fascia. Sagging of some rafters was also observed, indicating that the structural integrity of these members has been compromised.

It is strongly recommended that all decayed or damaged timber elements be promptly repaired or replaced to prevent further structural compromise. A full assessment of the roof covering and associated flashings should be carried out, and any necessary repairs undertaken to prevent ongoing moisture ingress. Engagement of a qualified carpenter and a licensed roofing contractor is advised to determine the full extent of the damage and perform all remedial works in accordance with current building

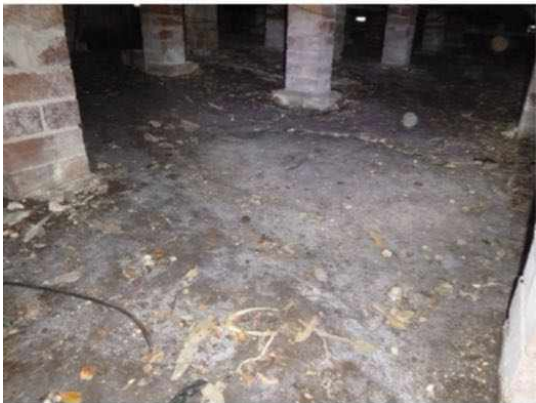
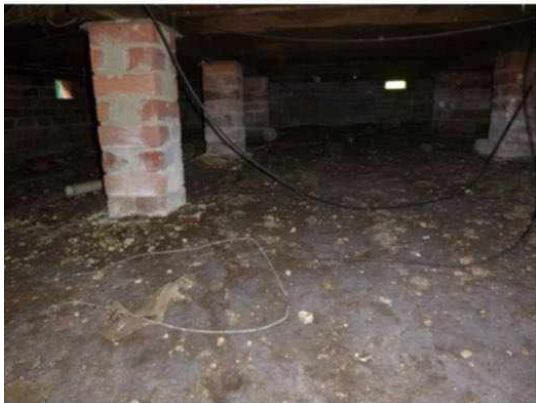
### Finding 2.03

Building:	Main Building
Location:	Subfloor
Finding:	Subfloor - Excessive Moisture identified.
Information:	Observations:

Evidence of excessive moisture was noted throughout the subfloor area, with visible mould growth in the soil. These findings indicate that moisture problems are ongoing and likely associated with substandard subfloor ventilation.

- Redirect all roof and surface water runoff away from the building to prevent further moisture ingress.
- Where subfloor drainage is inadequate, install an agricultural (Aggie) drain or equivalent drainage system.
- Consider the installation of fan-forced subfloor ventilation to improve airflow and assist in drying out excess moisture.
- Engage a qualified roof and drainage plumber experienced in site drainage to assess and rectify contributing issues.
- Consult a subfloor ventilation specialist to design and install an effective ventilation system suited to site conditions.

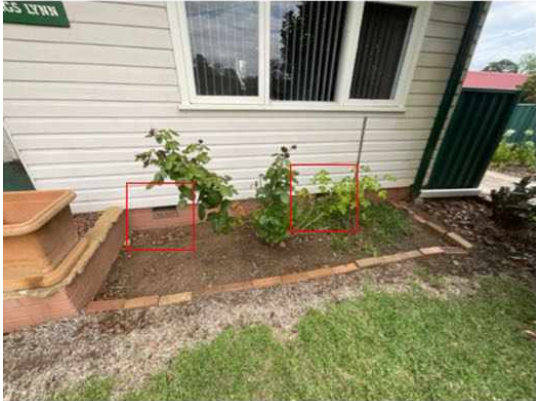
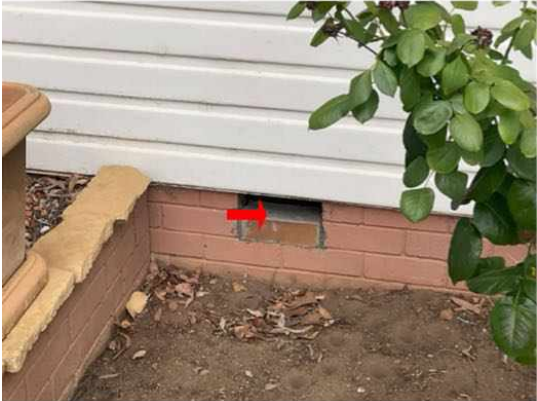
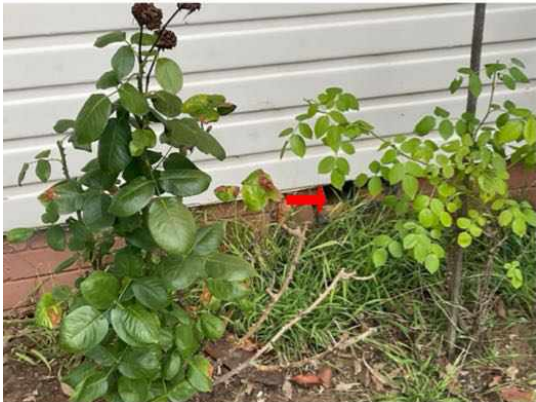
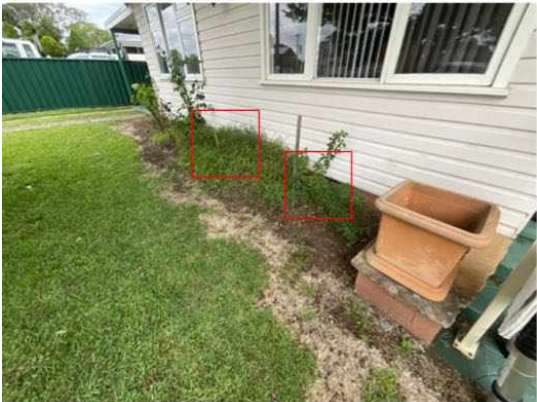
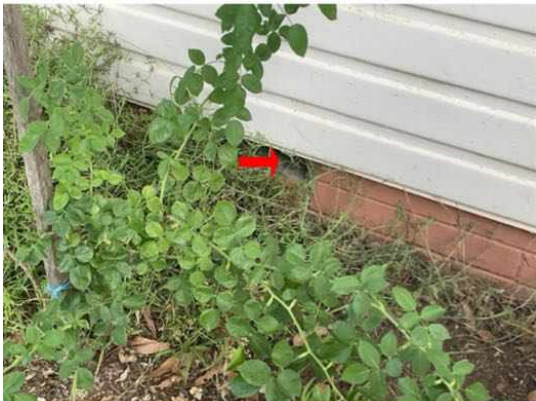
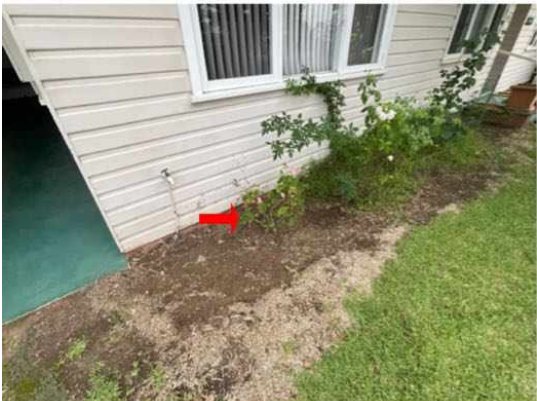
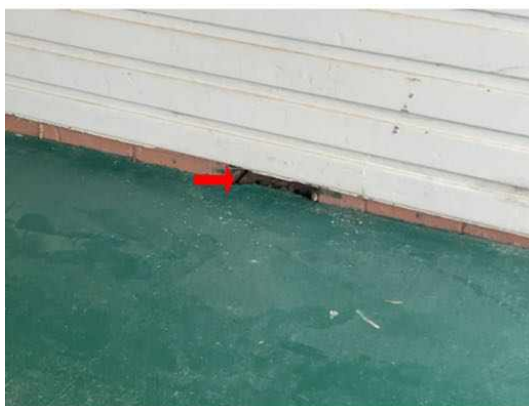
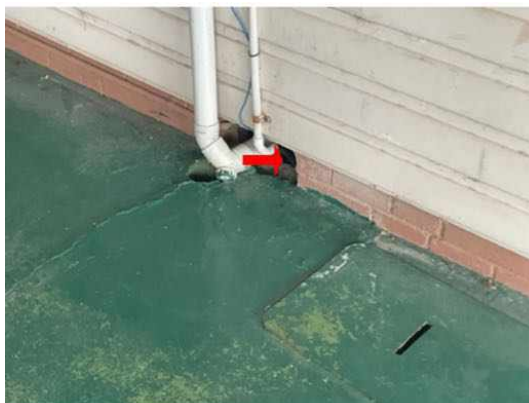
### Finding 3.02

Building:	Yard
Location:	Exterior walls - front
Finding:	Subfloor ventilation - particularly blocked and low
Information:	Subfloor Ventilation and Ground Levels – Moisture Risk

Perimeter landscaping and ground levels should be rectified to ensure adequate fall away from the building. As a general guide, paved surfaces should fall away from the structure by a minimum of 25 mm over the first metre, and bare ground should fall away by approximately 50 mm over the first metre. This will assist in preventing moisture from pooling against the building and entering the subfloor.

Where site drainage is inadequate or rectification is complex, a qualified plumber and landscaping contractor should be engaged to further assess the site and undertake appropriate remedial works to achieve and maintain a dry subfloor environment.

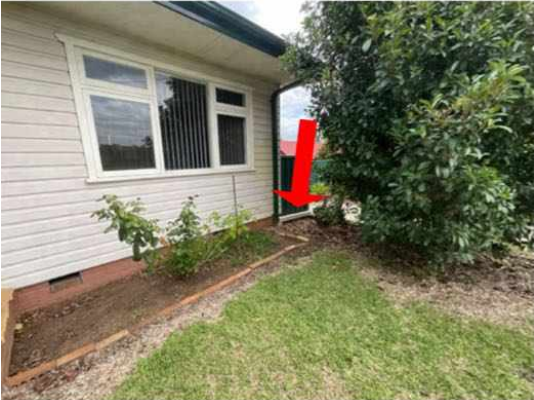
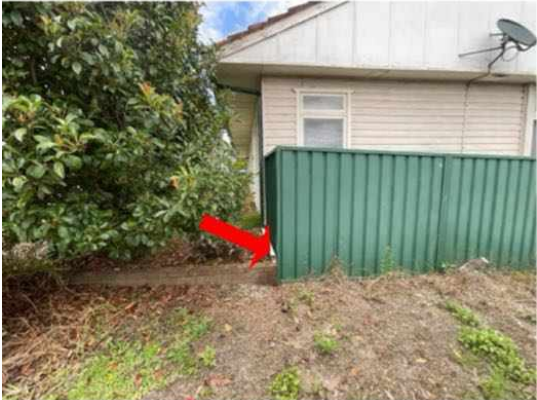
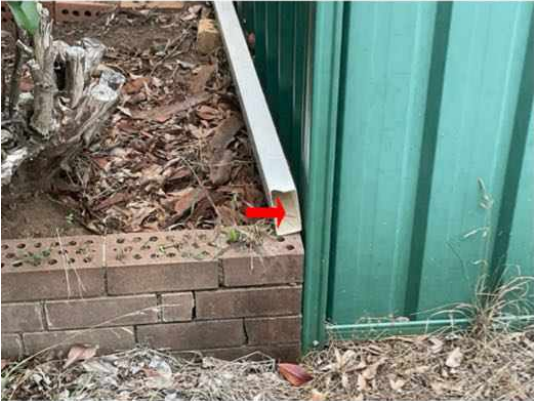
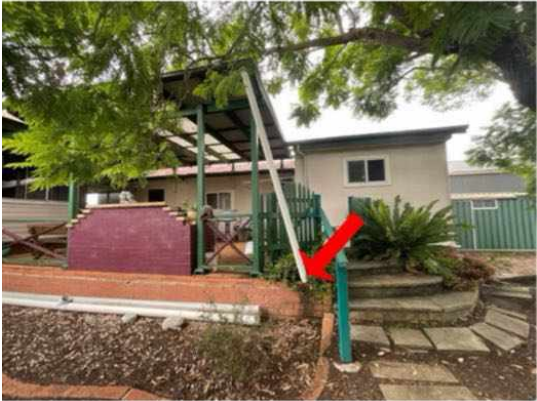
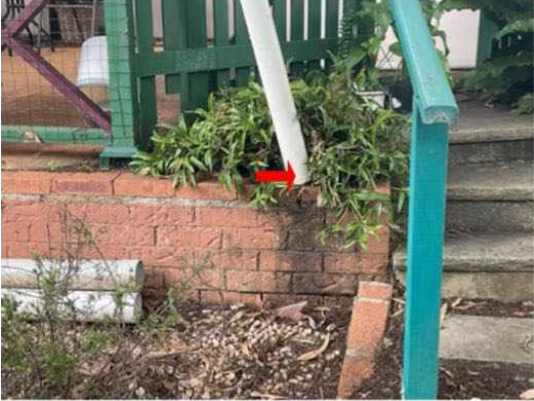
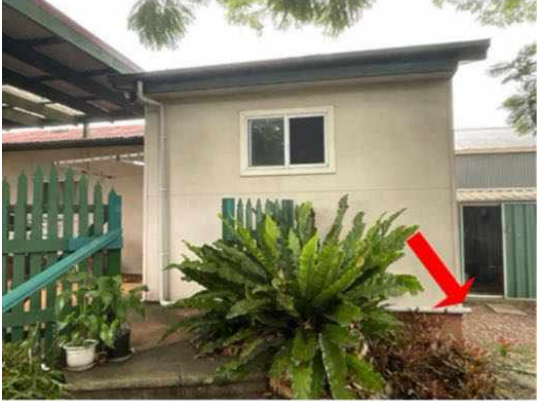
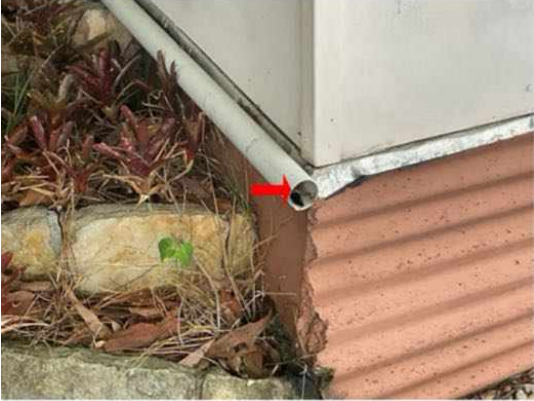
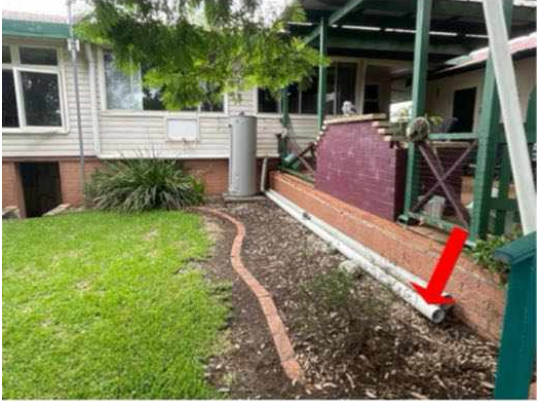
### Finding 3.03

Building:	Yard
Location:	All External Areas
Finding:	Downpipe - Unconnected.
Information:	Observation:

- Inspect the affected roof plumbing area, and
- Connect the downpipe to a compliant stormwater drainage system, or alternatively, install appropriate drainage measures to manage water flow and mitigate potential

property damage or pest risks.

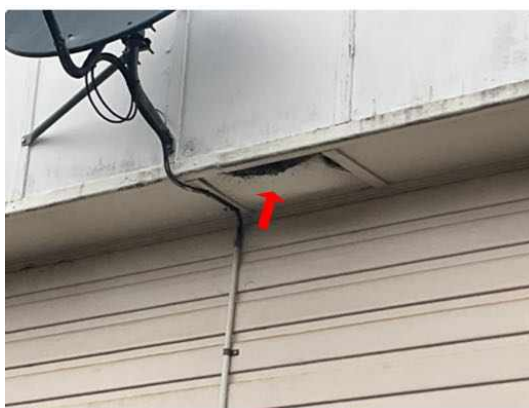
**Finding 3.05**

Building: Yard

- Minor rectification works are recommended. A qualified carpenter or general handyman should be appointed to reinstate and secure the eaves to ensure proper function and alignment.
- Early maintenance will help prevent more costly repairs from developing over time.

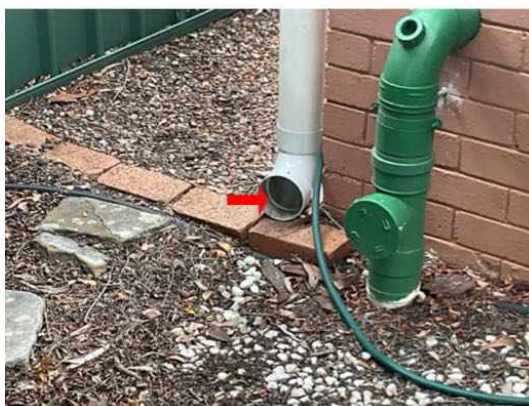
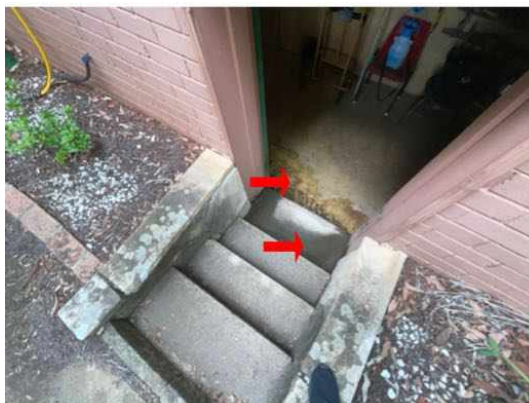
### Finding 3.06

Building: Yard  
 Location: Rear Elevation  
 Finding: Downpipe – Unconnected.  
 Information: Findings:

The current roof plumbing setup poses both compliance and moisture-management concerns, with the potential to contribute to structural or pest-related issues. Prompt rectification by a qualified professional is advised to ensure proper water management and protect the integrity of the building.

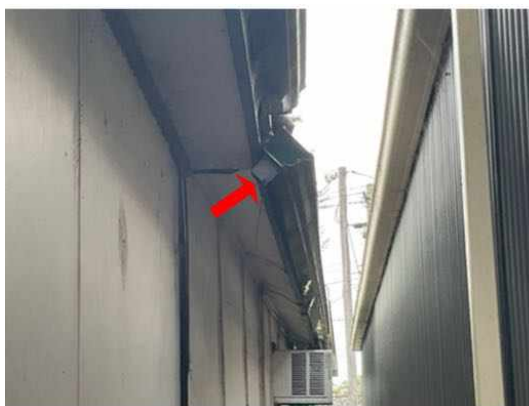
The absence of guttering and proper stormwater drainage in this area presents both functional and compliance issues. Prompt installation by a qualified roofing plumber is strongly recommended to mitigate moisture-related risks and ensure compliance with building standards.

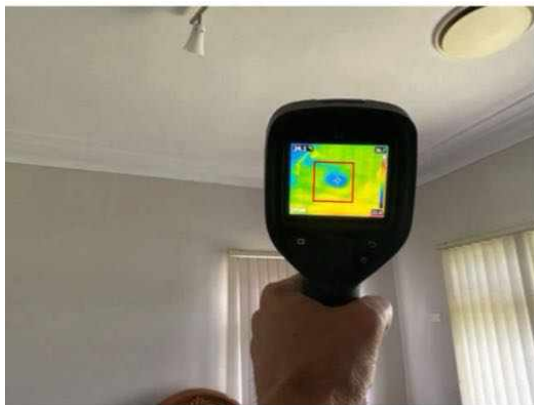
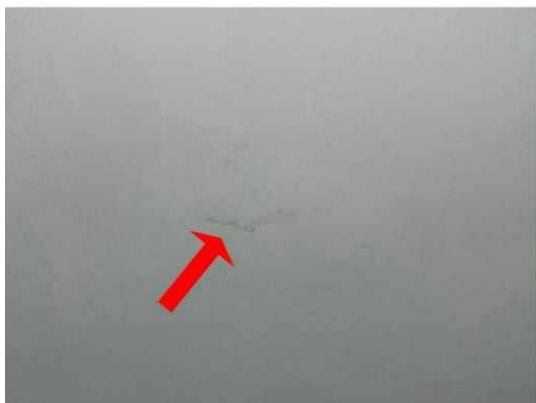
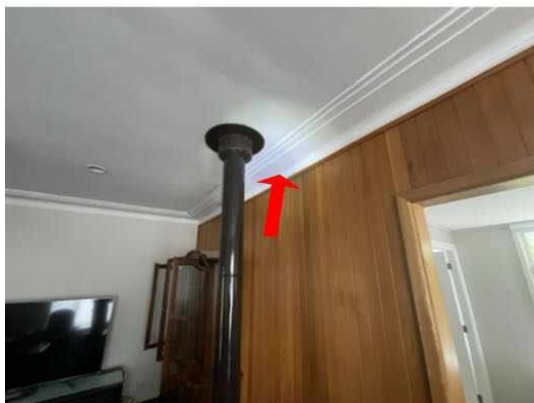
### Finding 3.10

Building:	Main Building
Location:	Bedroom and Living Room
Finding:	Ceiling - Water stained.
Information:	Observation:

Due to the visual-only nature of this pre-purchase inspection, it is not possible to conclusively determine whether water staining is active or inactive at the time of inspection. Further assessment under a special-purpose inspection is recommended if a more detailed diagnosis is required.

Additionally, it is important to note that even minor damage to roofing materials—such as lifted flashings, cracked tiles, or poorly sealed penetrations—can allow water ingress that may lead to costly internal damage. Close-up inspection by a roofing contractor is advised to assess the condition of the roof coverings and associated fixtures more accurately.

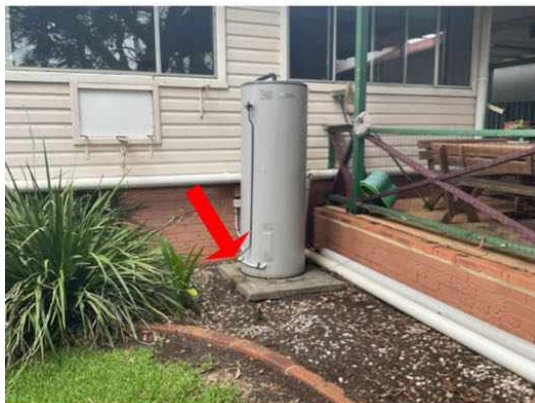
Building:	Main Building
Location:	External Areas
Finding:	Overflow Management – Risk of Termite Activity..
Information:	Observation: Water Pooling from HWS and Air Conditioning Overflows

Water discharge from the Hot Water System (HWS) pressure relief valve and air conditioning unit overflows was observed discharging close to the base of the structure, contributing to water pooling around the building perimeter.

Persistent moisture near the foundation or subfloor area significantly increases the likelihood of termite activity. Termites are highly attracted to damp environments, and stagnant water near structural elements provides ideal conditions for foraging and infestation.

Recommendation:

It is highly recommended that all overflows from the HWS and air conditioning units be redirected away from the building, preferably via fixed drainage or extension piping, to prevent water accumulation near the structure.

These minor corrective works should be undertaken promptly to minimise the risk of both termite ingress and potential structural damage due to ongoing moisture exposure.

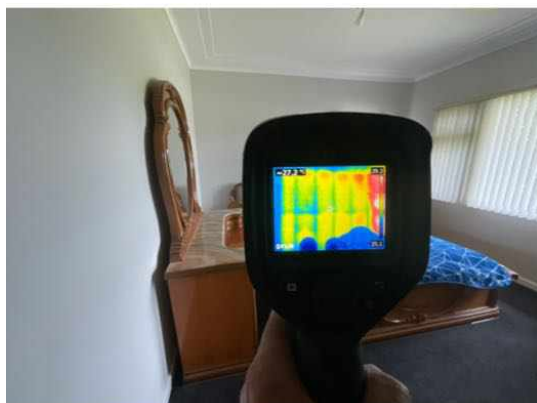
Termites release heat in the form of carbon dioxide and build mud tubes with high moisture content, which can create irregular heat patterns on surfaces such as walls, ceilings, and floors.

At the time of the inspection, no abnormalities indicating live termite activity were observed. However, it's important to note that various factors—such as obstructions, ambient temperature, and wall material/thickness—can impact the accuracy of thermal readings. In cases where surfaces are visually restricted or obstructed, a comprehensive thermal scan may not always be feasible.

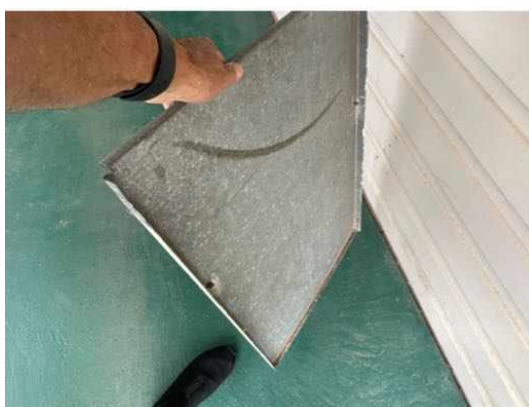
Building:	Main Building
Location:	All Areas
Finding:	Termite Management System - Missing Durable Notice..
Information:	Observation: Missing Durable Notice for Termite Management System

Proper maintenance and documentation are essential to ensure continued protection. Without a visible durable notice, there is no clear indication of what system (if any) is in place, which may limit the effectiveness of future termite inspections and hinder warranty claims.

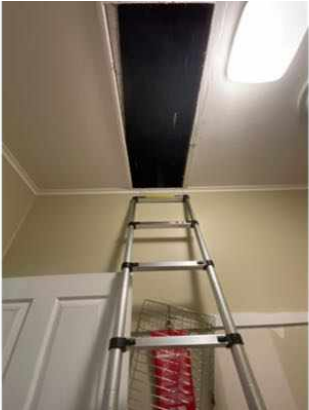
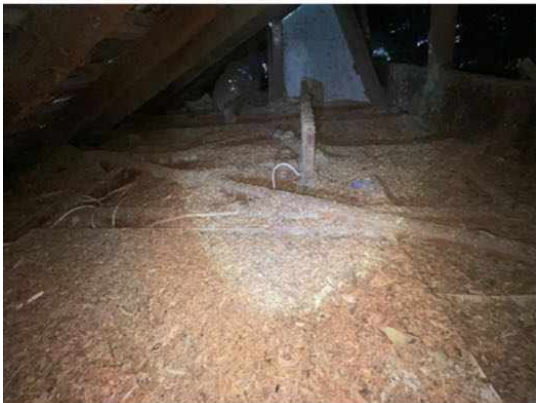
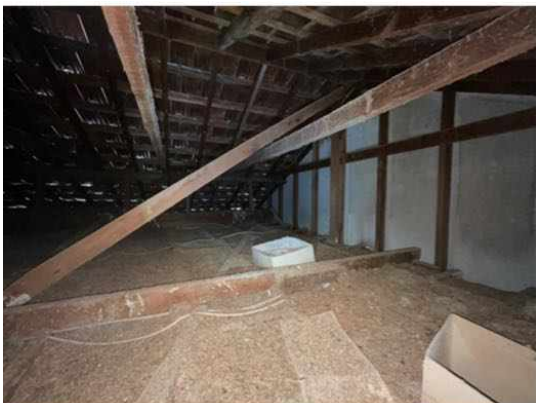
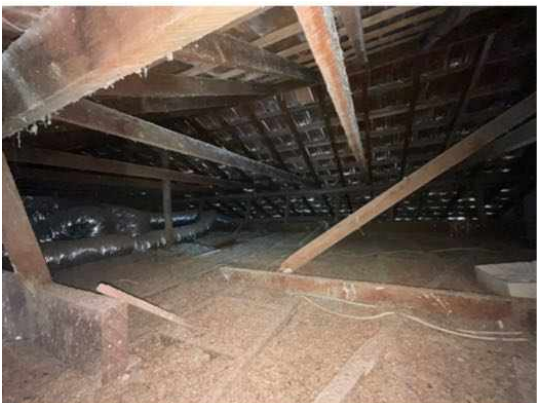
Inspector's Comments

The roof space inspection was limited by restricted access, insulation coverage, and accumulated debris. While no major structural defects were identified in accessible areas, cleaning of debris and further assessment of electrical services are recommended to reduce potential risks and to maintain the overall condition of the roof space.

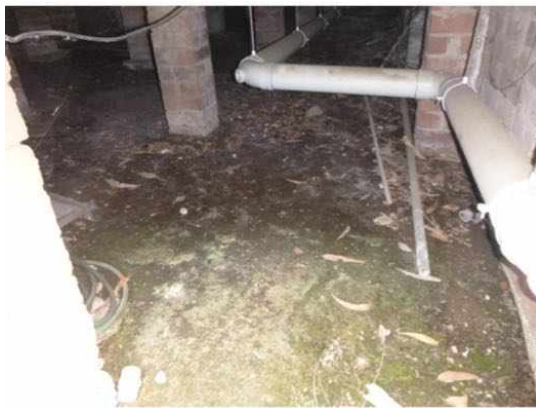
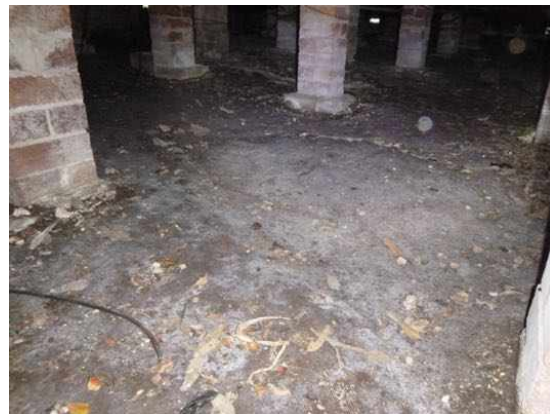
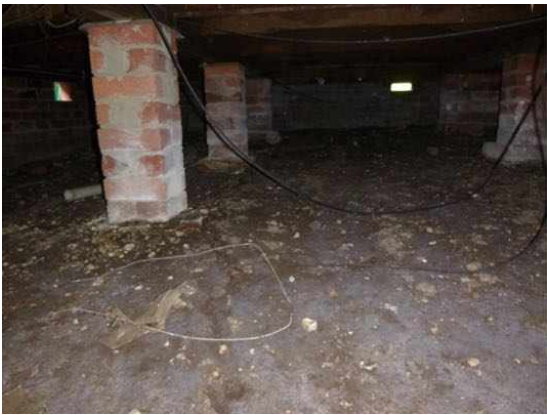
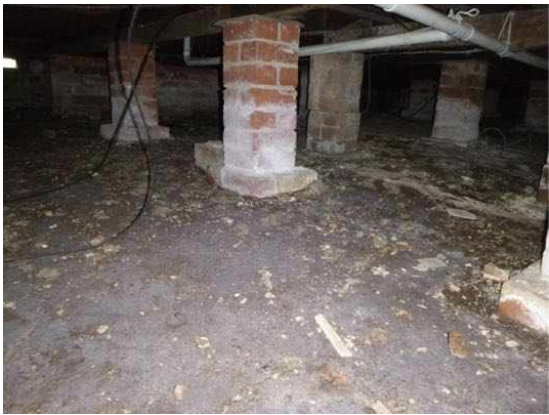
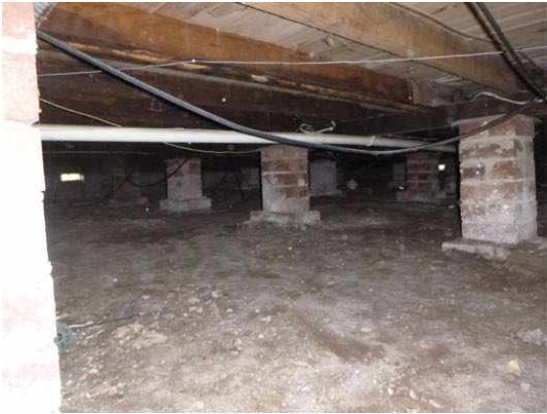
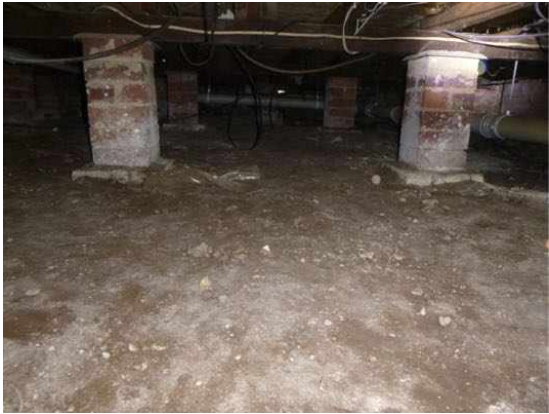
- Photographs were taken for reference.
- Subfloor conditions may vary depending on weather and seasonal moisture changes.
- Inaccessible areas may conceal defects that were not identifiable at the time of inspection.

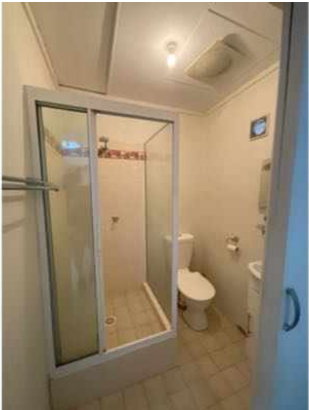
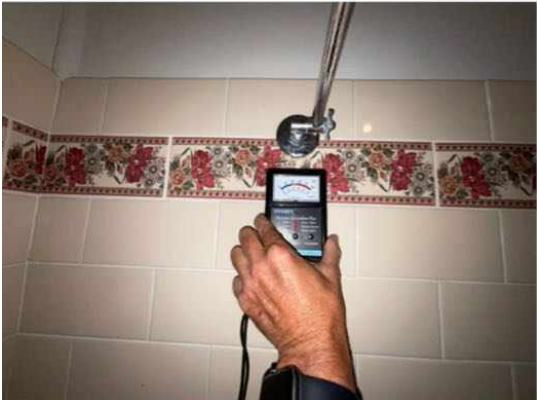
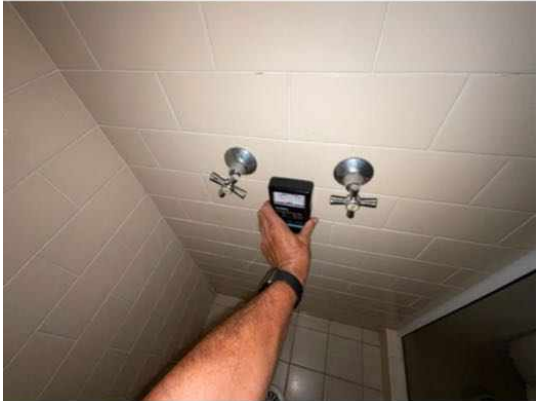
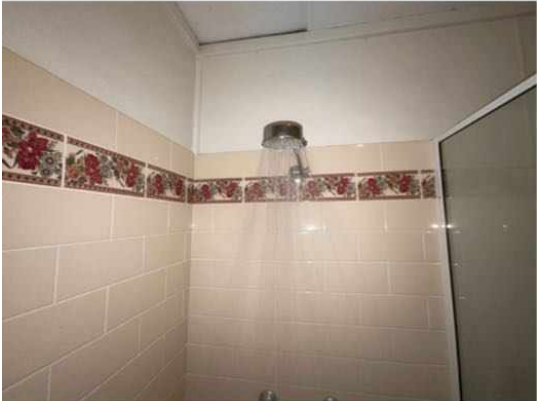
### Noted Item

- Where required, a sealant specialist or qualified tiling contractor should be appointed to carry out remedial sealing works.

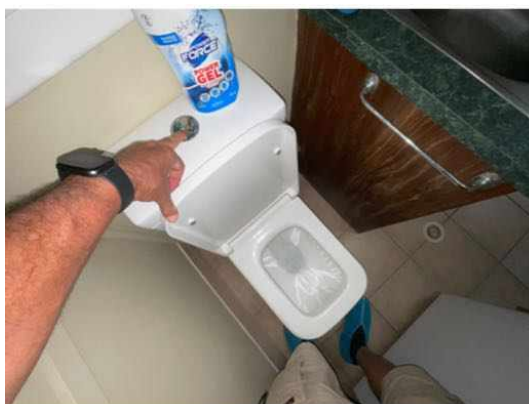
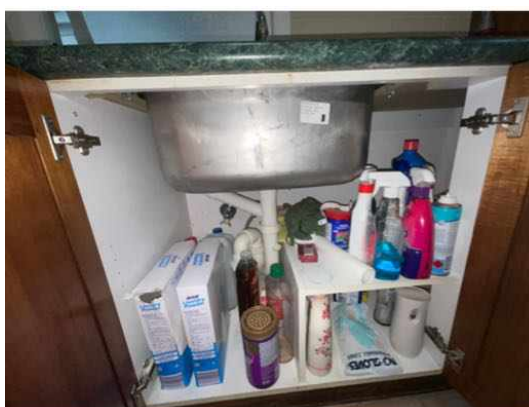
Building: Main Building  
 Location: Bathroom  
 Finding: Wet Areas - Bathroom(s) - Overall Condition & Recommendations.  
 Information: Overall Condition & Recommendations

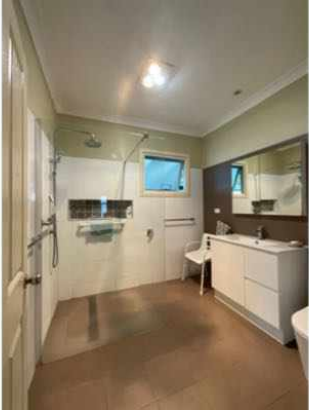
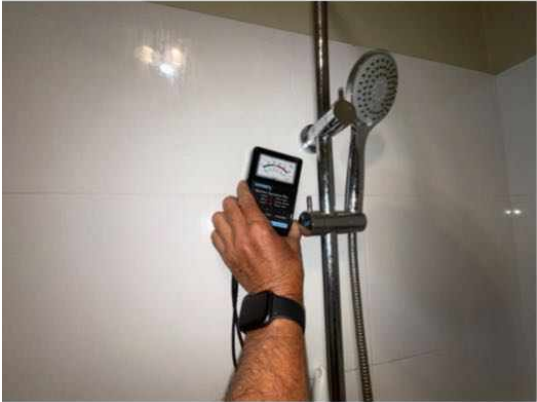
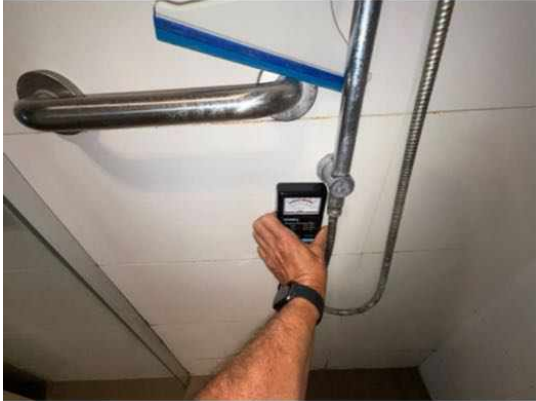
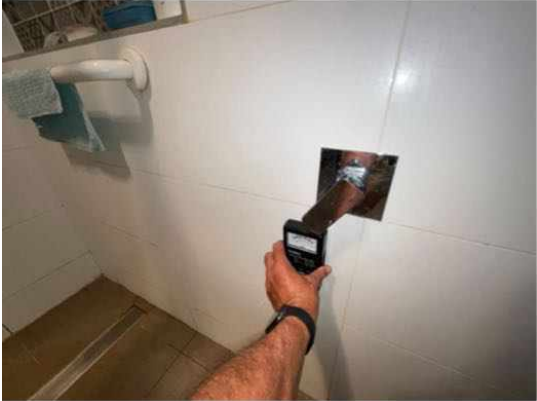
- Floor waste was found to be clear and free of blockages at the time of inspection. Further monitoring is advised after consistent use to identify any drainage issues or buildup requiring cleaning.

- No elevated moisture readings were detected around the tap fittings or behind the shower walls (as viewed from adjacent rooms), suggesting no active plumbing leaks at the time of inspection.

- Elevated moisture readings were found in the lower shower walls, which is a common occurrence with certain tile types that naturally absorb more moisture. This should be monitored over time.

- Sealing of grout and tiles is recommended to prevent moisture buildup and mould growth in damp areas such as showers.
- The condition of grout and sealant appeared to be serviceable , with some areas potentially requiring maintenance or replacement.

- Mould growth was noted in some areas of grout/sealant. Cleaning or, if necessary, replacing affected grout or sealant is recommended to maintain hygiene and waterproofing integrity.

- The exhaust fan appeared to be operational, which supports moisture control in the bathroom.

- No leaks were observed during flushing. The toilet operated normally, and the toilet pan appeared to be securely fixed to the floor.

- Basin(s) were water tested and inspected, with no leaks or blockages identified in the plumbing or drainage system at the time of inspection.
- Further monitoring is recommended after the basin(s) are placed under regular use to confirm ongoing performance and cleanliness.
- No visible water damage was observed to the vanity cabinetry at the time of inspection.
- Stored items inside the vanity obstructed full visibility during the inspection. It is advised that the area be re-inspected once all obstructions are removed.
