Building and Timber Pest Inspection Report

Inspection Date: Thu, 8 Jan 2026

Property Address: 31 George St, Berry NSW 2535, Australia

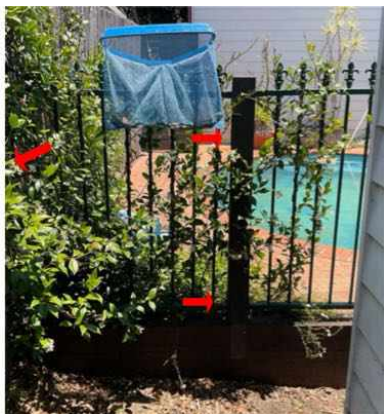
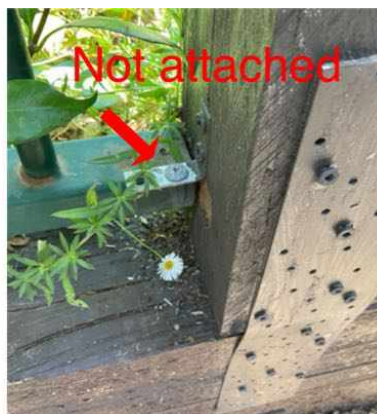
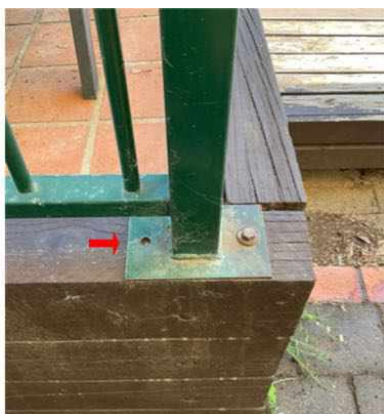
Building:	Building 1
Location:	Pictured pool area
Finding:	Additional fixings required
Information:	Evidence of insufficient fixings were evident on areas of the pool fence. Some areas need additional and replaced fixings to ensure their safety and longevity.

A carpenter should add additional fixings to these areas immediately for the safety of all vulnerable persons.

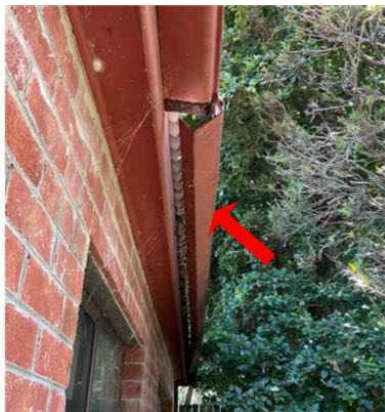
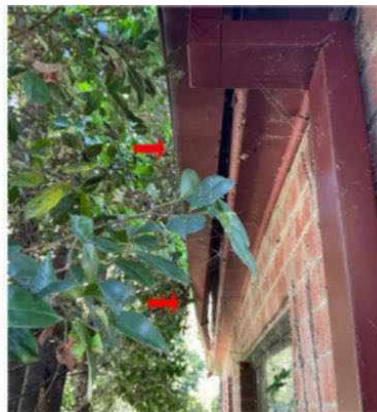
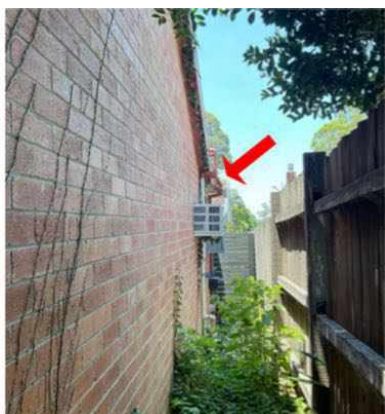
Finding 1.02

Building:	Building 1
Location:	Pictured flat areas
Finding:	Gutters Loose
Information:	This rear and left flat gutters are loose and requires immediate refixing. These areas may fall at any time and injure nearby persons.

If left unmanaged, this will deteriorate, causing potential for the development of other defects.

A carpenter or roof plumber should be appointed to perform these rectification works immediately.

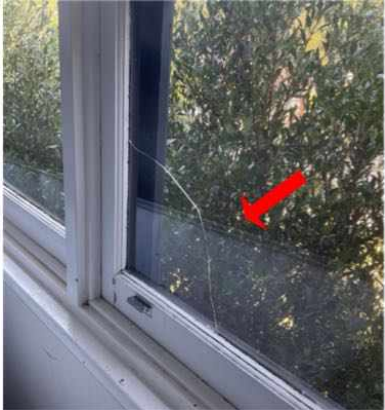
Finding 1.03

Building:	Building 1
Location:	Bedroom - Master
Finding:	Window - Cracked
Information:	Cracks were identified in the window in this front wall area. Cracking in windows is generally the result of impact damage, and is likely to develop further when left unmanaged.

The likelihood of this windowpane further cracking and shattering is increased exponentially, providing a safety hazard in the area. The cracked window also impairs the weather tightness of the building, creating potential for minor water leaks.

A qualified glazier is required to repair the window as soon as possible. Depending on the extent of the cracking, replacement of the window may be required. Please be advised that any persons coming into contact with the cracked window should do so with due caution to avoid any personal injury that may ensue.

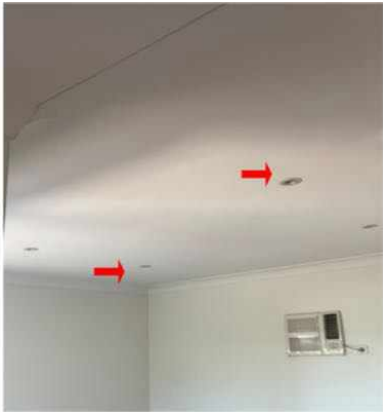
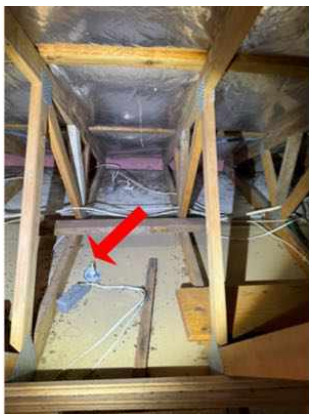
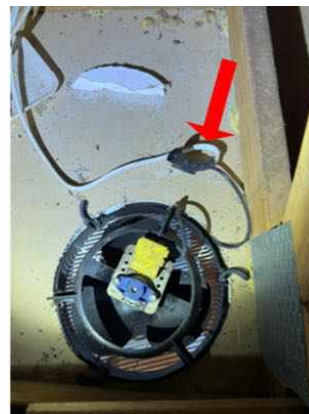
Finding 1.04

Building: Building 2
Location: Roof Cavity and described flat downlights
Finding: Electrical cables missing a junction box and lights faulty.
Information: The electrical fitting in the flat kitchen roof area was found to be missing a junction box at the time of inspection.

This missing fitting and loose cables does expose electrical works, and may create a safety hazard if there is potential contact with persons in the area.

Both the flat external lights and internal loungeroom lights are intermittent and do not appear to work consistently.

A Licensed electrician should be appointed to rectify these areas immediately.

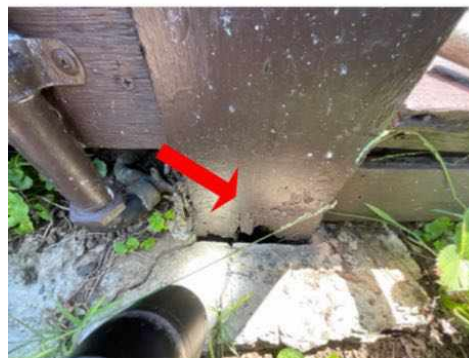
Finding 2.01

Building: Building 1
 Location: Granny Flat
 Finding: Wall - Loose
 Information: The wall in this area is loose and requires additional urgent support. The base of this post has severe wood rot and now provides no support.

If left unmanaged, the wall will fail, causing potential for injury.

A carpenter should be appointed to perform these rectification works immediately.

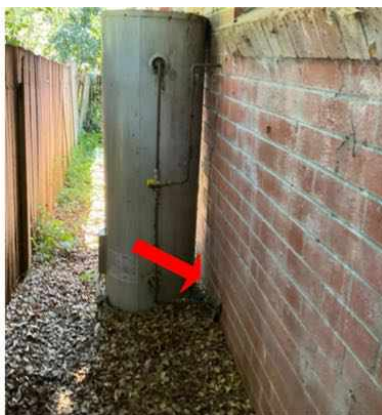
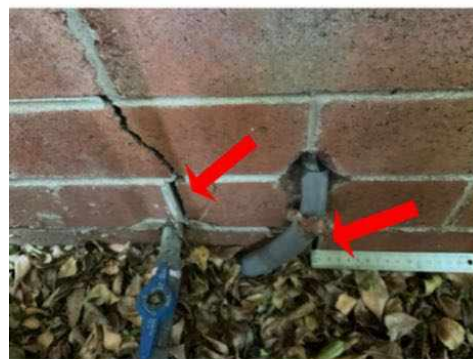
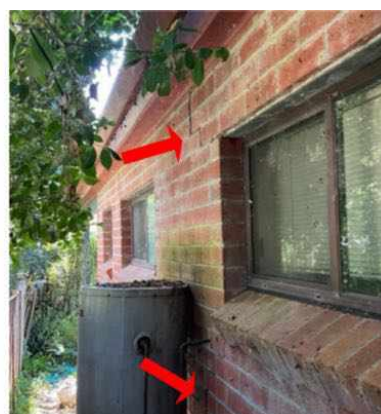
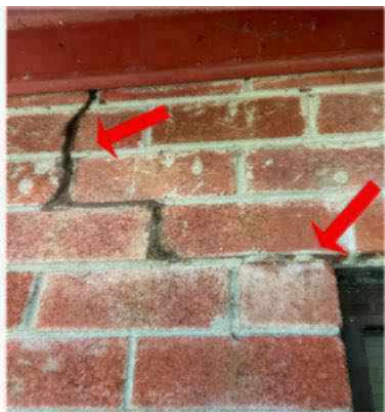
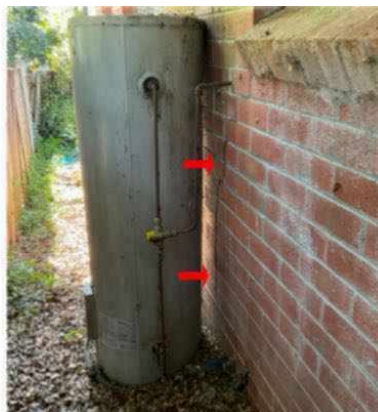
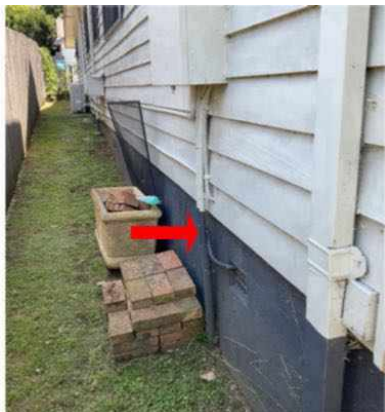
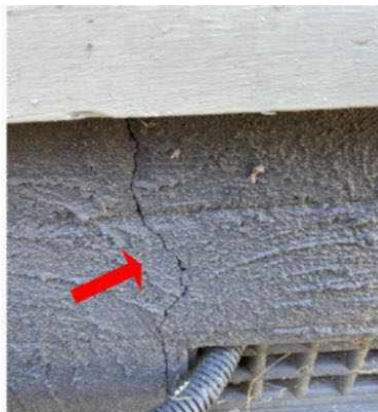
Finding 2.02

Building: Building 1
 Location: Exterior house wall & flat rear wall
 Finding: Step cracking to brickwork - major at base - 6mm
 Information: Step cracking was identified to the brickwork in the external rear flat wall area at the time of inspection. The crack at the bottom of this rear flat wall is 6mm (photos 1-3).

Most other cracks are 2-3mm.

The NSW Standards and Tolerances 2017 states cracks over 5mm in width are a major defect requiring rectification. This applies to the flat middle lower wall.

The other wall cracks are minor and should be monitored annually.

Step cracking, which is similar to other forms of cracking, has a variety of possible causes. However, the most common is the subsidence of adjacent footings.

Step cracking is a relatively common defect, and is most likely to occur adjacent to windows, doors and other openings. Mortar failure in the gaps between affected bricks indicates the stresses and tensions affecting the wall.

Where step cracking is extensive or severe in this case, the client is advised to consult a structural engineer. Minor step cracking can be used as a warning sign to address factors causing stress to the wall, which can include the effect of surrounding trees, water leaks, soil erosion, or even the presence of reactive soils in the surrounding area.

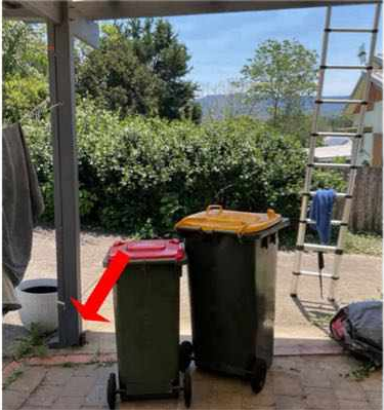
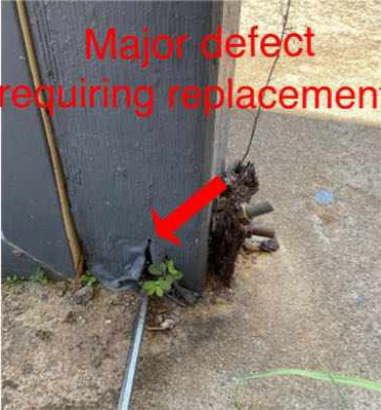
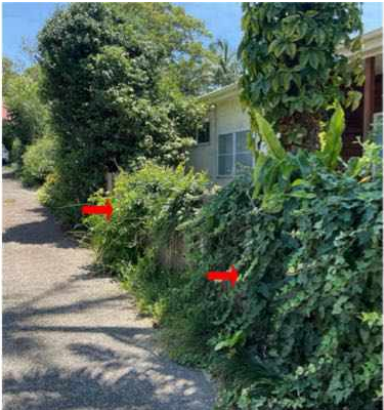
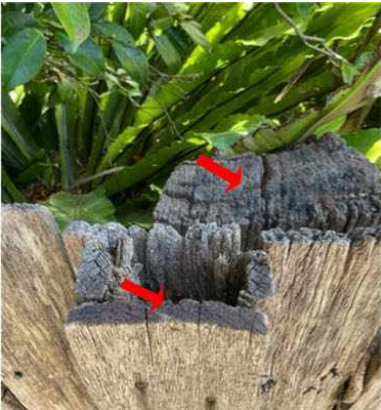
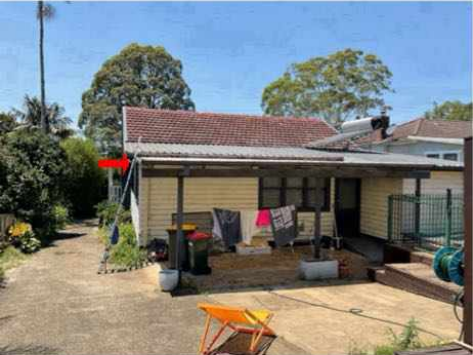
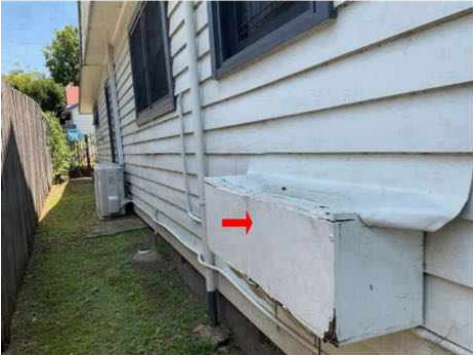
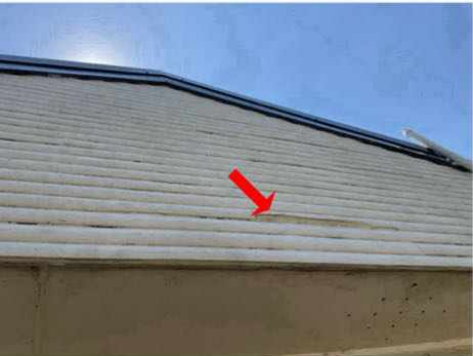
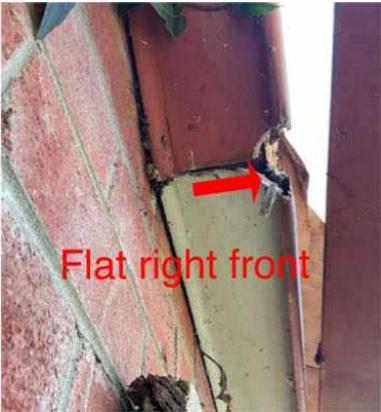
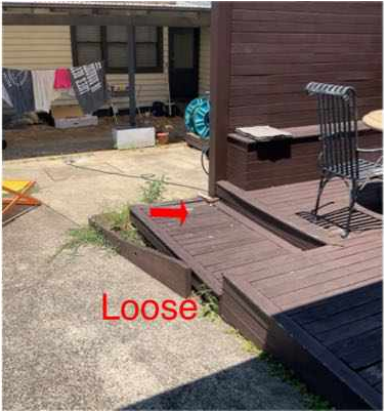
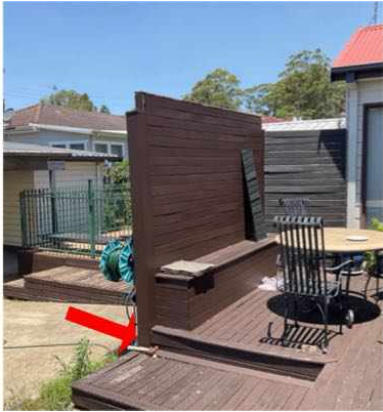
Finding 2.03

Building: Building 1
 Location: Pictured areas
 Finding: Wood rot
 Information: Both buildings show evidence of wood rot. The rot to the rear right pergola post is a major defect (pictures 1 & 2). This post has dropped and requires urgent replacement.

The following pictures show minor wood rot. Some areas of insufficient fall to gutters has resulted in wood rot to fascias and nearby areas.

Wood rot, also known as Fungal Decay, occurs when timbers and other cellulose building materials are exposed to damp conditions on an ongoing basis. This could be the result of exposure to weathering over a prolonged period of time, or the attraction of excessive moisture from other abutting building materials.

Early intervention and regular maintenance, particularly of exterior timbers, will prolong the useful life of these building elements. Prior to any works being performed, the cause of the moisture that has created the visible wood rot should be identified and addressed in a suitable manner. Replacement of affected timbers may then be a necessary step in protecting surrounding building elements from such deterioration.

A qualified carpenter or registered builder will be required to replace affected building materials.

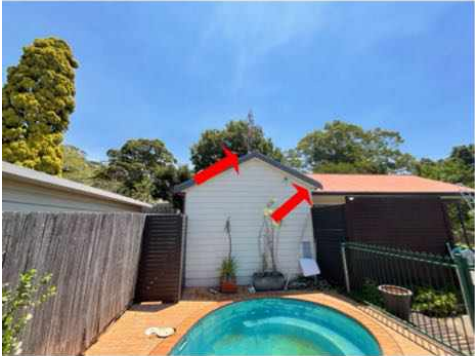
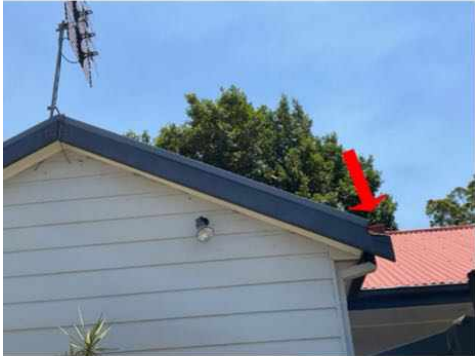
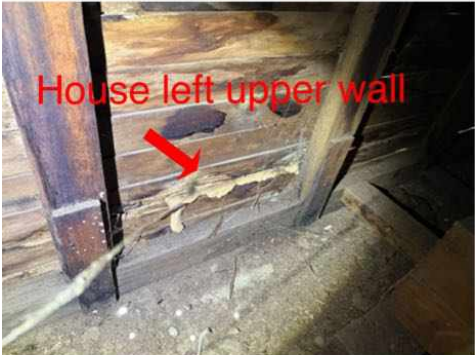
Finding 3.01

Building: Building 1
Location: Pictured areas
Finding: Wood rot (continued)
Information:

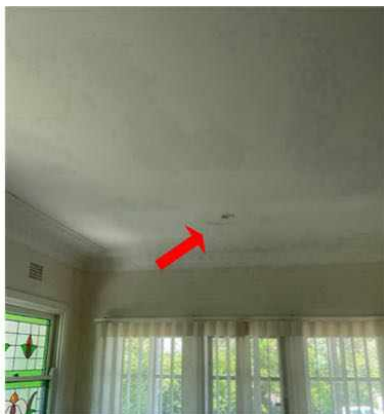
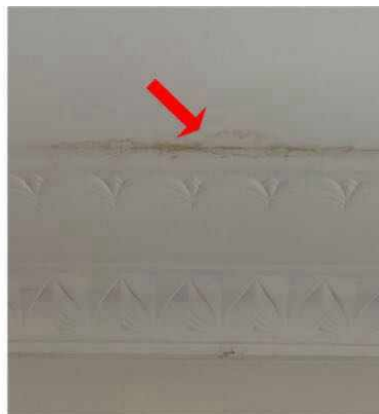
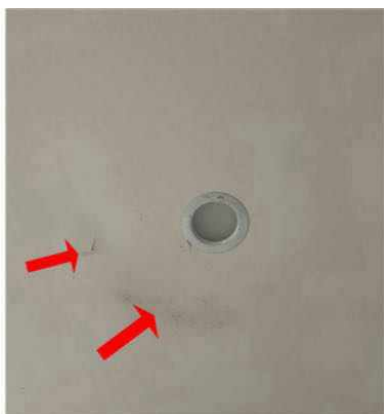
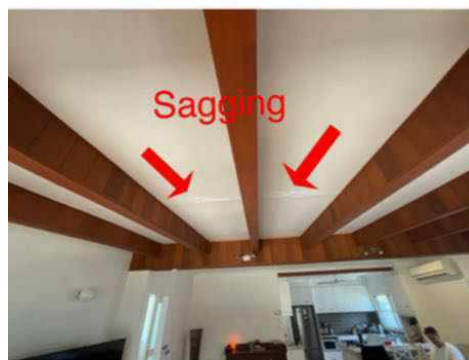
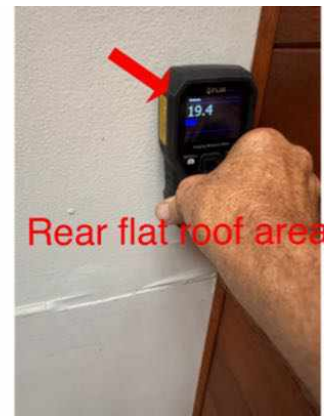
Finding 3.02

Building: Building 1
Location: Both Lounge Rooms
Finding: Ceilings - Water stained, minor mould and sagging and moisture in rear
Information: Water staining to ceiling linings in both lounge room ceilings was evident at the time of inspection. Water staining indicates that surfaces have been exposed to excessive moisture over time. The minerals and other elements in the water lead to staining, which may graduate to corrosion and deterioration if left unmanaged.

Where water staining is active in the case of the rear loungeroom (a low reading of 19.4 was recorded), a licensed roof plumber must be consulted to identify the cause of the staining and to provide advice on any reparation works that may be required. Replacement of any damaged structures is required.

Conversely, where water staining is old and inactive, as appears to be on the front loungeroom, the affected building materials may be repaired or replaced at client discretion.

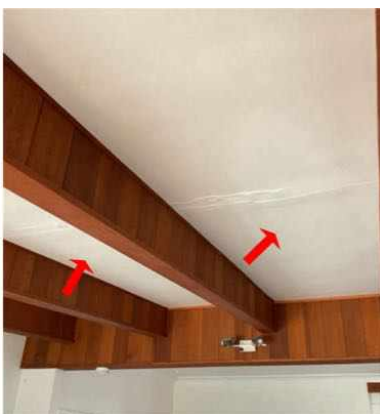
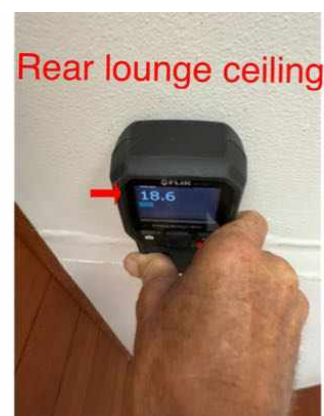
Finding 3.03

Building:	Building 1
Location:	Lounge Room rear and right bedroom
Finding:	Evidence of excessive moisture was present at the time of inspection
Information:	Excessive moisture was found in the rear loungeroom ceiling and right bedroom. The rear ceiling showed readings up to 19.4 and ten right bedroom up to 45.1.

This moisture can attract termites and produce conditions that promote termite attack fungal growth and wood decay.

Excessive moisture is generally caused by deteriorated inadequate or missing roof drainage, damaged sealant and cladding, leaking plumbing pipes or fixtures poorly plumbed HWS overflows or condenser units and poor site drainage.

It is highly recommended that all roof plumbing, drainage, external sealant etc be maintained regularly in order to prevent excessive moisture being present in the internal property.

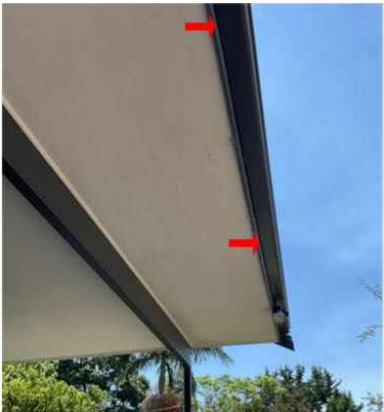
Finding 3.07

Building: Building 1
Location: Pictured Areas of both buildings
Finding: Sealant (external) - Missing.
Information: It was noted on inspection that areas of external sealant was missing to the external walls and roof areas of both buildings.

Flexible sealants should be applied to these affected areas to prevent any subsequent water damage that is likely to occur.

A sealant specialist or skilled handy person should be appointed to complete these works as soon as possible

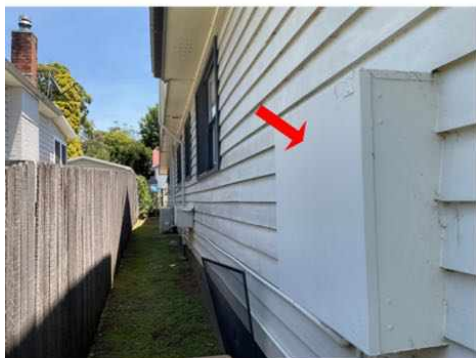
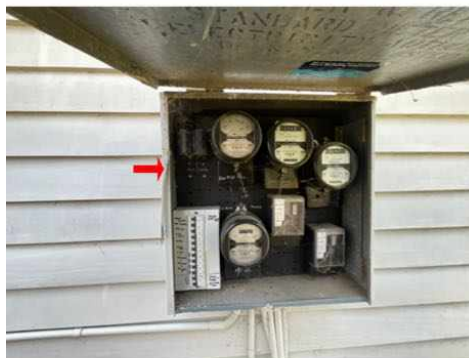
Building:	Building 1
Location:	Meter Box
Finding:	Termite Management System - no evidence of a chemical installation
Information:	The application of a post-construction chemical termite barrier is highly recommended for all properties. Such barriers are highly effective in preventing termite attack on any timber building elements throughout the property.

A durable notice should be placed in the switchboard unit to indicate current termite barriers. At the time of inspection, no durable notice was evident and it appeared as though no chemical termite management system has been installed, with no evidence to suggest preventative works taking place since the property was built.

The client must consider gaining further advice from a pest controller as to the costs and procedures involved with a 'chemical' application due to numerous conditions conducive to termite activity. It is recommended that obtaining such advice be a short-term priority.

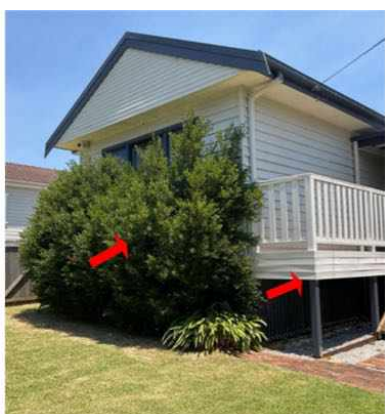
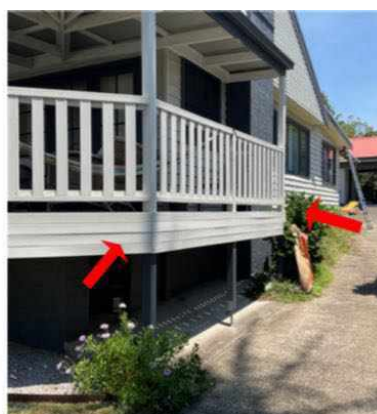
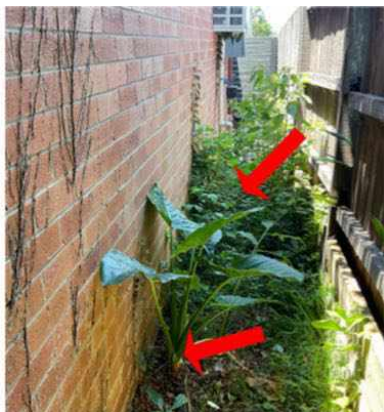
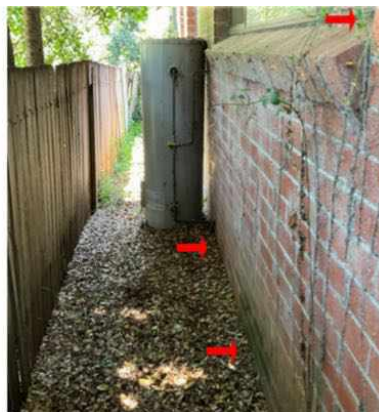
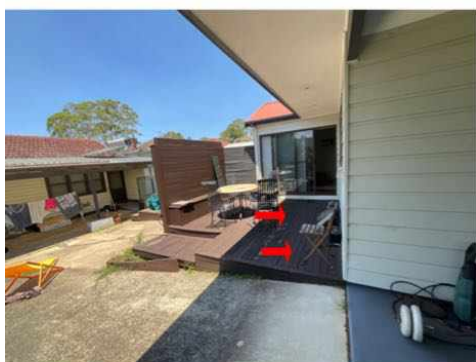
Finding 6.02

Building:	Building 1
Location:	Wall, flat and carport areas
Finding:	Bridging - Vegetation and decking
Information:	Where vegetation and decking obstructs inspection of building elements, also known as bridging as it provides a bridging point for the access of termites, full inspection can not be achieved. Consequently moisture or dampness may be present and the areas becomes conducive to termite activity. Plants and decks against or very close to buildings provide cover, shade and can provide an environment that is attractive to termite infestation.

The removal and replanting of plant species that do not provide "cover" or cutting back of existing vegetation and leaving a small gap between decking and the building walls will assist greatly in preventing Bridging from occurring.

The removal of any such stored building or plant materials that may be conducive to termite activity should be carried out as soon as possible and arrange re inspection to minimize the risk of termite attack.

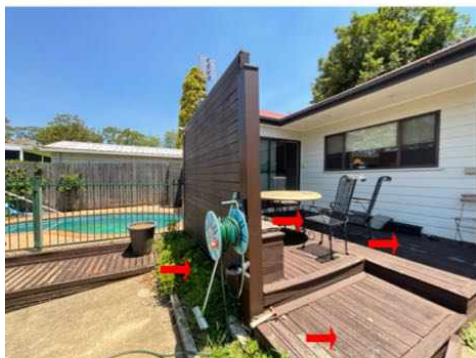
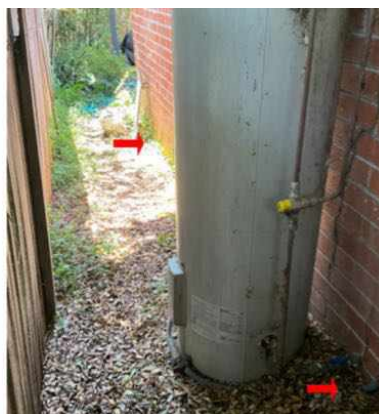
Finding 6.03

Building:	Building 1
Location:	Exterior walls
Finding:	Slab Edge - Exposure
Information:	An inspection zone of at least 75mm in relation to the exposed slab edge, between the bottom brick and the perimeter pavement, is required. This inspection zone should be maintained in order to force termites into the open where they can be detected more readily during regular inspections. The slab edge should not be concealed by anything that may prevent inspection of the area, including render, landscaping, soil, turf, paving, concrete cladding or other structures.

If the slab edge is not properly exposed there is a high risk of termite attack. Sometimes, in order to determine the type of slab, a suitably qualified person such as an architect or builder may be required to consult the construction plans.

Where the slab edge cannot be properly inspected, it is highly recommended that termite or timber pest inspections be carried out every 6-12 months to aid protection of the property against infestation.

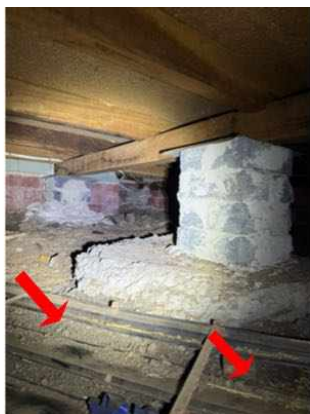
Finding 6.04

Building: Building 1
 Location: Subfloor
 Finding: Timber in contact with the ground
 Information: Any timbers in direct ground contact provide opportunity for concealed termite entry and are likely to be subject to premature rot and decay as the soil retains moisture or damp conditions against the timbers.

Removal of all waste timber and other items that is in direct contact with ground is highly advised. These areas are promoting mould and wood rot and is very attractive to termites.

Frequent pest inspections are advised to readily identify any termite activity in these areas.

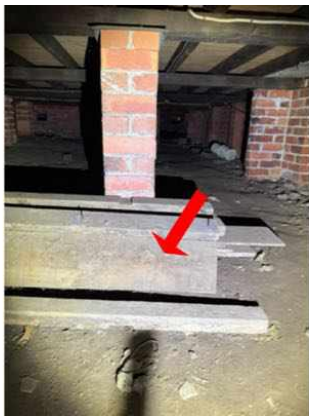
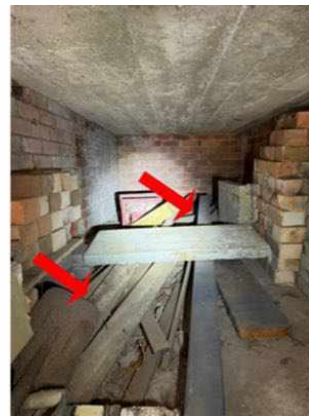
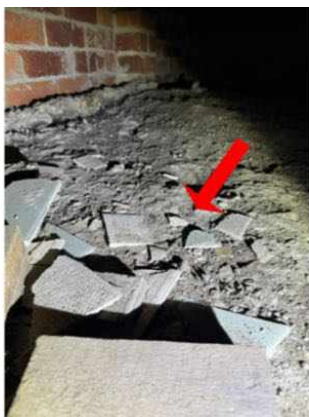
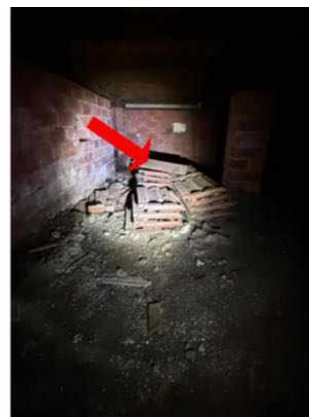
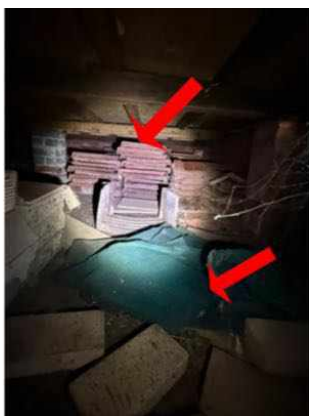
Finding 6.05

Building: Building 1
 Location: Subfloor
 Finding: Subfloor - Debris and building materials
 Information: An array of debris was found in the subfloor area at the time of inspection. Debris in this area restricts subfloor ventilation and creates potential for concealed pest entry.

Stored timbers and other materials may also make the area susceptible to termite activity and wood rot.

A clear and empty subfloor will be better ventilated and easier to maintain in a dry condition. The removal of any timber debris is vital in minimising the risk of termite or wood borer activity.

Debris in the subfloor should be removed as soon as possible. Depending on the location and amount of debris and stored items, the homeowner may elect to undertake this task. Alternatively there are a large number of rubbish removal subcontractors that could undertake these works.

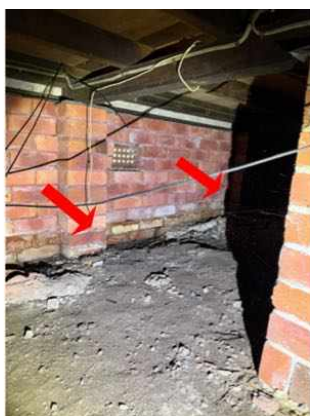
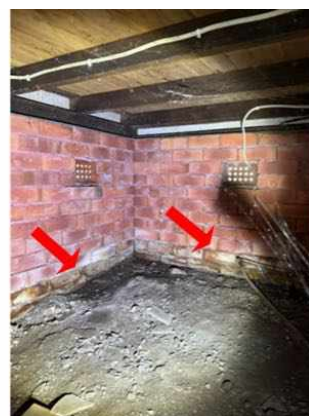
Finding 6.06

Building:	Building 1
Location:	Subfloor
Finding:	Damp - Rising
Information:	Rising damp describes the upward movement of water in low sections of building elements (e.g. walls) by capillary action - the movement of water through porous materials such as bricks, sandstone or mortar.

Rising damp is generally managed by the installation of a damp proof course during construction. A Damp Proof Course (DPC) is an impermeable barrier at the base of the wall above ground level. However, many 19th Century buildings have no damp course installed, or the materials have failed. The DPC may have been omitted as a consequence of poor workmanship, or it may have been bridged where materials built up against the side of the house allow moisture ingress above the DPC level.

The first step in addressing rising damp is to diagnose the cause. The identified cause should be addressed first before addressing the appearance and other defects which have resulted from the rising damp. If the original cause is not resolved, further cases of damp are likely to ensue, resulting in secondary defects.

Consultation with a qualified plumber is advised immediately to identify the cause of the damp and perform remedial works as required.

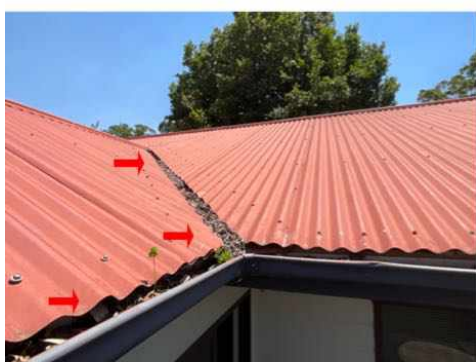
Finding 6.07

Building:	Building 1
Location:	Roof exterior
Finding:	Gutters - Full and blocked
Information:	The guttering on around the roof was found to be blocked at the time of the

Blocked gutters are likely to lead to high levels of moisture in the affected areas. Such moisture will not only cause rust and decay of the associated building materials, but can also provide conditions that are conducive to termite and timber pest activity. Blockages in gutters should therefore be removed immediately to ensure dry conditions are maintained.

It is highly advised that gutters be cleaned by the homeowner or a general handyperson as a matter of urgency.

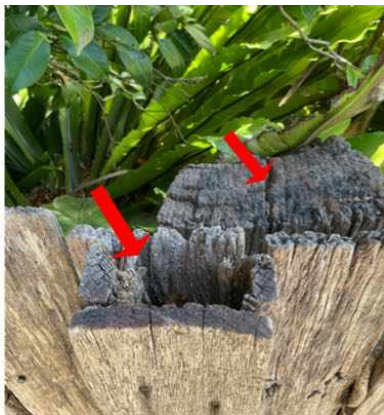
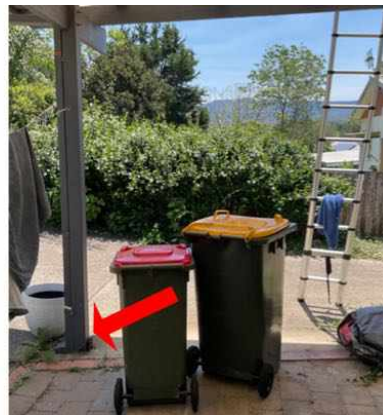
Finding 7.01

Building:	Building 1
Location:	Pictured areas
Finding:	Fungal decay - present (localised)
Information:	Fungal decay also known as wood decay or wood rot generally refers to the deterioration of timber elements when in contact with excessive levels of moisture for a prolonged period of time.

The development of fungal decay is accelerated by temperatures from 5degreeC to 40degreeC as well as the presence of oxygen. Generally fungal decay develops on timber elements that are in use in an external environment which are exposed to rain penetration.

In this case, the affected timber facias and wall areas are in a decaying state and will need replacement by a carpenter or licensed builder.

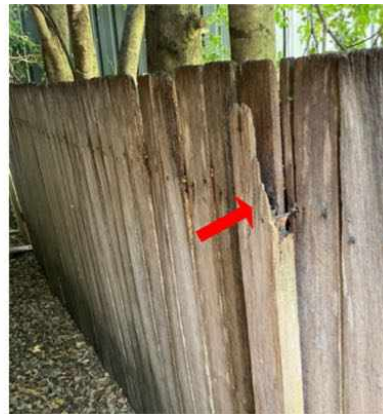
Finding 8.01

Building:	Building 1
Location:	External fence and front flat wall areas
Finding:	Evidence of wood borer activity identified
Information:	Wood borers small beetles that colonise in exposed timber elements are a common timber pest that are regularly mistaken for termites. Although wood borer activity is generally not detrimental to the affected timber they may lead to serious damage and

necessitate replacement of certain building elements if left unattended.

As no live wood borer activity was identified treatment is not required at this time. Replacement of affected timbers may be considered by the client for superficial reasons.

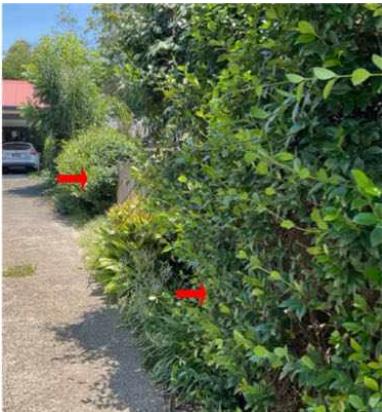
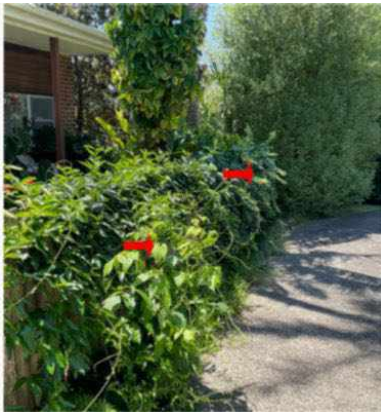
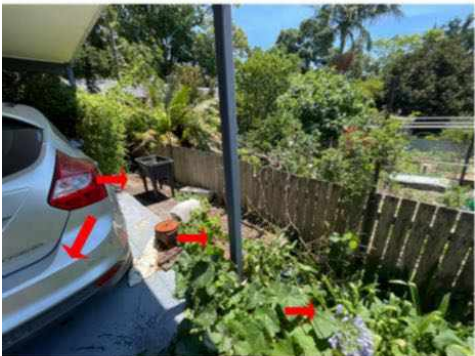
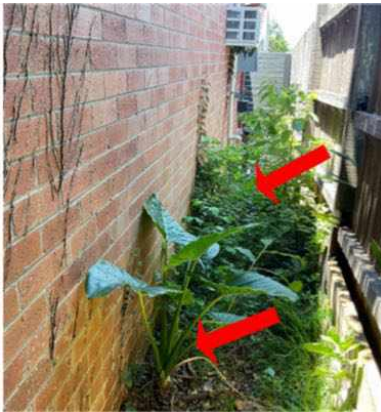
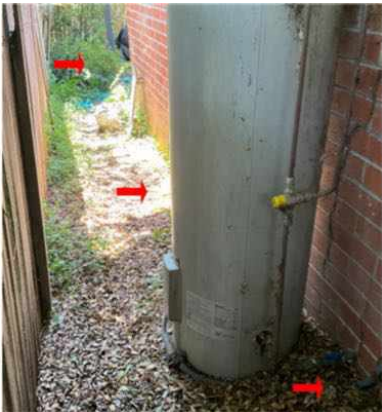
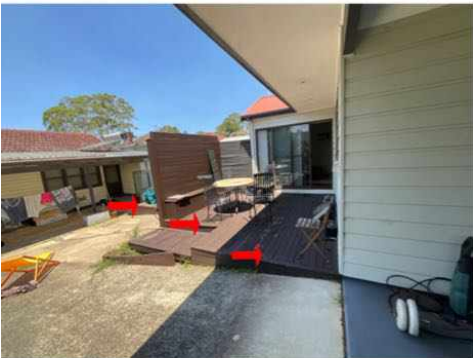
Building: Building 1
Location: All External Areas
Finding: Additional Photos - Obstructions and Limitations of EXTERNAL AREAS
Information: These photographs are an indication of the obstructions and limitations which impeded full inspection of external areas at the time of inspection. These obstructions can hide an array of defects and should be removed to allow full inspection to be

carried out. A re-inspection is recommended once the areas are made accessible.

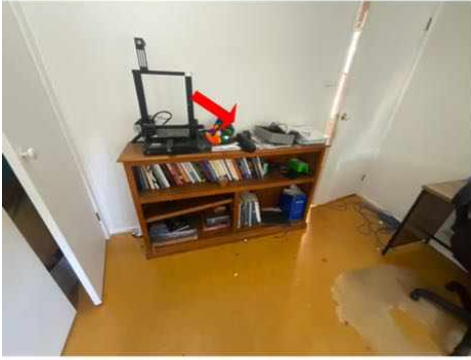
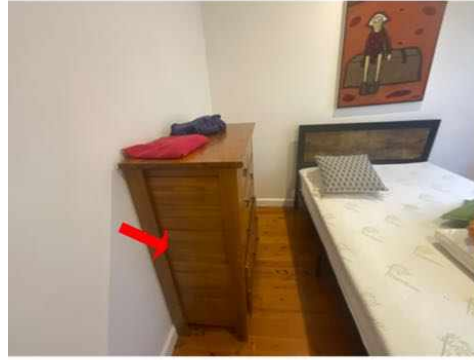
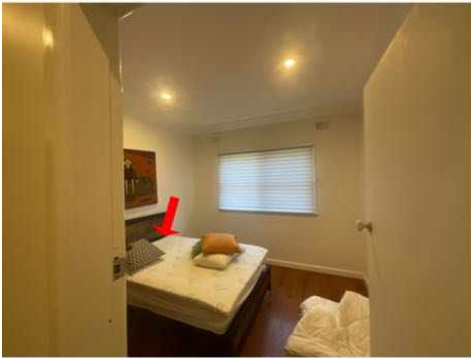
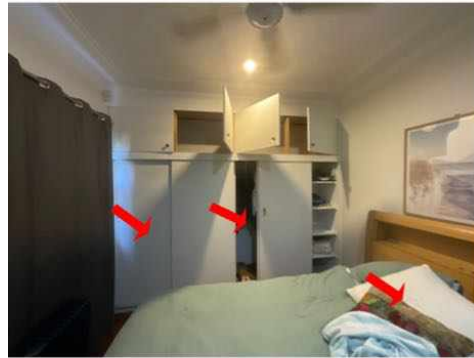
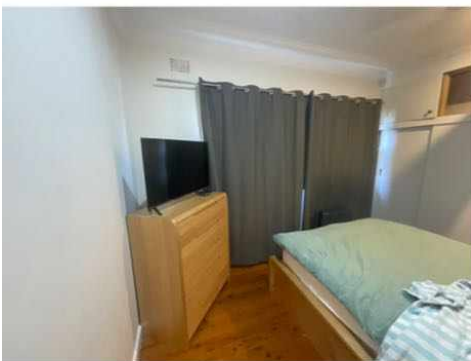
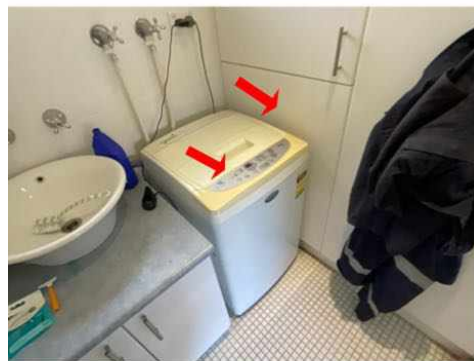
Building: Building 1
Location: All Internal Areas
Finding: Additional Photos - Obstructions and Limitations of INTERNAL AREAS
Information: These photographs are an indication of the obstructions and limitations which impeded full inspection of Internal areas at the time of inspection. These obstructions can hide an array of defects and should be removed to allow full inspection to be carried out. A re-inspection is recommended once the areas are made accessible.

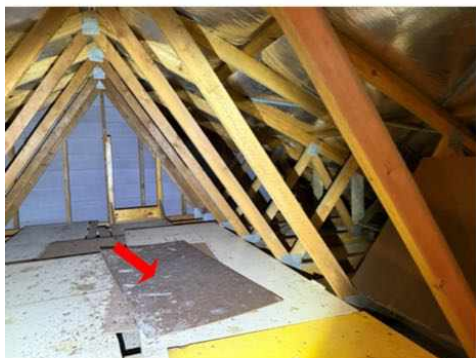
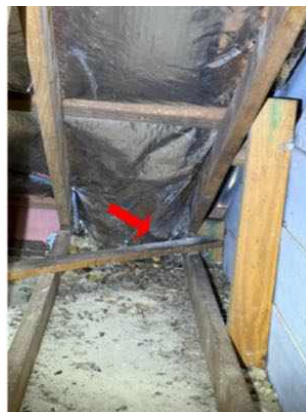
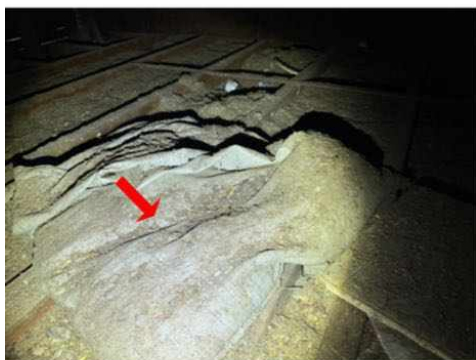
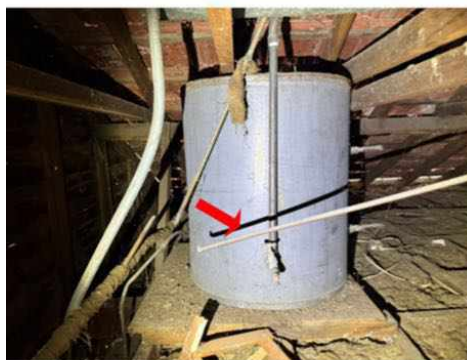
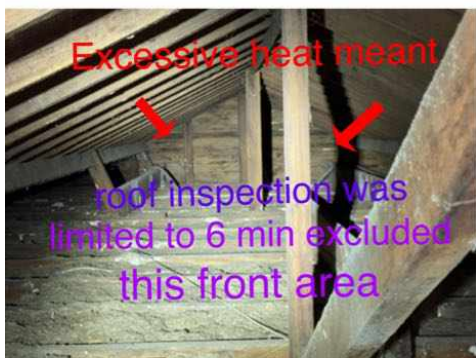
Building: Building 1
 Location: All Roof cavity areas
 Finding: Additional Photos - Obstructions and Limitations of the ROOF CAVITY
 Information: These photographs are an indication of the obstructions and limitations which impeded full inspection of roof cavity areas at the time of inspection. These obstructions can hide an array of defects and should be removed to allow full inspection to be carried out if applicable. A re-inspection is recommended once the areas are made accessible.

The inspection was also limited to areas with an allowable crawl space of 600mm x

600mm, in particular towards the external walls where the roof line diminishes, these areas were not accessible.

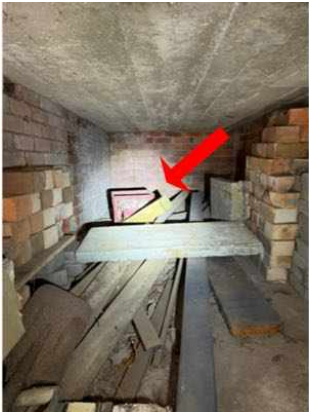
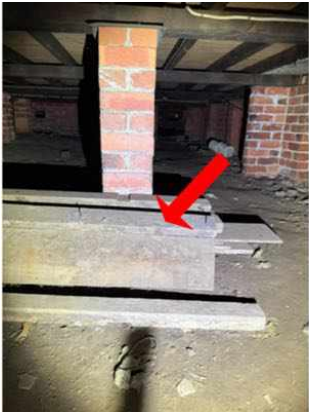
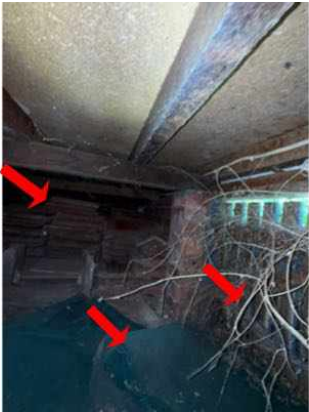
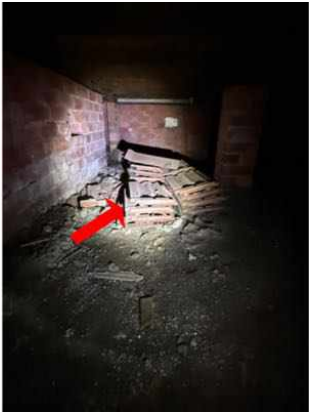
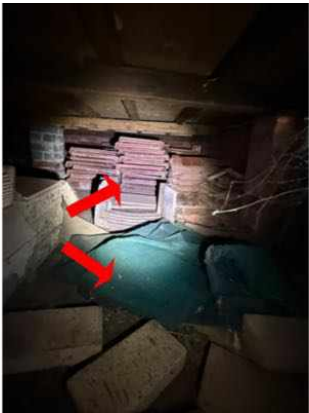
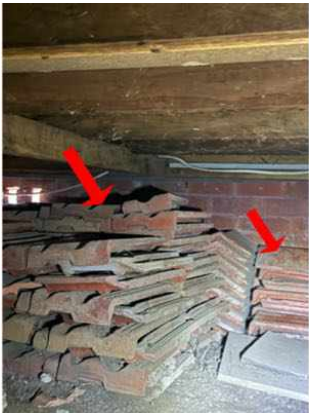
Building:	Building 1
Location:	Some Subfloor Areas
Finding:	Additional Photos - Obstructions and Limitations of SUBFLOOR AREAS
Information:	These photographs are an indication of the obstructions and limitations which impeded full inspection of subfloor areas at the time of inspection. These obstructions can hide an array of defects and should be removed to allow full inspection to be carried out. A re-inspection is recommended once the areas are made accessible.

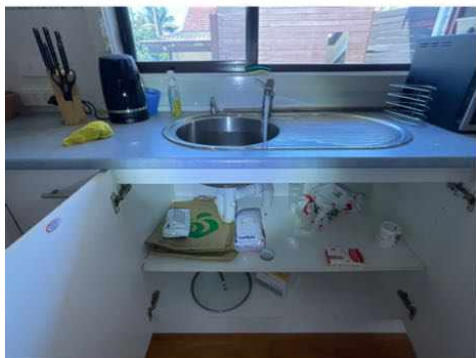
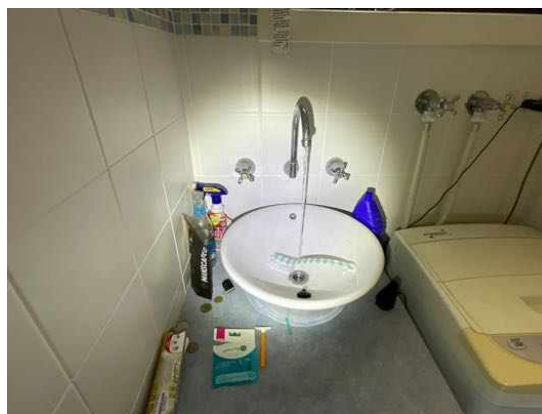
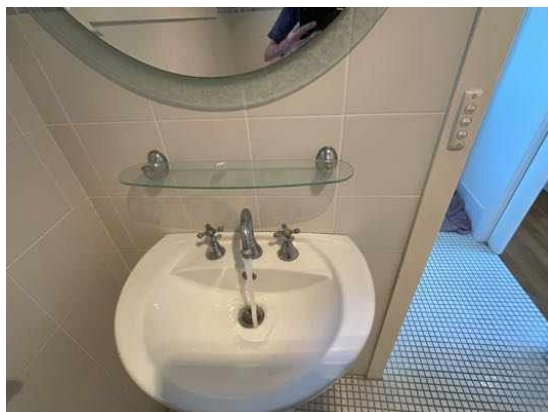
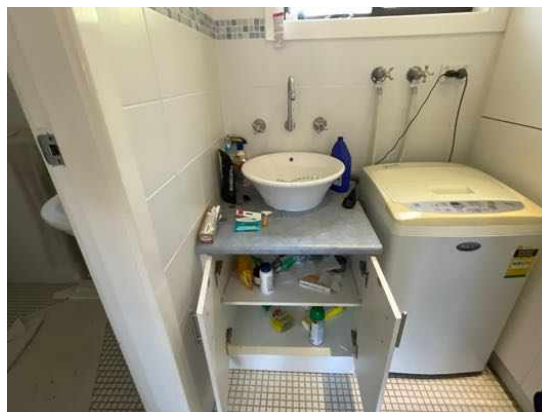
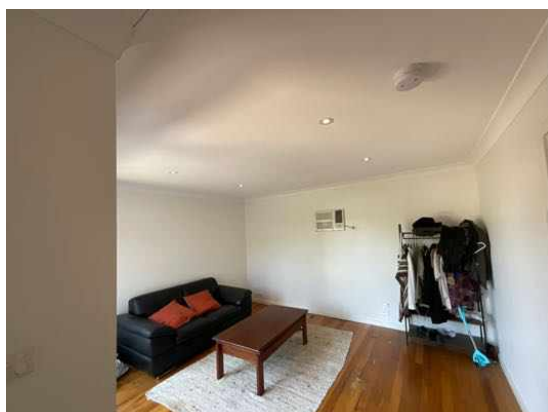
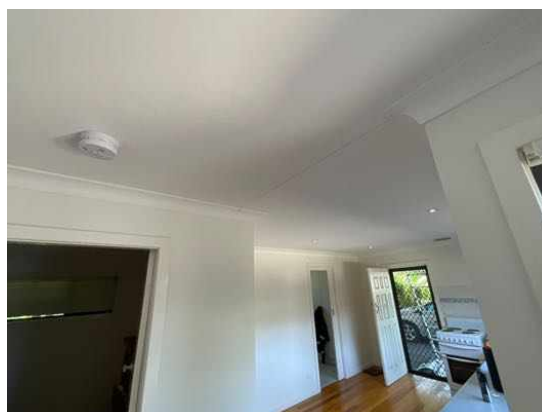
Building: Building 1
Location: All Internal Areas
Finding: Additional Photos
Information: Additional photos are provided for your general reference

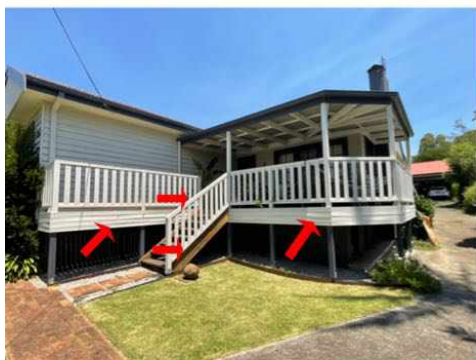
Building: Building 1
 Location: Front deck
 Finding: Elevated structure inspections
 Information: While this deck appears well constructed, where any elevated Structure (deck, balcony, verandah etc) is present, and this elevated structure is designed to accommodate people, you MUST have this structure checked by an engineer or other suitably qualified person.

You should also arrange annual inspections of the structure by an engineer or other suitably qualified person to ensure any maintenance, that may become necessary, is identified. Care must be taken not to overload the structure.

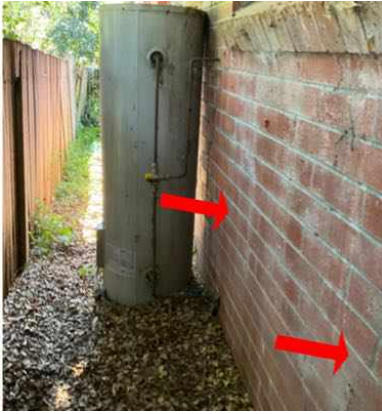
Building: Building 2
 Location: Granny Flat
 Finding: Expansion Joints - Masonry in small buildings
 Information: No expansion joints were visible in this 8 metre wall.

A structural engineer can be consulted for advice on whether an expansion joint should be installed in this area.

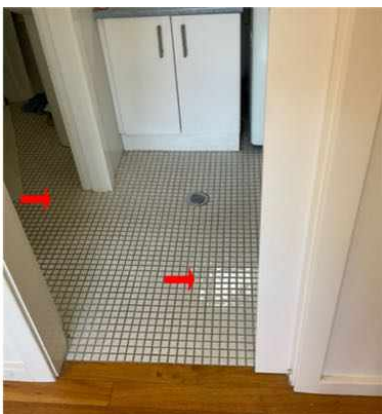
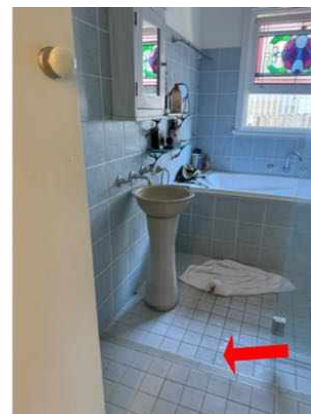
Building: Building 1
 Location: Bathrooms and laundry
 Finding: Waterproofing membranes - Information Only
 Information: Internal Water Proofing Membranes, are crucial in preventing water ingress into the property is important to know that the Membrane System used is to Australian Standards and has been installed correctly.

With older property's where this information is unavailable all wet areas should be monitored. If any leaks, water staining, peeling or bubbling of the paint become evident to any adjacent walls or ceilings below a licensed builder or waterproofing specialist is recommended to investigate further.
