# Building and Timber Pest Inspection Report

Inspection Date: Fri, 27 Mar 2026

Property Address: 77 Macpherson St, Mosman NSW 2088,  
Australia

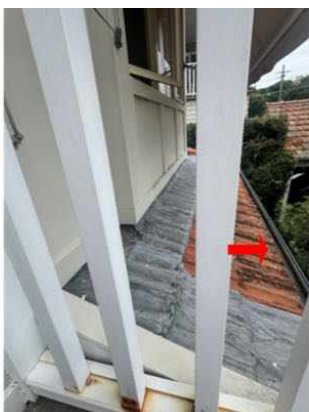
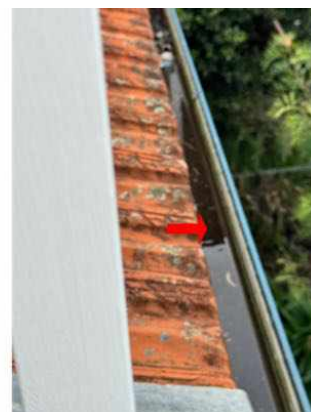
Building:	Main Building
Location:	Roof Exterior
Finding:	Gutters - Water pooling
Information:	Water was found to be pooling in sections of the roof guttering. This is generally a secondary defect caused by blocked or partially blocked gutters. Such blockages and subsequent water pooling are likely to lead to rust and water damage to associated structures if left unattended.

Any areas of guttering that shows evidence of water pooling should be checked for partial or full blockages and any secondary damage that may have occurred as a result. Depending on the extent of the damage, building elements may require repair and/or replacement to ensure adequate roof drainage and function of exterior plumbing system.

A roofing plumber should be appointed as soon as possible to rectify this issue. It is highly advised that all gutters be maintained on a frequent basis to ensure the condition of roof plumbing.

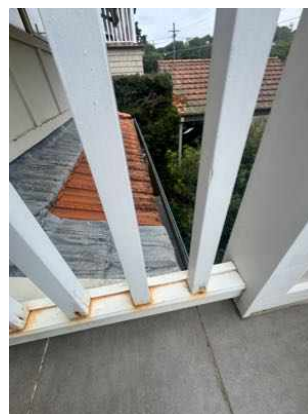
### Finding 3.03

Building:	Main Building
Location:	Balcony

Finding: Building element - Rusted or corroded  
 Information: This building element shows evidence of rusting and corrosion, which is likely to have developed as a result of excessive exposure to moisture and or inadequate coatings.

As surface rust provides no protection to the underlying iron, the deteriorating condition is likely to worsen if not addressed in the short-term future.

Where possible, the use of galvanized (treated) metals or aluminium coated metals aid in rust prevention, as does regular general maintenance. Rust formation can be controlled with coatings, such as paint, that isolate the iron from the environment.

Rusting and corrosion should be managed by ideally removing or limiting the affected surface from exposure to moisture. A registered builder may be appointed to replace any building elements that have been severely affected by rust or water damage.

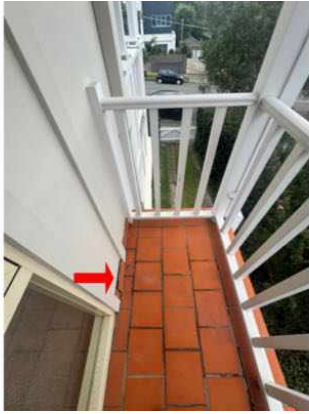
### Finding 3.04

Building: Main Building  
 Location: Balcony  
 Finding: Skirting tiles - Missing  
 Information: Skirting tiles were missing in this area at the time of inspection. Complete tiled skirting is important in preventing water ingress into the adjoining walls and flooring, protecting the areas against potential water damage. The incomplete skirting also detracts from the overall appearance of the area.

If left unmanaged, water ingress into adjoining areas may have major implications, and may potentially necessitate works to other building elements in the long-term future.

It is highly recommended that a tiling contractor be appointed to complete these minor works as soon as possible to prevent such damage from occurring.

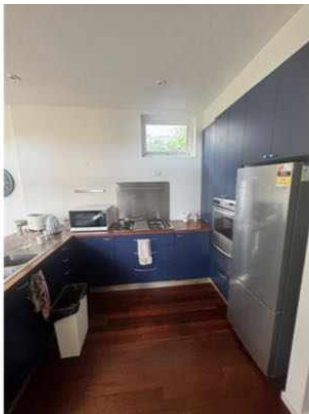
### Finding 3.05

Finding: Additional Photos - Obstructions and Limitations

Information: These photographs are an indication of the obstructions and limitations which impeded full inspection of the property at the time of inspection. These obstructions can hide an array of defects and should be removed to allow full inspection to be carried out. A re-inspection is recommended once the areas are made accessible.

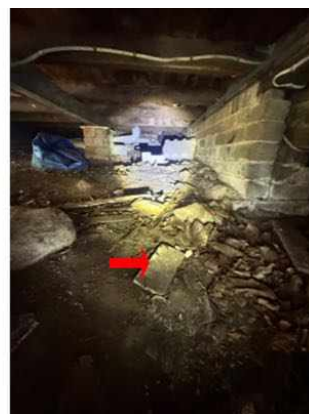
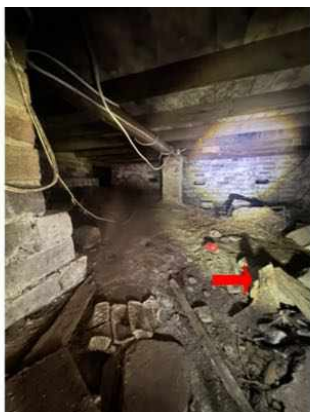
Building:	Main Building
Location:	Subfloor
Finding:	Subfloor - Debris
Information:	An array of debris was found in the subfloor area at the time of inspection. Debris in this area restricts subfloor ventilation and creates potential for concealed pest entry. Stored timbers and other materials may also make the area susceptible to termite activity and wood rot.

A clear and empty subfloor will be better ventilated and easier to maintain in a dry condition. The removal of any timber debris is vital in minimising the risk of termite or wood borer activity.

Debris in the subfloor should be removed as soon as possible. Depending on the location and amount of debris and stored items, the homeowner may elect to undertake this task. Alternatively there are a large number of rubbish removal subcontractors that could undertake these works.

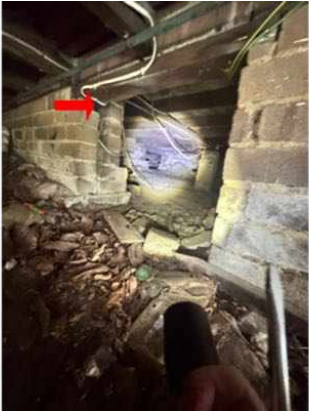
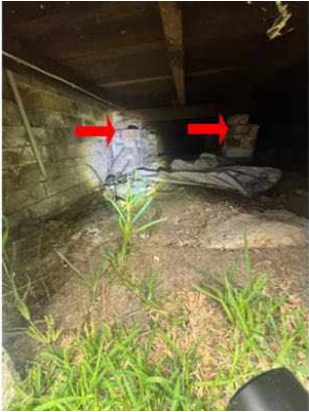
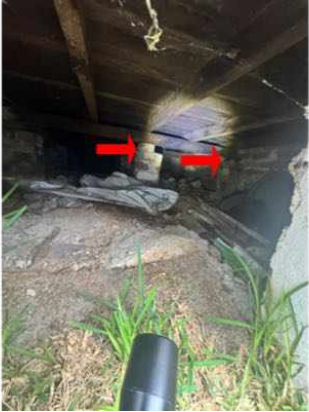
### Finding 6.02

Building:	Main Building
Location:	Subfloor
Finding:	Ant caps - Not installed
Information:	Ant caps have not been installed to the subfloor structure at the time of inspection. Generally, ant caps are installed to the intersection between the top of the stumps (or piers) and the subfloor structures.

Installed during the construction process, ant caps are designed to easily identify termite or pest ingress from stumps to the adjoining bearers.

Where ant caps have not been installed, frequent monitoring of these areas should be carried out in order to identify any signs of termite or timber pest workings.

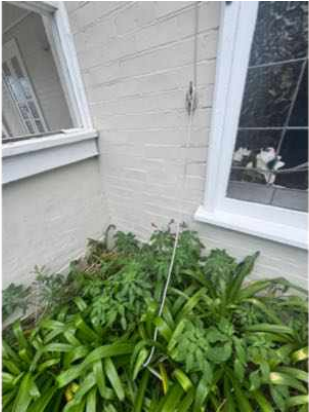
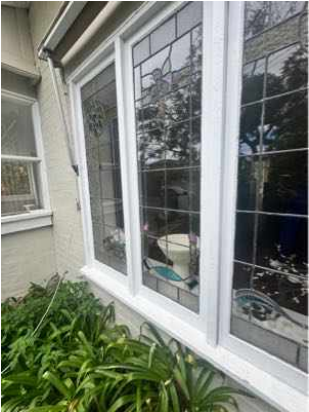
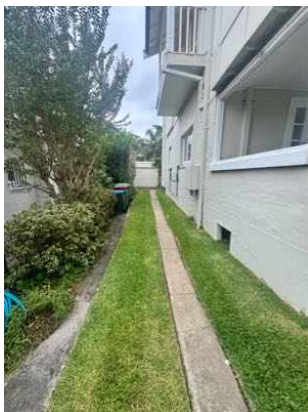
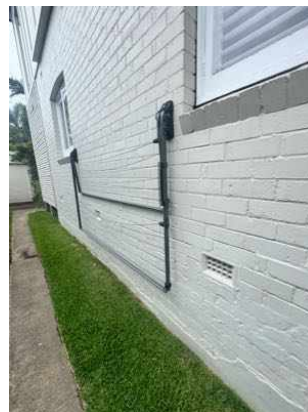
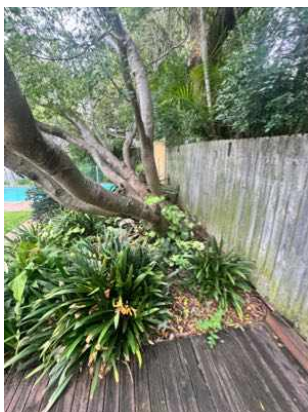
**Finding 6.03**

Building: Main Building  
Location: All External Areas  
Finding: Garden Beds - Conditions Conducive to Termites  
Information: Garden beds were found to be evident in the garden area. These garden beds can include untreated timber, and with a combination of moisture from watering hosing can make conditions conducive to termite activity and termite ingress.

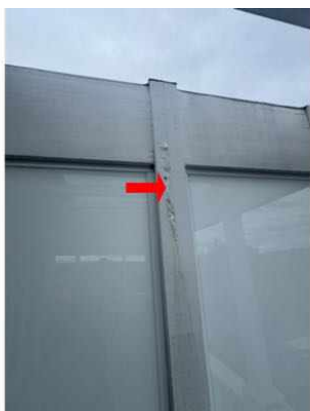
### Finding 7.01

Building:	Main Building
Location:	Balcony
Finding:	Wood rot
Information:	This building element shows evidence of wood rot. Wood rot, also known as Fungal Decay, occurs when timbers and other cellulose building materials are exposed to damp conditions on an ongoing basis. This could be the result of exposure to weathering over a prolonged period of time, or the attraction of excessive moisture from other abutting building materials. Contributing factors also include poor air ventilation in the area.

Wood rot is often associated with general damp problems and is evidenced by a 'musty' smell or mould and mildew occurring on surfaces. If left unmanaged, damp conditions can lead to further health problems and the decay of timbers will continue.

Early intervention and regular maintenance, particularly of exterior timbers, will prolong the useful life of these building elements. Prior to any works being performed, the cause of the moisture that has created the visible wood rot should be identified and addressed in a suitable manner. Replacement of affected timbers may then be a necessary step in protecting surrounding building elements from such deterioration.

A qualified plumber may be appointed to assess the cause of excessive moisture and to provide advice on any remedial works as required. A qualified carpenter or registered builder may also be required to replace affected building materials.

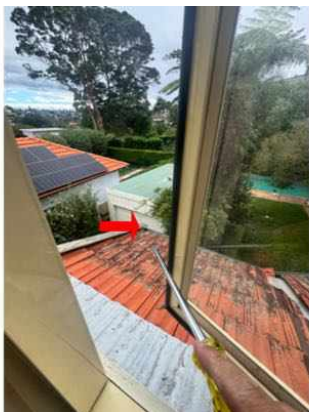
### Finding 7.02

Building:	Main Building
Location:	Roof Exterior
Finding:	Fascias - Wood rot
Information:	Wood rot was found to be affecting fascias and bargees in this area, evidenced by the presence of mould on the surface in some areas. Wood rot, also known as Fungal Decay, occurs when timbers and other cellulose building materials are exposed to damp conditions on an ongoing basis.

It is likely that this wood rot has developed as a result of faults in the roof plumbing, creating excessive moisture in this areas. Frequent exposure to rain and other weather conditions also make fascias and bargees susceptible to accelerated deterioration.

Early intervention and regular maintenance will prolong the useful life of these building elements. Prior to any works being performed, the cause of the moisture that has created the visible wood rot should be identified and addressed in a suitable manner.

It is advised that a roof plumber be appointed to inspect all roof plumbing and subsequently identify the cause of the wood rot. Replacement of affected fascias and bargees may then be a necessary step in protecting surrounding building elements from such deterioration.

A qualified plumber may be appointed to assess the cause of excessive moisture and to provide advice on any remedial works as required. A qualified carpenter or registered builder may also be required to replace affected building materials.

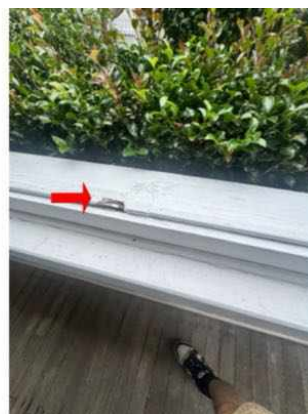
### Finding 7.03

Finding: Wood rot

Information: This building element shows evidence of wood rot. Wood rot, also known as Fungal Decay, occurs when timbers and other cellulose building materials are exposed to damp conditions on an ongoing basis. This could be the result of exposure to weathering over a prolonged period of time, or the attraction of excessive moisture from other abutting building materials. Contributing factors also include poor air ventilation in the area.

Wood rot is often associated with general damp problems and is evidenced by a 'musty' smell or mould and mildew occurring on surfaces. If left unmanaged, damp conditions can lead to further health problems and the decay of timbers will continue.

Early intervention and regular maintenance, particularly of exterior timbers, will prolong the useful life of these building elements. Prior to any works being performed, the cause of the moisture that has created the visible wood rot should be identified and addressed in a suitable manner. Replacement of affected timbers may then be a necessary step in protecting surrounding building elements from such deterioration.

A qualified plumber may be appointed to assess the cause of excessive moisture and to provide advice on any remedial works as required. A qualified carpenter or registered builder may also be required to replace affected building materials.

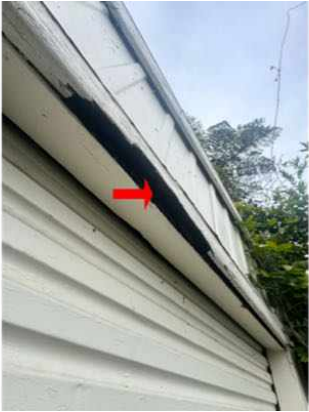
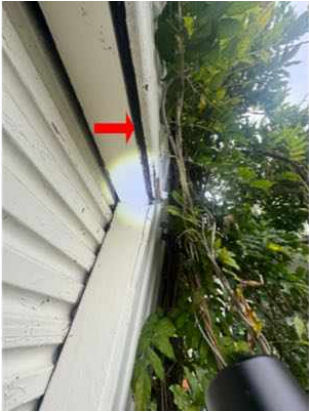
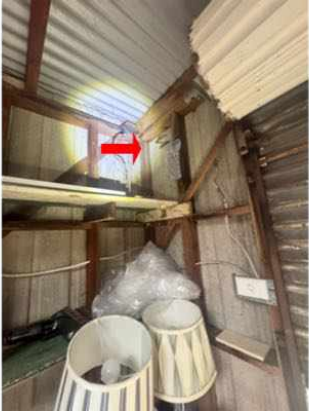
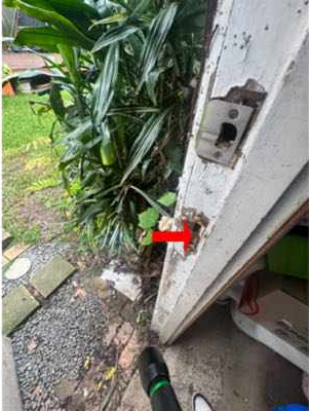
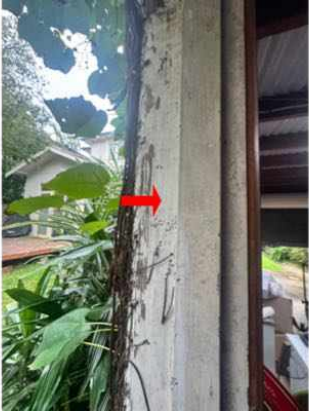
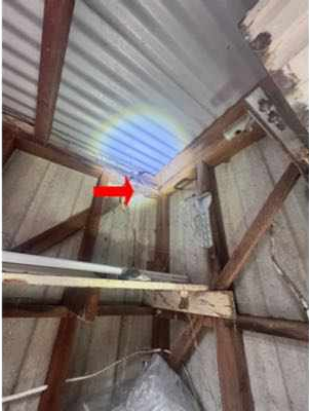
### Finding 7.04

Finding: Wood rot

Information: This building element shows evidence of wood rot. Wood rot, also known as Fungal Decay, occurs when timbers and other cellulose building materials are exposed to damp conditions on an ongoing basis. This could be the result of exposure to weathering over a prolonged period of time, or the attraction of excessive moisture from other abutting building materials. Contributing factors also include poor air ventilation in the area.

Wood rot is often associated with general damp problems and is evidenced by a 'musty' smell or mould and mildew occurring on surfaces. If left unmanaged, damp conditions can lead to further health problems and the decay of timbers will continue.

Early intervention and regular maintenance, particularly of exterior timbers, will prolong the useful life of these building elements. Prior to any works being performed, the cause of the moisture that has created the visible wood rot should be identified and addressed in a suitable manner. Replacement of affected timbers may then be a necessary step in protecting surrounding building elements from such deterioration.

A qualified plumber may be appointed to assess the cause of excessive moisture and to provide advice on any remedial works as required. A qualified carpenter or registered builder may also be required to replace affected building materials.

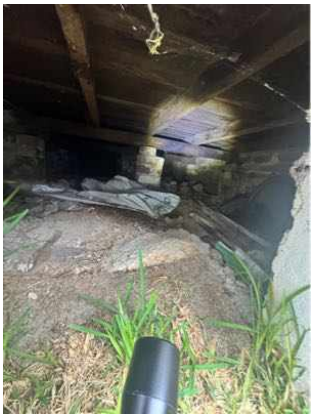
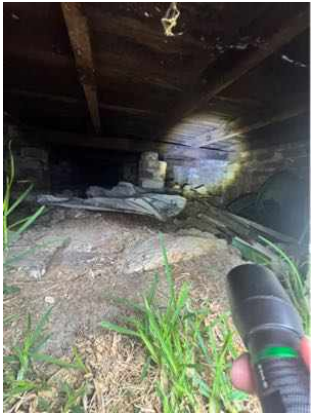
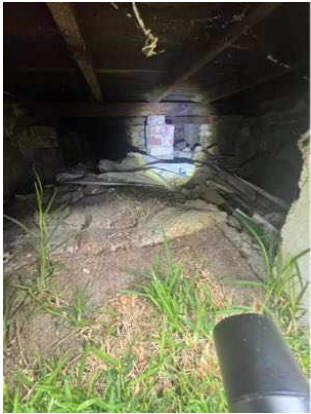
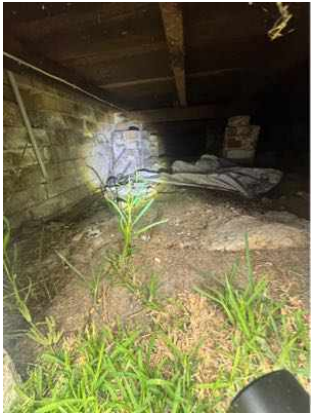
Building: Main Building  
Location: Subfloor  
Finding: Additional Photos - Obstructions and Limitations  
Information: These photographs are an indication of the obstructions and limitations which impeded full inspection of the property at the time of inspection. These obstructions can hide an array of defects and should be removed to allow full inspection to be carried out. A re-inspection is recommended once the areas are made accessible.

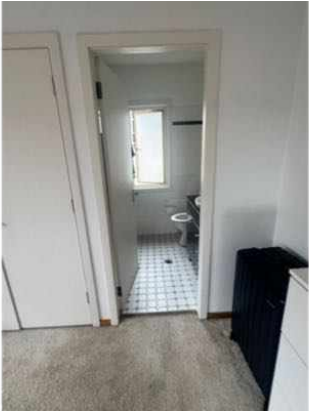
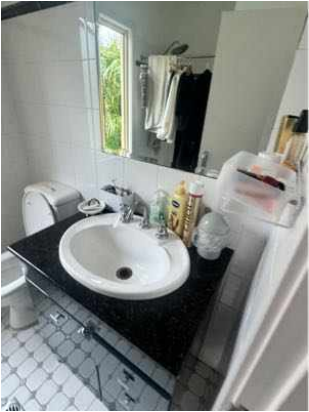
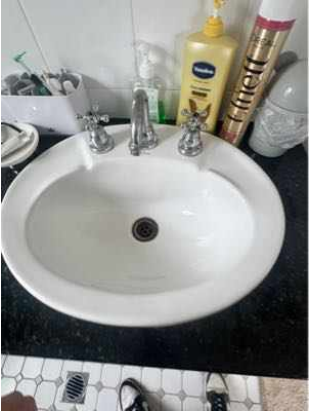
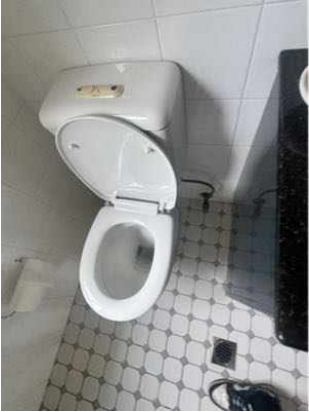
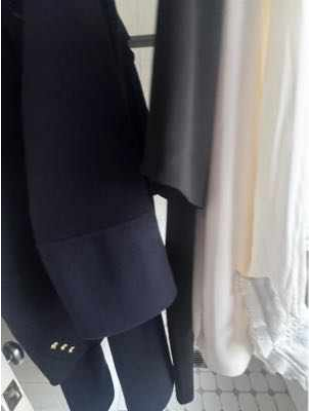
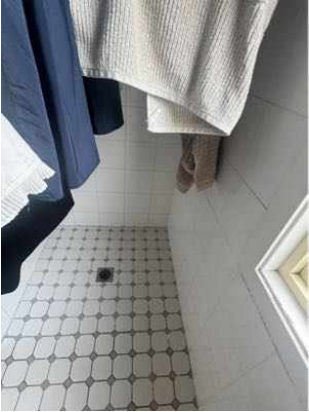
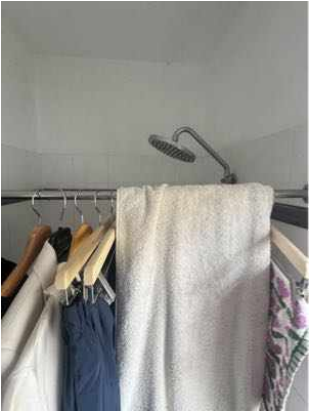
Building:	Main Building
Location:	Ensuite - Master
Finding:	Additional Photos - Obstructions and Limitations
Information:	These photographs are an indication of the obstructions and limitations which impeded full inspection of the property at the time of inspection. These obstructions can hide an array of defects and should be removed to allow full inspection to be carried out. A re-inspection is recommended once the areas are made accessible.

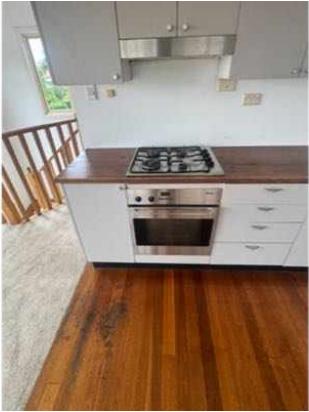
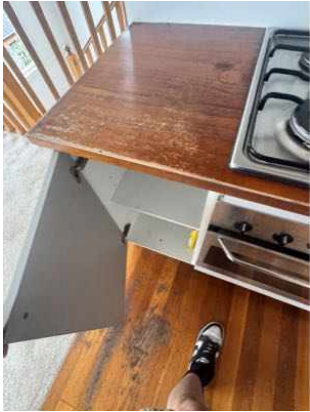
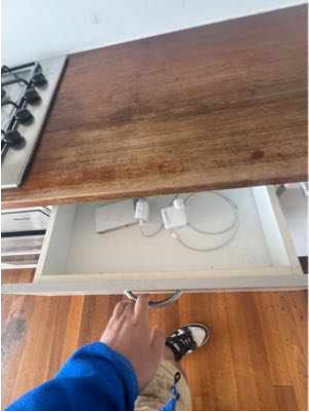
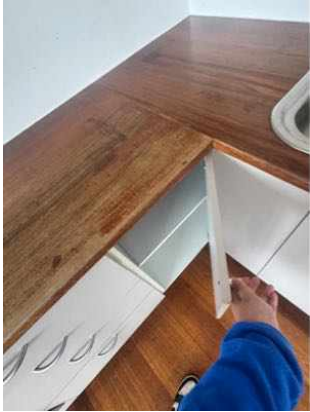
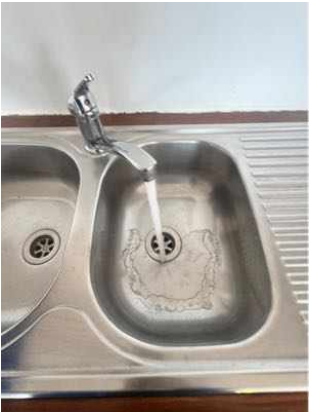
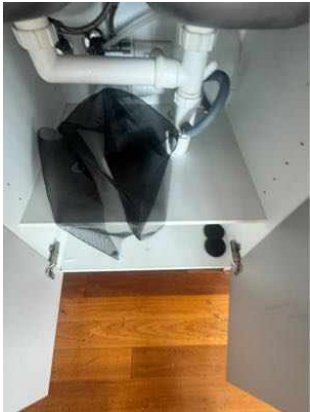
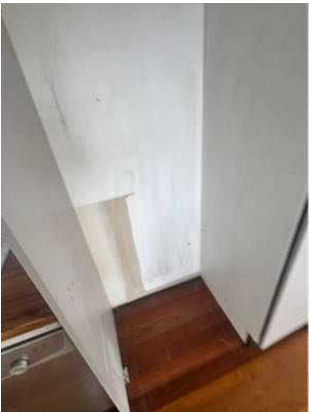
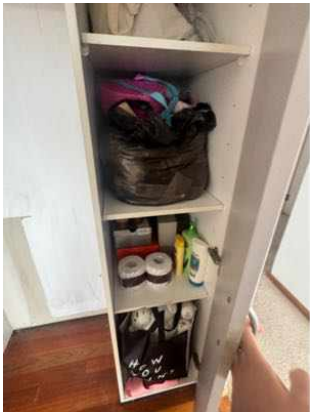
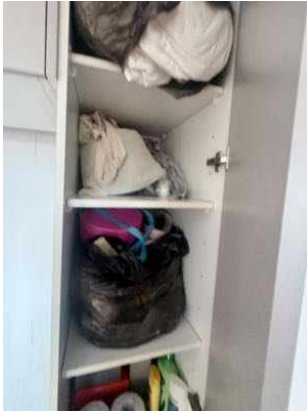
Building: Main Building  
 Location: Kitchenette  
 Finding: Additional Photos - Obstructions and Limitations  
 Information: These photographs are an indication of the obstructions and limitations which impeded full inspection of the property at the time of inspection. These obstructions can hide an array of defects and should be removed to allow full inspection to be carried out. A re-inspection is recommended once the areas are made accessible.

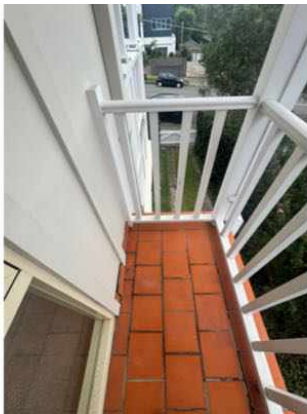
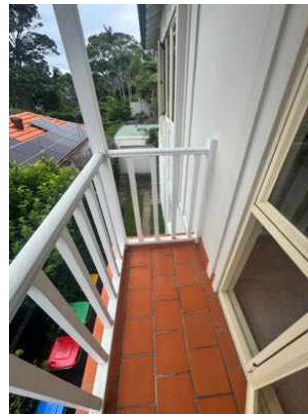
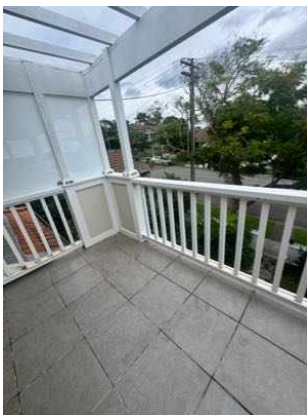
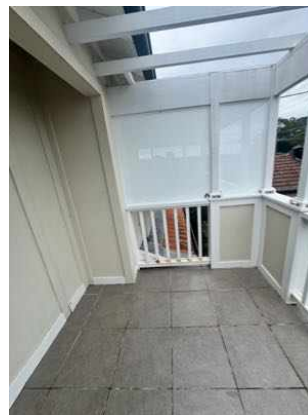
Finding: Additional Photos - Obstructions and Limitations

Information: These photographs are an indication of the obstructions and limitations which impeded full inspection of the property at the time of inspection. These obstructions can hide an array of defects and should be removed to allow full inspection to be carried out. A re-inspection is recommended once the areas are made accessible.

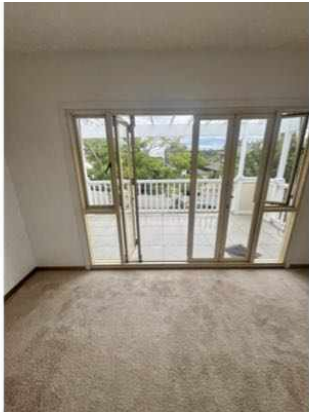
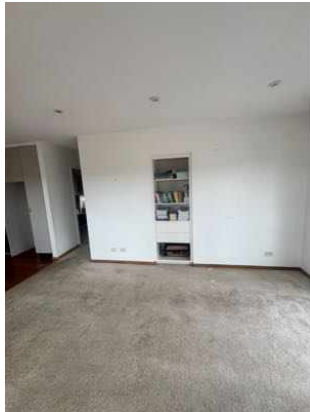
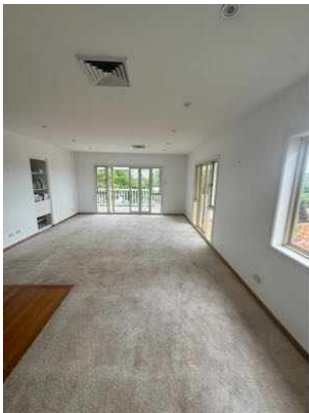
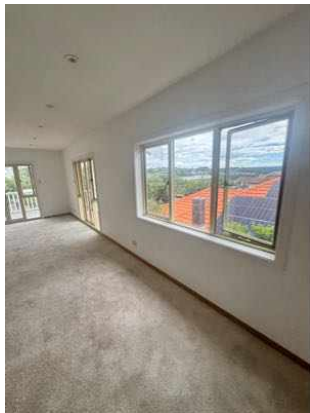
Building: Main Building  
Location: Living Room  
Finding: Additional Photos - Obstructions and Limitations  
Information: These photographs are an indication of the obstructions and limitations which impeded full inspection of the property at the time of inspection. These obstructions can hide an array of defects and should be removed to allow full inspection to be carried out. A re-inspection is recommended once the areas are made accessible.

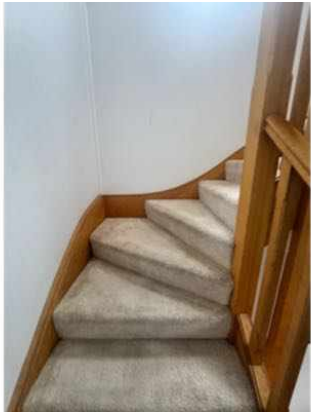
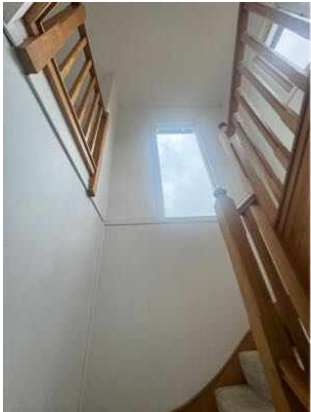
Building: Main Building  
Location: Stairs - Internal  
Finding: Additional Photos - Obstructions and Limitations  
Information: These photographs are an indication of the obstructions and limitations which impeded full inspection of the property at the time of inspection. These obstructions can hide an array of defects and should be removed to allow full inspection to be carried out. A re-inspection is recommended once the areas are made accessible.

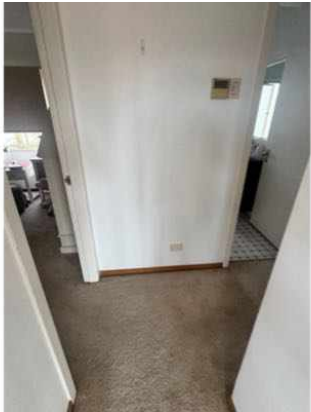
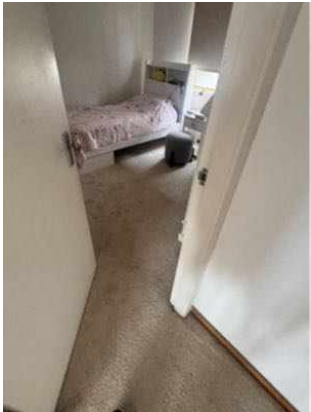
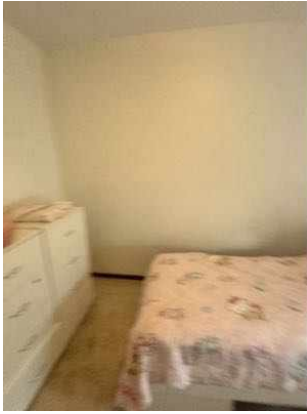
Building: Main Building  
Location: Bedroom 4  
Finding: Additional Photos - Obstructions and Limitations  
Information: These photographs are an indication of the obstructions and limitations which impeded full inspection of the property at the time of inspection. These obstructions can hide an array of defects and should be removed to allow full inspection to be carried out. A re-inspection is recommended once the areas are made accessible.

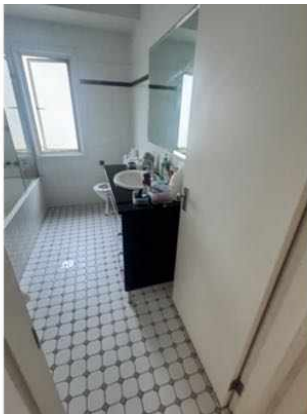
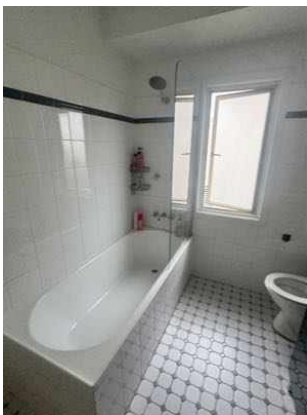
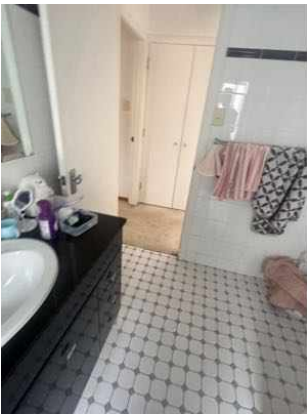
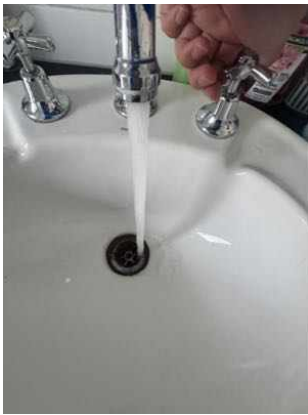
Information: These photographs are an indication of the obstructions and limitations which impeded full inspection of the property at the time of inspection. These obstructions can hide an array of defects and should be removed to allow full inspection to be carried out. A re-inspection is recommended once the areas are made accessible.

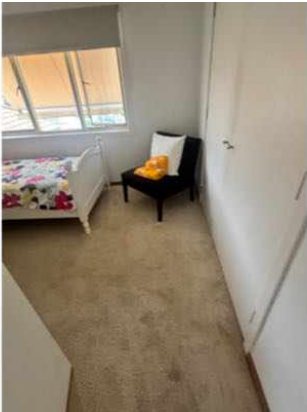
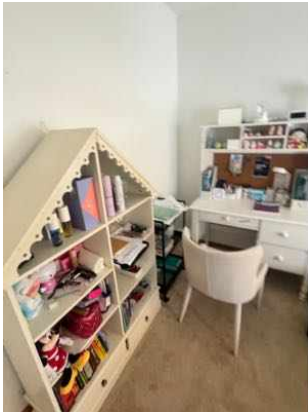
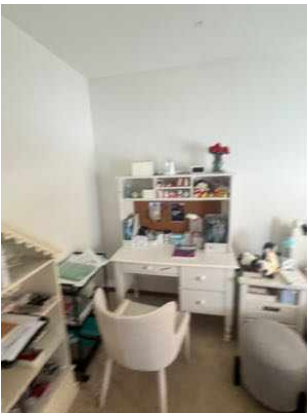
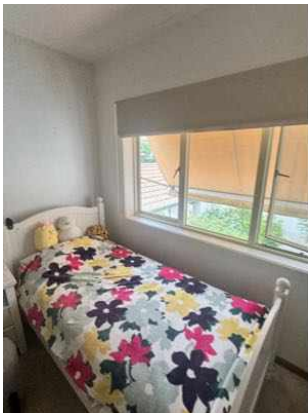
Building: Main Building  
Location: Bedroom 5  
Finding: Additional Photos - Obstructions and Limitations  
Information: These photographs are an indication of the obstructions and limitations which impeded full inspection of the property at the time of inspection. These obstructions can hide an array of defects and should be removed to allow full inspection to be carried out. A re-inspection is recommended once the areas are made accessible.

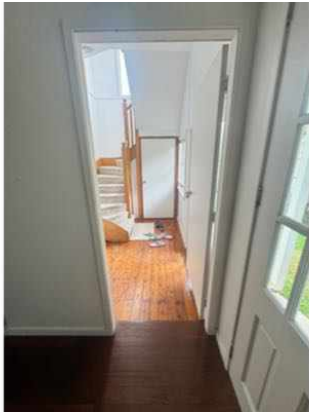
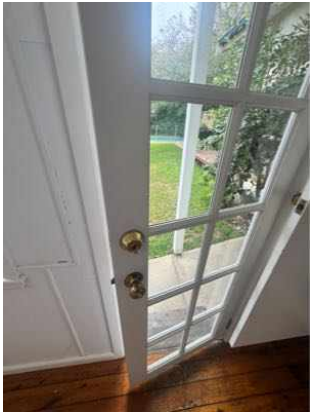
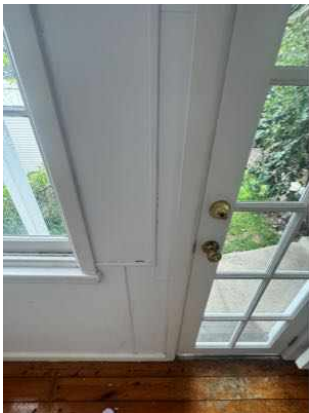
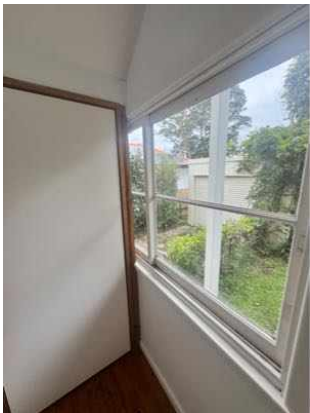
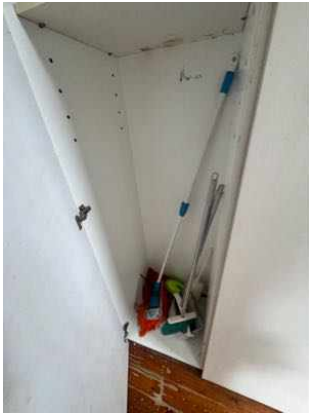
Building: Main Building  
Location: Entry  
Finding: Additional Photos - Obstructions and Limitations  
Information: These photographs are an indication of the obstructions and limitations which impeded full inspection of the property at the time of inspection. These obstructions can hide an array of defects and should be removed to allow full inspection to be carried out. A re-inspection is recommended once the areas are made accessible.

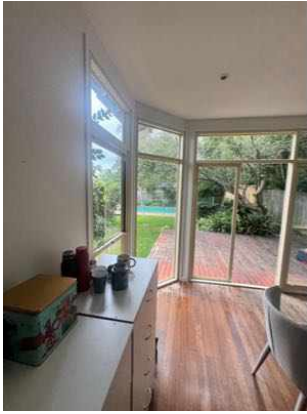
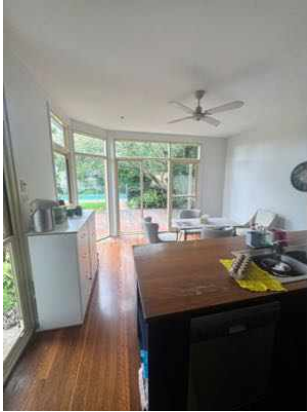
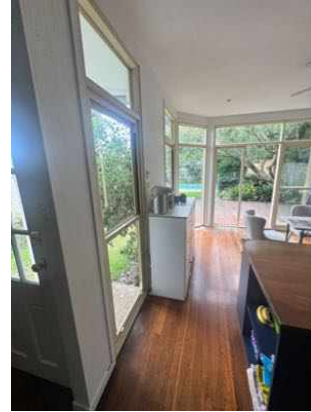
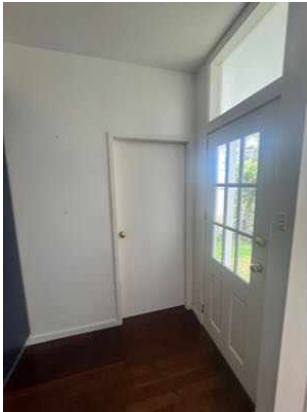
Building: Main Building  
Location: Dining Room  
Finding: Additional Photos - Obstructions and Limitations  
Information: These photographs are an indication of the obstructions and limitations which impeded full inspection of the property at the time of inspection. These obstructions can hide an array of defects and should be removed to allow full inspection to be carried out. A re-inspection is recommended once the areas are made accessible.

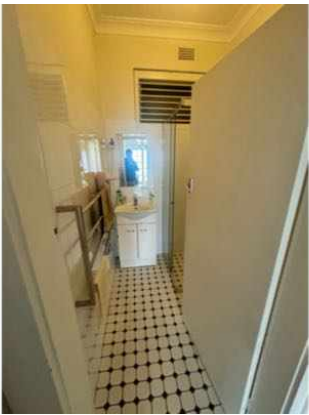
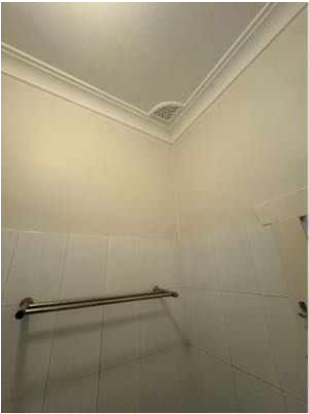
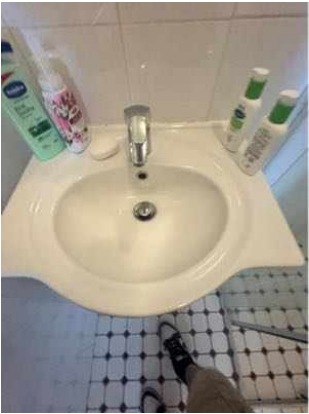
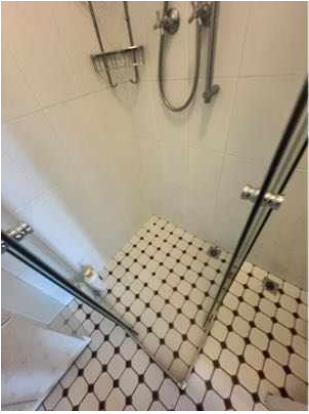
Building: Main Building  
 Location: Bathroom  
 Finding: Additional Photos - Obstructions and Limitations  
 Information: These photographs are an indication of the obstructions and limitations which impeded full inspection of the property at the time of inspection. These obstructions can hide an array of defects and should be removed to allow full inspection to be carried out. A re-inspection is recommended once the areas are made accessible.

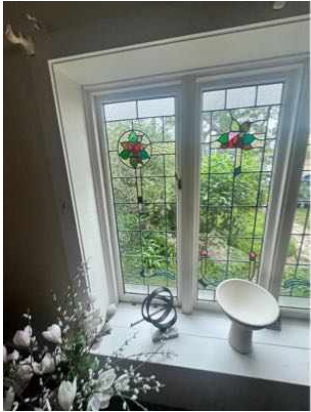
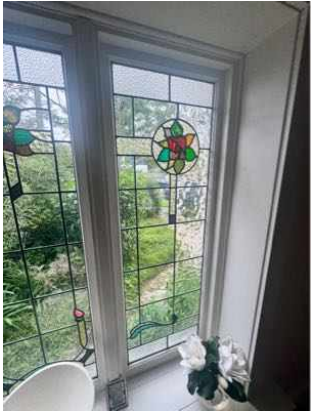
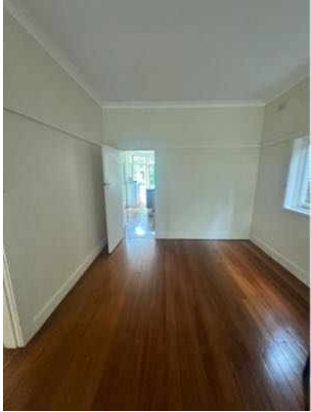
Information: These photographs are an indication of the obstructions and limitations which impeded full inspection of the property at the time of inspection. These obstructions can hide an array of defects and should be removed to allow full inspection to be carried out. A re-inspection is recommended once the areas are made accessible.

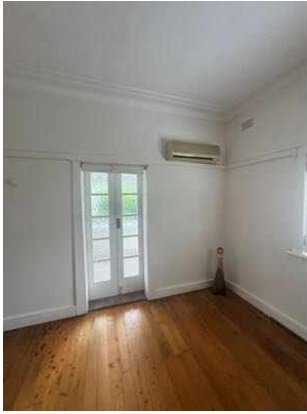
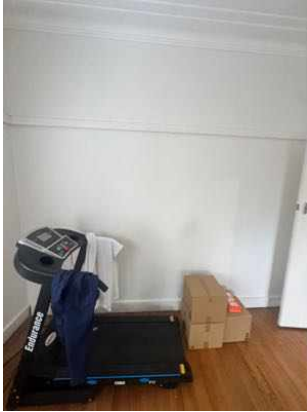
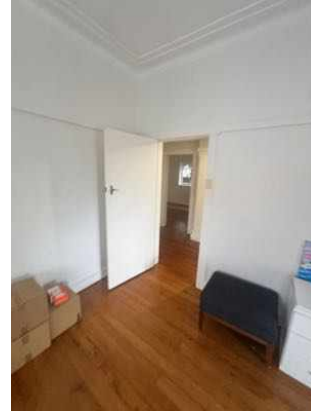
Building: Main Building  
Location: Bedroom 3  
Finding: Additional Photos - Obstructions and Limitations  
Information: These photographs are an indication of the obstructions and limitations which impeded full inspection of the property at the time of inspection. These obstructions can hide an array of defects and should be removed to allow full inspection to be carried out. A re-inspection is recommended once the areas are made accessible.

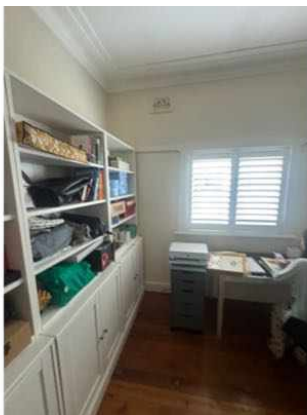
Information: These photographs are an indication of the obstructions and limitations which impeded full inspection of the property at the time of inspection. These obstructions can hide an array of defects and should be removed to allow full inspection to be carried out. A re-inspection is recommended once the areas are made accessible.

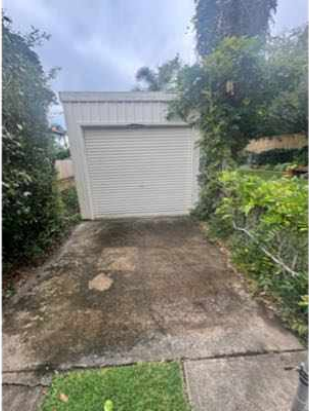
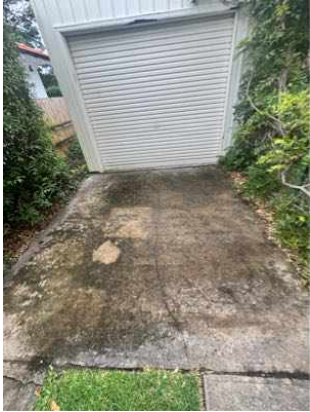
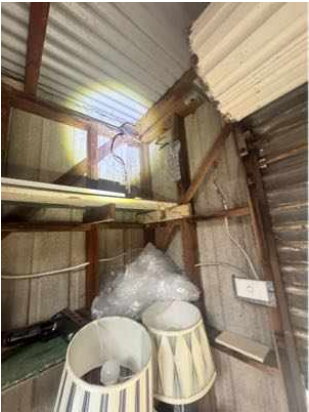
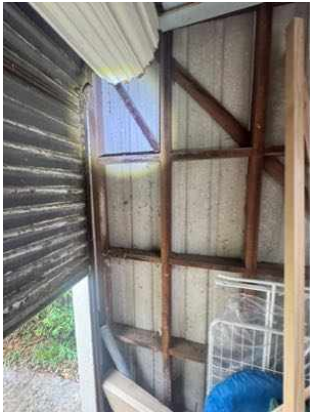
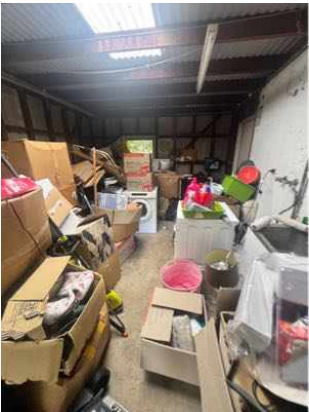
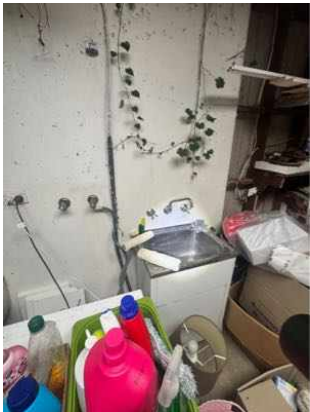
Building: Main Building  
Location: Garage  
Finding: Additional Photos - Obstructions and Limitations  
Information: These photographs are an indication of the obstructions and limitations which impeded full inspection of the property at the time of inspection. These obstructions can hide an array of defects and should be removed to allow full inspection to be carried out. A re-inspection is recommended once the areas are made accessible.

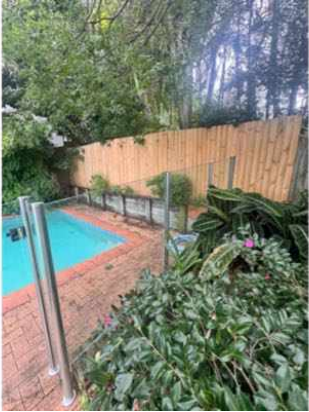
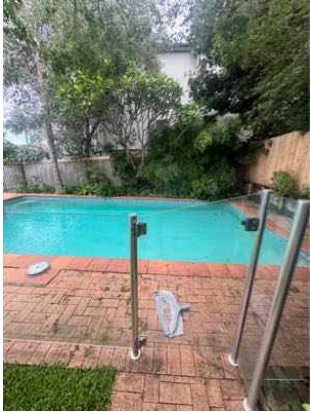
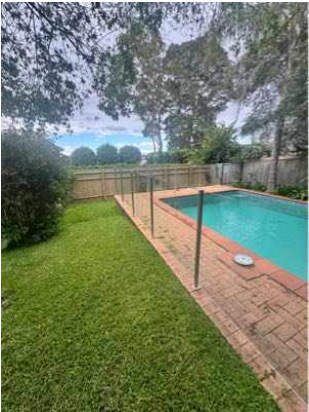
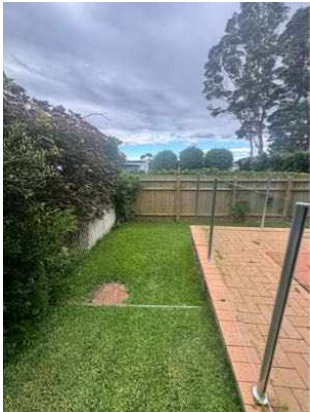
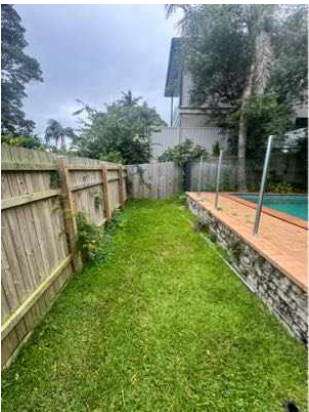
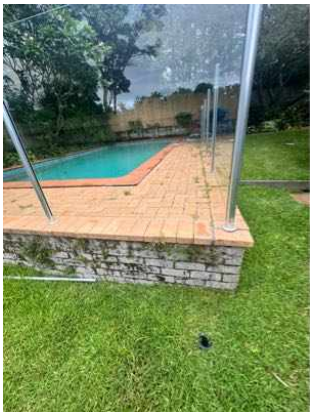
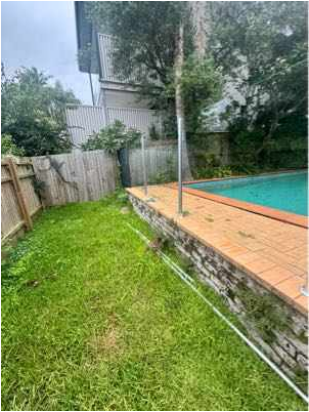
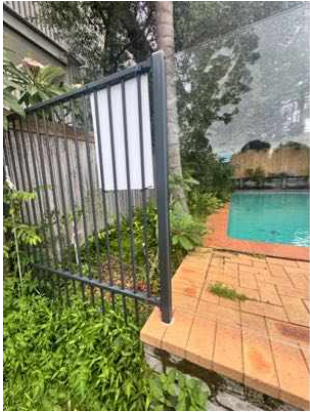
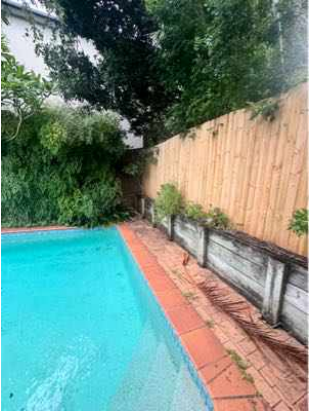
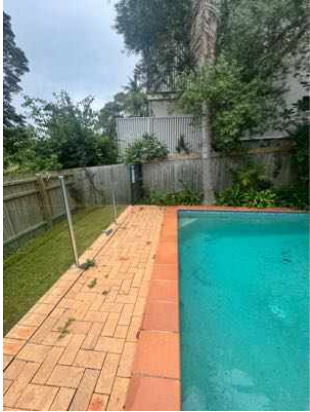
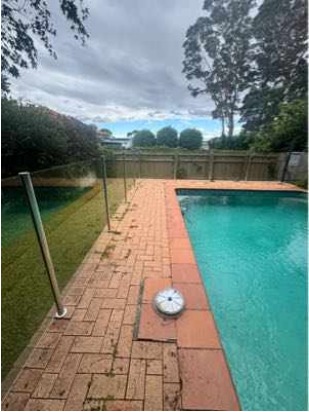
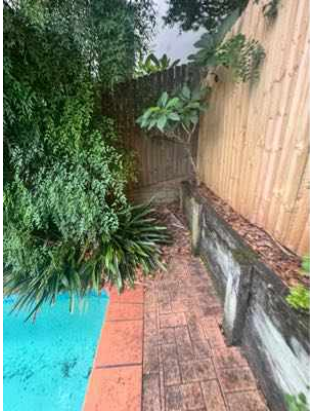
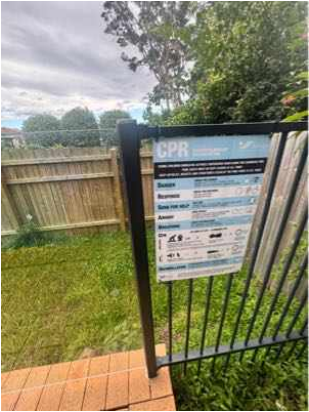
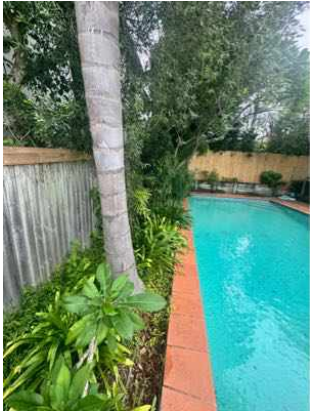
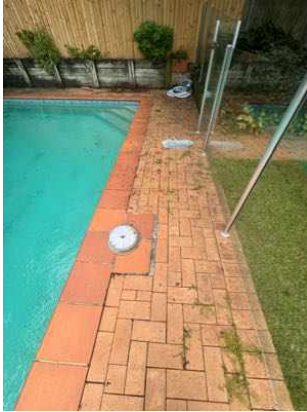
Building: Main Building  
Location: Swimming Pool - Below Ground  
Finding: Additional Photos - Obstructions and Limitations  
Information: These photographs are an indication of the obstructions and limitations which impeded full inspection of the property at the time of inspection. These obstructions can hide an array of defects and should be removed to allow full inspection to be carried out. A re-inspection is recommended once the areas are made accessible.

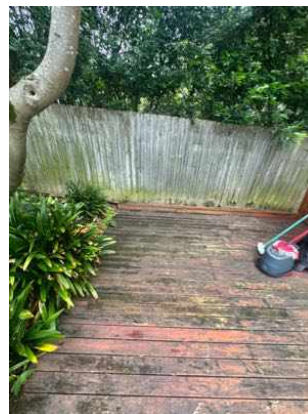
Building:	Main Building
Location:	Deck
Finding:	External Timber Balcony or Deck - Structural Stability
Information:	The load capacity of the external balcony or deck could not be verified during the inspection.

External timber structures are also constantly exposed to weather elements and can deteriorate in an accelerated manner, ongoing assessments are required.

It is highly recommended that a Structural Engineer further assess the external timber balcony or deck to inform the client of its load capacity. Regular maintenance inspections by competent practitioners is needed.
