Building and Timber Pest Inspection Report

Inspection Date: Wed, 25 Mar 2026

Property Address: 10/10 Carlisle St, St Kilda VIC 3182,
Australia

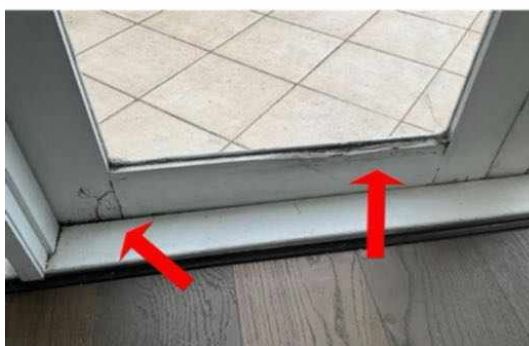
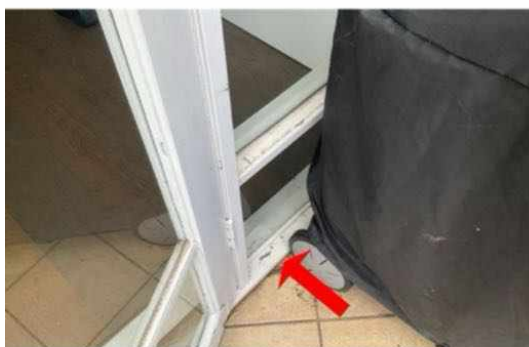
Finding: Door and window frames - extensive wood rot

Information: Extensive Wood rot was noted to the door and window frames leading onto the balcony. Due to the extent of the damage, this defect is classified as a major defect (* see definition below). It is suspected that this wood rot has occurred due to a lack of maintenance and painting to the timber surfaces.

Any External timbers that are frequently exposed to harsh weather conditions require adequate protection in order to maintain their condition. Where these areas have not been painted or treated adequately, general deterioration is likely to occur at an accelerated rate.

* a major defect as per the Australian standards for residential pre-purchase building inspections (AS4349.1-2007) is defined as "a defect of sufficient magnitude where rectification needs to be carried out in order to avoid unsafe conditions, loss of utility, or further deterioration of the property."

Repairs will need to be carried out to the doors and window frames. An invasive inspection will be required to determine the extent of the rotting within the timber. It is highly likely replacement of some items will be necessary.

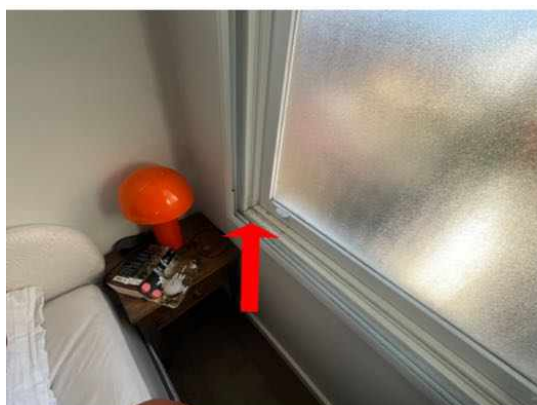
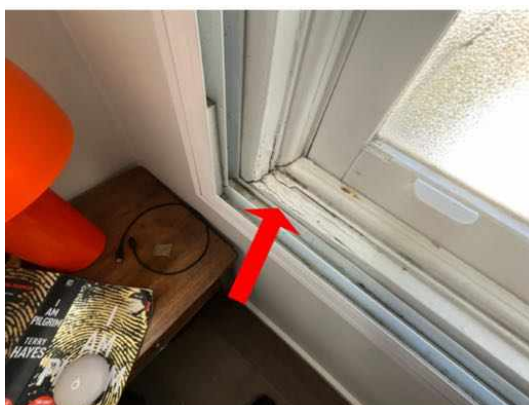
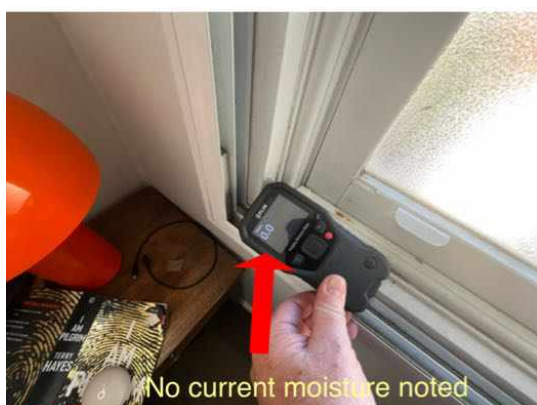
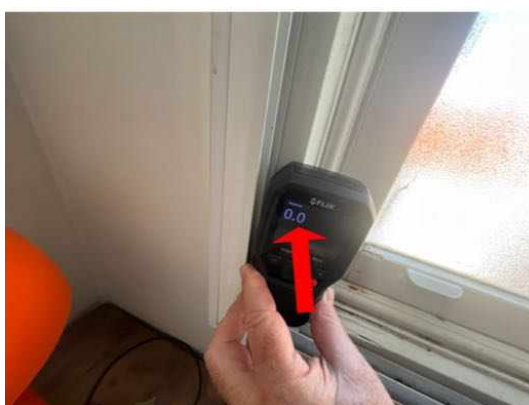
Finding 3.01

Finding: Window - Wood rot

Information: Wood rot was found to be affecting this external window. Wood rot, also known as Fungal Decay, occurs when timbers and other cellulose building materials are exposed to damp conditions on an ongoing basis.

It is likely that this wood rot has developed as a result of frequent exposure to rain and other weather conditions. It is suspected that failure to maintain the window frame over a prolonged period has resulted in it deteriorating at an accelerated rate, increasing its susceptibility to the development of wood rot.

Early intervention and regular maintenance will prolong the useful life of this building elements. Prior to any works being performed, any associated pipework or roof plumbing should be inspected by a licensed plumber for faults or leaks.

Repair of the affected window frame will be necessary to prevent further deterioration.

Remedial works should be performed by a qualified carpenter or registered builder as

a priority.

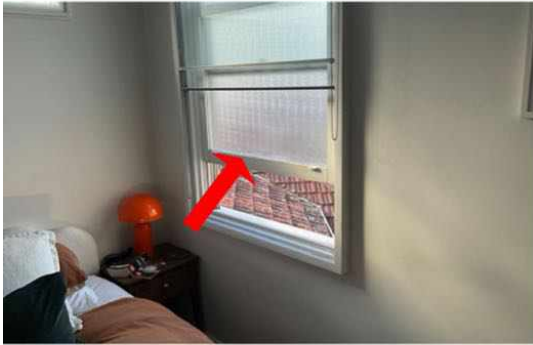
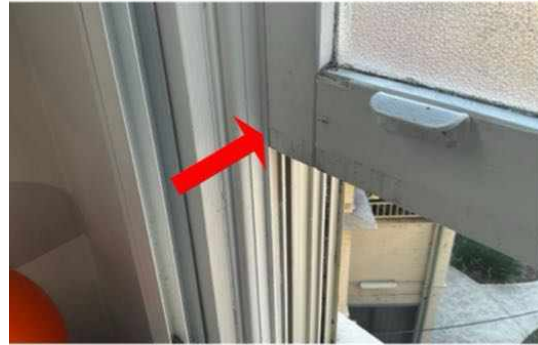
Finding 3.02

Information: The window in the bedroom was sticking and difficult to operate at the time of the inspection. Windows provide ventilation to the adjoining area and should be at a fully operational level to ensure user comfort. Restricted function of the window may also create potential for secondary defects to the associated building elements, such as damage to the window frames as well as a potential safety hazard if required for emergency egress from the building.

The most usual causes are swelling of timbers due to moisture, bulging or bowing of frames, or general material degeneration.

Easement will be required, which may involve some sanding and repainting. It will almost always include ensuring the areas are cleaned and free of any debris that may be detrimental to their operational state.

A competent handyman or window specialist may be engaged to perform this task.

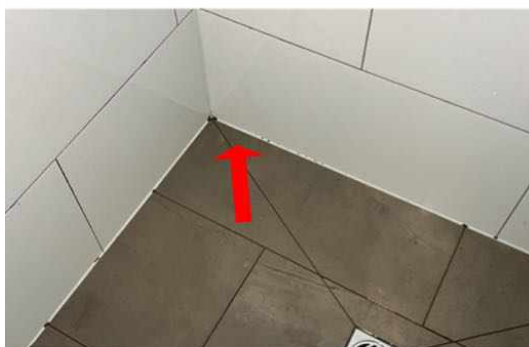
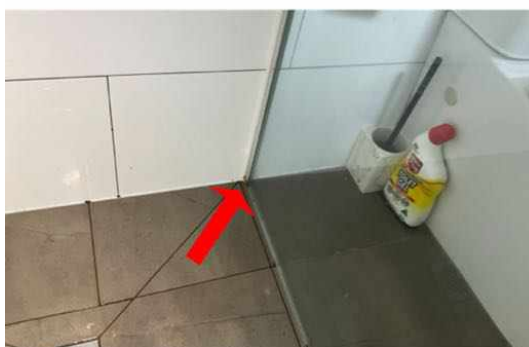
water damage that may occur. Regular maintenance and replacement of damaged or missing grout/ sealant is highly recommended to the wet areas, as this is a regular wear and tear defect. Both grout and sealant in areas that come into regular contact with water should be maintained for the long term care of your property.

A bathroom specialist or tiling contractor should be appointed to complete these works as a priority.

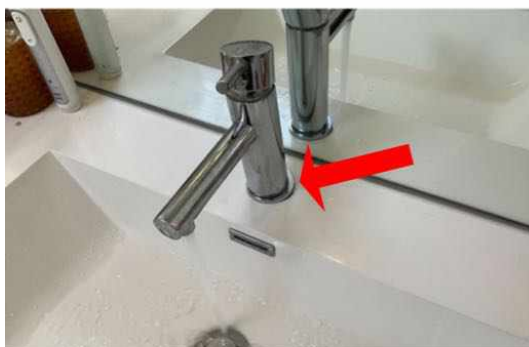
Failure to act on this defect may cause the the tap to further deteriorate and cause leaking.

Where taps or spouts are loose, a qualified plumber should be appointed to re-fix the plumbing fitting as a matter of urgency.

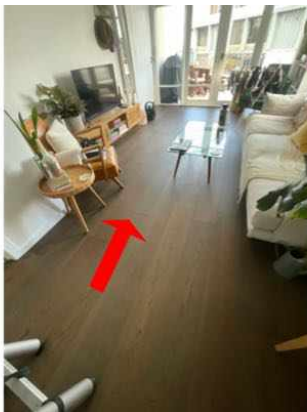
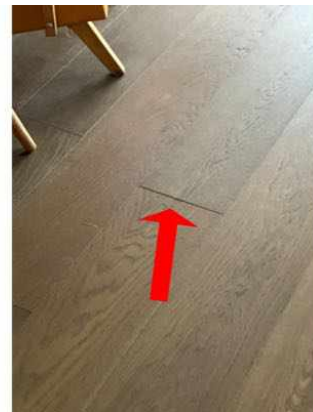
Note: photos included are examples of gaps found within the flooring. Other gaps may be present but not highlighted here.

Monitoring of the flooring is recommended to look for any changes. Should there be any further movement of the floorboards, a flooring specialist may be engaged to inspect the floor and advise of ways to repair the flooring.

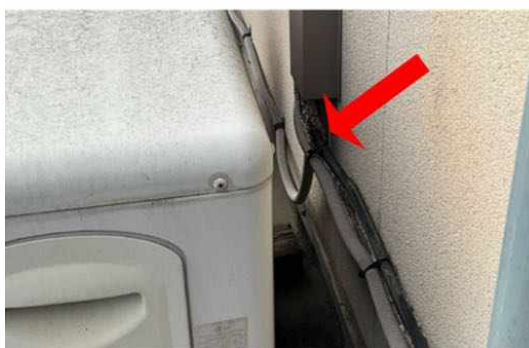
If left in an exposed position, it is likely that the deterioration will continue and worsen over time, potentially resulting in secondary building defects as well as a further loss in insulating properties.

Some areas of replacement of pipe insulation is likely to be required. Further preventative measures to remove or protect the material from future exposure are also advisable. Consultation with a licensed plumber is advised to gain quotes for the repair and/or replacement of deteriorated insulation.

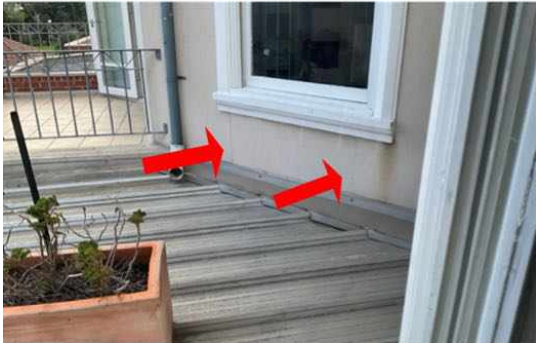
Should cracks increase in size or number, speak with your building inspector for further advice.

Consultation with a suitably qualified renderer should be sought to determine costs involved with any repairs necessary.

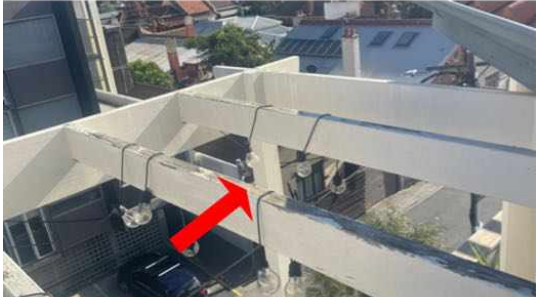
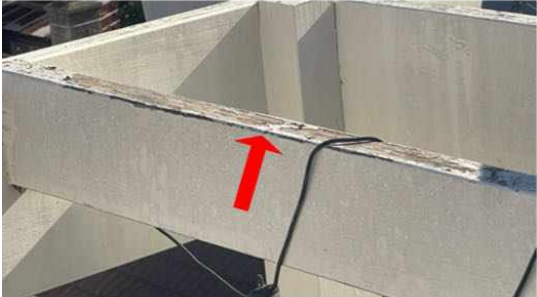
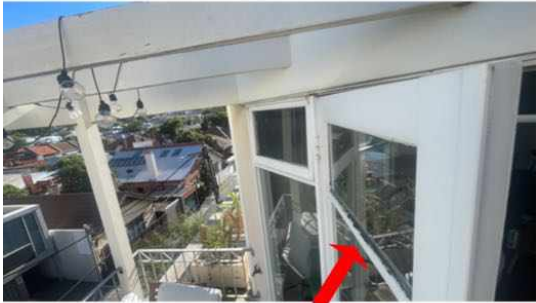
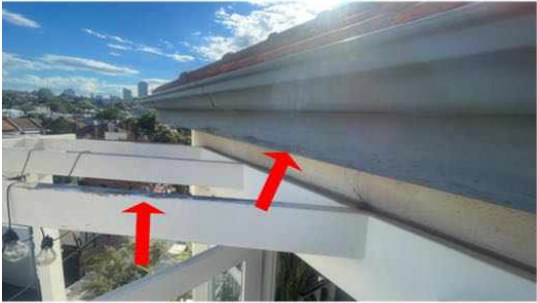
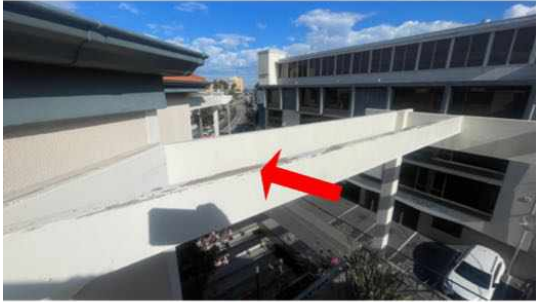
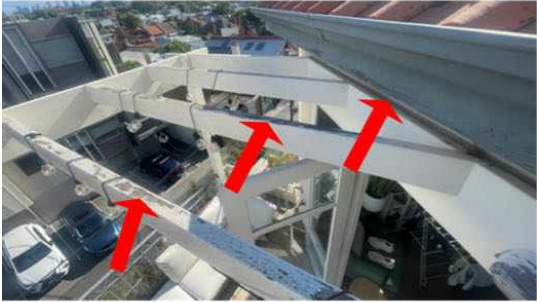
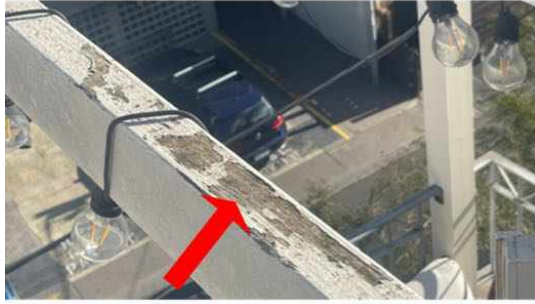
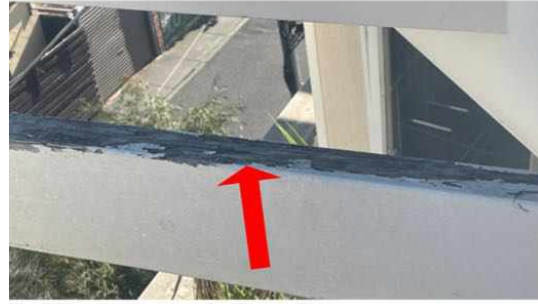
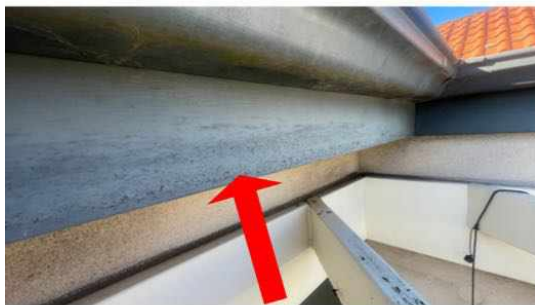
Finding 3.15

Building:
Location: All External Areas
Finding: Timber - exposed to weather
Information: External timbers that are frequently exposed to harsh weather conditions require adequate protection in order to maintain their condition. Where timbers have not been painted or treated adequately, general deterioration is likely to occur at an accelerated rate.

Adequate treatment of these timbers is required as soon as possible by a painting contractor or general handyman.

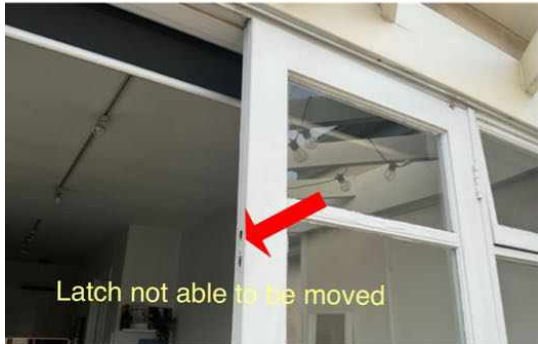
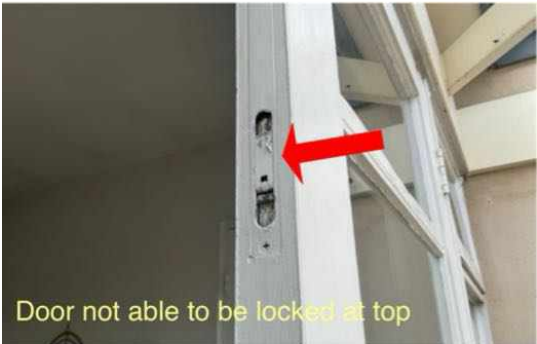
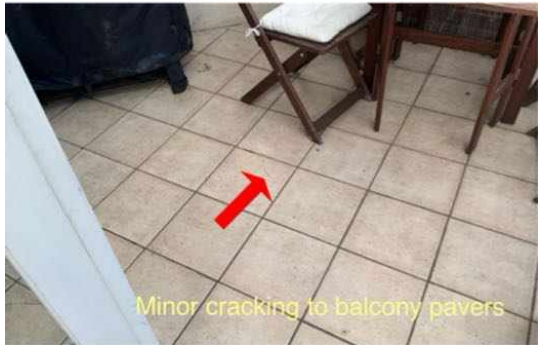
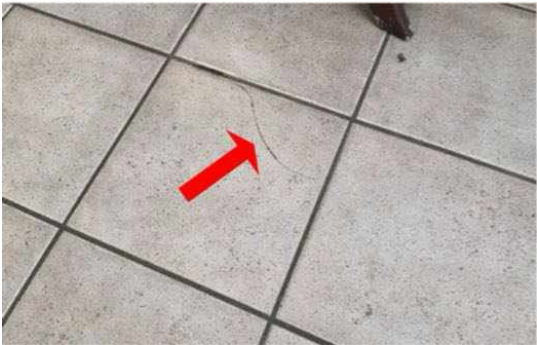
Finding 3.17

Building:
Location: All Areas
Finding: Additional Photos - minor defects
Information: Additional photos are provided for your general reference. Arrows have been included where necessary to highlight areas of importance.

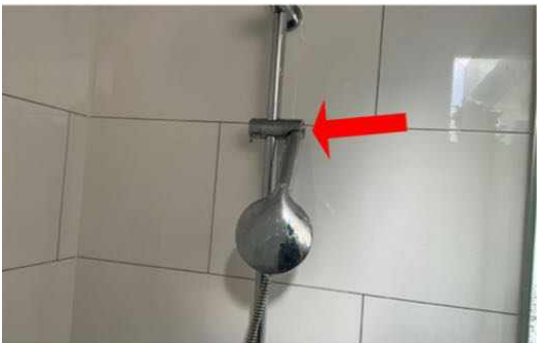
Shower head / hose damaged

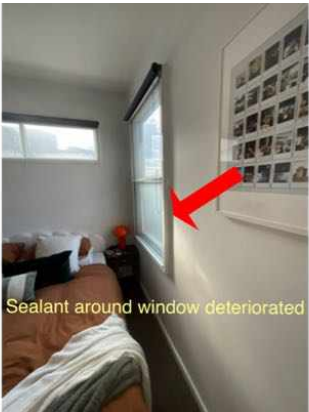
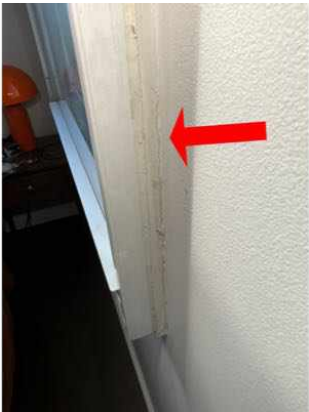
Sealant around window deteriorated

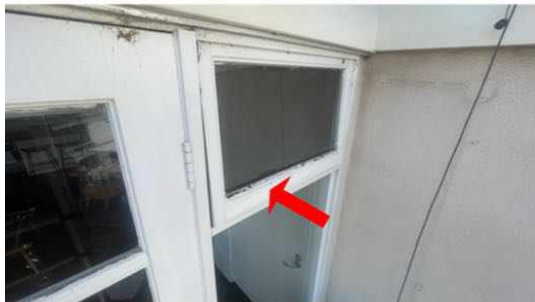
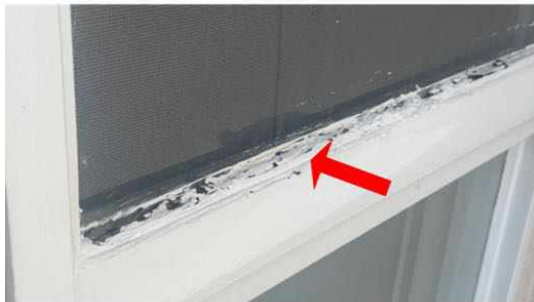
Finding: Fungal decay - conditions conducive to timber pest attack

Information: Fungal decay also known as wood decay or wood rot generally refers to the deterioration of timber elements when in contact with excessive levels of moisture for a prolonged period of time.

Generally fungal decay develops on timber elements that are in use in an external environment which are exposed to rain penetration.

There was however a major * defect noted - that being extensive wood rot to the door and window frames leading onto the balcony.

Decaying timbers can create an environment conducive to timber pest attack. It is recommended that the decaying timbers be repaired / replaced to lessen the risk of timber pests.

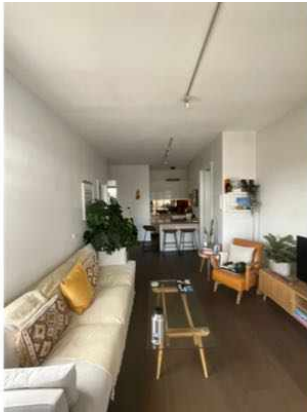
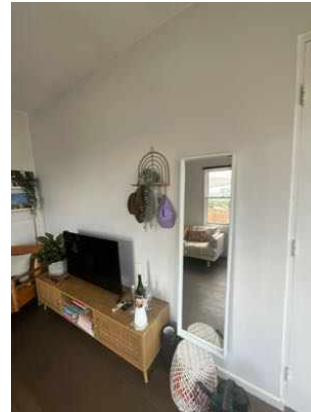
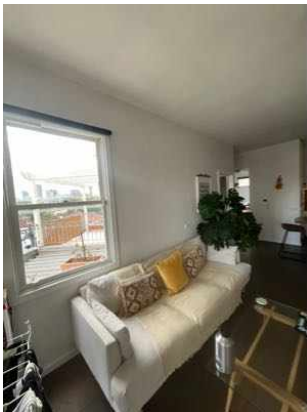
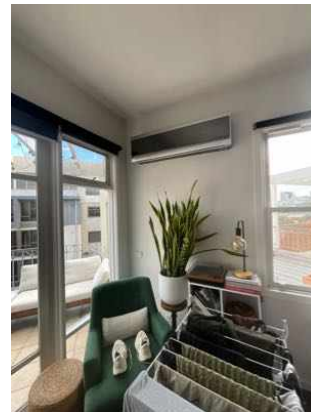
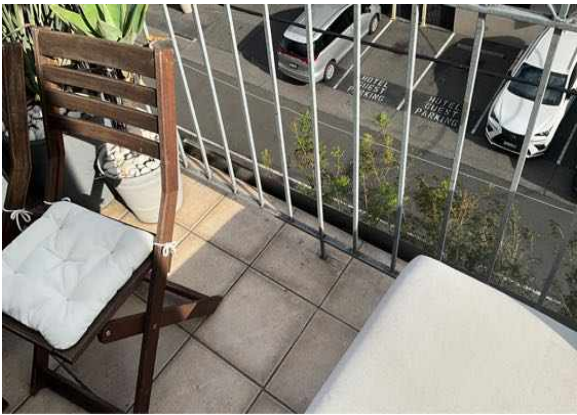
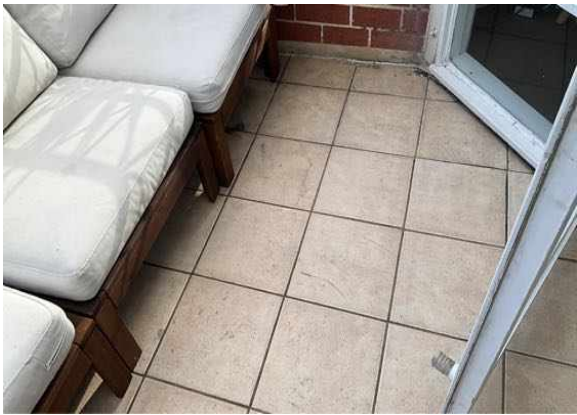
Information:

These photographs are an indication of the obstructions and limitations which impeded full inspection of the property at the time of inspection. These obstructions can hide an array of defects and should be removed to allow full inspection to be carried out. A re-inspection is recommended once the areas are made accessible.
