Building and Timber Pest Inspection Report

Inspection Date: Mon, 9 Mar 2026

Property Address: 71/3 Taylor St, Lidcombe NSW 2141,
Australia

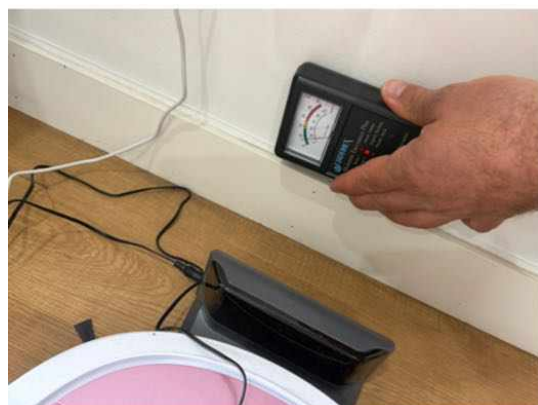
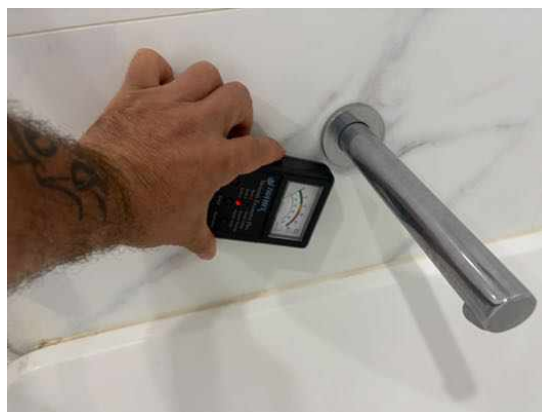
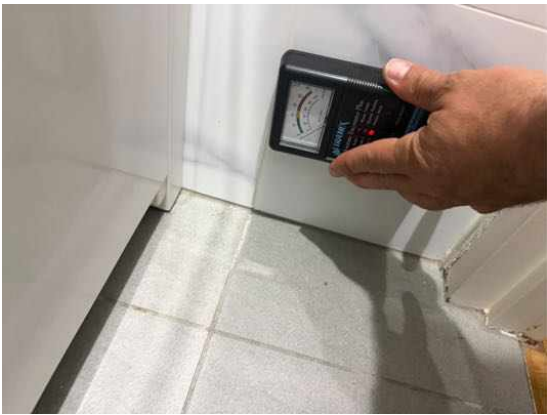
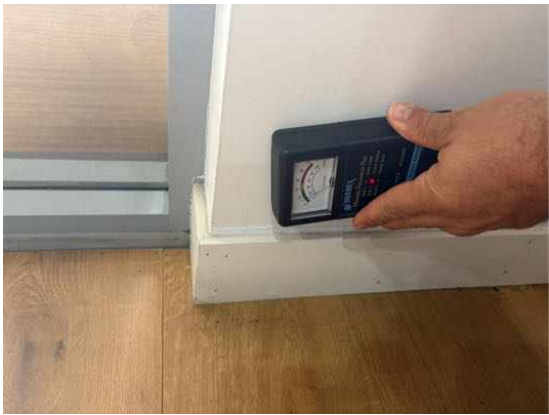
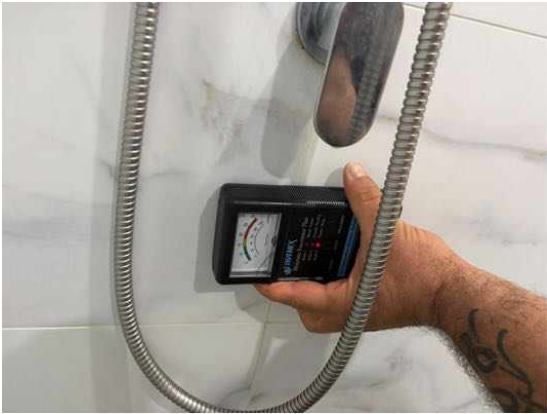
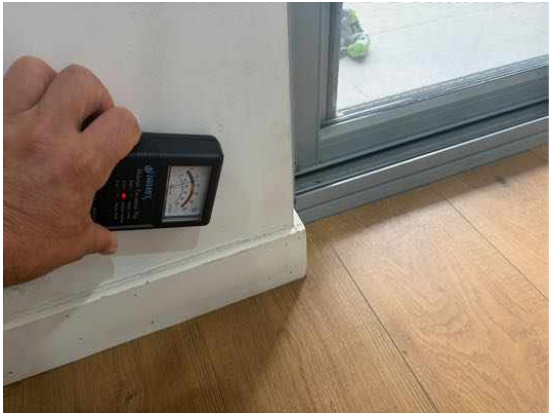
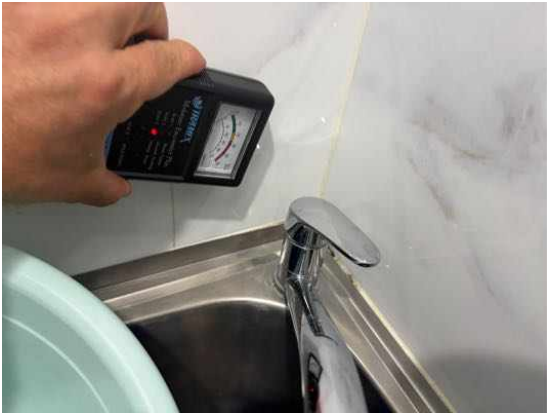
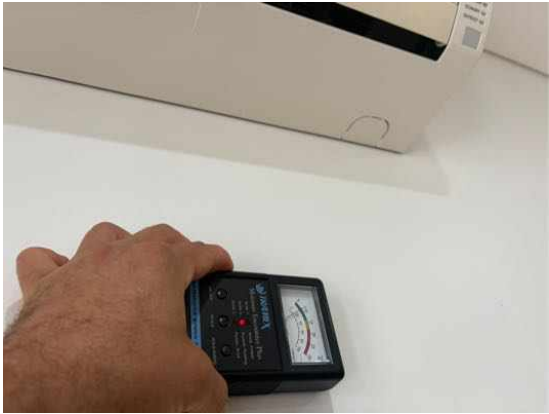
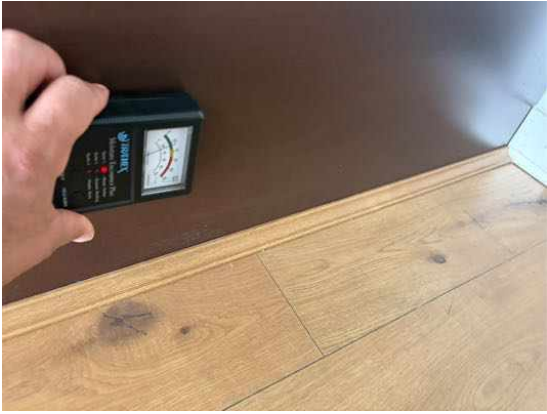
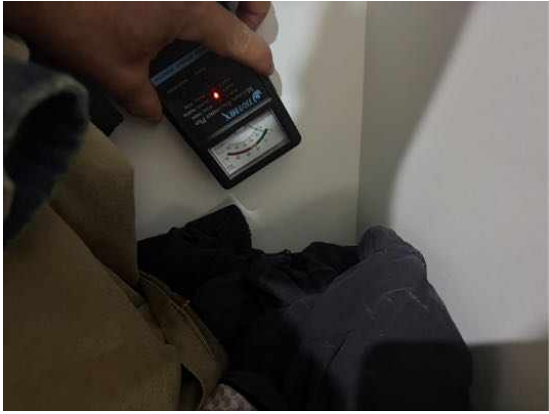
Building: Main Building
 Location: All Areas
 Finding: Moisture metre
 Information: During the inspection the property was checked for moisture using a moisture metre.

This is for information only.

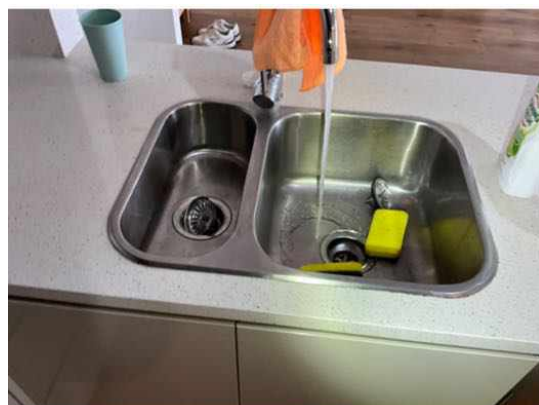
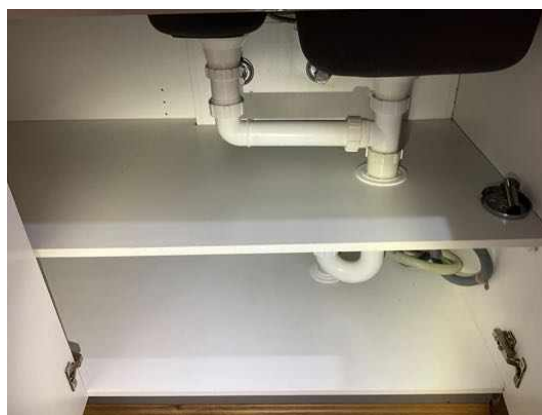
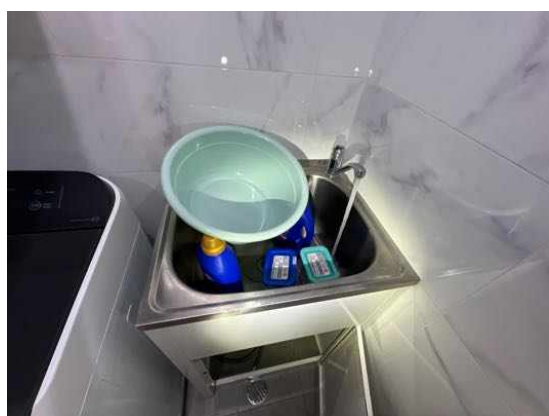
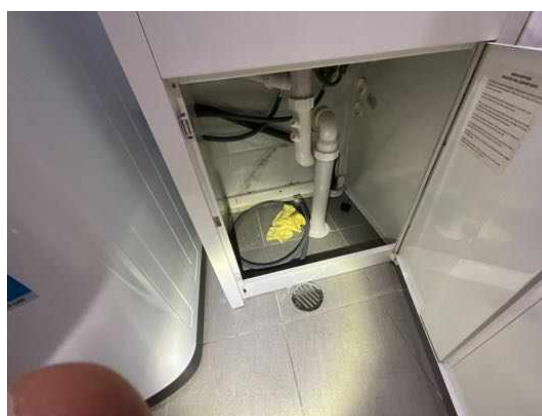
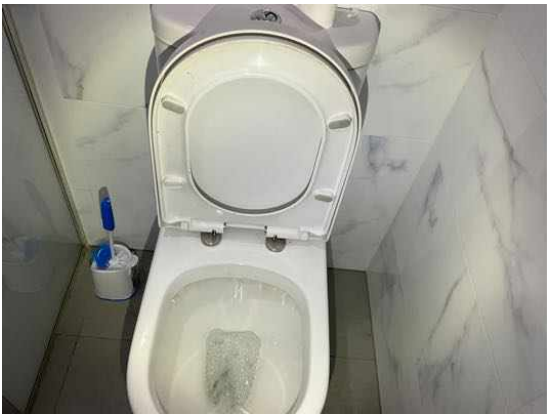
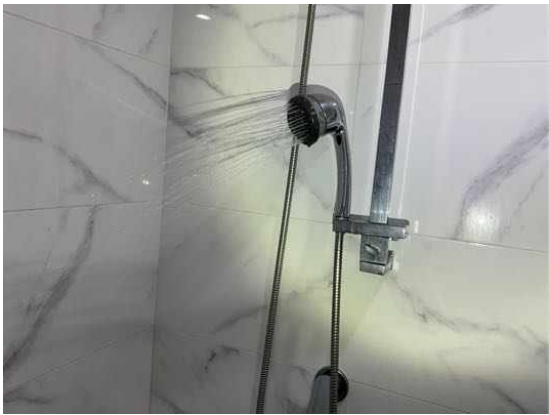
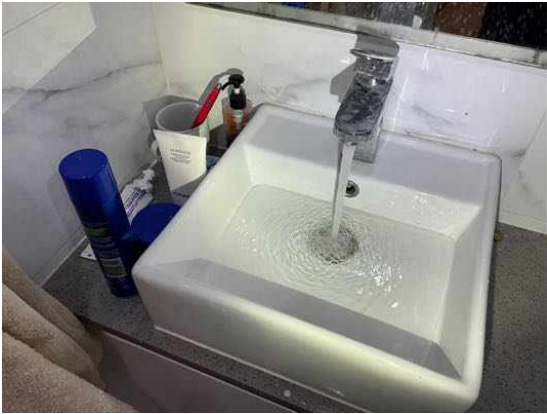
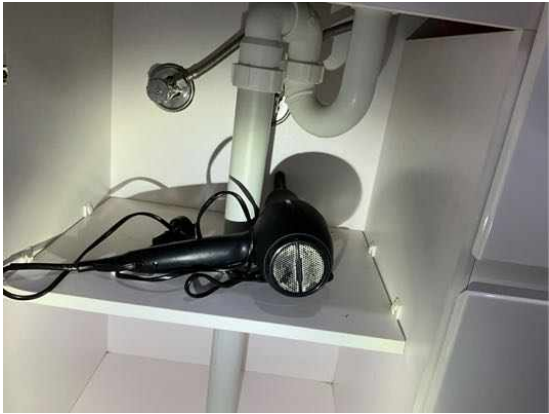
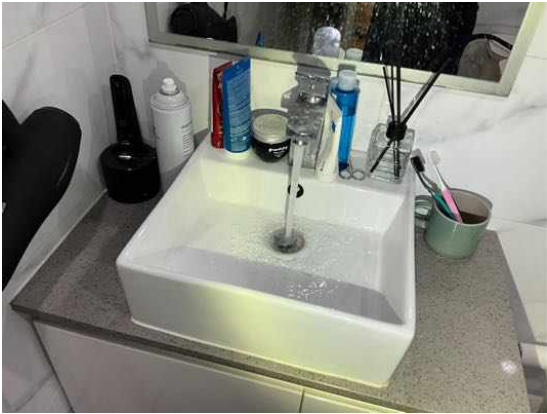
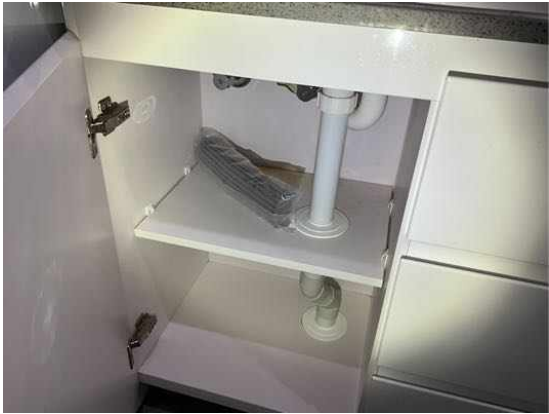
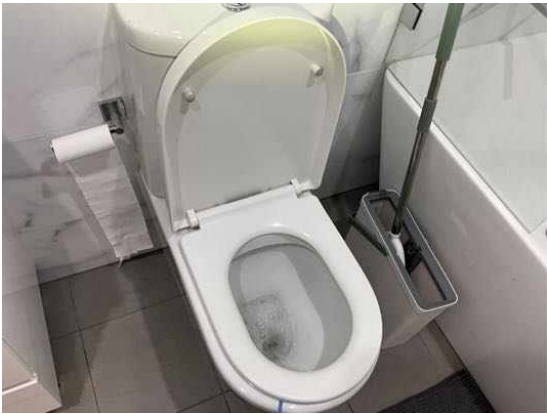
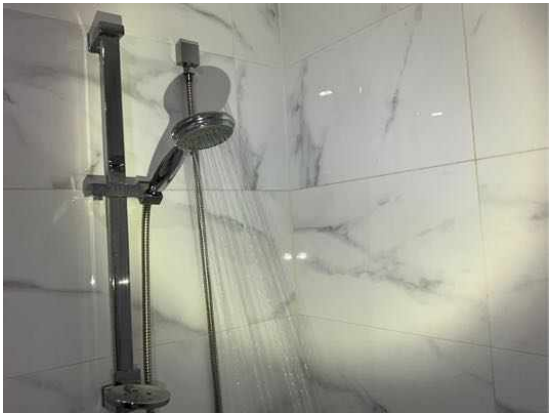
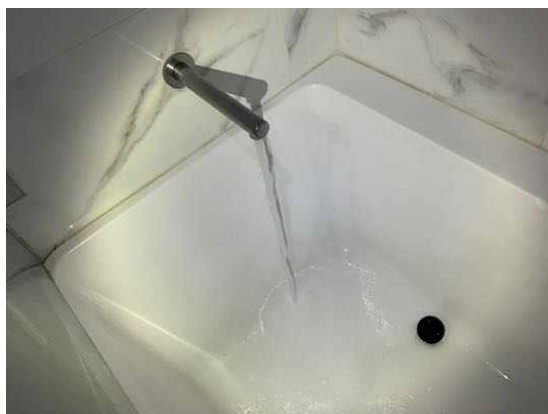
Building: Main Building
Location: All Wet Areas
Finding: Waterproofing
Information:

All taps, mixers and toilets were tested for operation, except for those obstructed. The waterproofing to the shower recess was assessed by checking the walls in and around the shower recess for varying moisture content. There were no significant variations across the tested areas. No sign of recent water damage was evident upon a visual inspection of the surrounding walls, where the visual nature of the inspection was possible.

Consequently, there is no conclusive evidence of any current shower recess leakage other than those which may have already been mentioned earlier in this report. It is reasonable to assume the shower waterproofing is sound. Note that if the shower is not used, or has not been used for some time, moisture readings would not vary significantly and this can lead to erroneous results. It is not possible under the visual inspection criteria (under which a prepurchase inspection is carried out) to categorically determine if there are leaks. If a more accurate assessment is required, a special purpose inspection should be requested. Alternatively, the assumption should be made that the shower may leak.

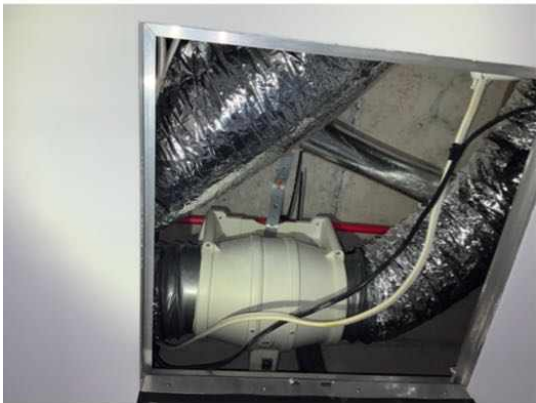
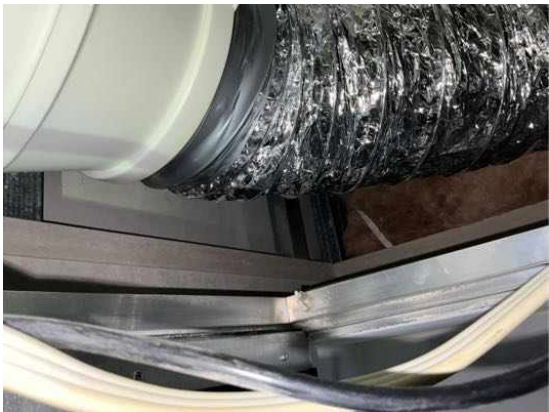
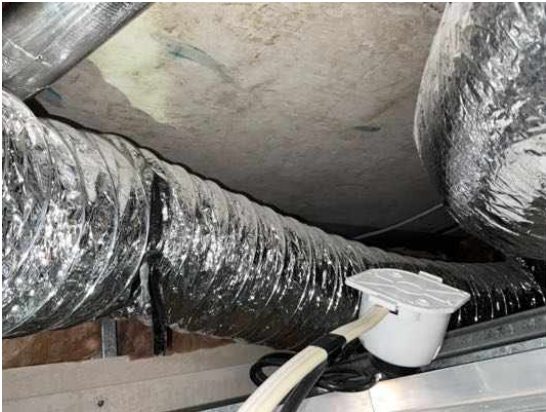
Building:	Main Building
Location:	Ceiling cavity
Finding:	Additional Photos- ceiling cavity
Information:	Additional photos are provided for your general reference. Arrows may have been included to highlight areas of importance. Please discuss these photos with your building consultant for clarification.

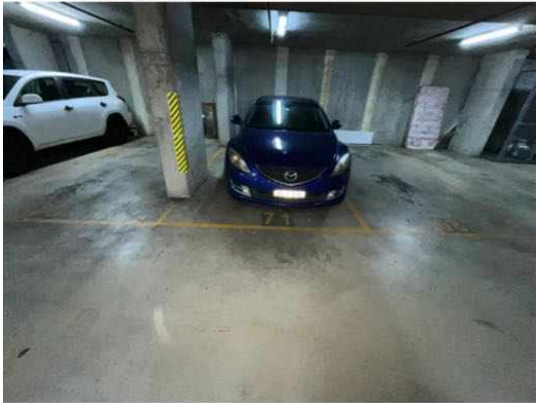
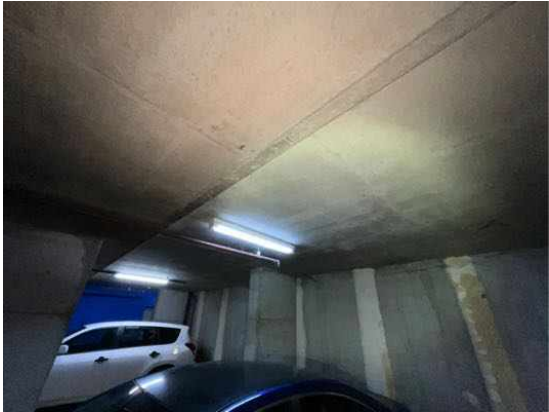
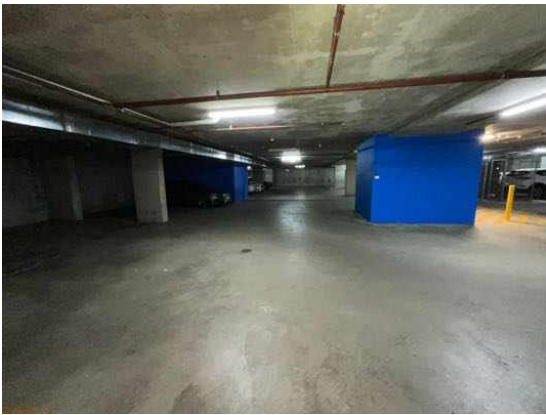
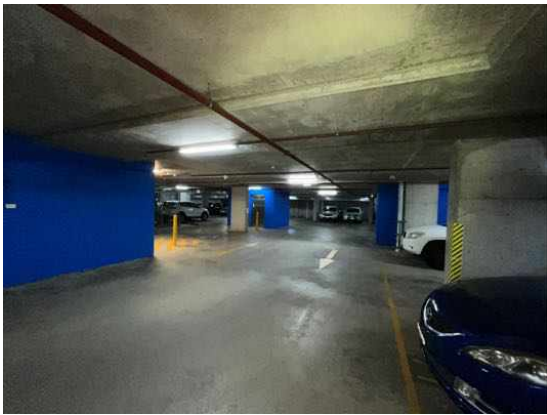
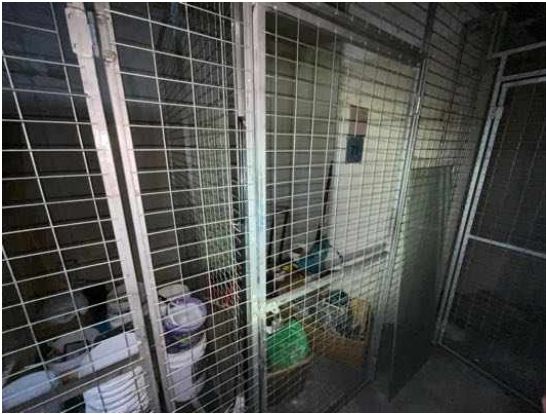
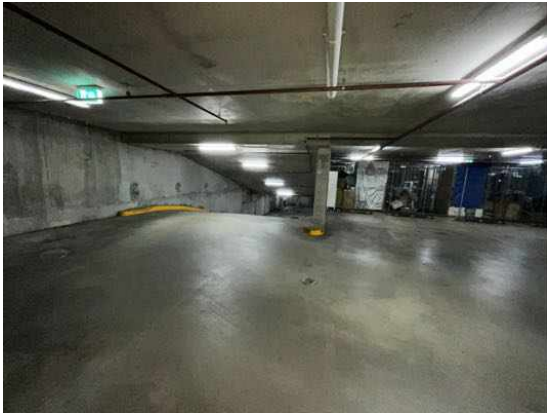
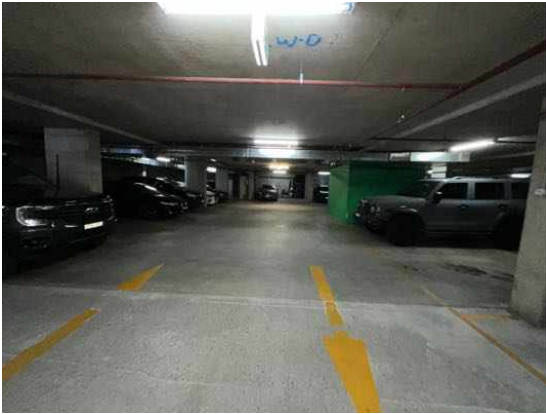
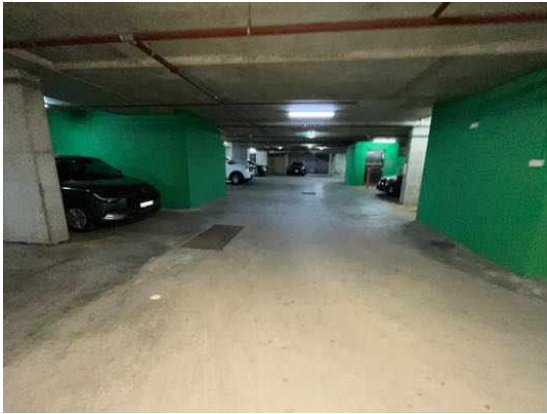
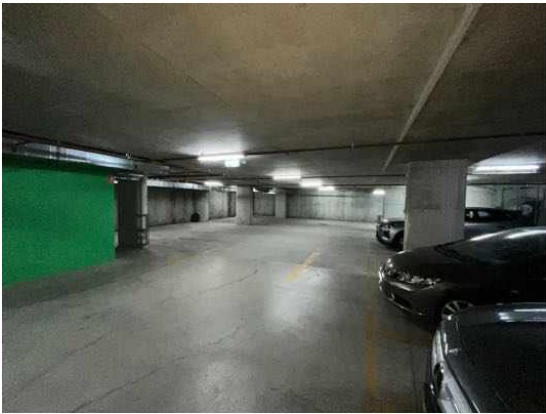
Building: Main Building
Location: Garage
Finding: Additional Photos- Garage
Information: Additional photos are provided for your general reference. Arrows may have been included to highlight areas of importance. Please discuss these photos with your building consultant for clarification.

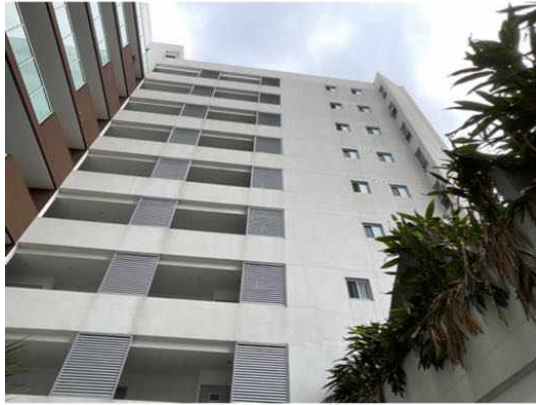
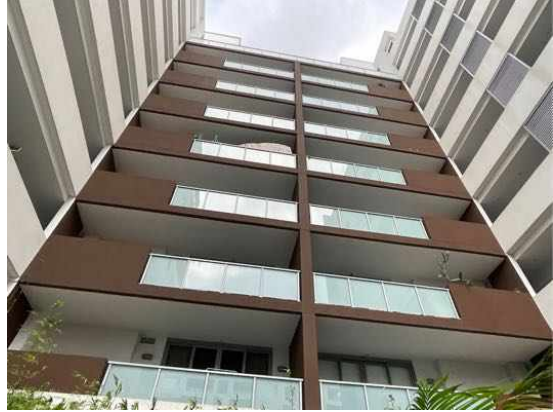
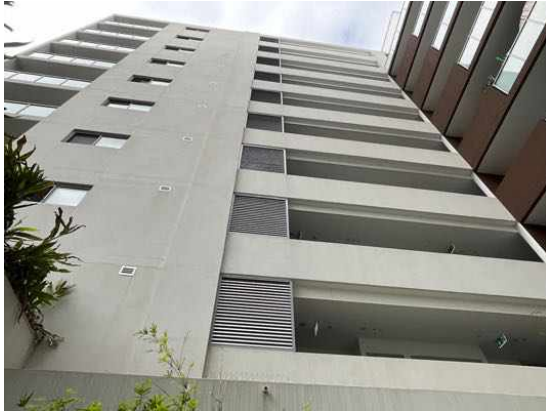
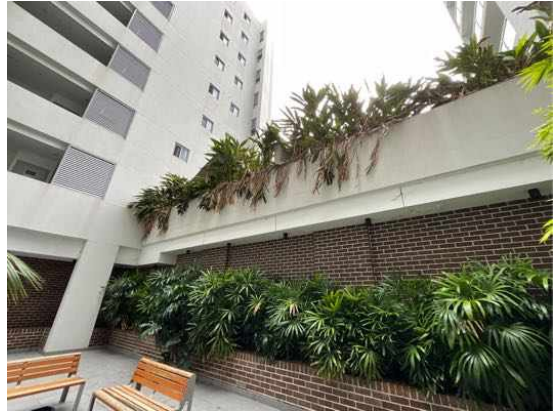
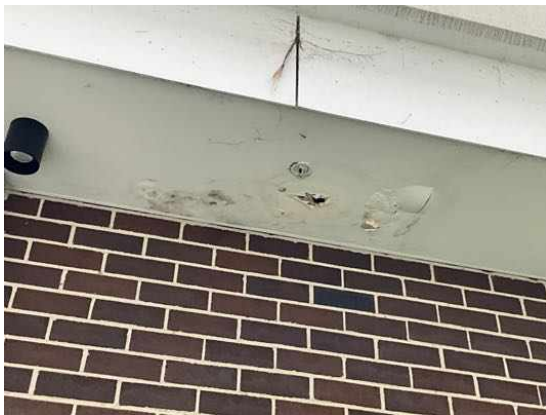
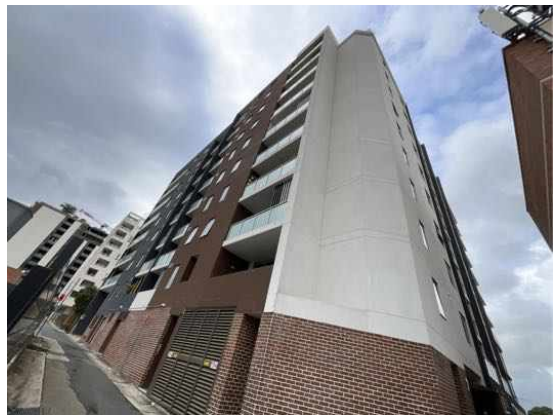
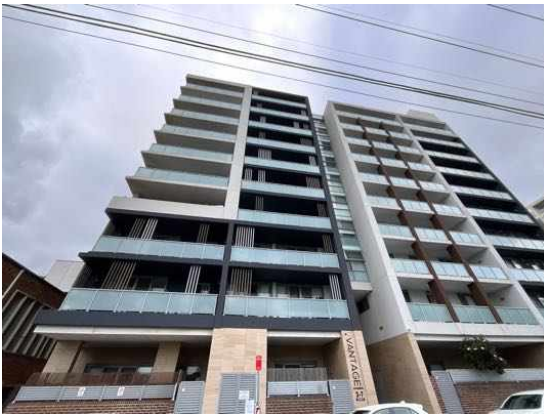
Building: Main Building
Location: Exterior
Finding: Additional Photos
Information:

Additional photos are provided for your general reference.

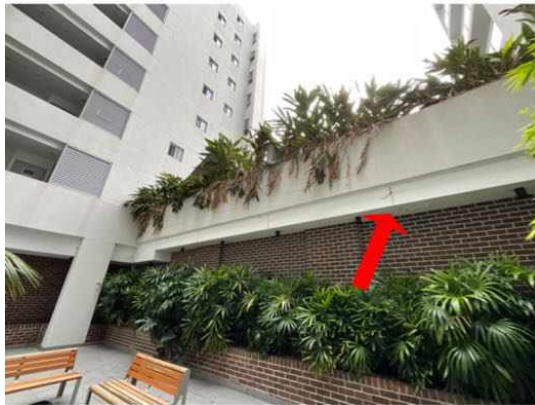
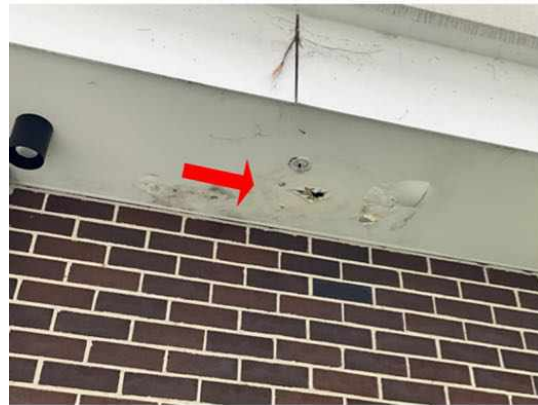
Building: Main Building
 Location: Other common areas
 Finding: Additional Photos
 Information: Additional photos are provided for your general reference.

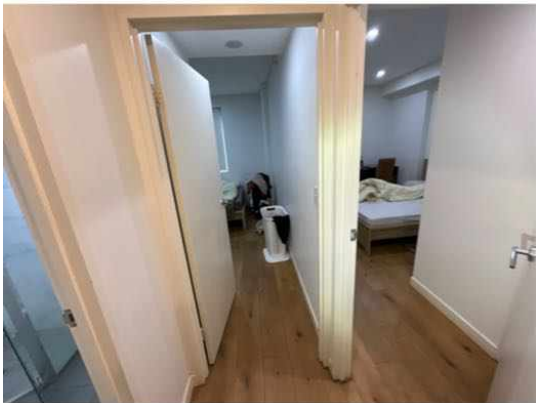
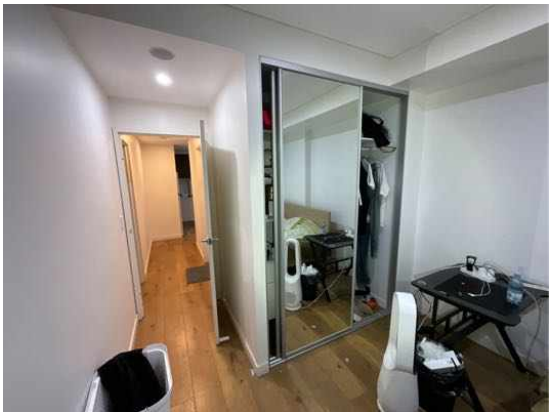
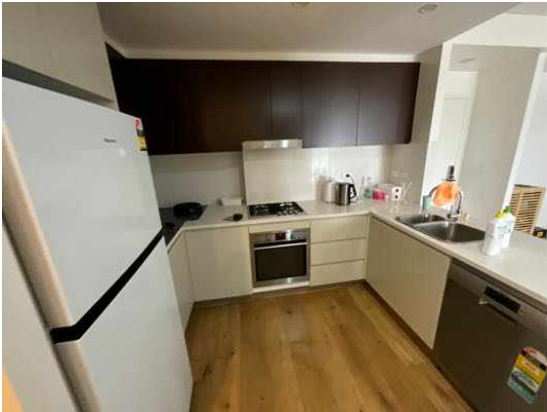
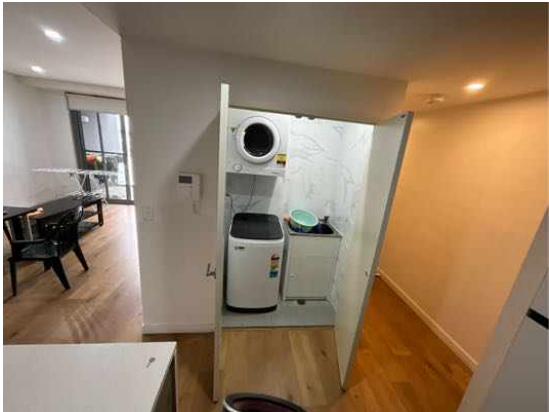
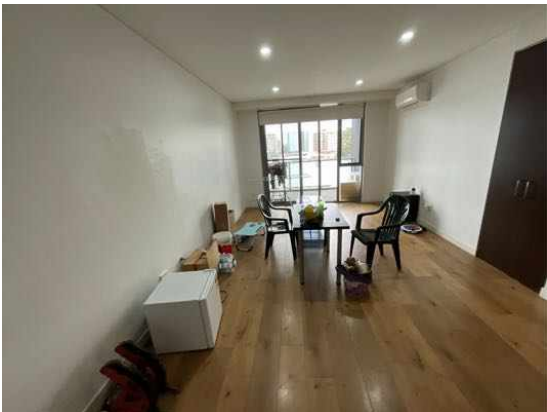
Building: Main Building
 Location: All Areas
 Finding: Additional Photos - Obstructions and Limitations
 Information: These photographs are an indication of the obstructions and limitations which impeded full inspection of the property at the time of inspection. These obstructions can hide an array of defects and should be removed to allow full inspection to be carried out. A re-inspection is recommended once the areas are made accessible.
