# Building and Timber Pest Inspection Report

Inspection Date: Tue, 24 Feb 2026

Property Address: 33/9 Miller St, Fitzroy North VIC 3068,  
Australia

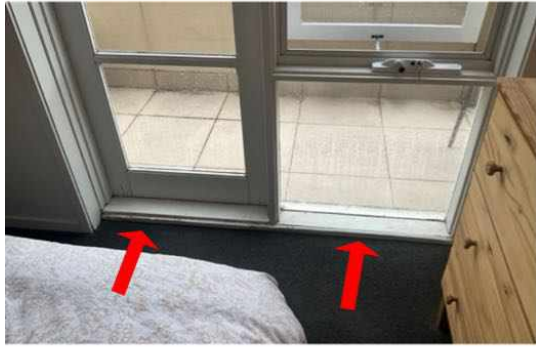
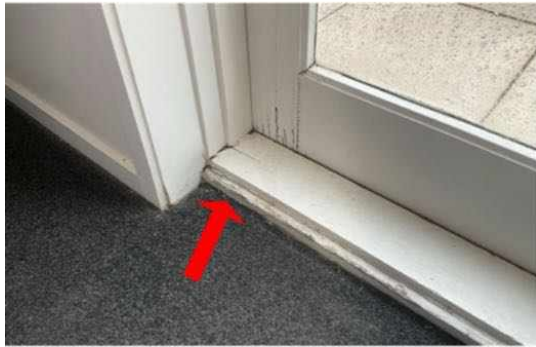
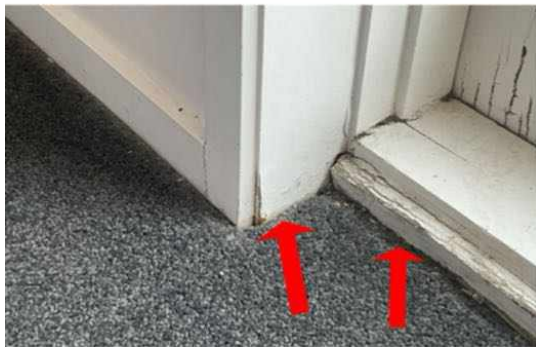
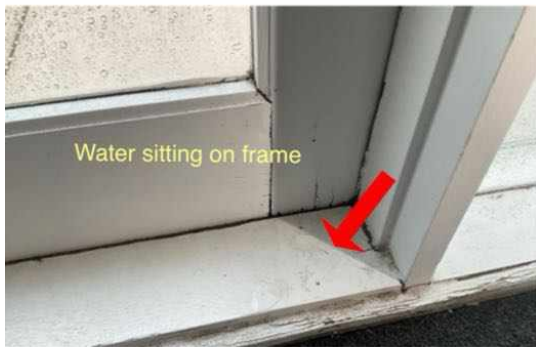
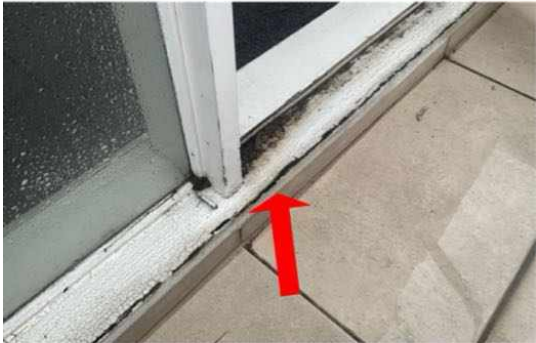
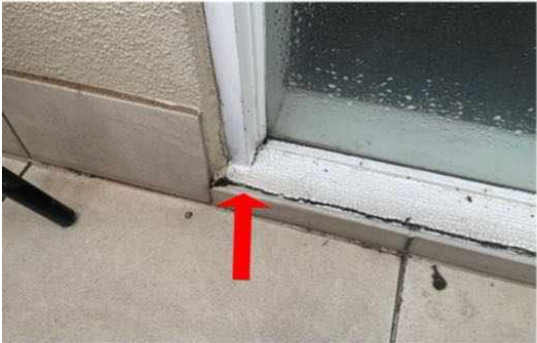
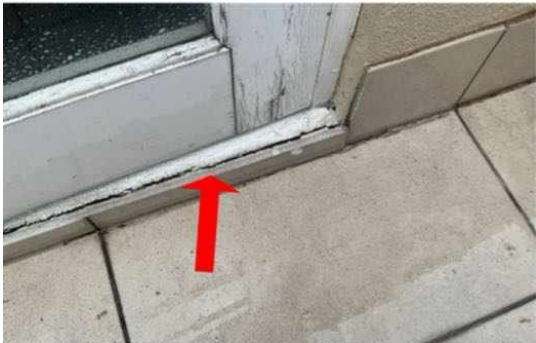
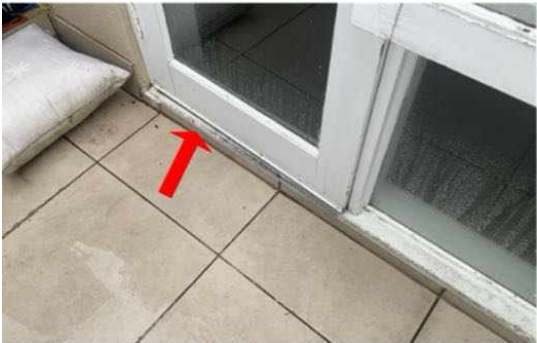
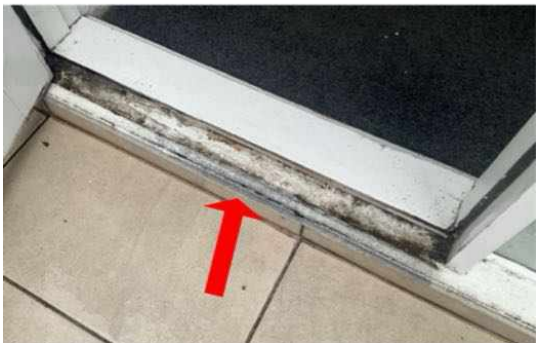
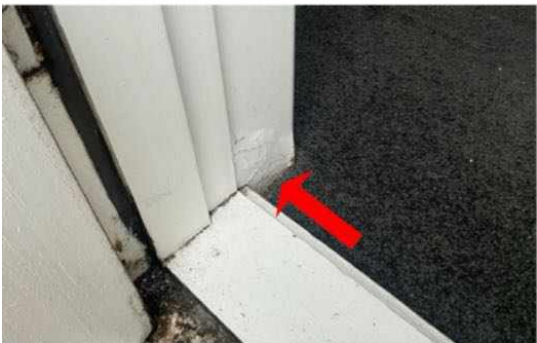
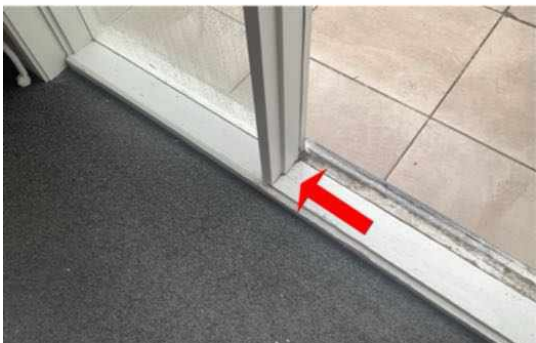
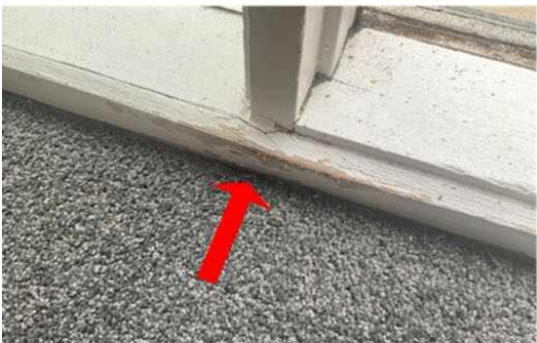
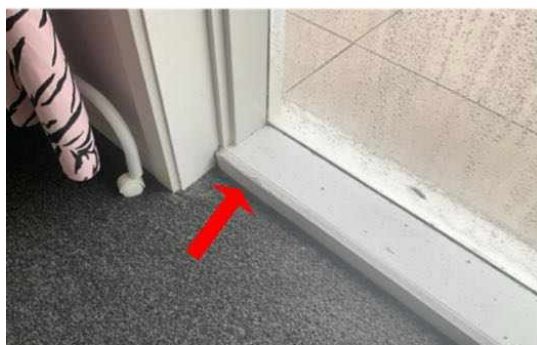
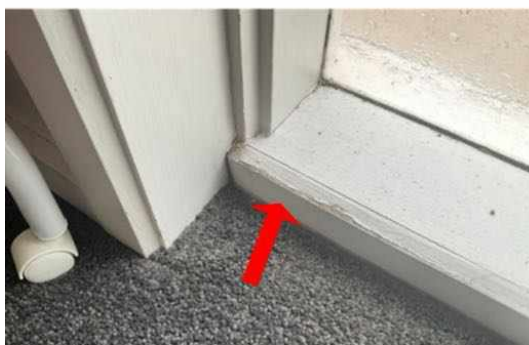
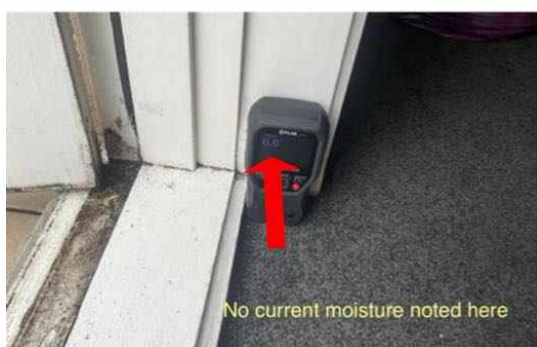
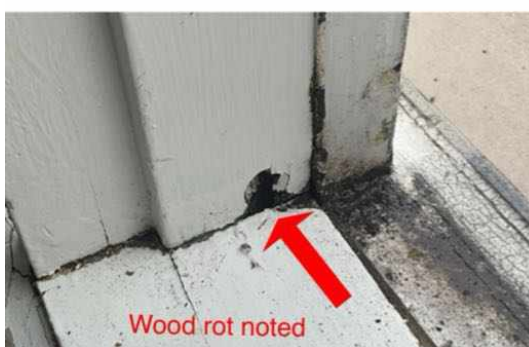
Finding: Moisture damage to skirting board and architrave at balcony door ( major defect)

Information: Evidence of moisture damage was identified to the skirting boards and door frames next to the balcony doors. Wood rot was noted within some areas of the framing. It was noted that the doors did not close properly which appears to have contributed to the moisture getting in a causing secondary damage. Water was actually sitting on the base of the frame inside the door. This defect is listed as a major defect\*

It is suspected that the damage has occurred as a result of excess moisture from external sources. Moisture was noted in some areas when tested with a moisture meter.

It is suspected that this may be an ongoing problem as there is no cover to prevent rain from directly hitting this area. If possible, an awning above these doors may provide some protection.

A licenced carpenter or competent handyman should be engaged as a matter of urgency to inspect the moisture damaged areas and repair or replace any items where necessary.

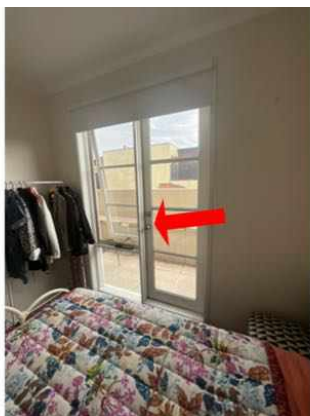
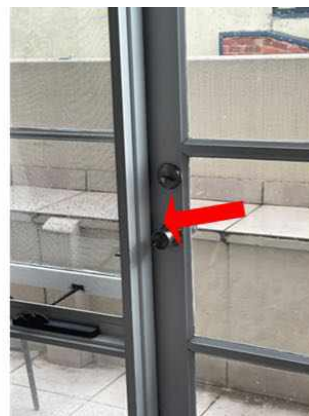
## Finding 2.02

Information: At the time of inspection, both door in the bedrooms did close and lock effectively. The left hand bedroom door closed but not completely flush with the framing. It is suspected that the door may be slightly warped due to moisture. The right hand bedroom door didn't close fully - suspected striker plate misalignment.

The doors should be inspected and repairs made as a matter of urgency. Failure to rectify these defects may result in further moisture ingress within the property.

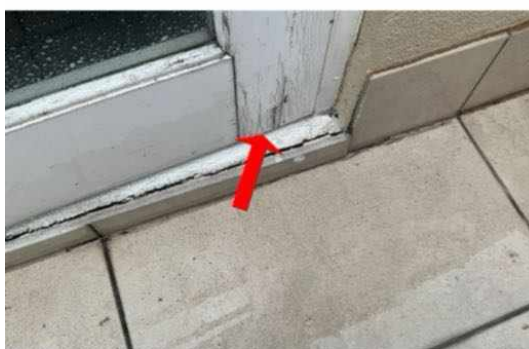
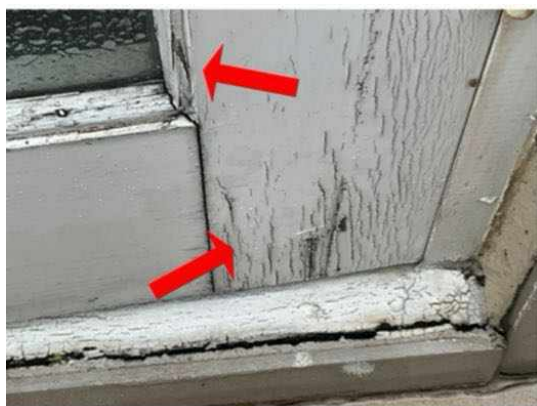
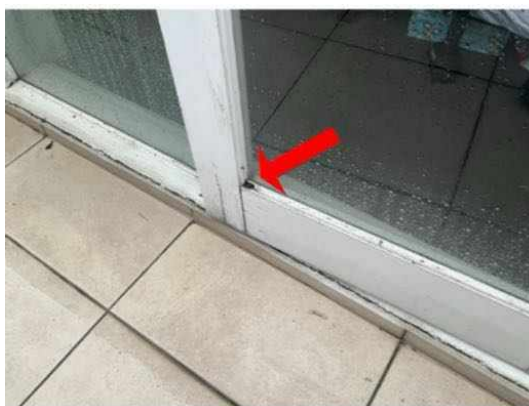
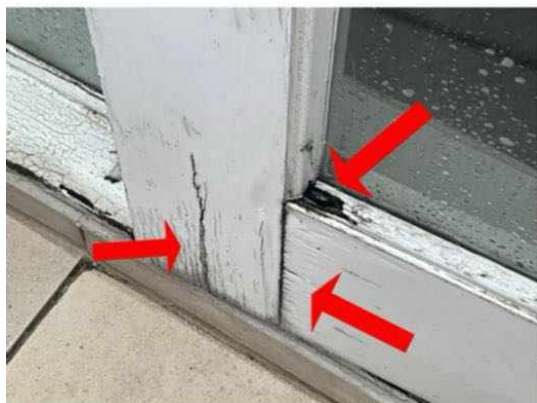
### Finding 2.03

Finding: Doors - Moisture damage and Wood rot noted

Information: Moisture damage and Wood rot was found to be affecting the external doors in this area. Wood rot, also known as Fungal Decay, occurs when timbers and other cellulose building materials are exposed to damp conditions on an ongoing basis.

It is likely that this wood rot has developed as a result of frequent exposure to rain and other weather conditions. It is suspected that failure to maintain the door over a prolonged period has resulted in it deteriorating at an accelerated rate, increasing its susceptibility to the development of wood rot. Constant exposure to the weather may have also contributed to the formation of the wood rot in this area.

Replacement of the affected door will be necessary.

A qualified carpenter or competent handyman should be engaged as a matter of urgency to perform this task..

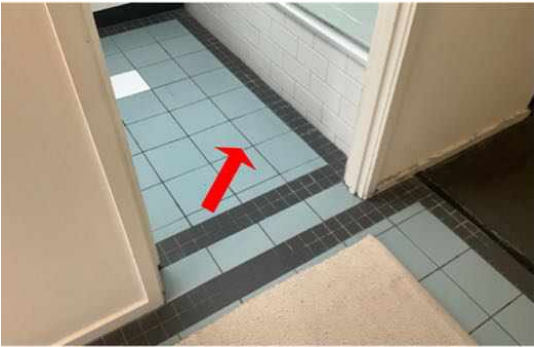
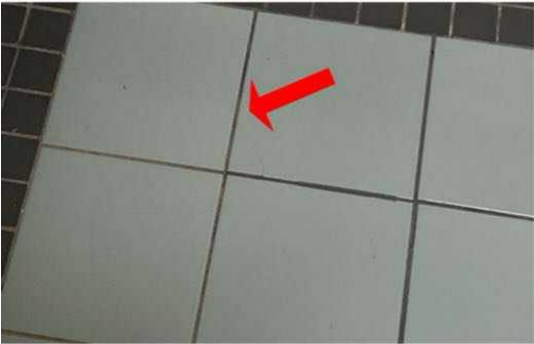
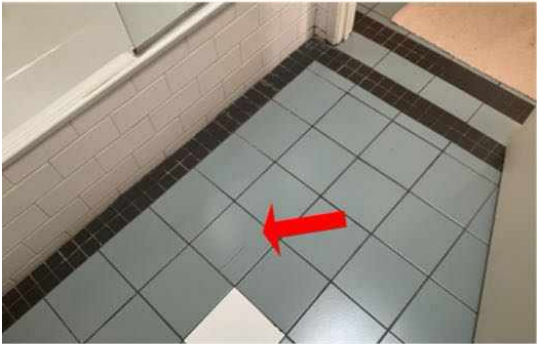
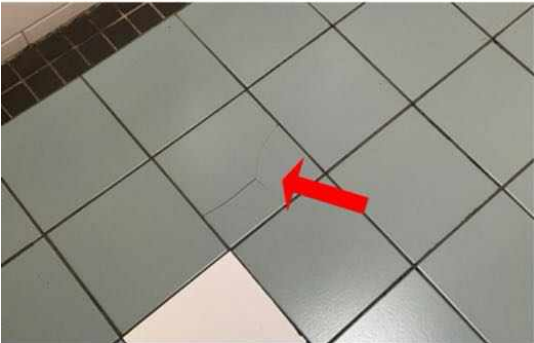
### Finding 2.04

Finding: Wet area tiles - Cracked or damaged

Information: Cracking was evident to the tiling in this area at the time of inspection. While the cracking appears to be minor, this area is frequently exposed to water, allowing potential for water penetration into adjoining sections of walls or flooring ( as was noted here)

If left unmanaged, water penetration in these areas will lead to further water damage, which is likely necessitate repair work to affected building elements.

Where water penetration has led to water damage, appointment of a relevant tradesperson will be required to repair damaged building elements.

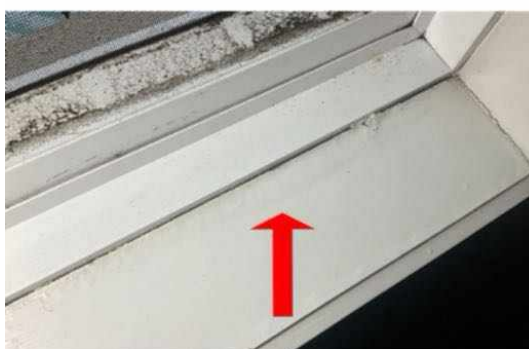
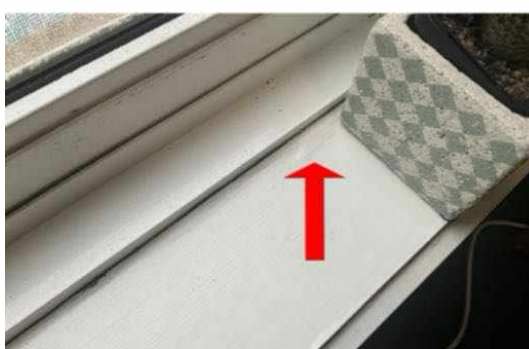
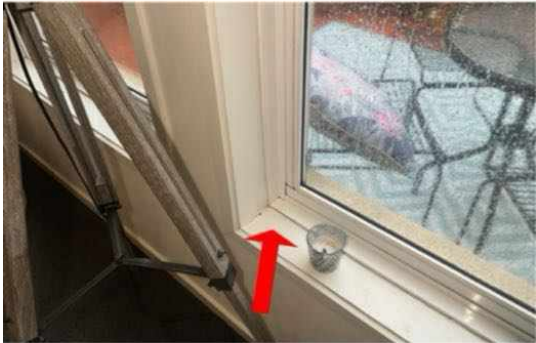
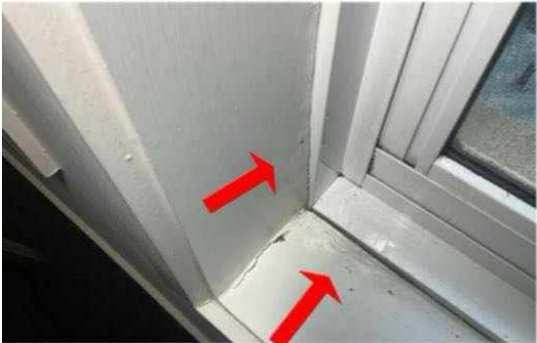
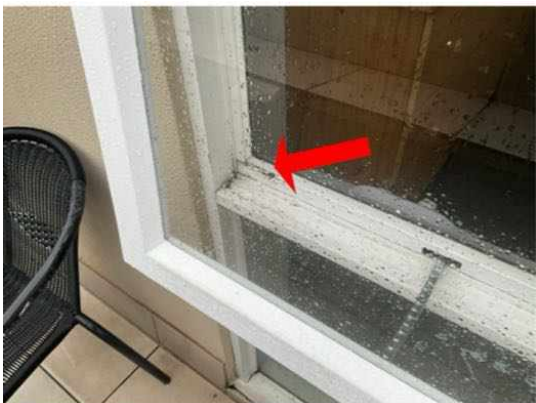
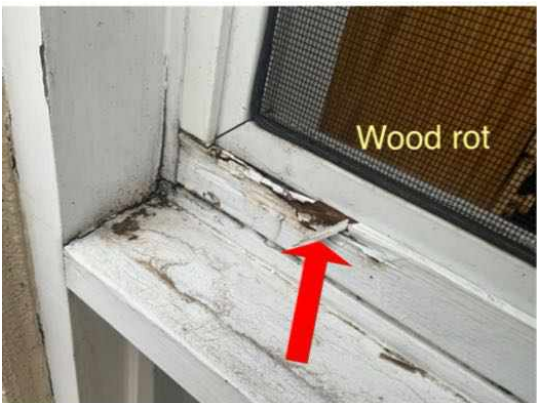
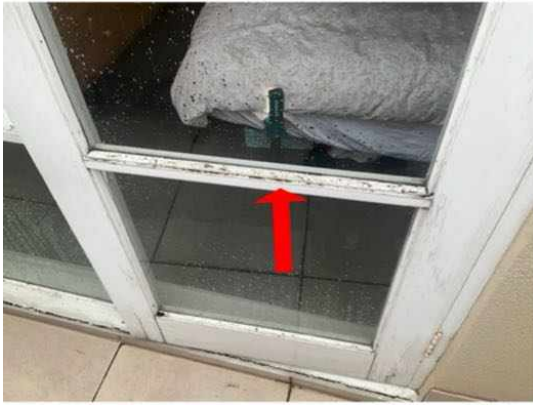
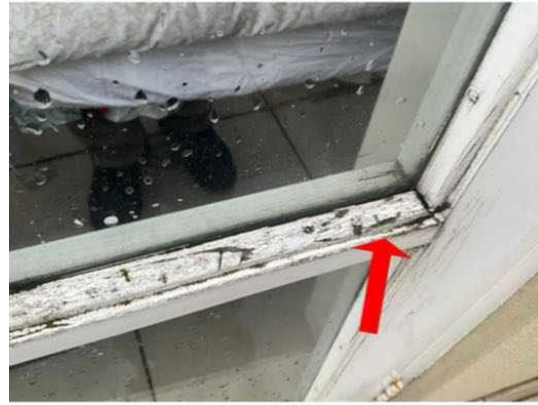
## Finding 2.05

Finding: Moisture damage to the windows

The sealant around all window should be replaced so as to ensure no further the moisture gets into the property. Repairs to damaged window frames should be carried out and all windows repainted.

A window specialist or a competent handyman maybe engaged to perform this task as a matter of urgency.

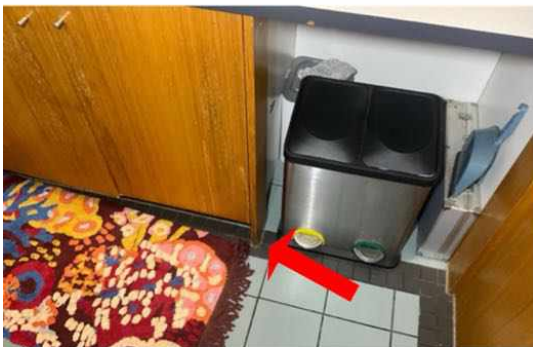
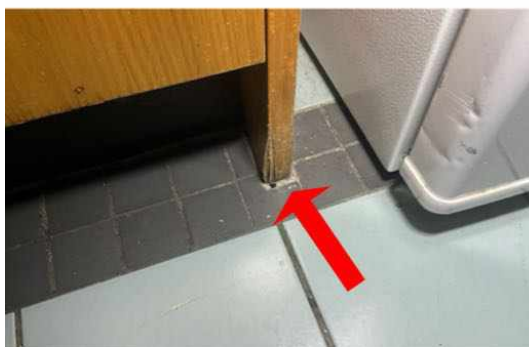
### Finding 3.01

Finding: Moisture damage to the kitchen cupboards

It is suspected that this has occurred as a result of excess moisture from internal spills. No current moisture was noted in the area when tested with a moisture meter.

A licenced carpenter or competent handyman should be engaged to inspect the moisture damaged areas and repair or replace any items where necessary.

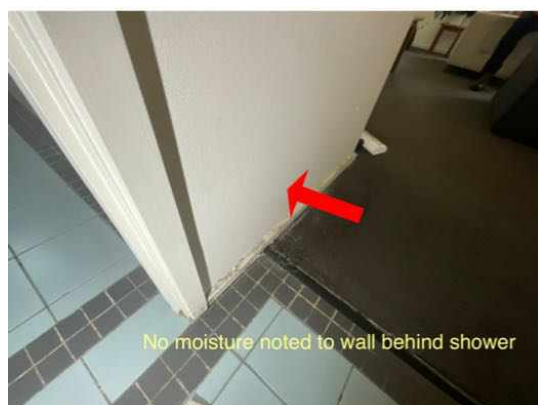
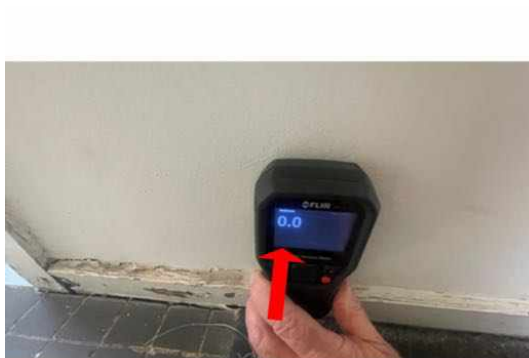
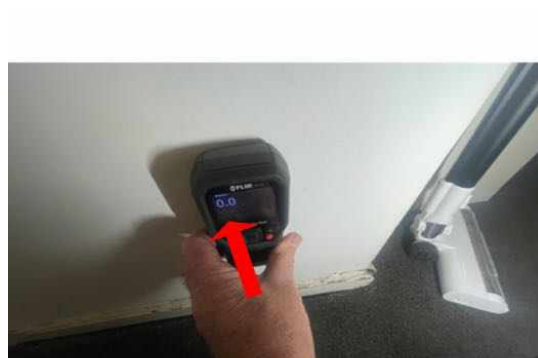
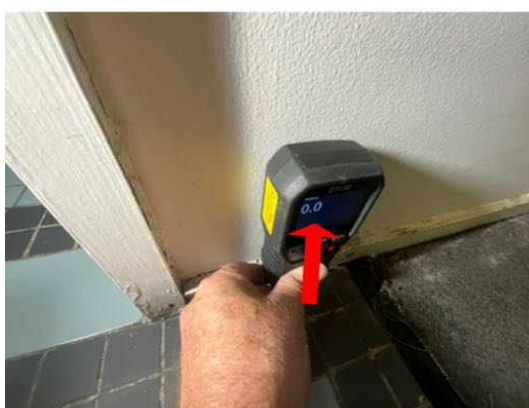
Finding: Shower - Damp noted within wall of shower

Information: Damp was evident to the lower part of the tiled walls within the shower alcove when tested with a moisture meter. This defect is quite common, and is suspected to have been caused by moisture permeating through the grouting in this area, which shows evidence of deterioration. Leaking pipes within the adjoining wall is also a possible cause although there was no moisture noted higher up the wall nor to the wall in the bedroom or living area behind the shower.)

Damp (or structural damp) refers to the presence of unwanted moisture in the structure of a building, either as the result of intrusion from outside, or condensation from within the structure. In the shower area, internal water leaks or other sources of excessive moisture are generally the cause of damp.

Unmanaged damp in the shower recess can facilitate the formation and development of mould and fungi growth. It is important to address damp conditions, as the World Health Organisation notes that excess moisture leads - on almost all indoor materials - to growth of microbes such as moulds, fungi and bacteria, which subsequently emit spores and other matter into the indoor air. Exposure to these contaminants is associated with a wide range of respiratory and other health-related problems.

Should the damp continue and/or staining to the walls behind the bathroom occurs, consultation with a qualified plumber or bathroom specialist would be advised immediately to identify the cause of damp and to perform remedial works as required.

Always ensure that sealant and grout is in good condition to prevent any moisture issues occurring in the future.

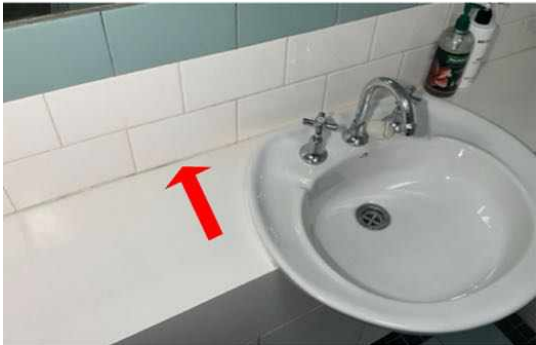
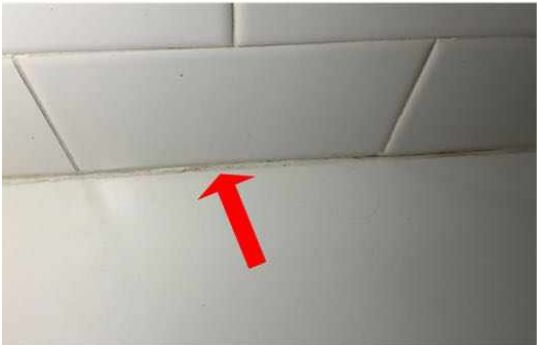
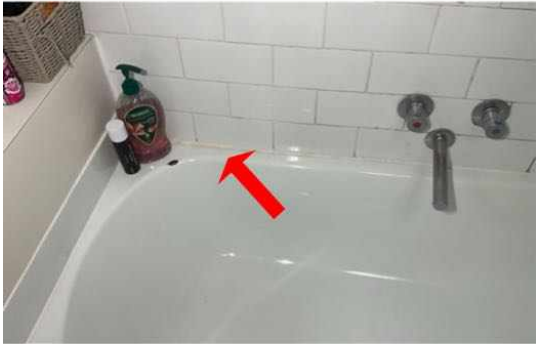
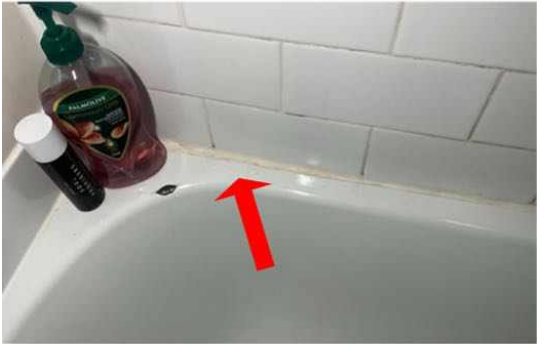
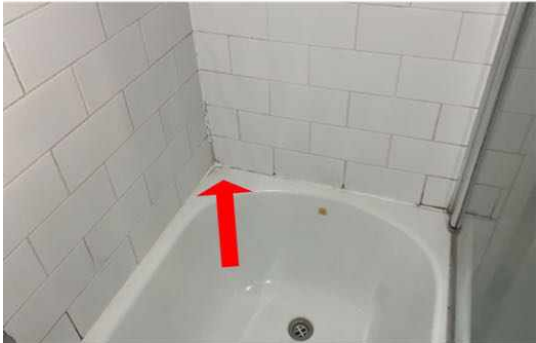
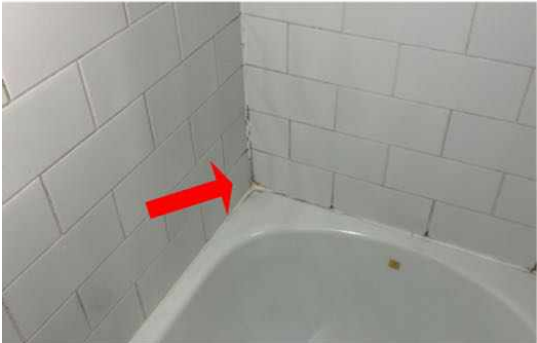
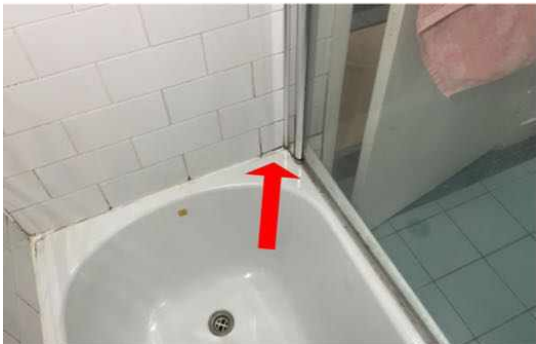
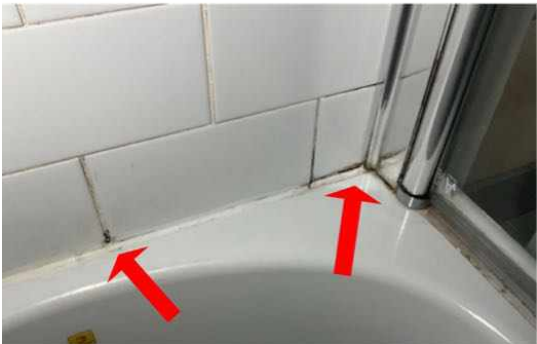
### Finding 3.03

Building:	
Location:	Bathroom
Finding:	Grout and sealant - Missing or degraded within the bathroom area
Information:	It was noted on inspection that grout or sealant is degraded to the shower and other areas within the bathroom.

Different materials move at different rates, generally causing cracking to grout at this point. Build up of moisture in the bathroom can also cause grout and sealants to degrade and become mouldy.

Any damaged or degraded materials should be scraped out and flexible and mould resistant materials should be applied to affected areas to prevent any subsequent water damage that may occur. Regular maintenance and replacement of damaged or missing grout/ sealant is highly recommended to the wet areas, as this is a regular wear and tear defect. Both grout and sealant in areas that come into regular contact with water should be maintained for the long term care of your property.

A bathroom specialist or tiling contractor should be appointed to complete these works as a matter of urgency.

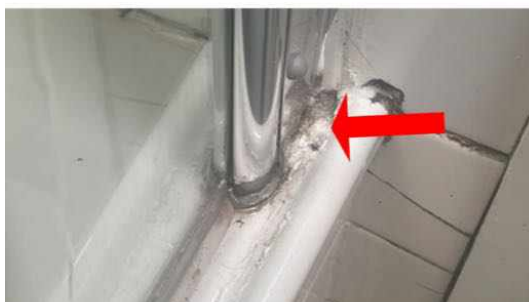
### Finding 3.04

Building:  
 Location: Bathroom  
 Finding: Shower screen seal - Leaking  
 Information: Leaking was evident to the shower screen close to where it meets the wall at the time of inspection. It is suspected that the leaking has occurred as a result of the screen not being sealed correctly in this area.

Leaking from the shower , where left unattended, can lead to water damage and necessitate extensive remedial works being required. Active water leaks may also create an environment that is susceptible to the formation and development of mould.

Appointment of a tiling contractor or competent handyman is required to repair / replace the sealant. Such works should be performed immediately to ensure that no further damage occurs.

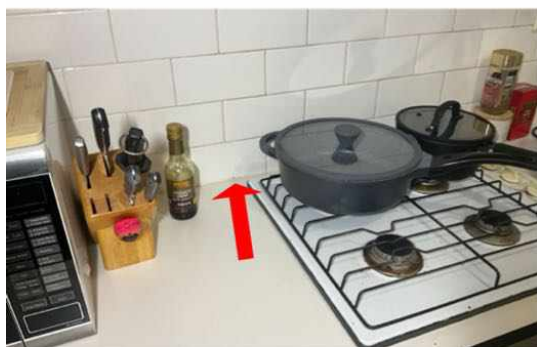
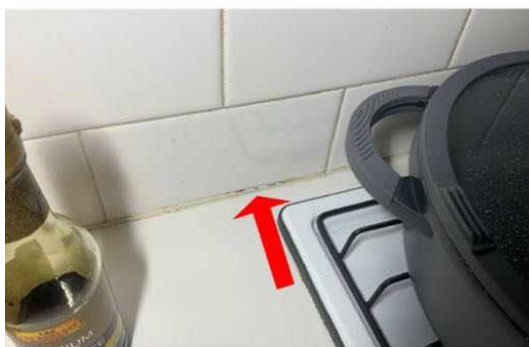
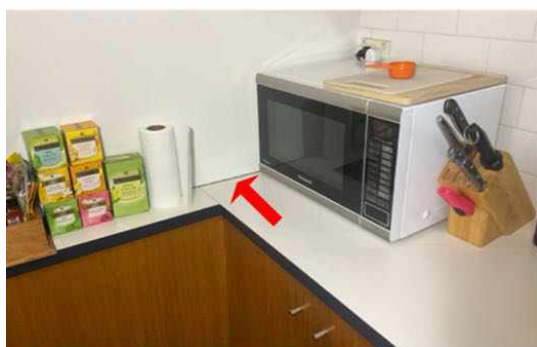
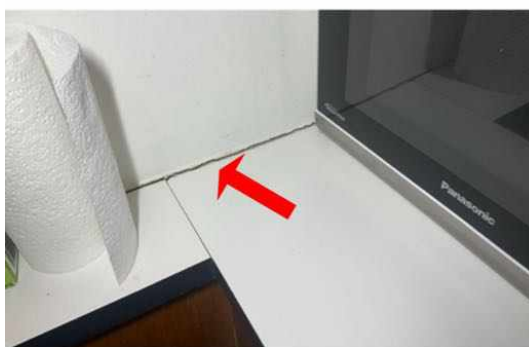
### Finding 3.05

Building:  
 Location: Kitchen  
 Finding: Grout/ sealant - Missing or degraded  
 Information: Grout/ sealant is missing or degraded in this area. Grout and sealant is used to protect gaps and crevices in building materials to ensure that they are water-tight and prevent water penetration to the associated structures.

Failure to do so may lead to further deterioration of the grout or sealant which in turn can lead to water damage to the surrounding area.

Where grout or sealant is missing, a tiling contractor should be appointed immediately to apply grout and re-apply any silicone where necessary.

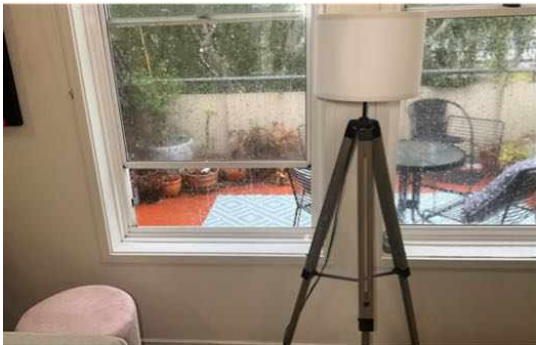
### Finding 3.06

Information: At the time of the inspection, the windows in this area were sticking slightly when opened. Windows provide ventilation to the adjoining area and should be at a fully operational level to ensure user comfort. Restricted function of the window may also create potential for secondary defects to the associated building elements, such as damage to the window frames as well as a potential safety hazard if required for emergency egress from the building.

The most usual causes of sticking with aluminium windows is slight misalignment of window within frame, buckling of the frame, or stiffness from lack of use. Easement may be required, which may involve slight adjustment to the window frames. It will almost always include ensuring the areas are cleaned and free of any debris that may be detrimental to their operational state.

A competent handyman can be engaged where necessary to address this issue.

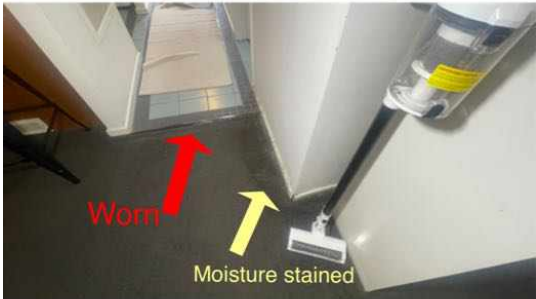
**Finding 3.07**

Building:  
 Location: All Areas  
 Finding: Carpet deteriorated in some areas  
 Information: At the time of inspection, some areas of the carpet throughout the property showed signs of wear . This is consistent with properties of this age.

Please note other areas of the property may have deteriorated carpet but not be shown here

The carpet may be replaced at the discretion of the homeowner.

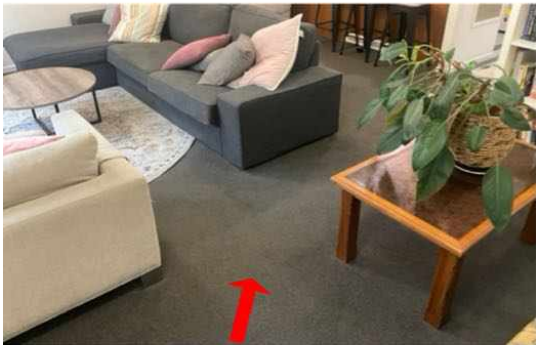
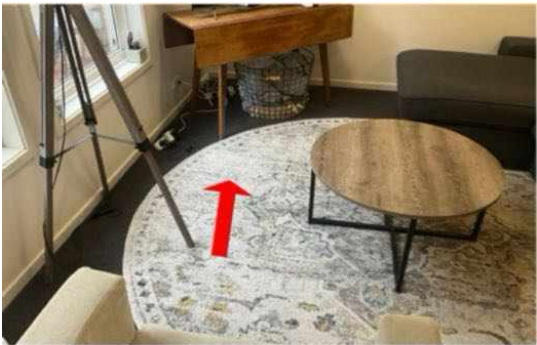
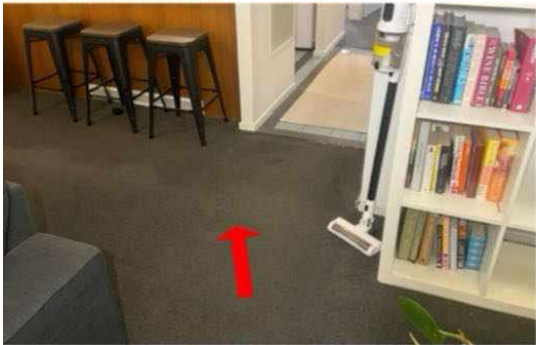
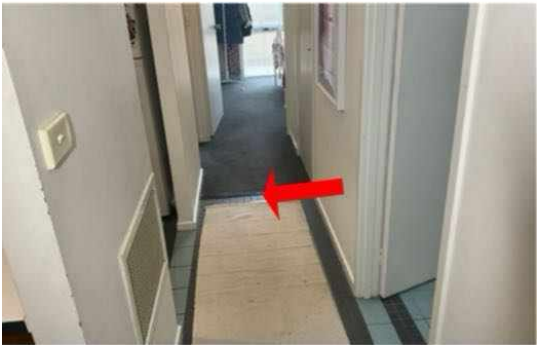
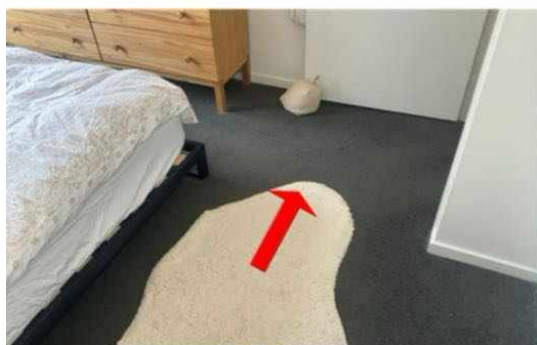
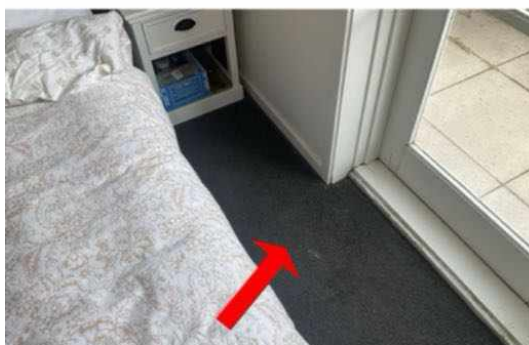
### Finding 3.08

Building:  
Location: All Areas  
Finding: Floor - very noisy when walked on  
Information: At the time of inspection, the internal flooring in this area was very noisy when walked on.

Noisy/ creaking floors may indicate that the flooring is coming loose from the supporting structure that they are installed on, or may be caused by more major issues with the supporting structures.

It is recommended that an invasive inspection of the flooring be made to determine the cause of the defect. Potential resolutions may involve regluing and screwing the floor down through to complete replacement of base of the flooring.

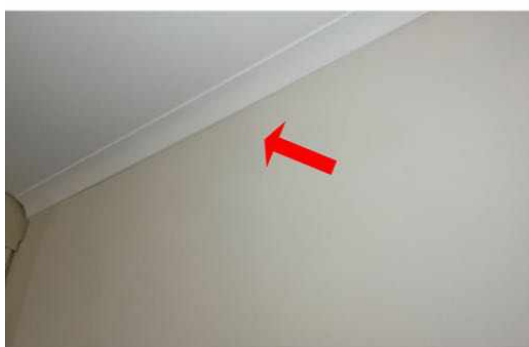
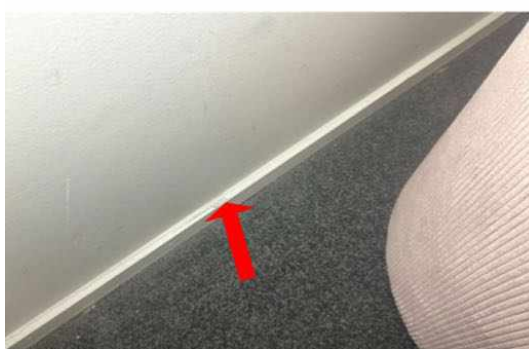
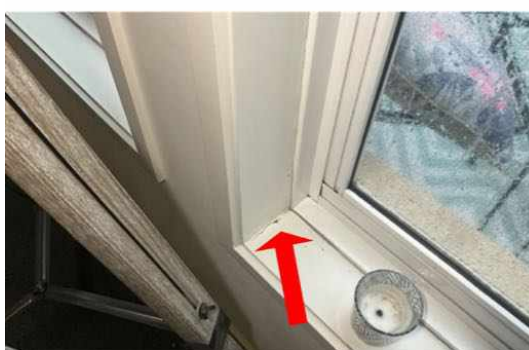
### Finding 3.09

Building:	
Location:	All Areas
Finding:	Cracking - fine
Information:	Some fine cracking was noted throughout the property.

Although fine cracks are quite noticeable, they are often only considered to be an appearance defect, and usually do not indicate any structural damage. Generally, the cause of a fine crack is indicative of a separation between building materials and finishes (e.g. paint, plaster, etc.) along joints.

Note: photos included are indicative of fine cracking noted at the the time of inspection. Other fine cracks may be present but not recorded here.

Cracking of this nature can generally be repaired with minor sanding, filling and/or repainting. Such works should be performed by a qualified painter or a general handyman.

Monitoring of all cracking should be conducted frequently. Always contact a building inspector should cracks widen, lengthen, or become more numerous.

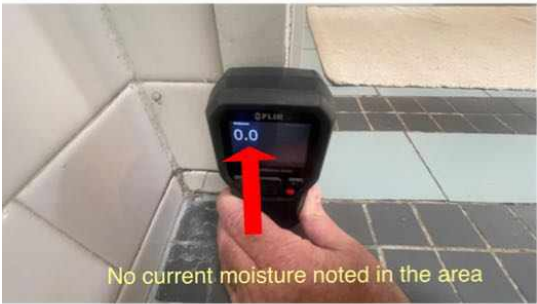
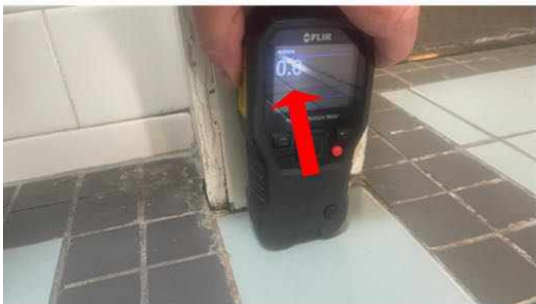
### Finding 3.10

Finding: Moisture damage to door frame and possible lack of a water stop.

Information: Evidence of moisture damage was identified to the door frame in the bathroom. It is suspected that this has occurred as a result of excess moisture from internal spills and possible moisture getting into the frame from under the tiles.

A water stop is a barrier which prevents moisture that may have seeped under the floor tiles to move out of the wet area into the hallway. This barrier forms part of the

waterproofing system in the bathroom. Having gaps at either end means the water stop is not complying with current standards. Standards have changed however over the years and bathrooms only needed to meet the standards that were applicable at the time of installation.

It is highly recommended a Tiler be engaged to inspect the area to improve the water tightness of the bathroom and prevent moisture exiting. This could involve sealing the ends of the water stop, through to installing new stops.

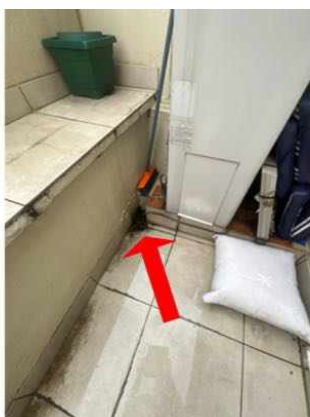
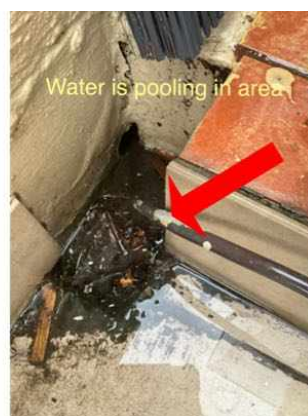
**Finding 3.11**

Location: Balcony  
 Finding: Balcony drain blocked  
 Information: At the time of inspection, the drain within the balcony was blocked, which can reduce its effectiveness in removing water from the balcony. This can potentially lead to flooding of the balcony which in turn can caused secondary defects to surrounding areas. Pooling water was noted in the area.

It is highly recommended that all drains be kept clear of leaf litter to ensure effective drainage of the area.

Clearing of all drains should be carried out by the homeowner as a matter of urgency.

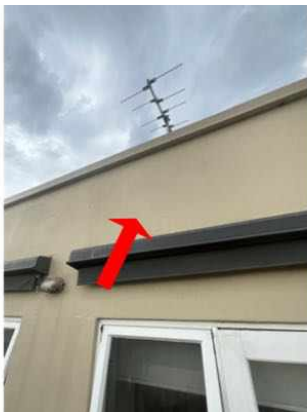
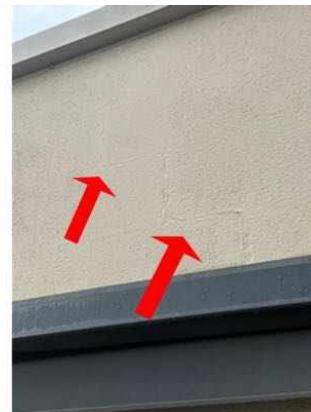
Finding: Brickwork - Step cracking ( possible owners corporation issue)

Information: Step cracking was identified to the external walls in these areas at the time of inspection. Step cracking, which is similar to other forms of cracking, has a variety of

possible causes. However, the most common is movement in the wall or the subsidence of adjacent footings.

Step cracking is a relatively common defect, and is most likely to occur adjacent to windows, doors and other openings. Mortar failure in the gaps between affected block work indicates the stresses and tensions affecting the wall.

Minor step cracking can be used as a warning sign to address factors causing stress to the wall, which can include the effect of surrounding trees, water leaks, soil erosion, or even the presence of reactive soils in the surrounding area.

Where step cracking is extensive or severe or is coupled with other forms of cracking to the brickwork, the client is advised to consult a structural engineer (not noted in this area)

It is highly recommended that the cracking be monitored for a period of time e.g. six months, to determine if there is any further cracking or active movement within the bricks. Should no further cracking or movement occur, the bricks may be patched by qualified bricklayer.

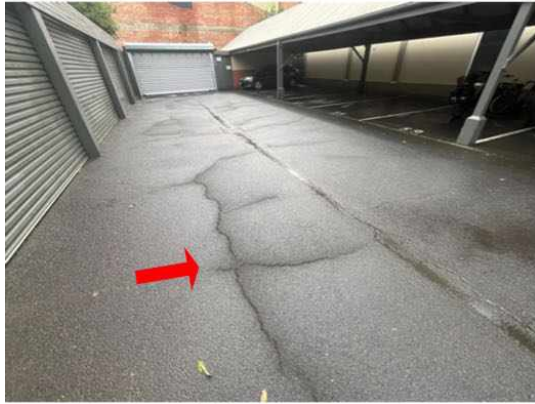
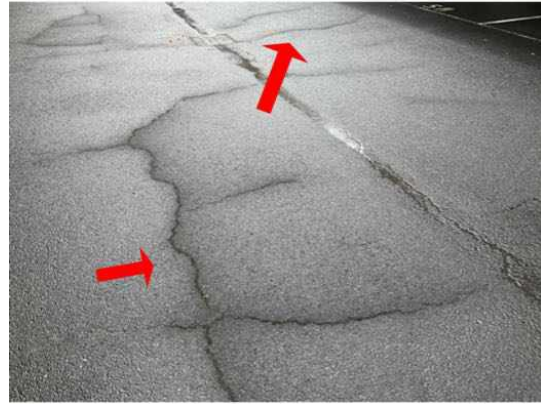
### Finding 3.15

Building:	
Location:	Driveway
Finding:	Cracking - Noticeable cracking to driveway paving ( probable owners corporation issue)
Information:	Noticeable cracks were identified in the concrete paving of the driveway. These noticeable cracks may lead to the development of tripping hazards and secondary defects if they develop further.

General age and expected deterioration of the paved areas is a common cause of this type of cracking. However, expansion and contraction of the driveway may also have occurred due to environmental factors. Such factors include variable moisture and weather conditions, the presence of trees and their roots having a settling or lifting affect on the soil, or the effect of load bearing, e.g. heavy vehicles over a sustained period of time.

Cracking to this degree may also be due to poor original installation of the driveway. Factors such as poor compaction of the sub surface and/or inadequate reinforcing of the slab may create cracking and other secondary defects. Noticeable cracks may also be due to subsidence of soils.

Please note: it is suspected this would be covered by the owners corporation. Your own enquiry should be made to determine whether this is the case.

The area should be monitored for any changes that may occur and potentially cause tripping hazards. Should this occur, repair or replacement of the concrete paving may

be necessary.

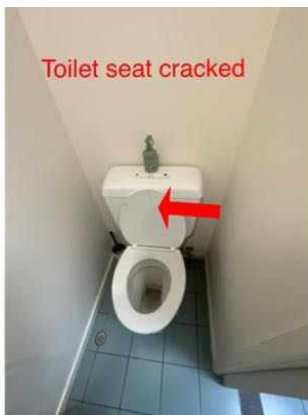
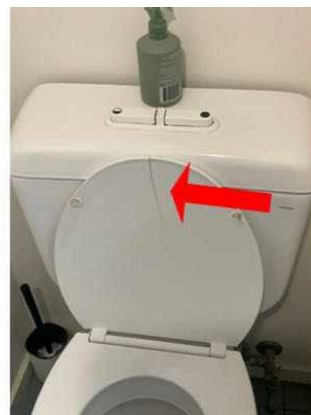
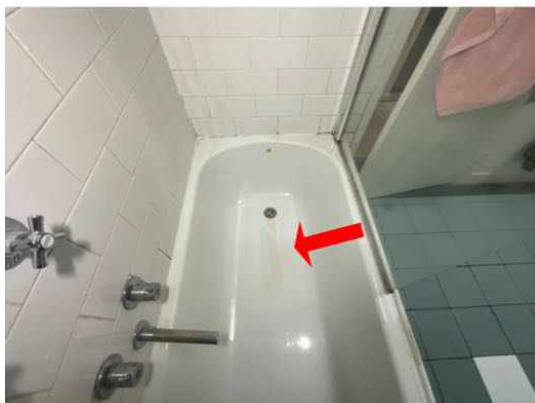
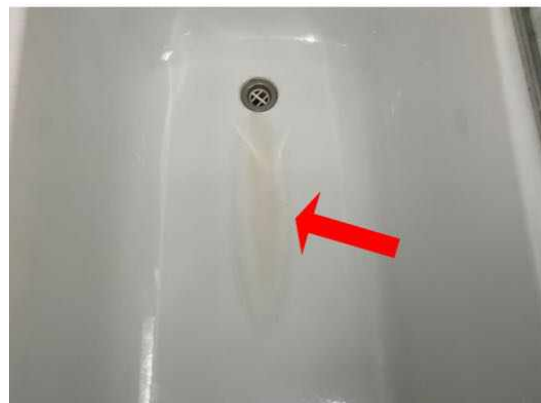
Finding: Additional Photos - minor defects

Information: Additional photos are provided for your general reference. Arrows have been included where necessary to highlight areas of importance.

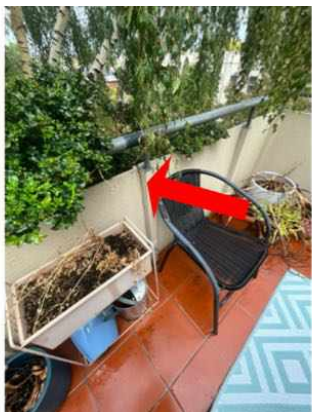
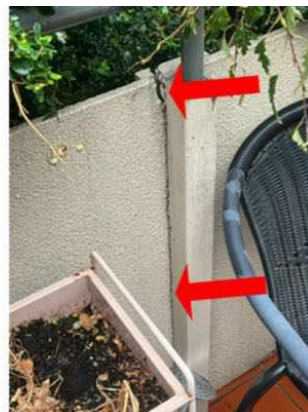
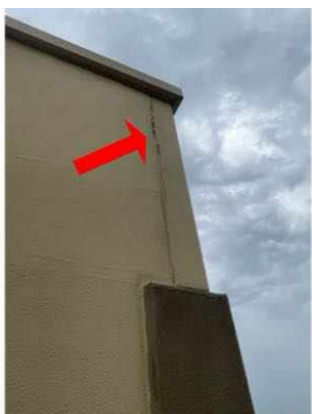
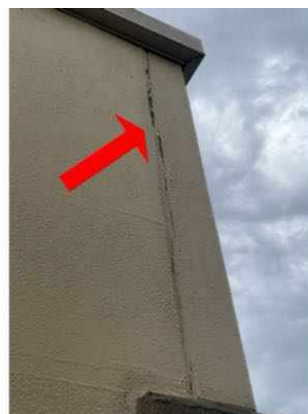
Information: Additional photos are provided for your general reference.

1. The solid wall on the balcony railing was damaged and loose at the time of inspection. This can pose a safety hazard as it make break completely.
2. The caulking in the expansion joints was deteriorated and needs replacing.
- 3.

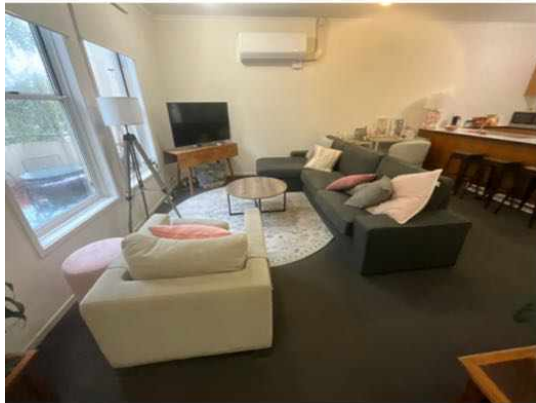
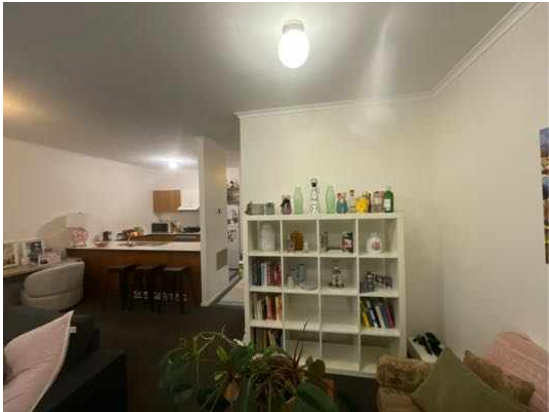
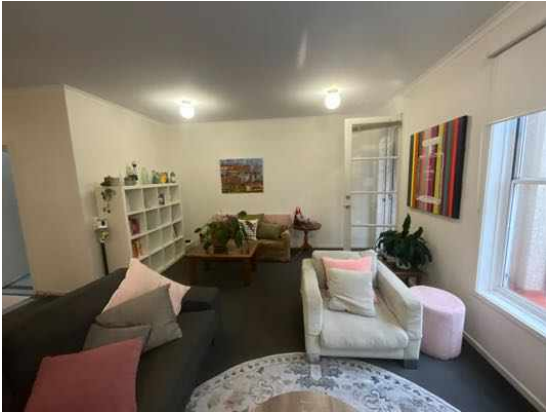
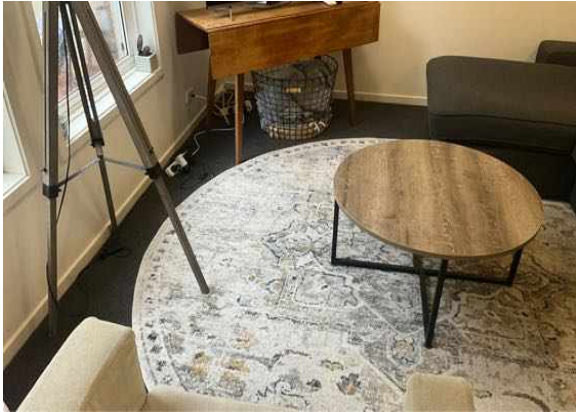
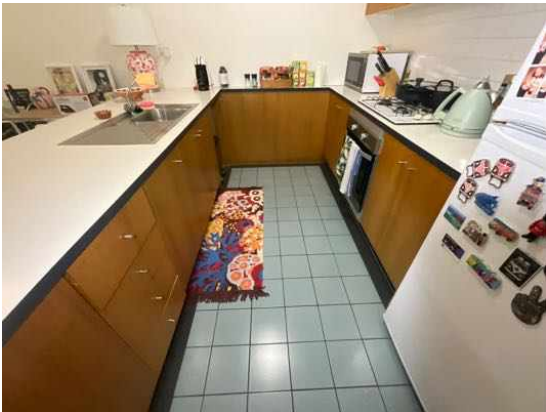
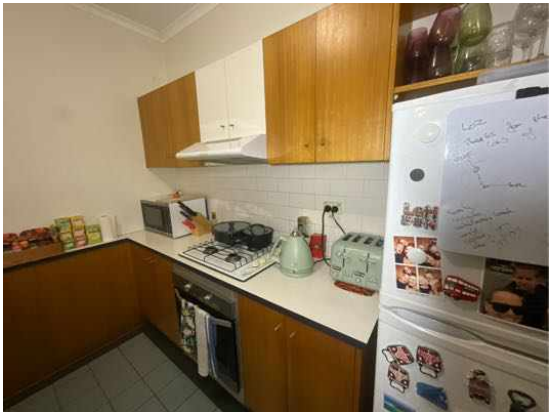
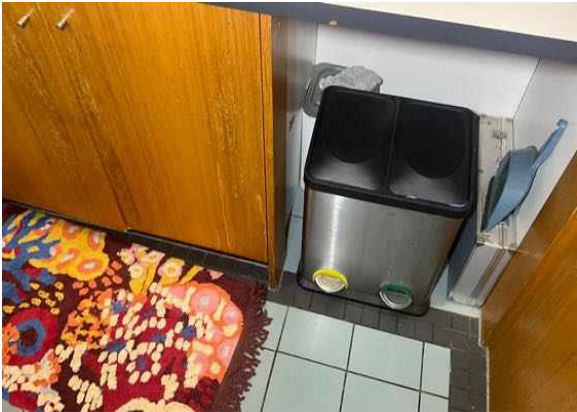
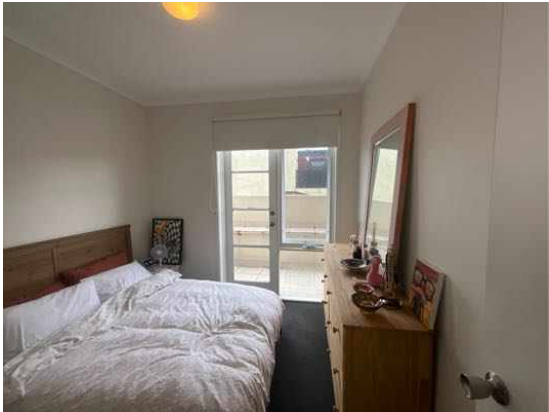
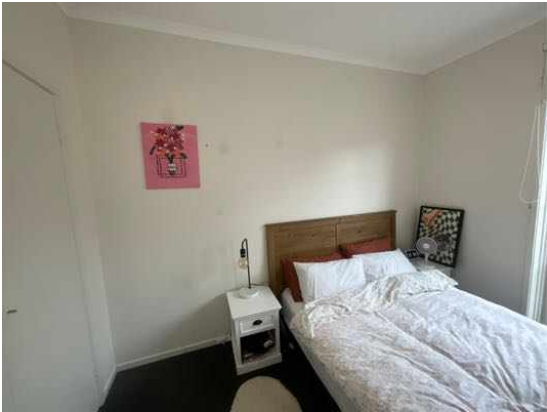
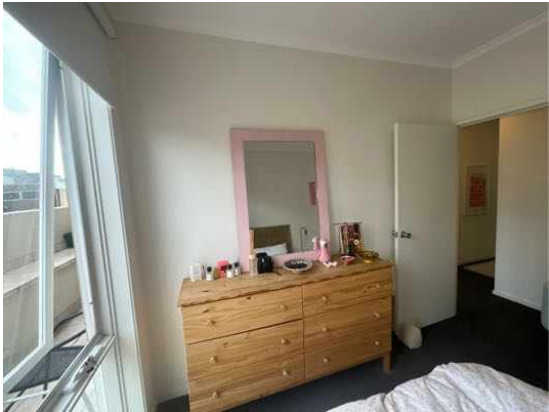
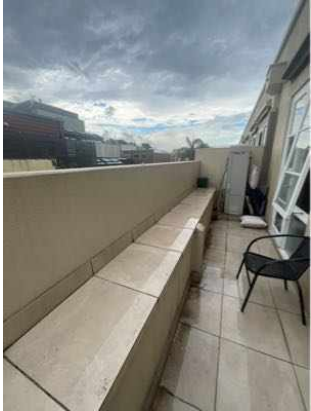
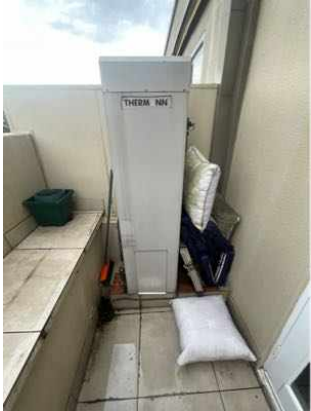
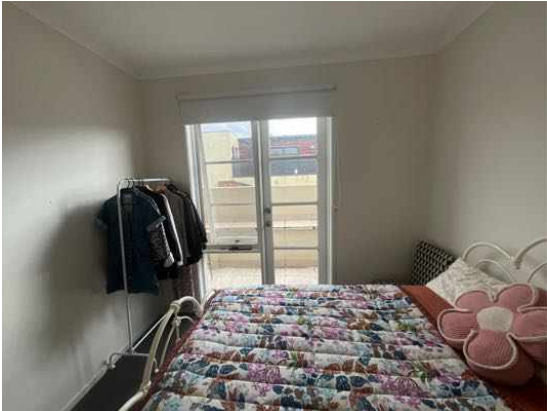
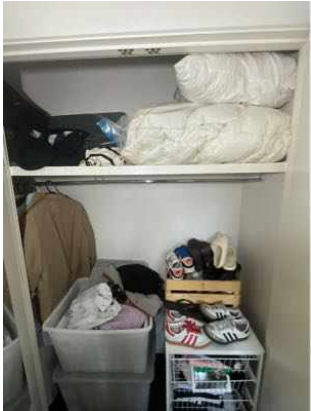
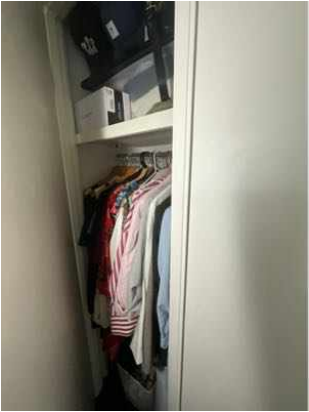
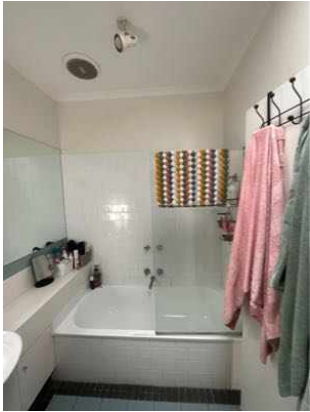
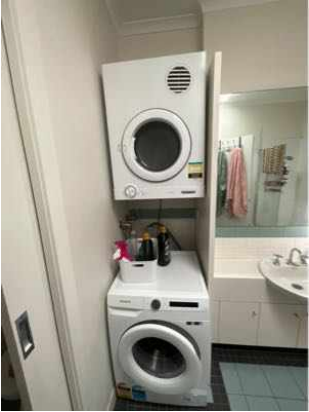
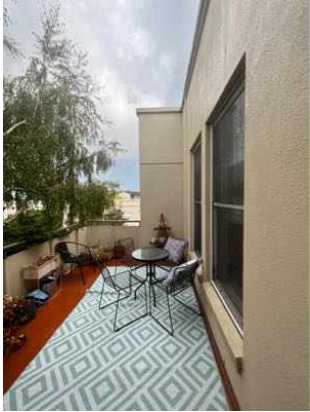
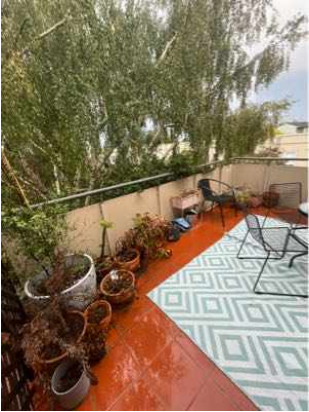
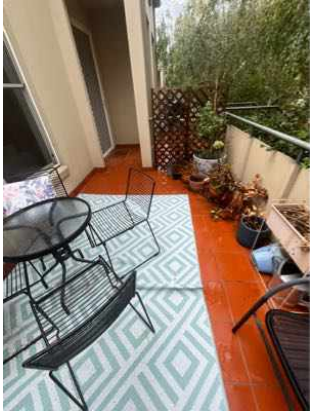
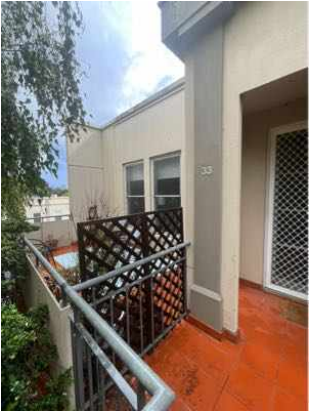
Finding: Additional Photos - Obstructions and Limitations

Information: These photographs are an indication of the obstructions and limitations which impeded full inspection of the property at the time of inspection. These obstructions can hide an array of defects and should be removed to allow full inspection to be carried out. A re-inspection is recommended once the areas are made accessible.
