Building and Timber Pest Inspection Report

Inspection Date: Wed, 11 Mar 2026

Property Address: 8 Borealis Wy, Box Hill NSW 2765, Australia

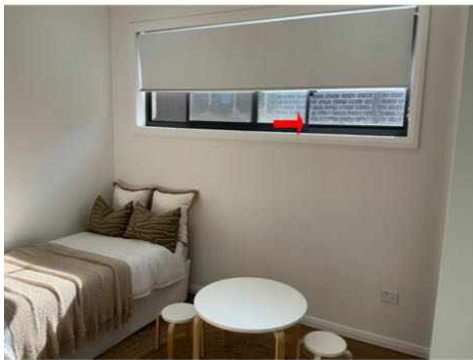
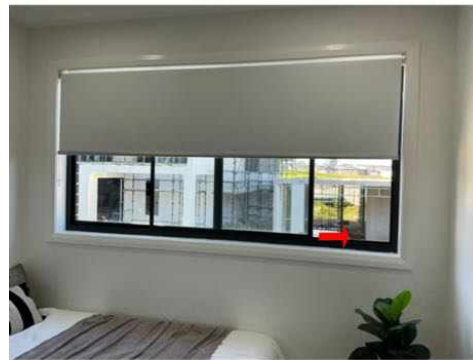
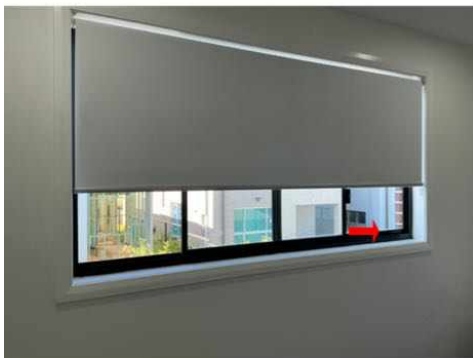
Building:	Main Building
Location:	Upstairs Bedroom 2, 3 & 4
Finding:	Window Restrictors - Recommended
Information:	Upstairs windows did not have window restrictors installed. Although not a requirement at the time of construction, it is advisable to install window opening restrictors on all second storey windows with sill heights below 1.7 meter and potential fall of 2 meters or more.

If you live in a strata scheme, window safety devices must be installed on all applicable windows by 13 March 2018. Residents with safety devices installed can still fully open their windows but it's recommended that devices be engaged whenever children are present, to prevent falls.

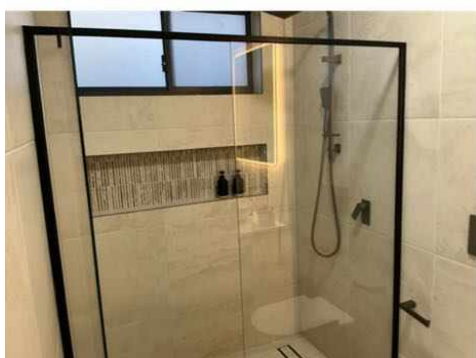
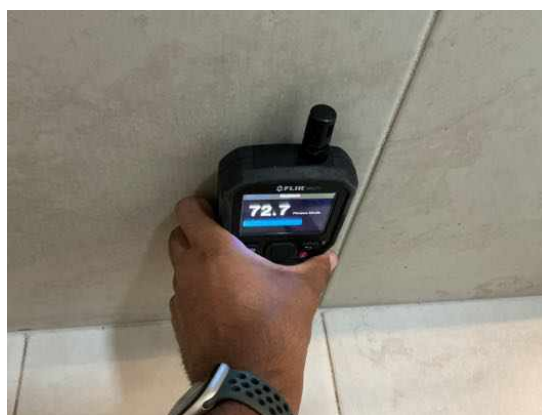
Building:	Main Building
Location:	Ground Floor Bathroom
Finding:	Excessive Moisture - Shower Damp
Information:	At the time of inspection, excessive moisture was noted within the shower area, which is a common issue in wet areas due to the continual exposure to water. This condition is typically caused by moisture seeping through grout lines and settling behind tiles, resulting in localised high-moisture zones. Provided there is no evidence of water staining or elevated moisture readings on the opposite side of the wall, this is considered a minor defect.

However, persistently damp conditions may act as conducive conditions for termite activity, as termites are strongly attracted to moisture-rich environments. It is recommended that the client ensures regular use of the exhaust fan and maintains adequate ventilation after shower use to promote drying and reduce long-term moisture build-up, thereby also reducing the risk of attracting termites.

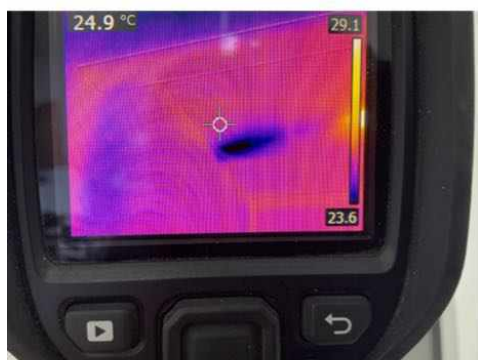
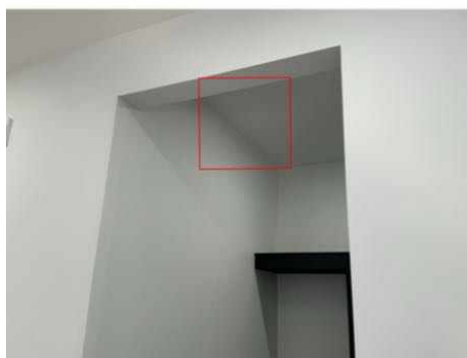
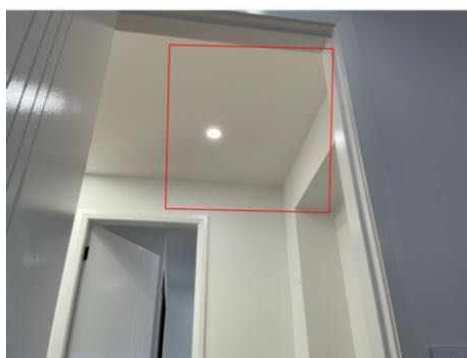
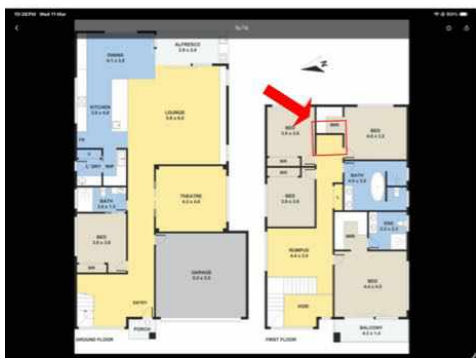
Finding 3.02

Location: Upstairs Hallway, Bedroom 4 Closet
Finding: Moisture Detected on Ceiling
Information: At the time of inspection, thermal imaging indicated a moisture signature on the ceiling surface. The affected area displayed temperature variations consistent with possible moisture presence.

The roof space above this area was inaccessible at the time of inspection, and therefore the exact source of the moisture could not be confirmed. Potential causes may include roof leaks, flashing defects, or gaps around roof penetrations such as skylights, which may allow water to enter the ceiling cavity during rainfall.

This matter should be treated as a priority, as ongoing moisture intrusion can lead to progressive damage to plasterboard, insulation, and structural elements, potentially resulting in more costly repairs and major defect if not addressed in a timely manner.

It is recommended that a qualified roofer be engaged to inspect the roof covering, flashing details, and the skylight installation to ensure there are no defects allowing water ingress.

If no roof-related issues are identified, the moisture may be associated with condensation from nearby air conditioning ducting or equipment, in which case an air conditioning specialist should be engaged to inspect the system and associated ductwork.

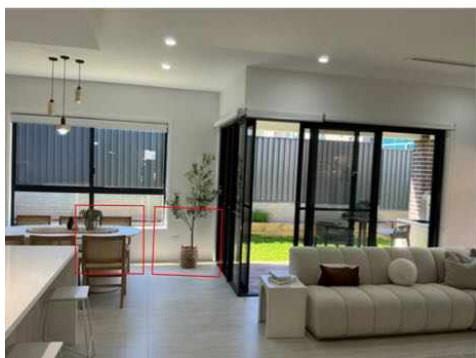
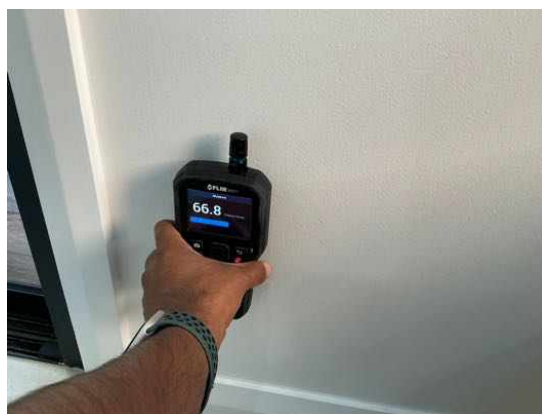
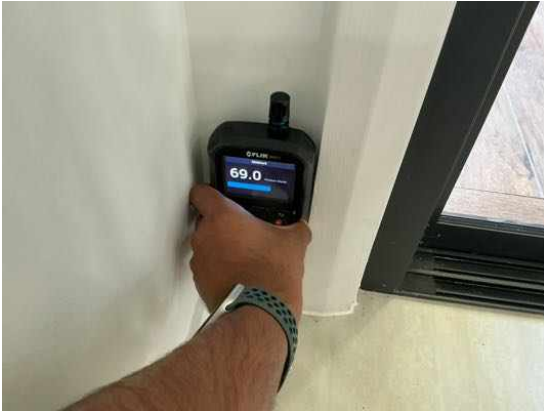
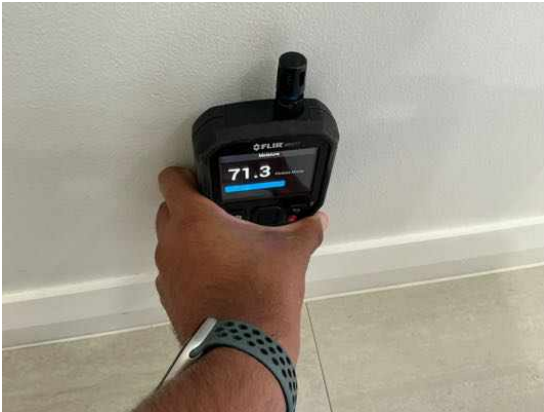
Finding 3.03

Building: Main Building
 Location: Dining Room
 Finding: Damp - Rising (Drainage Issue)
 Information:

At the time of inspection, evidence of rising damp was observed in areas of the building. External ground levels were noted to be higher than the internal floor level, with the surrounding ground surfaces sloping towards the building. This condition can allow moisture to migrate into the lower sections of the walls and flooring, which may lead to dampness, deterioration of building materials, and ongoing moisture-related issues.

While drainage points were observed at the rear of the property, the existing garden slope directs water towards the building foundation, and it appears that not all surface water is effectively captured by the drainage system.

To minimise moisture ingress, it is recommended that external ground levels be reduced where necessary and that site drainage be improved, ensuring that ground surfaces are graded to fall away from the building so that water is directed away from the foundation. Appropriate drainage solutions may be required to effectively manage surface water runoff.

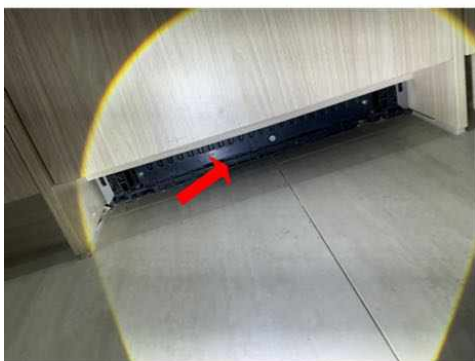
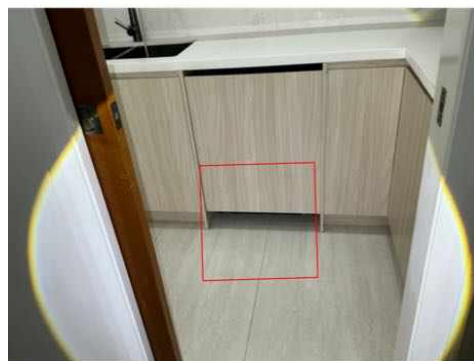
Finding 3.04

Building:	Main Building
Location:	Pantry - Walk In
Finding:	Infill Panel - Appliance
Information:	At the time of inspection, there was no cover installed beneath the oven, leaving an exposed gap between the appliance and the floor. This area is typically finished with an oven infill panel (also commonly referred to as a plinth or kickboard) to prevent debris, moisture, and pests from entering the void. The client is advised to seal or install a suitable infill panel to close off this opening and improve hygiene and finish. A suitably qualified handyman or cabinet installer can carry out this work.

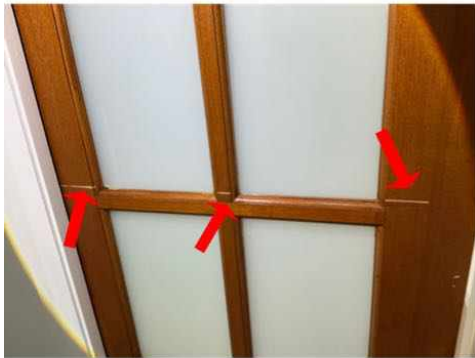
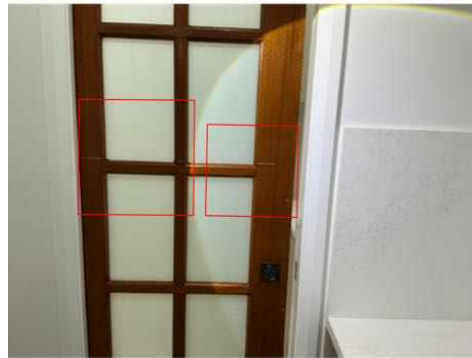
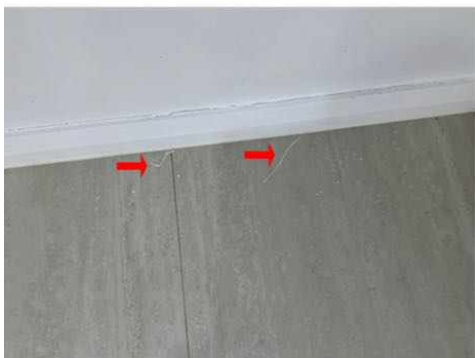
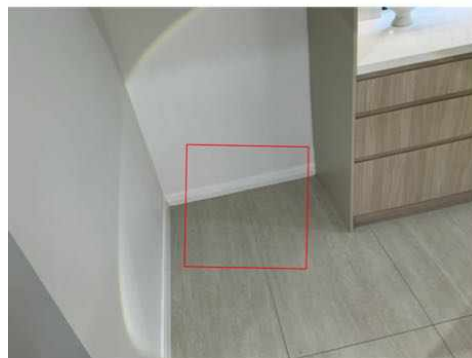
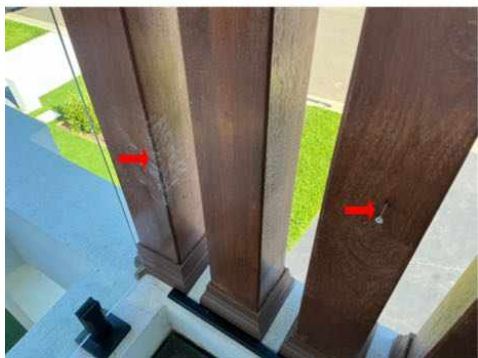
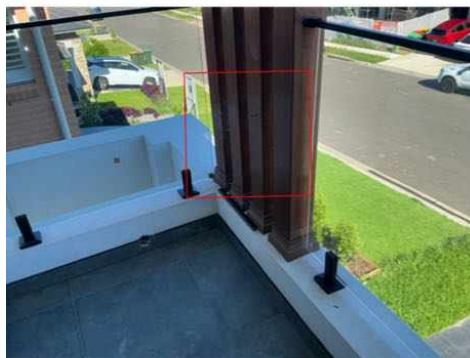
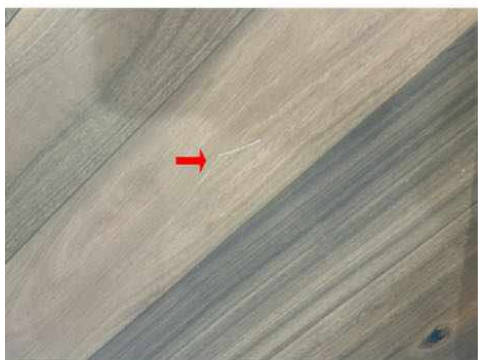
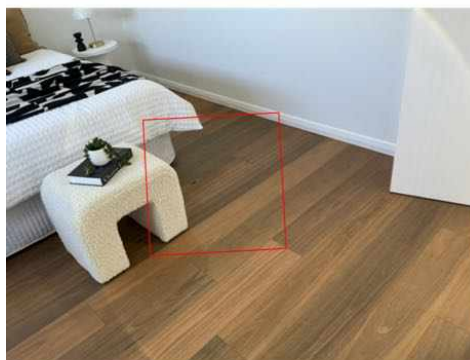
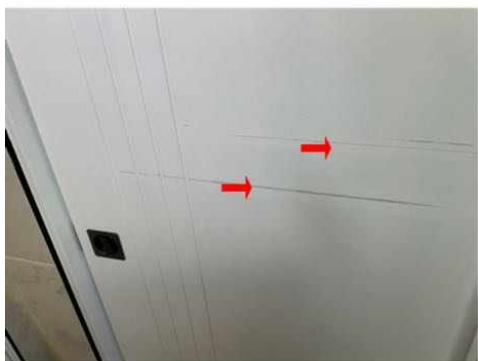
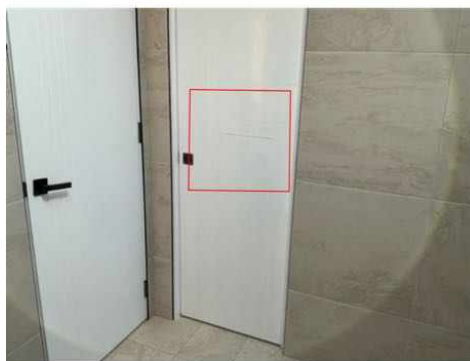
Finding 3.05

Finding: Maintenance and/or Wear and tear on building elements

Information: It was observed at the time of inspection that some building elements and areas around the property require general maintenance and/or exhibit signs of wear and tear. These typically include minor imperfections such as paint scuff marks, scratches on surfaces, small chips, nails or hooks left in walls from previous picture hanging, and other superficial blemishes.

These are generally considered minor items that are common in established homes. While they may be noticeable on visual inspection, they do not affect the structural integrity or functionality of the property. In most cases, these issues can be easily addressed by a qualified handyman as part of routine maintenance.

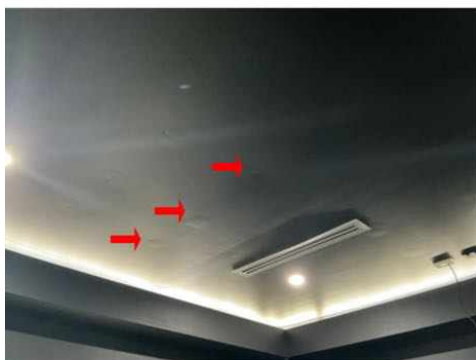
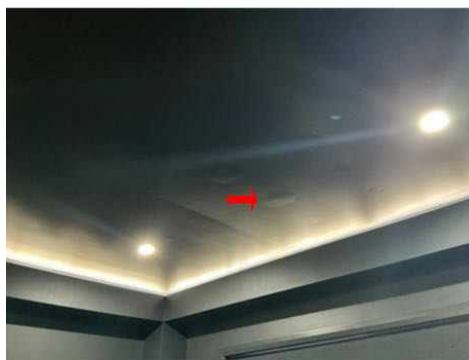
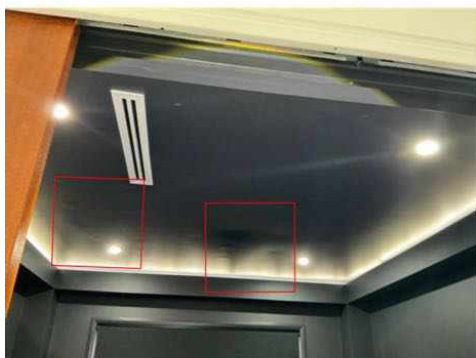
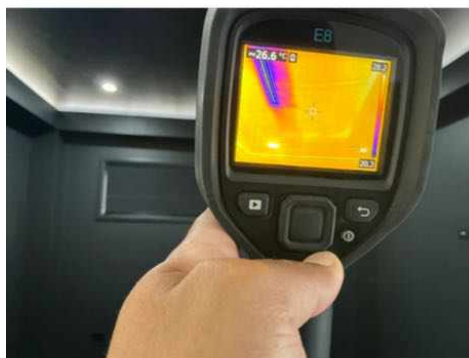
Finding 3.06

Building: Main Building
 Location: Theatre Room
 Finding: Substandard Ceiling Finish
 Information: At the time of inspection, multiple bumps and uneven areas were noted on the ceiling surface, which appear consistent with substandard plasterboard finishing or workmanship. The surface irregularities resemble swelling or poor finishing of the plasterboard joints.

A thermal imaging scan was carried out at the time of inspection, and the affected areas appeared dry with no evidence of active moisture intrusion. Based on the inspection, the irregularities are considered cosmetic and likely related to

workmanship rather than moisture-related damage.

It is recommended that a qualified plasterer be engaged to assess and rectify the ceiling finish, which may involve sanding, re-setting, and repainting the affected areas to achieve a uniform surface.

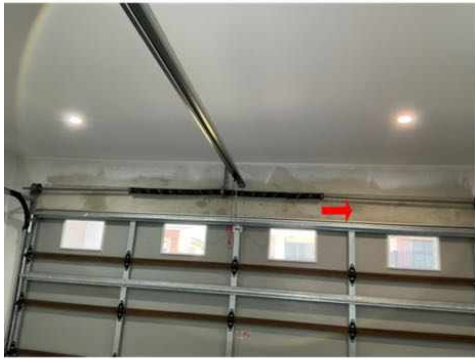
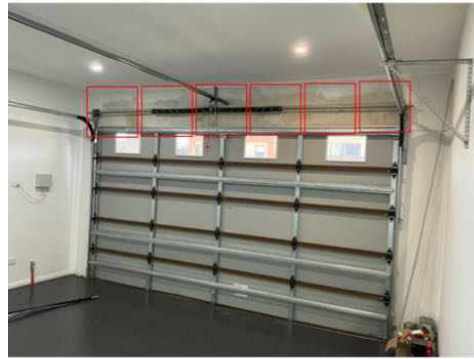
Finding 3.07

Building:	Main Building
Location:	Garage
Finding:	Paint Job - Unprofessional
Information:	The inspection identified an unprofessional paint job on the walls, characterized by uneven coverage, visible brush strokes, and areas where the paint appears to be peeling or chipping. This substandard application not only detracts from the aesthetic appeal of the interior but also raises concerns about the longevity and durability of the wall finish. Poor preparation or application techniques may lead to further deterioration, necessitating a complete repainting to achieve a smooth, uniform, and durable finish. Addressing this issue promptly will enhance the visual quality of the walls and ensure a more lasting and professional appearance. Although not a matter of immediate concern, the client can engage the services of a professional painter to repaint the surface.

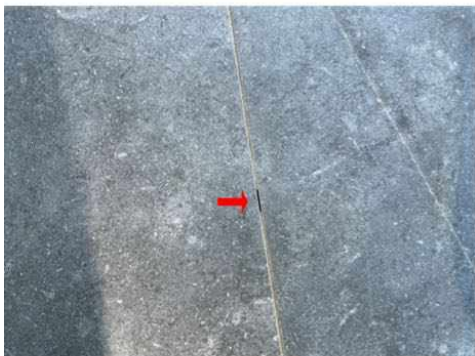
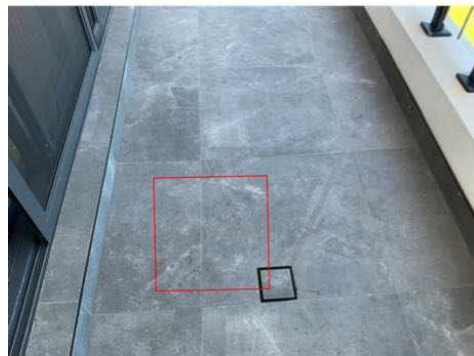
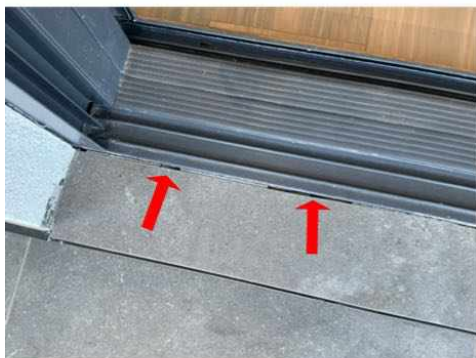
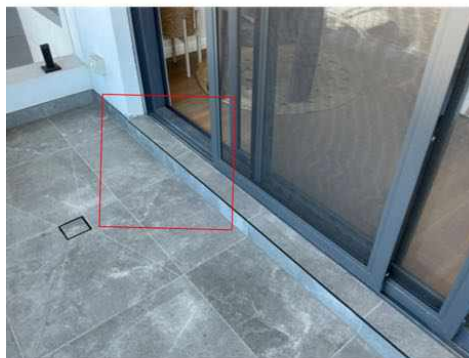
Finding 3.08

Finding: Sealant/Grouting - Missing/damaged (Exterior Areas)

Information: At the time of inspection, it was observed that the sealant or grout on the tiles in the exterior areas, such as balconies or patios, was missing or degraded, indicating a defect that compromises the integrity of the tiled surfaces.

This condition allows water to penetrate the gaps between tiles, potentially leading to moisture ingress, which can cause damage to underlying structures, including timber framing, subfloor materials, or concrete substrates, as well as promote mould growth, staining, and erosion of the surrounding materials over time.

It is recommended that the client engage a qualified tiler, such as a licensed tiling contractor or specialist, to assess the extent of the damage, remove and replace the degraded or missing sealant and grout with flexible, weather-resistant, and mould-resistant materials, and ensure proper installation to prevent future water ingress.

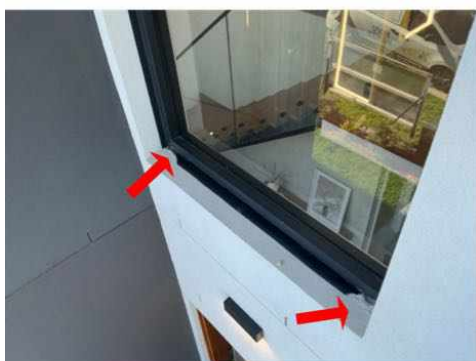
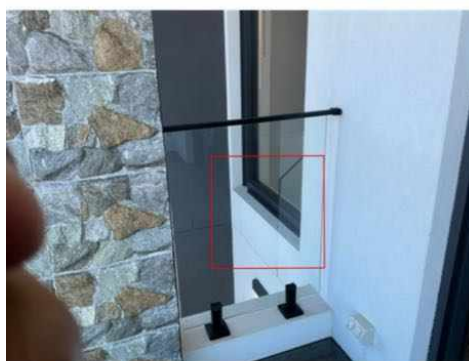
Finding 3.09

Building:	Main Building
Location:	Exterior walls - front
Finding:	Damaged Window Seal / Weather Seal
Information:	At the time of inspection, damage to the window weather seal (rubber sealing strip) was noted along the external edge of the window frame. The seal appeared partially deteriorated and damaged in sections.

Window seals play an important role in preventing water ingress, air leakage, and moisture penetration around the window assembly. When damaged or deteriorated, the effectiveness of the seal may be reduced, potentially allowing water or moisture to enter behind the window frame during heavy rain or wind-driven weather conditions.

It is recommended that a qualified window installer, glazier, or handyman be engaged to replace or repair the damaged weather seal to ensure the window remains properly sealed and protected from moisture ingress.

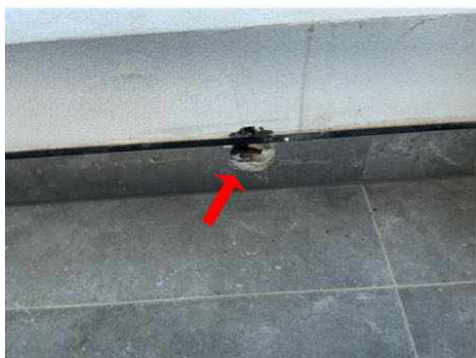
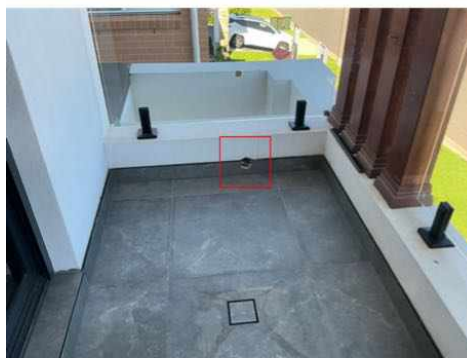
Information: At the time of inspection, the balcony overflow outlet was noted to be unfinished, with the surrounding area appearing incomplete and not properly sealed. Balcony overflow outlets are designed to allow excess water to discharge safely in the event that the primary floor waste becomes blocked or overwhelmed.

An unfinished or poorly sealed overflow outlet may affect the proper discharge of water and could allow moisture to penetrate surrounding building elements.

It is recommended that the builder be contacted and requested to send a qualified tradesperson to professionally complete and seal the overflow outlet, ensuring it is properly finished and functioning as intended.

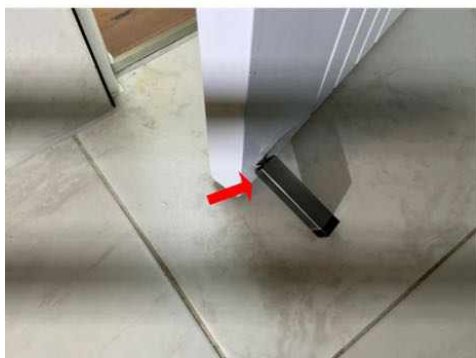
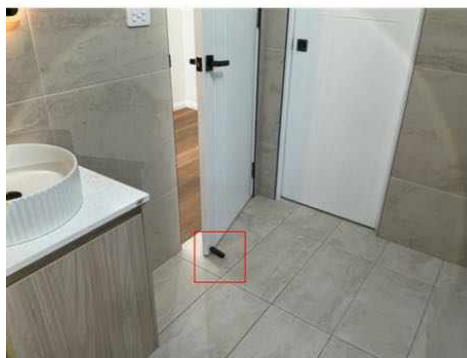
Finding 3.11

Building: Main Building
 Location: Upstairs Common Bathroom
 Finding: Door Stopper - Damaged
 Information: Door Stopper was noted as damaged at the time of inspection.

Door stoppers can become damaged due to various reasons, including excessive Force - Slamming doors forcefully can cause damage to the door stopper over time. The impact can lead to bending or breaking of the stopper. Poor Quality Materials - If the door stopper is made of low-quality materials, it may wear out or break more easily, especially with frequent use. Improper Installation - Incorrect installation, such as placing the door stopper in a position where it receives excessive force or stress, can lead to damage. Wear and Tear - Over time, general wear and tear from repeated contact with the door can cause degradation of the door stopper material. Inadequate Maintenance - Lack of regular maintenance or inspection can contribute to the deterioration of door stoppers. Checking for loose screws or other signs of damage can help prevent issues.

A general handyman should be appointed to fix the issue at owners discretion.

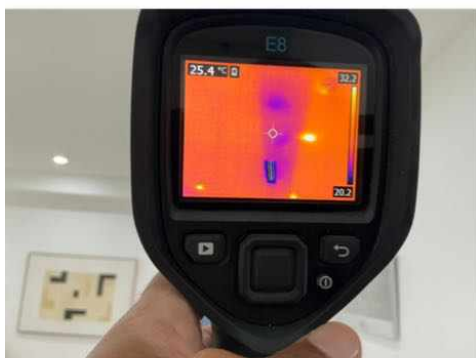
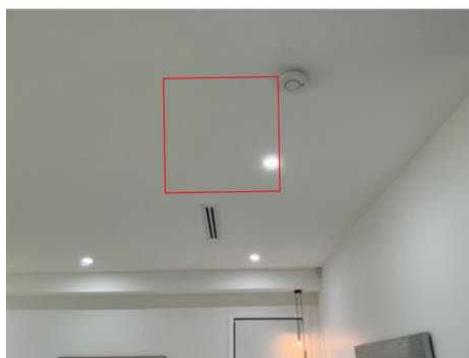
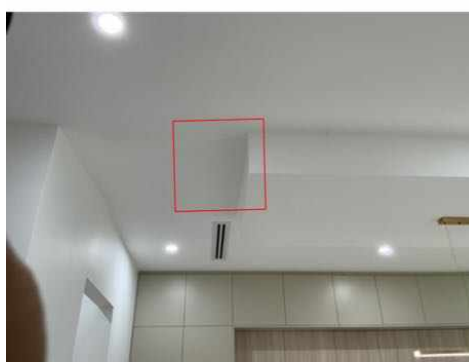
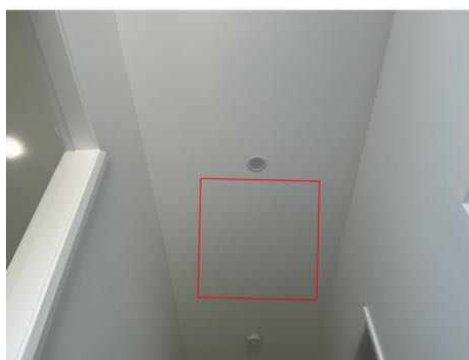
Finding 3.12

Building:	Main Building
Location:	Downstairs Hallway, Lounge, Kitchen
Finding:	Thermal Variation Noted Near Air Conditioning Vent
Information:	At the time of inspection, a thermal variation was noted on the ceiling surface adjacent to the air conditioning vent during thermal imaging. This pattern may be associated with the air conditioning ductwork located within the ceiling cavity, which appears to be positioned close to or directly against the plasterboard surface.

Such thermal signatures can occur where ductwork transfers cooler air temperatures to the ceiling lining, making the area visible under thermal imaging. No visible signs of active moisture damage were observed at the time of inspection.

However, it is also possible that condensation from the air conditioning system could produce similar thermal patterns if present. The client is therefore advised to monitor the area over time for any signs of moisture staining, dampness, or deterioration of the ceiling surface.

If evidence of condensation or moisture ingress becomes apparent, it is recommended that an air conditioning specialist be engaged to inspect the system and ductwork to ensure there are no leaks or insulation deficiencies.

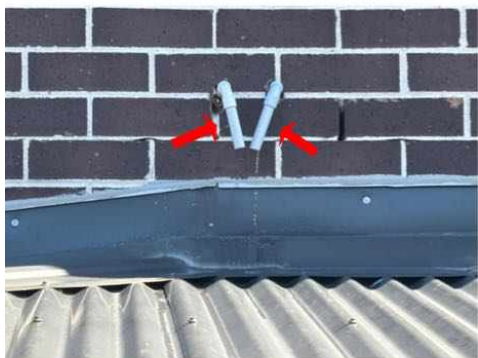
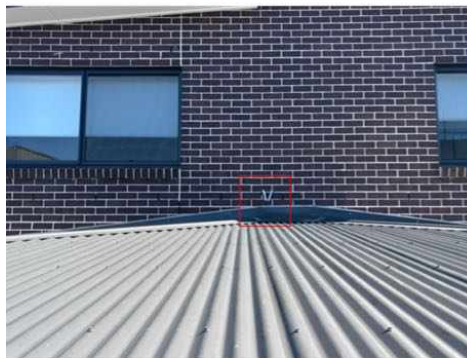
Finding 3.13

Building:	Main Building
Location:	Rear Roof above Alfresco
Finding:	Air Conditioning Overflow Pipes Discharging Near Roof Flashing
Information:	At the time of inspection, air conditioning condensate overflow pipes were observed discharging directly from the wall above the roof flashing. The outlets were positioned too close to the roof flashing, which can allow water to discharge directly onto the flashing and roofing surface.

This configuration can lead to repeated wetting of the flashing and adjacent roof materials, potentially contributing to premature deterioration, corrosion of metal components, or water ingress if flashing seals deteriorate over time.

It is recommended that an air conditioning specialist be engaged to extend the overflow pipes so that condensate water discharges safely into the gutter area or another appropriate drainage point. Proper extension will help ensure water is directed away from the wall and flashing, reducing the risk of moisture-related issues.

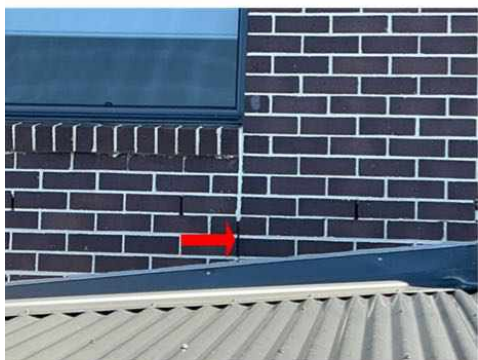
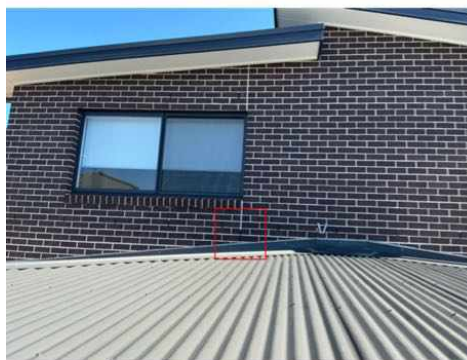
Finding 3.14

Finding: Missing/Deteriorated Sealant - Articulation Joint

Information: The inspection revealed that sealant is missing in the articulation joints of the property. This defect can compromise the structural integrity and stability of the building, allowing for unwanted movement and potential damage to the brickwork. The absence of sealant in these joints can also lead to water ingress, resulting in dampness and deterioration of internal materials. Immediate remedial action is necessary to reapply sealant to the articulation joints, ensuring the property maintains its structural soundness and resistance to weather-related issues.

Client is advised to consult bricklayer or registered builder to fix the issue at owner's expense.

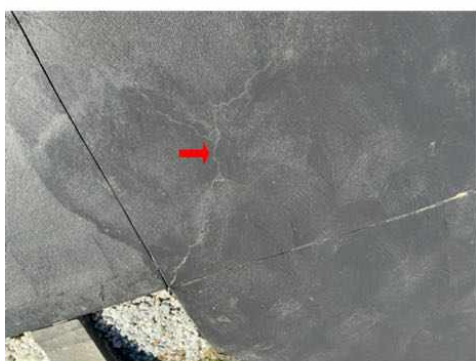
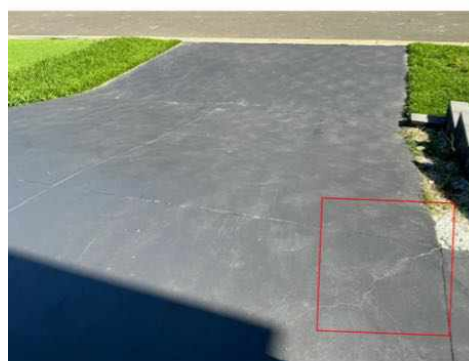
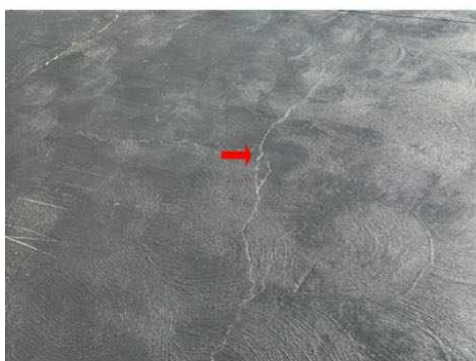
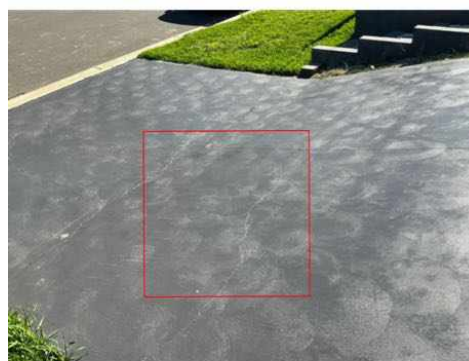
Finding 3.15

Building: Main Building
 Location: Driveway
 Finding: Crack in concrete slab - Category 1
 Information: A crack coded as Category 1 was identified in the slab. A Category 1 crack is described as a fine but noticeable crack, with the slab at an otherwise reasonable level.

To be considered Category 1, the approximate width of the crack is less than 1.0mm, or a less than 10mm change in offset when a 3m straight edge is placed over the defect.

Category 1 cracks should be monitored for a period of 12 months. At the end of the monitoring period, identified cracks that are rated greater than Category 2 are considered defects, and require rectification.

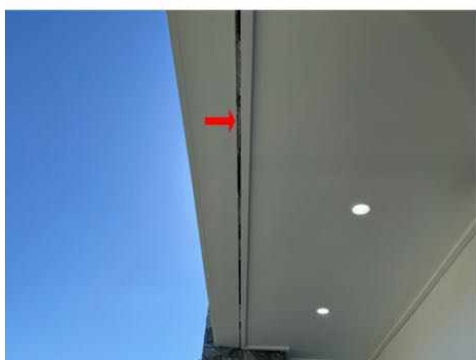
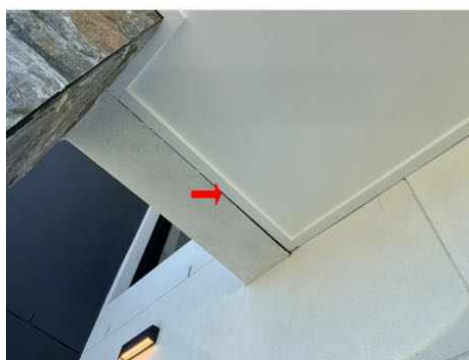
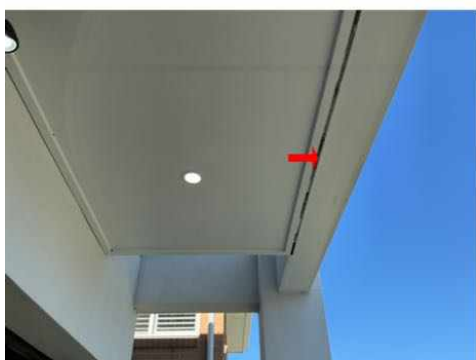
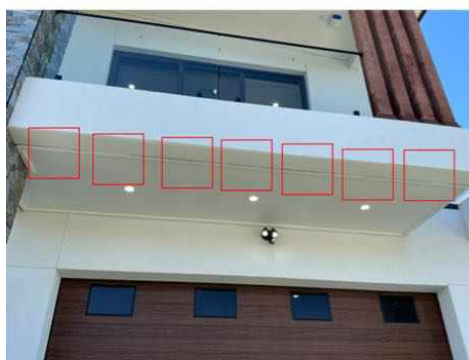
Finding 3.16

Building: Main Building
 Location: Under Balcony
 Finding: Gaps and Incomplete Sealing Noted Under Balcony Soffit
 Information: At the time of inspection, gaps and incomplete sealing were observed along the soffit lining beneath the balcony, particularly around the corner junctions. In these areas, the internal framing elements were partially visible, indicating that the joints and finishing

Unsealed gaps may allow moisture, dust, insects, and pests to enter the cavity, and can also lead to premature deterioration of internal framing components if exposed to weather conditions over time.

It is recommended that a qualified builder be engaged to properly seal and finish these junctions, ensuring that all soffit edges and corner joints are adequately closed and protected to prevent potential moisture ingress and improve the overall durability of the installation.

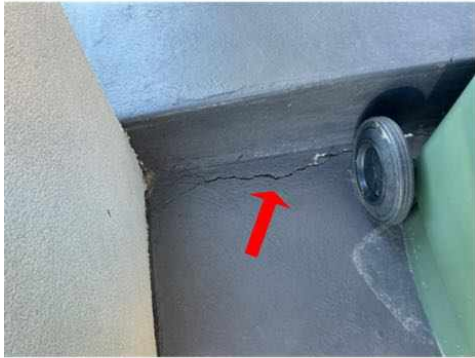
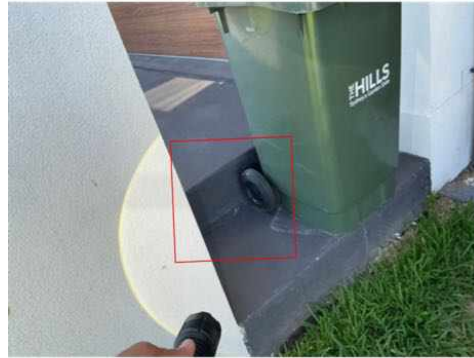
Finding 3.17

Building: Main Building
 Location: Steps Next to Driveway
 Finding: Crack in concrete slab - Category 3
 Information: A crack coded as Category 3 was identified in the slab. A Category 3 crack is described as a wide crack with obvious curvature or change in level, affecting the slab.

The approximate width of the crack to be considered Category 3 is greater than 2.0mm, or a change in offset of 15-25mm when a 3m straight edge is placed over the defect.

Category 3 cracks to slabs exceed allowable Standards and Tolerances, and are

considered defects requiring rectification.

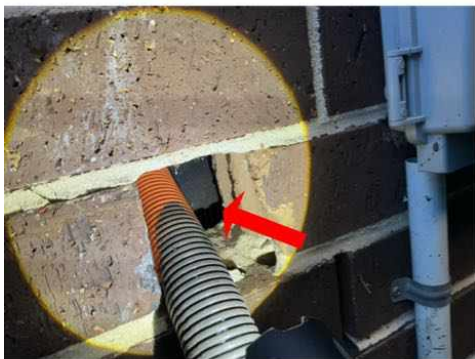
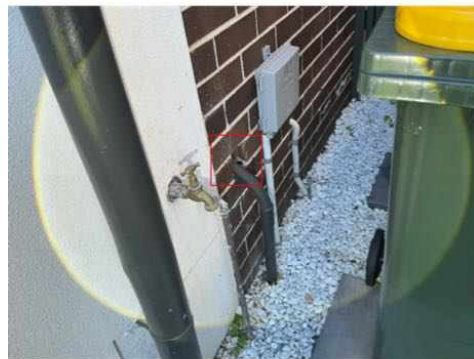
Finding 3.18

Building:	Main Building
Location:	Exterior walls - right side
Finding:	Areas - Not Sealed
Information:	At the time of inspection, certain areas were found to be unsealed, which may allow moisture ingress, pest entry, or air leaks. Gaps and unsealed sections can contribute to deterioration over time and reduce the overall integrity of the structure. It is recommended to seal the affected areas to prevent potential damage and ensure better protection against environmental factors.

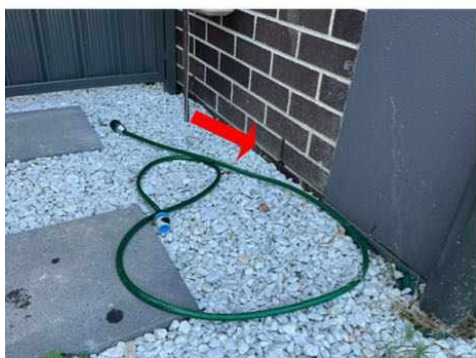
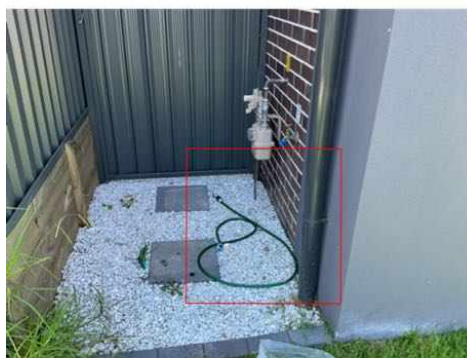
If the slab edge is not properly exposed there is a high risk of termite attack. Sometimes, in order to determine the type of slab, a suitably qualified person such as an architect or builder may be required to consult the construction plans.

Where the slab edge cannot be properly inspected, it is highly recommended that termite or timber pest inspections be carried out every 6-12 months to aid protection of the property against infestation.

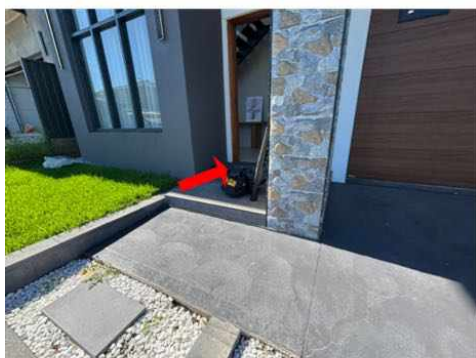
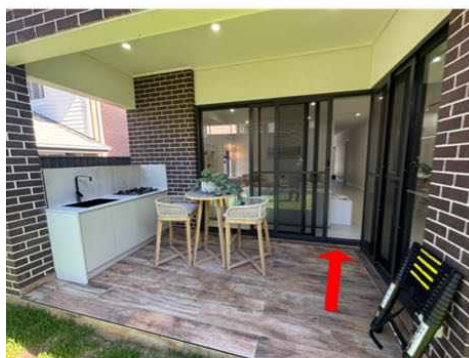
Finding 6.02

Building:	Main Building
Location:	Both Entries
Finding:	Bridging or Breaching of Termite Barriers - Adjacent Internal Flooring
Information:	Bridging is the spanning of a termite barrier or inspection zone so that subterranean termites are provided with passage over or around that barrier.

It is highly advised that a landscaper or relevant tradesperson be appointed to lower external grounds that are raised above or same as adjacent internal flooring. Alternatively if external grounds and internal flooring is level installation of a raised door sill may be appropriate in preventing any water pooling in the area. If the client wishes not to make any changes, then a qualified pest controller is recommended for termite treatment around the perimeter of the house and subfloor (if any) as soon as possible.

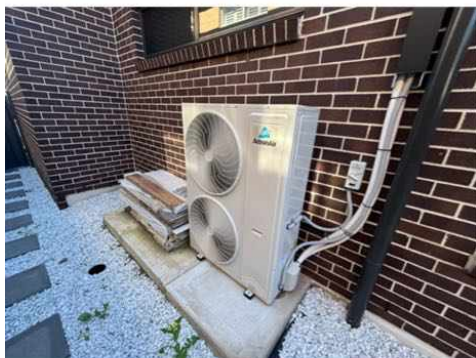
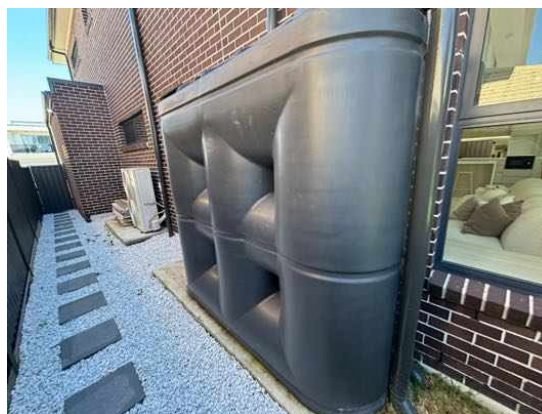
Finding 6.03

Building:	Main Building
Location:	Yard - Side
Finding:	Bridging Appliances/Water Tanks - Attachment to Buildings
Information:	Bridging occurs when items against a building provide a concealed entry point for termites into the building or by passing around a termite management system.

Where any part of an attachment to a building is not isolated and is not provided with a clear gap of not less than 25mm from the building, bridging occurs. Attachments to buildings such as hot water services, downpipes, verandahs, decks, steps, fences, service conduits and the like provide the opportunity for concealed entry.

Building attachments of this nature need to be frequently inspected for termite activity by a qualified inspector.

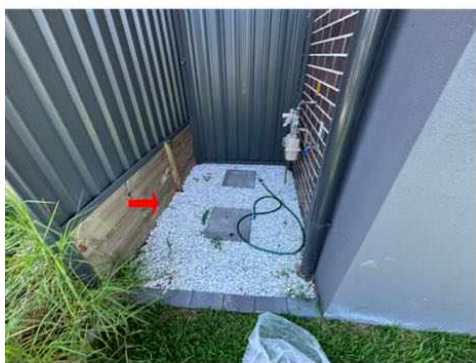
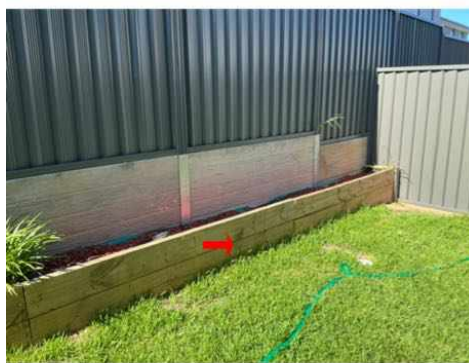
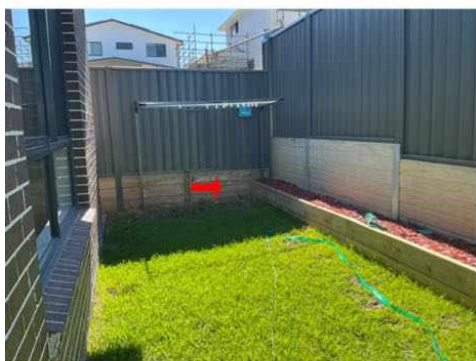
Finding 6.04

Building:	Yard
Location:	All Areas
Finding:	Building Materials in Direct Ground Contact - Conducive to Termites
Information:	Timber elements that are in direct contact with the ground and exposed to moisture or damp conditions are highly conducive to termite activity. This susceptibility arises because timber, when in contact with soil and dampness, creates an environment that is particularly attractive to termites, encouraging infestation and potential structural compromise. Whether the timber is used as a part of the building's construction or incorporated into fencing, its presence near or on the ground can become a pathway for termites to access and damage the property.

When exposed to excessive moisture, timber begins to deteriorate, developing conditions such as wood decay and rot. These compromised areas of timber are even more appealing to termites, as they are easier to infest and consume. This is especially true for untreated or non-durable timber, which lacks the protective treatments that can deter or withstand termite attacks. Termites can use these weakened, moisture-laden elements as a bridge into other parts of the structure, creating an entry point for potential infestations that can spread and cause extensive damage if left unchecked.

For any timber in direct contact with the external ground, special attention is required. The combination of moisture, untreated wood, and direct ground contact not only accelerates the decay process but also provides subterranean termites with a straightforward means of ingress into the structure. This entry can lead to termites moving undetected into other vulnerable areas, resulting in potentially significant structural issues and costly repairs.

To mitigate the risk of termite activity, it is imperative that any such materials or timber elements be appropriately treated or removed as soon as possible. Timbers that are necessary for use should be made durable through appropriate treatments and maintained to ensure they do not create conditions conducive to termites. Additionally, the client is advised to schedule regular termite treatments to maintain an effective barrier against infestations and ensure ongoing protection.

The client is strongly advised to assess the property for any timber elements that may be in direct contact with the ground and ensure prompt action is taken to remove or treat them effectively. Regular inspections, proactive maintenance, and consistent termite treatment are essential steps in minimising the risk of termite attack and protecting the structural integrity of the property. Taking these preventive measures is crucial for maintaining a termite-free environment and avoiding potentially costly damage and future repairs.

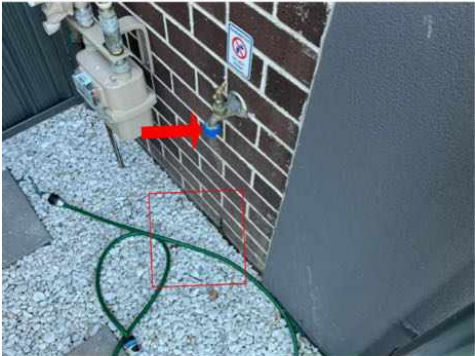
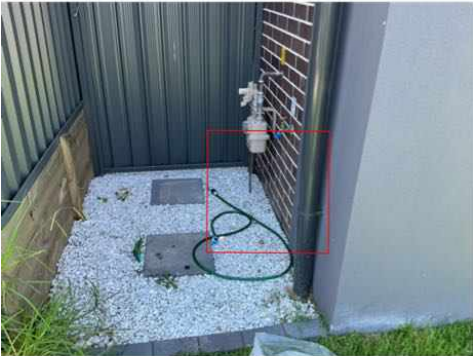
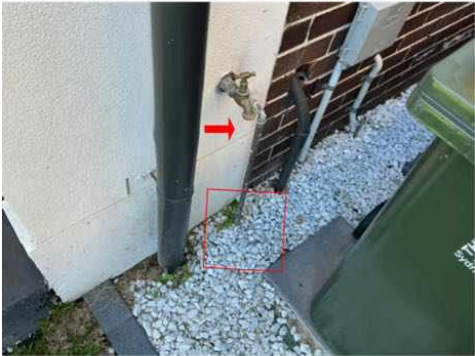
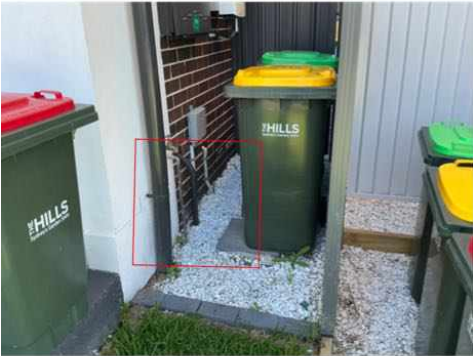
Finding 6.05

Building:	Main Building
Location:	Yard - Front
Finding:	No Stormwater Drain - Under Exterior Tap
Information:	The inspection identified that the exterior tap is not connected to a stormwater drainage system, allowing water to pool around the base. This can lead to moisture-related issues such as deterioration of nearby building materials, mould growth, and increased risk of termite activity—each of which may compromise the property's structural integrity and create health or safety concerns.

To prevent these risks, it is strongly recommended that a licensed plumber be engaged to assess the area and install appropriate drainage, such as a stormwater connection or splash block, to redirect water away from the property. Ongoing maintenance and monitoring of external water sources are also advised to ensure

long-term protection.

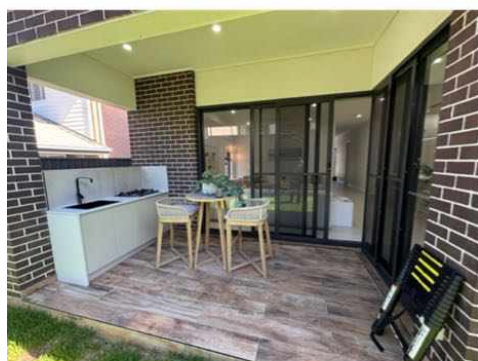
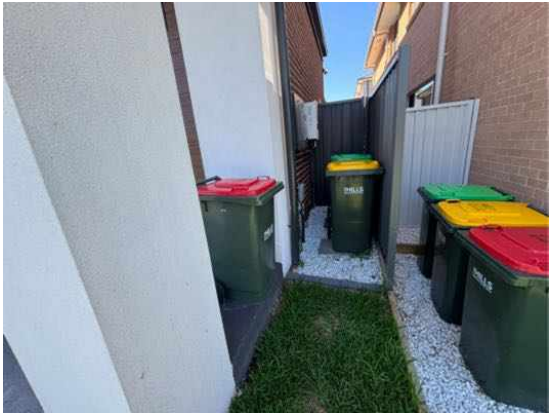
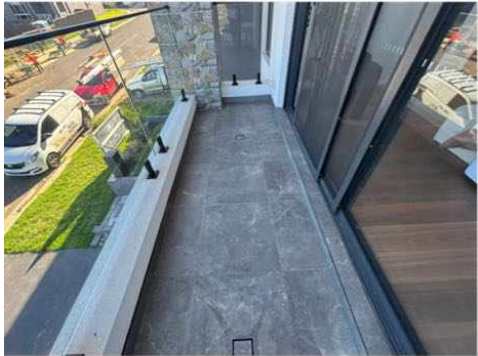
Building:	Main Building
Location:	All External Areas
Finding:	Obstructions and Limitations - External Areas
Information:	The attached photographs provide a visual representation of the obstructions and limitations that impeded a full inspection of the external areas of the property at the time of assessment. These obstructions, which may include vegetation, stored items, debris, or other physical barriers, can obscure potential defects and prevent a thorough evaluation of the property's condition. Obstructions of this nature can conceal a wide range of issues, such as structural damage, water ingress, pest infestations, or deteriorating building materials, which may not be visible during the initial inspection.

It is essential that these obstructions be cleared to allow for a comprehensive inspection of the external areas. Removing these barriers will enable a more accurate assessment of the property's condition and allow any hidden defects to be identified and addressed promptly. Failure to do so could result in undetected issues worsening over time, potentially leading to more costly repairs in the future.

Therefore, it is strongly recommended that the obstructions be removed and a re-inspection be scheduled once the affected areas are made fully accessible. This will ensure a complete evaluation of the property's exterior and provide the client with a clear understanding of any potential issues that may have been concealed during the initial inspection.

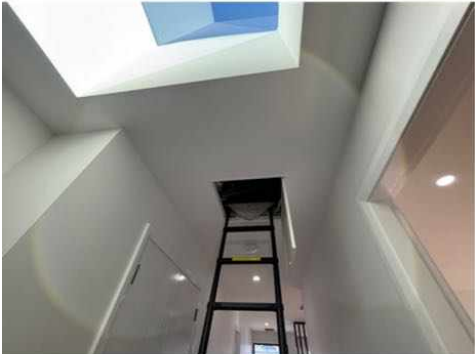
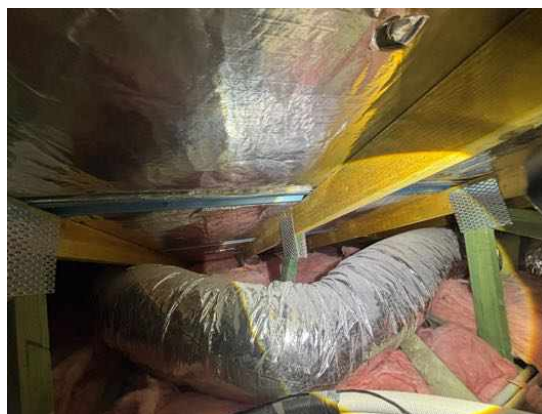
Building: Main Building
 Location: Roof Void
 Finding: Obstructions, Limitations, and General Roof Space Condition
 Information: The photographs provided document both the general condition and the obstructions and limitations that were present in the roof cavity of the main building at the time of inspection. These obstructions—such as insulation materials, stored items, structural elements, or electrical wiring—restricted safe and adequate access to key areas within the roof space. As a result, a comprehensive inspection of all components could not be completed.

Obstructions of this nature may conceal a variety of potential defects, including

damaged framing, compromised insulation, evidence of moisture ingress, pest activity, or electrical hazards. While no major issues were observed in the visible areas, the presence of these limitations means that some defects may remain undetected.

It is recommended that these barriers be removed or repositioned to facilitate full and safe access to the roof space. Once clear, a follow-up inspection should be conducted to allow for a thorough assessment of all concealed areas. This will help ensure that the condition of the roof cavity is accurately evaluated and any hidden issues are appropriately identified and addressed.
