Building and Timber Pest Inspection Report

Inspection Date: Wed, 11 Mar 2026

Property Address: 8 Borealis Wy, Box Hill NSW 2765, Australia

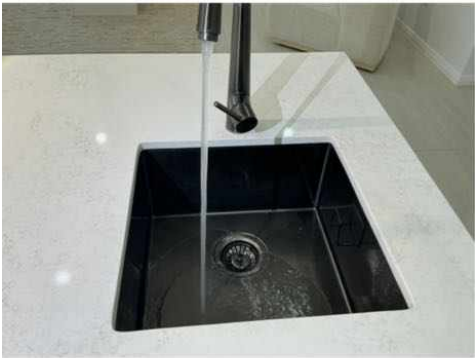
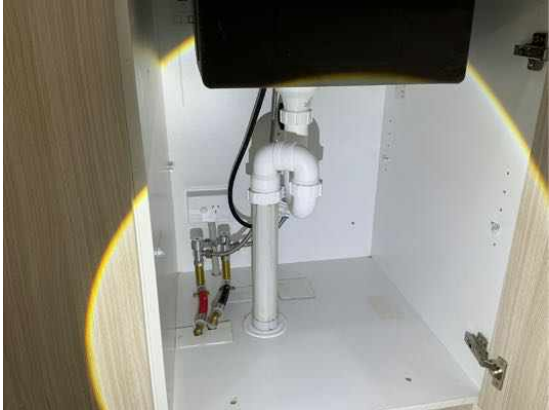
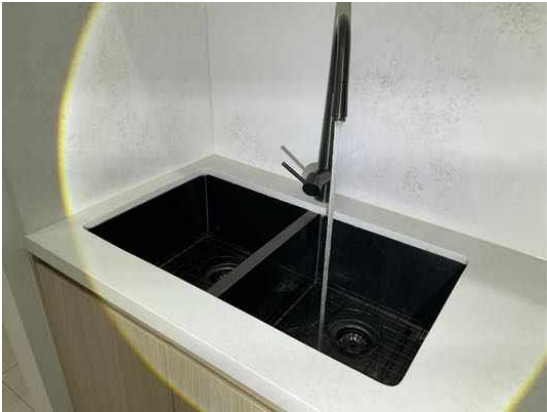
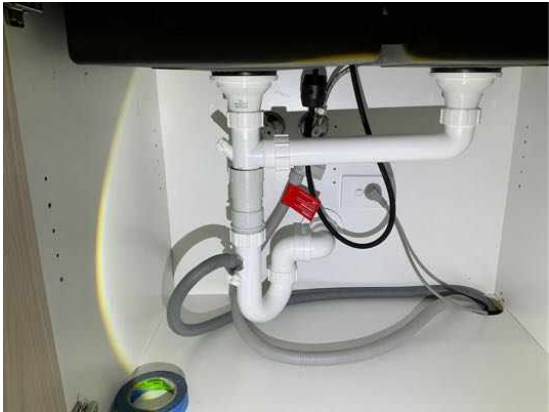
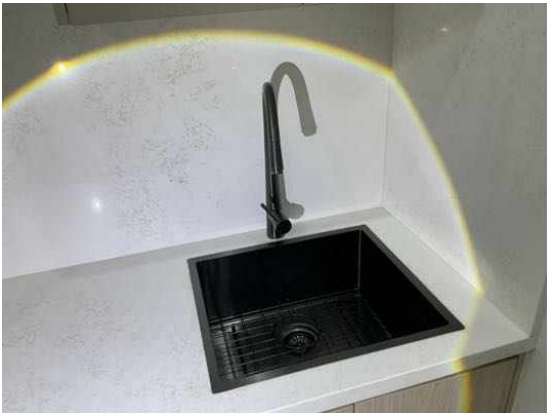
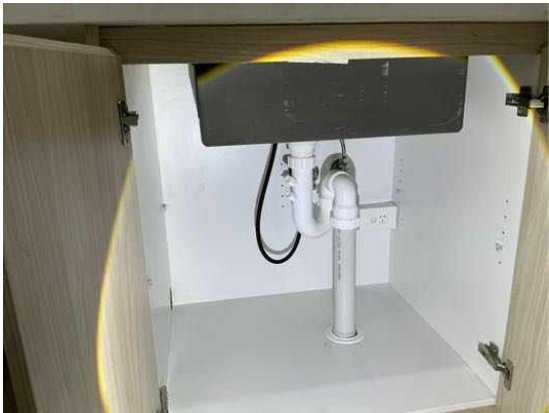
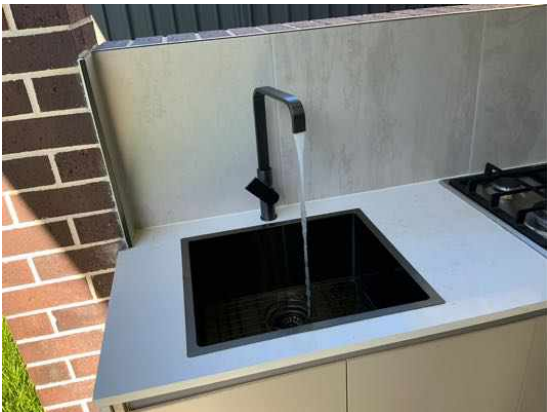
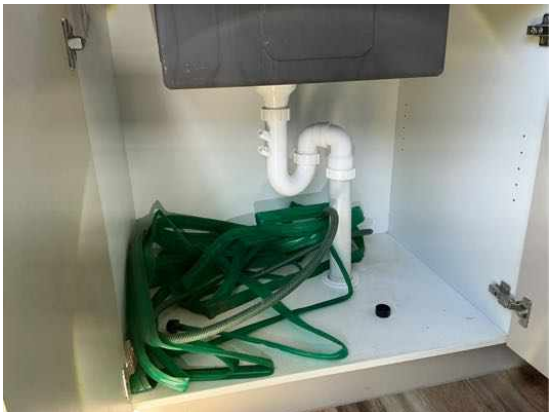
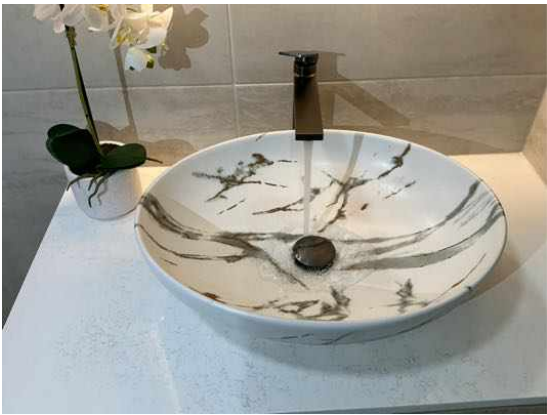
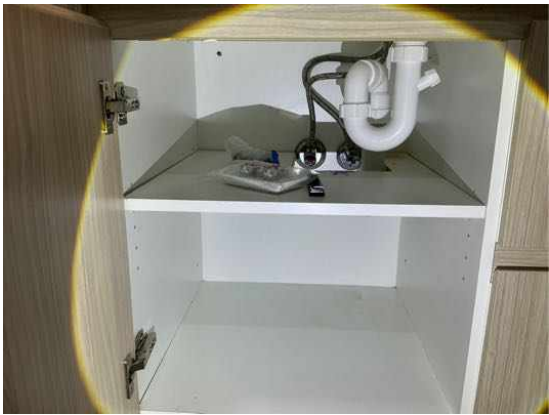
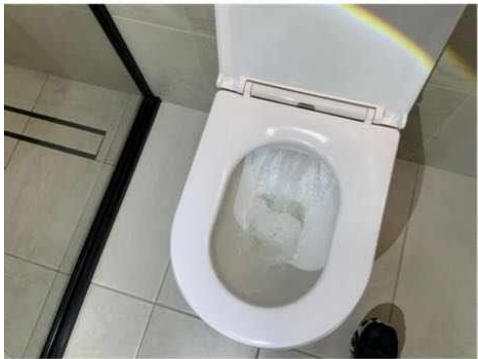
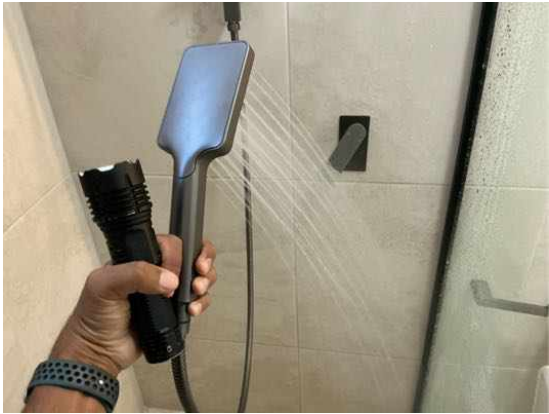
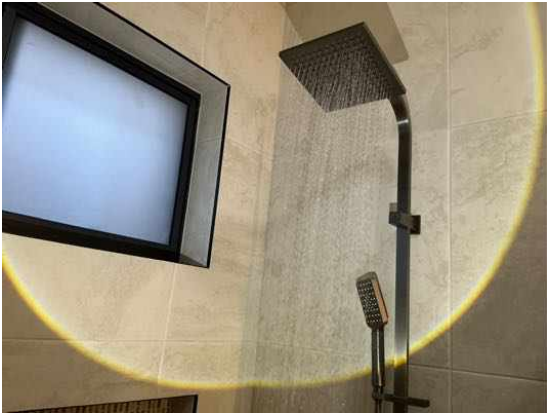
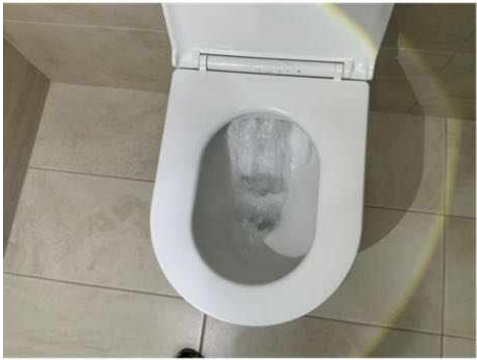
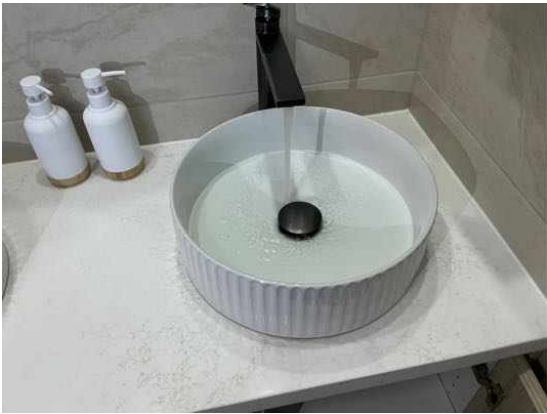
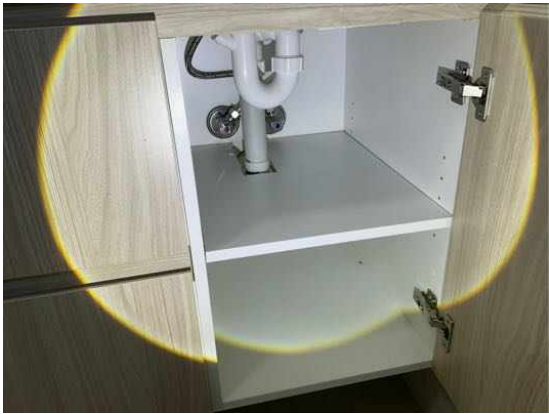
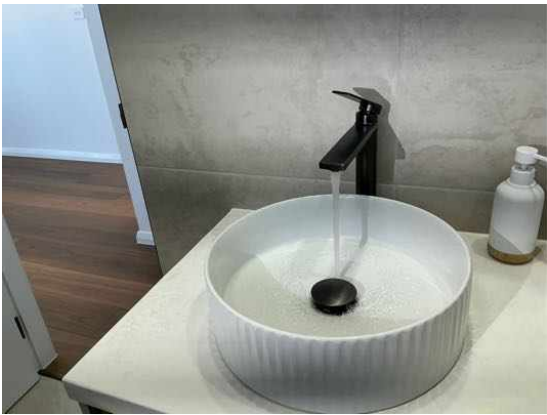
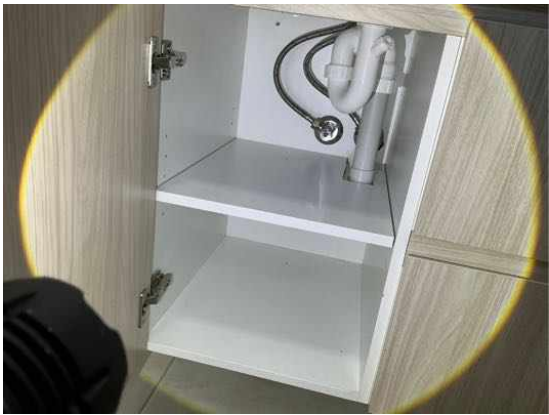
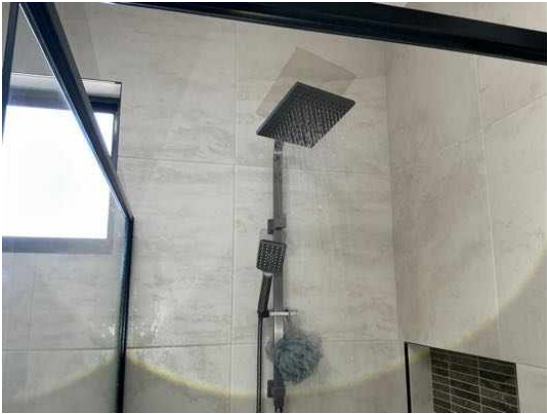
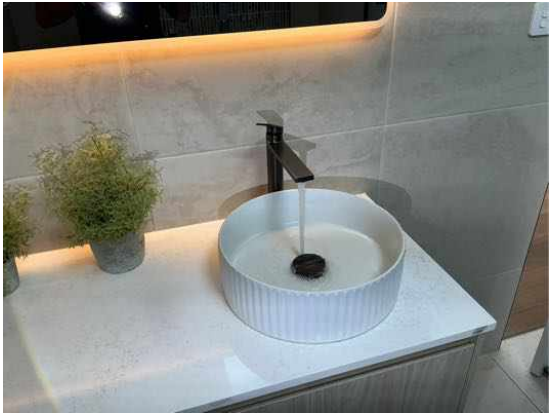
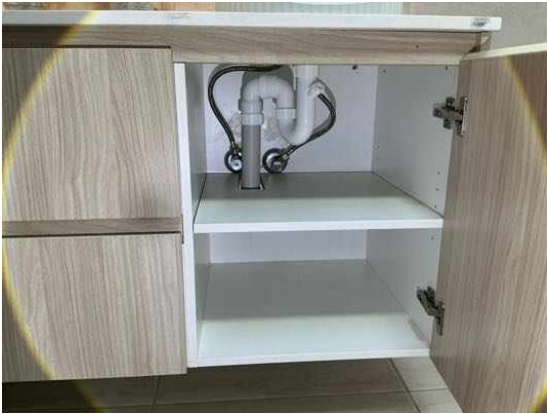
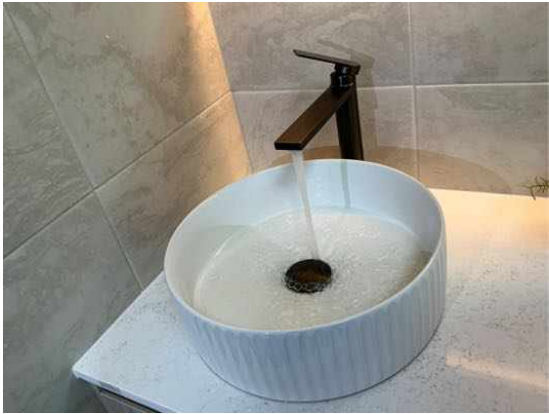
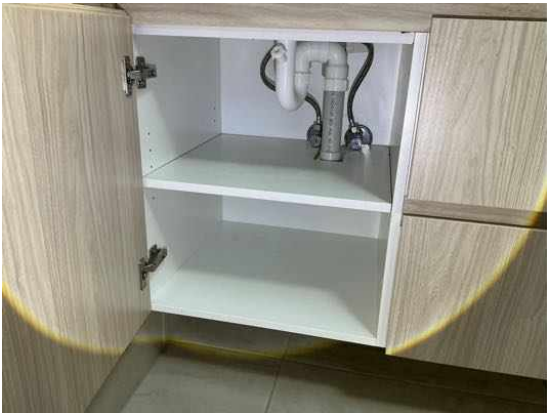
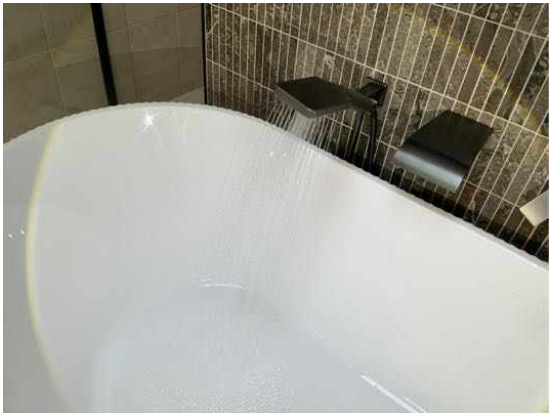
Building: Main Building
 Location: All Areas
 Finding: FYI - Taps, Drainage & Toilets Tested and Cabinetry Obstructions
 Information: During the inspection, all accessible taps, drainage systems, and toilets were tested for water flow and drainage efficiency, and checked for any visible signs of leakage. At the time of the inspection, no issues were noted in these areas. Unless highlighted in a separate defect statement, no immediate remedial work appears necessary. Supporting images may be found in the additional photos section for reference.

It is important to note that while a visual inspection of cupboards and cabinetry beneath sinks and vanities was undertaken, stored personal items and fixtures presented obstructions that limited full visibility of the internal areas. As per standard inspection practices, inspectors are not permitted to move or disturb personal belongings during the inspection process. Therefore, only visible and accessible sections were inspected, and concealed water damage or plumbing defects may not have been detected.

Given this, a re-inspection is recommended after all obstructions have been cleared to allow for a comprehensive assessment of these areas. Regular maintenance and monitoring of plumbing and drainage systems is also advised to ensure ongoing functionality and early detection of potential issues.

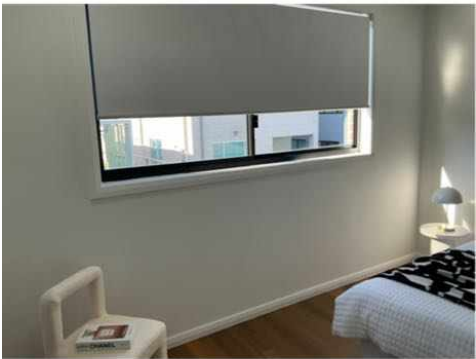
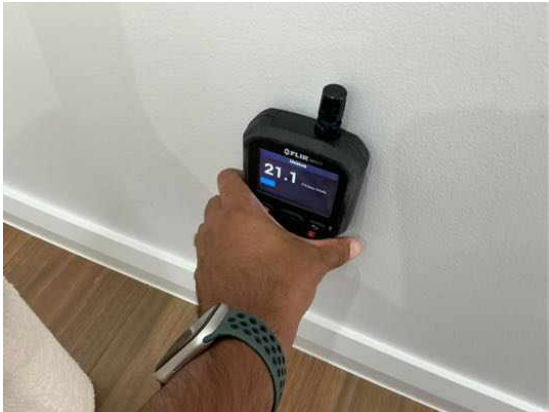
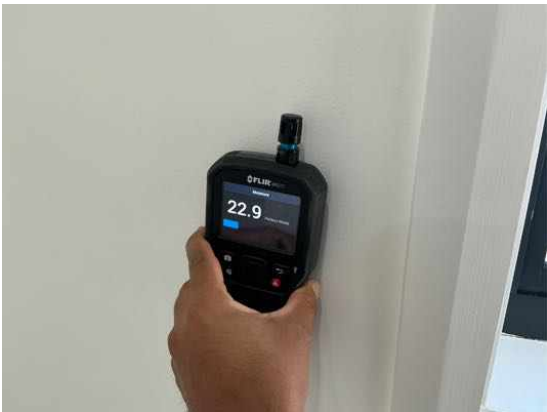
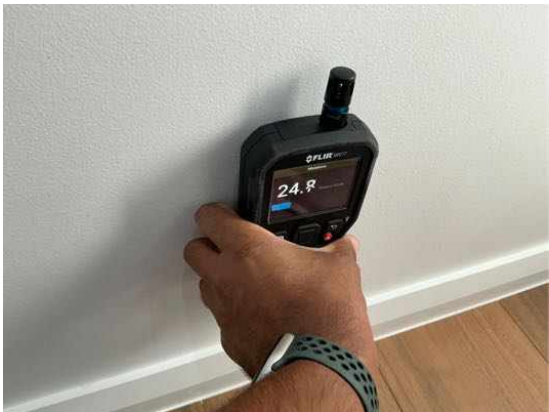
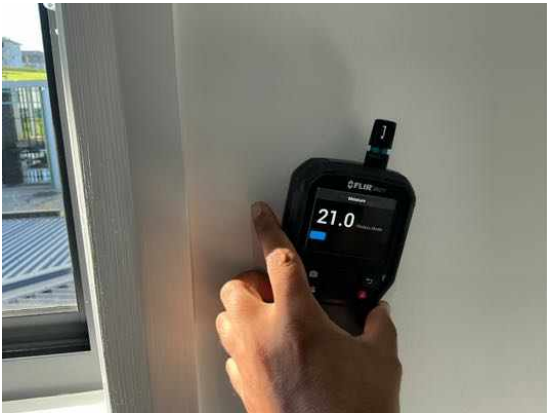
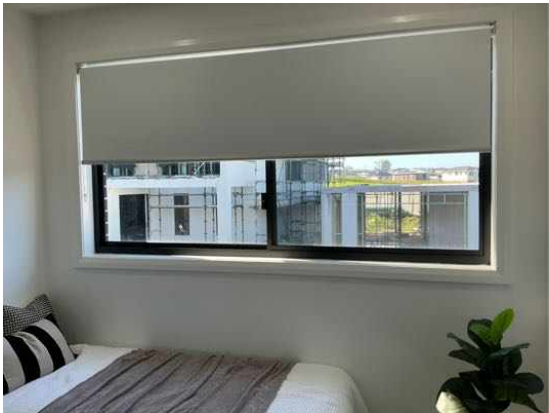
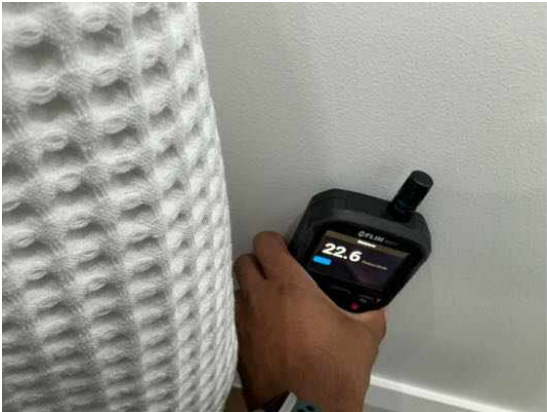
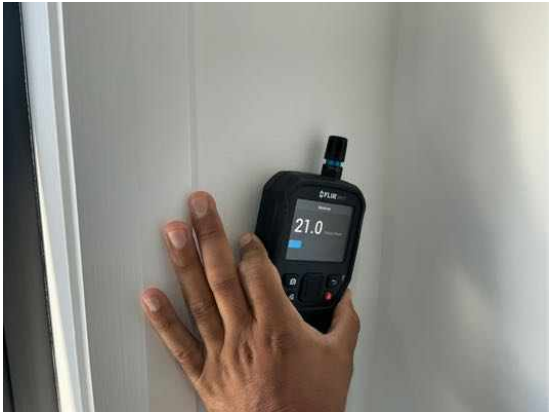
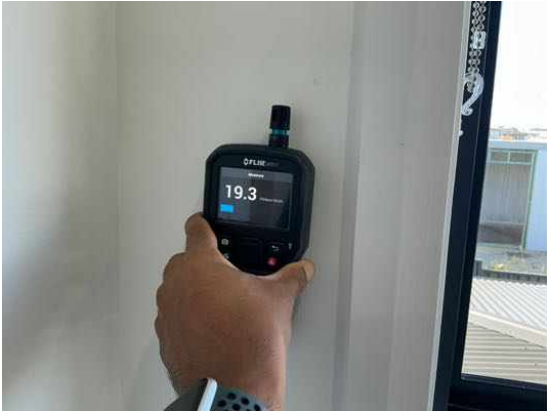
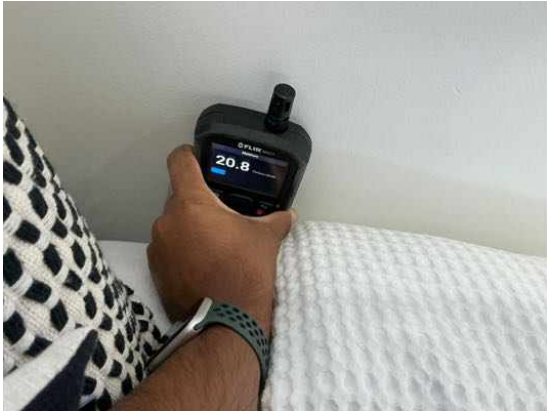
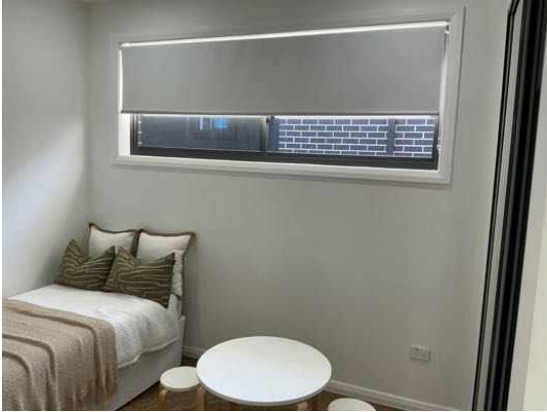
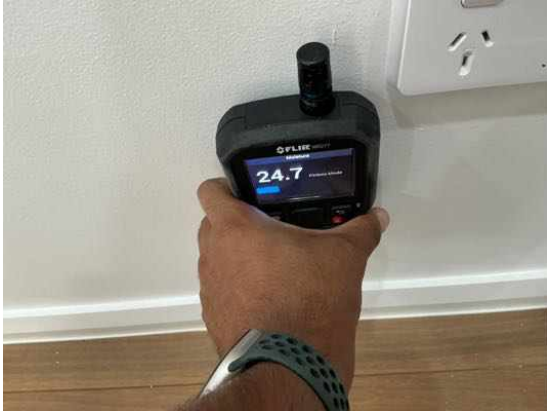
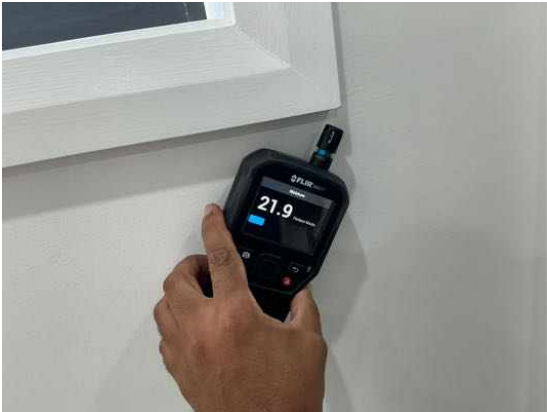
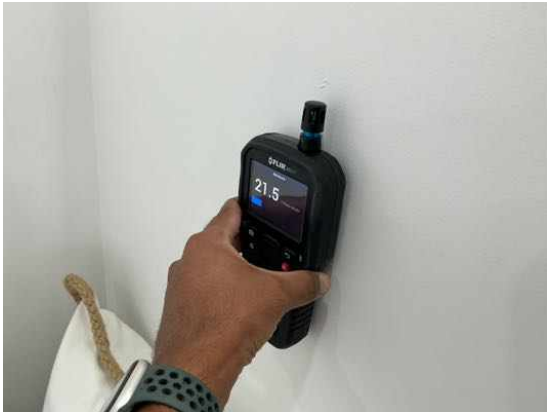
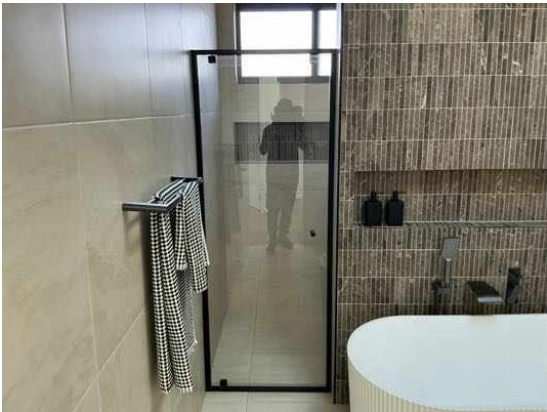
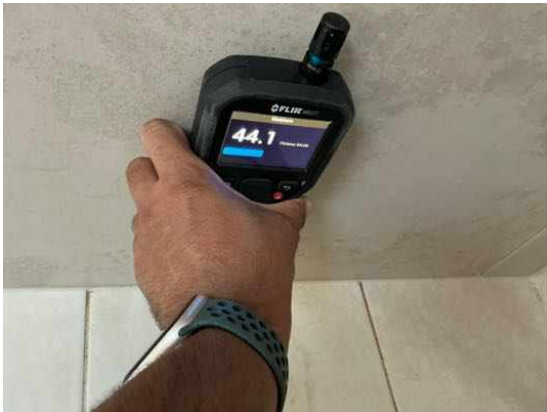
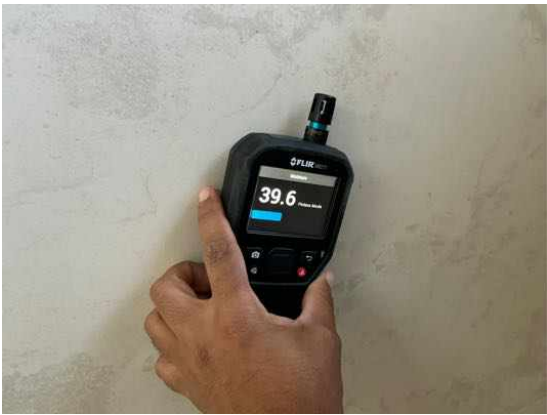
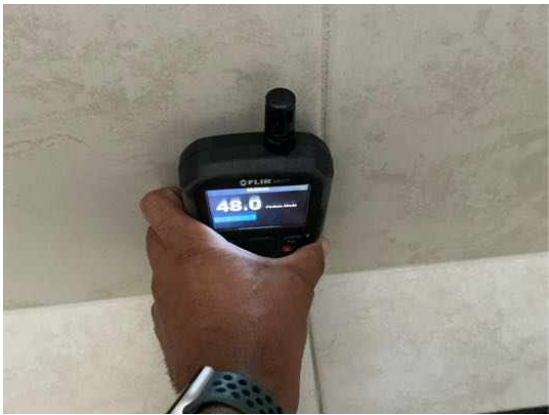
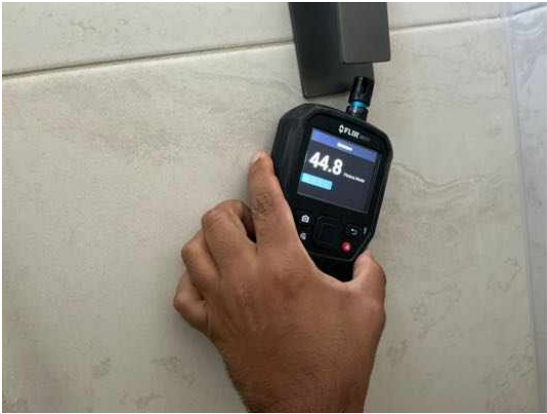
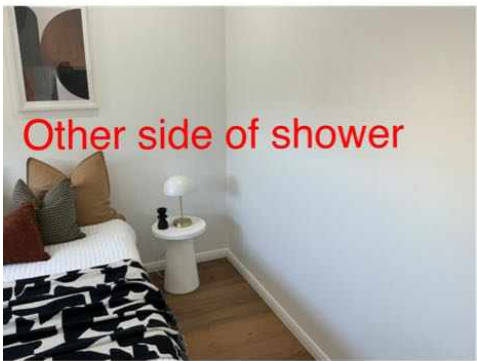
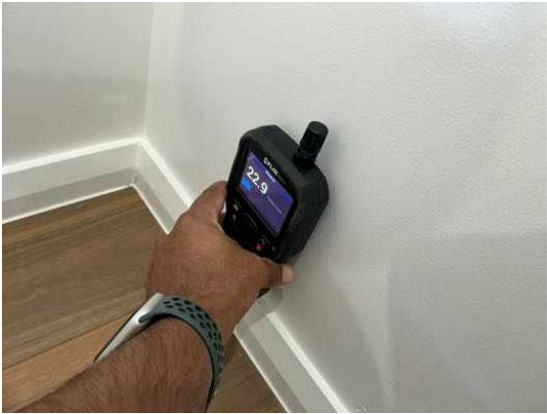
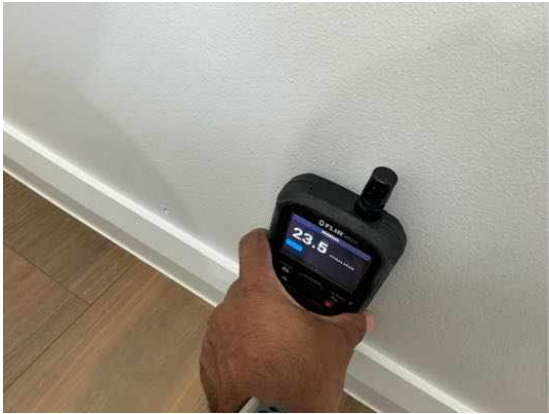
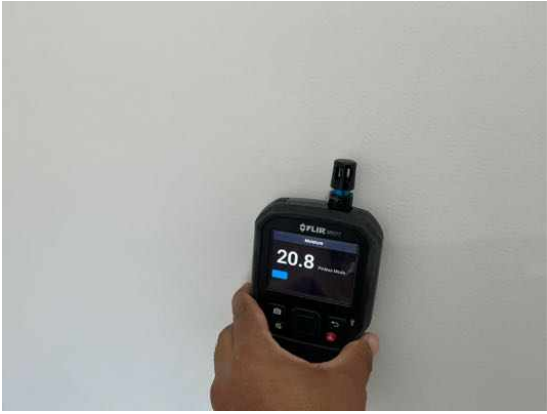
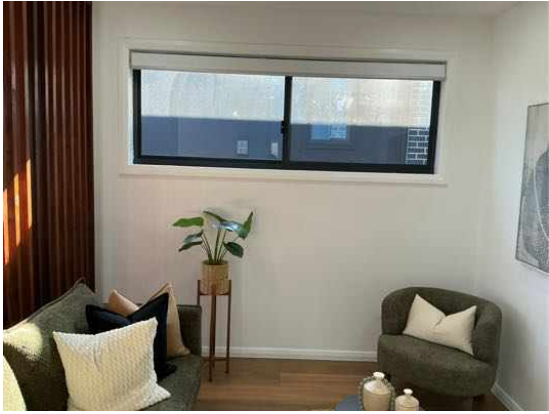
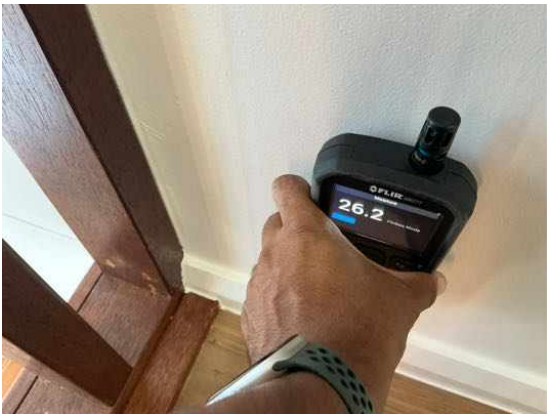
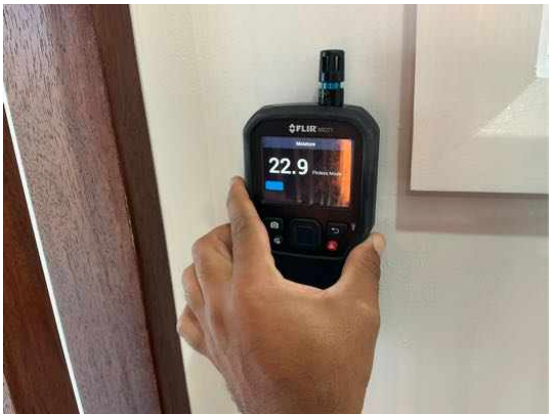
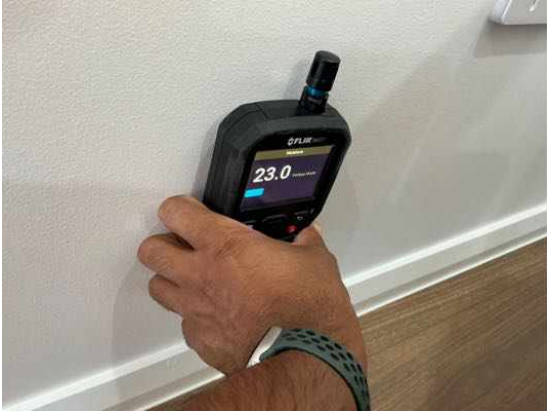
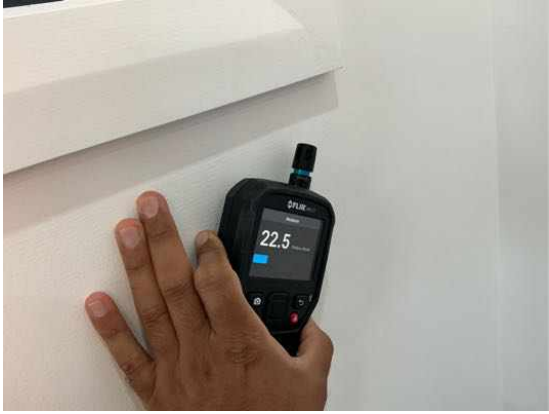
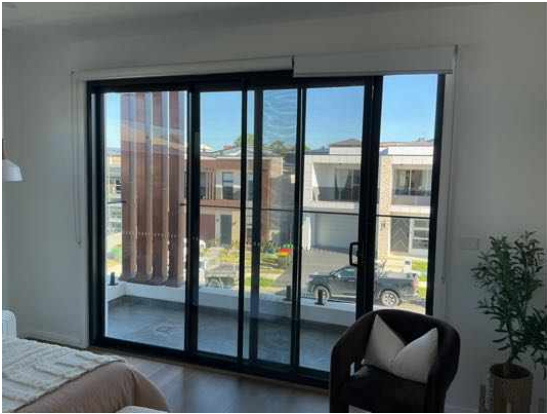
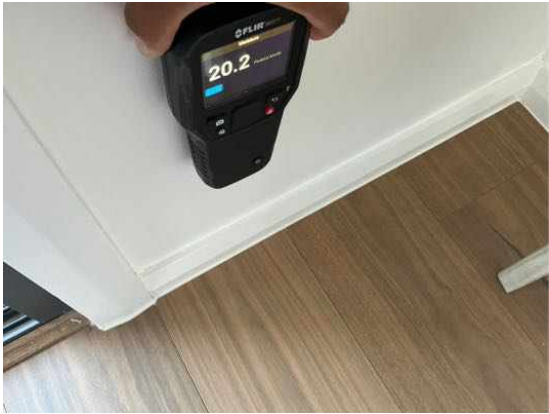
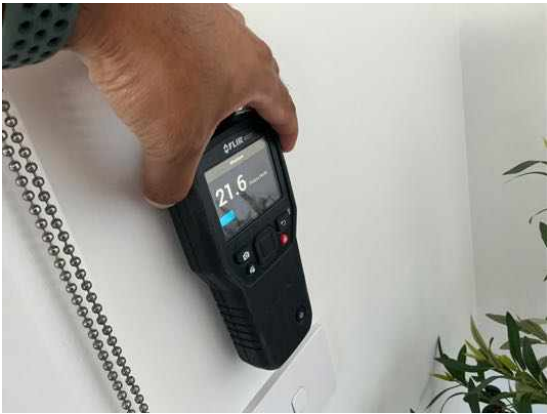
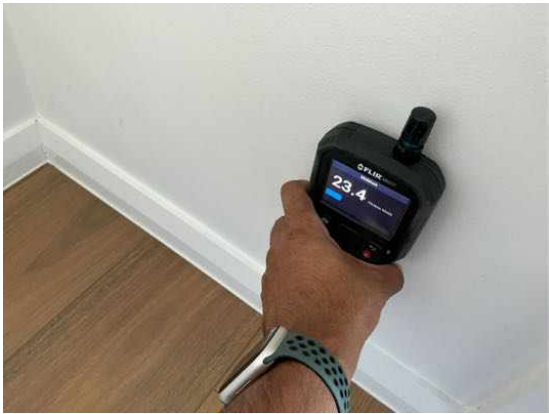
Building:	Main Building
Location:	All Areas
Finding:	Additional Photos - Moisture Meter Readings
Information:	Additional moisture meter reading photos have been provided for the property to offer further clarity on areas tested during the inspection. These photos are intended to give a visual reference for the specific locations where moisture levels were measured. These readings were taken at the time of the inspection to assess any potential moisture-related issues within the property. Any defects related to moisture that were identified during the inspection have been separately mentioned in the defect statements within the report.

For further clarification or additional information regarding the moisture readings, the client is encouraged to contact the building inspector directly. Regular monitoring of moisture-prone areas is recommended to ensure any emerging concerns are addressed promptly, particularly during wetter seasons or in high-humidity conditions.

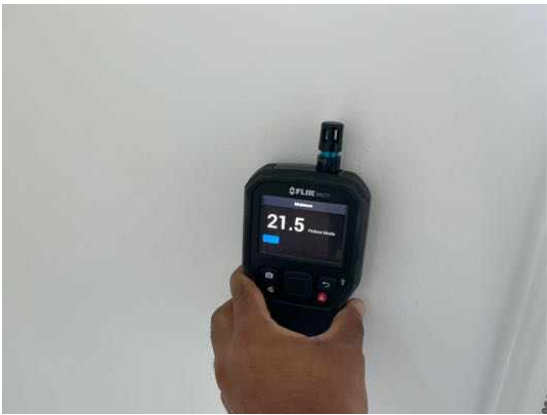
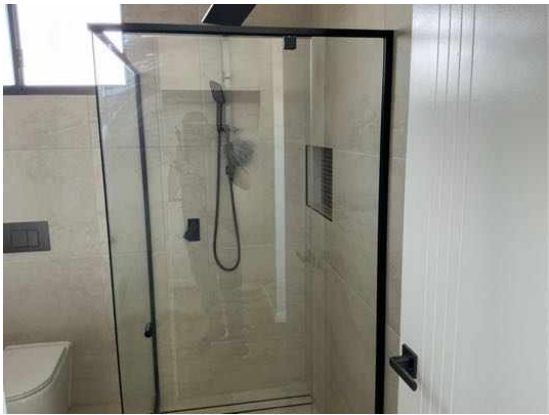
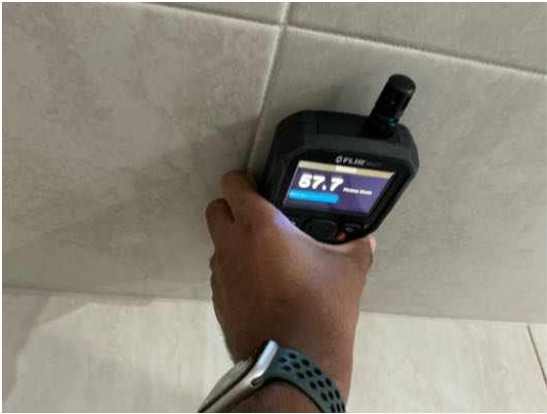
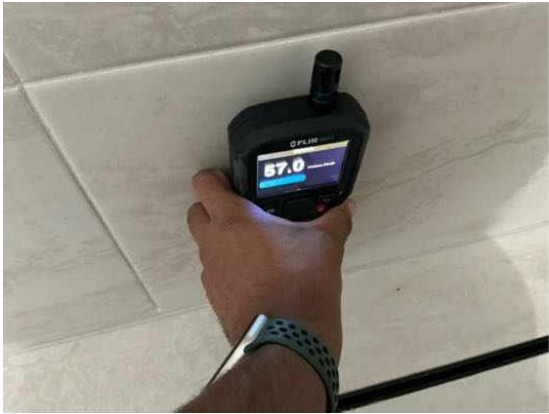
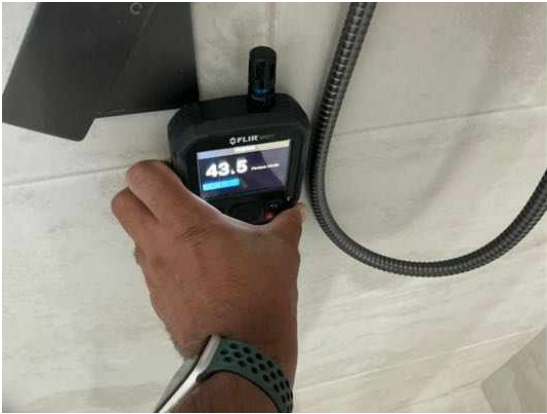
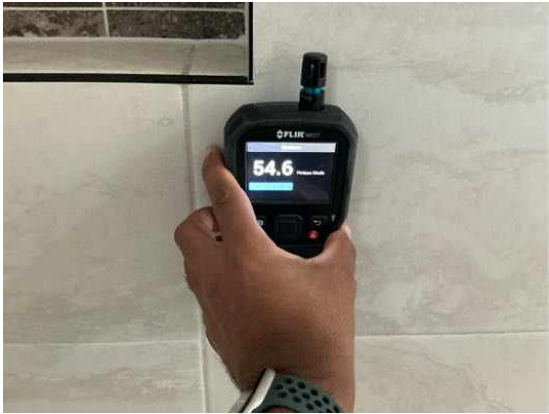
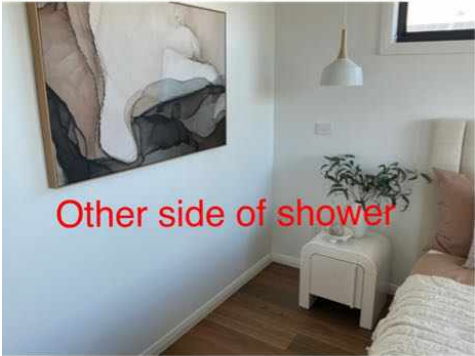
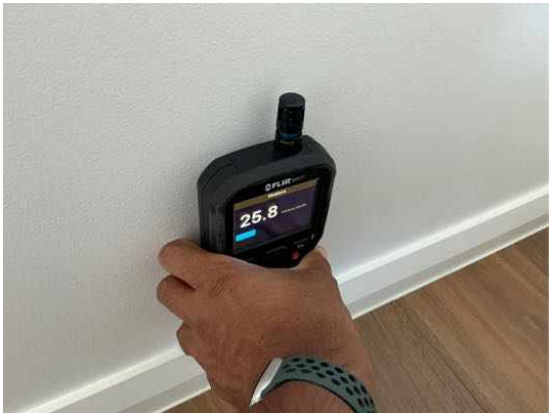
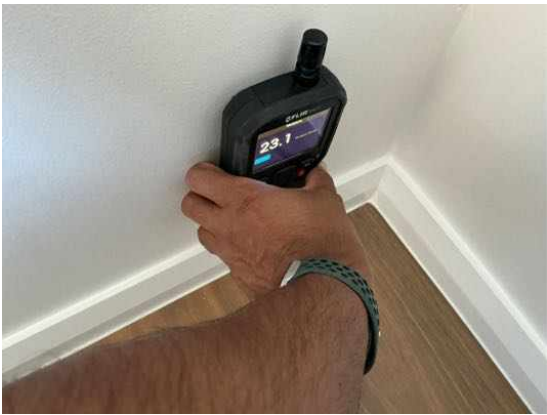
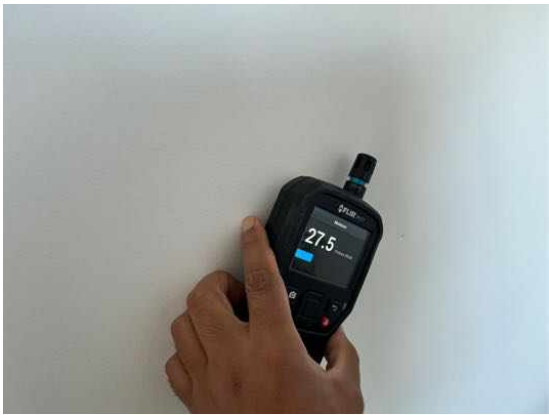
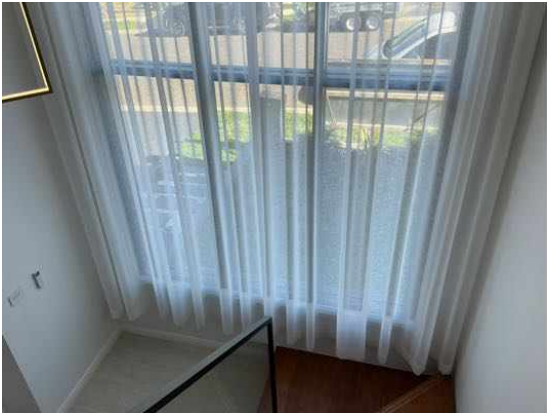
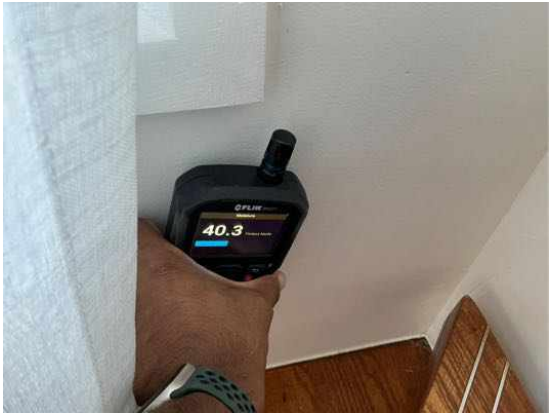
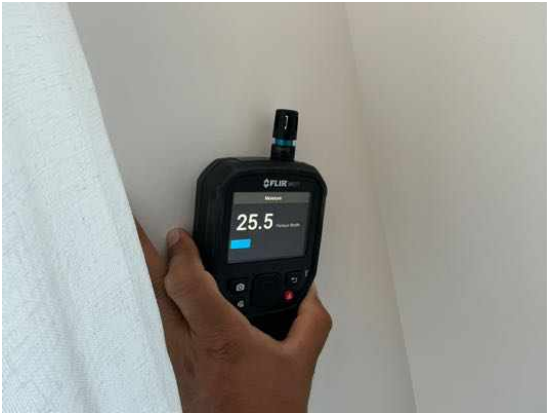
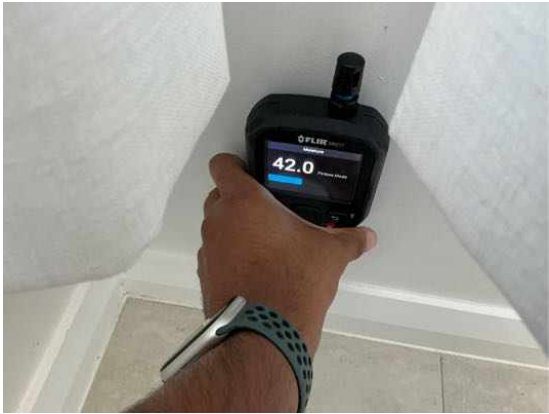
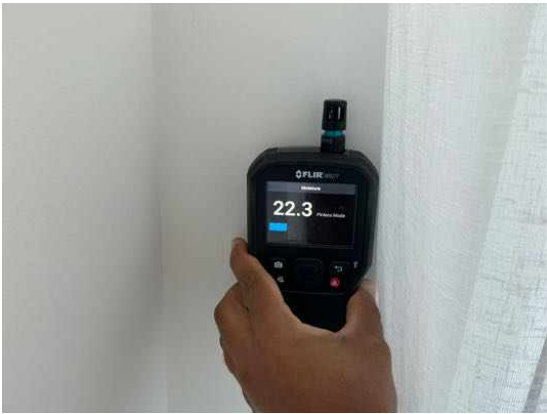
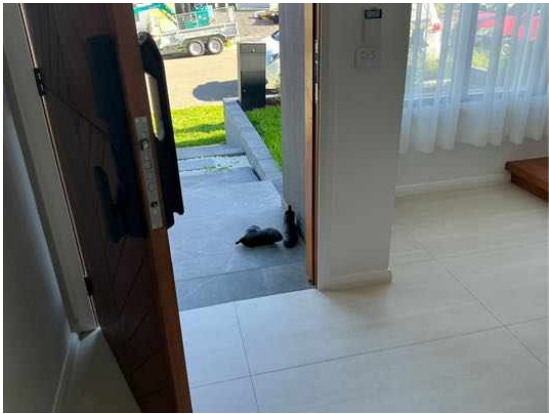
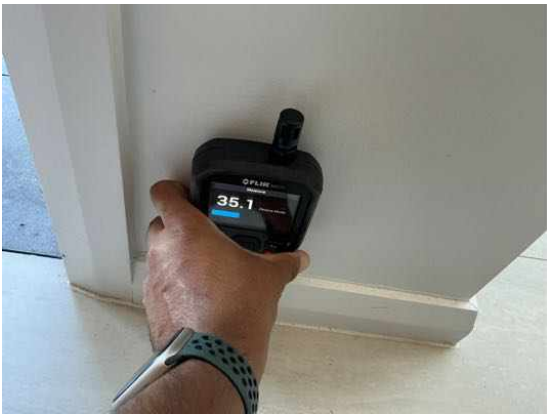
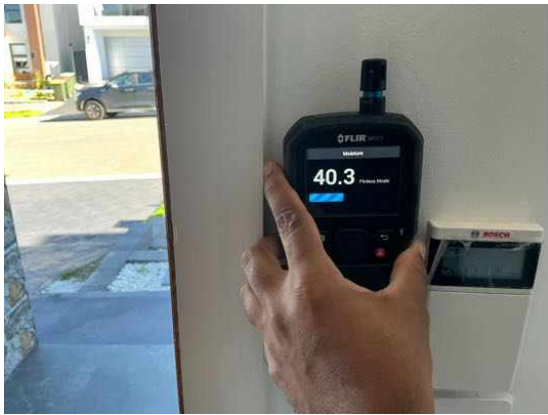
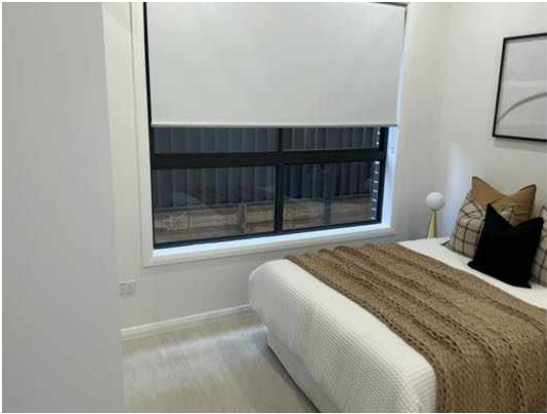
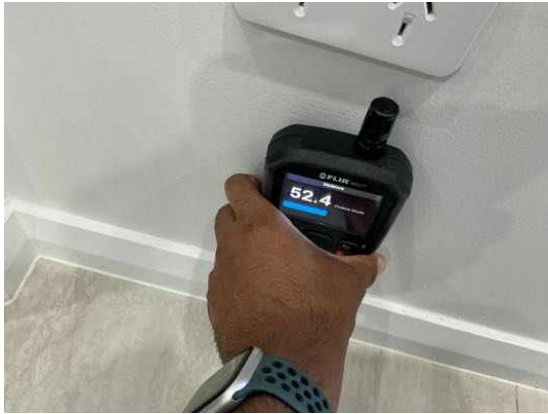
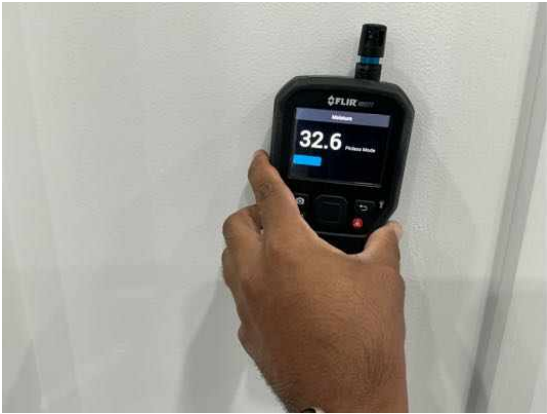
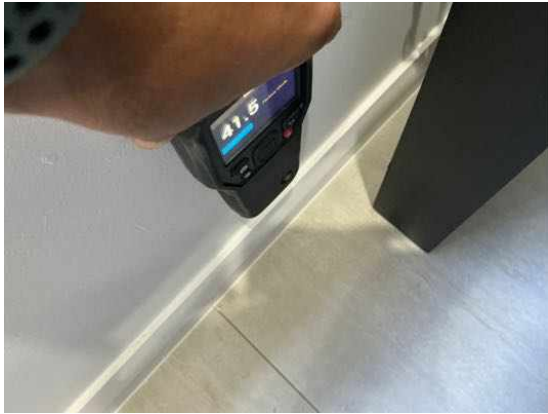
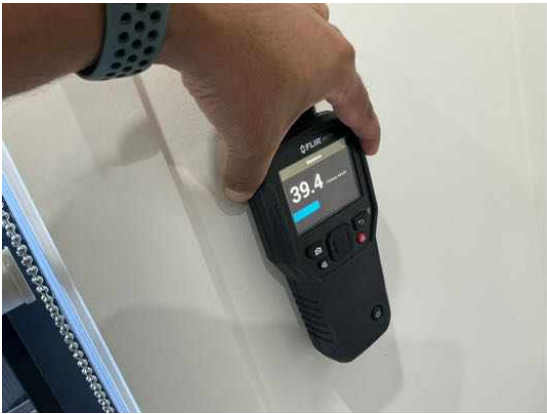
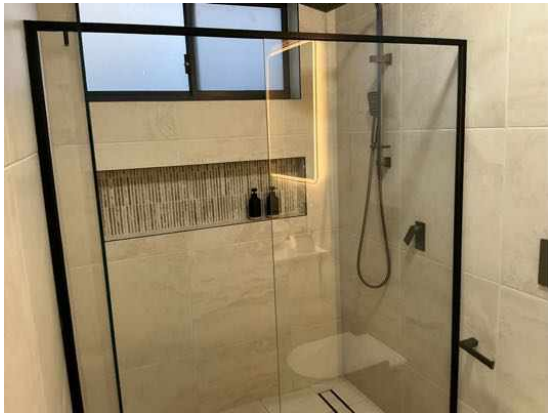
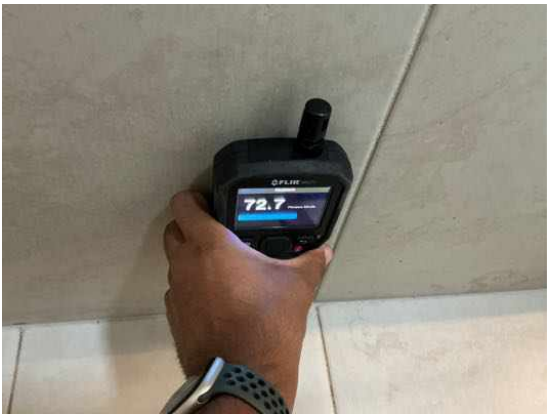
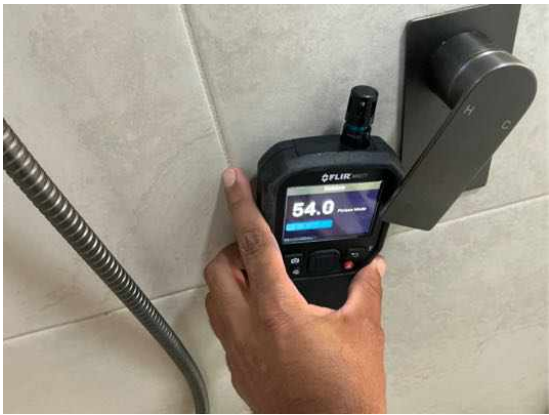
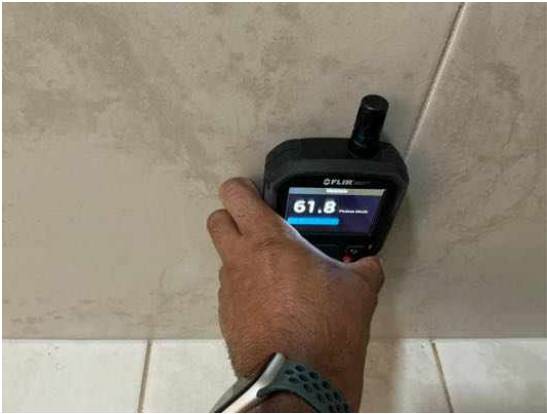
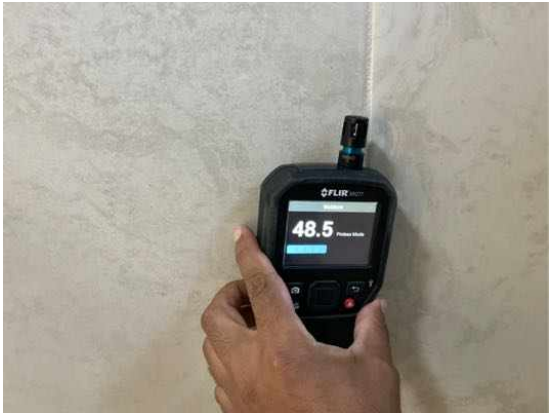
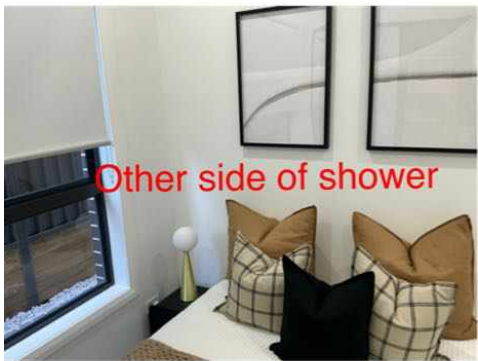
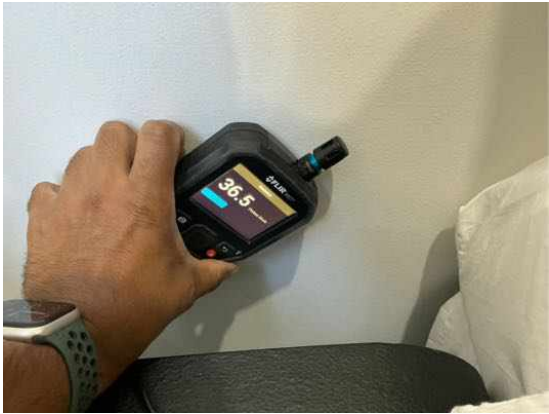
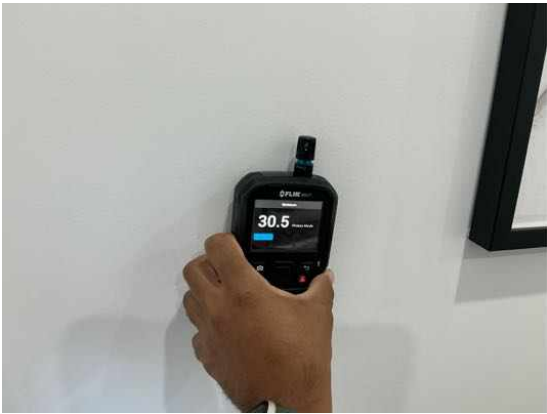
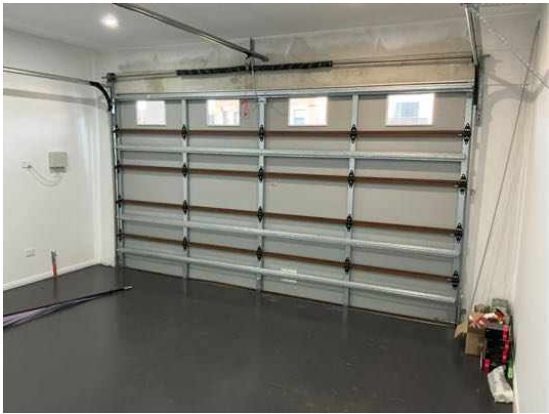
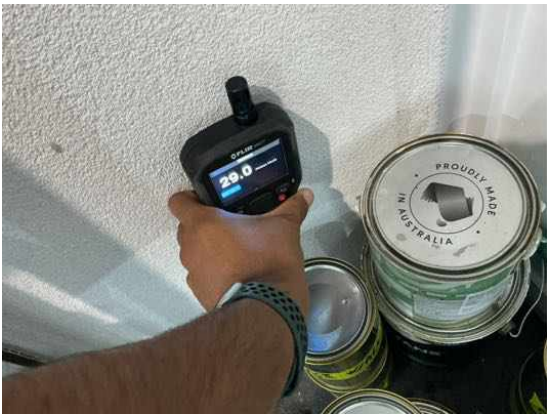
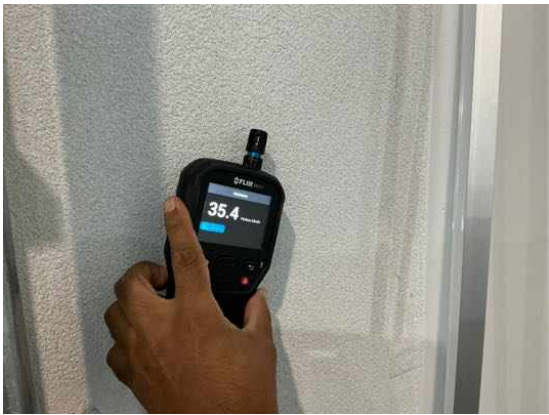
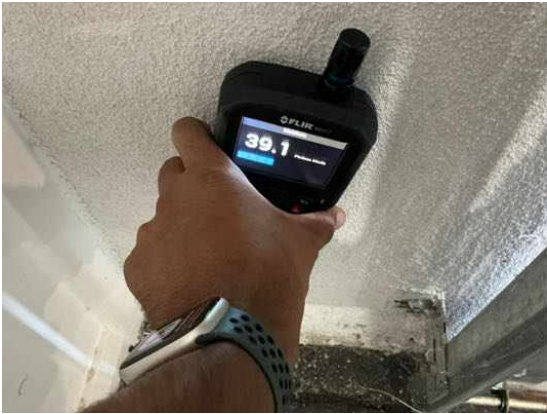
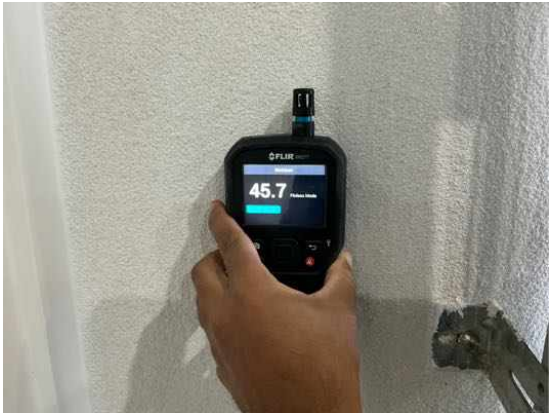
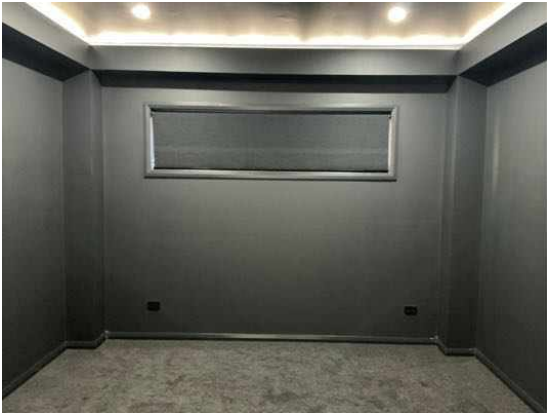
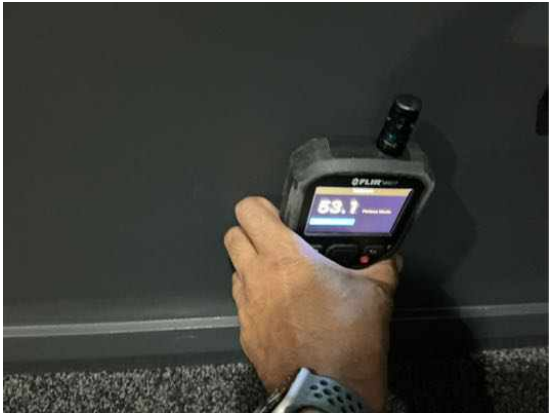
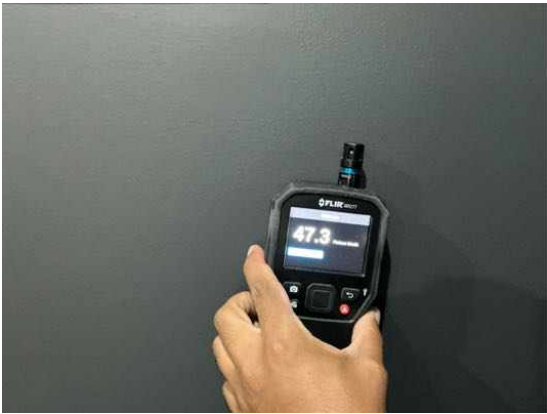
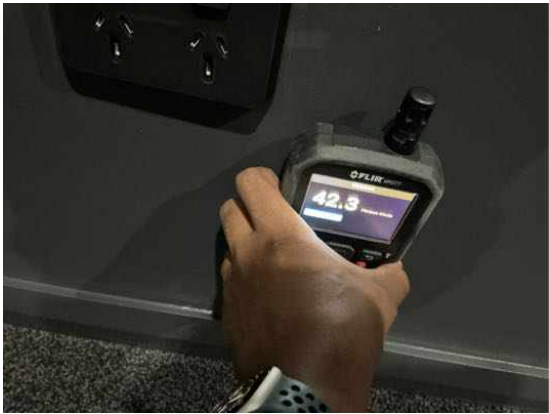
It is important for the client to understand that moisture levels can fluctuate over time due to various factors, including changes in weather, humidity, and environmental conditions. While the readings reflect the property's moisture levels during the inspection, they may not represent future conditions, and increased moisture could lead to issues such as dampness, mould growth, or deterioration of building materials if left unmonitored.

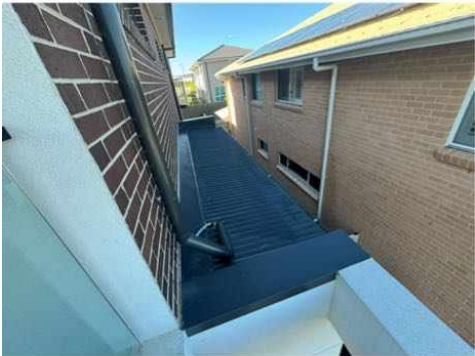
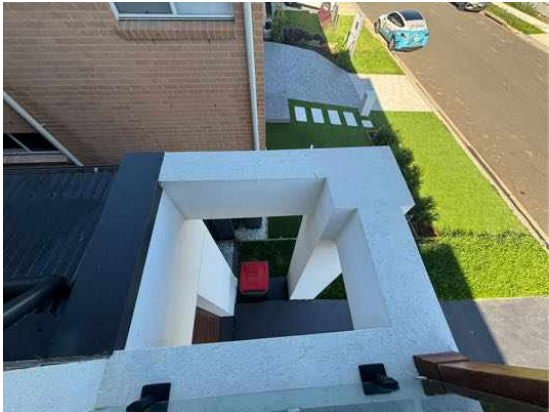
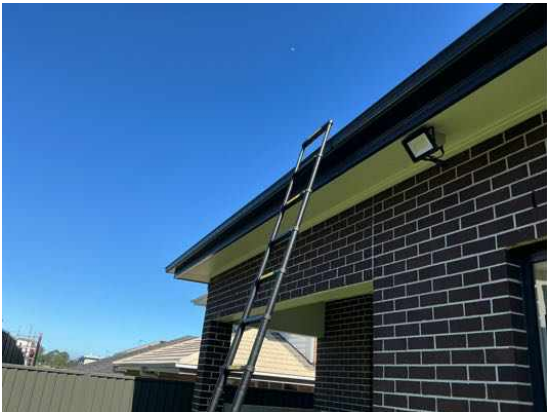
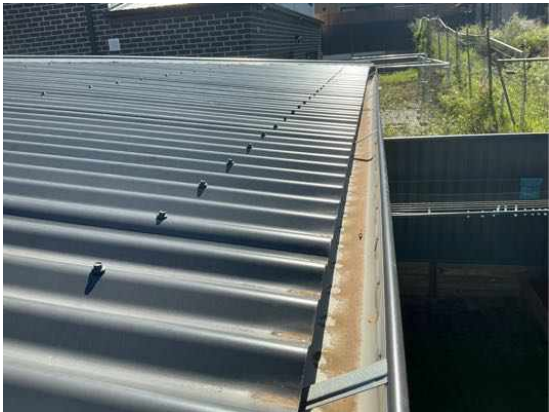
Building: Main Building
Location: Roof Exterior
Finding: Additional Roof Photos
Information:
