Building and Timber Pest Inspection Report

Inspection Date: Wed, 11 Mar 2026

Property Address: 8 Borealis Wy, Box Hill NSW 2765, Australia

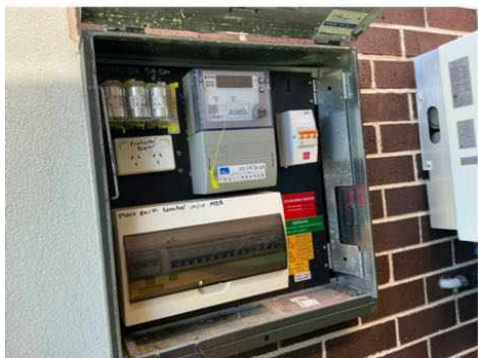
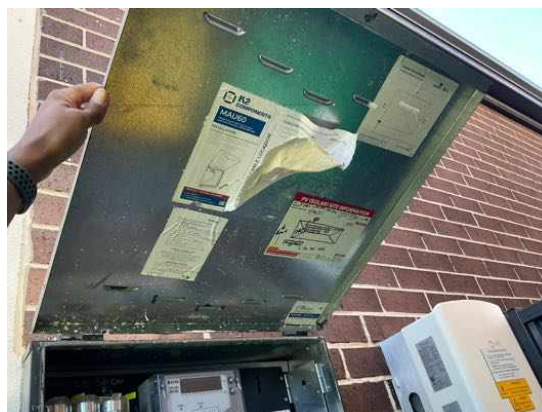
Building:	Main Building
Location:	Meter Box
Finding:	Termite Management Recommendation – No Evidence of Chemical Installation
Information:	At the time of inspection, there was no visible evidence of a chemical termite management system installed around the property. Chemical barriers are a key component of termite protection and are particularly important in preventing concealed termite entry into timber elements of the structure.

In accordance with standard requirements, a durable notice should be located within the electrical switchboard to detail any termite protection systems applied, including chemical treatments. No such notice was observed during the inspection.

It is recommended that the client engage a licensed pest controller to assess the suitability of installing a chemical barrier, and to provide advice on associated costs and procedures. This should be considered a short-term priority, particularly if the property has any history of termite activity or is located in a high-risk area.

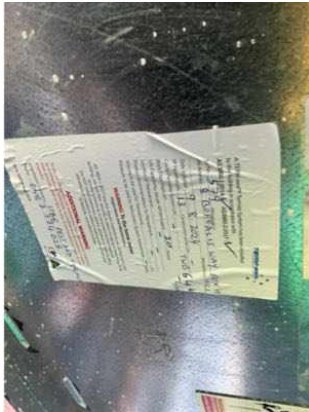
Where a Termite Management System has been identified you should refer to the type of barrier date of installation warranty conditions and any documentation provided by a builder or past owner. Consult the company who installed the barrier to confirm whether the system is still under warranty.

Most chemical termite management systems expire and require replenishment and all physical systems are primarily designed to prevent concealed entry.
