# Building and Timber Pest Inspection Report

Inspection Date: Tue, 10 Mar 2026

Property Address: 140 Victory Rd, Airport West VIC 3042, Australia

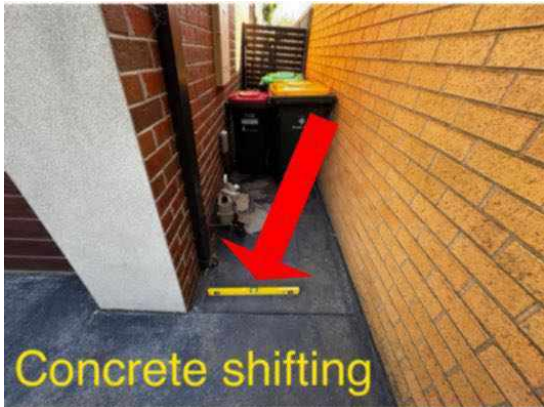
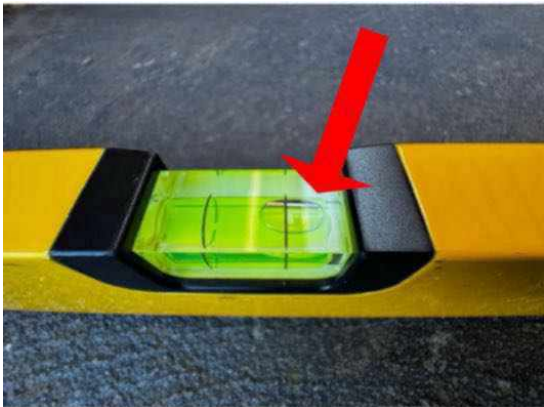
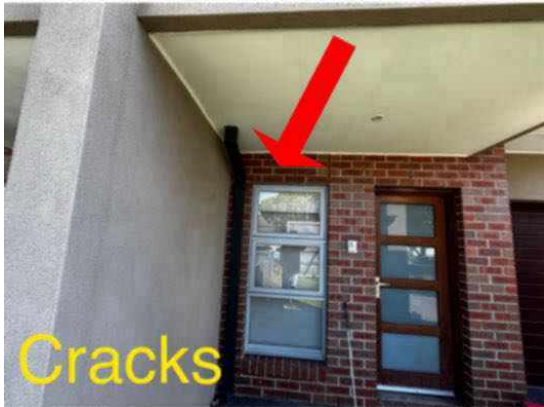
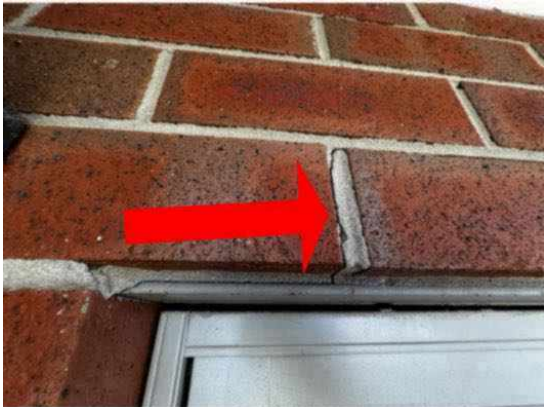
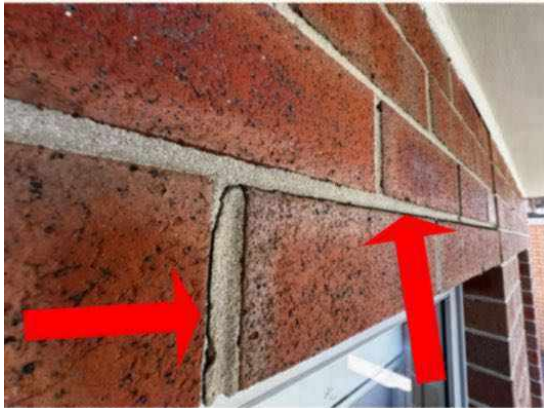
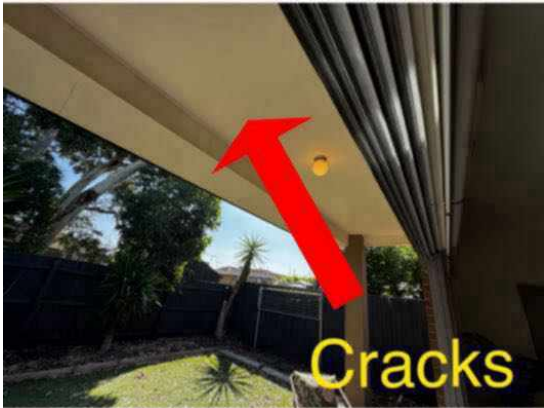
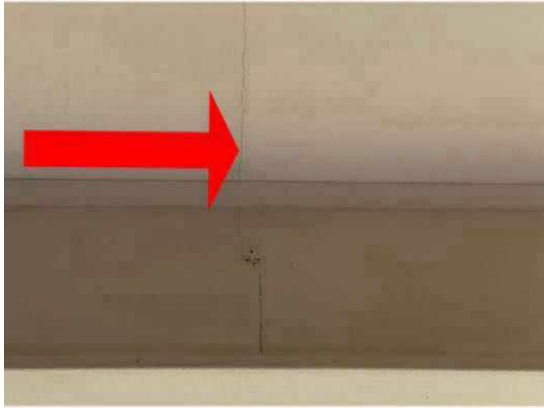
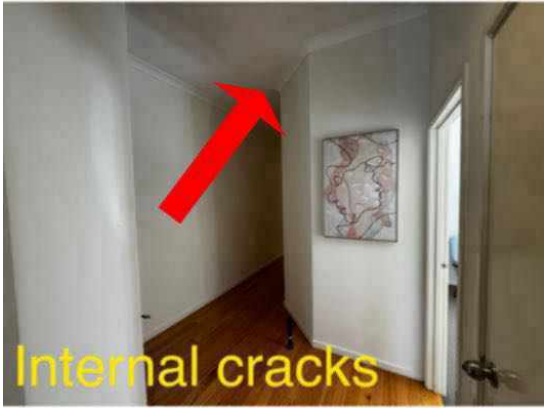
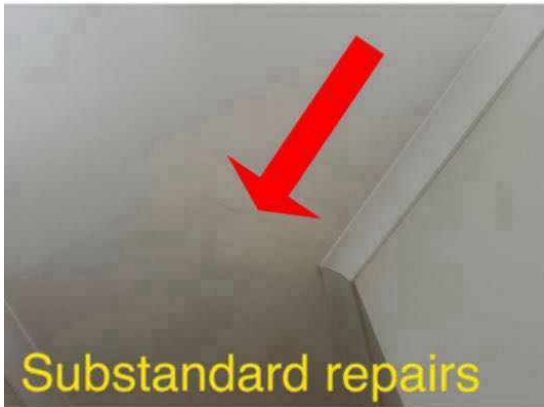
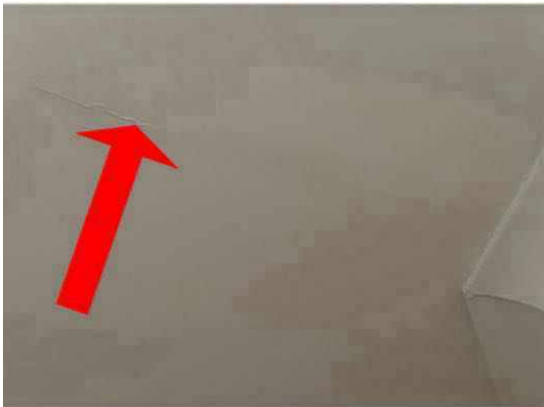
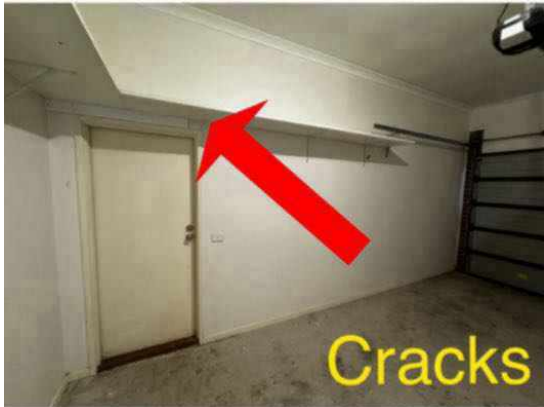
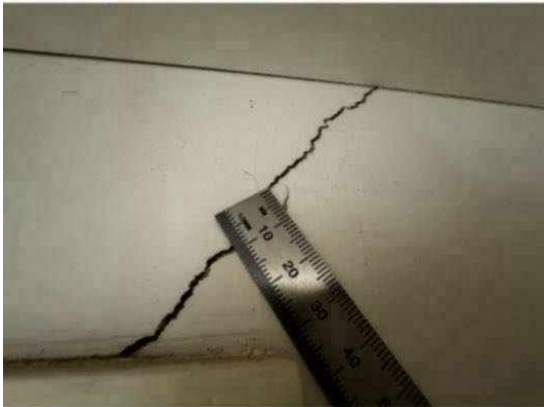
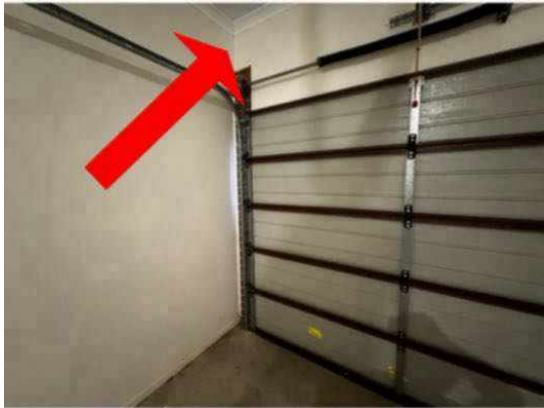
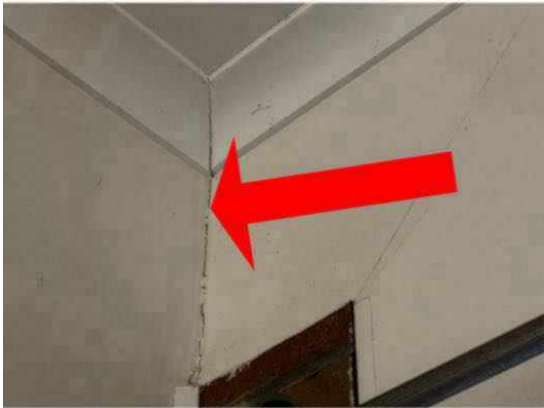
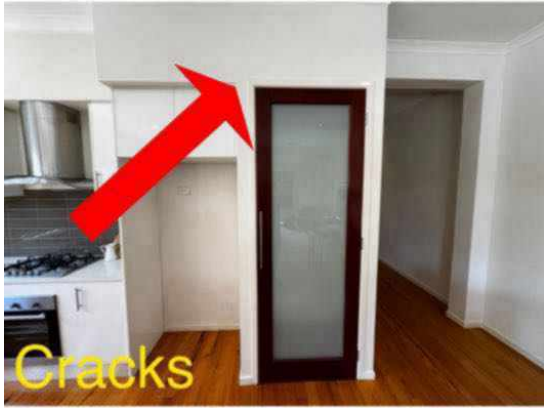
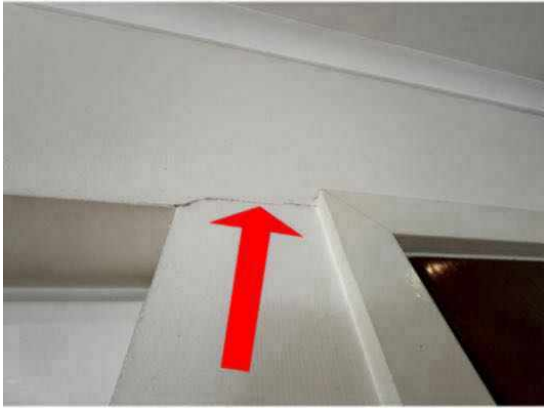
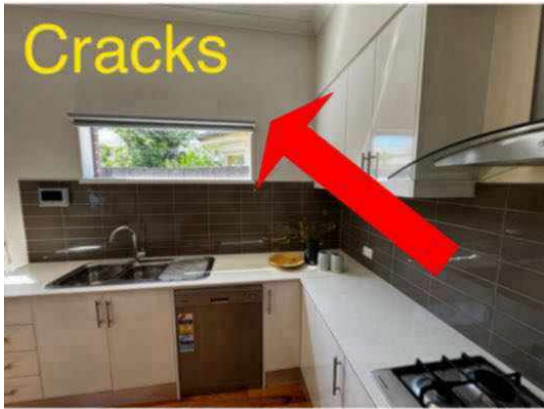
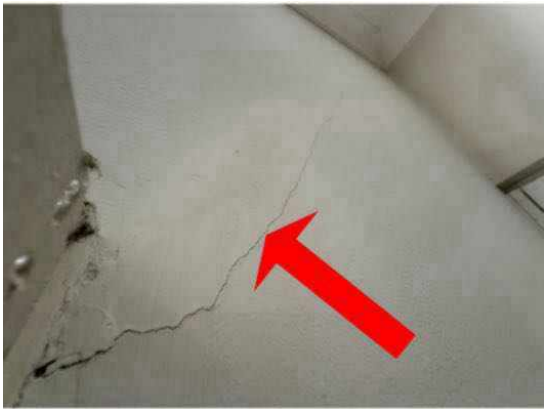
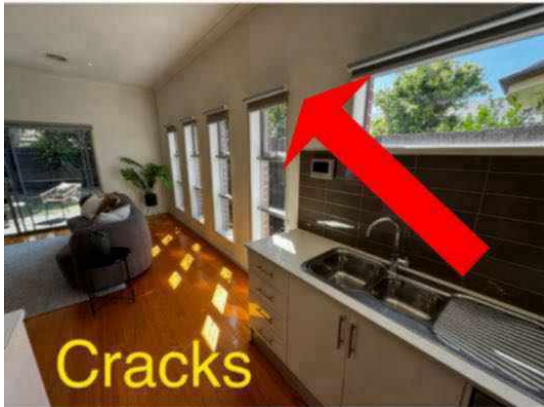
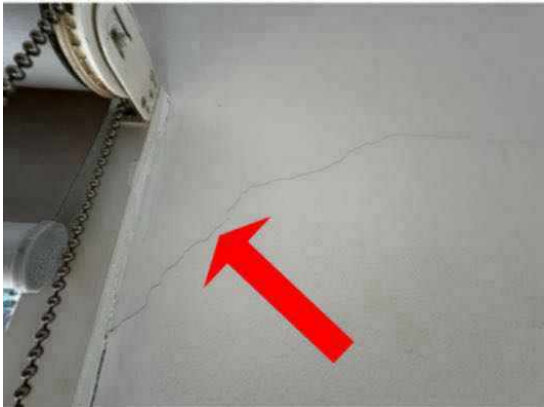
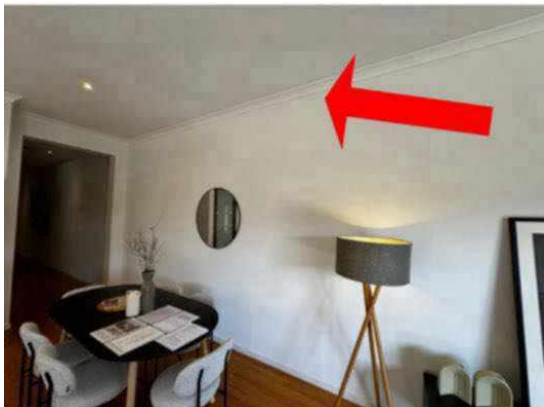
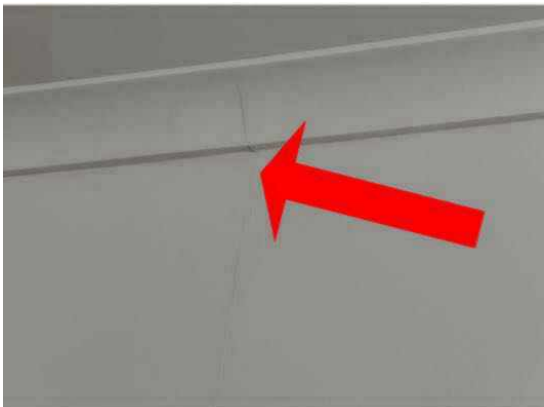
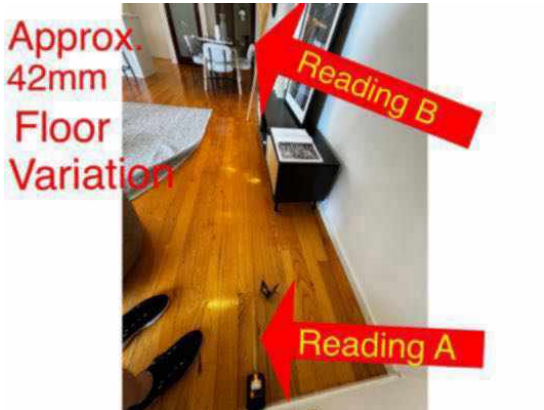
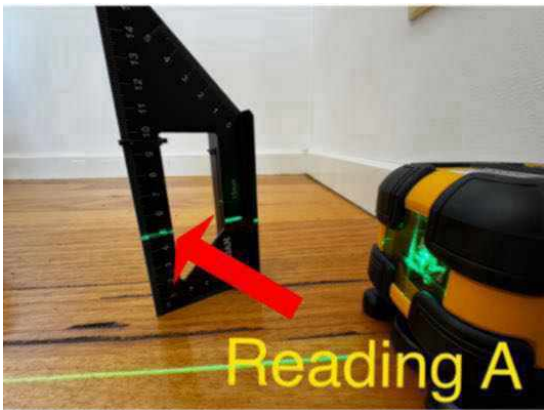
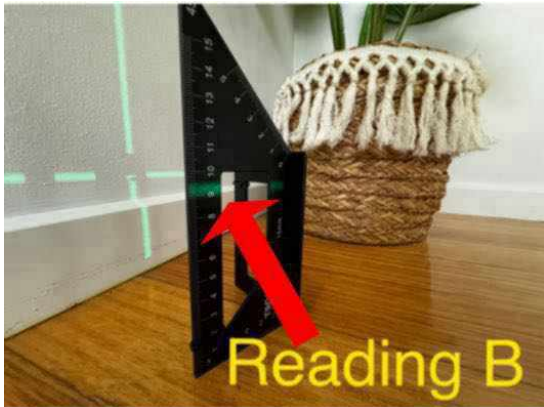
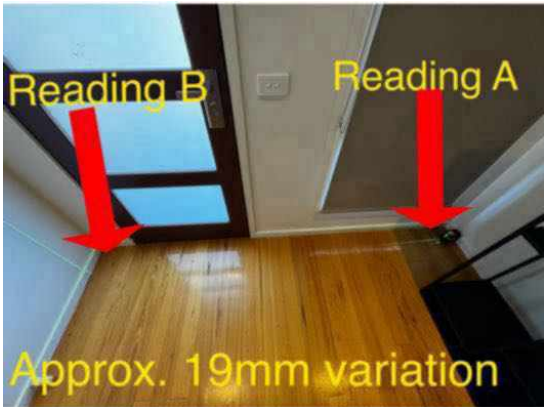
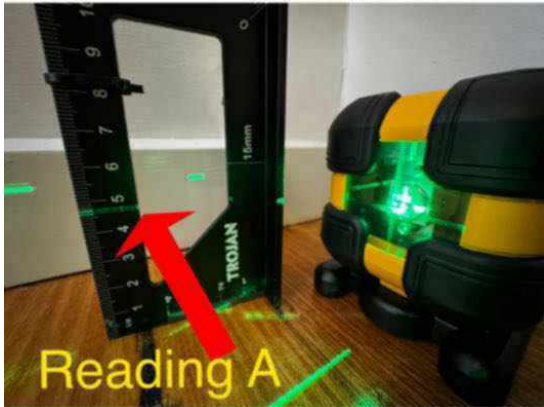
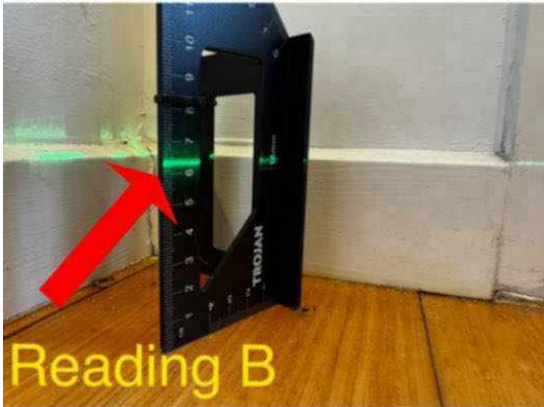
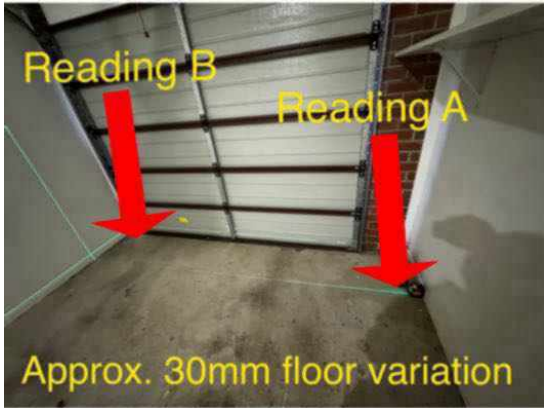
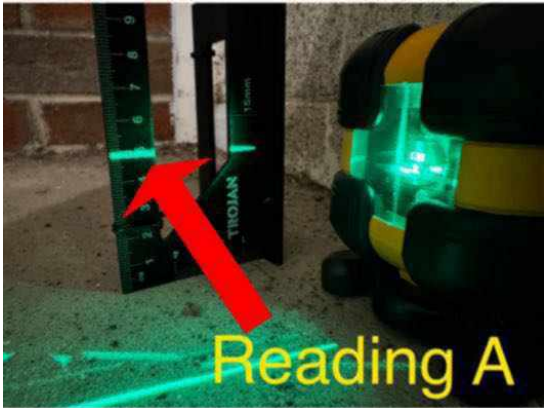
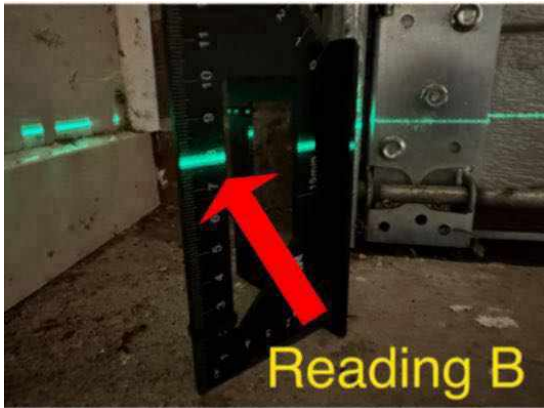
Building:	Main Building
Location:	Interior/Exterior Walls & Ceilingsd > All Areas
Finding:	Cracking and Floor Level Variation – Suspected Building Movement (Major Defect)
Information:	Cracking was observed to several internal and external areas of the building, including the front façade brickwork and rendering, the hallway ceiling, garage walls, kitchen walls, and the rear alfresco ceiling. The cracks were visible in both plaster finishes internally and masonry or rendered surfaces externally.

In addition to the cracking, floor level variations were detected in multiple areas of the building. Measurements were taken using a laser level and indicated notable variations across relatively short spans:

Further evidence of ground movement was observed externally, where a section of concrete paving to the right-hand side of the garage had sunk and was sloping toward the garage wall.

The combination of multiple cracking locations and significant floor level variations suggests the possibility of foundation movement or settlement affecting the building. In accordance with the defect classifications under AS 4349.1–2007 (Inspection of Buildings), defects that indicate possible structural movement affecting the serviceability of the building are classified as Major Defects.

It is recommended that the property be assessed by a qualified structural engineer to determine the cause and extent of the building movement and to provide appropriate rectification recommendations. Further investigation may include assessment of

foundation conditions, site drainage, soil conditions and structural elements of the building.

Immediate – Engineering assessment is recommended as soon as practicable to determine the cause of the movement and prevent potential progression of structural damage.

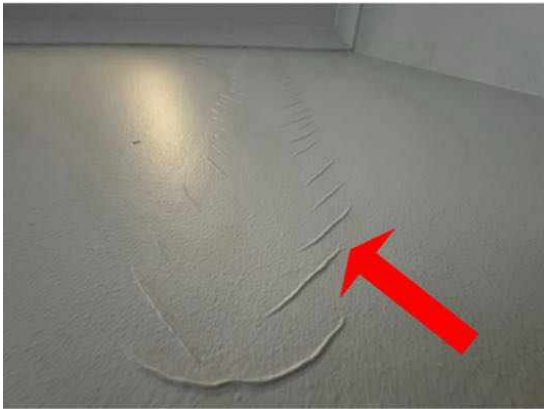
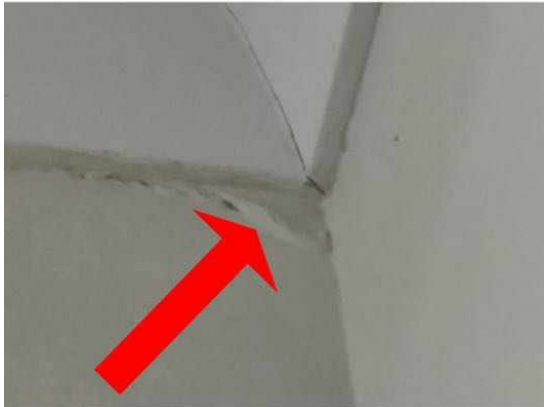
Building: Main Building  
Location: Main entry & Wet areas > All Areas  
Finding: Suspected Moisture Damage and Elevated Moisture Readings (Major Defect)  
Information: Suspected moisture damage was observed to the entry wall on the party wall side of the building. The plaster surface in this area showed visible swelling and rippling, which is typically consistent with historical moisture exposure. Moisture testing using a moisture meter was undertaken during the inspection; however, no elevated moisture readings were detected at the time of inspection in this particular wall area.

Suspected moisture damage

Immediate – Investigation and rectification are recommended as soon as practicable to prevent further moisture-related deterioration of building elements.

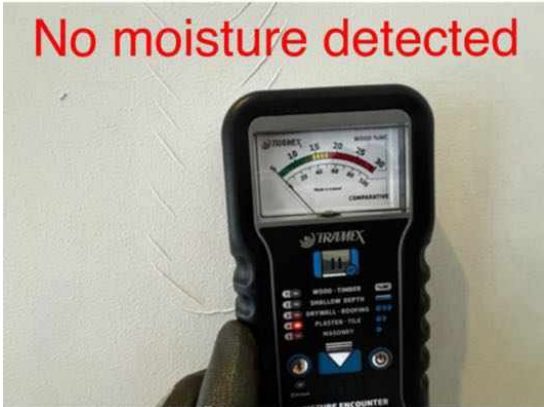
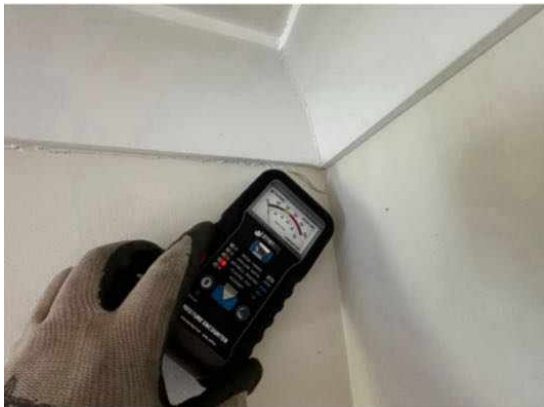
No moisture detected

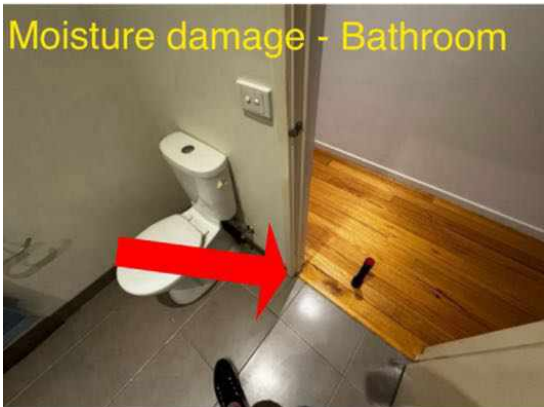
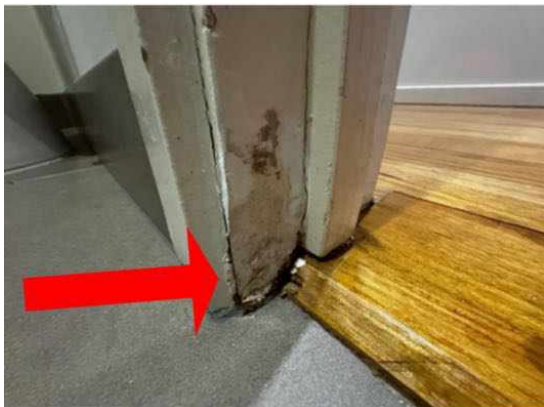
Moisture damage - Bathroom

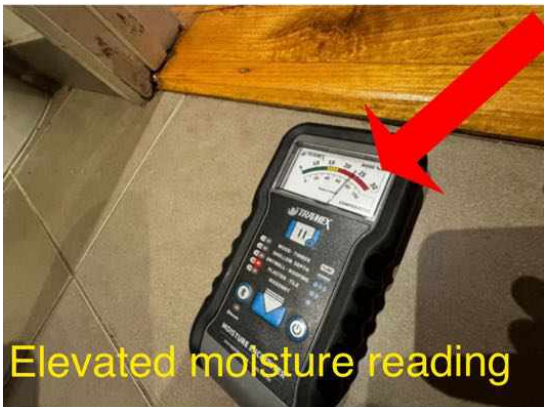
Elevated moisture reading

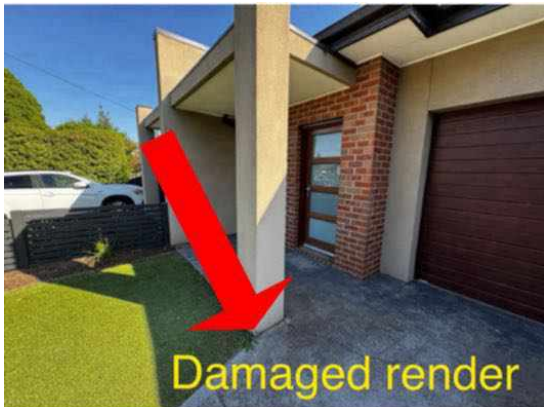
A small area of damage was observed to the rendered column on the front porch, likely caused by minor impact or wear and tear.

Damaged render

It is recommended that the damaged fencing, cracked paving and rendered column be repaired as part of routine maintenance. The rear decking should be inspected and repaired if necessary to ensure adequate structural support. The sagging porch ceiling lining should also be repaired or replaced.

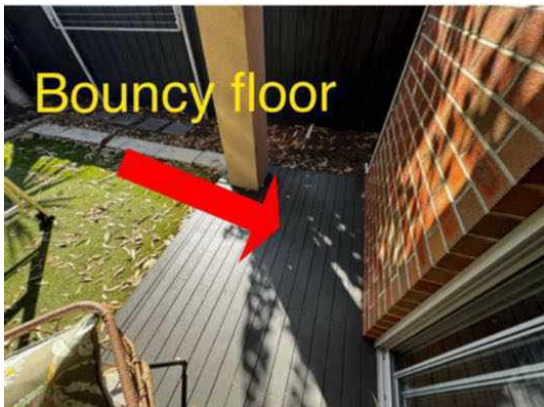
The rear timber decking was observed to feel bouncy underfoot, suggesting possible deterioration, inadequate support or movement within the substructure. Further investigation may be required to determine the exact cause.

Bouncy floor

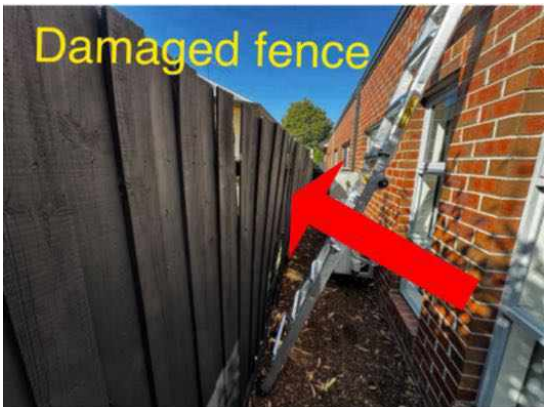
Building: Main Building  
 Location: All Areas > All Areas  
 Finding: External Building Defects  
 Information: Several external defects were observed during the inspection. Timber fencing to the front and rear yards was found to be damaged in several sections, which may require repair or replacement to restore stability and privacy.

Damaged fence

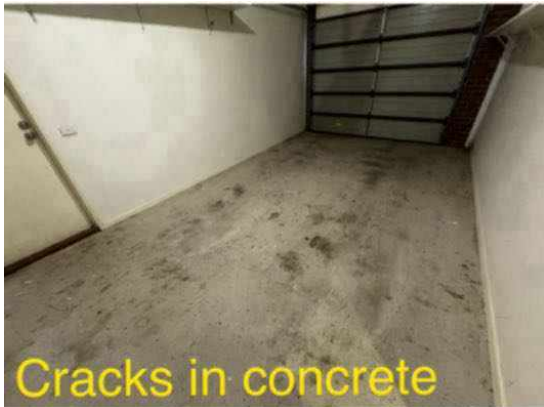
Cracks were observed in the garage concrete floor, however these cracks measured less than 5 mm in width and are consistent with typical minor shrinkage or settlement cracking commonly seen in concrete slabs.

Cracks in concrete

It is recommended that the affected items be repaired or maintained as required, including replacing or repairing the shower heads, rectifying the cooktop igniter and rangehood lighting, sealing benchtop joins, and addressing minor plaster damage and cosmetic defects as part of routine maintenance.

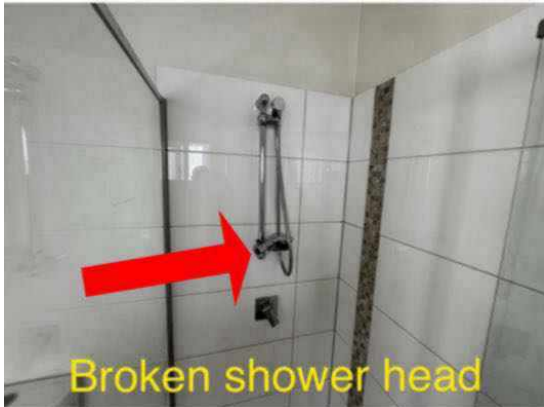
A broken shower head was observed in the ensuite, and the shower head in the main bathroom was leaking during operation, which may lead to unnecessary water wastage and should be repaired or replaced.

Broken shower head

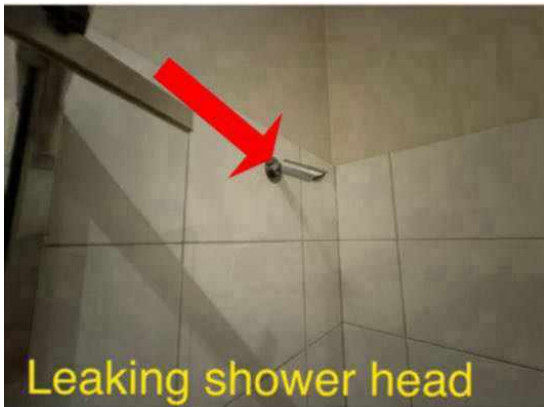
Leaking shower head

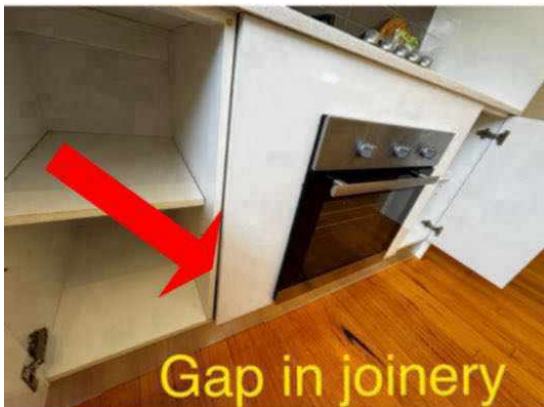
In the kitchen area, a visible gap was observed around the oven provision within the joinery, indicating that the joinery may not have been fitted tightly around the appliance space. A visible gap was also observed at the benchtop join, which may allow moisture or debris to accumulate if not properly sealed.

Gap in joinery

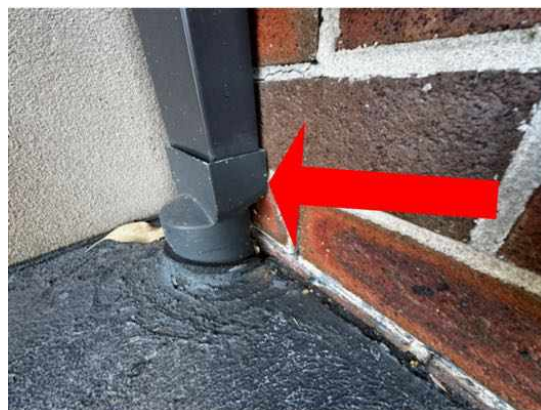
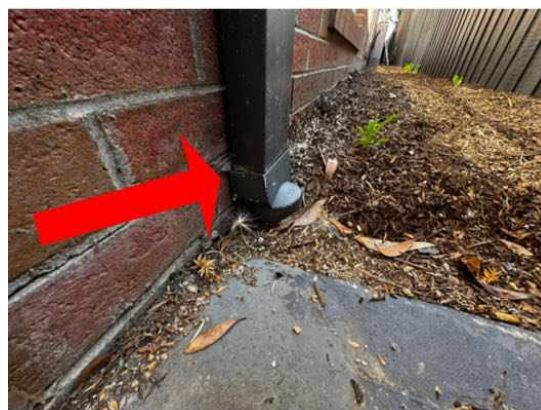
Building:	Main Building
Location:	Walls > All Areas
Finding:	Downpipes hard against brickwork concealing inspection zones (TP)
Information:	At the time of inspection, several downpipes were observed to be installed hard against the external brick walls. This configuration restricts visual access to the wall surface and slab edge behind the downpipes, making it difficult to identify early signs of termite activity.

Effective termite risk management relies on maintaining clear and accessible inspection zones to allow early detection of termite activity. Where services such as downpipes are installed directly against masonry walls, concealed termite entry paths may develop behind these elements without being readily visible, increasing the likelihood of undetected termite ingress.

As a result, the positioning of downpipes hard against the brickwork is considered to increase the risk of concealed termite entry. It is recommended that a licensed termite management or pest control contractor be engaged to assess these locations and provide advice on improving inspection access or implementing supplementary termite management measures to address the increased risk.

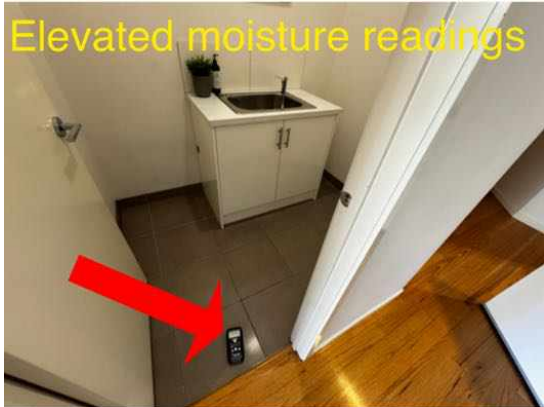
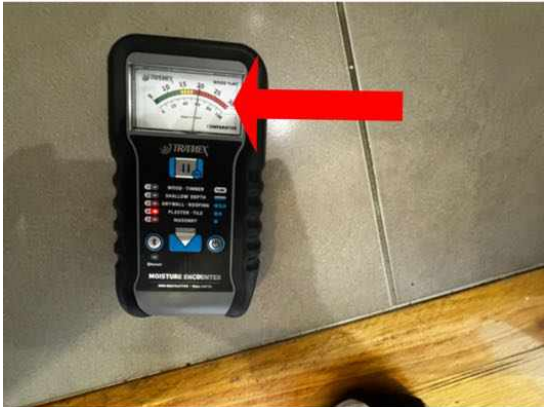
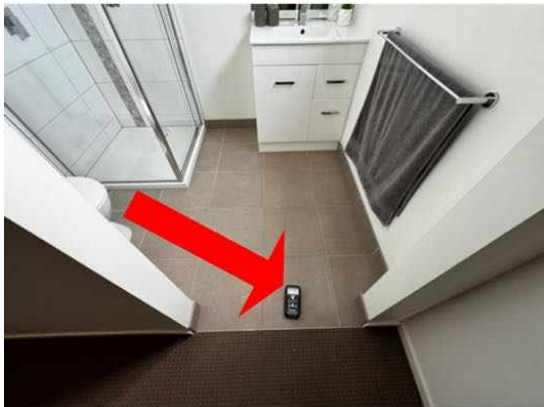
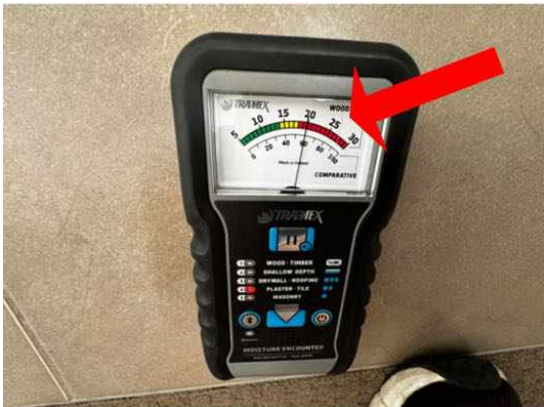
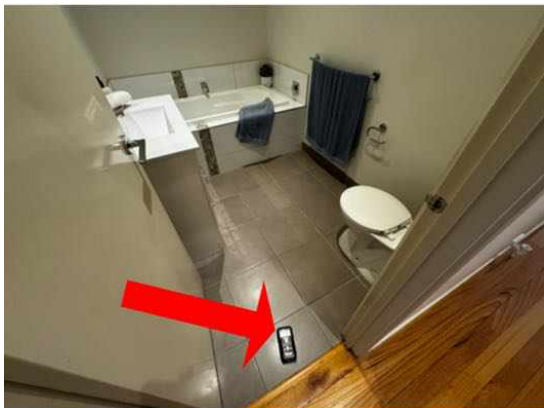
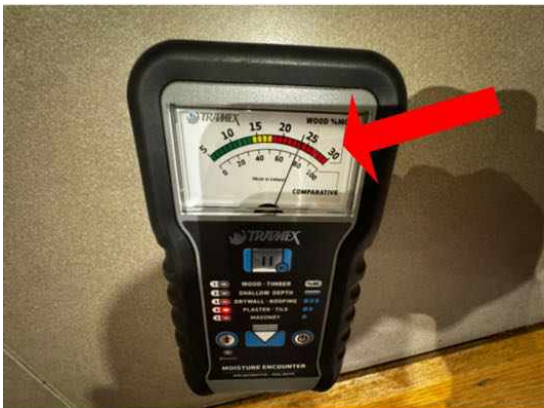
Building:	Main Building
Location:	Bathroom, ensuite, laundry > Ground Level
Finding:	Elevated moisture levels to bathroom, laundry & ensuite floor tiles (TP)
Information:	At the time of inspection, elevated moisture readings were detected using a moisture meter in the bathroom, laundry and the ensuite floor tiles. No active water leaks were observed during the inspection. Moisture readings in adjoining rooms were normal. It appears that the moisture is contained to these tiled areas only. Moisture damage was found to the door jamb and architrave in the bathroom. It is suspected that the moisture may be from conditions such as spills, or historic overflows or leakages from appliances or plumbing fixtures.

In accordance with AS 3660.2, wet areas and plumbing-related moisture issues are recognised as increasing termite risk, as persistent dampness within building elements can create conditions conducive to termite activity and concealed access. Ongoing moisture exposure may also lead to deterioration of surrounding materials, further elevating termite susceptibility.

Elevated moisture readings

As a result, the moisture issues identified within these areas are considered to increase the risk of termite activity and material deterioration. It is recommended that these areas are periodically monitored for ongoing moisture issues. Assessment is recommended by a licensed termite management or pest control contractor where elevated termite risk is identified.

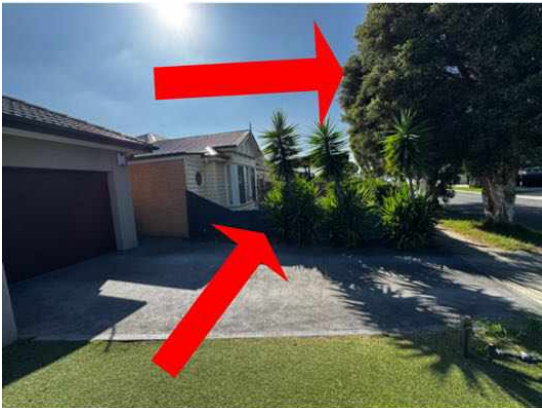
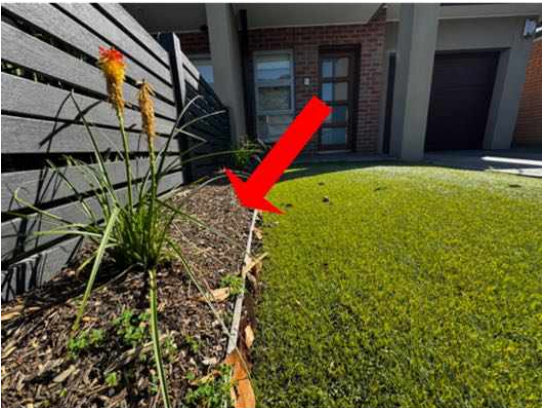
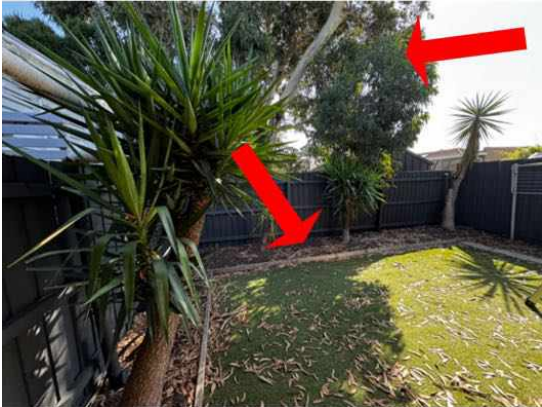
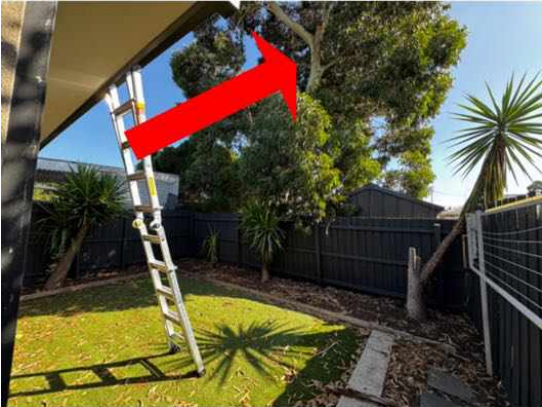
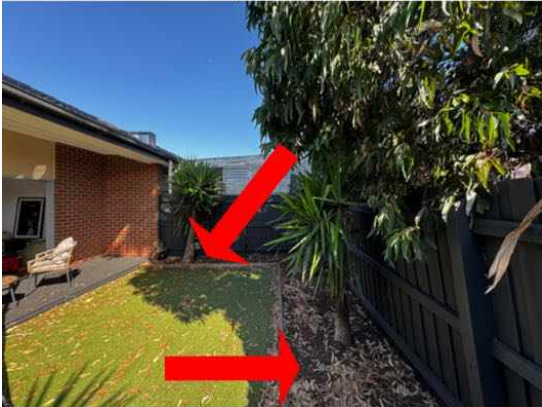
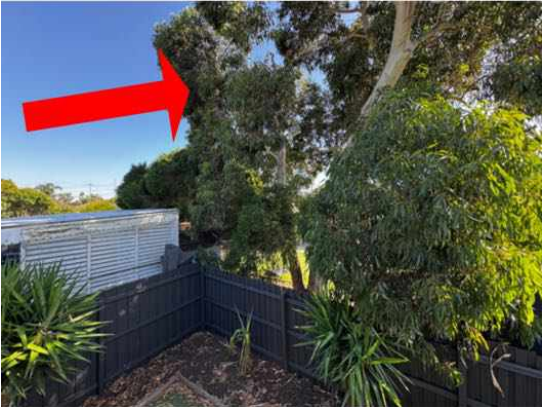
or support termite foraging activity are recognised as increasing termite risk to existing buildings. Mature trees, mulched garden beds, irrigation systems can all maintain damp soil conditions and may harbour termite colonies, allowing concealed termite activity to develop and potentially extend toward the building without early detection.

As a result, the extent of vegetation and moisture-retaining landscaping is considered to significantly increase the overall risk of termite activity to the property. It is recommended that a licensed termite management or pest control contractor be engaged to assess the site conditions and provide advice on appropriate risk reduction measures, which may include managing vegetation and mulch, controlling moisture sources, and integrating suitable termite management strategies appropriate for the existing building and site conditions.

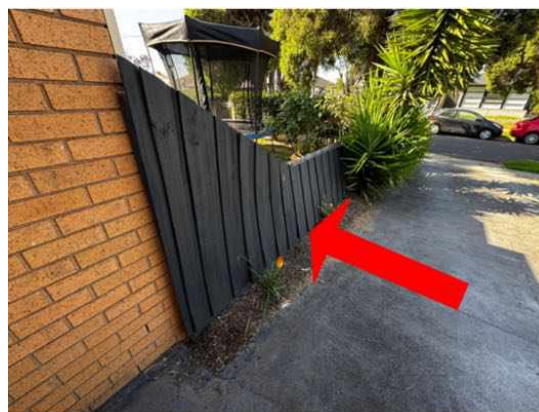
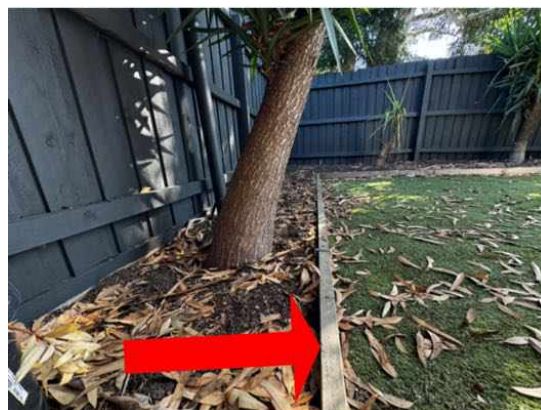
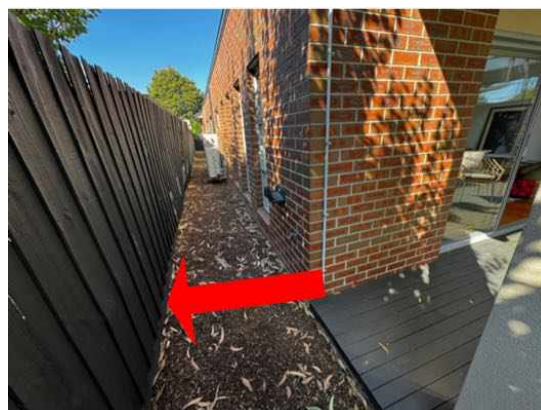
## Finding 6.04

Building:	Main Building
Location:	All Areas > All Areas
Finding:	Inground timber contact (TP)
Information:	At the time of inspection, in-ground timber contact was observed to the front, side and rear yards, including timber garden edging, fence posts and timber decking all in direct contact with the ground. These timber elements are positioned within the soil zone and in close proximity to the building and associated structures.

In accordance with AS 3660.2, conditions that facilitate termite access or provide a direct food source are recognised as increasing the risk of termite activity to existing buildings. Timber elements in direct contact with the ground are particularly vulnerable, as they can attract subterranean termites and support concealed foraging activity, potentially allowing termite colonies to establish and migrate toward nearby structures without early detection.

As a result, the presence of in-ground timber elements is considered to increase the risk of termite activity to the property. It is recommended that a licensed termite management or pest control contractor be engaged to assess these conditions and provide advice on appropriate risk mitigation measures, which may include removal or replacement of timber elements with non-susceptible materials, isolation of timber from soil contact, and integration of suitable termite management measures to suit the existing site conditions.

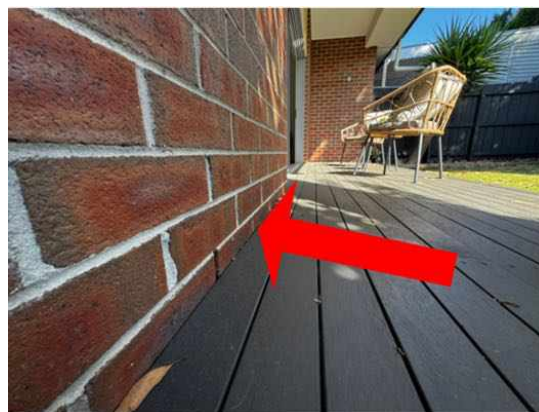
### Finding 6.05

Building:	Main Building
Location:	All Areas > All Areas
Finding:	Slab edge - concealed (TP)
Information:	At the time of inspection, the slab edge to most areas of the building was observed to be concealed behind concrete paving, landscaping and timber decking. This condition restricts clear visibility of the slab perimeter and limits the ability to visually inspect critical inspection zones intended for the early detection of termite activity.

Where slab edges and inspection zones are concealed, concealed termite entry paths may develop without early warning. In accordance with AS 3660.2, existing buildings are required to maintain conditions that allow for effective inspection and management of termite risk, noting that obstructions such as paving, paths, or landscaping can compromise the effectiveness of termite management measures. Where inspection zones are obstructed, the likelihood of undetected termite activity is increased.

As a result, the current configuration is considered to increase the risk of concealed termite entry to the building. It is recommended that a licensed termite management or pest control contractor be engaged to assess the extent of the concealed slab edges and provide advice on rectification options, which may include modifying paving or landscaping to reinstate suitable inspection access and integrating appropriate termite management measures to suit the existing conditions.

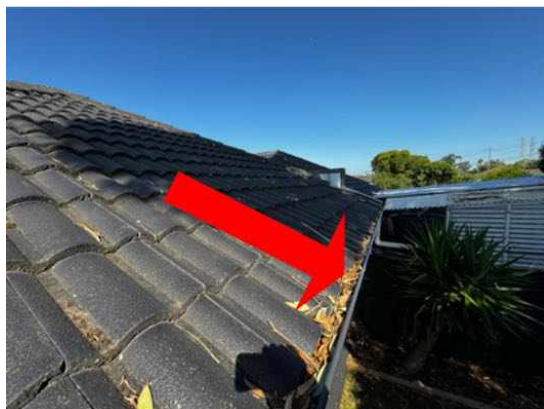
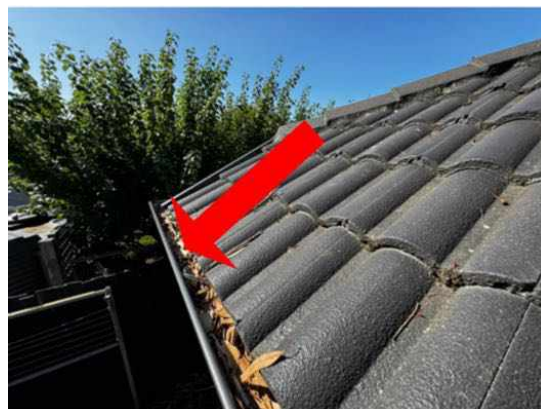
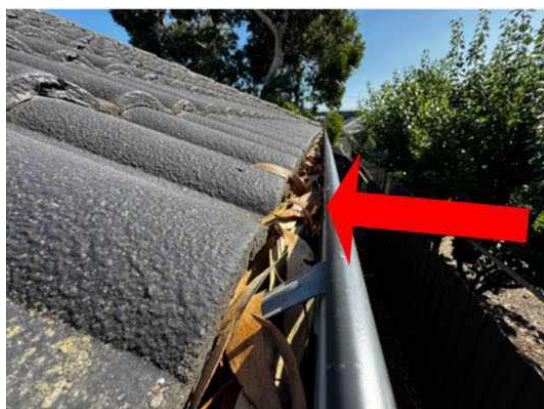
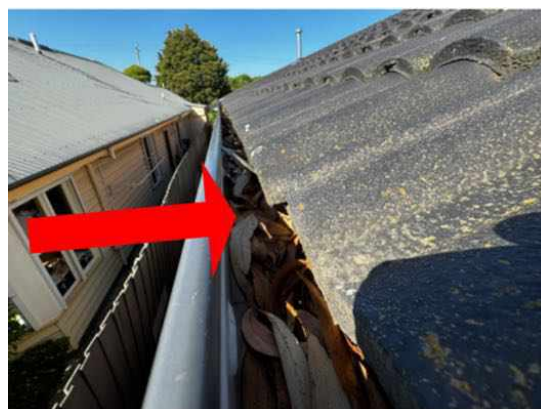
### Finding 6.06

Building:	Main Building
Location:	Roof Exterior > Rear,Rear Right,Centre Right
Finding:	Blocked gutters (TP)
Information:	At the time of inspection, organic debris was observed to the roof areas with partially blocked gutters and downpipes. These conditions promote prolonged moisture retention and reduced effectiveness of roof drainage, the issue is suspected to be associated with a lack of routine maintenance.

In accordance with AS 3660.2, conditions that promote ongoing dampness, moisture accumulation, or inadequate drainage are recognised as increasing termite risk to existing buildings, as elevated moisture levels can create environments conducive to termite foraging and concealed activity. Blocked gutters and downpipes may allow water to overflow or discharge against building elements, increasing moisture exposure to adjacent materials and reducing the effectiveness of termite risk management through visual inspection.

As a result, the observed organic debris and drainage issues are considered to increase moisture-related deterioration and elevate the overall risk of termite activity. It is recommended that an appropriately qualified roof plumber be engaged to clean and service the gutters and downpipes and that roof surfaces be maintained to reduce moisture retention, with ongoing monitoring and advice from a licensed termite

management or pest control contractor where elevated termite risk is identified.

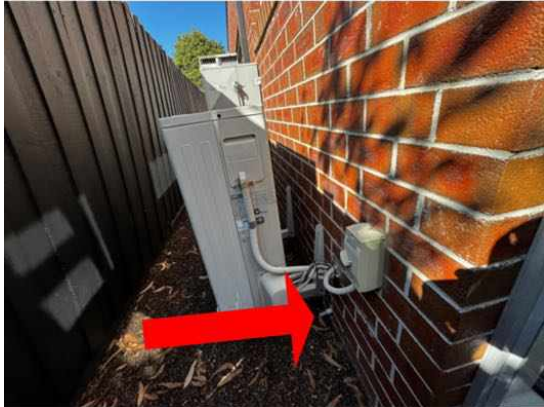
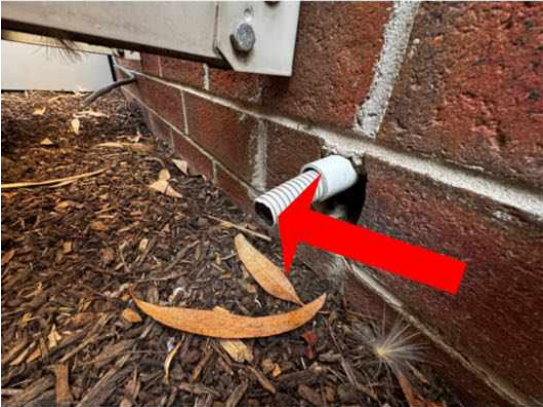
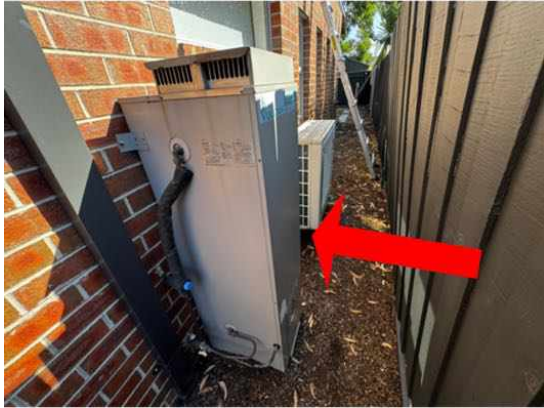
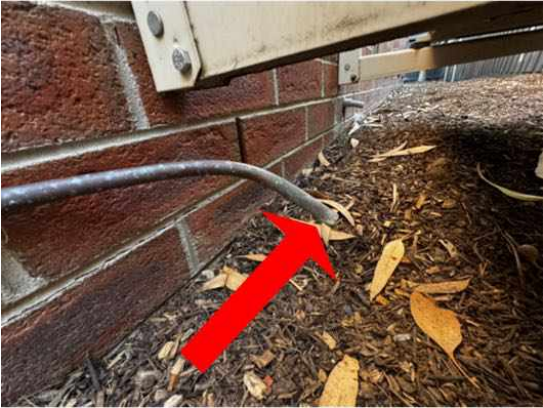
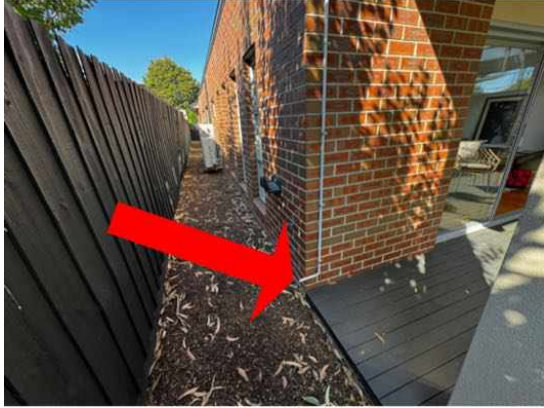
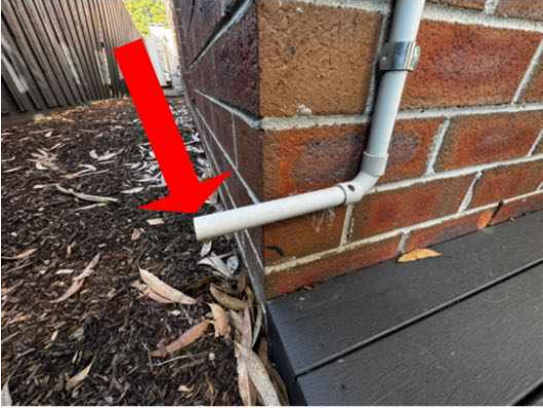
### Finding 6.07

Building:	Main Building
Location:	Walls > Centre Right,Rear Right
Finding:	Uncontrolled discharge from air conditioner and hot water unit (TP)
Information:	At the time of inspection, the air conditioner and hot water unit located to the side of the building was observed to have an overflow pipe discharging directly onto the ground, rather than being connected to a suitable drainage system. This condition allows ongoing moisture to accumulate at the base of the building and surrounding soil.

Conditions that promote persistent dampness or poor drainage around a building are recognised as conducive to termite activity, as elevated moisture levels can attract subterranean termites and support concealed foraging activity. Uncontrolled discharge from hot water system overflows may therefore increase moisture-related deterioration and termite risk.

As a result, the discharge from the air conditioner and hot water unit overflows is considered to contribute to conditions conducive to termite activity. It is recommended that a licensed plumber be engaged to connect the overflow pipe to an appropriate drainage point, ensuring that water is not discharged directly onto the

ground adjacent to the building, with further advice from a licensed termite management or pest control contractor where elevated termite risk is identified.
