# Building and Timber Pest Inspection Report

Inspection Date: Tue, 10 Mar 2026

Property Address: 140 Victory Rd, Airport West VIC 3042, Australia

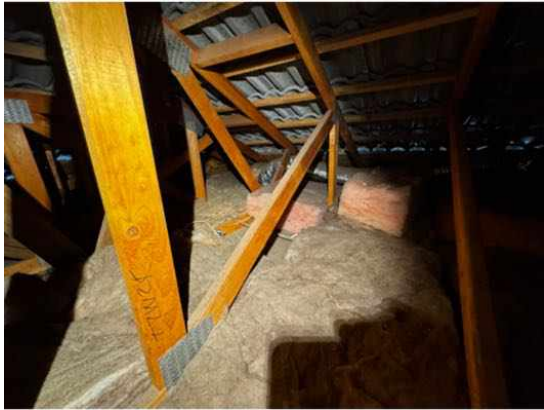
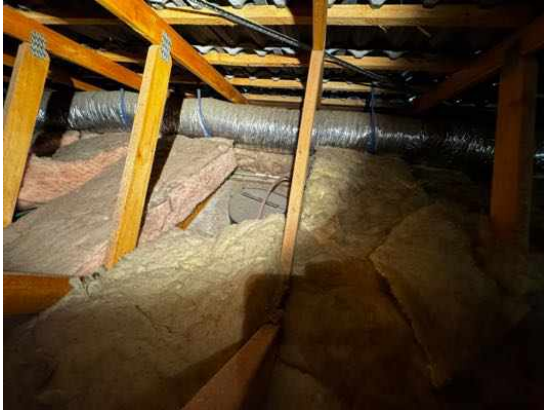
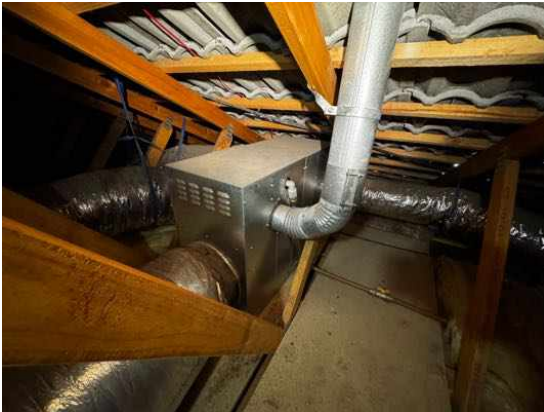
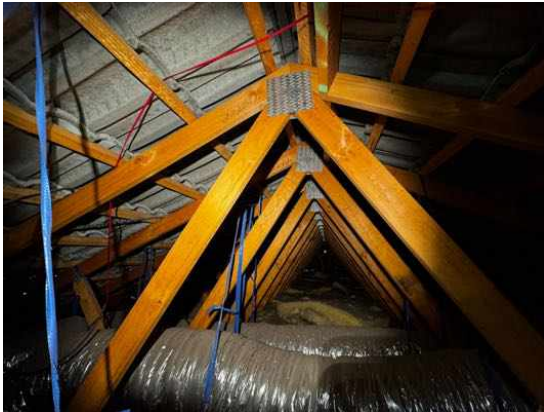
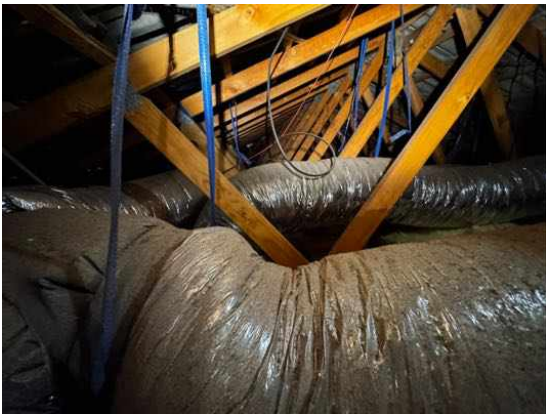
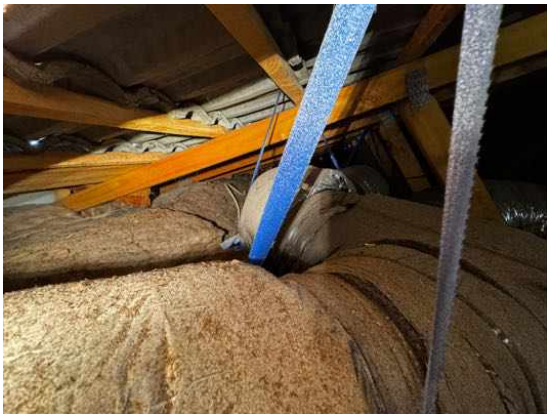
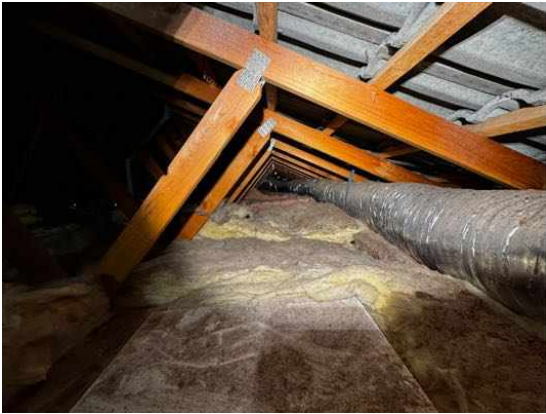
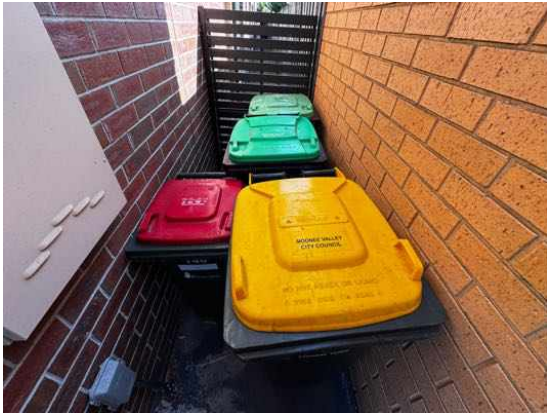
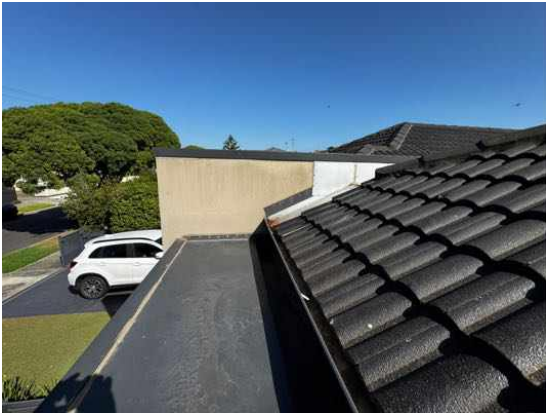
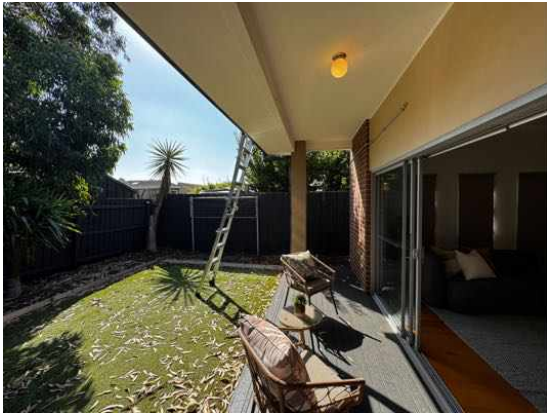
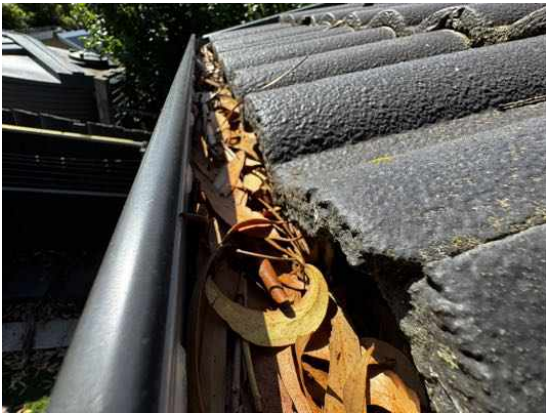
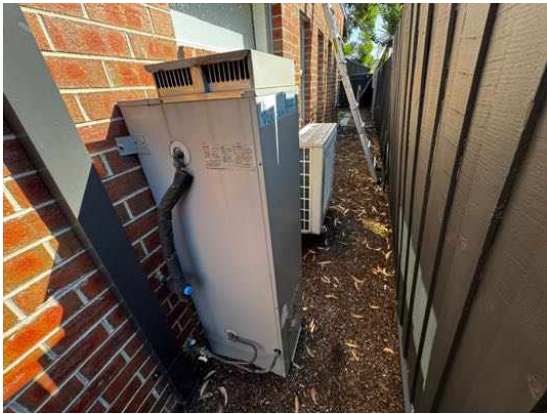
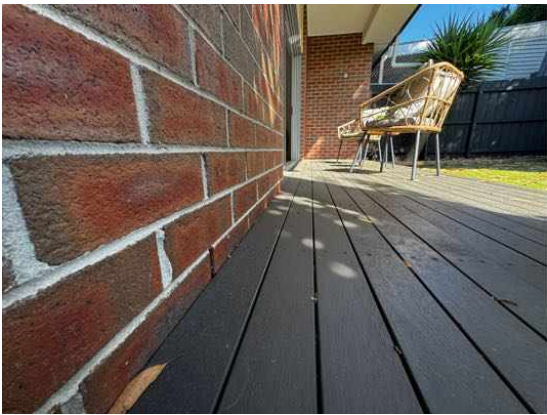
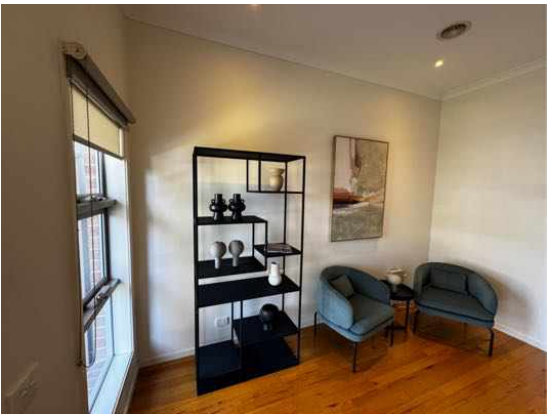
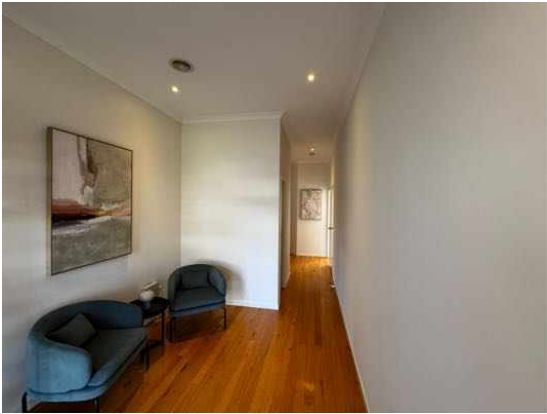
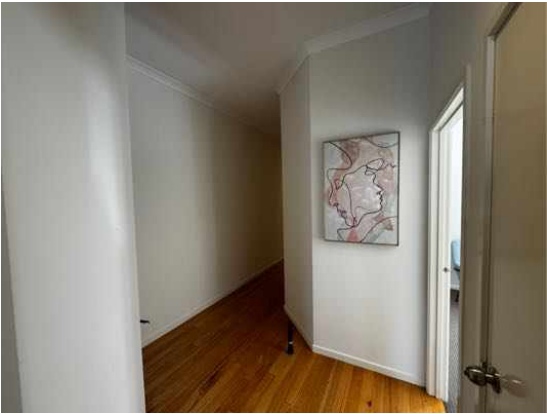
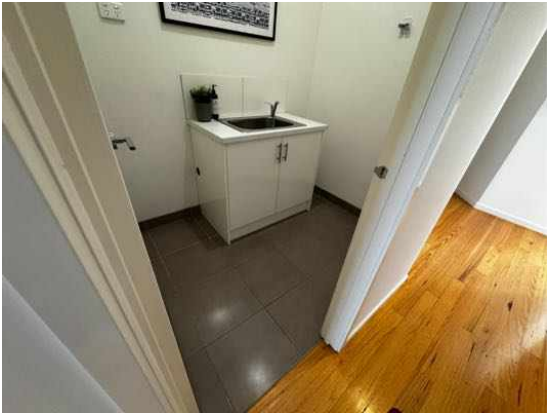
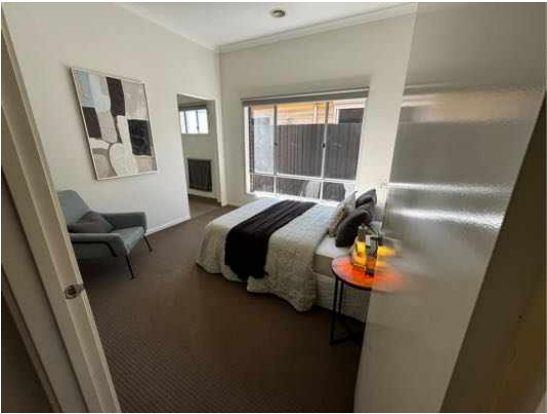
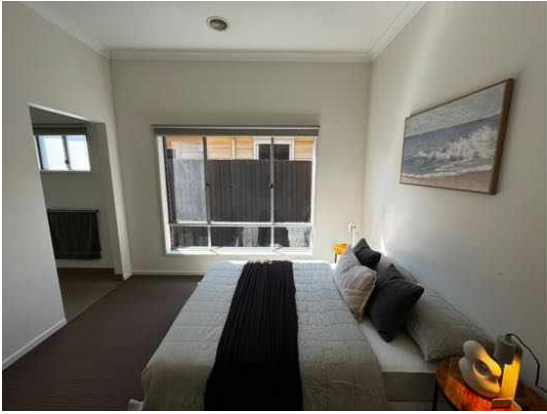
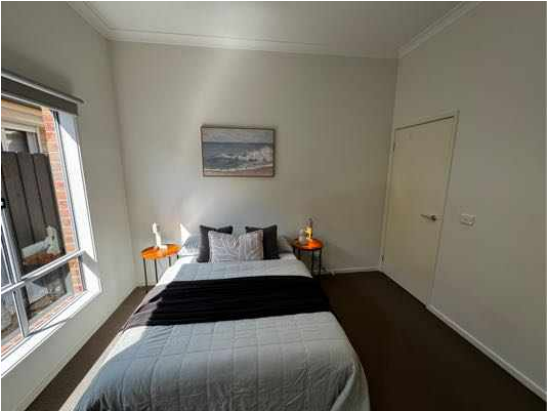
#### Noted Item

Building: Main Building  
Location: All Areas > All Areas  
Finding: Additional Photos - Obstructions and Limitations  
Information: These photographs are an indication of the obstructions and limitations which impeded full inspection of the property at the time of inspection. These obstructions can hide an array of defects and should be removed to allow full inspection to be carried out. A re-inspection is recommended once the areas are made accessible.

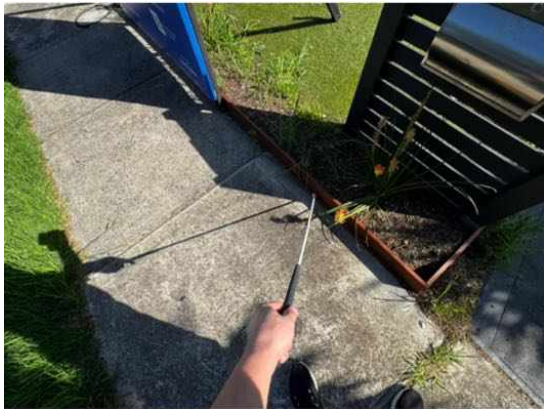
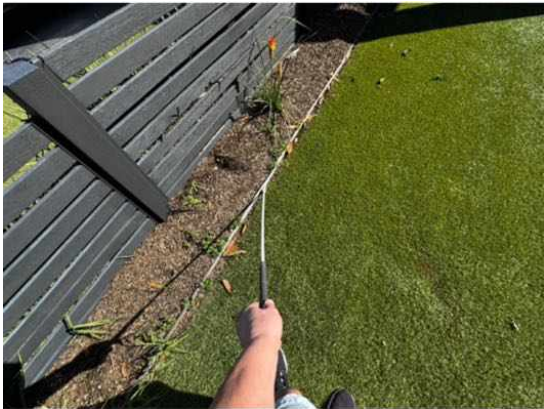
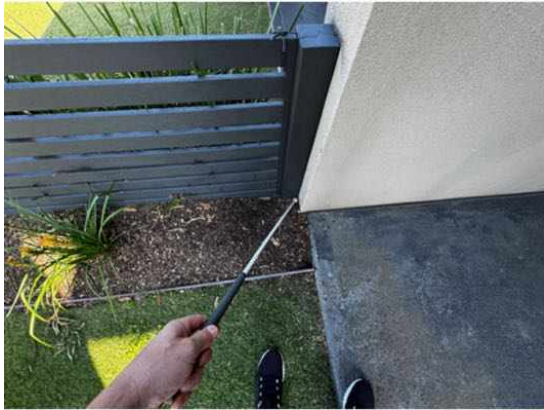
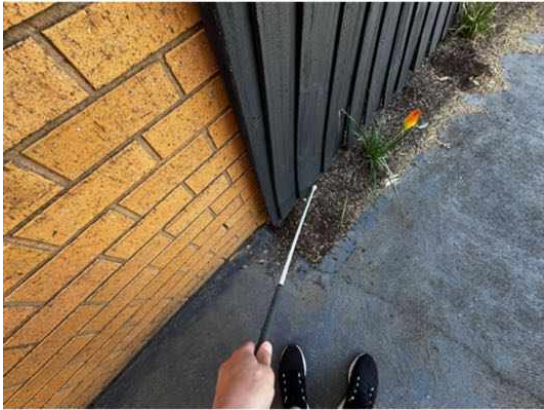
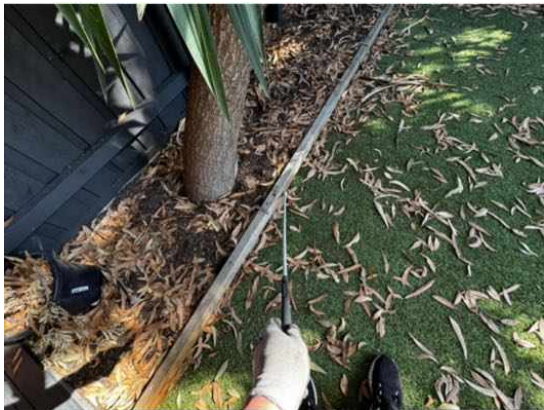
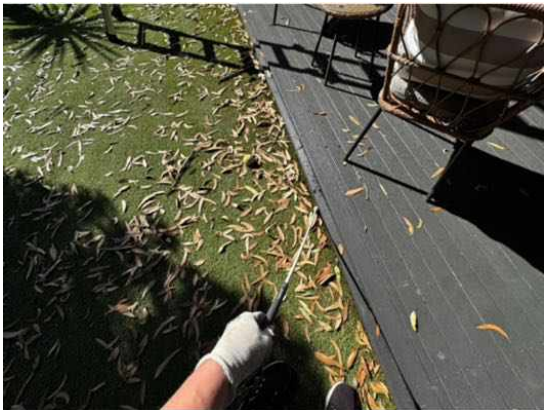
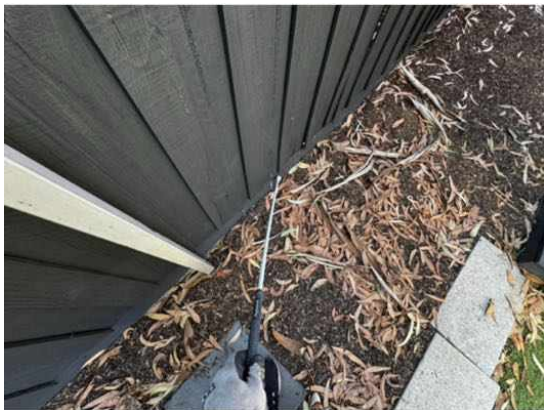
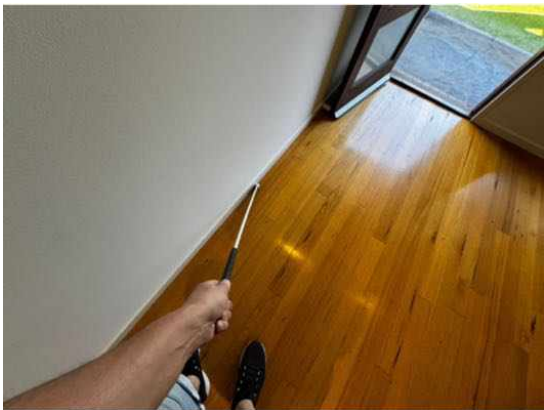
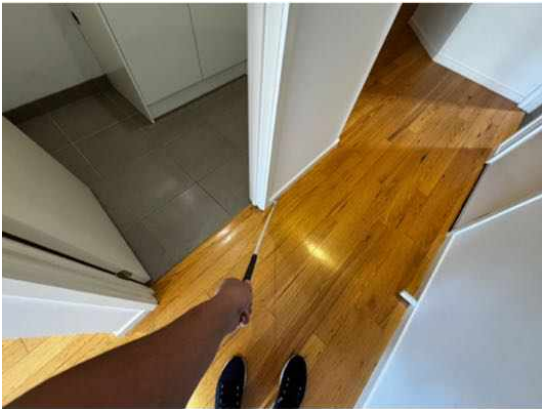
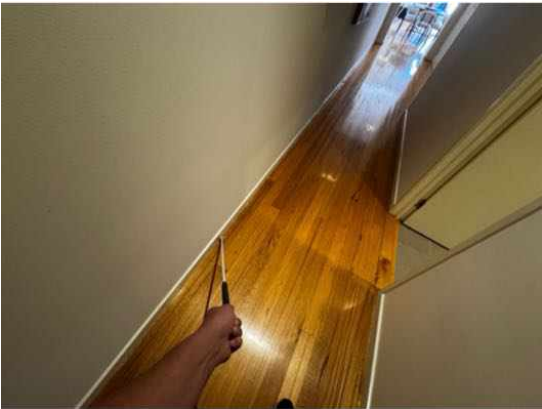
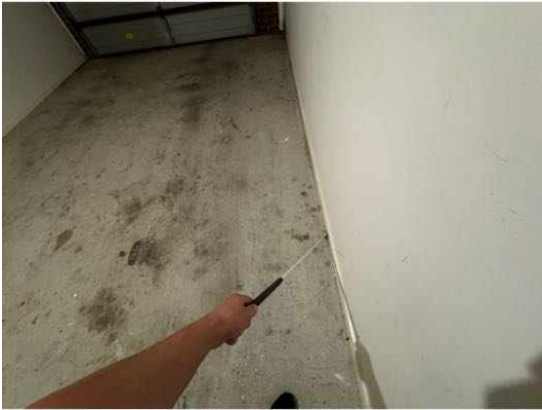
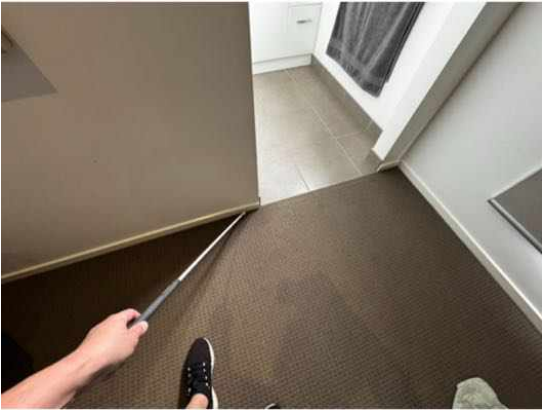
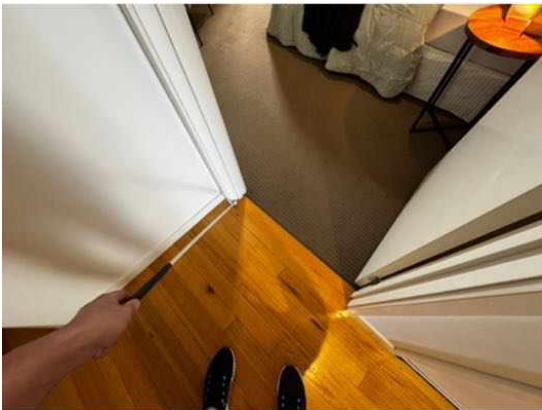
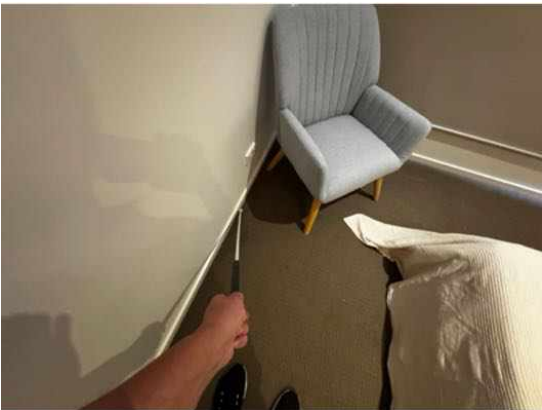
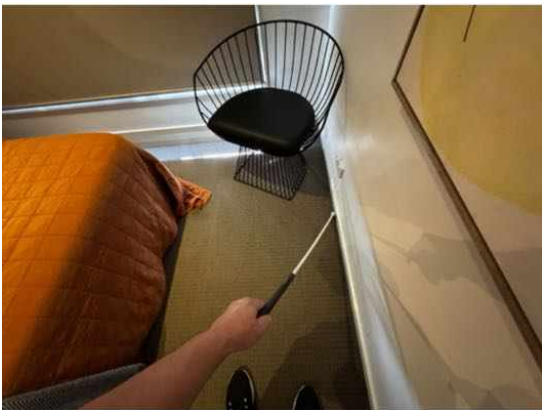
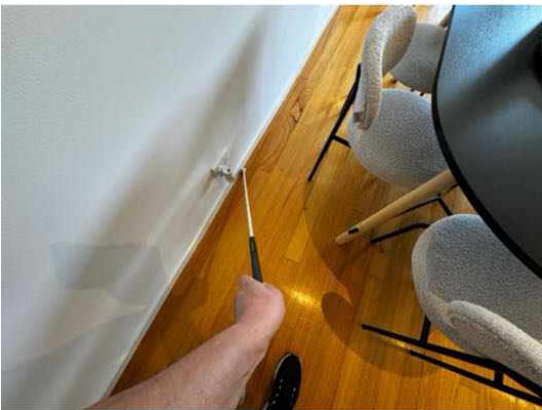
Building:	Main Building
Location:	All Areas > All Areas
Finding:	Termite investigation techniques (TP)
Information:	All accessible areas of the dwelling were inspected, with particular attention paid to wet areas, which were closely assessed for elevated moisture levels and temperature anomalies that may indicate conditions conducive to termite activity.

In an attempt to identify concealed or hidden timber pest activity, a range of inspection techniques were adopted. These included the use of a moisture meter to assess susceptible areas, sounding of timber elements using a handheld probing device, and visual assessment of materials for signs commonly associated with termite activity. These signs include moisture-related deterioration, deformation of timber, termite mud leads or bridging, and irregular or regular shaped holes within timber elements that may indicate pest-related damage.

It is noted that termite activity can generate increased moisture and localized temperature variations, and where such irregularities are detected, further investigation may be warranted. However, it is also acknowledged that certain obstructions, including floor coverings, wall linings, wall tiles, and fixed cabinetry such as bathroom fit-offs, can conceal termite activity and limit the effectiveness of visual inspection. As a result, the absence of visible evidence at the time of inspection does not eliminate the possibility of concealed termite activity within inaccessible or obstructed areas of the building.
