Building and Timber Pest Inspection Report

Inspection Date: Tue, 3 Mar 2026

Property Address: 6/143 Regent St, Redfern NSW 2016,
Australia

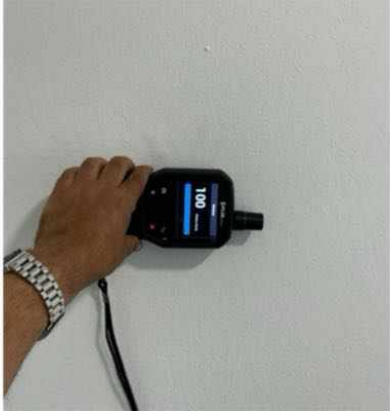
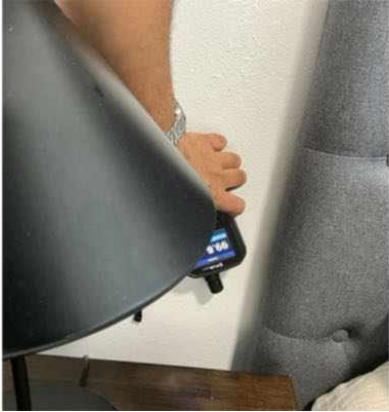
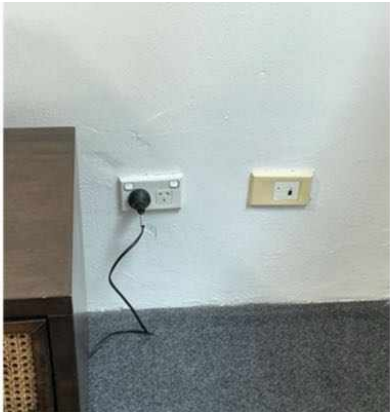
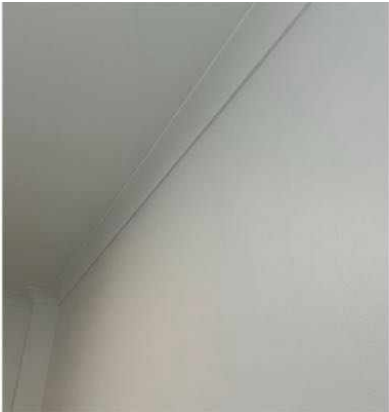
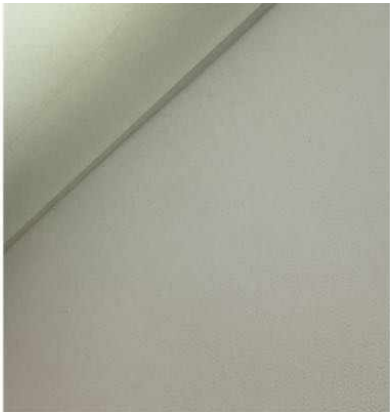
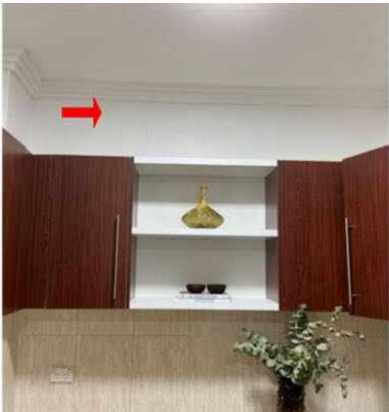
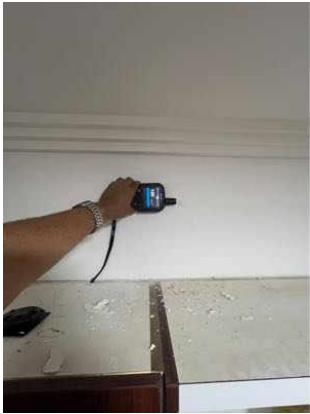
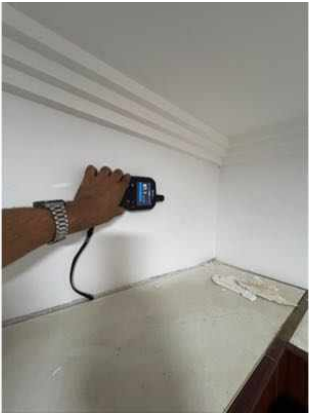
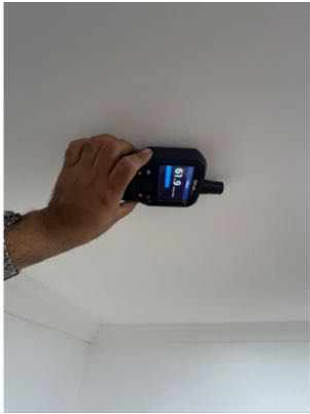
Building:	Main Building
Location:	All Internal Areas - left (Kitchen, bedroom, balcony)
Finding:	Damp
Information:	Damp (or structural damp) refers to the presence of unwanted moisture in the structure of a building, either as the result of intrusion from outside, or condensation from within the structure. Generally, structural damp is caused by rain penetration, rising damp, and leaks from plumbing pipes.

Unmanaged damp facilitates the formation and development of mould, fungi growth and wood rot, decaying associated building materials and compromising their structural integrity. Damage to finishes is also likely to occur, including lifting, bubbling, peeling and staining of paint, plaster and wallpaper.

The first step in addressing damp is to diagnose the cause. The identified cause should be addressed first prior to repairing the appearance and other defects which have resulted from the rising damp. If the original cause is not resolved, further cases of damp are likely to ensue, resulting in secondary defects.

Consultation with a strata appointed qualified plumber is advised immediately to identify the cause of damp and perform remedial works as required. Where excessive mould growth is present, further inspection by a specialist environmental health inspector should also be considered.

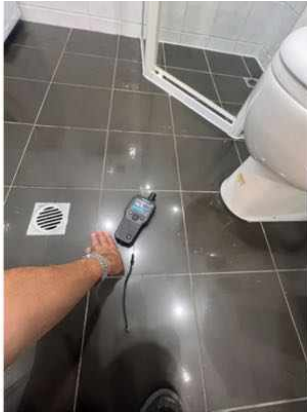
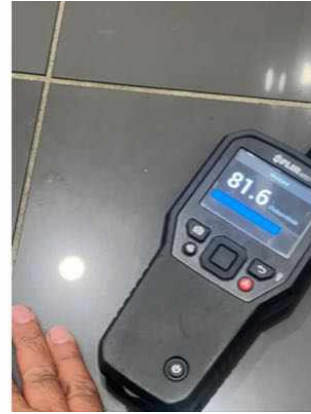
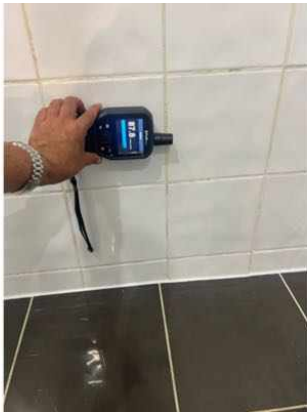
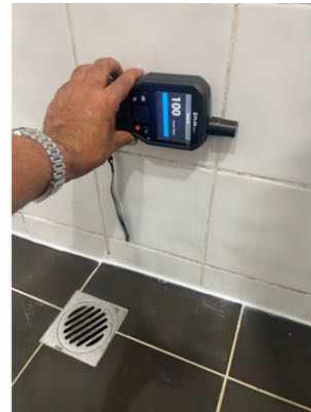
Finding 2.02

Building: Main Building
 Location: Bathroom
 Finding: Elevated Moisture Bathroom & Back of shower (Further investigation required)
 Information: Elevated moisture levels were detected to tiled surfaces in bathroom/shower areas. This may be due to porous or missing grout, cracked tiles or recent use, however the possibility of waterproofing membrane failure or plumbing leaks cannot be excluded. Persistent moisture ingress can lead to concealed damage, including timber rot and mould growth. Further investigation by a licensed plumber and/or waterproofing contractor is recommended as soon as possible. The back of shower area also showed elevated moisture with visible deterioration and/or repair was evident at the

time of inspection.

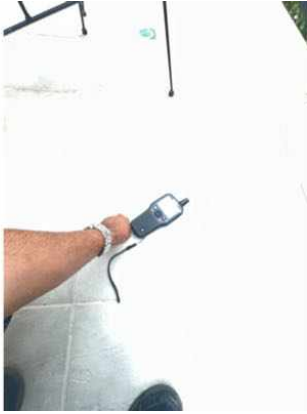
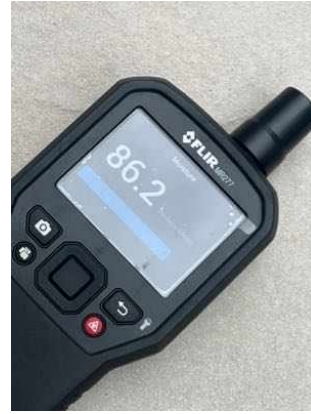
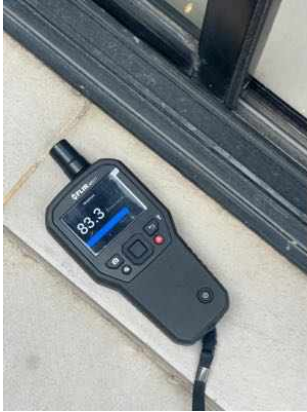
Finding 3.03

Building:	Main Building
Location:	Balcony
Finding:	Balcony Elevated Moisture - Strata (Further investigation required)
Information:	Elevated moisture was recorded at the base of the balcony adjacent wall and floor tiles. While no internal visible damage was visible at the time of inspection, balconies in multi-unit dwellings are high-risk areas for waterproofing failure, which can lead to leaks into adjoining units and significant rectification costs. Further investigation by a licensed waterproofing contractor is strongly recommended.

Depending on the strata plan, this area may form part of the common property, in which case remedial responsibility may rest with the owners corporation (strata). Purchasers should seek clarification from the strata manager and legal adviser prior to purchase.

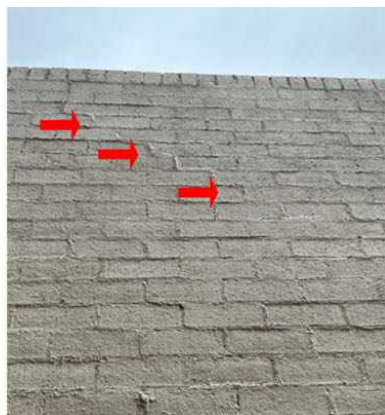
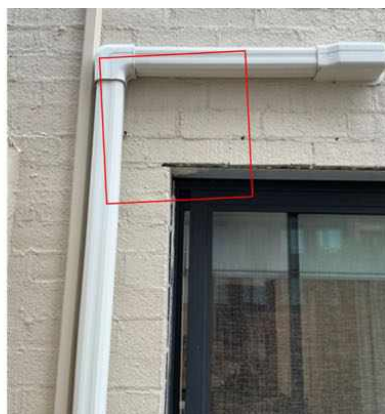
Finding 3.04

Building: Main Building
 Location: Balcony
 Finding: Brickwork - Step cracking
 Information: Step cracking was identified to the brickwork in this area at the time of inspection. Step cracking, which is similar to other forms of cracking, has a variety of possible causes. However, the most common is the subsidence of adjacent footings.

Step cracking is a relatively common defect, and is most likely to occur adjacent to windows, doors and other openings. Mortar failure in the gaps between affected bricks indicates the stresses and tensions affecting the wall.

Where step cracking is extensive or severe, the client is advised to consult a structural engineer. Minor step cracking can be used as a warning sign to address factors causing stress to the wall, which can include the effect of surrounding trees, water leaks, soil erosion, or even the presence of reactive soils in the surrounding area.

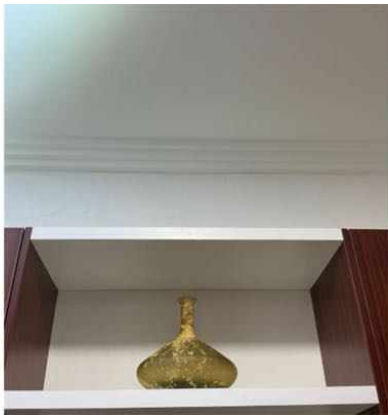
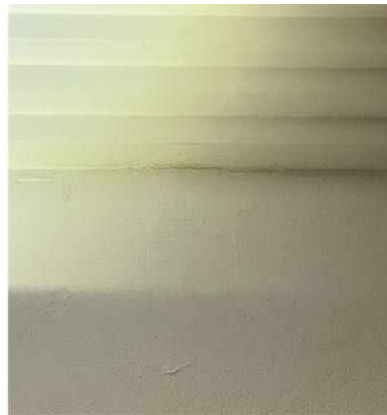
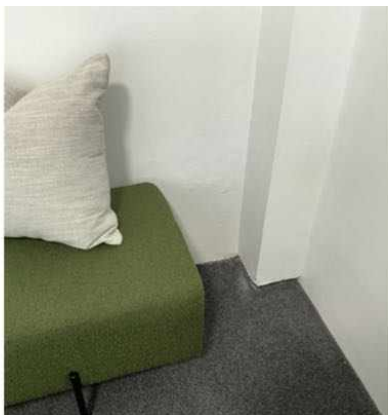
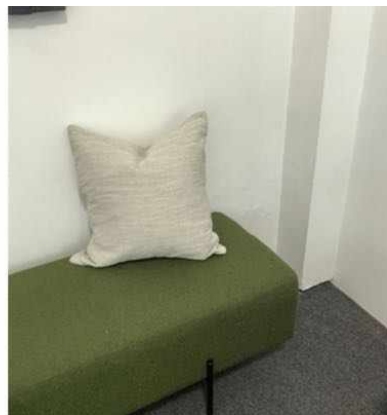
Building: Main Building
 Location: All Internal Areas
 Finding: Paint finish and hairline cracking
 Information: The paint finish in this area was identified as being incomplete at the time of inspection including some hairline minor cracking.

Whilst incomplete or missing paint finish is generally an appearance defect, it can also lead to the development of secondary building defects over time. Incomplete areas of paint finish expose the area to moisture, potentially accelerating the deterioration of underlying building materials.

Incomplete paint finishes should be sanded back, filled, leveled and painted, as applicable. Where inadequate or missing paint protection has led to the deterioration of the associated building element, repair and/or replacement of this building element may be required.

A painting contractor should be appointed as soon as possible to perform necessary works to aid the appearance of the affected area and to ensure the area is protected against further deterioration. Alternatively, the homeowner following manufacturer instructions may perform these works.

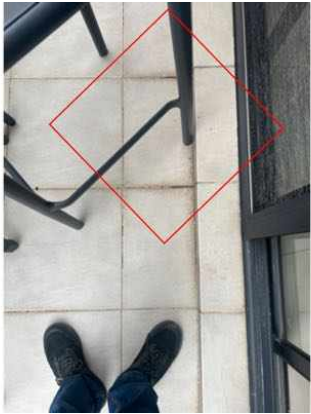
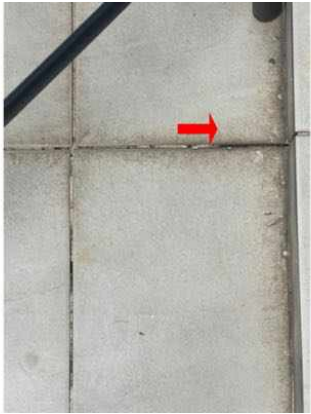
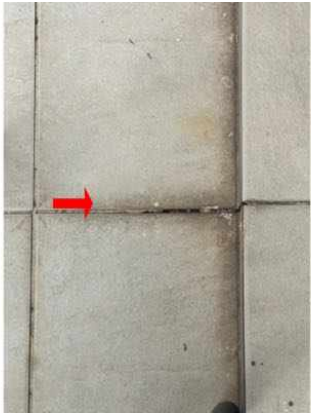
Finding 3.06

Building:	Main Building
Location:	All Internal Areas
Finding:	Sealant and grouting - Missing or degraded
Information:	It was noted on inspection that sealant or grout is degraded. There is also evidence of poor workmanship and excessive use of sealant. Silicone should never be used as a first line of defence against waterproofing. Further inspection by a licensed waterproofing contractor is highly recommended.

Different materials and floor areas move at different rates, generally causing cracking to grout or sealant at this point. A flexible sealant is required to allow for expected expansion and contraction, while keeping the joint water tight and protective of all associated building materials.

There appears to be excessive mould to the sealant and grout which will likely require scraping out and replacement.

Flexible and mould resistant materials should be applied to affected areas to prevent any subsequent water damage that is likely to occur. Regular maintenance and replacement of damage or missing or damaged sealant and grout is highly recommended to the wet areas, as this is a regular wear and tear defect. Sealant and grouting in areas that come into regular contact with water should be maintained for the long term care of your property.

A sealant specialist or tiling contractor should be appointed to complete these works as soon as possible.

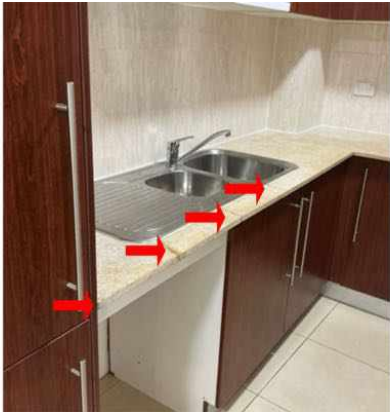
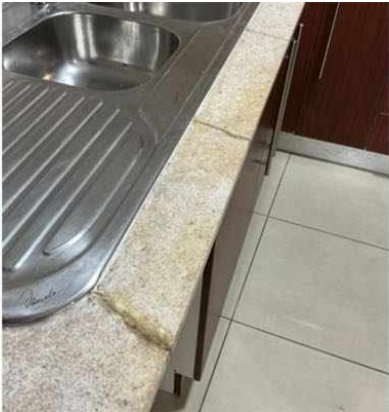
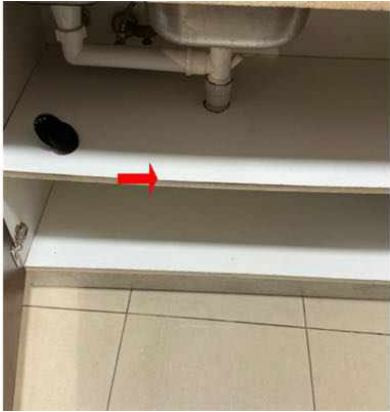
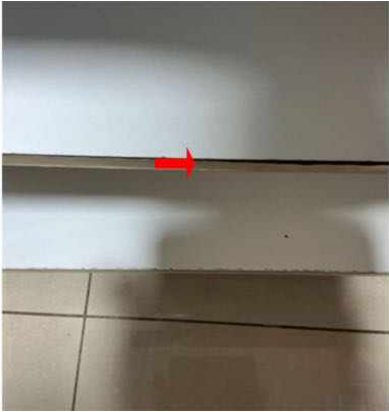
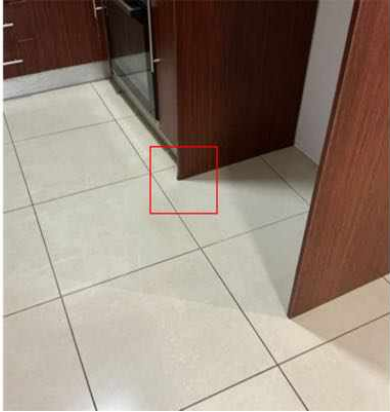
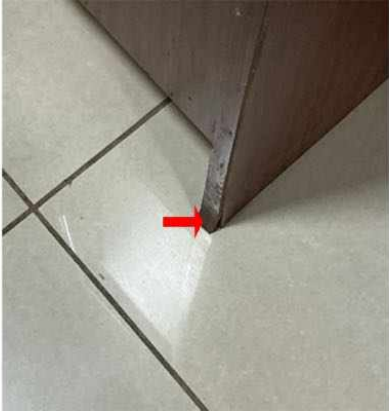
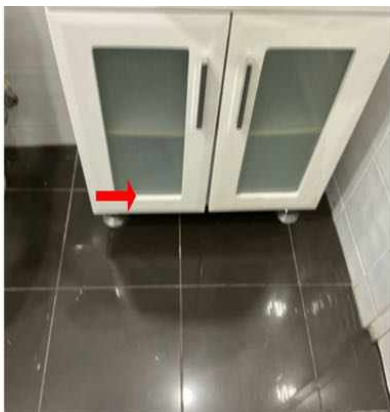
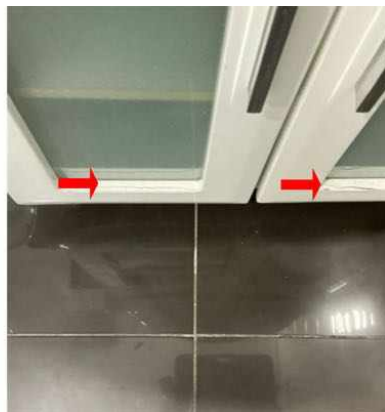
Finding 3.07

Building: Main Building
Location: All Internal Areas
Finding: Building element - Damaged - Kitchentop cracked , kitchen cabinet moisture damage , trim damaged kitchen , vanity moisture damage
Information: Breakage occurs generally when the building materials have either aged and decayed, or as a result of damage (accidental or deliberate).

Repair and/or replacement of broken elements is advised to ensure that additional secondary defects do not arise as a consequence. Such works are necessary, as all building elements play a key role in the operation and function of the overall structure and its performance.

A relevant tradesperson should be appointed to repair or replace the affected building element prior to any subsequent damage being caused.

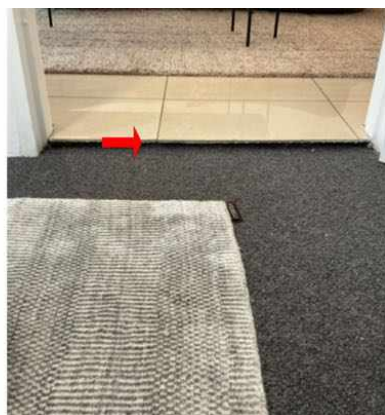
Finding 3.08

Information: The installation of this building element appears to have been completed to a substandard level of workmanship or is incomplete. Generally substandard repairs or installation are related to poor workmanship, the use of inappropriate materials, or a failure to complete installation to a suitable standard.

Where installation is substandard and/or incomplete, the client should contact the responsible trade to undertake rectification. Unfinished and substandard building works are likely to degrade more quickly and may create potential for secondary defects to associated building elements.

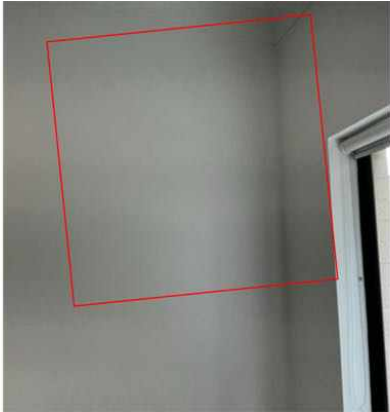
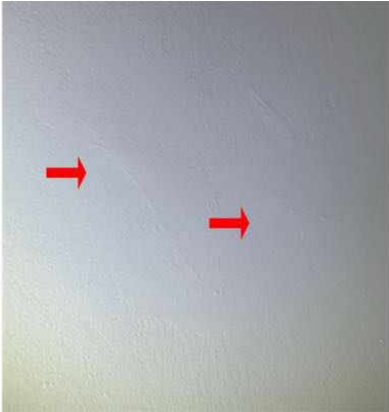
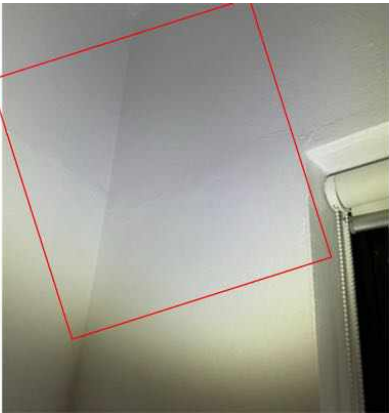
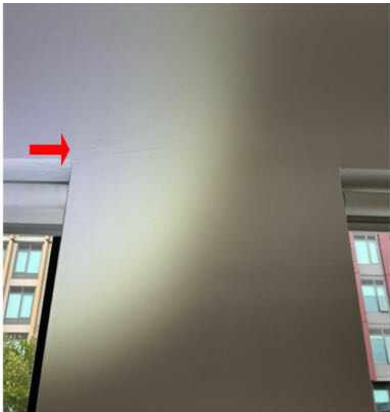
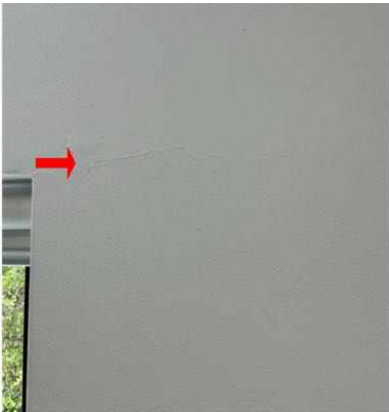
Finding 3.09

Finding: Cracks to internal render - Category 1 or repairs to some areas

Information: It has been observed that cracking to internal rendered surfaces has occurred. The degree of damage falls within Category 1, described as fine cracks that do not need repair and which are less than 1.0mm in width limit.

Damage of this category is not considered a defect for rectification. Always contact your building inspector should cracks widen, lengthen, or become more numerous.

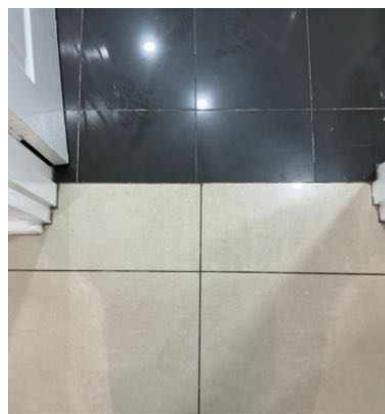
Building: Main Building
 Location: All Internal Areas
 Finding: Bathroom & external floor threshold
 Information: The bathroom floor is at the same level as the adjoining timber flooring. This configuration is typical in modern apartments and is permitted where compliant waterproofing and floor falls are provided. No evidence of moisture damage was observed at the time of inspection; however, waterproofing performance cannot be confirmed without invasive inspection.

Care should be taken to avoid excessive water migration beyond the bathroom during use.

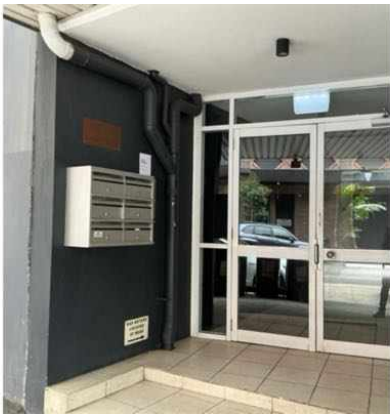
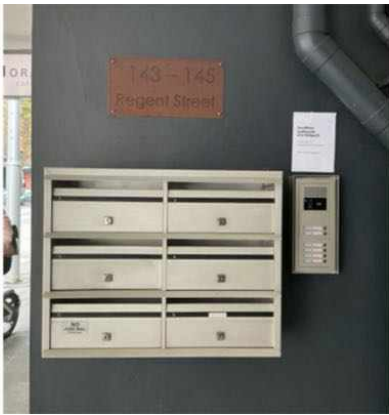
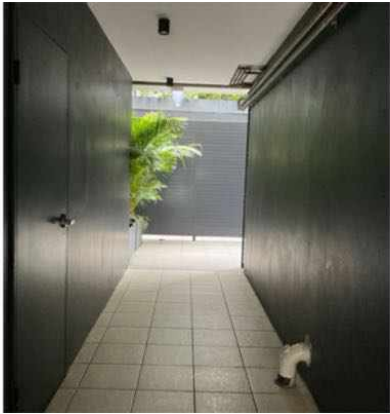
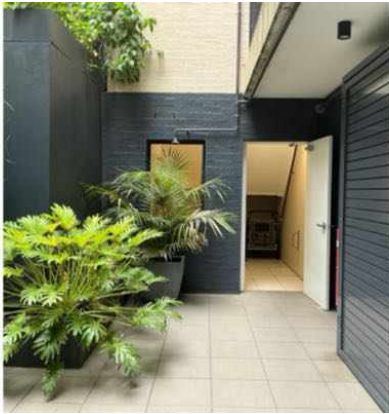
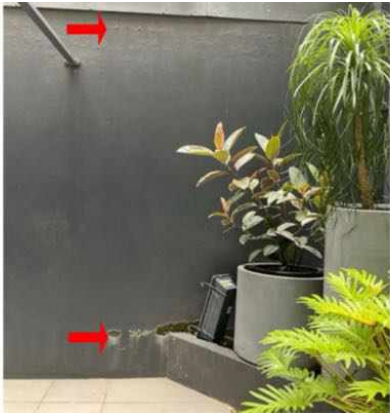
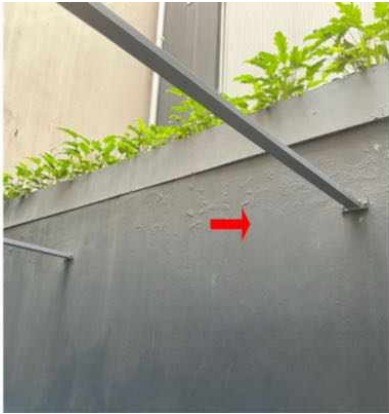
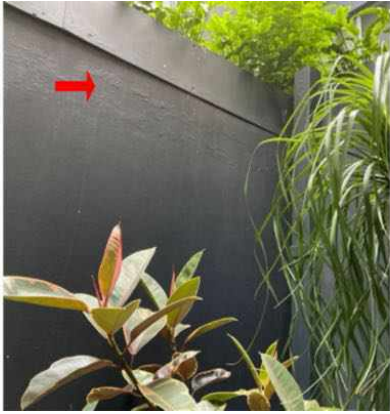
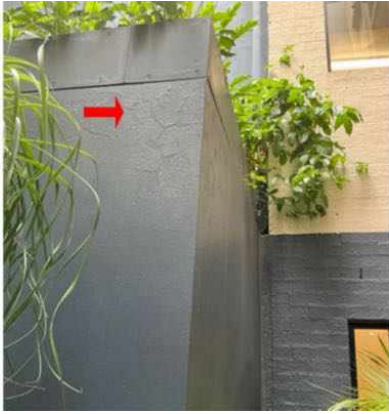
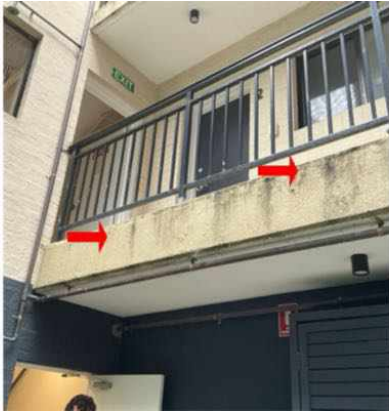
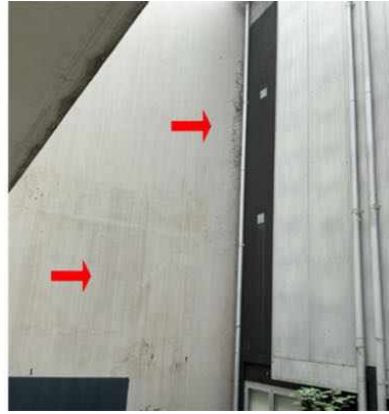
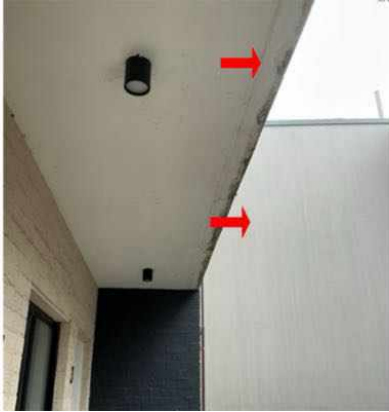
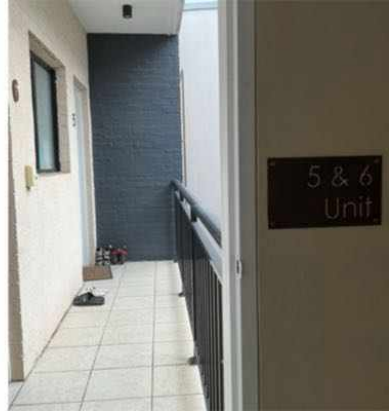
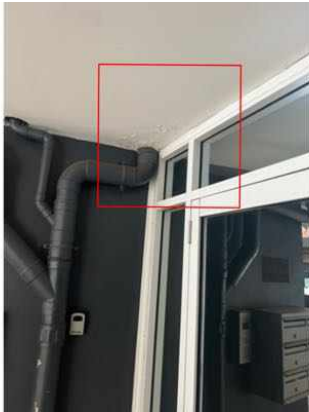
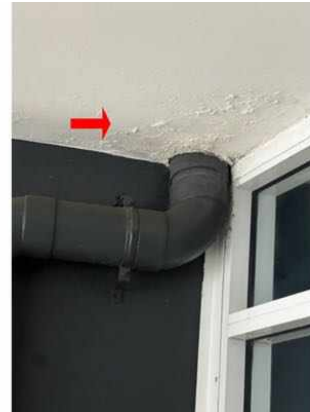
Building: Main Building
 Location: All External Areas
 Finding: Additional Photos - Obstructions and Limitations
 Information: These photographs are an indication of the obstructions and limitations which impeded full inspection of the property at the time of inspection. These obstructions can hide an array of defects and should be removed to allow full inspection to be carried out. A re-inspection is recommended once the areas are made accessible.

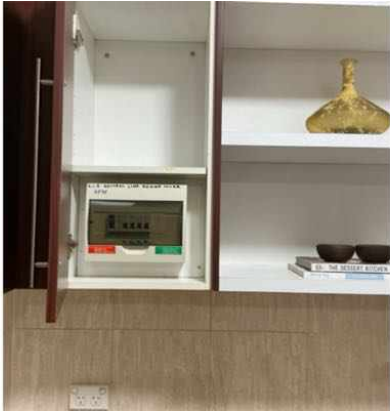
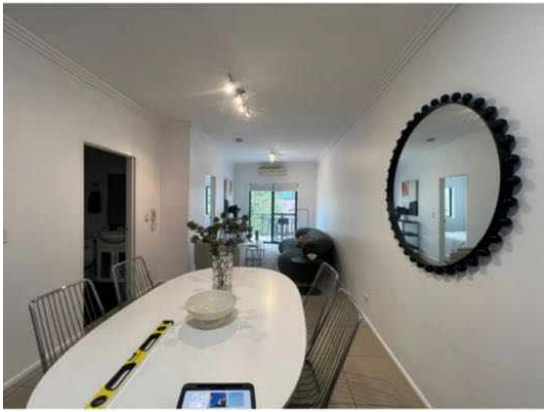
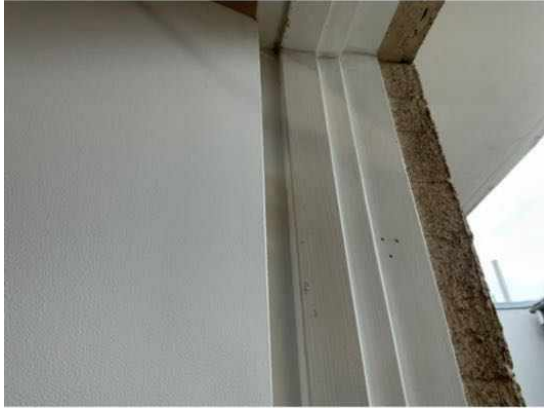
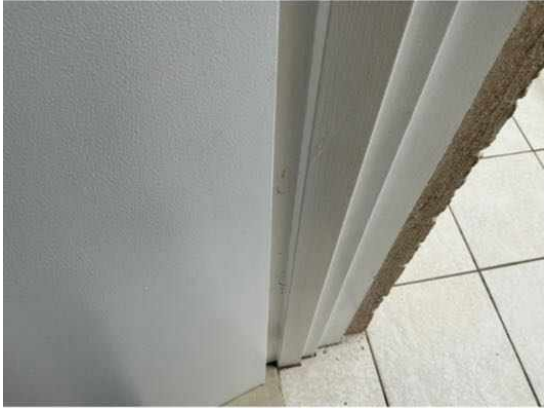
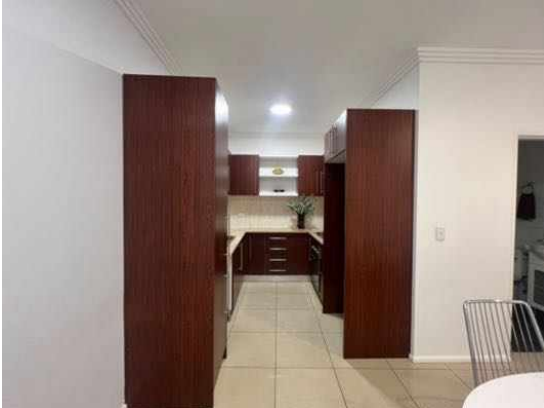
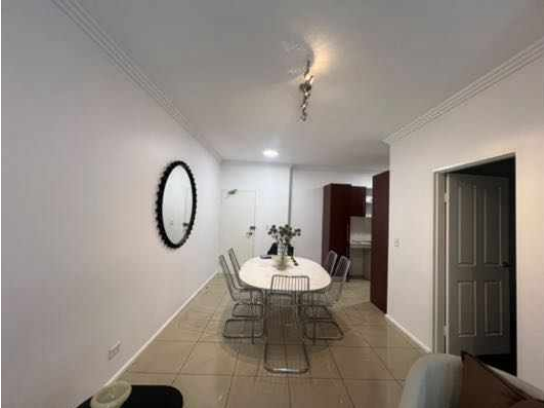
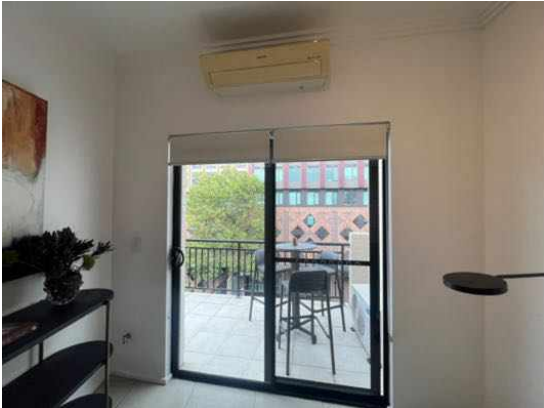
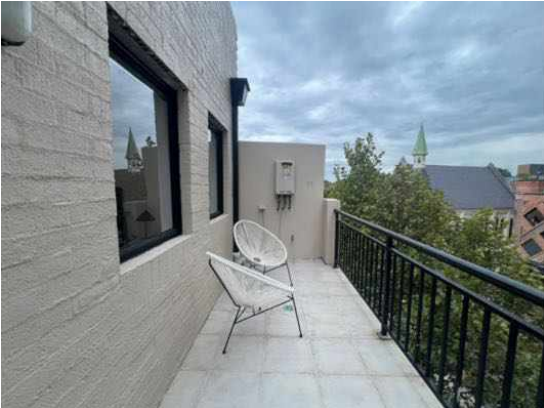
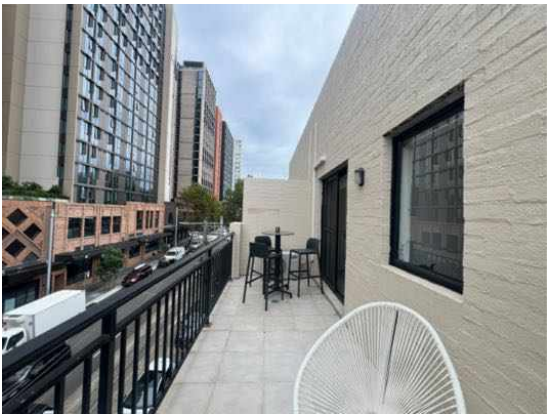
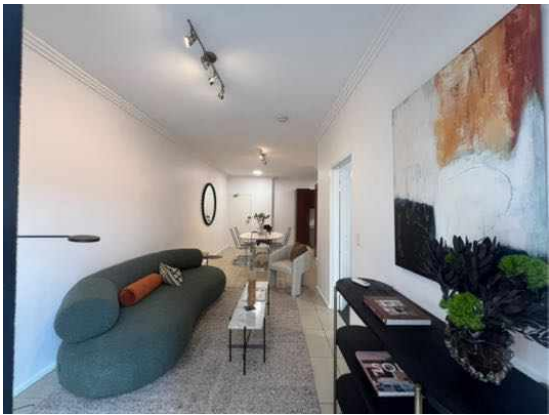
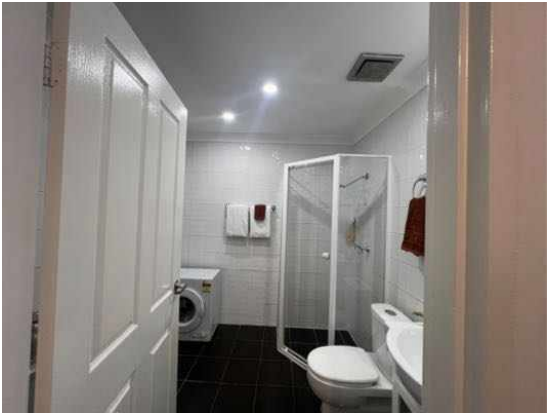
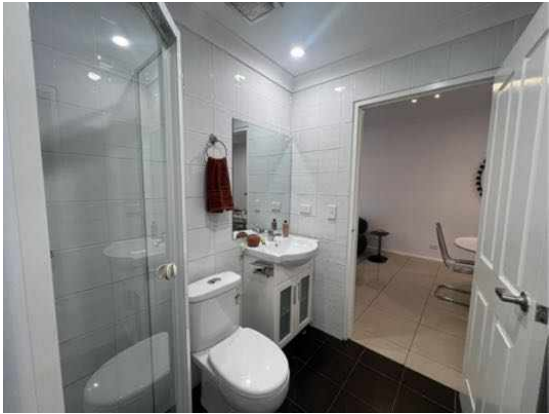
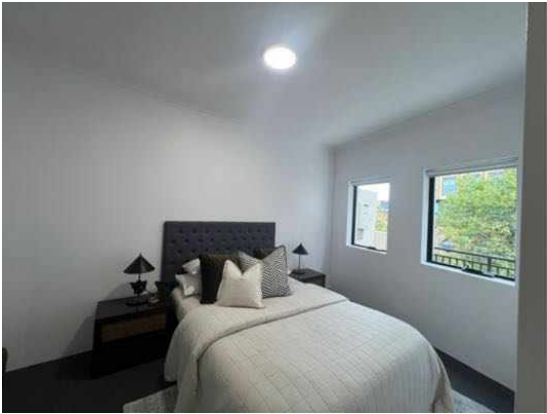
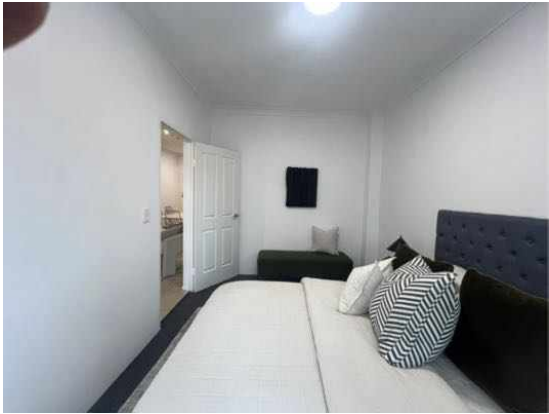
Building:	Main Building
Location:	All Internal Areas
Finding:	Additional Photos - Obstructions and Limitations
Information:	These photographs are an indication of the obstructions and limitations which impeded full inspection of the property at the time of inspection. These obstructions can hide an array of defects and should be removed to allow full inspection to be carried out. A re-inspection is recommended once the areas are made accessible.
