Building and Timber Pest Inspection Report

Inspection Date: Thu, 15 Jan 2026

Property Address: 3A Coach Cres, Currans Hill NSW 2567,
Australia

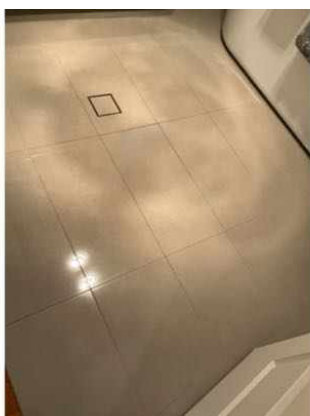
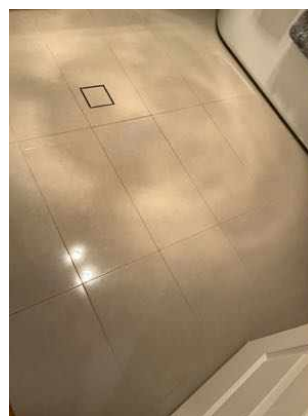
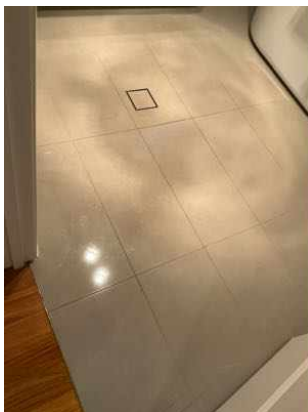
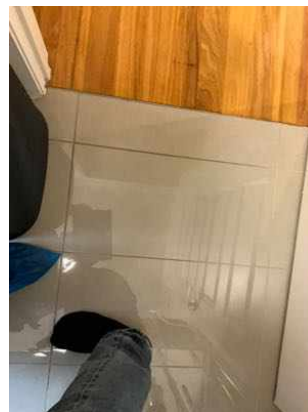
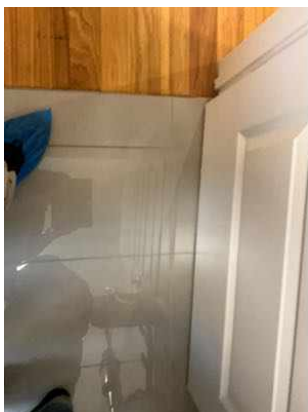
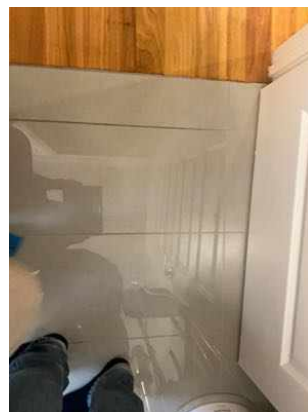
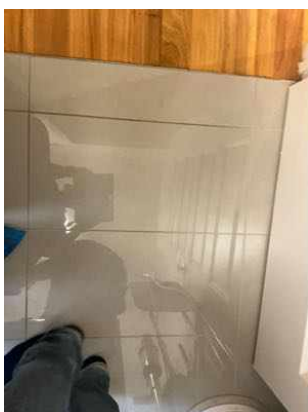
Building: Main Building
Location: All Areas
Finding: Floor Tiles – Glossy Finish in Wet Areas
Information: Glossy-finished floor tiles were observed within wet areas (e.g. bathroom). The slip resistance rating of these tiles could not be confirmed at the time of inspection.

- A licensed builder, tiler, or certified slip-resistance testing contractor can confirm compliance and undertake rectification if required (e.g. application of anti-slip treatment or tile replacement).

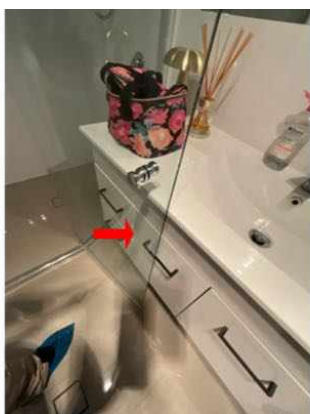
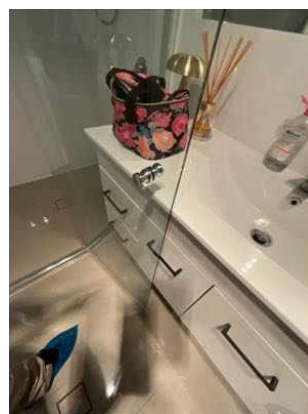
Finding 1.02

Building:	Main Building
Location:	Bathroom
Finding:	shower screen door hitting vanity unit
Information:	The shower screen door makes contact with the edge of the vanity unit when opened. This indicates inadequate clearance between the shower screen and the fixed bathroom fixture. The door's operation is impeded and presents a safety concern.
Implications:	<ul style="list-style-type: none">• Potential for impact damage to the vanity and shower screen.

- Increased risk of glass breakage, posing a personal injury hazard.
- Ongoing stress may lead to hardware failure or misalignment of the door.

This condition does not comply with the intent of AS 4349.1-2007, Appendix C – Significant Items, under “Defects in the condition of secondary and finishing elements,” specifically where normal use may cause failure or injury.

Engage a licensed glazier or shower screen installer to adjust or replace the screen to ensure proper clearance and safe operation. A cabinetmaker may be consulted if modification to the vanity is more feasible.

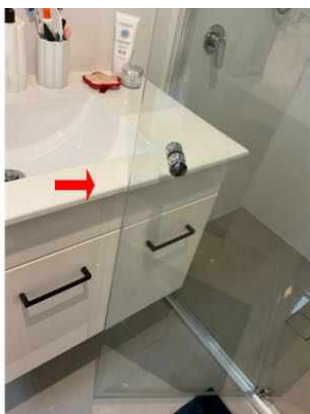
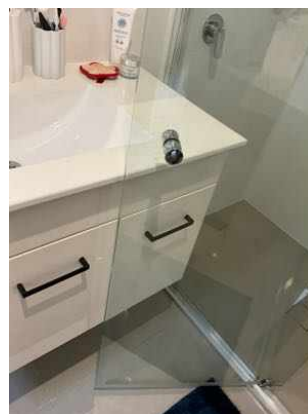
Finding 1.03

Building:	Main Building
Location:	Ensuite
Finding:	shower screen door hitting vanity unit
Information:	The shower screen door makes contact with the edge of the vanity unit when opened. This indicates inadequate clearance between the shower screen and the fixed bathroom fixture. The door's operation is impeded and presents a safety concern.

- Potential for impact damage to the vanity and shower screen.
- Increased risk of glass breakage, posing a personal injury hazard.
- Ongoing stress may lead to hardware failure or misalignment of the door.

This condition does not comply with the intent of AS 4349.1-2007, Appendix C –

Significant Items, under “Defects in the condition of secondary and finishing elements,” specifically where normal use may cause failure or injury.

Engage a licensed glazier or shower screen installer to adjust or replace the screen to ensure proper clearance and safe operation. A cabinetmaker may be consulted if modification to the vanity is more feasible.

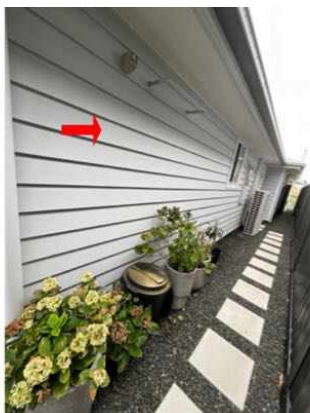
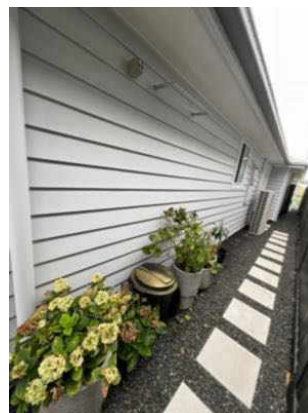
Finding 2.01

Building: Main Building
 Location: Exterior walls - left side
 Finding: Rainwater Tank – Missing / Not Installed
 Information: A rainwater tank was not observed at the property at the time of inspection, typical modern construction requires a rainwater harvesting system but is currently missing or not installed.

- Loss of stormwater reuse benefits (e.g. garden irrigation, toilet/laundry supply where applicable).
- Potential non-compliance with BASIX / development approval conditions, depending on council requirements.
- Increased reliance on mains water and higher water usage costs.
- Possible stormwater management issues if downpipes are not appropriately connected.

A licensed plumber or rainwater tank installer should be engaged to confirm compliance requirements and install an appropriately sized rainwater tank with correct plumbing connections, overflow, and mosquito-proofing as required by local council and standards.

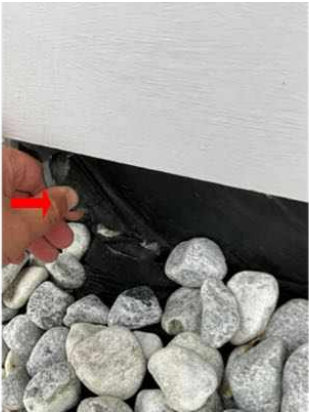
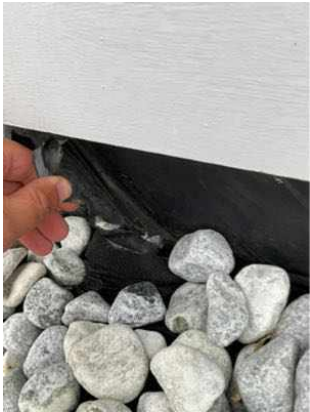
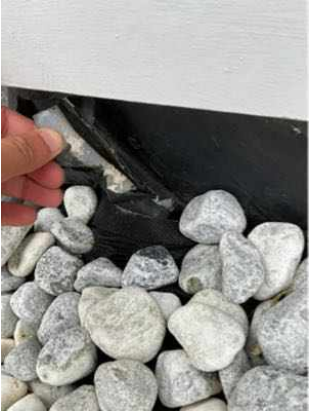
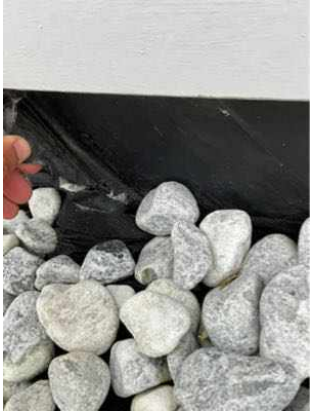
Finding 3.01

Building: Main Building
 Location: All Areas
 Finding: Flashing deteriorated
 Information: The flashing installed between the timber frameworks and the panels of the building is deteriorated. This deterioration includes visible corrosion, gaps, and cracks, which compromise the effectiveness of the flashing in preventing water ingress.

1. Water Ingress: Compromised flashing can lead to water penetration causing moisture to infiltrate the building envelope.
2. Structural Damage: Continuous exposure to moisture can lead to timber rot, weakening the structural integrity of the timber framework and surrounding materials.
3. Mold and Mildew Growth: Moist conditions promote mold and mildew growth, which can cause health issues for occupants and further damage building materials.
4. Insulation Damage: Water ingress can damage insulation, reducing the building's energy efficiency and increasing heating and cooling costs.
5. Aesthetic Issues: Water staining and damage can affect the building's appearance, potentially lowering property value and requiring costly repairs.

A licensed and qualified roofer with experience in flashing installation and repair should be engaged to address this issue. The contractor will:

- 1. Assess the extent of the deterioration.
- 2. Remove the damaged flashing.
- 3. Install new, properly sealed flashing to ensure water tightness.
- 4. Inspect adjacent areas for any signs of water damage and repair as needed.

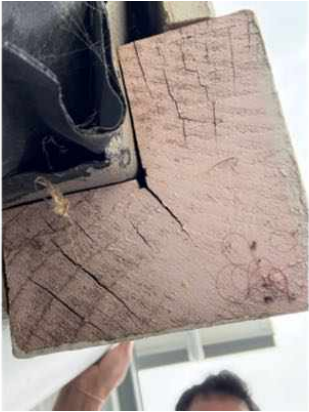
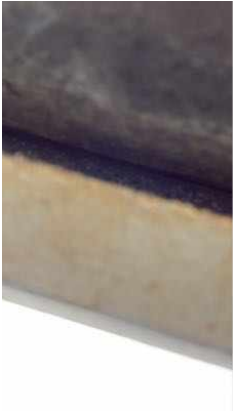
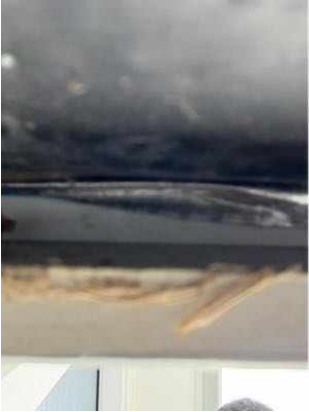
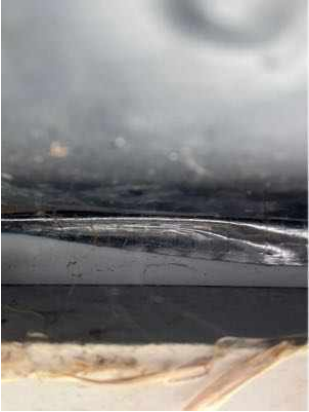
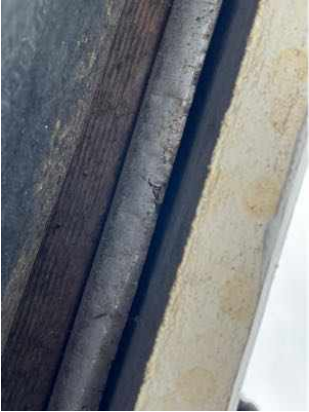
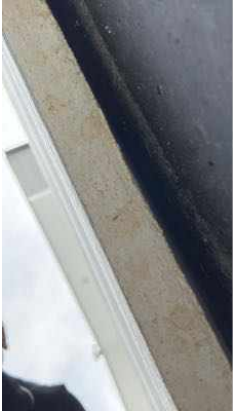
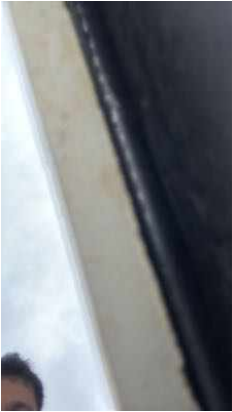
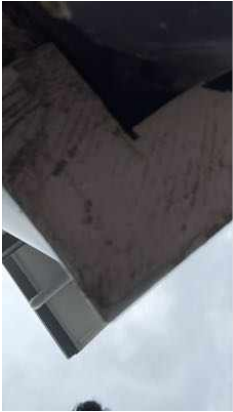
Finding 3.02

Building:	Main Building
Location:	Front Elevation
Finding:	External Cladding – Missing Bottom/starter Trims
Information:	The bottom trims / starter trims to the external wall cladding were observed to be missing in areas inspected. This has resulted in exposed lower edges of the cladding and gaps at the base.

- Increased risk of moisture ingress behind the cladding, potentially leading to deterioration of framing and wall components.
- Potential pest entry (including insects and vermin) through exposed gaps.
- Reduced durability of cladding due to exposure of cut edges.
- Possible non-compliance with manufacturer installation requirements and building standards.

The missing bottom trims should be installed to adequately seal and protect the lower edge of the cladding system.

A licensed builder or qualified cladding installer should be engaged to supply and install appropriate bottom trims in accordance with the cladding manufacturer's specifications and relevant Australian Standards.

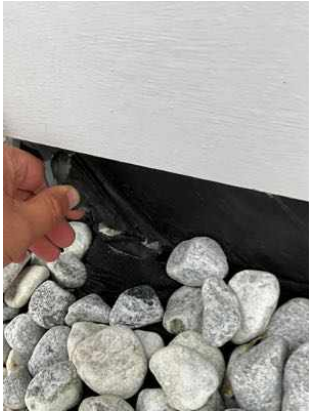
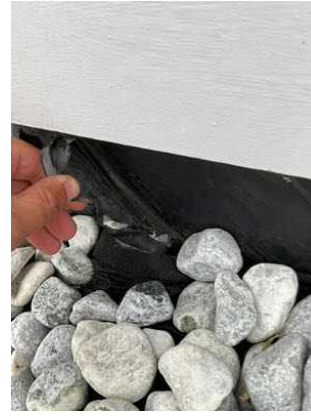
Finding 3.03

Building: Main Building
 Location: Alfresco
 Finding: Paint surface deteriorated
 Information: Sections of the paint in this area was found to have deteriorated. It's a generally an indication of excessive moisture in the area that is currently hidden by the painted surface.

The presence of excessive moisture can have major implications on associated building elements if left unattended. While only seemingly minor at this stage, the damage cannot be determined due to the paint, obstructing any further inspection of the damage.

It is highly advised that the affected paint to be cleaned to allow a further, more invasive inspection by a licensed builder/painter. Failure to act on this defect may necessitate major works in the future.

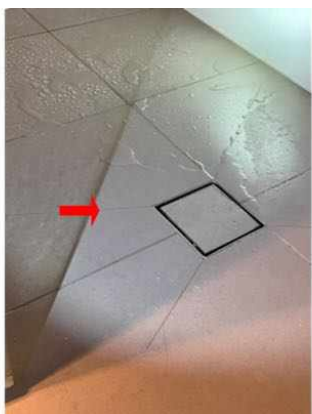
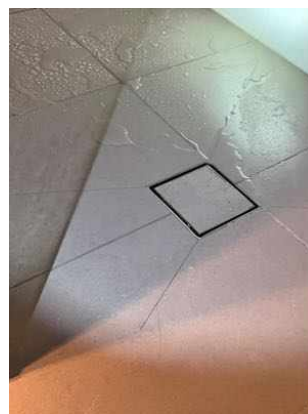
This pooling is minor overall but is still considered unsatisfactory, as standard tiling practices would not permit this situation to occur. Pooling water around floor wastes can create a slip hazard in extreme cases and create conditions that are conducive to mould growth over time. Where left unmanaged, the degradation of sealant and grouting is also likely to occur, possibly necessitating further repair works.

Remedial works may involve some sections of tiling and flooring repair and replacement. A tiling contractor or bathroom specialist should be appointed to provide further advice on reparation options and to perform works as necessary.

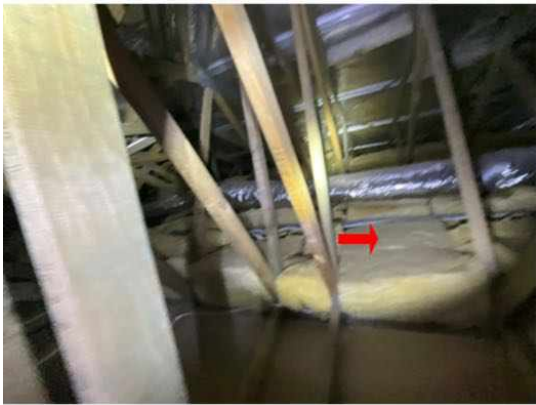
Finding 3.07

Building:	Main Building
Location:	Roof Void
Finding:	Exhaust fan not vented out
Information:	The exhaust fan located within the roof void is not appropriately ducted to the external atmosphere and is currently discharging moist air directly into the roof space. This is considered a defect under AS 4349.1, as it does not meet the minimum standard of residential building performance expected under normal residential building practices.

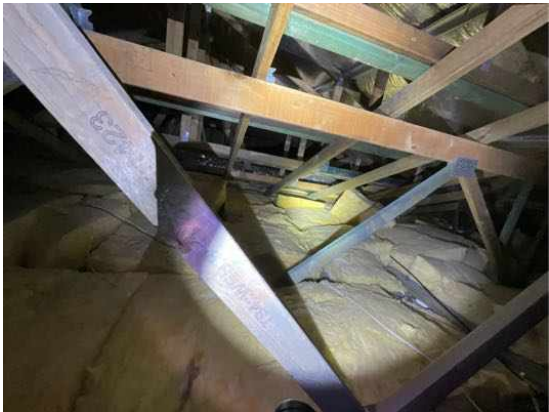
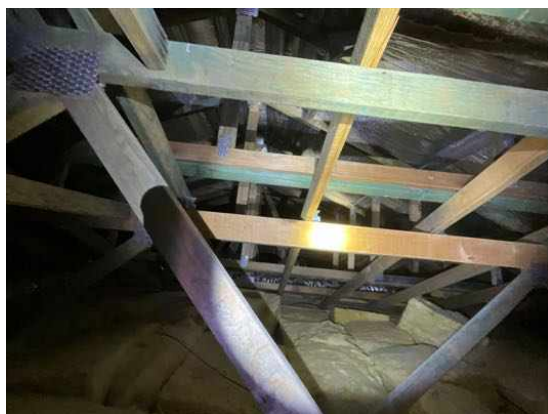
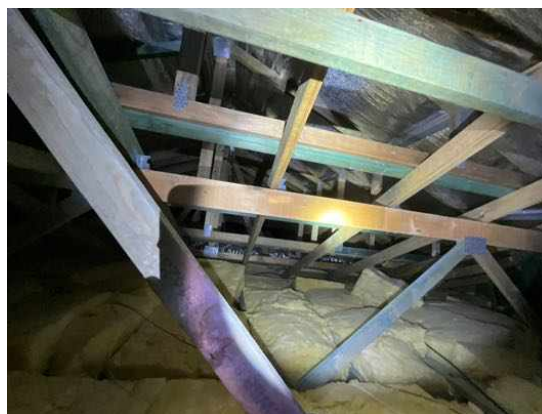
Information: Sections of insulation in the roof void have been poorly installed or moved from their original position and are covering down light fittings. While the down lights have been fitted with appropriate protective covers, the presence of this insulation creates a potential fire hazard.

Any insulation within the vicinity of down light fixtures should be moved and re-applied to more appropriate sections of the roof void, thus ensuring the area is fire-safe. An insulation contractor should be appointed as soon as possible to perform any necessary works as required.

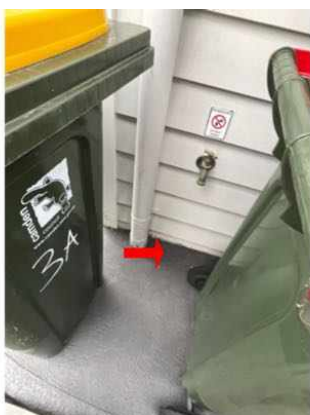
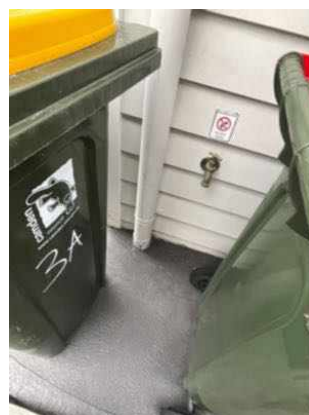
Finding 6.02

Building: Main Building
Location: All Areas
Finding: No Drain under tap
Information: There is no drain installed under the tap, leading to water accumulation and creating conducive conditions for timber pests. This defect needs immediate attention to prevent potential damage and pest infestation.
Risk:
1. Water Accumulation: Without proper drainage, water can accumulate around the base of the tap, leading to persistent dampness in the surrounding area.

2. Timber Pest Infestation: The damp environment created by standing water is highly conducive to timber pests, such as termites and wood borers, which thrive in moist conditions and can cause significant damage to wooden structures.

3. Structural Damage: Prolonged exposure to moisture can lead to wood rot and deterioration of structural timber, compromising the integrity of the building.

4. Health Hazards: Persistent dampness can also promote mold and mildew growth, posing health risks to occupants.

5. Aesthetic Damage: Water stains and damage to finishes and materials around the tap area can detract from the appearance of the building and lead to costly repairs.

A licensed plumber or a qualified building contractor can address this defect by:

1. Assessment: Evaluating the area to determine the best approach for installing a proper drainage system under the tap.
2. Installation: Installing a drain that effectively channels water away from the base of the tap, preventing water accumulation and dampness.
3. Repair and Prevention: Inspecting and repairing any existing water damage and implementing measures to prevent future water accumulation and pest infestations.

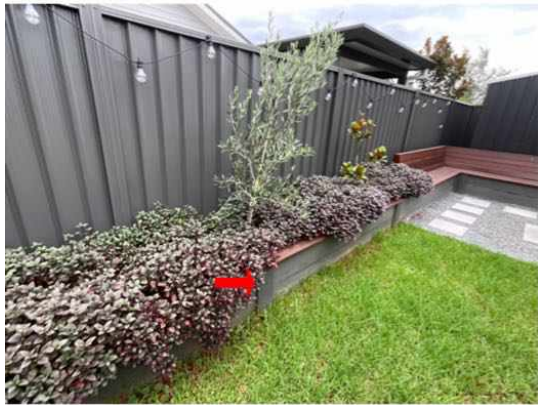
Finding 6.03

Building: Main Building
 Location: All Areas
 Finding: Timber on ground / conducive conditions to termite damage
 Information: Timber on the ground is indeed conducive to termite damage. Termites are known to thrive in moist environments, and wood in contact with soil or moisture is more susceptible to infestation.

To prevent this, it's important to keep timber elevated and away from direct ground contact. Regular inspections and proper termite control measures are also essential to protect your wooden structures from termite damage.

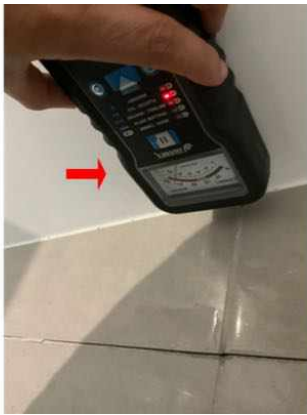
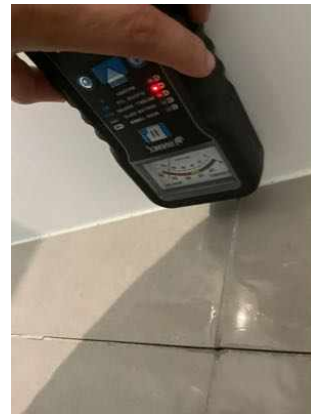
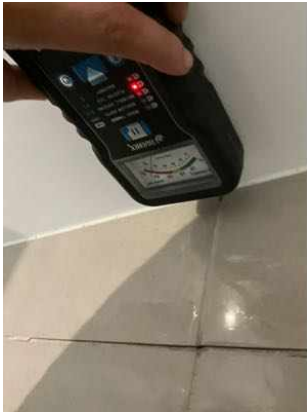
Finding 6.04

Building:	Main Building
Location:	Ensuite
Finding:	Excessive moisture - Conducive to Timber pest
Information:	Excessive moisture can attract termites and produce conditions that promote fungal growth and wood decay.

Excessive moisture is generally caused by deteriorated inadequate or missing roof drainage leaking plumbing pipes or fixtures poorly plumbed HWS overflows or condenser units and poor site drainage.

If mould growth has been found there may be environmental biological or health issues involved. In these cases an appropriately qualified inspector should also be contacted.

Prior to any remedial works being performed a qualified plumber should be appointed to further inspect the property and to identify the cause of the excessive moisture. Works to remove affected building elements may then be necessary and should be performed by an appropriate tradesperson.

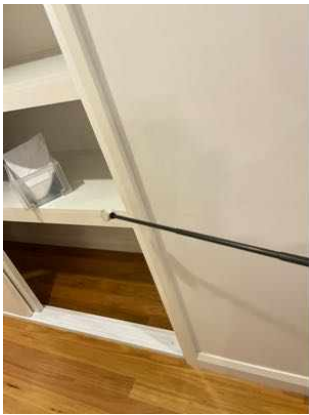
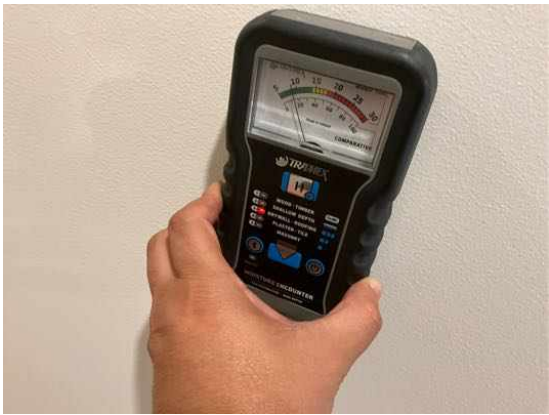
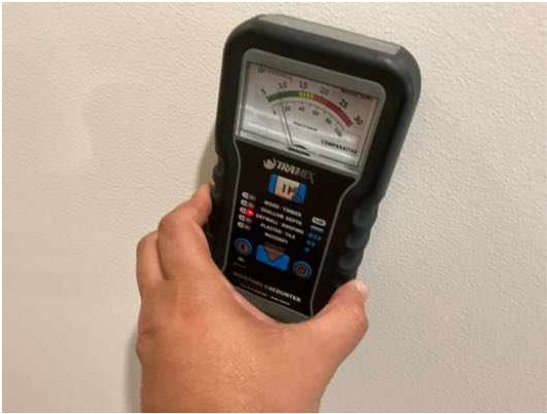
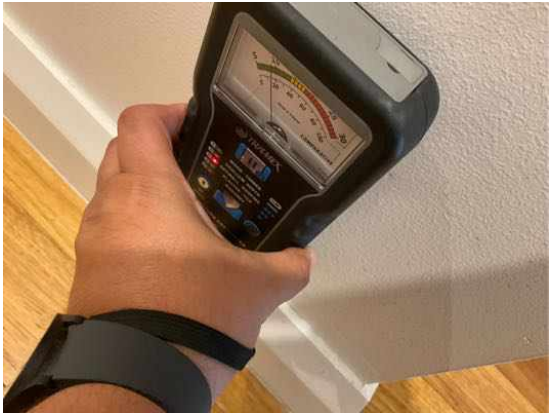
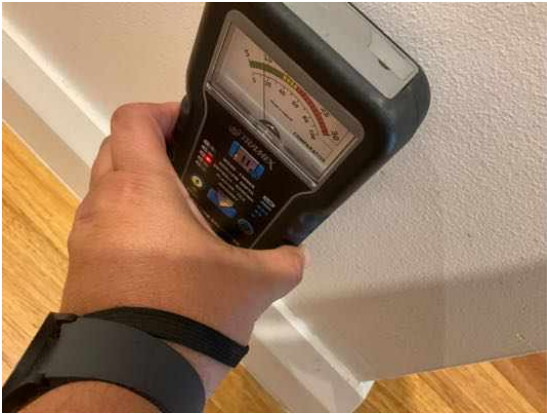
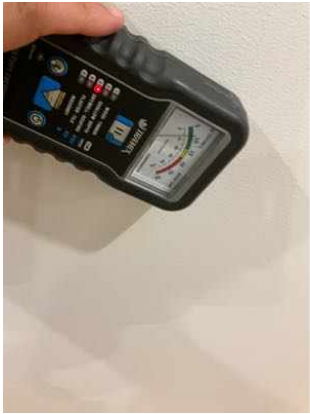
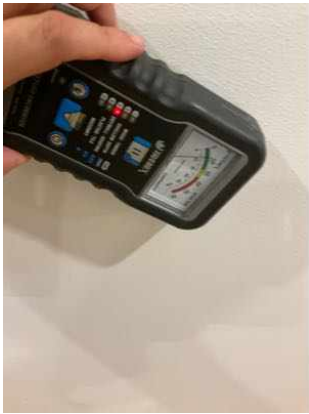
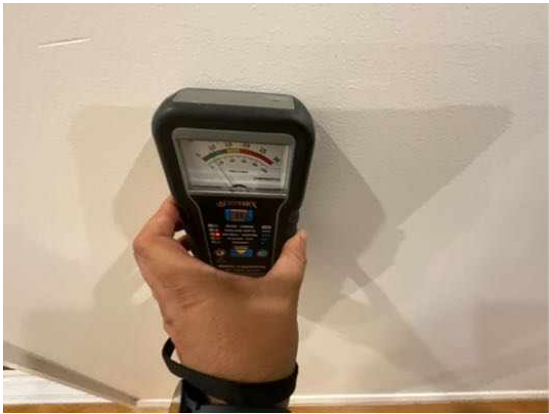
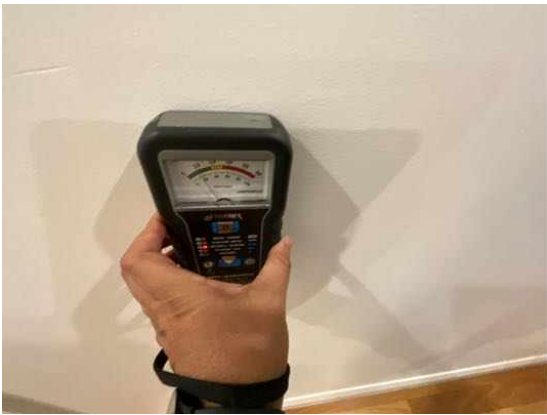
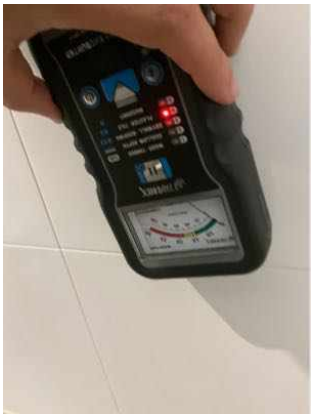
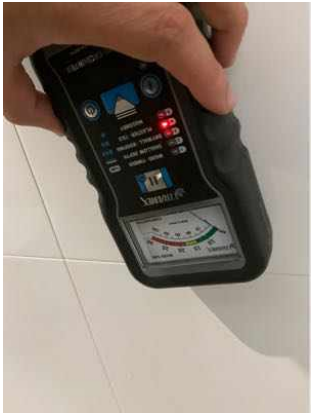
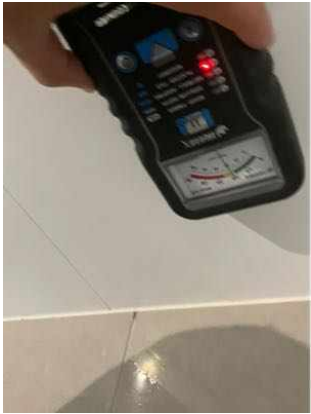
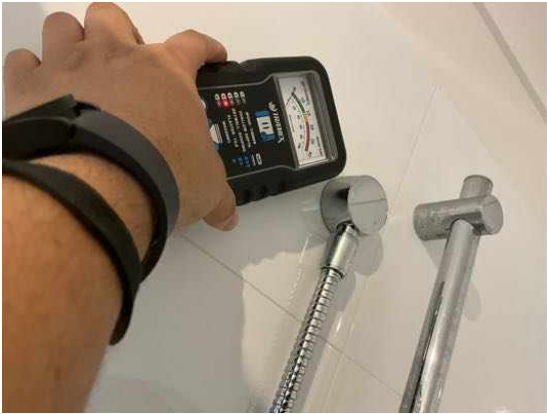
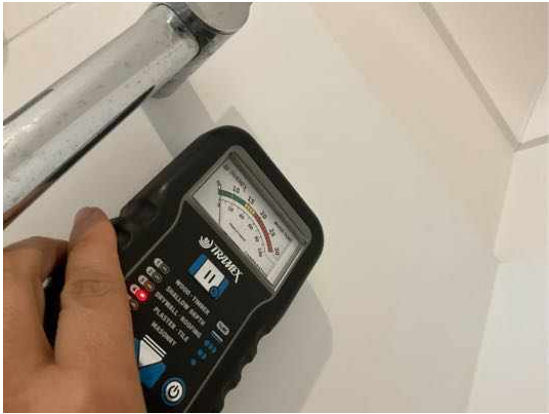
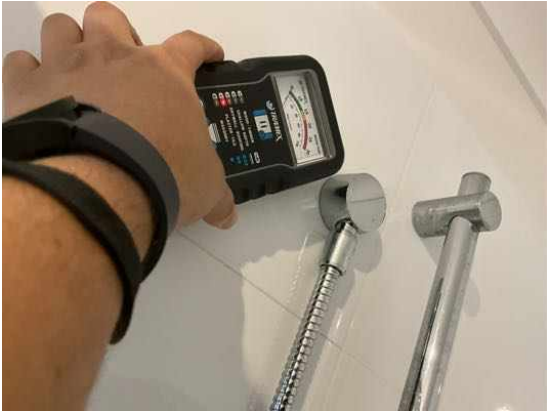
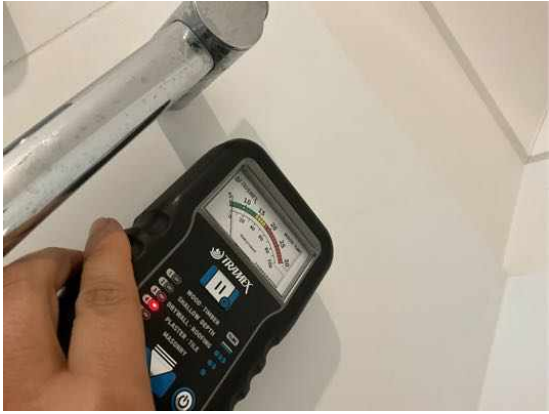
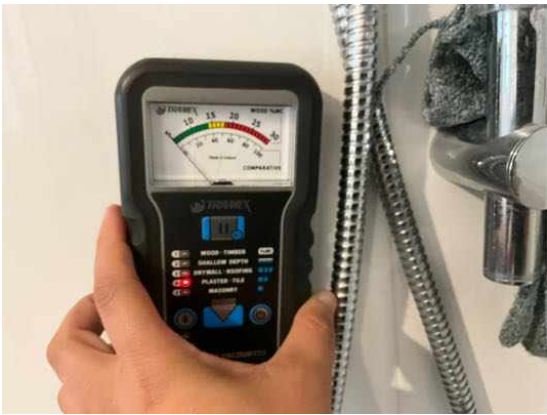
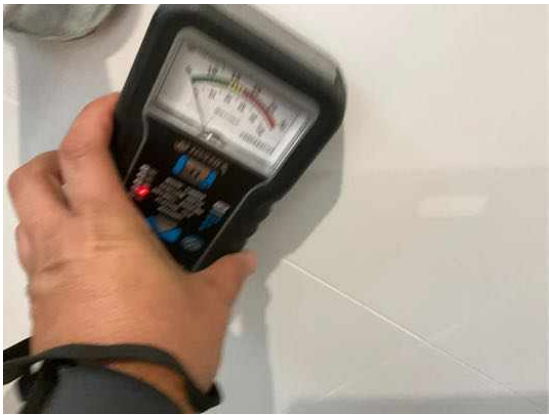
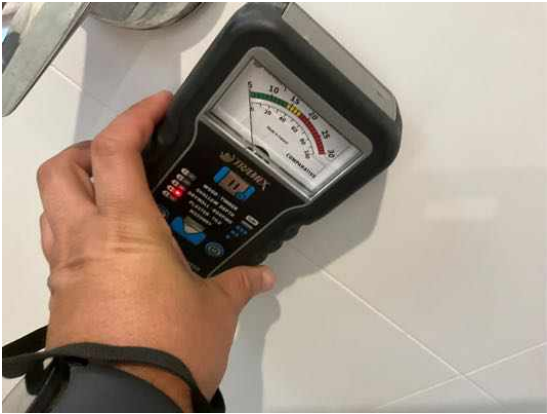
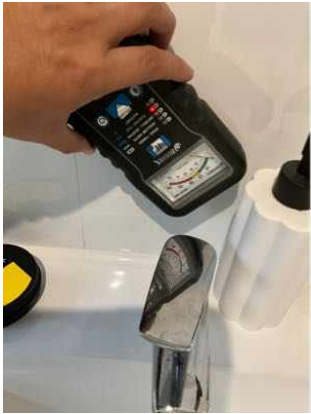
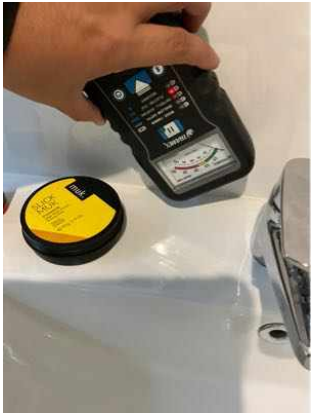
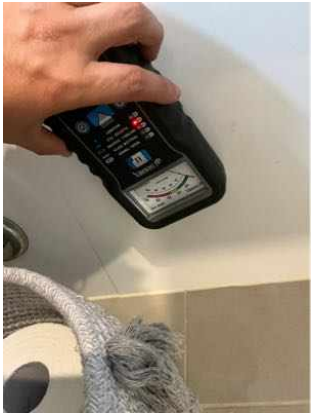
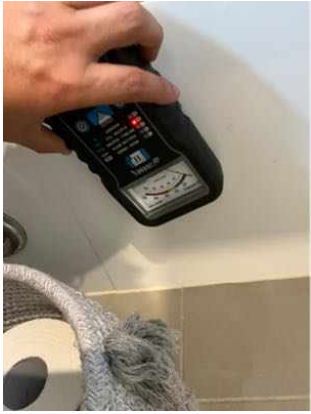
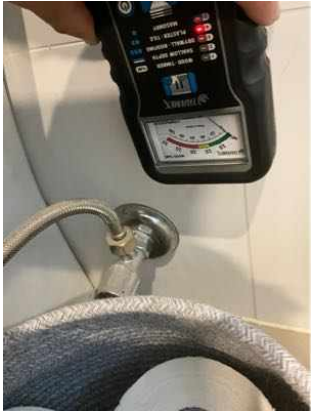
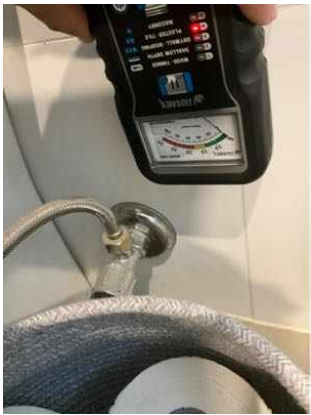
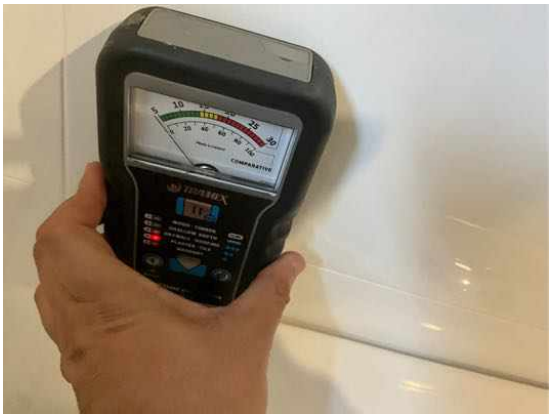
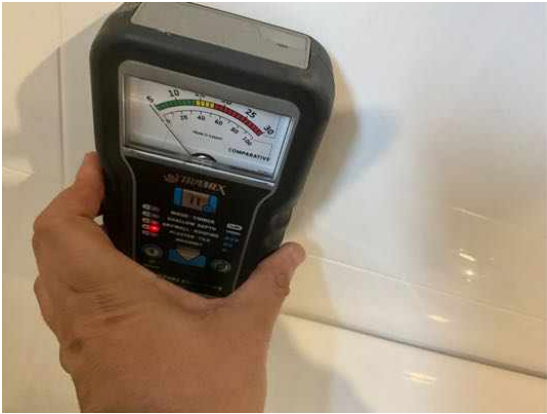
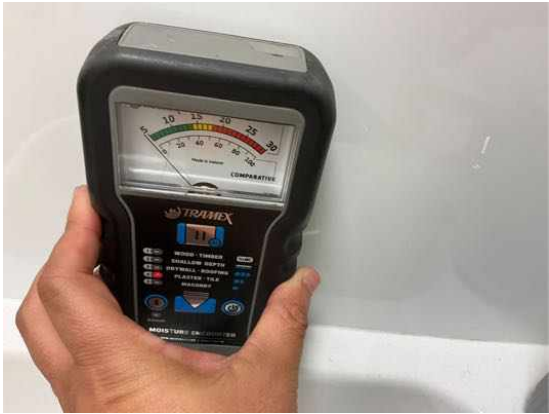
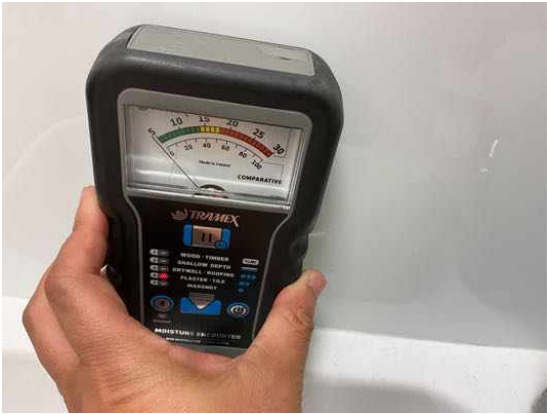
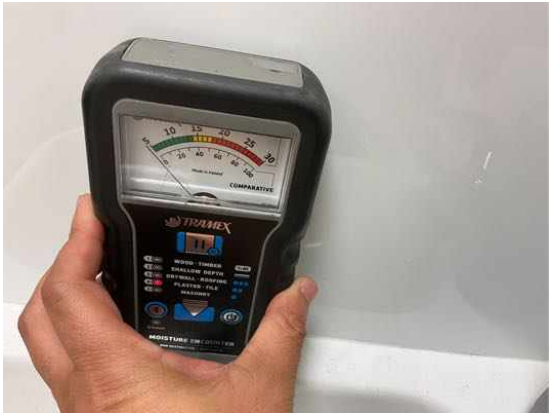
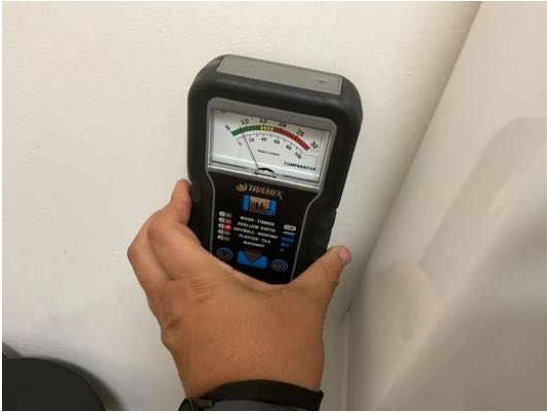
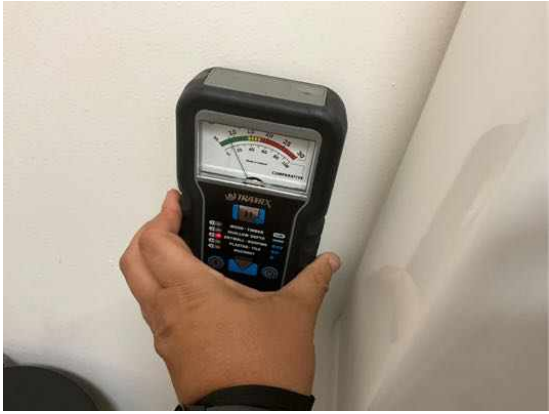
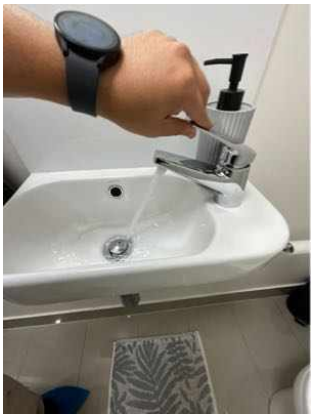
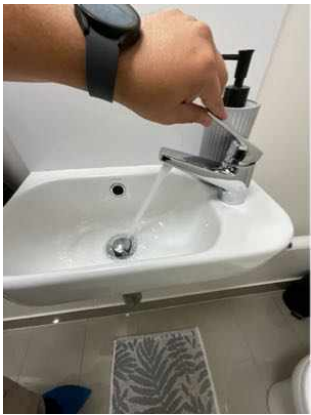
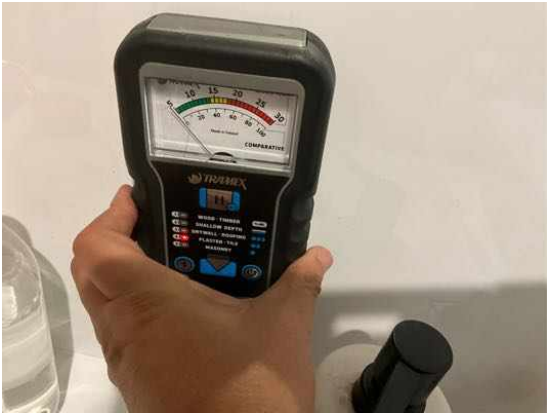
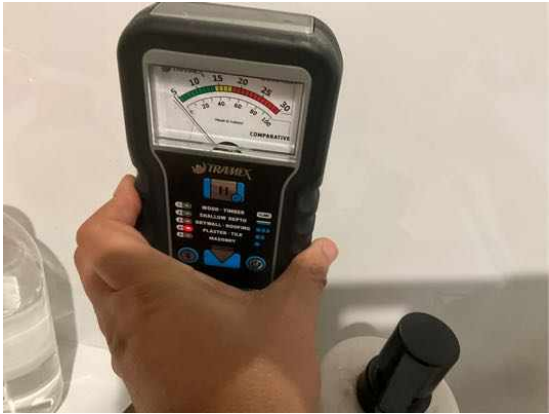
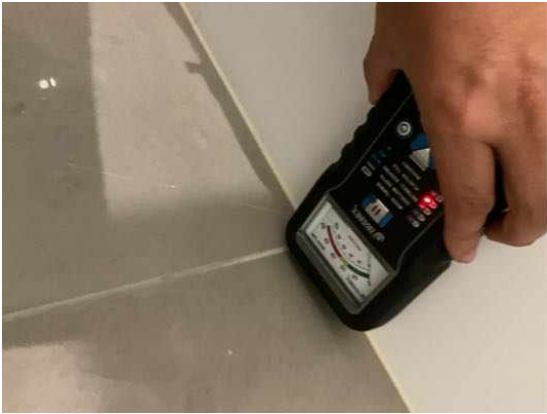
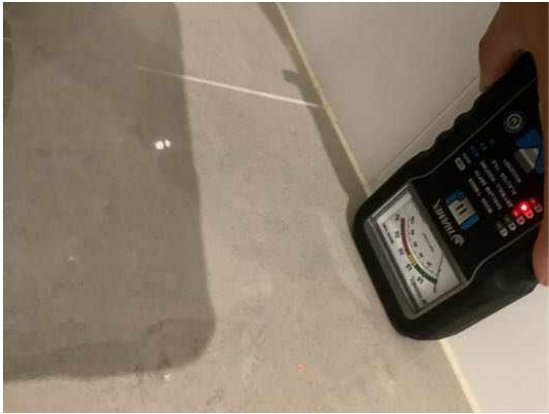
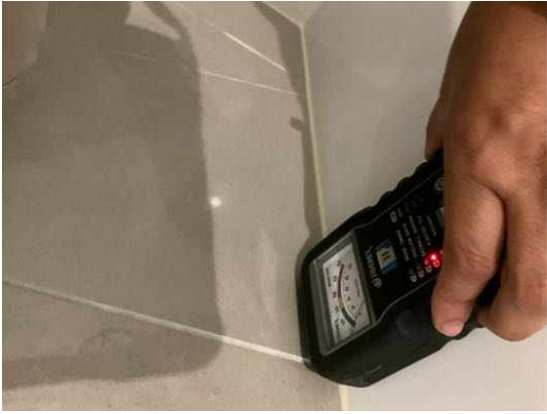
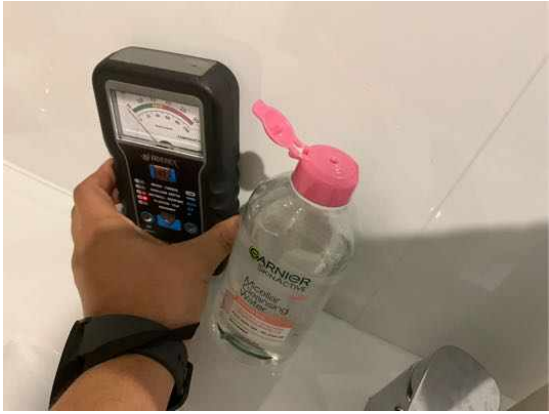
Building: Main Building
Location: All Areas
Finding: Additional Photos
Information: Additional photos are provided for your general reference

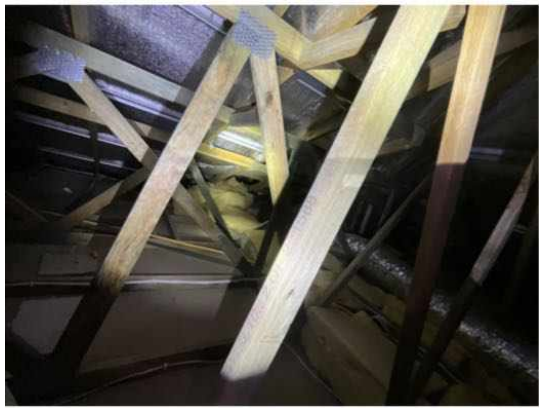
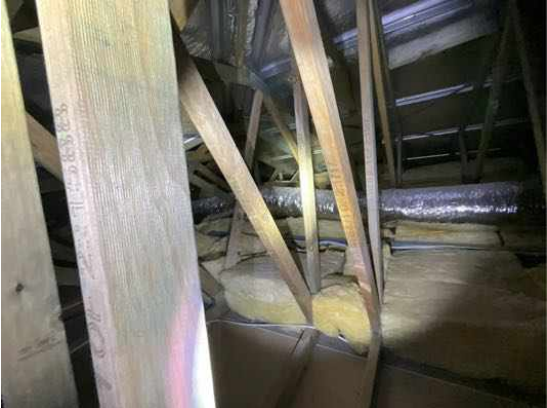
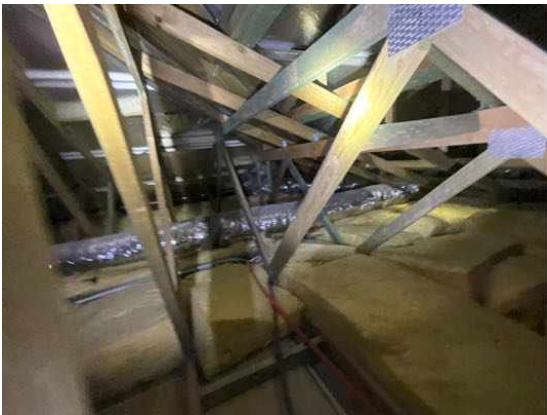
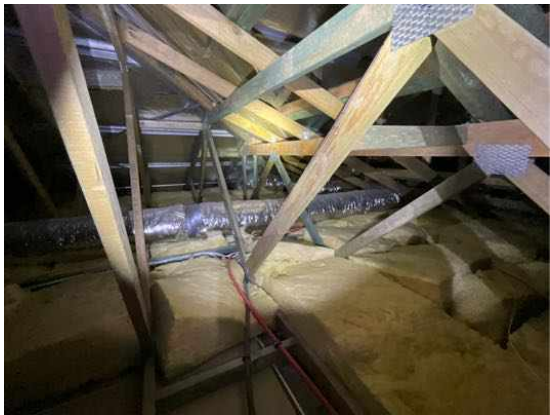
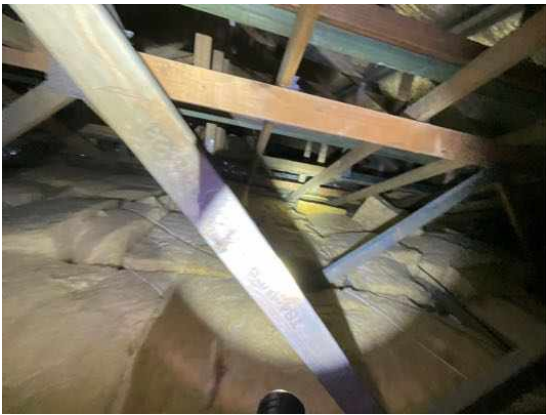
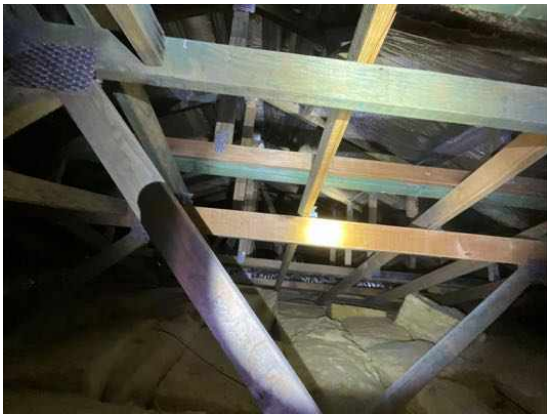
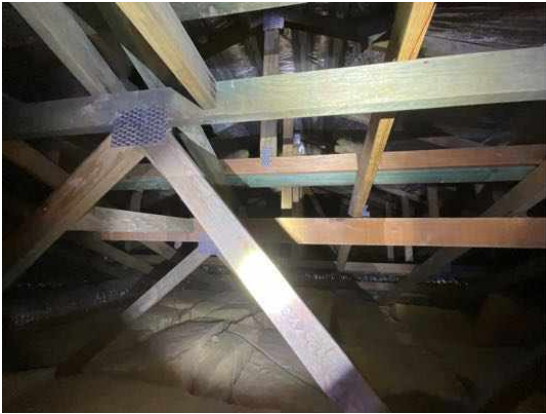
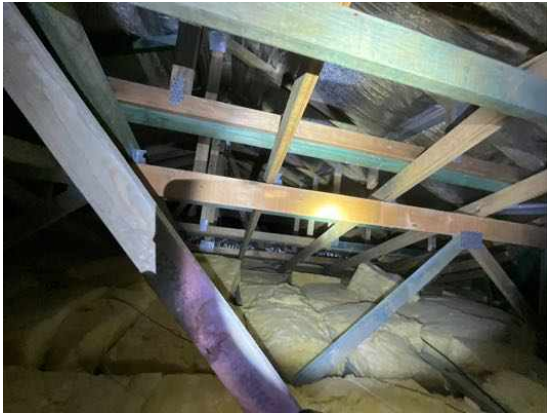
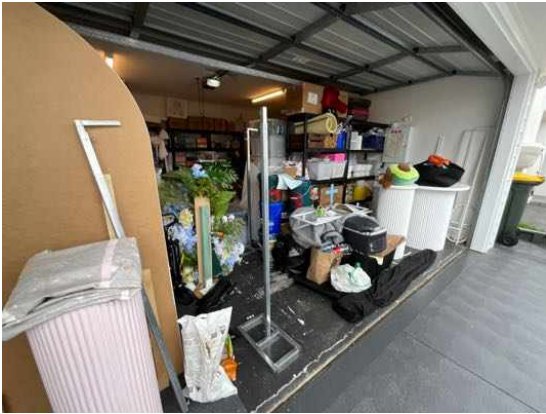
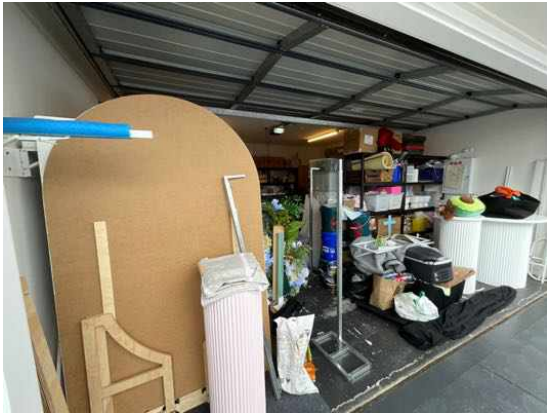
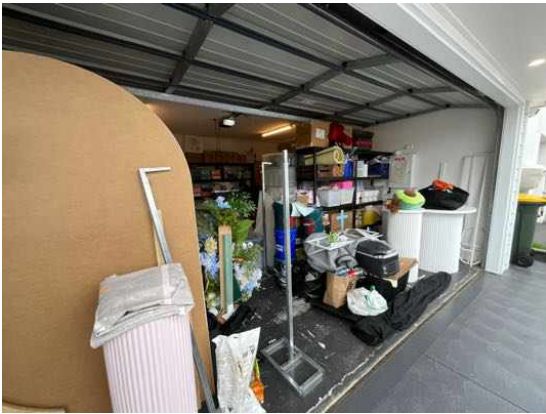
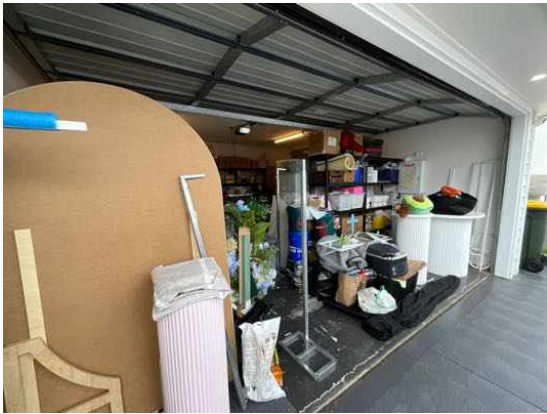
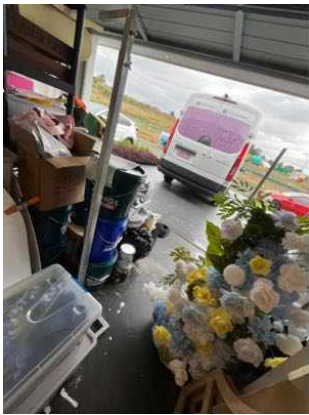
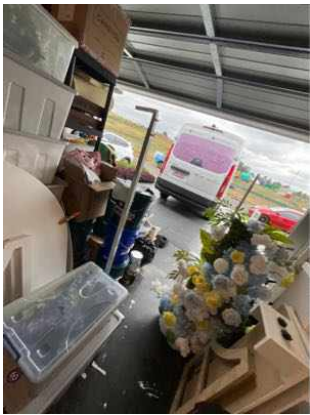
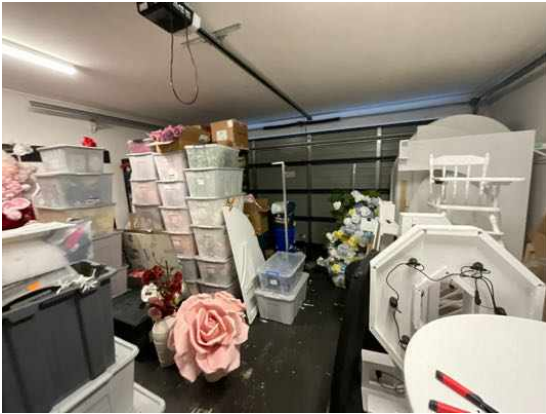
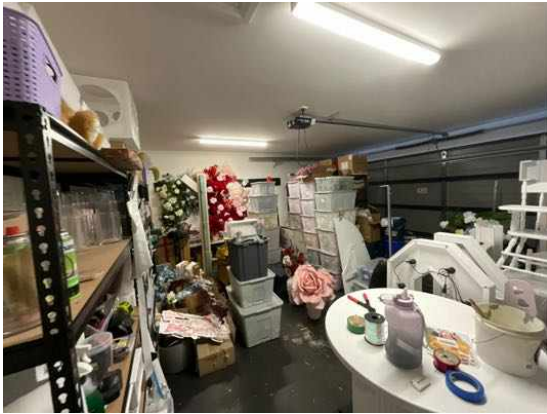
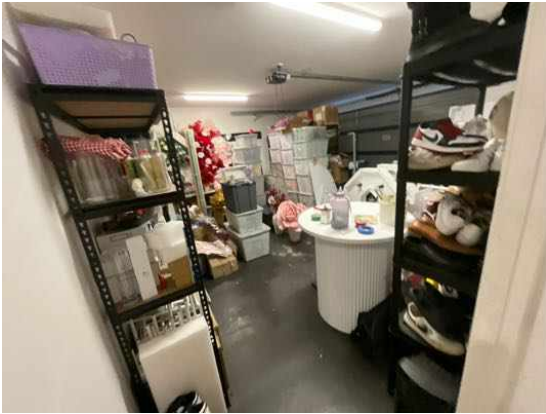
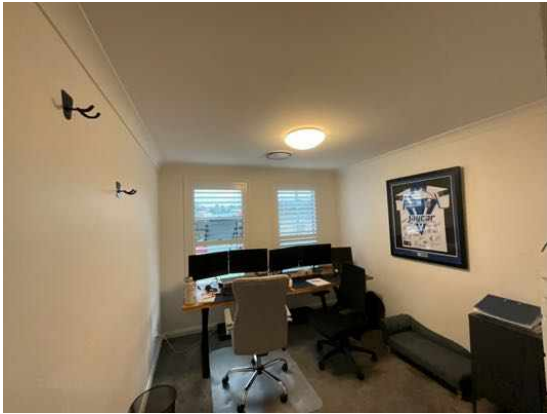
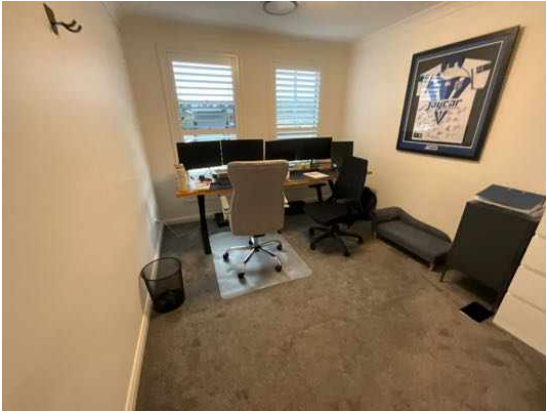
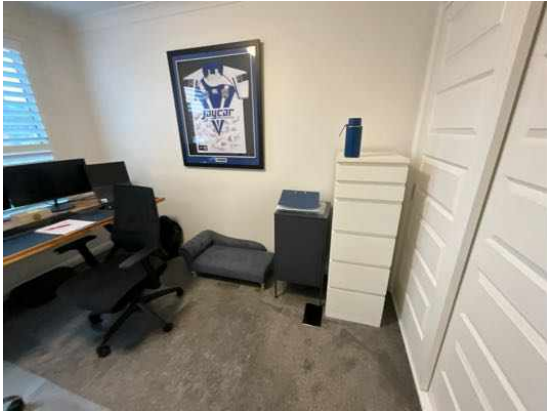
Building: Main Building
Location: All Areas
Finding: Additional Photos - Obstructions and Limitations
Information: These photographs are an indication of the obstructions and limitations which impeded full inspection of the property at the time of inspection. These obstructions can hide an array of defects and should be removed to allow full inspection to be carried out. A re-inspection is recommended once the areas are made accessible.

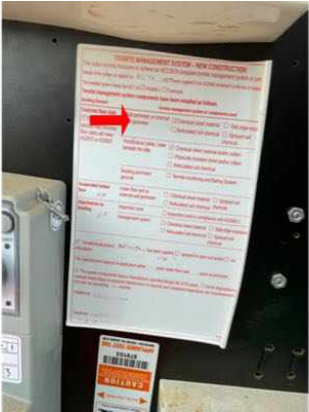
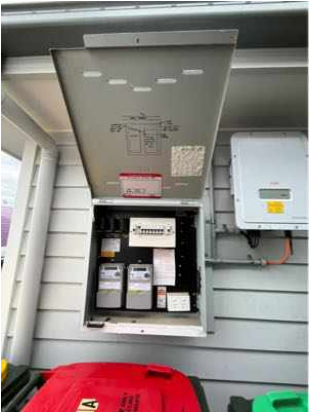
- Building: Main Building
- Location: Exterior walls - right side
- Finding: Evidence of Termite Management System - Durable notice / Legible Sticker - seek further information
- Information: The application of a pre & post-construction chemical termite barrier is highly recommended for all properties. Such barriers are highly effective in preventing termite

A durable notice placed in the switchboard unit to indicate termite barriers at the time of inspection.

Client must seek further information from the vendor or real estate agent if the conditions of termite management systems were maintained as per the label or seek advise from licensed pest controller.
