Building and Timber Pest Inspection Report

Inspection Date: Fri, 6 Feb 2026

Property Address: 4 Drapers Rd, Willow Vale NSW 2575,
Australia

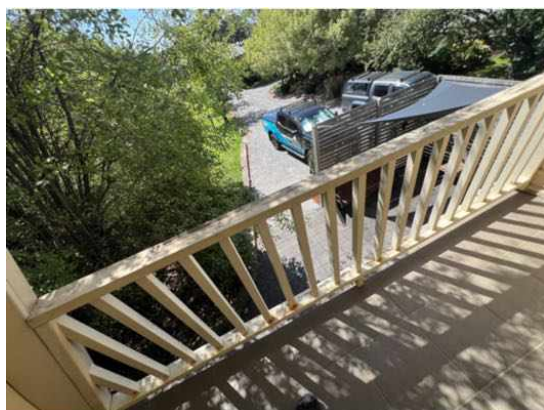
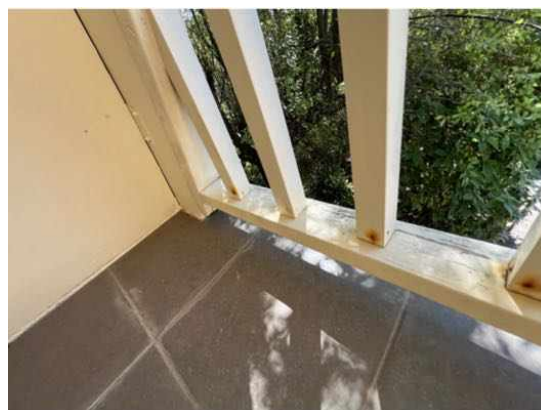
Building:	Building 1
Location:	Balcony
Finding:	Balustrade - Rusted Fixings
Information:	Corrosion was observed to fixings associated with the balustrade. Rusted fixings can reduce the effectiveness of connections over time and may contribute to loosening or instability of the balustrade if deterioration progresses.

Ongoing exposure to weather and moisture is a common contributing factor to this condition. Continued corrosion may lead to further deterioration of both fixings and adjoining timber elements.

It is recommended that a registered builder or qualified carpenter assess the balustrade fixings and determine whether repair or replacement is required to maintain adequate performance.

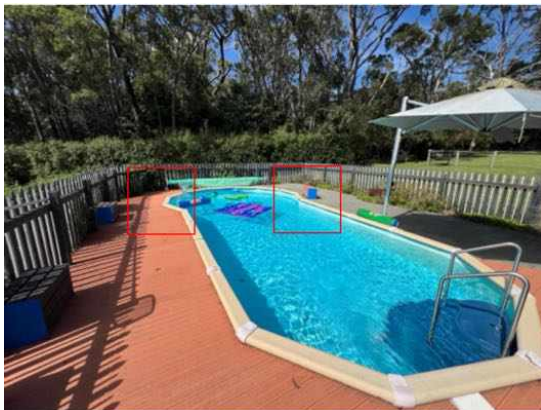
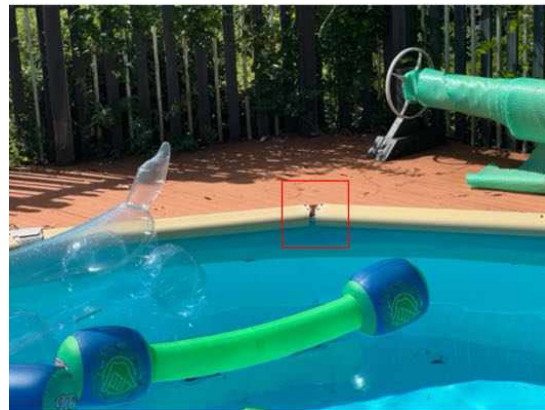
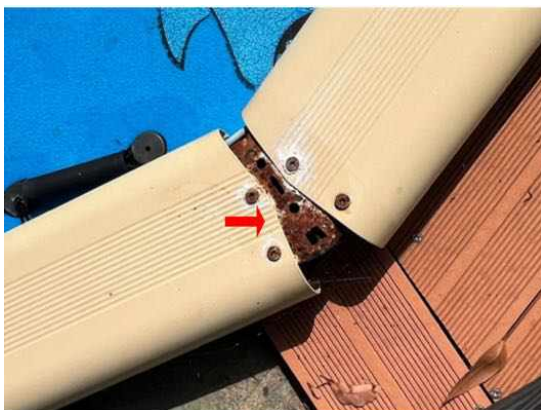
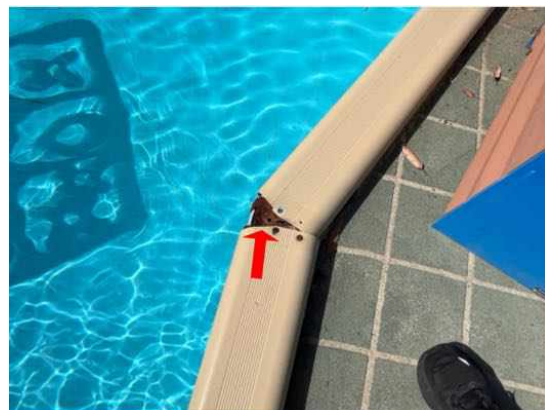
Finding 1.02

Building: Yard
 Location: Swimming Pool - Above Ground
 Finding: Building element - Rusted or corroded
 Information: This building element shows evidence of rusting and corrosion, which is likely to have developed as a result of excessive exposure to moisture and or inadequate coatings.

As surface rust provides no protection to the underlying iron, the deteriorating condition is likely to worsen if not addressed in the short-term future.

Where possible, the use of galvanized (treated) metals or aluminium coated metals aid in rust prevention, as does regular general maintenance. Rust formation can be controlled with coatings, such as paint, that isolate the iron from the environment.

Rusting and corrosion should be managed by ideally removing or limiting the affected surface from exposure to moisture. A registered builder may be appointed to replace any building elements that have been severely affected by rust or water damage.

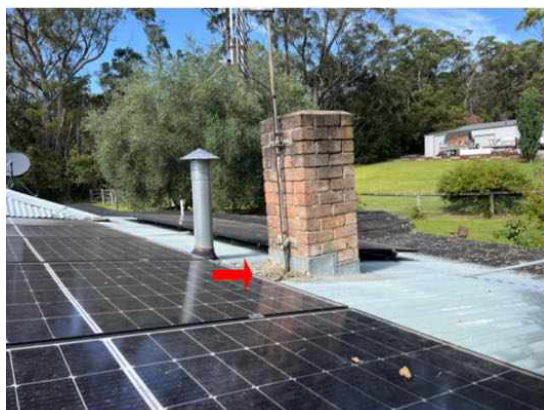
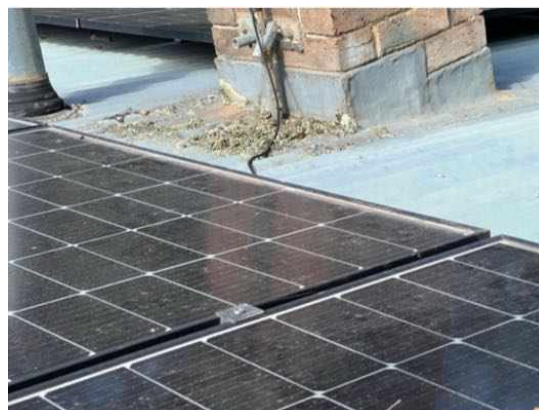
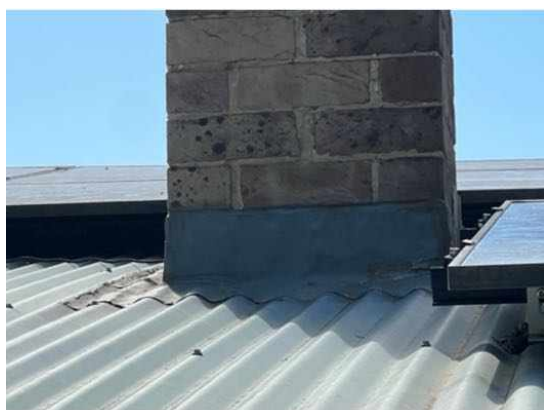
Finding 2.01

Location: Roof Exterior
 Finding: Roof plumbing - Flashing inadequate
 Information: Some sections of the roof are missing or have inadequate roof flashings. Flashings are metal and other materials which are applied to seals and intersections between roof coverings and building elements. They are designed to aid in weatherproofing of roof joins.

Flashings that are not installed adequately or are missing are likely to result in water penetration to the interior of the property, as well as creating excessively damp conditions against the exterior surfaces and around the base perimeter of the building.

Premature ageing and secondary building defects are imminent where roof plumbing is missing or inadequately installed. Additionally, water pooling also creates an environment that is susceptible to termite and pest infestation.

A roofing plumber should be appointed as soon as possible to install relevant roof plumbing materials, ensuring that no further damage is sustained.

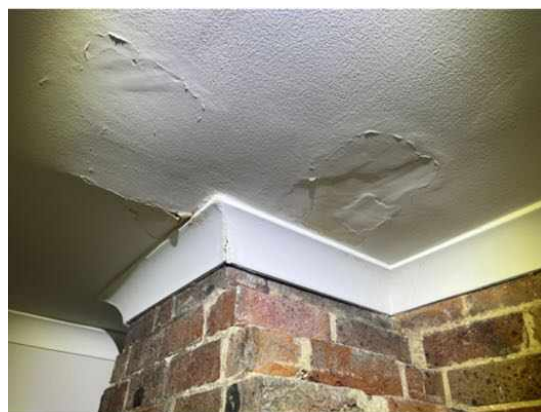
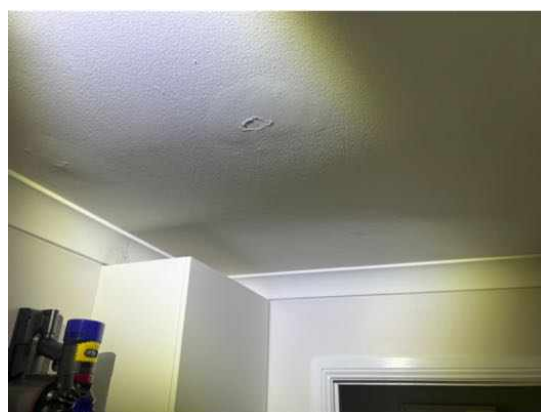
Finding 2.02

Building: Main Building
 Location: Laundry
 Finding: Ceiling - Sagging

Information: Sections of the ceiling were found to be sagging at the time of inspection. Sagging to the fixed ceiling structure generally indicates that the building materials have swollen, due to contact with water, or that fixings (e.g. nails or glue) have become loose and require reattachment.

In some cases, sagging ceiling linings may also indicate that there are structural issues, causing surfaces to warp, twist or sag. Where sagging appears to be major, appointment of a structural engineer is advised to further inspect the property and identify the source and rectification works required.

Where minor sagging is evident, comparatively minor works, such as re-gluing of ceiling sheets, may be required. Such works may be performed by relevant tradespeople, such as plasterers and painters. Where excessive moisture has caused the roofing structure to swell and sag, the source of the water leak should primarily be identified prior to any remedial works being performed.

The appropriate action should be taken by the client as soon as possible to ensure that any potential further damage is limited.

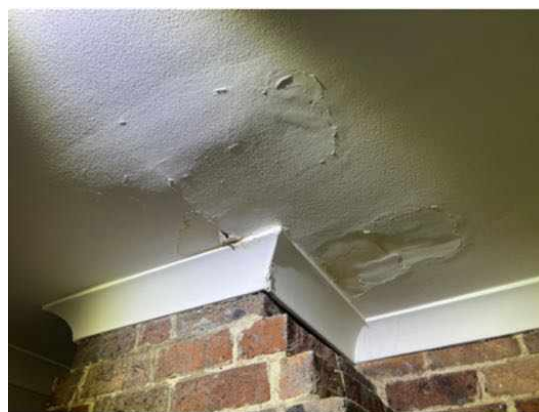
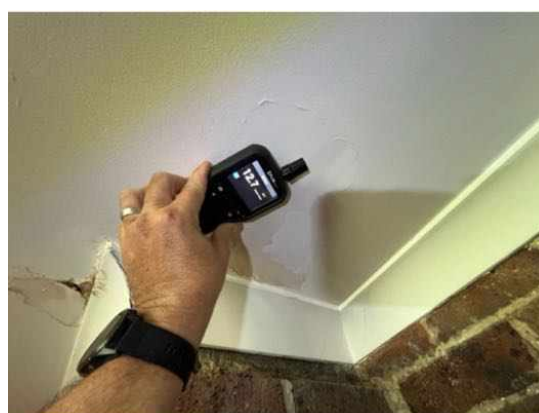
Finding 2.03

Building: Main Building
Location: Laundry

Finding: Ceiling - Water damaged.
Information: Water damage to the ceiling lining is generally an indication of excessive moisture being present in the roof void, usually via a leak to the roof covering.

Where water damage is evident to the ceiling, the primary requirement is to identify and rectify the source of the leak. A roofing plumber should be appointed as soon as possible to identify the leak and perform rectification works as necessary, ensuring the water damage is restricted.

Once the leak is repaired, consultation with relevant tradespeople, including plasterers and painters, is advised. Rectification works may include replacement of ceiling lining or minor repainting, depending on the extent of the damage.

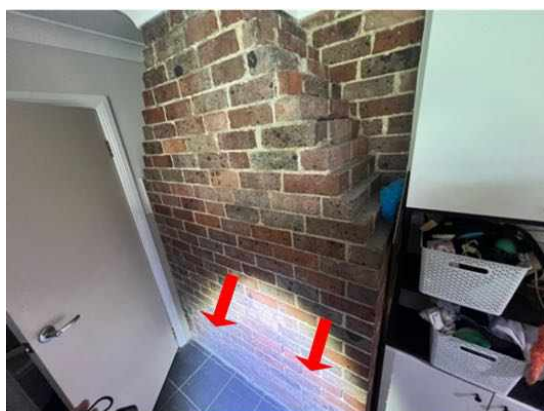
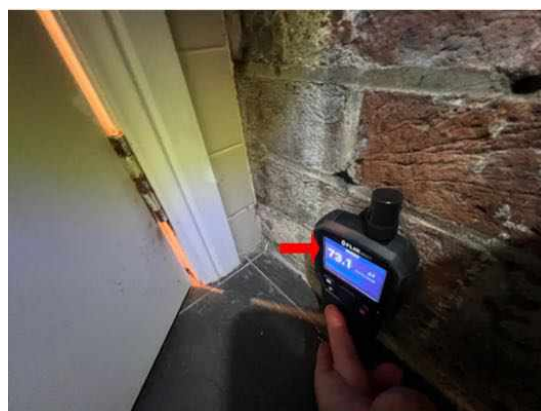
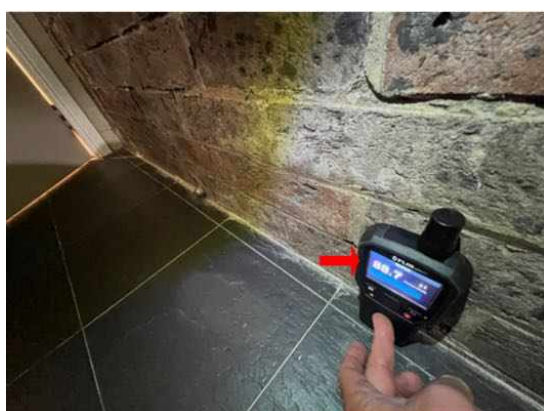
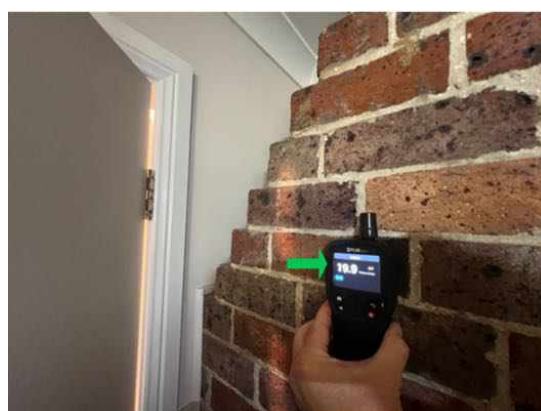
Finding 2.04

Building: Main Building
Location: Laundry
Finding: Damp - Rising
Information: Rising damp describes the upward movement of water in low sections of building elements (e.g. walls) by capillary action - the movement of water through porous materials such as bricks, sandstone or mortar.

wall above ground level. However, many 19th Century buildings have no damp course installed, or the materials have failed. The DPC may have been omitted as a consequence of poor workmanship, or it may have been bridged where materials built up against the side of the house allow moisture ingress above the DPC level.

The first step in addressing rising damp is to diagnose the cause. The identified cause should be addressed first before addressing the appearance and other defects which have resulted from the rising damp. If the original cause is not resolved, further cases of damp are likely to ensue, resulting in secondary defects.

Consultation with a qualified plumber is advised immediately to identify the cause of the damp and perform remedial works as required.

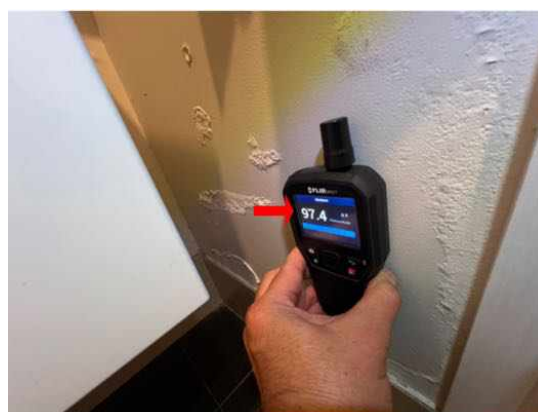
Finding 2.05

Building:	Main Building
Location:	Toilet (WC)
Finding:	Walls - Lateral damp
Information:	Lateral penetrating damp refers to the sideways movement of moisture,

predominantly from the surrounding ground, which tends to affect basement walls and other earth-retaining walls. The implications of unmanaged damp range from mould fungi growth, wood rot and decaying building materials, to finishes including lifting, bubbling, peeling and staining of paint, plaster and wallpaper.

It is important to address damp conditions as the World Health Organisation notes that excess moisture leads - on almost all indoor materials - to the growth of microbes such as moulds, fungi and bacteria, which subsequently emit spores and other matter into the indoor air. Exposure to these contaminants is associated with a wide range of respiratory and other health-related problems. Additionally, the development of damp in timber building elements also provides an environment that is conducive to termite / timber pest attack.

Structural waterproofing barriers or tanking barriers are often used to protect internal surfaces against the effects of lateral penetrating dampness. These types of work are generally undertaken where the source of the penetrating damp cannot be prevented.

Immediate consultation with a licensed plumber is advised to address the cause of the damp and to perform remedial works as necessary.

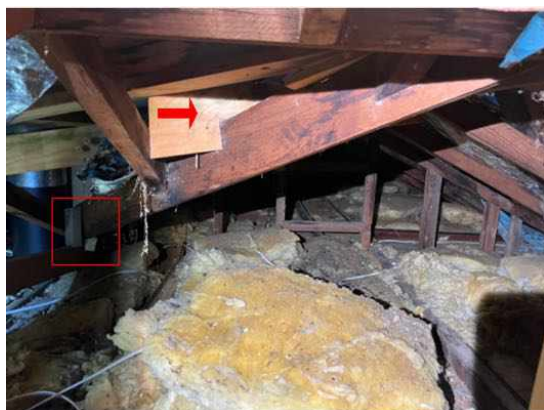
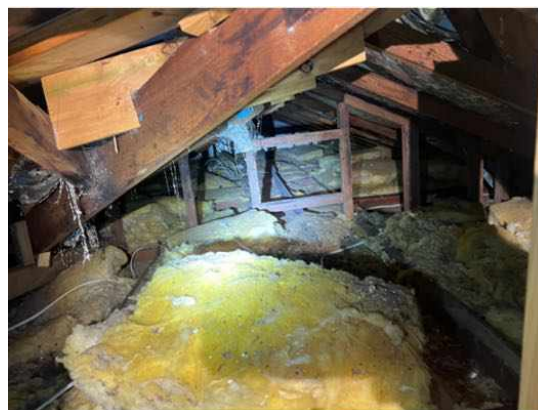
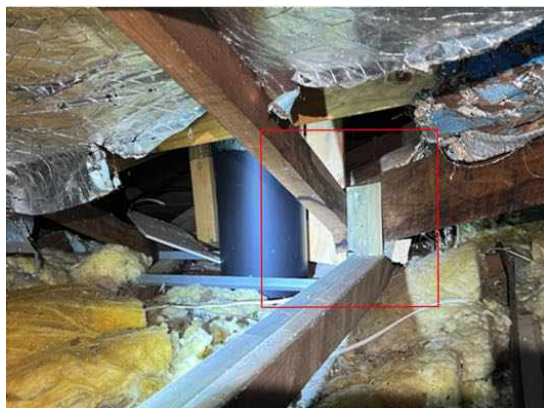
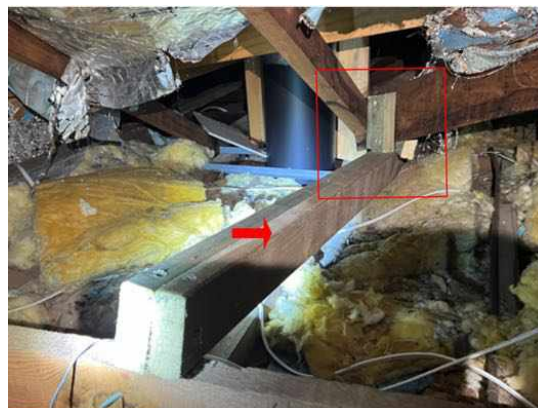
Finding 2.06

Building:	Main Building
Location:	Roof Void
Finding:	Roof structure - Removed or altered
Information:	Alterations to the roof structure have occurred. The modifications do not comply with current building practices and standards and require remedial works to reinstate to a suitable standard.

Replacement of major sections of roofing is likely to be required in order to comply with building regulations. Further assessment and necessary works should be performed immediately by a registered builder. Until works are completed to bring the roofing structure to an appropriate level, the surrounding area should be avoided by all persons as a safety precaution.

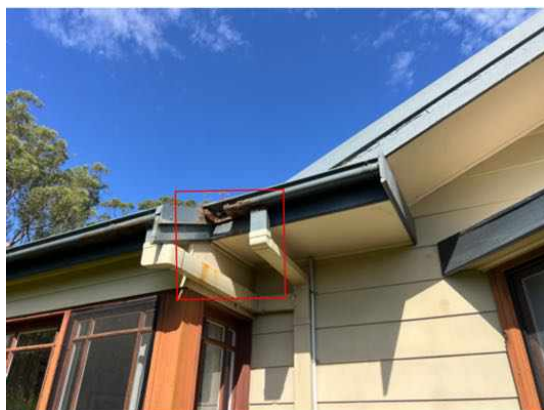
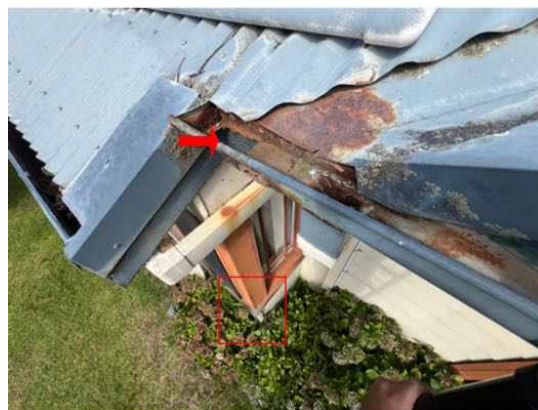
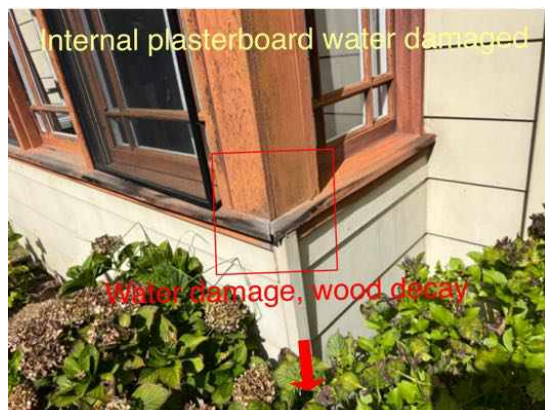
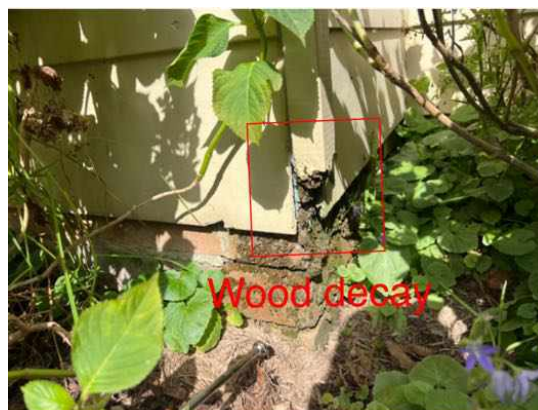
Finding 2.07

Building:	Main Building
Location:	Roof Exterior
Finding:	Water leak - External
Information:	Water leaks were found to be present to exterior plumbing work. Leaks are generally caused by deterioration of the plumbing elements over time, due to exposure to weather conditions, but may have also been caused by minor impact damage.

Such leaking creates damp conditions in the affected area, causing potential for water pooling and subsequent water damage if left unattended. These conditions may also attract termite attack, particularly if the area is subject to minimal levels of sun throughout daylight hours.

It is highly advised that a licensed plumber be appointed to rectify any water leaks that may be present. Areas of repair and replacement of plumbing fittings and fixtures may be required and, as such, a quotation should be sought.

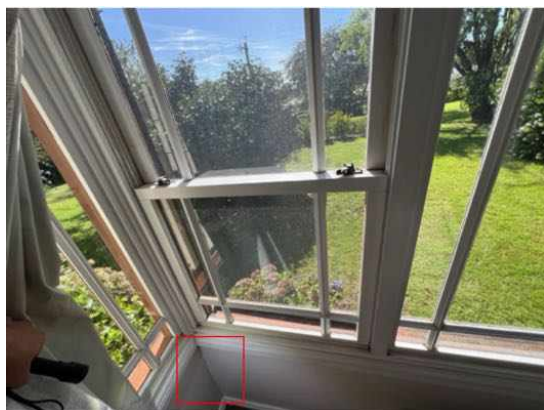
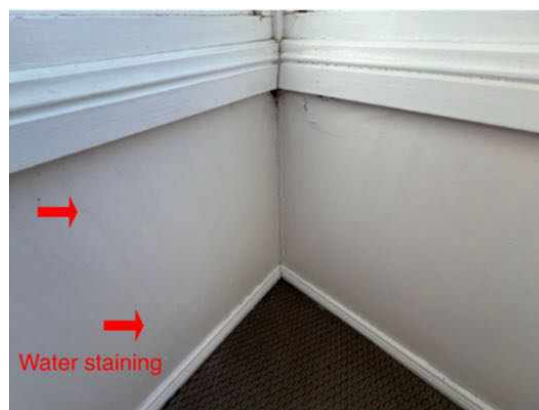
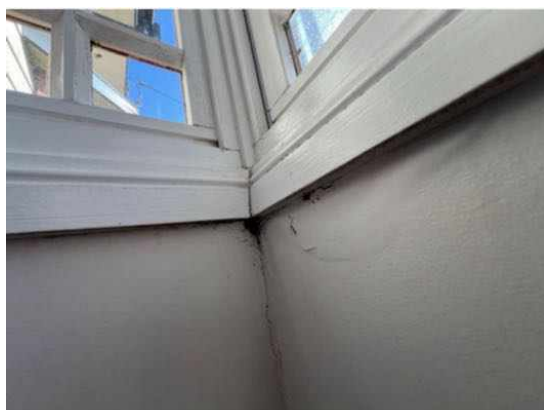
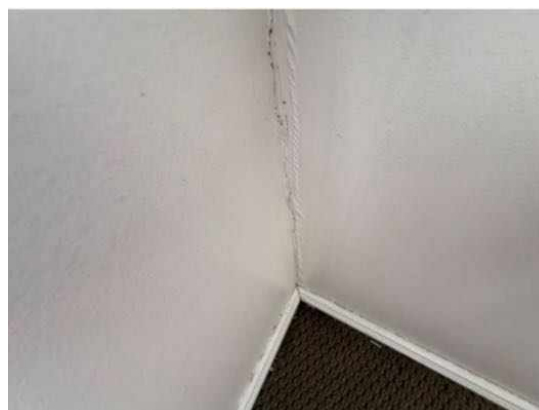
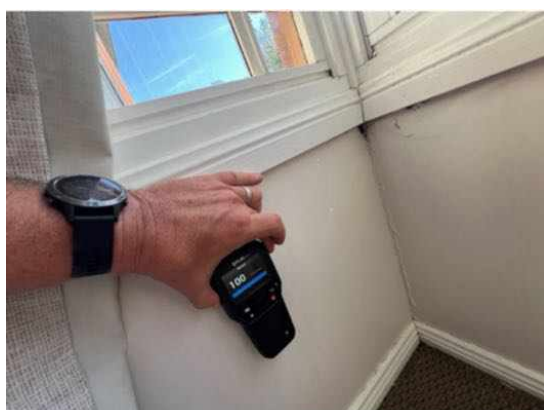
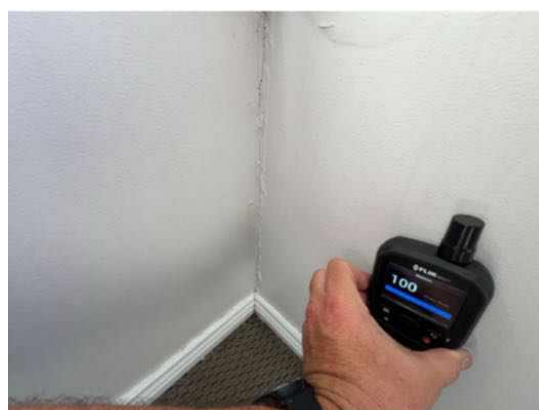
Finding 2.08

Building:	Main Building
Location:	Bedroom 3
Finding:	Wall - Water damaged
Information:	Water damage to the wall lining is generally an indication of excessive moisture being present within the wall, usually via moisture ingress. This may be associated with failed or deteriorated seals to window frames, sills, or penetrations, or roof or gutter issues allowing water to track down wall cavities.

Where water damage is evident to wall linings, the primary requirement is to identify and rectify the source of moisture. A registered builder should be appointed as soon as possible to investigate the cause and determine the appropriate rectification works required to restrict further moisture exposure.

Once the source of moisture is addressed, consultation with relevant tradespeople, including plasterers and painters, is advised. Rectification works may include replacement of wall lining or minor repainting, depending on the extent of the damage.

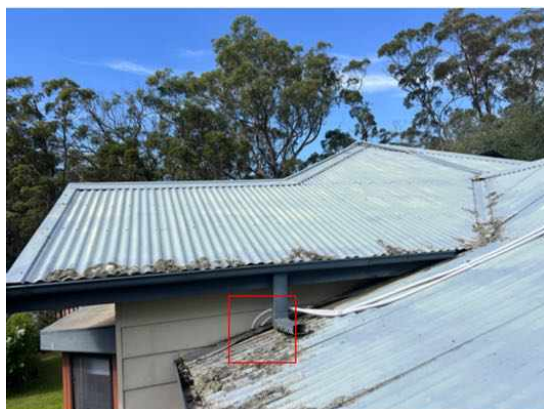
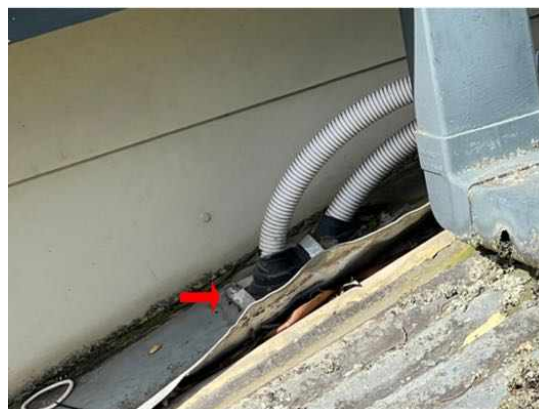
Finding 2.09

Building: Main Building
 Location: Roof Exterior
 Finding: Roof plumbing - Flashing penetration
 Information: A service penetration was observed to pass directly through the roof flashing at this location. Flashings are intended to remain continuous and intact to provide a primary waterproof barrier, and penetrating through a flashing compromises its ability to prevent water ingress.

Penetrations through flashings create a high risk point for water entry, allowing moisture to track beneath the roof covering and into the roof space. If left unmanaged, this condition may result in damage to associated building elements,

including ceiling linings, timber framing, mould growth, and potential electrical hazards.

The penetration and flashing arrangement should be rectified as a priority to reinstate effective weatherproofing. Repairs to any affected internal finishes should only be undertaken once the roof penetration has been correctly addressed.

It is recommended that a licensed roof plumber be engaged to assess the penetration and flashing configuration and carry out appropriate rectification works to ensure the roof remains weather-tight.

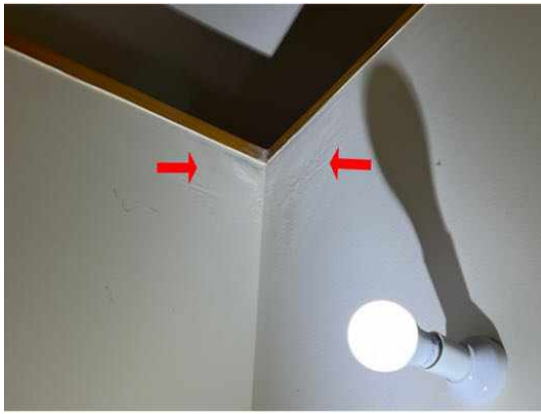
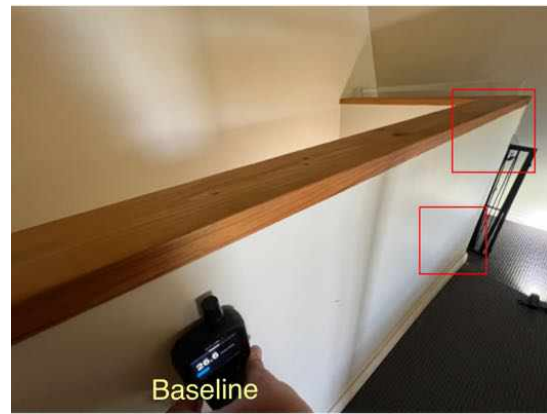
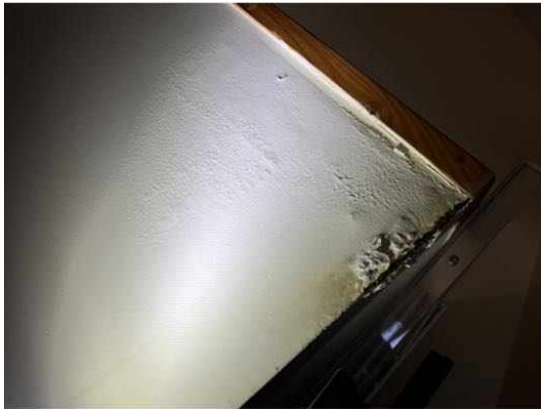
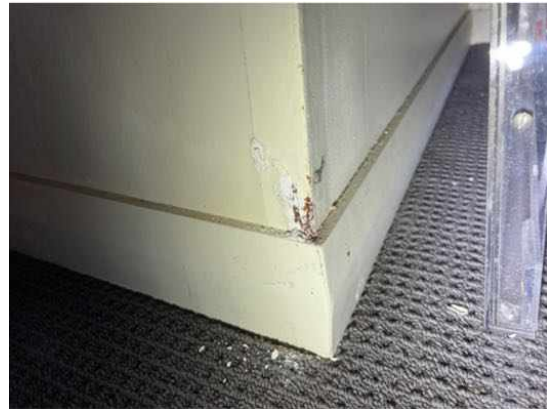
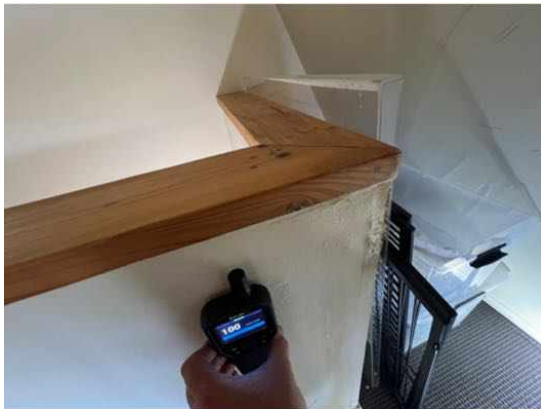
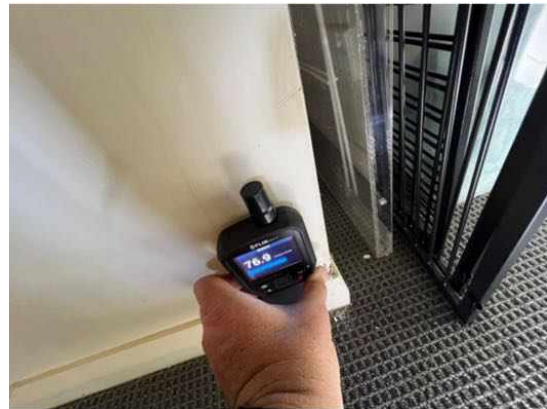
Building:	Building 1
Location:	Loft
Finding:	Walls - Water Damaged (localised)
Information:	Water damage was observed to a localised section of the wall lining in this area. The plaster finish is bubbled and deteriorated, with corrosion noted to the corner bead, and elevated moisture readings were recorded during inspection. These conditions indicate that excessive moisture is present within the wall structure.

Water damage of this nature may result from moisture ingress via adjoining building elements, concealed openings, or moisture tracking within wall cavities. While the ceiling above appeared to be in satisfactory condition, the exact source of moisture could not be confirmed without an invasive inspection.

Prolonged moisture exposure may lead to further deterioration of wall linings, corrosion of fixings, and concealed damage to adjacent building elements. Elevated moisture conditions also create an environment that is conducive to timber pest activity.

It is recommended that a registered builder be engaged to undertake further investigation, including invasive inspection if required, to determine the extent of any concealed damage. Once the source of moisture is identified, appropriate rectification works should be carried out, with repairs to wall linings completed as necessary.

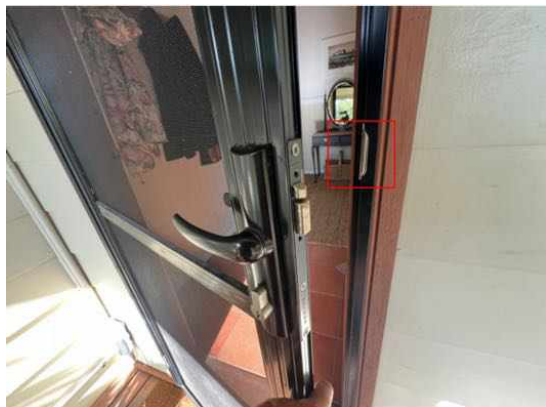
Finding 3.01

Information: It was noted that the door in this area was not latching during operation at the time of inspection. Whilst detracting from the functionality of this building element, this minor defect may also be a security risk, and may therefore have serious implications if left unattended.

It is suspected that this defect has occurred due to minor issues with the associated hinges. Such damage is identified as general wear and tear, which is expected for building elements of this age.

A qualified carpenter or general handyperson may be appointed to perform rectification works as necessary, at client discretion. If left unattended, further functional impairment is likely to occur.

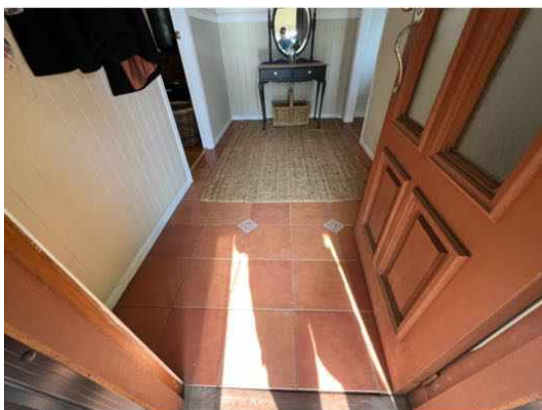
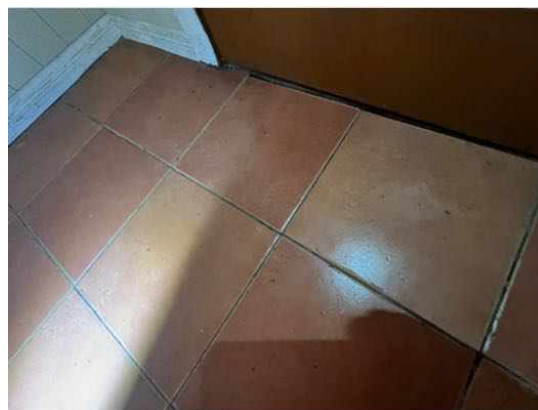
Finding 3.02

Information: Drummy tiled areas were identified at the time of inspection. The term 'drummy' refers to tiles that have become detached from their fixing, despite otherwise being in relatively good condition. Such defects are generally caused by physical or moisture damage to the area. Drummy tiled areas may also be a direct result of poor workmanship during the construction process.

Tiled areas may swell and shrink with changes in air humidity if the area has sustained moisture damage. Any exposure to moisture is capable of causing tiled areas to become drummy and/or cracked over a prolonged period of time. Drummy tiled areas generally require removal and replacement of affected tiles, with adequate sealant and grouting.

Specialist trades are available for these types of services. A registered builder may be required to undertake works if damage is extensive or if secondary building defects have resulted. Otherwise, it is advised that a tiling contractor be appointed to perform works as necessary. Immediate action is recommended to ensure that no further damage is sustained in the affected area.

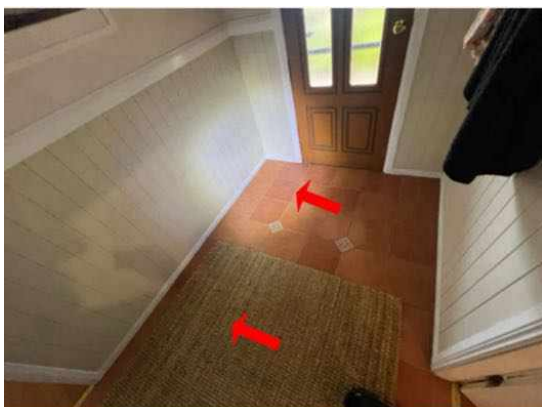
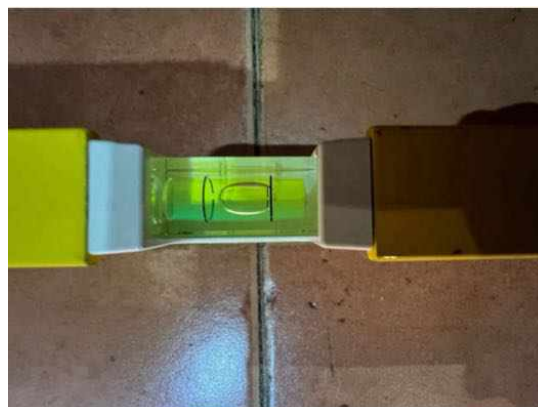
Finding 3.03

Information: The tiled flooring area appears to be uneven in this area. While this may indicate a failure of the subfloor structure, it is suspected, in this case, that the area has been subjected to poor tiling workmanship at the time of installation.

Where poor workmanship is the cause of uneven tiling, the tiled surface level is unlikely to decrease further. If unevenness does increase over time, this may indicate issues with the associated flooring structure.

Where uneven tiled flooring appears to be a result of poor tiling work, a tiling contractor should be appointed to re-instate the flooring at the discretion of the client. Where flooring remains uneven, further inspection of the flooring structure may be required.

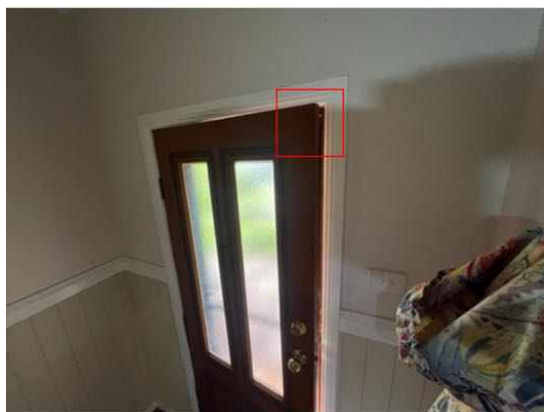
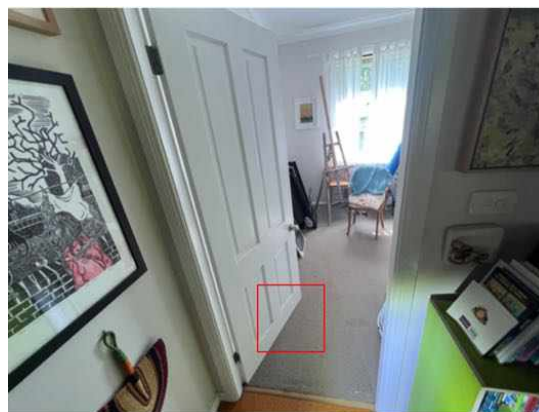
Finding 3.04

Information: Binding and/or jamming of several doors throughout the property were evident during standard operation. This defect inhibits the functionality of affected doors as well as creating potential for secondary defects to associated building elements, such as damage to the floor covering.

A door that binds to flooring or to the associated door frame may have several causes, ranging from minor defects, such as poor installation of the door or deteriorated hinges, through to major structural issues, such as damage to subfloor structures.

Where door binding/jamming appears to indicate major structural issues, a registered builder specialising in re-stumping should be appointed to provide an estimate on the cost of rectification.

For minor causes, a qualified carpenter or general handyperson should be appointed to perform minor rectification works at client discretion.

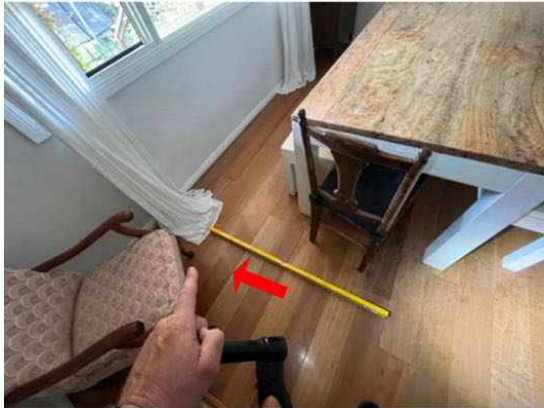
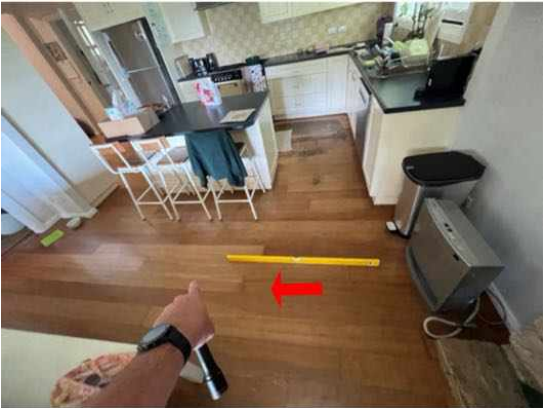
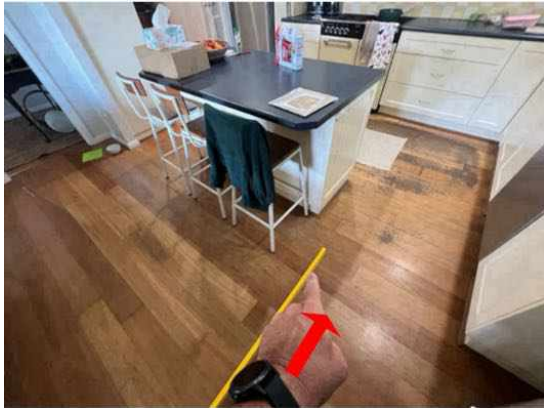
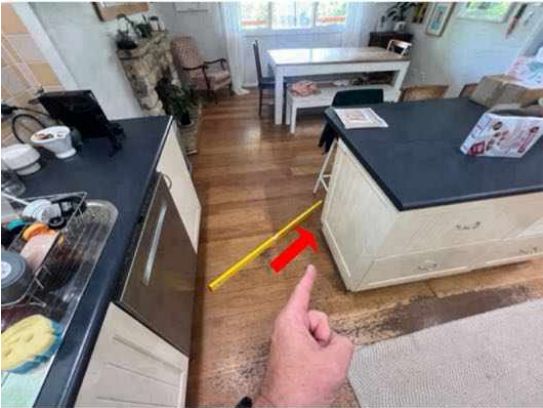
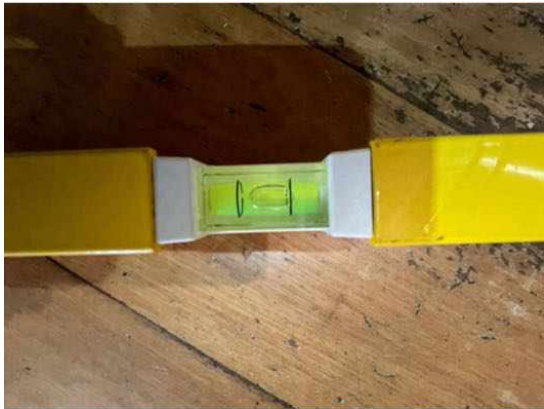
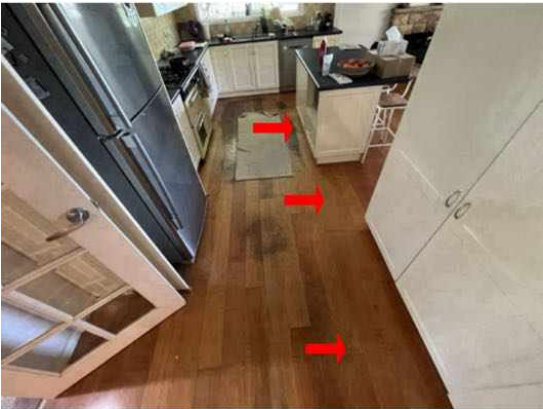
Finding 3.05

Building: Main Building
 Location: Dining Room, Kitchen, Living Room, Bedroom - Master, Bedroom 2, Bedroom 3
 Finding: Flooring - Uneven
 Information: The internal flooring in this area is out of level and uneven. Uneven flooring is likely to indicate minor defects such as expected movement of the foundations of the property, but may also indicate subsidence of the associated subfloor stumps.

It is advised that the flooring be closely monitored to identify any further movement. Where flooring remains relatively unchanged for an extended period of time (i.e. several months), it is likely that this defect has been caused by expected movement of the foundations of the property.

However, where flooring is uneven further, potentially invasive inspection of the subfloor structures and stumps in this area is required. In this case, works to repair are likely to be required, and would be carried out by a registered builder specialising in re-stumping.

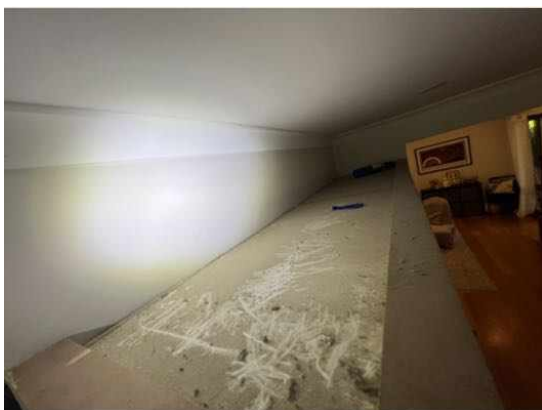
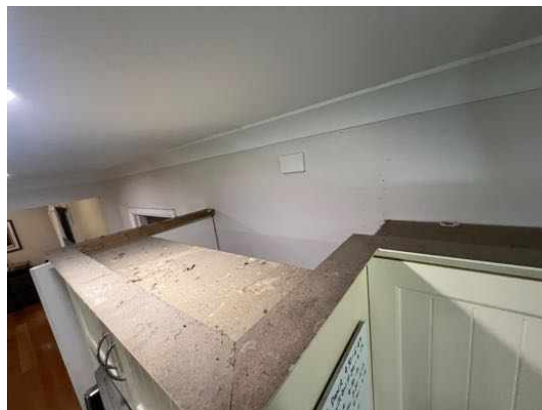
Finding 3.06

Building:	Main Building
Location:	Kitchen
Finding:	Surface - Requires cleaning
Information:	Regular cleaning and maintenance improves the longevity of all building elements. A build up of dirt and debris can reduce the useful life of building materials and may result in earlier replacement of items being required.

Excessive dirt is also likely to lead to secondary hazards, including potential health hazards, as the building elements begin to harbour bacteria and/or mould.

Remedial cleaning is recommended in order to improve the appearance of this area as well as to counteract the development of bacteria. Such works can be performed by a cleaning contractor and should be completed at the discretion of the client.

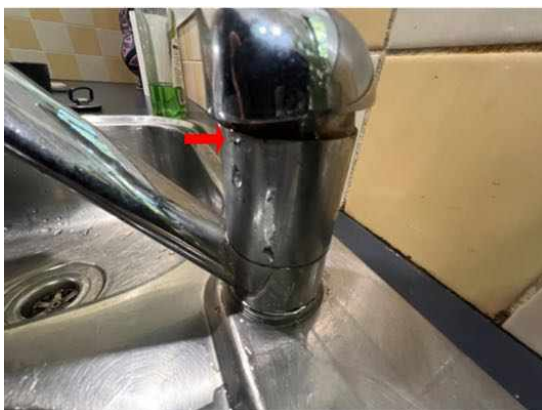
Finding 3.07

Finding: Tap/Mixer - Leaking

Information: The tap in this area was found to be leaking at the time of inspection. This is a common defect that is consistent with general ageing of the building element. However, it may be indicative of substandard plumbing workmanship if the tap is relatively new.

While this defect only seems minor, if left unmanaged, it is likely to result in the development of rust, water damage and/or extensive water usage.

It is advised that a handyman or licensed plumber be appointed to perform remedial works on the affected tap. Such works should be performed prior to the development of secondary defects to ensure adequate functionality of all associated building elements.

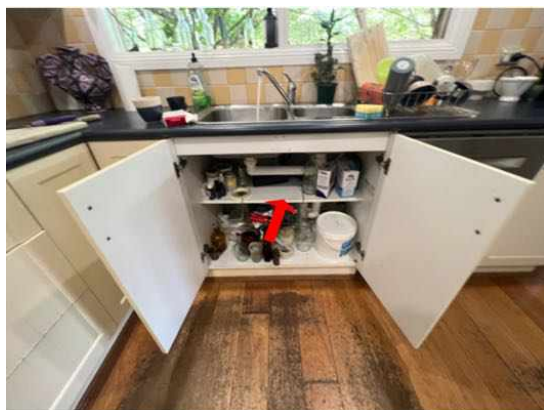
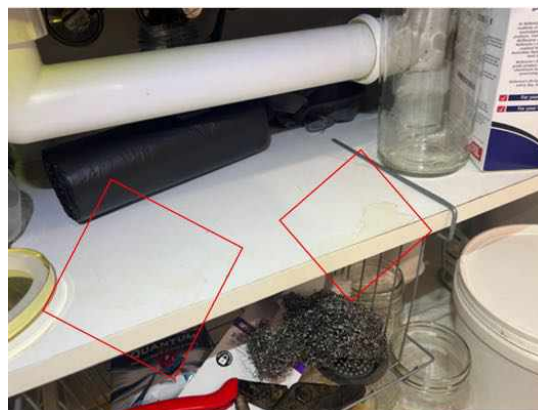
Finding 3.08

Finding: Water staining - sink cabinetry

Information: A water staining was observed to the cabinetry beneath the sink at the time of inspection. Water staining in this area is generally indicative of a previous or active leak from plumbing fixtures, waste connections, or sealant deterioration around the sink junction.

If left unmanaged, persistent moisture can lead to material deterioration, mould growth, and potential damage to adjacent cabinetry or flooring. It is advised that a licensed plumber be engaged to inspect the area, determine if an active leak is present, and undertake any necessary rectification works.

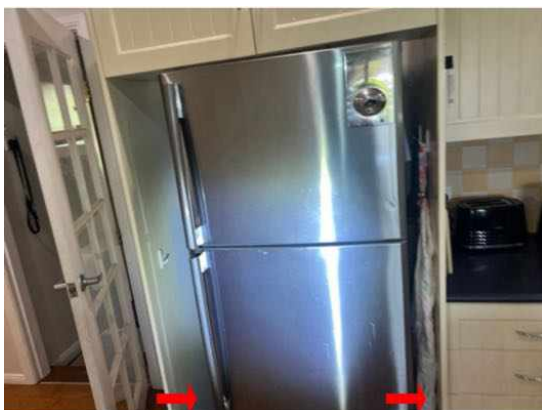
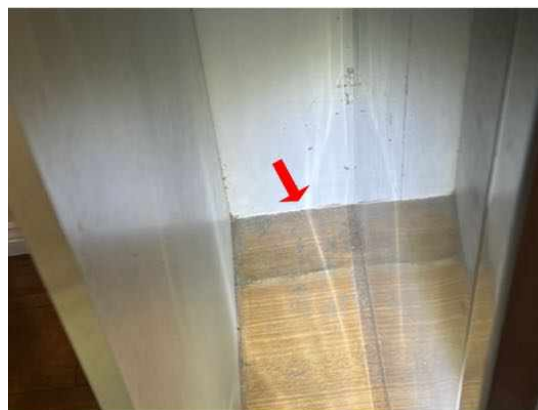
Finding 3.09

Finding: Skirting - Missing

Information: Skirting were missing in this area at the time of inspection. Complete tiled skirting is important in preventing water ingress into the adjoining walls and flooring, protecting the areas against potential water damage. The incomplete skirting also detracts from the overall appearance of the area.

If left unmanaged, water ingress into adjoining areas may have major implications, and may potentially necessitate works to other building elements in the long-term future.

It is highly recommended that a carpenter be appointed to complete these minor works as soon as possible to prevent such damage from occurring.

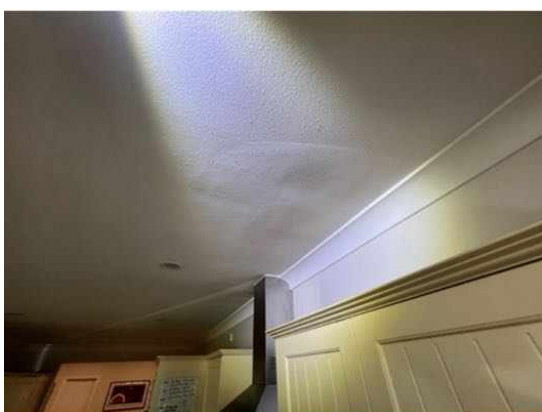
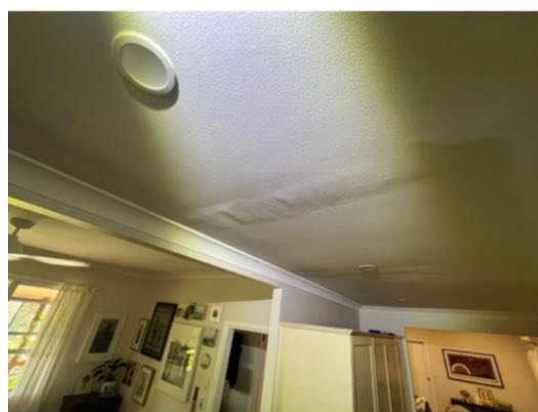
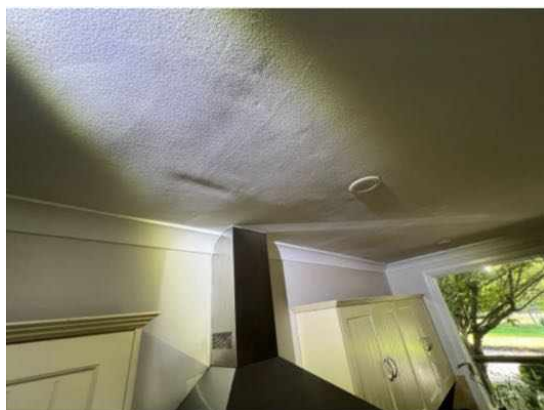
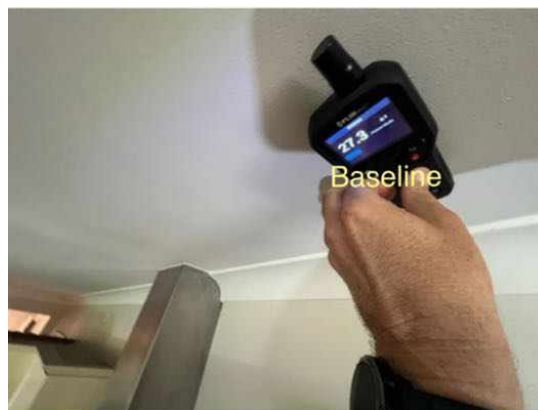
Finding 3.10

Building:	Main Building
Location:	Kitchen
Finding:	Ceiling Defects - Poor Finishing
Information:	Visual inspection revealed inconsistent flushing of joint lines. Minor sagging across ceiling surfaces suggests that back-blocking may have been omitted or poorly executed during installation. Additionally, evidence of substandard patching and finishing was noted in areas where previous defects have been addressed, but not to an acceptable visual standard.

Poor joint treatment, while generally not structural, can lead to further deterioration of ceiling linings if left unmanaged. These issues detract from the ceiling's appearance and may compromise the long-term durability of the plasterboard fixing.

Rectification by a qualified plasterer is recommended. Works should include securing loose fixings, re-flushing affected joints, and applying back-blocking where necessary to stabilise the ceiling structure and improve the visual condition.

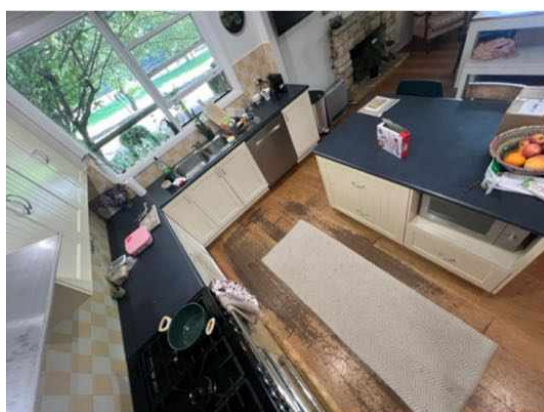
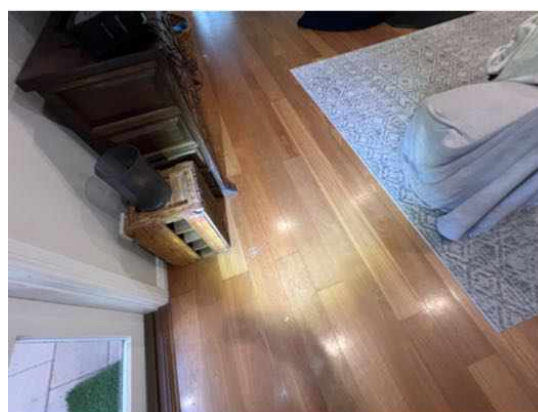
Finding 3.11

Building:	Main Building
Location:	Kitchen, Living Room
Finding:	Floors - bouncy
Information:	The internal flooring in this area was identified as being bouncy at the time of inspection. A bouncy floor surface generally presents as a discernible change in level as they are walked across, in noisy or creaking flooring, or in consequent movement of surrounding furniture and fixtures.

Bouncy floors generally indicate that the floorboards or the subfloor structures are coming loose from the joists that they are installed on. Bouncy flooring may also be the result of gaps between flooring and stumps or joist structures, which require packing.

The client is advised to seek quotations for required repairs from a Registered Builder specialising in re-stumping. The potential resolution may range from packing gaps in subfloor structures through to replacement of subfloors stumps and refixing of flooring.

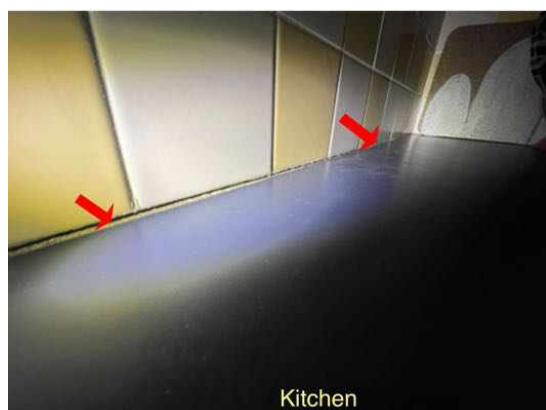
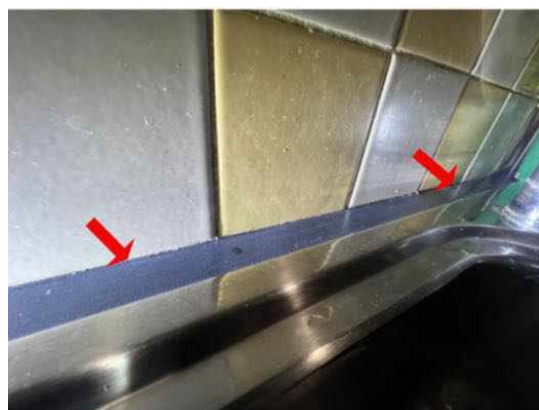
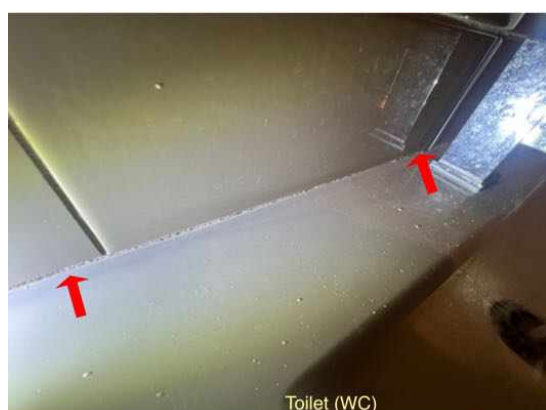
Finding: Sealant - degraded
 Information: It was noted on inspection that sealant or grout is degraded to this area.

Different materials move at different rates, generally causing cracking to grout or sealant at this point. A flexible sealant is required to allow for expected expansion and contraction, while keeping the joint water tight and protective of all associated building materials.

Flexible and mould resistant materials should be applied to affected areas to prevent any subsequent water damage that is likely to occur. Regular maintenance and replacement of damage or missing or damaged sealant and grout is highly recommended to the wet areas, as this is a regular wear and tear defect. Sealant and grouting in areas that come into regular contact with water should be maintained for the long term care of your property.

A sealant specialist or tiling contractor should be appointed to complete these works as soon as possible

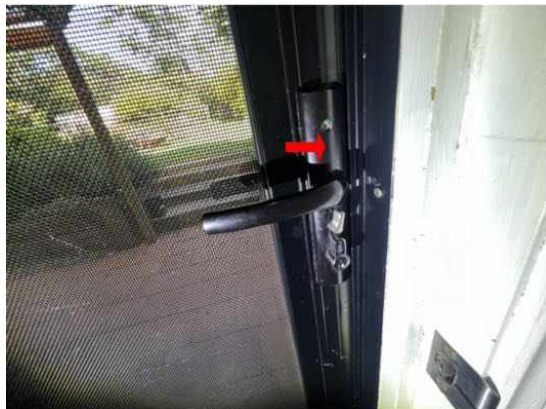
Finding 3.13

Building: Main Building
 Location: Foyer - Bathroom/Laundry
 Finding: Door Handle - Loose

Information: The door handle in this area was identified as loose at the time of inspection. A loose door handle can impede the proper operation of the door and, if left unattended, may lead to further deterioration or damage to the associated door structure.

This defect is typically caused by wear and tear, insufficient fixing, or deterioration of the handle's components.

It is recommended that a qualified carpenter or general handyperson be appointed to secure or replace the handle to restore its functionality and ensure proper operation.

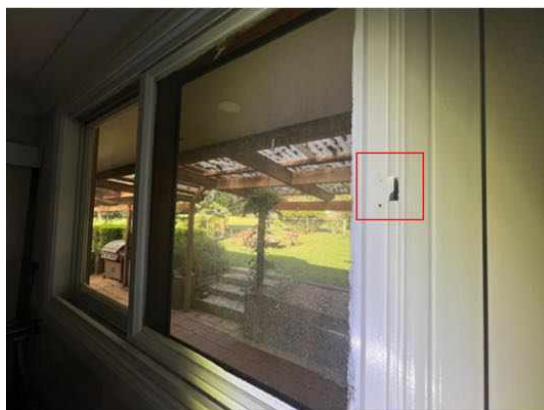
Finding 3.14

Finding: Window - Missing lock mechanism

Information: The lock mechanism to the window was found to be missing at the time of inspection. Breakage occurs generally when the building materials have aged and decayed, but may be indicative of impact damage (accidental or deliberate).

Repair and/or replacement of the window winder/lock is advised to improve the operational state of the associated window.

A qualified carpenter should be appointed to repair/replace the window winder/lock at the client's discretion.
