Building and Timber Pest Inspection Report

Inspection Date: Fri, 6 Feb 2026

Property Address: 4 Drapers Rd, Willow Vale NSW 2575,
Australia

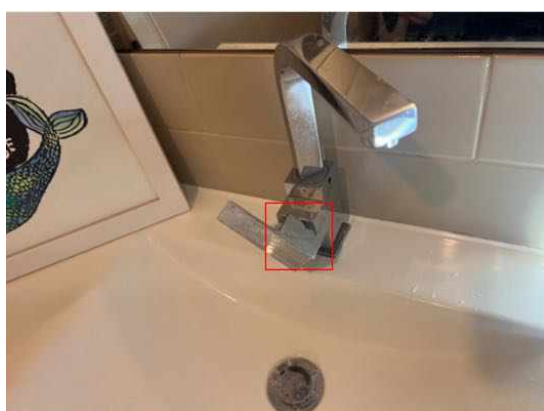
Finding 3.15

Building:	Main Building
Location:	Toilet (WC)
Finding:	Tap - Water hammer
Information:	This tap shows evidence of water hammer being present. Water hammer, a pressure surge resulting when a fluid is forced to suddenly change direction, is a common defect in plumbing fittings, particularly those that are aged and not frequently maintained. Water hammer is generally caused by factors that create high water pressure in the affected plumbing fixture, usually evidenced by a faint banging noise during operation of the affected tap.

Although water hammer is generally considered to be a minor defect, subsequent damage such as erosion of tap hardware and/or water damage to associated building elements is likely to occur if left unmanaged.

A licensed plumber should be appointed as soon as possible to replace any affected tap hardware and perform any remedial works as necessary. Please be advised that the appointment of a cabinet maker or qualified carpenter may be necessary if water damage to associated building elements has occurred.

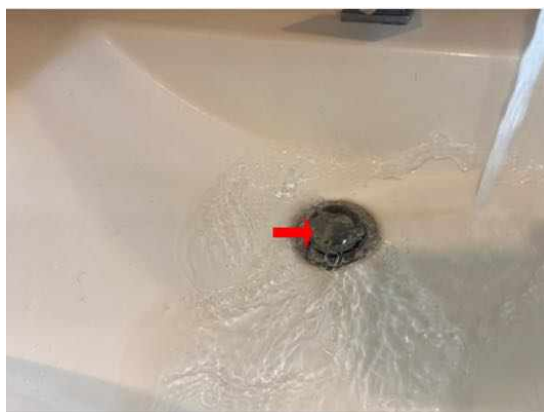
Finding 3.16

Location: Toilet (WC)
 Finding: Pop up waste - stiff /not operating
 Information: The plug waste is not functioning as intended, failing to pop up when engaged. This defect is common in pop-up waste mechanisms, which rely on a spring-loaded or lever mechanism to open and close the drain.

Inability to open or close the drain properly can lead to water retention in the sink, causing inconvenience in daily use. If left unrepaired, the mechanism may further deteriorate, potentially leading to a full malfunction or water drainage issues.

Engage a licensed plumber to inspect the plug waste mechanism and determine if the issue can be repaired or if the waste needs replacement. Ensure that the replacement waste is properly installed and tested for smooth operation.

Regular maintenance of pop-up wastes, such as cleaning debris from the mechanism, can help prevent similar issues from occurring in the future.

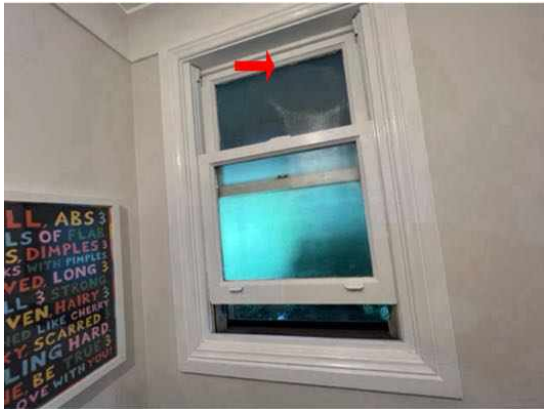
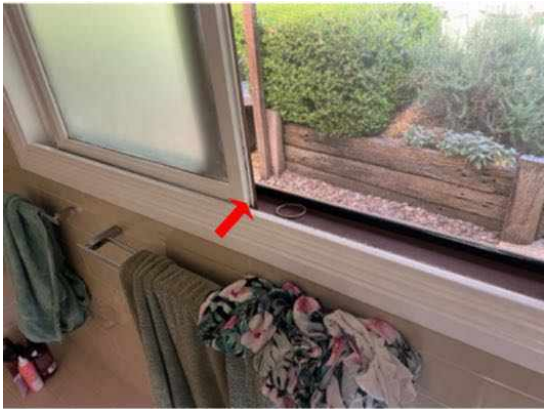
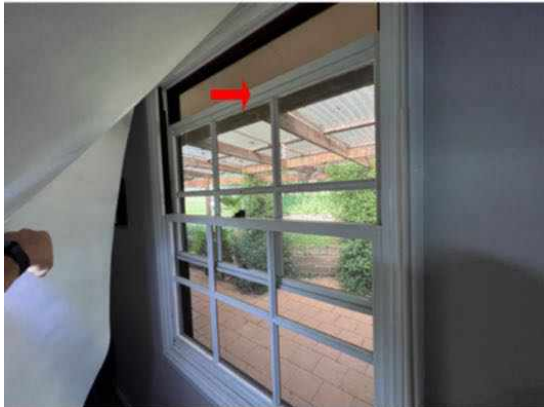
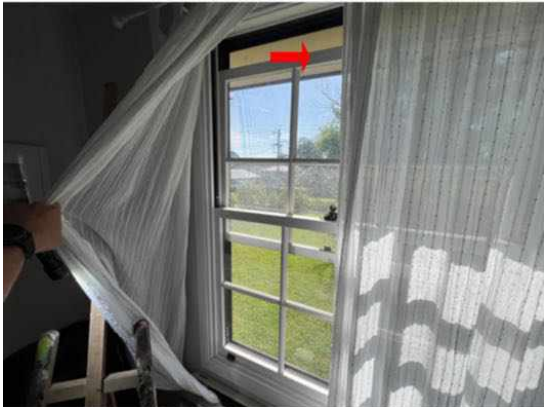
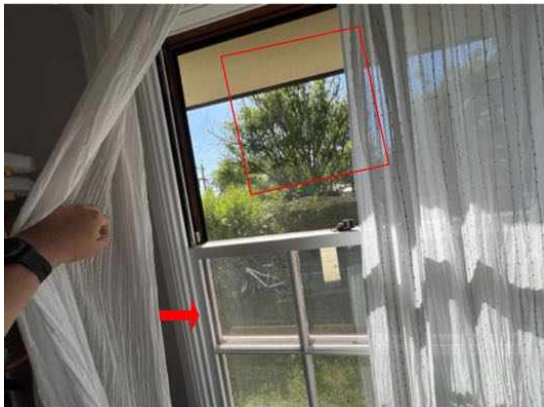
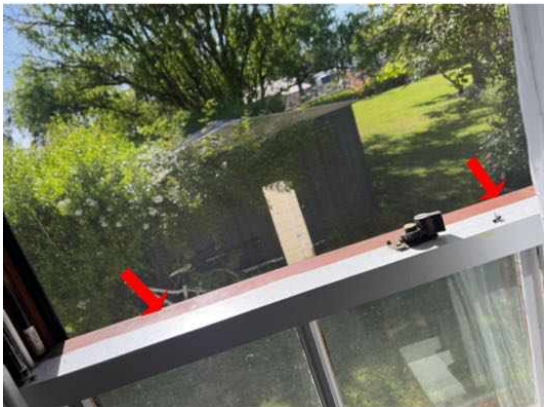
Finding 3.17

Building: Main Building
 Location: Toilet (WC), Bathroom, Bedroom - Master, Bedroom 4, Bedroom 5
 Finding: Window service recommended
 Information: Some windows throughout the property were found not to be fully operational. This may be due to the fact that they did not open, stiff to open, did not stay open or were binding at time of inspection. A window service is recommended.

Windows provide ventilation to the adjoining area and should be at a fully operational level to ensure user comfort.

A competent general handyman or carpenter may be engaged at the clients discretion.

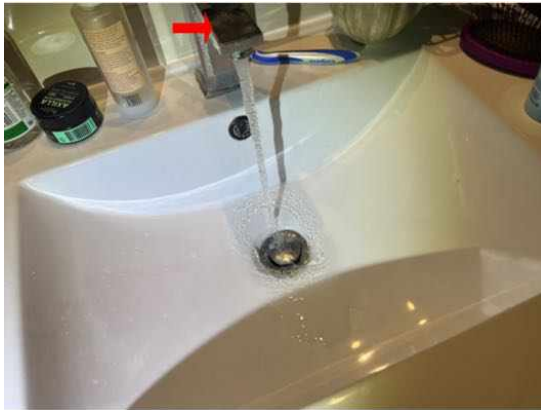
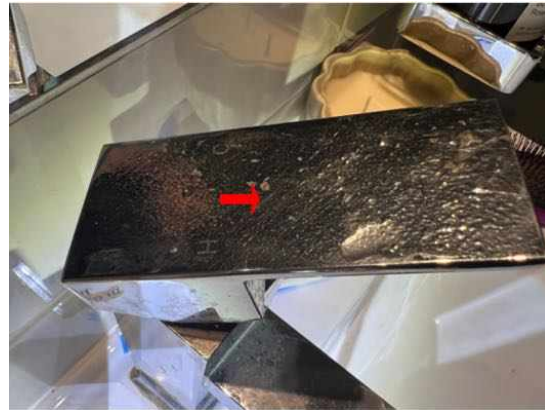
Finding 3.18

Building: Main Building
 Location: Bathroom
 Finding: Mixer - Rusted or corroded
 Information: This building element shows evidence of rusting and corrosion, which is likely to have developed as a result of excessive exposure to moisture and or inadequate coatings.

As surface rust provides no protection to the underlying iron, the deteriorating condition is likely to worsen if not addressed in the short-term future.

Rusting and corrosion should be managed by ideally removing or limiting the affected surface from exposure to moisture. A licensed plumber may be appointed to replace

any building elements that have been severely affected by rust or water damage.

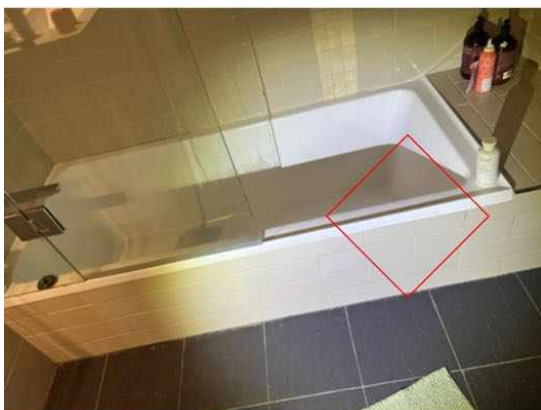
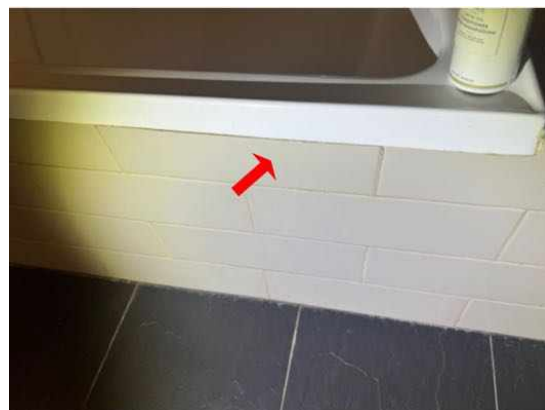
Finding 3.19

Building:	Main Building
Location:	Bathroom
Finding:	Tiles - Drummy or Popped (grout degraded)
Information:	It was noted on inspection that grout is degraded to the tiled area and noticeable popped tiles.

Drummy or Popped tiles indicate that the bond between the tiles and the substrate has weakened, likely due to moisture exposure or improper installation. This can lead to tiles detaching completely over time, which may cause safety hazards. Gaps in the grout further compromise the waterproofing of the surface, allowing moisture to penetrate behind the tiles. This can cause water damage, mold growth, and deterioration of the underlying structure. The drummy effect and loose tiles also affect the visual quality and longevity of the tiled surface.

Engage a qualified tiler to carefully remove and replace the drummy or popped tiles.

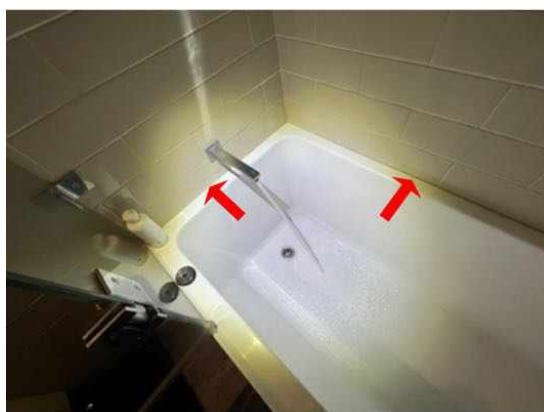
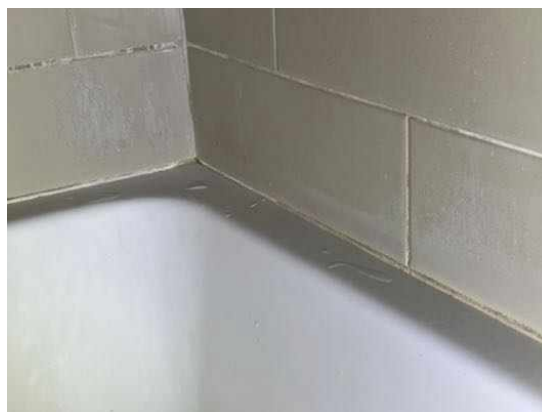
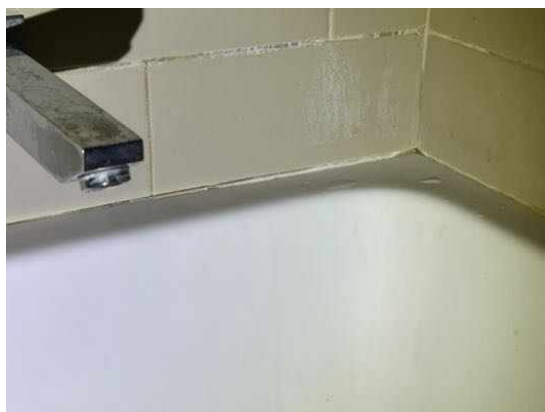
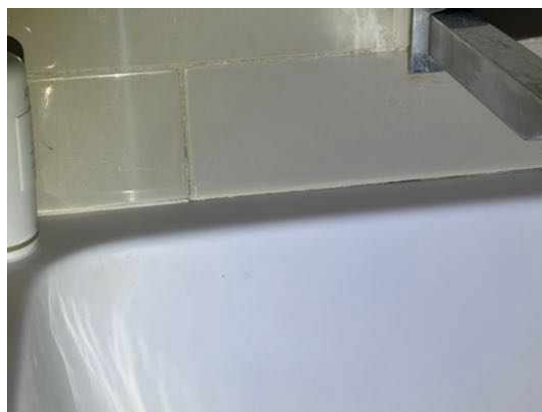
Finding 3.20

Location: Bathroom
Finding: Sealant and grouting - Missing or damaged
Information: It was noted on inspection that sealant or grout is degraded to the tiled shower alcove and or other areas of the bathroom.

Different materials and floor areas move at different rates, generally causing cracking to grout or sealant at this point. A flexible sealant is required to allow for expected expansion and contraction, while keeping the joint water tight and protective of all associated building materials.

There appears to be excessive mould to the sealant and grout which will likely require scraping out and replacement.

Flexible and mould resistant materials should be applied to affected areas to prevent any subsequent water damage that is likely to occur. Regular maintenance and replacement of damage or missing or damaged sealant and grout is highly recommended to the wet areas, as this is a regular wear and tear defect. Sealant and grouting in areas that come into regular contact with water should be maintained for the long term care of your property.

A sealant specialist or tiling contractor should be appointed to complete these works as soon as possible

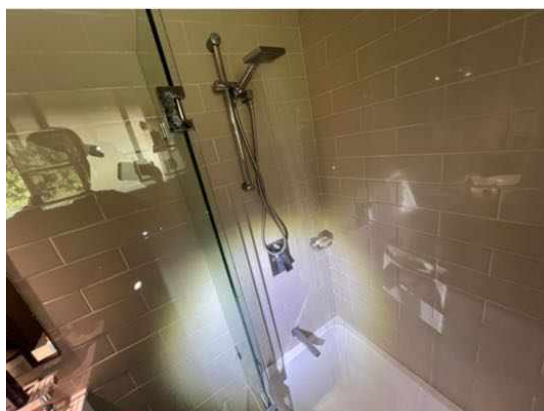
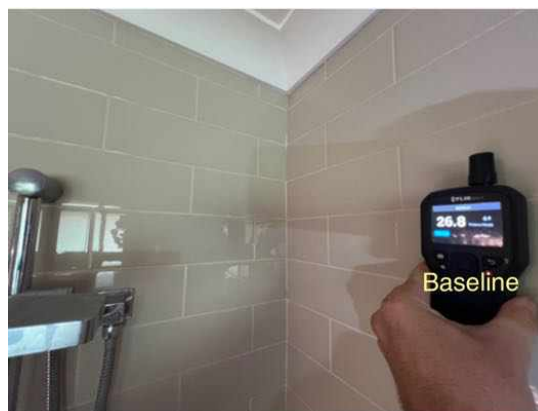
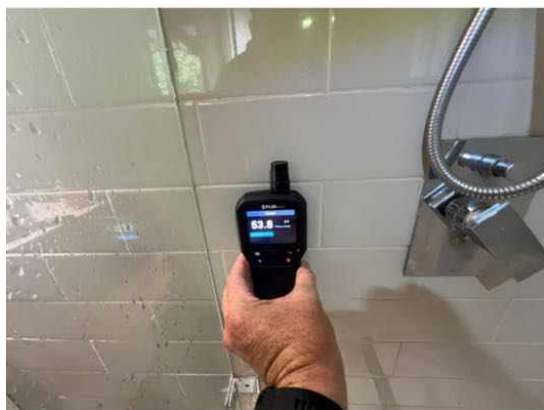
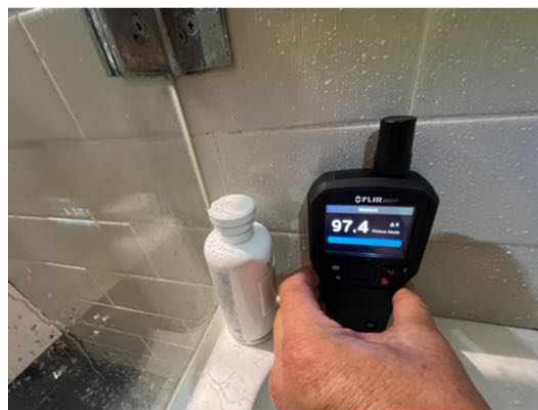
Finding 3.21

Building: Main Building
Location: Bathroom
Finding: Moisture in Shower
Information: Moisture is evident behind the tiles to the shower alcove. This defect is quite common, and is suspected to have been caused by moisture permeating through the grouting in this area. Leaking pipes within the adjoining wall is also a possible cause.

Damp (or structural damp) refers to the presence of unwanted moisture in the structure of a building, either as the result of intrusion from outside, or condensation from within the structure. In the shower area, internal water leaks or other sources of excessive moisture are generally the cause of damp. Always ensure that sealant and grout is in good condition to prevent any moisture issues occurring in the future.

Please note, the moisture meter used operates on the principle of electrical impedance, generating a low-frequency alternating electric field between its electrodes. The instrument measures moisture content within the material at a maximum depth of 19mm below the surface, rather than on the surface itself.

As a result, surface moisture such as residual water on shower tiles does not influence the reading, ensuring that the measurement reflects subsurface moisture levels within the building material, not superficial wetness.

Consultation with a qualified plumber or bathroom specialist is advised to identify the cause of damp and to perform remedial works as required.

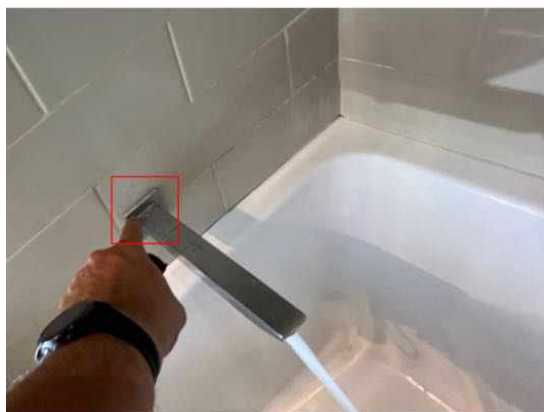
Finding 3.22

Building:	Main Building
Location:	Bathroom
Finding:	Bath spout - Loose
Information:	The bath spout was observed to be loose at its connection point at the time of inspection. This condition is commonly caused by poor installation, deterioration of sealant, or movement in the fixture over time.

A bath spout may lead to water leakage behind the wall/floor, potentially causing moisture damage and deterioration of associated building elements if left unmanaged.

It is recommended that a licensed plumber be engaged to assess and properly secure the spout to prevent further movement and potential water ingress.

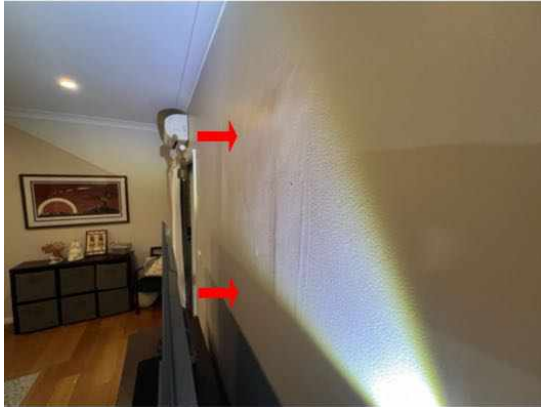
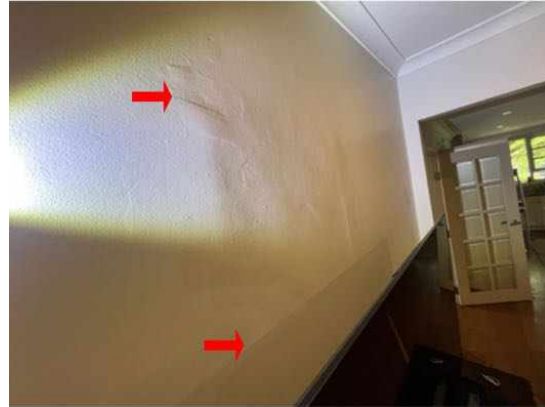
Finding 3.23

Building:	Main Building
Location:	Living Room
Finding:	Wall - substandard works (behind shower recess).
Information:	Patching to the wall lining was observed to have been completed to a substandard level. The patching appears irregular and detracts from the overall quality and presentation of the wall surface.

While no active moisture ingress or damage was identified at the time of inspection, the presence patching behind a shower recess indicates that previous repair or alteration works have been carried out. The reason for these works could not be determined.

It is highly recommended that a qualified plasterer be engaged to complete any rectification works as required to restore a uniform and appropriate finish. The client may also wish to make further enquiries with the vendor regarding any previous works undertaken to this wall.

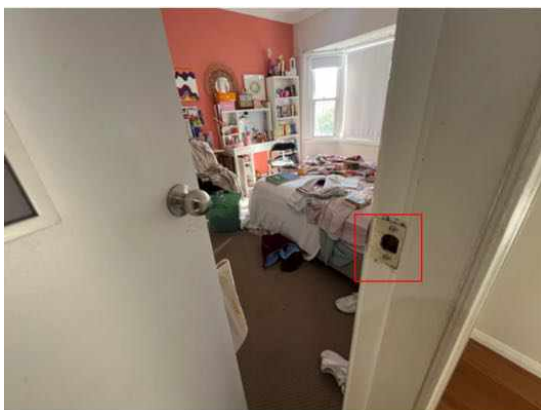
Finding 3.24

Building:	Main Building
Location:	Bedroom 2
Finding:	Doors - Striker plates misaligned. Doors rattle when closed.
Information:	The striker plates to a few doors throughout the home appear to have become misaligned and has consequently resulted in the door's operation being compromised.

This is a common defect and is expected in a property of this age, whether being due to substandard installation or general deterioration of the door hardware.

Readjustment of the striker plate is recommended at client discretion. Works such as these can be completed by a general handyman or qualified carpenter.

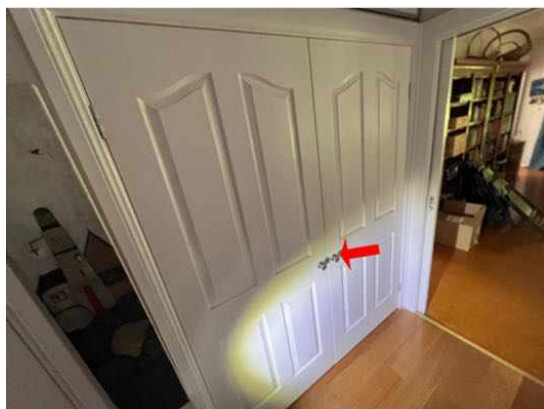
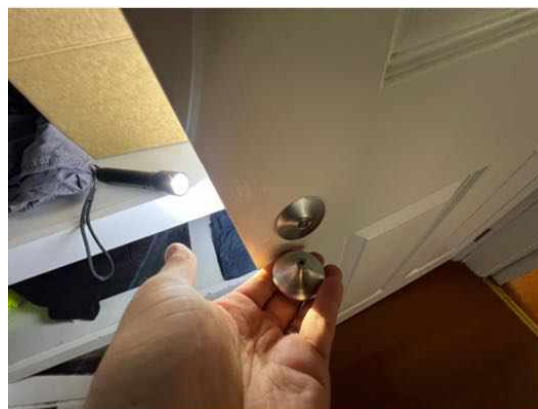
Finding 3.25

Building: Main Building
 Location: Hall
 Finding: Door - damage handle
 Information: The door handle in this area was found to be damaged at the time of inspection. Breakage occurs generally when the building materials have aged and decayed, but may be indicative of impact damage (accidental or deliberate).

Repair and/or replacement of the broken door handle is advised to improve the operational state of the associated door.

A qualified carpenter or general handyman should be appointed to repair/replace the door handle at the client's discretion.

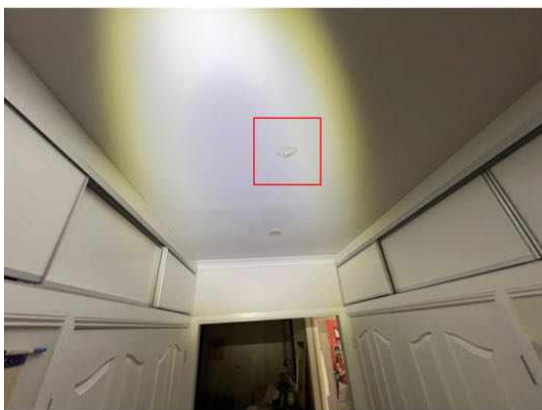
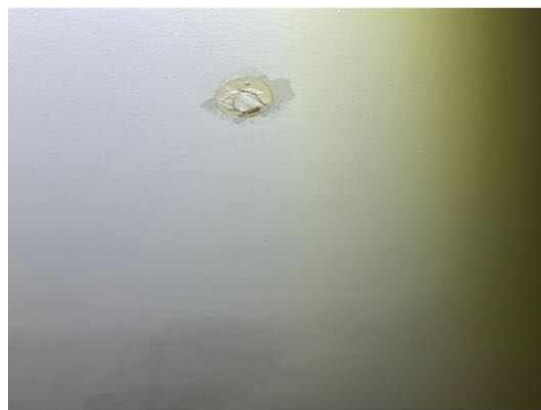
Finding 3.26

Building: Main Building
 Location: Hall
 Finding: Ceiling - Damaged
 Information: Breakage occurs generally when the building materials have either aged and decayed, or as a result of damage (accidental or deliberate).

Repair and/or replacement of broken elements is advised to ensure that additional secondary defects do not arise as a consequence. Such works are necessary, as all building elements play a key role in the operation and function of the overall structure and its performance.

A plasterer, painter or handyman should be appointed to repair or replace the affected building element prior to any subsequent damage being caused.

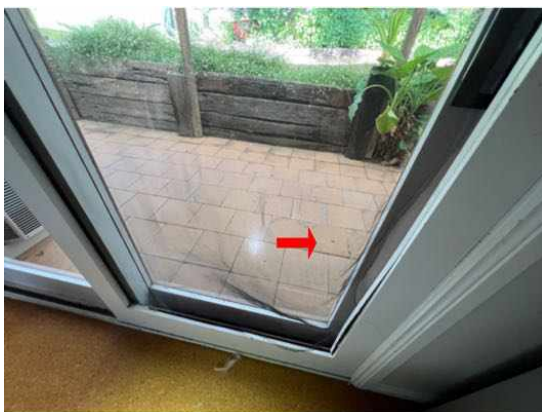
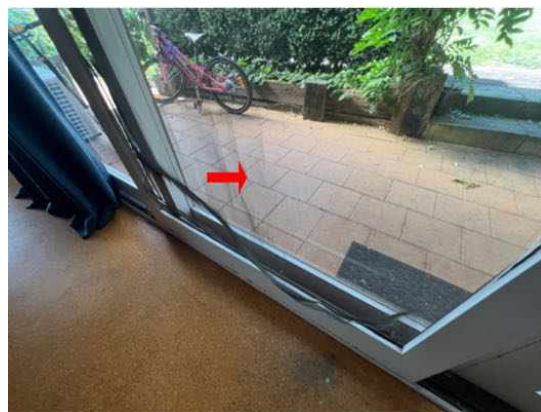
Finding 3.27

Building:	Main Building
Location:	Family Room
Finding:	Flyscreen - Damaged
Information:	The Flyscreen is as a result of damage (accidental or deliberate).The building element detracts from the operational state of the window.

Where not replaced/repared, damaged flyscreens allow pest and insect ingress into the adjoining room/s. Such works are necessary, as all building elements play a key role in the operation and function of the overall structure and its performance.

A general handy person may be appointed to replace/repair Flyscreen at the discretion of the client.

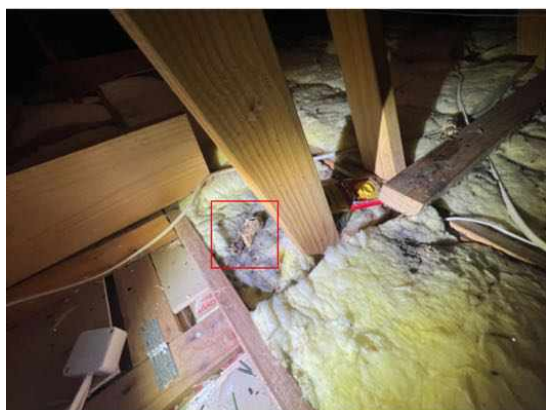
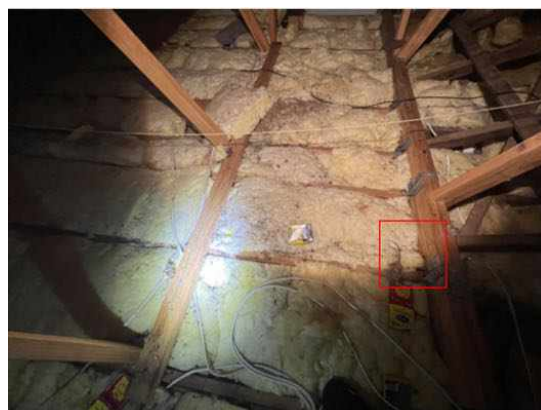
Finding 3.28

Building:	Main Building
Location:	Roof Void
Finding:	Evidence of Vermin
Information:	Evidence of pests or rodents faeces and carcass in the roof space at time of inspection. Rodents can cause issues ranging from smells and stains through to physical damage to wiring and other elements in the roof void. A licensed pest

controller should be appointed to free the roof void of any pests and to install deterrents or seal access points to ensure that rodents cannot enter the roof space as easily.

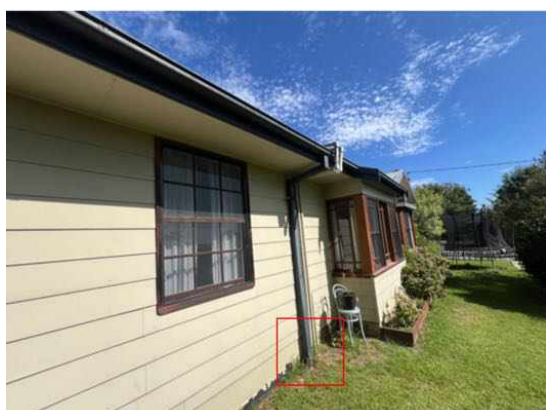
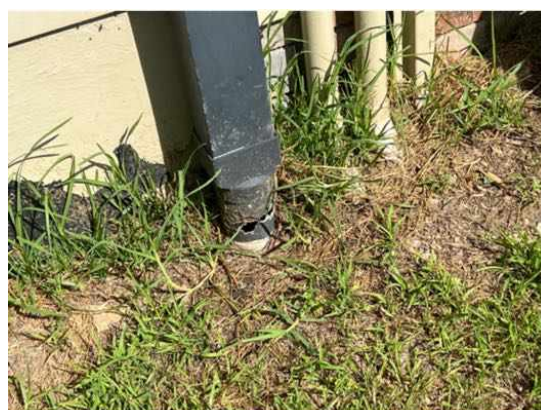
Finding 3.29

Building: Main Building
 Location: Exterior walls - front
 Finding: Downpipe - Damage, conditions conducive to termites
 Information: The downpipe in this area shows visible damage, which hinders its ability to effectively direct water away from the building. This creates conditions conducive to termite activity by increasing the likelihood of water pooling around the foundation. Prolonged moisture retention can lead to structural degradation, soil erosion, or water ingress into lower building areas, all of which may attract and sustain termite infestations.

The observed damage may be attributed to impact, corrosion, or general wear. It is recommended that a licensed roof plumber be engaged to inspect the downpipe and carry out necessary repairs or replacement as a priority to mitigate moisture-related risks and potential termite activity.

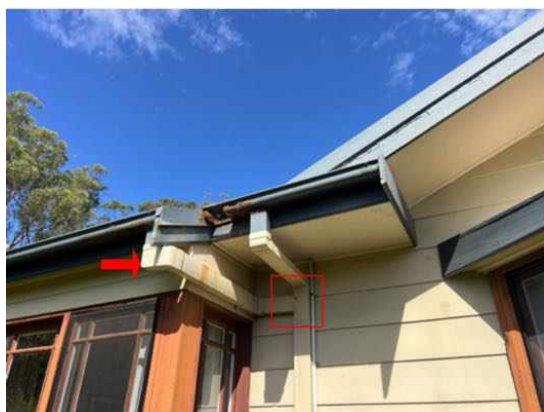
Finding 3.30

Location: Exterior walls - front
 Finding: Roof plumbing - Insufficient capacity
 Information: It is suspected that the roof plumbing to the exterior roof is insufficient in capacity and is not adequately managing the volume of rainwater that it is required to drain. The result is generally that the plumbing overflows during periods of heavy rainfall, creating damp conditions against external surfaces and the base of the building perimeter.

If left unmanaged, the excess moisture in this areas may allow the formation and development of an environment that is conducive to rust, corrosion and rot, creating potential for secondary defects to all associated building elements. Damp conditions are also conducive to termite and pest activity, further exacerbating the risk of the environment.

Appointment of a roofing plumber is recommended to replace any inadequate drainage systems to ensure proper drainage to this area. In the interim, it is important to ensure that all roof plumbing is free of any debris or blockages.

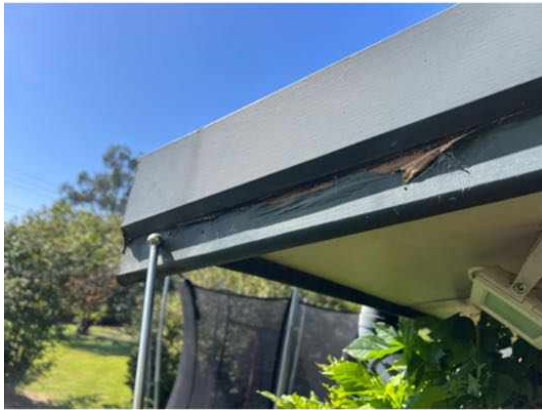
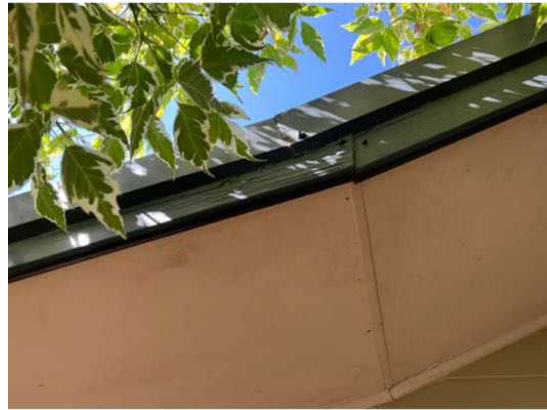
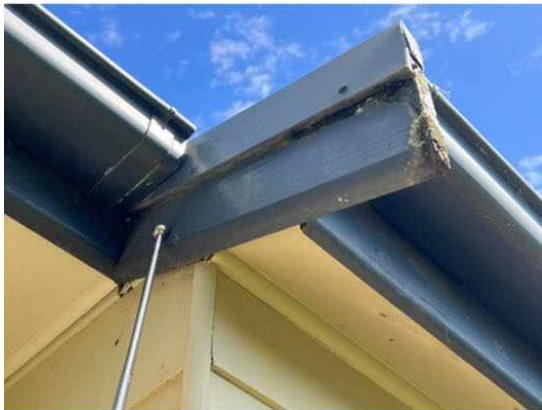
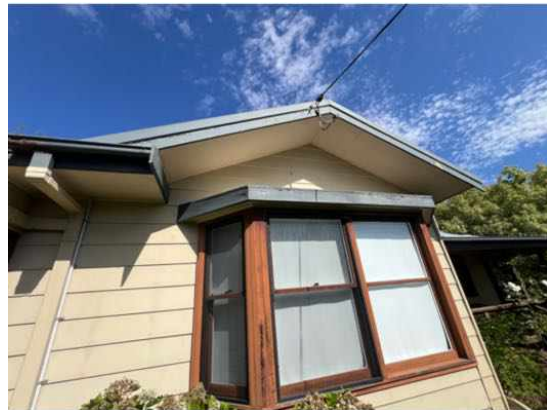
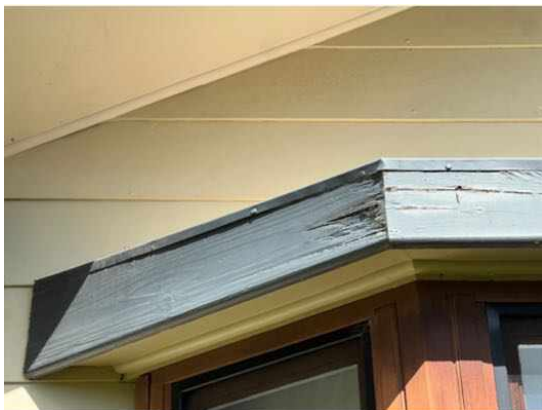
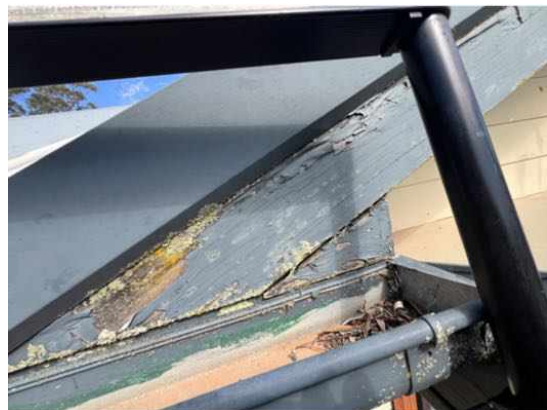
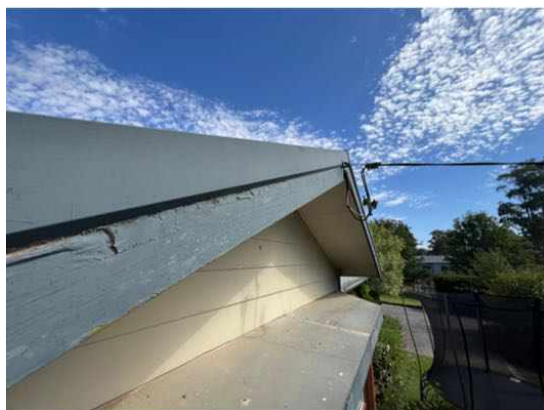
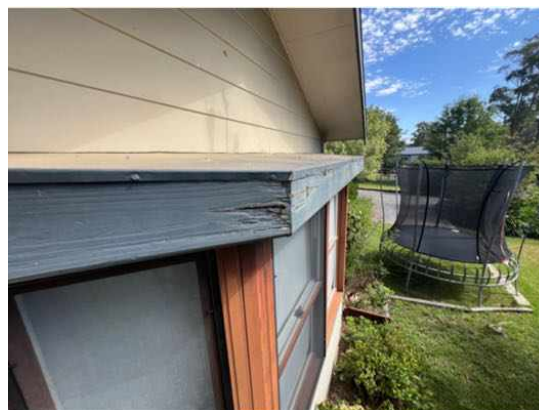
Building: Main Building
 Location: Roof Exterior
 Finding: Fascias - Wood rot
 Information: Wood rot was found to be affecting fascias and barges in this area, evidenced by the presence of mould on the surface in some areas. Wood rot, also known as Fungal Decay, occurs when timbers and other cellulose building materials are exposed to damp conditions on an ongoing basis.

It is likely that this wood rot has developed as a result of faults in the roof plumbing, creating excessive moisture in this areas. Frequent exposure to rain and other weather conditions also make fascias and barges susceptible to accelerated deterioration.

Early intervention and regular maintenance will prolong the useful life of these building elements. Prior to any works being performed, the cause of the moisture that has created the visible wood rot should be identified and addressed in a suitable manner.

It is advised that a roof plumber be appointed to inspect all roof plumbing and subsequently identify the cause of the wood rot. Replacement of affected fascias and barges may then be a necessary step in protecting surrounding building elements from such deterioration.

A qualified plumber may be appointed to assess the cause of excessive moisture and to provide advice on any remedial works as required. A qualified carpenter or registered builder may also be required to replace affected building materials.

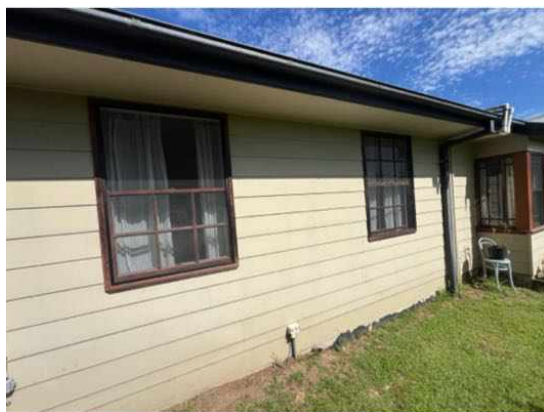
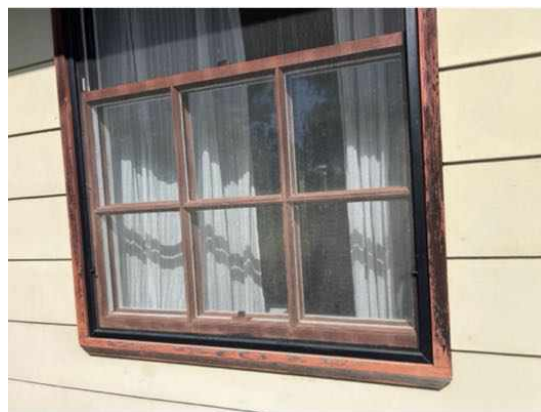
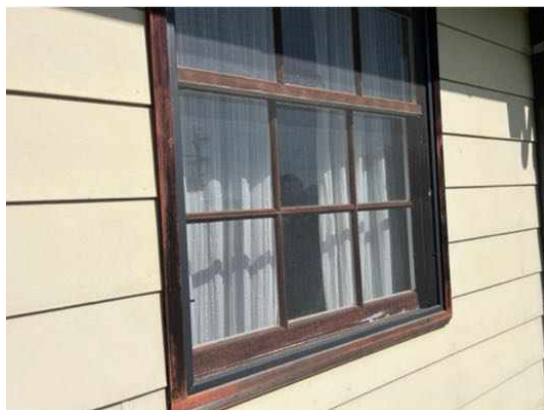
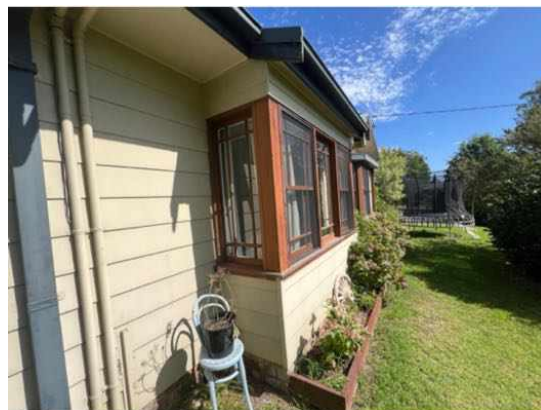
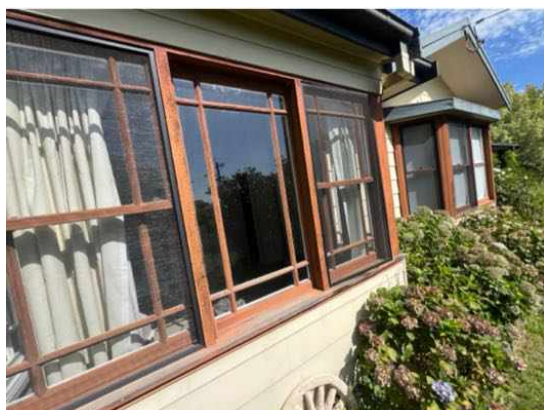
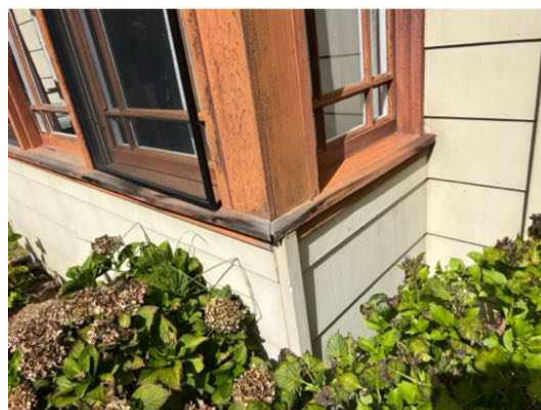
Finding 3.32

Building:	Main Building
Location:	Exterior walls - front
Finding:	Windows - Wood rot
Information:	Wood rot was found to be affecting external windows. Wood rot, also known as Fungal Decay, occurs when timbers and other cellulose building materials are exposed to damp conditions on an ongoing basis.

It is likely that this wood rot has developed as a result of frequent exposure to rain and other weather conditions. It is suspected that failure to maintain the window frames over a prolonged period has resulted in them deteriorating at an accelerated rate, increasing their susceptibility to the development of wood rot. Leaks in roof plumbing or associated pipework may have also contributed to the formation of the wood rot in this area.

Early intervention and regular maintenance will prolong the useful life of these building elements. Prior to any works being performed, any associated pipework or roof plumbing should be inspected by a licensed plumber for faults or leaks.

Repair and/or replacement of affected window frames may be a necessary step in protecting surrounding building elements from such deterioration. Remedial works should be performed by a qualified carpenter or registered builder as soon as possible to prevent any further damage.

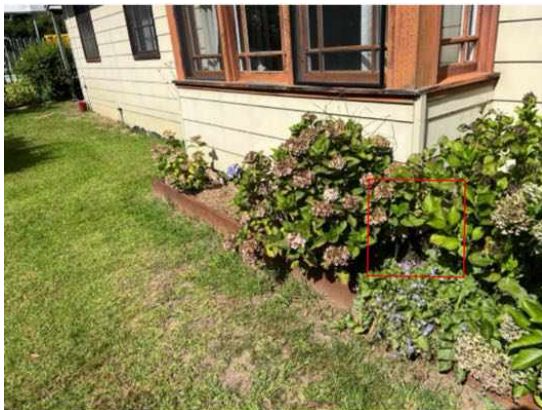
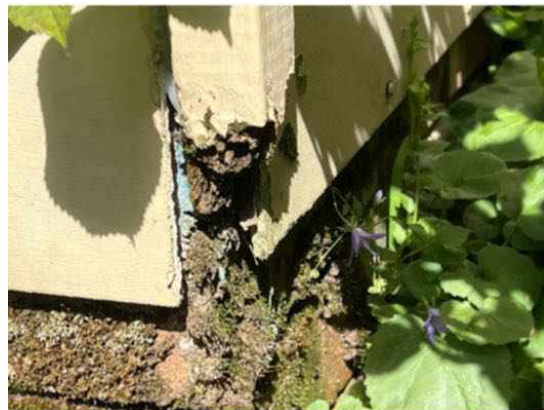
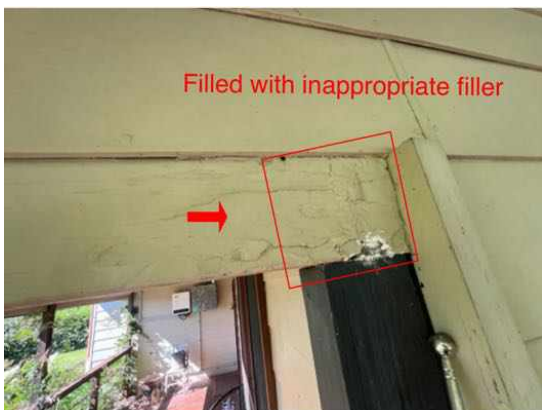
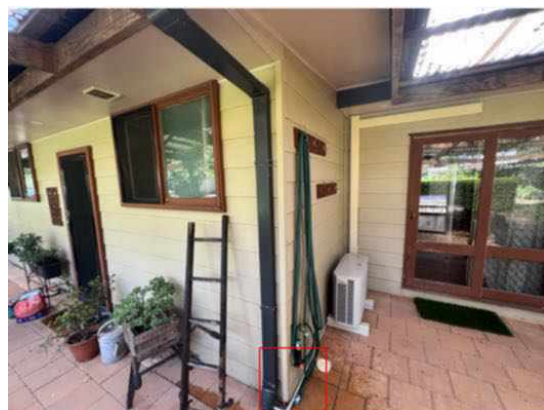
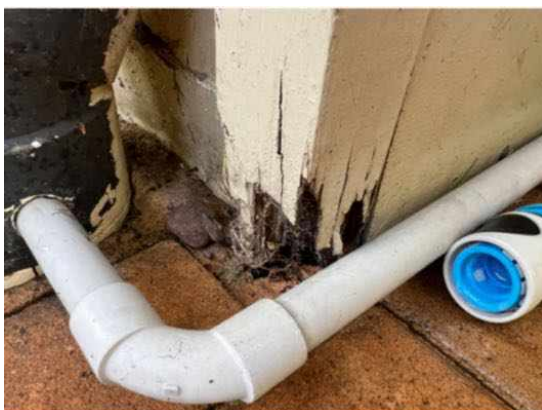
Finding 3.33

Building:	Main Building
Location:	Exterior walls - front, side, rear
Finding:	Wood rot
Information:	This building element shows evidence of wood rot. Wood rot, also known as Fungal Decay, occurs when timbers and other cellulose building materials are exposed to damp conditions on an ongoing basis. This could be the result of exposure to weathering over a prolonged period of time, or the attraction of excessive moisture from other abutting building materials. Contributing factors also include poor air ventilation in the area.

Wood rot is often associated with general damp problems and is evidenced by a

'musty' smell or mould and mildew occurring on surfaces. If left unmanaged, damp conditions can lead to further health problems and the decay of timbers will continue.

Early intervention and regular maintenance, particularly of exterior timbers, will prolong the useful life of these building elements. Prior to any works being performed, the cause of the moisture that has created the visible wood rot should be identified and addressed in a suitable manner. Replacement of affected timbers may then be a necessary step in protecting surrounding building elements from such deterioration.

A qualified plumber may be appointed to assess the cause of excessive moisture and to provide advice on any remedial works as required. A qualified carpenter or registered builder may also be required to replace affected building materials.

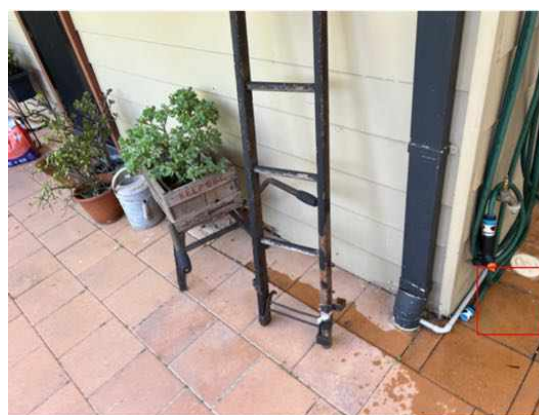
Finding 3.34

Building:	Main Building
Location:	Exterior walls - rear
Finding:	External taps - Not plumbed for drainage
Information:	The External taps is not plumbed or connected to suitable drainage, which has resulted in the surrounding area becoming excessively damp. These damp conditions can lead to secondary defects such as rot, rust or corrosion of associated building elements, the formation of fungal decay, or even the creation of potential slip hazards. When coupled with poor site drainage, pooling of water may also attract termite activity to this area. It is highly recommended that a qualified plumber be appointed to install adequate drainage to the overflow. These works will ensure that the area remains dry and free of any secondary defects.

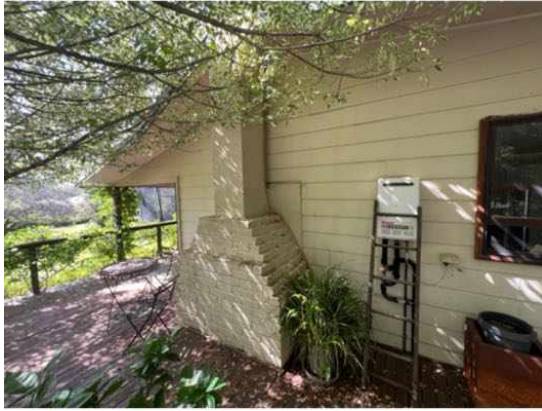
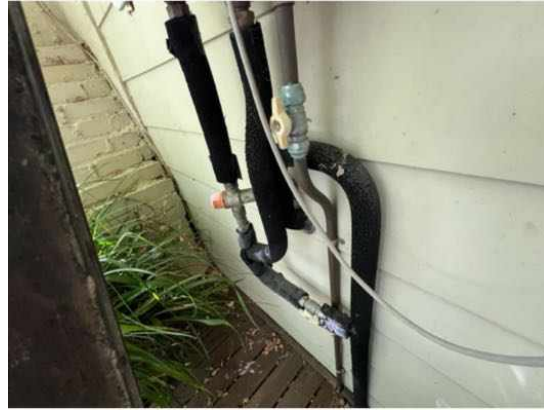
Finding 3.35

Building:	Main Building
Location:	Exterior walls - right side
Finding:	Pipework - Insulation deteriorated
Information:	Sections of the pipe insulation show evidence of damage and deterioration. It is suspected that this deterioration has developed as a result of excessive exposure to weather, including UV exposure in daylight. Deteriorated insulation reduces the effectiveness of the material in helping to maintain the desired temperature and work most efficiently.

If left in an exposed position, it is likely that the deterioration will continue and worsen over time, potentially resulting in secondary building defects as well as a further loss in insulating properties.

Some areas of replacement of pipe insulation is likely to be required. Further preventative measures to remove or protect the material from future exposure are also advisable. Consultation with a licensed plumber is advised to gain quotes for the repair and/or replacement of deteriorated insulation.

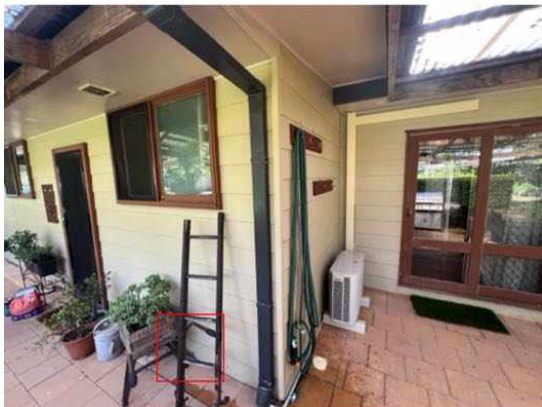
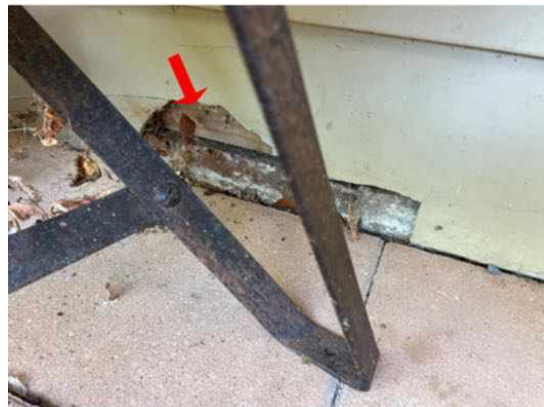
Finding 3.36

Finding: Weatherboard - Damaged

Information: The weatherboard cladding in this area was observed to be physically damaged, with sections broken away and the underlying wall framing exposed. Damage of this nature reduces the effectiveness of the external cladding as a weather barrier and compromises the protection of the supporting structure.

Exposed framing is vulnerable to moisture ingress, which may lead to timber decay, internal dampness, and accelerated deterioration of associated building elements if left unmanaged. Openings of this type also increase the risk of timber pest activity due to accessible and unprotected timber components.

It is recommended that a qualified carpenter be engaged to assess the extent of the damage and carry out appropriate repairs to reinstate the cladding and restore the weather-tightness of the building envelope. Prompt rectification is advised to minimise the risk of secondary damage.

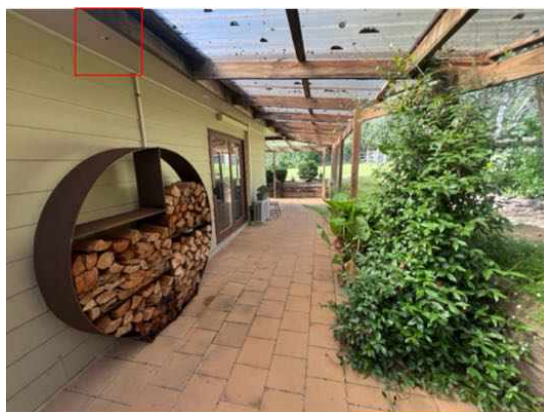
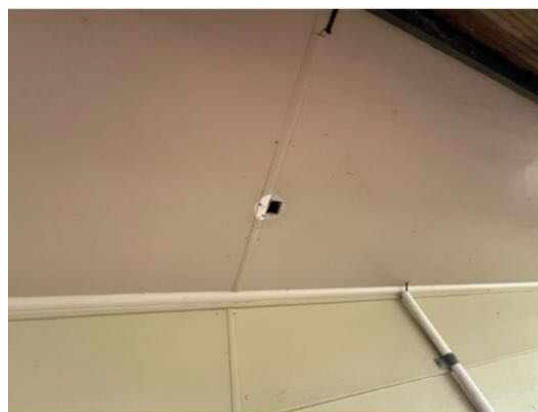
Finding 3.37

Location: Exterior walls - rear
 Finding: Eave Lining - Damaged
 Information: Breakage occurs generally when the building materials have either aged and decayed, or as a result of damage (accidental or deliberate).

Repair and/or replacement of broken elements is advised to ensure that additional secondary defects do not arise as a consequence. Such works are necessary, as all building elements play a key role in the operation and function of the overall structure and its performance.

A carpenter should be appointed to repair or replace the damaged eave lining prior to any subsequent damage being caused.

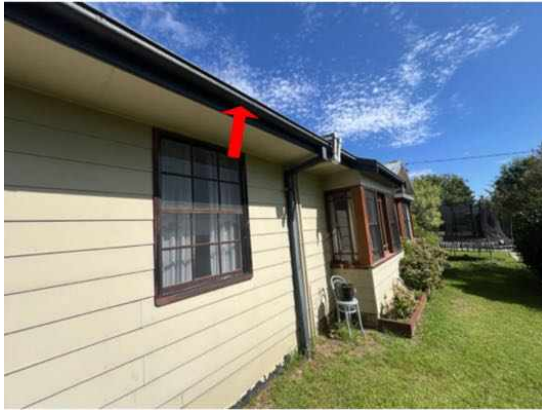
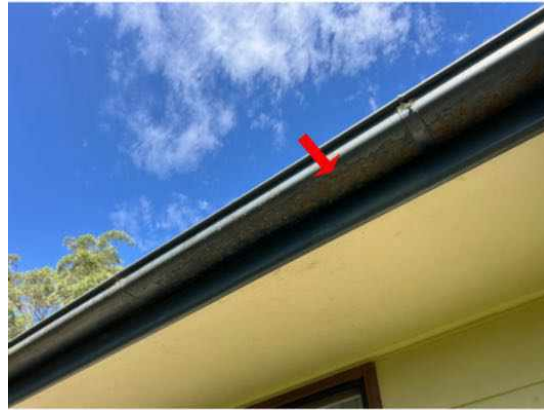
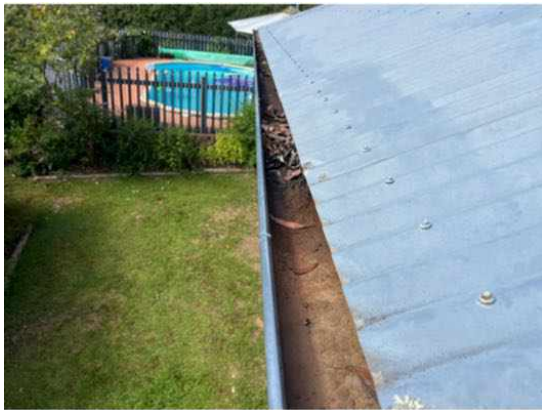
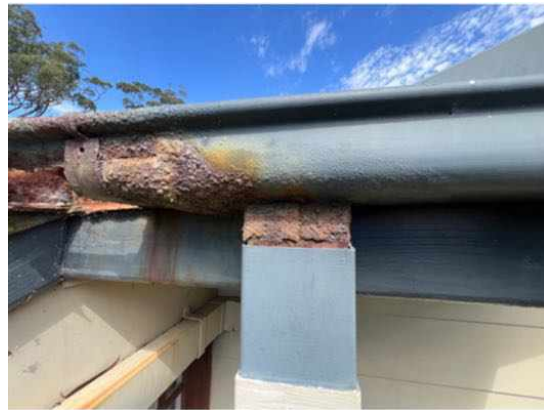
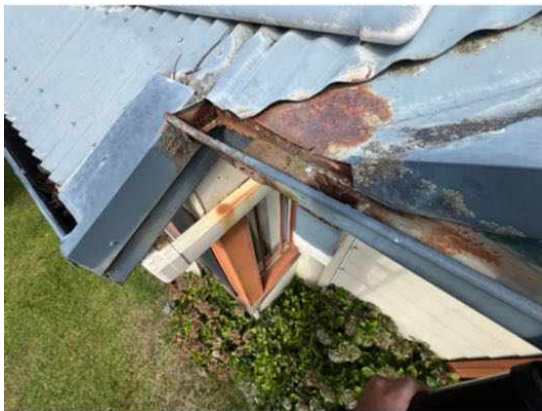
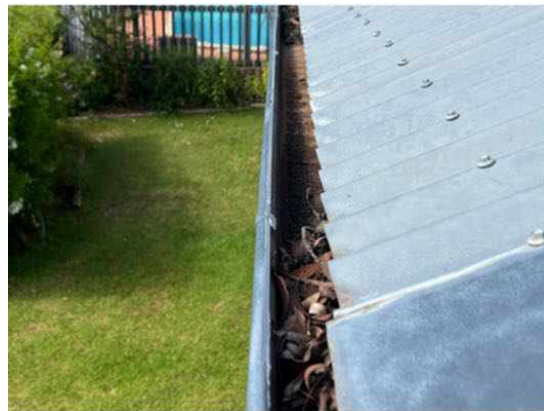
Finding 3.38

Building: Main Building
 Location: Roof Exterior
 Finding: Roof plumbing - Rusted or corroded
 Information: The roof plumbing has areas of rust and corrosion. It is suspected that this has been caused by blockages, resulting in pooling or standing water, that have prematurely rusted elements of the roof plumbing.

Rusted roof plumbing will generally develop holes and leaks that can affect other building elements with poor drainage of storm water. Poorly drained roof areas will also lead to damp conditions surrounding the base perimeter of the building which, if left unmanaged, can lead to a range of secondary building defects.

Repair and/or replacement of rusted roof plumbing is highly required in order to reinstate the roof drainage system to a fully operational level. To further maintain these areas, gutters should be cleaned frequently, allowing the avoidance of any partial blockages.

A licensed plumber or specialist roof restoration company should be appointed to undertake these works. It is advised that such works be completed as soon as possible to prevent any further damage and deterioration.

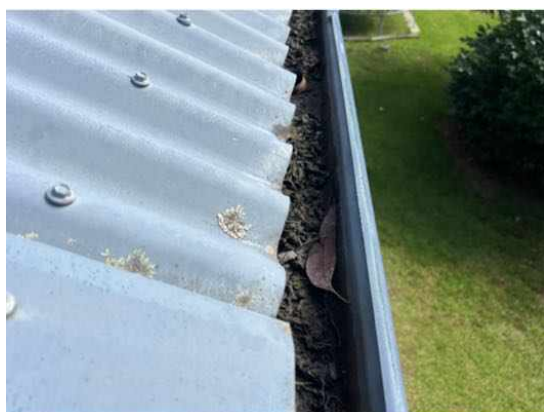
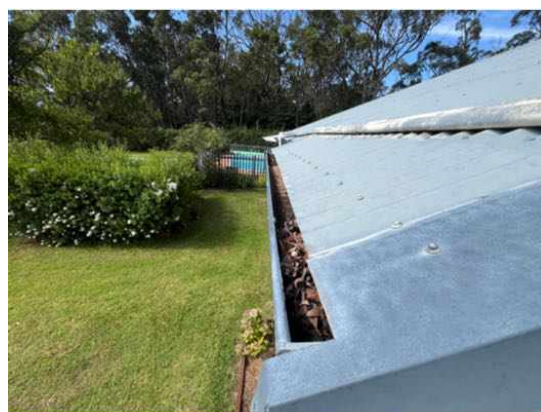
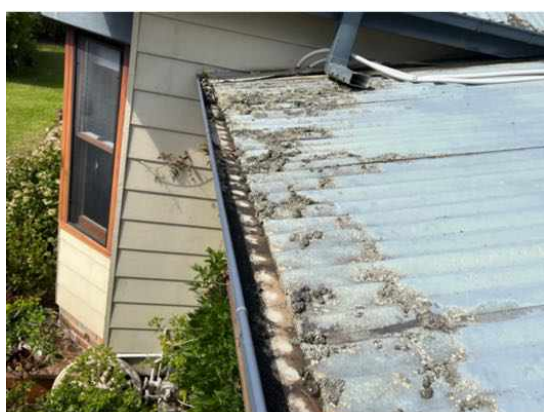
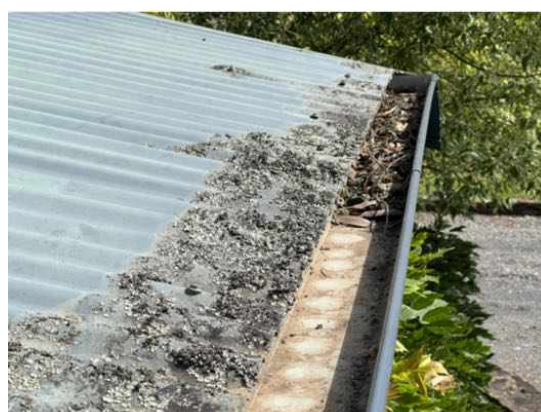
Finding 3.39

Building:	Main Building
Location:	Roof Exterior
Finding:	Gutters - Blocked
Information:	Roof plumbing structures, such as guttering and downpipes, should be free of all debris to prevent blockages. Blockages of the guttering and downpipes will lead to pooling and accumulated water overflows, which is likely to subsequently flood eaves and exterior walls.

Blocked gutters are likely to lead to high levels of moisture in the affected areas. Such moisture will not only cause rust and decay of the associated building materials, but can also provide conditions that are conducive to termite and timber pest activity. Blockages in gutters should therefore be removed immediately to ensure dry conditions are maintained.

Consult a Licensed Plumber for further specific advice on remedial works that may be required. In the interim, it is highly advised that blocked gutters be removed by the homeowner or a general handyperson as a matter of urgency.
