Building and Timber Pest Inspection Report

Inspection Date: Fri, 6 Feb 2026

Property Address: 4 Drapers Rd, Willow Vale NSW 2575,
Australia

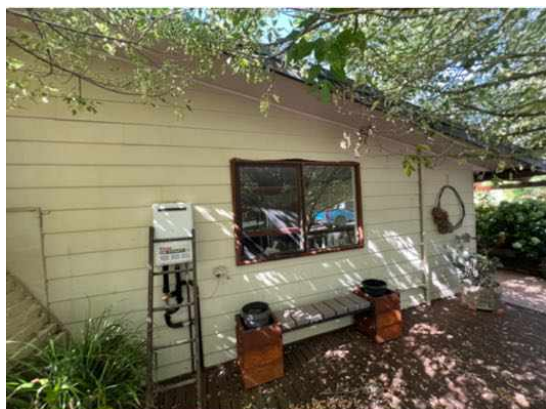
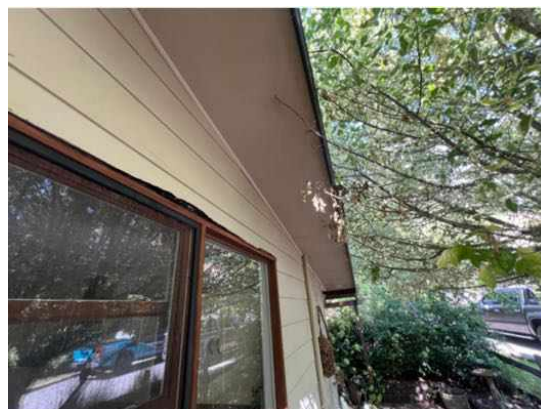
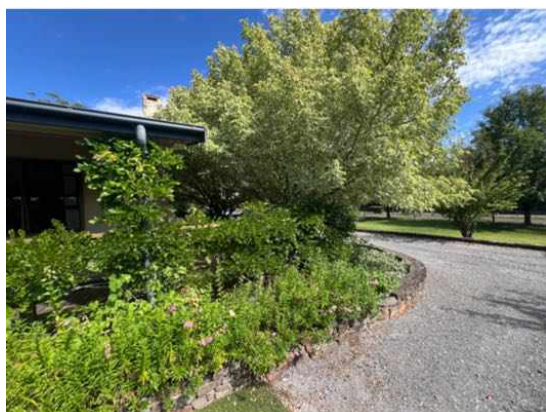
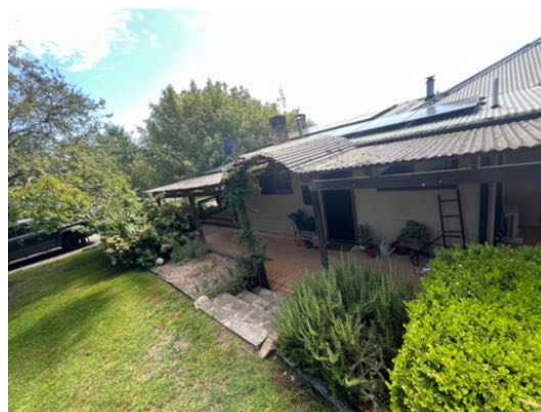
Finding 3.40

Building:	Yard
Location:	The Site
Finding:	Trees - Overhanging and filling gutters
Information:	Overhanging trees often result in excessive amounts of leaf debris accumulating in gutters.

Gutters are a critical part of the building's management of storm water and rain. It is therefore important that they be kept clear to prevent secondary damage to associated building elements, including exterior and interior walls, ceiling linings and any adjoining building elements. Where gutters are blocked, pooling of rainwater is

likely to occur, fast-tracking rust and corrosion of the roof plumbing elements.

It is highly advised that all overhanging tree branches be removed as soon as possible to prevent any further damage. Repair and/or replacement of sections of damaged guttering may also be required where the extent of the damage necessitates.

Such works should be performed by the homeowner; however, appointment of a landscape contractor or an arborist may be required. Consultation with a licensed roof plumber is required where guttering has been damaged.

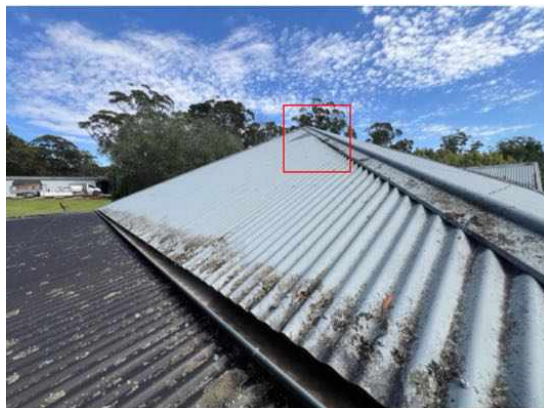
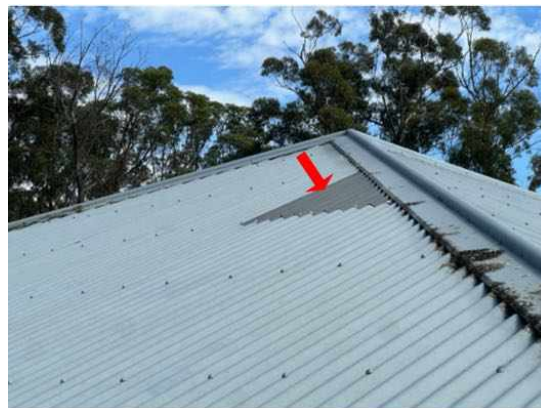
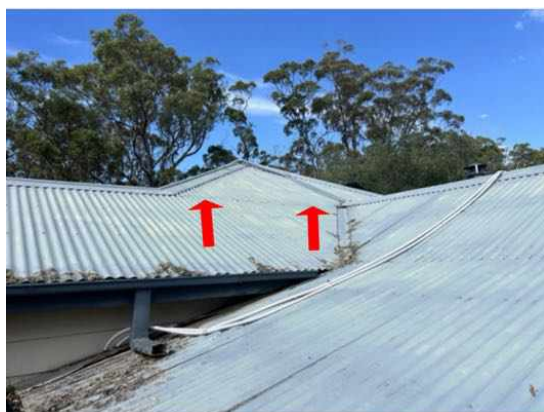
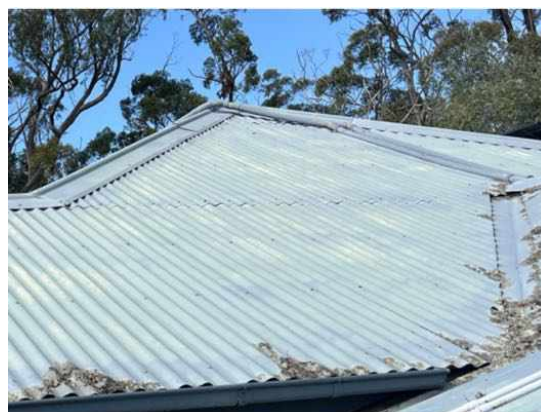
Building:	Main Building
Location:	Roof Exterior
Finding:	Roof Sheetting - Patched Installation
Information:	Sections of the roof sheetting were observed to have been patched, with multiple sheets joined together where a single continuous sheet would ordinarily be expected. This type of installation is not consistent with standard roofing practices and introduces additional joints and overlaps within the roof covering.

Patched or pieced roof sheetting increases the risk of water penetration, particularly at sheet joints and fixings, and may lead to premature deterioration of the roof covering and associated building elements. Over time, this condition may contribute to

moisture ingress, internal water damage, and reduced weatherproof performance.

It is recommended that a licensed roofing contractor be engaged to assess the patched roof sheeting and provide advice on appropriate rectification works to ensure the roof covering is made weather-tight and durable.

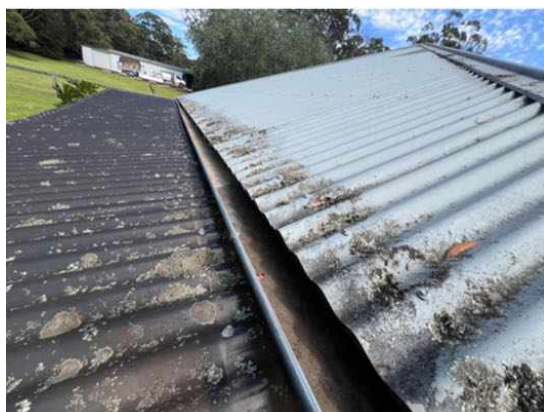
Finding 3.42

Building:	Main Building
Location:	Roof Exterior
Finding:	Metal Roof - Lichen Growth
Information:	Upon inspection of the exterior roofing, sections of the Colorbond metal roof were observed to have lichen growth present. While the roof sheeting itself appeared to be in generally fair condition, the presence of lichen indicates ongoing exposure to moisture and environmental conditions.

Lichen growth on metal roofing can retain moisture against the roof surface and, if left unmanaged, may contribute to deterioration of protective coatings over time. In addition, accumulated growth may restrict the effective flow of rainwater toward gutters and drainage points.

It is recommended that the roof be cleaned to remove lichen growth using appropriate, non-abrasive methods suitable for metal roofing. A roof maintenance or roof restoration contractor can be consulted for further advice at the client's

discretion.

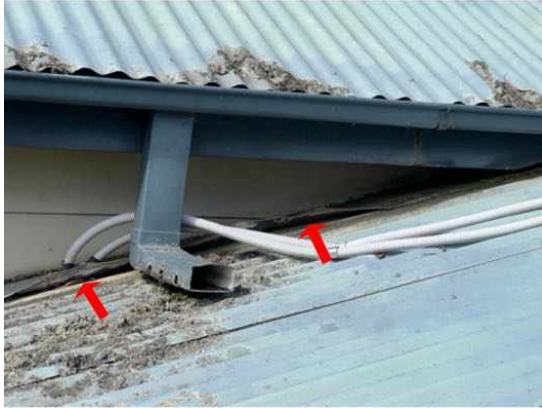
Finding 3.43

Building:	Main Building
Location:	Roof Exterior
Finding:	Roof plumbing - Loose flashing
Information:	Metal and other material flashings are applied to seals and intersections between roof coverings and building elements. They are designed to aid in weatherproofing of roof joins, and require regular inspection and maintenance as they are more subject to rust-related deterioration.

The flashing in this section of the exterior roofing appears to have come loose from its original fixing. It is suspected that this minor defect has occurred as a result of general deterioration over time.

Re-fixing and potential replacement of certain areas of flashing is advised to promote adequate roof drainage and protection from water penetration. Failure to perform these works may result in water damage and accelerated deterioration of associated building elements.

A roofing contractor or roofing plumber should be appointed as soon as possible to restore the flashing to a fully operational state.

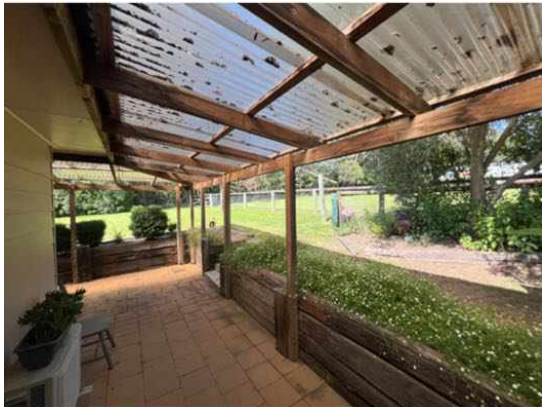
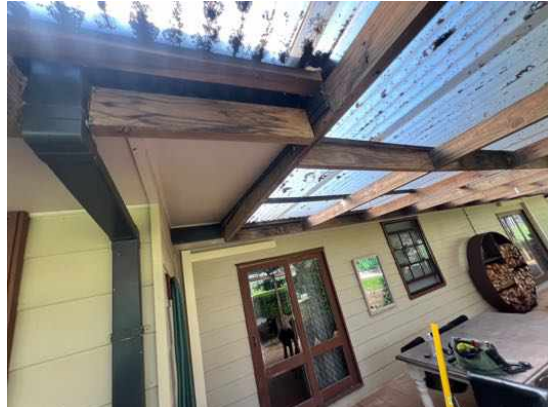
Finding 3.44

Information: External timbers that are frequently exposed to harsh weather conditions require adequate protection in order to maintain their condition. Where timbers have not been painted or treated adequately, general deterioration is likely to occur at an accelerated rate.

If left unattended, replacement of these timbers is likely to be necessary in the short-term future. Adequate treatment of these timbers is required as soon as possible by a painting contractor or general handyman.

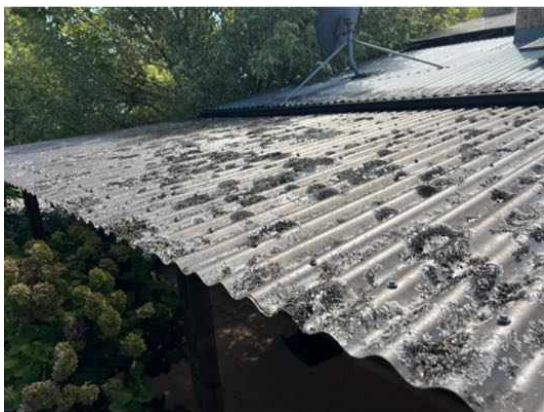
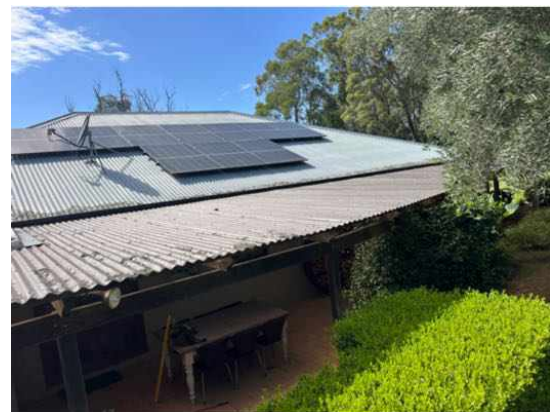
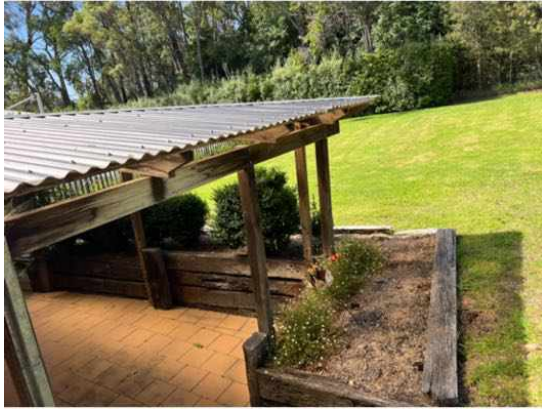
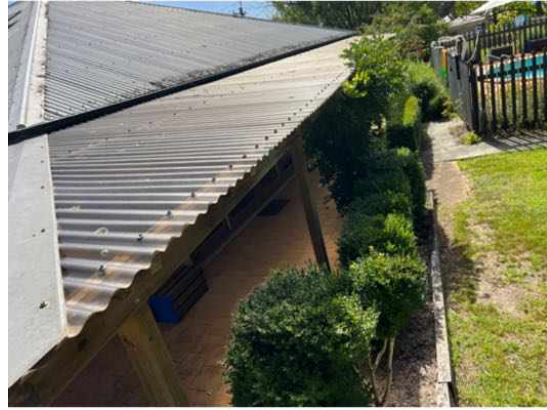
Finding 3.45

Information: The absence of guttering at this property increases the risk of water pooling around the foundation, which creates conditions highly conducive to termite activity. Without adequate guttering, rainwater is not effectively directed away from the building, potentially causing prolonged moisture retention, soil erosion, or water ingress into lower areas. These conditions can attract termites and facilitate their movement into the structure.

It is recommended that a licensed roof plumber install guttering to ensure proper water drainage and minimise the risk of moisture-related issues and termite infestations. This work should be prioritised to protect the building's structural integrity.

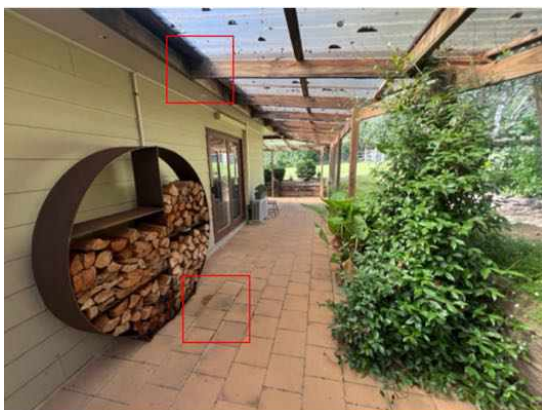
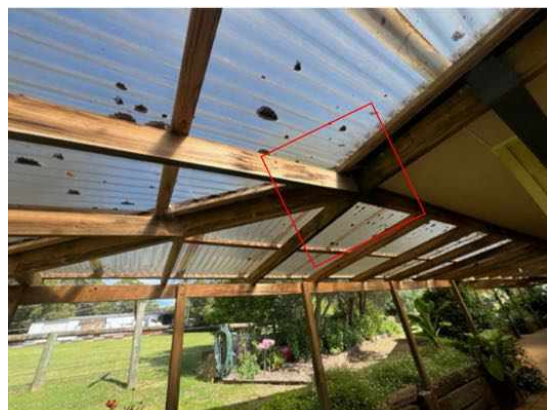
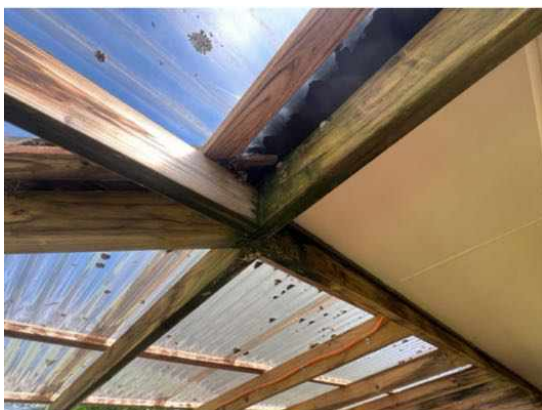
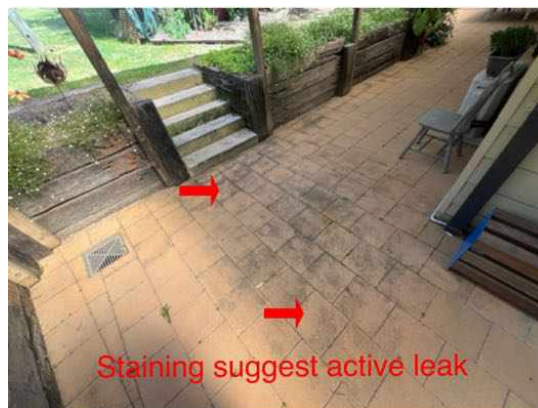
Finding 3.46

Finding: Water staining

Information: Water staining was evident in this area at the time of inspection. Water staining indicates that surfaces have been exposed to excessive moisture over time. The minerals and other elements in the water lead to staining, which may graduate to corrosion and deterioration if left unmanaged.

While mostly an appearance defect, water staining can be indicative of more serious defects, which may be currently concealed by other building elements.

Where water staining is active, a licensed plumber must be consulted to identify the cause of the staining and to provide advice on any reparation works that may be required. Replacement of any broken or damaged structures is advised.

Conversely, where water staining is old and inactive, affected building materials may be repaired or replaced at client discretion. A qualified carpenter or registered builder may be appointed to perform these works.

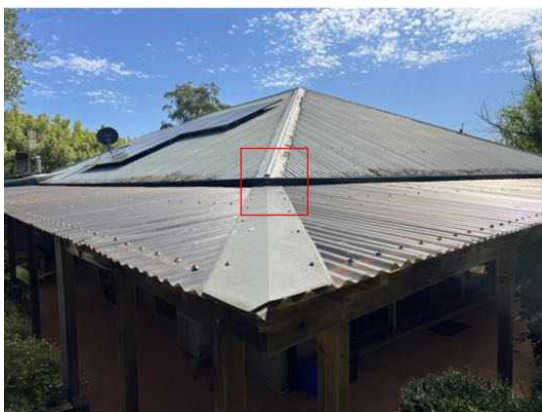
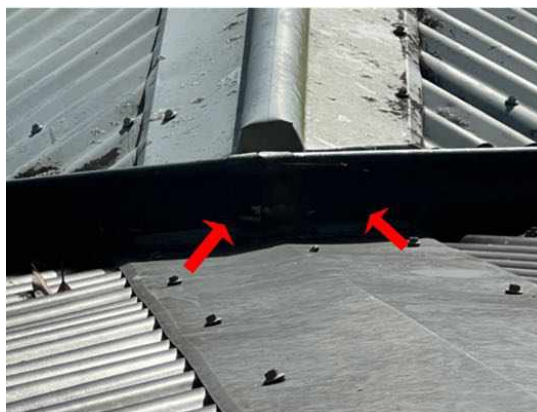
Finding 3.47

Building:	Main Building
Location:	Pergola
Finding:	Roof flashing - non-standard
Information:	The roof flashing that has been installed does not appear to comply with current building practice. However the flashing appears to be in an acceptable condition and is fulfilling its purpose in ensuring the roof covering is weather-tight.

Whilst retrospective fixing is not required if flashing begins to come loose from its fixing or deteriorates as evidenced by roof leaks a roofing plumber should be appointed immediately to replace the building element.

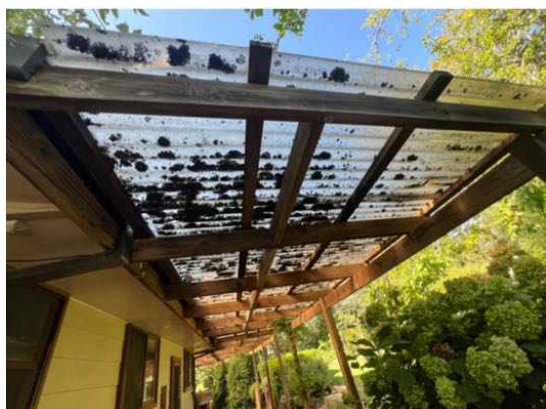
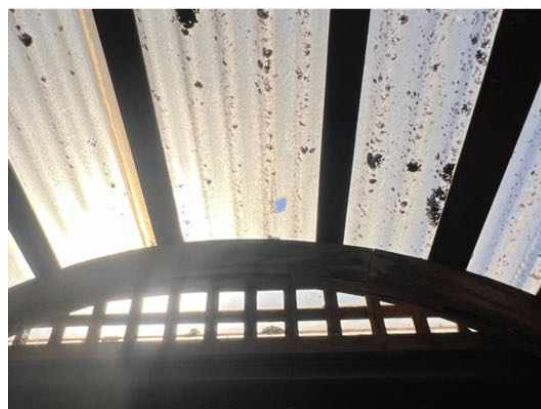
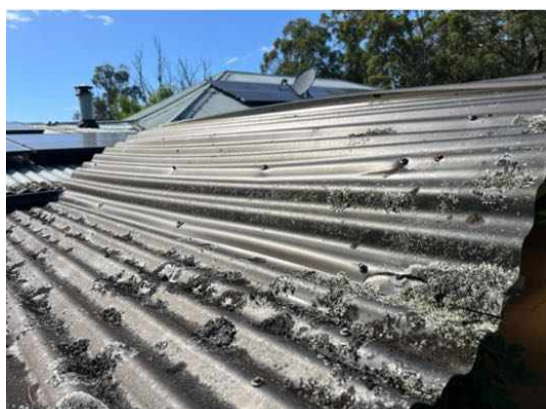
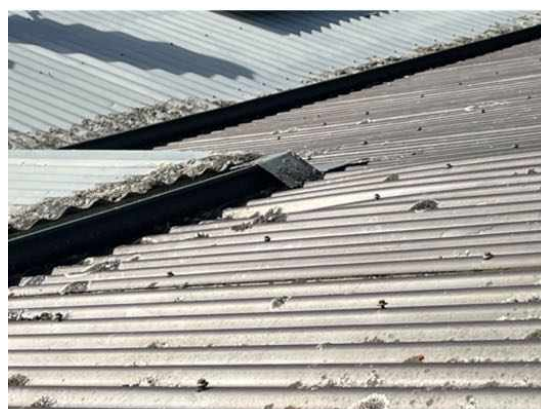
Finding 3.48

Building:	Main Building
Location:	Pergola
Finding:	Polycarbonate sheeting - Damaged
Information:	The polycarbonate sheeting has deteriorated as a result of exposure to weather conditions over a prolonged period of time. Exposure to elements, such as heavy rain and hailstorms, is likely to damage polycarbonate sheeting, which is not as strong as other roof coverings.

Further deterioration of the polycarbonate sheeting is likely to occur if left unmanaged. Such deterioration creates potential for water penetration and secondary damage to the internal roofing structure, accelerating deterioration of all associated building elements.

Repair and replacement of several sections of the sheeting is required. Appointment of a roofing restorer is required to perform these works as soon as possible to prevent any further damage being sustained.

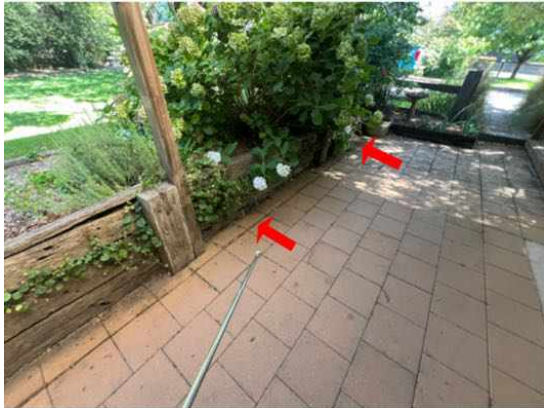
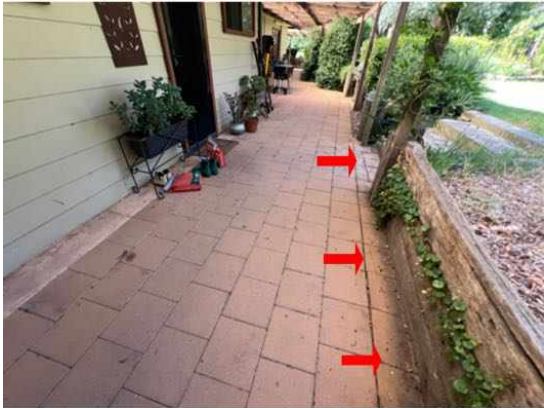
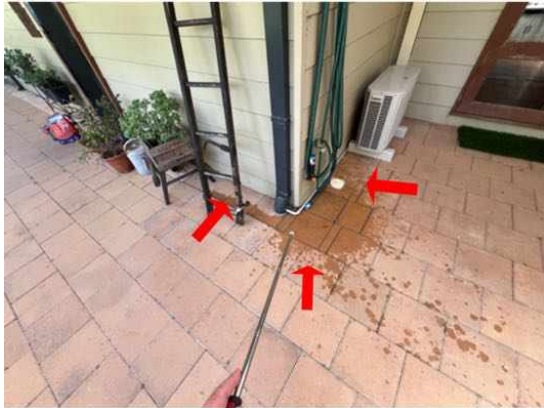
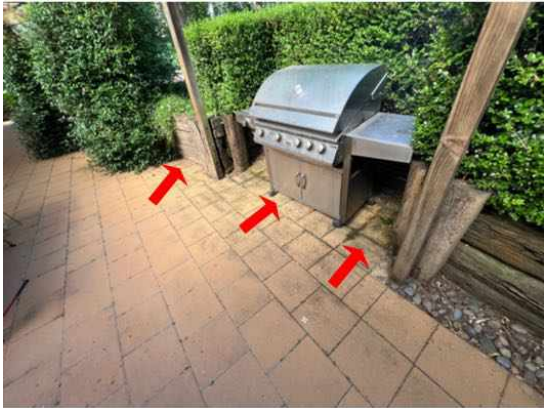
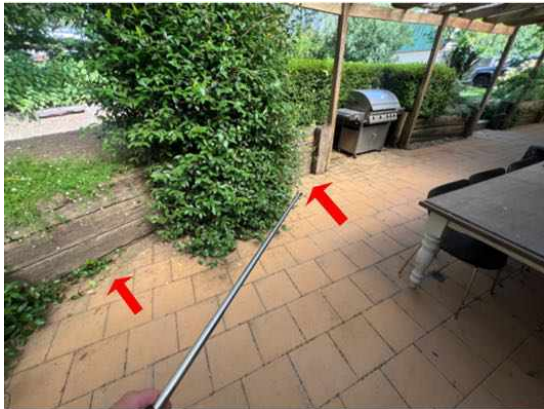
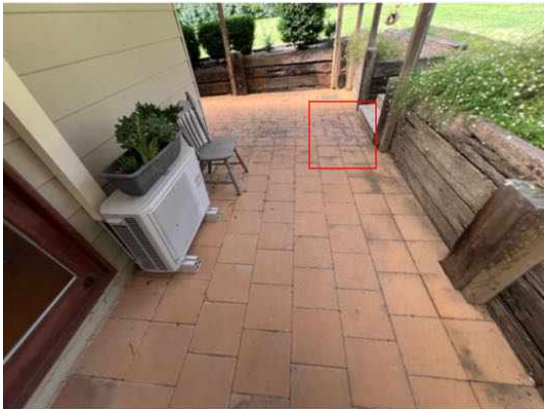
Finding 3.49

Building:	Main Building
Location:	Yard - Back
Finding:	Paving - Uneven
Information:	Sections of the external paved area are uneven, creating a potential trip hazard. It appears as though the area has been subject to rough installation, or that paving sections have lifted due to movements in the foundation of the property.

Where paving creates a trip hazard, personal injury may ensue if due caution is not taken by all persons within this area.

Re-paving of the area is required as soon as possible to remedy this situation. Further consultation with a specialist concreter is advised.

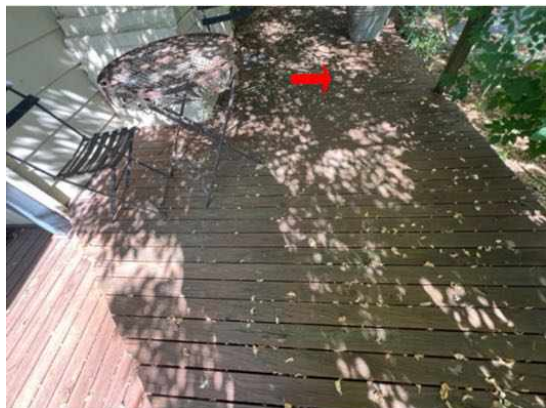
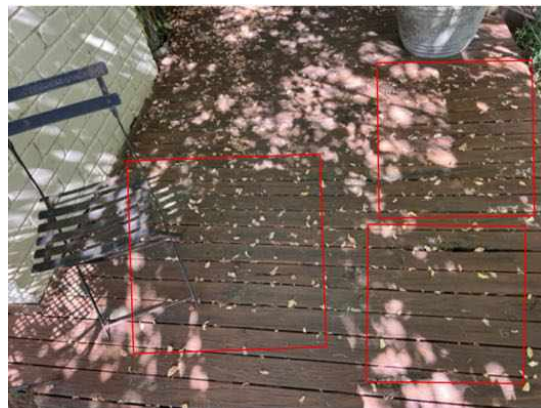
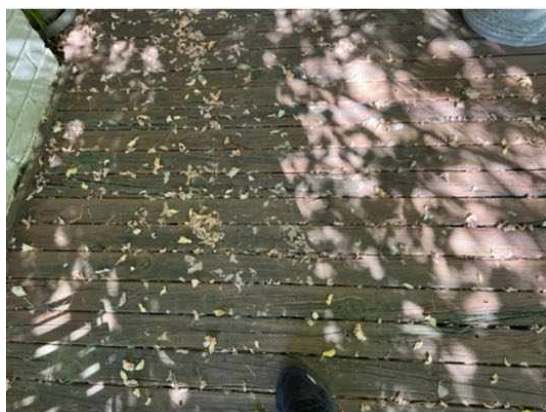
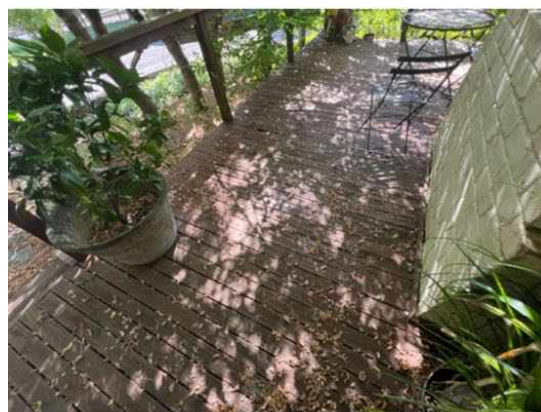
Finding 3.50

Building: Main Building
Location: Deck
Finding: Timber Deck - Bouncy Surface.
Information: The timber deck was identified as being bouncy at the time of inspection. A bouncy deck surface generally presents as noticeable movement or flexing when walked upon, creaking noises, or movement of surrounding furniture and fixtures.

Bouncy boards likely due to insufficient thickness, excessive spacing of joists, or material deterioration. It also typically indicates that the deck boards or subframe

structures are inadequately secured to the supporting joists or bearers. It may also result from gaps between the subframe and support posts, which require packing.

A registered builder, licensed carpenter or deck specialist should be engaged to assess and rectify the issue to ensure the deck's stability and longevity.

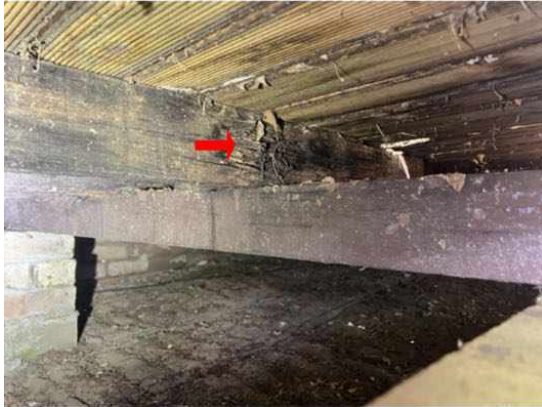
Finding 3.51

Building:	Main Building
Location:	Deck
Finding:	Subfloor structure - Wood rot
Information:	The subfloor structures are showing signs of deterioration and wood rot (fungal decay) of the timbers. It is suspected that this defect has developed as a result of damp conditions in the subfloor.

Damp conditions cause the timbers to fail, resulting in the subfloor structures failing to bear the load (or weight) of the building as originally intended. Without repairs and maintenance, including potential replacement of affected elements, it is likely that serious structural faults will result, as well as an array of minor defects.

The presence of wood rot to the subfloor structure is also conducive to termite infestation. As timber stumps are in direct contact with the ground, concealed termite is made possible. Such entry is made easier if the timbers become non-durable due to even slight wood rot.

Where wood rot is present to any structural timber, rectification or replacement of the affected timber building element is required. The adequate timeframe for such works are dependent on the severity of the rot. Where rot has developed to become widespread, replacement of sections of the subfloor structure may be required. Consultation with a structural engineer or registered builder specialising in re-stumping is highly advised as soon as possible.

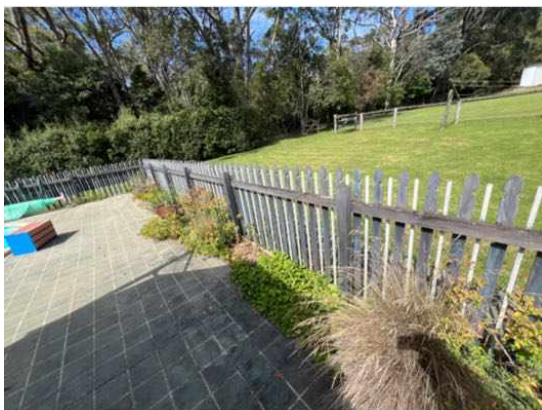
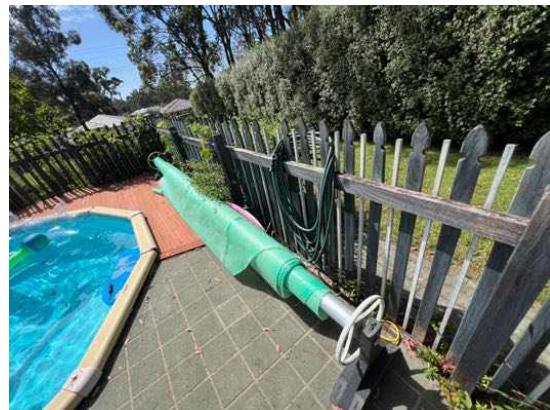
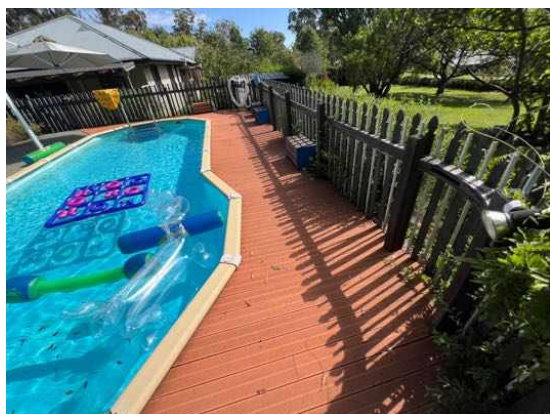
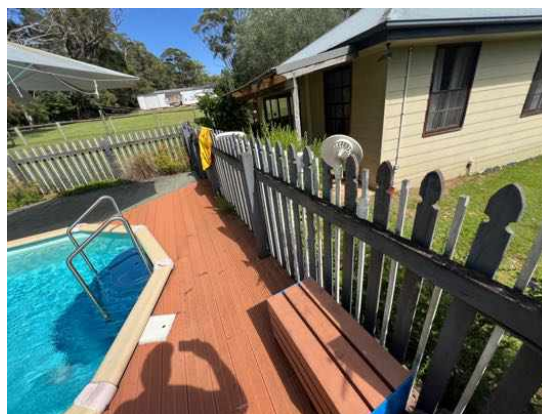
Finding 3.52

Building:	Yard
Location:	Swimming Pool - Above Ground
Finding:	Pool fencing - Inspection required
Information:	It is suspected that areas of the pool fencing do not to comply with Australian Standards and do not appear to be safe. Assessment of the pool area is required.

Please note that this inspection does not cover pool fencing and other pool fittings and fixtures. It is highly advised that a specialist be appointed to inspect the pool and surrounding area and provide advice on rectification works that may be required.

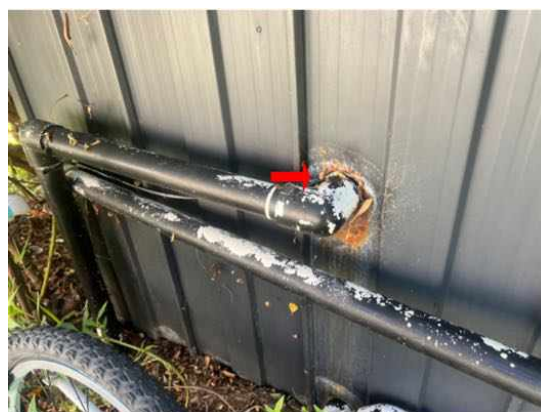
Building:	Yard
Location:	Shed
Finding:	Metal Sheets – Surface Rust and Deterioration (pool shed)
Information:	Surface rust and deterioration were observed to metal sheeting located adjacent to

the pool pump area. The sheeting is not in direct contact with the ground; however, exposure to moisture and chlorinated air from the pool equipment area is likely contributing to corrosion. Prolonged exposure under these conditions can accelerate rusting and lead to progressive weakening of the material.

If left unmanaged, continued corrosion may affect the durability and appearance of the metal components. The client should seek advice from a registered builder to assess the extent of deterioration and advise on maintenance or replacement as required.

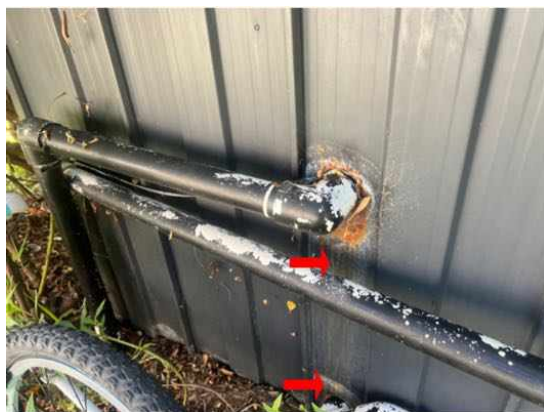
Finding 3.55

Finding: Water staining

Information: Water staining was evident in this area at the time of inspection. Water staining indicates that surfaces have been exposed to excessive moisture over time. The minerals and other elements in the water lead to staining, which may graduate to corrosion and deterioration if left unmanaged.

While mostly an appearance defect, water staining can be indicative of more serious defects, which may be currently concealed by other building elements.

Where water staining is active, a licensed plumber must be consulted to identify the cause of the staining and to provide advice on any repair works that may be required. Replacement of any broken or damaged structures is advised.

Conversely, where water staining is old and inactive, affected building materials may be repaired or replaced at client discretion. A qualified carpenter or registered builder may be appointed to perform these works.

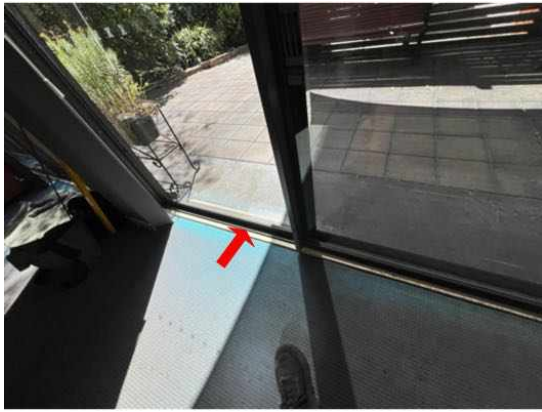
Information: The door in this area was jammed and difficult to slide along the associated tracks at the time of the inspection. Restricted function of the affected door may pose as a potential safety hazard if required for emergency egress from the building.

Generally, factors such as general age of the building element and a lack of maintenance are the usual causes for this type of defect.

Replacement of door hardware or tracks may be required, as well as minor repairs and cleaning. A registered builder or general handy person will be required to repair the affected doors.

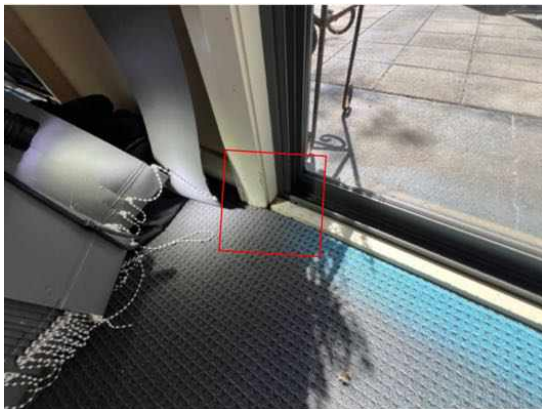
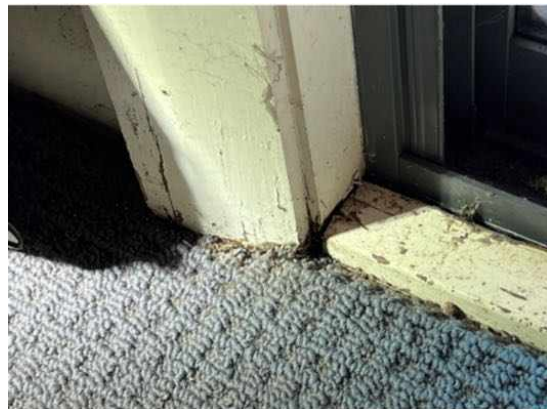
Finding 3.58

Building:	Building 1
Location:	Dining Room, Balcony
Finding:	Water staining - internal
Information:	Water staining was observed to internal surfaces at the time of inspection, indicating exposure to excessive moisture over time. This may result from past leaks, ground moisture, or inadequate drainage. While primarily an appearance defect, water staining can also signal concealed damage.

If active, the moisture may contribute to corrosion, rot, or fungal decay, particularly if allowed to persist unchecked.

It is recommended that a licensed plumber assess for any ongoing moisture ingress. Where staining is old and inactive, a qualified tiler or registered builder may be engaged to repair or replace affected materials at the client's discretion.

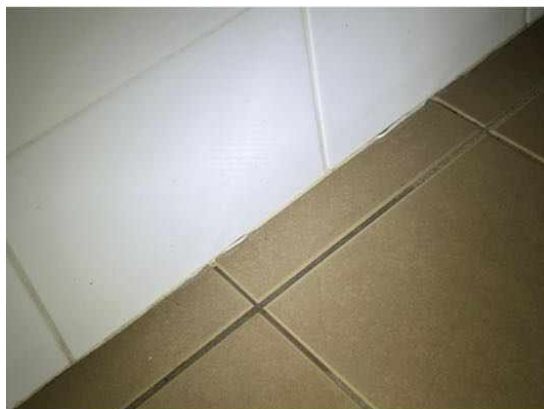
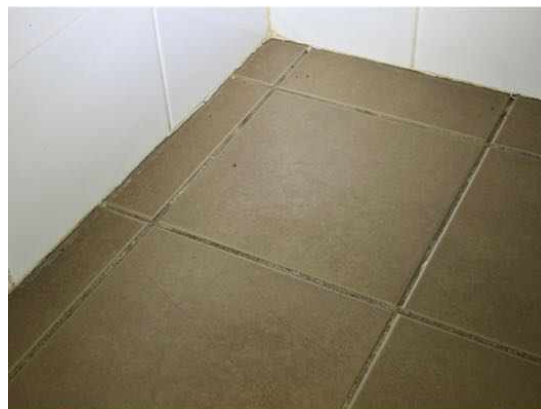
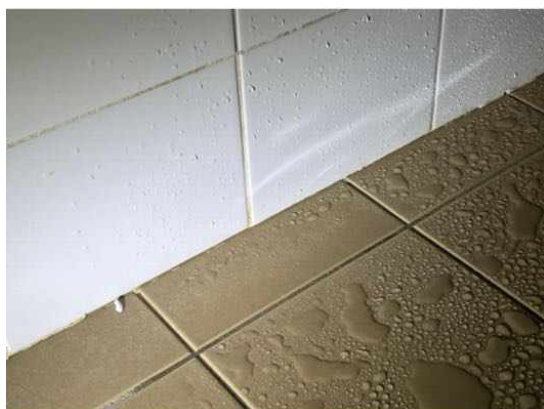
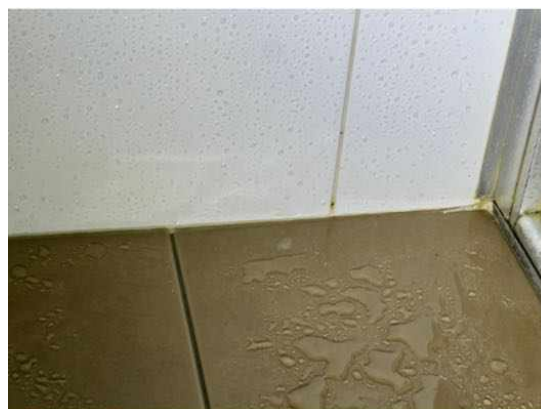
Finding 3.62

Building:	Building 1
Location:	Bathroom
Finding:	Moisture in Shower
Information:	Moisture is evident behind the tiles to the shower alcove. This defect is quite common, and is suspected to have been caused by moisture permeating through the grouting in this area. Leaking pipes within the adjoining wall is also a possible cause.

Damp (or structural damp) refers to the presence of unwanted moisture in the structure of a building, either as the result of intrusion from outside, or condensation from within the structure. In the shower area, internal water leaks or other sources of excessive moisture are generally the cause of damp. Always ensure that sealant and grout is in good condition to prevent any moisture issues occurring in the future.

Consultation with a qualified plumber or bathroom specialist is advised to identify the cause of damp and to perform remedial works as required.

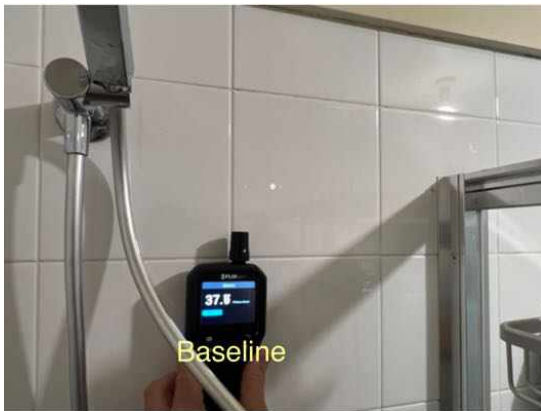
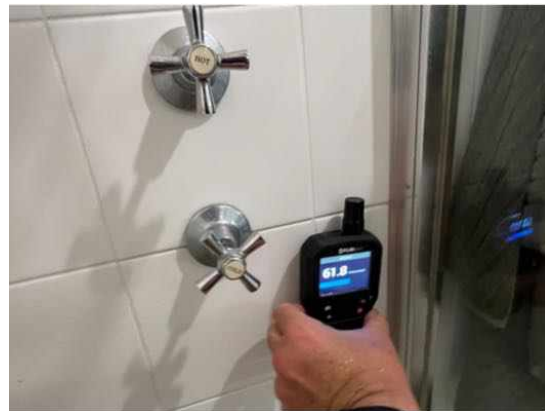
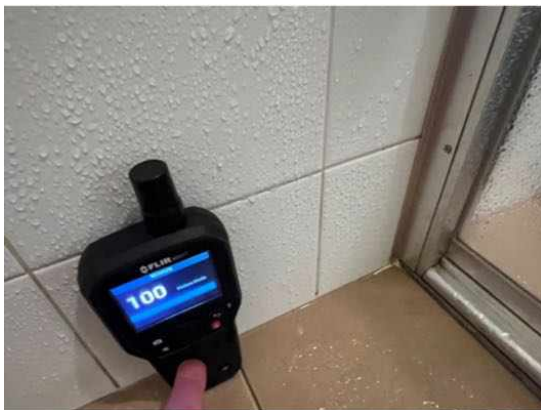
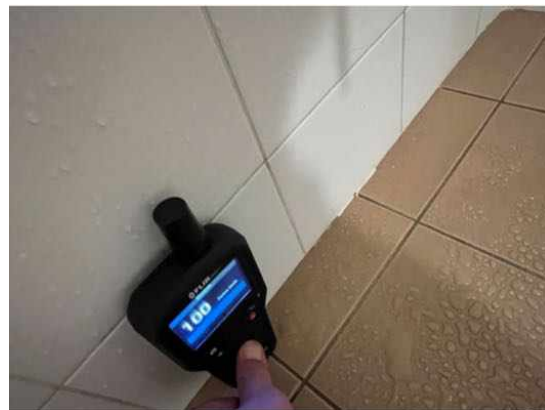
Finding 3.63

Building:	Building 1
Location:	Bathroom
Finding:	Shower screen - active leak
Information:	A active leak was identified to the shower screen, likely due to deteriorated or inadequate sealant. If left unmanaged, water ingress may lead to damage to adjacent walls and flooring, as well as creating conditions conducive to mould growth.

Resealing is recommended to restore a watertight seal and prevent further deterioration.

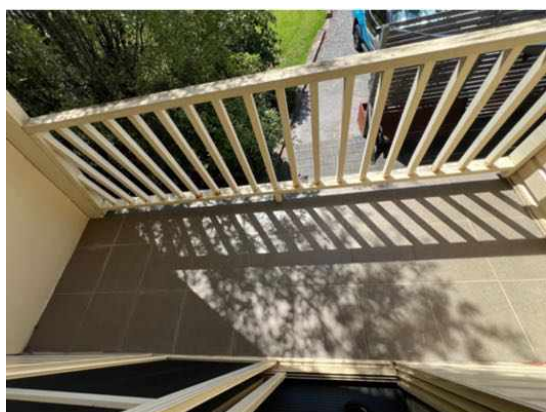
Finding 3.66

Information: Drummy tiled areas were identified at the time of inspection. The term 'drummy' refers to tiles that have become detached from their fixing, despite otherwise being in relatively good condition. Such defects are generally caused by physical or moisture damage to the area. Drummy tiled areas may also be a direct result of poor workmanship during the construction process.

Tiled areas may swell and shrink with changes in air humidity if the area has sustained moisture damage. Any exposure to moisture is capable of causing tiled areas to become drummy and/or cracked over a prolonged period of time. Drummy tiled areas generally require removal and replacement of affected tiles, with adequate sealant and grouting.

Specialist trades are available for these types of services. A registered builder may be required to undertake works if damage is extensive or if secondary building defects have resulted. Otherwise, it is advised that a tiling contractor be appointed to perform works as necessary. Immediate action is recommended to ensure that no further damage is sustained in the affected area.

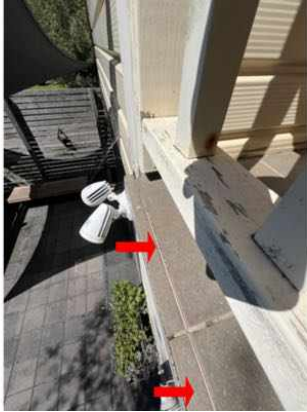
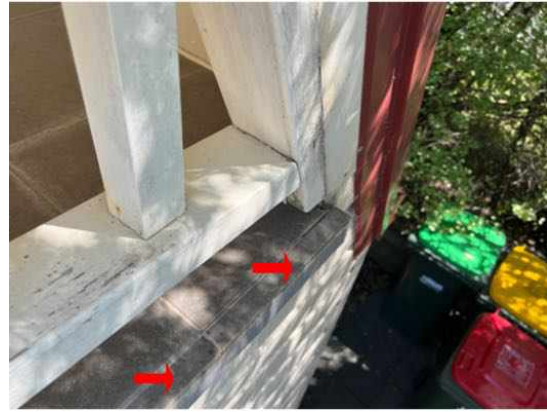
Finding 3.67

Building:	Building 1
Location:	Balcony
Finding:	Balustrade - Timber Decay
Information:	Timber Decay was observed to sections of the external balustrade. This type of condition is commonly associated with prolonged exposure to moisture and general weathering over time.

If left unmanaged, timber deterioration may progress and reduce the durability and effectiveness of the balustrade, potentially leading to further decay and the need for more extensive repairs in the future.

It is recommended that a registered builder or qualified carpenter assess the affected balustrade components and carry out maintenance or repair as required to limit further deterioration and maintain serviceability.

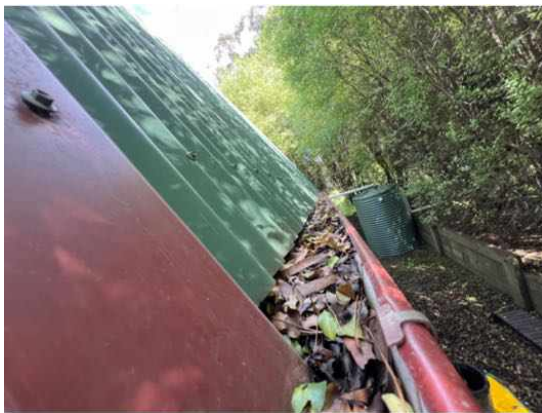
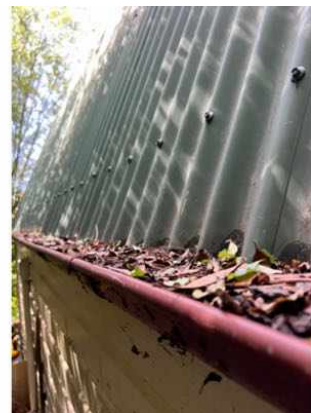
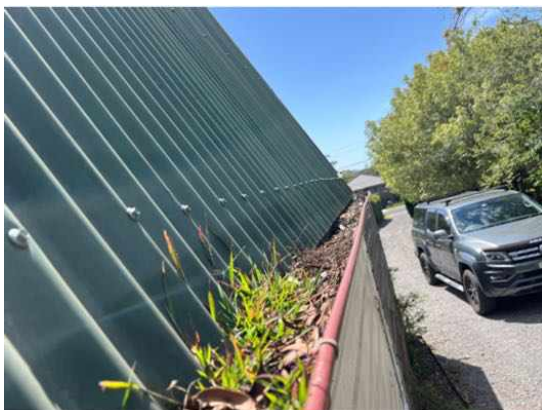
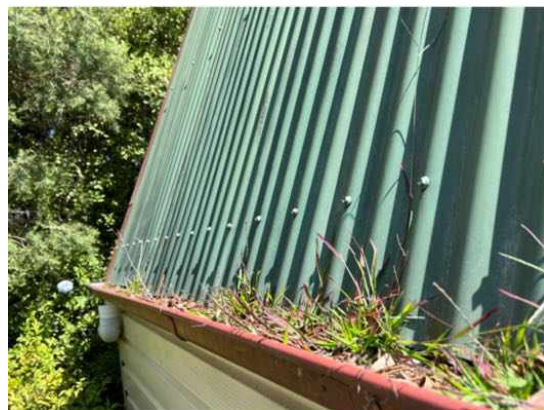
Finding 3.72

Building:	Yard
Location:	The Site
Finding:	Trees - Overhanging and filling gutters
Information:	Overhanging trees often result in excessive amounts of leaf debris accumulating in gutters.

Gutters are a critical part of the building's management of storm water and rain. It is therefore important that they be kept clear to prevent secondary damage to associated building elements, including exterior and interior walls, ceiling linings and any adjoining building elements. Where gutters are blocked, pooling of rainwater is likely to occur, fast-tracking rust and corrosion of the roof plumbing elements.

It is highly advised that all overhanging tree branches be removed as soon as possible to prevent any further damage. Repair and/or replacement of sections of damaged guttering may also be required where the extent of the damage necessitates.

Such works should be performed by the homeowner; however, appointment of a landscape contractor or an arborist may be required. Consultation with a licensed roof plumber is required where guttering has been damaged.

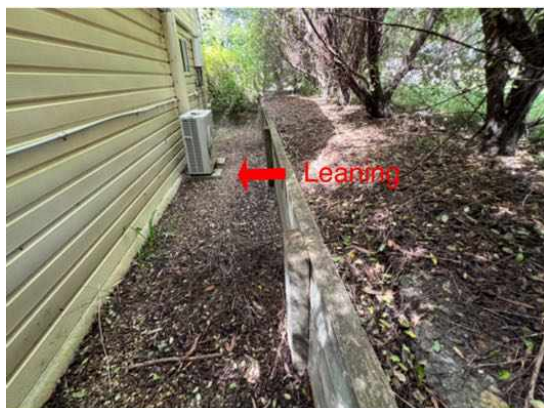
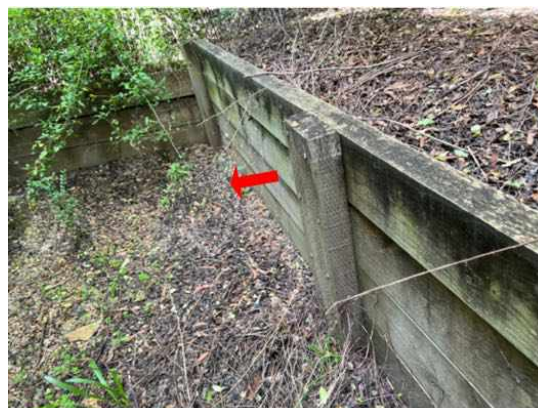
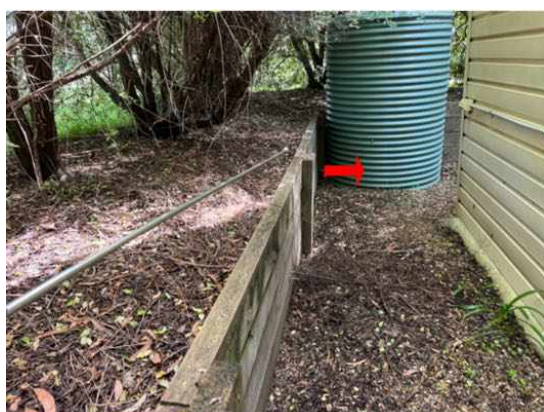
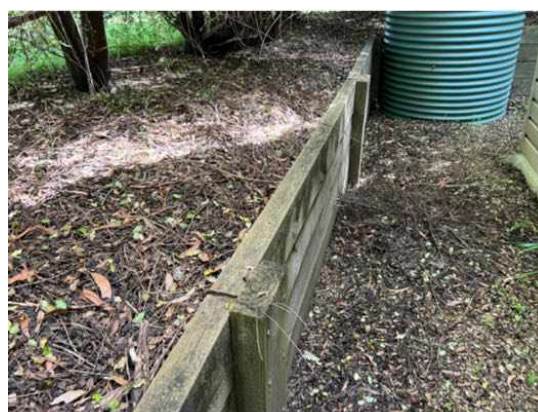
Finding 4.01

Building:	Yard
Location:	Yard - Back
Finding:	Evidence of live termite activity was identified (species unknown)
Information:	Live termite activity was found on the property. This may be in the form of mud trails the identification of a live termite nest or termites found to be attacking timber building elements. The species of the termites could not be identified at the time of inspection which may impact on the mode of eradication. Works to eradicate live termites should be undertaken immediately to prevent any further damage that will inevitably ensue.

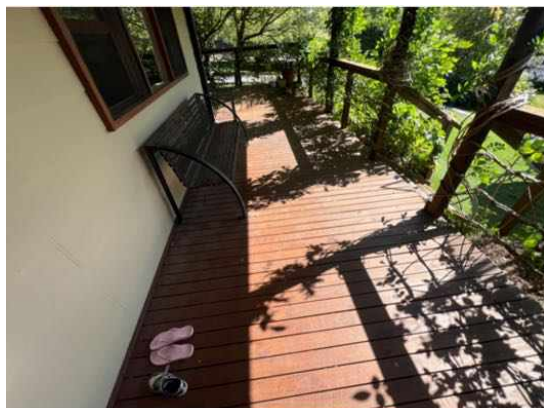
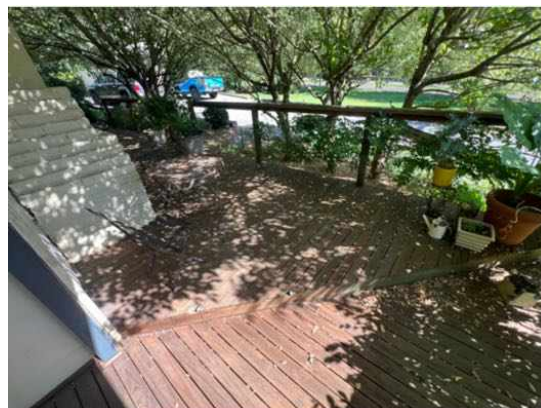
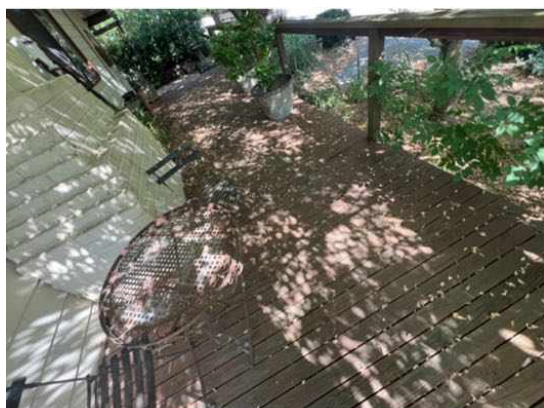
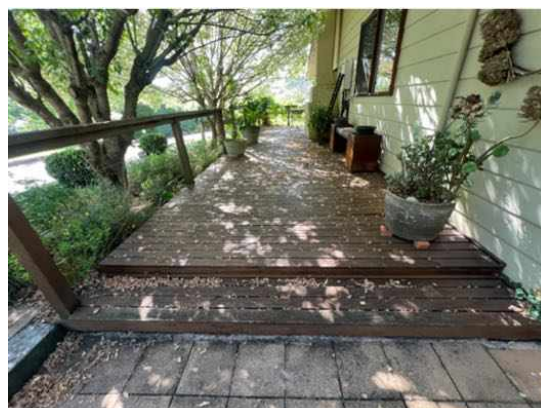
Finding 6.07

Building:	Main Building
Location:	Pergola
Finding:	Bridging of physical termite barriers - Concrete Patio
Information:	The tiled concrete pad to the patio/alfresco including other areas directly abuts dwelling causing bridging. Bridging is the span of a physical termite barrier or inspection zone so that subterranean termites have an entry point over or around that barrier.

Where a concrete patio is retrospectively installed against an external wall, this provides a concealed entry point for termites.

The client should consider obtaining further advice from a timber pest technician regarding treatments required in this area. It is recommended that obtaining such advice be a short-term priority.

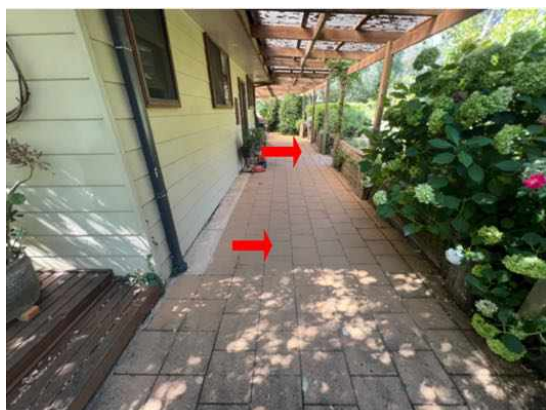
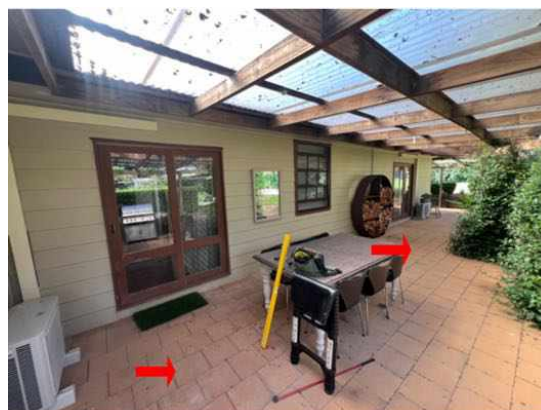
Finding 6.08

Building: Main Building
 Location: Pergola
 Finding: Bridging of termite barrier - Posts.
 Information: Posts that are attached to home from ground to structure without a 75mm inspection zone (metal stirrup) causes a bridging point. Bridging of termite barriers occurs when termites bridge (usually by building a mud tunnel) a termite barrier or inspection zone or where termites have a passage allowing them to bridge the barrier.

Generally this takes the form of finished ground levels external paving or concrete being retrospectively installed above the damp course level the adjacent internal floor level and weep and ventilation holes.

Where bridging has occurred full inspection is prevented and termites may enter a property in a concealed or undetectable manner.

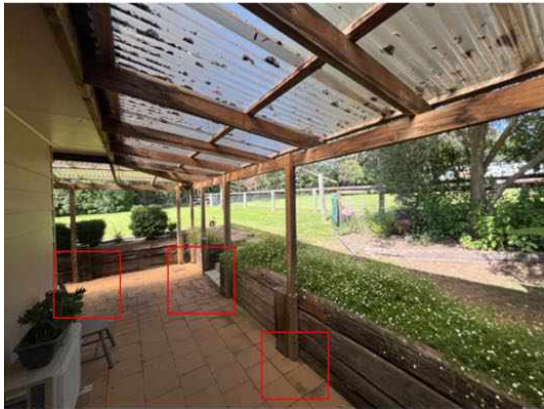
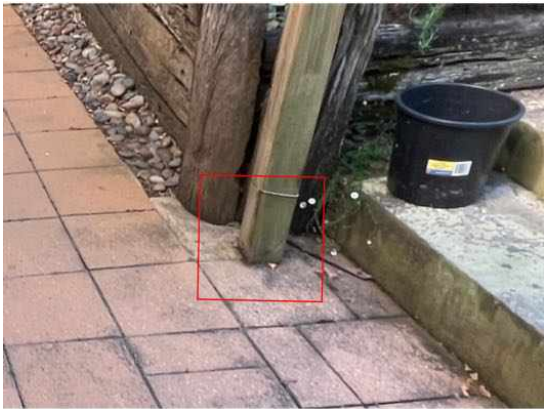
Finding 6.09

Building: Main Building
 Location: All External Areas
 Finding: Bridging - Attachments to Buildings.
 Information: Bridging occurs when items against a building provide a concealed entry point for termites into the building or by passing around a termite management system.

Where any part of an attachment to a building is not isolated and is not provided with a clear gap of not less than 25mm from the building, bridging occurs. Attachments to buildings such as hot water services, downpipes, verandahs, decks, steps, fences, service conduits and the like provide the opportunity for concealed entry.

Building attachments of this nature need to be frequently inspected for termite activity by a qualified inspector
