Building and Timber Pest Inspection Report

Inspection Date: Fri, 6 Feb 2026

Property Address: 4 Drapers Rd, Willow Vale NSW 2575,
Australia

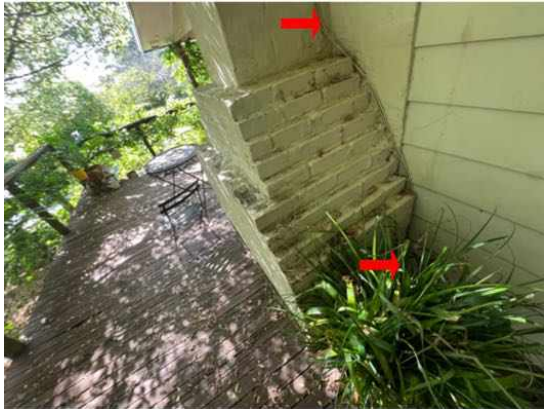
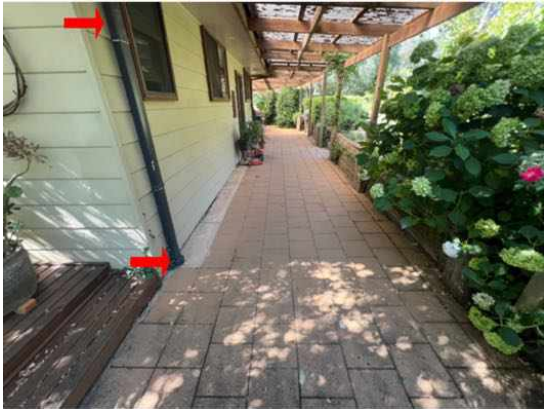
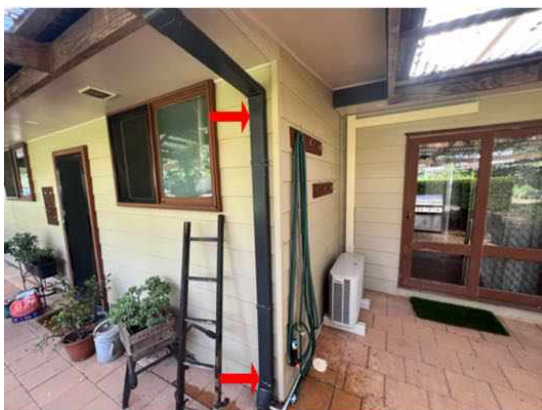
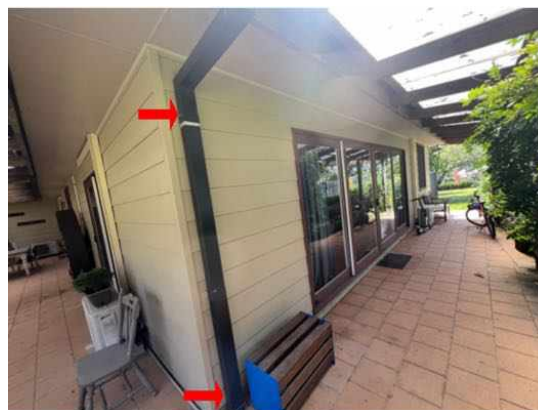
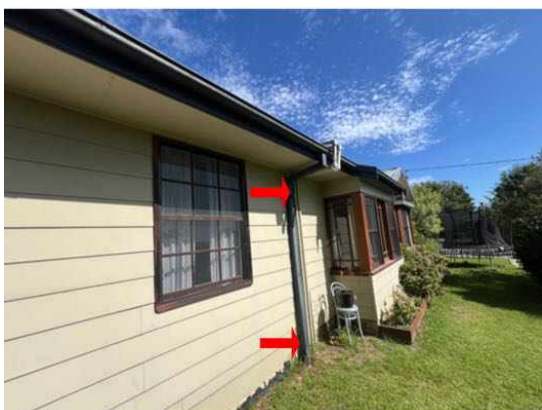
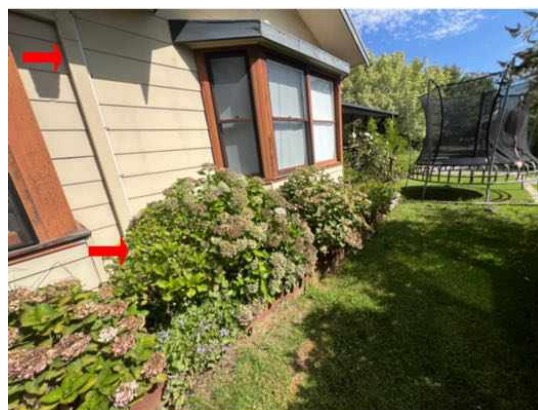
Finding 6.10

Building:	Main Building
Location:	Exterior walls - front
Finding:	Downpipe - Damage, conditions conducive to termites
Information:	The downpipe in this area shows visible damage, which hinders its ability to effectively direct water away from the building. This creates conditions conducive to termite activity by increasing the likelihood of water pooling around the foundation. Prolonged moisture retention can lead to structural degradation, soil erosion, or water ingress into lower building areas, all of which may attract and sustain termite infestations.

The observed damage may be attributed to impact, corrosion, or general wear. It is recommended that a licensed roof plumber be engaged to inspect the downpipe and carry out necessary repairs or replacement as a priority to mitigate moisture-related risks and potential termite activity.

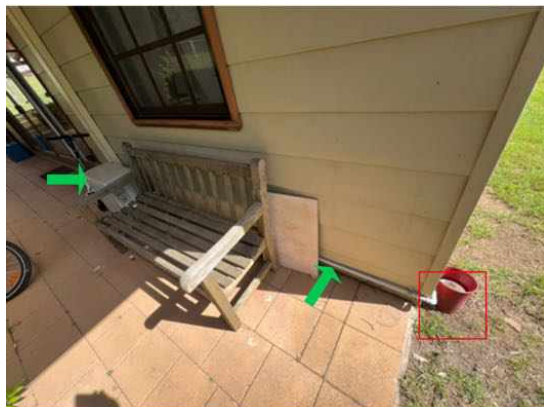
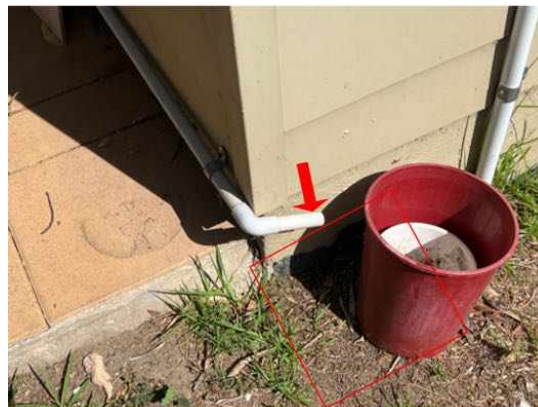
Finding 6.14

Building:	Main Building
Location:	Exterior walls - rear
Finding:	External taps - Not plumbed for drainage
Information:	The External taps is not plumbed or connected to suitable drainage, which has resulted in the surrounding area becoming excessively damp. These damp conditions can lead to secondary defects such as rot, rust or corrosion of associated building elements, the formation of fungal decay, or even the creation of potential slip hazards. When coupled with poor site drainage, pooling of water may also attract termite activity to this area. It is highly recommended that a qualified plumber be appointed to install adequate drainage to the overflow. These works will ensure that the area remains dry and free of any secondary defects.

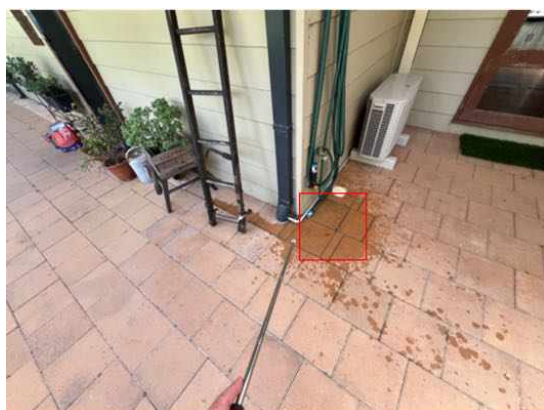
Finding 6.15

Building:	Building 1
Location:	Water Tank - Barn
Finding:	Overflow - Not plumbed for drainage
Information:	The overflow is not plumbed or connected to suitable drainage, which has resulted in the surrounding area becoming excessively damp. These damp conditions can lead to secondary defects such as rot, rust or corrosion of associated building elements, the

formation of fungal decay, or even the creation of potential slip hazards. When coupled with poor site drainage, pooling of water may also attract termite activity to this area. It is highly recommended that a qualified plumber be appointed to install adequate drainage to the overflow. These works will ensure that the area remains dry and free of any secondary defects.

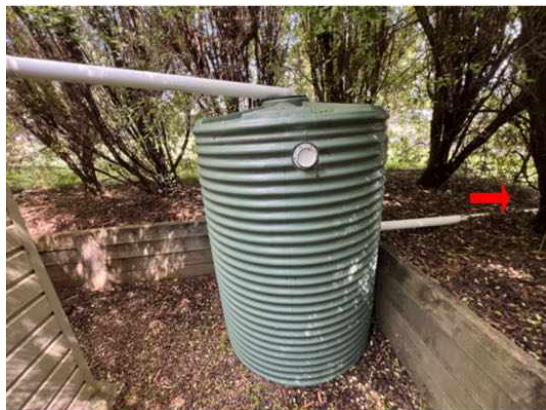
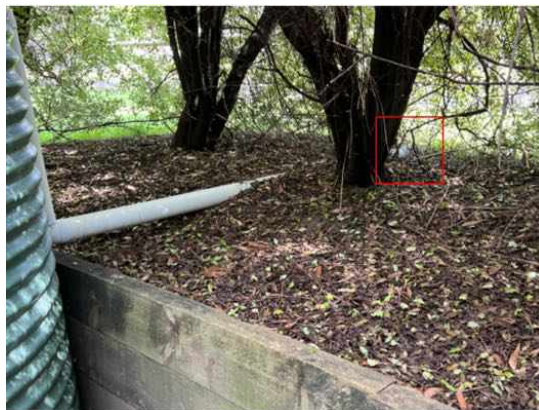
Finding 6.16

Building:	Main Building
Location:	All External Areas
Finding:	Garden Beds - Conditions Conducive to Termites
Information:	Garden beds were observed around the perimeter of the building, obstructing visual inspection of lower wall areas and providing potential concealed termite entry points.

Raised soil levels and retained moisture from watering can allow termites to access wall cavities or weep holes undetected, while timber edging materials may further encourage activity.

It is recommended that garden beds be reduced or cleared from the building perimeter, or that regular timber pest inspections be carried out in accordance with AS 4349.3 or AS 3660.2 to monitor risk.

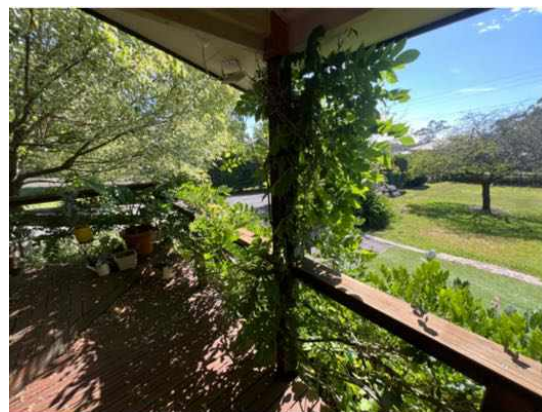
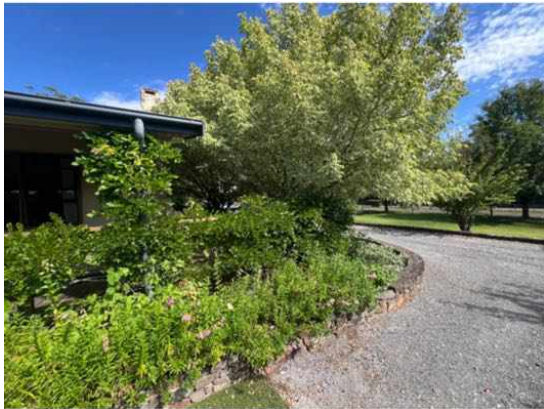
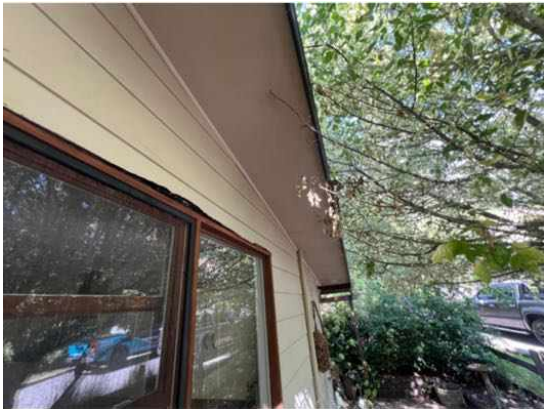
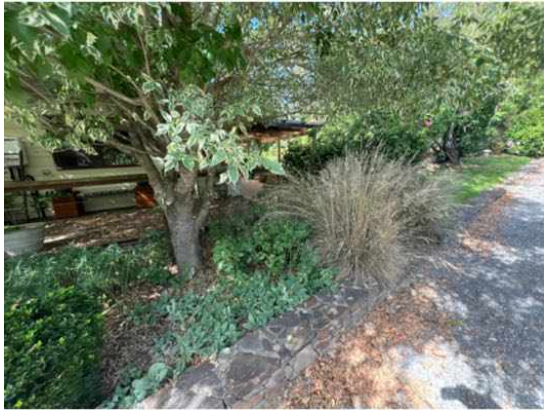
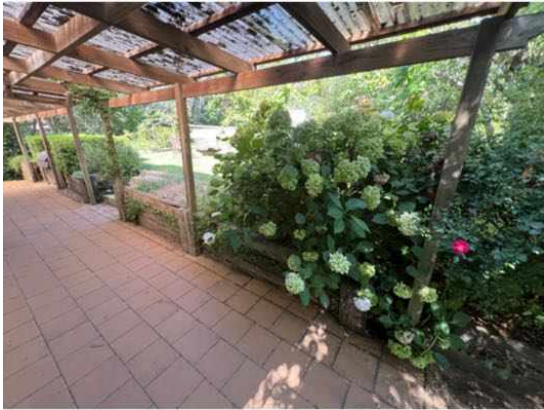
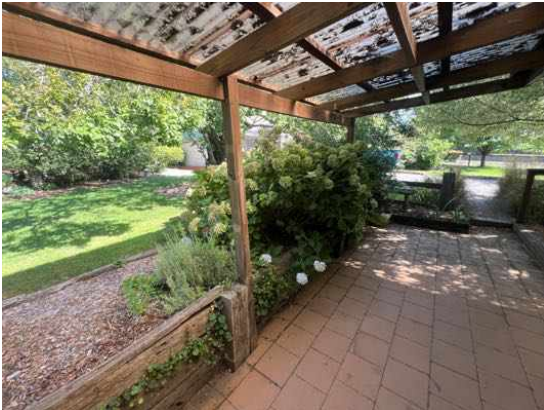
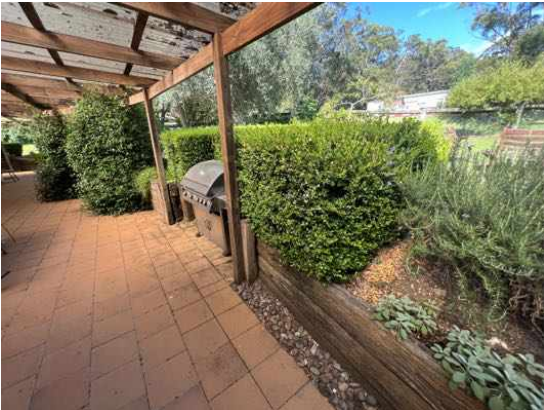
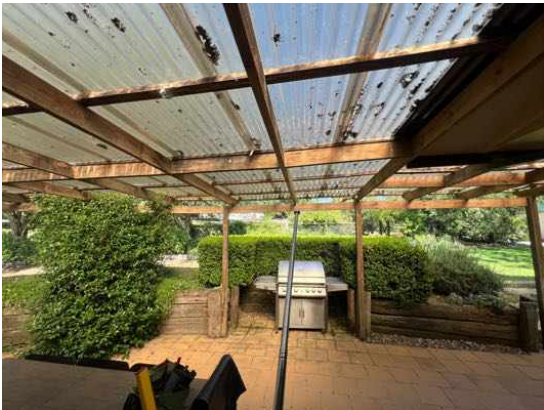
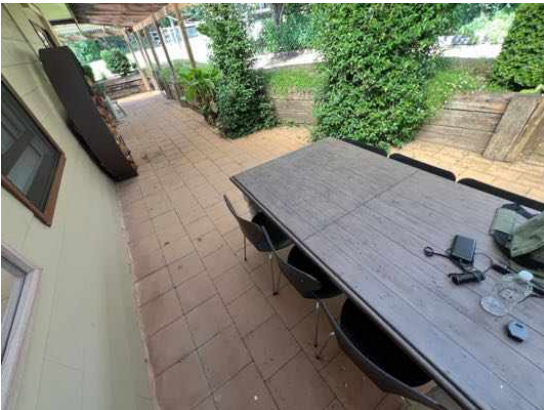
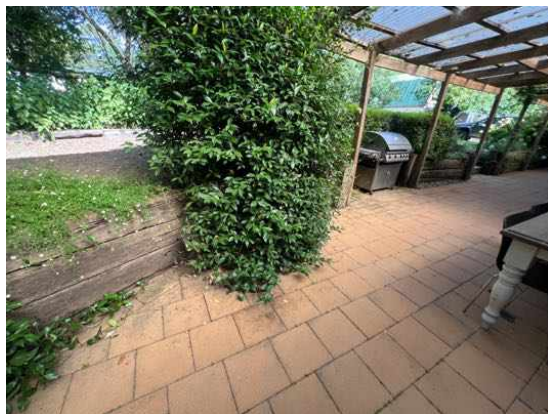
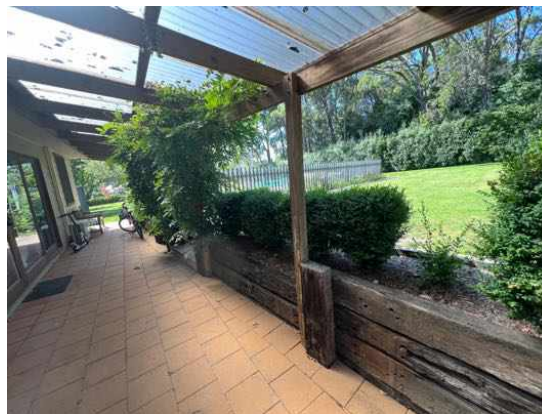
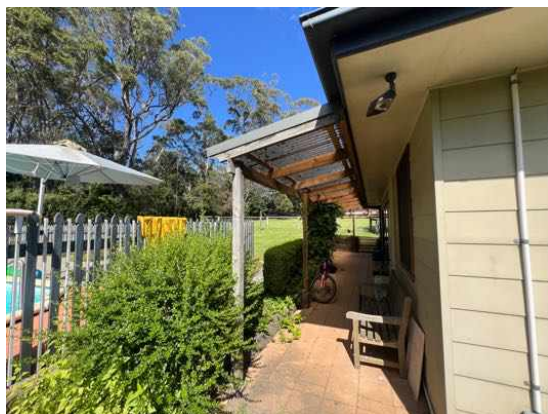
Finding 6.17

Building:	Main Building
Location:	All External Areas
Finding:	Vegetation Against Building - Conducive to Termite Activity
Information:	Vegetation and trees were observed in direct contact or in close proximity to the building at the time of inspection. This condition creates a conducive environment for termite activity by providing concealed access points, retaining moisture against the structure, and reducing ventilation. Additionally, vegetation can contribute to organic debris buildup, further increasing the risk of pest infestation.

It is recommended that all vegetation be trimmed back to allow adequate clearance from the building. Ongoing maintenance is advised to reduce the risk of termite activity and improve ventilation around the structure. Regular termite inspections should also be conducted to monitor for any signs of infestation.

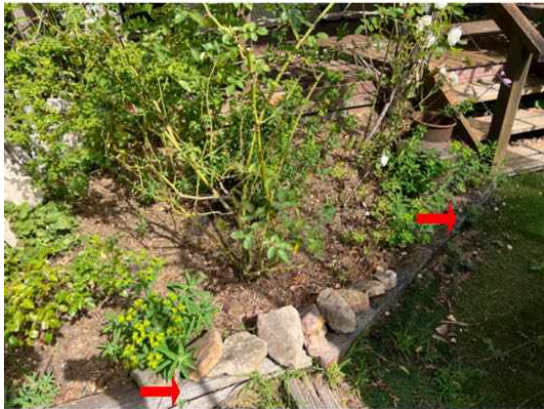
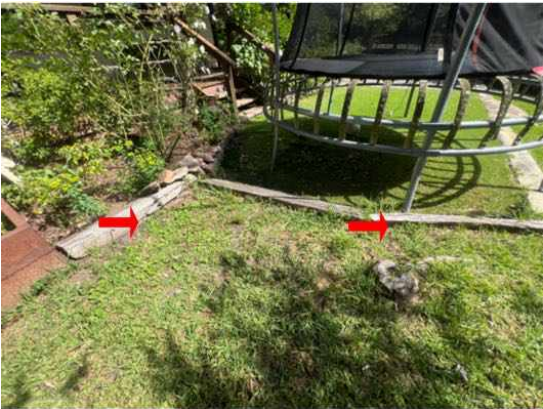
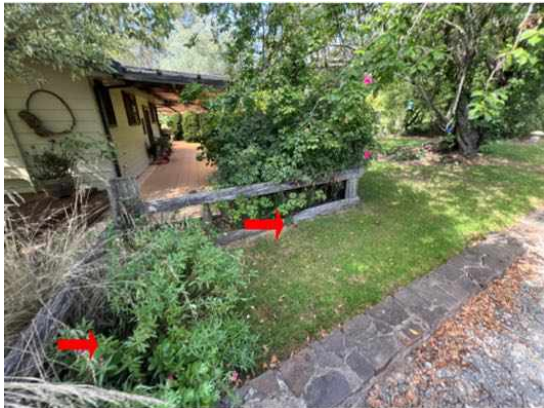
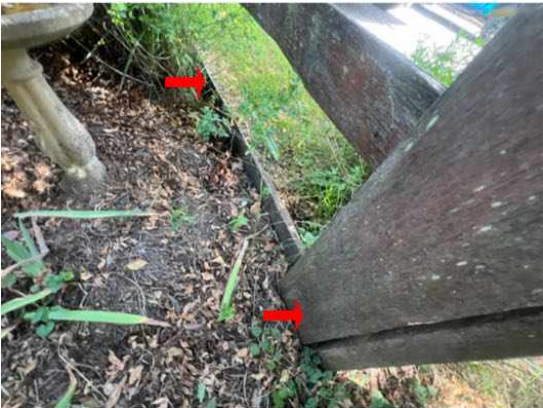
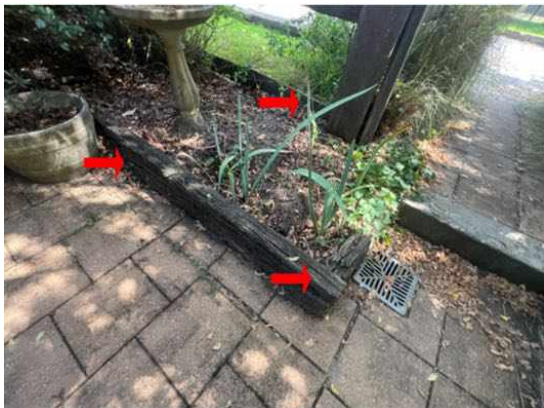
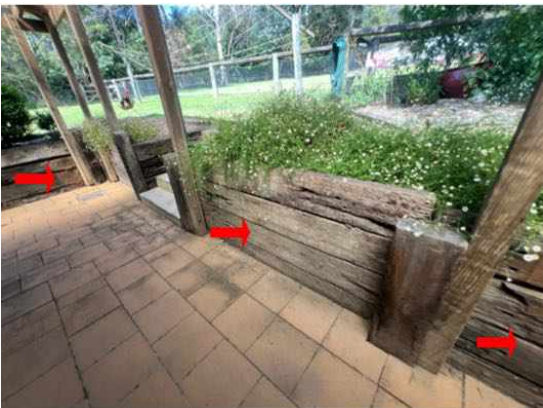
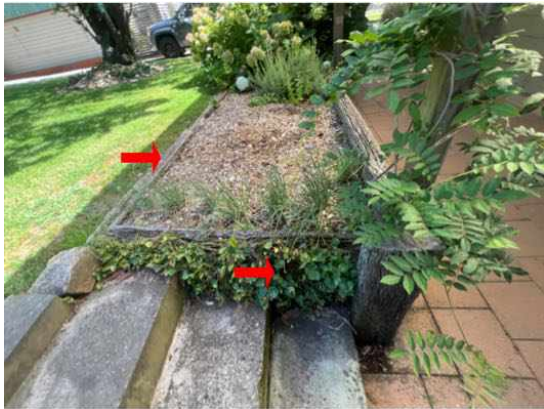
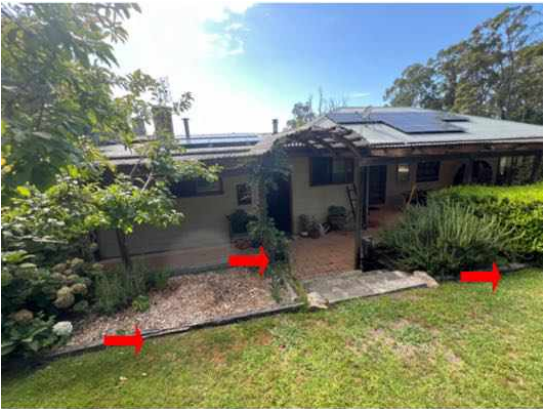
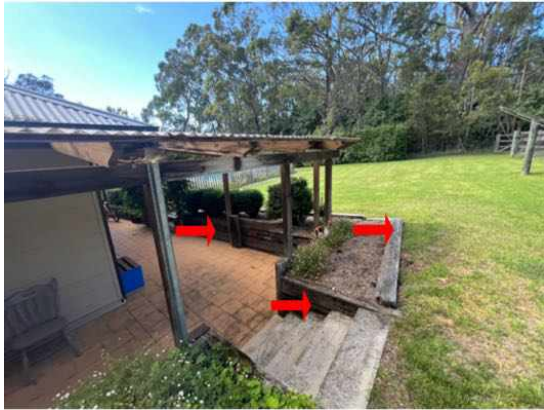
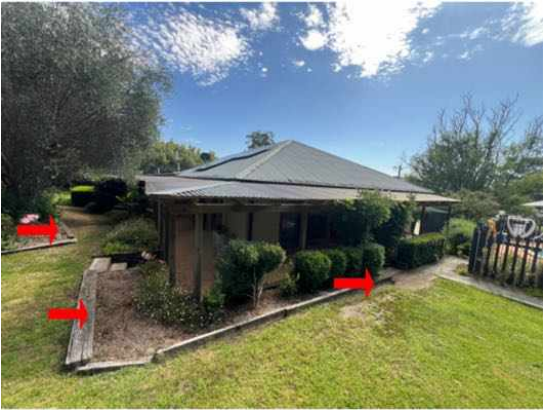
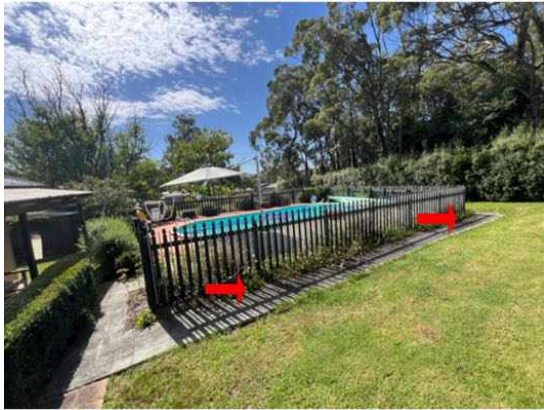
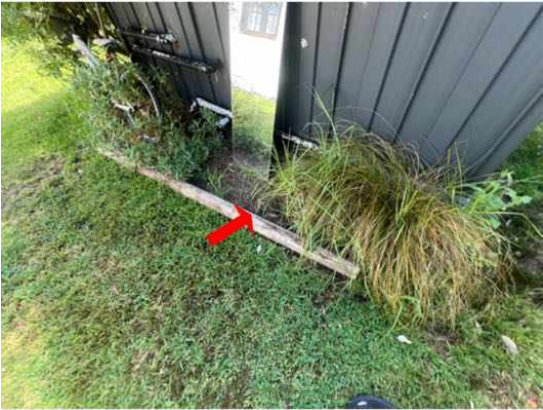
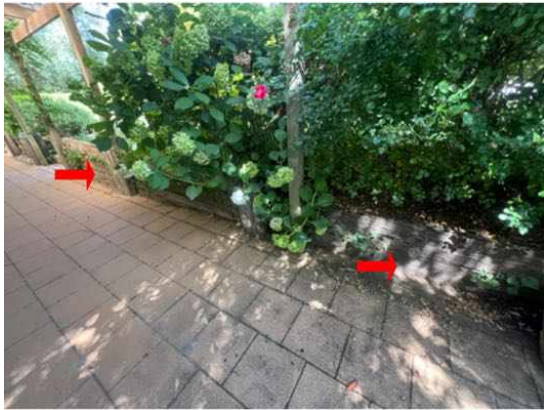
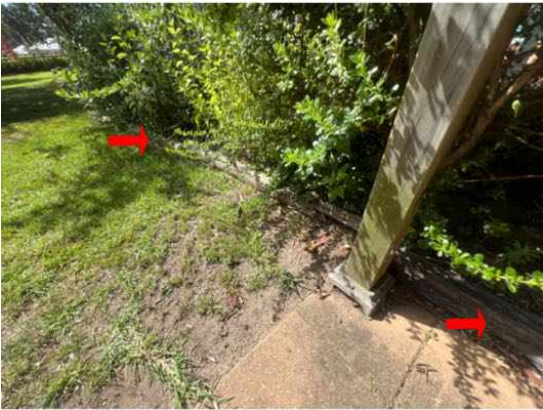
Building:	Yard
Location:	All External Areas
Finding:	Building materials in direct ground contact - conducive to termites
Information:	Where timber elements are in direct contact with the ground and consequently moisture or dampness they become conducive to termite activity. Whether timber is used as a building element part of a fencing structure or stored as an unused item they can provide an environment that is attractive to termite infestation.

When met with excessive moisture timber begins to decay and develop wood rot. Any timbers that are in direct contact with external grounds especially if left untreated or

non-durable also provide ingress for subterranean termites into that particular element. The removal of any such materials that may be conducive to termite activity should be removed as soon as possible to minimise the risk of termite attack.

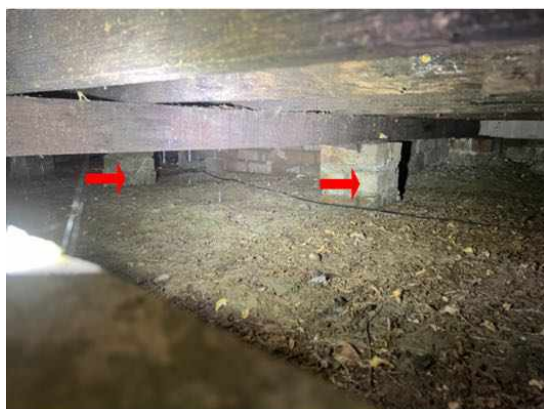
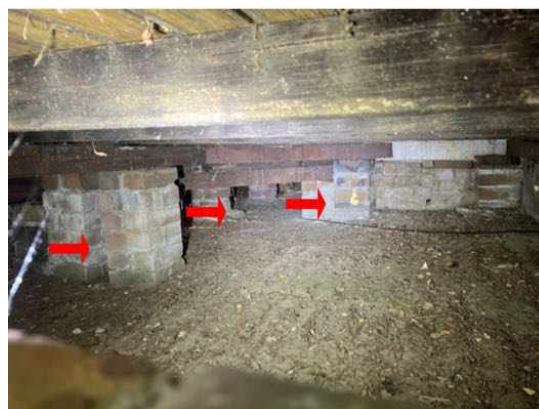
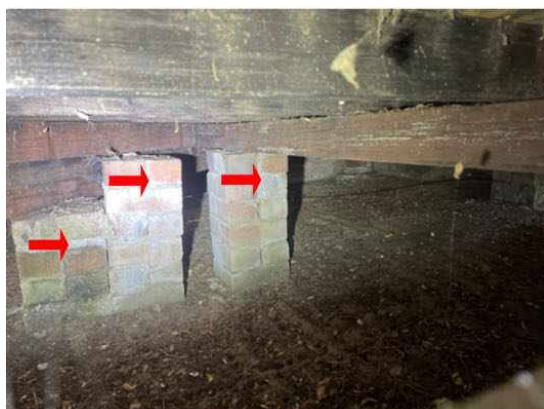
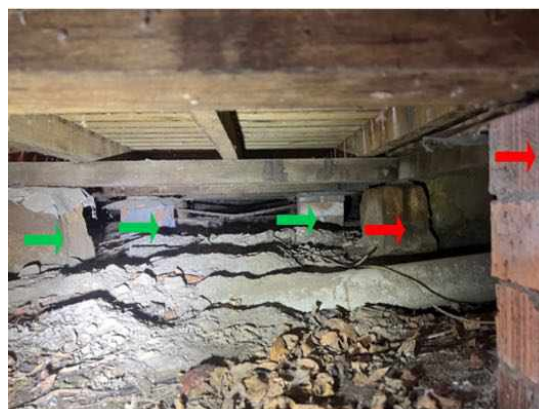
Finding 6.22

Building:	Main Building
Location:	Subfloor
Finding:	Ant caps - Not installed
Information:	Ant caps have not been installed to the subfloor structure at the time of inspection. Generally, ant caps are installed to the intersection between the top of the stumps (or piers) and the subfloor structures.

Installed during the construction process, ant caps are designed to easily identify termite or pest ingress from stumps to the adjoining bearers.

Where ant caps have not been installed, frequent monitoring of these areas should be carried out in order to identify any signs of termite or timber pest workings.

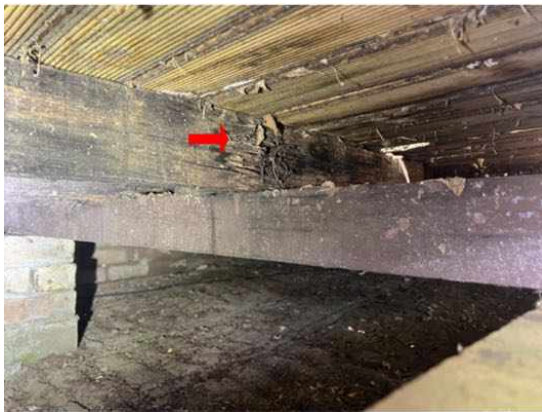
Finding 6.23

Building:	Main Building
Location:	Deck
Finding:	Subfloor structure - Wood rot
Information:	The subfloor structures are showing signs of deterioration and wood rot (fungal decay) of the timbers. It is suspected that this defect has developed as a result of damp conditions in the subfloor.

Damp conditions cause the timbers to fail, resulting in the subfloor structures failing to

bear the load (or weight) of the building as originally intended. Without repairs and maintenance, including potential replacement of affected elements, it is likely that serious structural faults will result, as well as an array of minor defects.

The presence of wood rot to the subfloor structure is also conducive to termite infestation. As timber stumps are in direct contact with the ground, concealed termite is made possible. Such entry is made easier if the timbers become non-durable due to even slight wood rot.

Where wood rot is present to any structural timber, rectification or replacement of the affected timber building element is required. The adequate timeframe for such works are dependent on the severity of the rot. Where rot has developed to become widespread, replacement of sections of the subfloor structure may be required. Consultation with a structural engineer or registered builder specialising in re-stumping is highly advised as soon as possible.

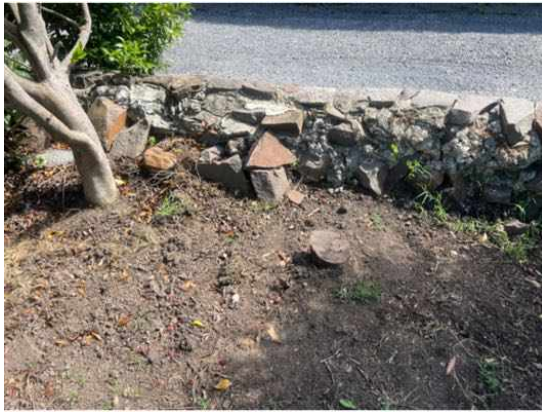
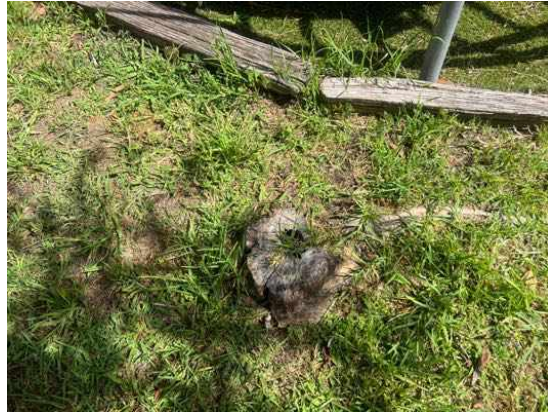
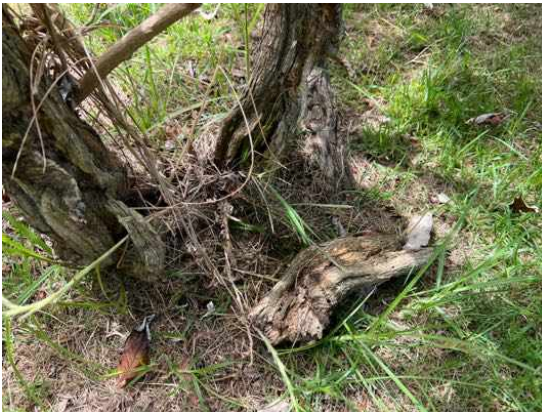
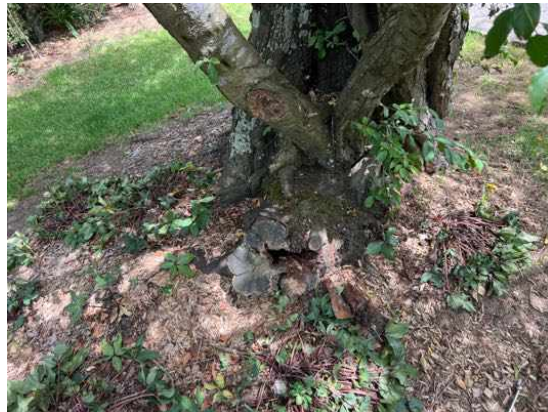
Finding 6.24

Building:	Yard
Location:	The Site
Finding:	Stumps, Dead or Decayed Trees - conducive conditions
Information:	Stumps and/or dead or decaying trees were observed within the property boundary during the inspection. These elements are recognised as significant conducive conditions, as they retain moisture and provide a cellulose-rich environment ideal for sustaining termite activity.

Even in the absence of visible termite workings at the time of inspection, decayed timber material can support undetected subterranean termite harbourage, particularly when located in close proximity to the dwelling. The risk of concealed termite ingress into structural timbers is increased when such materials are not removed or managed appropriately.

The client is advised to consult a licensed pest management professional to assess the site and determine whether treatment or removal of the stumps or trees is required. Ongoing timber pest inspections should be maintained at regular intervals to

monitor for any future activity.

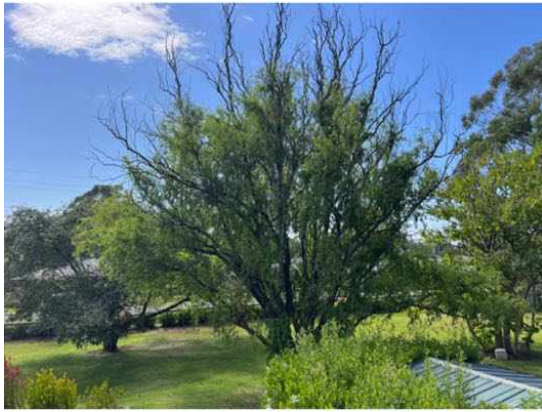
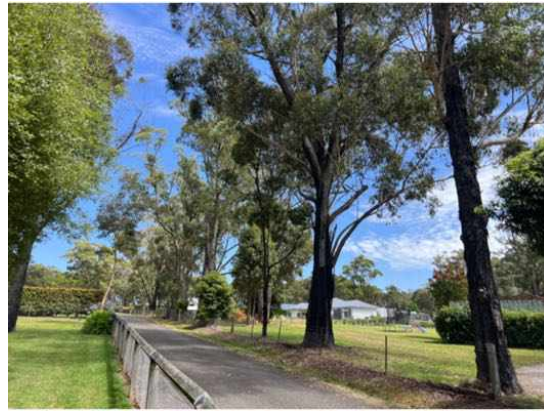
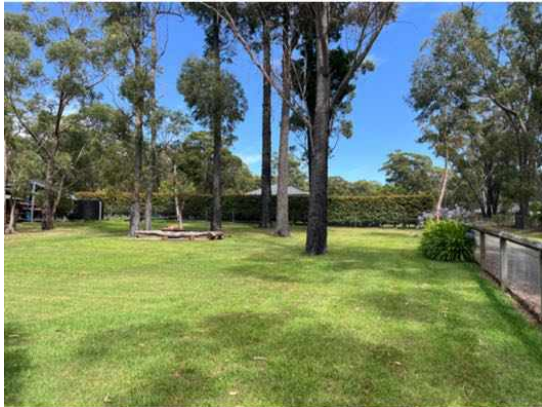
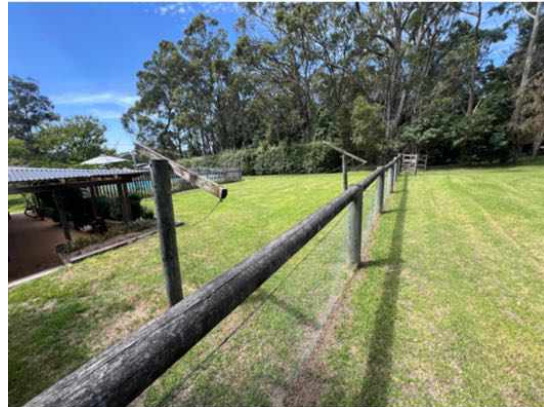
Building:	Yard
Location:	The Site
Finding:	Timber Pest Risk – Trees Within 50m of Dwelling
Information:	Mature trees were identified within 50 metres of the dwelling. The presence of trees in close proximity to the structure increases the risk of termite activity, as trees provide a natural food source and nesting environment for termites. Tree roots can also contribute to excessive moisture retention in the soil, creating conducive conditions for timber pest activity.

Regular monitoring for signs of termite activity is advised. A licensed pest inspector should be engaged to assess the area and provide further recommendations on risk mitigation and management.

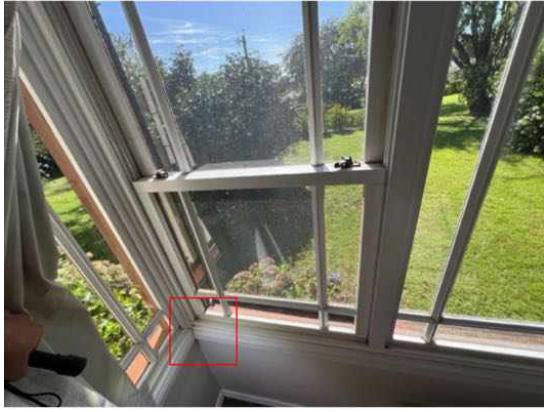
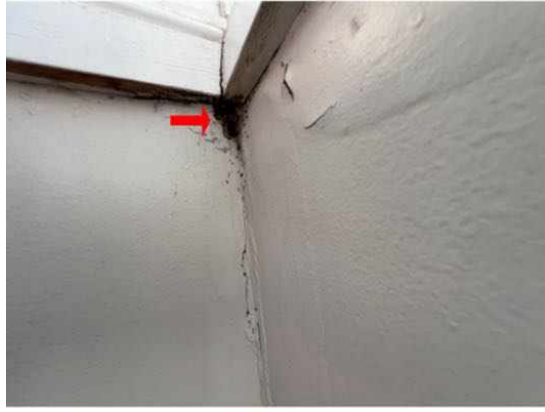
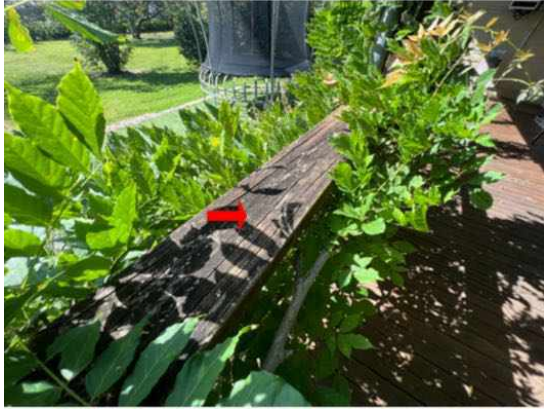
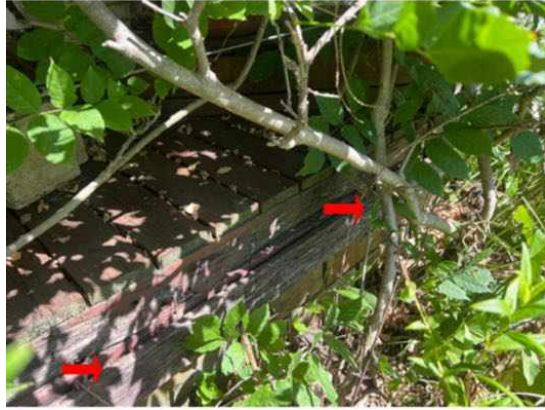
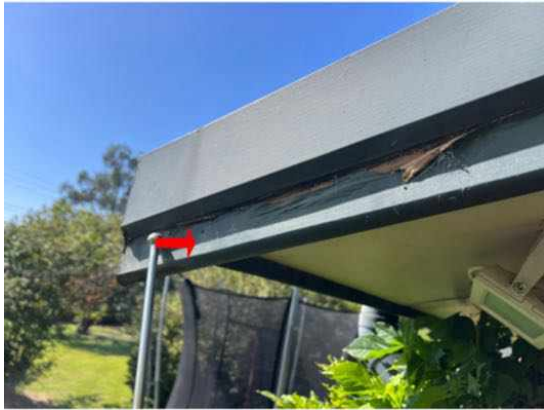
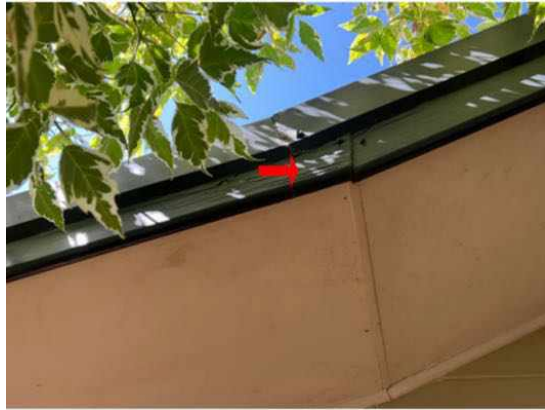
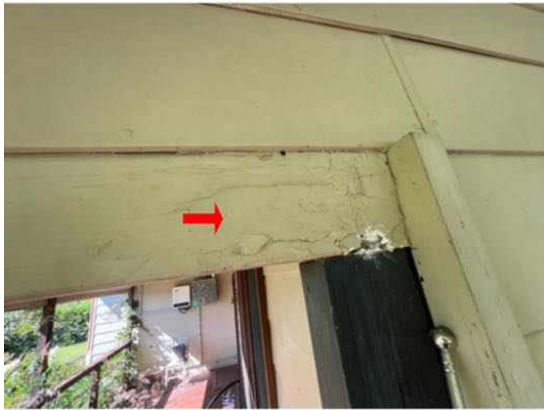
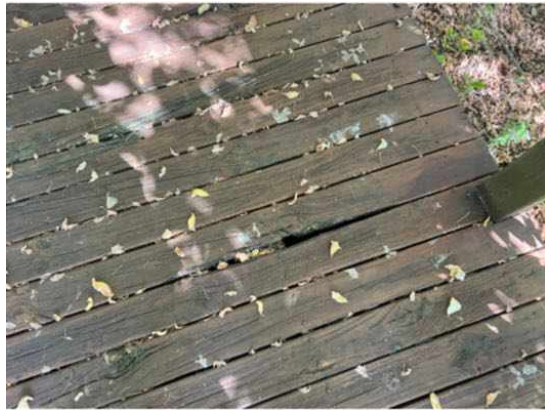
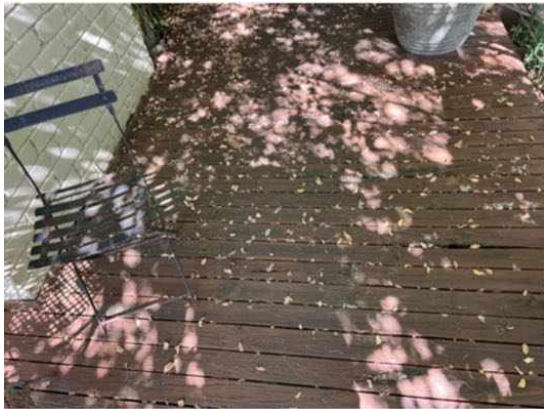
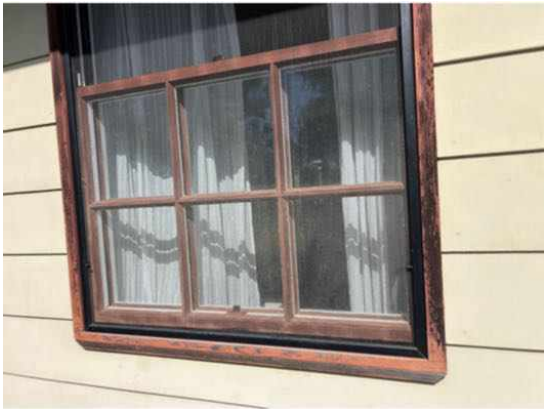
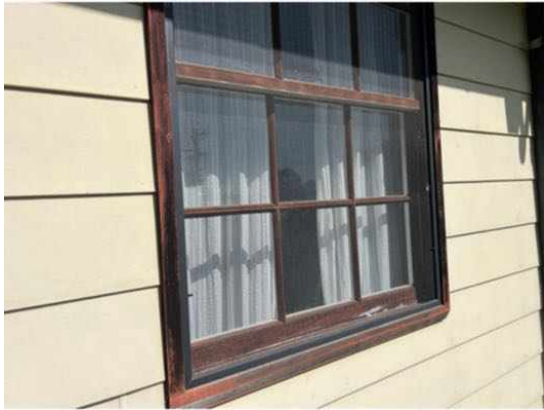
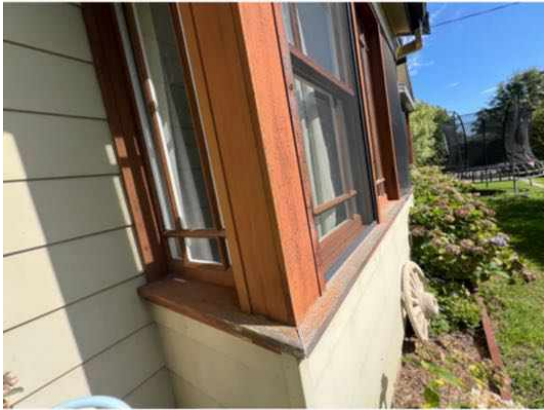
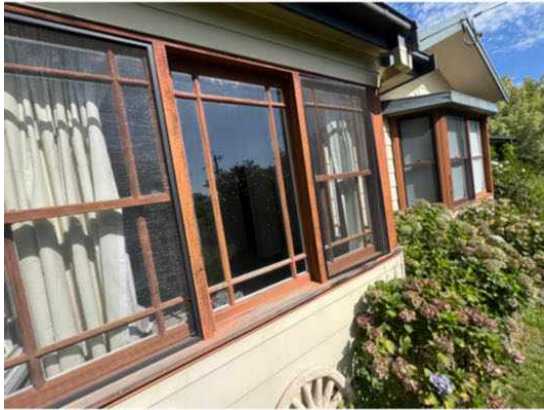
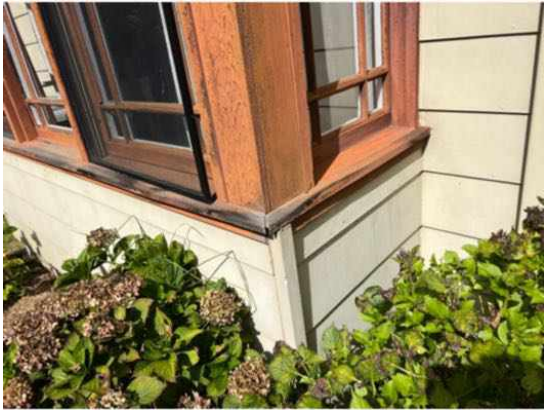
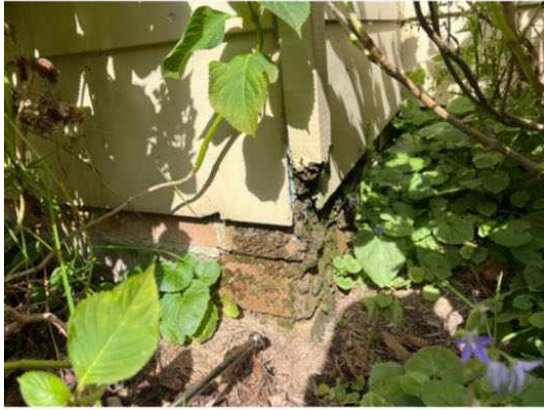
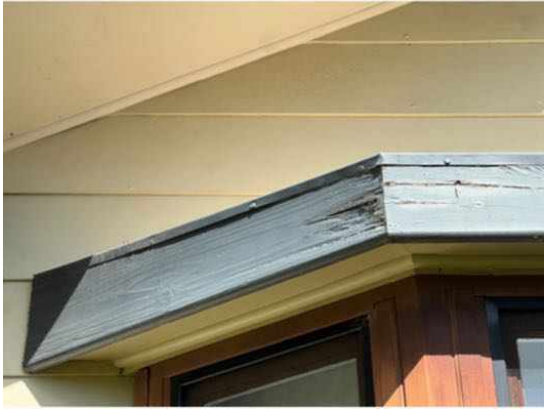
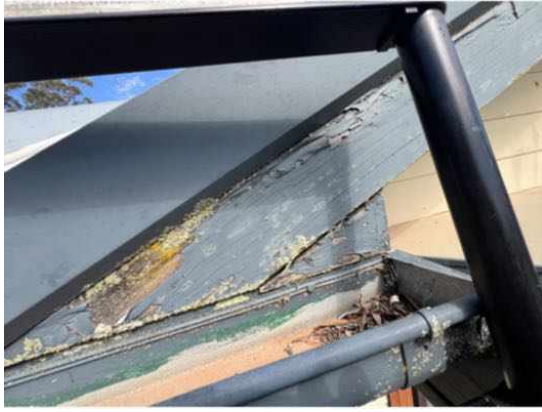
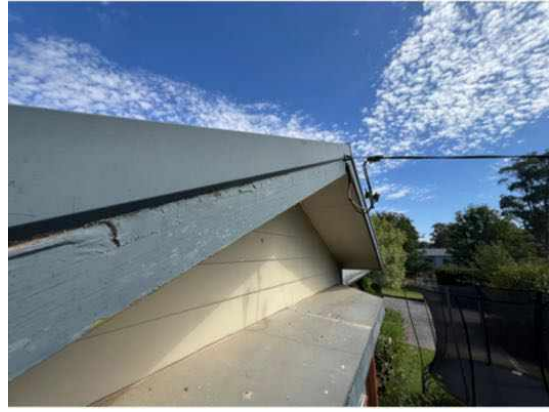
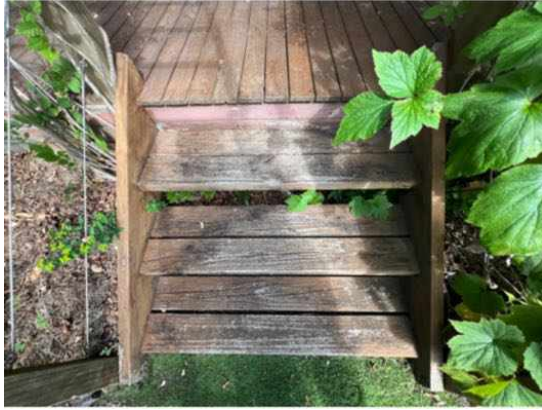
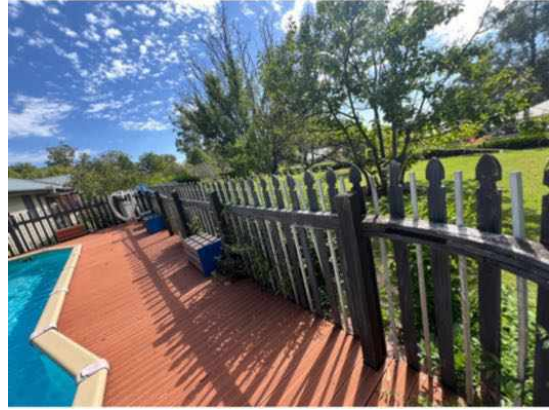
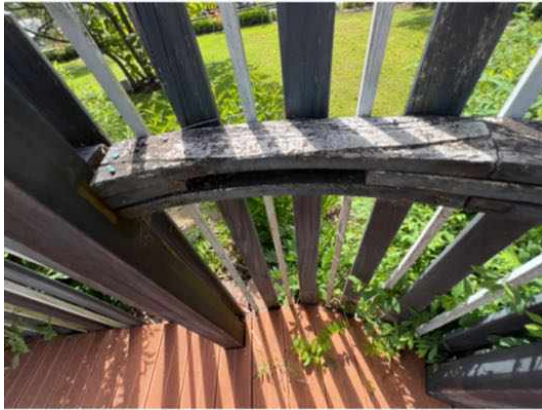
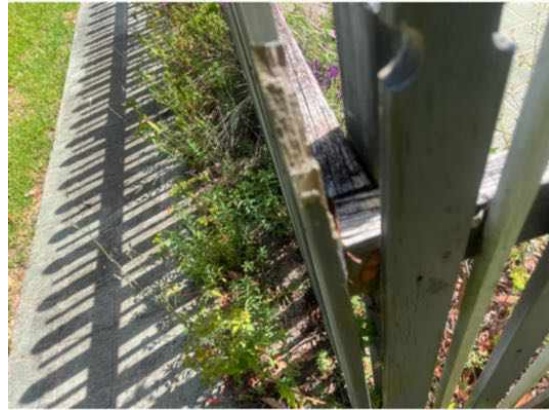
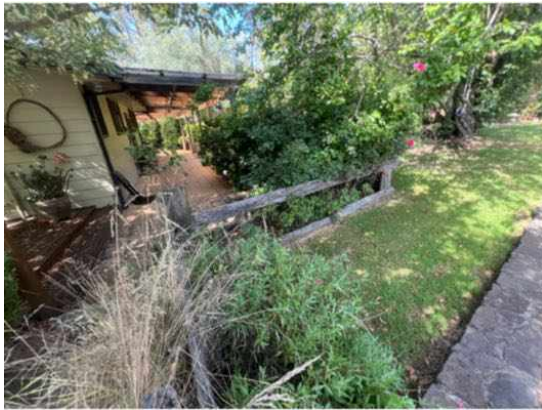
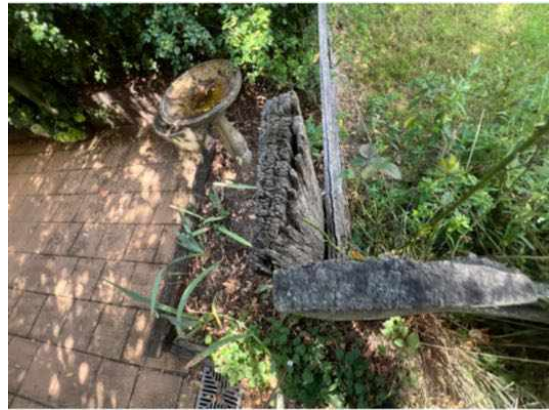
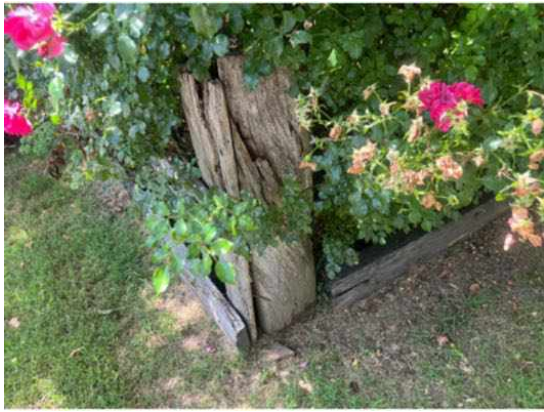
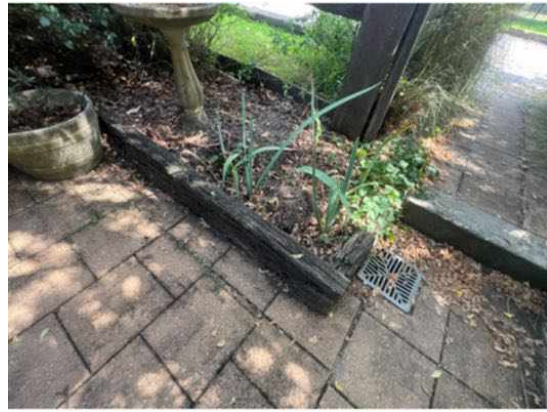
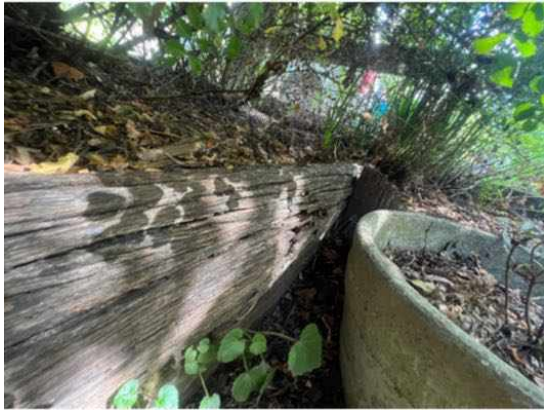
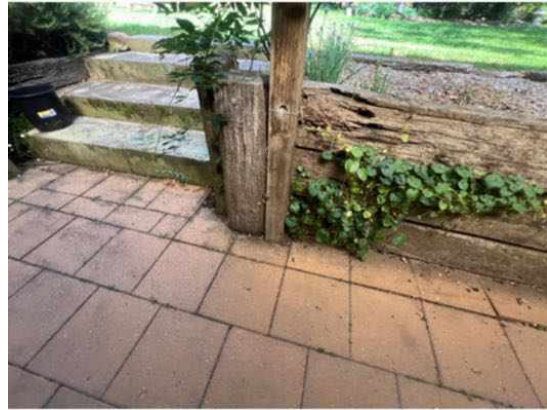
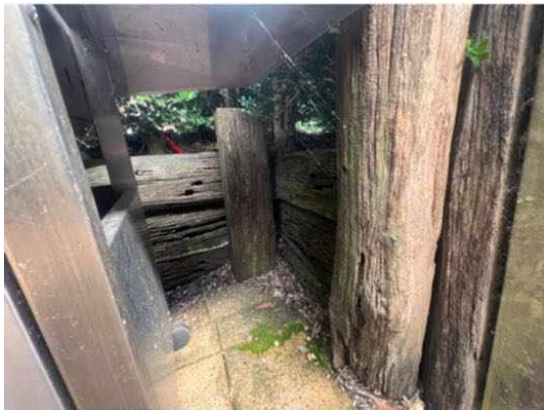
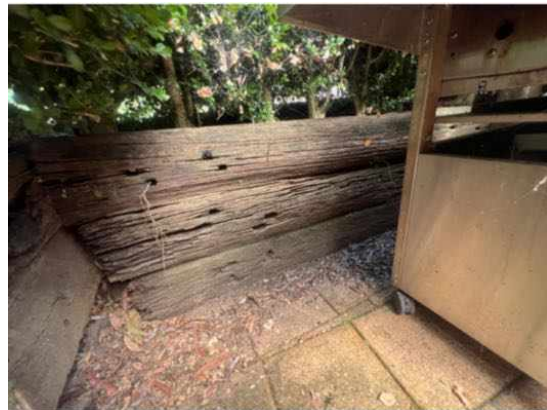
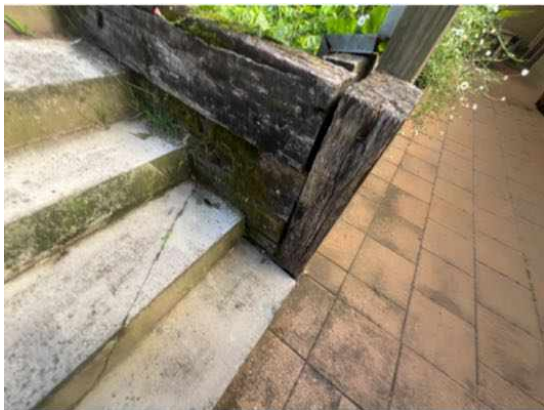
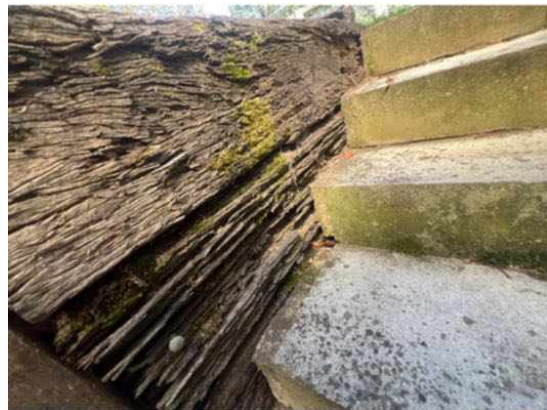
Finding 7.01

Evidence of fungal decay activity and/or damage

Building:	Main Building
Location:	All External Areas
Finding:	Fungal decay - present (localised)
Information:	Fungal decay also known as wood decay or wood rot generally refers to the deterioration of timber elements when in contact with excessive levels of moisture for a prolonged period of time.

The development of fungal decay is accelerated by temperatures in the range of 5degreeC to 40degreeC as well as the presence of oxygen. Generally fungal decay develops on timber elements that are in use in an external environment which are exposed to rain penetration.

In this case although the affected timber element is in a decaying state the extent of any visible damage appears to be localised to a specific area and is yet to spread to other parts of the building element or affect adjoining structures. The fungal decay is therefore likely to be of a relatively superficial nature with minimal impact on the structural integrity or tensile strength of the timber element.

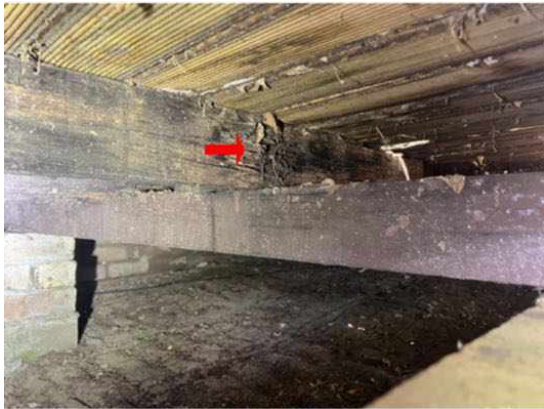
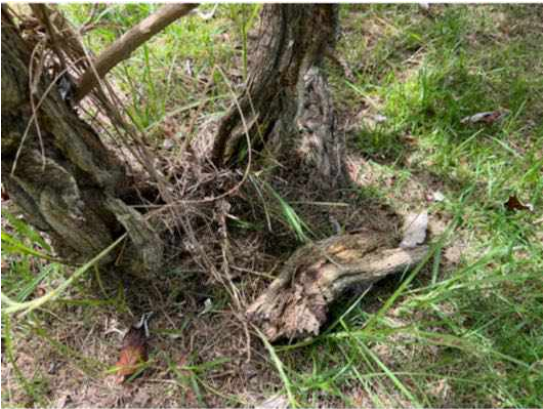
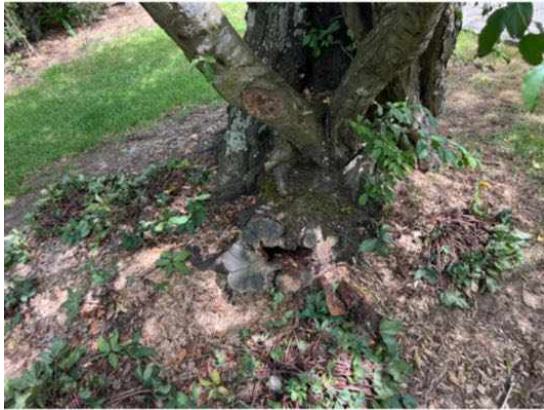
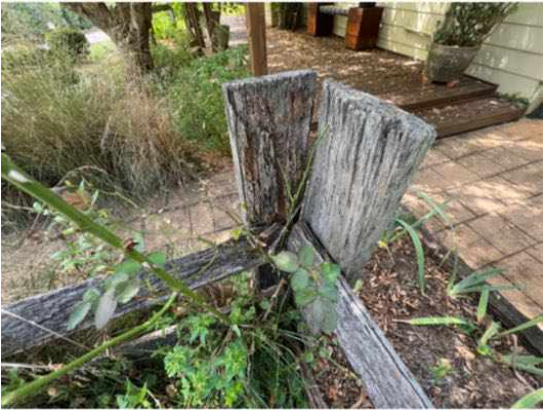
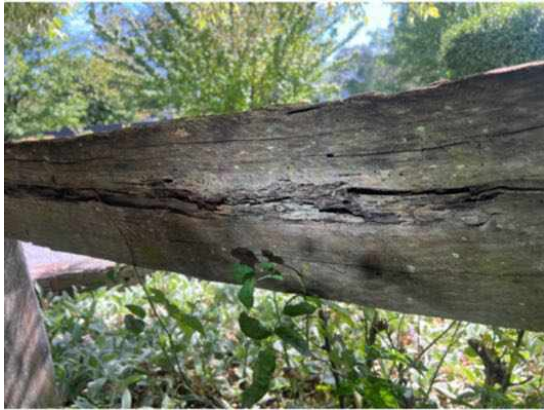
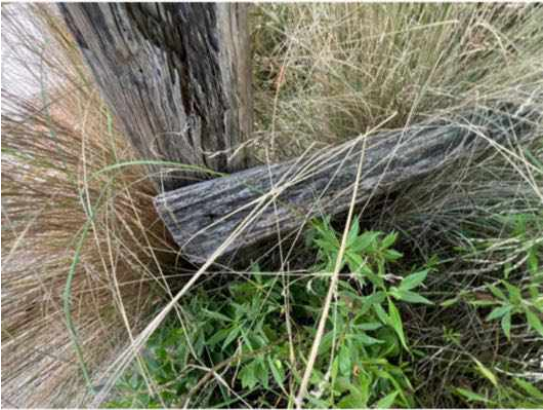
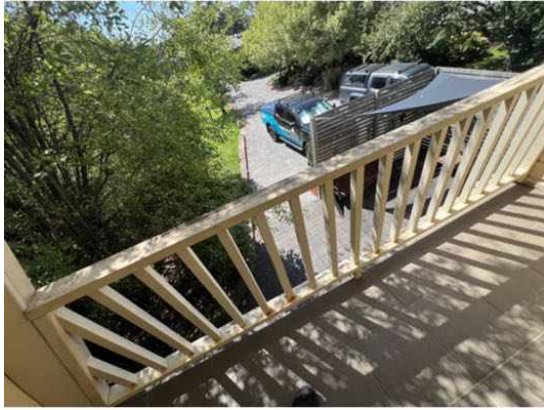
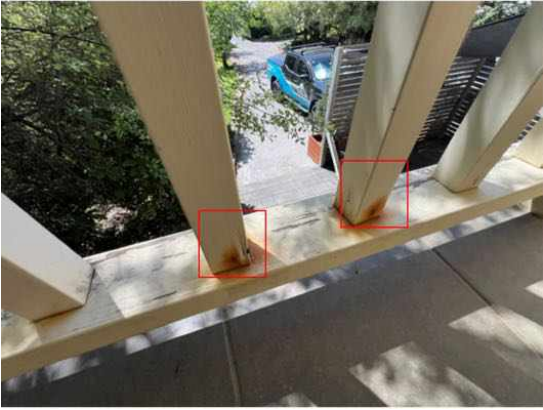
Finding 8.01

Building: Yard
 Location: The Site
 Finding: Evidence of wood borer activity identified
 Information: Wood borers small beetles that colonise in exposed timber elements are a common timber pest that are regularly mistaken for termites. Although wood borer activity is generally not detrimental to the affected timber they may lead to serious damage and necessitate replacement of certain building elements if left unattended.

The other commonly known borer the Anobium borer is more likely to attack floorboards and may cause severe structural damage to flooring areas.

As no live wood borer activity was identified treatment is not required at this time. Replacement of affected timbers may be considered by the client for superficial reasons.
