Building and Timber Pest Inspection Report

Inspection Date: Fri, 6 Feb 2026

Property Address: 4 Drapers Rd, Willow Vale NSW 2575,
Australia

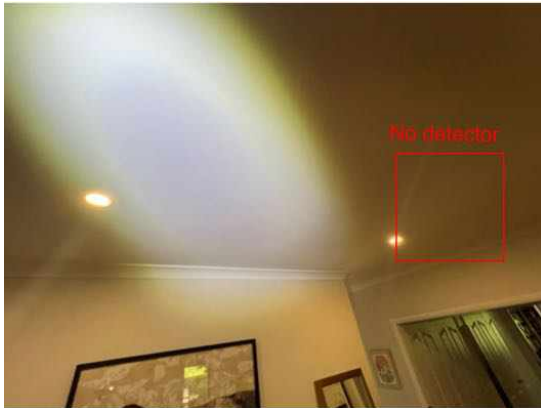
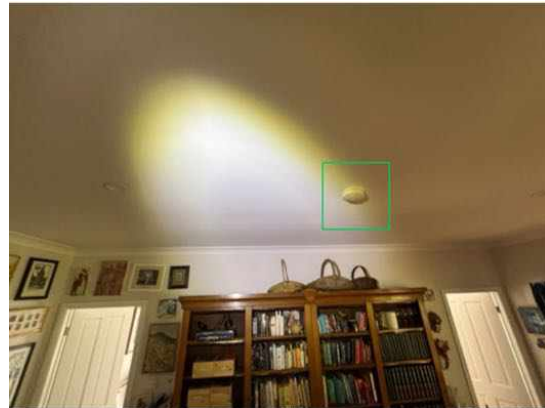
Building:	Building 1
Location:	Loft
Finding:	Smoke Detectors and Alarms
Information:	Reporting on Smoke Detectors or Alarms, including hard wired smoke detection systems and their legislative requirements, is outside the Scope of this Report.

Always ensure sufficient working and suitable smoke detectors are installed prior to occupying any building. Additionally, it is advised that all smoke detectors be tested by the homeowner on a monthly basis.

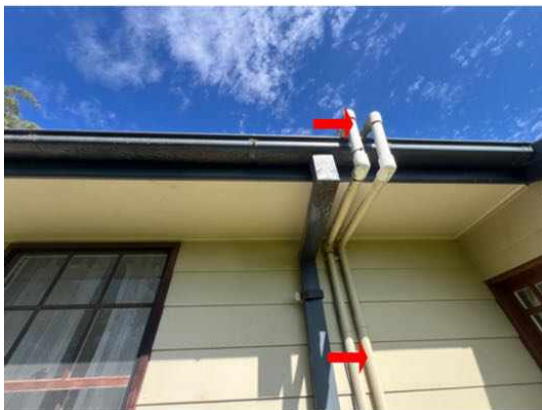
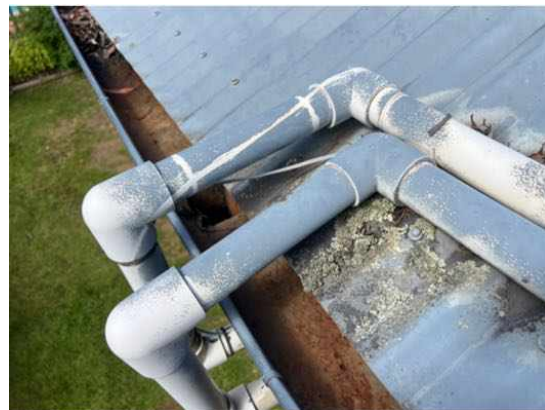
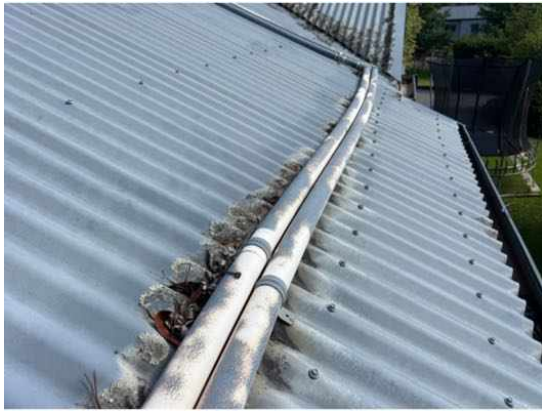
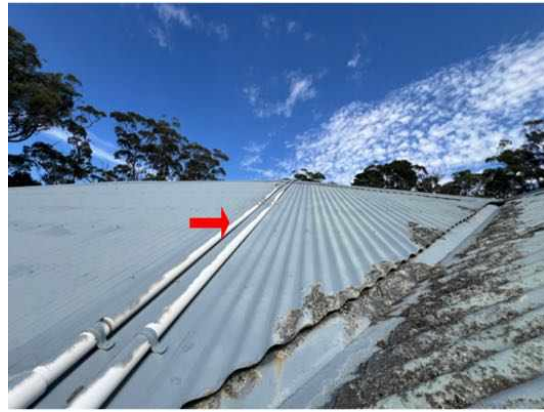
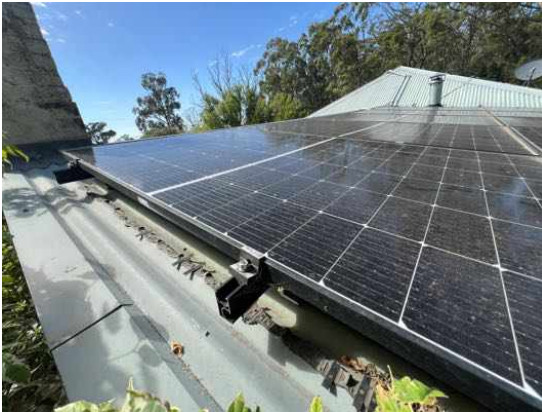
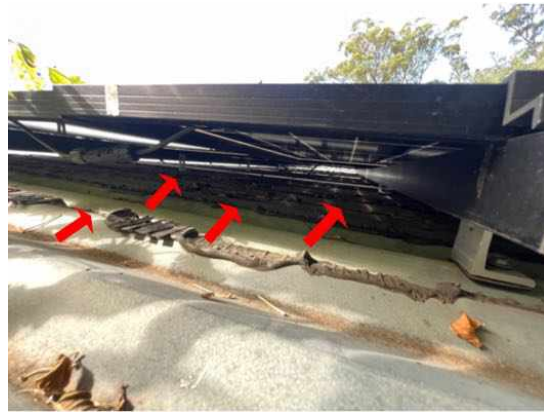
Building: Main Building
 Location: Roof Exterior
 Finding: Solar Installation (Conduit Routing)
 Information: The solar panel installation was observed to include surface-mounted conduit routed across sections of the roof to the meter box, rather than being concealed or more directly aligned with the point of electrical connection. This approach differs from more streamlined installation methods commonly adopted to reduce visual impact and limit exposure of components.

While no operational issues were identified at the time of inspection, exposed conduit routed in this manner may be more susceptible to weathering, UV exposure, debris accumulation, or accidental damage over time. The installation also detracts from the overall presentation of the roof covering.

This item is noted for the client's information only. The client may wish to make further enquiries with the installer or vendor regarding the installation method and any available alternatives, particularly if future roof works or maintenance are planned.

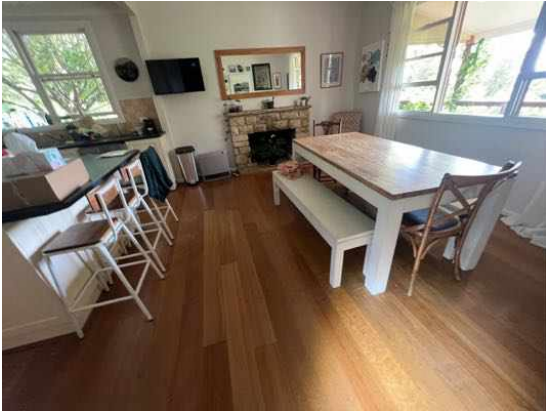
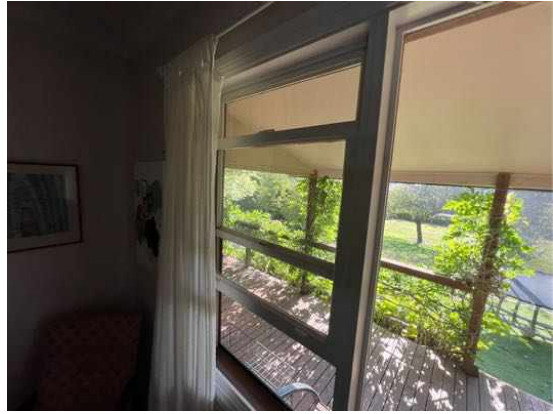
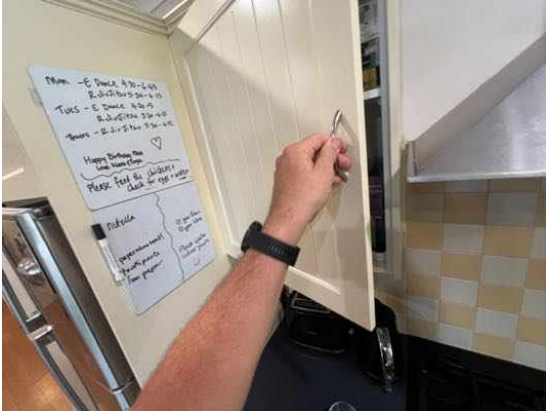
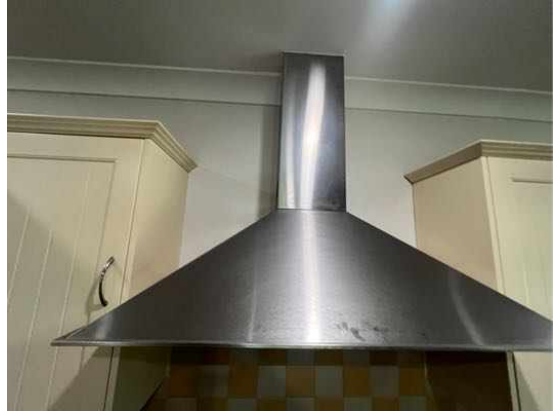
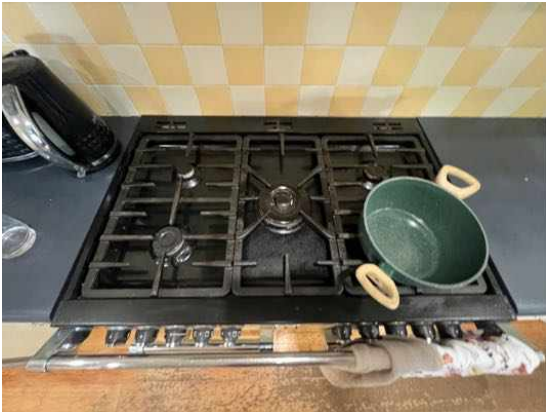
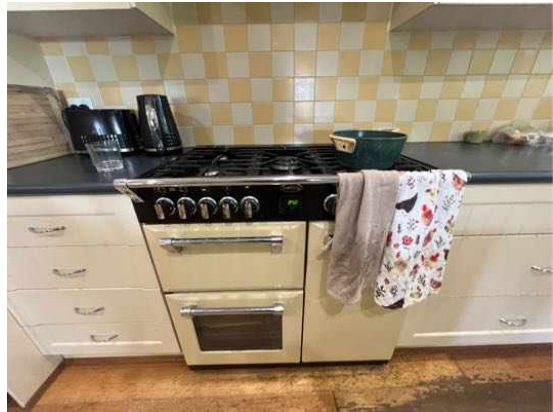
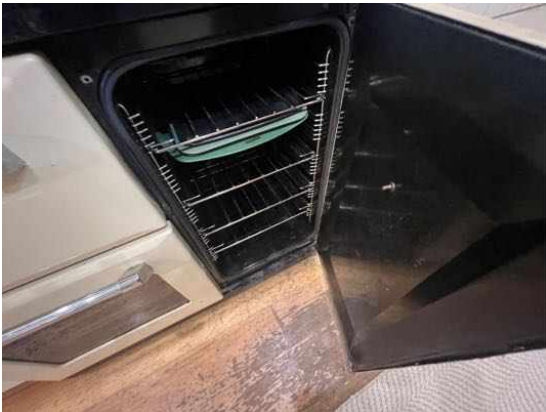
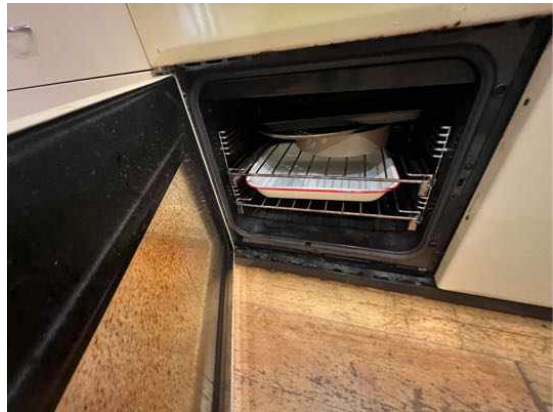
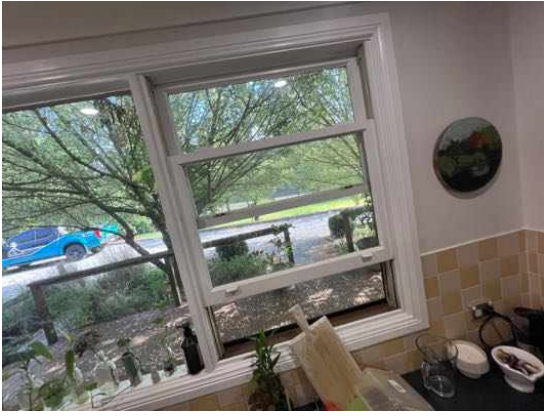
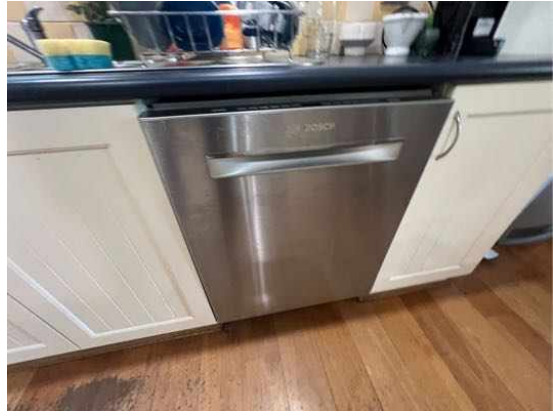
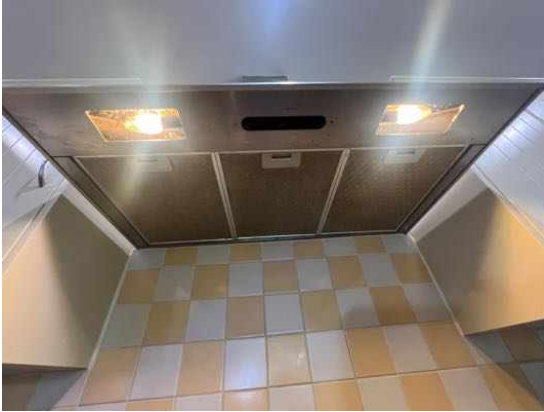
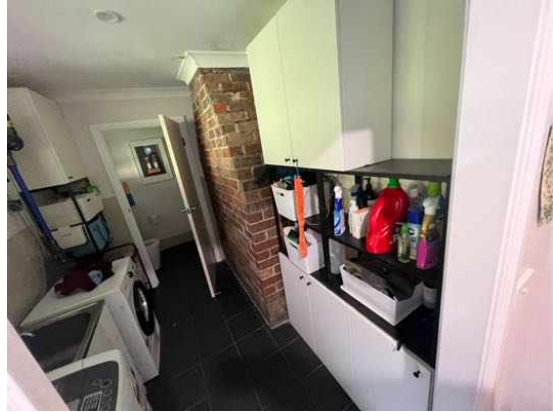
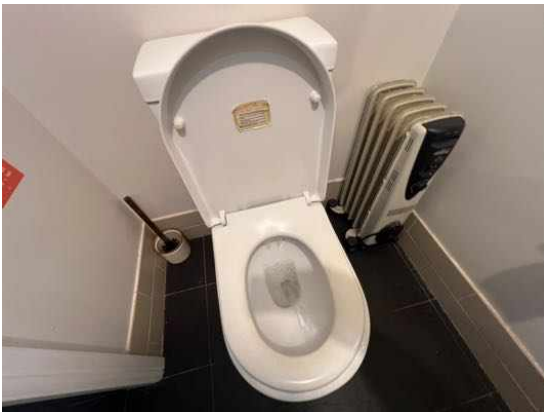
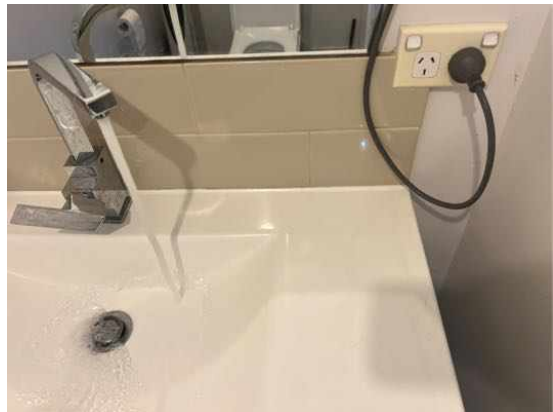
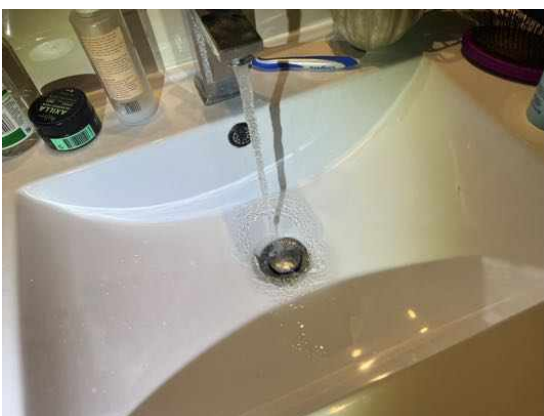
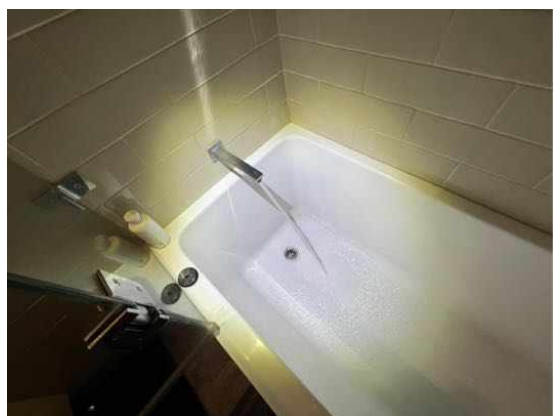
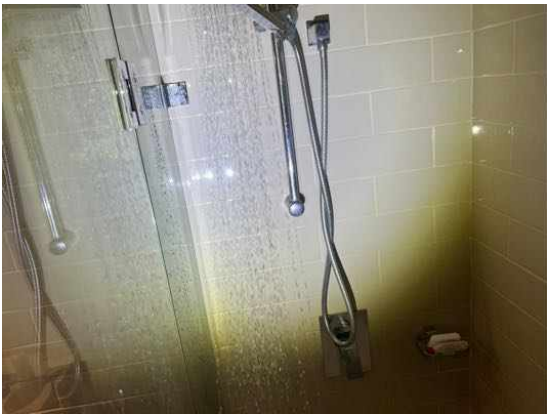
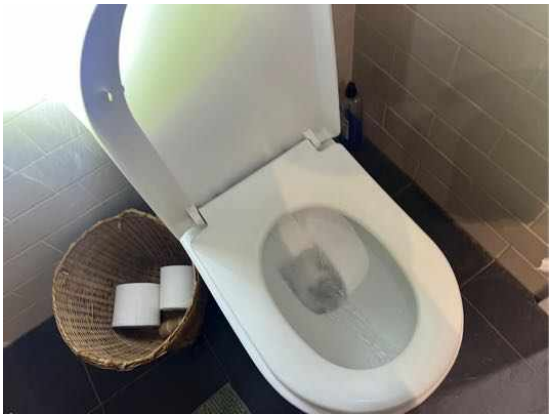
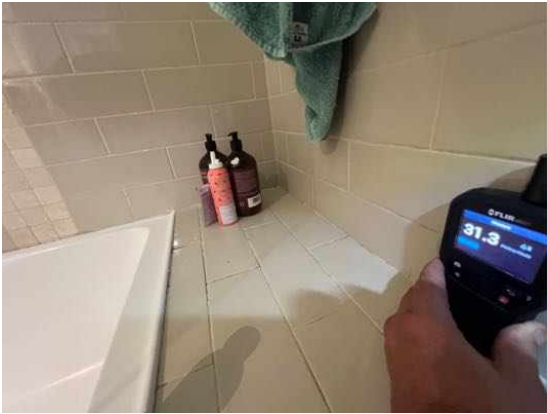
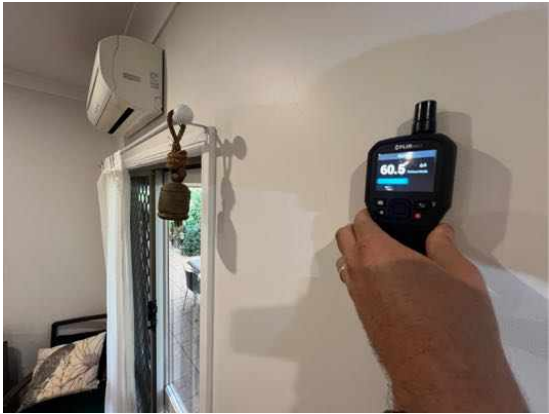
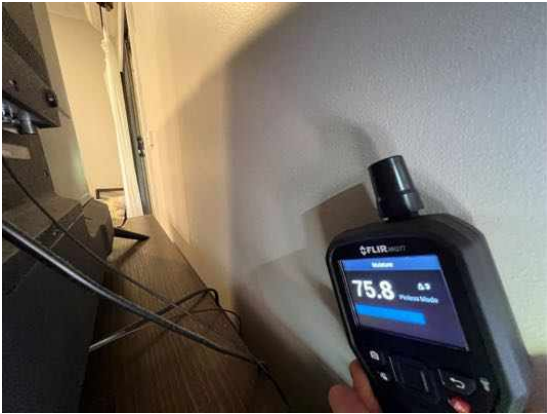
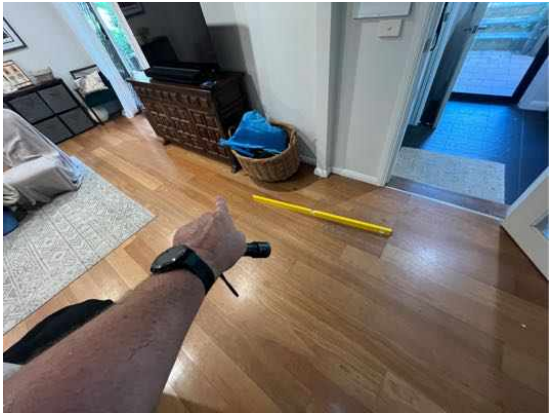
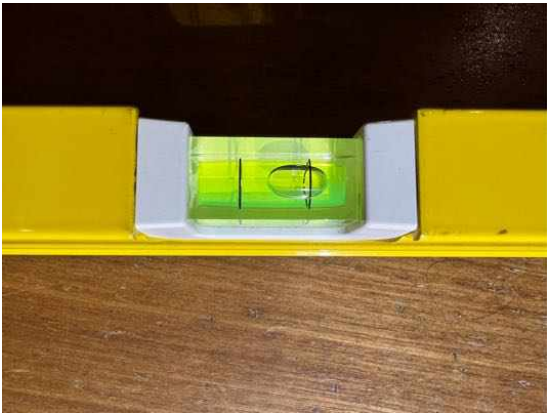
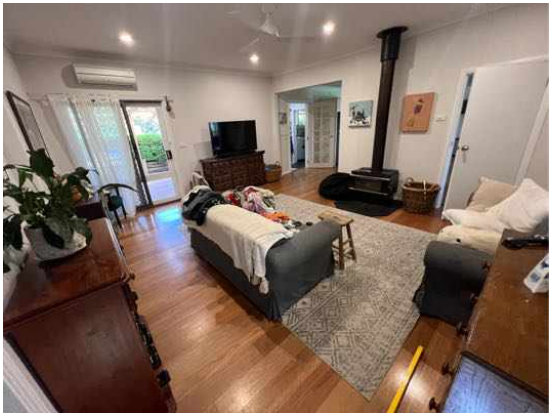
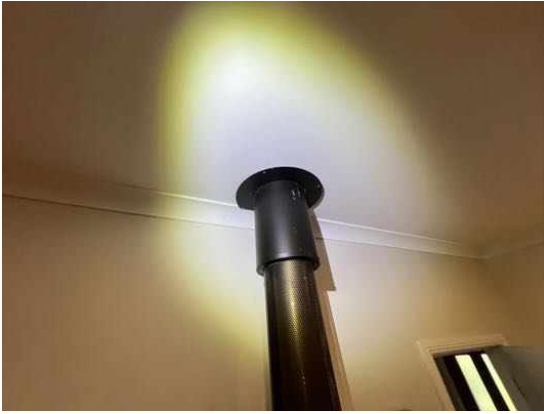
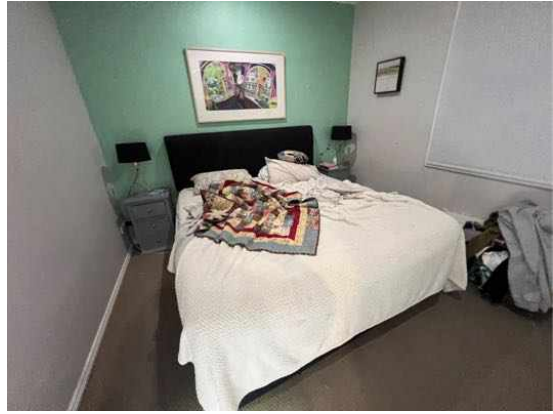
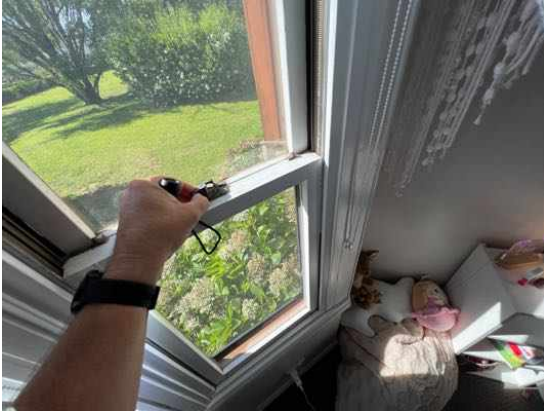
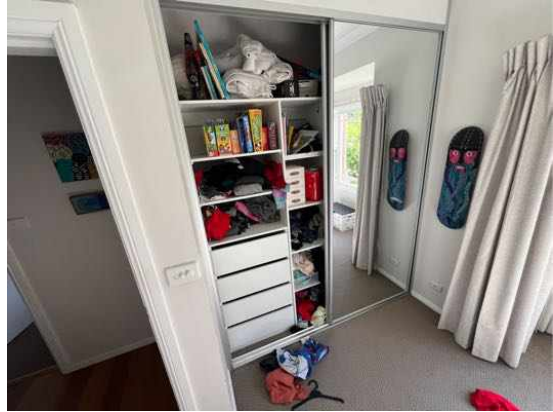
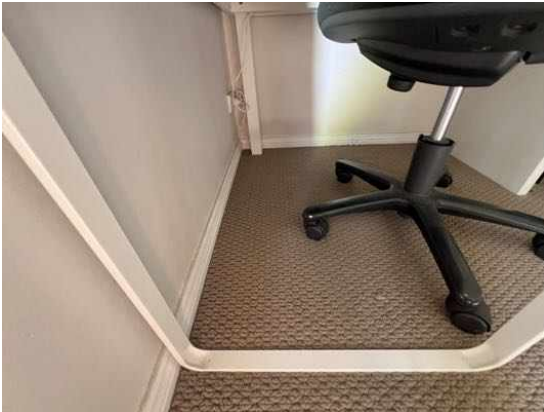
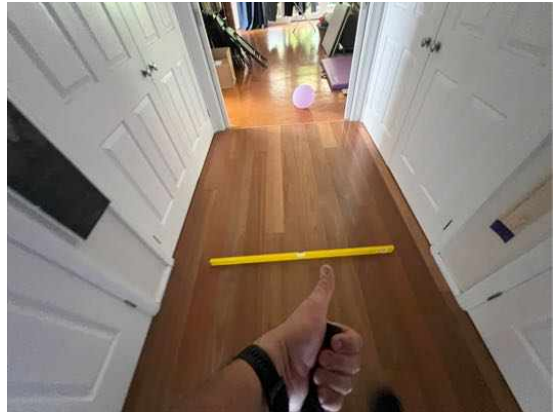
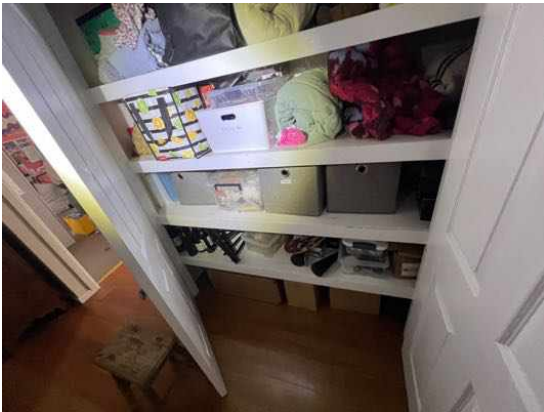
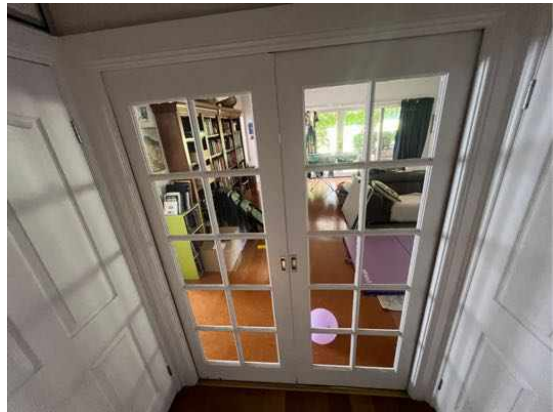
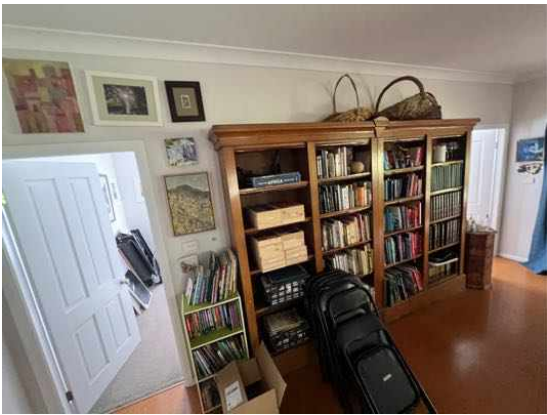
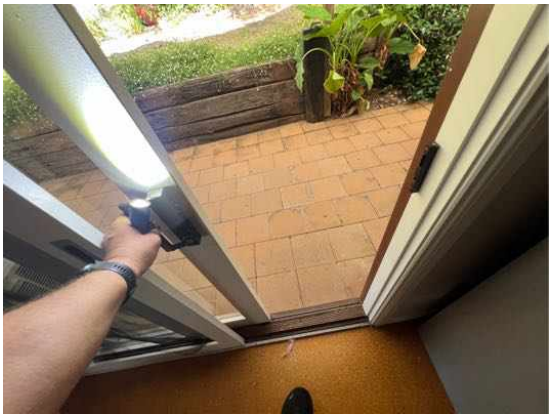
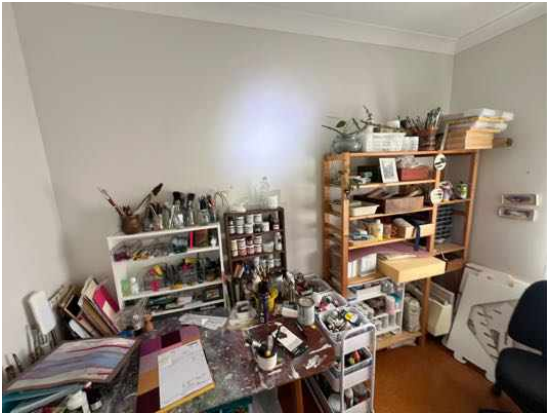
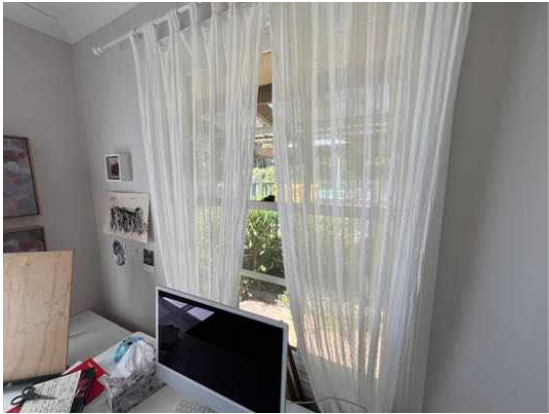
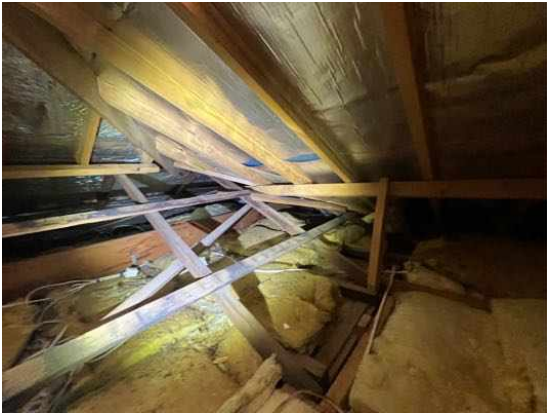
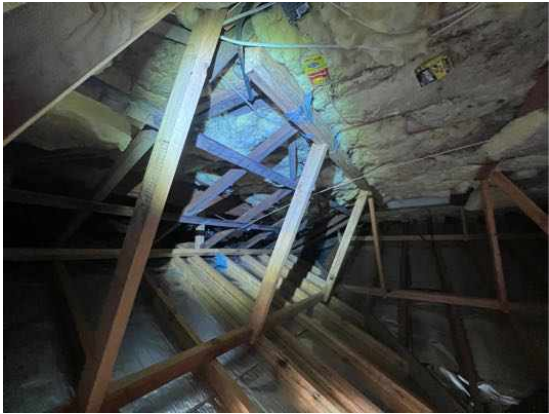
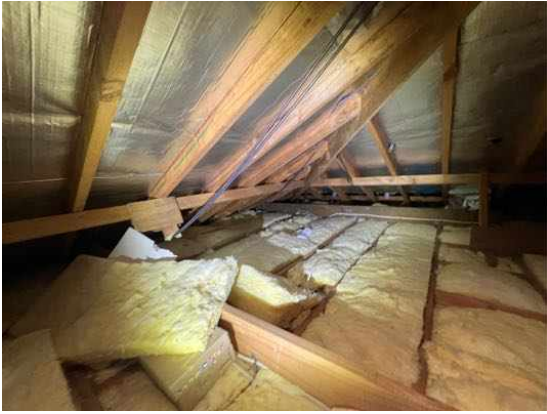
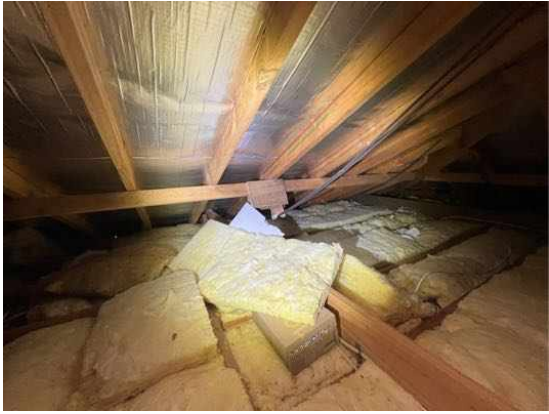
Building:
Location: All Areas
Finding: FYI - Additional Photos
Information: Additional photos are provided for your general reference and may include obstructions, testing of water & windows, moisture readings or minor maintenance items.

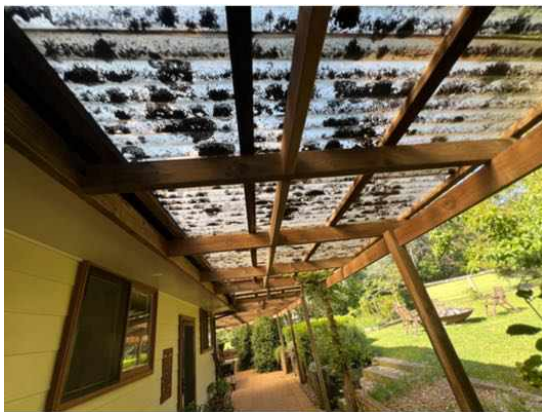
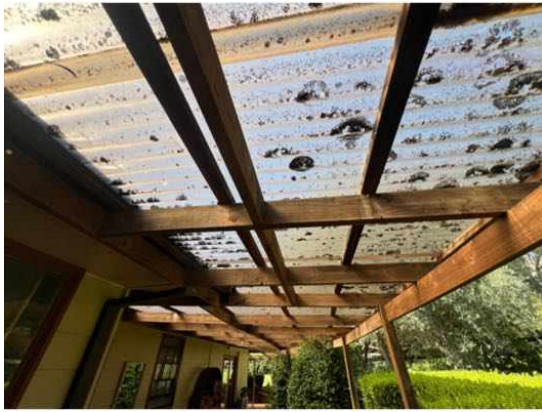
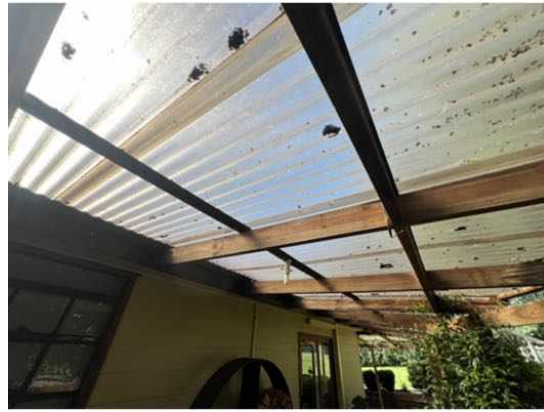
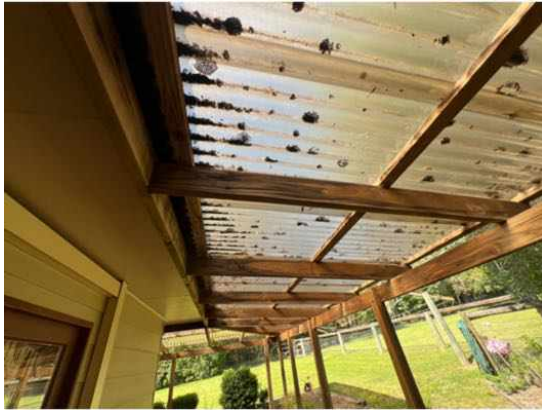
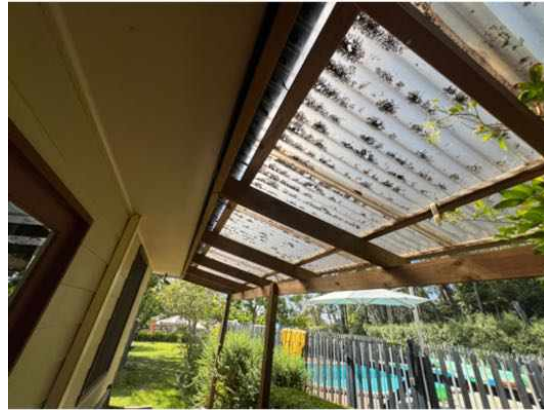
Building:	Main Building
Location:	Pergola
Finding:	Additional structure built without a permit (Suspected) NSW
Information:	The pergola structure abutting the house is suspected to have been constructed without the necessary council approval. In New South Wales, approval is generally required prior to construction of such structures, either by way of a Complying Development Certificate (CDC) or through the Development Application (DA) process followed by a Construction Certificate.

It is strongly recommended that the purchaser request formal documentation from the vendor confirming whether the pergola structure has been approved. If no approval can be produced, the current owner should be asked to obtain a Building Information Certificate and provide a structural assessment confirming that the structure is safe and built in accordance with current building standards.

This inspection report does not constitute formal approval, and any informal assessment should not be relied upon to confirm compliance. Further enquiries with the local council or an accredited certifier are strongly recommended prior to settlement.

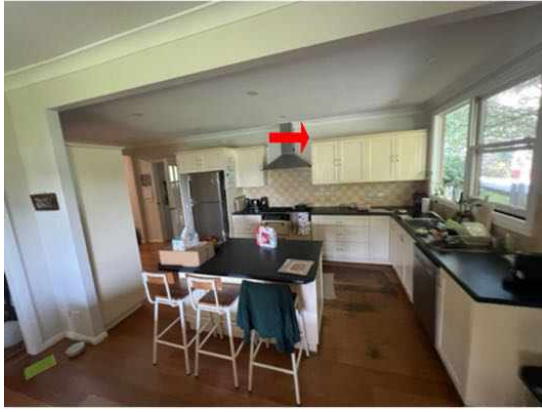
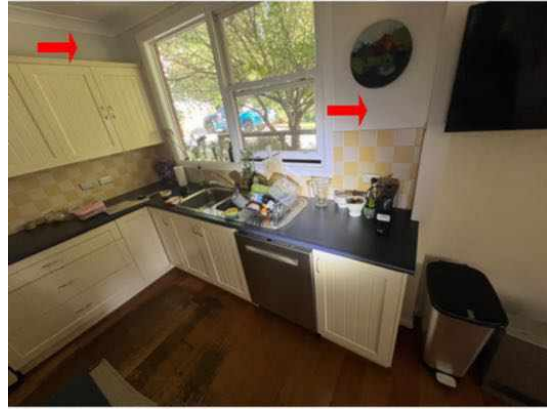
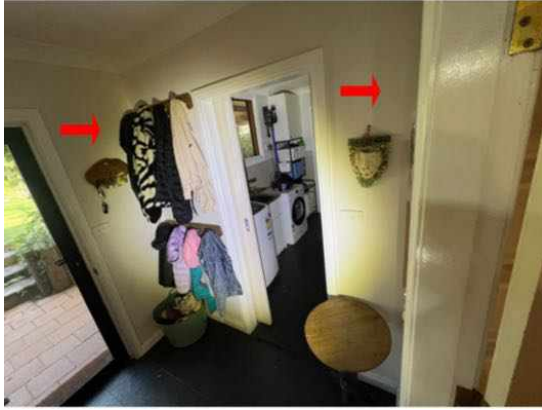
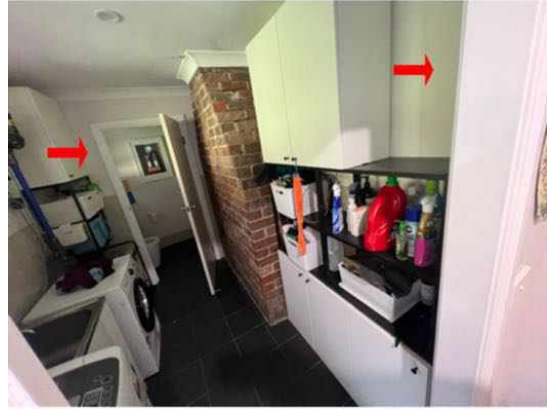
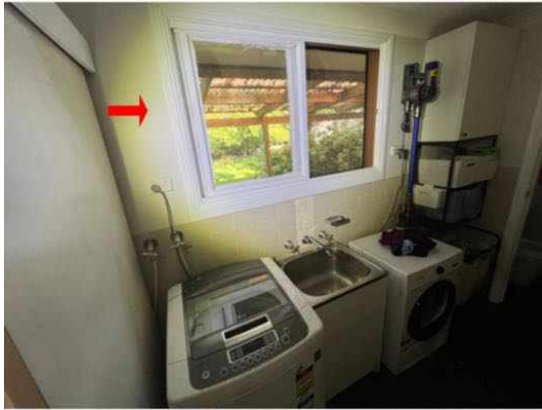
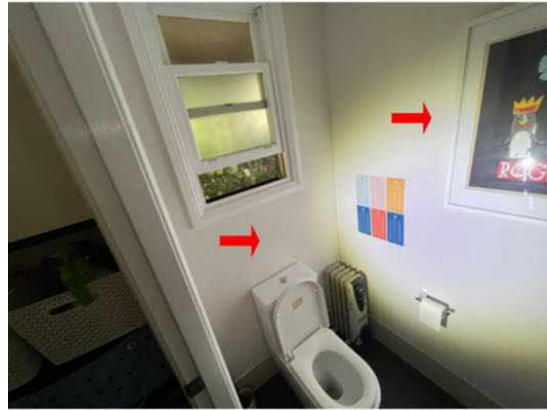
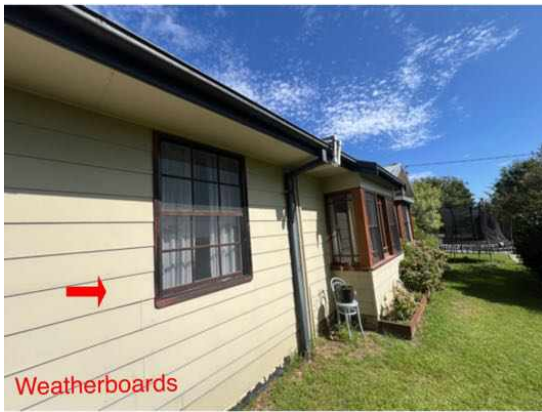
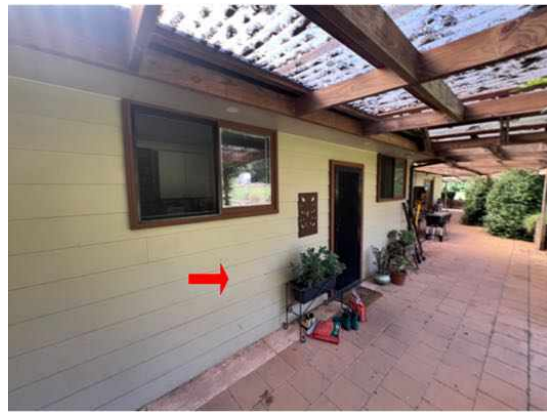
Building:	Main Building
Location:	Kitchen, Foyer (bathroom/laundry), Laundry, Toilet (WC), weatherboards
Finding:	Asbestos - Suspected ACM Identified on Site
Information:	Reporting on Asbestos is outside the Scope of this Report. This suspected defect is highlighted as a caution only. We suspect, based on our experience in the building industry, that there is a higher risk of the identified building element containing asbestos.

As Asbestos Reporting is outside the scope of this report, we advise that you consider a separate Asbestos Inspection and Condition Audit, which can include the taking of samples for definitive confirmation of the presence of Asbestos.

In the interim, the client is advised to act with caution, especially when considering any damage to building materials general wear and tear renovations extensions demolition and general maintenance activities due to the suspected presence of Asbestos.
