Building and Timber Pest Inspection Report

Inspection Date: Tue, 17 Mar 2026

Property Address: unit 34/24 Walker St, Rhodes NSW 2138,
Australia

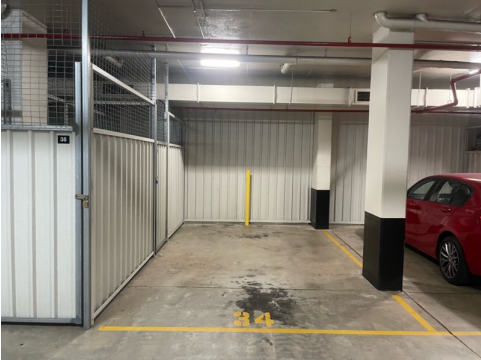
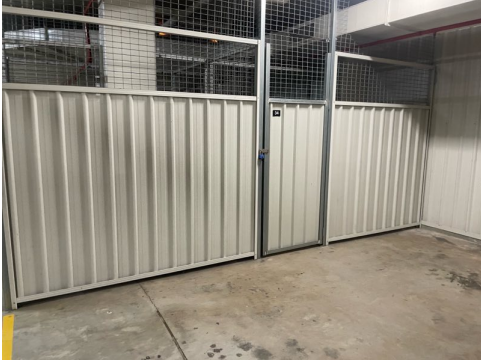
Noted Item

Information: The attached photograph illustrates the unit parking storage areas. This image is provided for reference purposes only to show the general location and condition of these areas at the time of inspection.
