Building and Timber Pest Inspection Report

Inspection Date: Tue, 10 Mar 2026

Property Address: 39 Hollywood St, Monterey NSW 2217,
Australia

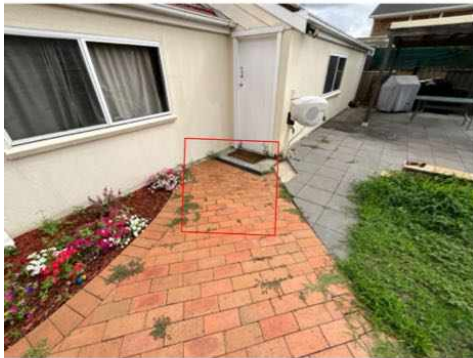
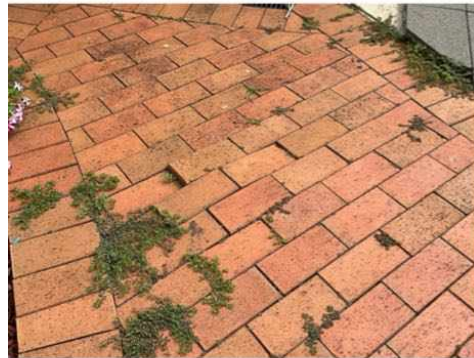
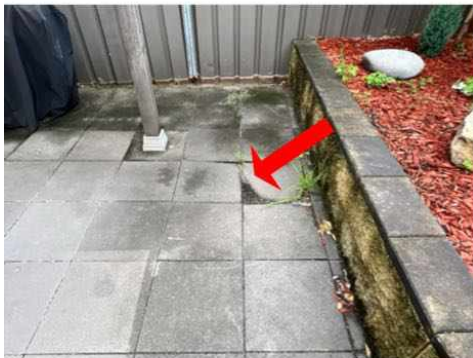
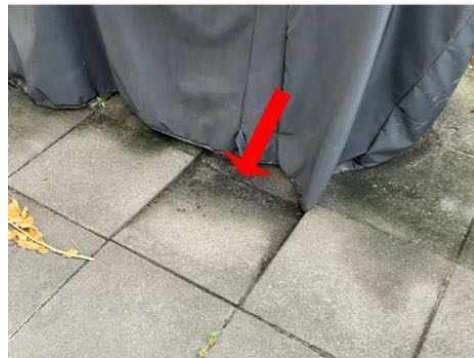
Leading to a potential trip hazard. Personal injury may ensue if due caution is not taken by all persons within this area.

Re-paving of the area is required as soon as possible to remedy this situation. Further consultation with a paving specialist is advised.

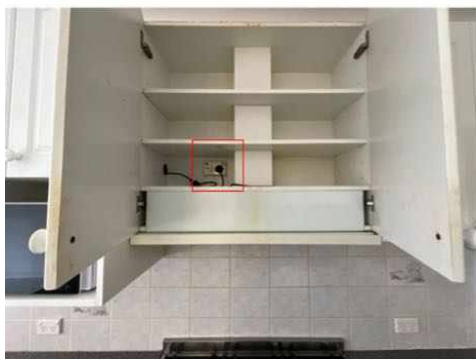
Finding 1.02

Building: Main Building

If left unattended this will worsen over time with the possibility of exposing electrical wires.

A licenced electrician should be engaged immediately to rectify this safety hazard

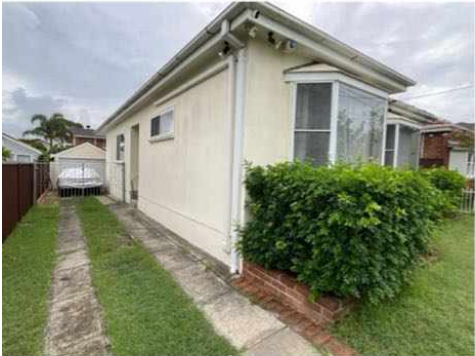
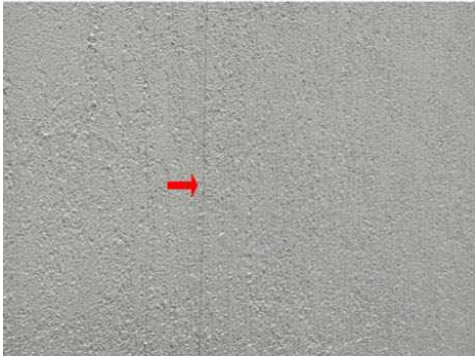
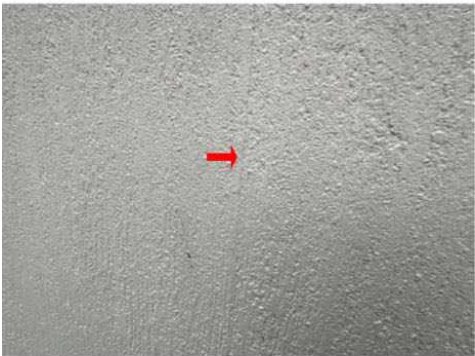
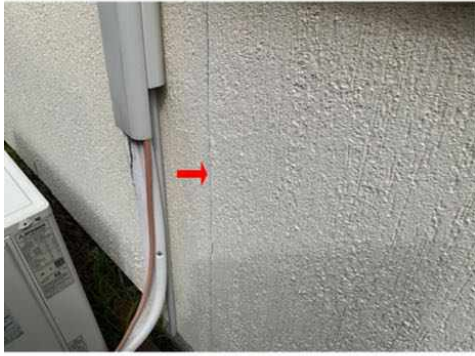
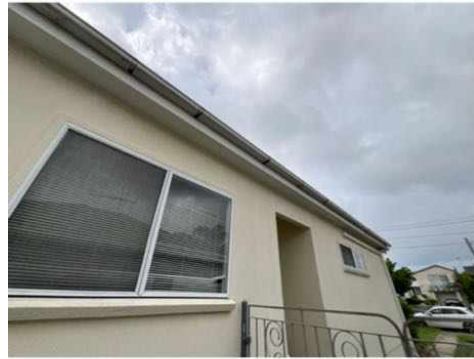
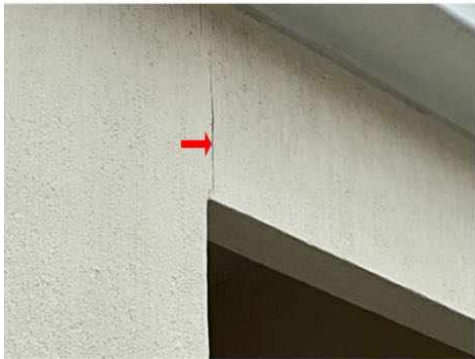
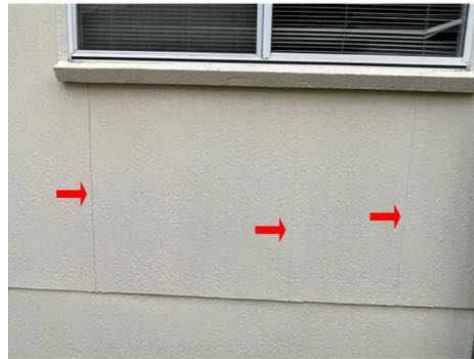
Finding 3.01

Minor Defect

Possible rectification of wall cladding cracking includes repairing or replacing damaged sections, improving joint detailing for movement tolerance, sealing gaps to prevent moisture ingress, and reinforcing the structure if necessary to address underlying movement or settling issues.

A remedial builder may be engaged to rectify this issue.

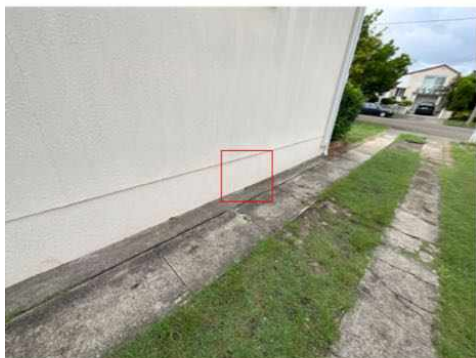
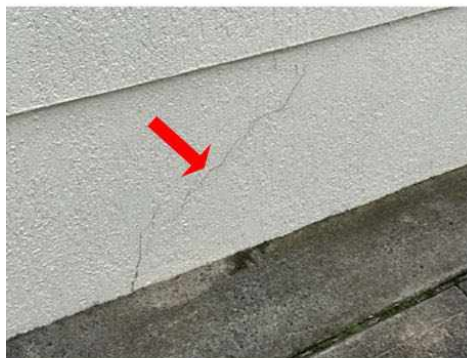
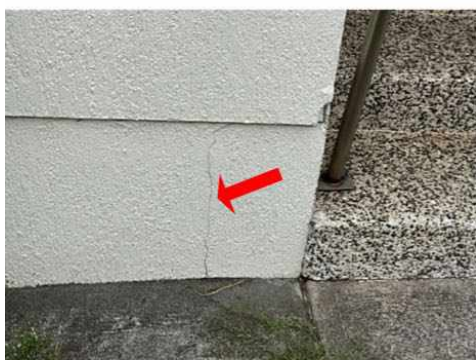
Building:	Main Building
Location:	All Areas
Finding:	Cracking to external rendered surfaces.
Information:	It has been observed that cracking to several external rendered surfaces including, but not limited to the photos in this report has occurred.

Cracking to render is generally the result of minor movement of the substructure i.e brickwork, concrete or block work that the render is adhered to.

All cracking to render should be monitored over time

Should cracks widen or reappear after patching, it is advised to contact a building inspector for further investigation.

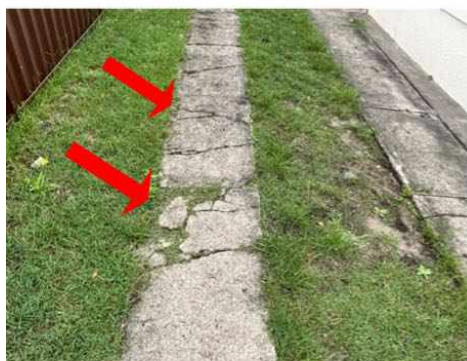
Finding 3.03

Building:	Main Building
Location:	Driveway
Finding:	Concrete paving-Subsidence
Information:	The concrete paving has several areas of subsidence to the substrate causing lipping in the paved area.

Lipping in the slab is likely to lead to the development of trip hazards.

Deterioration of the substrate is a common cause of this type of defect.

Where factors include variable moisture conditions, uncontrolled water flows under the concrete paving, the presence of trees and their roots having a settling or lifting effect on the soil.

Poor compaction of the sub surface and/or inadequate reinforcing of the slab may create lipping and other secondary defects.

Monitoring of this area is recommended , with the potential of engaging a specialist

concreter to advise on rectification or replacement of the paved area.

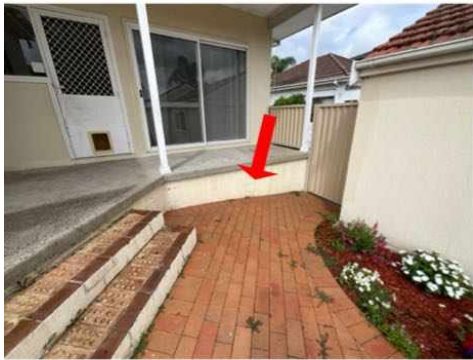
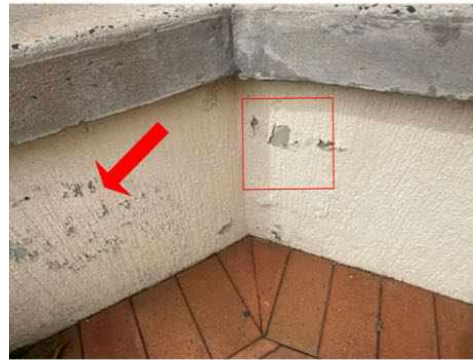
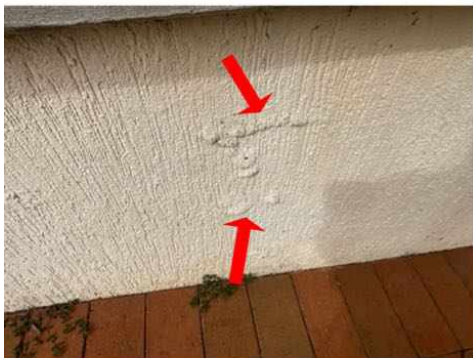
Finding 3.04

Building:	Main Building
Location:	Verandah
Finding:	Exterior building painted surface Peeling and/or bubbling
Information:	Sections of external paint including but not limited to the photos in this report were found to have bubbled and/or peeled.

Bubbling or peeling paint occurs when there is a failure of adhesion between the paint and the surface it's applied on.

Moisture ingress: Often due to inadequate sealing, leaking gutters, downpipes, or poor flashing details allowing water to penetrate the substrate.

Incompatible paint systems: Use of incorrect primers or topcoats, or painting over damp substrates, can cause poor adhesion.

UV exposure and weathering: Prolonged exposure to sunlight and moisture can break down paint films, especially on north and west-facing elevations.

Timber movement: Expansion and contraction of timber elements can lead to cracking and flaking of the paint film.

A licensed painting contractor should assess the affected areas to determine the extent of deterioration.

Please note: Any moisture-related causes be identified and rectified prior to repainting (e.g., fixing leaks, improving drainage, repairing flashing).

Surfaces need to be properly prepared, including removal of loose paint, cleaning, drying, and application of an appropriate primer and weather-resistant paint system.

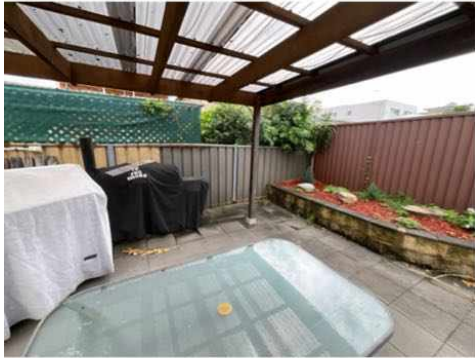
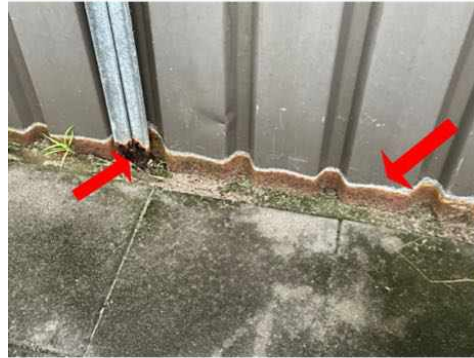
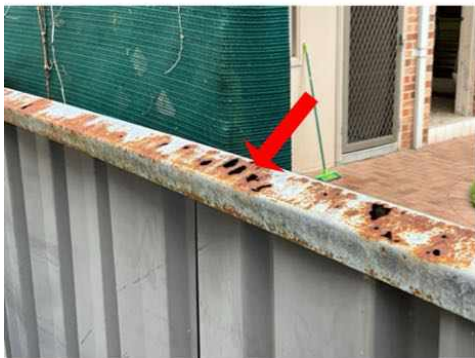
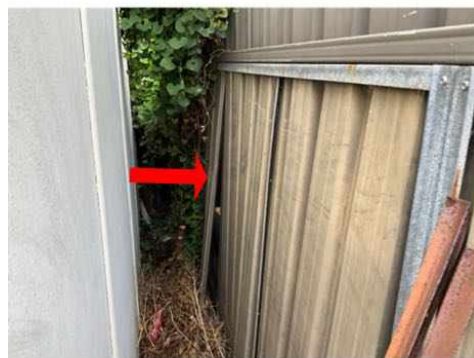
Finding 3.05

Building:	Main Building
Location:	Yard - Back
Finding:	Fencing - Deteriorated
Information:	It was noted at the time of inspection that sections of the fencing throughout the property have deteriorated. Typically fencing deteriorates due to age and or wear, rot and or rust which is generally expected for a structure of this age, due to prolonged exposure to weather conditions. Sometimes inadequate installation or maintenance

If left unattended, it is likely that further damage will occur. It is suspected that repair of several elements of the fencing may be required however replacement may be a consideration of the client also.

A licensed fencing contractor should be appointed to provide further advice and perform rectification works as necessary.

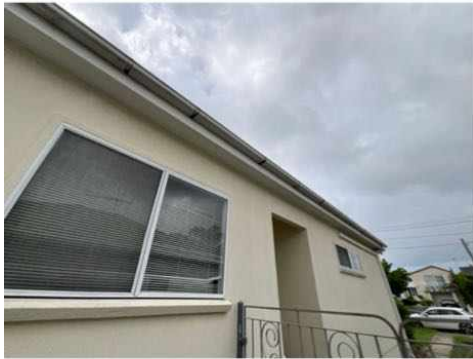
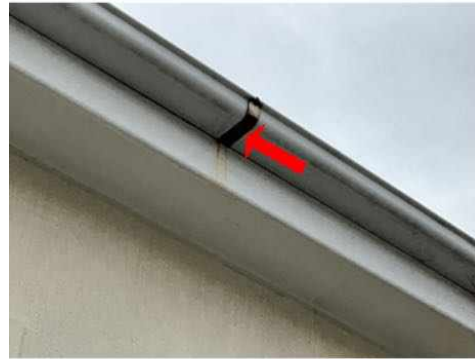
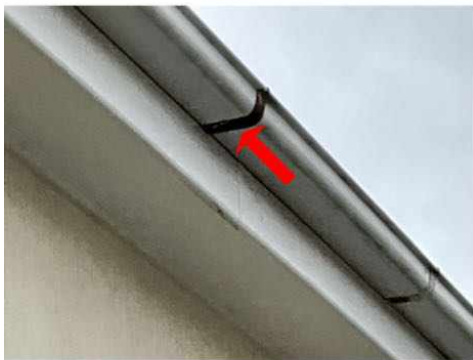
Finding 3.06

Building:	Main Building
Location:	Roof Exterior
Finding:	Gutter brackets rusted
Information:	Several gutter brackets were observed to be affected by rust and corrosion.

Deterioration of the metal brackets can reduce their structural strength and may eventually lead to sections of the gutter becoming loose, sagging, or failing to adequately support the guttering system.

This condition may also contribute to poor stormwater drainage if the gutter line becomes uneven.

It is recommended that the affected brackets be assessed and replaced by a qualified

roof plumber as required to ensure the guttering system remains securely fixed and functions as intended.

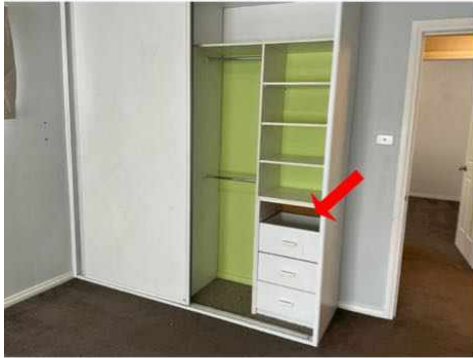
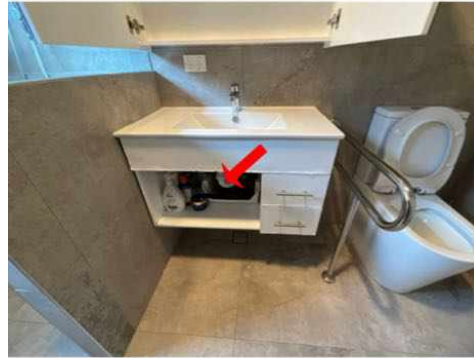
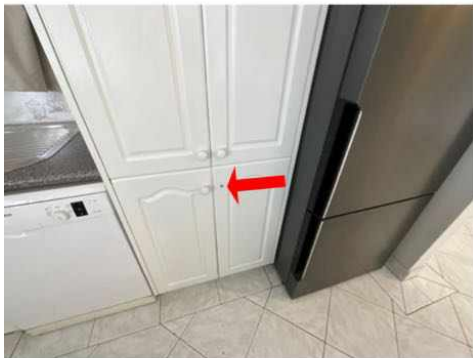
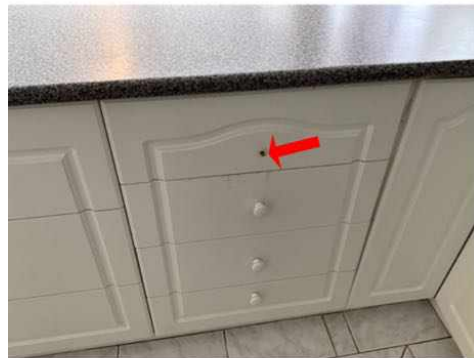
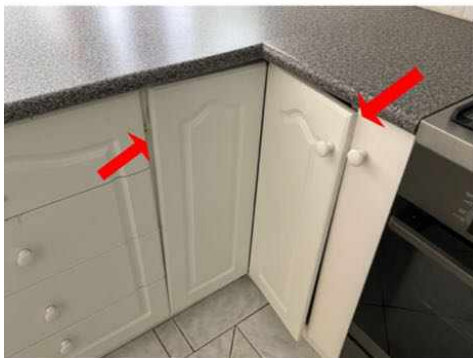
Finding 3.07

Building:	Main Building
Location:	All Areas
Finding:	Deteriorated-Cabinetry
Information:	The cabinetry in several areas has deteriorated.

This may be the result of general wear and tear due to age which may include but not limited to deteriorated hinges and latches, missing handles, damage to bench tops and shelving.

In some cases the deteriorated cabinetry may be as a direct result of water damage due to leaking pipes or unsealed bench tops allowing water to penetrate the cabinets.

If left unmanaged the cabinetry will deteriorate further which may lead to more costly repairs in the future.

Rectification works may include minor repair work or replacement of the cabinetry depending on the extent of the damage.

It is highly advised to engage a remedial builder to determine and rectify what is causing the deterioration prior to any rectification work to the cabinetry

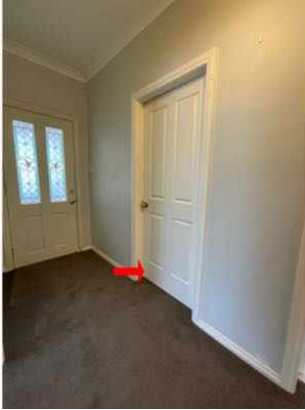
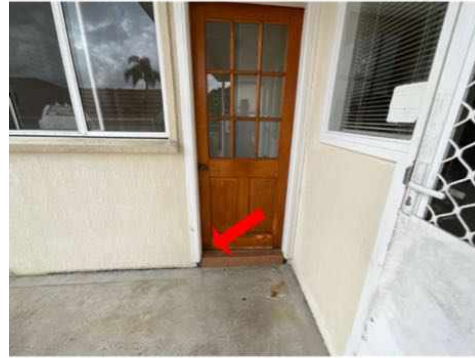
Finding 3.08

Building: Main Building
Location: Bedroom 2;Laundry
Finding: Door binding
Information: Binding of this door is evident during standard operation.

This defect inhibits the functionality of the affected door as well as creating potential for secondary defects to associated building elements, such as the door frame.

A door that binds to the associated door frame may have several causes, ranging from minor defects, such as poor installation of the door, deteriorated hinges or swelling of timber doors due to excessive moisture in the area.

A qualified carpenter should be appointed to advise on suitable rectification works.

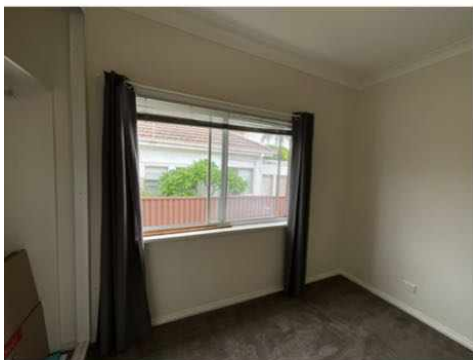
Finding 3.09

Building: Main Building
 Location: Bedroom 2
 Finding: Window - Missing latch
 Information: The latch to the window was missing at the time of the inspection. Absence of the latch limits the operation of the window and may pose as a safety risk.

Replacement of the latch should be conducted as soon as possible.

A window installation company should be appointed to perform these works to improve the operational state of the affected window and improve the safety of the internal area.

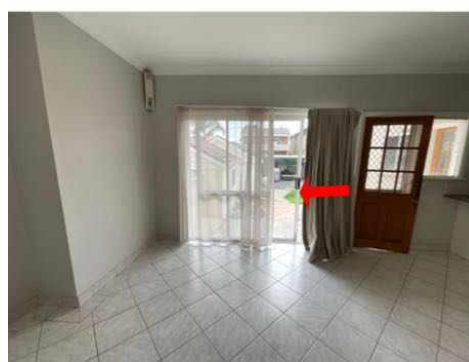
Finding 3.10

Restricted function of these elements may pose as a potential safety hazard if required for emergency egress from the building.

Generally, factors such as age and a lack of maintenance are the usual causes for this type of defect.

Replacement of hardware or frame may be required, as well as minor repairs and cleaning. A registered builder will be required to repair the windows and doors.

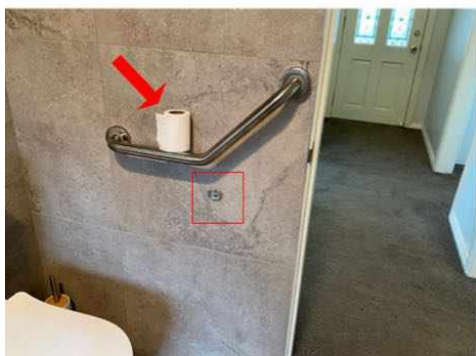
Finding 3.11

Building: Main Building
 Location: Bathroom
 Finding: Toilet roll holder - Missing
 Information: Although some building elements may seem irrelevant or unnecessary, all building elements play a key role in the operation and function of the overall structure and its performance.

Replacement of any missing building element should be conducted as soon as possible to ensure that no damage or functional issues occur to associated building materials.

The appropriate tradesperson should be appointed as soon as possible to replace the missing building element.

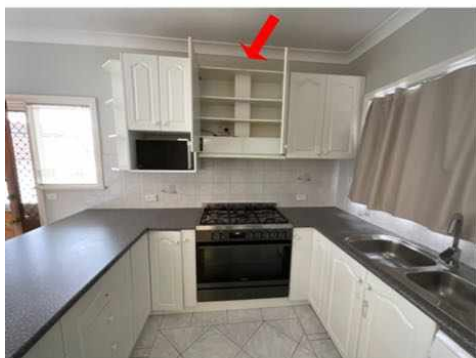
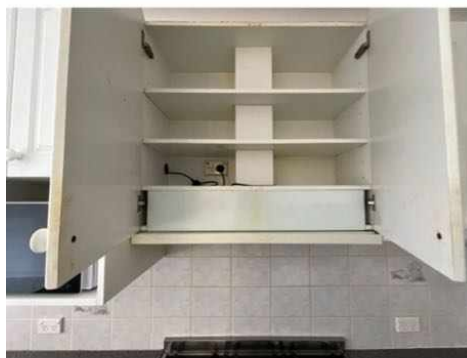
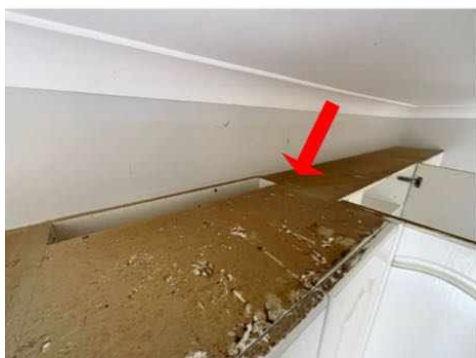
Building:	Main Building
Location:	Kitchen
Finding:	Rangehood - Vented into cabinet
Information:	The range hood exhaust fumes was found to lead directly into the kitchen, rather than being flued and venting to the exterior of the building.

This will lead to a build-up of grease and grime in the surrounding area, which can pose as a fire hazard.

Without re-direction to the exterior of the building, the Rangehood is not considered fully operational and is deemed a minor safety hazard.

It is therefore preferable that the flue be re-directed to vent into the external environment.

A remedial builder should be appointed as soon as possible to provide further consultation on the scope of these works and to provide quotations for any necessary works.

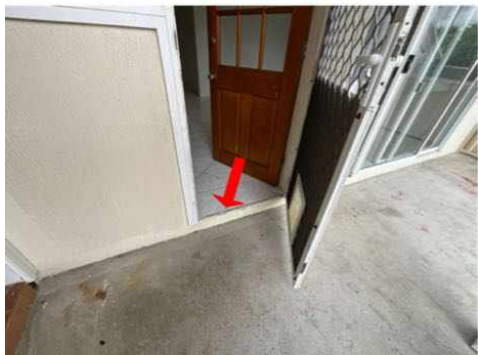
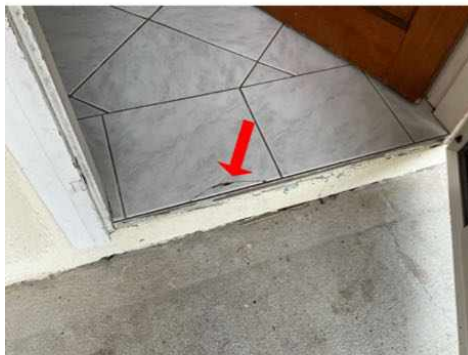
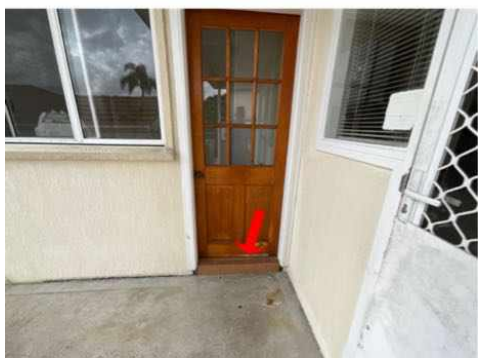
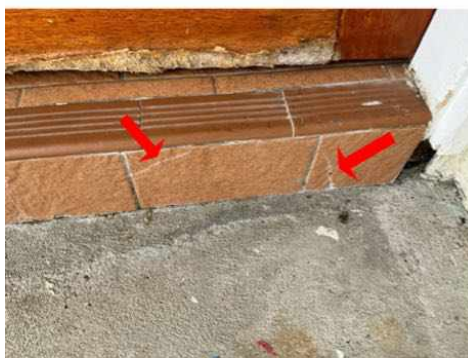
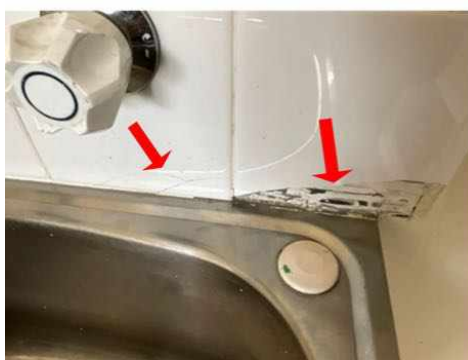
Finding 3.14

Building:	Main Building
Location:	All Areas
Finding:	Tiles - Cracked or Damaged
Information:	At the time of inspection cracking or damage was evident to the tiling in several areas throughout the property.

If left unmanaged, water penetration to these areas may lead to subsequent water damage, which is likely necessitate repair work to affected building elements.

A tiling contractor should be appointed to replace cracked or damaged tiles ensure

that no further water damage occurs.

The re-application of silicone and grouting throughout remaining tile work is also advised, to further protect the area against water penetration.

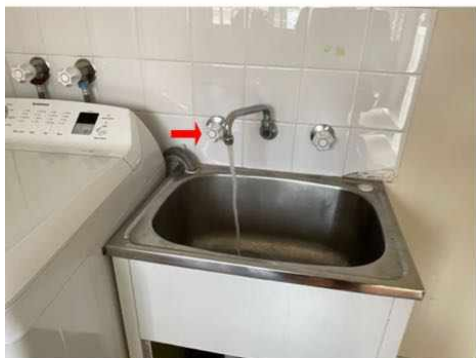
Finding 3.15

Building: Main Building
 Location: Laundry
 Finding: Hot Water defective
 Information: During the inspection, the hot water outlet in this area was observed to spit and splutter while in operation.

This condition can indicate the presence of air within the plumbing system, inconsistent water pressure, or a possible issue with the hot water system or associated pipework.

Failure to address this issue may lead to reduced performance of the hot water service or further deterioration of the plumbing system over time.

It is recommended that a licensed plumber investigate the cause of this condition and undertake any necessary repairs or adjustments.

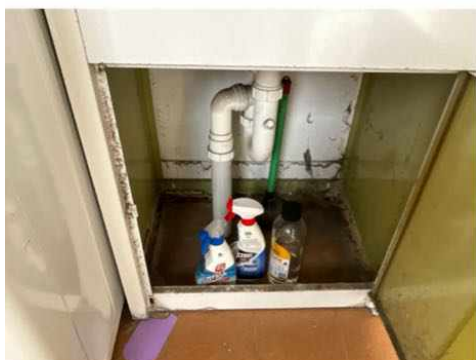
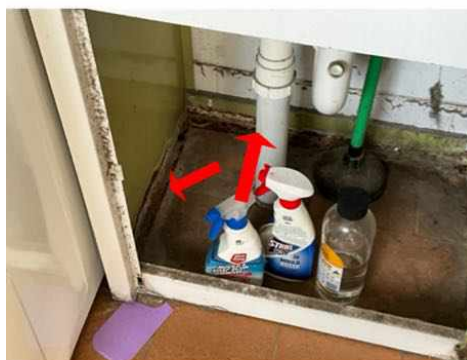
Finding 3.16

Finding: Laundry tub - Rusted or corroded

Information: The laundry tub was observed to have visible rusting and surface deterioration. This condition is typically the result of prolonged exposure to moisture and general wear over time and may lead to further corrosion or eventual failure of the fixture if left unaddressed.

It is recommended that the laundry tub be repaired where possible or replaced to prevent further deterioration and potential leakage. Routine maintenance and ensuring the area remains dry when not in use may help prolong the life of the fixture.

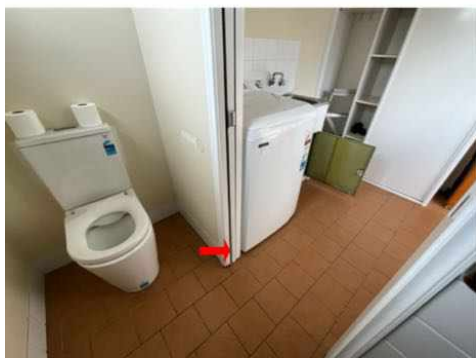
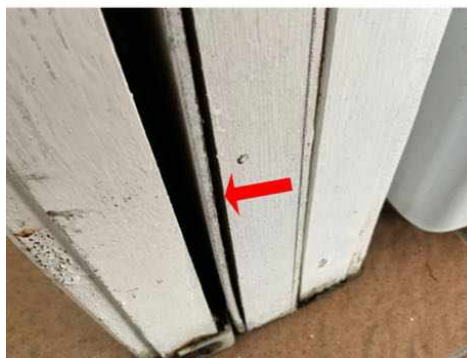
Finding 3.17

Building:	Main Building
Location:	Laundry
Finding:	Delamination of doors (loose veneer)
Information:	Loose veneer creates a flap or visible separation along the edge of the door.

The delamination of timber doors generally occurs as a result of moisture penetrating the wood or insufficient glue when the door was manufactured. Substandard paint application will also allow moisture to penetrate the timber.

Repair will generally involve re-gluing the timber veneer to the substrate.

A qualified carpenter may assist in the rectification of the door.

Regular maintenance such as painting the door around all edges will reduce the chances of moisture entering the door, prolonging the life of the door.

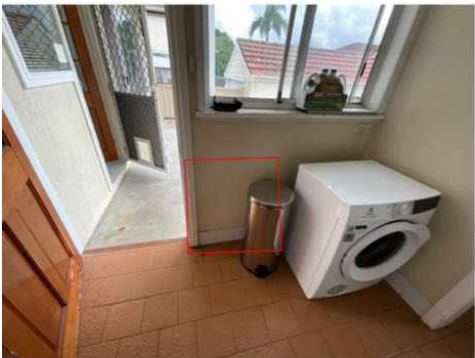
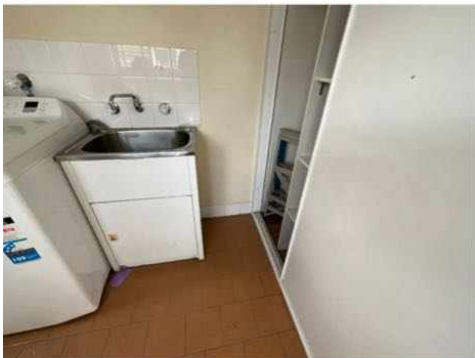
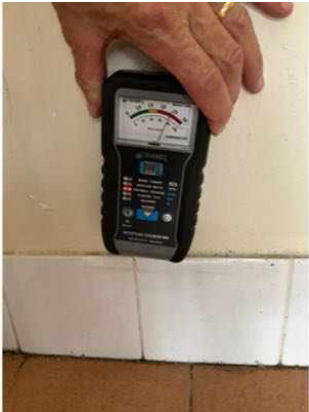
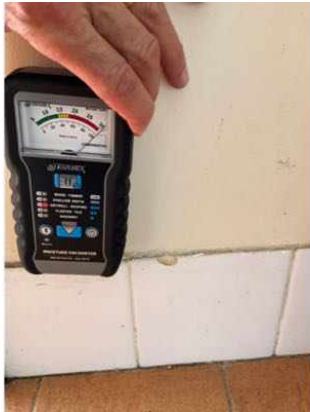
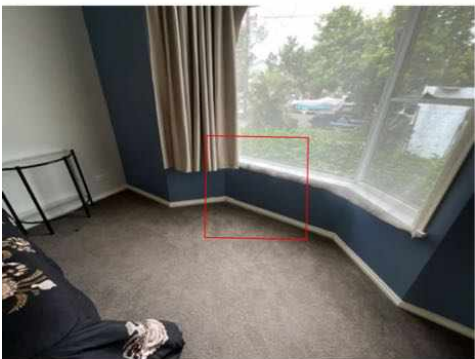
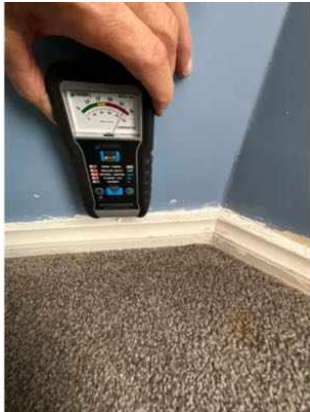
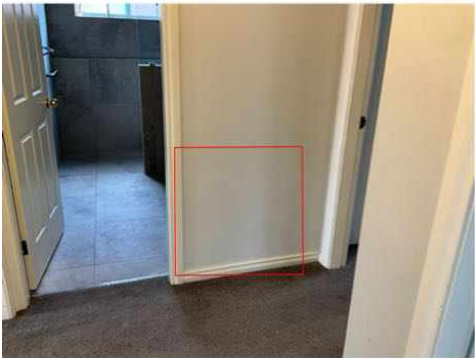
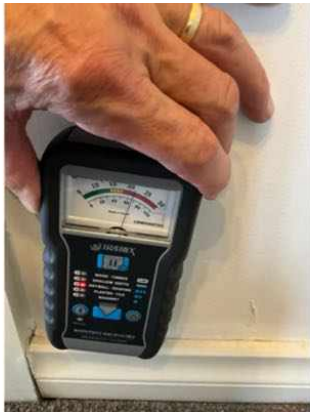
Building:	Main Building
Location:	All Areas
Finding:	High Moisture Reading
Information:	At the time of inspection, it was noted that there was high moisture readings to several areas around the building.

High moisture readings can have several causes: from water migrating into the plasterboard, live termite activity or different types of building material eg ACM board or an electrical bracket interfering with the moisture readings.

Constant monitoring of the area or an invasive inspection is recommended to confirm these findings.

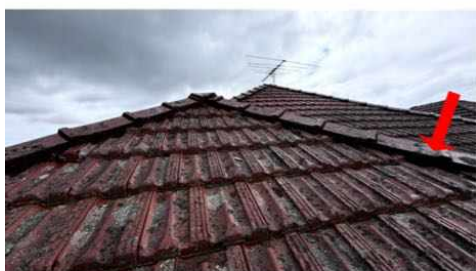
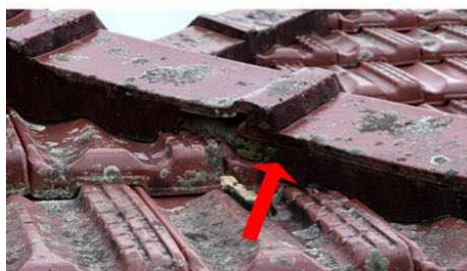
Finding 3.19

Building:	Main Building
Location:	Roof Exterior
Finding:	Mortar - Deterioration
Information:	Mortar, or 'bedding', is the material which fills joints and intersections between tiles and other building elements on the exterior roof covering, such as gable ends, hip capping and valleys. Upon inspection of the exterior roof, it was noted that sections of the mortar show varying levels of deterioration.

Mortar generally deteriorates as a result of frequent exposure to weather conditions over a prolonged period of time. Mortar that is deteriorating may allow water ingress into the roof void, putting associated building elements and roofing structures at risk of water damage. Deteriorated mortar also detracts from the functionality of roof tiles and other roofing elements, potentially decreasing weather tightness and roof drainage.

Mortar deterioration can be attended by a roofing contractor.

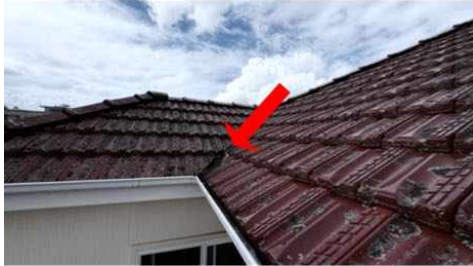
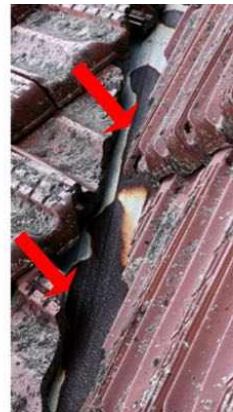
Finding 3.20

Building:	Main Building
Location:	Roof Exterior
Finding:	Roof valley - Rusted or corroded
Information:	The roof valleys have areas of rust and corrosion. It is suspected that this has been caused by blockages or debris, resulting in pooling or standing water, that have prematurely corroded the valleys.

Rusted valleys will generally develop holes and leaks that can affect other building elements with poor drainage of storm water. Poorly drained roof areas will also lead to damp conditions surrounding the base perimeter of the building as well as the roof void which, if left unmanaged, can lead to a range of secondary building defects.

Repair and/or replacement of rusted roof valleys is highly required in order to reinstate the roof drainage system to a fully operational level. To further maintain these areas, gutters and valleys should be cleaned frequently, allowing the avoidance of any partial blockages.

A licensed plumber or specialist roof restoration company should be appointed to undertake these works. It is advised that such works be completed as soon as possible to prevent any further damage and deterioration.

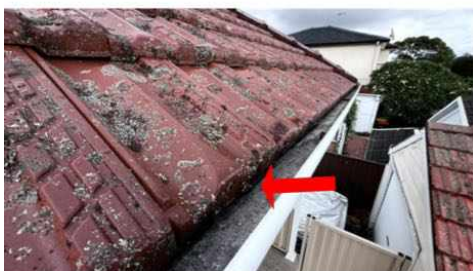
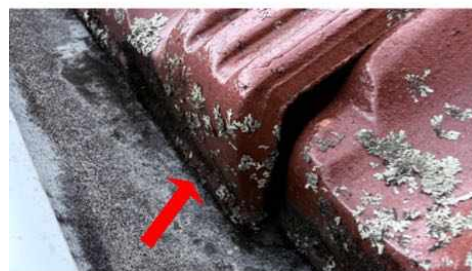
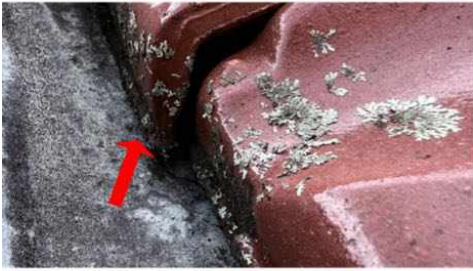
Finding 3.21

Building:	Main Building
Location:	Roof Exterior
Finding:	Roof tiles touching gutter
Information:	The roof tiles along this section have been installed too low and are in contact with the gutter. Roof tiles should generally have a small clearance from the gutter to allow correct drainage and prevent debris accumulation or water tracking back toward the fascia. Tiles resting on the gutter can restrict water flow and may contribute to premature gutter deterioration.

It is recommended that a licensed roofing contractor assess this area and adjust the first course of tiles or gutter position as required to achieve appropriate clearance and drainage.

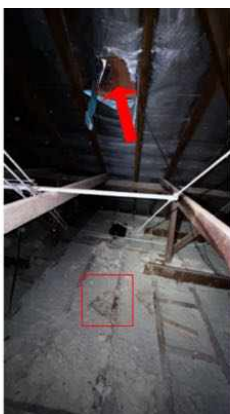
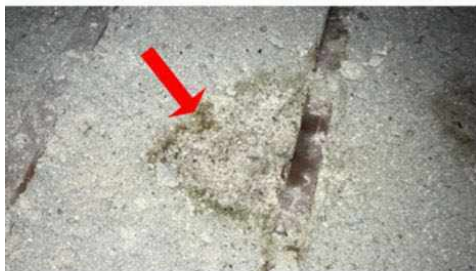
Finding 3.22

Building:	Main Building
Location:	Roof Void
Finding:	Insulation Damp
Information:	During inspection of the roof void, areas of insulation were found to be damp.

It appears that the source of the moisture may be due to roof leaks above where the sarking is damaged.

Damp insulation can reduce thermal performance and, if left unresolved, may promote mould growth and deterioration of adjacent building materials. As well as be conducive to vermin and other pests.

It is recommended that a suitably qualified roofing or plumbing contractor investigate the cause and carry out necessary remedial works.

Damaged or wet insulation should be replaced to restore effectiveness.

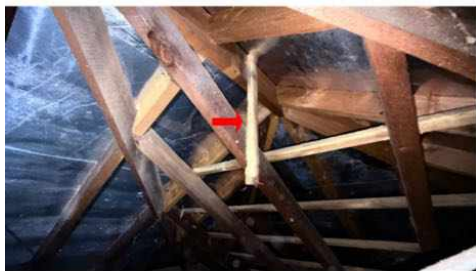
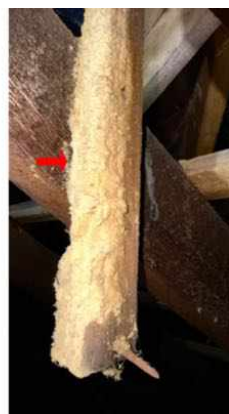
Finding 3.23

Building:	Main Building
Location:	Roof Void
Finding:	Early signs of Chemical delignification
Information:	Upon inspection of the roof space it was observed that several timbers have displayed early signs of Chemical delignification

Chemical delignification is a form of timber degradation with the chemical breakdown of timber building elements.

This breakdown of the Lignin —the natural glue that holds wood fibers together— is generally due to prolonged exposure to airborne pollutants, especially acidic or alkaline chemicals. It commonly affects roofing timbers, particularly in areas with high humidity and pollution impacting the structural integrity and tensile strength of the affected building element.

Please note: Due to the sarking covering the roof tiles battons the battons could not be inspected for Chemical delignification

Due to the early detection it is highly advised to monitor the area for further deterioration of the timbers.

Where timber building elements have deteriorated to a level where structural integrity has been compromised repair and / or replacement is required immediately by a remedial builder to ensure the safety of the associated structures. The likely cause of the chemical delignification should also be investigated and dealt with accordingly.

It is highly advised to avoid walking on the roof until this major defect has been rectified.

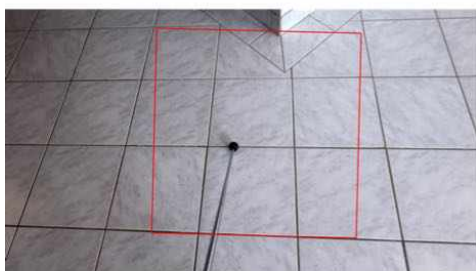
Finding 3.24

Building:	Main Building
Location:	All Areas
Finding:	Tiles - Drummy
Information:	Drummy tiled areas were identified at the time of inspection. The term 'drummy' refers to tiles that have become detached from their fixing, despite otherwise being in relatively good condition. Such defects are generally caused by physical or moisture damage to the area. Drummy tiled areas may also be a direct result of poor workmanship during the construction process.

Tiled areas may swell and shrink with changes in air humidity if the area has sustained moisture damage. Any exposure to moisture is capable of causing tiled areas to become drummy and/or cracked over a prolonged period of time. Drummy tiled areas generally require removal and replacement of affected tiles, with adequate sealant and grouting.

Specialist trades are available for these types of services. A registered builder may be required to undertake works if damage is extensive or if secondary building defects have resulted. Otherwise, it is advised that a tiling contractor be appointed to perform works as necessary. Immediate action is recommended to ensure that no further damage is sustained in the affected area.

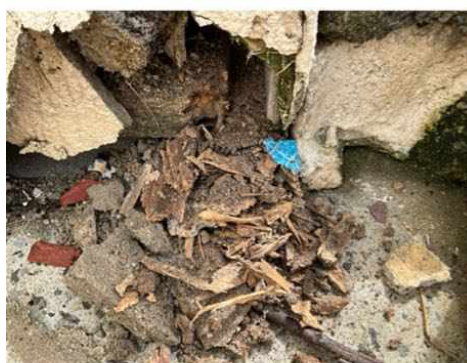
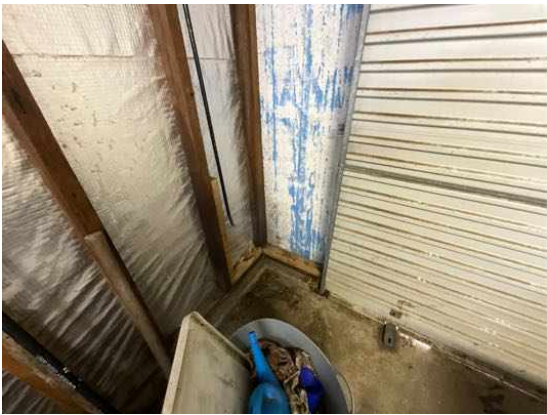
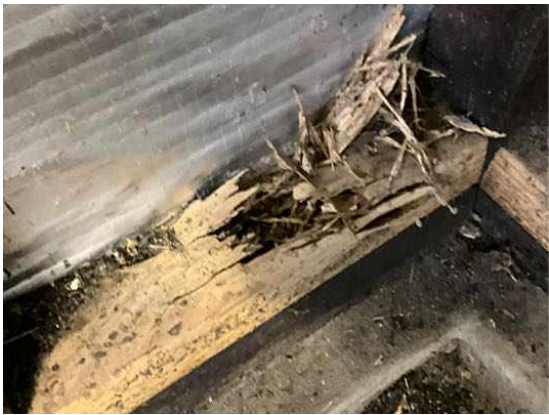
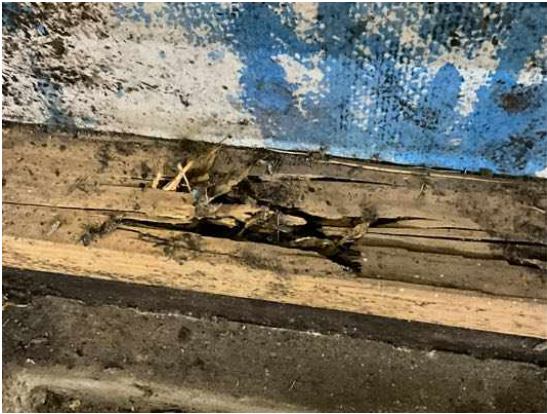
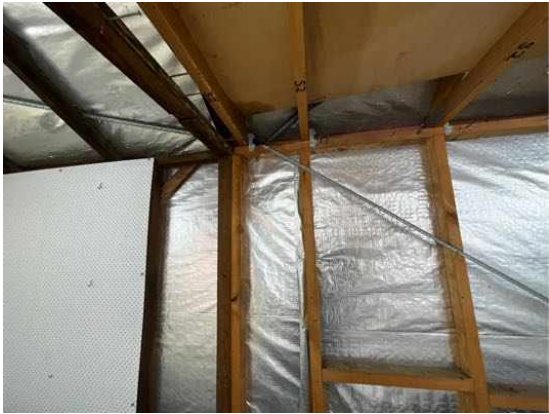
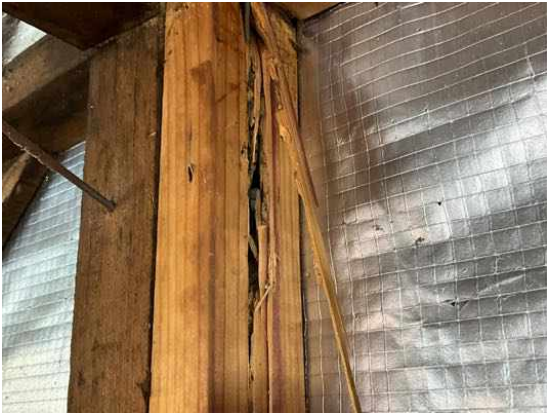
Building:	Main Building
Location:	Garage;Roof void
Finding:	Evidence of termite damage was identified
Information:	Termite damage was found on the property.

This is considered a major defect as live termites can cause significant structural damage to timber and adjoining building materials if not treated immediately.

The extent of damage already caused cannot be determined without an invasive inspection.

An invasive inspection is recommended to assess the extent of concealed damage.

A structural assessment by a qualified builder or engineer may be required depending on the level of timber damage found.

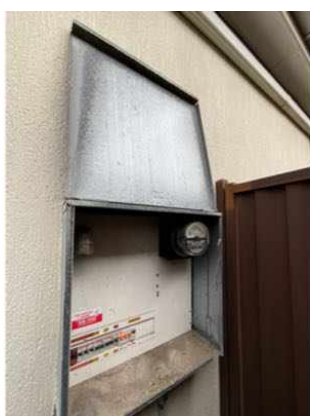
Finding 6.01

Building:	Main Building
Location:	Meter Box
Finding:	No Evidence of a current chemical termite management system
Information:	The application of a post-construction chemical termite barrier is highly recommended for all properties, particularly if live termite activity has been found on the site previously.

The client may consider gaining further advice from a pest controller as to the costs and procedures involved with this application.

It is recommended that obtaining such advice be a short-term priority.

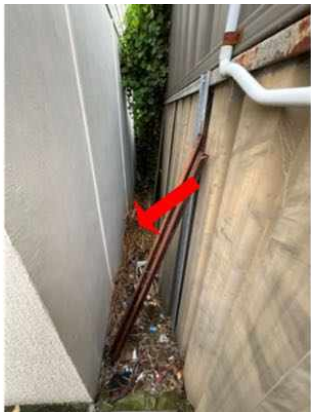
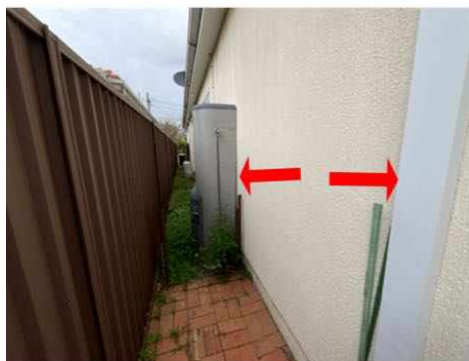
Finding 6.02

Building:	Main Building
Location:	All External Areas
Finding:	Bridging termite barrier - Attachments to Buildings
Information:	Bridging occurs when items against a building provide a concealed entry point for termites into the building or by passing around a termite management system.

Attachments to buildings such as hot water services, air conditioning units, downpipes, verandahs, decks, steps, fences, service conduits and the like provide the opportunity for concealed entry.

Where bridging has occurred, full inspection is prevented and termites may enter a property in a concealed or undetectable manner.

It is recommended that minimum 75mm clearance below the bottom of weep or ventilation holes be maintained where possible, otherwise annual inspections should be conducted by a licensed pest control company. Vegetation should also be kept clear of walls to allow regular inspection of all areas.

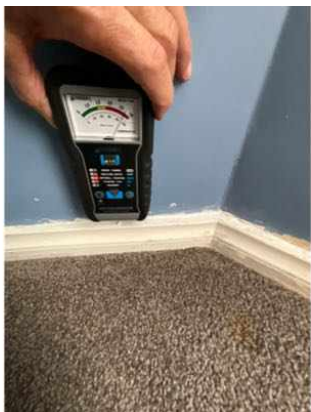
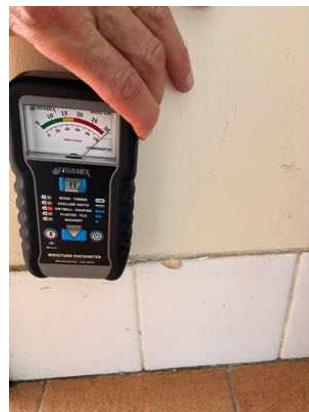
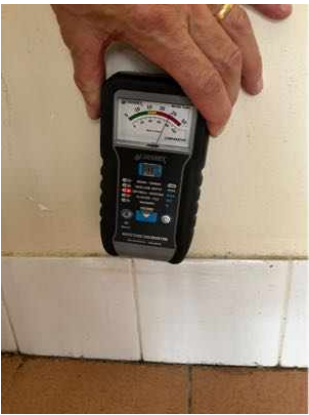
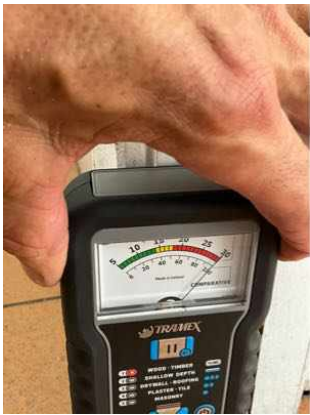
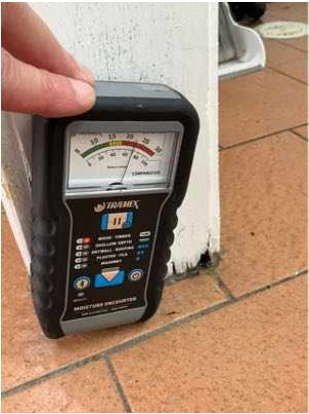
Finding 6.03

Building:	Main Building
Location:	All Areas
Finding:	High moisture reading-conducive conditions to termite activity.
Information:	High moisture readings were detected in the plasterboard during the inspection, which may be conducive to termite activity.

Termites are attracted to damp environments, as moisture softens building materials and facilitates easier access and tunneling.

Elevated moisture levels within or behind plasterboard can indicate potential leaks, poor ventilation, or drainage issues, all of which can create ideal conditions for concealed termite infestation.

Further investigation by a licensed builder or termite specialist is recommended, which may include removal of sections of plasterboard to identify the source of moisture and assess for any signs of active or previous termite presence.

Prompt rectification of moisture issues is essential to reduce the risk of future termite activity.

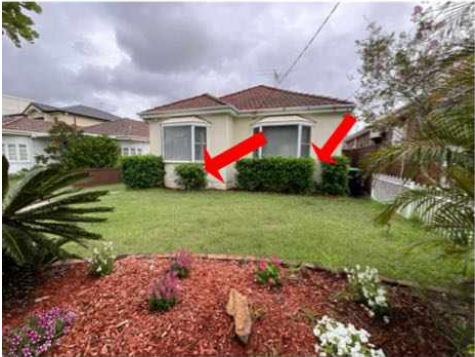
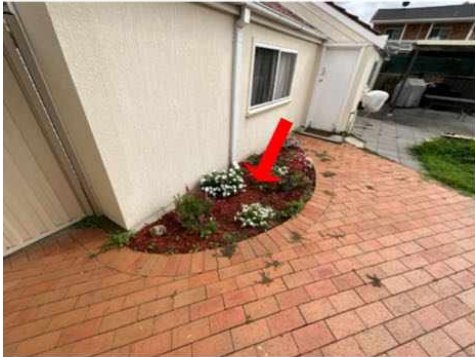
Finding 6.04

Building: Main Building
 Location: All Areas
 Finding: Garden bed- conducive to timber pest activity.
 Information: Garden beds were found to be evident in the garden area. These garden beds which lay against the building and allow easy undetected ingress for termites can include untreated timber, and with a combination of moisture from watering can make conditions conducive to termite activity.

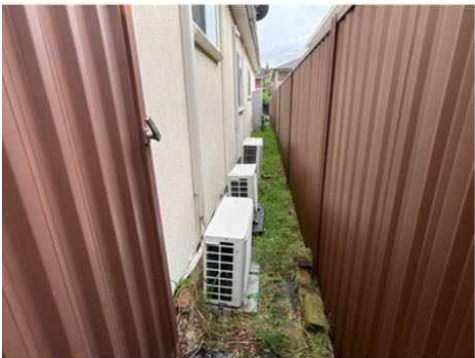
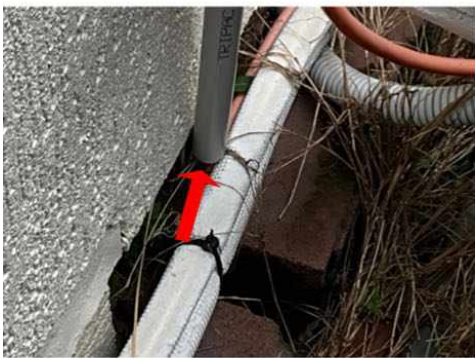
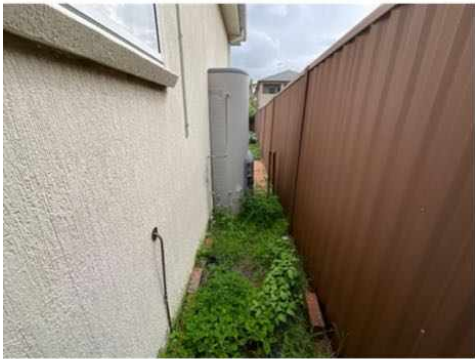
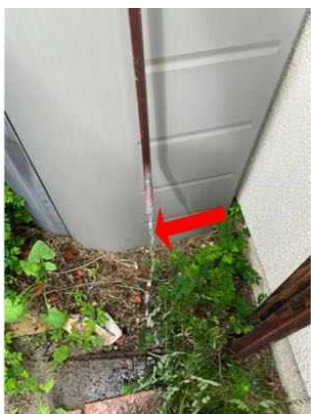
Finding 6.05

Building: Main Building
Location: Exterior walls - right side
Finding: HWS/AC overflow not connected
Information: The Hot Water System (HWS) and A/C overflows were found to be disconnected from storm water drainage and is creating excessive moisture in the surrounding area. These damp conditions can lead to secondary defects such as rot, rust or corrosion of associated building elements, the formation of fungal decay, or even the creation of potential slip hazards. When coupled with poor site drainage, pooling of water may also attract termite activity to this area. It is highly recommended that a licensed plumber be appointed to connect the HWS and A/C overflows in order to prevent such an environment from being created. These minor works should be carried out as soon as possible.

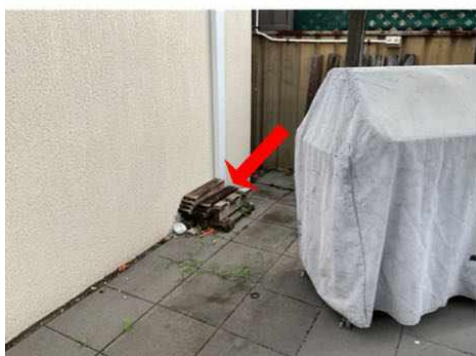
Finding 6.06

Building:	Main Building
Location:	Yard - Back
Finding:	In ground contact
Information:	Any timbers in direct ground contact provide opportunity for concealed termite entry and are likely to be subject to premature rot and decay as the soil retains moisture or damp conditions against the timbers.

Remove untreated timber that is in direct contact with external grounds. Consider replacement with more durable materials i.e. treated timber or non timber elements. Frequent pest inspections are advised to readily identify any termite activity in these areas.

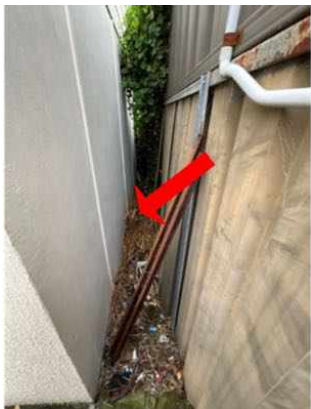
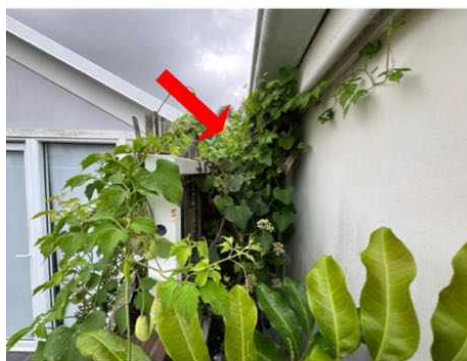
Finding 6.07

Building:	Main Building
Location:	Yard - Back
Finding:	Excessive Vegetation
Information:	Fallen vegetation and organic debris were observed on the property.

These materials create conducive conditions for timber pests, including termites, by providing moisture, shelter, and potential food sources.

It is recommended that all such debris be removed and the area maintained to reduce the risk of future termite activity.

It is strongly recommended that a termite specialist be consulted regarding the installation of a termite management to suit the property.

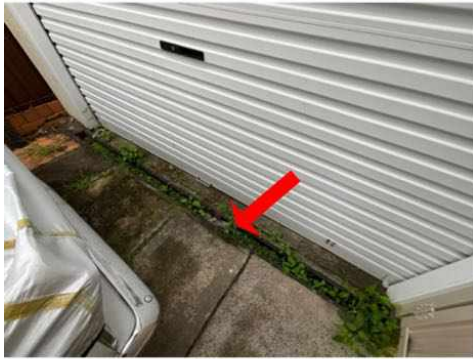
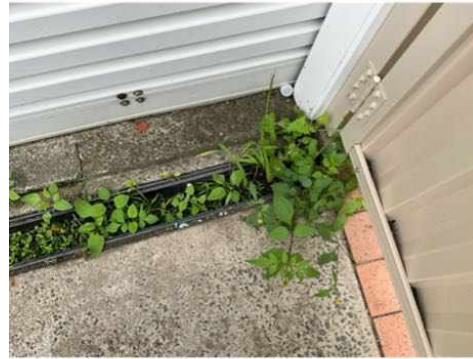
Finding 6.08

Building:	Main Building
Location:	Driveway
Finding:	Drains-Blocked
Information:	Drains , should be free of all debris to prevent blockages.

Blocked drains are likely to lead to high levels of moisture in the affected areas. Such moisture will not only cause rust and decay of the associated building materials, but can also provide conditions that are conducive to termite and timber pest activity.

Blockages in drains should therefore be removed immediately to ensure dry conditions are maintained.

It is highly advised that blocked drains be cleaned of all debris at the behest of the homeowner as a matter of urgency.

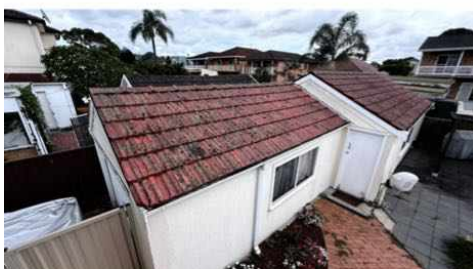
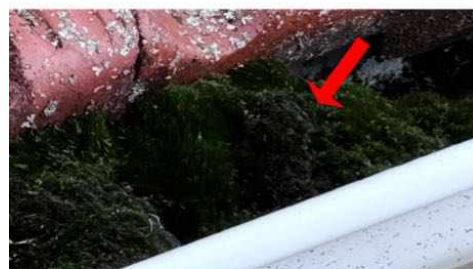
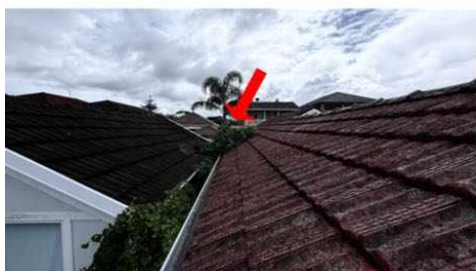
Finding 6.09

Blocked gutters, downpipes and valleys are likely to lead to high levels of moisture to the affected area.

Such moisture will not only cause rust and decay of the associated building materials, but can also provide conditions that are conducive to termite and timber pest activity as well as mould growth.

Blockages should therefore be removed to ensure dry conditions are maintained.

It is highly advised that blocked gutters, downpipes and valleys be cleaned frequently.

Where areas have a high tree density, installing a gutter guard may be an option in preventing leaves accumulating in the gutters and associated roofing elements.
