Building and Timber Pest Inspection Report

Inspection Date: Tue, 10 Mar 2026

Property Address: 39 Hollywood St, Monterey NSW 2217,
Australia

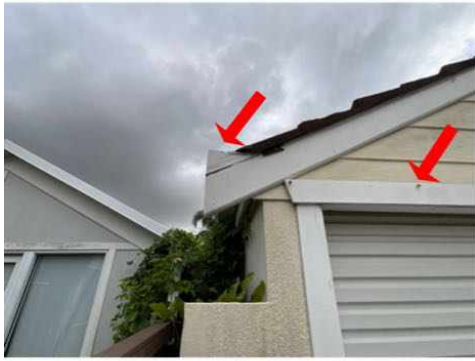
Finding 7.01

Building:	Main Building
Location:	Fascia
Finding:	Fascias - Wood rot
Information:	Wood rot was found to be affecting fascias and barges in this area.

Wood rot, also known as Fungal Decay, occurs when timbers and other cellulose building materials are exposed to damp conditions on an ongoing basis.

It is likely that this wood rot has developed as a result of frequent exposure to rain and other weather conditions also make fascias and barges susceptible to accelerated deterioration.

Early intervention and regular maintenance will prolong the life of these building elements. Prior to any works being performed, the cause of the moisture that has created the visible wood rot should be identified and addressed in a suitable manner.

It is advised that a roof plumber be appointed to inspect all roof plumbing and subsequently identify the cause of the wood rot.

Replacement of affected fascias and barges may then be a necessary step in protecting surrounding building elements from such deterioration.

A qualified carpenter or registered builder may also be required to replace affected building materials.

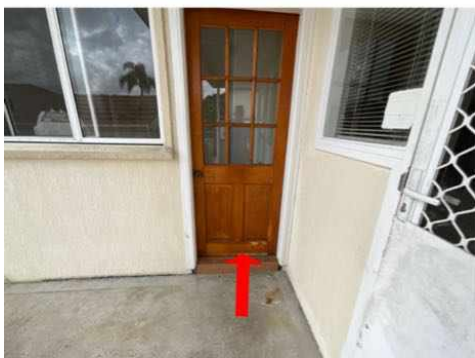
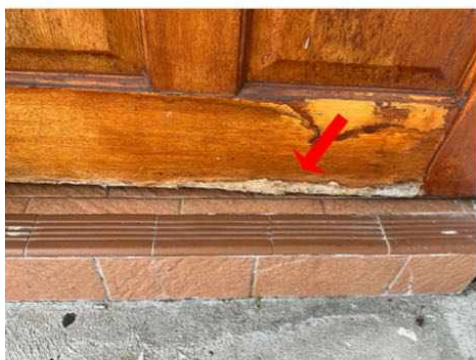
Finding 7.02

Building:	Main Building
Location:	Laundry
Finding:	External doors - Wood rot
Information:	Wood rot was found to be affecting external doors.

Wood rot, also known as Fungal Decay, occurs when timbers and other cellulose building materials are exposed to damp conditions on an ongoing basis.

It is likely that this wood rot has developed as a result of frequent exposure to rain and other weather conditions.

It is suspected that failure to maintain the doors and associated frames over a prolonged period has resulted in them deteriorating at an accelerated rate, increasing their susceptibility to the development of wood rot.

Repair and/or replacement of affected doors and frames may be performed by a qualified carpenter or registered builder as soon as possible to prevent any further damage.

Early intervention and regular maintenance will prolong the useful life of these building elements.

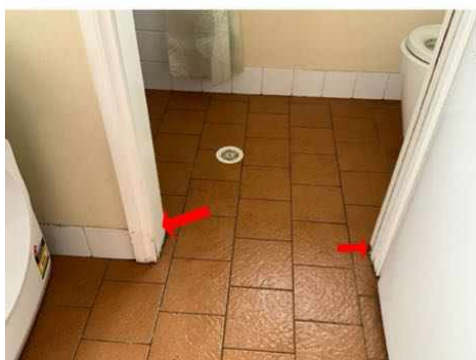
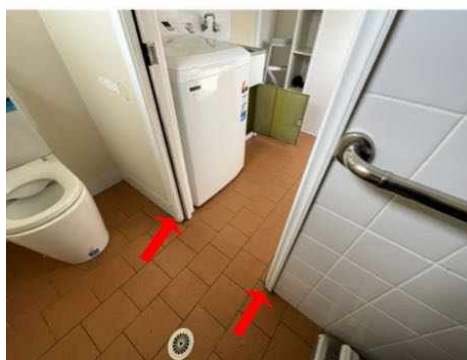
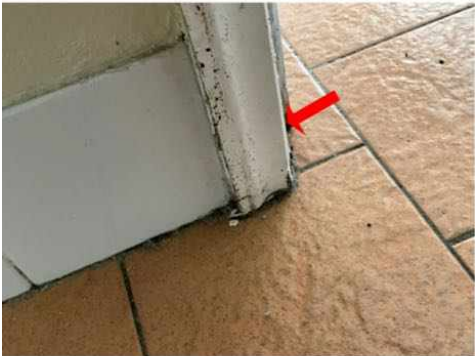
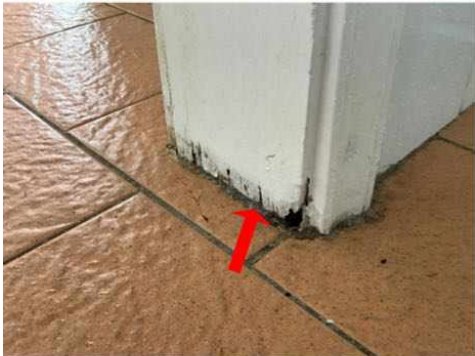
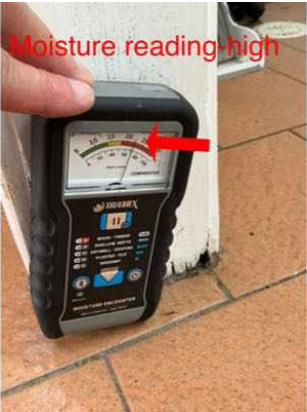
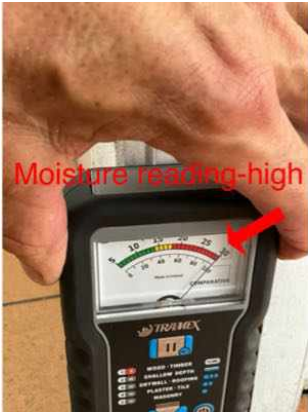
Finding 7.03

Building:	Main Building
Location:	Laundry
Finding:	Wood rot - internal door frame
Information:	Wood rot was found to be affecting the door frame in this area .

Wood rot, also known as Fungal Decay, occurs when timbers and other cellulose building materials are exposed to damp conditions on an ongoing basis.

It appears that this wood rot has developed as a result of frequent exposure to water coming from the shower recess. Possible cause may be the failure of water proofing membrane in the shower and bathroom

This has resulted in the door frame deteriorating at an accelerated rate, increasing their susceptibility to the development of wood rot.

A remedial builder and waterproofing specialist may be consulted in order to positively identify the exact reason for the leak, before commencing remedial works to rectify this issue.

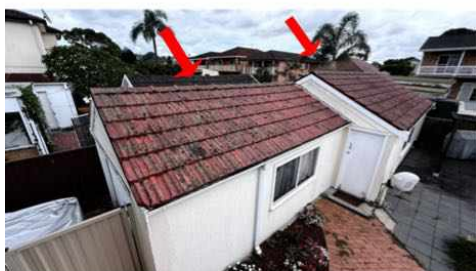
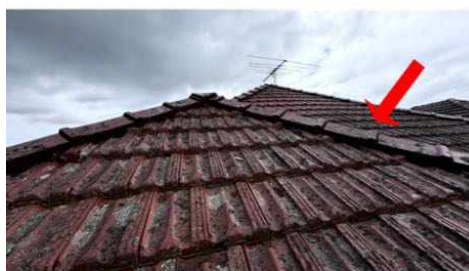
Noted Item

Building: Main Building
 Location: Roof Exterior
 Finding: Roof exterior condition
 Information: The roof exterior, including associated flashings and roof plumbing components

(gutters and downpipes), was inspected wherever safely accessible with a 3.6 m ladder and from any safe viewing position. All areas accessed were found to be in a serviceable condition unless noted otherwise elsewhere in this report.

It should also be noted that flat or skillion roof areas, particularly those incorporating box gutters, are at a higher-than-normal risk of water ingress during extreme weather conditions. This increased risk can arise from multiple potential causes, some of which may not be evident during a visual inspection.

Where a full inspection was not possible—due to, but not limited to, height restrictions, ladder limitations, roof steepness, obstructions, or restricted visibility (line of sight)—it is recommended that a qualified roofing contractor be engaged to undertake a comprehensive inspection of those areas.

As the roof is the building element most exposed to weathering, the likelihood of deterioration is high. It is strongly advised that the roof be inspected at regular intervals to assess the condition and integrity of all roofing elements, including tiles, roof sheets, skylights, roof vents, flashings, solar panel fixings, guttering, and downpipes.

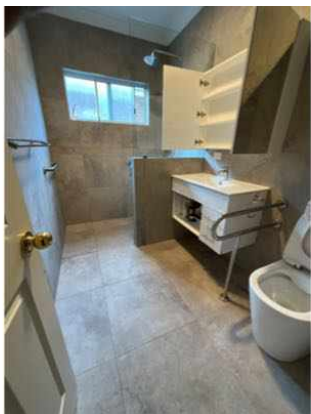
Building:	Main Building
Location:	All wet Areas
Finding:	Water Proofing Membranes
Information:	Internal Water Proofing Membranes, are crucial in preventing water ingress into the property.

With older property's where this information is unavailable all wet areas should be monitored. If any leaks, water staining, peeling or bubbling of the paint become evident to any adjacent walls or ceilings below a licensed builder or waterproofing specialist is recommended to investigate further.

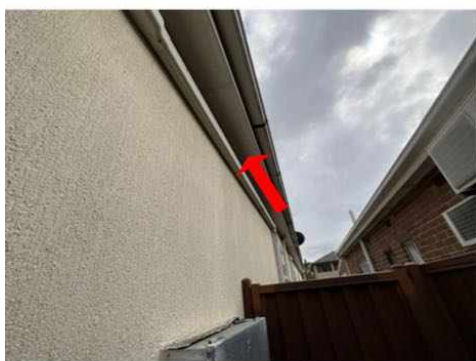
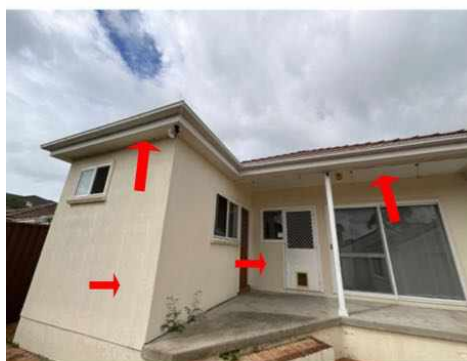
Building: Main Building
 Location: All Areas
 Finding: Asbestos - Suspected ACM Identified on Site
 Information: Reporting on Asbestos is outside the Scope of this Report. This suspected defect is highlighted as a caution only. We suspect, based on our experience in the building industry, that there is a higher risk of the identified building element containing asbestos.

As Asbestos Reporting is outside the scope of this report, we advise that you consider a separate Asbestos Inspection and Condition Audit, which can include the taking of samples for definitive confirmation of the presence of Asbestos.

In the interim, the client is advised to act with caution, especially when considering any damage to building materials general wear and tear renovations extensions demolition and general maintenance activities due to the suspected presence of Asbestos.

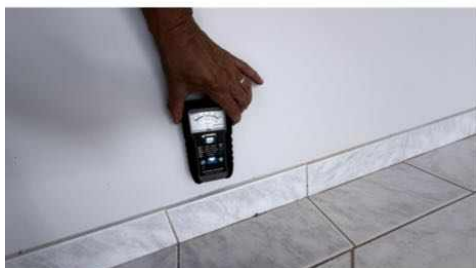
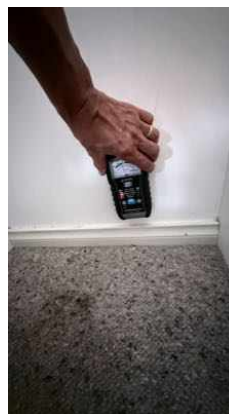
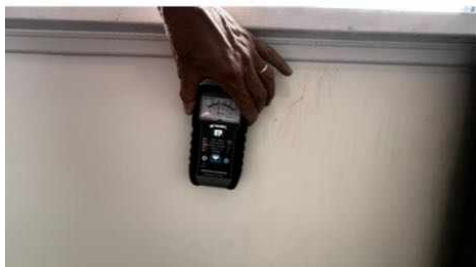
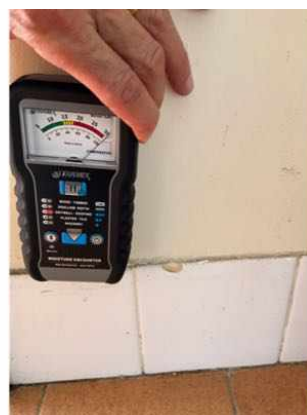
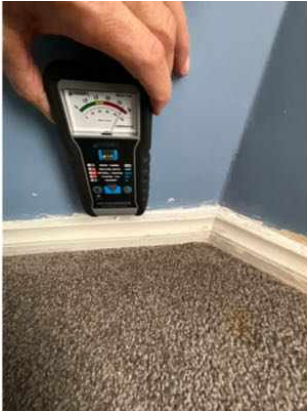
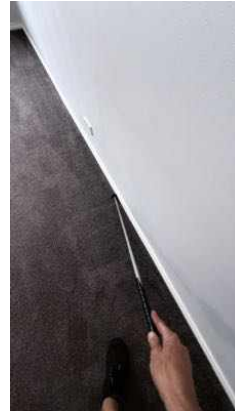
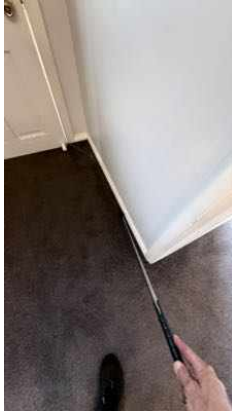
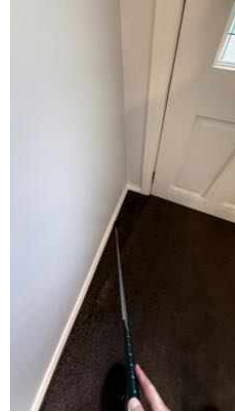
Building: Main Building
Location: All Areas
Finding: Termite Techniques
Information: All areas of the dwelling are checked with particular attention paid to wet areas which were closely assessed to check for excessive levels of moisture and temperature anomalies.

In an attempt to identify the presence of hidden timber pest activity, a variety of techniques are adopted to identify irregularities including, a moisture meter reading of susceptible areas, sounding of timber elements using a device called a "donga" visual assessment of materials affected by moisture or signs of deformity, trails and bridging constructed by termites, irregular and regular shaped holes in timber elements indicating pest destruction.

Termite activity generates high temperatures and moisture and if this irregularity is found further investigation which may include the removal of wall and ceiling linings is highly recommended.

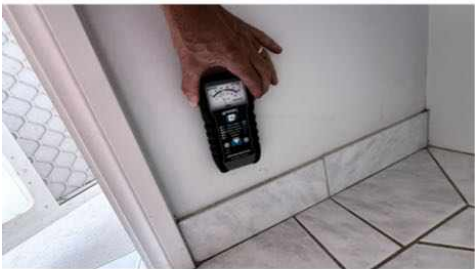
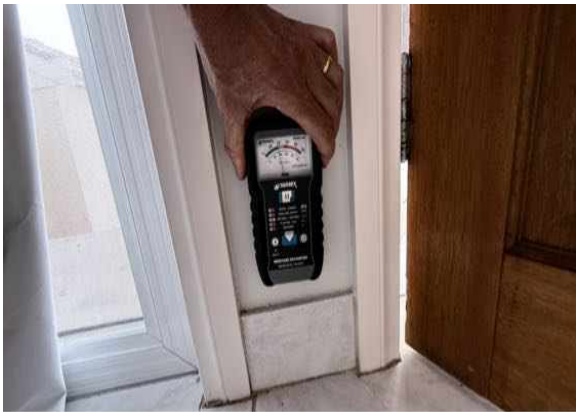
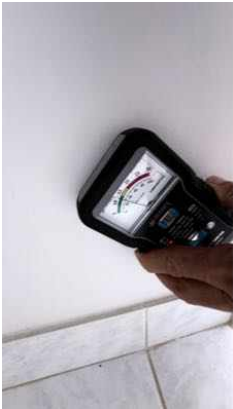
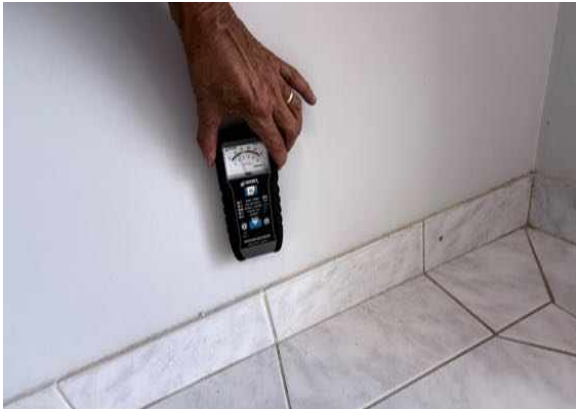
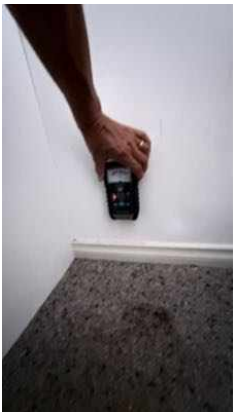
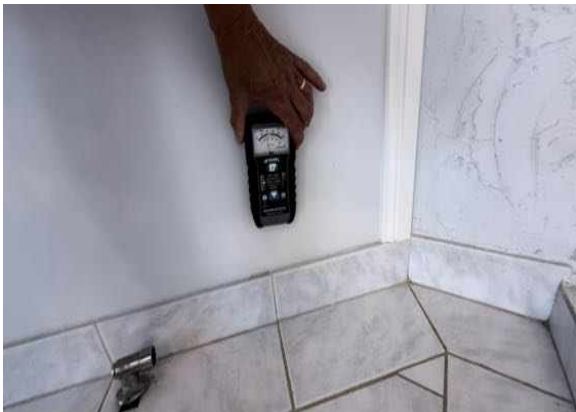
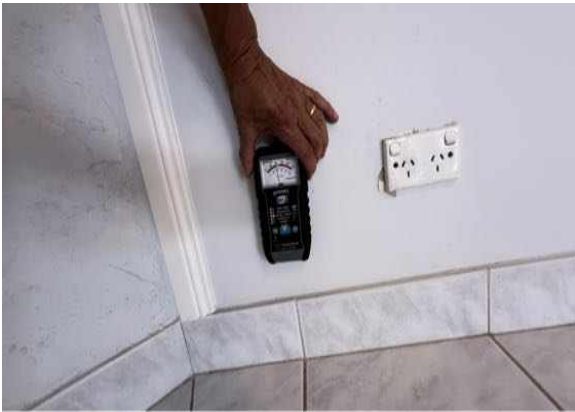
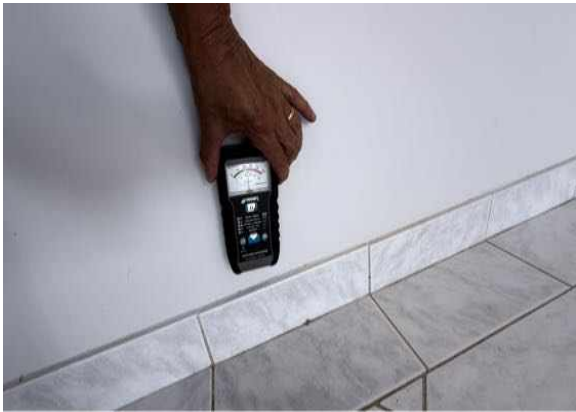
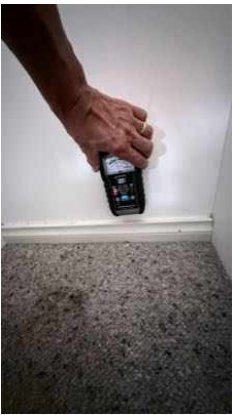
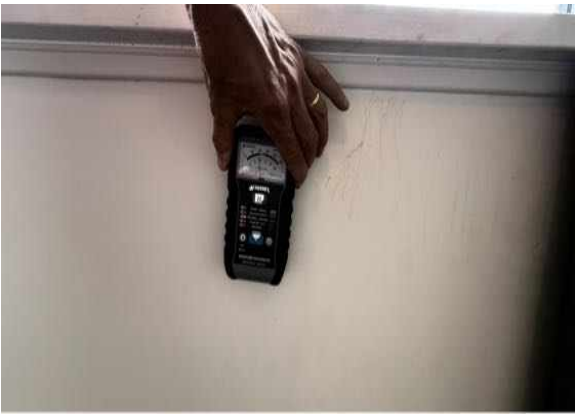
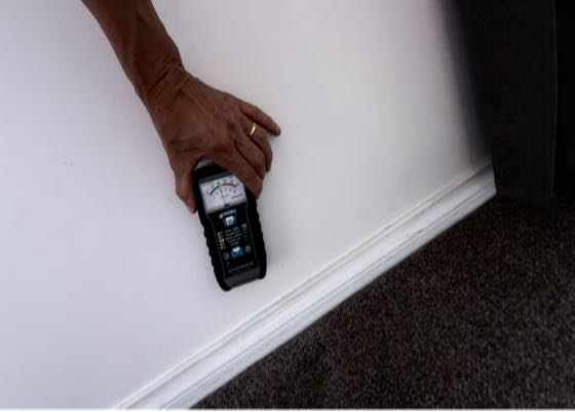
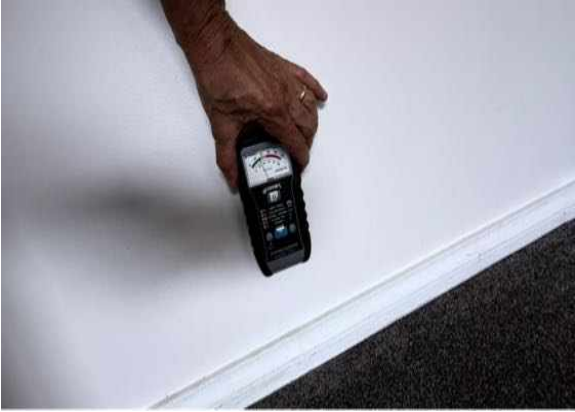
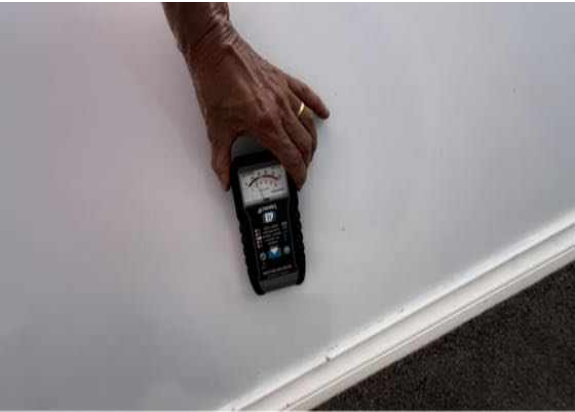
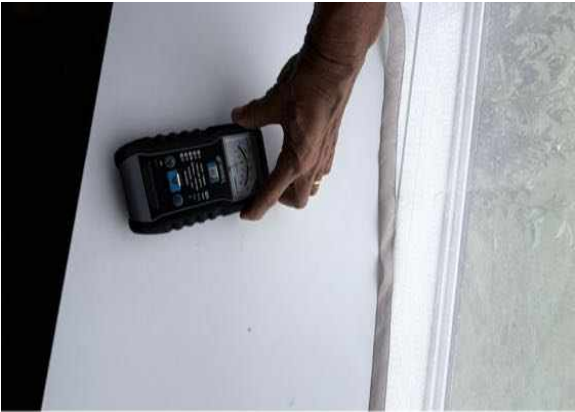
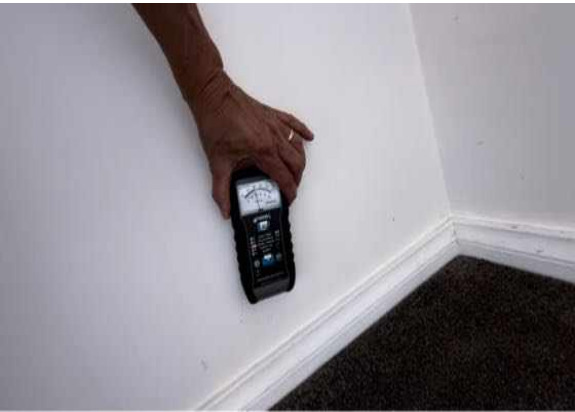
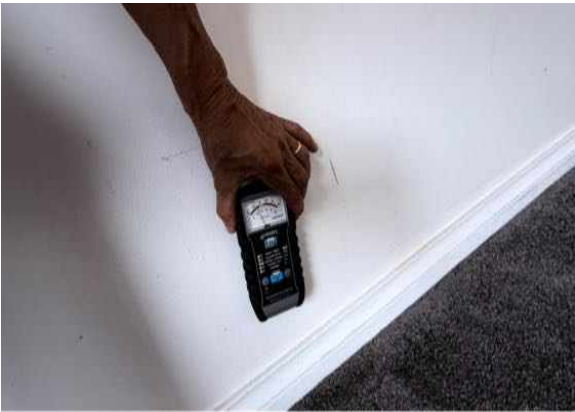
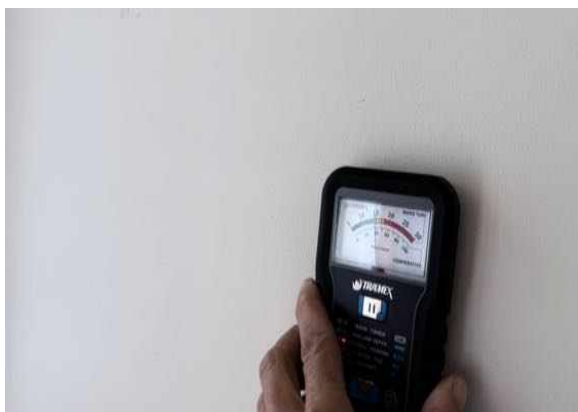
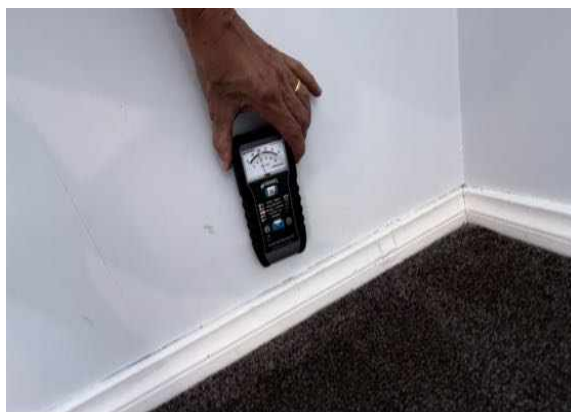
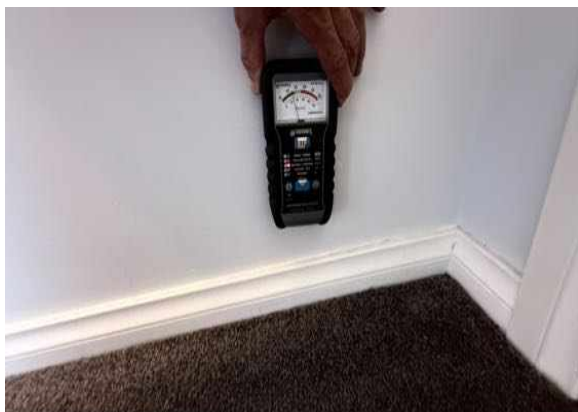
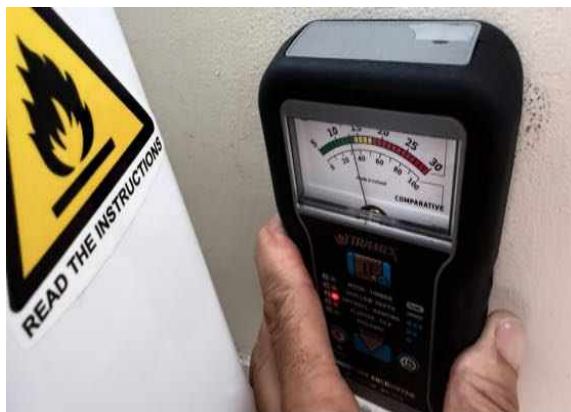
Building:	Main Building
Location:	All Areas
Finding:	Moisture readings
Information:	At the time of inspection, low moisture readings were noted in several accessible areas of the property, including, but not limited to, those shown in the accompanying photographs.

These areas were evaluated for elevated moisture levels and temperature irregularities, which can indicate potential issues such as hidden leaks, failing waterproofing, timber pest activity or poor ventilation.

Identifying such conditions is essential, as prolonged moisture can result in structural deterioration, mould growth, and an increased risk of timber pest activity.

Any anomalies detected during the inspection have been documented in this report and may warrant further invasive investigation to determine their source and extent.

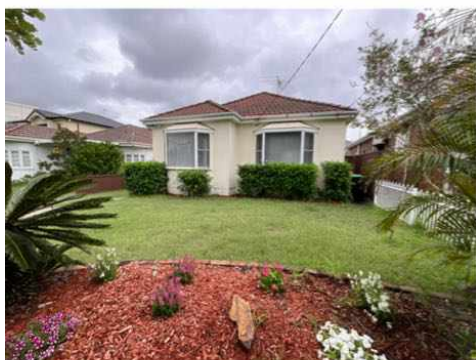
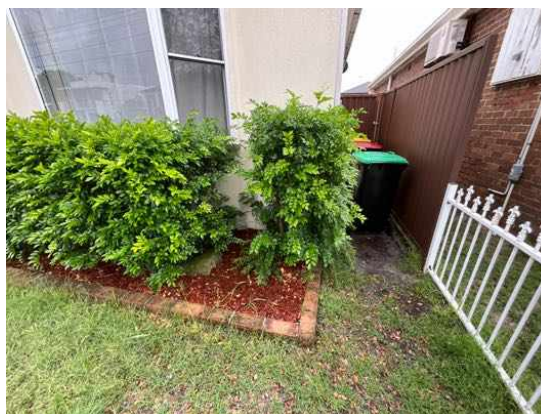
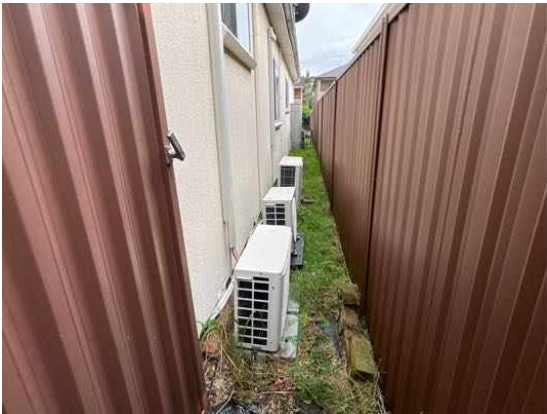
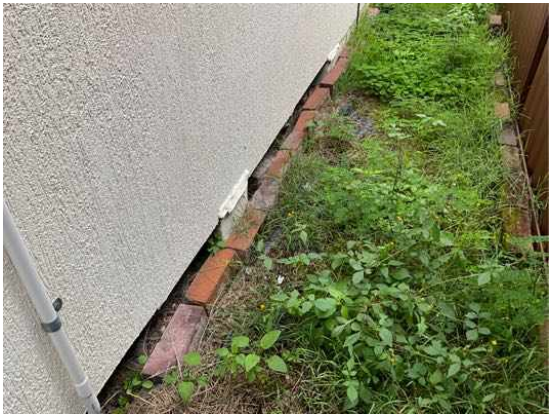
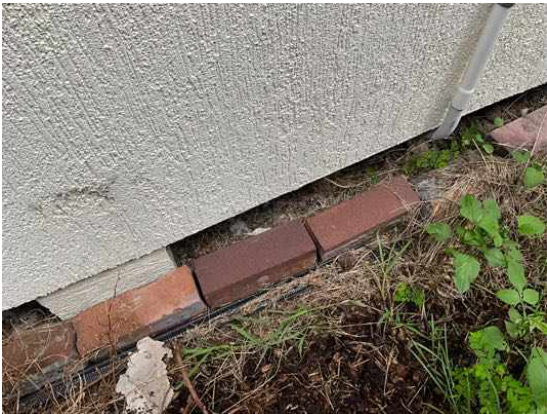
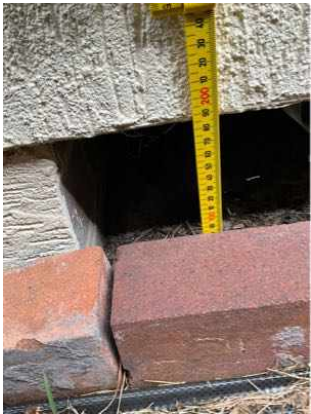
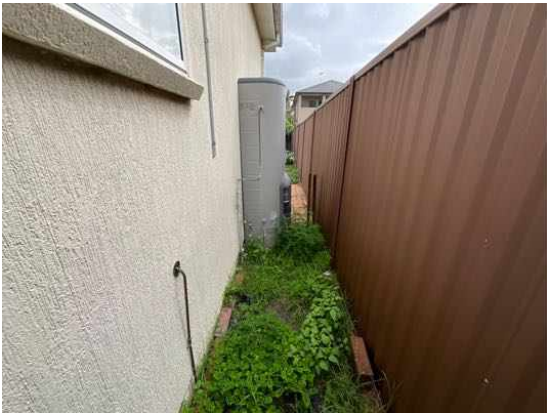
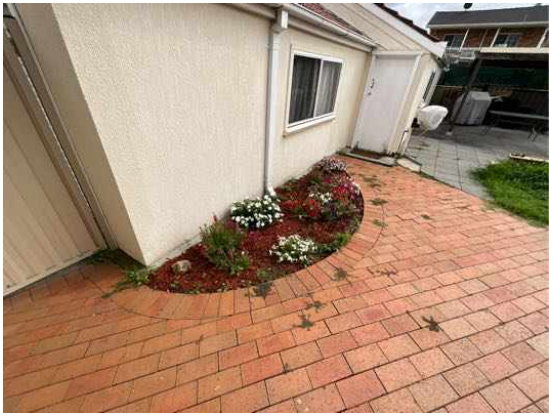
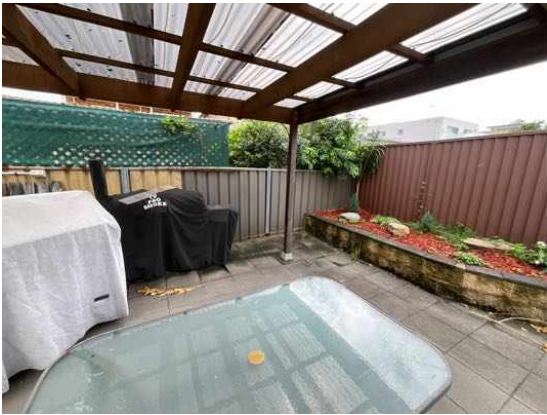
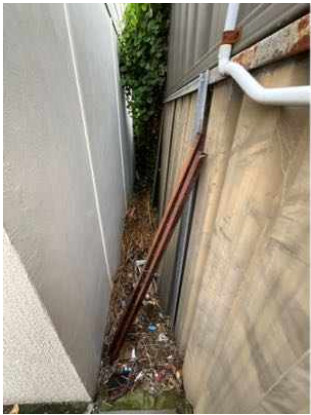
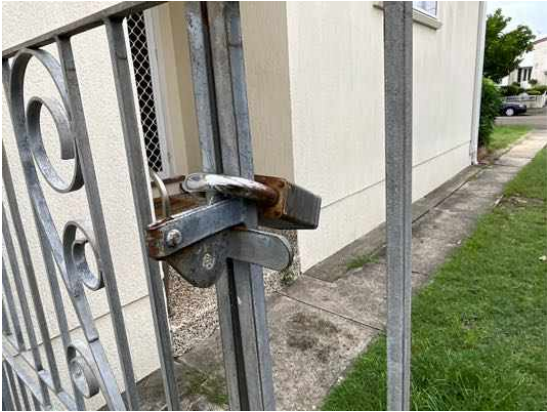
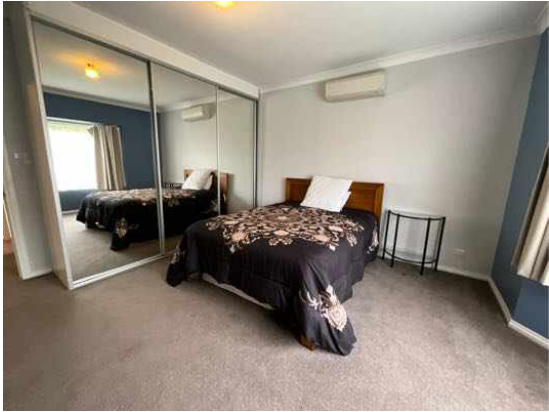
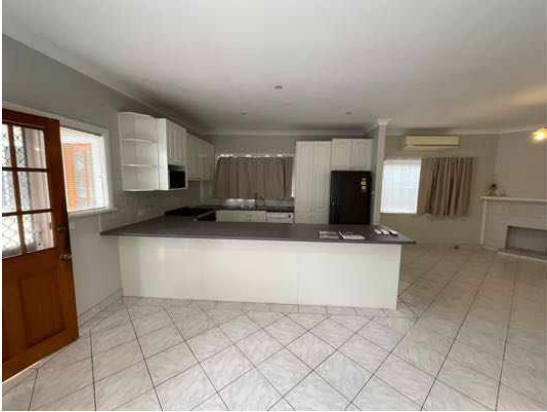
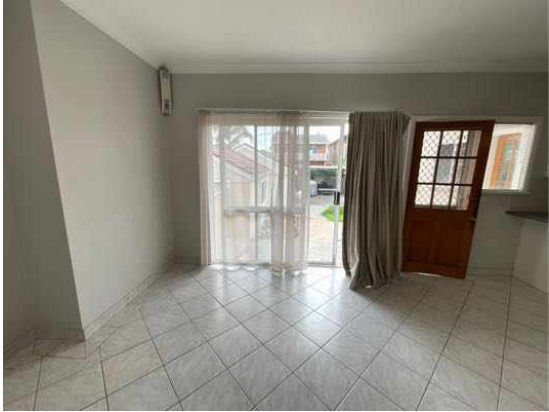
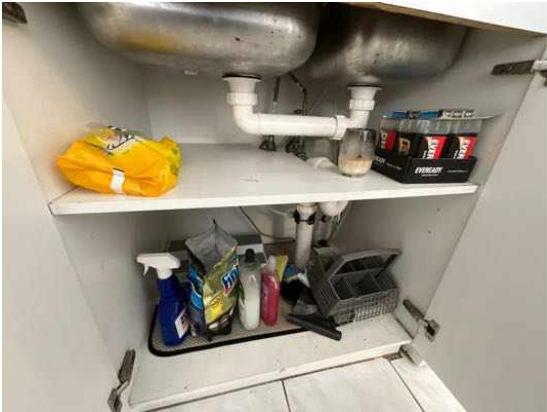
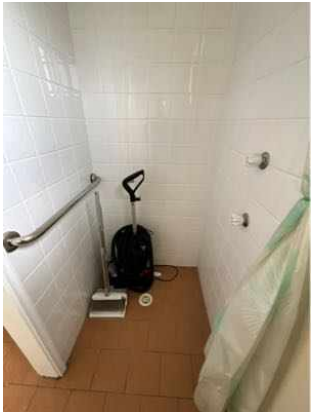
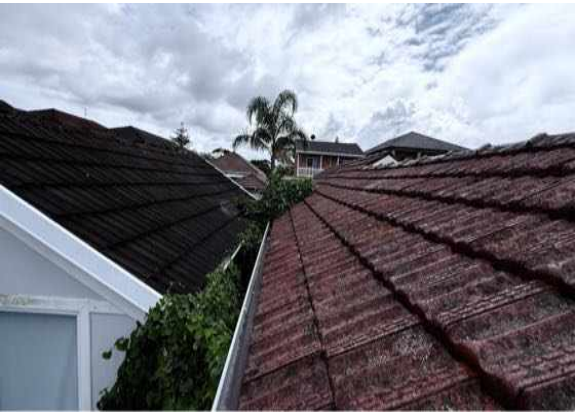
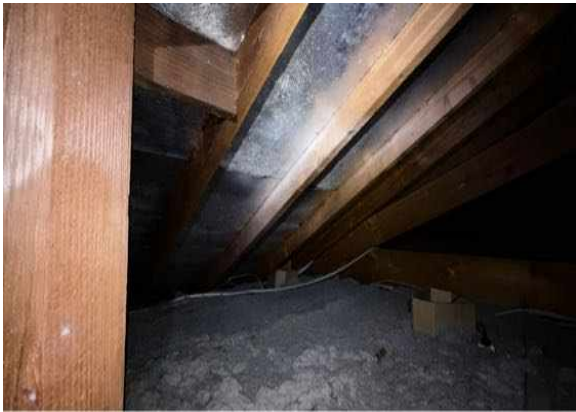
Building: Main Building
 Location: All Areas
 Finding: Obstructions and Limitations-additional photos
 Information: The photographs represent only a small sample of the obstructions and limitations to areas (where applicable) of the roof void, subfloor, internal and external areas that restricted a full inspection of the property. Such obstructions may conceal a variety of defects and should be removed to allow a comprehensive inspection to be carried out.

A re-inspection is strongly recommended once these areas are made fully accessible.
