Building and Timber Pest Inspection Report

Inspection Date: Fri, 27 Mar 2026

Property Address: 1/205 N Rocks Rd, North Rocks NSW 2151,
Australia

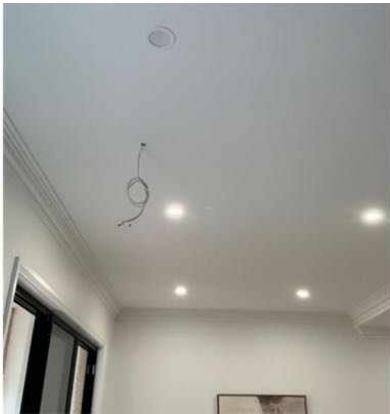
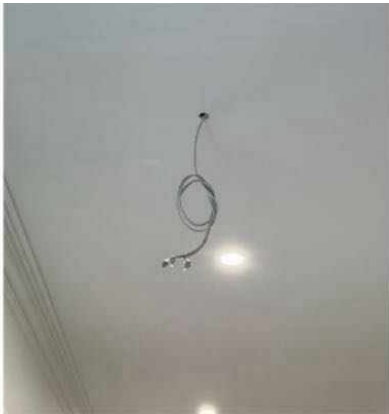
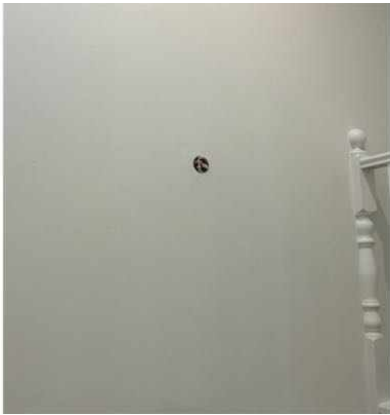
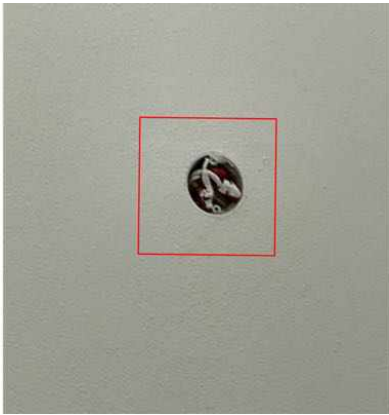
Finding 1.01

Building: Main Building
Location: All Internal Areas
Finding: Electrical wires
Information: Electrical wiring was observed protruding from the ceiling and/or wall with insulated connector terminals in place and the connection in the wall appears to have been taped. While the wiring appears terminated, it remains exposed and incomplete. It is recommended that a suitable light fitting or compliant cover be installed and the wiring secured by a licensed electrician.

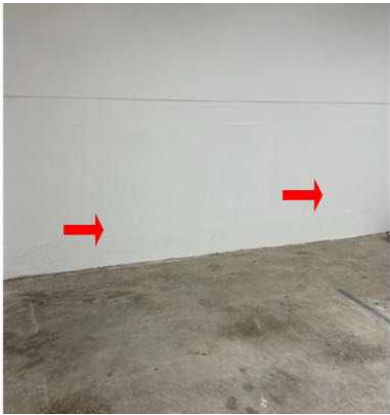
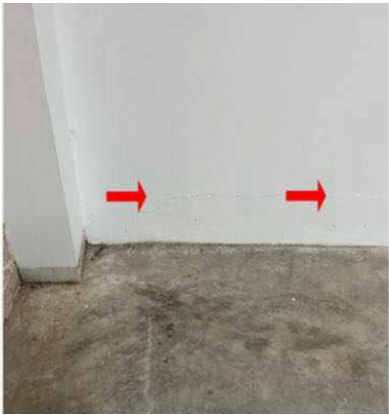
Finding 3.01

Building: Main Building
Location: Garage - Retaining wall
Finding: Elevated Moisture, cracking and past repairs – Further Investigation Recommended
Information: Elevated moisture readings were noted with some areas also showing signs of dampness and cracking, although no significant structural damage was evident at the time of inspection, dampness can contribute to deterioration if left unaddressed. A further investigation by a licensed plumber or waterproofing specialist is recommended to confirm the source and ensure no concealed issues are developing. The cracking to render appear to has been repaired, the extent of repairs could not be determined during a visual non invasive inspection and should be accessed by a licensed builder.

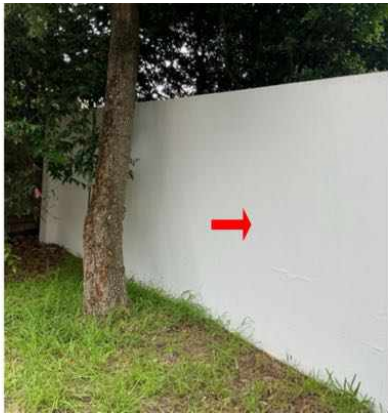
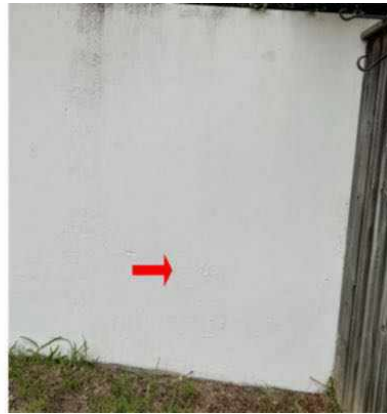
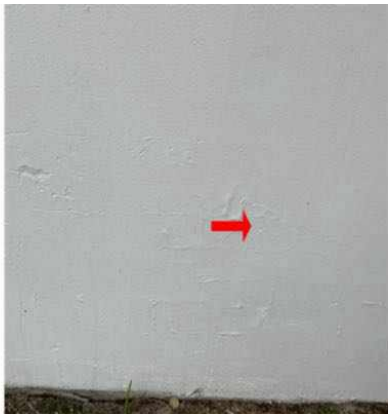
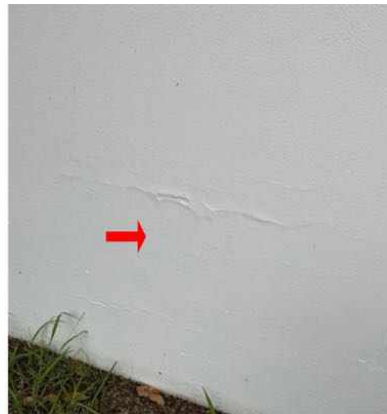
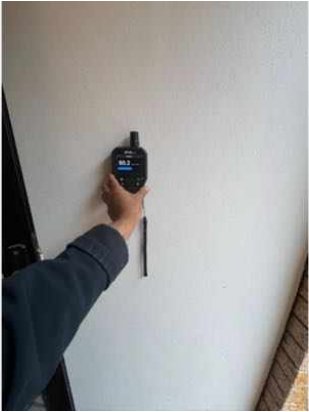
Finding 3.02

Building:	Main Building
Location:	All External Areas - Rear boundary wall, Right Party wall
Finding:	Damp
Information:	Damp (or structural damp) refers to the presence of unwanted moisture in the structure of a building, either as the result of intrusion from outside, or condensation from within the structure. Generally, structural damp is caused by rain penetration, rising damp, and leaks from plumbing pipes.

Unmanaged damp facilitates the formation and development of mould, fungi growth and wood rot, decaying associated building materials and compromising their structural integrity. Damage to finishes is also likely to occur, including lifting, bubbling, peeling and staining of paint, plaster and wallpaper.

Consultation with a qualified plumber is advised immediately to identify the cause of damp and perform remedial works as required. Where excessive mould growth is present, further inspection by a specialist environmental health inspector should also be considered.

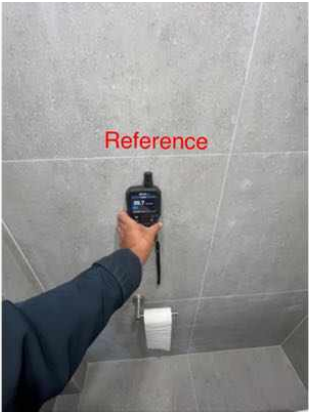
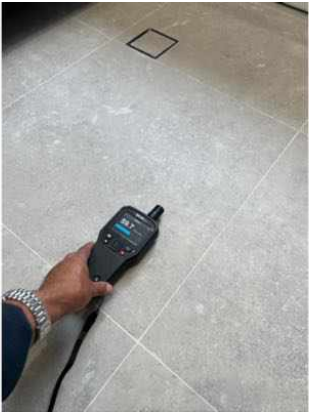
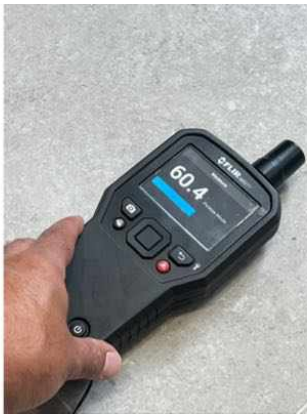
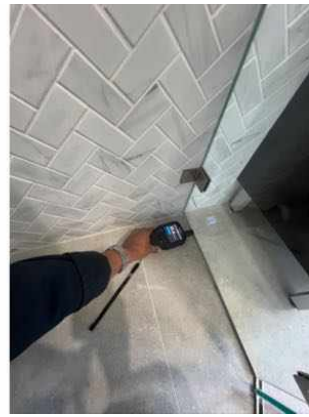
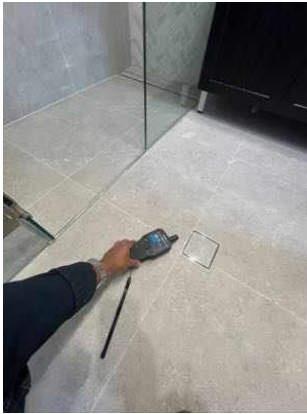
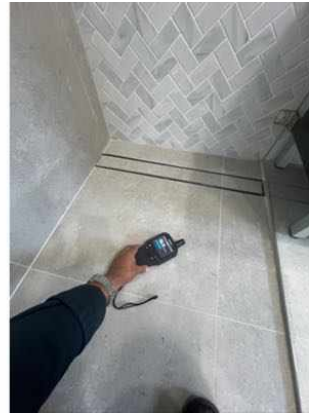
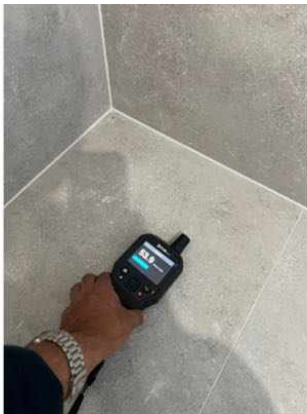
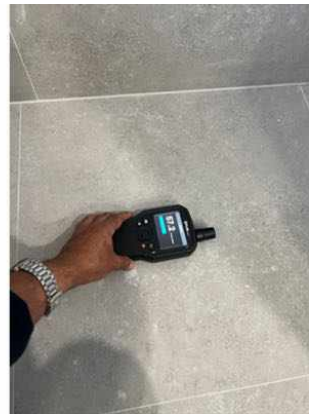
Finding 3.03

Building: Main Building
 Location: Bathroom, ensuite
 Finding: Elevated Moisture Bathroom (No visible deterioration noted)
 Information: Elevated moisture levels were detected to tiled surfaces in bathroom/shower areas. Persistent moisture ingress can lead to concealed damage, including timber rot and mould growth.

Elevated moisture readings in tiled wet areas can occur from normal shower use, age/deterioration of waterproofing membranes, plumbing leaks or moisture absorption through grout lines. While no damage was visible, elevated readings may indicate moisture retention behind tiles, which can be a conducive condition for future deterioration if not monitored.

Monitor the area over time for signs of drumming, efflorescence, tile movement, or grout deterioration. Further inspection by a licensed waterproofing is recommended (e.g., pressure testing, membrane assessment).

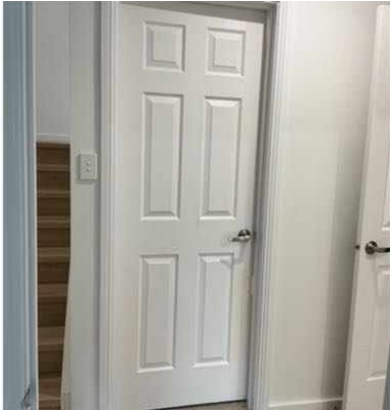
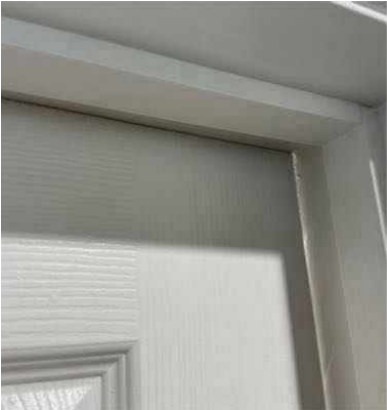
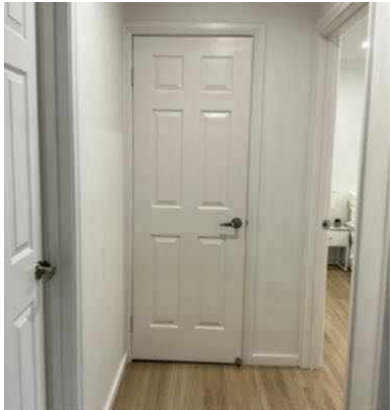
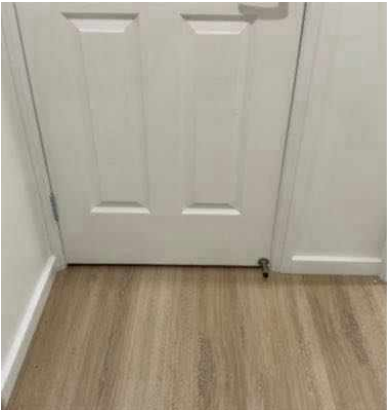
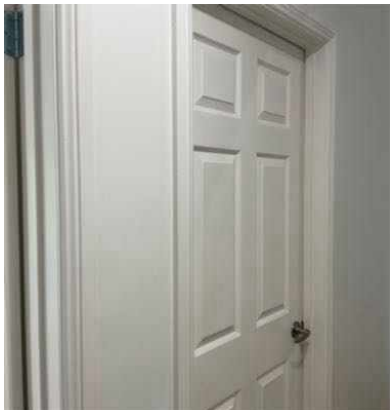
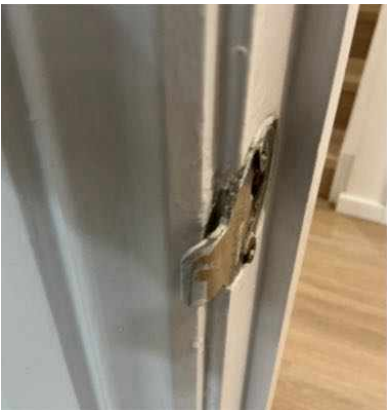
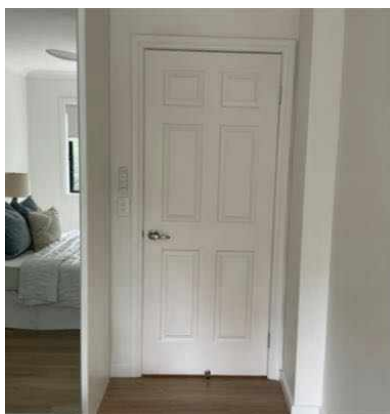
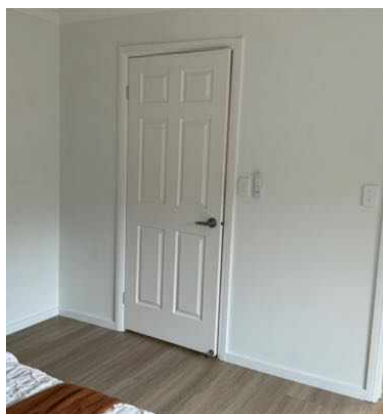
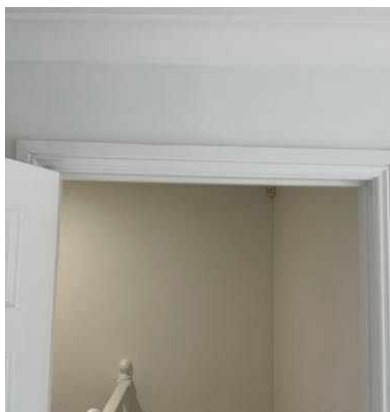
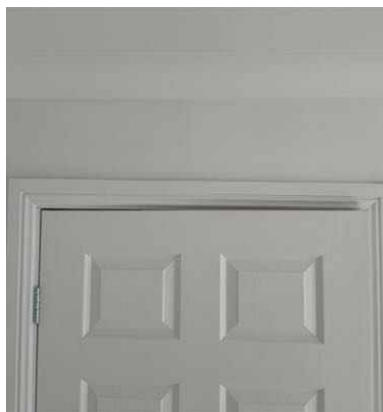
Finding 3.04

Building:	Main Building
Location:	Toilet (WC), bathroom, bedroom, bedroom level 2
Finding:	Doors - Binding/Jamming
Information:	Binding and/or jamming of several doors were evident during standard operation. This defect inhibits the functionality of affected doors as well as creating potential for secondary defects to associated building elements, such as damage to the floor covering.

Where door binding/jamming appears to indicate major structural issues, a registered builder specialising in re-stumping should be appointed to provide an estimate on the cost of rectification.

For minor causes, a qualified carpenter or general handyperson should be appointed to perform minor rectification works at client discretion.

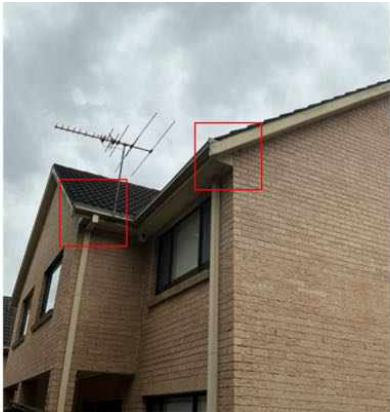
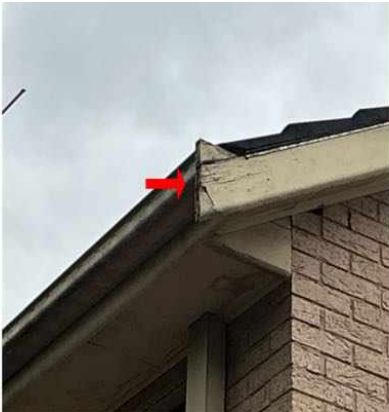
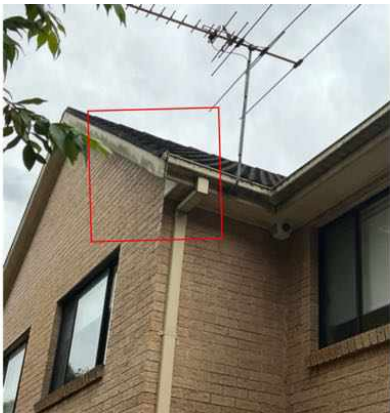
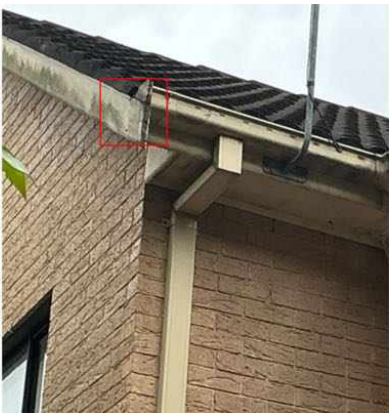
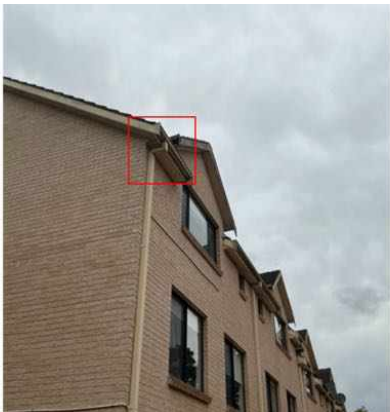
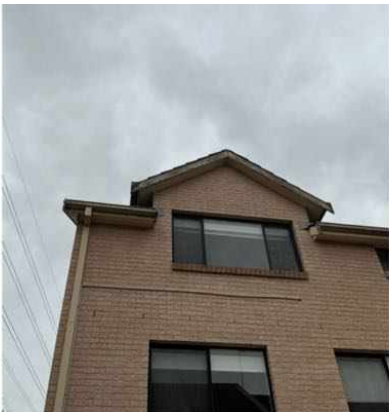
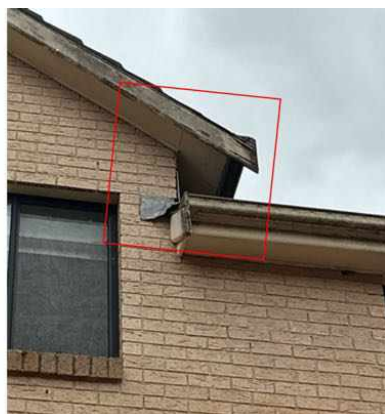
Finding 3.05

Building:	Main Building
Location:	All External Areas
Finding:	Fascias - Wood rot
Information:	Wood rot was found to be affecting fascias and barges in this area, evidenced by the presence of mould on the surface in some areas. Wood rot, also known as Fungal Decay, occurs when timbers and other cellulose building materials are exposed to damp conditions on an ongoing basis.

A qualified plumber may be appointed to assess the cause of excessive moisture and

to provide advice on any remedial works as required. A qualified carpenter or registered builder may also be required to replace affected building materials.

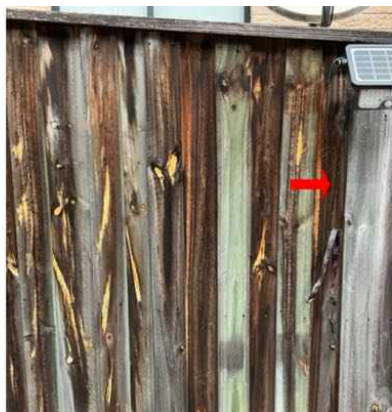
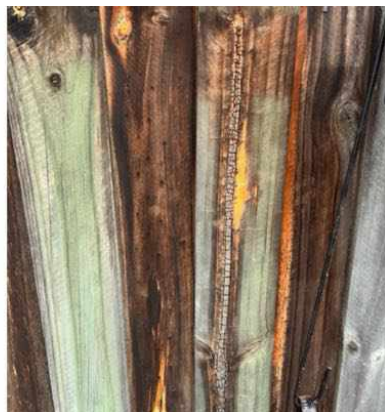
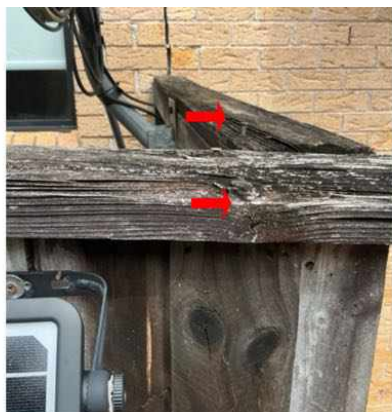
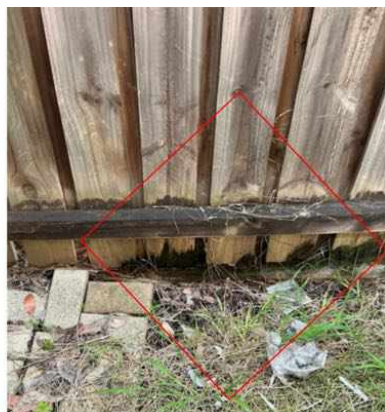
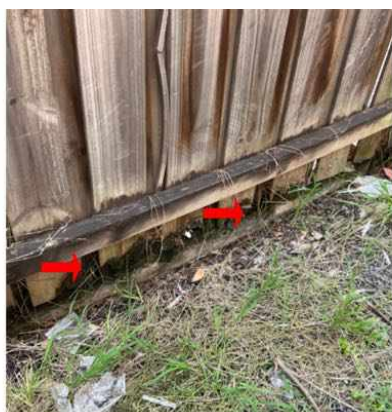
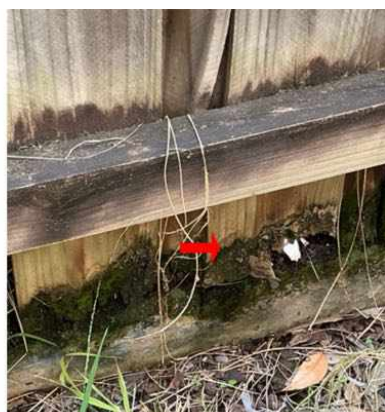
Building:	Main Building
Location:	All External Areas
Finding:	Wood rot to some areas
Information:	This building element shows evidence of wood rot. Wood rot, also known as Fungal Decay, occurs when timbers and other cellulose building materials are exposed to damp conditions on an ongoing basis. This could be the result of exposure to weathering over a prolonged period of time, or the attraction of excessive moisture from other abutting building materials. Contributing factors also include poor air ventilation in the area.

Wood rot is often associated with general damp problems and is evidenced by a 'musty' smell or mould and mildew occurring on surfaces. If left unmanaged, damp conditions can lead to further health problems and the decay of timbers will continue.

Early intervention and regular maintenance, particularly of exterior timbers, will prolong the useful life of these building elements. Prior to any works being performed, the cause of the moisture that has created the visible wood rot should be identified and addressed in a suitable manner. Replacement of affected timbers may then be a necessary step in protecting surrounding building elements from such deterioration.

A qualified plumber may be appointed to assess the cause of excessive moisture and to provide advice on any remedial works as required. A qualified carpenter or registered builder may also be required to replace affected building materials.

Even though Liverpool termite activity was not visible. A further invasive inspection by a licensed termite technician its also highly recommended to eliminate possibility of potential termite activity.

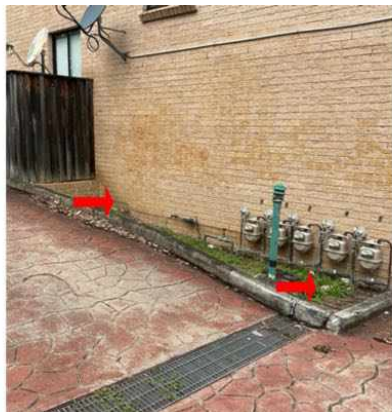
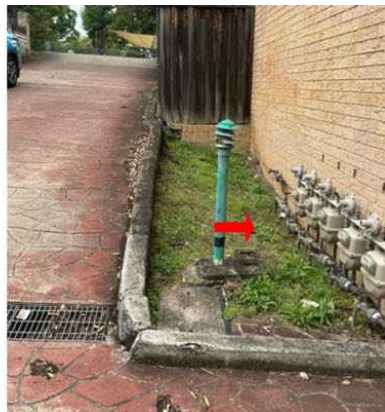
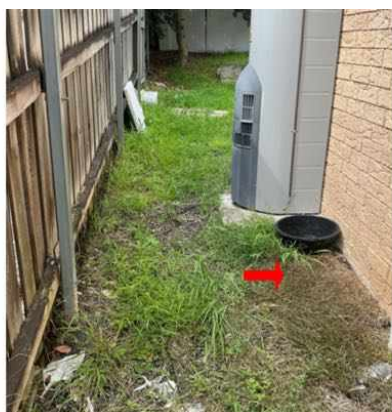
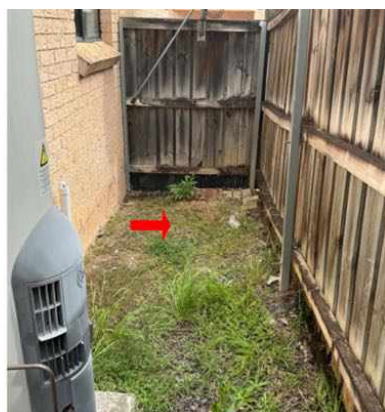
Finding 3.07

Building:	Main Building
Location:	All External Areas
Finding:	Site drainage - Inadequate
Information:	The site drainage in this area was found to be inadequate at the time of inspection, creating potential for subsequent water damage to associated building elements.

It is important that water does not lie against the base of walls; surrounding paths and ground levels should be sloped to drain water away from walls. Downpipes should not disgorge stormwater onto lower walls or plinths. Stormwater should be carried away by large, regularly cleaned drains. Ground levels may need to be lowered to expose a buried DPC.

Where site drainage is inadequate, installation of an Agricultural (Aggie) Drain may be required. A qualified plumber should be appointed to further inspect the property and perform any remedial works as necessary. Water damage and secondary defects are likely to occur if left unmanaged.

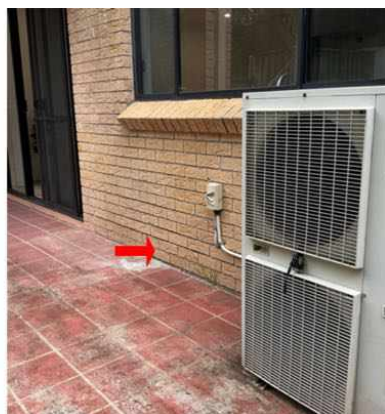
Finding 3.08

Finding: DPC & Weep Holes

Information: The ground level is nearly flushed or level with no visible step-down or separation from the weep holes or the damp-proof course (DPC). This presents a moisture risk, as AS 2870 and NCC Volume 2 Part 3.1.2 require ground levels or hard surfaces to be at least 75 mm below the DPC or the lowest course of brickwork with weep holes to prevent rising damp or lateral moisture ingress. Monitoring is recommended along with creating a 75 mm clearance or isolation gap along the wall line as required by NCC Vol 2 Part 3.1.2.3 and AS 2870 Clause 5.3.3. Monitor for any signs of rising damp or efflorescence.

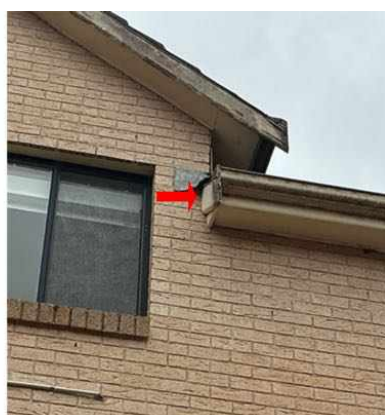
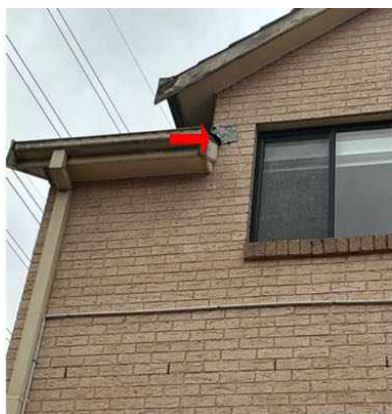
Finding 3.09

Building:	Main Building
Location:	Roof Exterior
Finding:	Roof plumbing - Loose flashing (Possible water ingress)
Information:	Metal and other material flashings are applied to seals and intersections between roof coverings and building elements. They are designed to aid in weatherproofing of roof joins, and require regular inspection and maintenance as they are more subject to rust-related deterioration.

The flashing in this section of the exterior roofing appears to have come loose from its original fixing. It is suspected that this minor defect has occurred as a result of general deterioration over time.

Re-fixing and potential replacement of certain areas of flashing is advised to promote adequate roof drainage and protection from water penetration. Failure to perform these works may result in water damage and accelerated deterioration of associated building elements.

A roofing contractor or roofing plumber should be appointed as soon as possible to restore the flashing to a fully operational state.

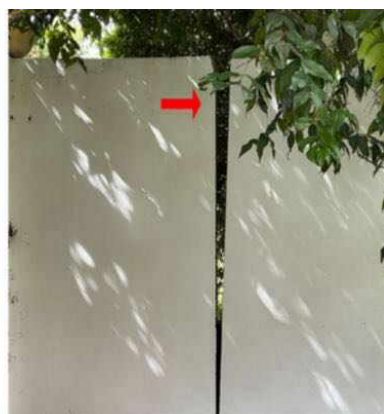
Finding 3.10

Building:	Main Building
Location:	All External Areas
Finding:	Boundary wall observation
Information:	A vertical separation gap is visible between adjoining external wall panels, with the joint appearing open and misaligned at the top.

The separation indicates movement or inadequate jointing between panels, which may be due to, Thermal expansion/contraction, Ground movement or footing settlement, Insufficient fixing or joint detailing. Open joints can allow Water ingress behind panels, Debris accumulation, Long-term deterioration of fixings or framing. Vegetation in close proximity may also contribute to movement and moisture retention at the base.

Further assessment by a licensed bricklayer or licensed builder is recommended.

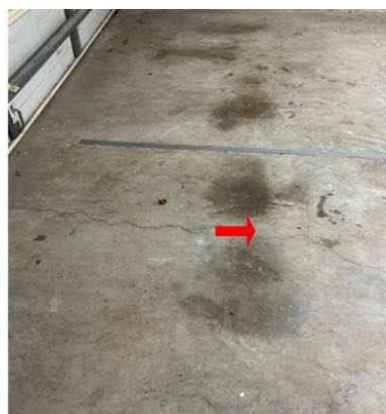
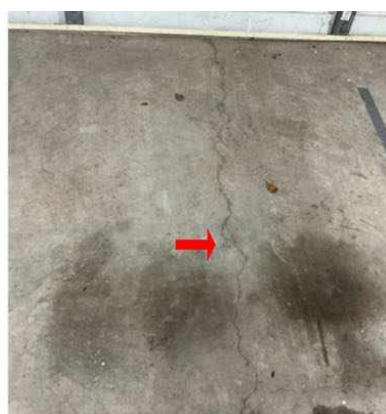
Finding 3.11

Building:	Main Building
Location:	All External Areas
Finding:	Cracking - External Concrete Paving Damage Category 2 - Distinct (less than 3mm)
Information:	Distinct cracks were identified in external concrete paving. Distinct cracks are generally found in older concrete paving, and may also present as a trip hazard as

General age and expected deterioration of the paved areas is a common cause of this type of cracking. However, expansion and contraction of the slab may also have occurred due to environmental factors. Such factors include variable moisture and weather conditions, the presence of trees and their roots having a settling or lifting affect on the soil, or the effect of load bearing, e.g. heavy vehicles over a sustained period of time.

Cracking to this degree may also be due to poor original installation of the concrete. Factors such as poor compaction of the sub surface and/or inadequate reinforcing of the slab may create cracking and other secondary defects.

Repairs are likely to be required to prevent further cracking and to reduce hazards associated with cracking, such as tripping. Monitoring of all cracking should be conducted frequently. Always contact a building inspector should cracks widen, lengthen, or become more numerous.

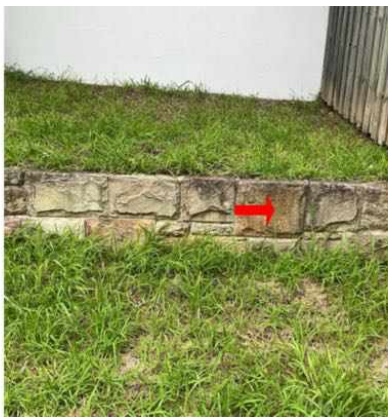
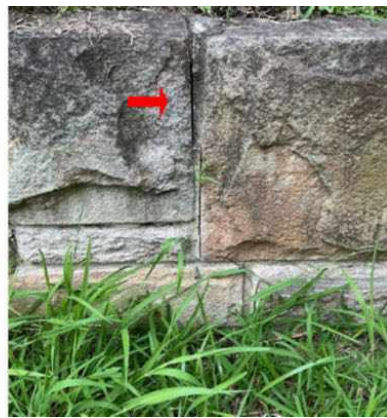
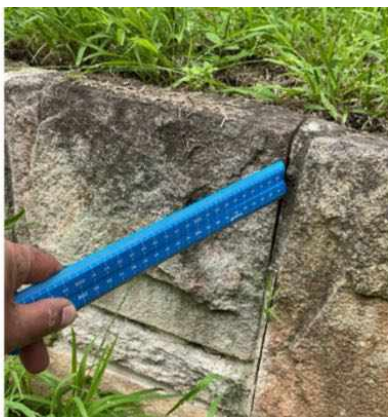
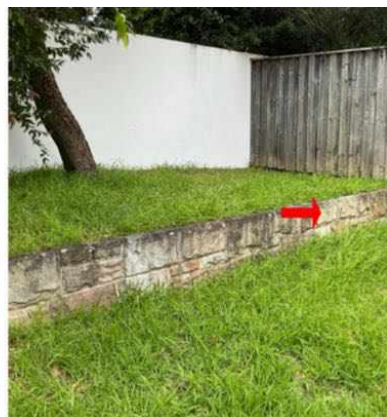
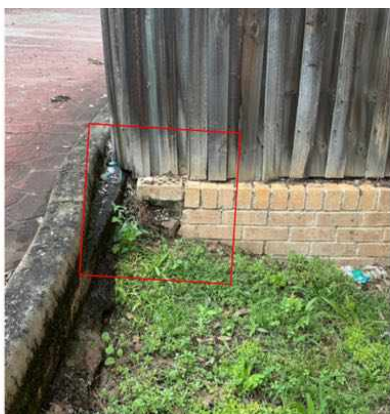
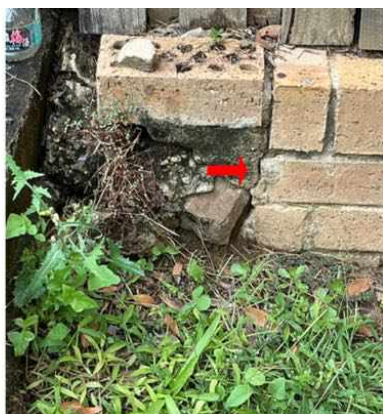
Finding 3.12

Building:	Main Building
Location:	All External Areas - Rear
Finding:	Retaining wall - Defective - cracking and possible displacement in exterior boundary wall

Information: The retaining wall in this area was found to be defective at the time of inspection. Generally, defective retaining walls are caused by poor original design or material use. However, deteriorated retaining walls may also be a result of substandard construction, poor site drainage or unmanaged stormwater flows.

If left unmanaged, the retaining wall may become a safety hazard if it continues to destabilise. Where retaining walls further rot and decay, an environment is created that is conducive to termite and pest infestation.

Significant repair and replacement should be expected. Where retaining walls are considered structural walls, a structural engineer / surveyor should be consulted regarding required remedial works. Otherwise, a landscaper or retaining wall installer may be appointed to repair or replace the wall, at the discretion of the client.

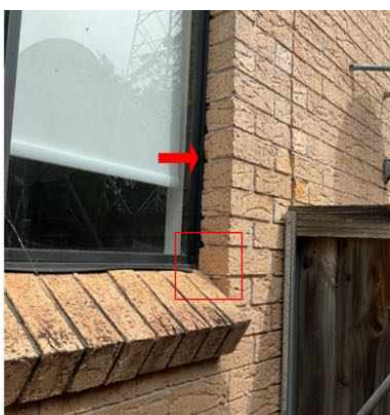
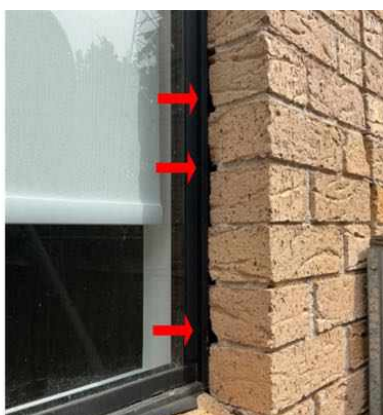
Finding 3.13

Building:	Main Building
Location:	All External Areas
Finding:	Gap Between Window Frame and Masonry to some areas
Information:	A visible gap is present between the external window frame and the adjacent masonry wall. This gap may allow water ingress, air infiltration, and potential pest entry if not adequately sealed. Over time, such exposure can contribute to frame deterioration, internal water damage, or reduced thermal performance. Sealing or filling the gap with a suitable weatherproof compound is recommended to maintain the integrity of the building envelope, in accordance with good building practice and AS 4349.1

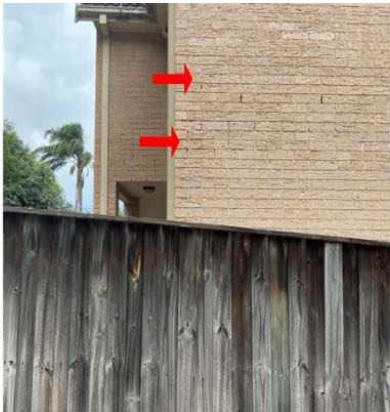
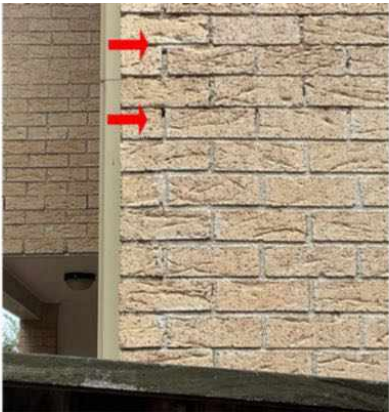
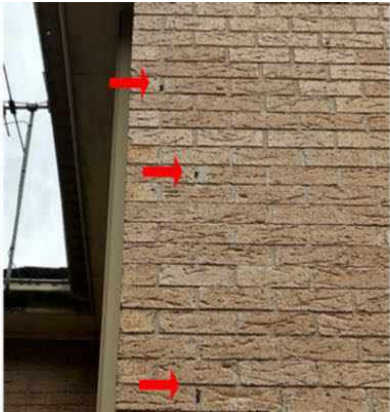
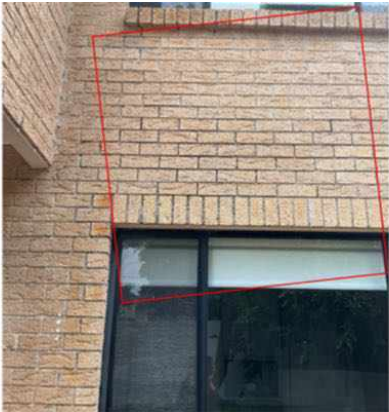
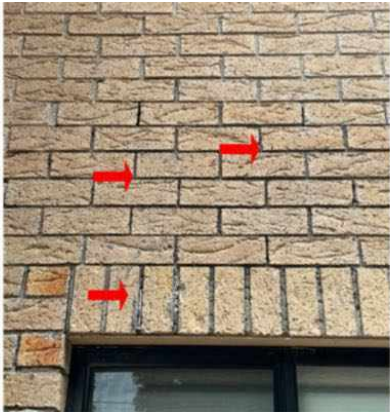
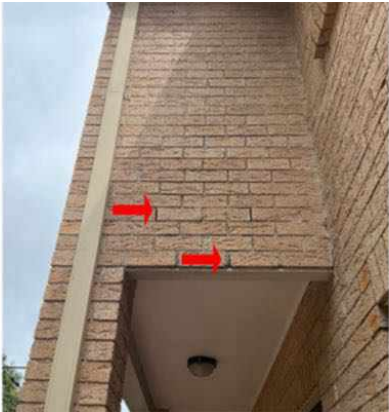
Finding 3.14

Building:	Main Building
Location:	All External Areas
Finding:	Brickwork - Deteriorated mortar to some areas
Information:	Mortar, or 'bedding', is the material which fills joints and intersections between bricks in masonry walls and structures. Sections of mortar in this brickwork were identified as having deteriorated, which is generally expected for a property of this age and condition.

Mortar may deteriorate as a result of age of building materials, minor movement of

bricks, or frequent exposure to weathering. Mortar should be replaced to ensure that bricks remain in their intended location and to prevent gaps, which would allow water or moisture ingress and secondary damage as a result.

Mortar deterioration can be addressed by a bricklayer where areas of deterioration are localised and easily accessible. Alternatively, appointment of a registered builder is advised, to repoint large areas of decaying mortar. Where secondary structural defects have become evident, consultation with a structural engineer may be required.

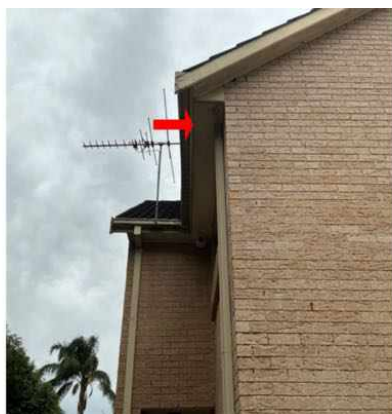
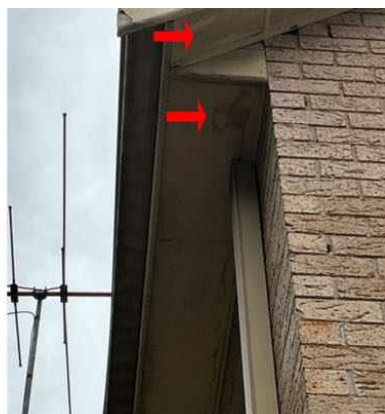
Finding 3.15

Location: All External Areas
 Finding: Water staining - Eaves
 Information: Water staining was evident in this area at the time of inspection. Water staining indicates that surfaces have been exposed to excessive moisture over time. The minerals and other elements in the water lead to staining, which may graduate to corrosion and deterioration if left unmanaged.

While mostly an appearance defect, water staining can be indicative of more serious defects, which may be currently concealed by other building elements.

Where water staining is active, a licensed plumber must be consulted to identify the cause of the staining and to provide advice on any reparation works that may be required. Replacement of any broken or damaged structures is advised.

Conversely, where water staining is old and inactive, affected building materials may be repaired or replaced at client discretion. A qualified carpenter or registered builder may be appointed to perform these works.

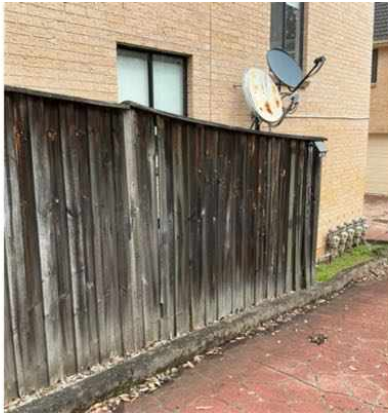
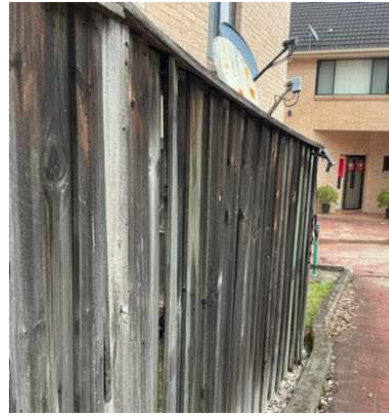
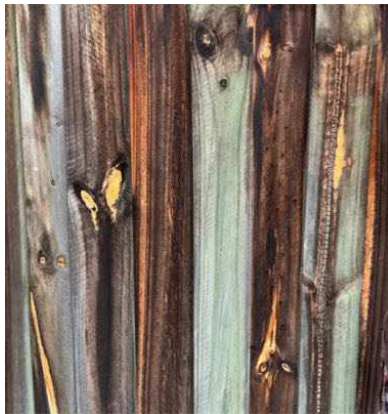
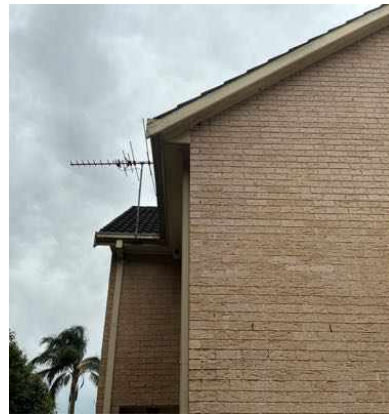
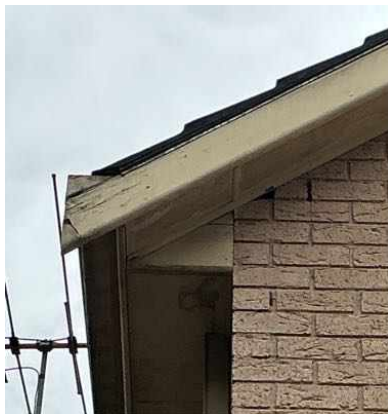
Finding 3.16

Building: Main Building
 Location: All External Areas
 Finding: Building element - Damaged - Fence damaged , Hole not sealed left side near roof (moisture ingress possible) ,
 Information: Breakage occurs generally when the building materials have either aged and decayed, or as a result of damage (accidental or deliberate).

Repair and/or replacement of broken elements is advised to ensure that additional secondary defects do not arise as a consequence. Such works are necessary, as all building elements play a key role in the operation and function of the overall structure and its performance.

A relevant tradesperson should be appointed to repair or replace the affected building element prior to any subsequent damage being caused.

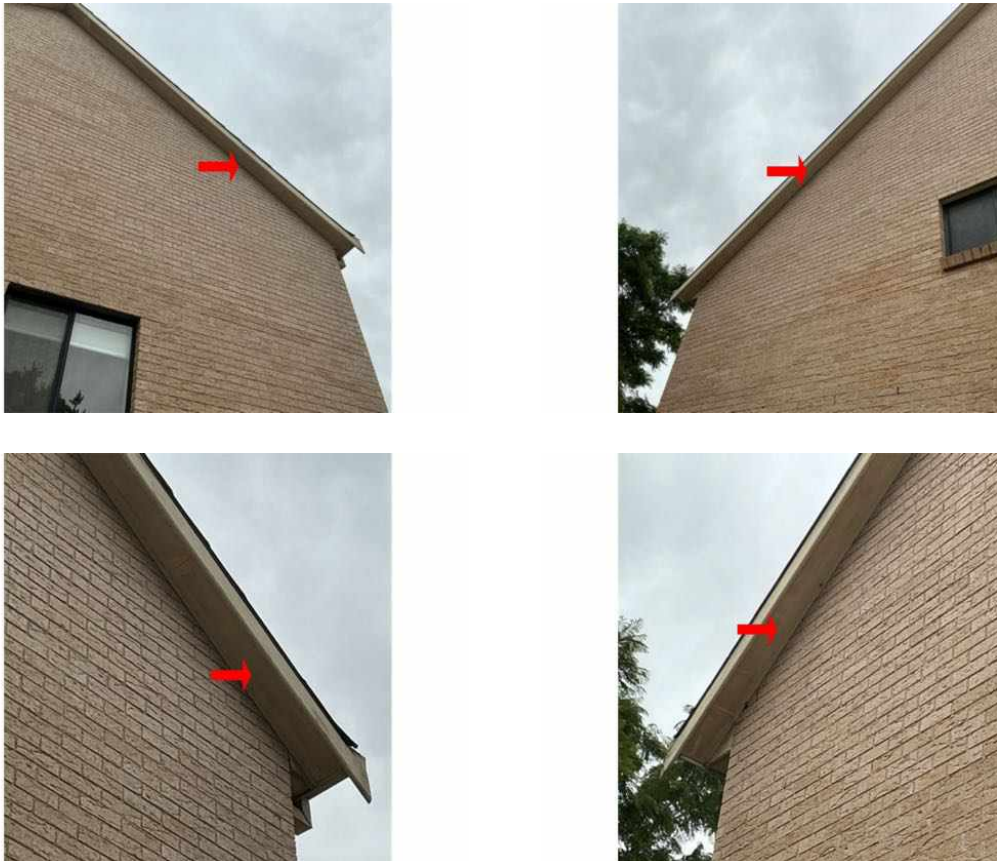
Finding 3.17

Building:	Main Building
Location:	All External Areas
Finding:	External painting deteriorated - Eaves
Information:	Whilst incomplete or missing paint finish is generally an appearance defect, it can also lead to the development of secondary building defects over time. Incomplete areas of paint finish expose the area to moisture, potentially accelerating the deterioration of underlying building materials.

Degraded paint finishes should be sanded back, filled, leveled and painted, as applicable. Where inadequate or missing paint protection has led to the deterioration

of the associated building element, repair and/or replacement of this building element may be required.

A painting contractor should be appointed as soon as possible to perform necessary works to aid the appearance of the affected area and to ensure the area is protected against further deterioration. Alternatively, the homeowner following manufacturer instructions may perform these works.

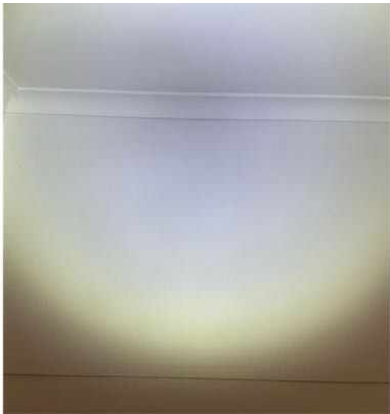
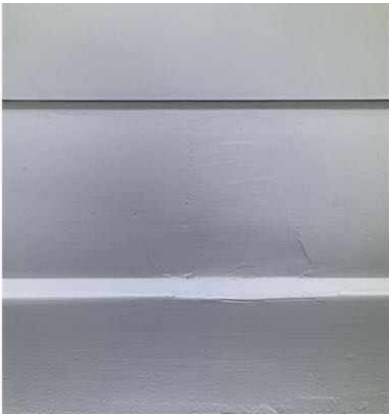
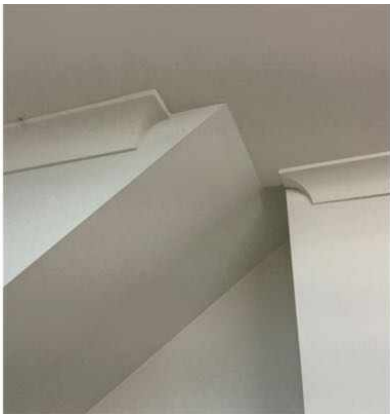
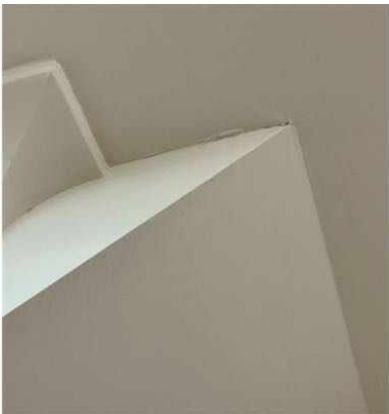
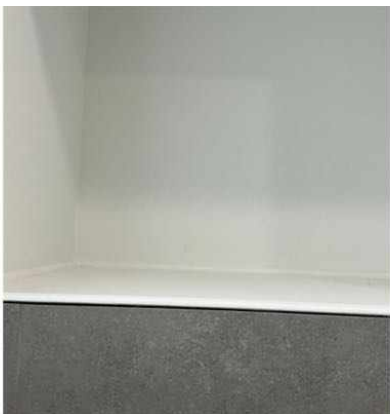
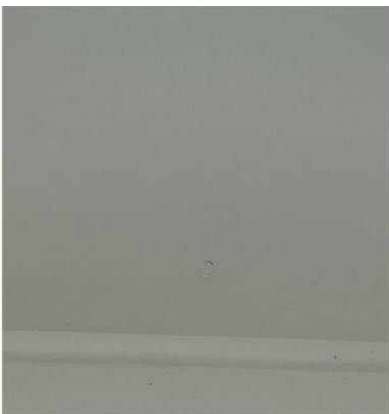
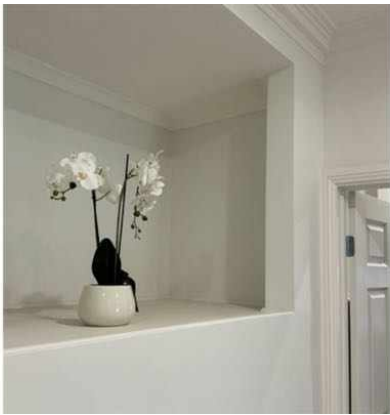
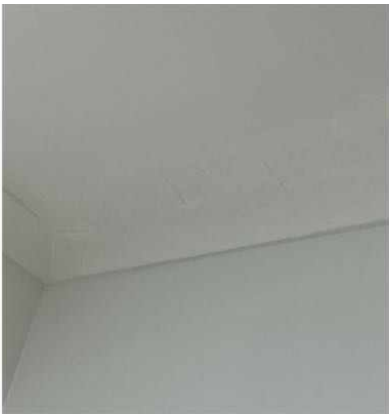
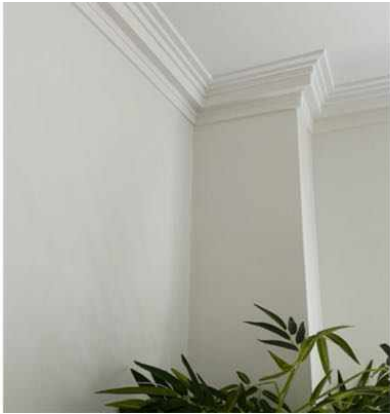
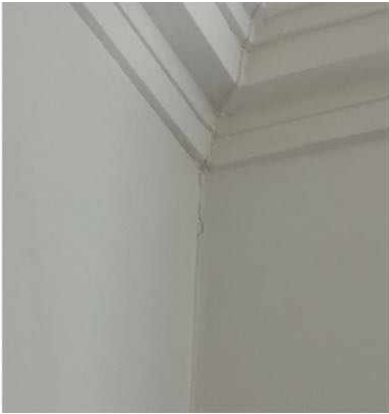
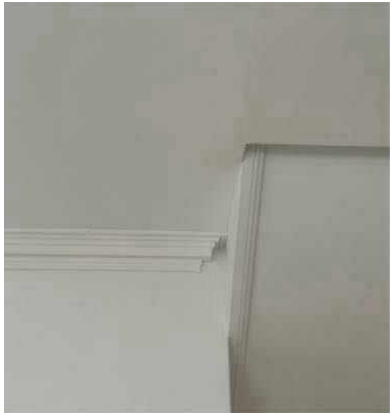
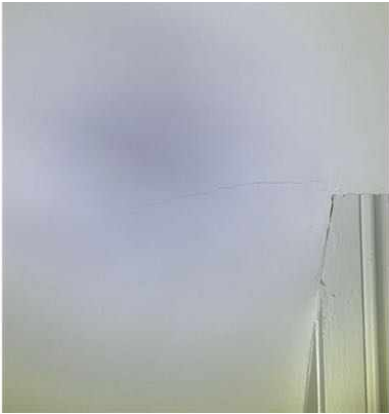
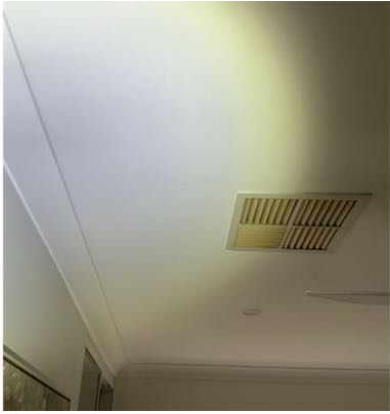
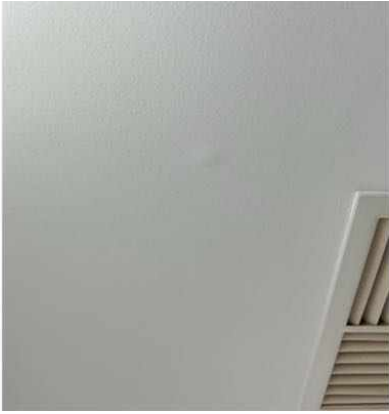
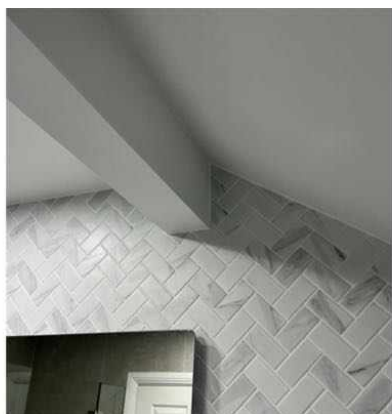
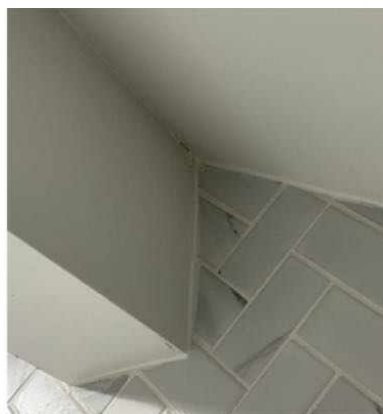
Building:	Main Building
Location:	All Internal Areas
Finding:	Paint Finish & Hairline Cracking - To some areas
Information:	The paint finish in this area was identified as being incomplete at the time of inspection including some hairline minor cracking.

Whilst incomplete or missing paint and minor cracking and imperfections in finish is generally an appearance defect, it can also lead to the development of secondary building defects over time. Incomplete areas of paint finish expose the area to moisture, potentially accelerating the deterioration of underlying building materials.

Incomplete paint finishes should be sanded back, filled, leveled and painted, as applicable. Where inadequate or missing paint protection has led to the deterioration of the associated building element, repair and/or replacement of this building element

may be required.

A painting contractor should be appointed as soon as possible to perform necessary works to aid the appearance of the affected area and to ensure the area is protected against further deterioration. Alternatively, the homeowner following manufacturer instructions may perform these works.

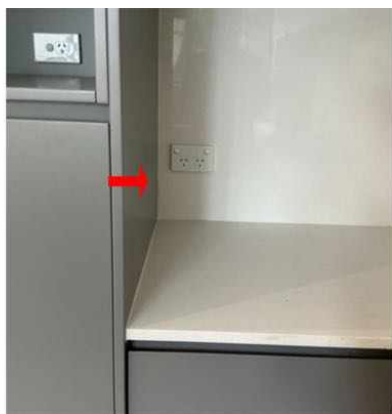
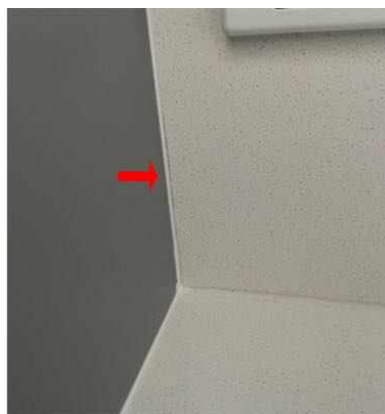
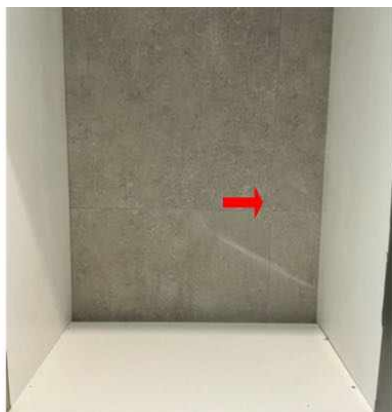
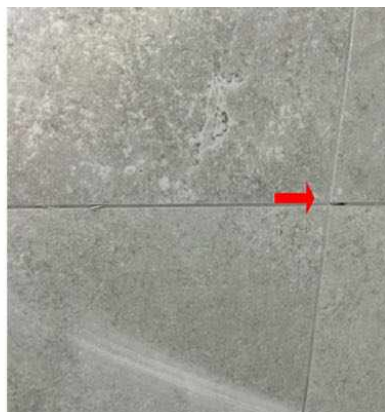
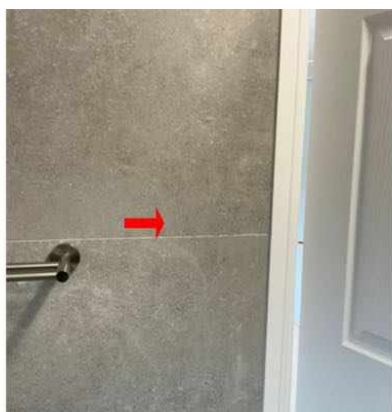
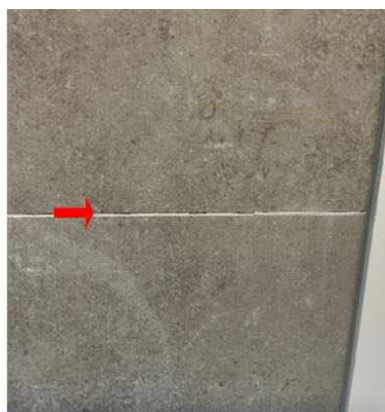
Finding 3.19

Building:	Main Building
Location:	All Internal Areas
Finding:	Sealant and grouting - Missing or degraded to some areas
Information:	It was noted on inspection that sealant or grout is degraded. There is also evidence of poor workmanship and excessive use of sealant. Silicone should never be used as a first line of defence against waterproofing. Further inspection by a licensed waterproofing contractor is highly recommended.

Different materials and floor areas move at different rates, generally causing cracking to grout or sealant at this point. A flexible sealant is required to allow for expected expansion and contraction, while keeping the joint water tight and protective of all associated building materials.

There appears to be excessive mould to the sealant and grout which will likely require scraping out and replacement.

Flexible and mould resistant materials should be applied to affected areas to prevent any subsequent water damage that is likely to occur. Regular maintenance and replacement of damage or missing or damaged sealant and grout is highly recommended to the wet areas, as this is a regular wear and tear defect. Sealant and grouting in areas that come into regular contact with water should be maintained for the long term care of your property.

A sealant specialist or tiling contractor should be appointed to complete these works as soon as possible.

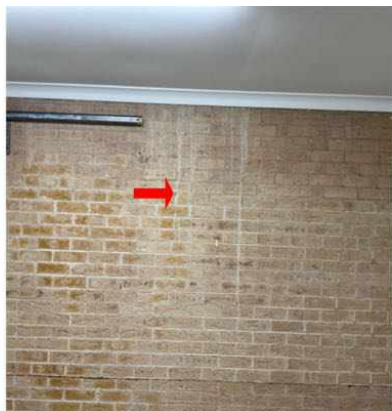
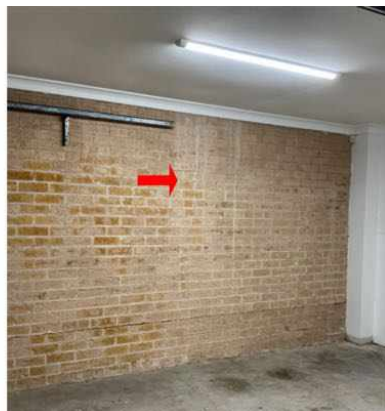
Finding 3.20

Building: Main Building
 Location: Garage
 Finding: Walls - Water stained
 Information:

Water staining to sections of the walls in this area was evident at the time of inspection. Water staining indicates that surfaces have been exposed to excessive moisture over time. The minerals and other elements in the water lead to staining, which may graduate to corrosion and deterioration if left unmanaged.

While mostly an appearance defect, water staining can be indicative of more serious defects, which may be currently concealed by wall linings.

Where water staining is active, a licensed plumber must be consulted to identify the cause of the staining and to provide advice on any reparation works that may be required. Replacement of any broken or damaged structures is advised.

Conversely, where water staining is old and inactive, affected building materials may be repaired or replaced at client discretion.
