Building and Timber Pest Inspection Report

Inspection Date: Fri, 27 Mar 2026

Property Address: 1/205 N Rocks Rd, North Rocks NSW 2151,
Australia

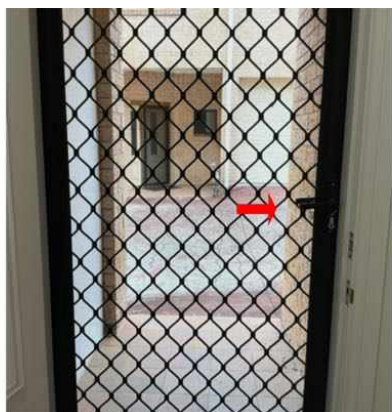
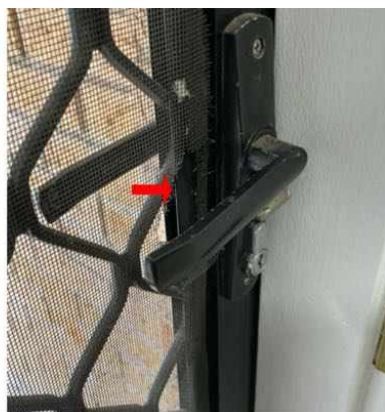
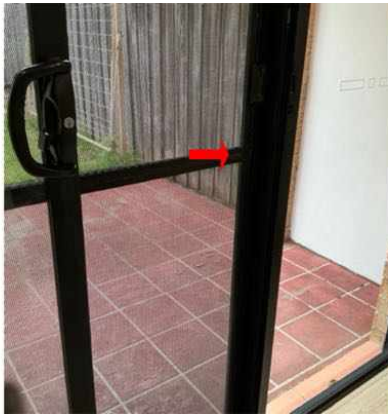
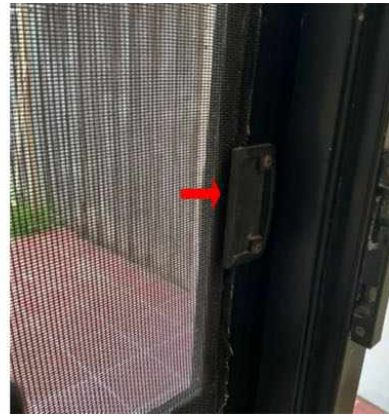
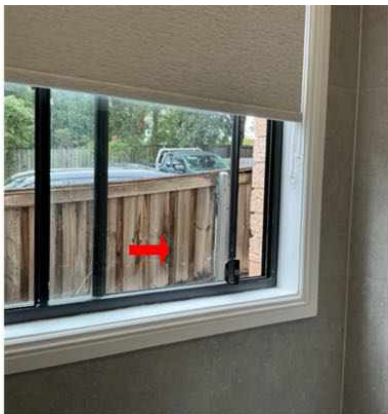
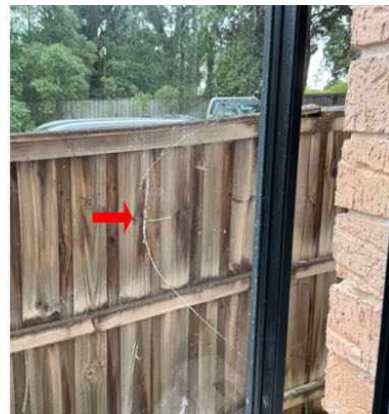
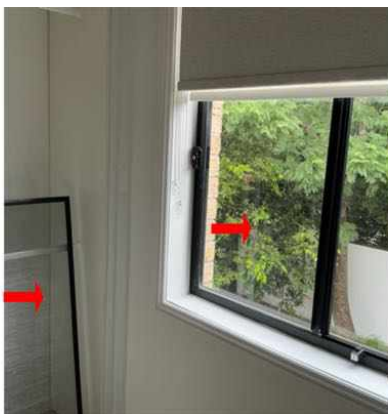
Finding 3.21

Building: Main Building
 Location: All Internal Areas
 Finding: Building element - Damaged - Front/rear flyscreen damage , crack in window laundry , flyscreen missing bedroom
 Information: Breakage occurs generally when the building materials have either aged and decayed, or as a result of damage (accidental or deliberate).

Repair and/or replacement of broken elements is advised to ensure that additional secondary defects do not arise as a consequence. Such works are necessary, as all building elements play a key role in the operation and function of the overall structure and its performance.

A relevant tradesperson should be appointed to repair or replace the affected building element prior to any subsequent damage being caused.

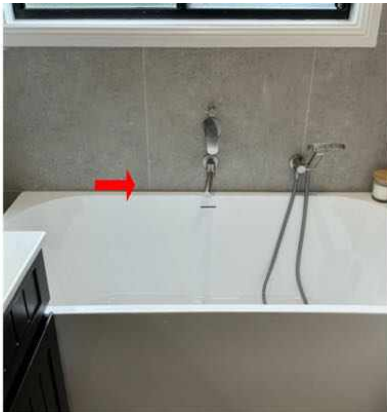
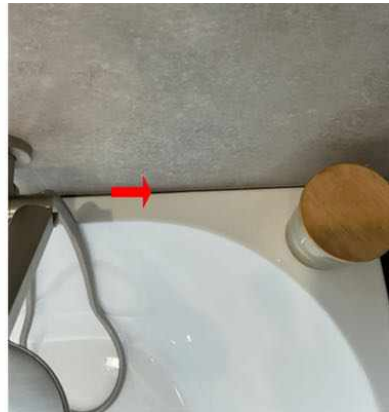
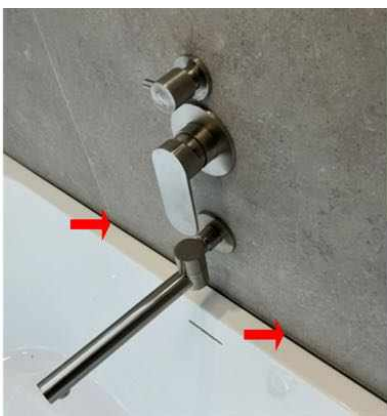
Finding 3.22

Building:	Main Building
Location:	Bathroom
Finding:	Incomplete or substandard works - Unsealed Junction Between Bathtub and Wall
Information:	A gap was observed between the bathtub edge and adjacent wall tiling, with no sealant present.

Where bathtubs are installed adjacent to walls, junctions should be adequately sealed to prevent water ingress. The current unsealed gap may allow water to penetrate behind the fixture, leading to moisture-related deterioration and potential hygiene concerns.

It is recommended that the junction between the bathtub and wall be sealed with an appropriate waterproof sealant to prevent moisture ingress and improve durability.

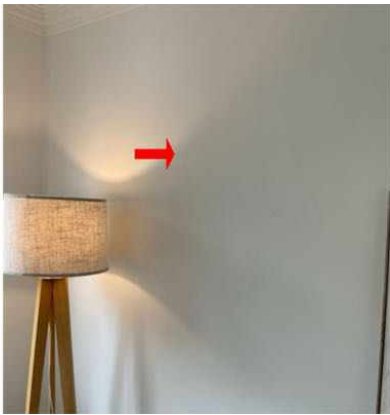
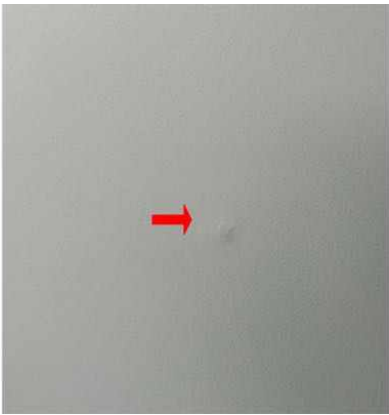
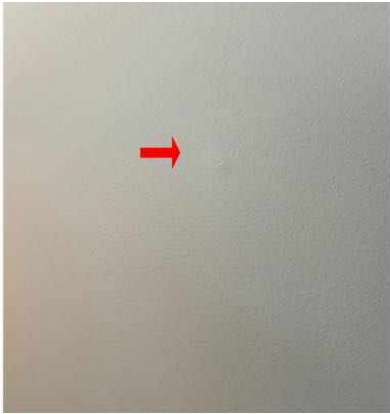
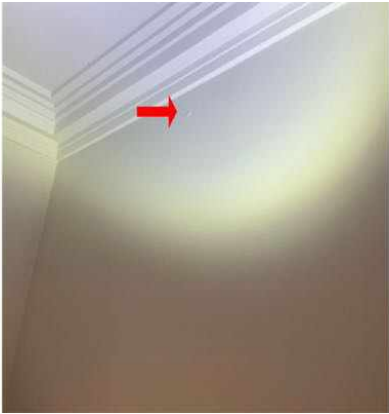
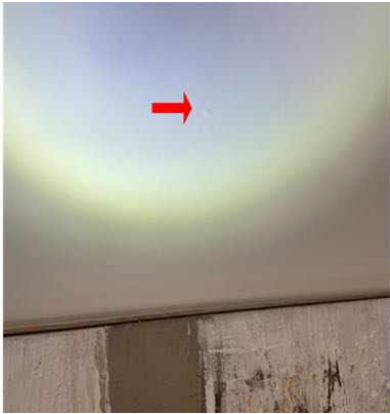
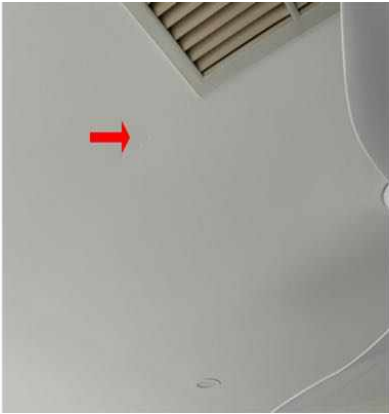
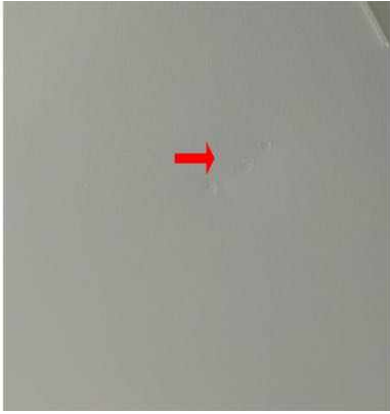
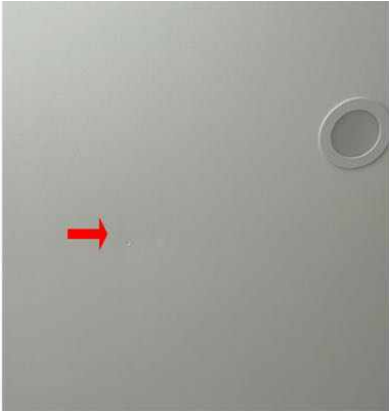
If left unmanaged, the ceiling sheets may become loose and unstable, increasing the rate of deterioration of the internal ceiling and creating potential for the development of secondary defects.

Re-fastening of popped nails will help to maintain the stability of the internal ceiling and associated building elements. Such minor works will also help to improve the appearance of the affected area and secure the ceiling sheets, so as to prevent the onset of ceiling sagging. These works should be performed by a qualified carpenter or plasterer at client discretion.

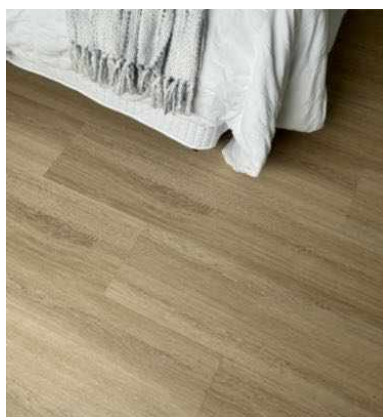
Finding 3.25

Building:	Main Building
Location:	All Internal Areas
Finding:	Bouncy/uneven Floor to some areas
Information:	floor flexing/minor unevenness was noted in isolated areas during normal walking conditions. This condition is typical of timber-framed floor systems and may be attributed to minor deflection in floor joists, insufficient subfloor support, or age-related settlement of structural elements.

No visible signs of structural damage or distress were observed at the time of inspection. If the deflection worsens or causes concern, further assessment by a licensed builder or carpenter is recommended. Remedial work may include installation of additional support noggins, blocking, or subfloor stiffening to reduce bounce and improve floor rigidity.

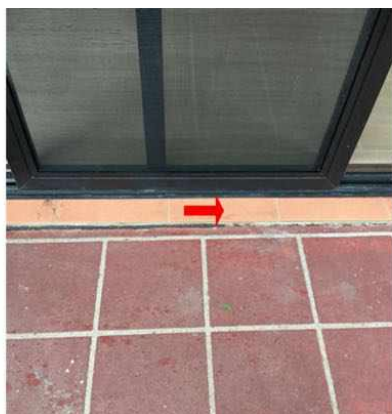
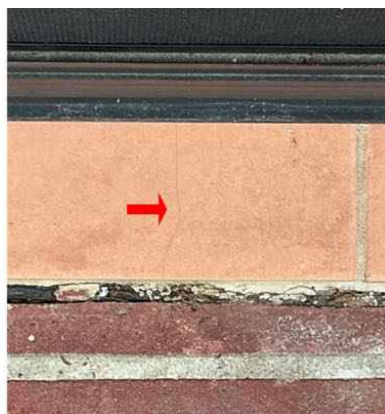
Finding 3.26

Building:	Main Building
Location:	All Internal Areas
Finding:	Tiles - Cracked or damaged
Information:	Cracking was evident to the tiling in this area at the time of inspection. While the cracking appears to be minor, this area is frequently exposed to water, allowing potential for water penetration into adjoining sections of walls or flooring.

If left unmanaged, water penetration to these areas may lead to subsequent water damage, which is likely necessitate repair work to affected building elements.

A tiling contractor should be appointed to ensure that no further water damage occurs. The re-application of silicone and grouting throughout remaining tile work is also advised, to further protect the area against water penetration.

Where water penetration has led to water damage, appointment of a relevant tradesperson may be required to repair damaged building elements.

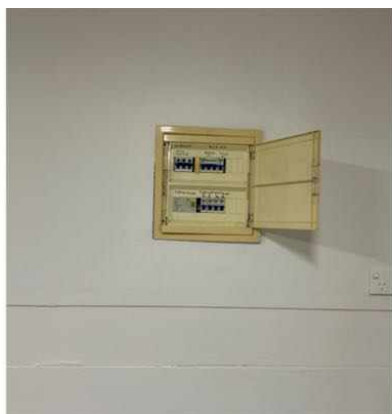
Building:	Main Building
Location:	All External Areas
Finding:	Termite Management System - no evidence of a chemical installation
Information:	The application of a post-construction chemical termite barrier is highly recommended for all properties, particularly if live termite activity has been found on the site previously. Such barriers are highly effective in preventing termite attack on any timber building elements throughout the property.

A durable notice should be placed in the switchboard unit to indicate current termite barriers. At the time of inspection, it appeared as though no termite management system has been installed, with no evidence to suggest preventative works taking place.

The client may consider gaining further advice from a pest controller as to the costs and procedures involved with this application. It is recommended that obtaining such advice be a short-term priority.

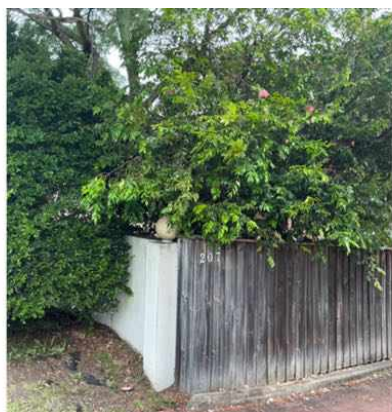
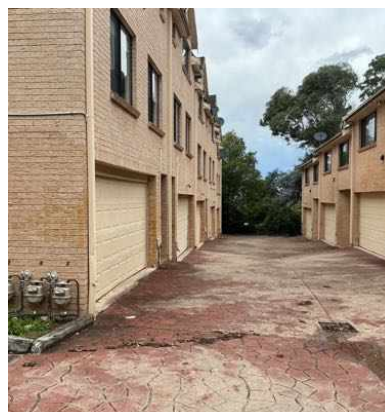
Finding 6.02

Building:	Main Building
Location:	All External Areas
Finding:	Trees within 50m
Information:	Trees within 50m of the property can be conducive to termite activity. It is recommended an invasive inspection of all trees within 50m to the property be carried out by a qualified pest control expert.

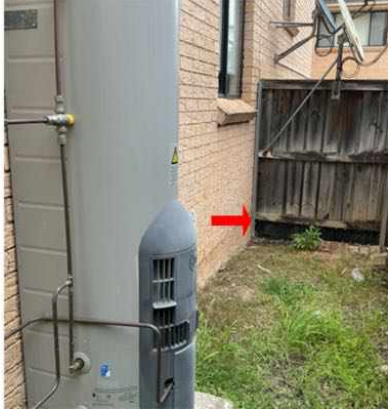
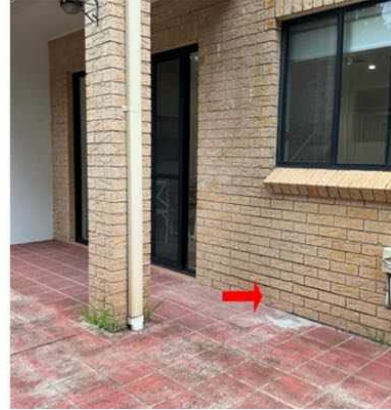
Finding 6.03

Building:	Main Building
Location:	All External Areas
Finding:	Slab Edge - Exposure
Information:	An inspection zone of at least 75mm in relation to the exposed slab edge, between the bottom brick and the perimeter pavement, is required. This inspection zone should be maintained in order to force termites into the open where they can be detected more readily during regular inspections. The slab edge should not be concealed by anything that may prevent inspection of the area, including render, landscaping, soil, turf, paving, concrete cladding or other structures.

an architect or builder may be required to consult the construction plans.

Where the slab edge cannot be properly inspected, it is highly recommended that termite or timber pest inspections be carried out every 6-12 months to aid protection of the property against infestation.

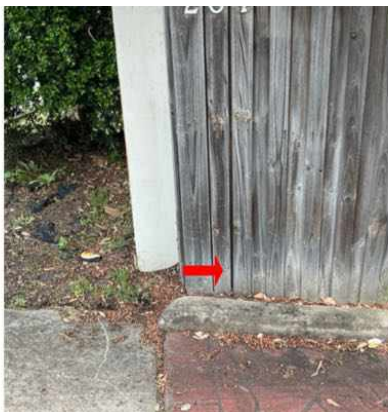
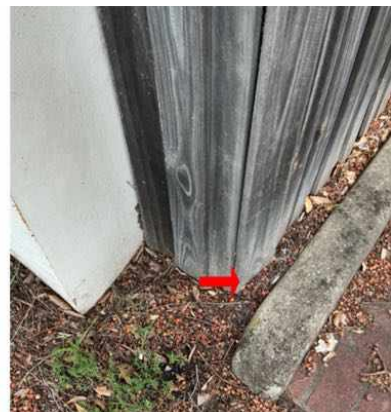
Finding 6.04

Building:	Main Building
Location:	All External Areas
Finding:	In ground contact - Timber
Information:	Any timbers in direct ground contact provide opportunity for concealed termite entry and are likely to be subject to premature rot and decay as the soil retains moisture or damp conditions against the timbers.

Remove untreated timber that is in direct contact with external grounds. Consider replacement with more durable materials i.e. treated timber or non timber elements. Frequent pest inspections are advised to readily identify any termite activity in these areas.

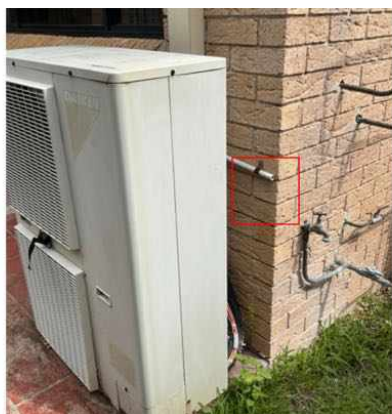
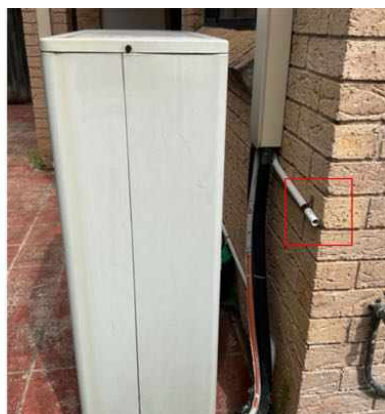
Building: Main Building
 Location: All External Areas
 Finding: Air conditioner - Disconnected overflow
 Information: The Air Conditioner (A/C) overflow was found to be disconnected from storm water drainage and is creating excessive moisture in the surrounding area.

Such leaking creates an environment which is conducive to an array of defects, including water damage to associated building elements and the attraction of termite or timber pest infestation.

It is highly recommended that a licensed plumber be appointed to connect the A/C overflow in order to prevent such an environment from being created. These minor works should be carried out as soon as possible.

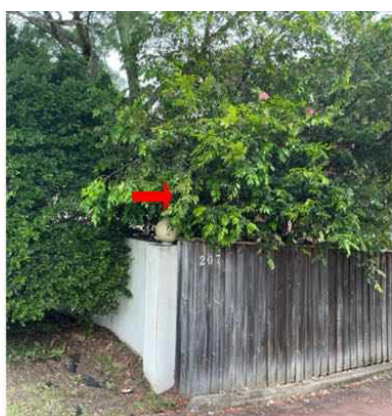
Finding 6.07

Building:	Main Building
Location:	All External Areas
Finding:	Bridging - Vegetation
Information:	Where vegetation obstructs inspection of building elements, also known as bridging as it provides a bridging point for the access of termites, full inspection can not be achieved. Consequently moisture or dampness may be present and the areas becomes conducive to termite activity. Plants against or very close to buildings provide cover, shade and can provide an environment that is attractive to termite infestation.

The removal and replanting of species that do not provide "cover" or cutting back of existing vegetation will assist greatly in preventing Bridging from occurring.

The removal of any such materials that may be conducive to termite activity should be carried out as soon as possible and arrange re inspection to minimize the risk of termite attack.

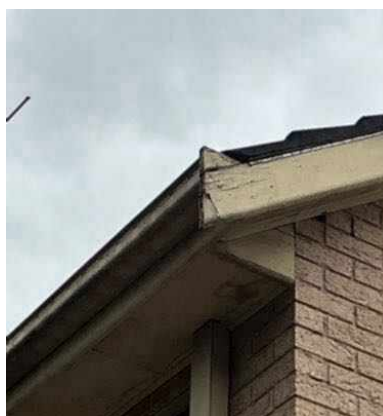
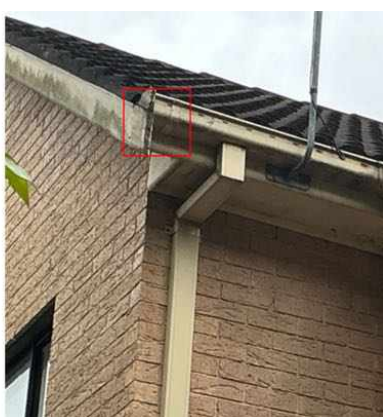
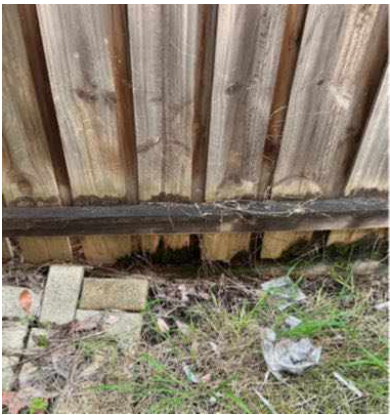
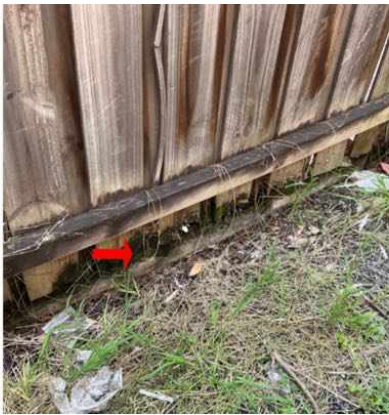
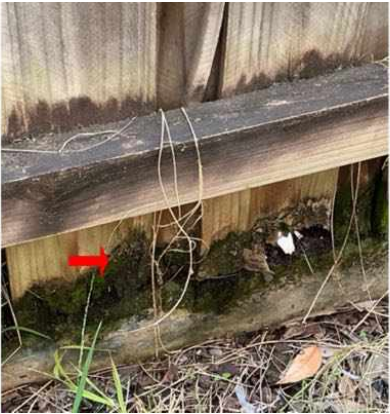
Finding 7.01

Building:	Main Building
Location:	All External Areas - Fascia , fence
Finding:	Fungal decay - present to some areas
Information:	Fungal decay also known as wood decay or wood rot generally refers to the deterioration of timber elements when in contact with excessive levels of moisture for a prolonged period of time.

The development of fungal decay is accelerated by temperatures in the range of 5degreeC to 40degreeC as well as the presence of oxygen. Generally fungal decay develops on timber elements that are in use in an external environment which are exposed to rain penetration.

In this case although the affected timber element is in a decaying state the extent of any visible damage appears to be localised to a specific area and is yet to spread to other parts of the building element or affect adjoining structures. The fungal decay is therefore likely to be of a relatively superficial nature with minimal impact on the structural integrity or tensile strength of the timber element.

A further invasive inspection by a licensed timber pest technician is highly recommended to check for concealed activity.

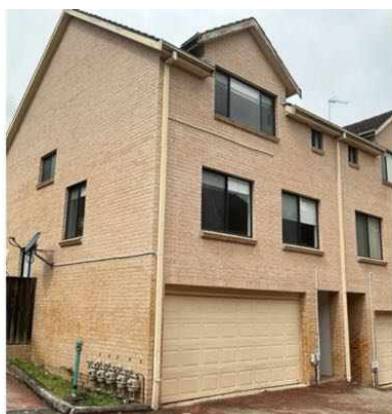
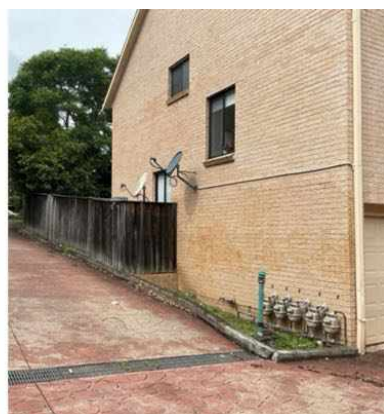
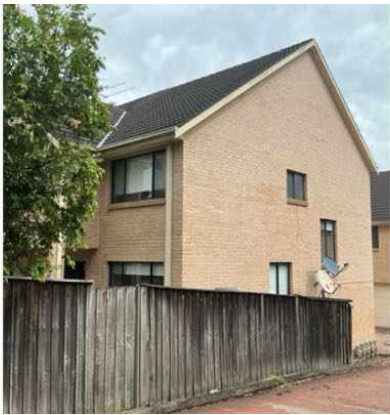
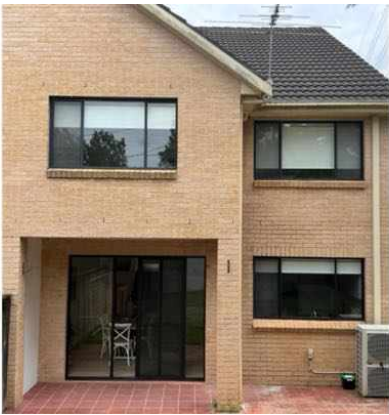
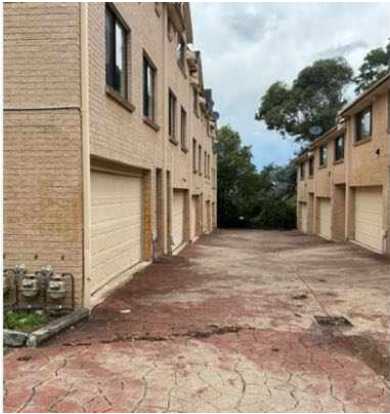
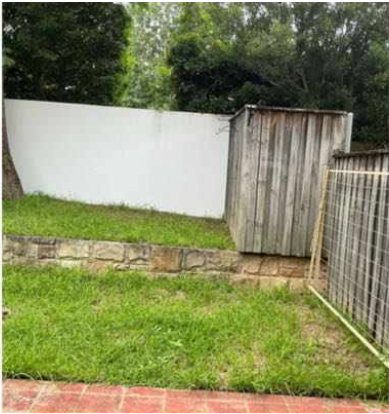
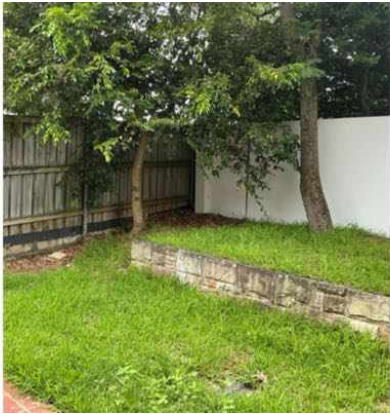
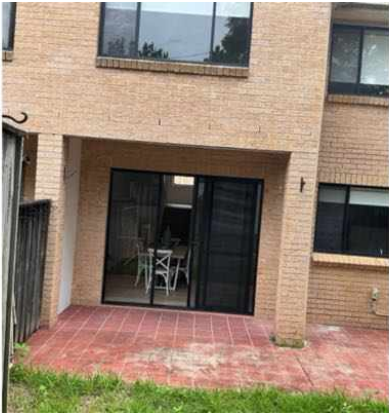
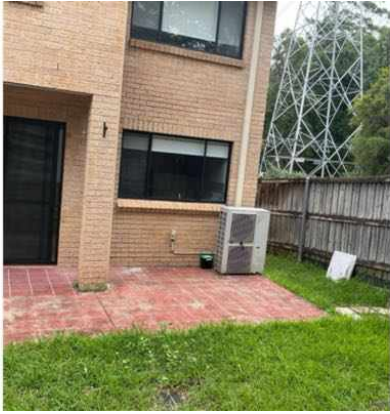
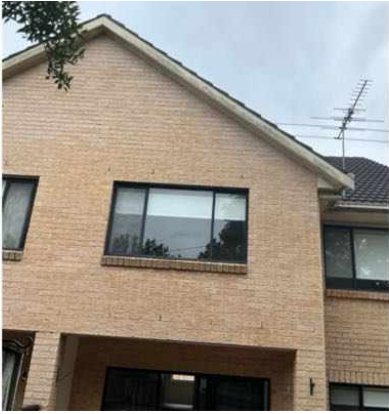
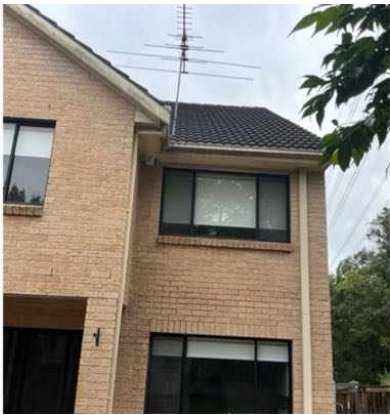
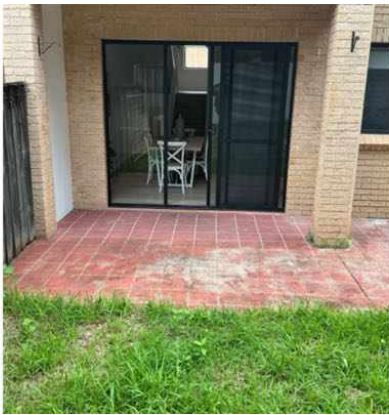
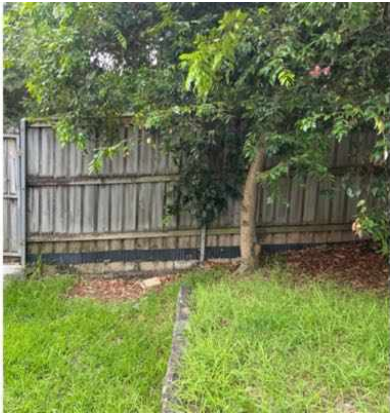
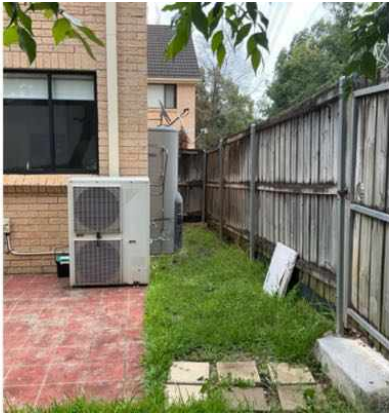
Building:	Main Building
Location:	All External Areas
Finding:	Additional Photos - Obstructions and Limitations
Information:	These photographs are an indication of the obstructions and limitations which impeded full inspection of the property at the time of inspection. These obstructions can hide an array of defects and should be removed to allow full inspection to be carried out. A re-inspection is recommended once the areas are made accessible.

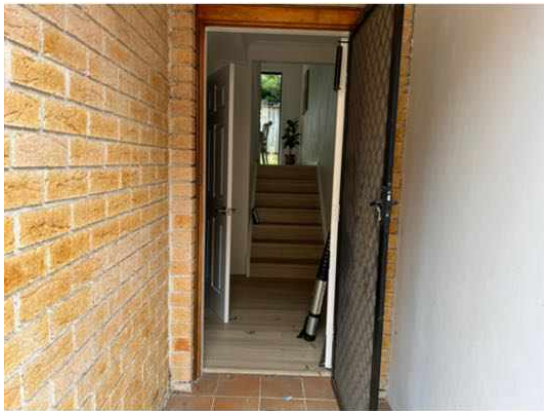
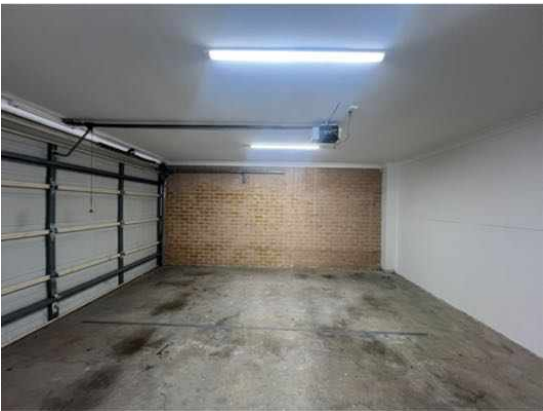
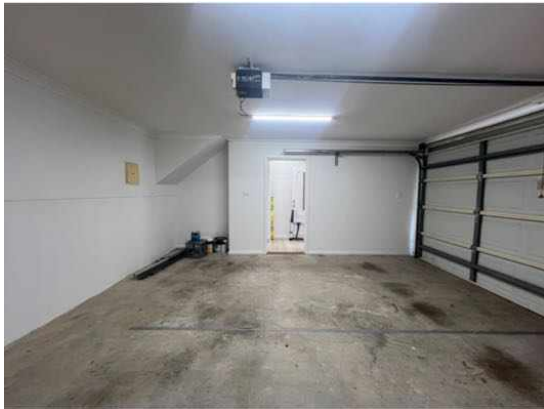
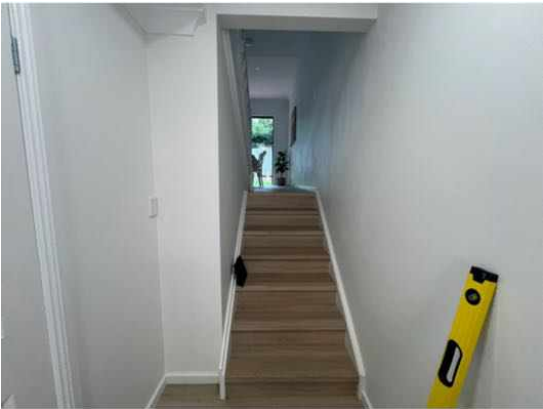
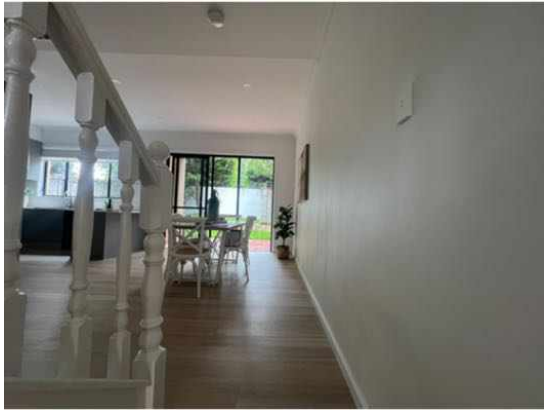
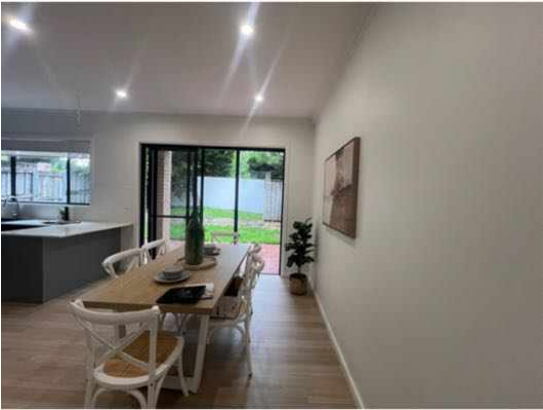
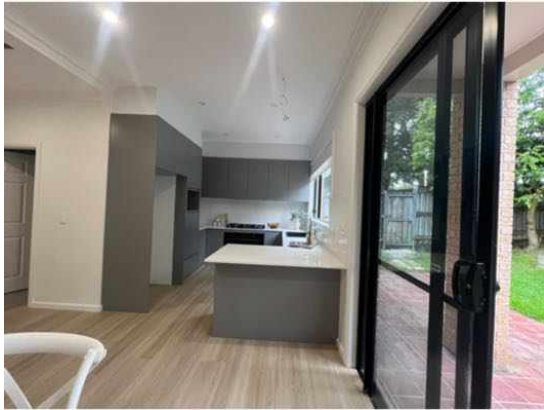
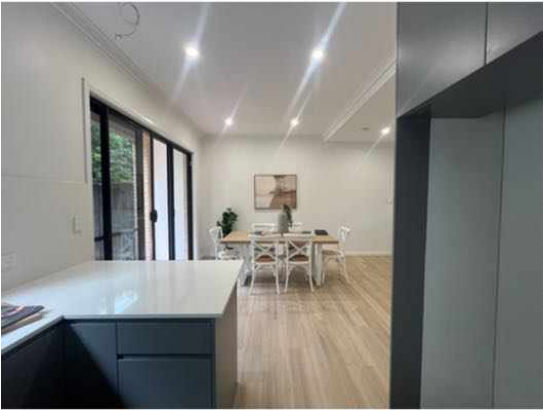
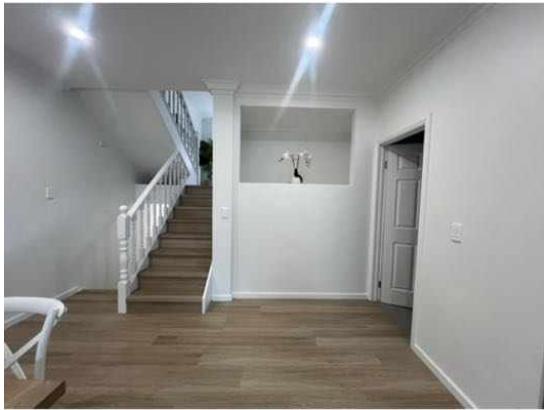
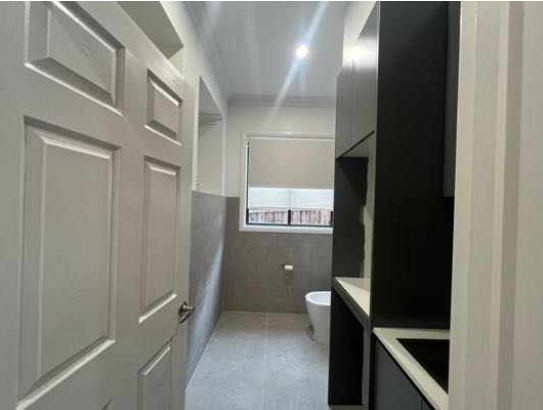
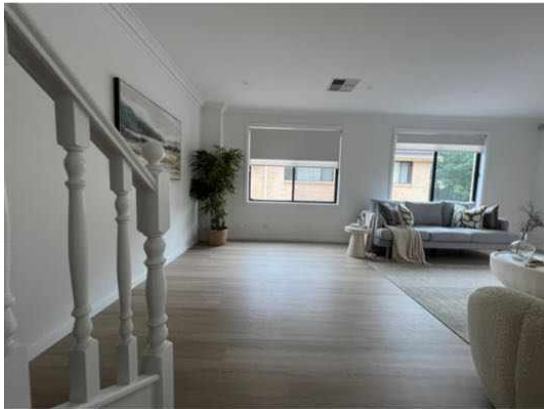
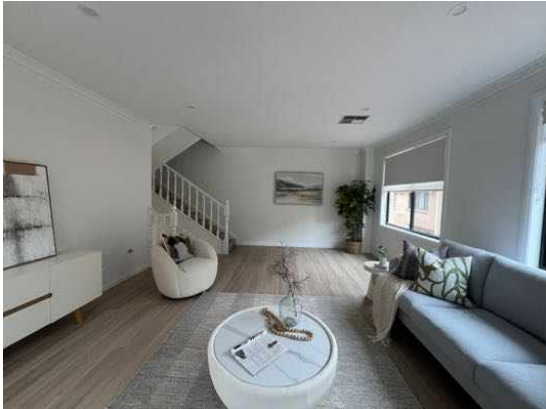
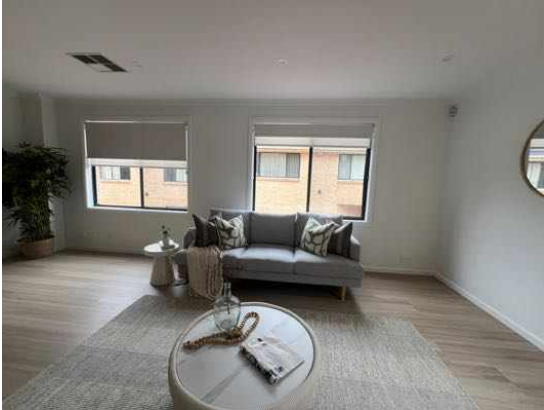
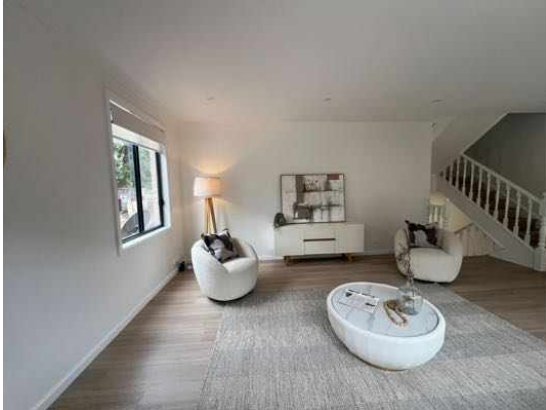
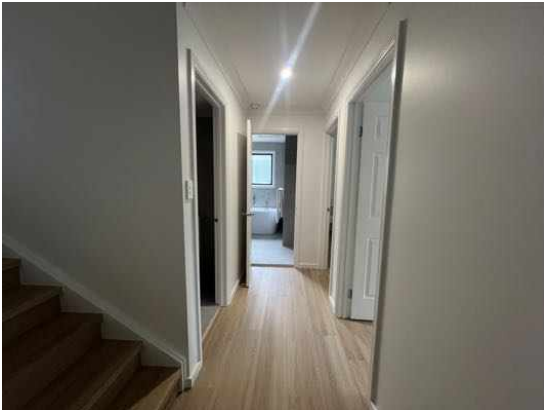
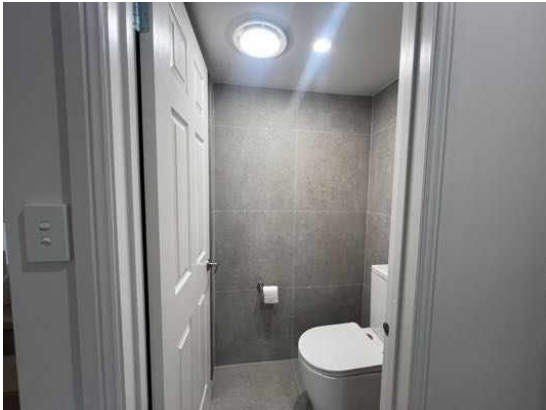
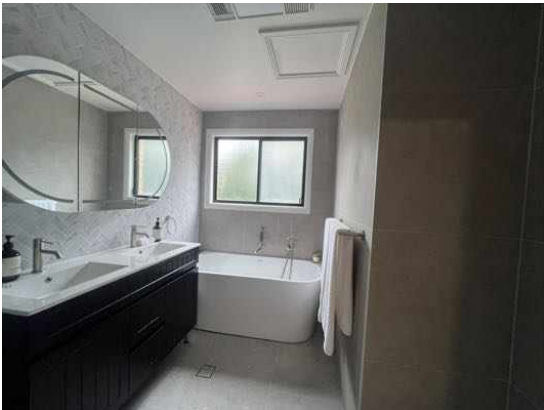
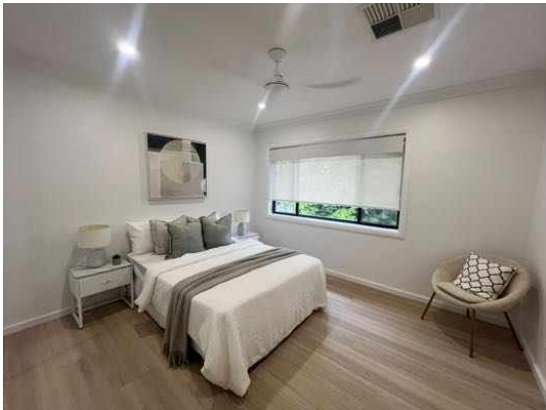
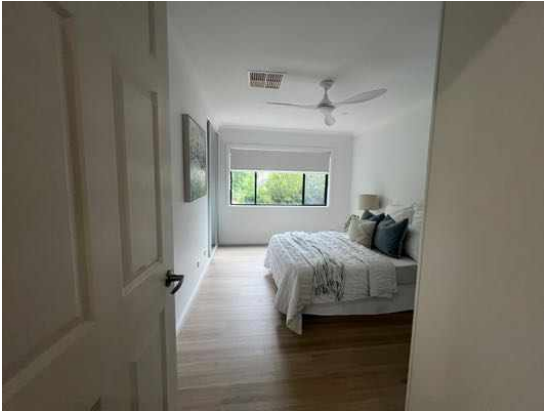
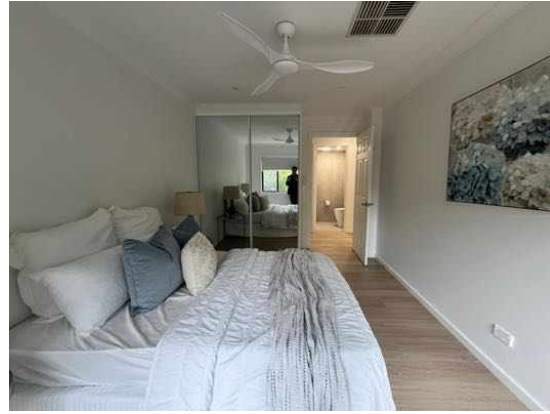
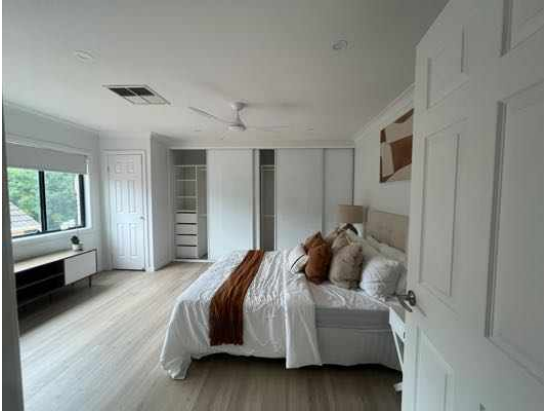
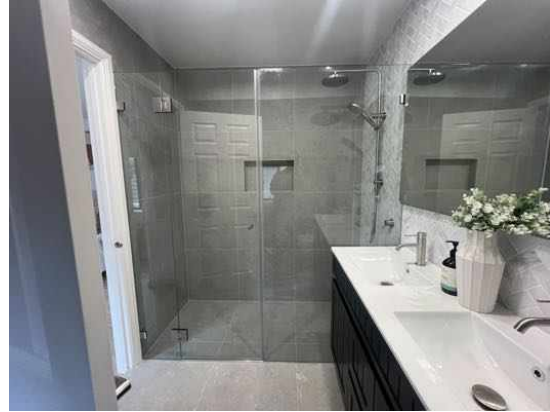
Building: Main Building
Location: All Internal Areas
Finding: Additional Photos - Obstructions and Limitations
Information: These photographs are an indication of the obstructions and limitations which impeded full inspection of the property at the time of inspection. These obstructions can hide an array of defects and should be removed to allow full inspection to be carried out. A re-inspection is recommended once the areas are made accessible.

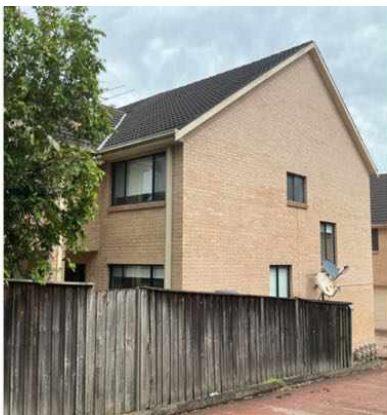
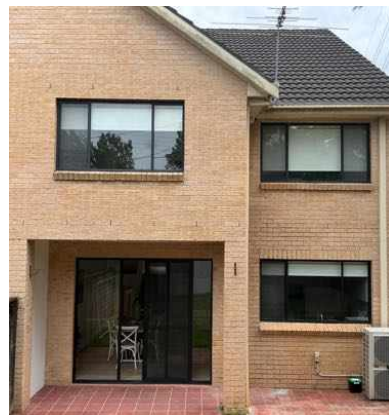
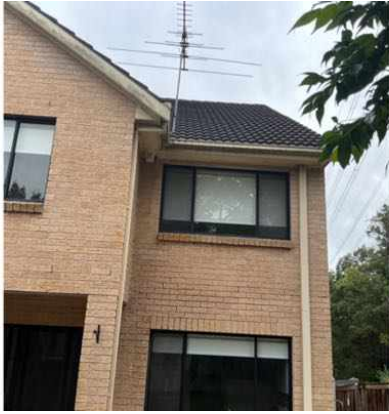
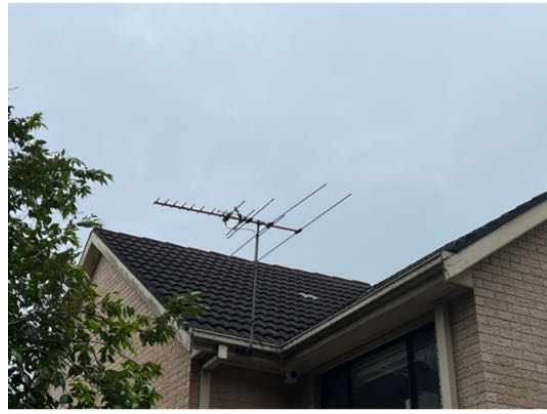
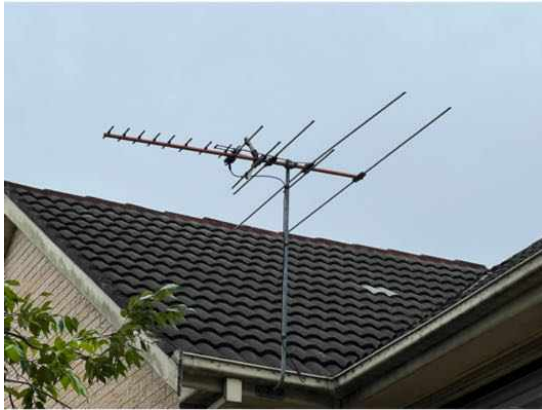
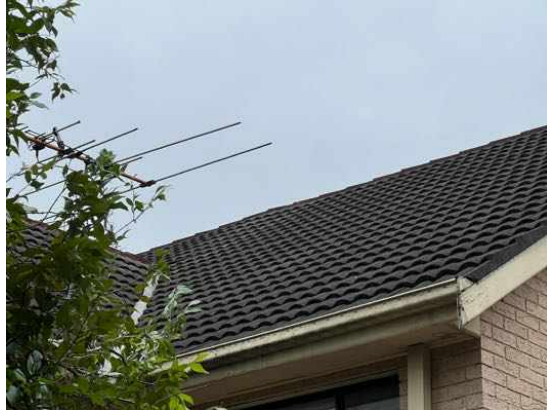
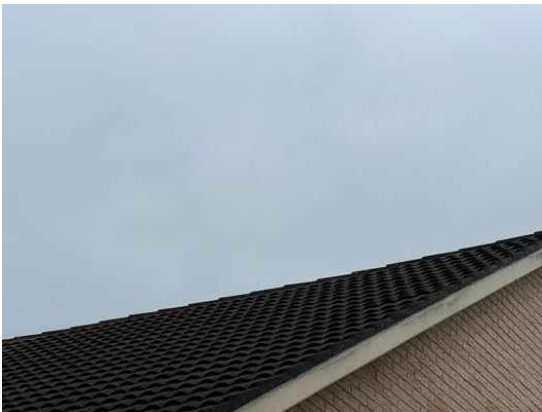
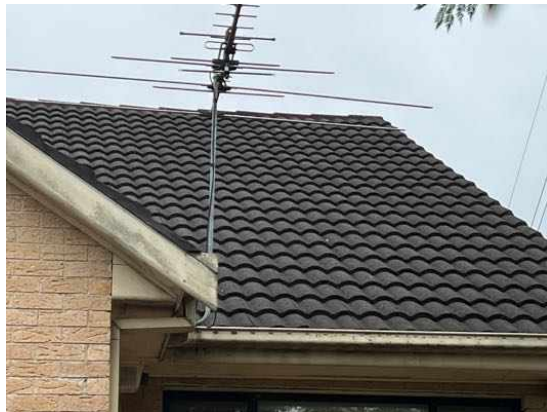
Building: Main Building
 Location: Roof Exterior
 Finding: Additional Photos - Obstructions and Limitations
 Information: These photographs are an indication of the obstructions and limitations which impeded full inspection of the property at the time of inspection. These obstructions can hide an array of defects and should be removed to allow full inspection to be carried out. A re-inspection is recommended once the areas are made accessible.

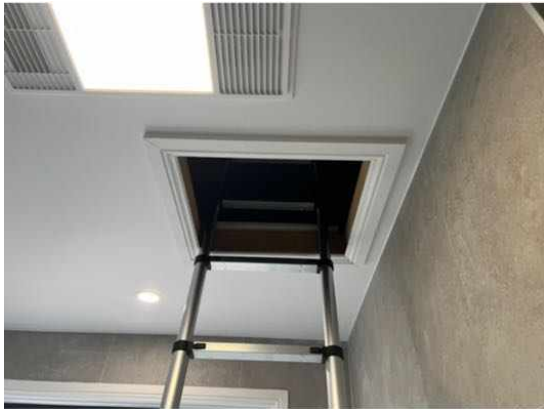
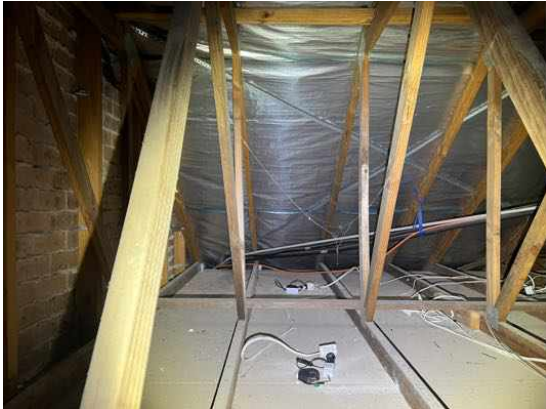
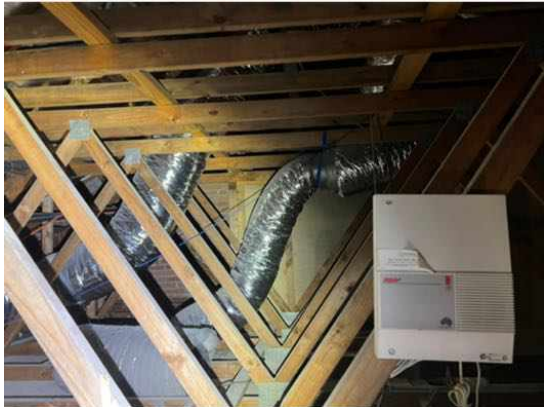
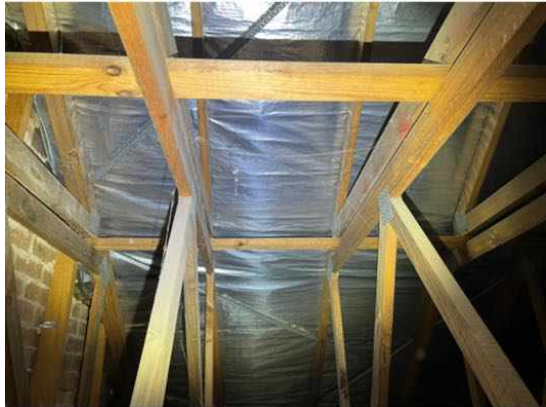
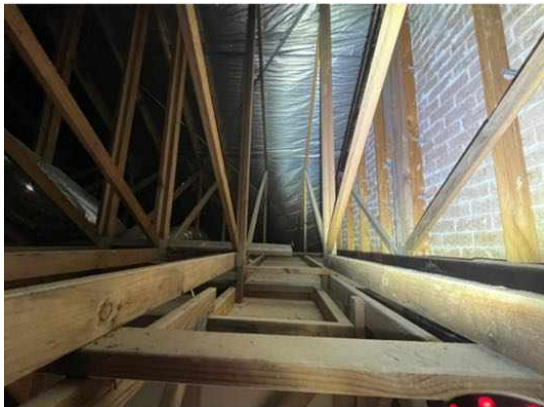
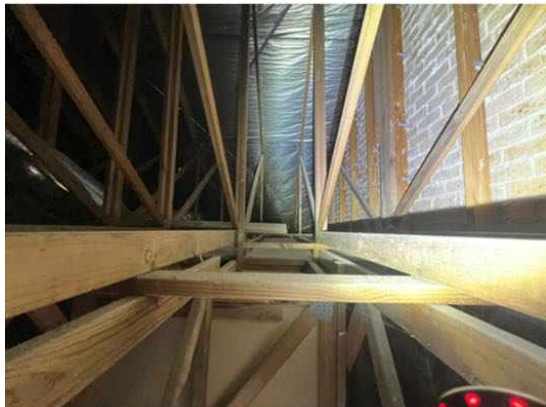
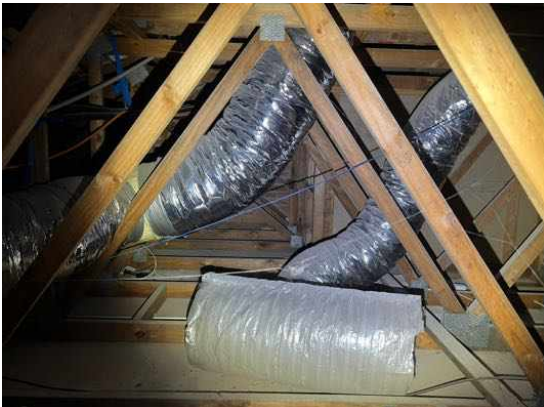
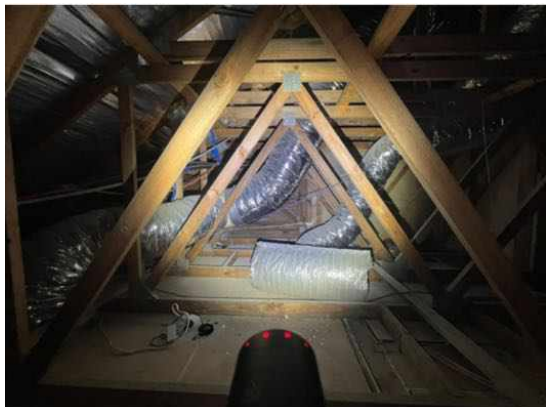
Building:	Main Building
Location:	Roof Void
Finding:	Additional Photos - Obstructions and Limitations
Information:	These photographs are an indication of the obstructions and limitations which impeded full inspection of the property at the time of inspection. These obstructions can hide an array of defects and should be removed to allow full inspection to be carried out. A re-inspection is recommended once the areas are made accessible.
