Building and Timber Pest Inspection Report

Inspection Date: Wed, 11 Mar 2026

Property Address: 16 Panorama Parade, Moruya NSW 2537,
Australia

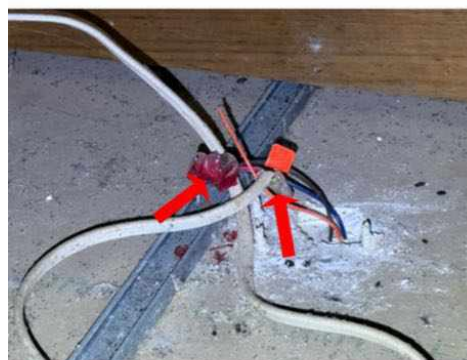
Building:	Building 1
Location:	Roof Cavity - left middle
Finding:	Electrical cables missing a junction box
Information:	The electrical fitting in this roof area was found to be missing a junction box at the time of inspection.

This missing fitting and loose cables does expose electrical works, and may create a safety hazard if there is potential contact with persons in the area.

A Licensed electrician should be appointed to rectify these areas immediately.

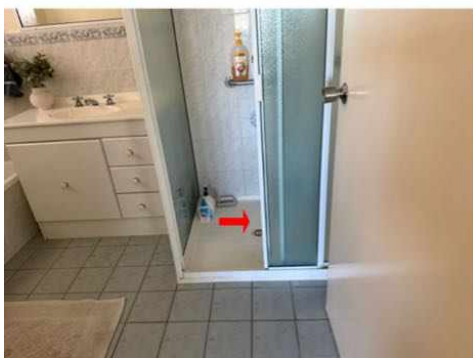
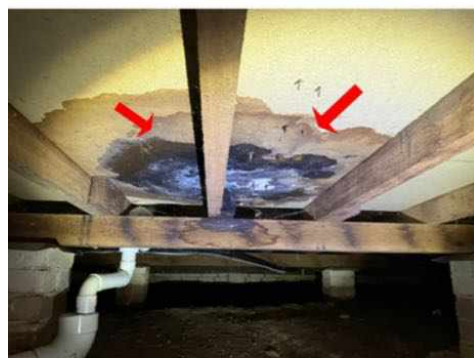
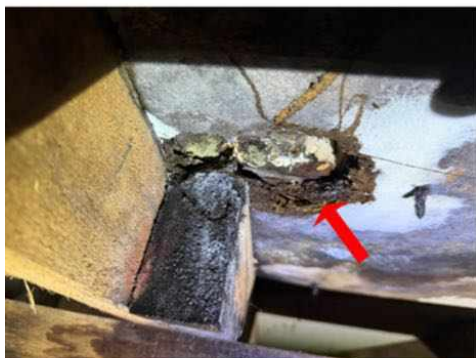
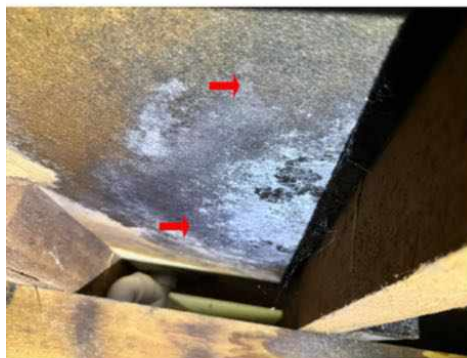
Building: Building 1
 Location: Bathrooms and laundry
 Finding: Waterproofing membrane and flooring damage
 Information: Internal Water Proofing Membranes, are crucial in preventing water ingress into the property.

It appears this membrane has failed causing major flooring damage requiring replacement.

Quotes should be sought before purchase from bathroom renovation companies to replace the damaged flooring and waterproofing membrane.

These replacements costs are likely be substantial.

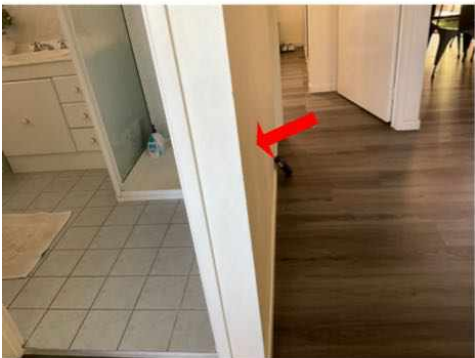
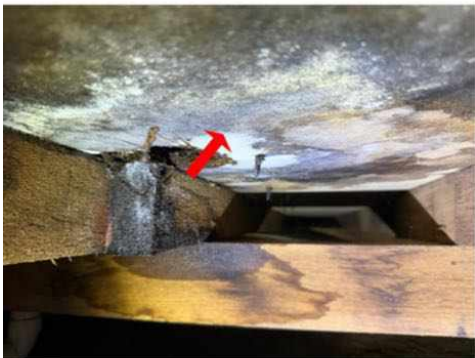
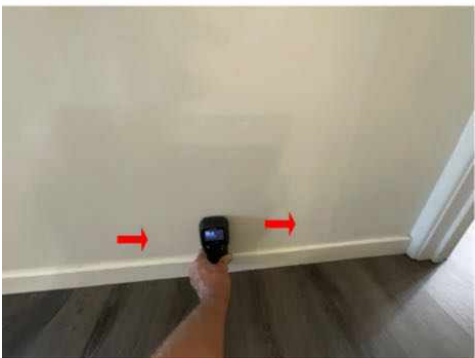
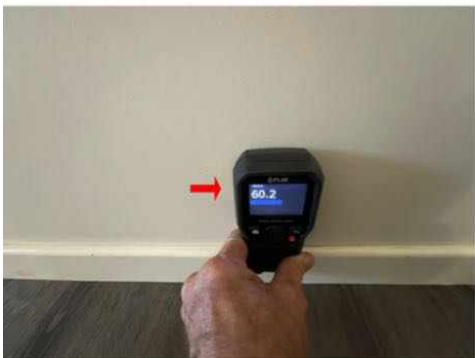
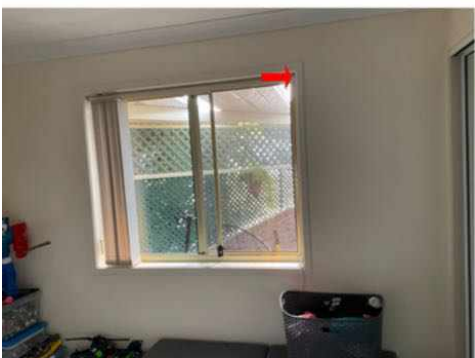
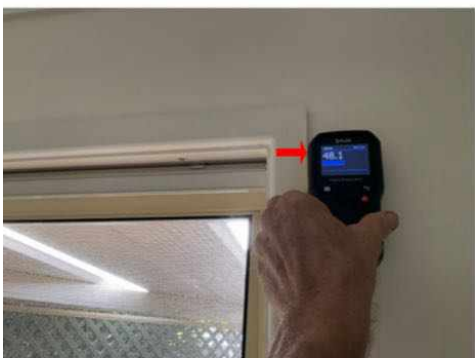
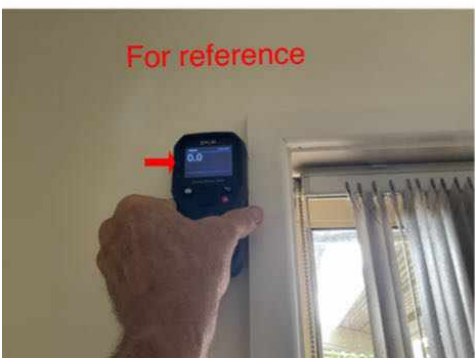
Finding 3.01

Building:	Building 1
Location:	Hall/ bathroom wall and rear left bedroom external wall
Finding:	Evidence of excessive moisture was present at the time of inspection
Information:	Excessive moisture was found in the hall/ shower wall and rear left bedroom right wall. Medium readings of 60.2 and 48.1 were recorded in these areas respectively.

This can attract termites and produce conditions that promote termite attack, fungal growth and wood decay.

Excessive moisture appears to be caused by a bathroom leak in the hall wall. The rear bedroom moisture is suspected to be caused by full and overflowing roof gutters.

It is highly recommended that all plumbing and drainage fixtures and fittings, waterproofing membranes, sealant and grout and roof gutters be maintained regularly in order to prevent excessive moisture being present in the internal property.

A full bathroom renovation is likely to be required.

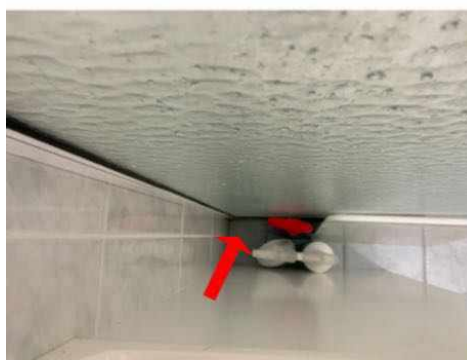
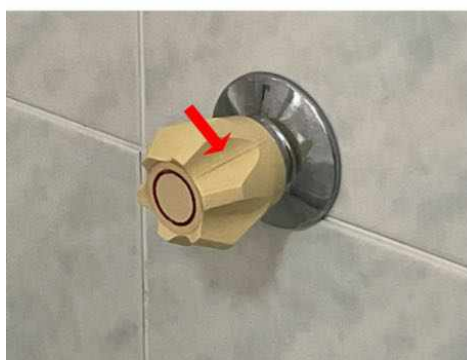
Finding 3.02

Building: Building 1
Location: Bathroom
Finding: Shower screen leaking and other bathroom defects.
Information: Leaking was evident to the left shower screening at the time of inspection. It is suspected that the leaking has occurred as a result missing sealant. Leaking from the shower , where left unattended, is likely to lead to water damage to adjoining flooring and walls. Such damage can lead to water damage and necessitate extensive remedial works being required. Appointment of a sealant expert is required to repair or replace this missing sealant. Such works should be performed as soon as possible to ensure that no further damage occurs.

- a missing bath tap handle (still working)
- a cracked shower tap handle
- approx ten cracked floor tiles and one cracked shower lower wall tile were evident.

A full bathroom renovation is likely to be required.

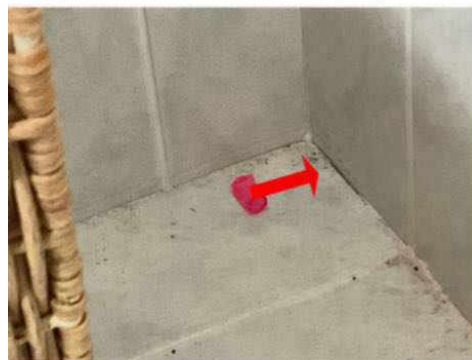
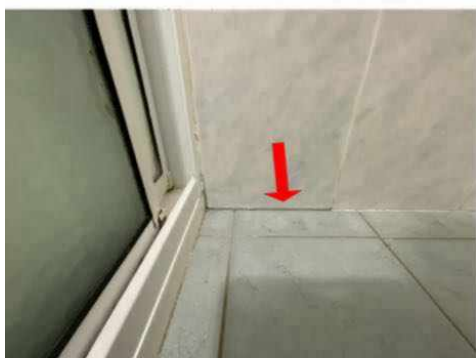
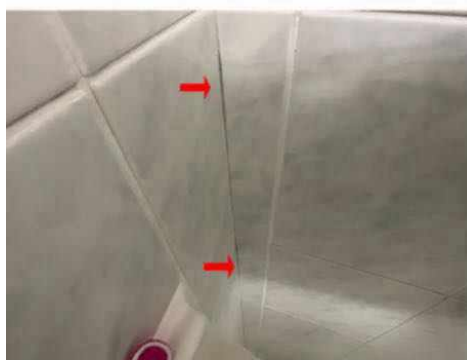
Finding 3.03

Building:	Building 1
Location:	Bathroom
Finding:	Sealant and grouting - Missing or damaged
Information:	It was noted on inspection that sealant or grout is degraded to these pictured wet areas.

Different materials and floor areas move at different rates, generally causing cracking to grout or sealant at this point. A flexible sealant is required to allow for expected expansion and contraction, while keeping the joint water tight and protective of all associated building materials.

Flexible and mould resistant materials should be applied to affected areas to prevent any subsequent water damage that is likely to occur. Regular maintenance and replacement of damage or missing or damaged sealant and grout is highly recommended to the wet areas, as this is a regular wear and tear defect. Sealant and grouting in areas that come into regular contact with water should be maintained for the long term care of your property.

A sealant specialist or tiling contractor should be appointed to complete these works as soon as possible

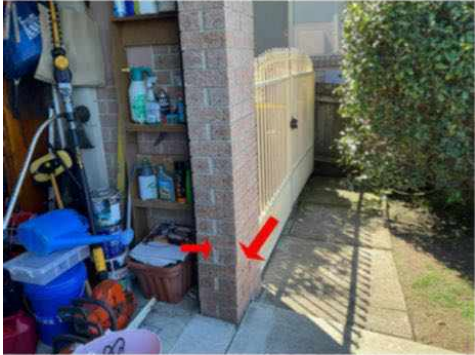
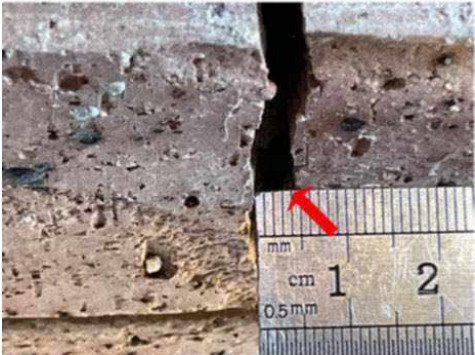
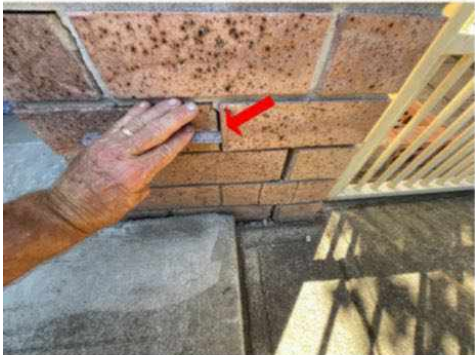
Finding 3.04

Building:	Building 1
Location:	Exterior front house and rear yard walls
Finding:	Step cracking to brickwork (minor under 5mm)
Information:	Step cracking was identified to the brickwork in three areas of the right front walls and 4 areas of the rear yard small retaining walls at the time of inspection.

Step cracking, which is similar to other forms of cracking, has a variety of possible causes. However, the most common is the subsidence of adjacent footings.

Step cracking is a relatively common defect, and is most likely to occur adjacent to windows, doors and other openings. Mortar failure in the gaps between affected bricks indicates the stresses and tensions affecting the wall.

The rear yard step cracking either side of the rear steps in the 790mm wall, is over 5mm, however, due to it having no bearing on the house, this is mentioned in this report as a minor defect. Adding drainage behind these rear retaining wall areas will likely stop movement of these

If step cracking is extensive or severe (over 5mm) the client is advised to consult a structural engineer. The pictured minor house step cracking can be used as a warning sign to address factors causing stress to the wall, which can include the effect of water leaks, soil erosion, or even the presence of reactive soils in the surrounding

These areas should be monitored annually and if any house wall cracking exceeds 5mm, a structural engineers advice is required. These cracks are currently 1-3mm.

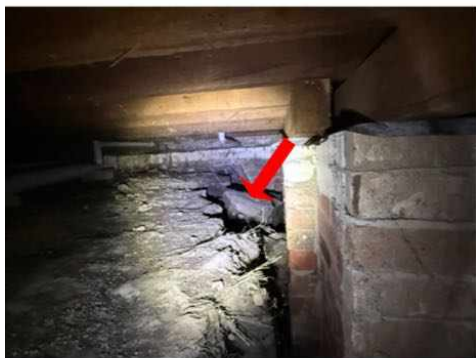
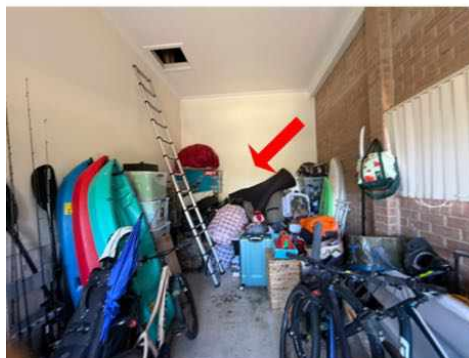
Finding 3.05

Building:	Building 1
Location:	Subfloor behind garage
Finding:	Subsidence - monitor annually
Information:	It appears that this area of soil in the rear right subfloor behind the garage has been affected by movement, often referred to as sinking or subsidence. General subsidence is usually initiated by changes in soil moisture content. The most critical factor is identifying the specific causes, and identifying if this is a recurring or ongoing problem, or one that has been resolved by previous works in the past.

At this point it is recommended to contain the rear house storm water flows, ensure pavements flow away from buildings to lessen any excessive wetting and drying effects.

If any moisture is found in the rear garage area when all stored items have been removed, this area will need to be reinspected by a licensed plumber. If other impact damage is found in the rear garage wall, a structural engineers assessment will be required of the rear garage wall.

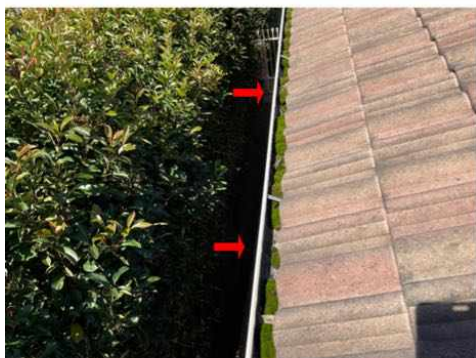
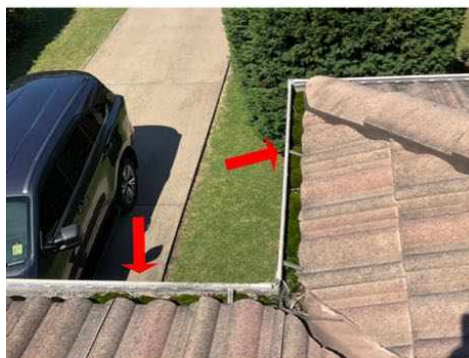
Finding 3.06

Building: Building 1
 Location: Roof exterior
 Finding: Gutters - Full and blocked
 Information: The guttering on around the roof was found to be blocked at the time of the inspection. Roof plumbing structures, such as guttering and downpipes, should be free of all debris to prevent blockages. Blockages of the guttering and downpipes will lead to pooling and accumulated water overflows, which is likely to subsequently flood eaves and exterior walls.

Blocked gutters are likely to lead to high levels of moisture in the affected areas which can cause rust and decay of the gutters and downpipes and wood rot to adjoining timber areas. Blockages in gutters should therefore be removed immediately to ensure dry conditions are maintained.

It is highly advised that gutters be cleaned by the homeowner or a general handyperson as a matter of urgency.

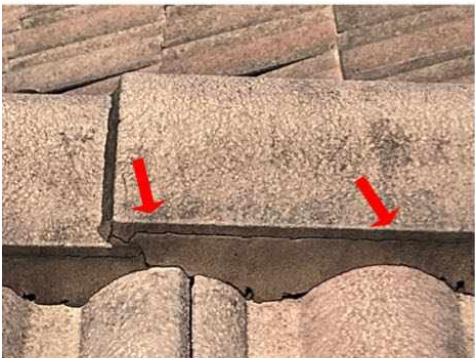
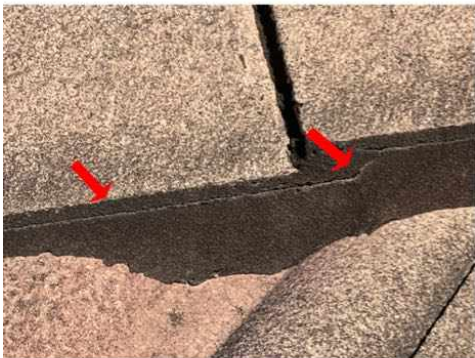
Building: Building 1
 Location: Roof Exterior
 Finding: Roofing areas - Weathered
 Information: Upon inspection of the exterior roofing, the majority of the roof areas were considered to be in a good condition. While weathering of these pictured areas is consistent with the age of the property, minor maintenance works are required.

Re-sealing and replacing small areas of gaps, damage or rust the may be considered as an interim solution by the client to help preserve and extend the life span of these roofing areas. Where left unmanaged, deteriorating roofing materials are likely to lead to a number of secondary defects, including minor water leaks and weather exposure to internal roofing structures.

Consultation with a roofing contractor is highly advised to gain advice on cost of remedial works that may be required in the short to medium term.

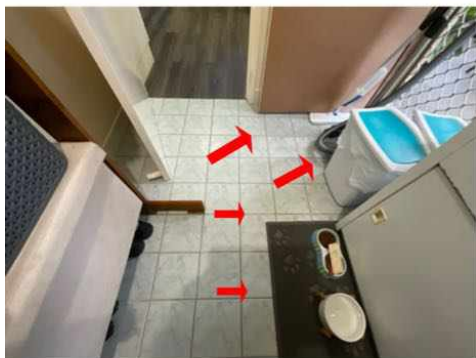
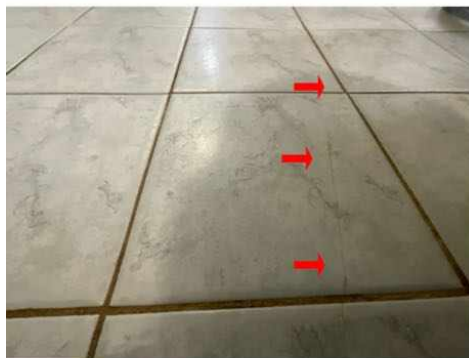
Building: Building 1
Location: Bathroom, laundry
Finding: Tiles cracked
Information: Cracked tiles were evident in these pictured areas at the time of inspection. It is suspected that this cracking has occurred as a result of minor settlement.

Cracked tiles throughout the household detract from the overall appearance of the affected areas. In wet areas of kitchens and laundrys, it can lead to water damage of adjoining walls and floors.

Replacement of cracked tiles is recommended as soon as possible. A tiling contractor may be appointed to perform these works. Where cracks become more numerous, contact a licensed building inspector for further investigation.

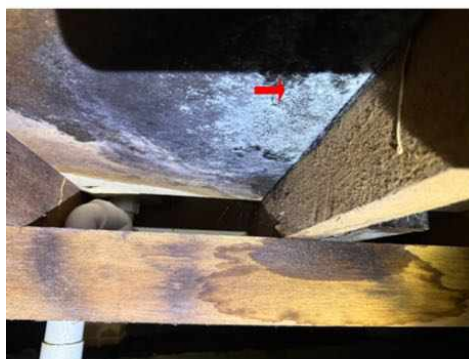
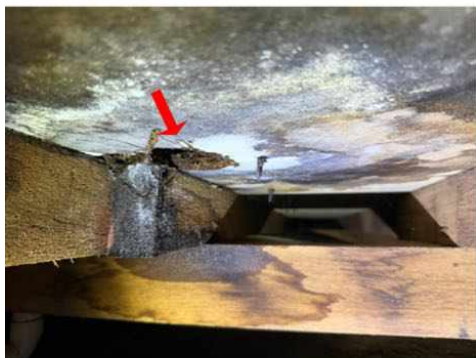
Finding 3.11

Building:	Building 1
Location:	Fence and subfloor areas
Finding:	Wood rot under bathroom and small fence areas
Information:	These pictured areas shows evidence of wood rot. Wood rot, also known as Fungal Decay, occurs when timbers and other cellulose building materials are exposed to damp conditions on an ongoing basis. This could be the result of exposure to weathering over a prolonged period of time, or the attraction of excessive moisture from other abutting building materials.

Early intervention and regular maintenance, particularly of exterior timbers, will prolong the useful life of these building elements. Prior to any works being performed, the cause of the moisture that has created the visible wood rot should be identified and addressed in a suitable manner. Replacement of affected timbers may then be a necessary step in protecting surrounding building elements from such deterioration.

A qualified carpenter or registered builder may also be required to replace affected building materials.

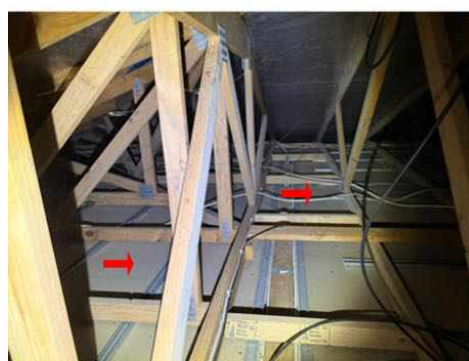
Finding 3.12

Building:	Building 1
Location:	All Roof cavity areas
Finding:	Insulation - Missing
Information:	Upon inspection of the roof void it was noted that insulation is not present (sarking was fitted and in good condition).

Insufficient insulation will result in a comparatively higher cost to heat and cool a property as there is a lack of Insulation (or uneven coverage of insulation) which works as a barrier to heat transfer. This helps to keep out unwanted heat in summer and preserves warmth inside your home in winter. It can also help soundproof your home from unwanted airborne noise transfer.

Where insulation is absent, the area does not meet current Australian Standards. Installation of adequate insulation is required and should be conducted as soon as possible.

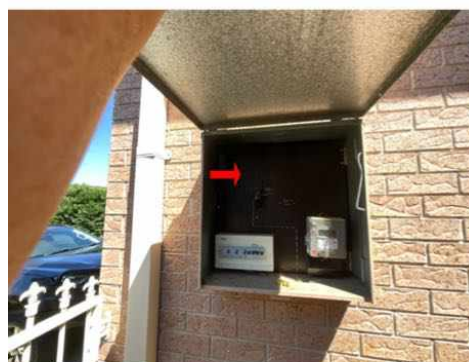
Building:	Building 1
Location:	Meter Box
Finding:	Termite Management System - no evidence of a chemical installation
Information:	The application of a post-construction chemical termite barrier is highly recommended for all properties. Such barriers are highly effective in preventing termite attack on any timber building elements throughout the property.

A durable notice should be placed in the switchboard unit to indicate current termite barriers. At the time of inspection, no durable notice was evident and it appeared as though no chemical termite management system has been installed, with no evidence to suggest preventative works taking place since the property was built.

The client may consider gaining further advice from a pest controller as to the costs and procedures involved with a 'chemical' application. It is recommended that obtaining such advice be a short-term priority.

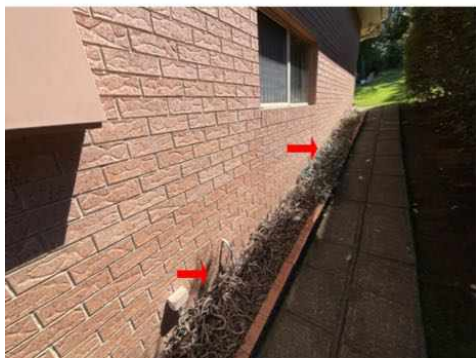
Finding 6.02

Building:	Building 1
Location:	Exterior walls
Finding:	Slab Edge - Exposure
Information:	An inspection zone of at least 75mm in relation to the exposed slab edge, between the bottom brick and the perimeter pavement, is required. This inspection zone should be maintained in order to force termites into the open where they can be detected more readily during regular inspections. The slab edge should not be concealed by anything that may prevent inspection of the area, including render,

If the slab edge is not properly exposed there is a high risk of termite attack. Sometimes, in order to determine the type of slab, a suitably qualified person such as an architect or builder may be required to consult the construction plans.

Where the slab edge cannot be properly inspected, it is highly recommended that termite or timber pest inspections be carried out every 6-12 months to aid protection of the property against infestation.

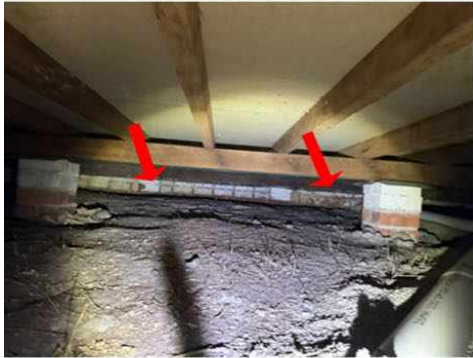
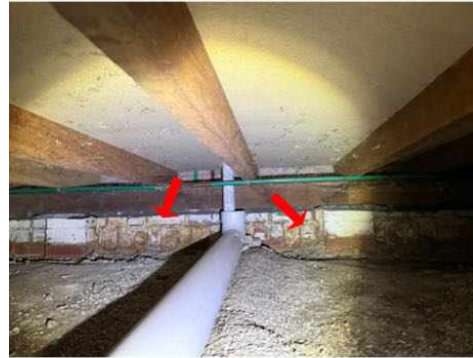
Finding 6.03

Building:	Building 1
Location:	Subfloor
Finding:	Damp - Rising
Information:	Rising damp is common in most subfloors. This describes the upward movement of water in low sections of building elements (e.g. walls) by capillary action - the movement of water through porous materials such as bricks, sandstone or mortar.

Rising damp is generally managed by the installation of a damp proof course during construction. A Damp Proof Course (DPC) is an impermeable barrier at the base of the wall above ground level. However, many 19th Century buildings have no damp course installed, or the materials have failed. The DPC may have been omitted as a consequence of poor workmanship, or it may have been bridged where materials built up against the side of the house allow moisture ingress above the DPC level.

The first step in addressing rising damp is to diagnose the cause. The identified cause should be addressed first before addressing the appearance and other defects which have resulted from the rising damp. If the original cause is not resolved, further cases of damp are likely to ensue, resulting in secondary defects.

Consultation with a qualified plumber is advised immediately to identify the cause of the damp and perform remedial works as required.

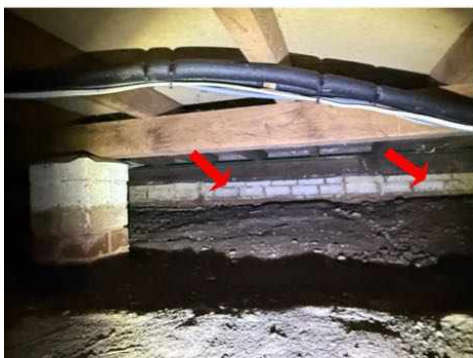
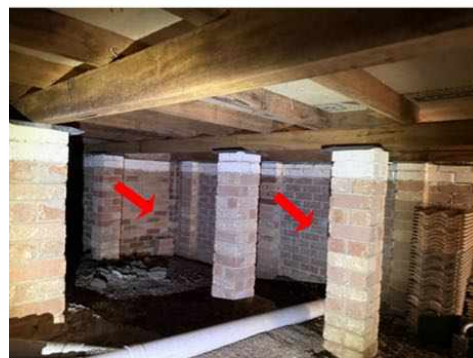
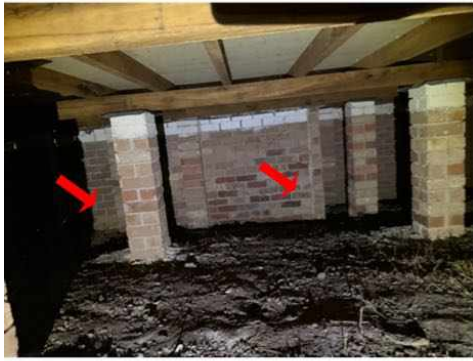
Finding 6.04

Building:	Building 1
Location:	Subfloor
Finding:	Subfloor ventilation - Inadequate
Information:	Adequate subfloor ventilation aids in preventing excessive moisture wood rot and termite activity by ensuring a dry subfloor environment.

Where ventilation is substandard or blocked, it is usually caused by factors such as failure to install adequate vents during construction or earth and vegetation covering vents. Low subfloor clearance and stored items or debris in the subfloor also restricting airflow.

Subfloor ventilation can be improved in most cases by addressing the causes such as exposing subfloor vents, installing additional vents, installing mechanical ventilation and removing debris from the subfloor.

A registered builder should be appointed as soon as possible to perform these works as necessary.

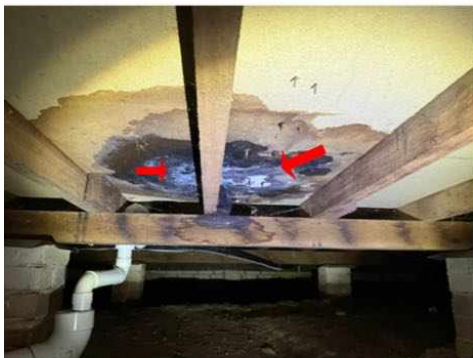
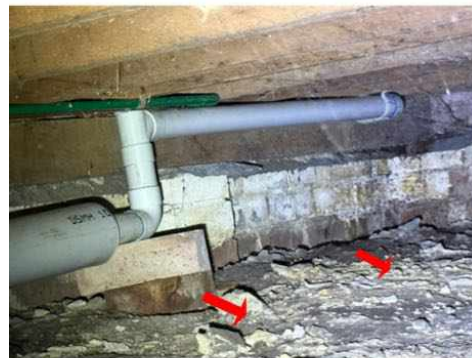
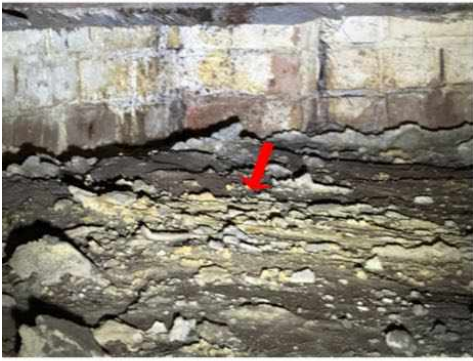
Subfloor mould is generally caused by moisture ingress (from the bathroom) lack of external drainage, lack of adequate ventilation and subfloor debris present. These issues need rectification to stop mould development. Any mould found during the inspection should be cleaned immediately by a cleaning contractor or the homeowner as applicable.

Generally, the client is advised to ensure that the general environment is free of moisture and humidity to aid in the prevention of mould formation and development.

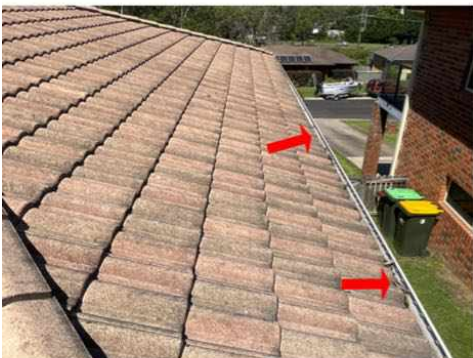
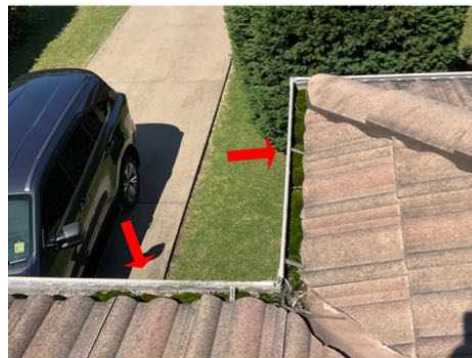
Finding 6.06

Building:	Building 1
Location:	Roof exterior
Finding:	Gutters - Full and blocked
Information:	The guttering on around the roof was found to be blocked at the time of the inspection. Roof plumbing structures, such as guttering and downpipes, should be free of all debris to prevent blockages. Blockages of the guttering and downpipes will lead to pooling and accumulated water overflows, which is likely to subsequently flood eaves and exterior walls.

Blocked gutters are likely to lead to high levels of moisture in the affected areas. Such moisture will not only cause rust and decay of the associated building materials, but can also provide conditions that are conducive to termite and timber pest activity. Blockages in gutters should therefore be removed immediately to ensure dry conditions are maintained.

It is highly advised that gutters be cleaned by the homeowner or a general handyperson as a matter of urgency.

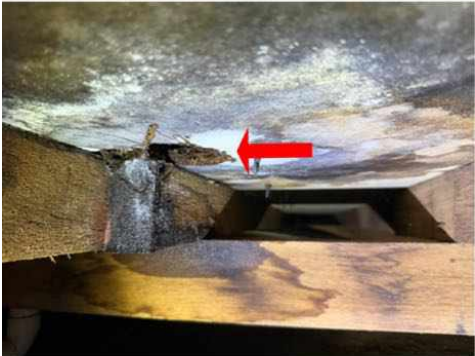
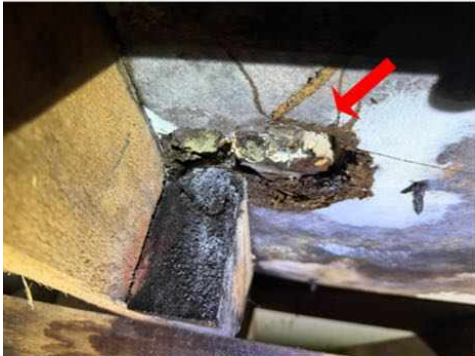
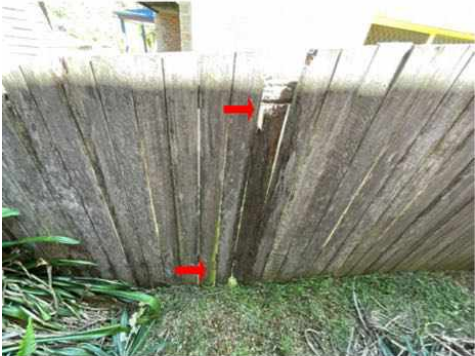
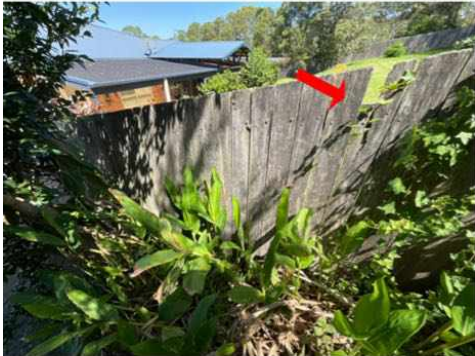
Finding 7.01

Building: Building 1
Location: Subfloor under bathroom and small fence areas
Finding: Fungal decay - present (localised)
Information: Fungal decay also known as wood decay or wood rot generally refers to the deterioration of timber elements when in contact with excessive levels of moisture for a prolonged period of time.

Note - See ALL wood rot photos, all these show fungal decay.

In this case, the affected timber element is in a decaying state and will need replacement by a carpenter or licensed builder.

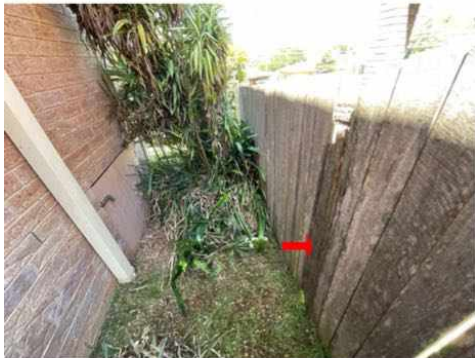
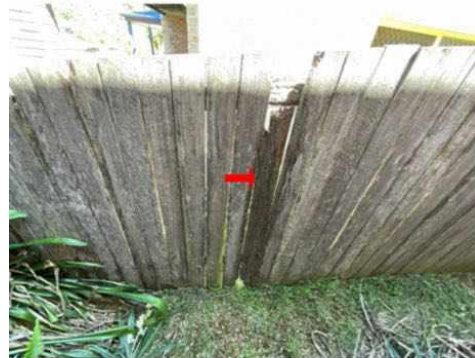
Finding 8.01

Building: Building 1
Location: Fence areas
Finding: Evidence of wood borer activity identified
Information: Wood borers small beetles that colonise in exposed timber elements are a common timber pest that are regularly mistaken for termites. Although wood borer activity is generally not detrimental to the affected timber they may lead to serious damage and necessitate replacement of certain building elements if left unattended.

As no live wood borer activity was identified treatment is not required at this time. Replacement of affected timbers may be considered by the client for superficial reasons.

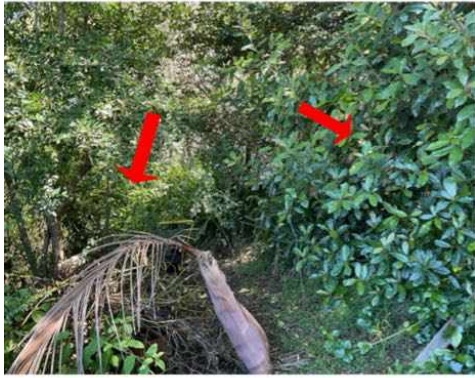
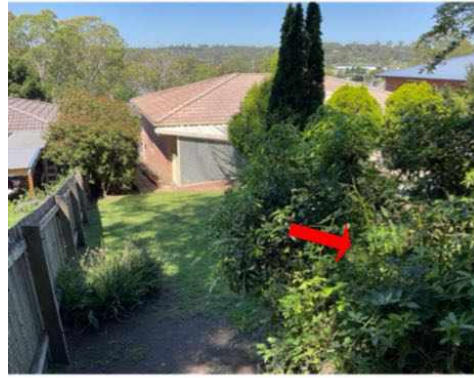
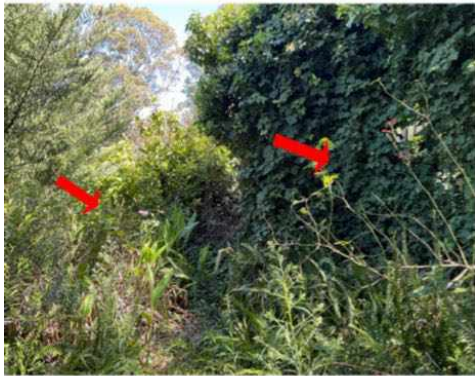
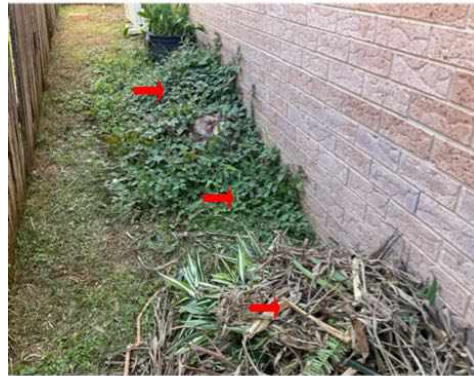
Building: Building 1
 Location: All External Areas
 Finding: Additional Photos - Obstructions and Limitations of EXTERNAL AREAS
 Information: These photographs are an indication of the obstructions and limitations which impeded full inspection of external areas at the time of inspection. These obstructions can hide an array of defects and should be removed to allow full inspection to be carried out. A re-inspection is recommended once the areas are made accessible.

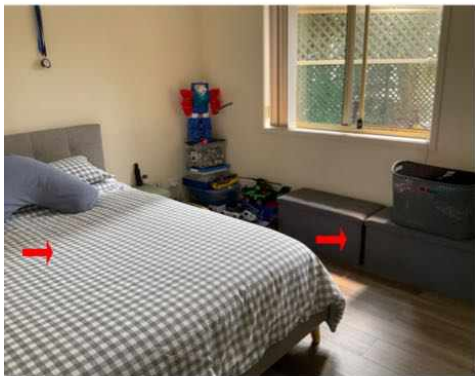
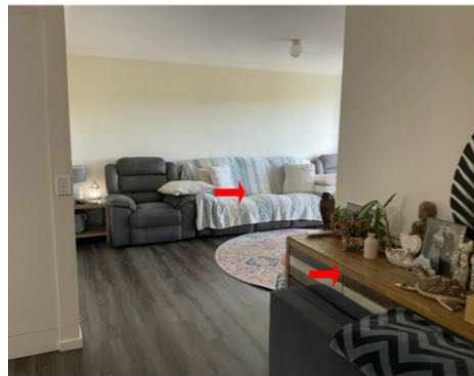
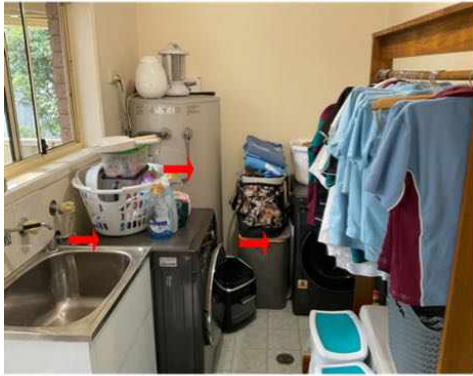
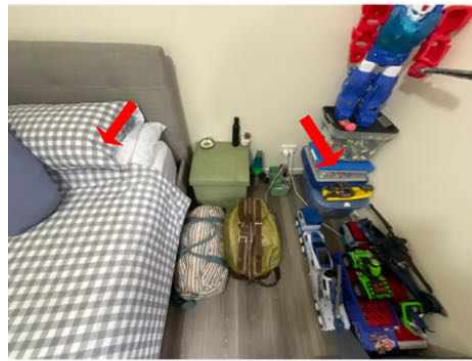
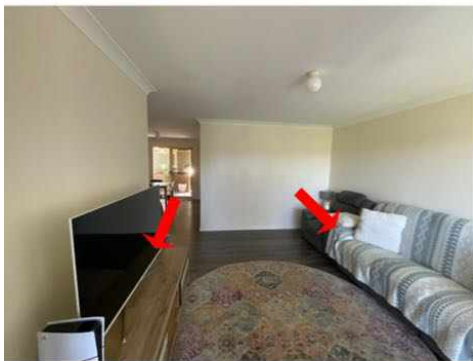
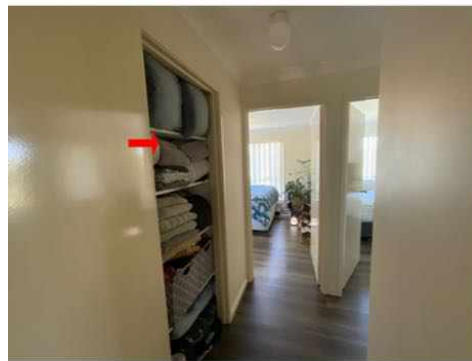
Building: Building 1
Location: All Internal Areas
Finding: Additional Photos - Obstructions and Limitations of INTERNAL AREAS
Information: These photographs are an indication of the obstructions and limitations which impeded full inspection of Internal areas at the time of inspection. These obstructions can hide an array of defects and should be removed to allow full inspection to be carried out. A re-inspection is recommended once the areas are made accessible.

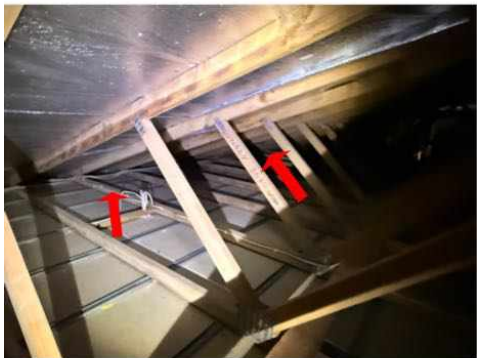
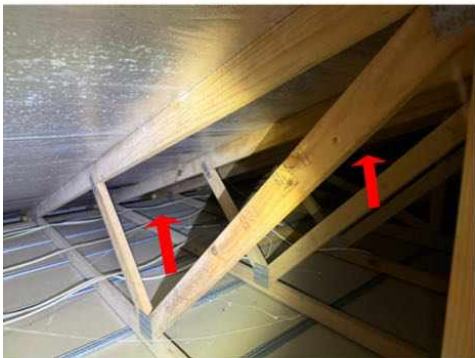
Building: Building 1
 Location: All Roof cavity areas
 Finding: Additional Photos - Obstructions and Limitations of the ROOF CAVITY
 Information: These photographs are an indication of the obstructions and limitations which impeded full inspection of roof cavity areas at the time of inspection. These obstructions can hide an array of defects and should be removed to allow full inspection to be carried out if applicable. A re-inspection is recommended once the areas are made accessible.

The inspection was also limited to areas with an allowable crawl space of 600mm x 600mm, in particular towards the external walls where the roof line diminishes, these areas were not accessible.

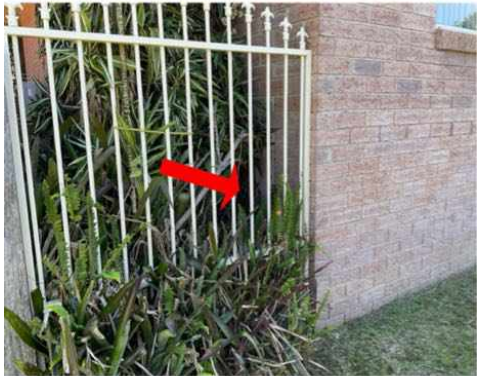
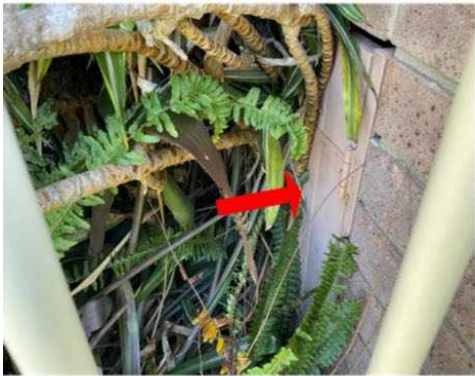
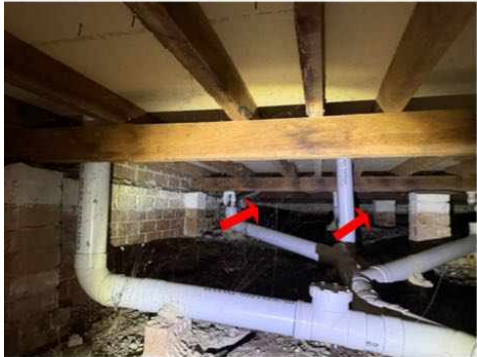
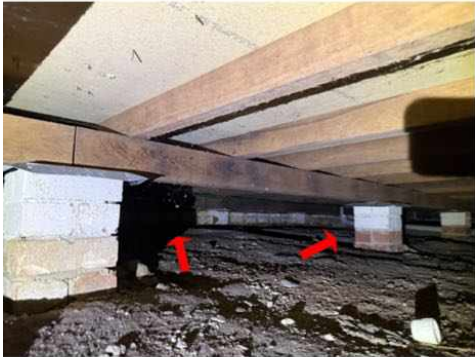
Building: Building 1
Location: All Subfloor Areas
Finding: Additional Photos - Obstructions and Limitations of SUBFLOOR AREAS
Information: These photographs are an indication of the obstructions and limitations which impeded full inspection of subfloor areas at the time of inspection. These obstructions can hide an array of defects and should be removed to allow full inspection to be carried out. A re-inspection is recommended once the areas are made accessible.

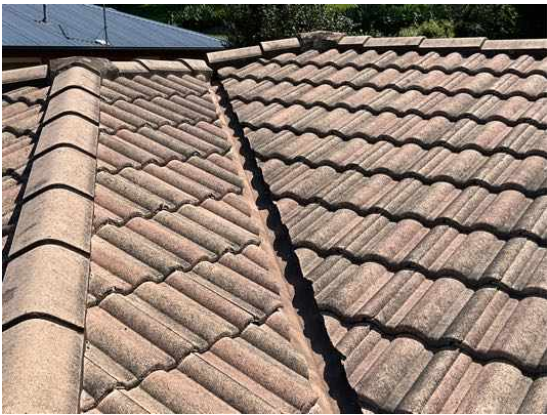
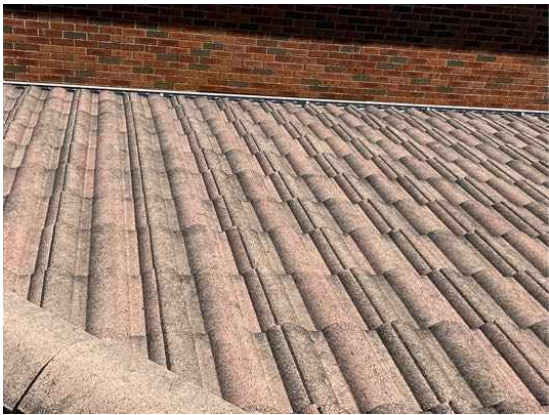
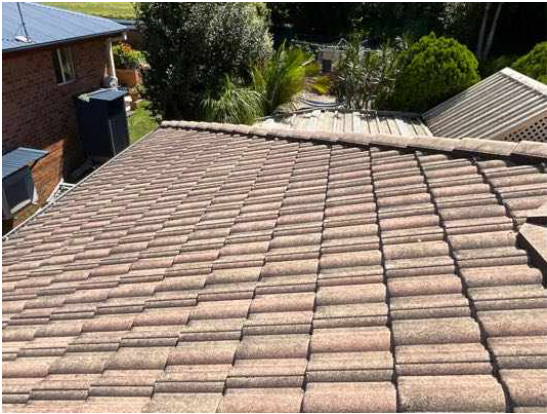
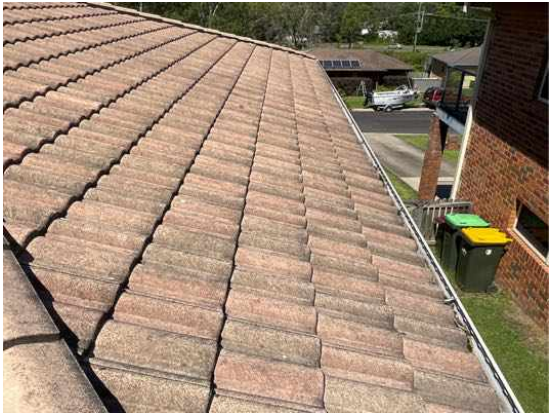
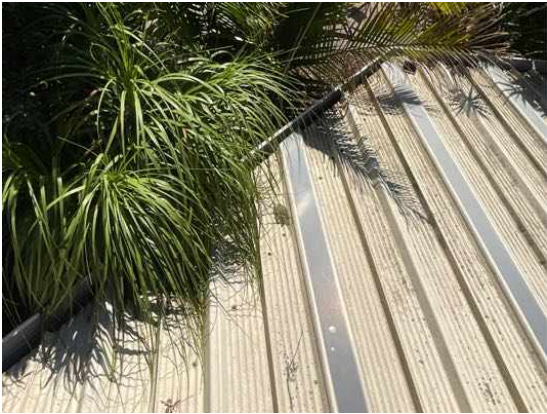
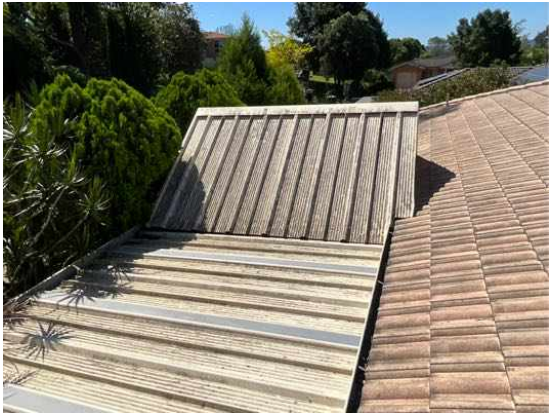
Building: Building 1
Location: All External Areas
Finding: Additional Photos
Information: Additional photos are provided for your general reference

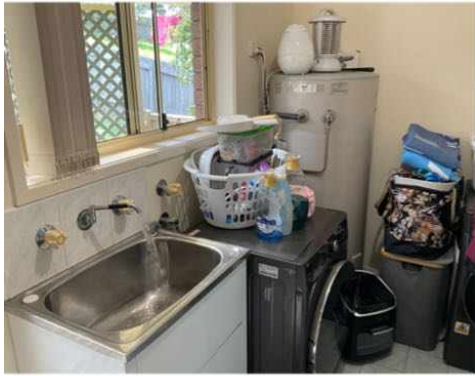
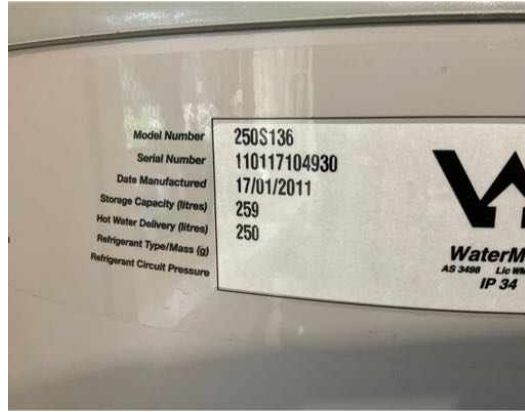
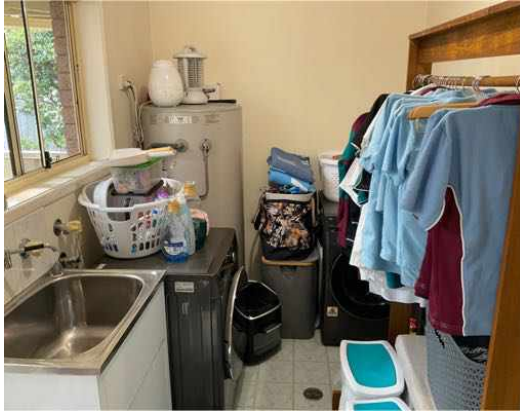
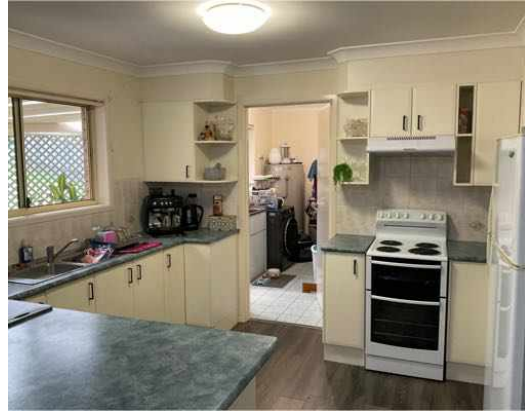
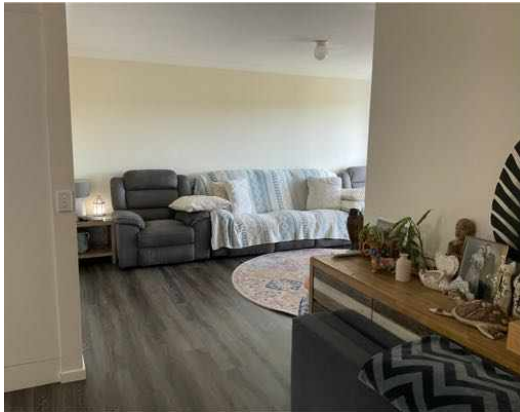
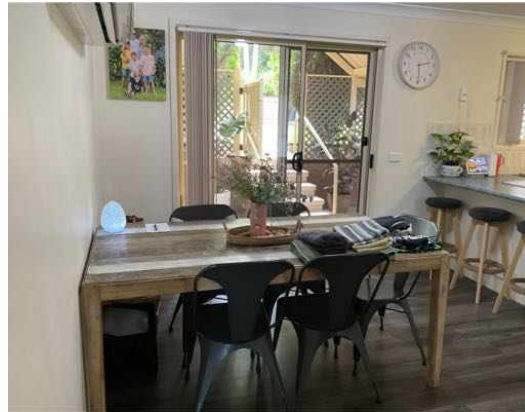
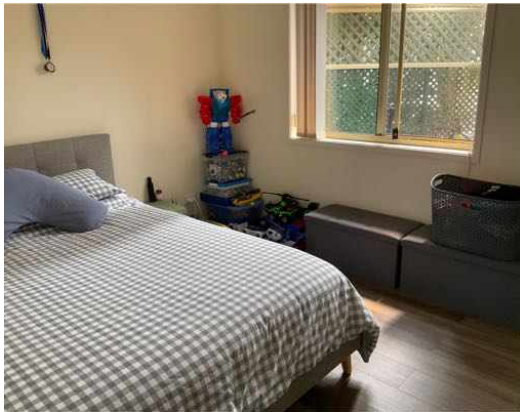
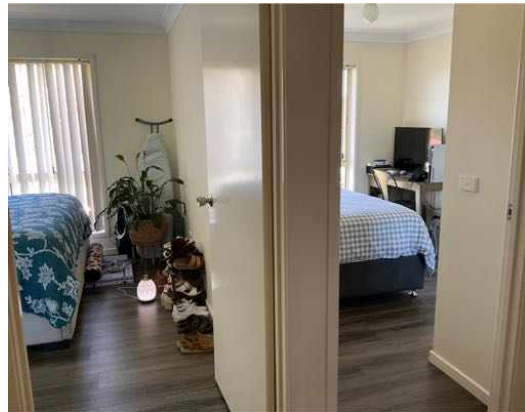
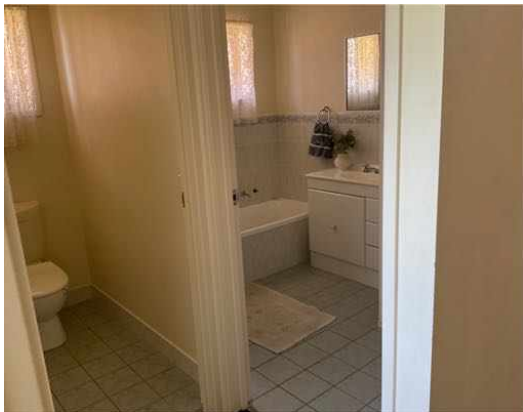
Building: Building 1
Location: All Internal Areas
Finding: Additional Photos
Information: Additional photos are provided for your general reference

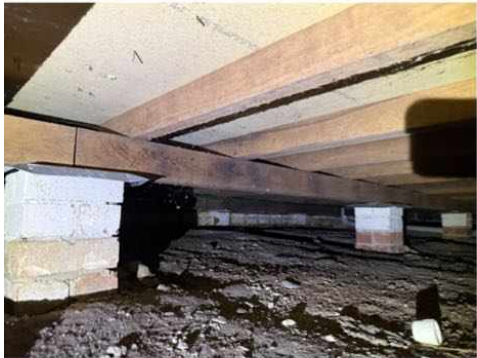
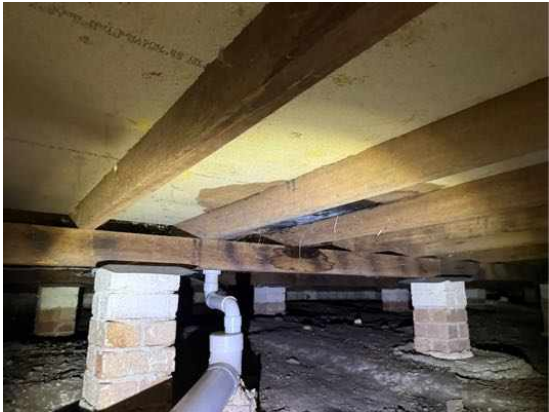
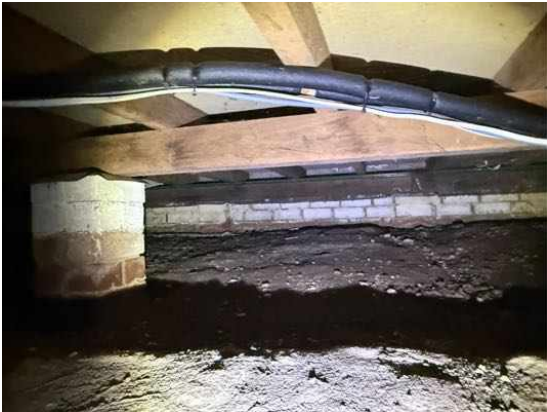
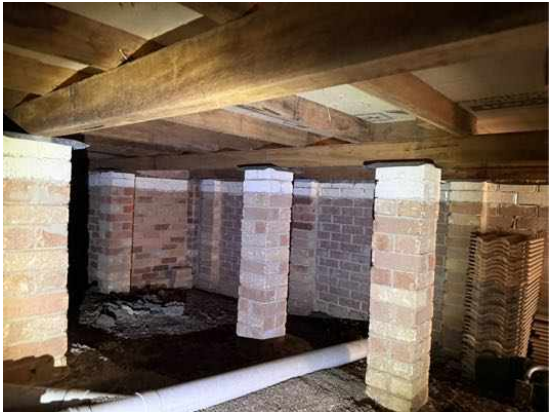
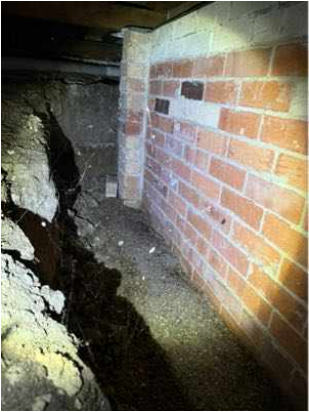
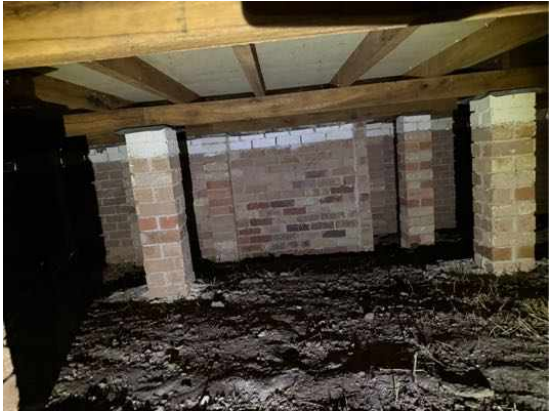
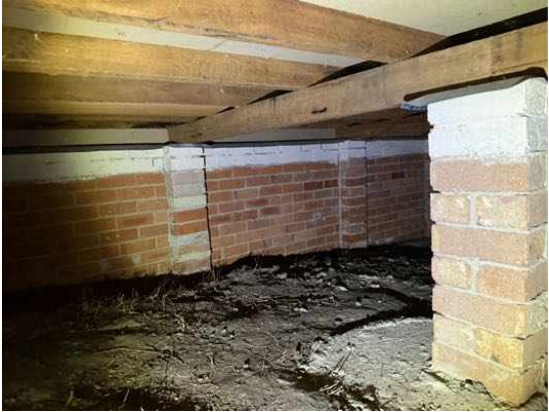
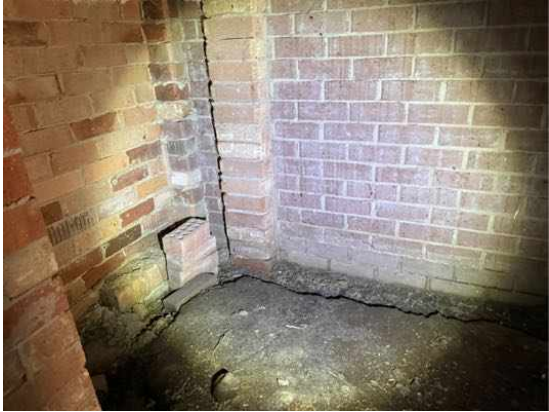
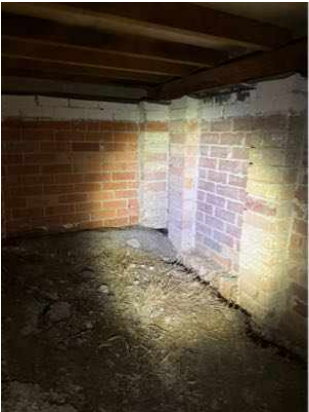
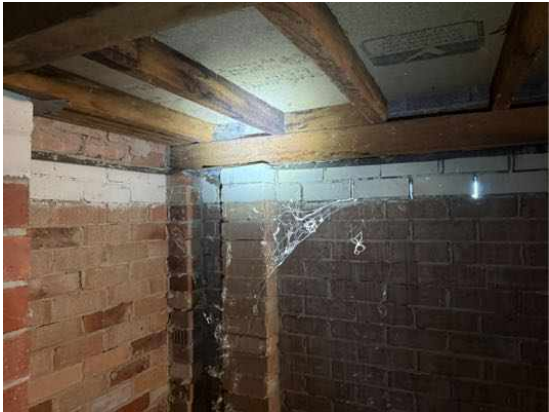
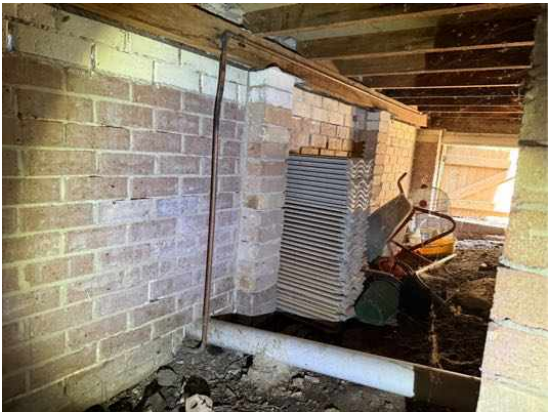
Building: Building 1
Location: All Subfloor Areas
Finding: Additional Photos
Information: Additional photos are provided for your general reference
