Building and Timber Pest Inspection Report

Inspection Date: Thu, 22 Jan 2026

Property Address: 16 Torwood Street, Warrimoo NSW 2774

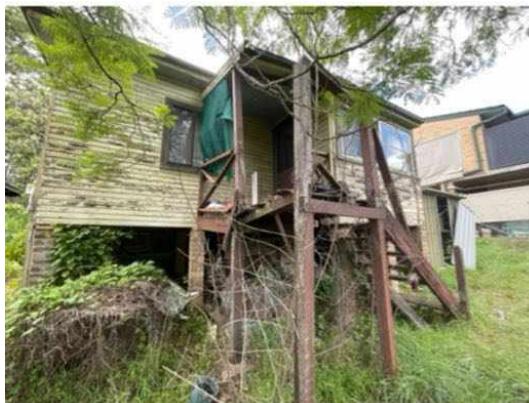
Building:	Main Building
Location:	Balcony
Finding:	Safety Hazard – Rear Balcony, Stairs and Veranda Roof Structure
Information:	Observation:

The rear balcony and associated stairs have collapsed due to advanced timber decay, resulting in a significant loss of structural integrity. The balcony balustrades (balusters) and stair components are damaged, missing, and assessed as being beyond economical repair.

In addition, the roof covering above the veranda is sagging noticeably. This condition appears to be directly related to deterioration and damage to the supporting post, which is no longer providing adequate structural support to the roof framing above.

The collapsed balcony and stairs present an immediate and serious safety hazard, with a high risk of injury due to potential falls or further structural failure. The compromised veranda support post significantly increases the risk of additional roof movement, partial collapse, or progressive damage to the roof structure and covering. These conditions represent a substantial risk to occupants, visitors, and contractors accessing the area.

Urgent action is required. It is strongly recommended that the affected area be restricted from use immediately. A suitably qualified and licensed builder should be engaged without delay to remove the failed balcony, stairs, balustrades, and damaged support post, and to design and construct compliant replacement structures. The veranda roof structure and roof covering should be thoroughly assessed and repaired or rebuilt as necessary to restore structural stability and ensure compliance with current safety and building standards.

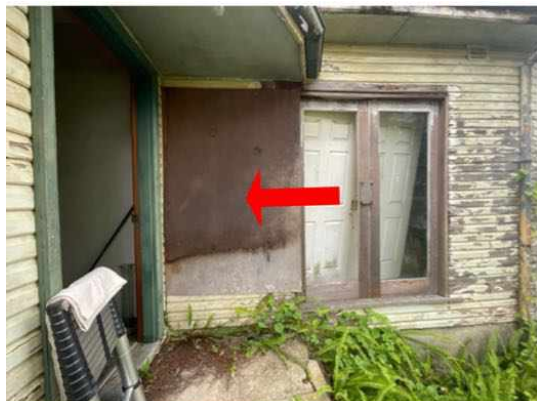
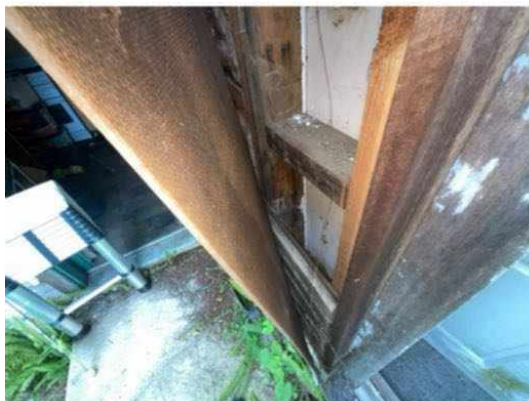
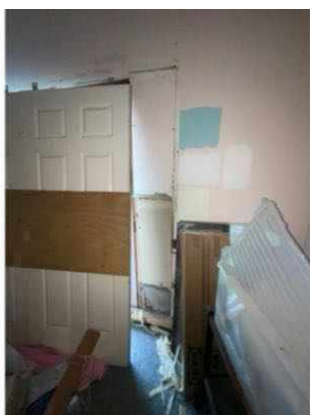
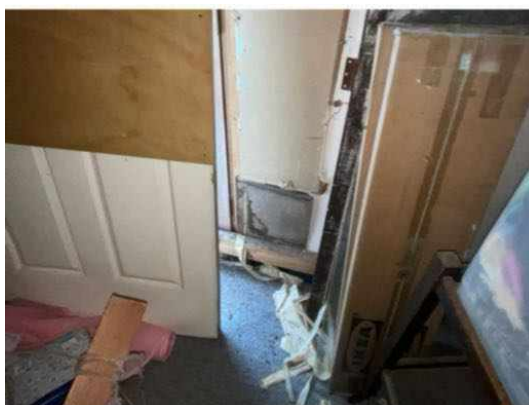
Finding 2.01

Building: Main Building
 Location: Exterior walls - front
 Finding: Major Defect – Termite Damage.
 Information: Location: Front External Wall

Condition: Evidence of Termite Damage

Evidence consistent with termite damage was identified to the front external wall area at the time of inspection. Timber wall cladding is missing or has been removed in this location, and previous works appear to have been undertaken to provide interim weather protection. Internally, wall linings in the corresponding area have been removed and subsequently patched, indicating prior remedial or investigative works.

Termite damage is considered a major defect due to the potential for concealed structural damage and the difficulty in confirming the extent and activity status without invasive investigation. Concealed termite damage may exist behind wall linings, ceiling linings, or other inaccessible building elements, including structural framing. If termites remain active, ongoing damage may continue to occur, potentially compromising the structural integrity of the building and resulting in significant repair costs.

Termite damage can be extensive, concealed, and costly to repair. This finding should be considered a significant risk factor and carefully assessed as part of the client's purchase decision.

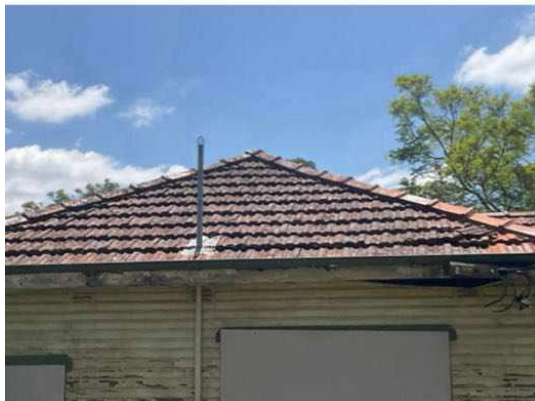
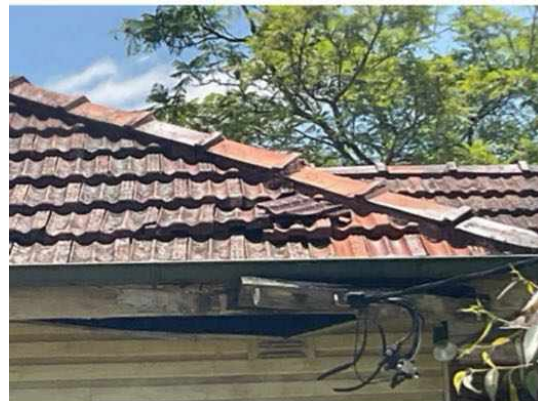
Finding 2.02

Building: Main Building
 Location: Roof Exterior
 Finding: Roof Covering – Inspection Summary
 Information: Access & Limitations

The tiled roof covering was assessed as being in poor condition, with active leaks observed at the time of inspection. Maintenance and repair works are required to ensure continued weather resistance. Access limitations applied due to roof height and pitch, and the inspection was limited to areas that could be viewed safely.

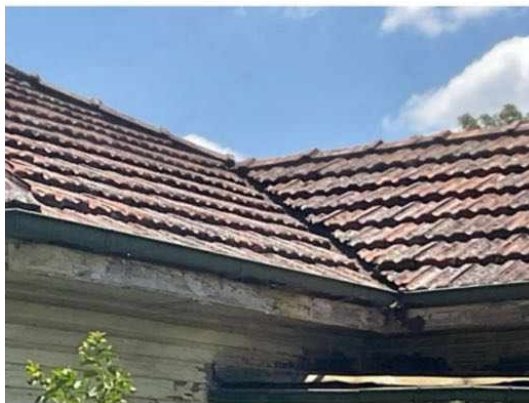
Finding 2.03

Building:	Main Building
Location:	All Areas
Finding:	Major Defect – Damaged Eaves
Information:	Observation:

Rectification works are required. It is recommended that a suitably qualified and licensed carpenter or builder be engaged to further assess the extent of damage and carry out necessary repairs or replacement of the affected eaves. All works should ensure the eaves are correctly aligned, securely fixed, and reinstated in accordance with current building standards to restore effective weather protection and prevent further deterioration.

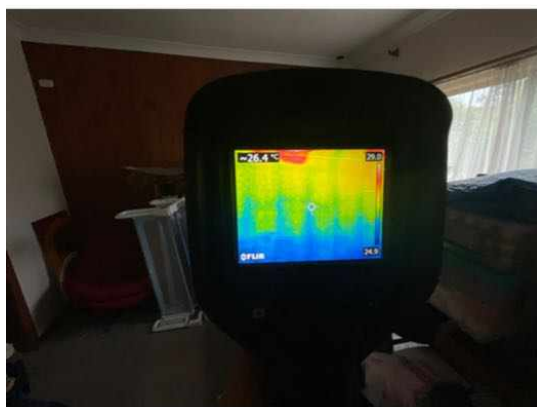
Building: Main Building
 Location: All Areas
 Finding: Evidence of live termite activity was not visible at the time of the inspection..
 Information: Termite Activity – Important Advisory

At the time of the inspection, no abnormalities indicating live termite activity were observed. However, it's important to note that various factors—such as obstructions, ambient temperature, and wall material/thickness—can impact the accuracy of thermal readings. In cases where surfaces are visually restricted or obstructed, a comprehensive thermal scan may not always be feasible.

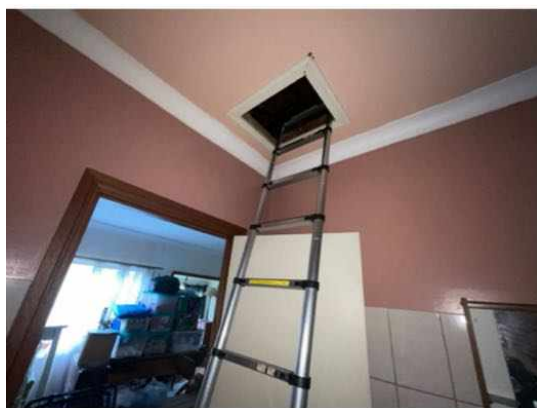
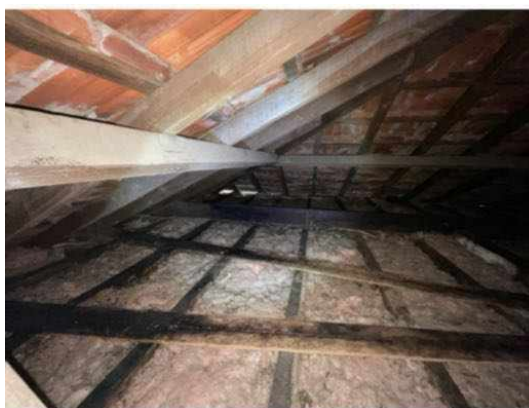
Due to access limitations within the roof space, the inspection was restricted. The presence of structural irregularities, moisture staining, and pest evidence highlights the importance of further investigation prior to purchase. Any recommended remedial works should be considered as part of the client's overall purchase decision.

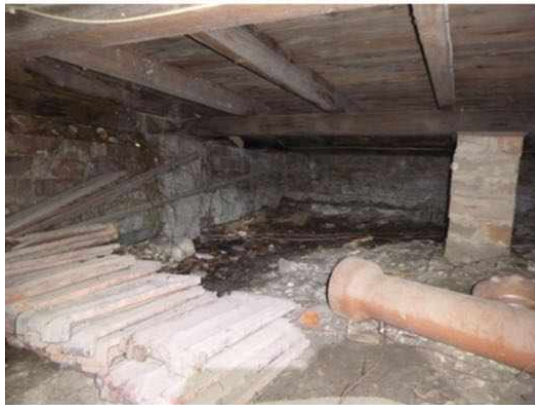
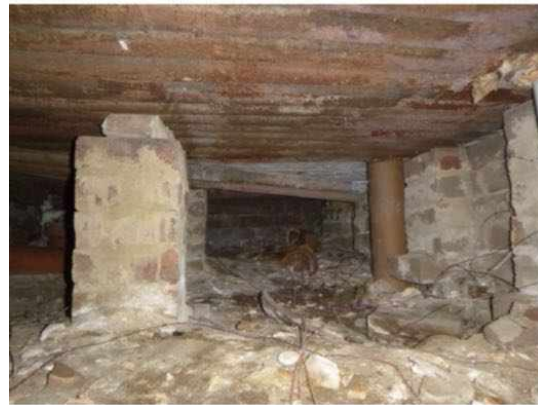
Building: Main Building
 Location: Subfloor
 Finding: Subfloor Inspection Summary
 Information:

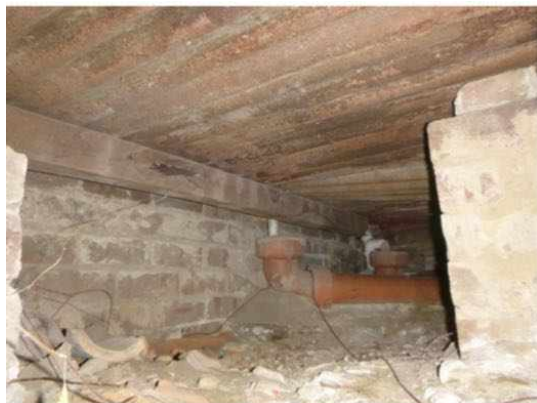
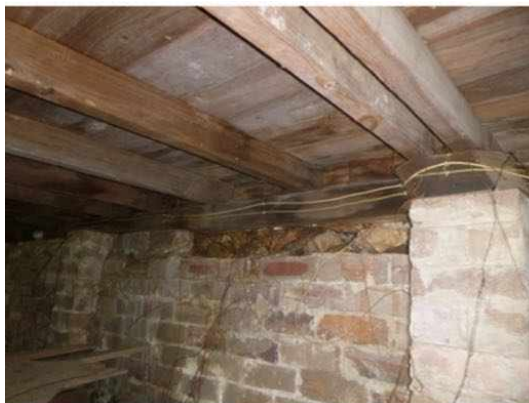
Building: Main Building
 Location: All Areas
 Finding: Water service - Disconnected.
 Information: Important Limitation – Plumbing Fixtures Not Tested

- A licensed plumber should be appointed promptly to:
- Inspect the water meter and mains supply
- Test the plumbing system for any hidden leaks
- Confirm the integrity of the water service and associated pipework

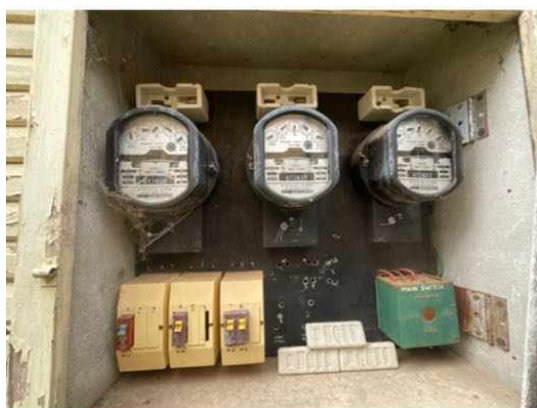
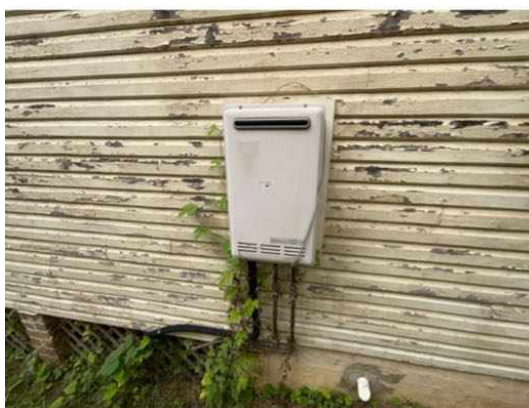
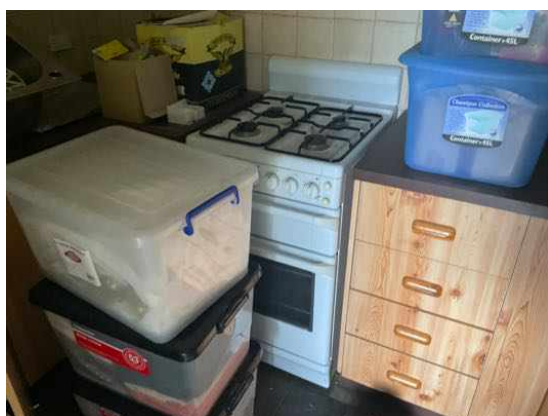
Building:	Main Building
Location:	All Areas
Finding:	Plumbing, Electrical & Gas Installations – Scope and Recommendations.

While this inspection includes observations of visually apparent defects relating to plumbing and electrical elements, it does not assess compliance with current regulations. Legislation requires that any such assessment be undertaken and documented by licensed electricians and plumbers.

- Any gas appliances (if applicable) must be inspected by a licensed gas plumber to confirm they are operating safely and efficiently.
- We also recommend that all other plumbing and electrical installations be thoroughly checked by qualified professionals to ensure they are functioning correctly and meet current safety and compliance standards.
