Building and Timber Pest Inspection Report

Inspection Date: Thu, 26 Mar 2026

Property Address: u9/601 Elgar Rd, Mont Albert North VIC
3129

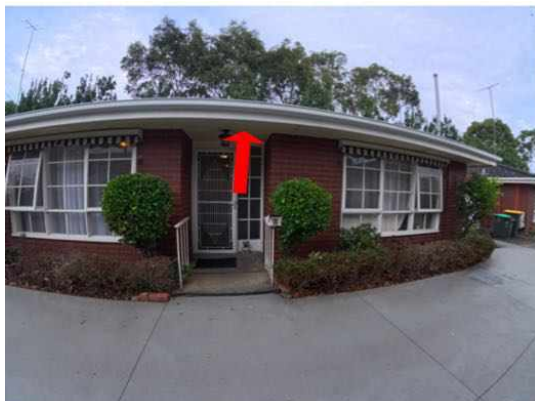
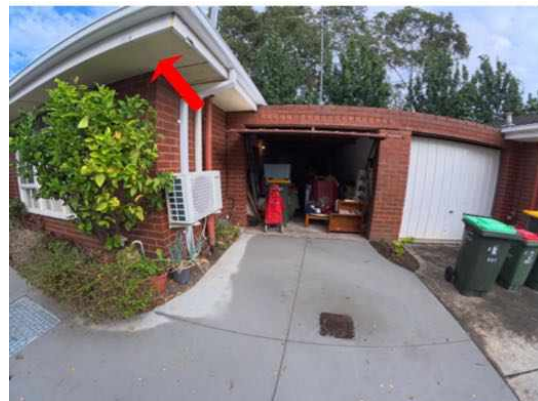
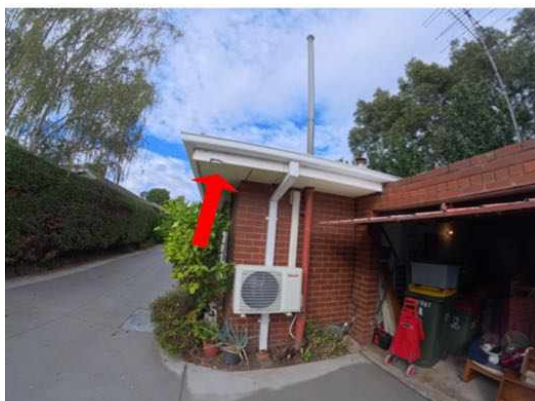
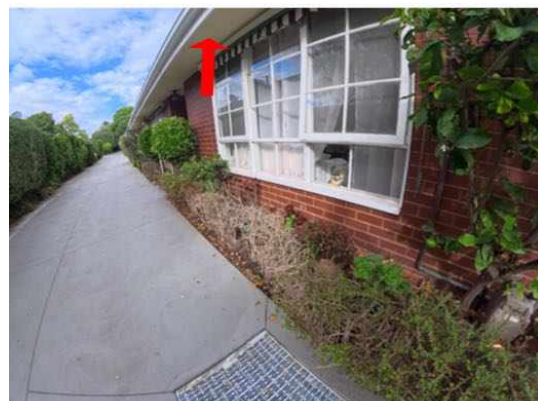
Building:	Main Building
Location:	Roof Eave Sheets
Finding:	Asbestos - Suspected ACM Identified on Site (Roof Eave sheets)
Information:	Reporting on Asbestos is outside the Scope of this Report. This suspected defect is highlighted as a caution only. We suspect, based on our experience in the building industry, that there is a higher risk of the identified building element containing asbestos.

As Asbestos Reporting is outside the scope of this report, we advise that you consider a separate Asbestos Inspection and Condition Audit, which can include the taking of samples for definitive confirmation of the presence of Asbestos.

In the interim, the client is advised to act with caution, especially when considering any damage to building materials general wear and tear renovations extensions demolition and general maintenance activities due to the suspected presence of Asbestos.

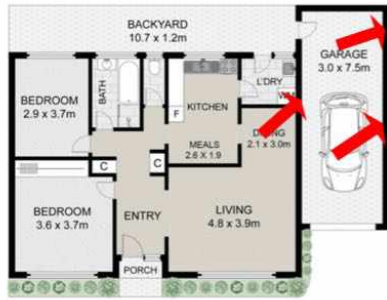
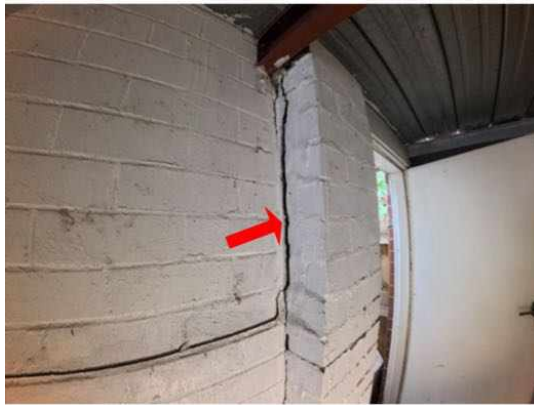
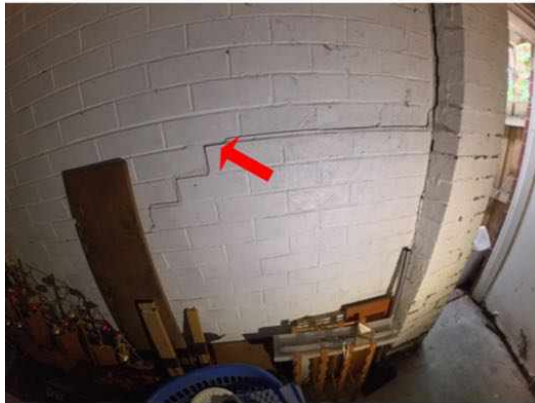
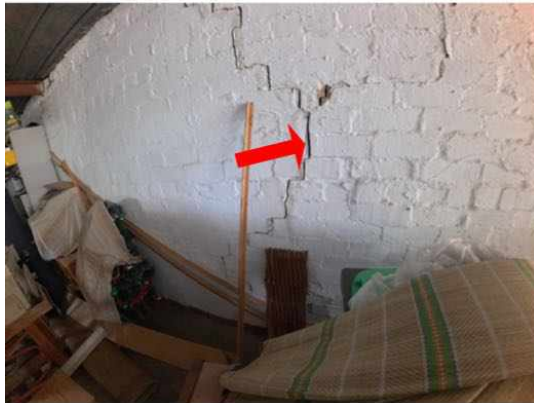
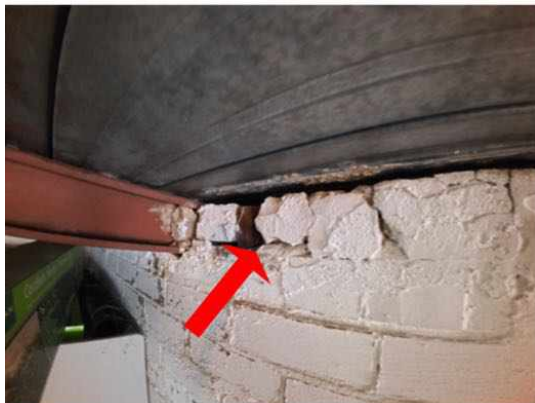
Building:	Main Building
Location:	Garage
Finding:	Brick Wall – Stepped Cracking Observed (3–10mm)
Information:	At the time of inspection, stepped cracking was observed in the brick wall, with crack widths ranging approximately from 3mm up to 10mm. This type of cracking typically follows the mortar joints and is commonly associated with foundation movement, footing settlement, or differential movement within the structure.

Cracks of this magnitude are considered significant and may indicate ongoing structural movement rather than superficial or cosmetic issues. Potential contributing factors may include reactive soil conditions, moisture variation, inadequate footing support, or poor site drainage.

If left unaddressed, such cracking may lead to further structural movement, widening of cracks, water ingress, and potential compromise of the building's integrity.

It is strongly recommended that the owner engage a qualified structural engineer to assess the extent and cause of the cracking. Remedial works may include foundation stabilisation (e.g. underpinning), crack repair, and improvement of site drainage conditions. Ongoing monitoring is also advised to determine whether movement is active.

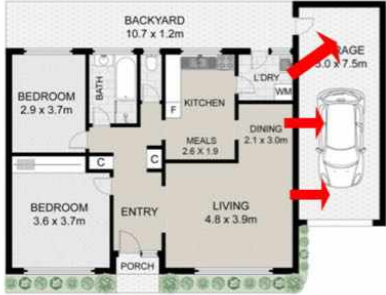
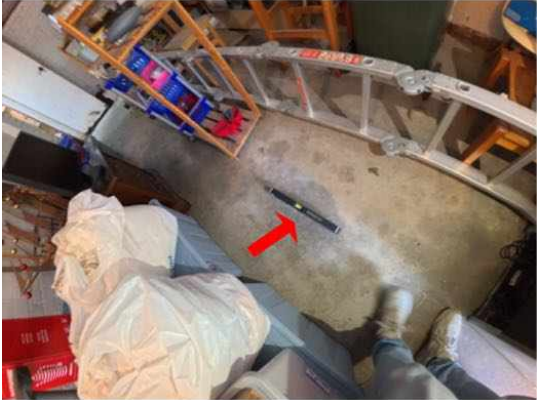
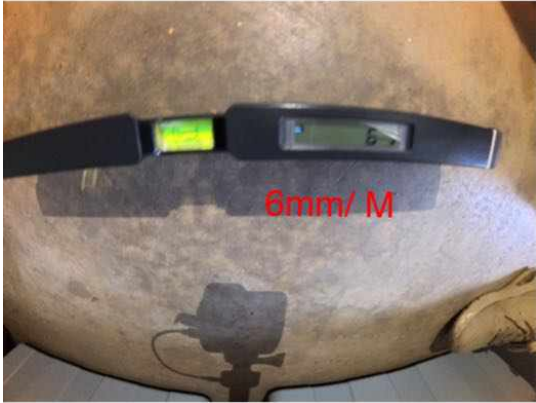
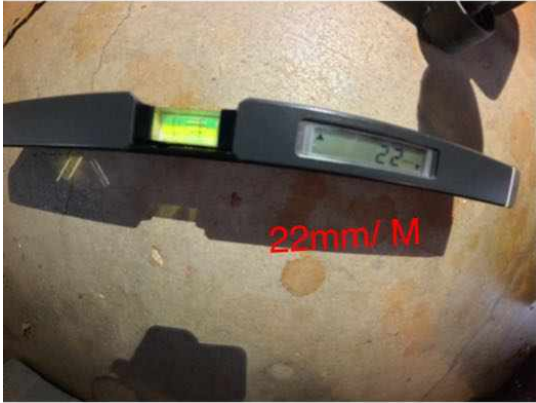
Finding 2.02

Building: Main Building
 Location: Garage
 Finding: Garage Floor – Severe Unevenness
 Information: At the time of inspection, the garage concrete floor was observed to be severely uneven, with an estimated slope of approximately 35mm per metre, which is considered excessive and beyond acceptable construction tolerances.

This condition may be associated with foundation movement, slab settlement, poor workmanship, or subgrade failure. In some cases, it may also indicate ongoing structural movement affecting the slab.

If left unaddressed, this may result in water drainage issues, trip hazards, progressive cracking, and potential impact on adjacent structural elements.

It is recommended that the owner engage a qualified structural engineer or builder to assess the cause of the unevenness. Remedial works may include re-leveling, grinding, or structural rectification depending on severity.

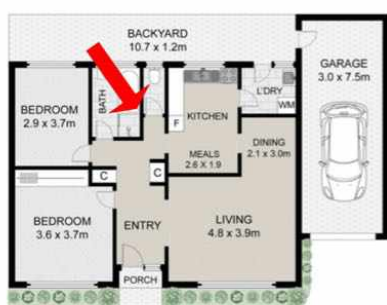
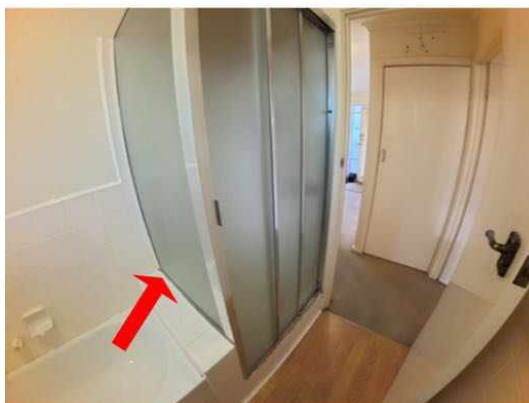
Finding 2.03

Building:	Main Building
Location:	Bathroom
Finding:	Bathroom – Shower Area Water Leaking Around Shower Screen
Information:	During the inspection, active signs of water leakage were observed around the shower screen perimeter within the bathroom.

Moisture readings taken around the shower screen frame and adjoining wall junctions indicated elevated levels compared to unaffected areas.

This condition was recorded at the time of inspection as a waterproofing defect.

Until repairs are completed, water usage in this shower should be minimised to prevent further leakage or hidden water damage.

All remedial works must comply with AS 3740 and AS 3958.1 standards.

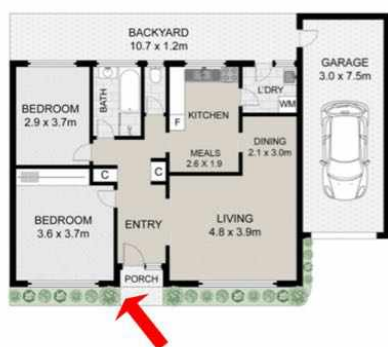
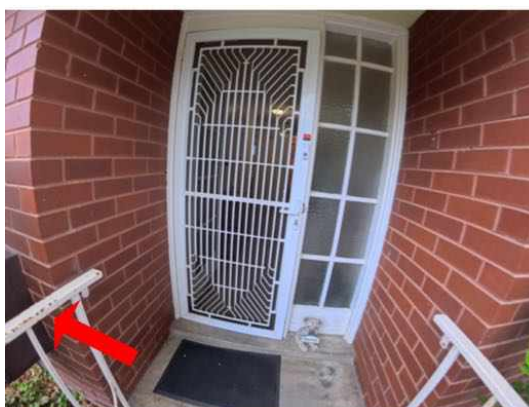
Finding 3.01

While the current extent of corrosion appears to be surface-level, if left untreated, it may lead to progressive material deterioration, reduced structural integrity, and potential safety concerns.

It is recommended that the owner engage a qualified tradesperson to treat the affected areas, which may include removal of rust, application of anti-corrosion treatment, and repainting or recoating. Severely affected sections may require repair or replacement to ensure durability and safety.

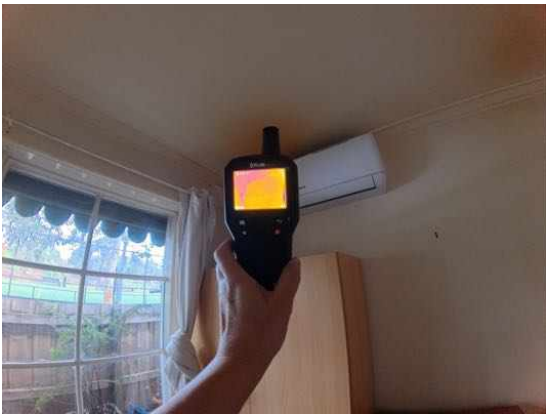
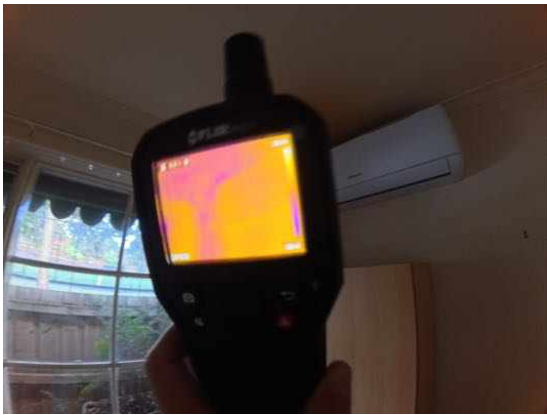
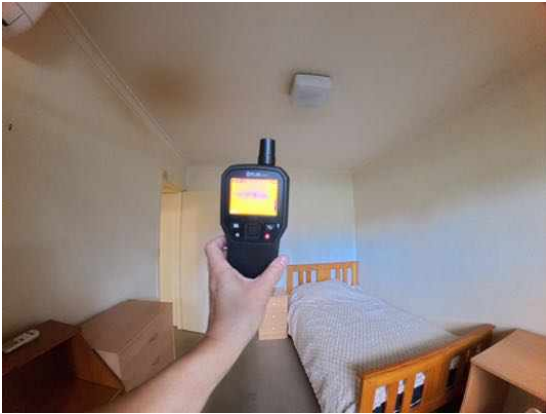
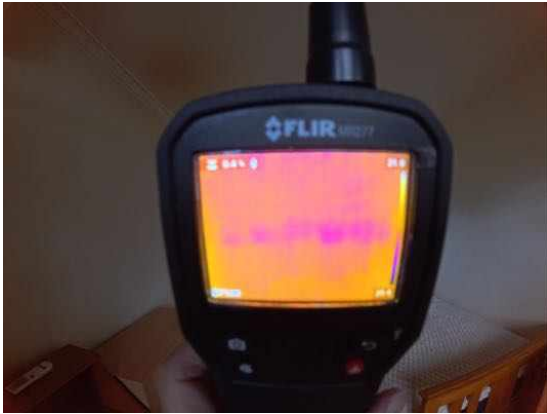
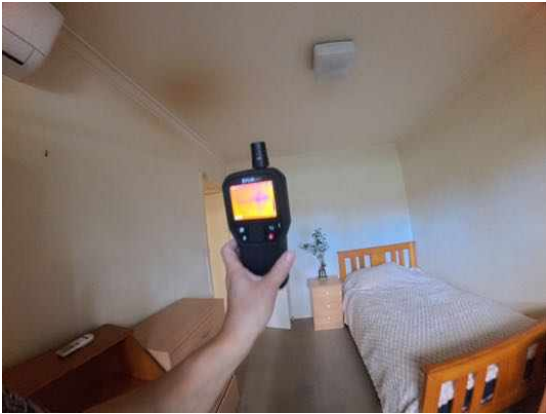
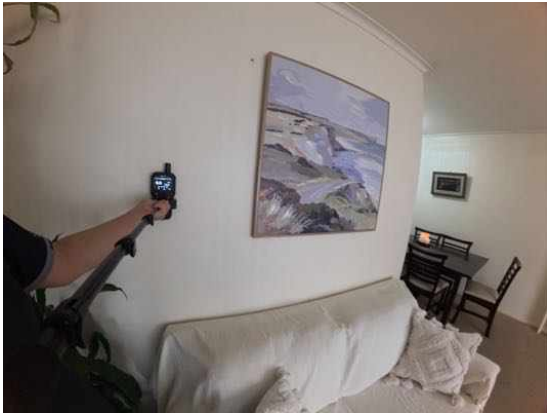
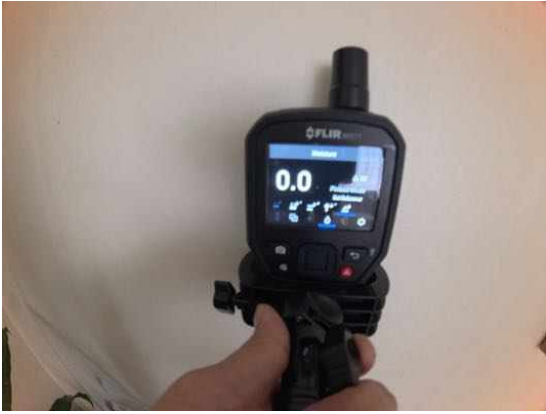
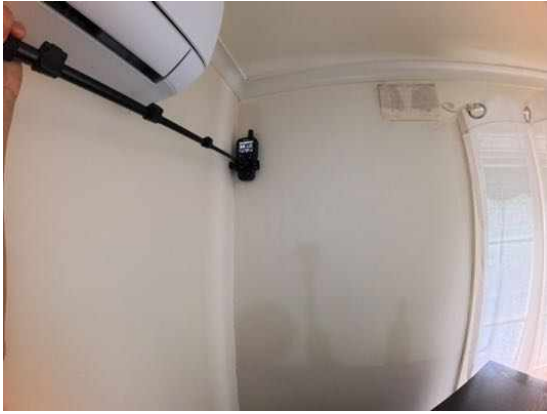
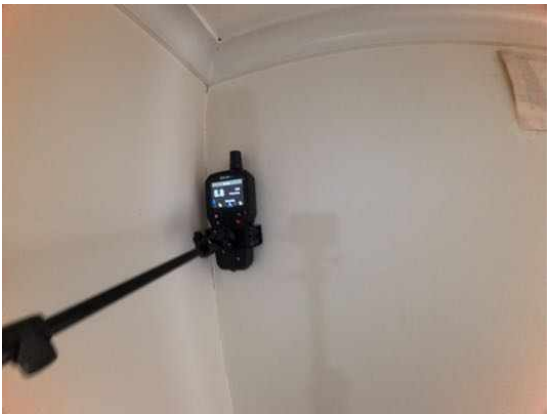
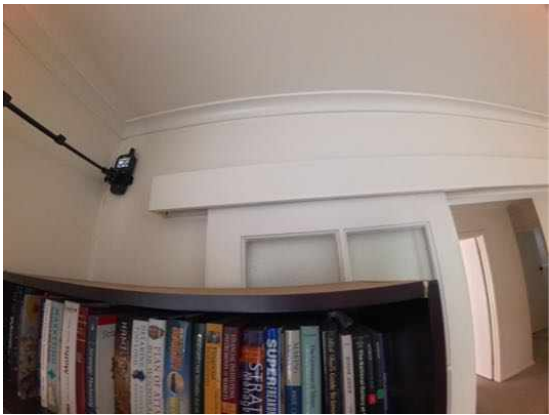
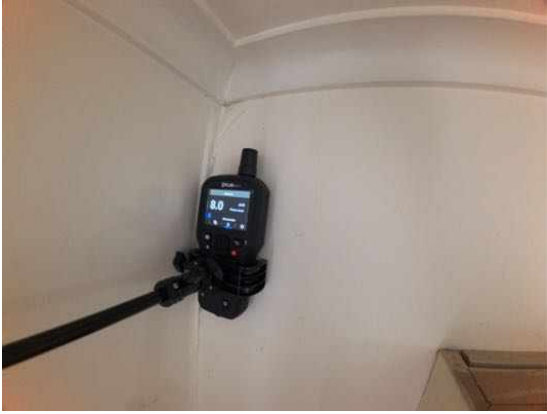
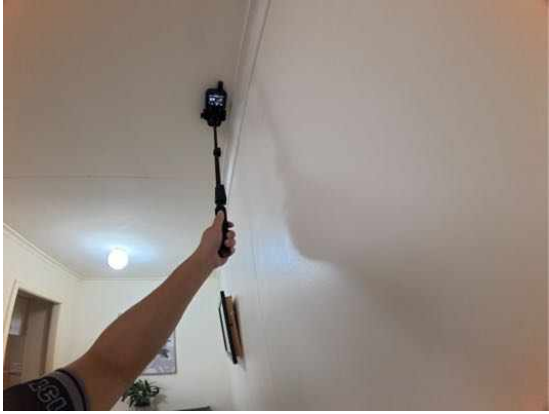
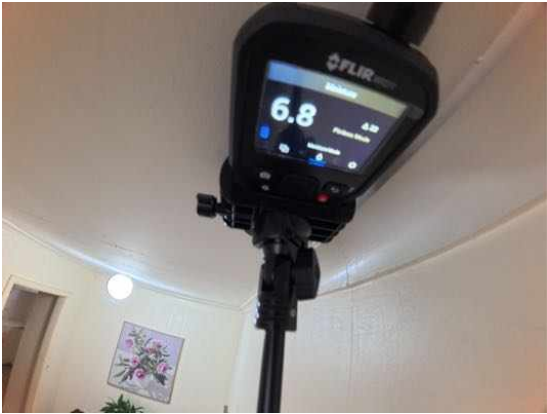
Building:	Main Building
Location:	All Internal Areas
Finding:	Ceiling – Moisture Testing (Minor Moisture Detected)
Information:	At the time of inspection, moisture testing to the ceiling area identified minor elevated

moisture readings. While no active leakage was directly observed, the presence of moisture indicates possible water ingress.

Based on the overall site observations, including accumulation of leaves and debris within the roof gutter system, there is a strong likelihood that blocked gutters may have caused water backflow (overflow), allowing moisture to enter the ceiling space.

If left unaddressed, this condition may lead to water staining, deterioration of ceiling materials, mould growth, and potential damage to internal building elements.

It is recommended that the owner engage a qualified roof plumber or contractor to clean the gutters, ensure proper drainage, and inspect the roof and gutter system for any defects. Ongoing monitoring of the ceiling area is also advised to confirm whether moisture levels stabilise after rectification.

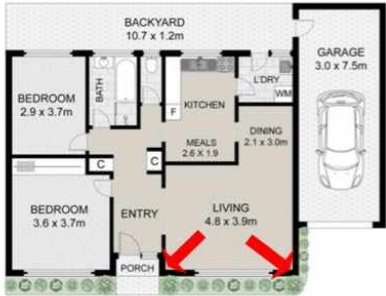
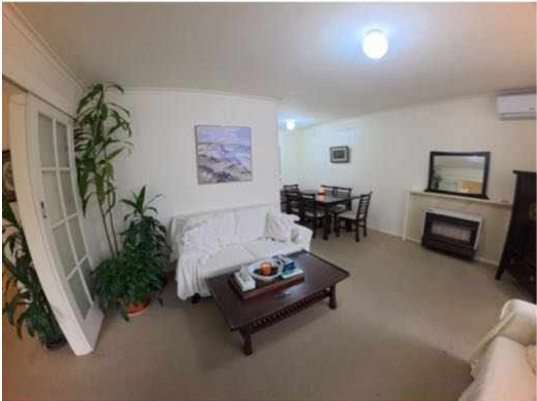
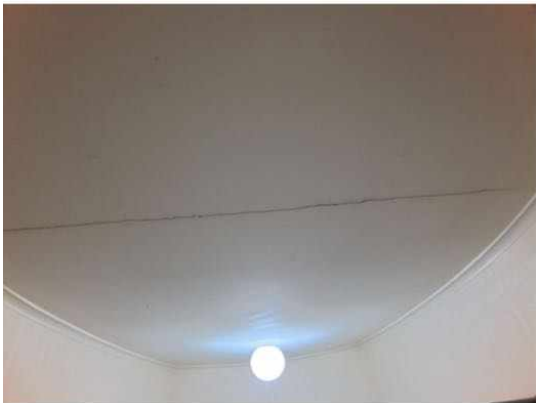
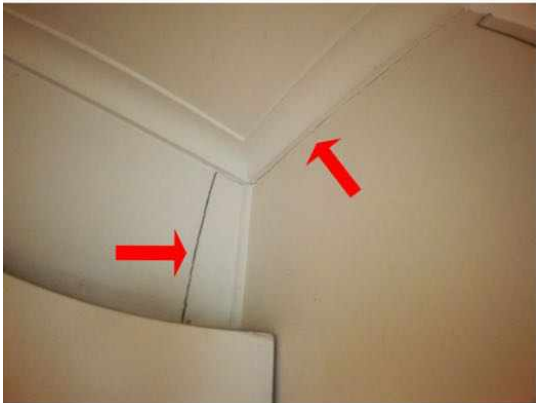
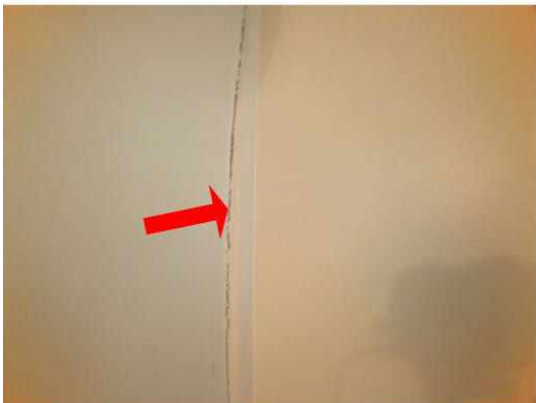
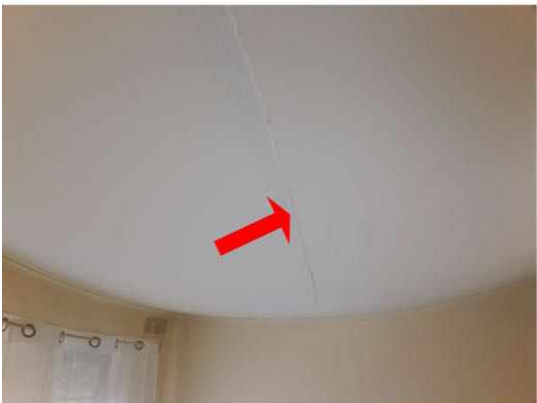
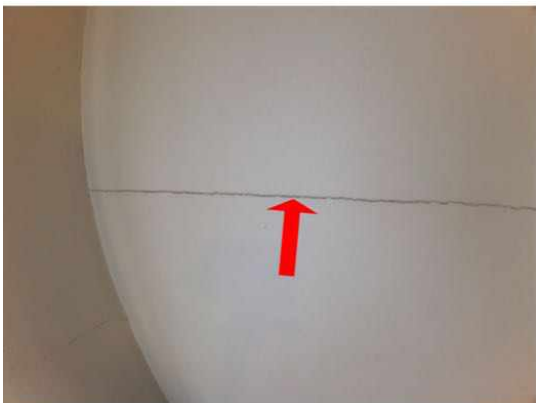
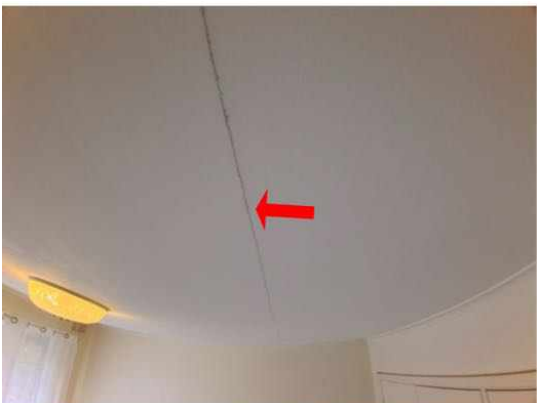
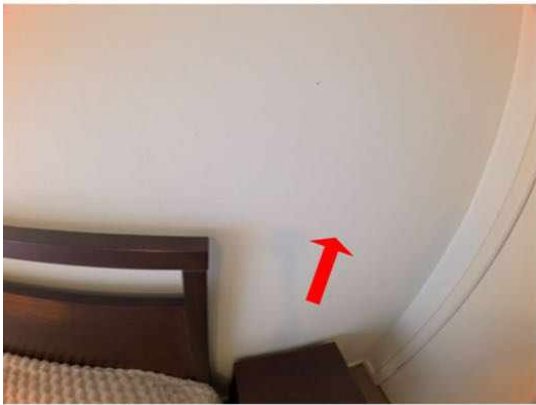
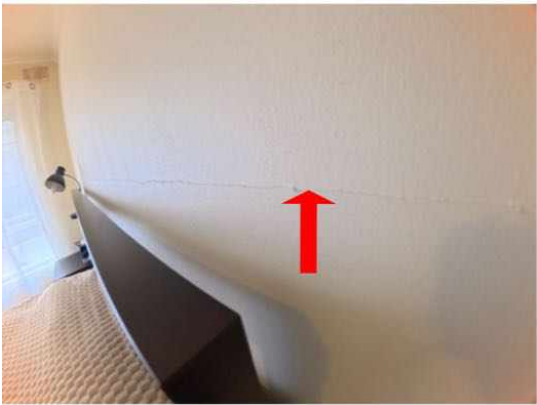
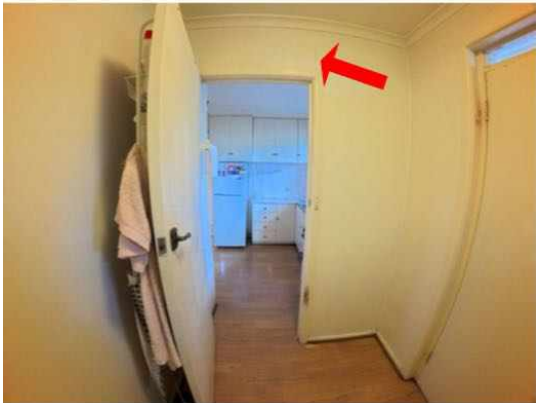
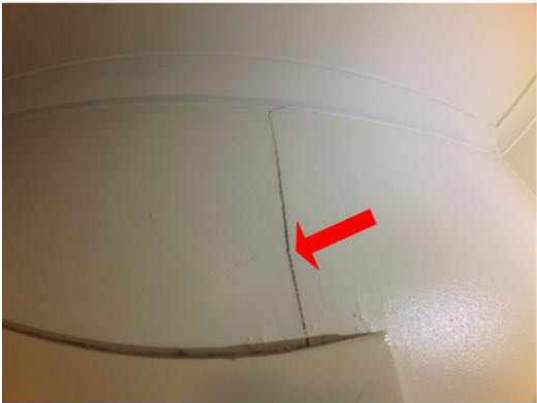
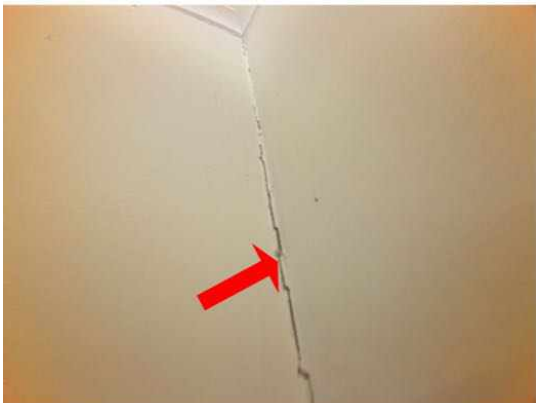
Finding 3.03

Building: Main Building
Location: All Internal Areas
Finding: Wall & Ceiling – Multiple Cracks Observed (Minor 1–3mm)
Information: At the time of inspection, multiple minor cracks (approximately 1–3mm in width) were observed to the wall and ceiling surfaces. Such cracking is commonly associated with building movement, material expansion and contraction, or minor settlement.

Based on site observations, it is possible that water ingress into the ceiling space (potentially due to gutter overflow/backflow) and/or additional loading from solar panel installation on the roof may have contributed to the observed cracking.

While the cracks are currently considered minor in nature, ongoing contributing factors may lead to further cracking, surface deterioration, or movement of building elements over time.

It is recommended that the owner monitor the affected areas. If cracks widen, extend, or become more numerous, further assessment by a qualified builder or structural professional is advised. Any identified water ingress issues should also be addressed to prevent ongoing damage.

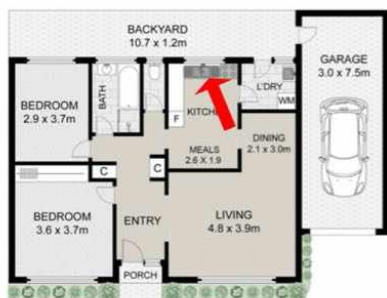
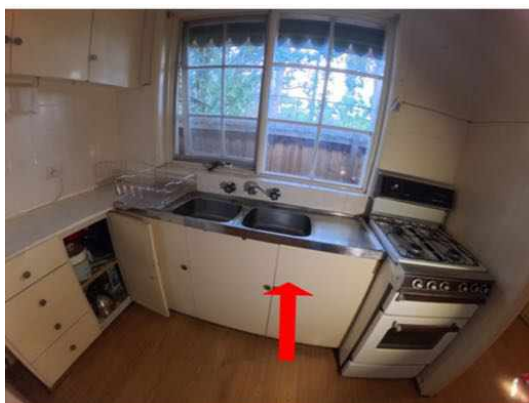
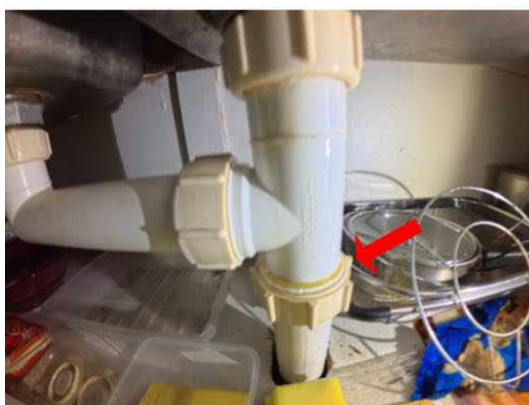
Finding 3.04

Building: Main Building
 Location: Kitchen
 Finding: Kitchen Sink – Water Leakage Observed

Information: At the time of inspection, a water leak was observed at the kitchen sink area, with moisture accumulation inside the cabinet beneath the sink. The leak is likely due to loose pipe connections, deteriorated sealant, or aging plumbing components.

If not addressed promptly, this condition may lead to material deterioration (swelling, warping, or decay of cabinetry and surrounding finishes), mould and bacterial growth, potential electrical hazards if moisture reaches nearby outlets, and increased risk of pest activity.

It is recommended that the owner engage a licensed plumber to inspect and repair the leak. Damaged components should be replaced or resealed where necessary. Consideration may also be given to installing moisture barriers or waterproof liners within the cabinet to reduce the risk of future damage.

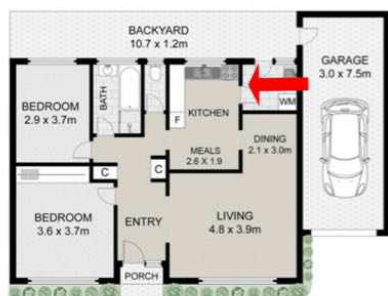
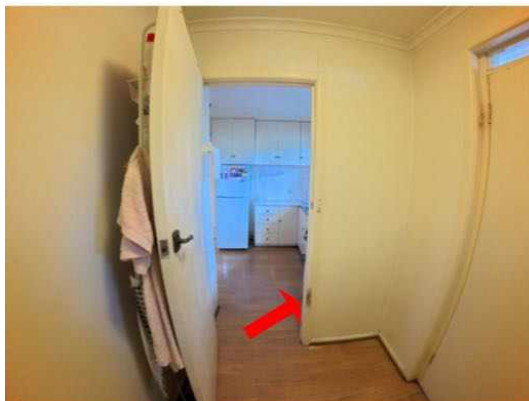
Finding 3.05

Building: Main Building
 Location: Laundry
 Finding: Internal Wall Finishes – Scratches and Dents (General Wear and Tear)
 Information: During the inspection, scratches and dents were observed on the internal wall surfaces of the property.

The defects were noted in multiple areas throughout the dwelling, including common living areas and hallways, which are typically subject to regular use and contact.

The scratches and dents appear consistent with general wear and tear from everyday use rather than structural or workmanship issues.

It is recommended that the owner engages a qualified painter or plasterer to carry out minor surface preparation and touch-up painting where necessary.

This maintenance work will help restore the wall finish appearance and maintain the property in good condition.

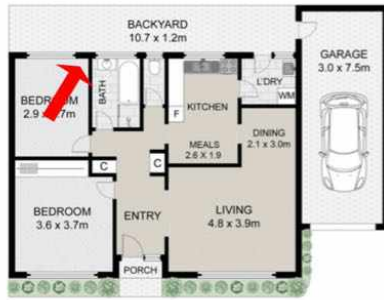
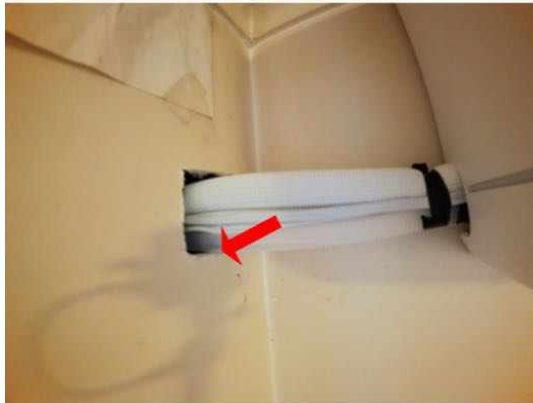
Finding 3.06

Building:	Main Building
Location:	Bedroom
Finding:	Wall Penetration – Not Sealed (Air Conditioning Pipe)
Information:	At the time of inspection, an air conditioning pipe penetration through the plaster wall was observed to be not properly sealed, with visible gaps around the opening.

Unsealed penetrations may allow air leakage, moisture ingress, dust accumulation, and potential pest entry into the wall cavity. Over time, this may lead to material deterioration, reduced energy efficiency, and possible internal damage within concealed areas.

It is recommended that the owner engage a qualified tradesperson to properly seal the penetration using appropriate materials to ensure a complete and durable finish.

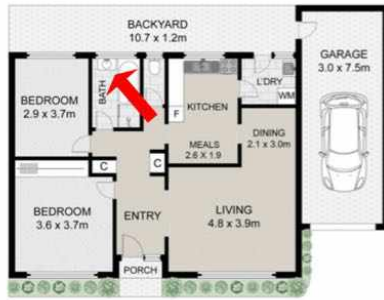
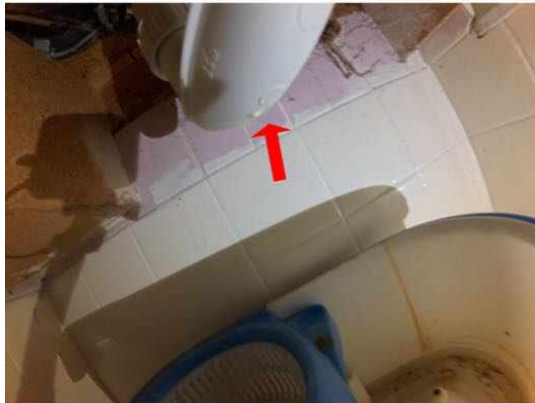
Finding 3.07

Building: Main Building
 Location: Bathroom
 Finding: Bathroom Basin – Water Leakage Observed
 Information: At the time of inspection, water leakage was observed from the bathroom basin pipework, likely originating from pipe connections, trap fittings, or deteriorated seals.

Ongoing leakage may result in moisture accumulation within the cabinet or surrounding areas, which can lead to material deterioration, mould growth, and potential damage to adjacent building elements if left unaddressed.

It is recommended that the owner engage a licensed plumber to inspect and repair the leaking pipework, and to replace any defective components to prevent further water damage.

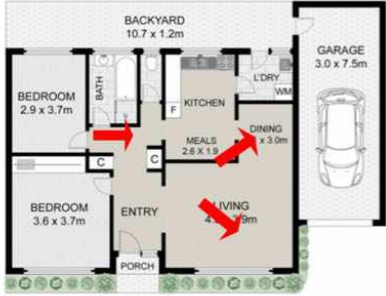
Finding 3.08

Information: At the time of inspection, nails are found popping out of the plasterboard, nails and screws are held by the friction between them and the surface that they are applied to. Over time, the nails and screws can back out, which is often a result of general ageing and deterioration of the building structure.

If left unmanaged, internal wall and ceiling sheeting may become loose and unstable, increasing the rate of deterioration of these building elements and creating potential for the development of secondary defects.

Re-fastening of popped nails will help to maintain the stability of these, and associated, building elements. Such minor works will also help to improve the appearance of the affected area and secure the linings. These works should be performed by a qualified carpenter or plasterer at client discretion.

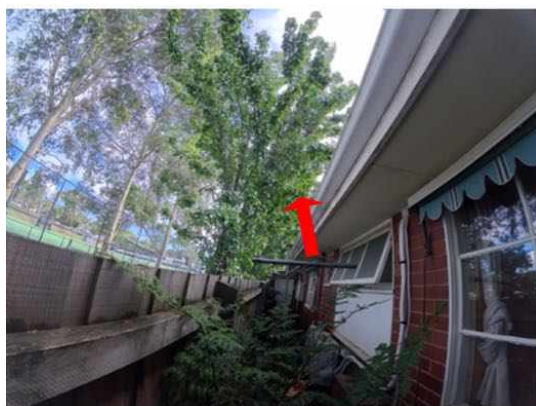
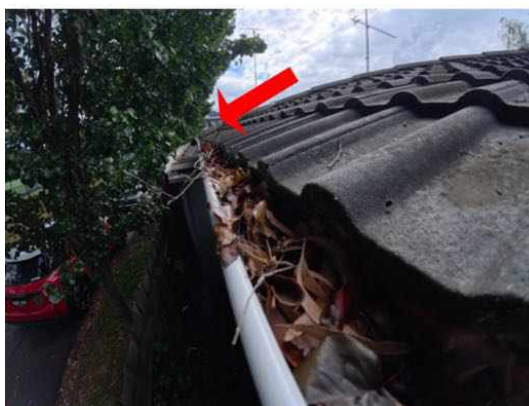
Building: Main Building
Location: All External Areas
Finding: Bridging - Vegetation
Information: Where vegetation obstructs inspection of building elements, also known as bridging as it provides a bridging point for the access of termites, full inspection can not be achieved. Consequently moisture or dampness may be present and the areas becomes conducive to termite activity. Plants against or very close to buildings provide cover, shade and can provide an environment that is attractive to termite infestation.

The removal and replanting of species that do not provide "cover" or cutting back of existing vegetation will assist greatly in preventing Bridging from occurring.

The removal of any such materials that may be conducive to termite activity should be carried out as soon as possible and arrange re inspection to minimize the risk of termite attack.

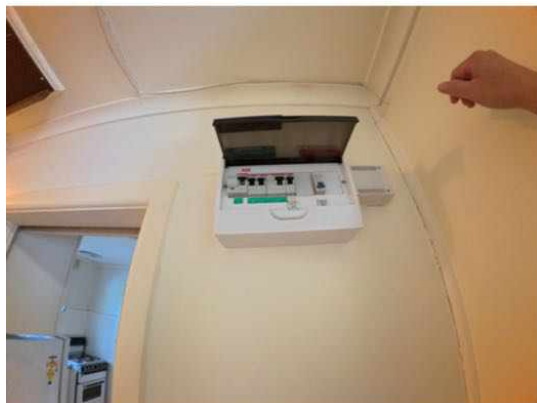
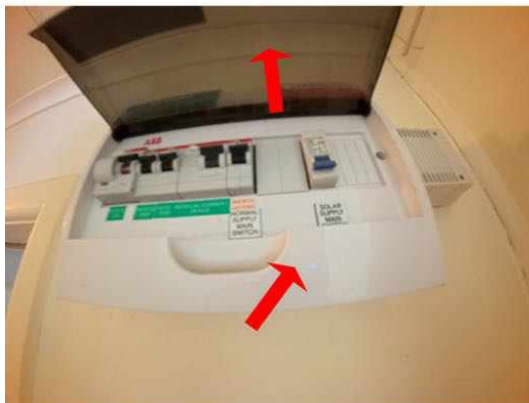
Finding 6.02

Building:	Main Building
Location:	All External Areas
Finding:	Termite Management System - no evidence of a chemical installation
Information:	The application of a post-construction chemical termite barrier is highly recommended for all properties, particularly if live termite activity has been found on the site previously. Such barriers are highly effective in preventing termite attack on any timber building elements throughout the property.

A durable notice should be placed in the switchboard unit to indicate current termite barriers. At the time of inspection, it appeared as though no termite management system has been installed, with no evidence to suggest preventative works taking place.

The client may consider gaining further advice from a pest controller as to the costs and procedures involved with this application. It is recommended that obtaining such advice be a short-term priority.

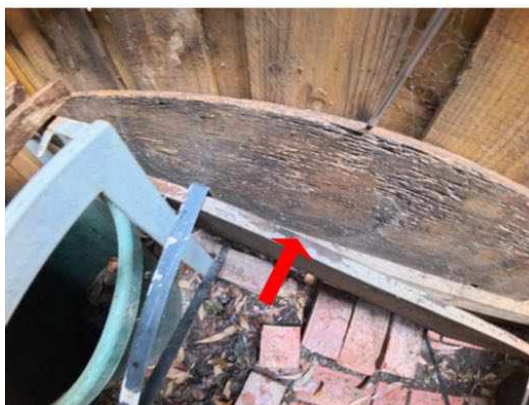
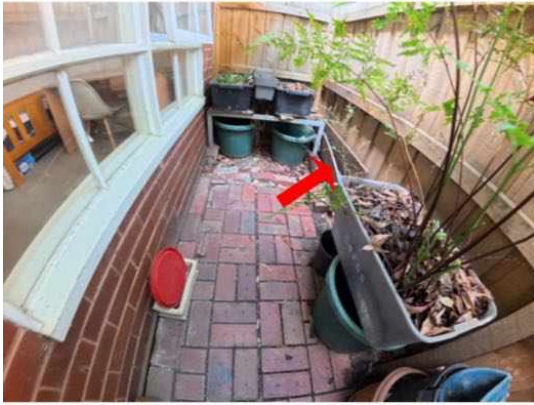
Finding 6.03

Building:	Yard
Location:	Back Yard / Subfloor
Finding:	Stored Items - Conducive to Timber Pest food sources
Information:	At the time of inspection, the following condition was observed: stored items were present within the garden.

The presence of stored materials can obstruct inspection access and create concealed conditions that are conducive to timber pest activity.

Stored items may retain moisture and restrict ventilation, increasing the likelihood of timber decay, mould growth, and termite infestations. In accordance with AS 4349.3, such conditions are classified as conducive to timber pest activity and may conceal existing infestations.

It is recommended that all stored items be removed from the garden to allow adequate ventilation, inspection access, and to reduce conditions conducive to timber pest activity.

The property owner should remove these stored items before further timber pest activity and damage occur, and engage a licensed Timber Pest Management company to implement appropriate pest management and control measures.

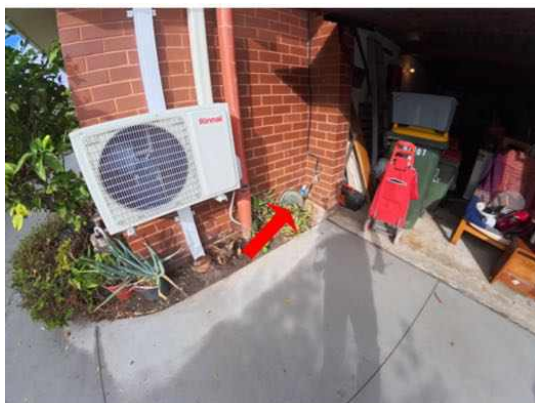
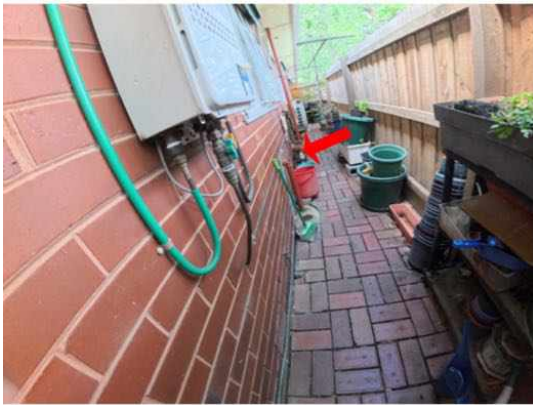
Finding 6.04

Building:	Yard
Location:	Yard - Front
Finding:	Garden Water Tap and Drain Misalignment
Information:	During the inspection, it was observed that the outdoor water tap is not properly aligned with the adjacent ground drain. As a result, discharged water does not flow directly into the drainage point and may instead accumulate around the base of the tap, creating localized damp conditions.

This installation issue reduces drainage efficiency and may lead to persistent moisture in the surrounding area. Prolonged water pooling can create a slip hazard, increase the likelihood of soil saturation near the building perimeter, and potentially contribute to moisture migration toward foundations. Ongoing damp conditions may also create an environment conducive to termite and timber pest activity, particularly where nearby timber elements or subfloor areas are present.

It is recommended that a licensed plumber be engaged to assess and rectify the installation. Rectification may involve repositioning the tap, adjusting the drainage alignment, improving surface fall, or installing an appropriate drainage or diversion system to ensure effective water discharge and minimise associated risks.

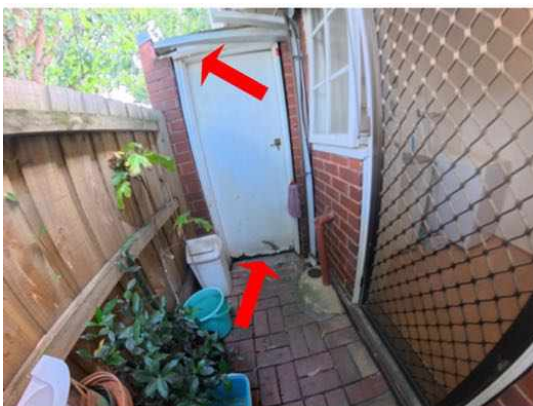
Finding 7.01

Building: Yard
 Location: Sub-floor Entry Gate, Timber Fence
 Finding: Fungal decay - absent at the time of inspection
 Information: At the time of inspection, no evidence of fungal decay was observed within the accessible areas inspected.

No visible signs of timber softening, discolouration, moisture-related deterioration, or fungal growth were identified during the inspection.

No further action is required at this stage.

Ongoing monitoring and routine maintenance are recommended to minimise the risk of future moisture-related fungal decay.
