Building and Timber Pest Inspection Report

Inspection Date: Thu, 26 Mar 2026

Property Address: u9/601 Elgar Rd, Mont Albert North VIC
3129

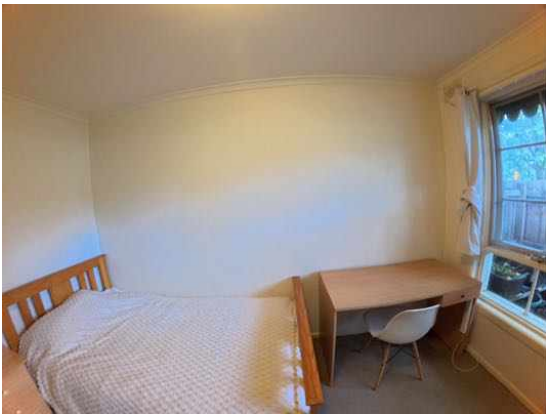
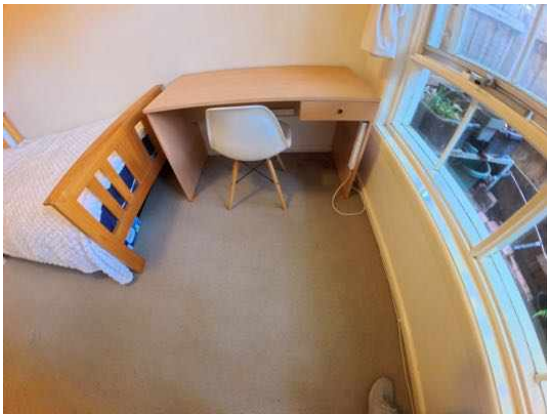
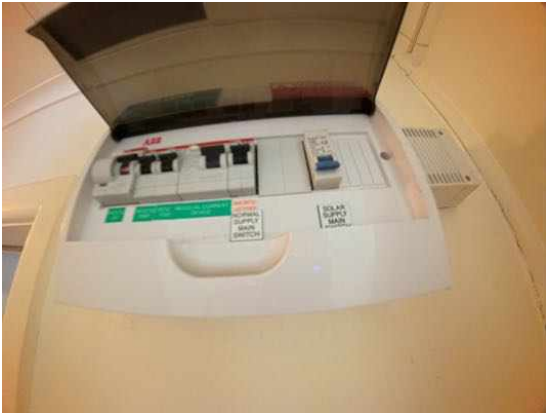
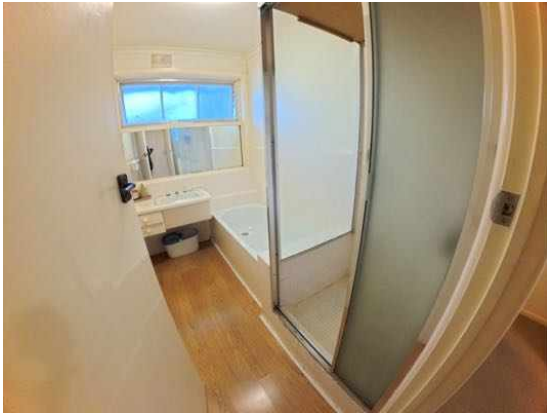
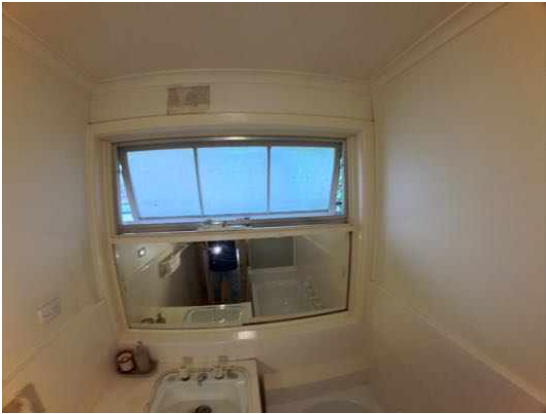
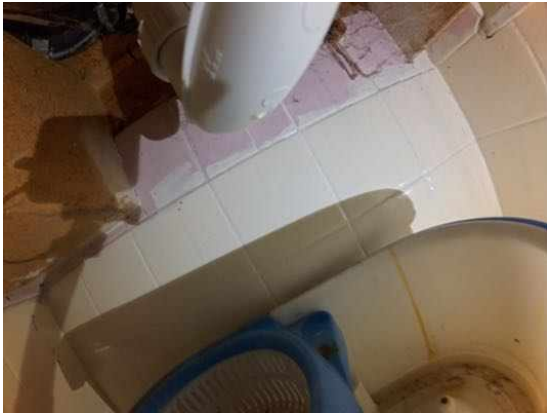
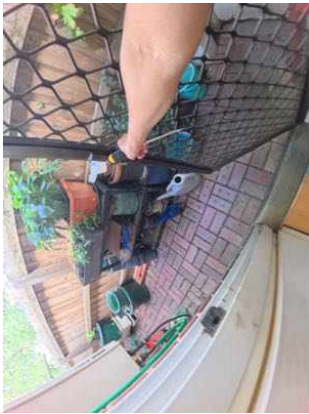
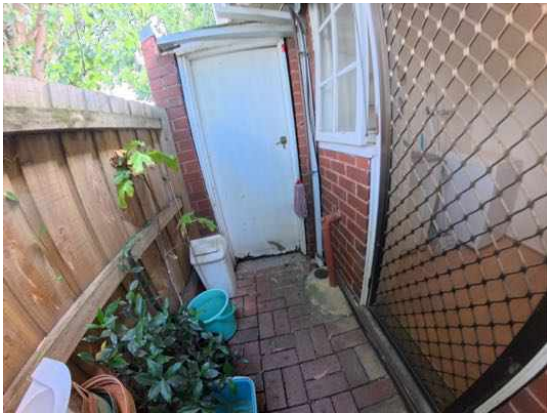
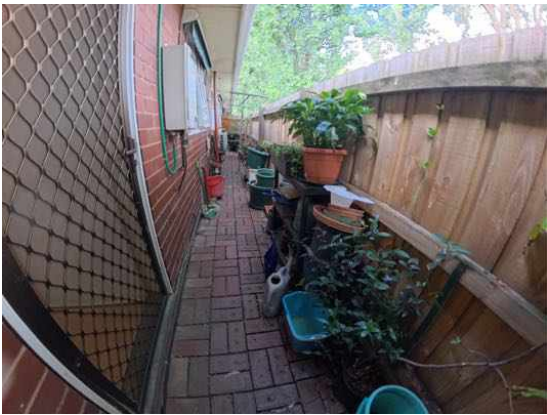
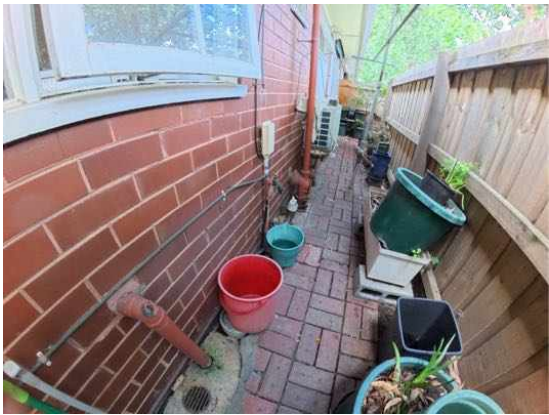
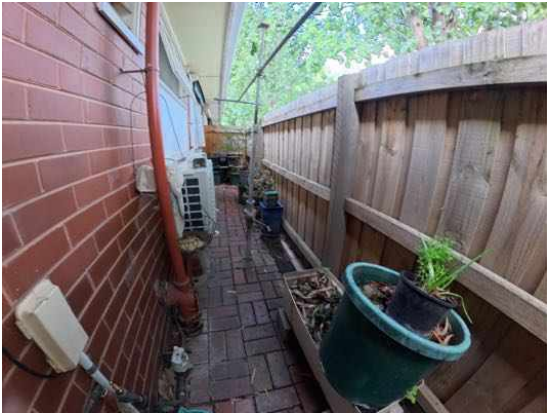
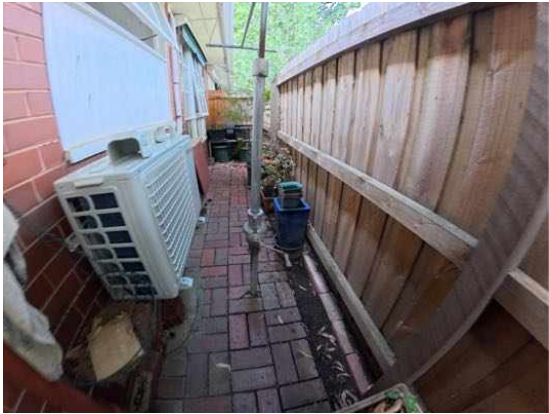
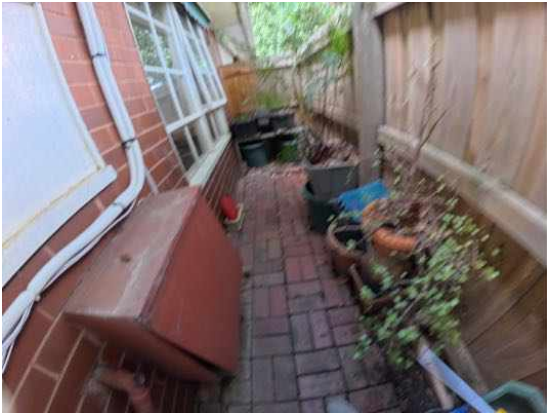
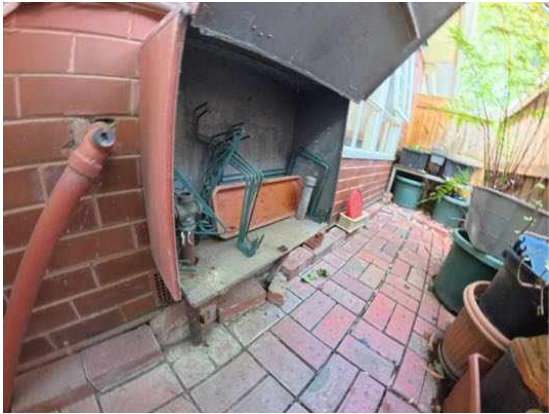
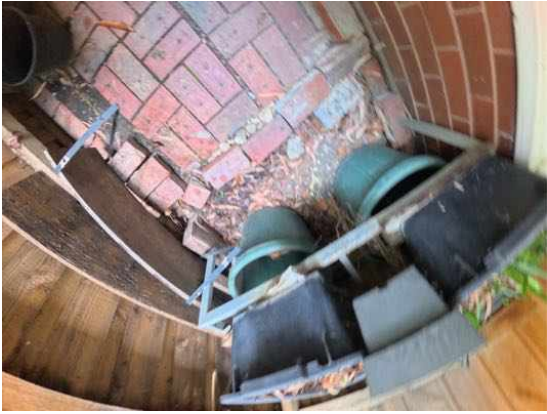
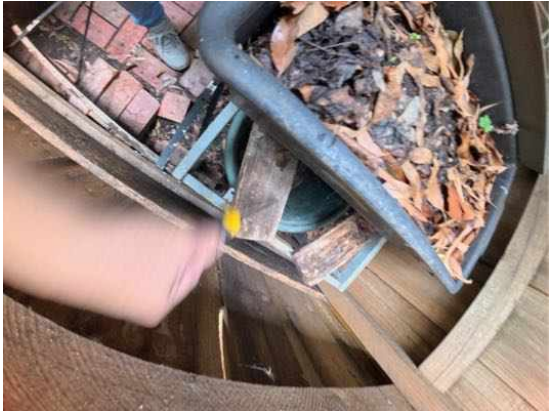
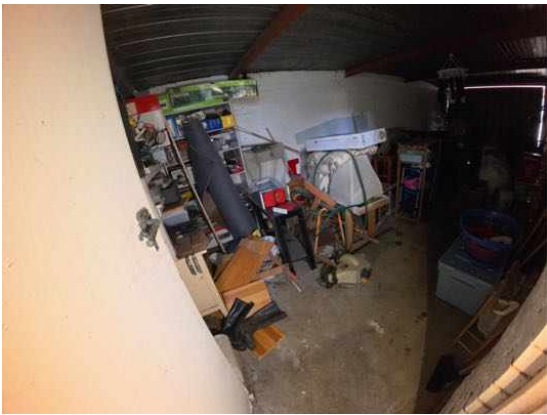
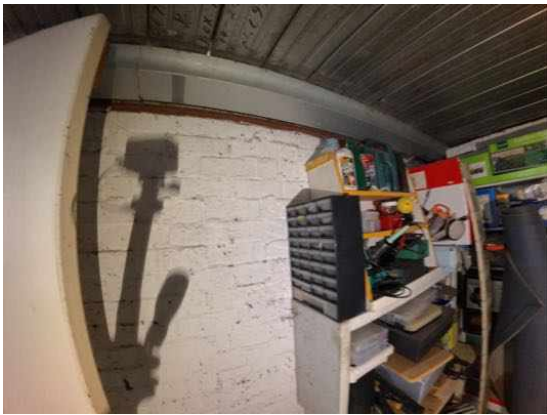
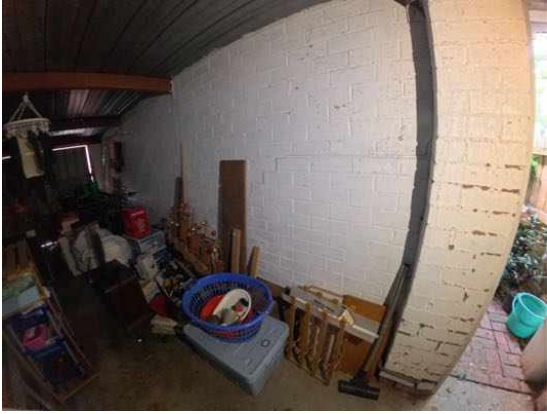
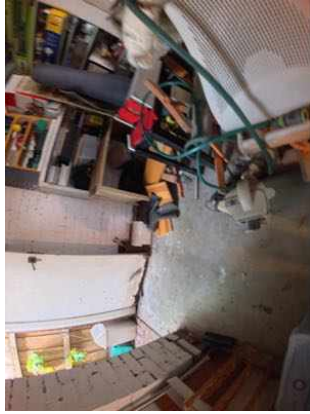
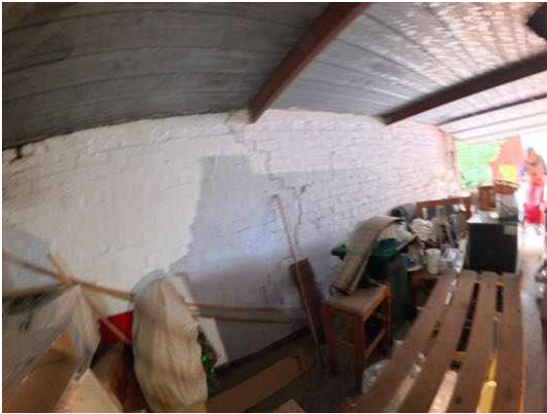
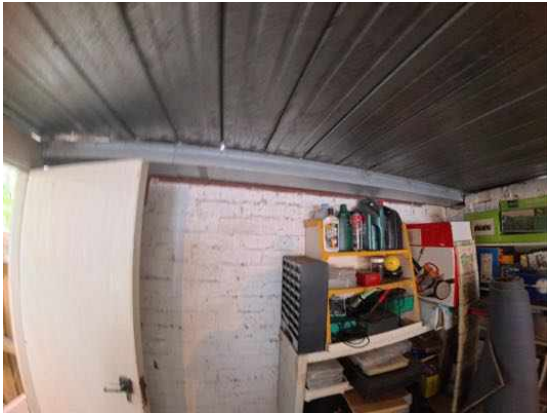
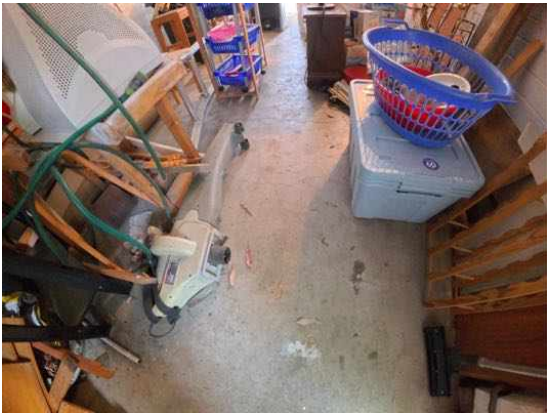
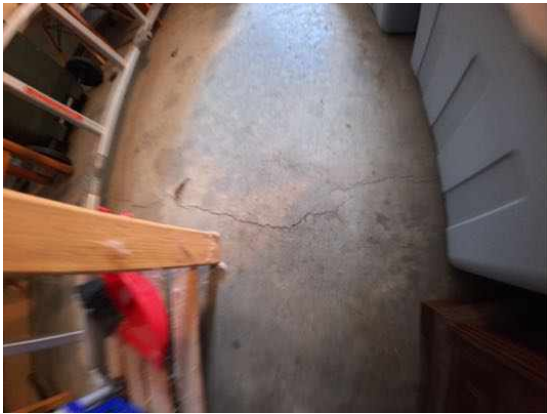
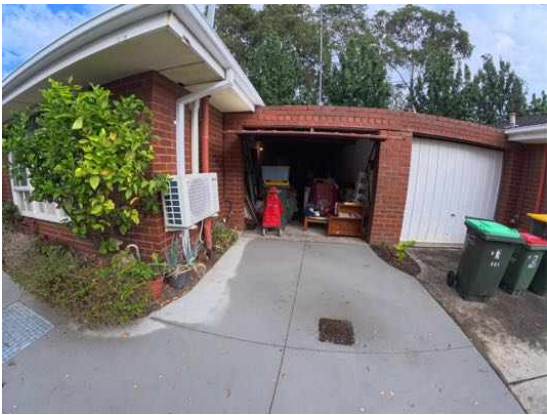
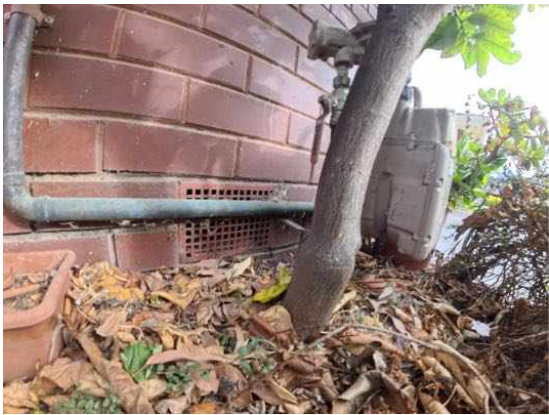
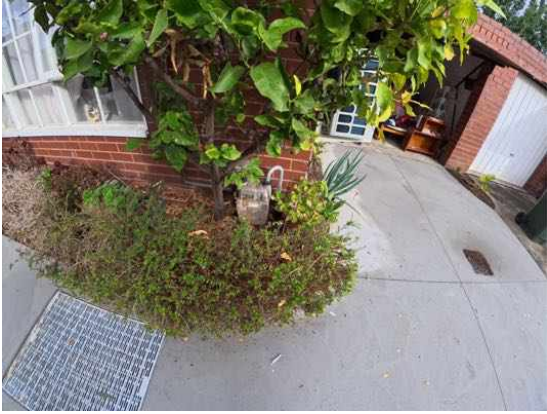
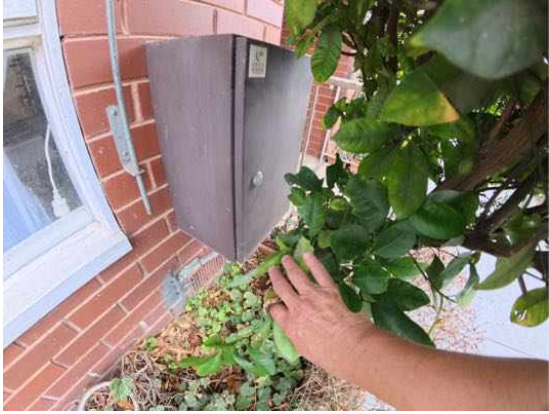
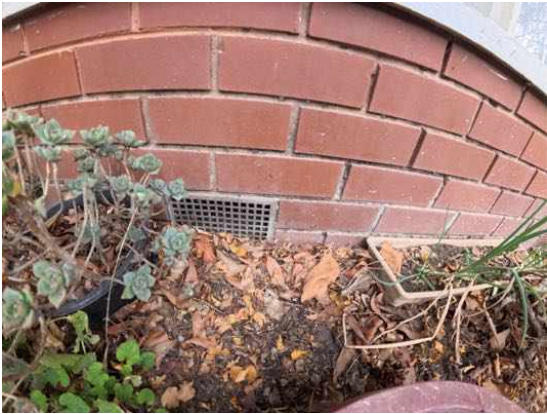
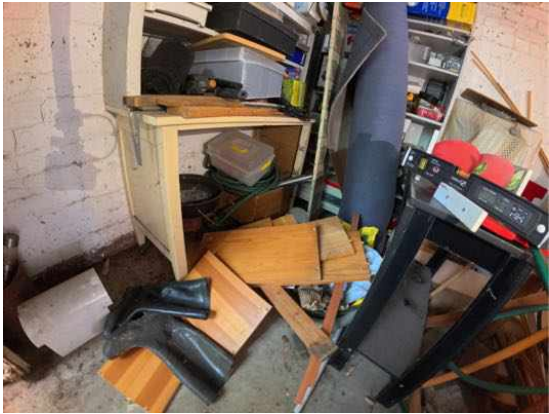
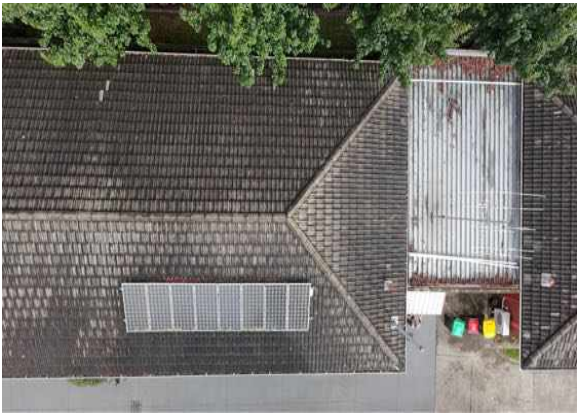
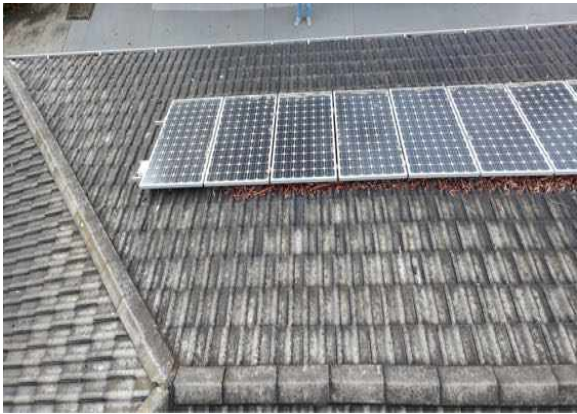
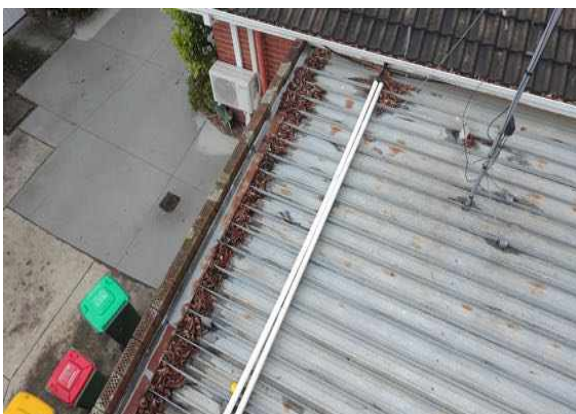
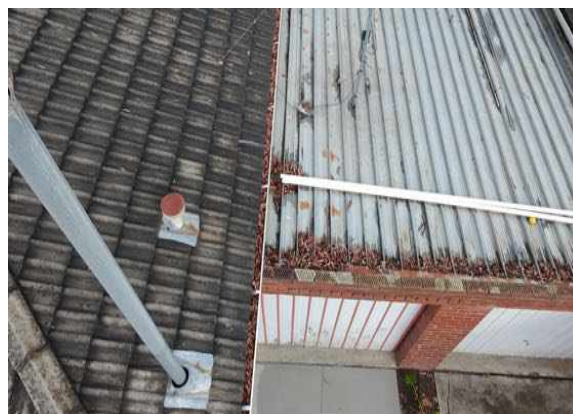
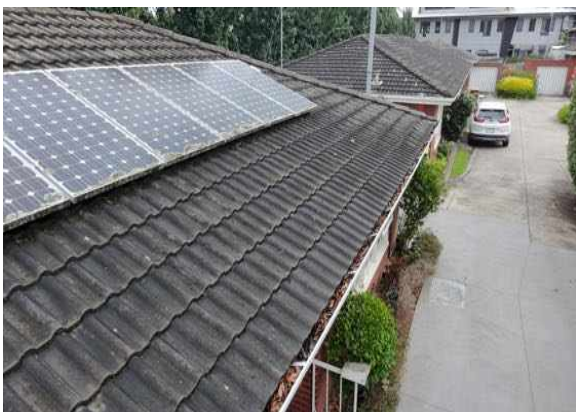
Building: Main Building
Location: Meter Box
Finding: Additional Photos - Obstructions and Limitations
Information: These photographs are an indication of the obstructions and limitations which impeded full inspection of the property at the time of inspection. These obstructions can hide an array of defects and should be removed to allow full inspection to be carried out. A re-inspection is recommended once the areas are made accessible.

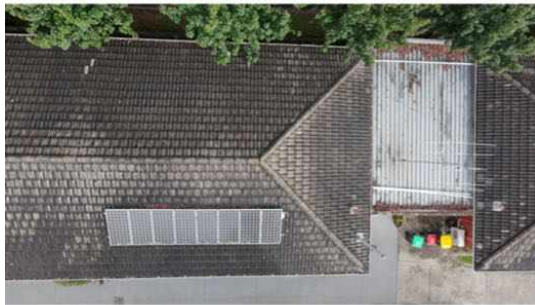
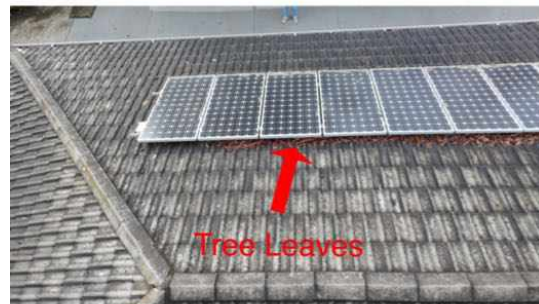
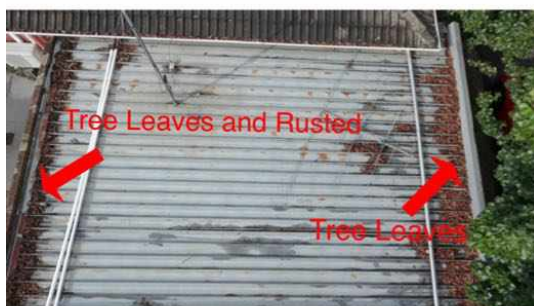
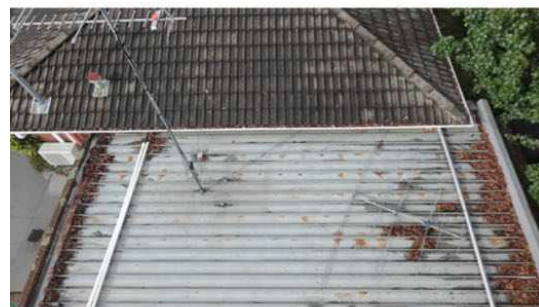
Building: Main Building
 Location: Roof Exterior
 Finding: Roof Condition Checking – Drone Observation Report
 Information: During the inspection, the roof structure and external cladding were visually assessed using drone-assisted observation.

The roof was found to be in generally serviceable condition, with several maintenance or minor defects noted, including:

At the time of inspection, debris accumulation was observed within sections of the roof gutters. The debris consisted primarily of leaves and general organic material that had collected over time.

Accumulated debris within gutters can restrict the proper flow of rainwater, potentially leading to water pooling, gutter overflow, and increased moisture around the roof edge and building perimeter. If left unaddressed, this condition may contribute to premature deterioration of gutter components

At the time of inspection, sections of building paper (sarking) were observed to be exposed within the roof space. Sarking functions as a secondary weather barrier beneath the roof covering, assisting in preventing moisture ingress and improving the overall weather resistance of the roof system.

Where sarking is exposed or displaced, it may indicate that the material is not properly installed or secured. It is also possible that the sarking may be exposed at the lower wall junctions or external eave areas, which may reduce its effectiveness in preventing the entry of moisture, dust, or wind-driven rain into the roof cavity. Although no active water leakage was observed at the time of inspection, the exposed condition may increase the risk of moisture penetration if not addressed.

In addition, no active leakage was observed at the time of inspection, although past moisture staining was evident in isolated areas.

Routine maintenance is recommended to prevent deterioration.

It is recommended that the owner engages a licensed roofer or roof plumber to:

If structural deformation or active leakage is later identified, a licensed roof plumber, builder or structural engineer should carry out a detailed assessment.

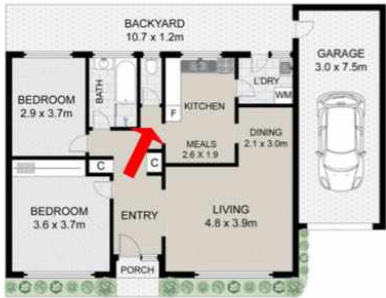
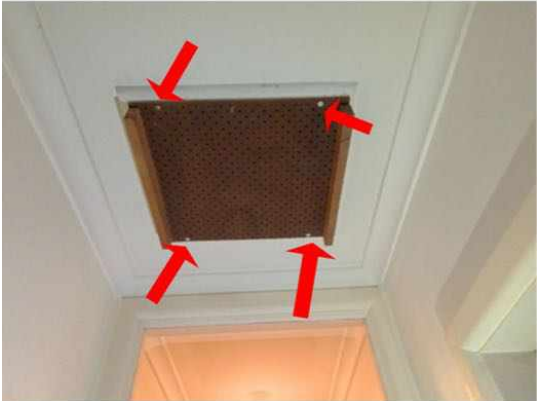
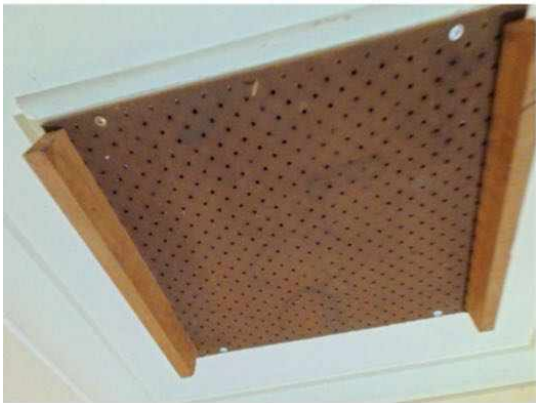
Building: Main Building
Location: Hallway
Finding: Roof Space – Unable to Access (Manhole Fixed/Sealed)
Information: At the time of inspection, the roof space could not be accessed as the manhole access point was fixed/sealed and unable to be opened.

As a result, the condition of the roof space, including roof framing, insulation, and any potential signs of water ingress, structural issues, or pest activity, could not be assessed.

It is recommended that the owner arrange for the manhole to be safely opened or reinstated for access, and a follow-up inspection be carried out to assess the roof space condition.
