Building Inspection Report

Inspection Date: Wed, 25 Mar 2026

Property Address: 6/181 Riversdale Rd, Hawthorn VIC 3122,
Australia

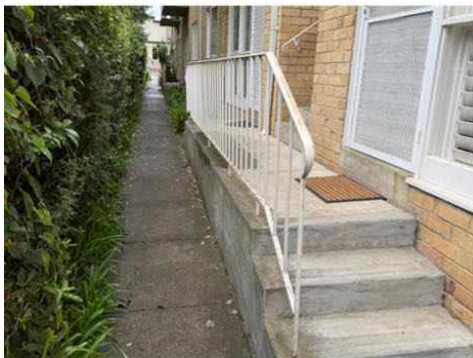
Defects 3.01

Building:	Building 1
Location:	All Areas > All Areas
Finding:	Building element - Rusted or corroded
Information:	Some exterior building elements and materials that show evidence of rusting and corrosion, has likely developed as a result of excessive exposure to moisture, harsh weather conditions and or inadequate coatings. A surface that is found to be rusted provides no protection to the underlying iron, the deteriorating condition is likely to worsen if not addressed and left unmanaged, it is therefore recommended that the relevant tradespersons remove as much rust as possible, clean and re-paint these areas.

Where possible, the use of galvanized (treated) metals or aluminium coated metals aid in rust prevention, as does regular general maintenance. Rust formation can be controlled with coatings, such as paint, that isolate the iron from the environment. Rusting and corrosion should be managed by ideally removing or limiting the affected surface from exposure to moisture and harsh weather conditions. A qualified painter or other relevant tradespersons may be appointed to paint affected areas and a qualified carpenter to replace any building elements that have been severely affected by rust or water damage.

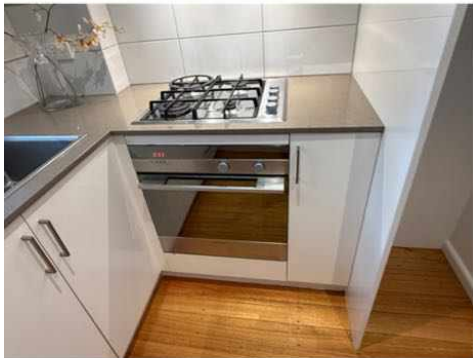
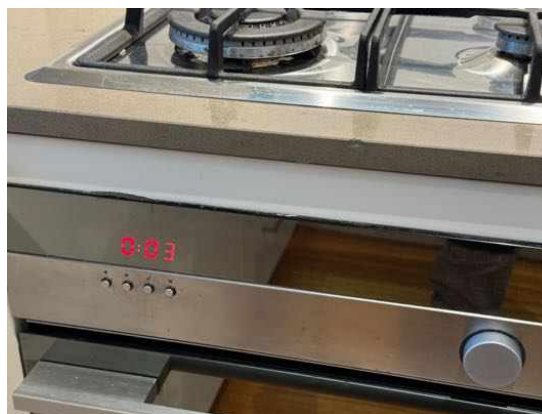
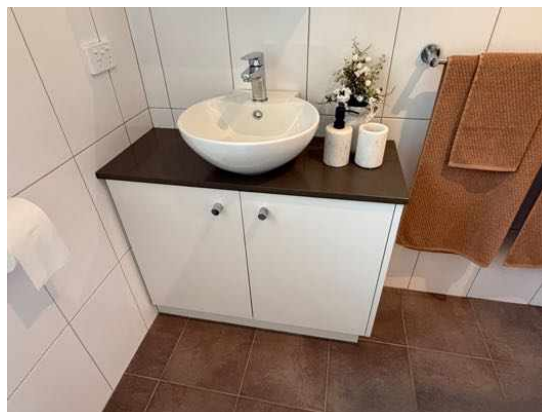
Defects 3.02

Building: Building 1
 Location: Kitchen > All Areas
 Finding: Kitchen cabinetry
 Information: The kitchen cabinetry showed signs of some minor damage. Some maintenance, remedial work or repair may be required to ensure further deterioration does not continue any further. These defects may detract from the overall looks of the cabinetry, in most cases it does not necessarily affect the operational state of the cabinetry.

To improve the operation of these affected cabinets, cabinet doors or drawers, a qualified cabinet maker or carpenter may be appointed to rejuvenate rectify or repair any cabinetry as deemed to be necessary. Such works should be completed at discretion of the client.

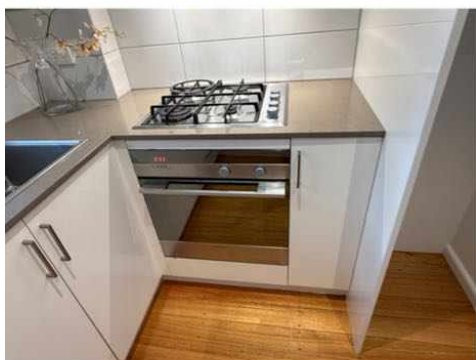
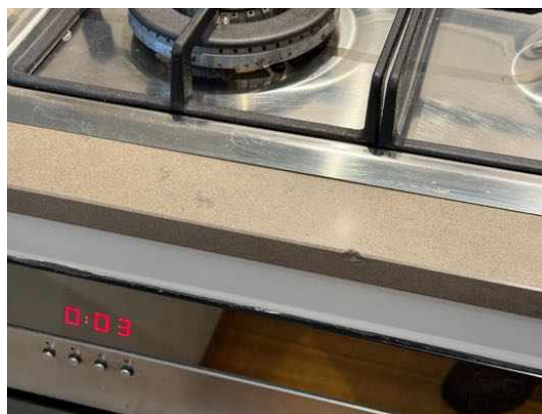
Defects 3.03

Building:	Building 1
Location:	Kitchen > All Areas
Finding:	Chip to kitchen bench top.
Information:	Although this chip is noticeable, it is only considered to be an appearance defect, and usually will not indicate any overall bench top damage. Generally, the cause of a bench top chips are accidental impacts. Chips of this nature can generally be repaired by the relevant tradespersons or bench-top installers. Such works should be performed by a qualified bench top installers. Monitoring of all chips should be conducted periodically to ensure no further damage is occurring.

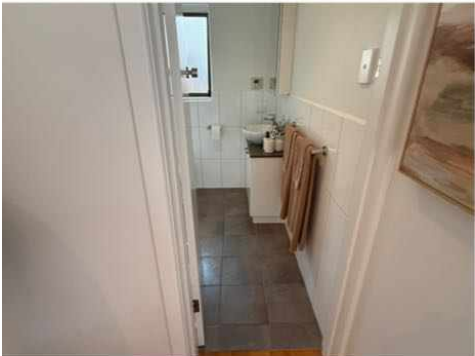
Defects 3.05

Building: Building 1
Location: Bathroom > All Areas
Finding: Bathroom towel rail - toilet roll holder loose
Information: Bathroom towel rail and toilet roll holder were observed to be loose and may require maintenance to be good, this occurs generally due to substandard installation or poor trade practices. A qualified carpenter should be appointed to repair or replace the affected towel rails, at the clients discretion.

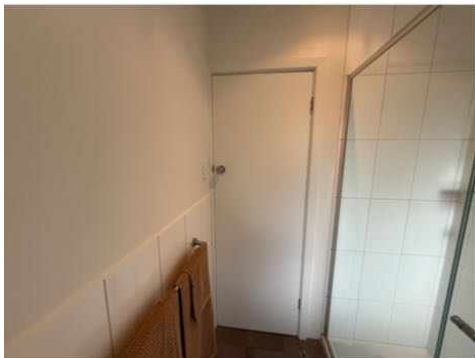
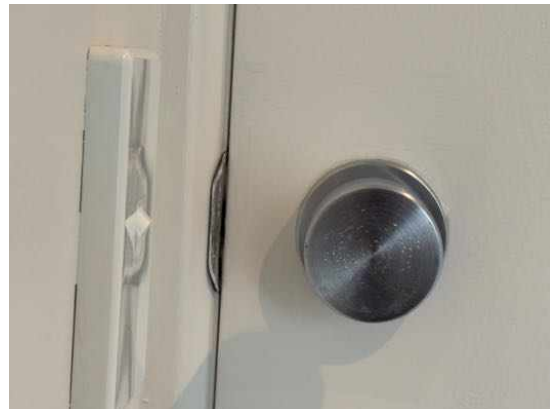
Defects 3.06

Building: Building 1
 Location: Bedroom > All Areas
 Finding: Door handles
 Information: Bathroom and the bedroom door handles were too stiff and will either require new door handles the correct maintenance to make good. There is a high possibility that occupants will get stuck in these rooms if not repaired properly and immediately. When door handles are found to be hard to operate, this will make it difficult for occupants to safely egress the interior areas. All doors should be rectified to ensure they operate easily during standard operation. These doors and door hardware defects may inhibit a safe and timely egress in the case of an emergency.

Some of these doors require immediate attention to ensure their functionality is not compromised, they are suspected to create secondary defects and damage to the associated door frames if left unmanaged. The wardrobe doors are also aged, damaged and deteriorated and may cause secondary defects from deteriorated hinges. A qualified carpenter should be appointed to perform minor rectification works at the clients discretion.

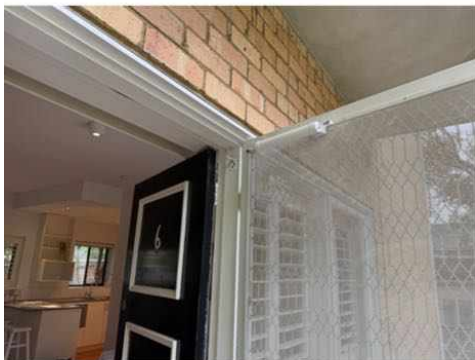
Defects 3.07

Building: Building 1
Location: Front wire door > All Areas
Finding: Front flywire door closer
Information: At the time of the inspection the front flywire door closer appeared to be broken and not fitted, this may need to be rectified or replaced to make good.

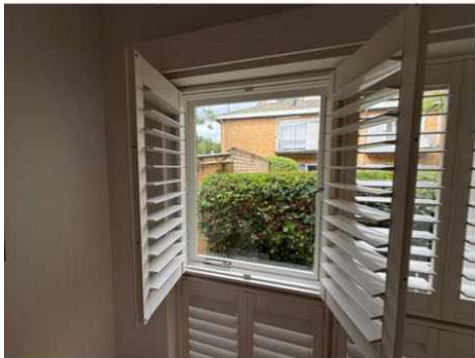
Defects 3.08

Some flyscreens were found to be missing to the windows throughout the home at the time of inspection. Whether the flyscreens have not been installed or have been removed for maintenance and or painting purposes, this missing building element detracts from the operational state of the window. Where not replaced, missing flyscreens allow pest and insect ingress into the adjoining room/s. It is advised that all missing building elements be installed or replaced in order to ensure the full function of all building structures. A qualified carpenter may be appointed to replace flyscreens at the discretion of the client.

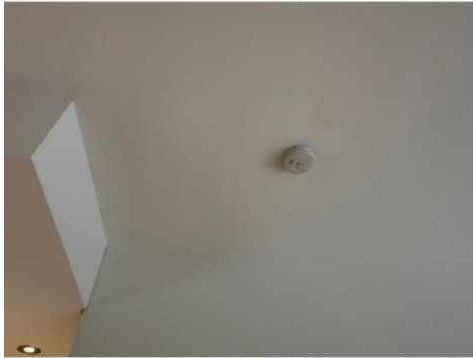
Noted Item

Building: Building 1
Location: All Areas > All Areas
Finding: Smoke detectors and alarms
Information: Reporting on Smoke Detectors or Alarms, including hard wired smoke detection systems and their legislative requirements, is outside the Scope of this Report. Please note that this defect is highlighted as a caution only. We suspect, based on our experience in the building industry, that smoke detectors are sometimes get overlooked, or they may be in a poor condition, so we recommend that they always should be addressed prior to occupation to improve occupant safety.

Always ensure sufficient working and suitable smoke detectors are installed prior and

during to occupying any building. Additionally, it is advised that all smoke detectors be tested by the homeowner on a monthly basis.

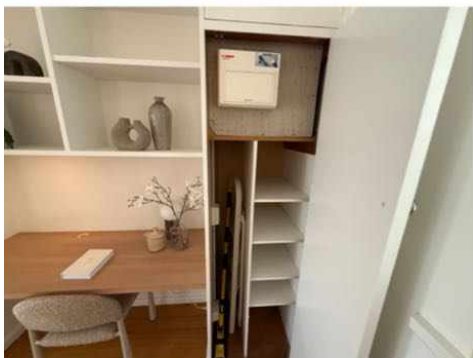
Building: Building 1
 Location: All Areas > All Areas
 Finding: Termite Management System - no evidence of a chemical installation or durable notice
 Information: At the time of the inspection no application of a chemical termite barrier or durable notice was observed. Such barriers are highly effective and highly recommended for all properties in preventing termite attack on any timber building elements throughout the property.

A durable notice should be placed in the switchboard unit or in the another accessible area to indicate current termite barriers. At the time of inspection, no evidence to suggest preventative works taking place. The client may consider gaining further advice from builders or a pest controller and as to the costs and procedures involved with this application. It is recommended that obtaining such advice be a short-term priority.
