Building and Timber Pest Inspection Report

Inspection Date: Wed, 4 Feb 2026

Property Address: 6309/1 Morton St, Parramatta NSW 2150,
Australia

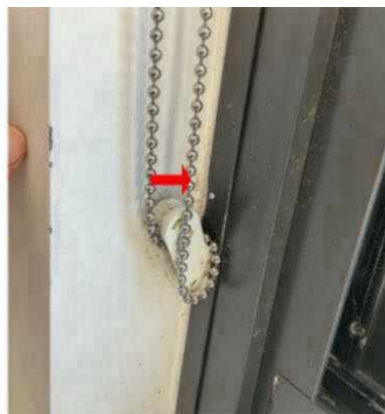
Finding: Minor Mould Growth and elevated moisture

Information: Minor mould growth was observed to the internal window reveal, with elevated moisture readings recorded below the window at the time of inspection. No visible material deterioration was observed. This condition is commonly associated with condensation, limited ventilation, and external environmental influences such as weather exposure and temperature differentials across the building envelope. The exact cause could not be confirmed due to the non-invasive nature of the inspection. Cleaning, improved ventilation, and ongoing monitoring are recommended, with further investigation advised if the condition persists.

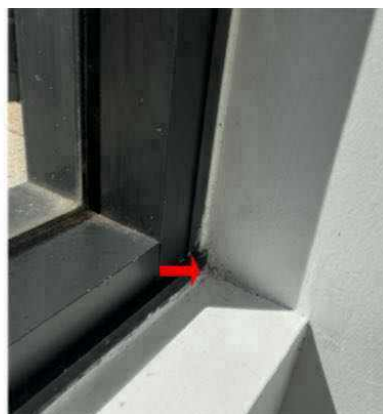
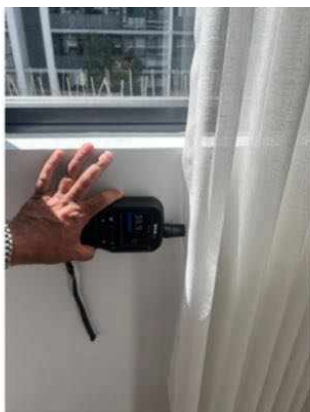
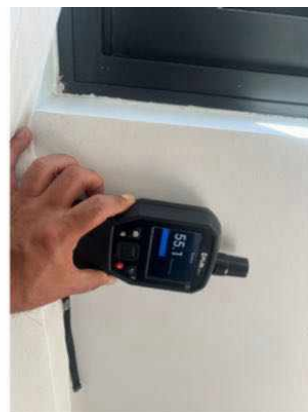
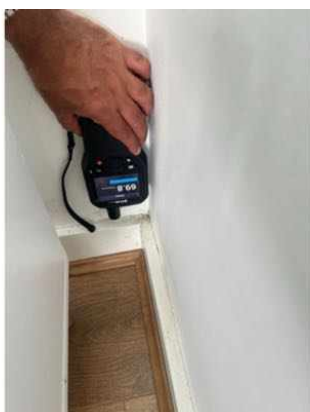
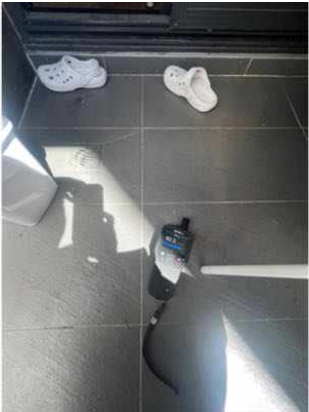
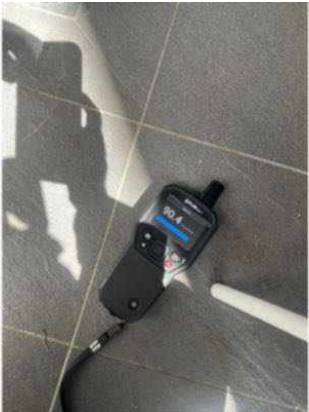
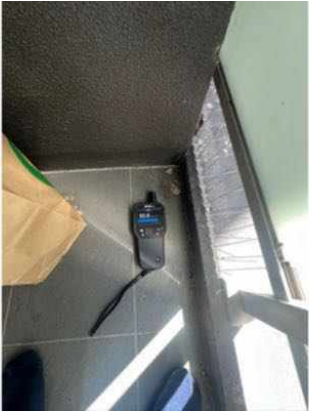
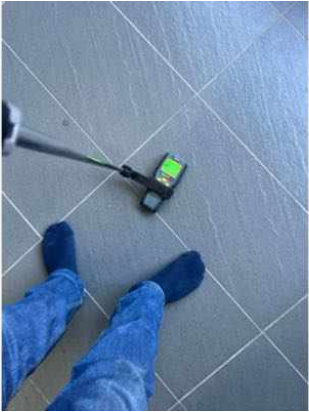
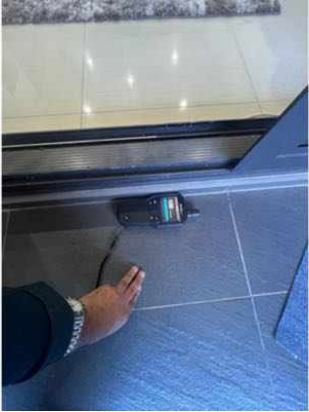
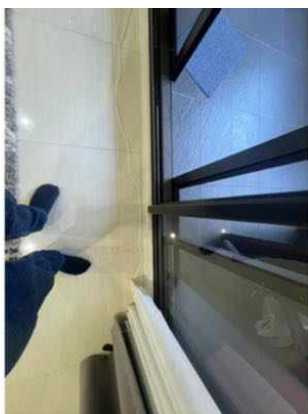
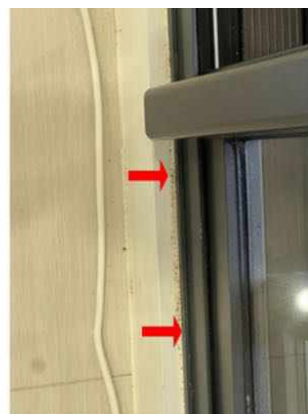
Finding 3.02

Building:	Main Building
Location:	Balcony
Finding:	Elevated moisture and minor mould growth
Information:	Elevated moisture readings were recorded to the tiled floor surfaces and adjacent wall bases when tested using a non-invasive (pinless) moisture meter, and minor mould growth was observed at the base of the sliding door. No visible evidence of moisture ingress, tile debonding, grout deterioration, staining, or material damage was observed at the time of inspection. The elevated readings may be associated with environmental factors such as condensation, limited ventilation, or moisture migration through tiled finishes, however, the exact cause could not be confirmed due to the

non-invasive nature of the inspection. Ongoing monitoring is recommended, with further investigation by a strata-appointed waterproofing contractor if the condition persists.

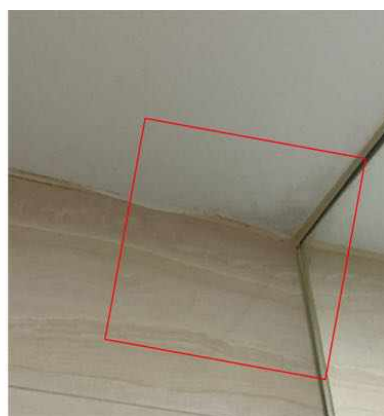
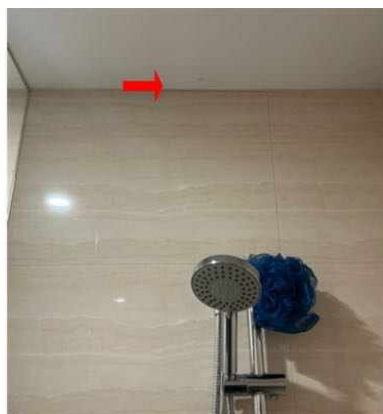
Finding 3.03

Finding: Water Staining - Humidity or Ventilation

Information: The ceiling surface shows peeling paint and water staining on the walls faint commonly consistent with humidity-related staining, often found in bathroom or wet areas with insufficient ventilation. While there is no visible sagging or major water damage, the pattern suggests prolonged moisture exposure, possibly due to steam accumulation or minor condensation issues. According to AS 4349.1–2007 (Appendix C), this would be classified as a minor defect unless further deterioration or active leaks are found. Recommend improving mechanical or natural ventilation, cleaning the surface with mould treatment, and monitoring for recurrence.

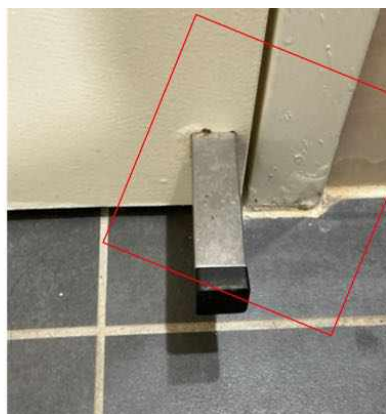
Finding 3.04

Building:	Main Building
Location:	Ensuite
Finding:	Wet-Area Door Jambs – Moisture Staining / Decay
Information:	Minor moisture staining and early signs of deterioration were observed at the base of the wet-area door jamb and architraves. This is commonly due to water splashing or moisture tracking from the bathroom floor into adjacent joinery. At the time of inspection, the condition appears superficial and non-structural, consistent with general wear typical of wet-area use.

It is recommended that the door junctions be resealed with a suitable moisture-resistant sealant and that ventilation and drainage within the bathroom be maintained to reduce further dampness.

For information only — further inspection by a licensed carpenter or waterproofing contractor is recommended to confirm the extent of deterioration and verify whether remedial sealing or minor replacement works are warranted.

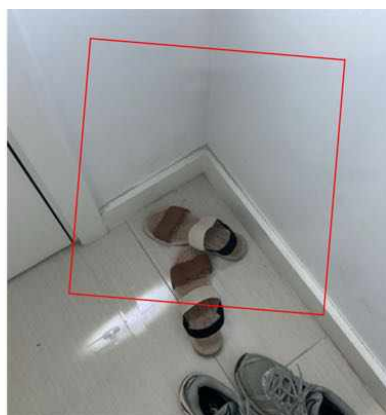
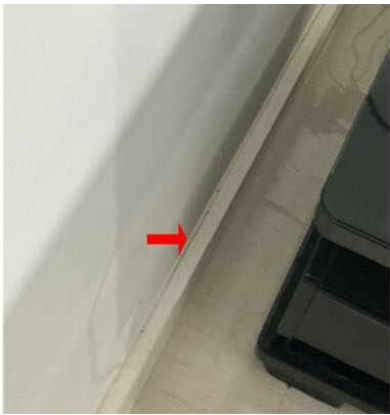
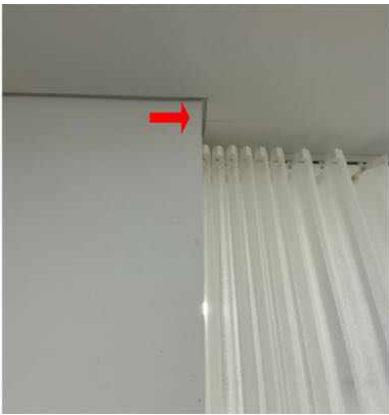
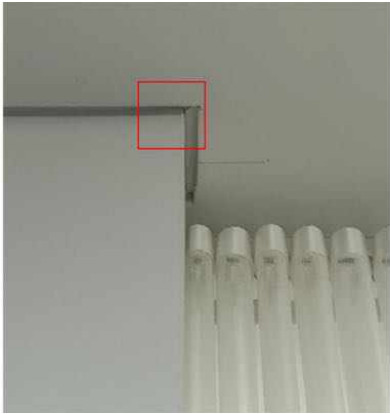
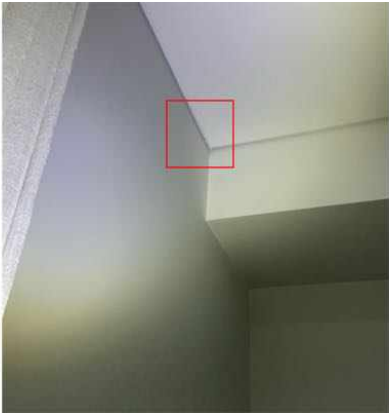
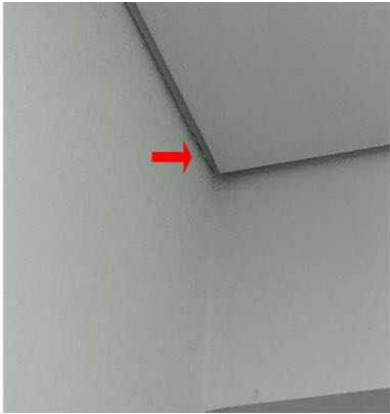
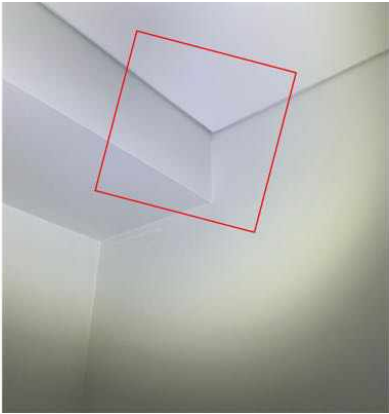
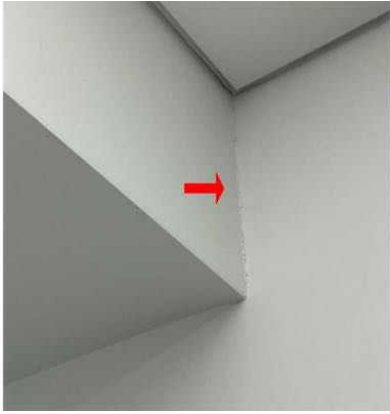
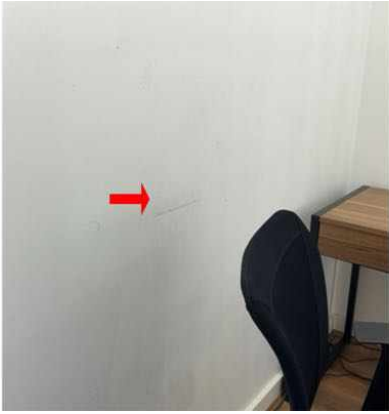
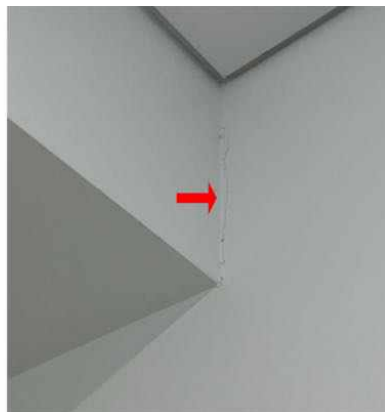
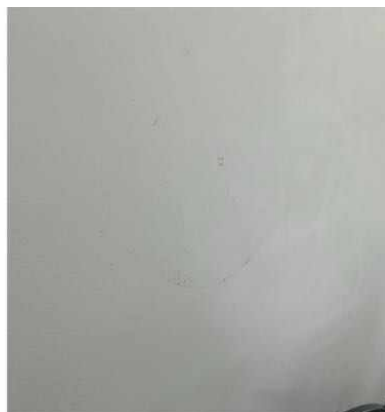
Finding 3.05

Building:	Main Building
Location:	All Internal Areas
Finding:	Paint finish and hairline cracking
Information:	The paint finish in this area was identified as being incomplete at the time of inspection including some hairline minor cracking.

Whilst incomplete or missing paint finish is generally an appearance defect, it can also lead to the development of secondary building defects over time. Incomplete areas of paint finish expose the area to moisture, potentially accelerating the deterioration of underlying building materials.

Incomplete paint finishes should be sanded back, filled, leveled and painted, as applicable. Where inadequate or missing paint protection has led to the deterioration of the associated building element, repair and/or replacement of this building element may be required.

A painting contractor should be appointed as soon as possible to perform necessary works to aid the appearance of the affected area and to ensure the area is protected against further deterioration. Alternatively, the homeowner following manufacturer instructions may perform these works.

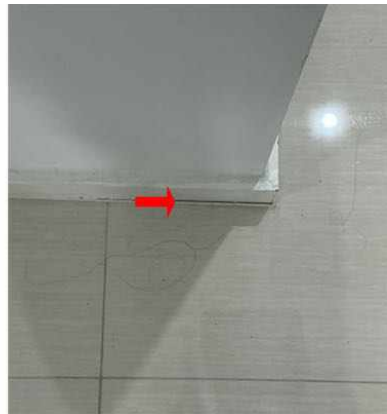
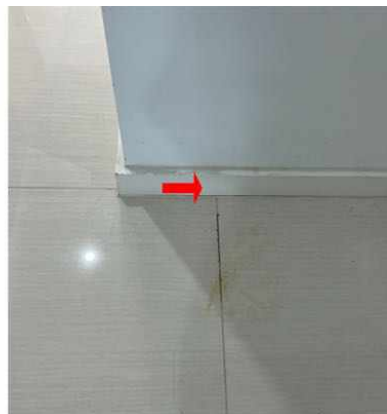
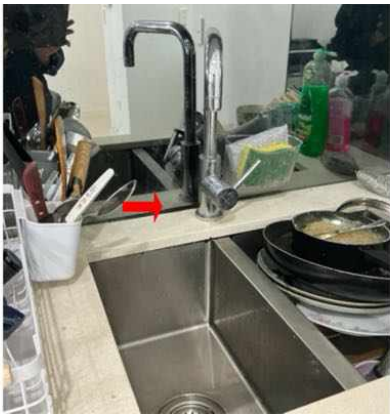
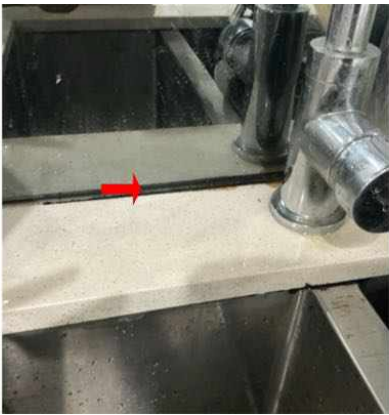
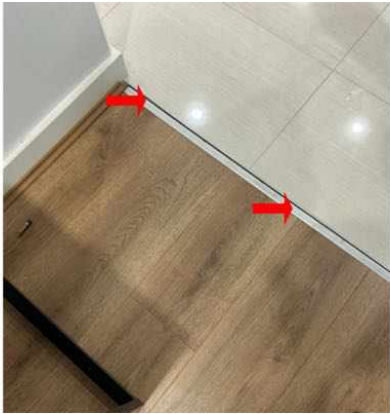
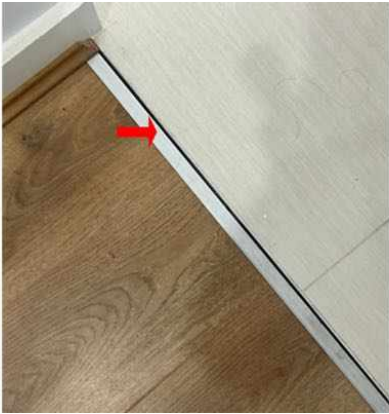
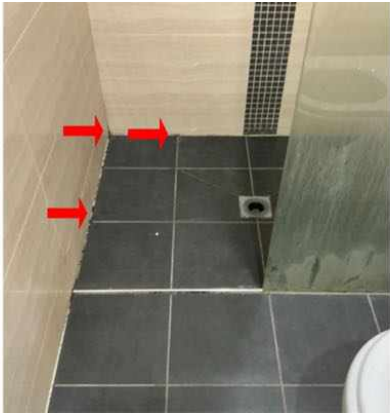
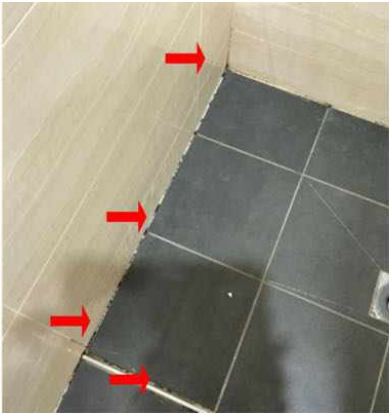
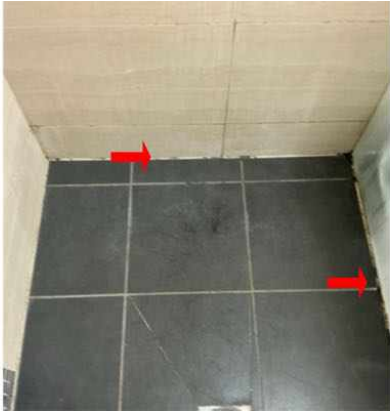
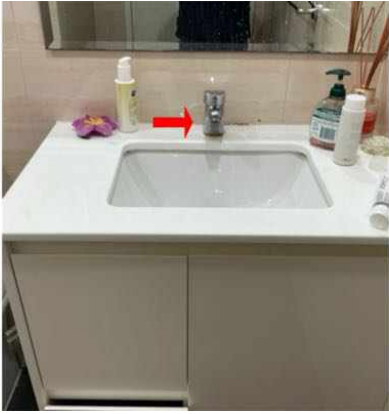
Finding 3.06

Building:	Main Building
Location:	All Internal Areas
Finding:	Sealant and grouting - Missing or degraded
Information:	It was noted on inspection that sealant or grout is degraded. There is also evidence of poor workmanship and excessive use of sealant. Silicone should never be used as a first line of defence against waterproofing. Further inspection by a licensed waterproofing contractor is highly recommend

Different materials and floor areas move at different rates, generally causing cracking to grout or sealant at this point. A flexible sealant is required to allow for expected expansion and contraction, while keeping the joint water tight and protective of all

There appears to be excessive mould to the sealant and grout which will likely require scraping out and replacement.

Flexible and mould resistant materials should be applied to affected areas to prevent any subsequent water damage that is likely to occur. Regular maintenance and replacement of damage or missing or damaged sealant and grout is highly recommended to the wet areas, as this is a regular wear and tear defect. Sealant and grouting in areas that come into regular contact with water should be maintained for the long term care of your property.

A sealant specialist or tiling contractor should be appointed to complete these works as soon as possible

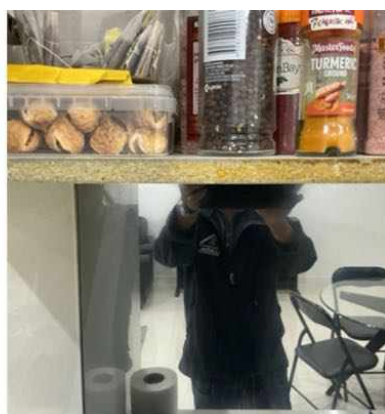
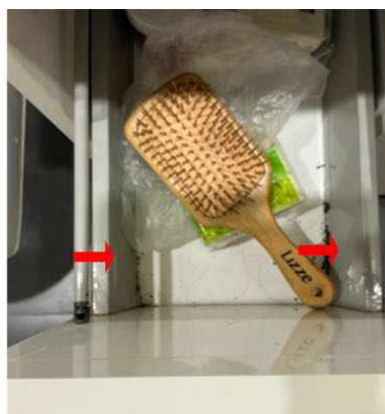
Finding 3.07

Building:	Main Building
Location:	All Internal Areas
Finding:	Building element - Damaged - Cabinet trim missing kitchen , bathrooms mirror desilvering , vanity drawer water damage bathroom ,
Information:	Breakage occurs generally when the building materials have either aged and decayed, or as a result of damage (accidental or deliberate).

Repair and/or replacement of broken elements is advised to ensure that additional secondary defects do not arise as a consequence. Such works are necessary, as all building elements play a key role in the operation and function of the overall structure and its performance.

A relevant tradesperson should be appointed to repair or replace the affected building element prior to any subsequent damage being caused.

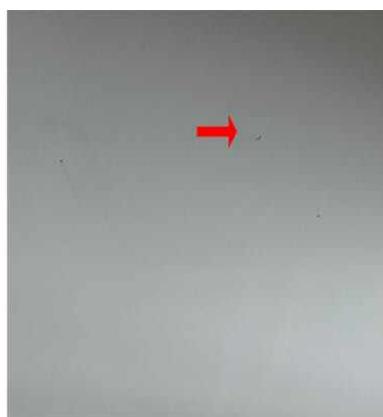
general ageing and deterioration of the building structure.

If left unmanaged, the ceiling sheets may become loose and unstable, increasing the rate of deterioration of the internal ceiling and creating potential for the development of secondary defects.

Re-fastening of popped nails will help to maintain the stability of the internal ceiling and associated building elements. Such minor works will also help to improve the appearance of the affected area and secure the ceiling sheets, so as to prevent the onset of ceiling sagging. These works should be performed by a qualified carpenter or plasterer at client discretion.

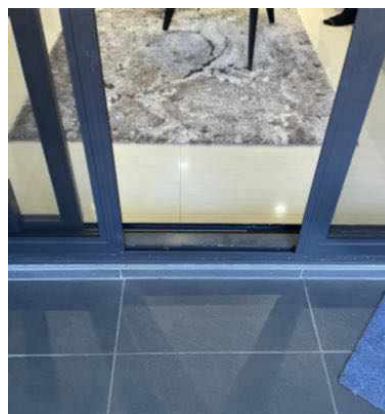
Building:	Main Building
Location:	Balcony
Finding:	Balcony Floor Level Differential
Information:	The balcony finished surface appears to be close to, or at the same level as, the internal floor. Standard construction practice requires a step-down of approximately 50 mm unless a fully engineered threshold drainage system is provided. No such drainage features were visible during inspection. This configuration increases the risk of water ingress. Confirmation of the balcony waterproofing detail through strata/building management is recommended.

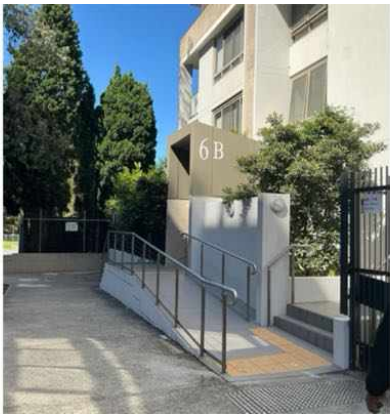
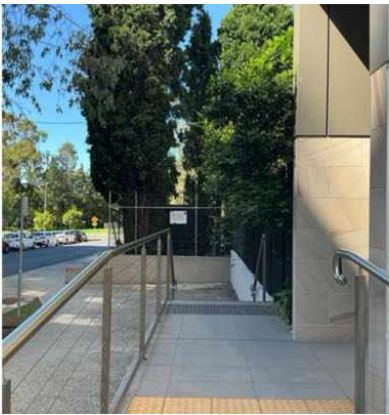
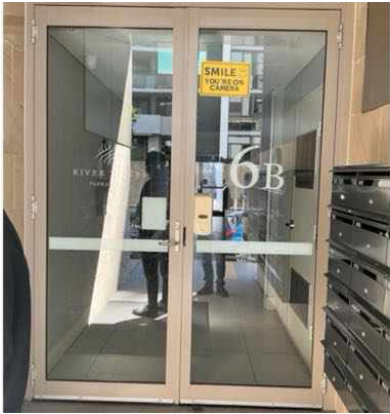
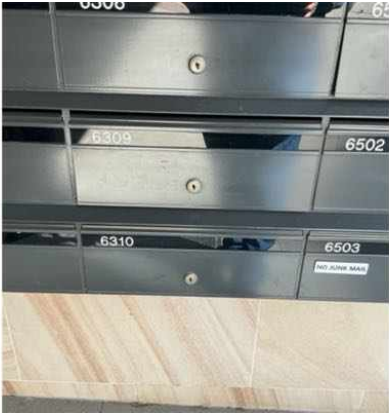
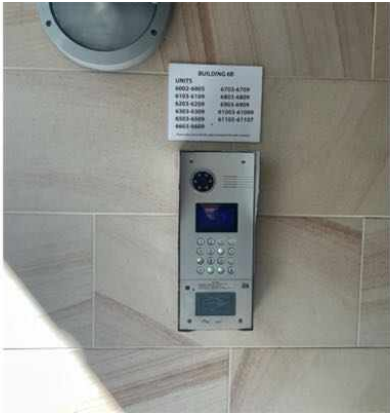
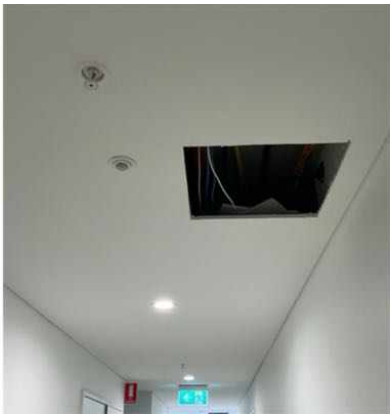
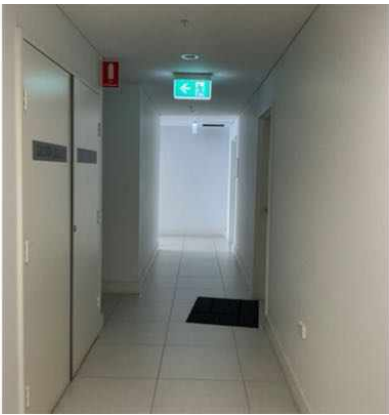
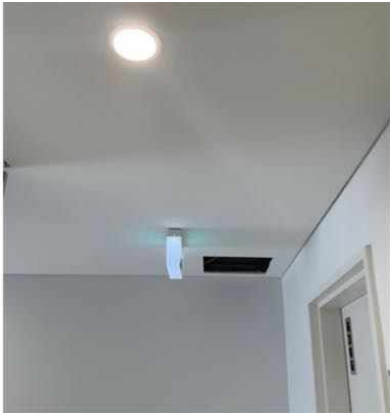
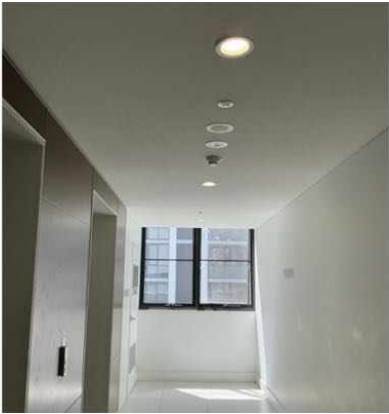
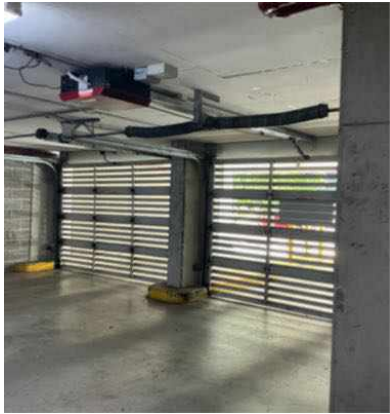
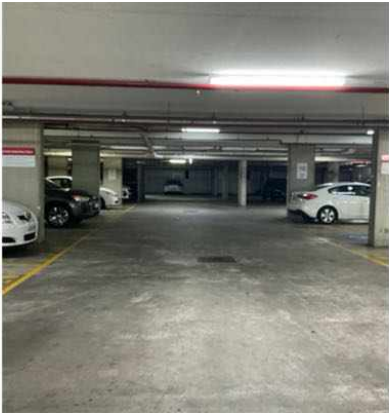
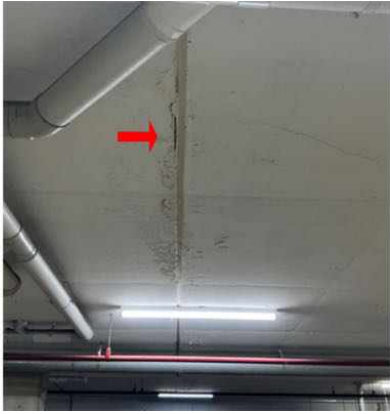
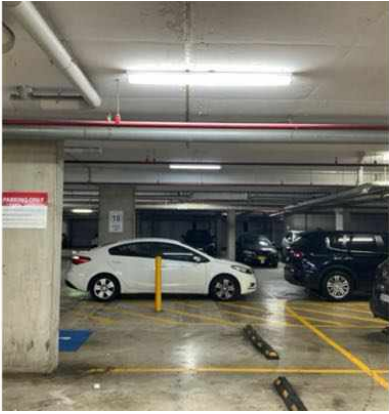
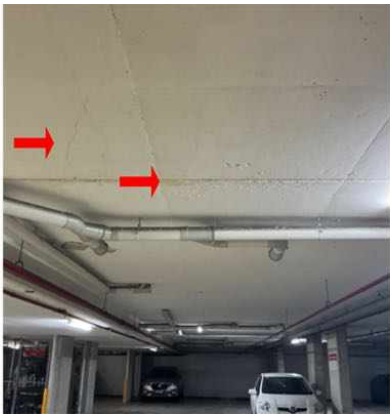
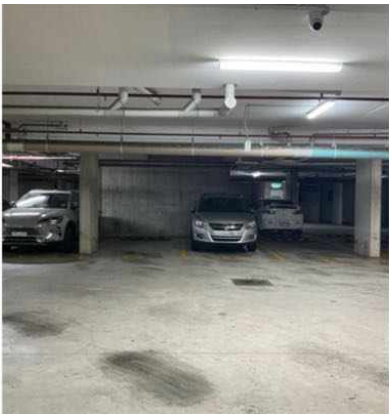
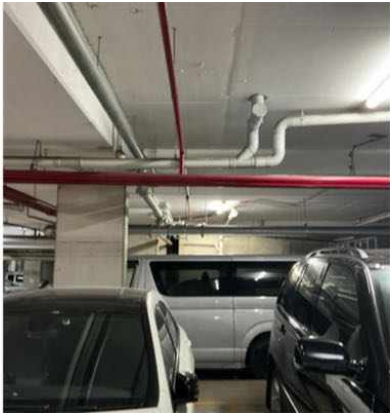
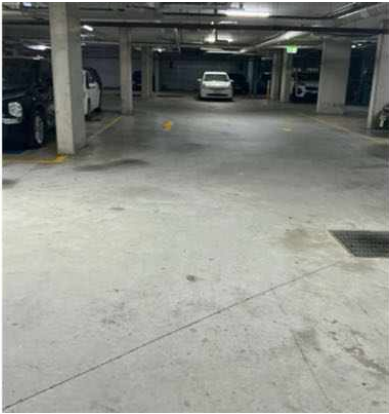
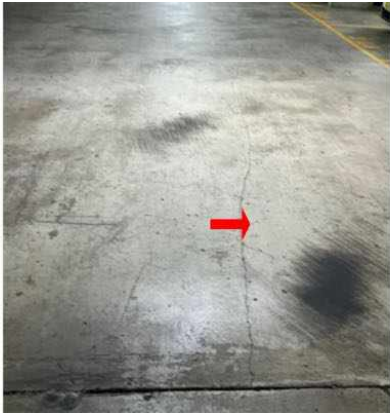
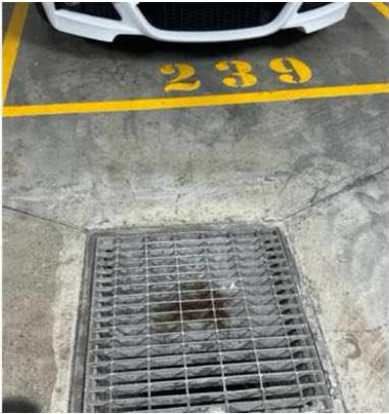
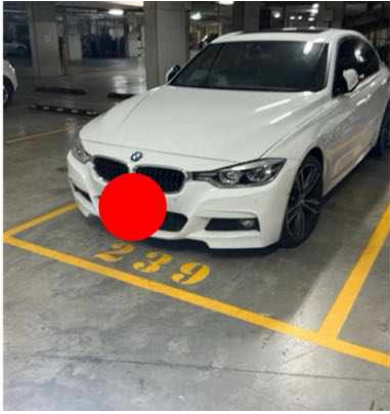
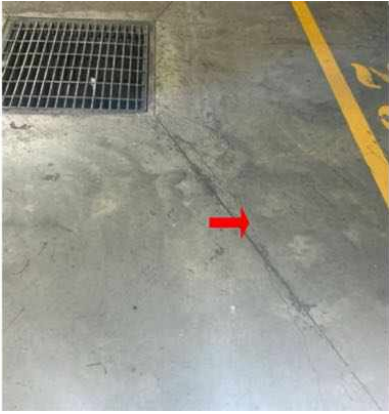
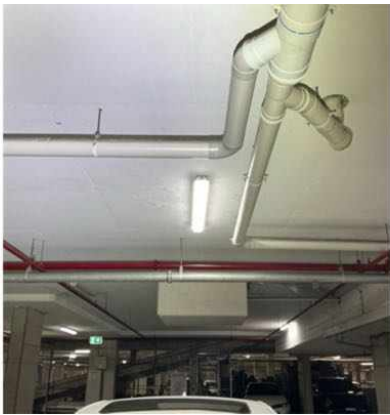
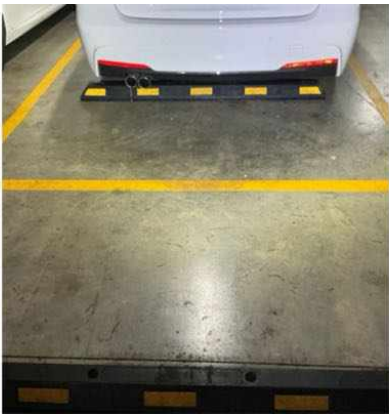
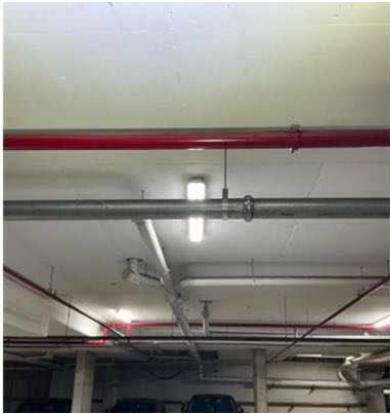
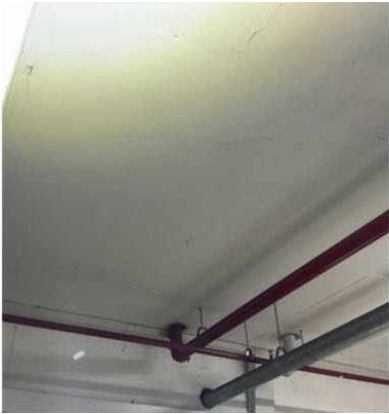
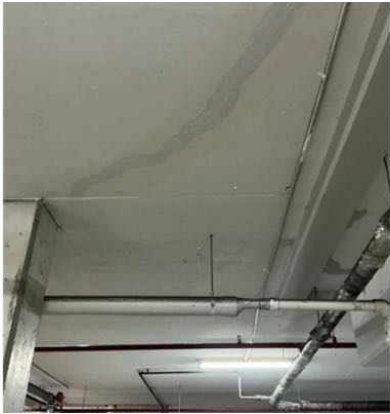
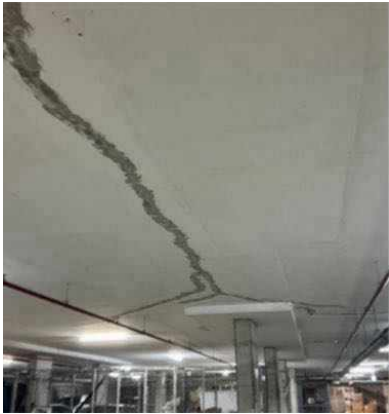
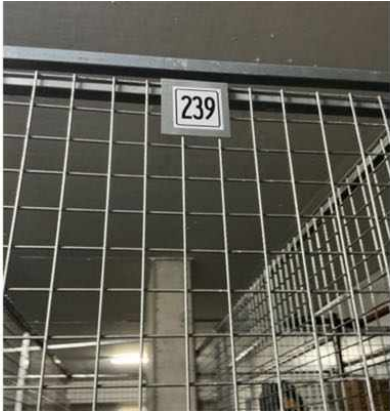
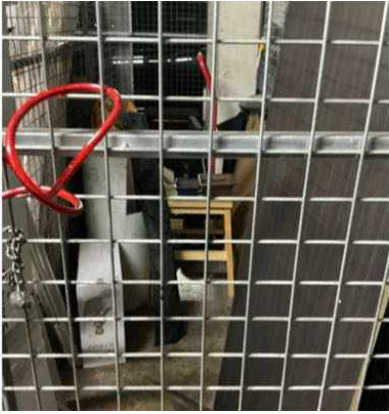
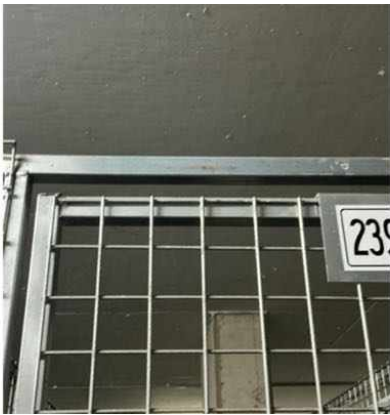
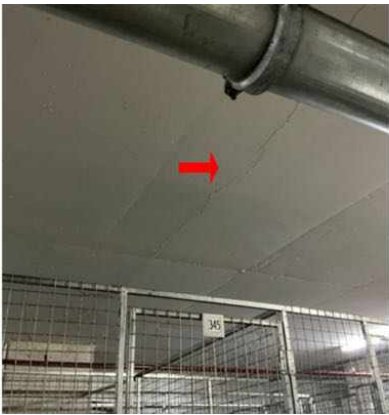
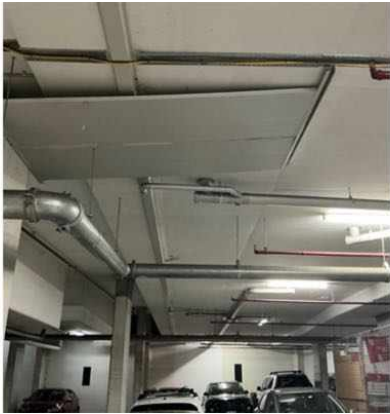
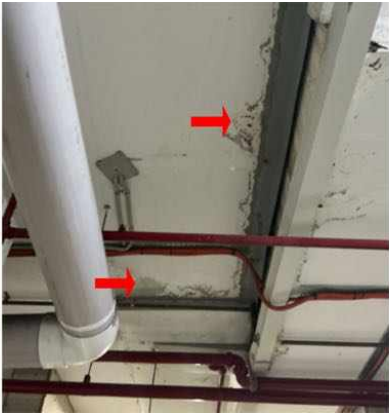
Building:	Main Building
Location:	All External Areas
Finding:	Additional Photos - Obstructions and Limitations
Information:	These photographs are an indication of the obstructions and limitations which impeded full inspection of the property at the time of inspection. These obstructions can hide an array of defects and should be removed to allow full inspection to be carried out. A re-inspection is recommended once the areas are made accessible.

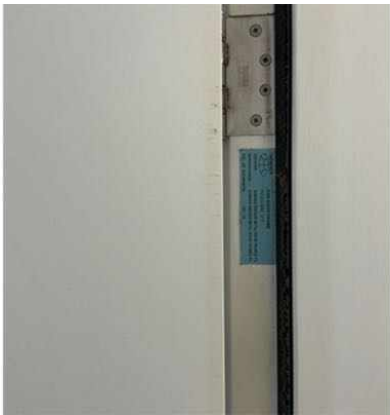
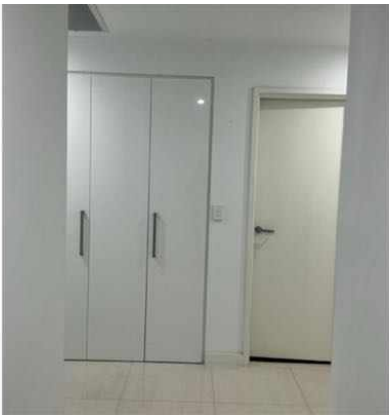
Building: Main Building
Location: All Internal Areas
Finding: Additional Photos - Obstructions and Limitations
Information: These photographs are an indication of the obstructions and limitations which impeded full inspection of the property at the time of inspection. These obstructions can hide an array of defects and should be removed to allow full inspection to be carried out. A re-inspection is recommended once the areas are made accessible.
