Building and Timber Pest Inspection Report

Inspection Date: Wed, 25 Mar 2026

Property Address: 14 Helen St, Drouin VIC 3818, Australia

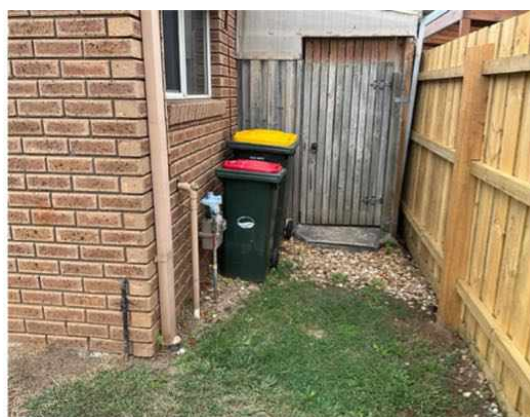
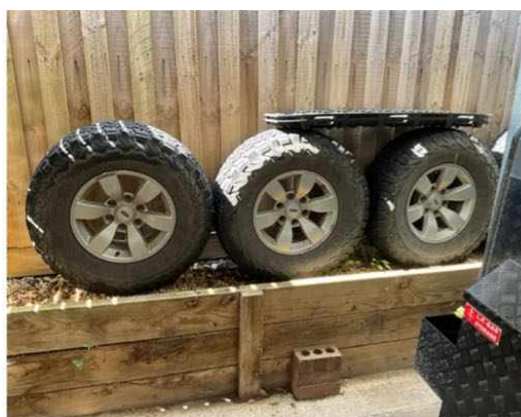
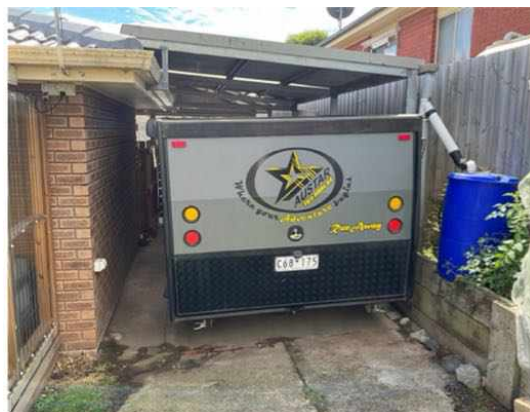
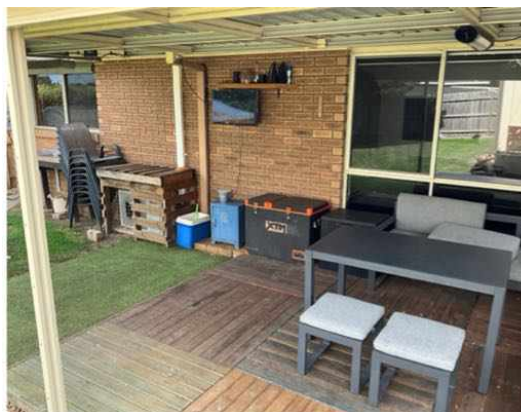
Building: Main Building
 Location: All External Areas
 Finding: Obstructions and Limitations - External areas
 Information: These photographs are an indication of the obstructions and limitations which impeded full inspection of the external areas of the property at the time of inspection. These obstructions can hide an array of defects and should be removed to allow full inspection to be carried out. A re-inspection is recommended once the areas are made accessible.

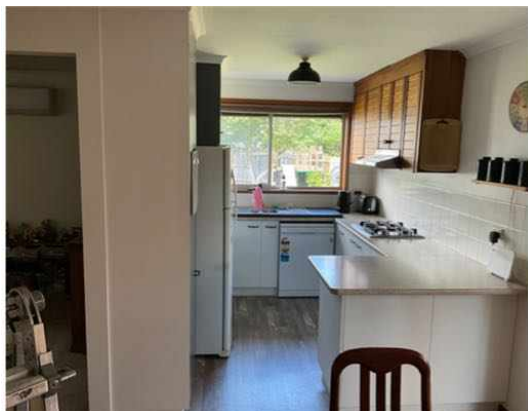
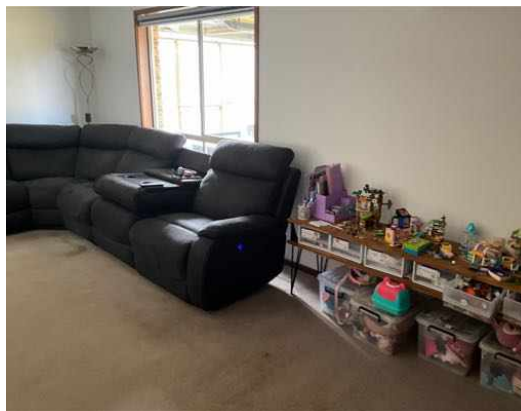
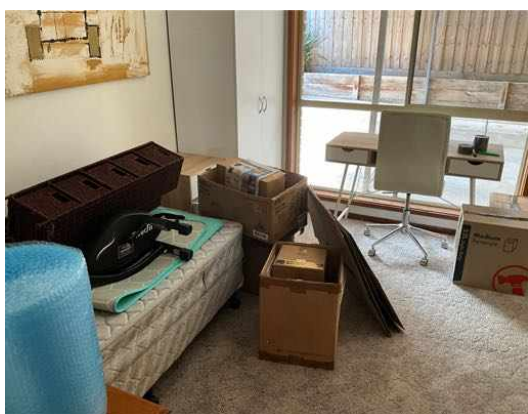
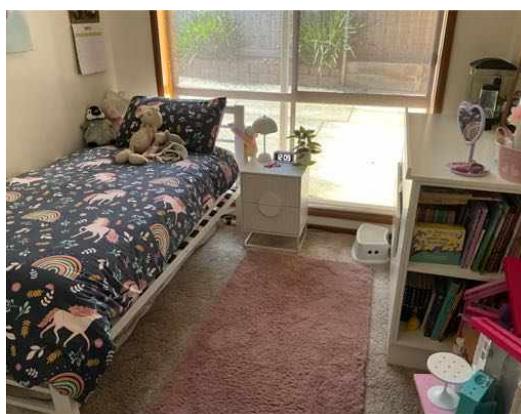
Building: Main Building
 Location: All Internal Areas
 Finding: Obstructions and Limitations - Internal areas
 Information: These photographs are an indication of the obstructions and limitations which impeded full inspection of the internal areas of the property at the time of inspection.

These obstructions can hide an array of defects and should be removed to allow full inspection to be carried out. A re-inspection is recommended once the areas are made accessible.

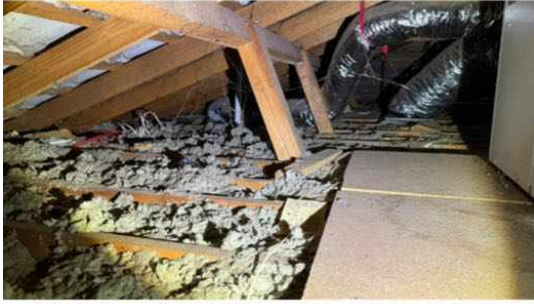
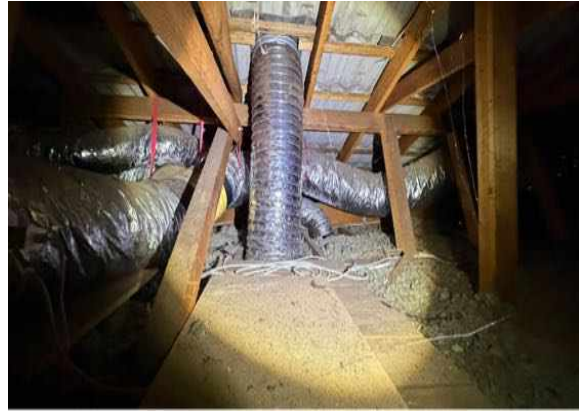
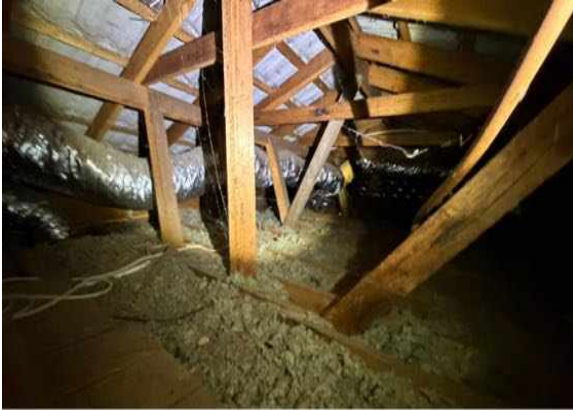
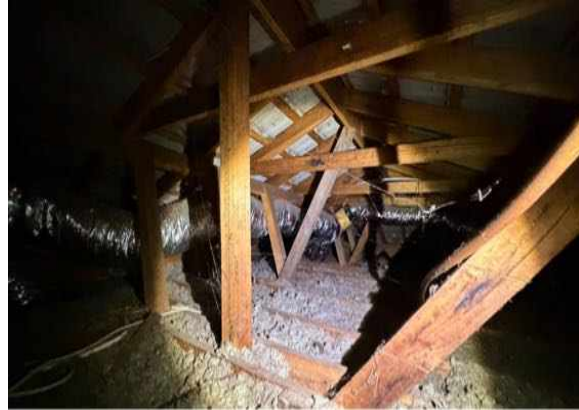
Building: Main Building
Location: Roof Void
Finding: Obstructions and Limitations - Roof Cavity
Information: These photographs are an indication of the obstructions and limitations which impeded full inspection of the roof cavity of the main building at the time of inspection. These obstructions can hide an array of defects and should be removed to allow full inspection to be carried out. A re-inspection is recommended once the areas are made accessible.
