# Building and Timber Pest Inspection Report

Inspection Date: Fri, 6 Mar 2026

Property Address: 7 Karoola St, Busby NSW 2168, Australia

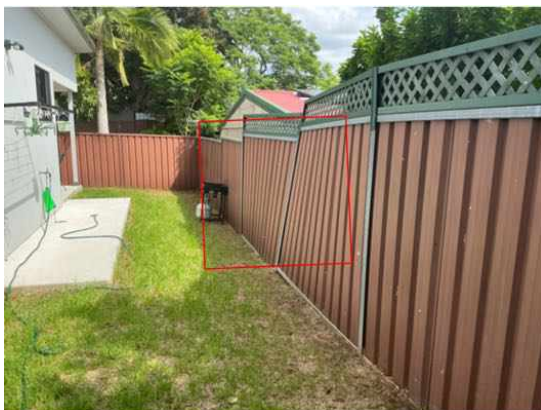
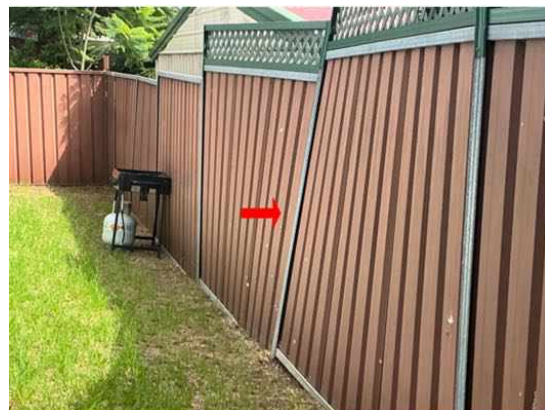
Information: A section of the Colorbond fence is visibly leaning at or near the post, indicating potential movement or failure of the post footing or connection. This may be the result of inadequate installation, poor soil conditions, water undermining the footing, or physical impact.

A leaning fence post compromises the structural stability and alignment of the fence, which may worsen over time if not addressed. It may also lead to loosening of panels and connections, and reduce the overall durability and appearance of the fence.

A qualified fencing contractor should assess the affected section to determine the cause of the movement. Rectification may involve straightening or replacing the post, reinforcing the footing, or adjusting the alignment of the panels. Timely repair is recommended to prevent further damage or collapse of the fence section.

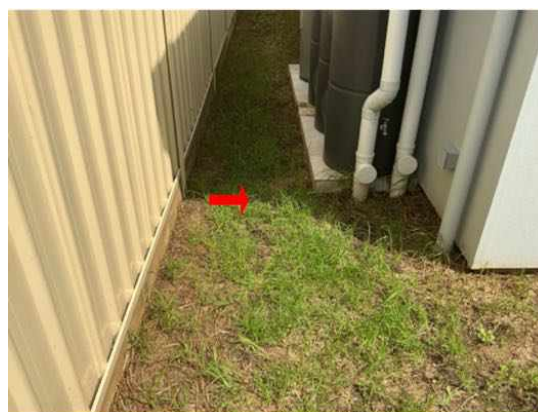
#### Finding 3.02

Building: Main Building

Location:	Granny Flat
Finding:	Site drainage - Inadequate
Information:	The site drainage was found to be inadequate at the time of inspection, creating potential for subsequent water damage to associated building elements.

It is important that water does not lie against the base of walls; surrounding paths and ground levels should be sloped to drain water away from walls. Downpipes should not discharge stormwater onto lower walls or plinths. Stormwater should be carried away by large, regularly cleaned drains. Ground levels may need to be lowered to expose a buried DPC.

Where site drainage is inadequate, installation of an Agricultural (Aggie) Drain may be required. A qualified plumber should be appointed to further inspect the property and perform any remedial works as necessary. Water damage and secondary defects are likely to occur if left unmanaged.

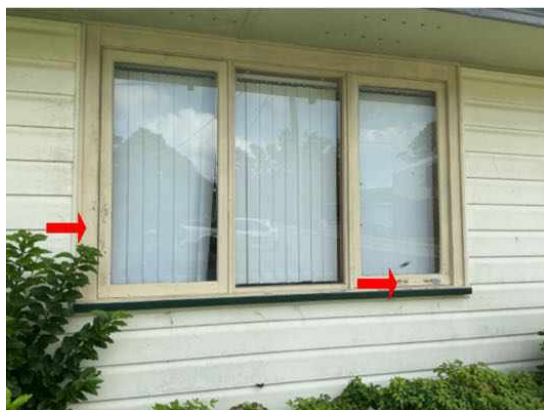
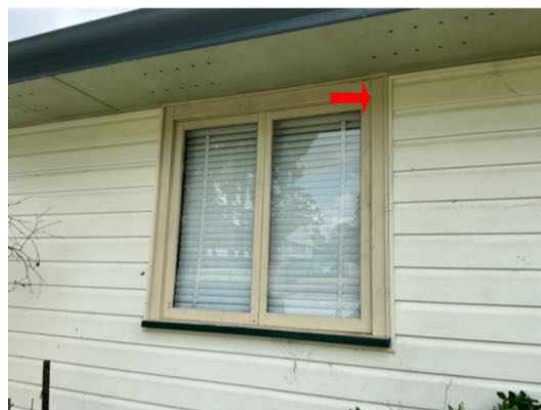
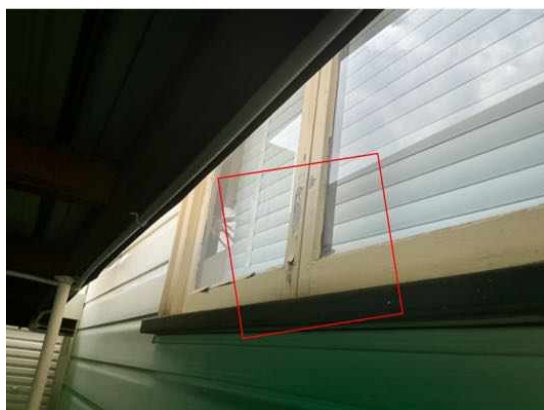
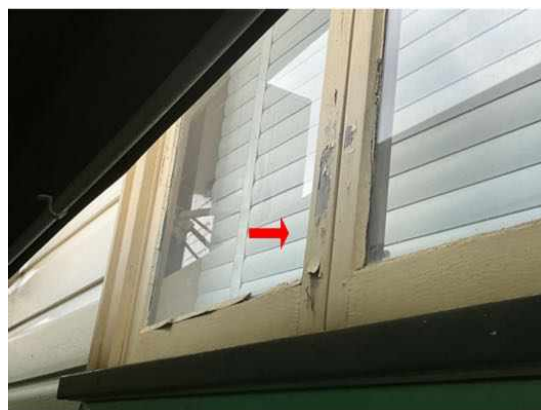
### Finding 3.03

Building:	Main Building
Location:	All External Areas
Finding:	Timber Windows - Weathered
Information:	The timber-framed windows throughout the property are showing signs of weathering and deterioration, including peeling paint, surface cracking, and general wear, likely resulting from prolonged exposure to the elements and a lack of routine maintenance.

Timber windows require regular sealing, painting, and inspection to prevent moisture ingress, timber decay, and eventual structural compromise. If left unaddressed, ongoing deterioration may lead to rot, air and water leaks, and costly repair or replacement.

It is recommended that a qualified tradesperson assess the extent of the damage and undertake repairs or restoration, followed by an appropriate maintenance schedule to preserve the condition of the timber.

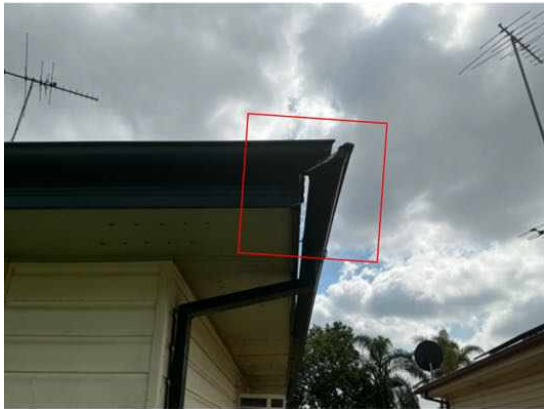
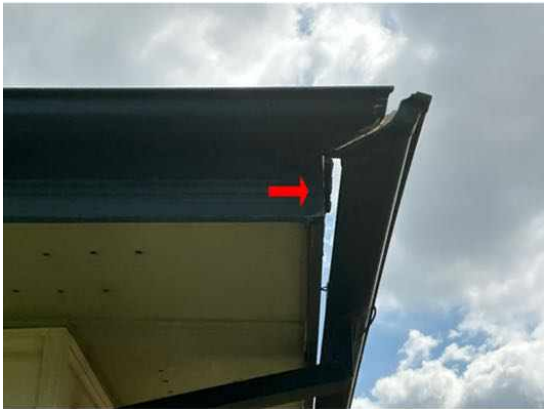
### Finding 3.04

Building:	Main Building
Location:	Exterior walls - right side
Finding:	Gutter/Fascia Damaged/Deteriorated
Information:	Breakage and deterioration occurs generally when either the metal/timber has aged and decayed with excessive moisture, or as a result of damage (accidental or deliberate).

Repair and/or replacement of the gutter is advised to ensure that additional secondary defects do not arise as a consequence. Such works are necessary, as all building elements play a key role in the operation and function of the overall structure and its performance.

A licensed roof plumber should be appointed immediately to repair or replace the damaged gutter prior to any subsequent damage being caused.

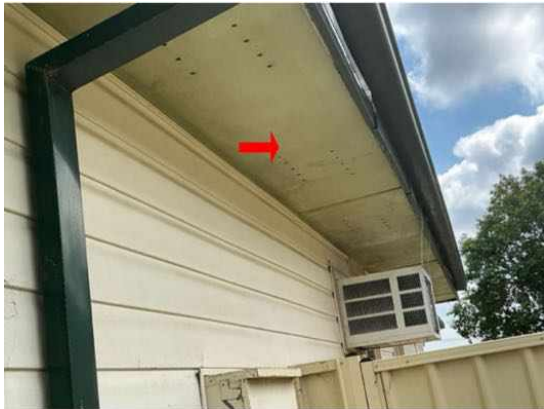
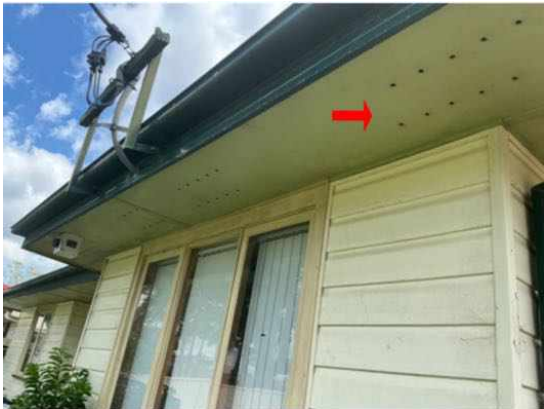
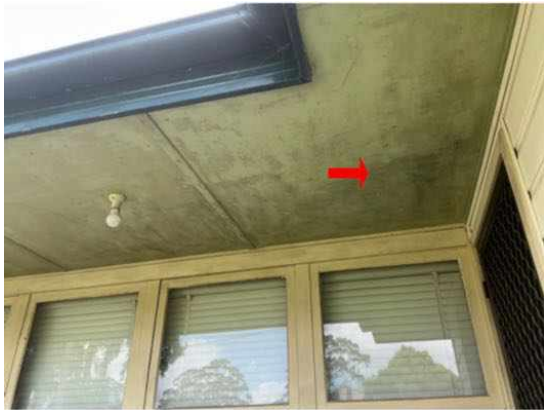
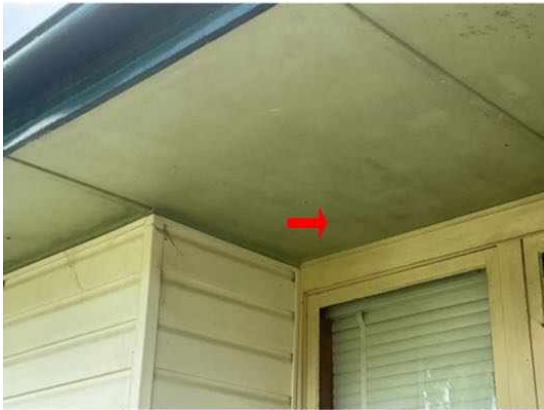
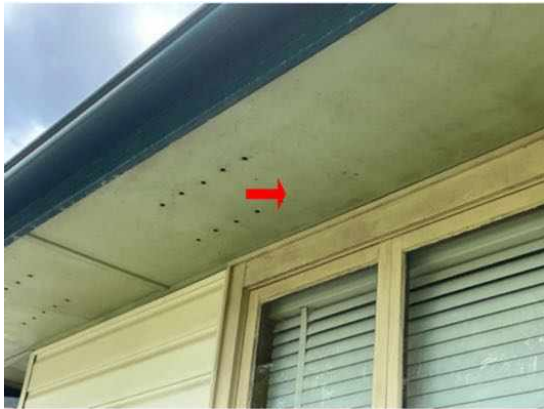
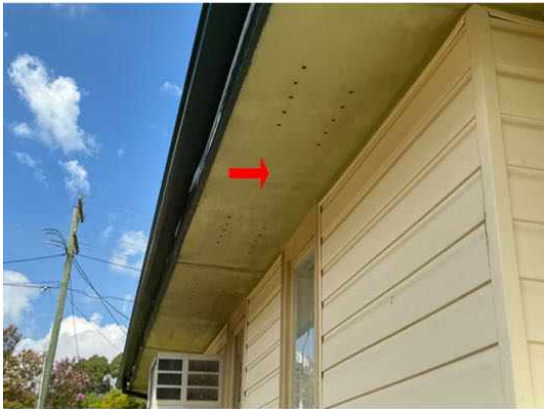
**Finding 3.05**

Building: Main Building  
Location: Eaves  
Finding: External Walls and Eaves - Condition  
Information: At the time of inspection, the exterior walls and eaves were in fair condition for their age, exhibiting typical signs of weathering and age-related wear consistent with prolonged exposure to the elements.

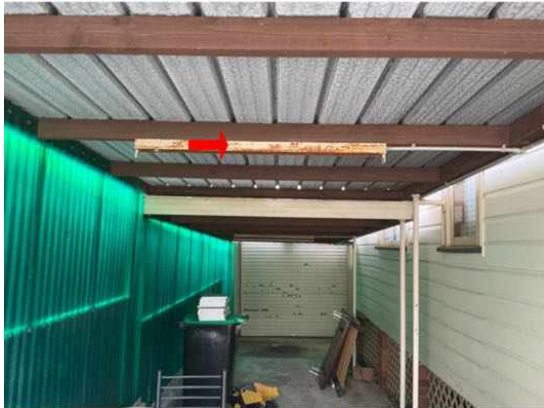
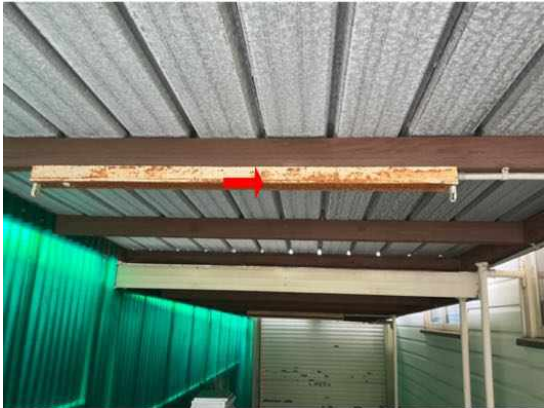
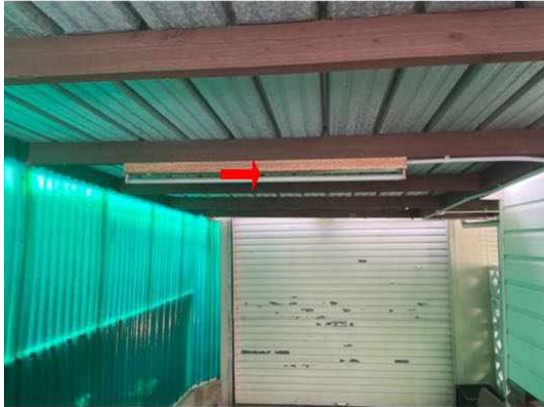
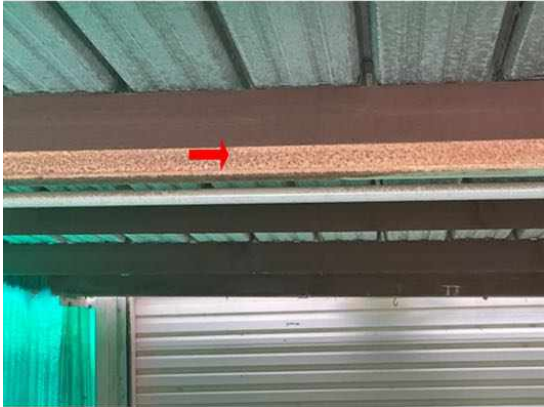
**Finding 3.06**

Building: Main Building  
 Location: Carport  
 Finding: Light Fitting - Rusting  
 Information: The external light fitting is exhibiting signs of rust and corrosion, likely due to prolonged exposure to weather elements. This may affect the fitting's structural integrity and electrical safety if left unaddressed.

Replace the light fitting with a corrosion-resistant model suitable for outdoor use (e.g. IP-rated and made from stainless steel or powder-coated aluminum). Ensure all electrical connections are weatherproofed in accordance with relevant standards.

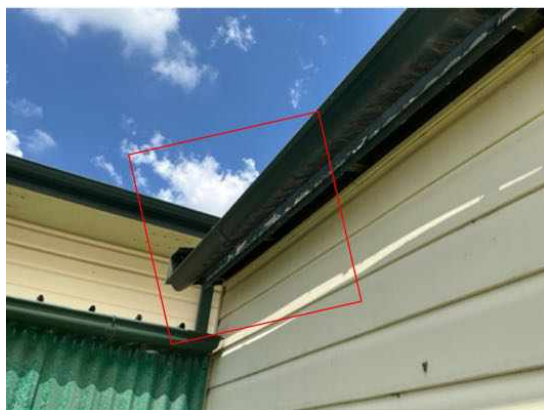
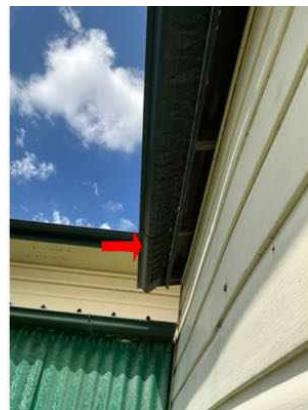
### Finding 3.07

Building:	Main Building
Location:	Garage
Finding:	Gutter/Fascia Damaged/Deteriorated
Information:	Breakage and deterioration occurs generally when either the metal/timber has aged and decayed with excessive moisture, or as a result of damage (accidental or deliberate).

Repair and/or replacement of the gutter is advised to ensure that additional secondary defects do not arise as a consequence. Such works are necessary, as all building elements play a key role in the operation and function of the overall structure and its performance.

A licensed roof plumber should be appointed immediately to repair or replace the damaged gutter prior to any subsequent damage being caused.

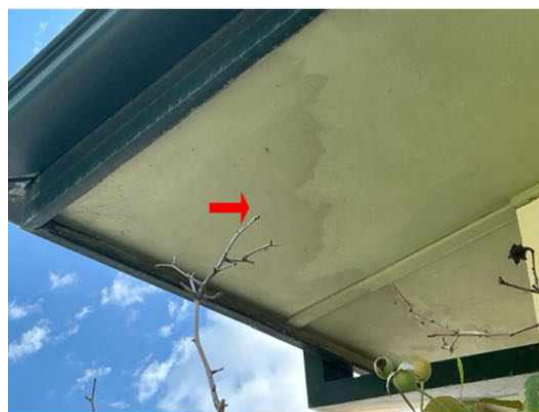
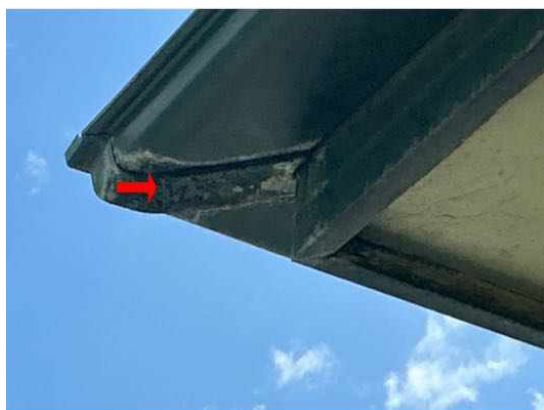
### Finding 3.08

Building:	Main Building
Location:	Exterior walls - left side
Finding:	Water leak - External (suspected)
Information:	A suspected water leak was found in this area at the time of inspection. Whilst it was

not leaking at the time of inspection there were blatant signs of water ingress. Water leaks can be detrimental to surrounding building elements; their potential causes include damage to plumbing fittings and fixtures, through to water damage and deterioration of associated building elements, as depicted in the attached photographs.

Rust, corrosion, decay and water damage are potential outcomes where a minor water leak is left unattended. More serious defects may also result, such as electrical hazards, or water damage to structural building elements.

In extreme cases, structural damage may develop due to a prolonged water leak.

It is highly advised that internal water leaks be addressed by a licensed plumber as a matter of relative urgency.

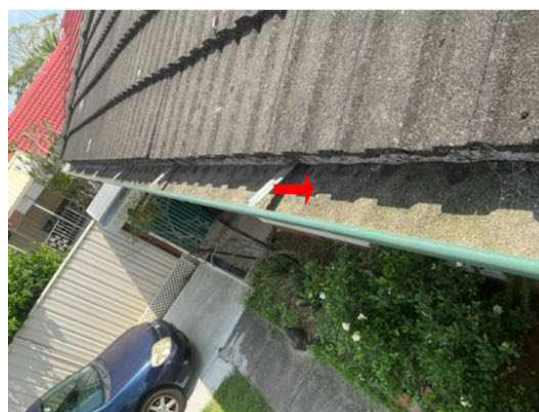
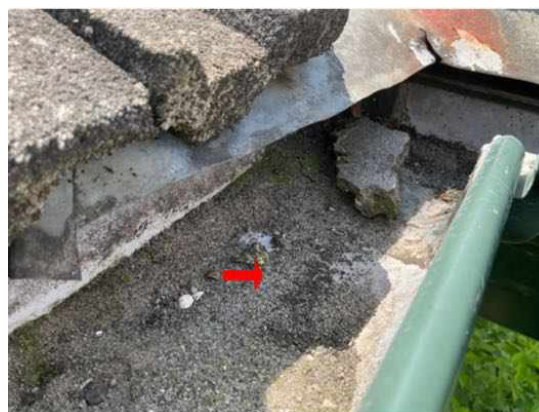
### Finding 3.09

Building:	Main Building
Location:	Roof Exterior
Finding:	Gutters - Debris
Information:	Roof plumbing structures, such as guttering and downpipes, should be free of all debris to prevent blockages. Blockages in the guttering and downpipes will lead to pooling and accumulated water overflow, which is likely to flood the eaves and exterior walls.

In addition to blockages, leftover materials in the gutters could also cause damage. These materials, if not cleared, may contribute to rust, decay, and further deterioration of the building materials. Over time, moisture buildup caused by blockages and debris can also create conditions which could lead to additional structural issues.

Blockages and debris should be removed immediately to ensure dry conditions are maintained.

It is recommended to consult a licensed plumber for specific advice on any necessary remedial works. In the interim, it is strongly advised that a general handyman clear the building material as a matter of urgency to prevent further damage.

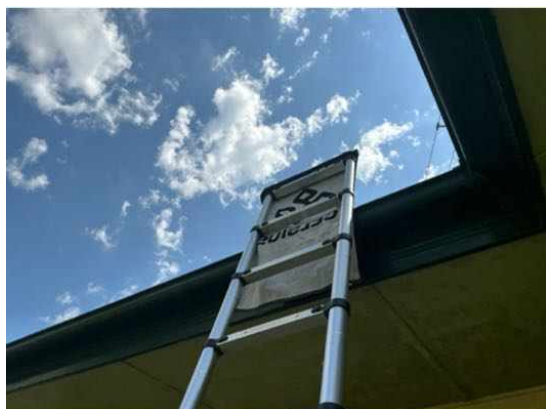
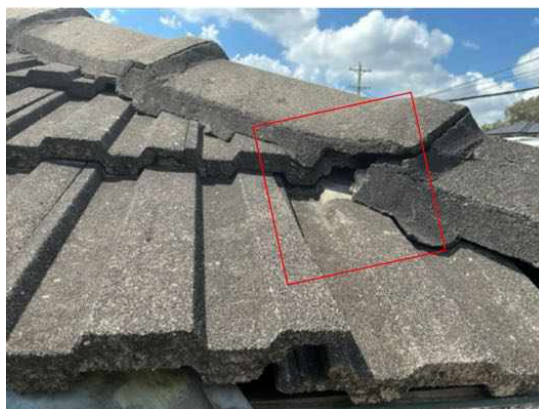
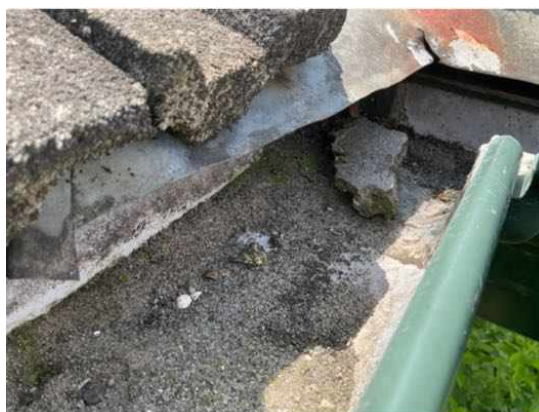
### Finding 3.10

Building:	Main Building
Location:	Roof Exterior
Finding:	Roof tiles - Weathered
Information:	Upon inspection of the exterior roofing, the majority of roof tiles were considered to be in a fair condition. While weathering of the tiles is consistent with the age of the property, maintenance works are required.

Isolated areas of mortar have come loose on the ridges and minor cracking is also present. Re-pointing and re-sealing may be considered as an interim solution by

Where left unmanaged, deteriorating roof tiles are likely to lead to a number of secondary defects, including minor water leaks and weather exposure to internal roofing structures.

Consultation with a roofing contractor is highly advised to gain advice on cost of remedial works that may be required in the short to medium term. Remedial works are likely to increase the longevity of the exterior roofing structure.

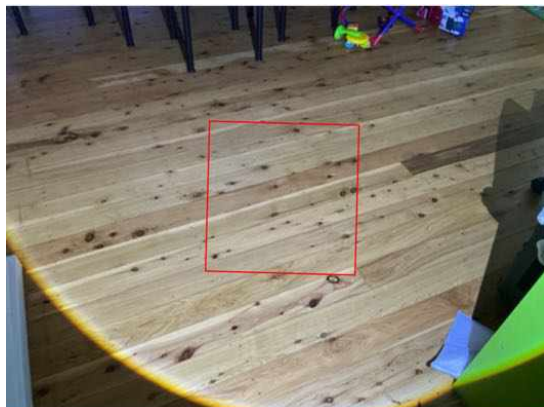
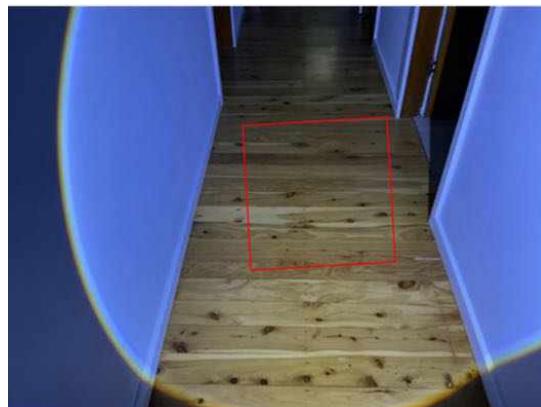
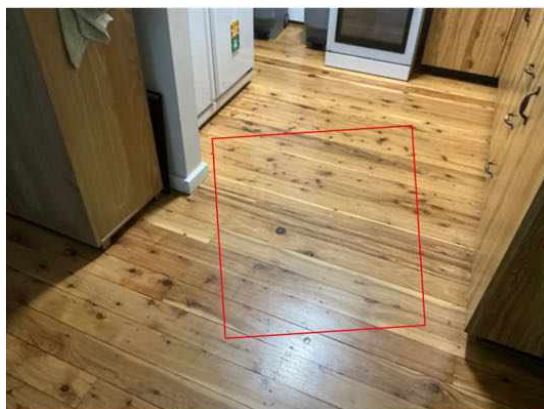
### Finding 3.11

Building:	Main Building
Location:	All Internal Areas
Finding:	Floors - Squeeking/Bouncing
Information:	The internal flooring was identified as being bouncy as pictured at the time of inspection. A bouncy floor surface generally presents as a discernible change in level as they are walked across, in noisy or creaking flooring, or in consequent movement of surrounding furniture and fixtures.

Bouncy floors generally indicate that the floorboards or the subfloor structures are coming loose from the joists that they are installed on. Bouncy flooring may also be the result of gaps between flooring structures, which require packing.

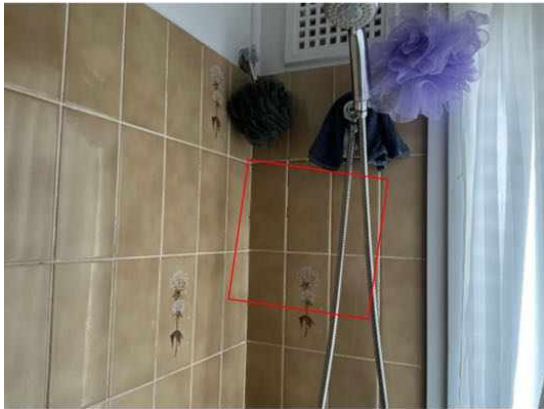
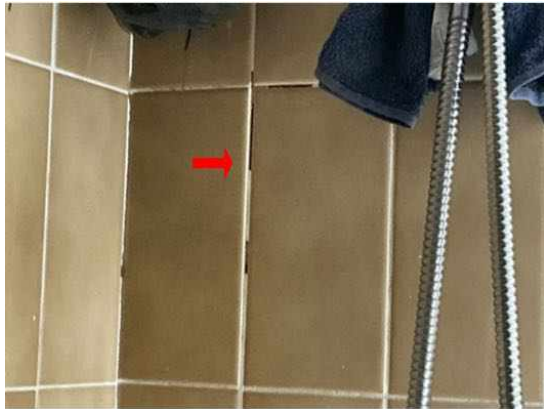
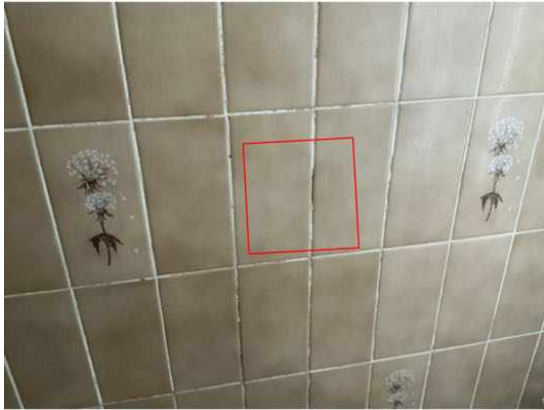
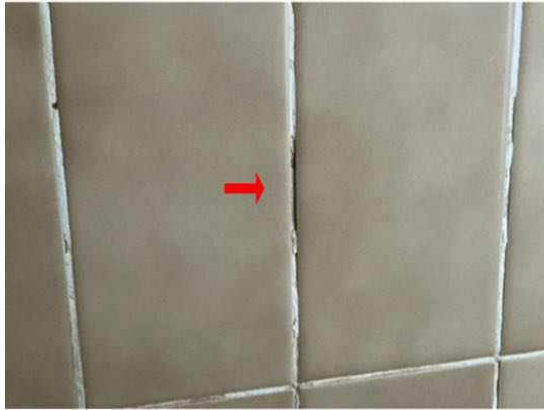
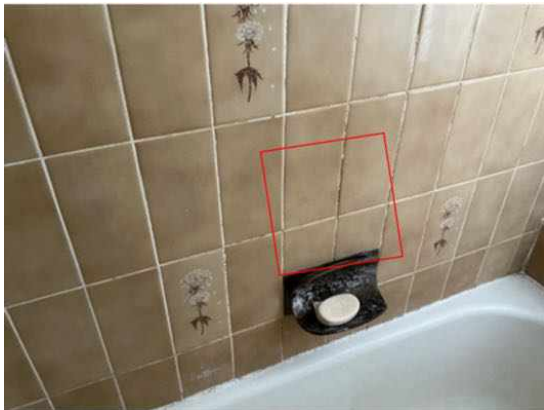
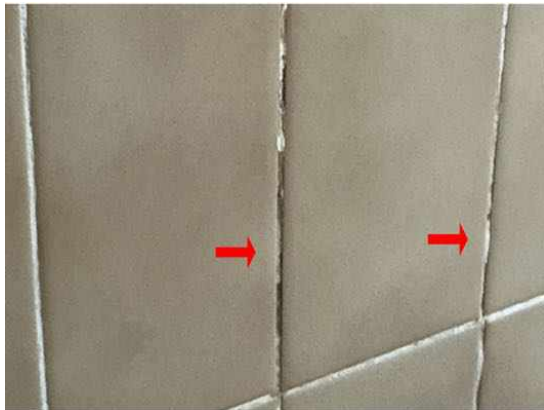
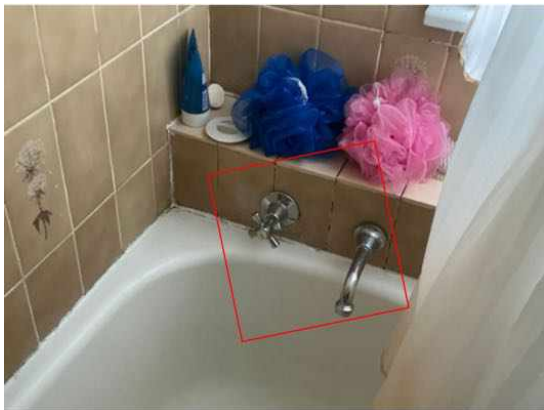
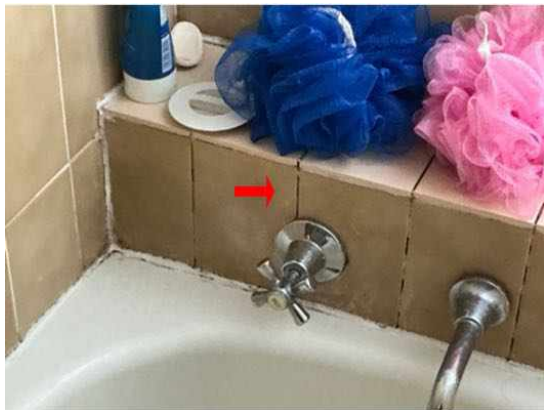
It should be noted that all junctions of vertical and horizontal tiles should be joined by a bead of silicone as the grout wears away over time.

Where grout is missing, a tiling contractor should be appointed immediately to apply grout and re-apply any silicone where necessary. Failure to do so is likely to lead to water damage to the surrounding area.

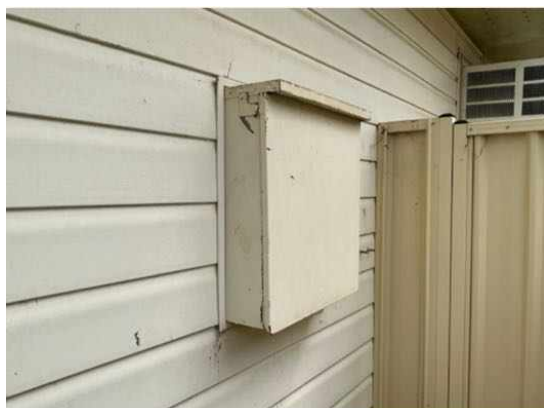
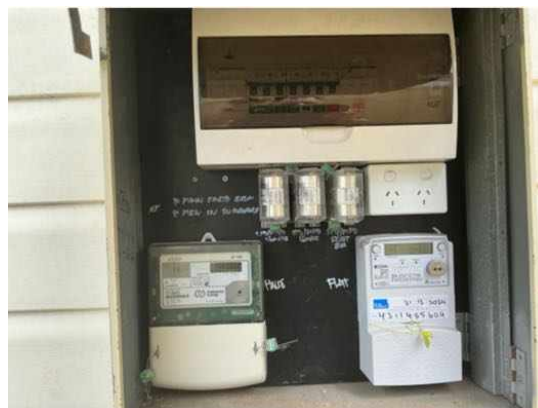
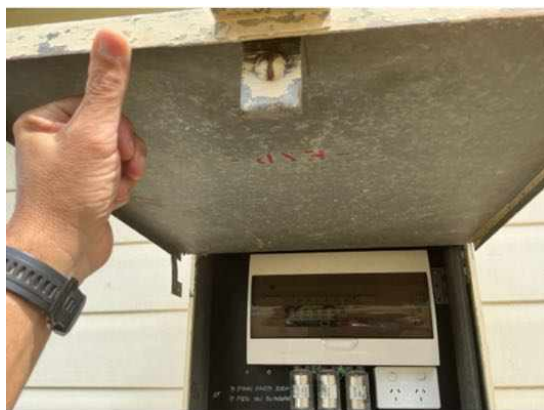
Evidence of this sticker has NOT been located in the meter box. Please see photos attached

Where a Termite Management System has not been identified you should consult a licensed pest inspector immediately to undergo further investigation in what measures would be necessary to maintain a functional pest management system. It is also recommended that a Licensed Pest Controller attend to determine the viability of the current or past treatments

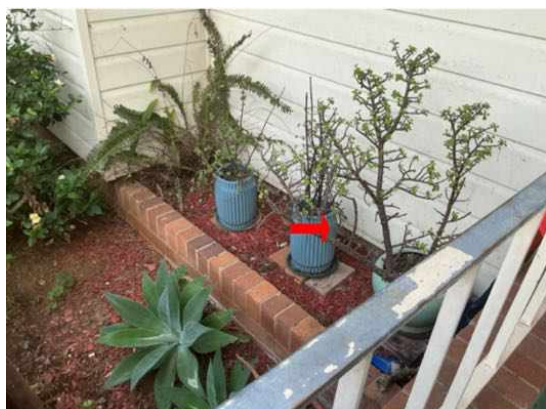
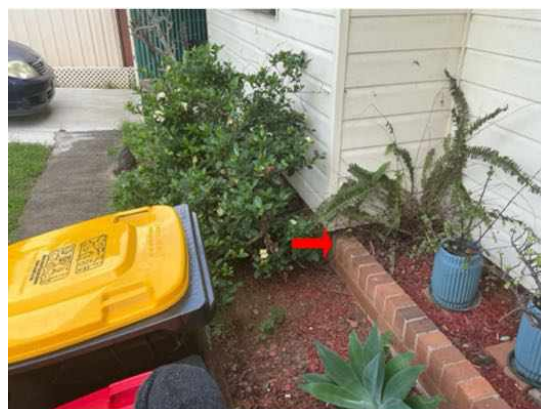
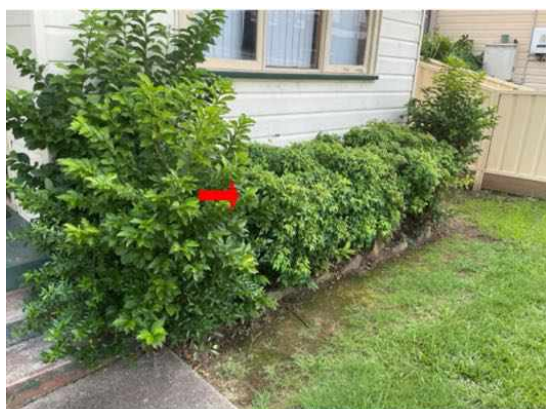
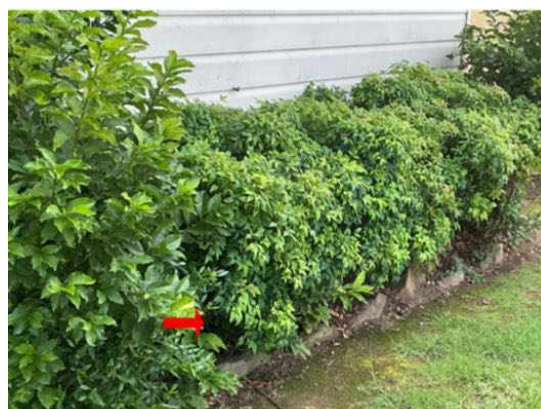
## Finding 6.02

Building:	Main Building
Location:	All External Areas
Finding:	Garden Beds - Conditions Conducive to Termites
Information:	Garden beds were observed in direct contact with the building's perimeter across various areas of the property. In some areas, untreated timber and mulch were used. This configuration, combined with regular watering or hosing, creates conditions conducive to termite activity and increases the risk of termite ingress into the structure.

Garden beds placed against external walls, particularly those incorporating untreated timber or excessive mulch, can retain moisture and create hidden entry points for termites. This undermines the effectiveness of termite barriers, compromises weep hole visibility, and elevates the risk of concealed termite activity that may lead to structural damage.

Implement regular pest inspections and engage a licensed pest control specialist to assess and manage termite protection systems.

The current placement and construction of garden beds present a termite risk and deviate from best practice recommendations for termite management. Rectification and professional input from both a landscaper and pest management specialist are advised to ensure the building remains protected while achieving the desired landscape design.

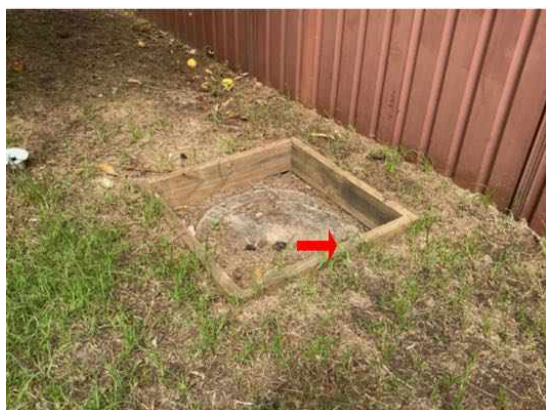
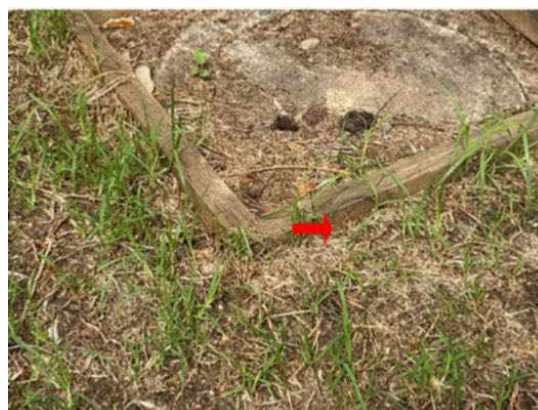
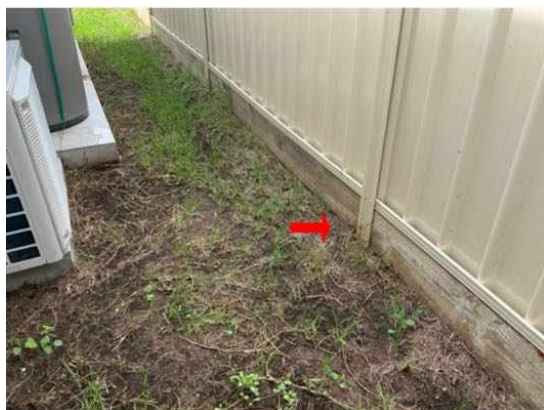
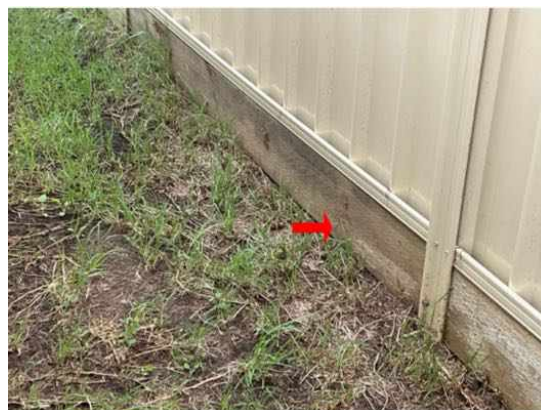
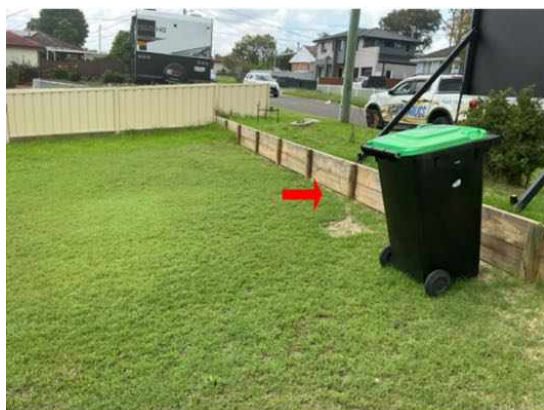
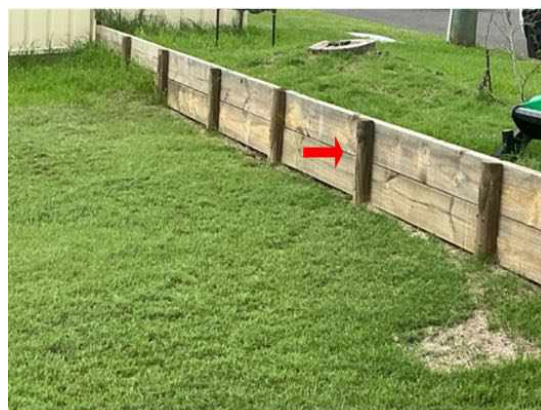
### Finding 6.03

Building:	Main Building
Location:	All External Areas
Finding:	Timber Materials In Direct Ground Contact- Conducive to Termites
Information:	Timber elements that are in direct contact with the ground and exposed to moisture or damp conditions are highly conducive to termite activity. This susceptible arises because of timber, when in contact with soil and dampness, create an environment that is particularly attractive to termites, encouraging infestation and potential structural compromise. Whether the timber is used as part of the building construction or incorporated into fencing, the presence near or on the ground can become a pathway for termites to access And damage the property.

When exposed to excessive moisture, timber begins to deteriorate developing

condition such as wood decay or rot. These compromised areas of timber are even more appealing to termites as they are easier to infest and consume. This is especially true for untreated or non-durable timber, which lacks the protective treatments that can deter or withstand termite attacks. Termites can use these weakened moisture laden elements as a bridge into other parts of the structure, creating an entry point for potential infestations that can spread and cause extensive damage if left unchecked.

For any timber in direct contact with the external ground special attention is required the combination of moisture untreated wood and direct ground contact not only accelerate the decay process but also provide subterranean termites with a straightforward means of ingress into the structure this can lead to termites moving undetected into other vulnerable areas resulting in potentially significant structural issues and costly repairs.

To mitigate the risk of termite activity it is imperative that any such materials or timber elements be appropriately treated or removed as soon as possible. Timbers that are necessary for use should be made durable through appropriate treatments and maintained to ensure they do not create conditions conducive to termites. Additionally the client is advised to schedule regular termite treatments to maintain an effective barrier against infestations and ensure ongoing protection.

Regular inspections, proactive maintenance and consistent termite treatment are essential steps in minimising the risk of termite attack and protecting the structural integrity of the property. Taking these preventative measures is crucial for maintaining a termite free environment and avoiding potentially costly damage and future repairs.

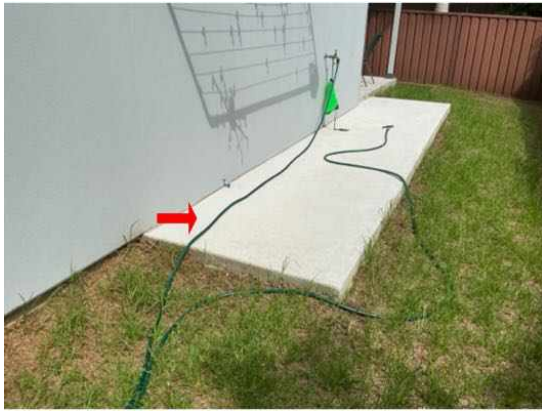
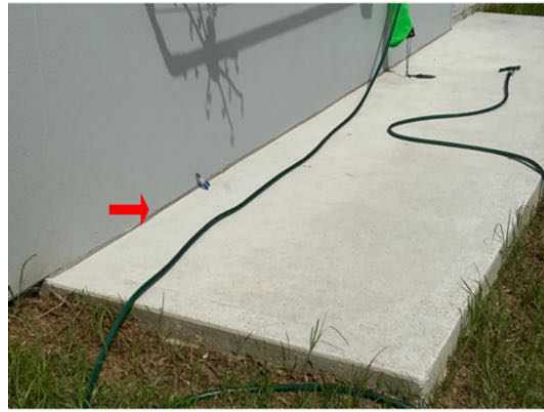
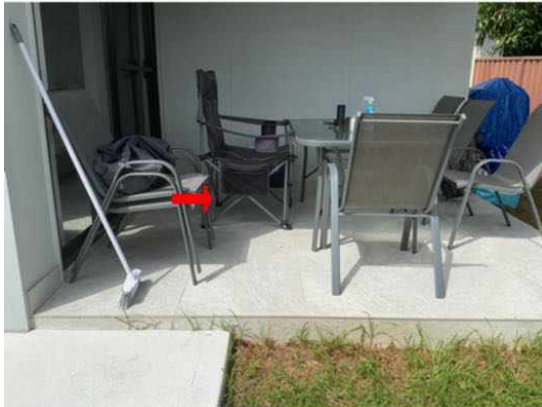
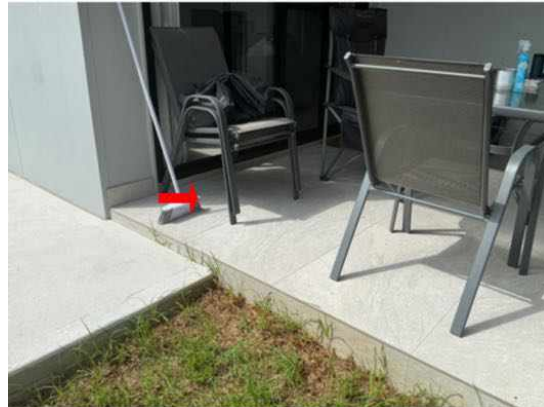
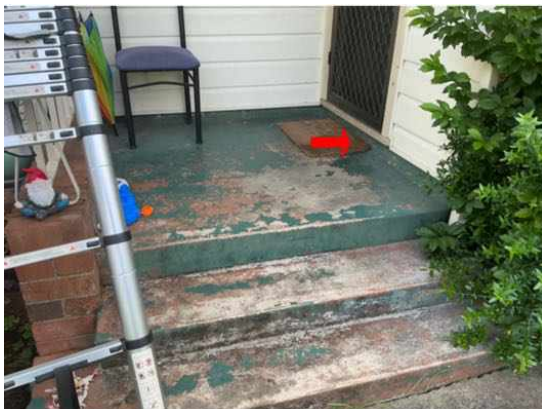
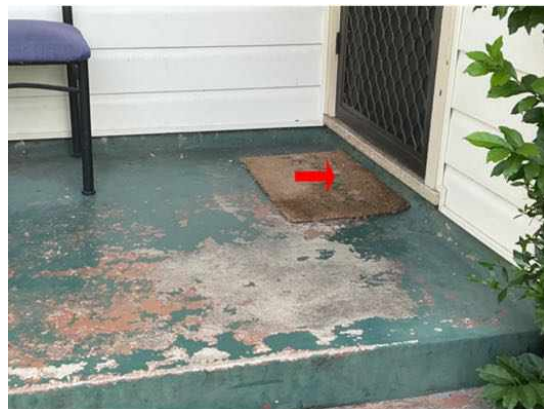
### Finding 6.04

Building:	Main Building
Location:	All External Areas >
Finding:	Bridging Of Physical Barriers - Patios/Porches
Information:	Breaching is the spanning of a physical termite barrier or inspection zone so that subterranean termites are provided with an entry point over or around that barrier.

The concrete porch/patios are providing a concealed entry point at the time of the inspection. Where the location of the porch is retrospectively installed against an external wall this will provide a concealed entry point for termites.

The client should consider gaining further advice from a timber pest technician as to treatments required in this area. It is recommended that obtaining such advice be a short-term priority.

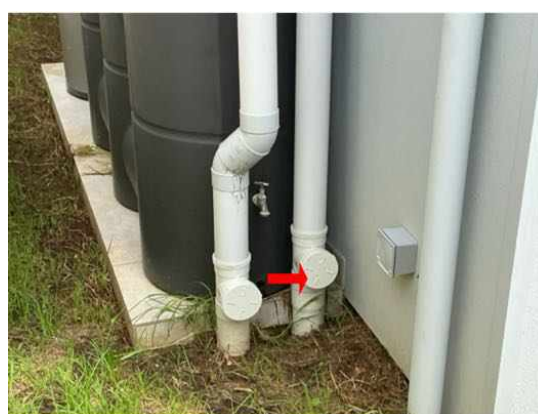
### Finding 6.05

Building:	Main Building
Location:	All External Areas
Finding:	Bridging or Obstruction - Air Conditioner, Hot Water Tank
Information:	Bridging of termite barriers is a significant concern, as it occurs when termites bypass the intended protective barrier or inspection zone, often through the construction of Mud tunnels or by finding a passage that allows them to traverse the barrier undetected. This bridging comprises the effectiveness of the termite protection system and increases the risk of termite infestation entering the property in a concealed or undetectable manner, which can lead to potentially severe damage overtime.

During the inspection it was noted that certain obstructions such as an air

conditioning unit, hot water unit, storage shed, or various stored goods, impeded the clear visual inspection of the external walls and weep holes in the affected area. These obstructions create blindspots that prevent a thorough assessment of the termite barrier and the condition of the wall surfaces. The presence of such obstructions can limit the ability to detect early signs of termite activity or breaches in the protective barrier, thereby increasing the likelihood of undetected termite intrusion.

The weep holes and external walls play a critical role in maintaining the property structural integrity and ensuring that moisture and termites do not infiltrate concealed spaces. When these areas are obstructed, it becomes impossible to carry out a complete inspection, which may compromise the ability to detect termite activity or vulnerabilities in the barrier system.

To mitigate risk it is strongly recommended that all obstructions be moved away from the external walls and weep holes to allow for a comprehensive visual inspection. This step will ensure that both current and future inspections can be conducted thoroughly, enabling the detection of any termite activity, potential bridging, or breaches in the barrier. Maintaining clear access to these areas is crucial for the continued effectiveness of the termite management system and for safeguarding the property from potential damage.

It is also the responsibility of the property owner and Client to take these preventative steps and ensure that regular termite treatments are conducted to maintain the barriers effectiveness and avoid costly future repairs. Proactive measures such as keeping external walls free from obstructions conducting regular inspections, getting termite treatment done on regular basis and addressing any identified issues promptly will help maintain the integrity of the termite barrier and reduce the risk of concealed termite entry. Taking this precaution is essential for protecting the long-term safety and value of the property.

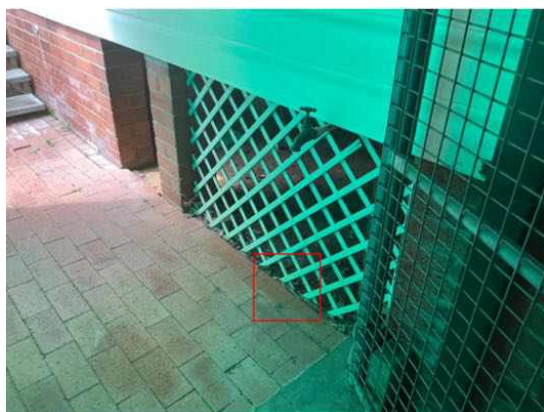
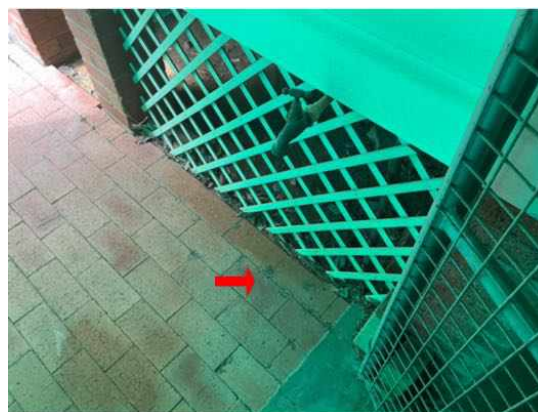
### Finding 6.06

**Finding:** Outdoor Tap - Conductive  
**Information:** The external garden taps were found to have inadequate drainage at the time of inspection, creating potential for subsequent water damage to associated building elements. In this case the waste is not directly beneath the water tap which poses a significant risk of water pooling around the base of the tap which can result in a series of moisture related problems that could compromise the structural integrity of the property and create an unsafe environment.

Excessive moisture encourages the growth of mould and mildew, which can spread to other areas of the property. This not only affects the aesthetics but can also have serious health implications for occupants particularly those with respiratory conditions or allergies.

Stagnant water around an exterior tap can attract pests such as termites which thrive in moist environments. This creates a pathway for these pest to enter the property and cause extensive damage to wooden structures. The presence of termites can compromise the property structural integrity and lead to costly and invasive repairs if not promptly address.

It is highly recommended that a licensed plumber be engaged to inspect the exterior tap area comprehensively and determine the best course of action. This may involve the installation of a stormwater drain or other drainage solution designed to redirect water away effectively by taking these measures the property owner or client can significantly reduce the risk of structural damage mould growth and termite attack insuring the property remains safe and well maintained

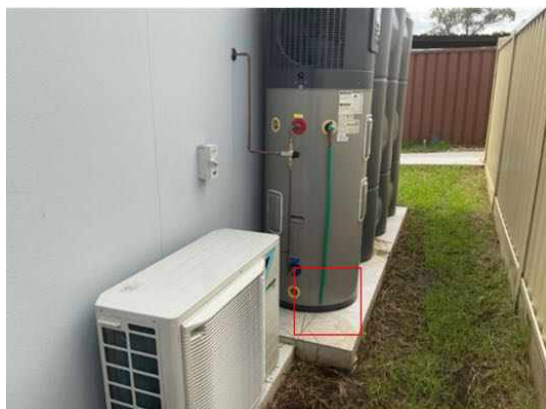
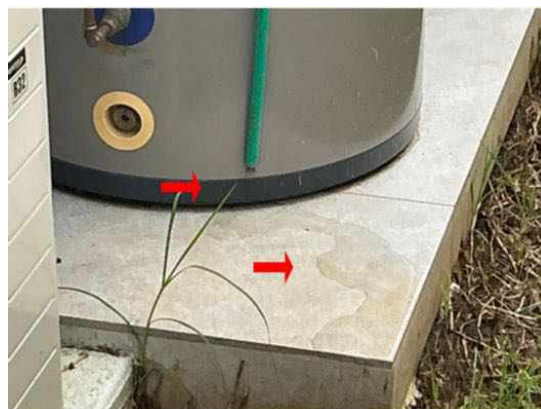
### Finding 6.07

**Building:** Main Building  
**Location:** Granny Flat  
**Finding:** HWS - Disconnected overflow  
**Information:** The Hot Water System overflow was found NOT to be connected to the storm water drainage and is creating excessive moisture in the surrounding area.

Poorly aligned materials can and will lead to further damage to nearby areas.

It is highly recommended that a licensed plumber be appointed to connect the A/C overflow in order to prevent such an environment from being created. These minor works should be carried out as soon as possible.

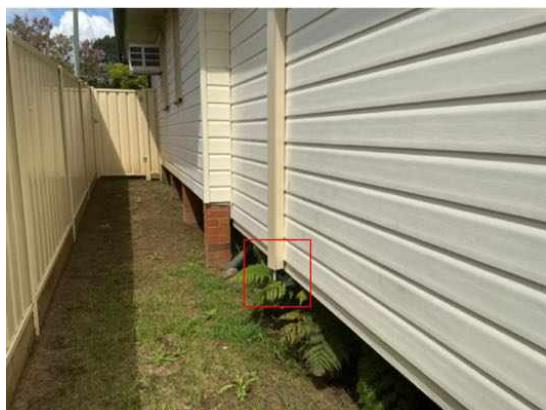
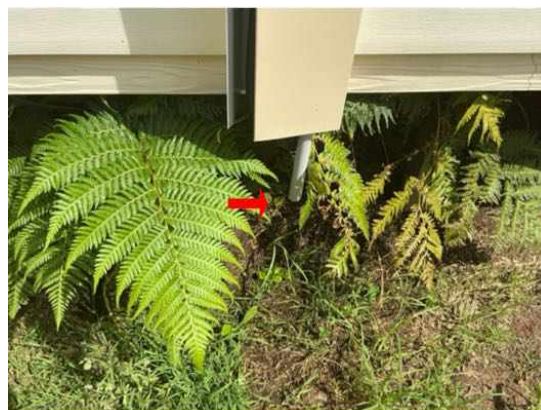
### Finding 6.08

Building:	Main Building
Location:	Exterior walls - right side
Finding:	Air conditioner - Disconnected overflow
Information:	The Air Conditioner overflow was found NOT to be connected to the storm water drainage and is creating excessive moisture in the surrounding area.

Poorly aligned materials can and will lead to further damage to nearby areas.

It is highly recommended that a licensed plumber be appointed to connect the A/C overflow in order to prevent such an environment from being created. These minor works should be carried out as soon as possible.

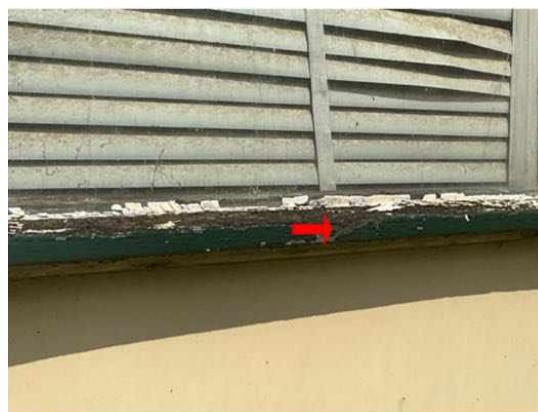
#### Finding 7.01

Building: Main Building  
Location: Garage  
Finding: Wood Rot - General  
Information: Wood rot was found to be affecting the external timber material. Wood rot, also known as Fungal Decay, occurs when timbers and other cellulose building materials are exposed to damp conditions on an ongoing basis.

It is likely that this wood rot has developed as a result of excessive moisture in this areas. Frequent exposure to rain and other weather conditions also make fascias and barges susceptible to accelerated deterioration.

It is advised that replacement of affected timber elements as soon as possible.

A qualified carpenter or registered builder is required immediately to replace the affected building materials.

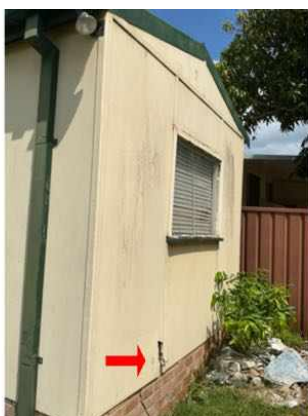
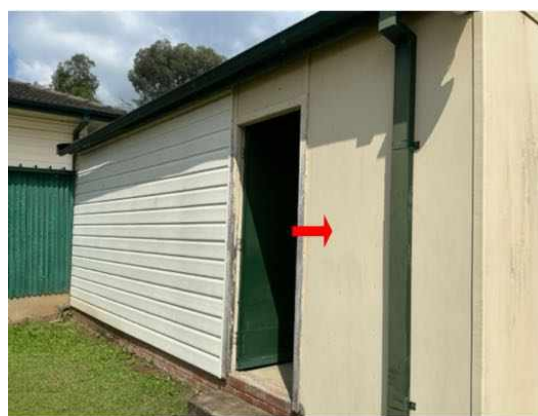
As Asbestos Reporting is outside the scope of this report, we advise that you consider a separate Asbestos Inspection and Condition Audit, which can include the taking of samples for definitive confirmation of the presence of Asbestos.

In the interim, the client is advised to act with caution, especially when considering any damage to building materials general wear and tear renovations extensions demolition and general maintenance activities due to the suspected presence of Asbestos.

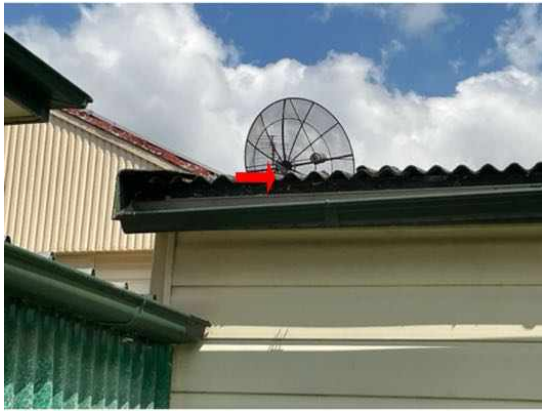
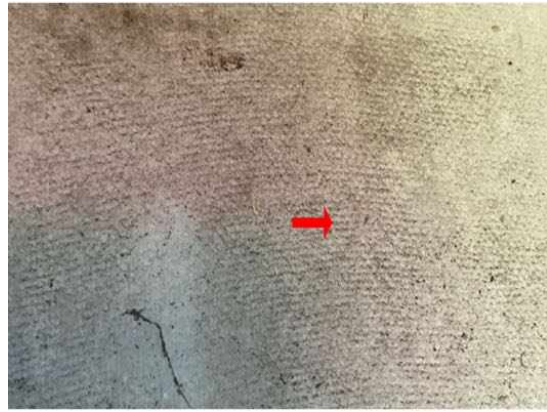
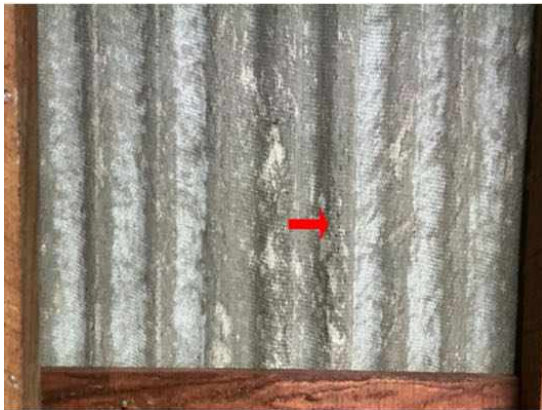
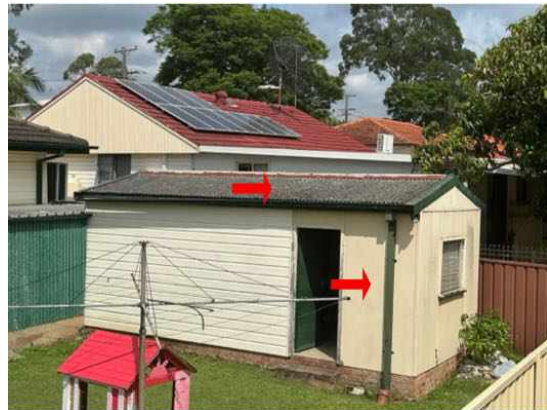
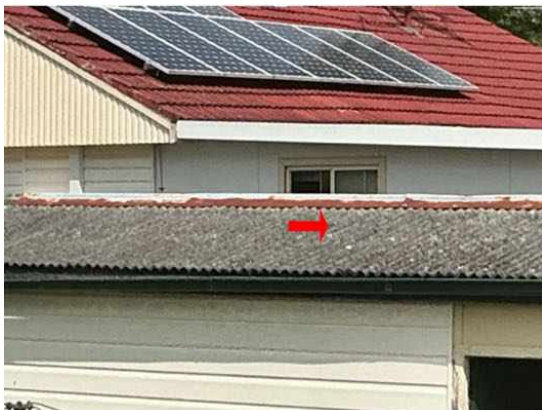
Building:	Main Building
Location:	Garage
Finding:	Asbestos - Suspected
Information:	Reporting on Asbestos is outside the Scope of this Report. This suspected defect is highlighted as a caution only. We suspect, based on our experience in the building industry, that there is a higher risk of this property containing asbestos.
