# Building and Timber Pest Inspection Report

Inspection Date: Fri, 6 Mar 2026

Property Address: 7 Karoola St, Busby NSW 2168, Australia

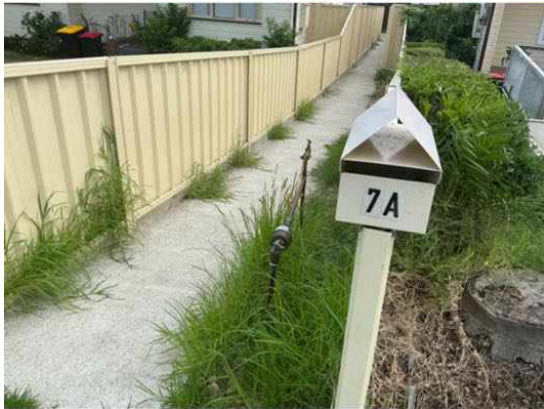
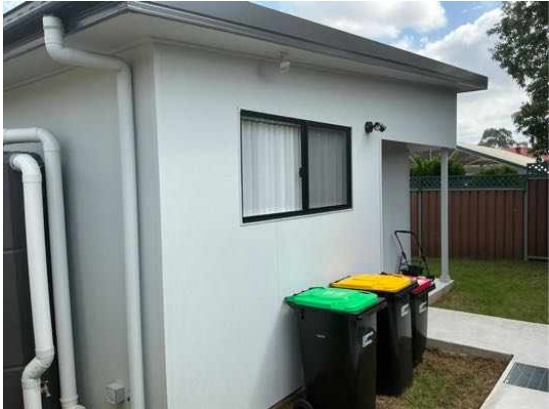
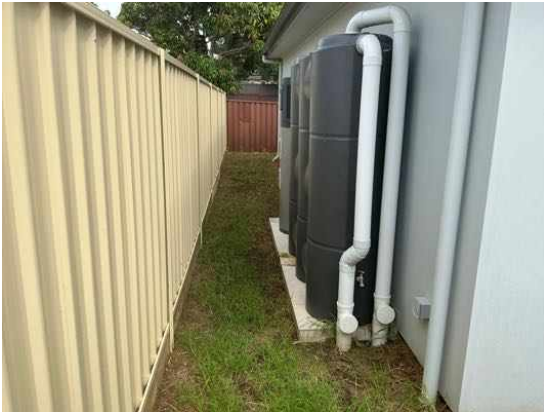
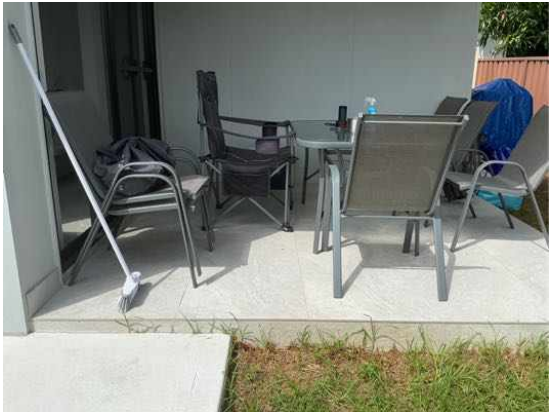
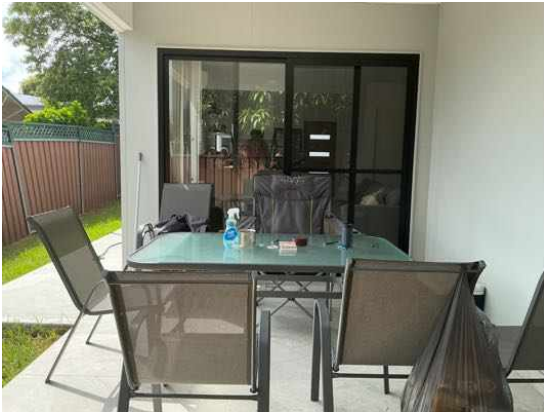
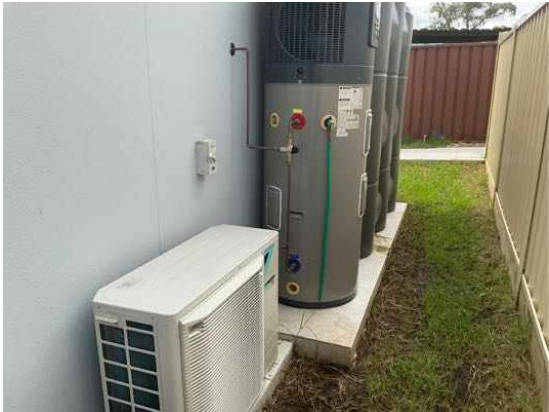
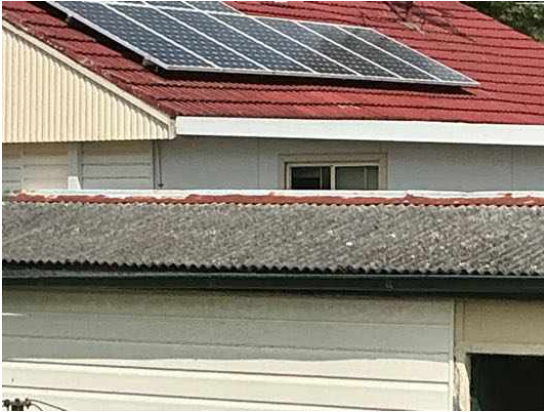
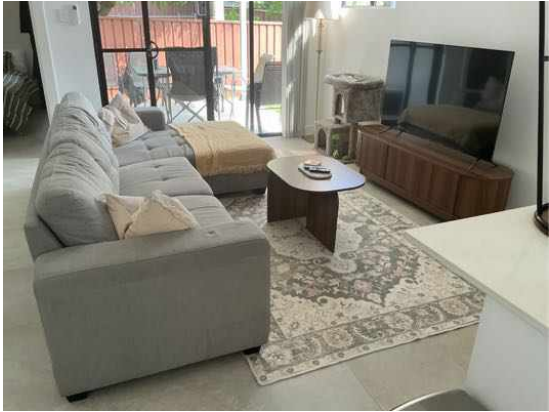
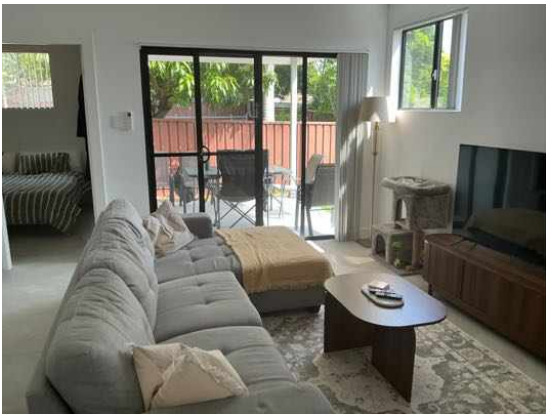
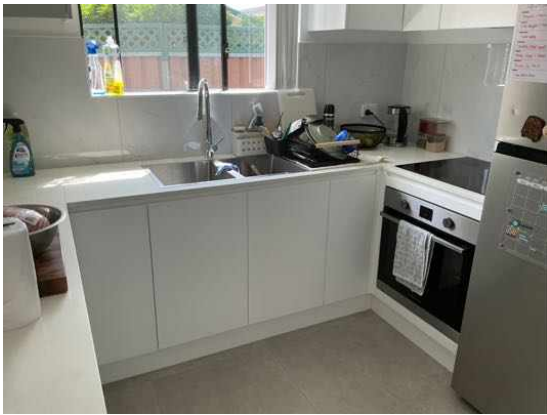
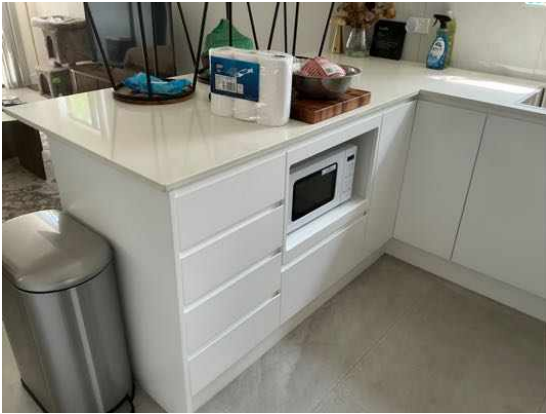
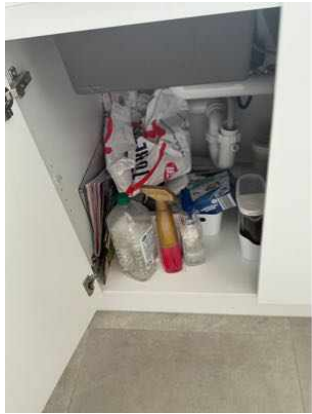
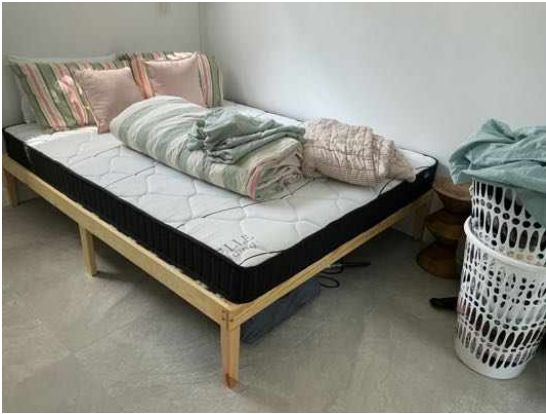
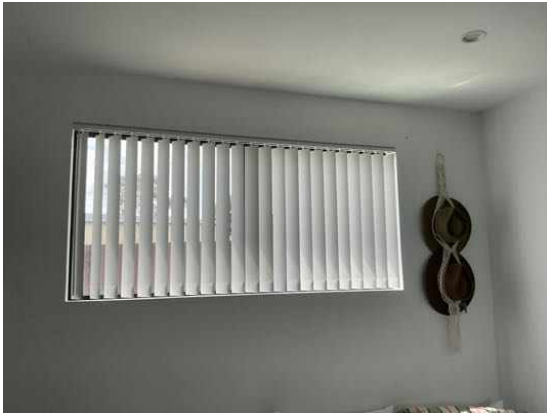
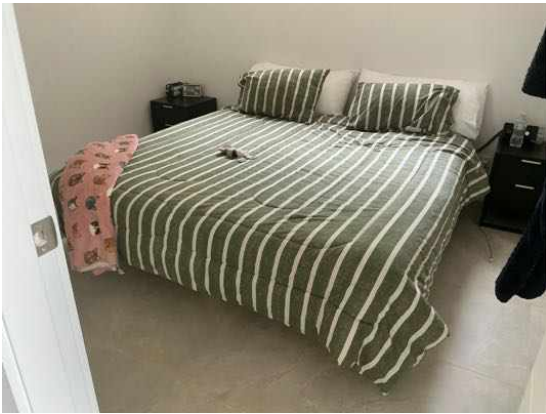
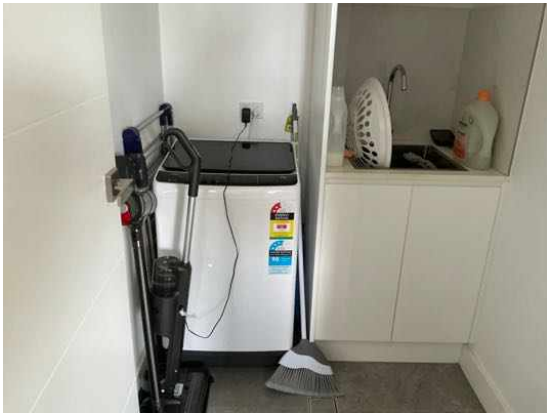
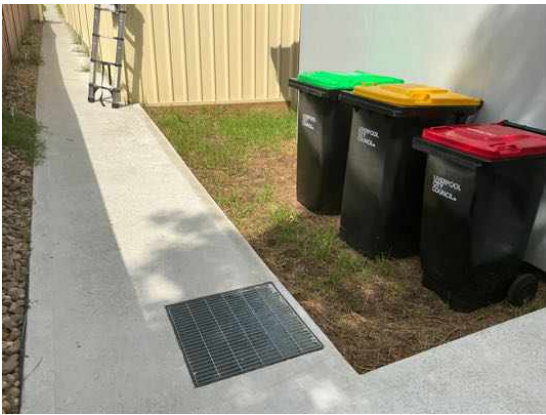
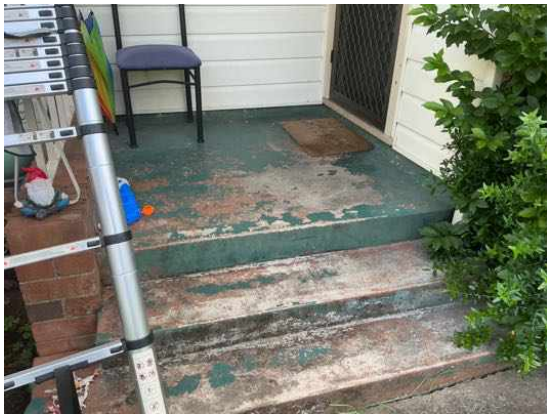
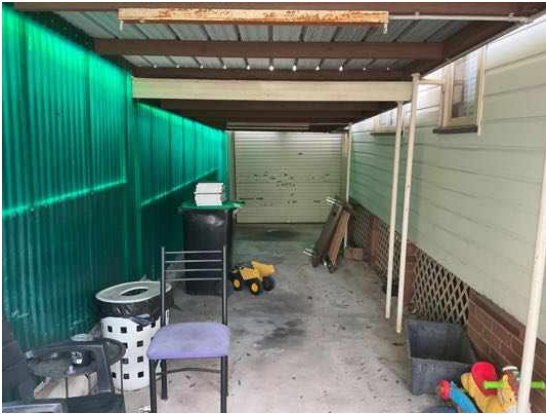
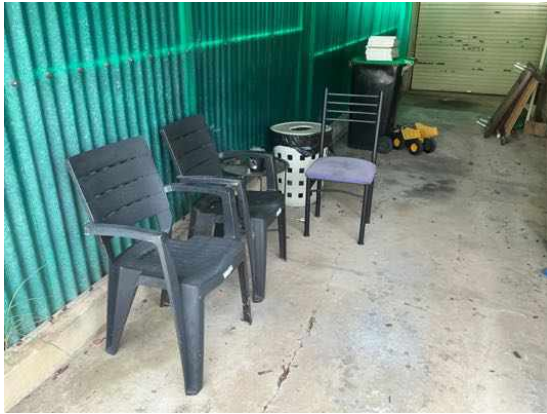
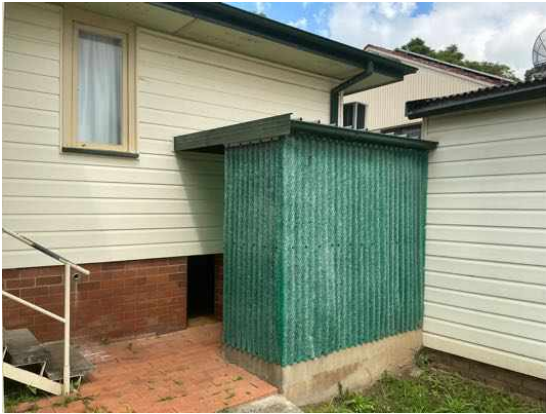
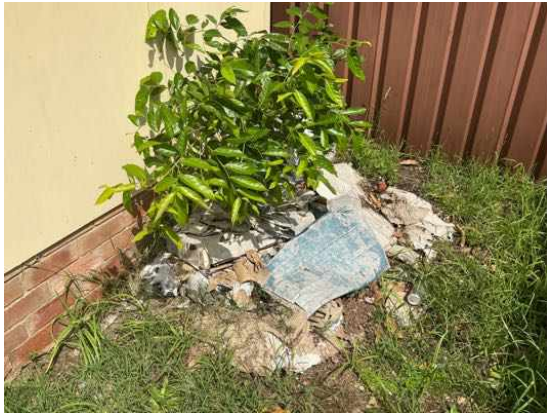
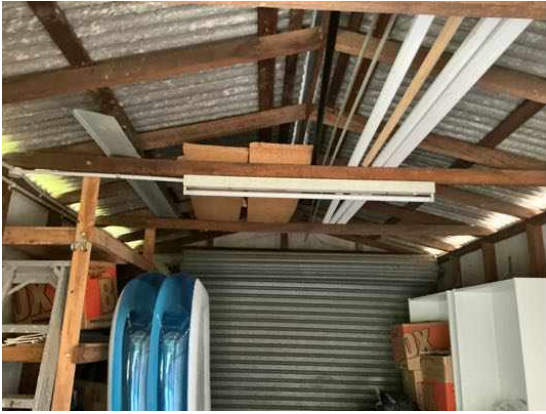
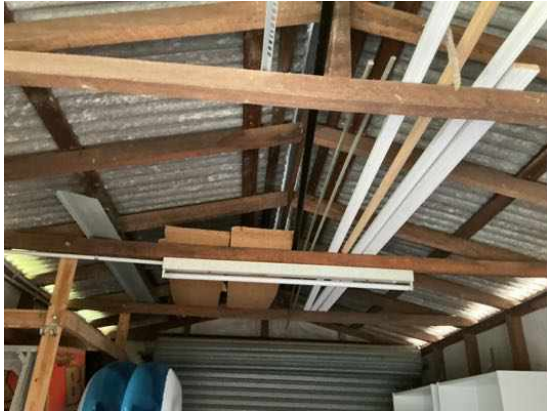
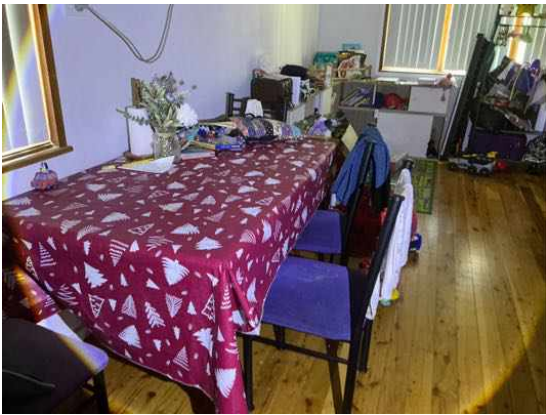
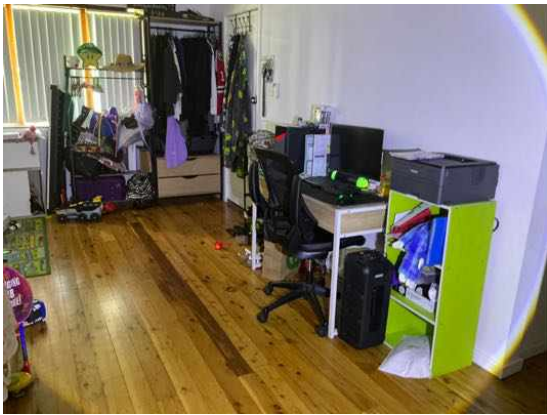
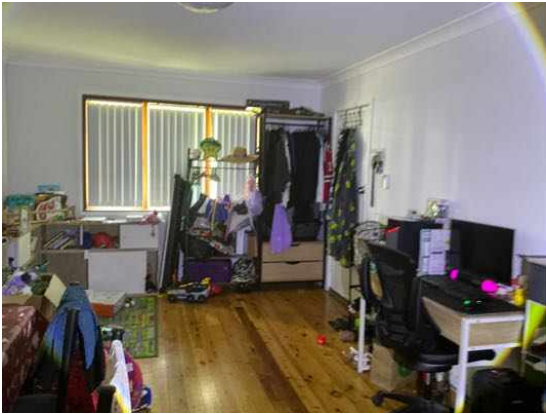
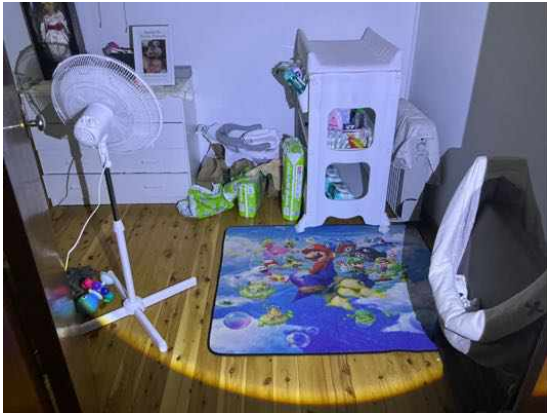
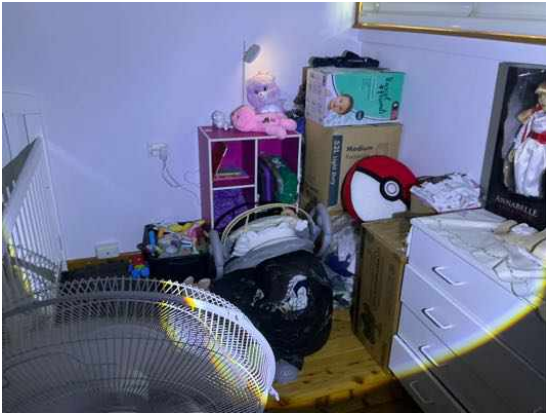
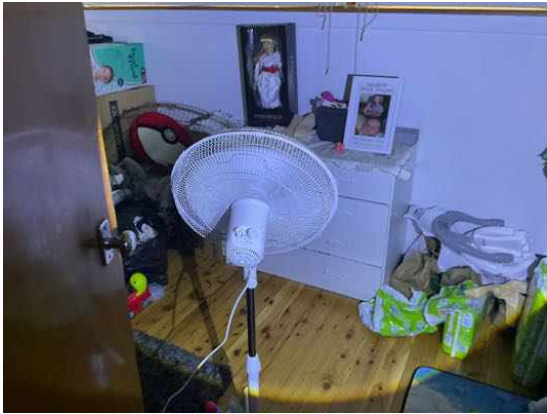
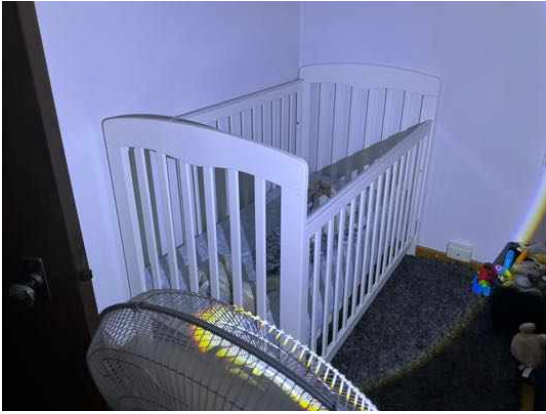
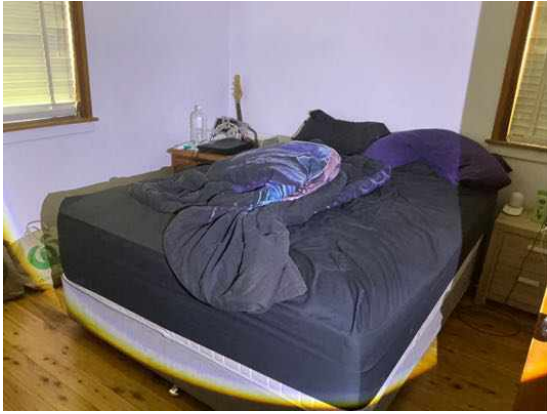
Building:	Main Building
Location:	All Areas
Finding:	Additional Photos - Obstructions and Limitations
Information:	These photographs are an indication of the obstructions and limitations which impeded full inspection of the property at the time of inspection. These obstructions can hide an array of defects and should be removed to allow full inspection to be carried out. A re-inspection is recommended once the areas are made accessible.

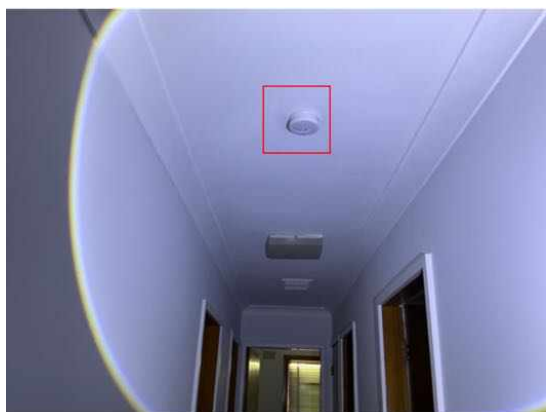
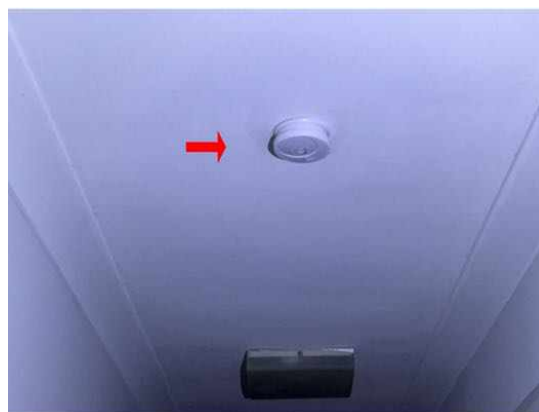
Building: Main Building  
Location: All Internal Areas  
Finding: Smoke Detectors and Alarms  
Information: Reporting on Smoke Detectors or Alarms, including hard wired smoke detection systems and their legislative requirements, is outside the Scope of this Report.

Always ensure sufficient working and suitable smoke detectors are installed prior to occupying any building. Additionally, it is advised that all smoke detectors be tested by the homeowner on a monthly basis.

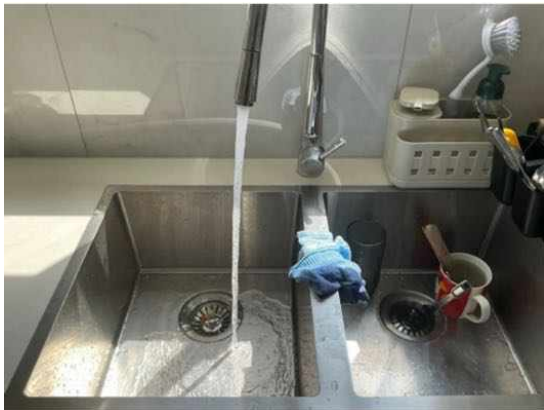
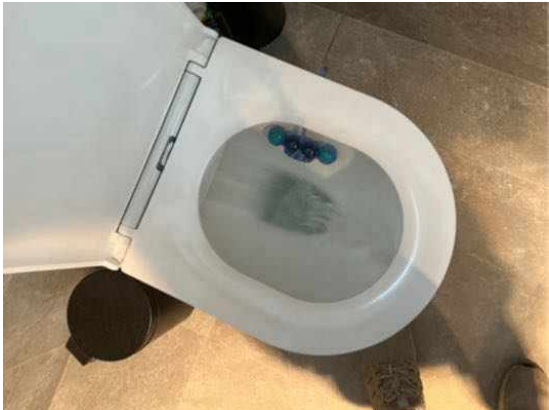
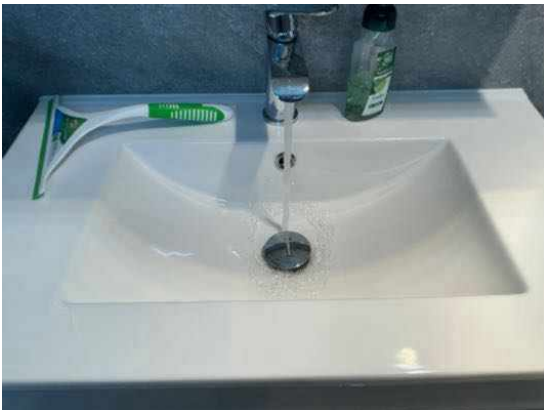
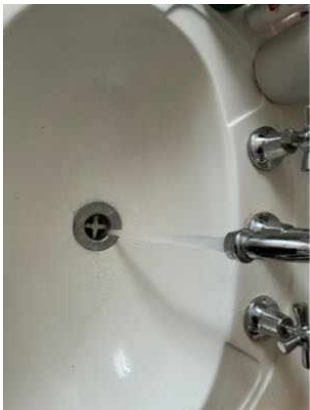
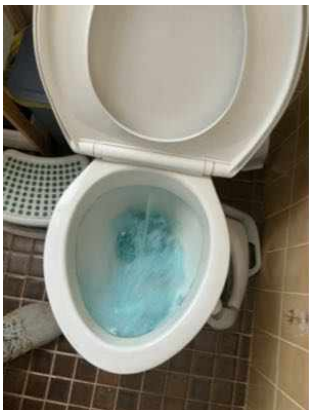
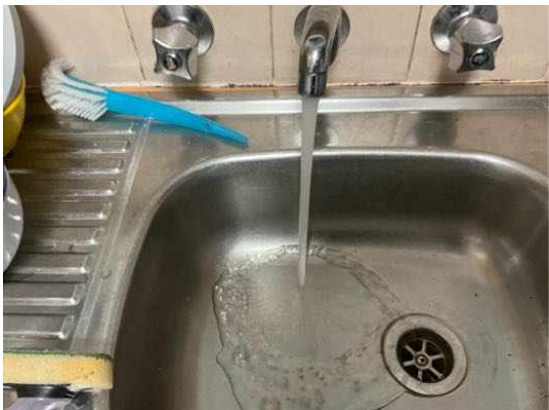
Building: Main Building  
 Location: All Wet Areas  
 Finding: Taps, Drainage and Toilets Tested  
 Information: During the inspection, taps, draining systems and toilets were checked for both water flow and drainage efficiency, as well as inspected for any visible signs of leakage at the time of the inspection. No issues were noted in these areas, unless highlighted in a separate, no immediate remedial work appears to be necessary for these items. Any relevant photo's Documenting these inspections may be found in the additional photo section for reference.

However, it is important to note that while a thorough inspection of cupboards and cabinetry was conducted the presence of instructions such as stored items or fixtures may have limited full visibility of potential water damage or hidden defects. These obstructions can conceal underlying issues that may not be immediately visible during the initial inspection. Furthermore, conditions can change after the inspection has been carried out and defects or damage could be revealed once obstructions are removed or as time progresses.

Given this, it is strongly recommended that a reinspection be conducted after all obstructions have been removed from the cupboards to allow for a full thorough assessment of these areas. This will ensure that any concealed damage or defects are identified and addressed in a timely manner. Regular maintenance and monitoring of plumbing and drainage systems are also advised to insure long-term functionality and to prevent future problems from arising.

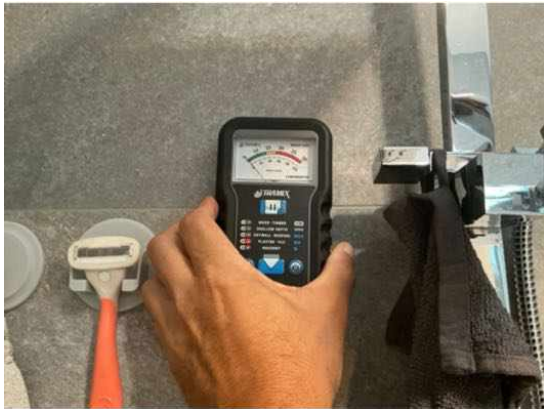
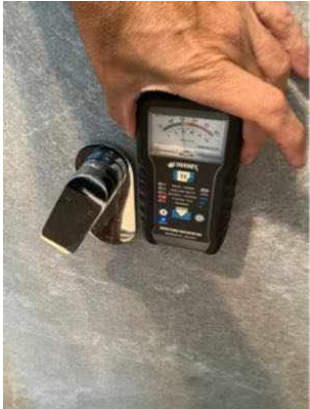
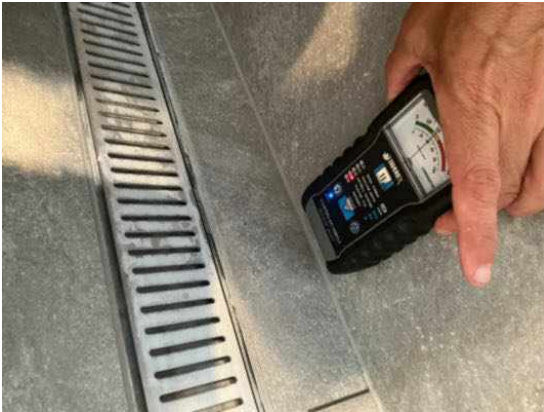
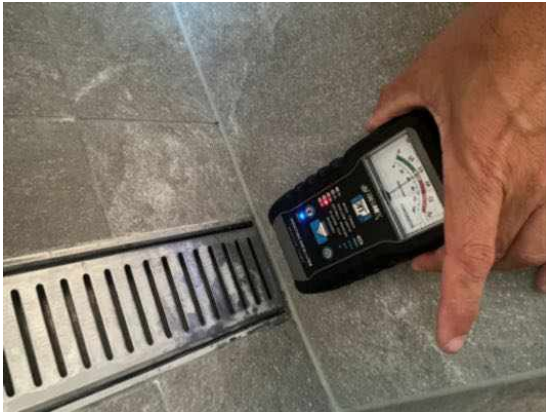
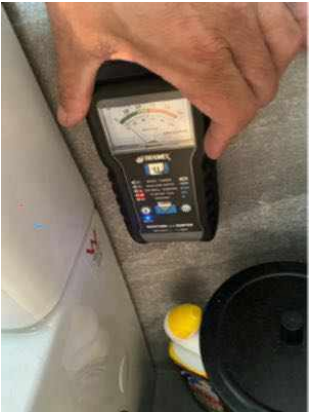
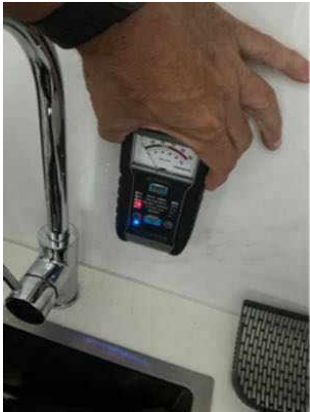
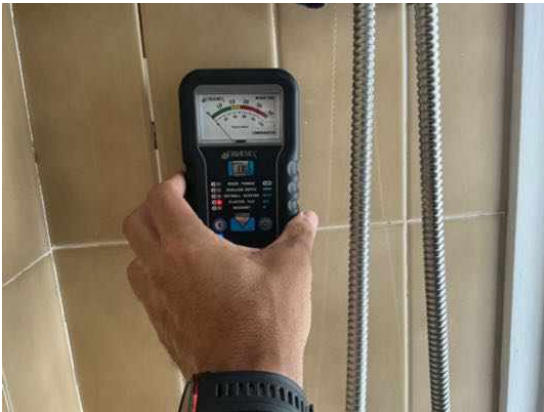
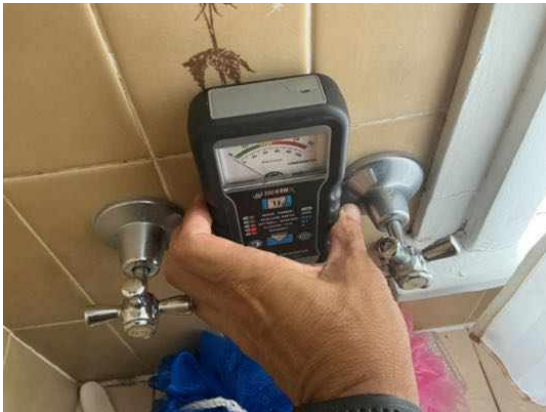
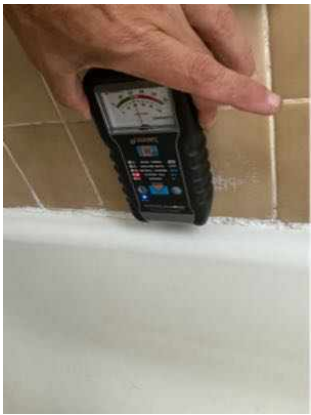
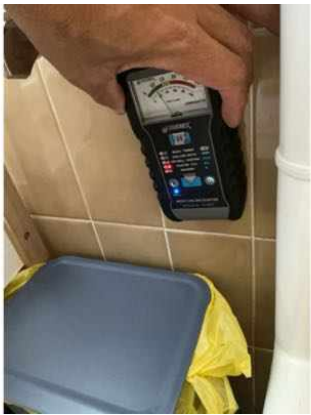
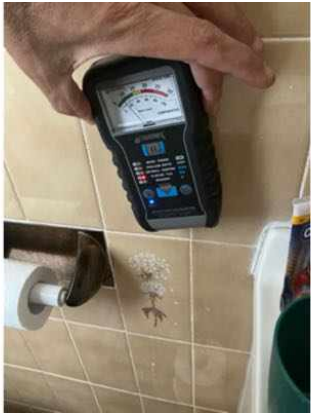
Building: Main Building  
Location: All Internal Areas  
Finding: Photos added Moisture Readings - Wet Areas  
Information: Additional photos are provided for your general reference.

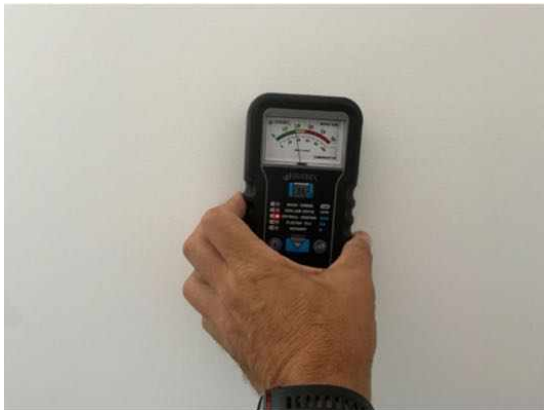
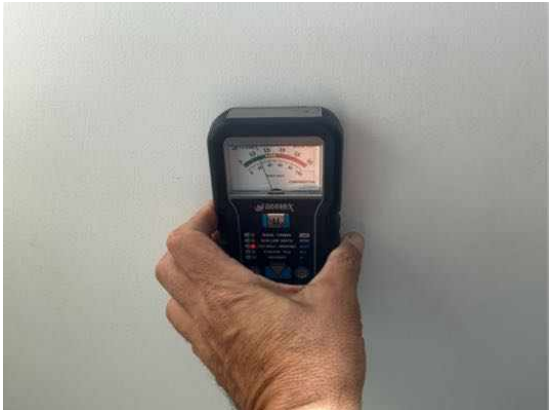
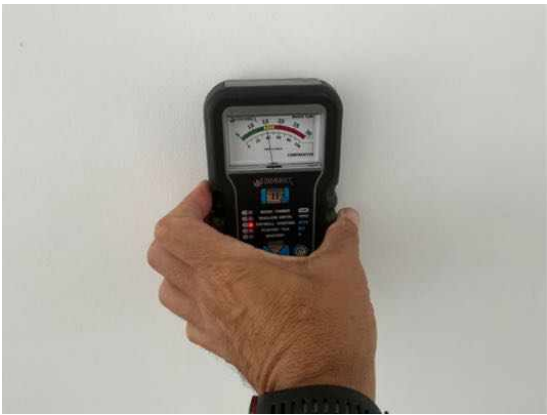
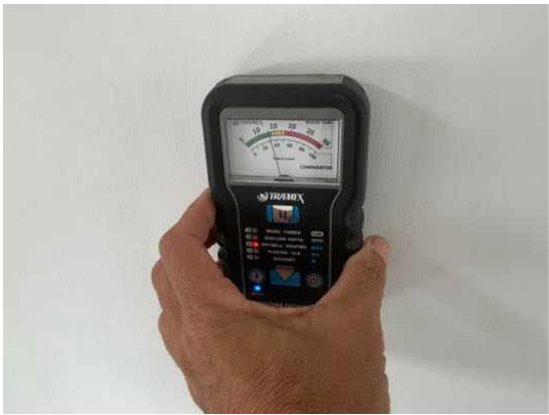
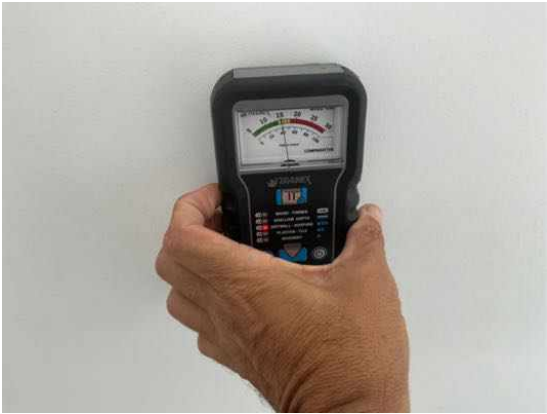
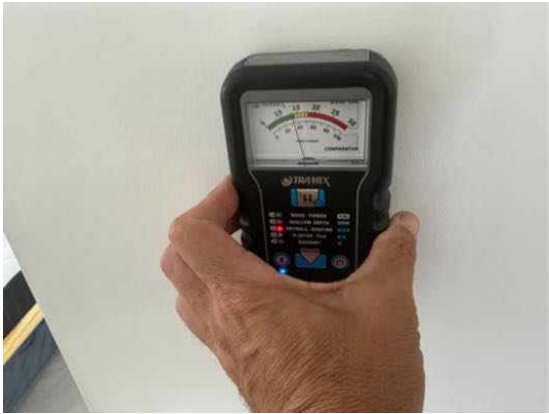
Building: Main Building  
Location: All Internal Areas  
Finding: Photos added Moisture Readings - Other Areas  
Information: Additional photos are provided for your general reference.

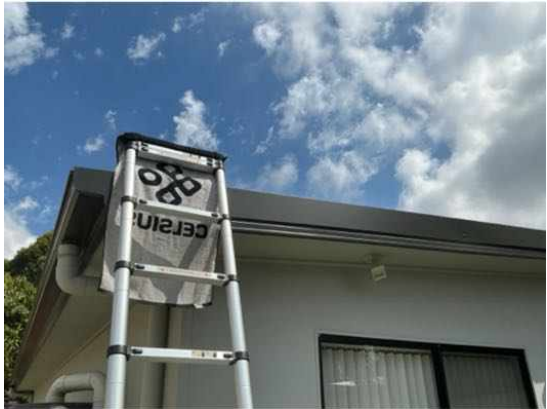
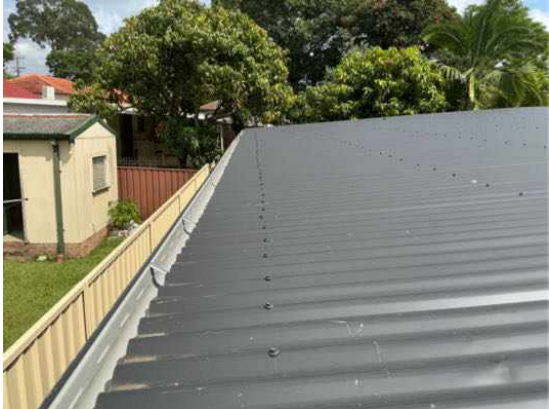
Building: Main Building  
Location: Roof Exterior  
Finding: Additional Photos Roof  
Information: Additional photos are provided of the general roof area for your general reference at the time of inspection.

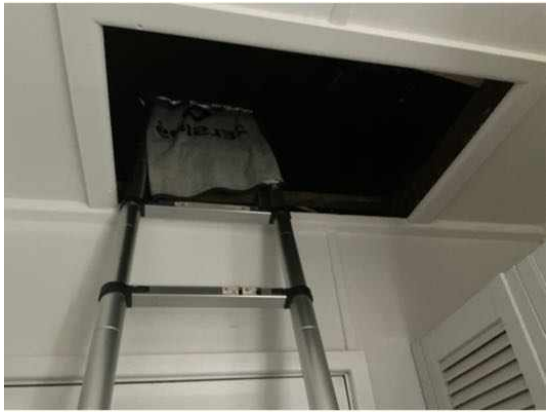
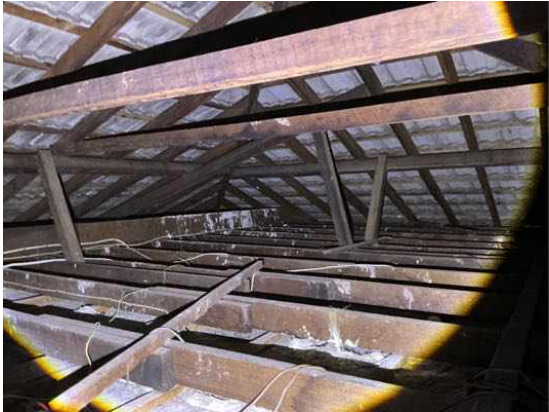
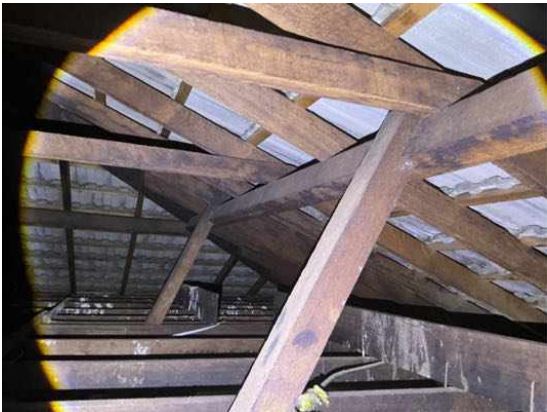
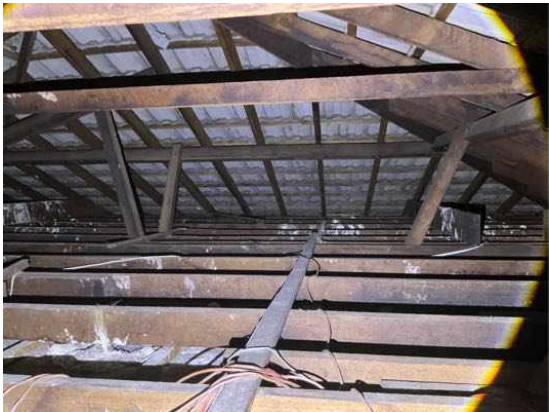
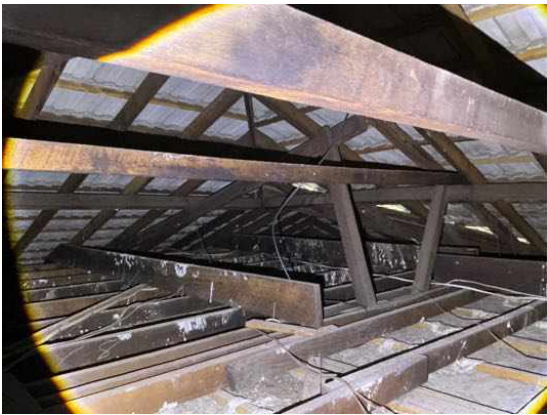
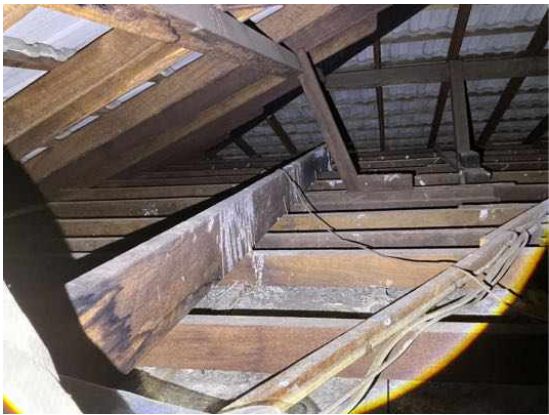
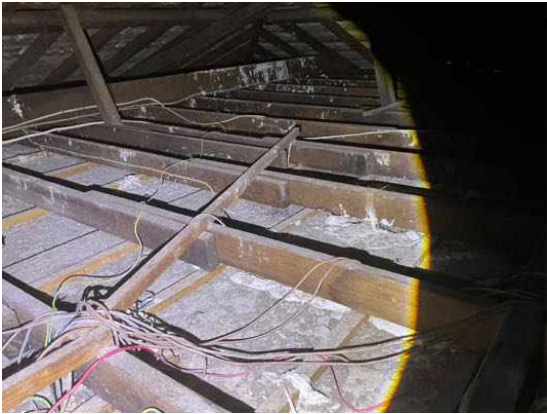
Building: Main Building  
Location: Roof Void  
Finding: Additional Photos Roof Void  
Information: Additional photos are provided of the general roof void for your general reference at the time of inspection.

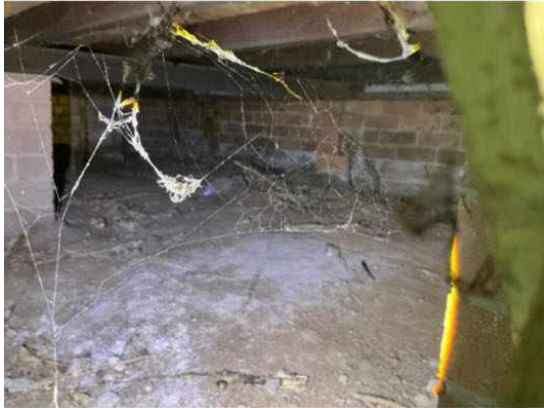
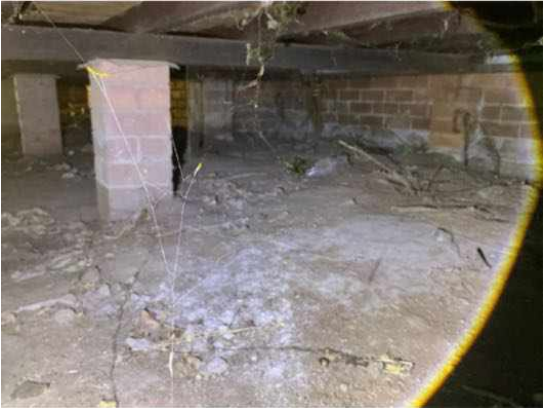
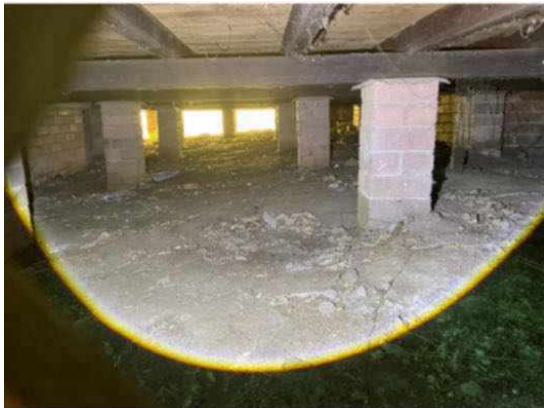
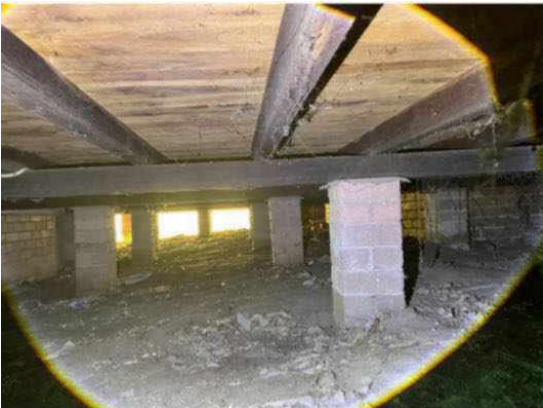
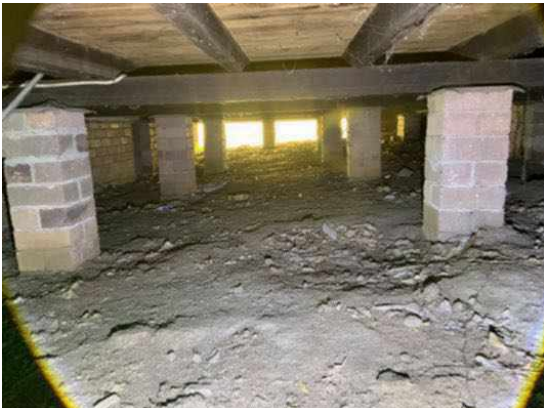
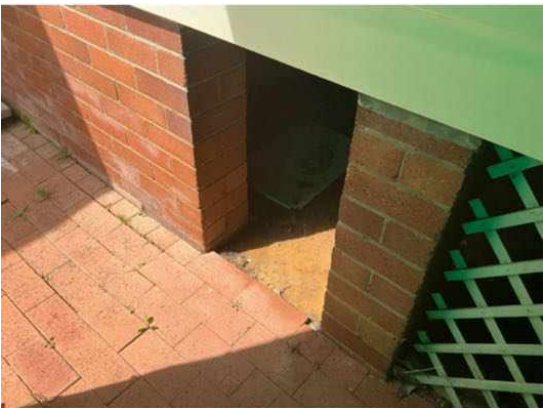
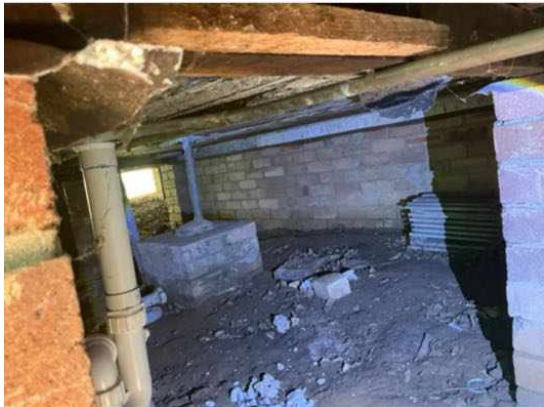
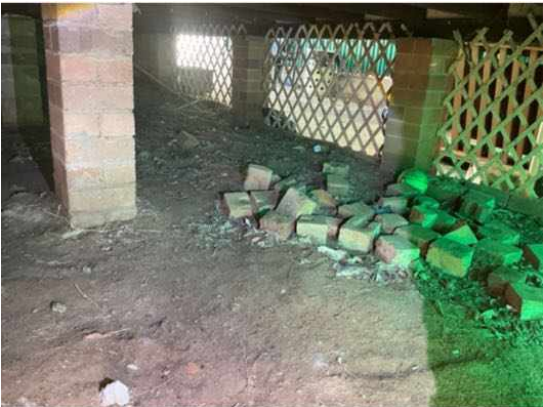
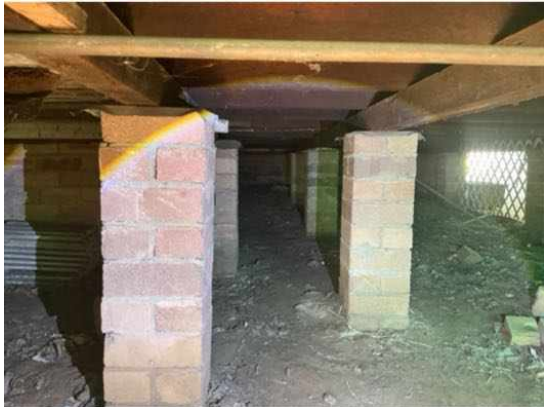
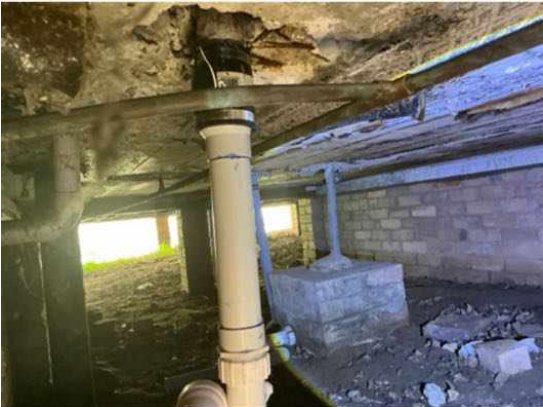
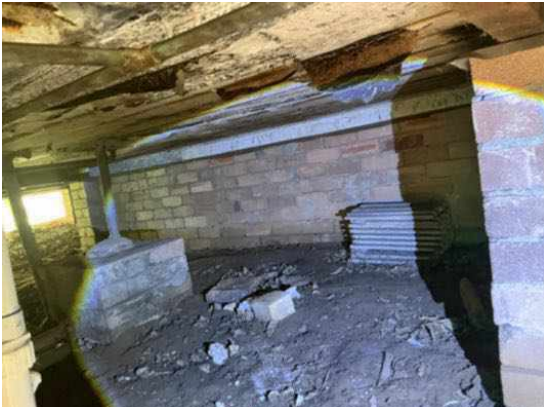
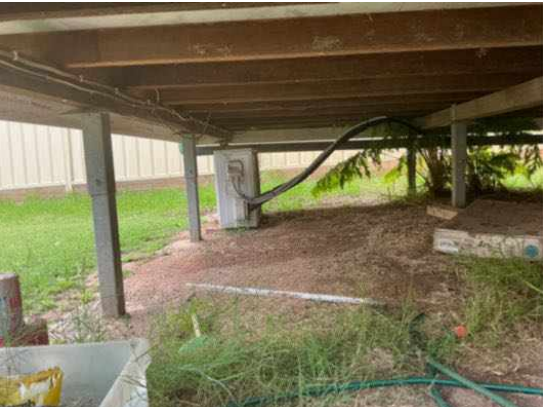
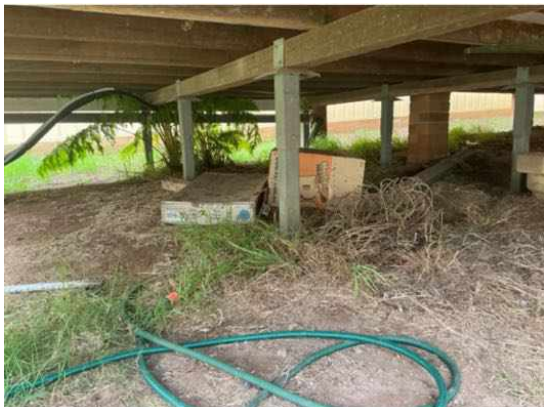
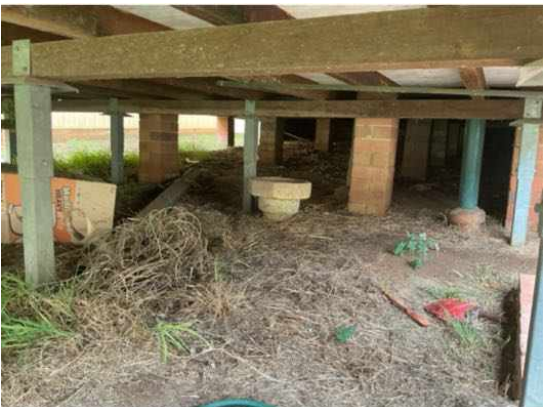
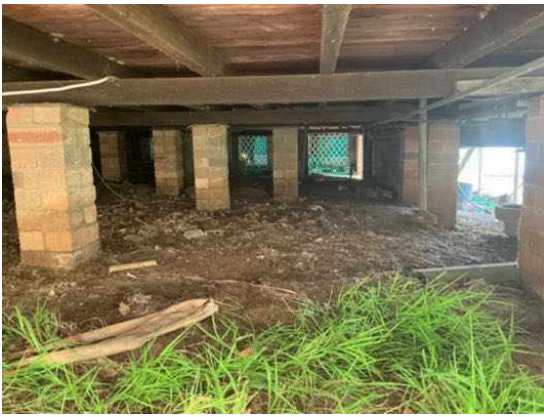
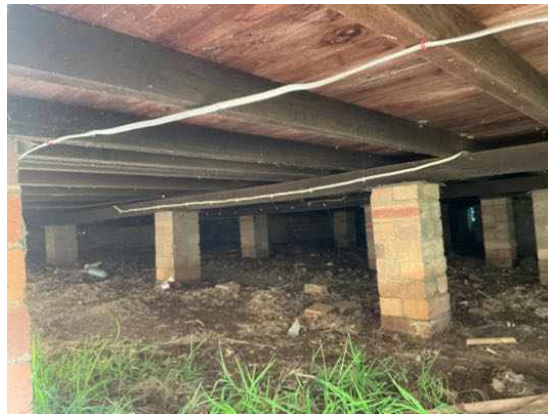
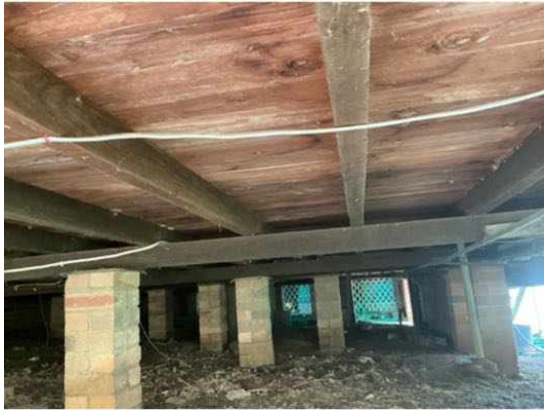
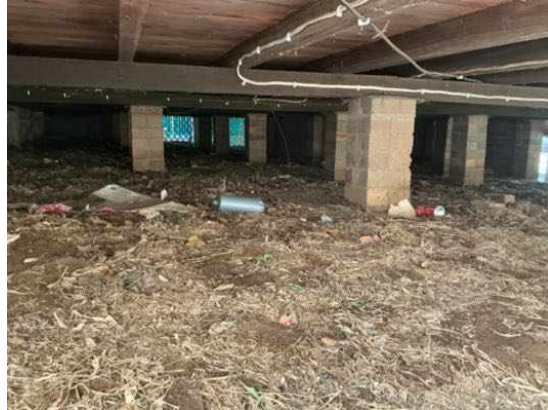
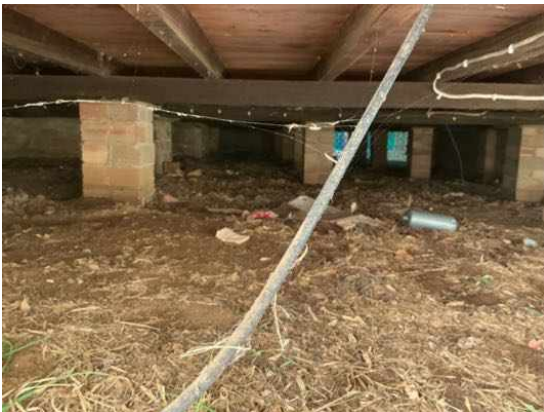
Building: Main Building  
Location: Subfloor  
Finding: Additional Photos - Subfloor  
Information: Additional photos are provided for your general reference

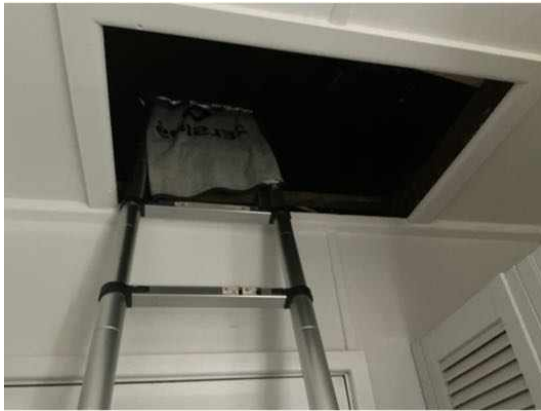
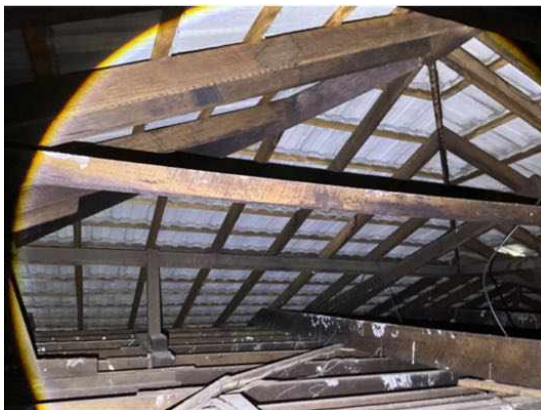
Building: Main Building  
 Location: Roof Void  
 Finding: Insulation - Inadequate  
 Information: Upon inspection of the roof void it was noted that there is a lack of adequate insulation.

Insufficient insulation will result in a comparatively higher cost to heat and cool a property as there is a lack of Insulation (or uneven coverage of insulation) which works as a barrier to heat transfer. This helps to keep out unwanted heat in summer and preserves warmth inside your home in winter. It can also help soundproof your home from unwanted airborne noise transfer.
