Building and Timber Pest Inspection Report

Inspection Date: Tue, 10 Mar 2026

Property Address: 13A Leicester St, West Richmond SA 5033,
Australia

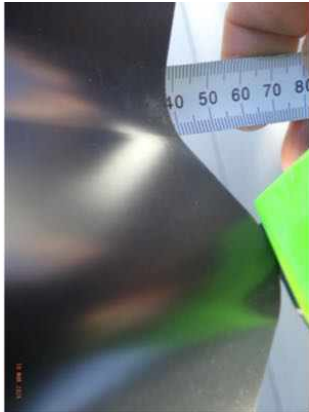
Building:	Building 1
Location:	Roof Exterior
Finding:	Exterior roof - Insufficient overhang
Information:	It was identified that there is insufficient overhang of the roofing into the guttering which is likely leading to water making its way behind the gutter which has in turn damaging the fascia which could also lead to an array of secondary related building defects.

Such defects are likely to include material deterioration, leaks and/or corrosion of associated building materials.

Over time, if this defect is not addressed further building defects will develop.

If leaking becomes apparent then consultation with a roofing plumber would be required regarding repair works.

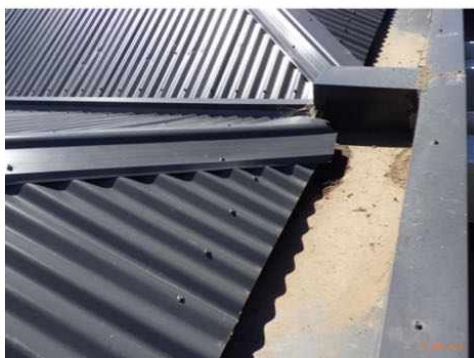
Finding 3.02

Building: Building 1
 Location: Roof Exterior
 Finding: Box gutters non compliant pre purchase.
 Information: It was noted that compliance issues exist with the box gutter system on the roof, main issues being

(b)Gutters discharge, Box gutters to discharge at the downstream end without change of direction (i.e. not to the side).

Monitoring the areas recommended and should issues arise then a licensed roofer should be appointed to give advice quotation and make repairs to ensure no leaks in the future.

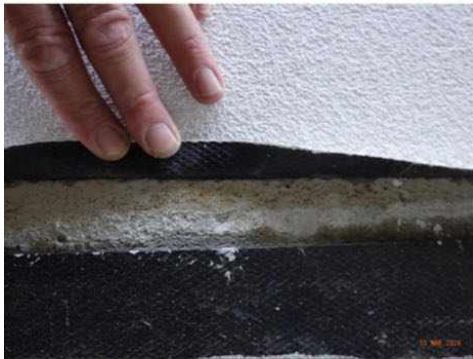
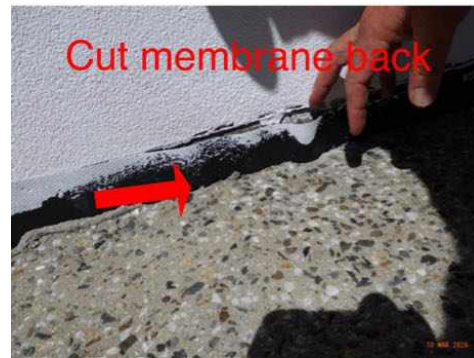
There has been a damp proof membrane installed at the junction of the perimeter of pavement to house. This should be cut down to pavement level to allow the slab edge to breathe and create a visual barrier to inspect for termites.

Membrane should be cut down to perimeter pavement level immediately to allow full inspection of the slab edge.

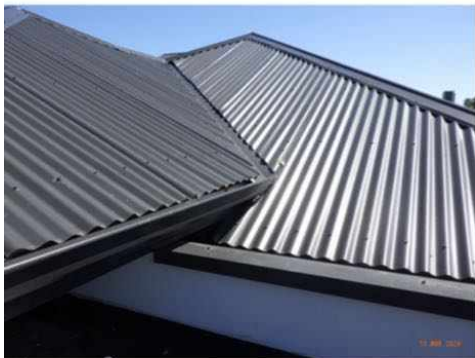
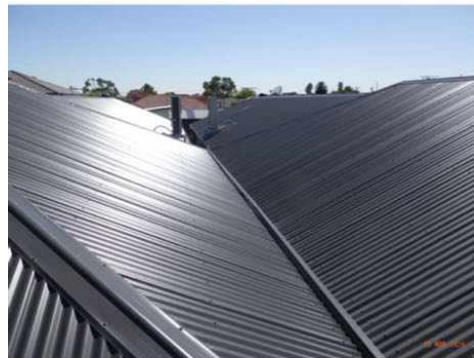
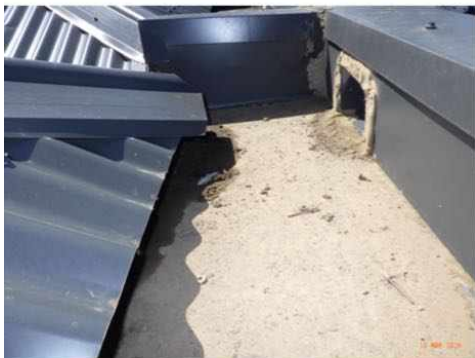
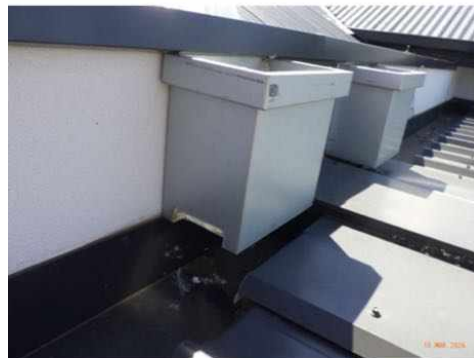
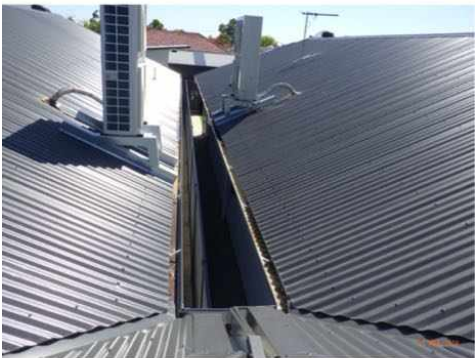
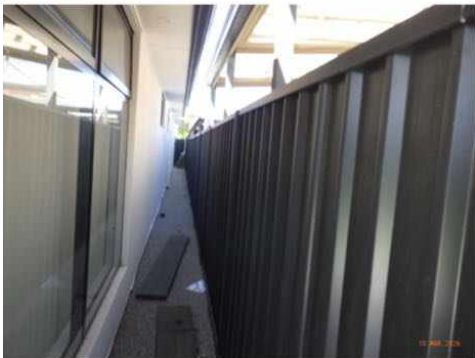
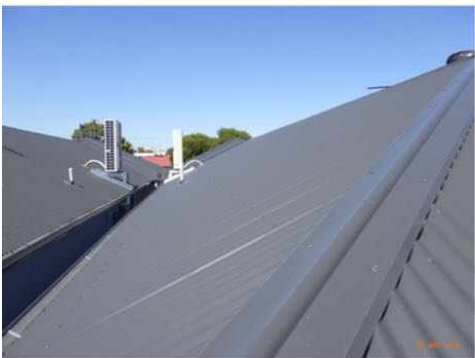
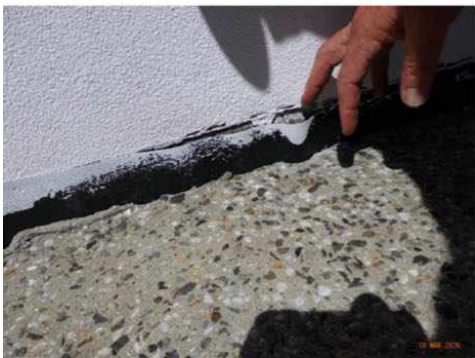
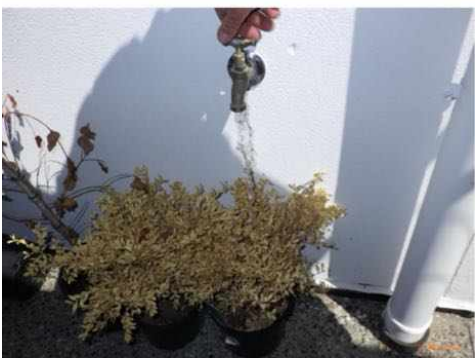
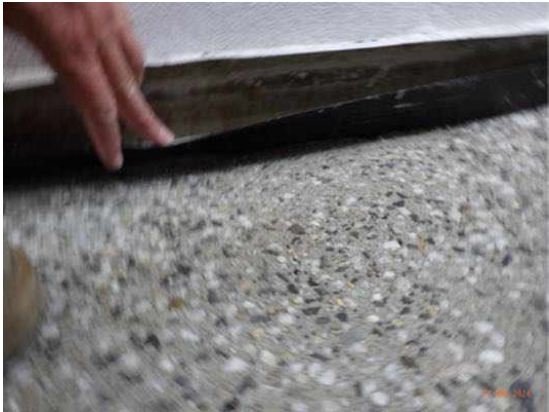
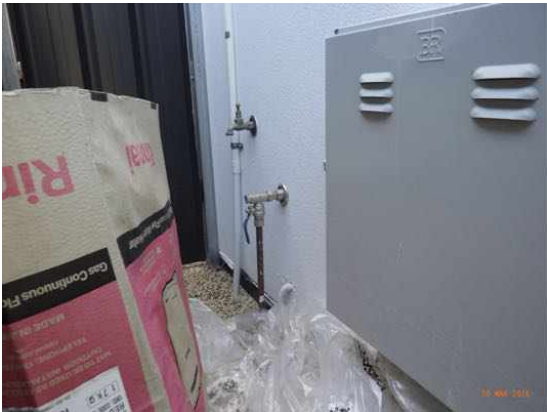
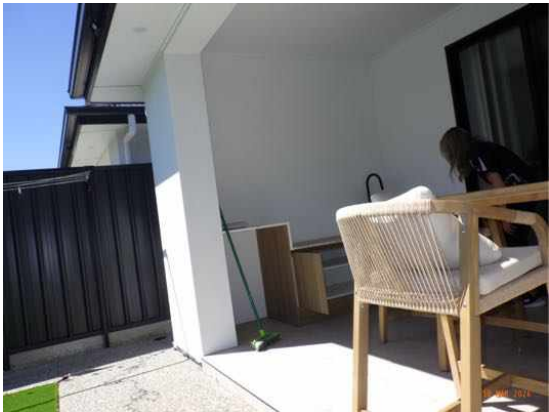
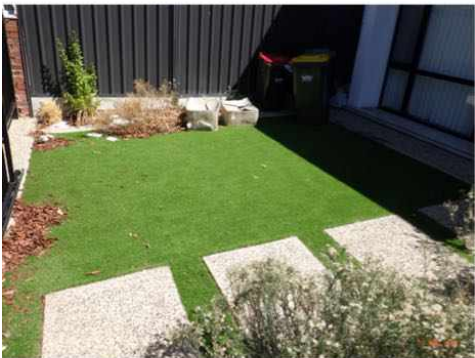
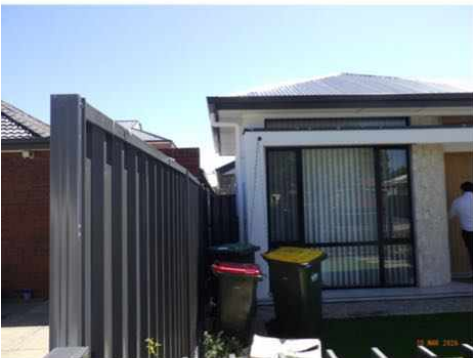
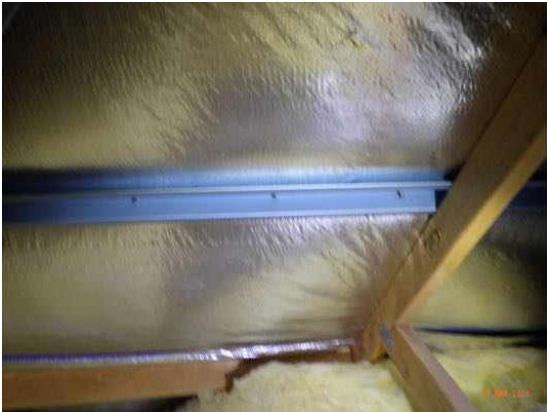
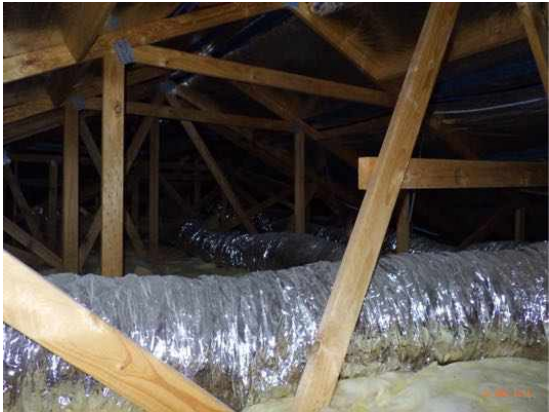
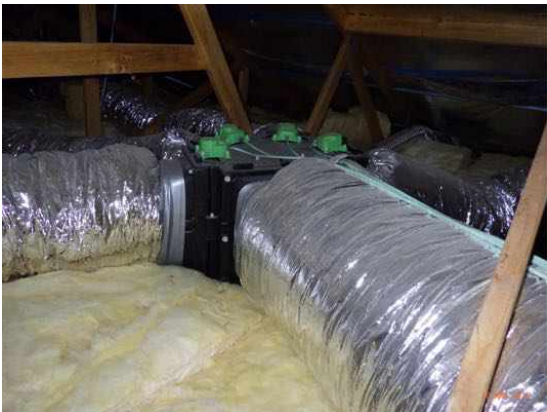
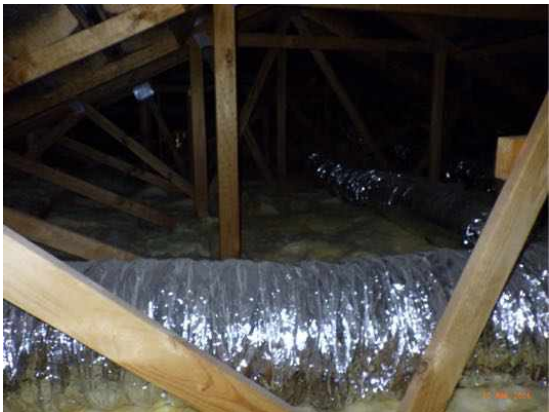
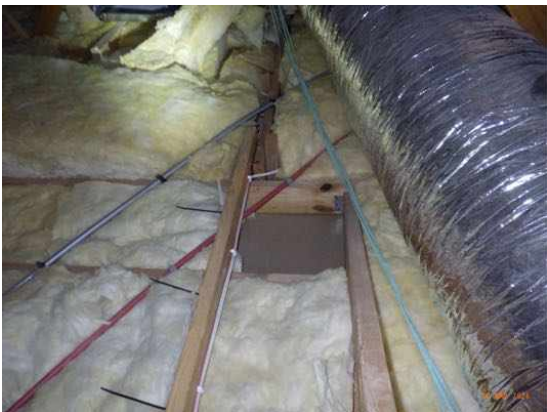
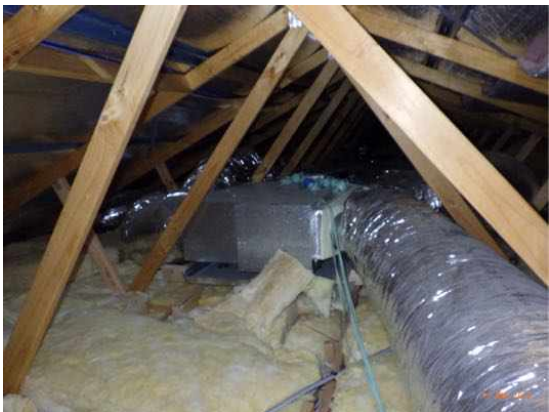
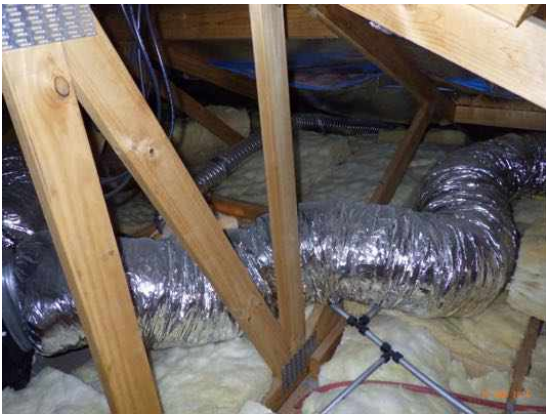
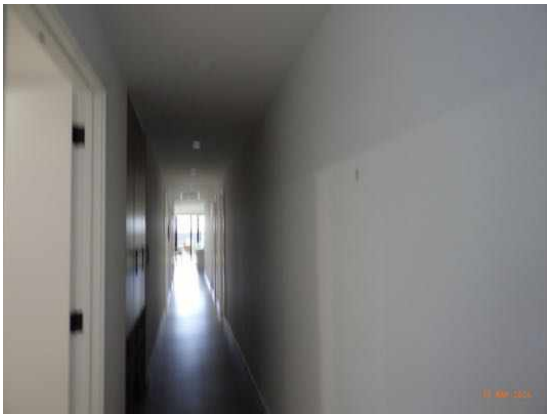
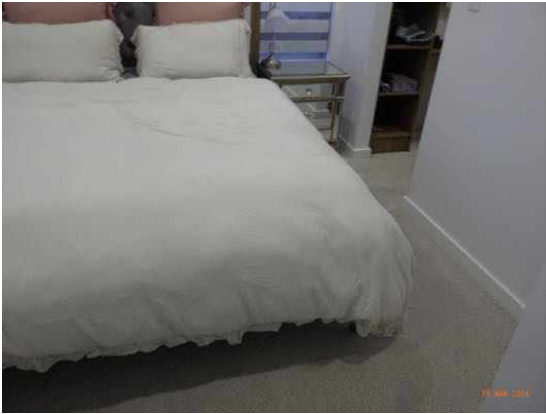
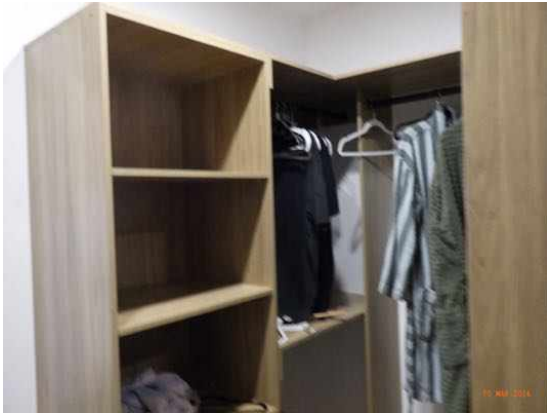
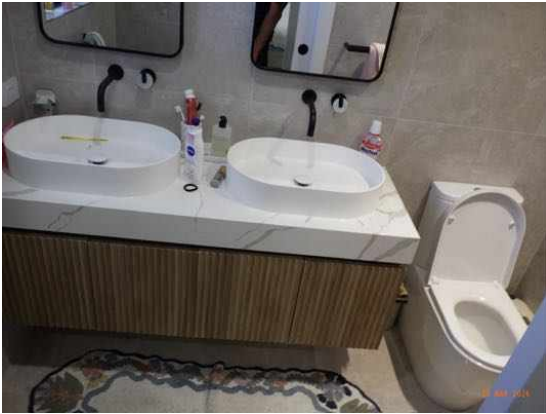
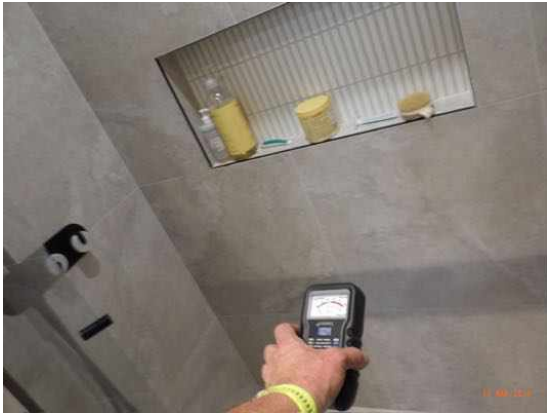
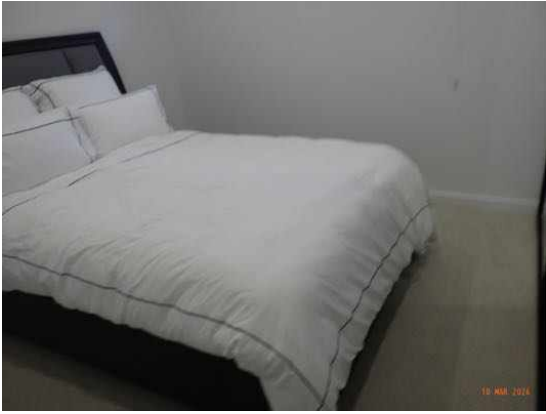
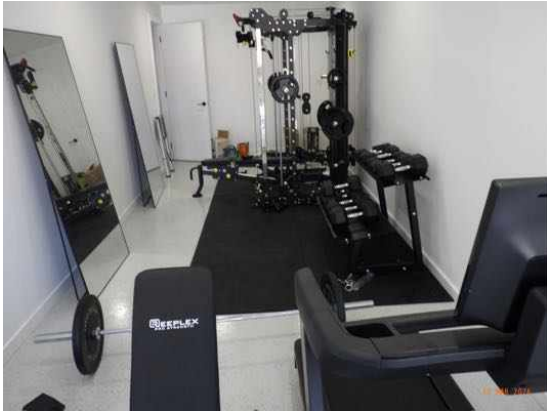
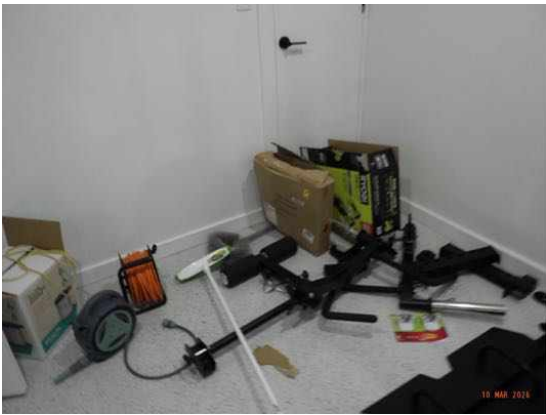
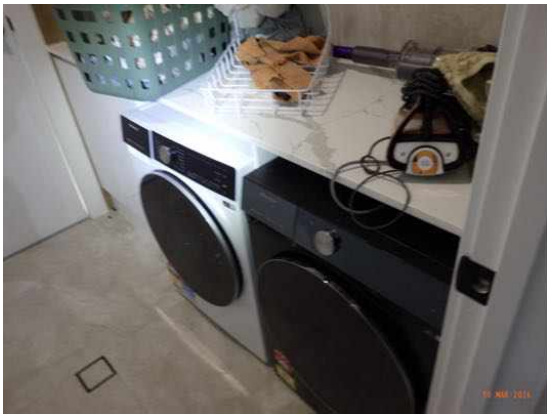
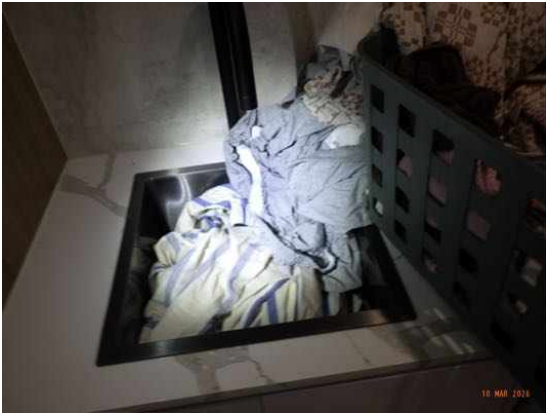
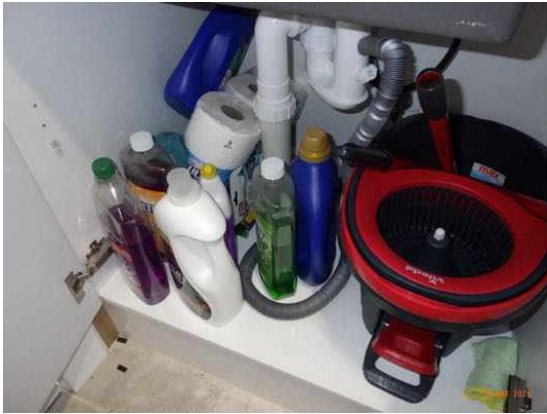
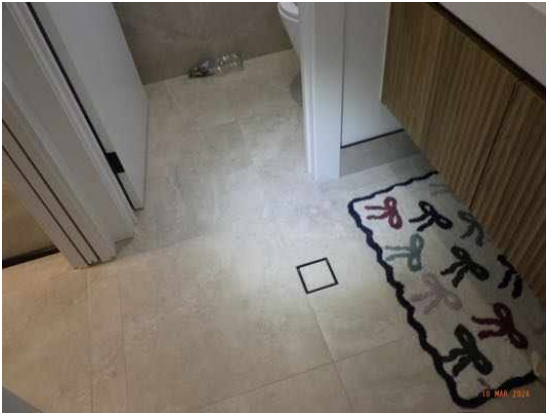
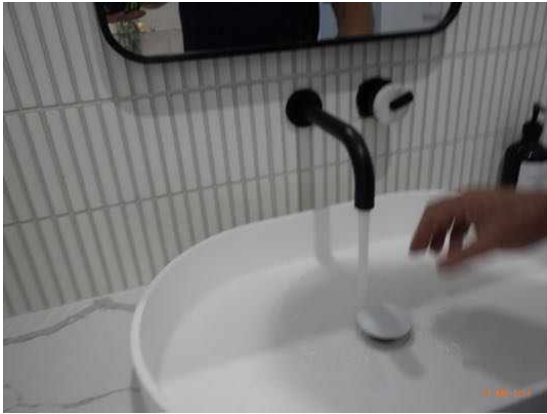
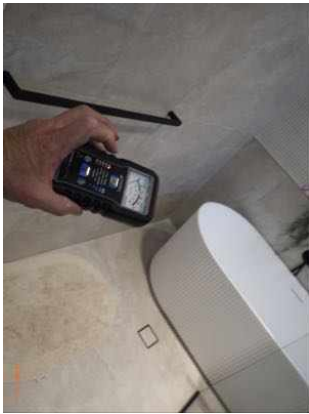
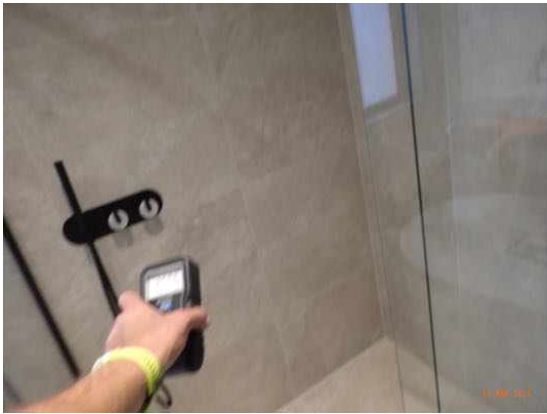
Building: Building 1
Location: All Areas
Finding: Additional Photos - Obstructions and Limitations
Information:

These photographs are an indication of the obstructions and limitations which impeded full inspection of the property at the time of inspection. These obstructions can hide an array of defects and should be removed to allow full inspection to be carried out.
