# Building and Timber Pest Inspection Report

Inspection Date: Tue, 17 Mar 2026

Property Address: 2/126 Somers Ave, Macleod VIC 3085,  
Australia

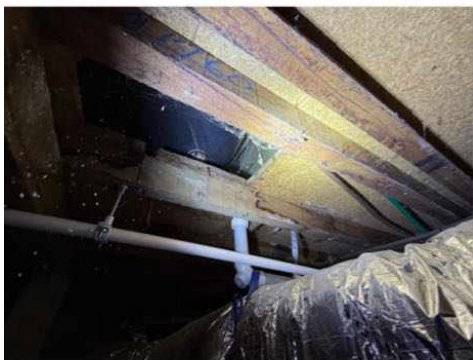
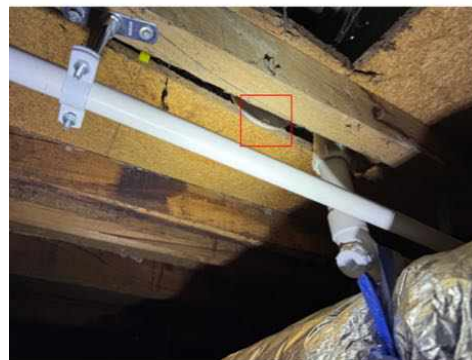
Building:	Main Building
Location:	Subfloor
Finding:	Minor Leak from Bath Tub Drain (Subfloor Area)
Information:	During the water test, a minor leak was observed from the bath tub drain connection within the subfloor area. Evidence of minor moisture staining and dripping was noted; however, no significant timber decay or structural wood rot was evident at the time of inspection.

Although the issue currently appears minor, ongoing leakage can introduce excessive moisture into the subfloor environment, which may lead to timber deterioration, mould growth, subsidence issues or deterioration of surrounding materials over time.

It is recommended that a licensed plumber inspect and rectify the leaking drain connection as soon as practicable to prevent further moisture ingress and potential future damage to the subfloor structure.

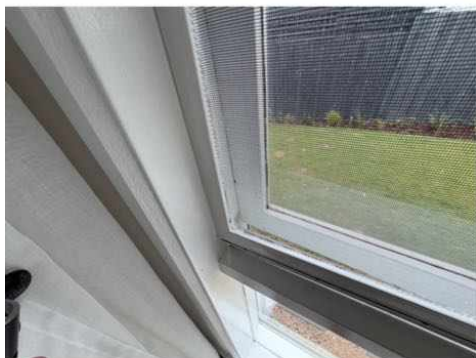
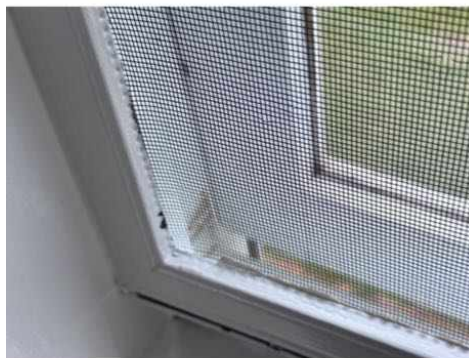
Information: During the inspection, the window was noted to be jamming and not operating smoothly when opening and closing. This is likely due to minor misalignment of the window sash, friction within the track, or minor build-up of paint/debris along the frame and hardware. While the issue is currently minor and does not appear to affect the structural integrity of the window, continued use in this condition may lead to increased wear on the locking mechanism and window components.

It is recommended that the window tracks, hinges, and locking mechanism be inspected and adjusted as necessary, and that any debris or paint obstruction be cleaned or trimmed to allow smooth operation. Minor maintenance or adjustment by a handyman or window technician should rectify the issue.

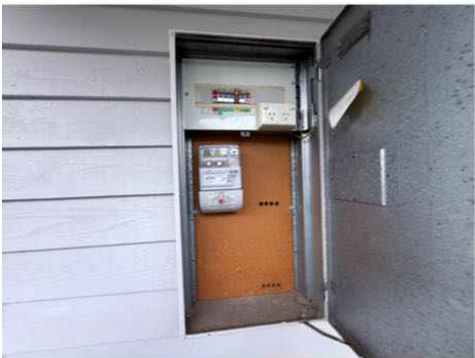
Building:	Main Building
Location:	Meter Box
Finding:	Termite Management System - no evidence of a chemical installation
Information:	The application of a post-construction chemical termite barrier is highly recommended for all properties, particularly if live termite activity has been found on the site previously. Such barriers are highly effective in preventing termite attack on any timber building elements throughout the property.

A durable notice should be placed in the switchboard unit to indicate current termite barriers. At the time of inspection, it appeared as though no termite management system has been installed, with no evidence to suggest preventative works taking place.

The client may consider gaining further advice from a pest controller as to the costs and procedures involved with this application. It is recommended that obtaining such advice be a short-term priority.

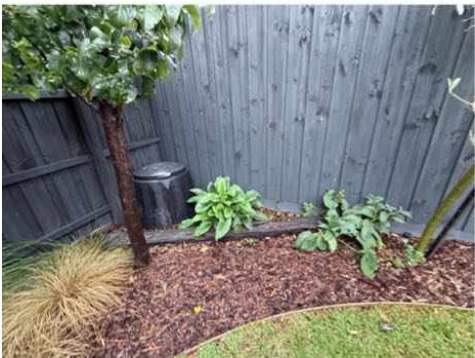
**Finding 6.02**

Building: Main Building  
 Location: All External Areas  
 Finding: Garden Bed/ Mulch - Conditions Conducive to Termites  
 Information: Mulch were found around the property. These areas can include untreated timber, and with a combination of moisture from watering hosing can make conditions conducive to termite activity and termite ingress.

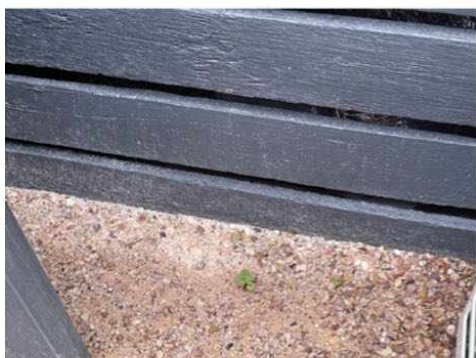
**Finding 6.03**

Location: All External Areas  
 Finding: In ground contact  
 Information: Any timbers in direct ground contact provide opportunity for concealed termite entry and are likely to be subject to premature rot and decay as the soil retains moisture or damp conditions against the timbers.

Remove untreated timber that is in direct contact with external grounds. Consider replacement with more durable materials i.e. treated timber or non timber elements. Frequent pest inspections are advised to readily identify any termite activity in these areas.

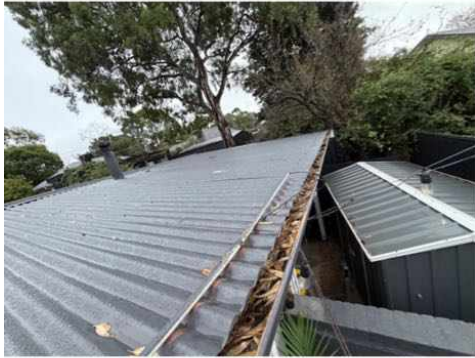
### Finding 6.04

Building: Main Building  
 Location: Roof Exterior  
 Finding: Gutters - Blocked  
 Information: Roof plumbing structures, such as guttering and downpipes, should be free of all debris to prevent blockages. Blockages of the guttering and downpipes will lead to pooling and accumulated water overflows, which is likely to subsequently flood eaves and exterior walls.

Blocked gutters are likely to lead to high levels of moisture in the affected areas. Such moisture will not only cause rust and decay of the associated building materials, but can also provide conditions that are conducive to termite and timber pest activity. Blockages in gutters should therefore be removed immediately to ensure dry conditions are maintained.

Consult a Licensed Plumber for further specific advice on remedial works that may be required. In the interim, it is highly advised that blocked gutters be removed by the homeowner or a general handyperson as a matter of urgency.

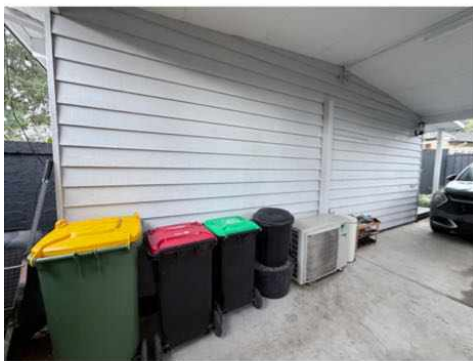
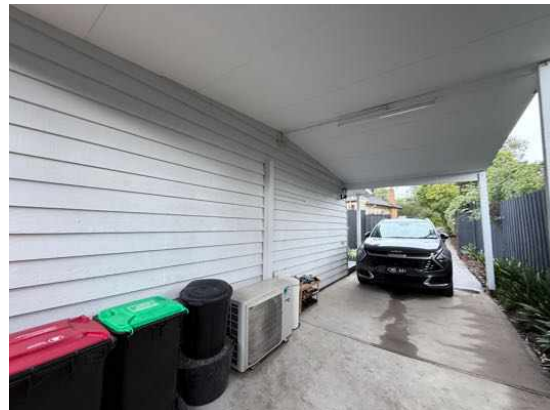
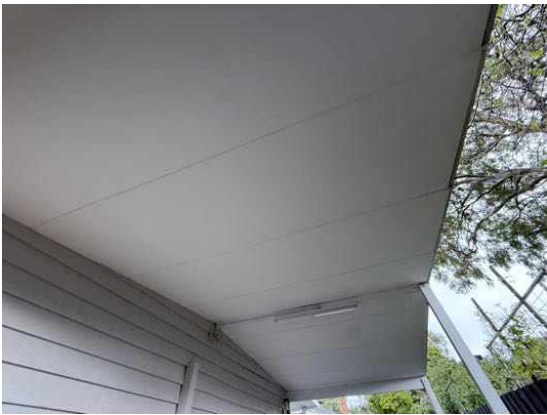
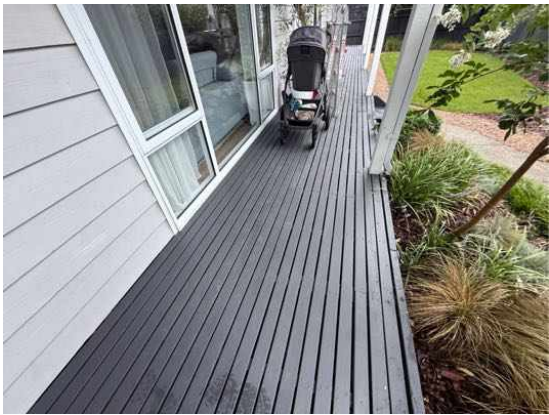
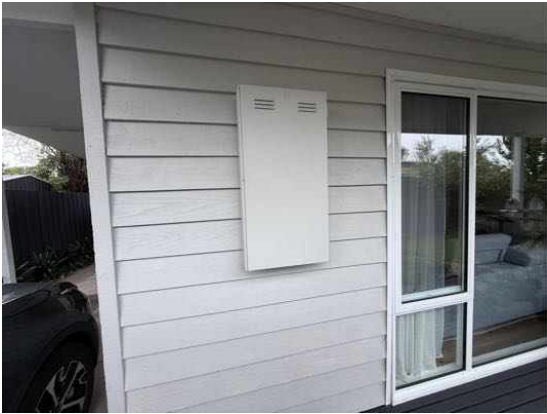
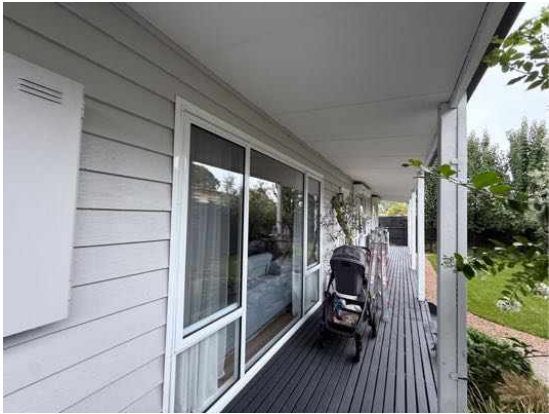
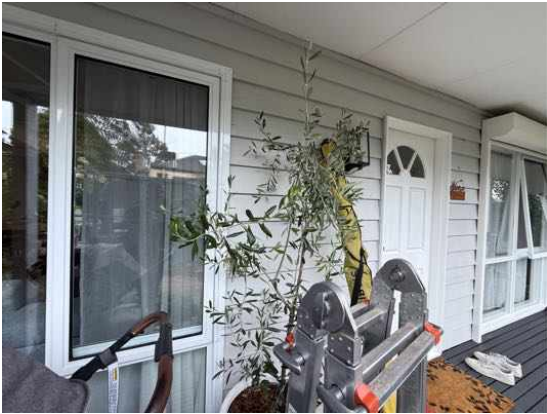
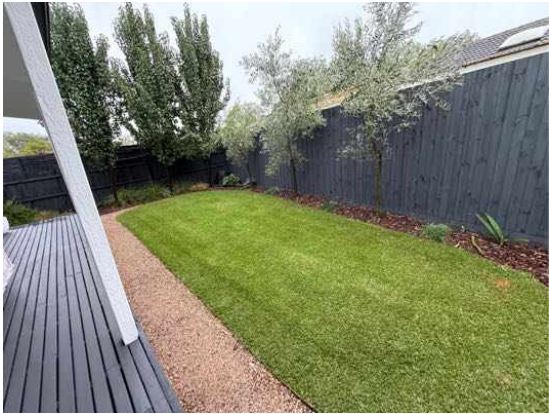
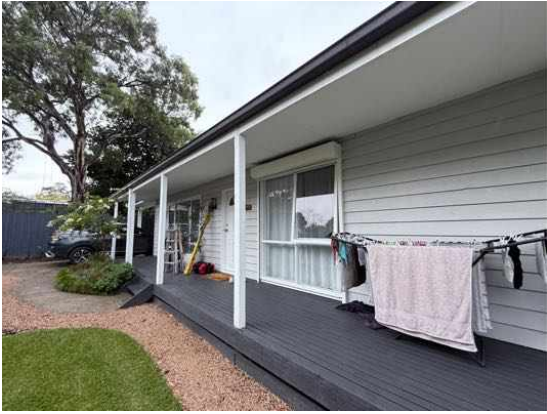
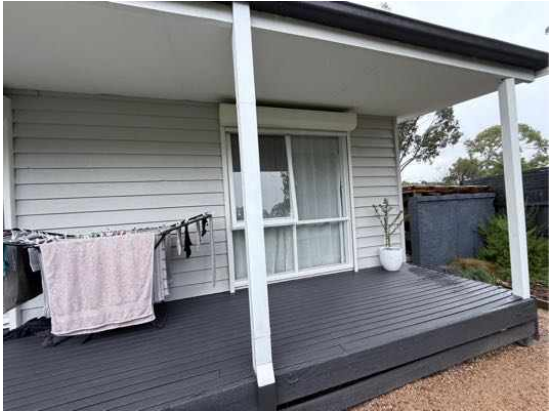
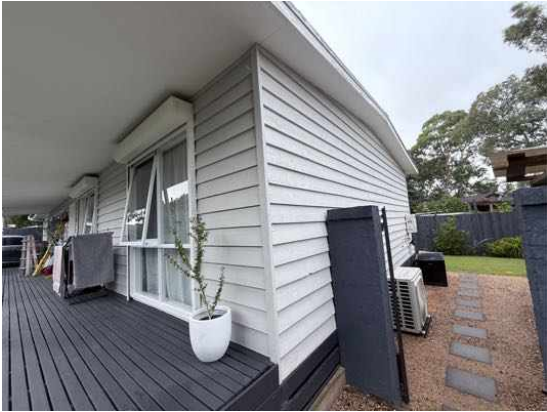
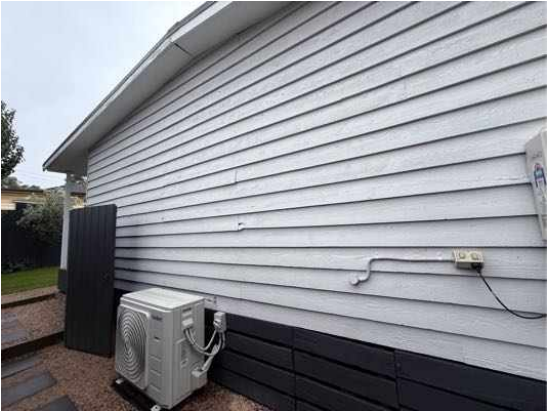
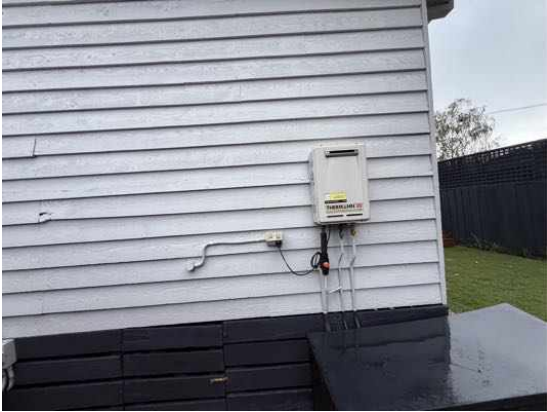
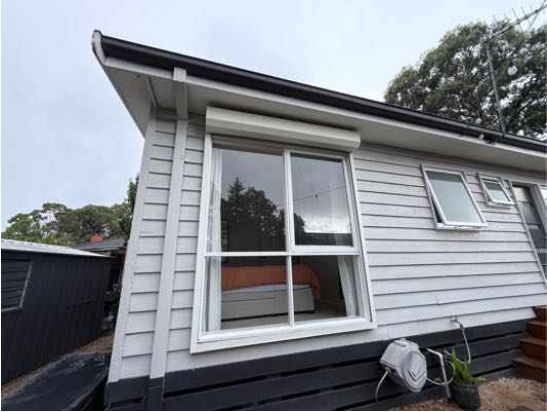
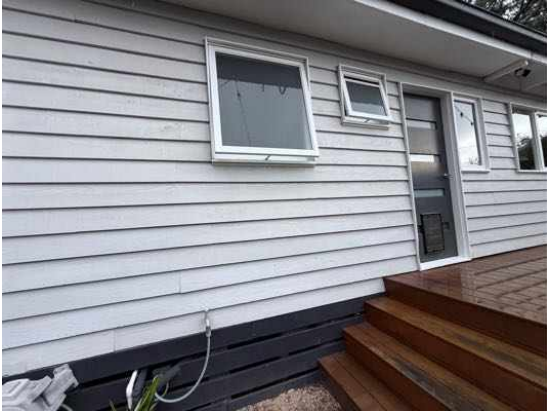
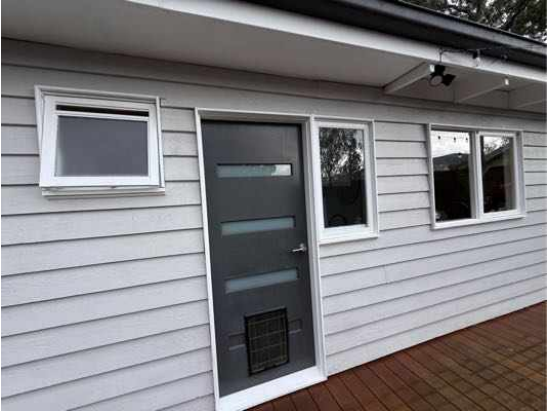
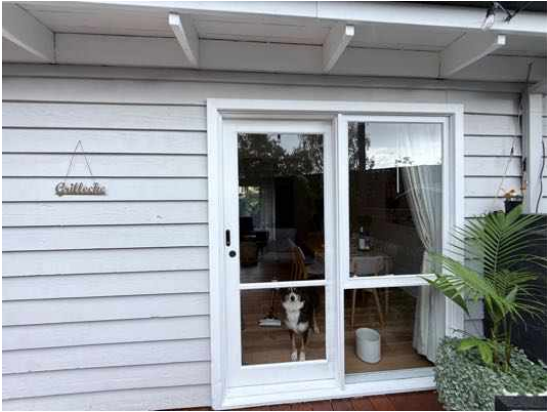
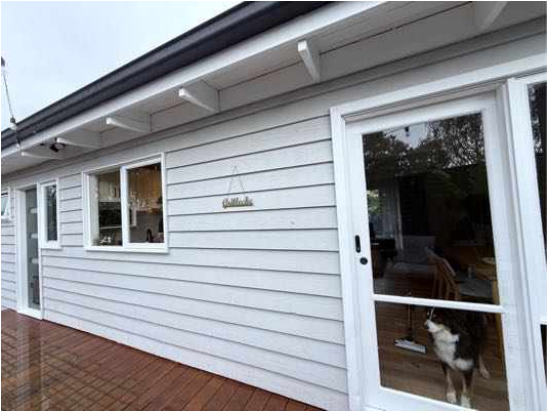
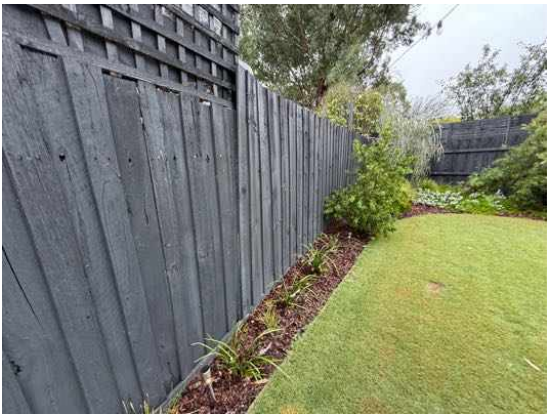
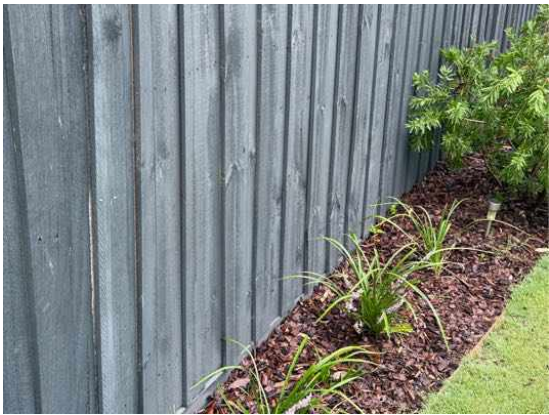
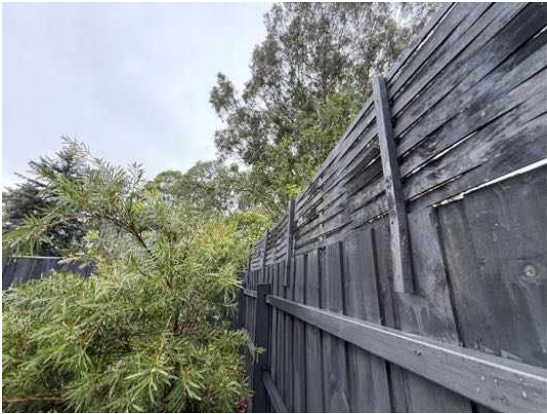
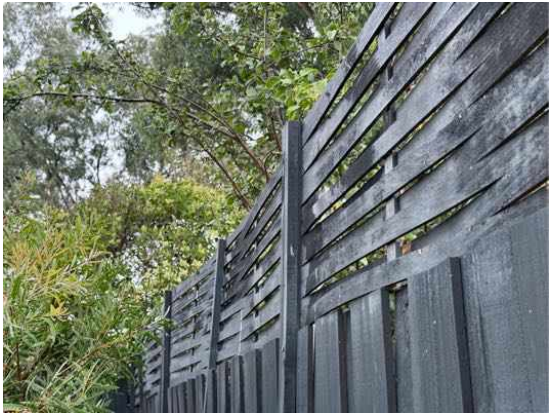
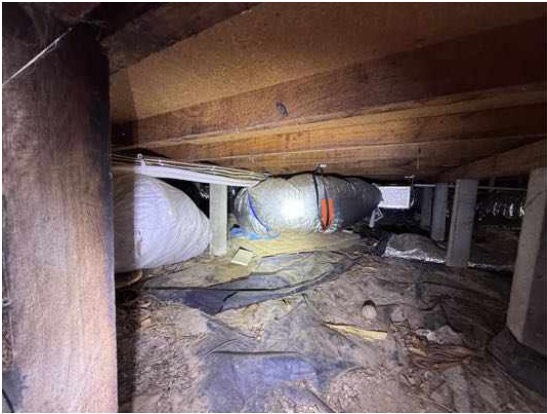
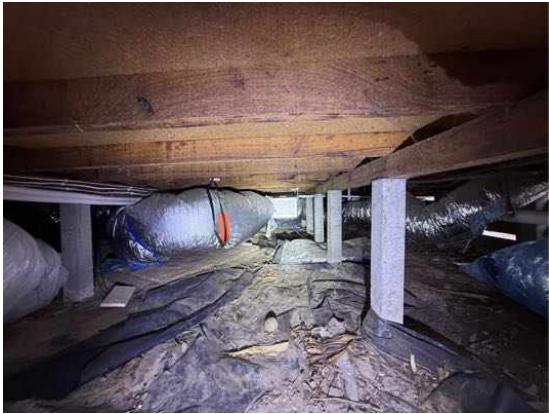
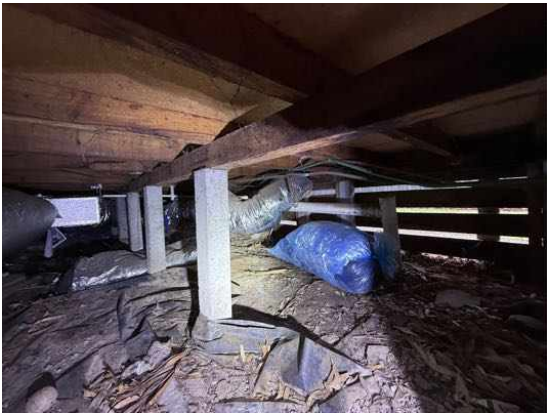
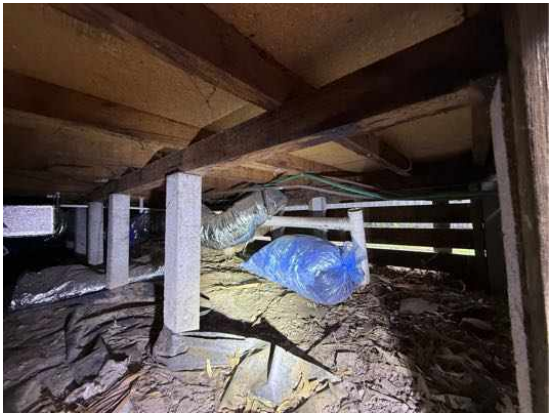
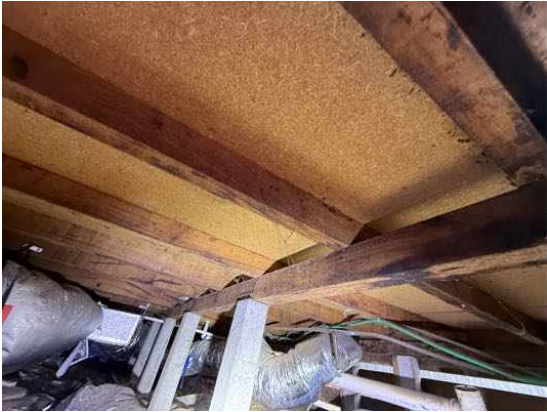
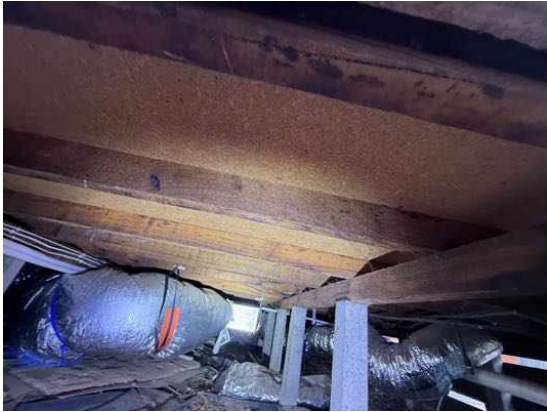
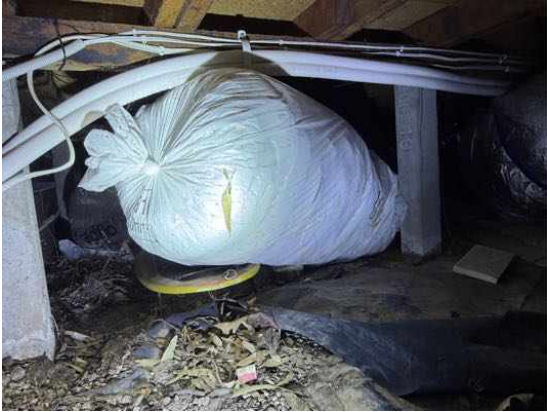
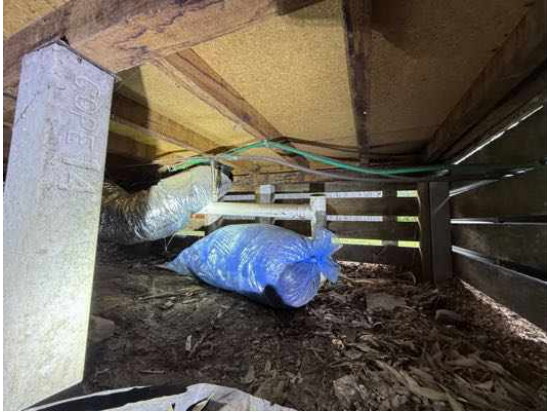
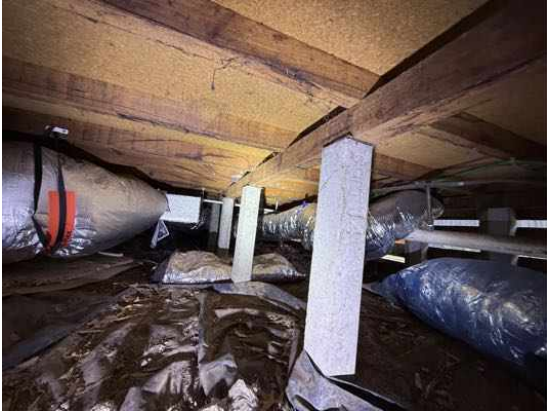
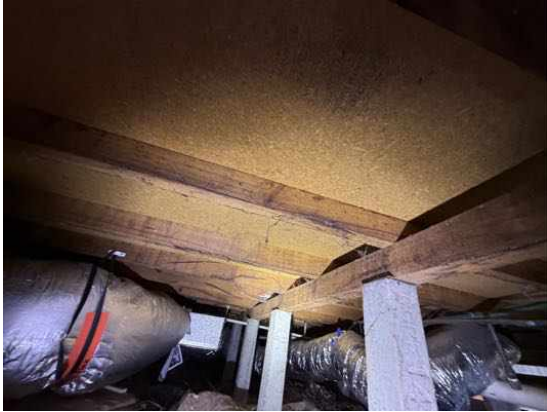
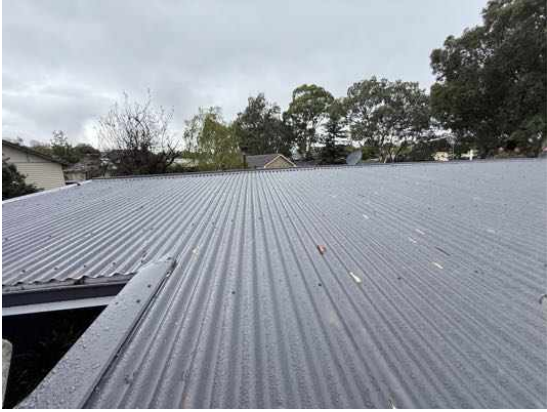
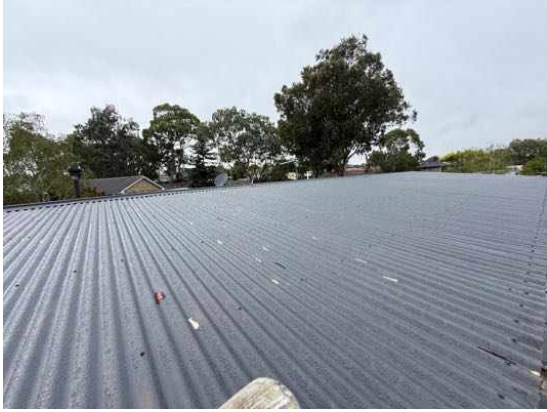
Building: Main Building  
Location: All Areas  
Finding: Additional photos & Obstruction/Limitations.  
Information: Additional photos for general documentation. May have some minor maintenance items not listed in the defects section.

Furthermore, some photographs are an indication of the obstructions and limitations which impeded full inspection of the property at the time of inspection. These obstructions can hide an array of defects and should be removed to allow full inspection to be carried out. A re-inspection is recommended once the areas are made accessible.
