Building and Timber Pest Inspection Report

Inspection Date: Fri, 20 Feb 2026

Property Address: 99 Gilbert St, Tumbarumba NSW 2653,
Australia

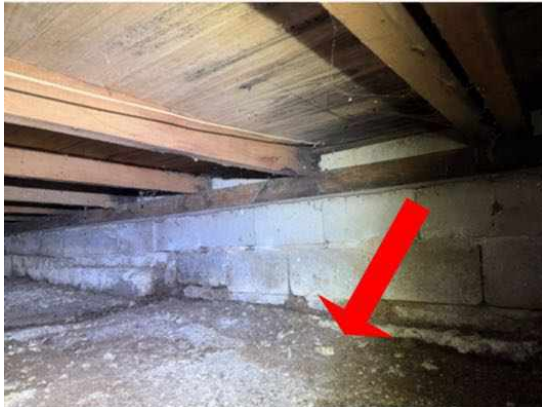
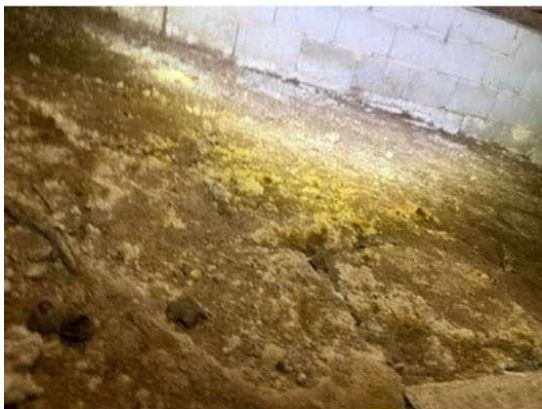
Building: Main Building
Location: Subfloor
Finding: Subfloor & Stumps - Moist Conditions & Mould
Information: Moist conditions and mould growth were evident in areas of the sub floor and the stumps at the time of inspection. Causes of this defect can be attributed to water pooling against the property, insufficient ventilation, and/or associated leaking.

Where moist conditions are in the subfloor, this creates areas conducive to timber pest activity, and can lead to deterioration of the stumps overtime.

Consultation with a licensed plumber specialising in drainage is advised promptly, to provide further advice and remedial works where necessary. It is also advised that a mould remediation specialist and subfloor ventilation specialist be engaged, to provide further advice.

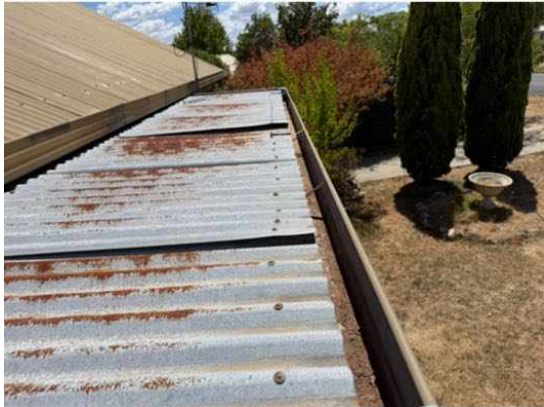
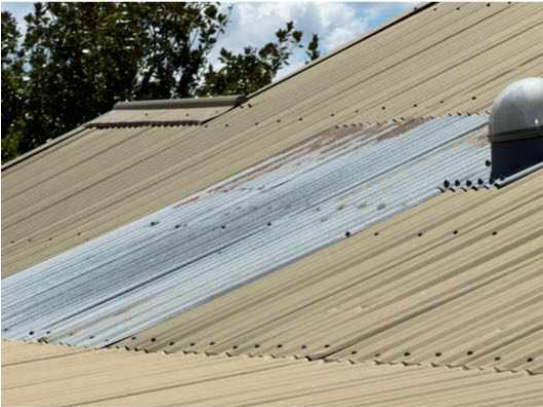
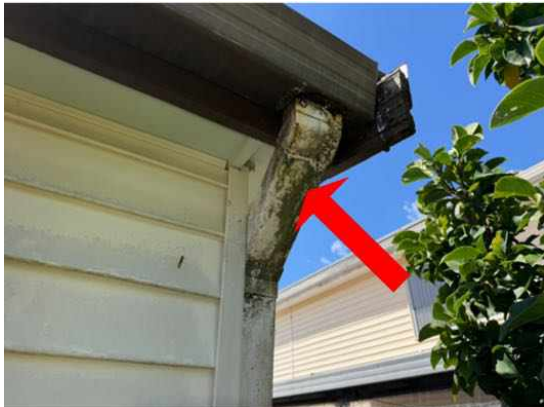
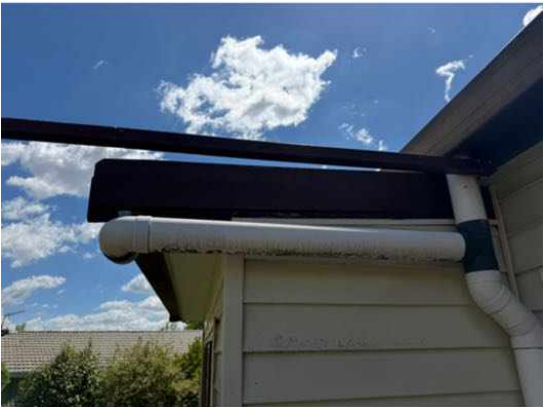
Finding 3.03

Building: Main Building
Location: Roof Sheets, Roof Plumbing
Finding: Roof Plumbing - Rust, Loose & Leaking
Information: It appears that areas of the down-pipes were leaking, creating an environment conducive to termite activity. Loose and rusted roof sheeting of the front porch & main roof was also noted. Recommend consulting with a licensed roof plumber and roofing contractor in the short term, to provide further advice & remedial works where necessary.

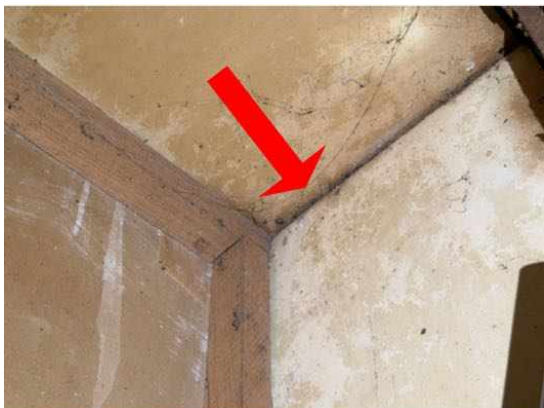
Finding 3.07

Building:	Main Building
Location:	Bedroom Cupboard
Finding:	Mould - Present
Information:	Light mould growth was identified at, but not limited to, the bedroom cupboard. Recommend engaging a cleaning contractor promptly, to clean/remove the mould growth & ensure the general environment has sufficient airflow & light penetration to aid in the prevention of mould formation & development.

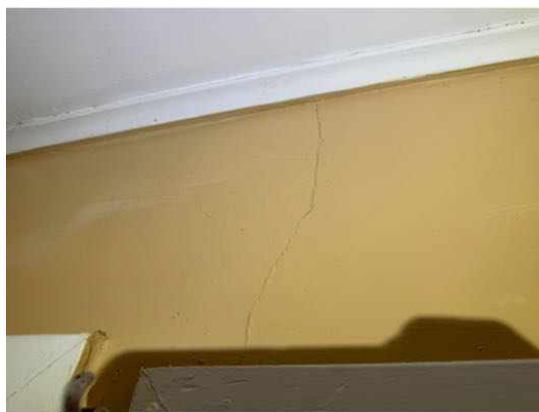
Finding 3.08

Building:	Main Building
Location:	All Internal Areas
Finding:	Cracking - External & Internal
Information:	Cracking was identified to some areas of the brickwork and internal wall linings at the time of inspection. Cracking has a variety of possible causes, however, the most common is general movement of adjacent footings and/or expansion / contraction of building materials.

Cracking is a relatively common defect, and is most likely to occur adjacent to windows, doors and other openings.

The client should monitor the cracking. Should the cracking lengthen, widen or become more numerous, the client should consult with a structural engineer promptly to provide further advice.

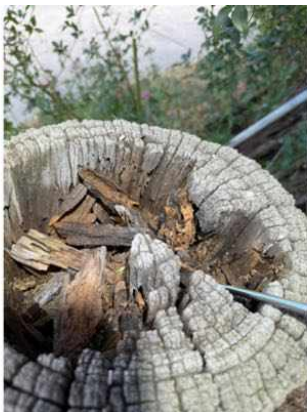
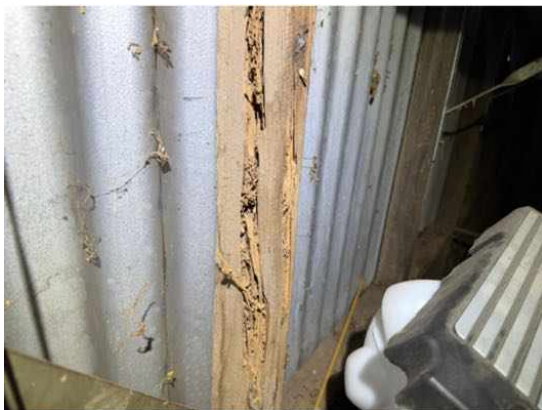
Building: Main Building
Location: Subfloor, Shed, Fence Post
Finding: Evidence of termite workings & damage
Information: Although no live termite activity was identified at the time of inspection, previous termite damage was identified at, but not limited to, areas of the shed framing, fence post and timber debris in the subfloor.

The client should engage a licensed pest controller promptly, to provide further advice regarding installation of a termite treatment.

6 monthly ongoing termite inspections, conducted by a qualified termite inspector, are also recommended

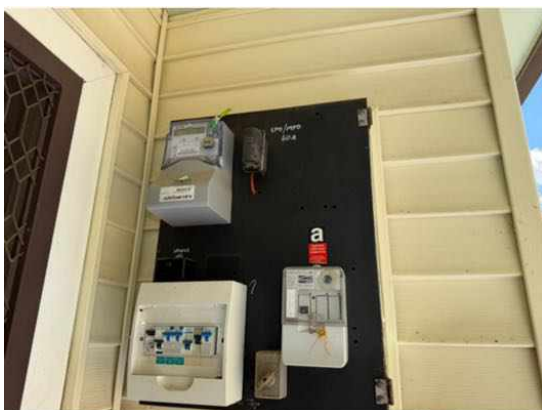
Finding 6.01

Building:	Main Building
Location:	Switchboard
Finding:	Termite Management System - no evidence of a chemical installation
Information:	The application of a termite barrier is strongly recommended, as it appears no termite management system has been installed, with no evidence or durable notice to suggest works taking place. Generally, a durable notice is placed in the meter box to indicate current termite barriers.

Such barriers are highly effective in preventing termite attack on the building and therefore should be installed.

Recommend seeking further advice from a licensed pest controller.

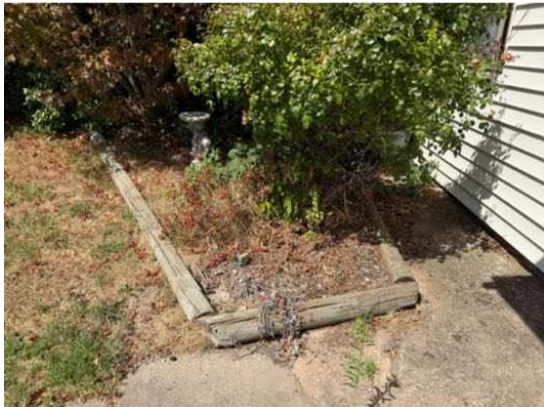
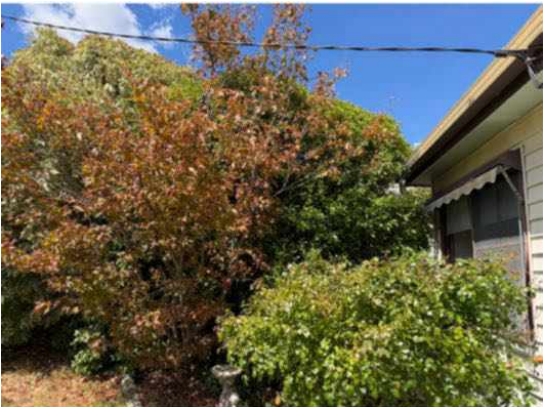
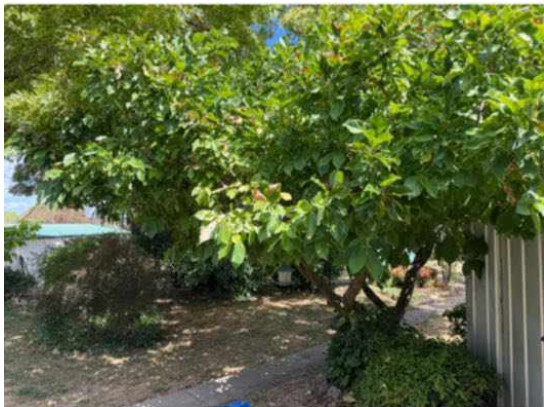
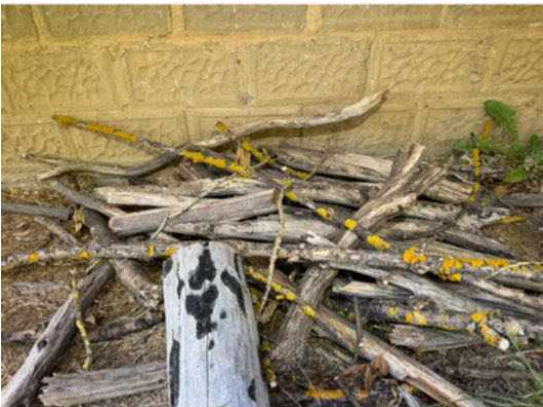
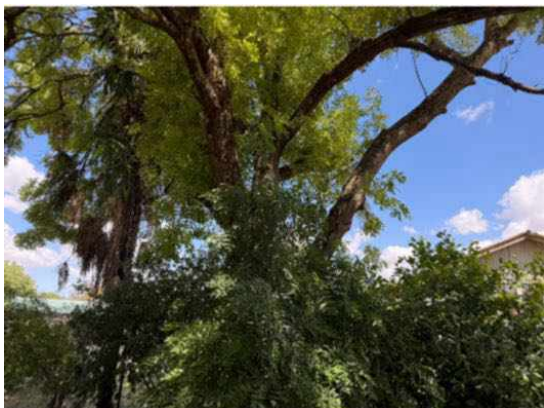
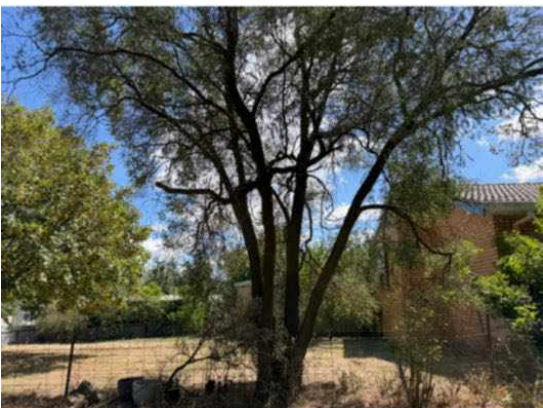
Finding 6.02

Building:	Main Building
Location:	All External Areas
Finding:	Timber in direct ground contact & trees - conducive to termites

Where timber materials are in direct contact with the ground and consequently moisture, they become conducive to termite activity. The tree stumps, timber debris in the subfloor, landscaping timbers, and trees surrounding the building create an environment conducive to termite infestation.

Where feasible, any timbers in direct contact with the ground should be removed and any trees in close proximity to the building should be removed or test drilled (inspected) at least annually to reduce the risk of termite infestation & detect any early signs of termite activity.

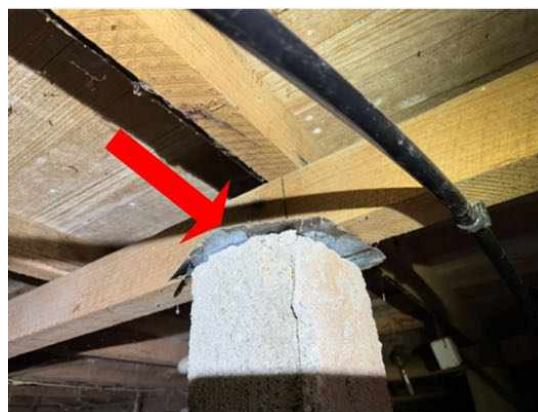
Finding 6.03

Building:	Main Building
Location:	Subfloor
Finding:	Ant caps - Inadequate
Information:	It was found that the ant caps that have been installed are inadequate. Ant caps are designed to easily identify termite or pest ingress from stumps to the adjoining bearers.

Where ant caps are inadequate, this poses as an obstruction to the inspection and frequent monitoring of these areas should be carried out in order to identify any early signs of termite workings. Recommend engaging a licensed carpenter to install adequate ant caps to the subfloor.

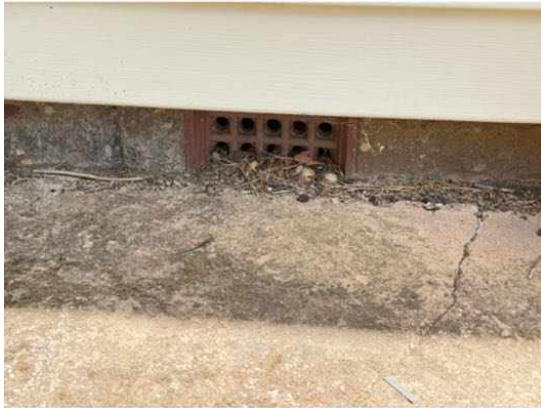
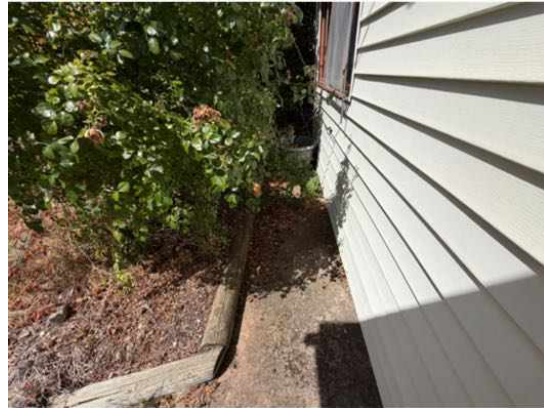
Finding 6.04

Building:	Main Building
Location:	All external areas, Down-pipe
Finding:	Potential Water pooling - against property
Information:	It appears that there are potential areas around the perimeter of the property that could be susceptible to water pooling. A disconnected down-pipe was noted at, but not limited to the front elevation.

Where insufficient site drainage and insufficient drainage of taps, roof plumbing, hot water system & aircon overflows are present, water pooling is likely to occur, and can create areas conducive to timber pests and potential damage to the subfloor structure overtime, if neglected.

Recommend consulting with a licensed plumber in the short term to further assess and provide remedial advice.

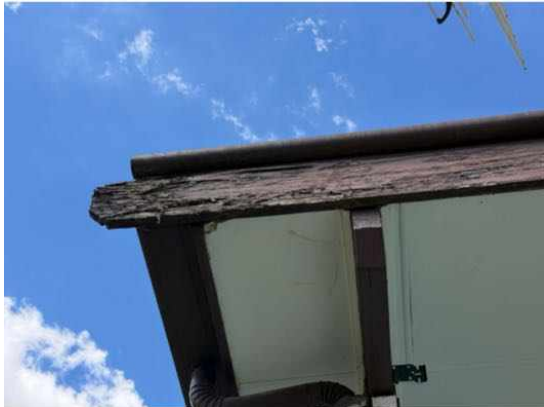
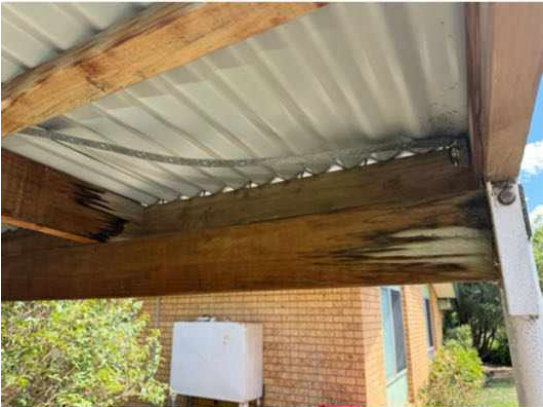
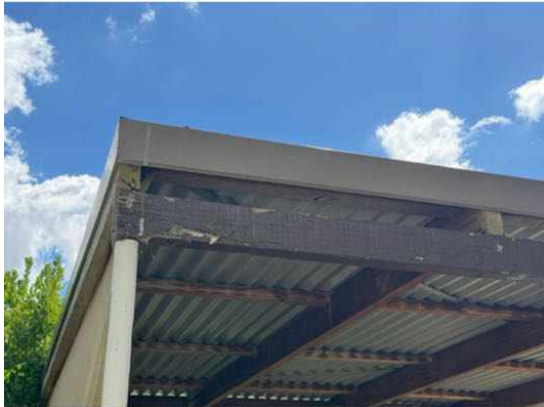
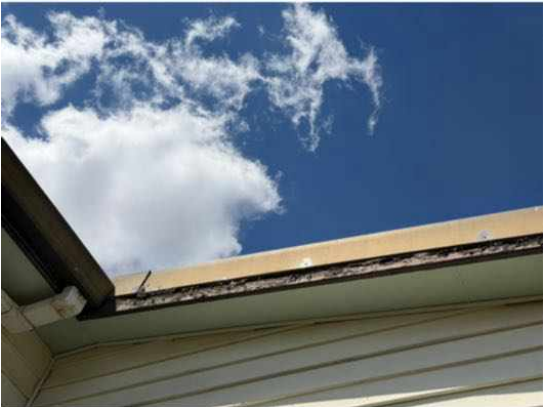
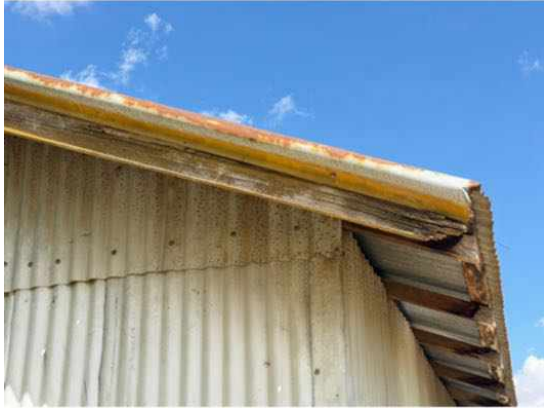
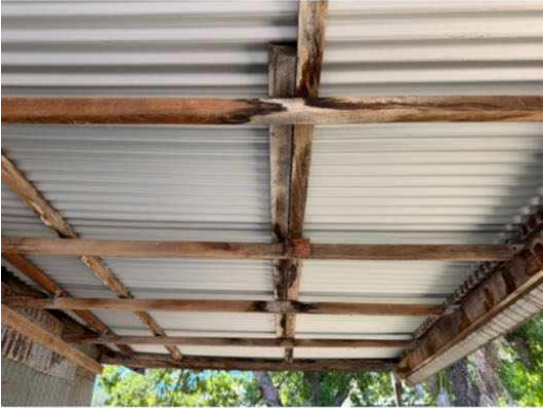
Finding 7.01

Building: Main Building
Location: Windows, Fascias, Subfloor, Carport & Shed Framing
Finding: Fungal decay & weathering
Information: Areas of fungal decay (wood rot) & weathering were identified at but not limited to some window frames, fascia's, shed & carport framing and some subfloor timbers. For areas of fungal decay, the client can engage a licensed carpenter at their discretion to replace affected materials.

For areas of general weathering, it is advised the client engage a licensed painter to apply protective sealant or coating to areas of weathered external timbers.

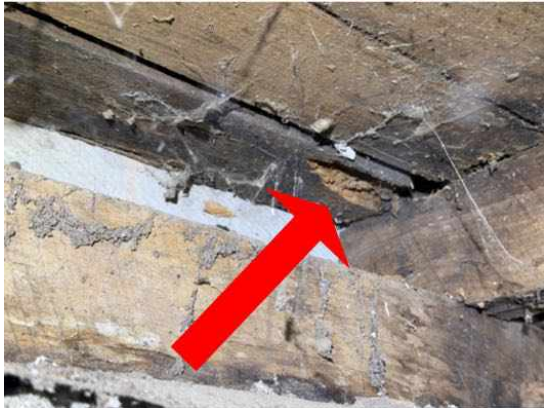
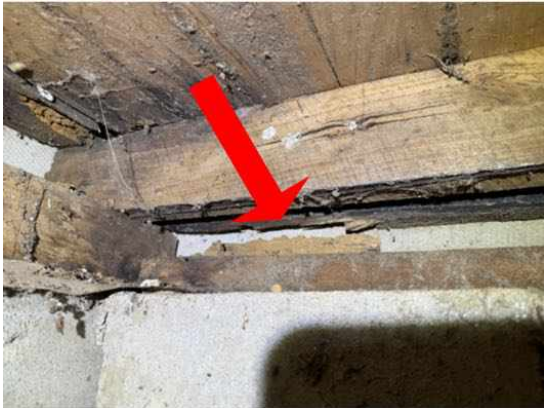
Finding 8.01

Building:	Main Building
Location:	Subfloor
Finding:	Evidence of wood borer damage identified (powder-post)
Information:	Evidence of previous Lyctus Borer (powder-post beetle) damage was identified at but not limited to the edge of some timbers in the subfloor. Wood borer damage is generally considered superficial damage to the affected timber. As no live wood borer activity was identified treatment is not required.

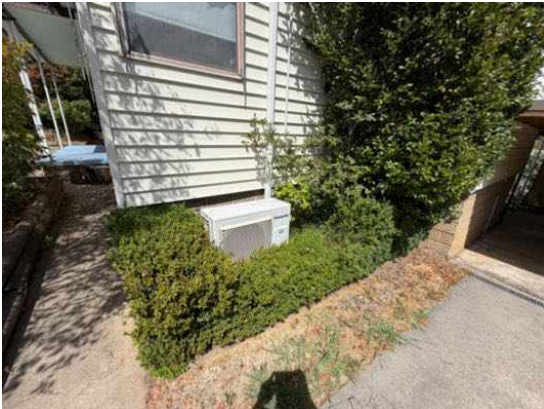
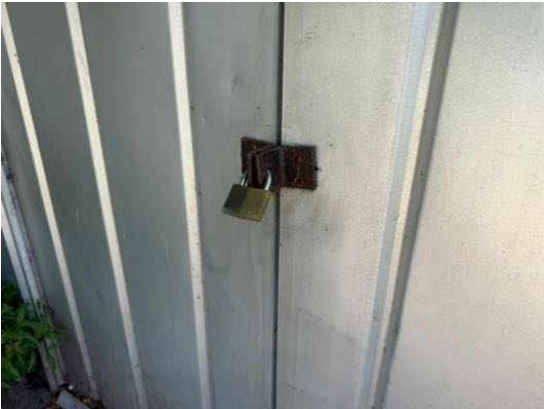
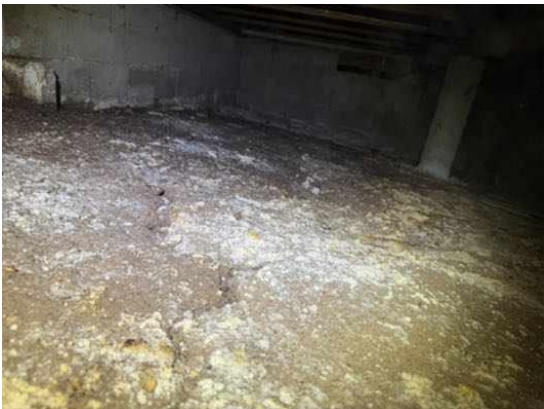
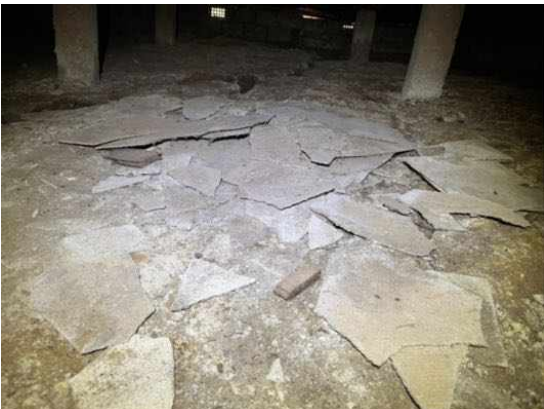
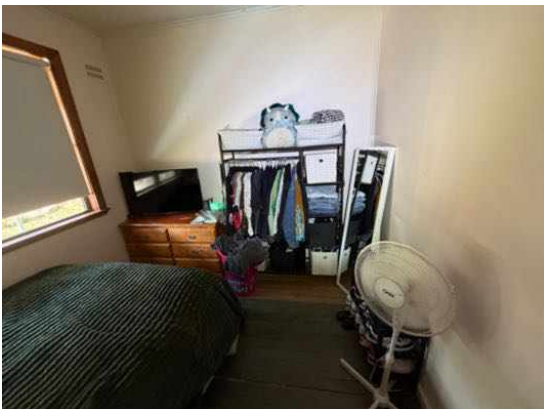
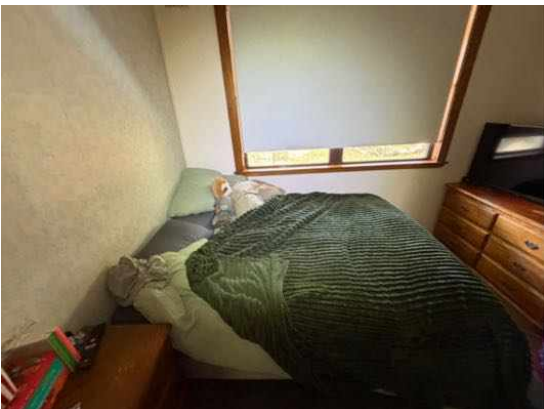
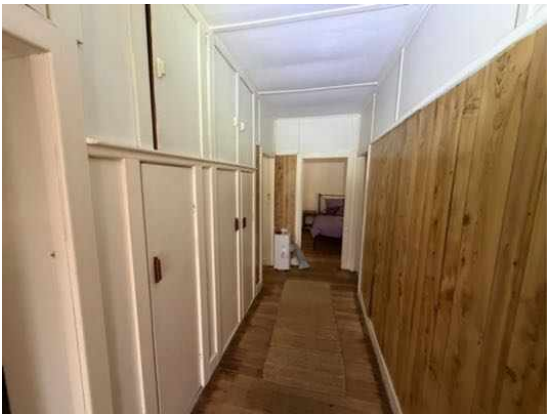
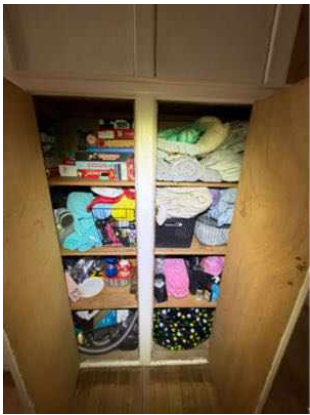
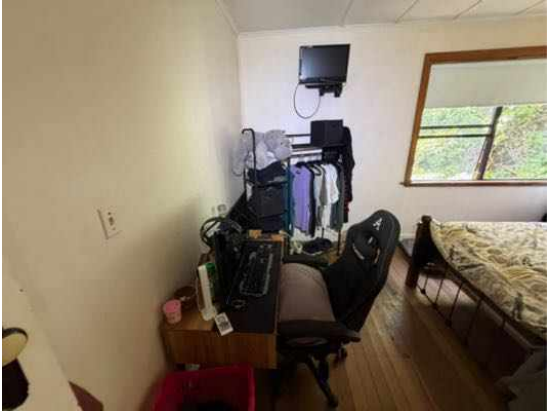
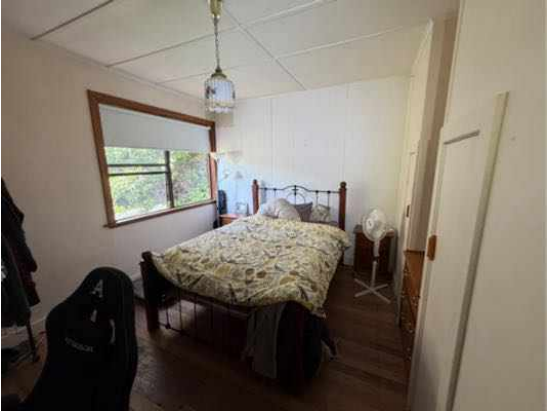
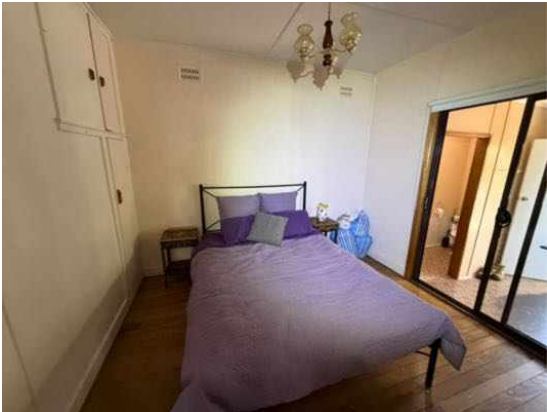
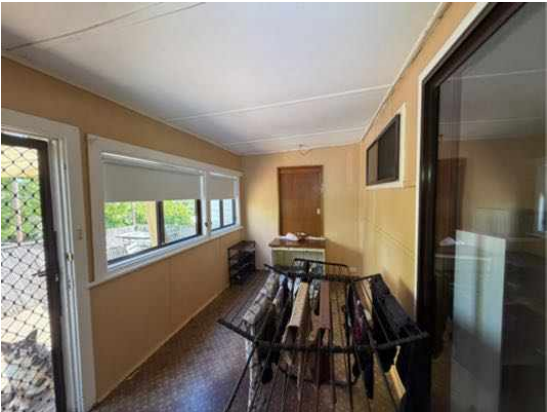
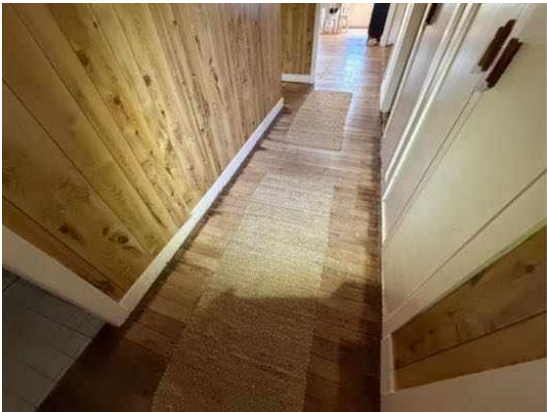
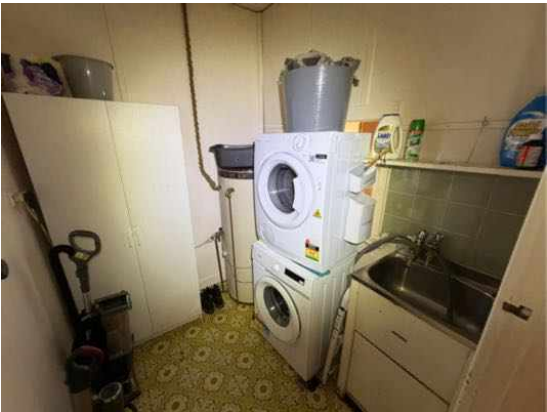
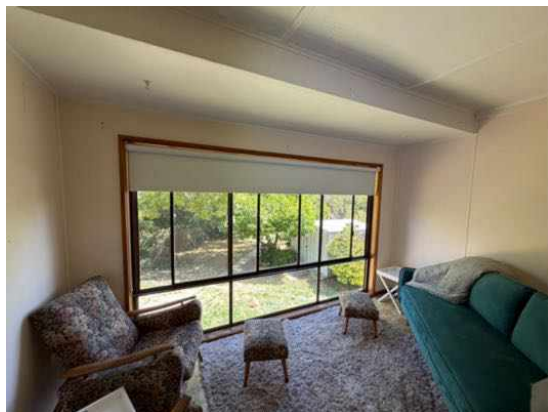
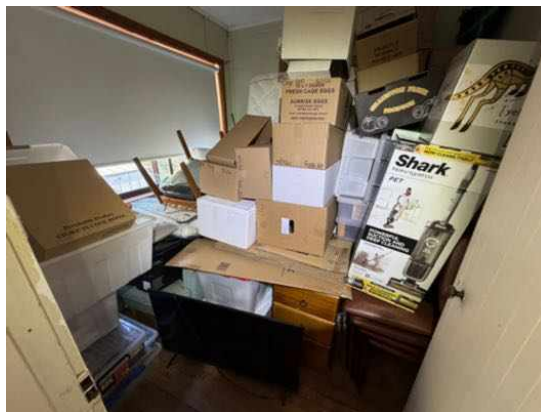
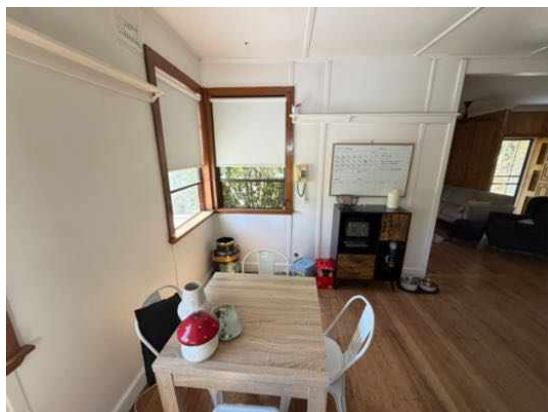
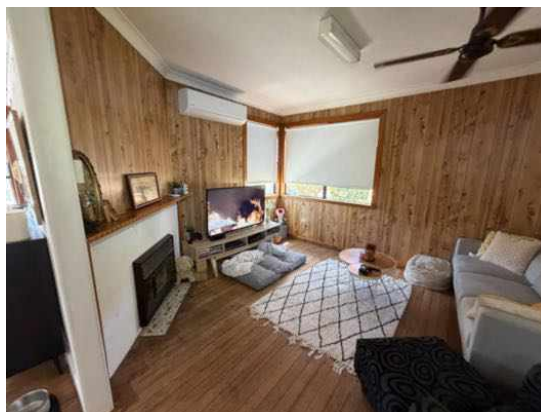
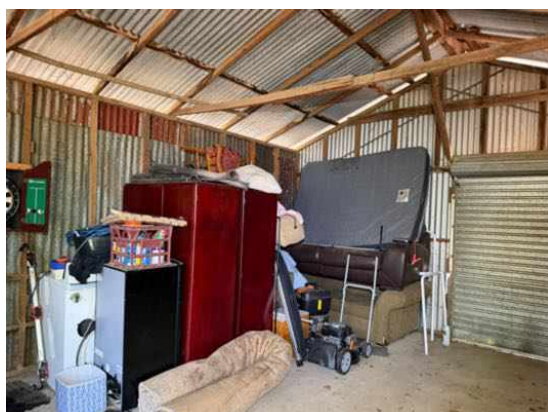
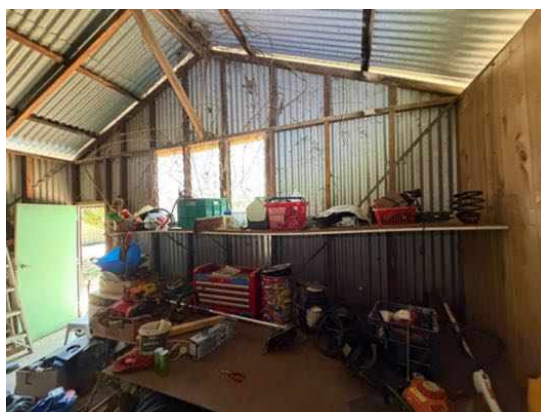
Several limitations and obstructions impeded the inspection and, if feasible, should be removed, and a further inspection should be performed. The roof void was unable to be inspected due to no access to the access hole, and small access hole installed. The subfloor was unable to be fully inspected due to mould growth, no access to the rear section, and piles of suspected asbestos debris present. Recommend gaining access to these areas and a re-inspection be conducted, prior to client's completion of due diligence. Indicative images below depict some of the obstructions encountered.

Building: Main Building
Location: All Areas
Finding: Additional Photos - Obstructions and Limitations
Information: These photographs are an indication of the obstructions and limitations which impeded full inspection of the property at the time of inspection. These obstructions can hide an array of defects and should be removed to allow full inspection to be carried out. A re-inspection is recommended once the areas are made accessible.

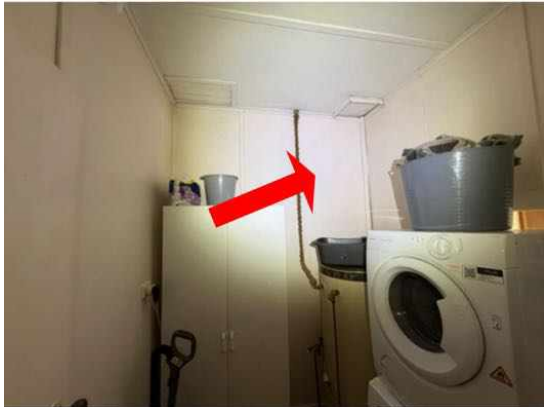
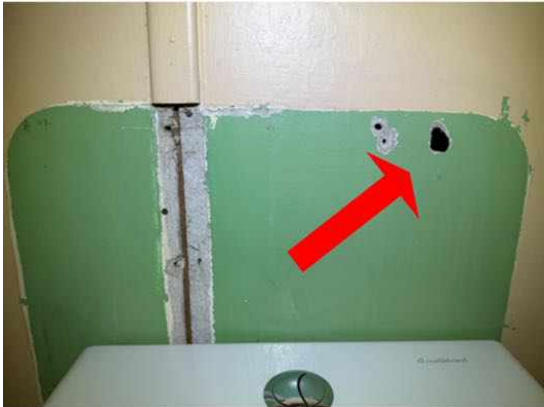
Building: Main Building
 Location: Switchboard, Internal Wall & Ceiling Linings, Cupboards, Original Cladding
 Finding: Asbestos - Suspected ACM Identified on Site
 Information: This suspected defect is highlighted as a caution only as reporting on asbestos is outside the scope of this report. It is suspected that the materials including but not limited to the switchboard lining, internal wall & ceiling linings, cupboards & original cladding may be ACM's (Asbestos containing material)

It is advised that the client consider a separate Asbestos Inspection and Condition Audit, which can include the taking of samples for definitive confirmation of the presence of Asbestos, carried out by a licensed Asbestos Inspector. In the interim, no

works should be conducted to these areas without further specialist advice.
