# Building and Timber Pest Inspection Report

Inspection Date: Mon, 9 Mar 2026

Property Address: 93/370 Gainsborough Dr, Pimpama QLD  
4209, Australia

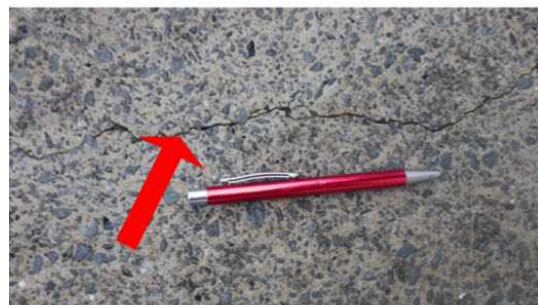
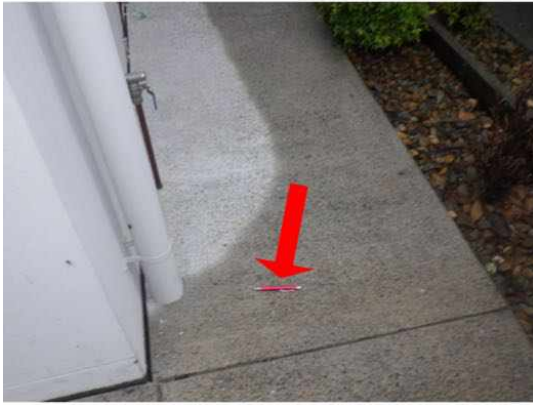
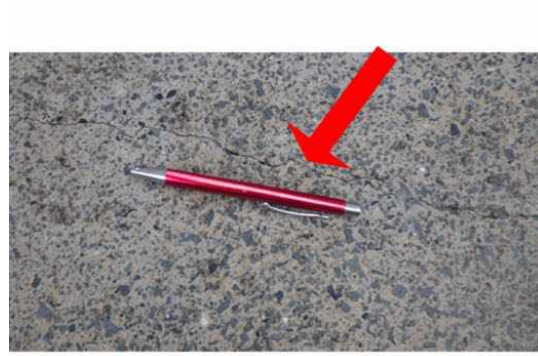
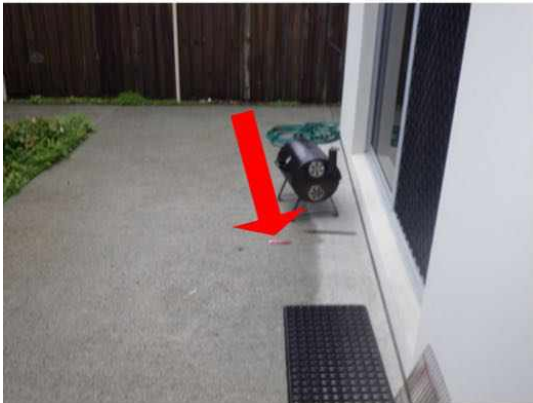
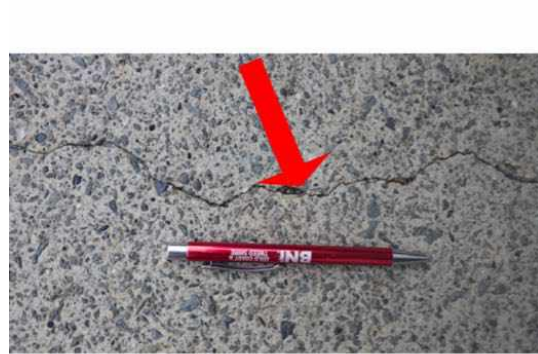
Building: Main Building  
Location: Driveway > Ground Level  
Finding: Cracking in concrete slab - Category 1  
Information: Minor cracking coded as Category 0 - 1 was identified in the driveway and footpaths concrete slab. A Category 1 crack is described as a fine but noticeable crack, with the slab at an otherwise reasonable level.

To be considered Category 1, the approximate width of the crack is less than 1.0mm, or a less than 10mm change in offset when a 3m straight edge is placed over the defect.

Category 1 cracks should be monitored for a period of 12 months. At the end of the monitoring period, identified cracks that are rated greater than Category 2 are considered defects, and require rectification.

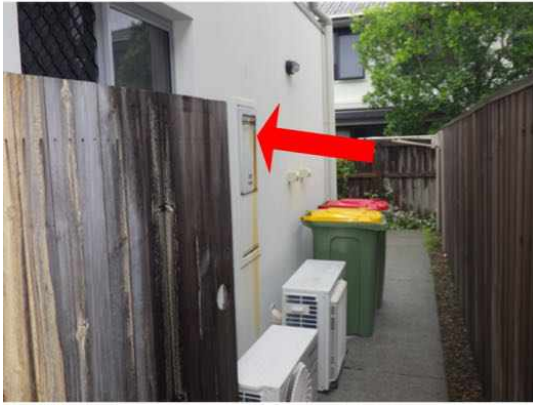
### Finding 3.02

Building: Main Building  
 Location: Exterior walls - right side > Centre Right  
 Finding: Gas System - Cover Plates  
 Information: At the time of inspection the front cover plate to the gas instant hot water unit showed signs of surface rust or rusting.

The cover plate should be in good condition to prevent moisture from penetrating the gas unit systems protective shell.

It is recommended a plumber is contacted regarding replacement of the front cover plates. Alternatively a licensed painter could be engaged to treat or seal the rusted area with an approved protective coating.

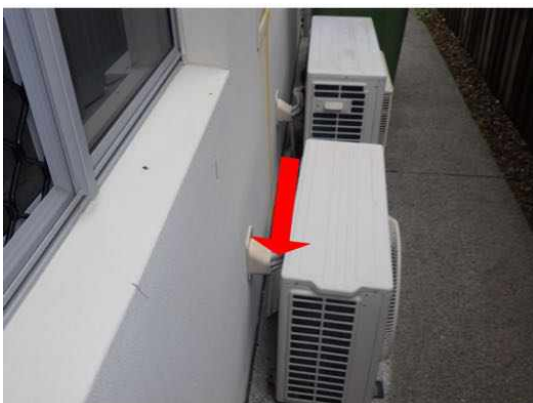
### Finding 3.03

Building: Main Building  
 Location: Exterior walls - right side > Centre Right  
 Finding: Pipework - Insulation deteriorated  
 Information: At the time of inspection sections of the air conditioning unit pipe work insulation showed evidence of damage and deterioration. It is suspected that this deterioration has developed as a result of excessive exposure to weather, including UV exposure in daylight. Deteriorated insulation reduces the effectiveness of the material in helping to maintain the desired temperature and work most efficiently.

If left in an exposed position, it is likely that the deterioration will continue and worsen over time, potentially resulting in secondary building defects as well as a further loss in insulating properties.

Some areas of replacement of pipe insulation is likely to be required. Further preventative measures to remove or protect the material from future exposure are also advisable. Consultation with a licensed air conditioning installer is advised to gain quotes for the repair and/or replacement of deteriorated insulation.

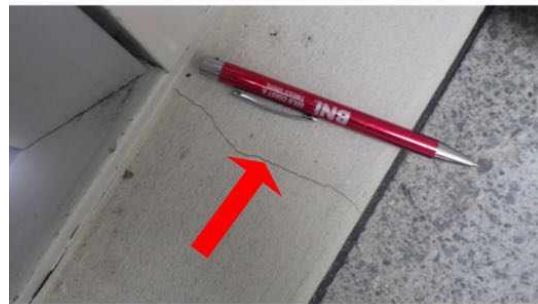
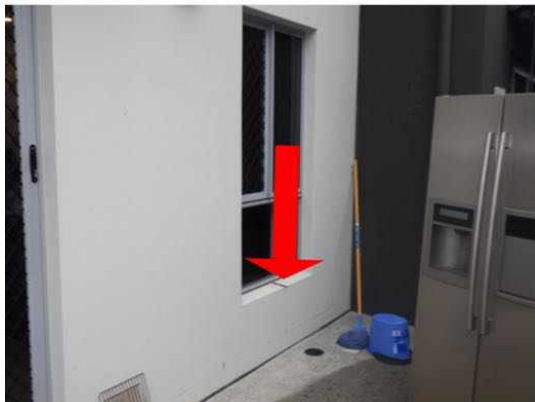
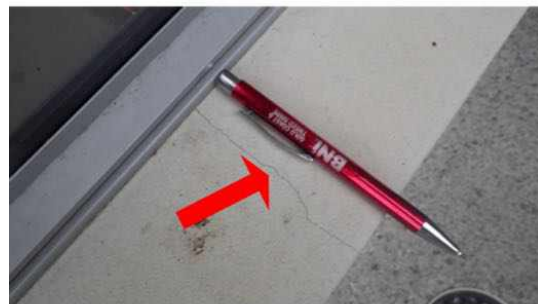
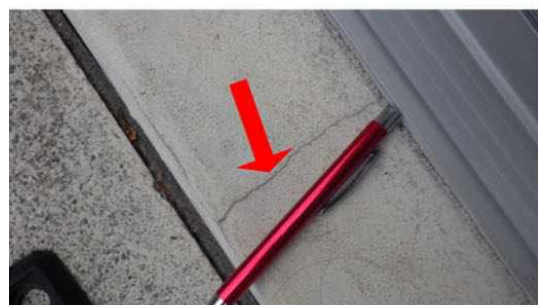
### Finding 3.04

Building: Main Building  
 Location: Exterior walls - right side & rear. > Existing

Finding: Cracks to External render - Category 1

Information: It has been observed that fine cracking and/or superficial damage to external window and door sill rendered surfaces has occurred (as per example photos). The degree of damage falls within Category 1, described as fine cracks that do not need repair and which are less than 1.0mm in width limit.

A qualified solid plasterer could be consulted for further advice.

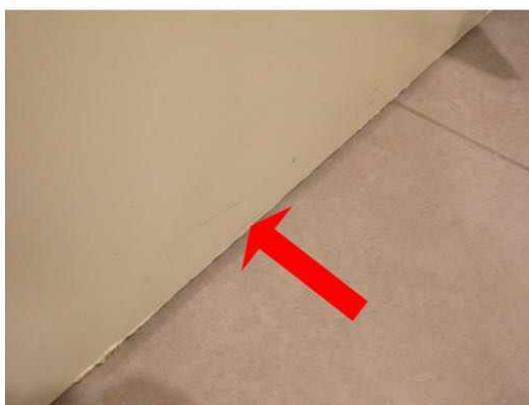
### Finding 3.05

Building: Main Building  
 Location: Powder Room > Front  
 Finding: Damaged Door  
 Information: The door leading into the powder room has suffered damage to the bottom edge.

Damage occurs generally when the building materials have aged and decayed, but in this instance the damage appears to be the result of exposure to moisture, possibly from the bottom and/or top edges of the door not being sealed with a suitable paint or sealant at the time of construction.

A qualified carpenter or general handyman could be appointed to repair/replace the door at the clients discretion.

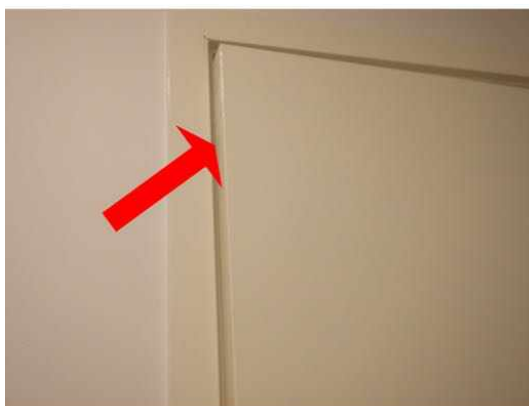
### Finding 3.06

Building: Main Building  
 Location: Powder Room > Front  
 Finding: Door - Binding/Jamming  
 Information: Binding and/or jamming of the powder room door on the door frame was evident during standard operation. This defect inhibits the functionality of affected door as well as creating potential for secondary defects to associated building elements, such as damage to the door framing.

A door that binds to the associated door frame or sill may have several causes, such as poor installation of the door or deteriorated hinges.

A qualified carpenter or general handyperson could be appointed to perform minor rectification works at client discretion.

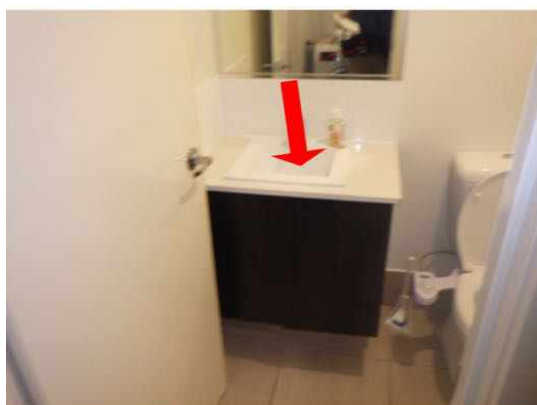
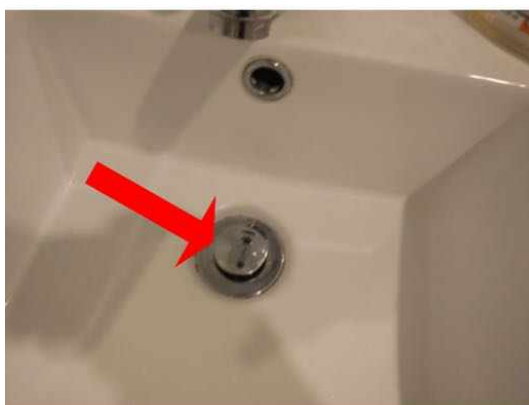
### Finding 3.07

Building: Main Building  
 Location: Powder Room > Rear Left  
 Finding: Basin - Pop up waste stiff.  
 Information: The powder room basin pop up waste was stiff to operate at the time of inspection. It is advised that maintenance is carried out on the waste so as it functions as intended.

A handyman could be appointed to perform any remedial works where required.

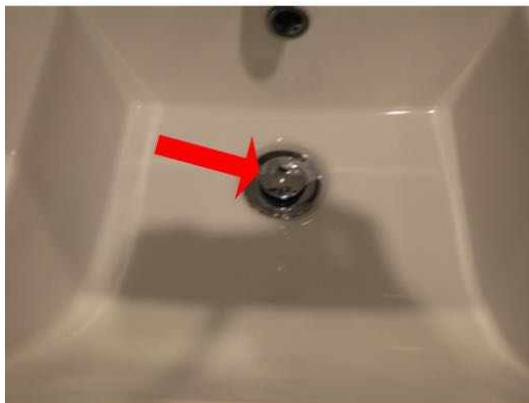
### Finding 3.08

Building: Main Building  
 Location: Bathroom > Centre,Rear  
 Finding: Basin - Pop up waste stiff.  
 Information: The bathroom basin pop up waste was stiff to operate at the time of inspection. It is advised that maintenance is carried out on the waste so as it functions as intended.

A handyman could be appointed to perform any remedial works where required.

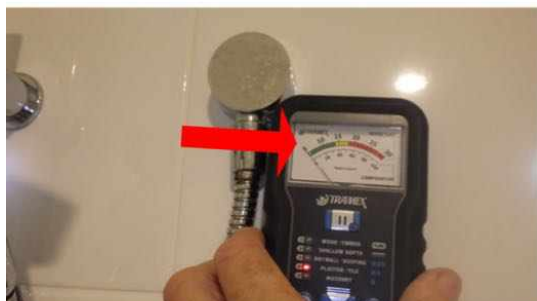
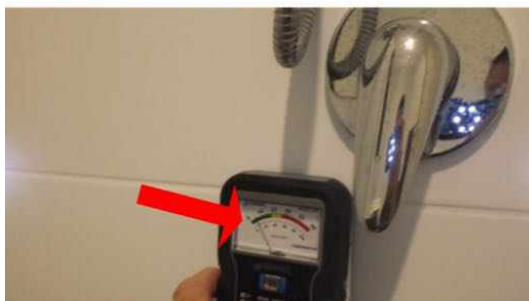
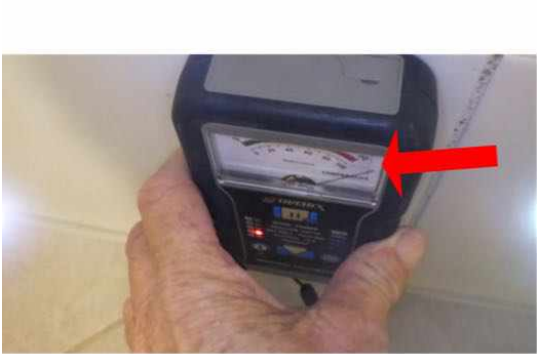
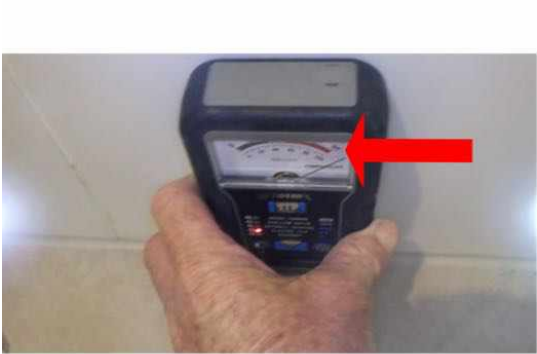
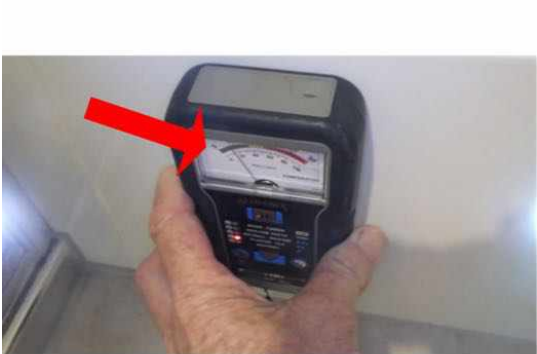
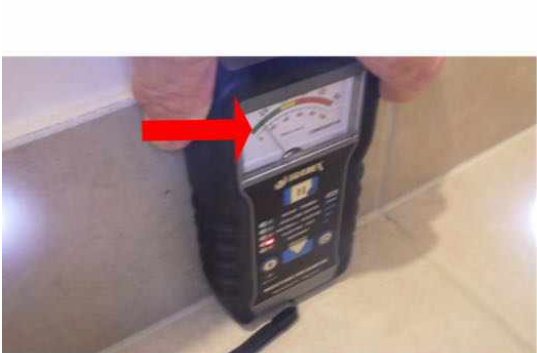
### Finding 3.09

Building: Main Building  
 Location: Bathroom > Rear Right  
 Finding: Shower - Monitor  
 Information: Elevated moisture level readings were recorded to the lower 300mm of wall to the bathroom shower alcove at the time of inspection. There was no elevated moisture level readings around the tap area, and no elevated readings transferring outside the shower cubicle or to the other side of the wall in the areas where moisture readings were able to be obtained. Both sealant and grout appear in good condition at present.

This defect is quite common, and is suspected to have been caused by moisture permeating or leaching through the grouting and perhaps gaps in the sealant.

Monitoring the area is advised and if any visual signs of excessive moisture appear (peeling paint, mould) then consultation with a qualified plumber or bathroom specialist would be advised to identify the cause of damp and to perform remedial works as required.

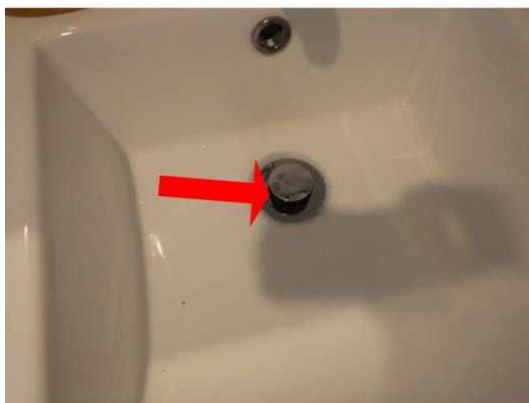
Finding 3.10

Building: Main Building  
 Location: Ensuite > Front Right  
 Finding: Basin - Pop up waste stiff.  
 Information: The ensuite basin pop up waste was stiff to operate at the time of inspection. It is advised that maintenance is carried out on the waste so as it functions as intended.

A handyman could be appointed to perform any remedial works where required.

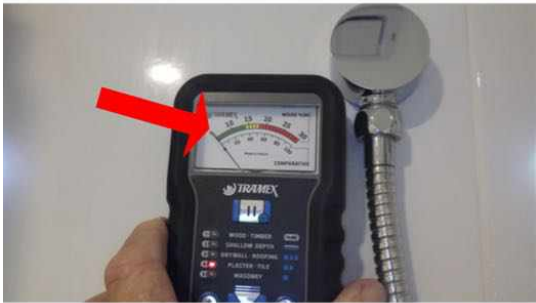
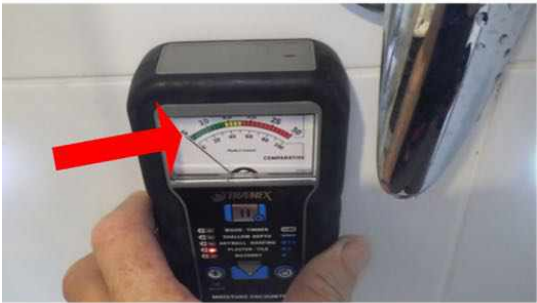
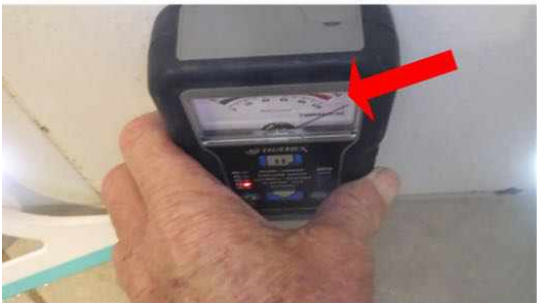
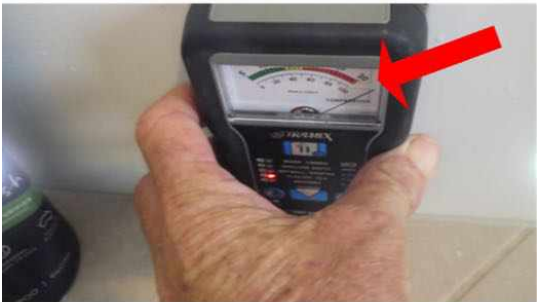
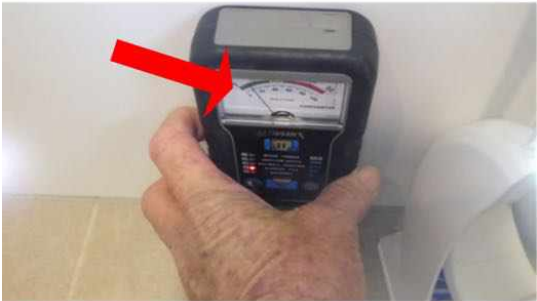
### Finding 3.11

Building: Main Building  
 Location: Ensuite > Rear Left  
 Finding: Shower - Monitor  
 Information: Elevated moisture level readings were recorded to the lower 300mm of wall to the ensuite shower alcove at the time of inspection. There was no elevated moisture level readings around the tap area, and no elevated readings transferring outside the shower cubicle or to the other side of the wall in the areas where moisture readings were able to be obtained. Both sealant and grout appear in good condition at present.

This defect is quite common, and is suspected to have been caused by moisture permeating or leaching through the grouting and perhaps gaps in the sealant.

Monitoring the area is advised and if any visual signs of excessive moisture appear (peeling paint, mould) then consultation with a qualified plumber or bathroom specialist would be advised to identify the cause of damp and to perform remedial works as required.

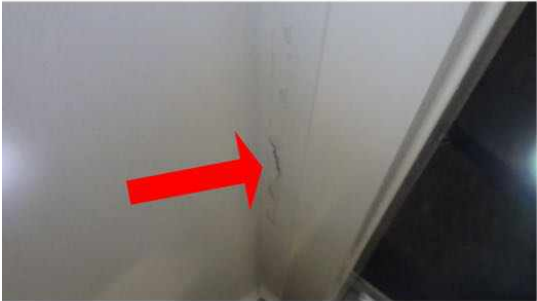
Building: Main Building  
Location: Internal Areas > Existing  
Finding: Wear and Tear  
Information: At the time of inspection the building interior showed signs of minor cracking and/or scuffing to wall surfaces (as per example photos).

The level of damage appears consistent with general deterioration and/or wear and tear.

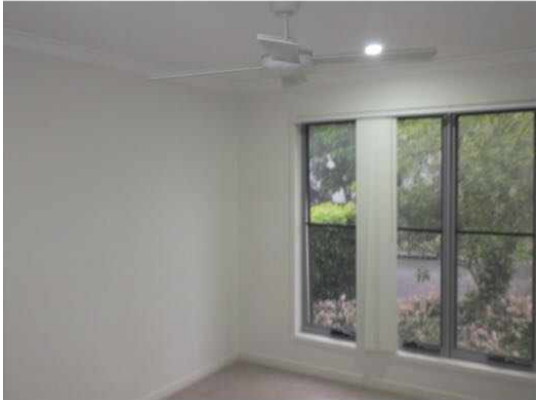
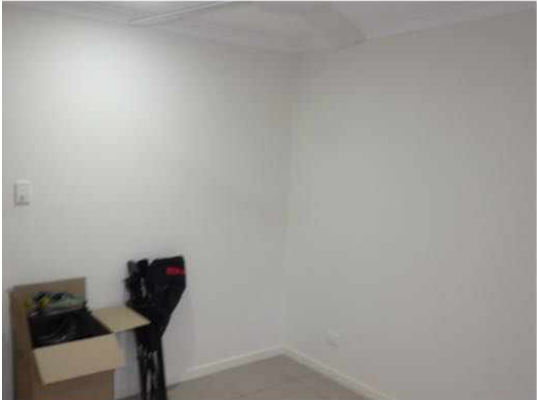
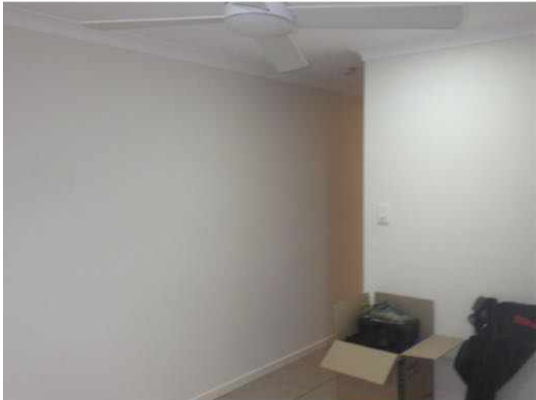
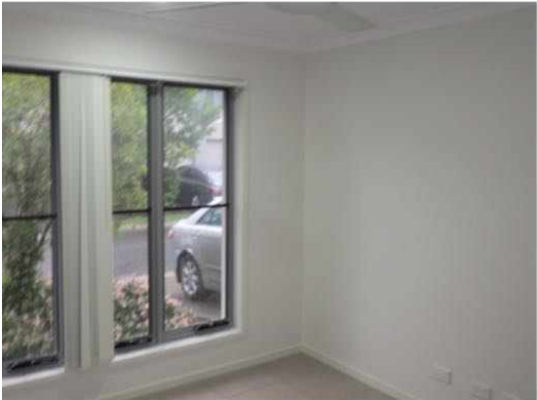
Building: Main Building  
Location: Lounge Room > Existing

Finding: No obvious defect  
Information: No obvious defects found at the time of inspection.

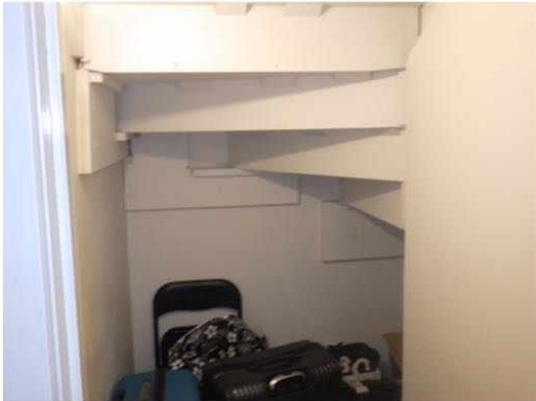
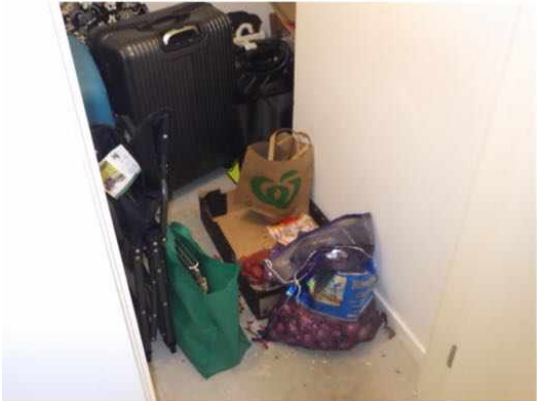
Building: Main Building  
Location: Under Stair Void or Storeroom > Existing  
Finding: No obvious defect  
Information: No obvious defects found at the time of inspection.

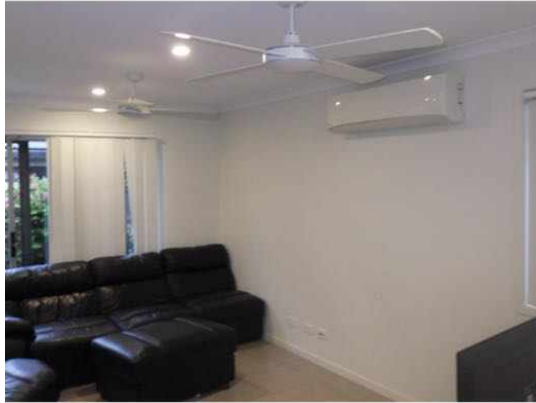
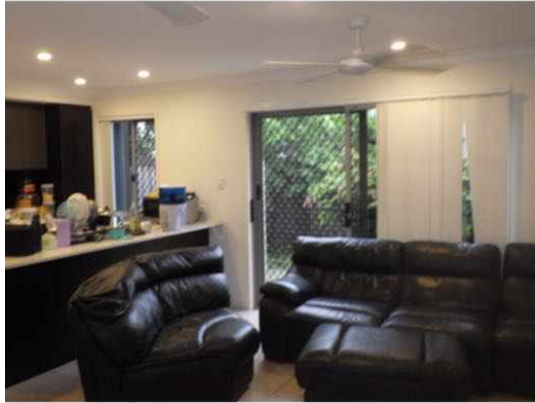
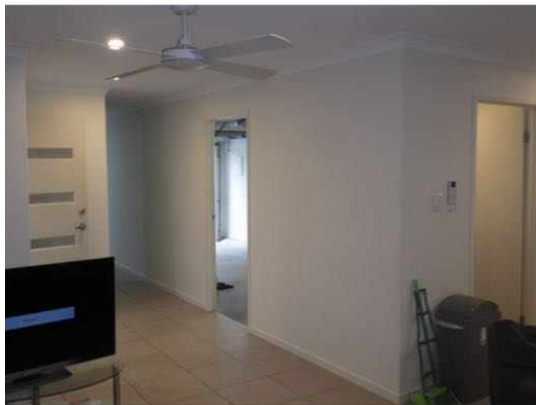
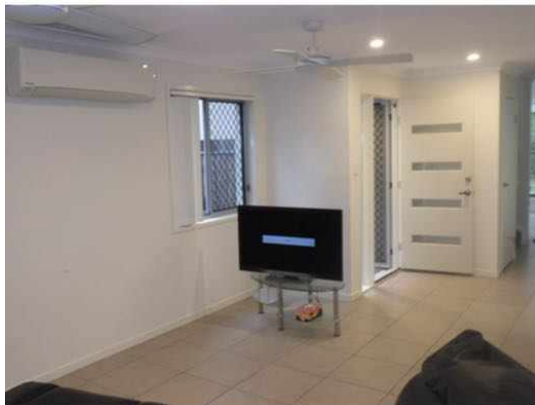
Building: Main Building  
Location: Living/Dining Room > Existing  
Finding: No obvious defect  
Information: No obvious defects found at the time of inspection.

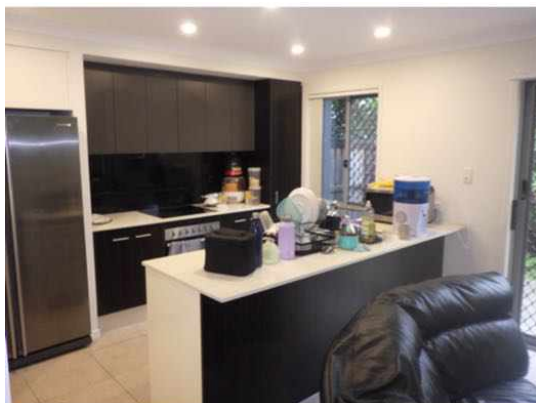
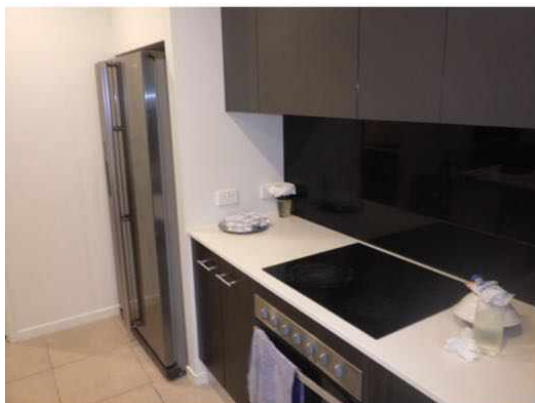
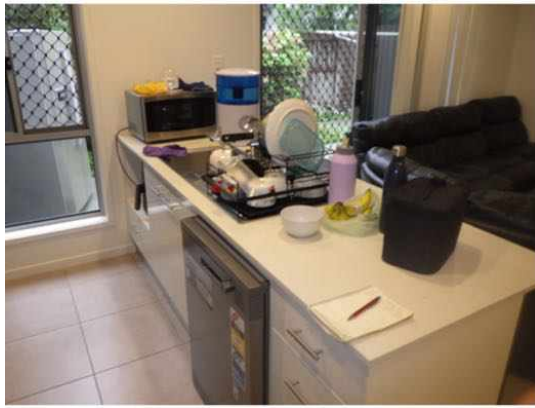
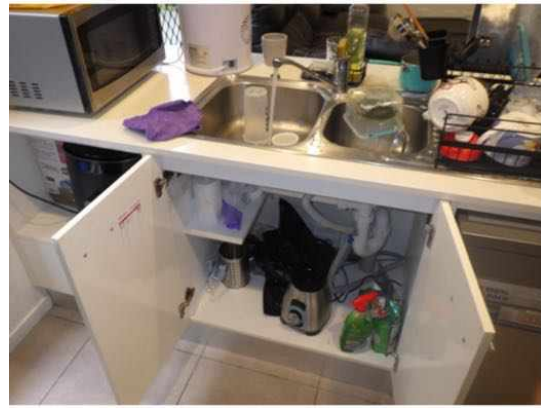
Building: Main Building  
Location: Kitchen > Existing  
Finding: No obvious defect  
Information: No obvious defects found at the time of inspection.

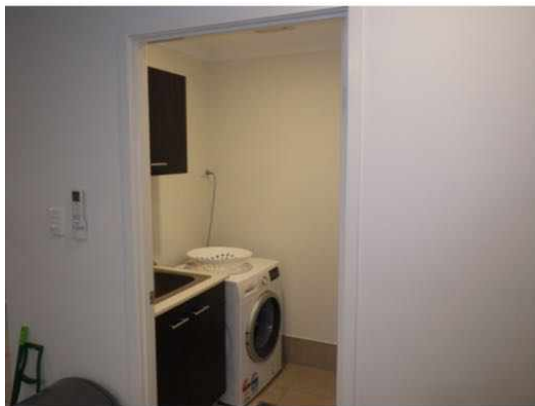
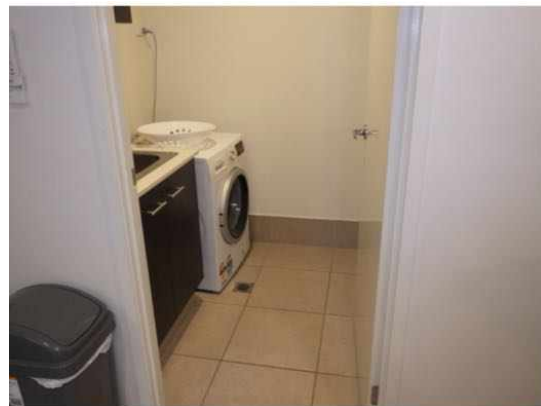
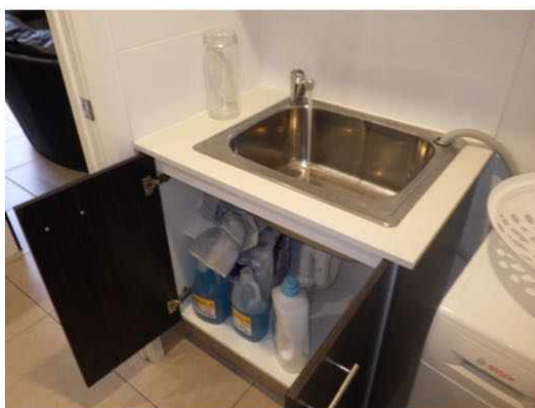
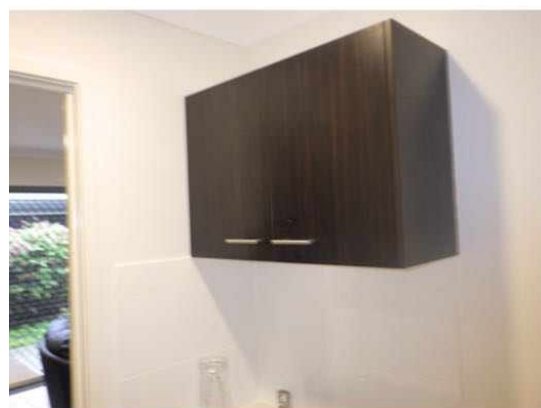
Building: Main Building  
Location: Laundry > Existing  
Finding: No obvious defect  
Information: No obvious defects found at the time of inspection.

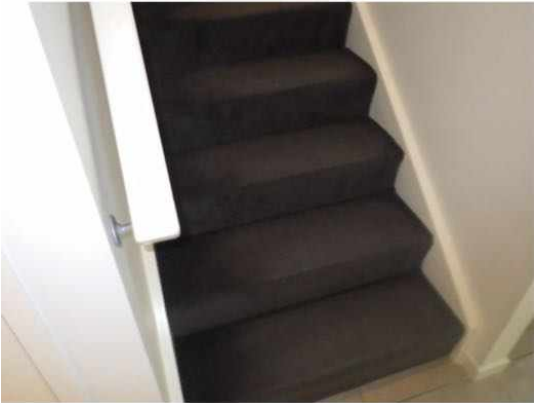
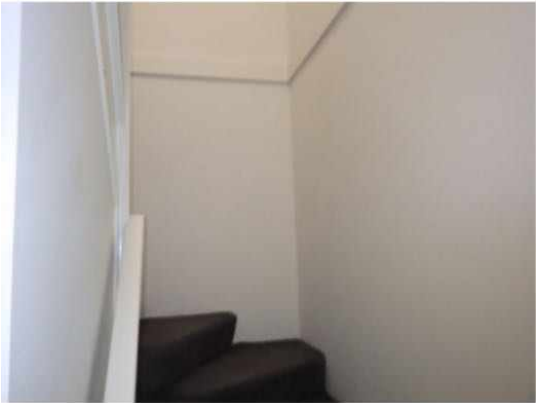
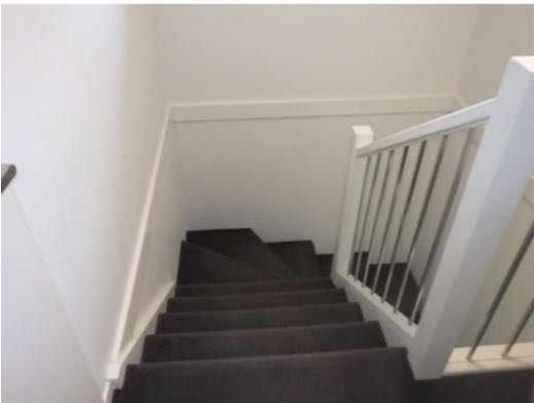
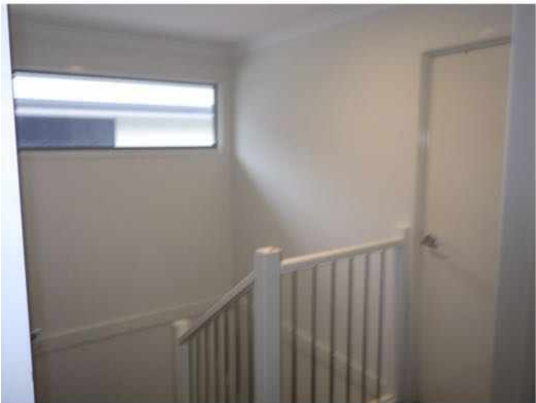
Building: Main Building  
Location: Stairs - Internal > Existing  
Finding: No obvious defect

Information: No obvious defects found at the time of inspection.

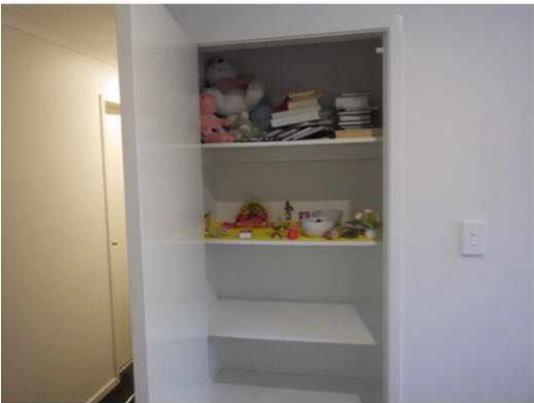
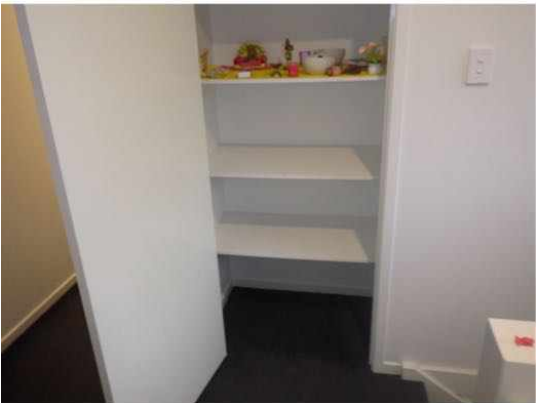
Building: Main Building  
Location: Linen Cupboard > Existing  
Finding: No obvious defect  
Information: No obvious defects found at the time of inspection.

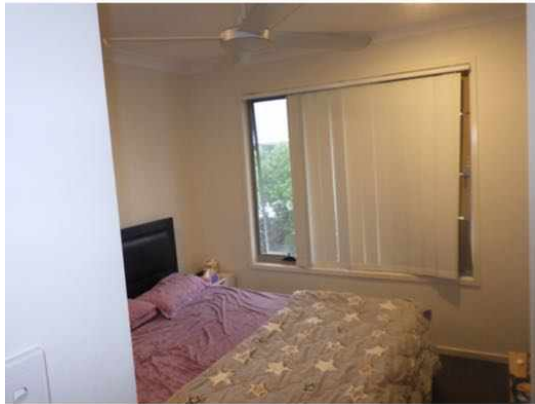
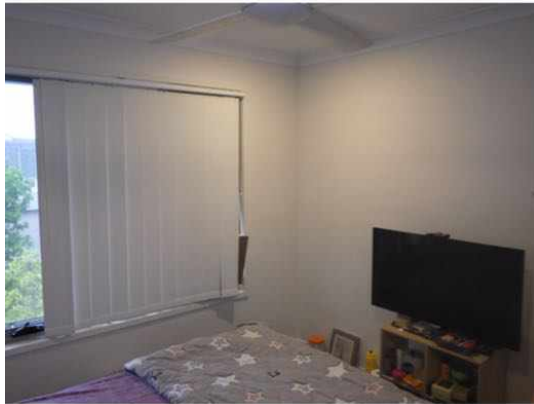
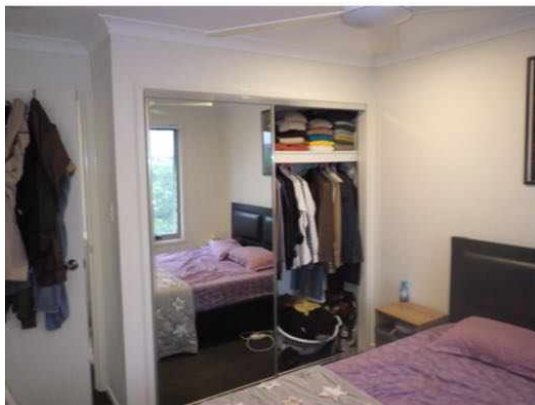
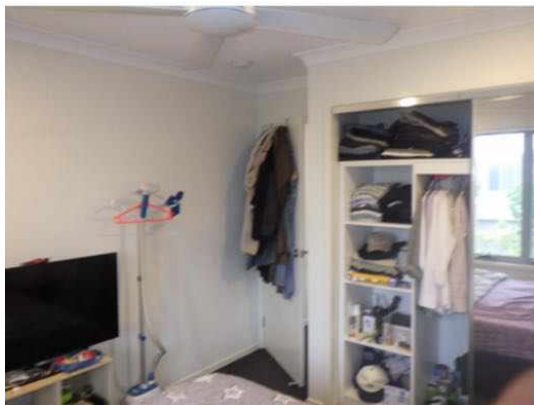
Location: Bedroom 4 > Existing  
Finding: No obvious defect  
Information: No obvious defects found at the time of inspection.

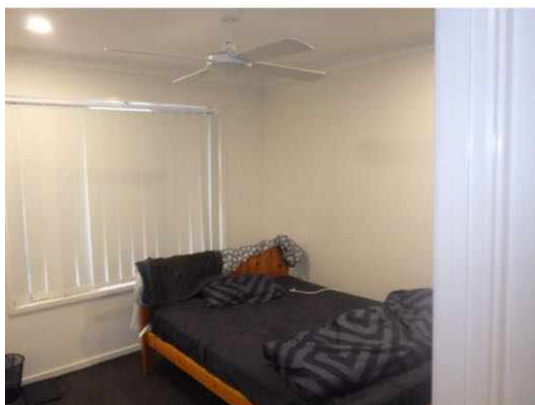
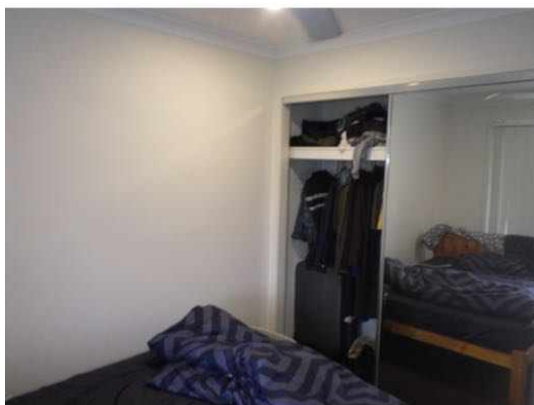
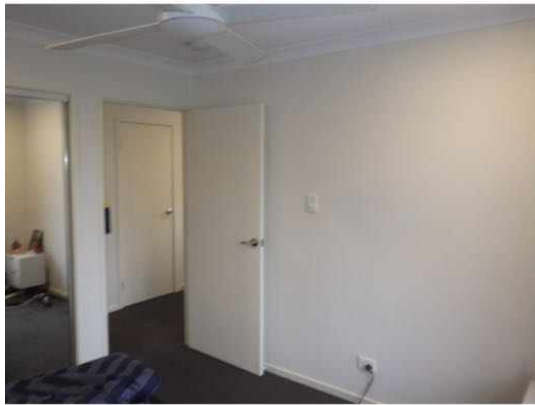
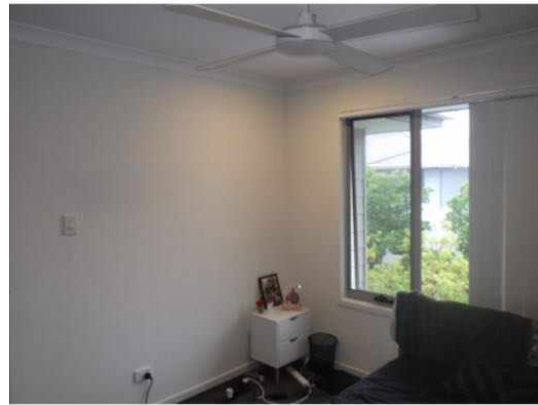
Building: Main Building  
Location: Bedroom 3 > Existing  
Finding: No obvious defect  
Information: No obvious defects found at the time of inspection.

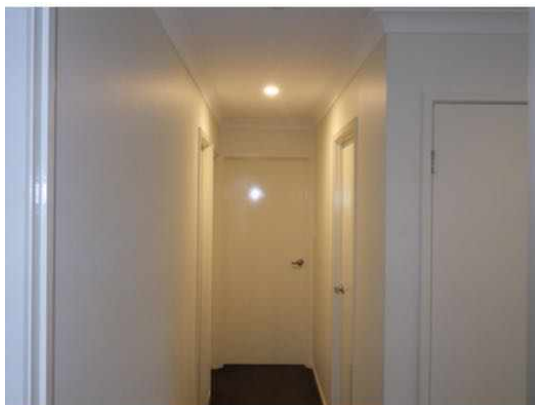
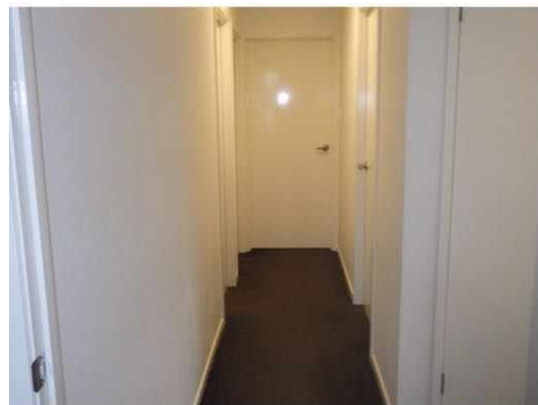
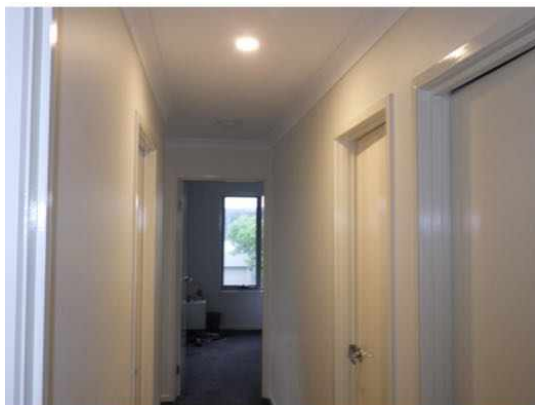
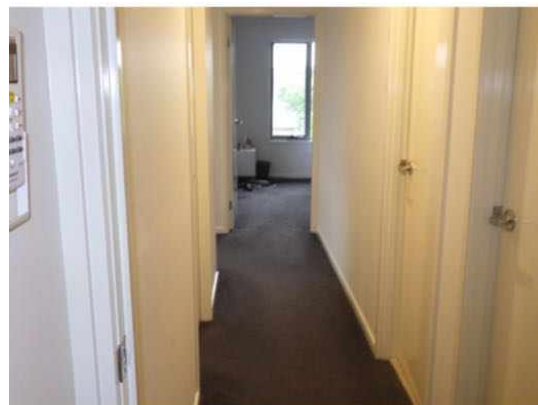
Building: Main Building  
Location: Hallway 2 > Existing  
Finding: No obvious defect  
Information: No obvious defects found at the time of inspection.

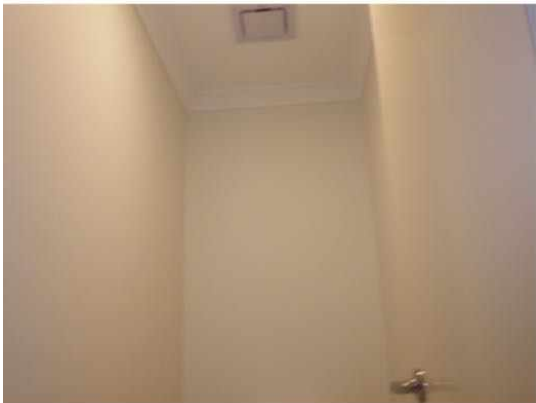
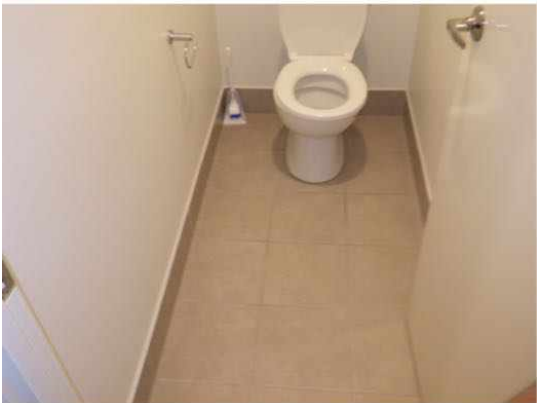
Building: Main Building  
Location: Toilet (WC) > Existing  
Finding: No obvious defect

Information: No obvious defects found at the time of inspection.

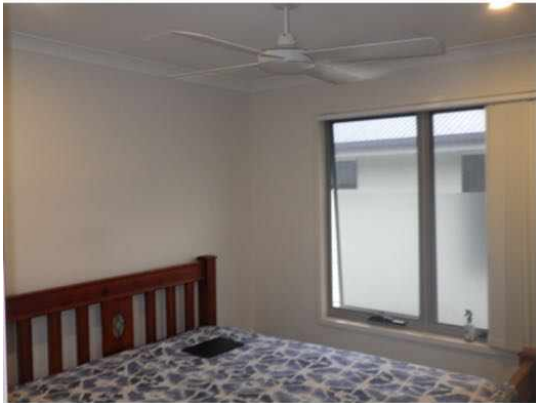
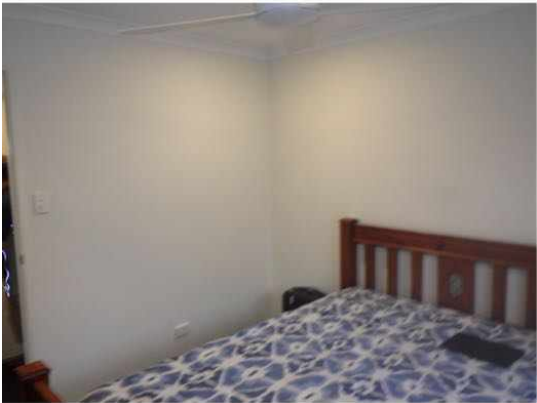
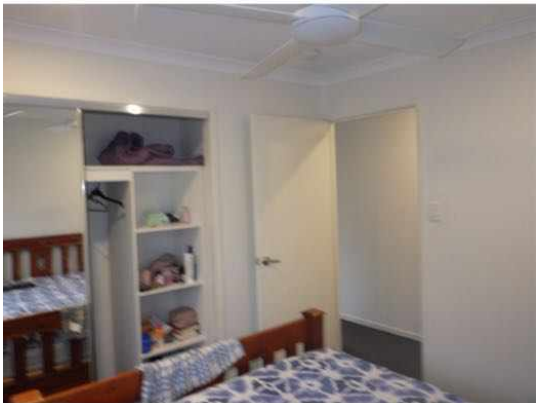
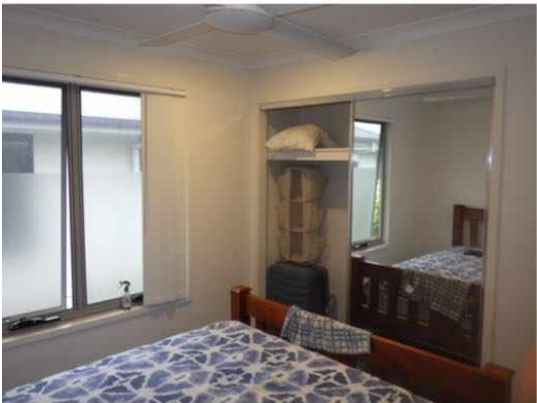
Building: Main Building  
Location: Bedroom 2 > Existing  
Finding: No obvious defect  
Information: No obvious defects found at the time of inspection.

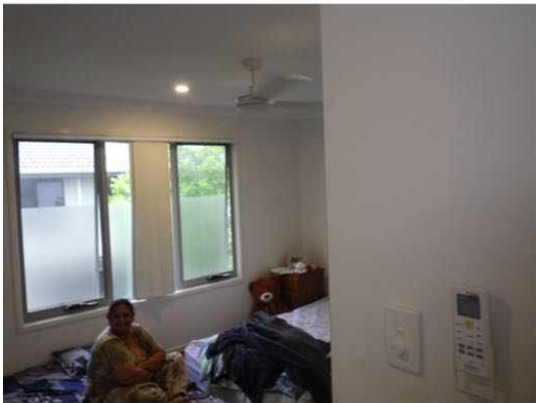
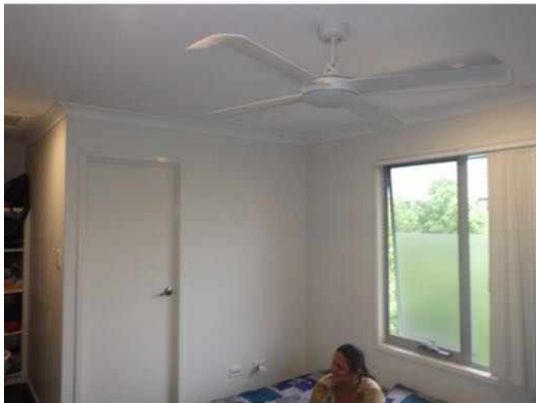
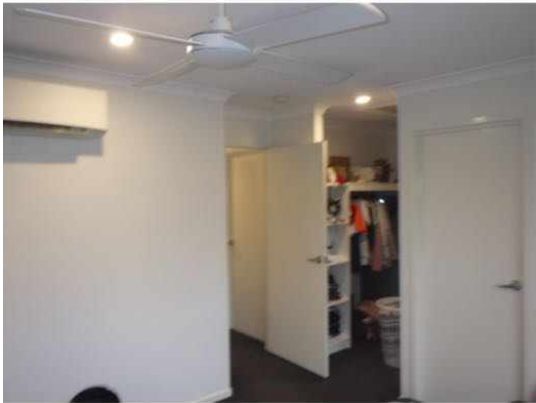
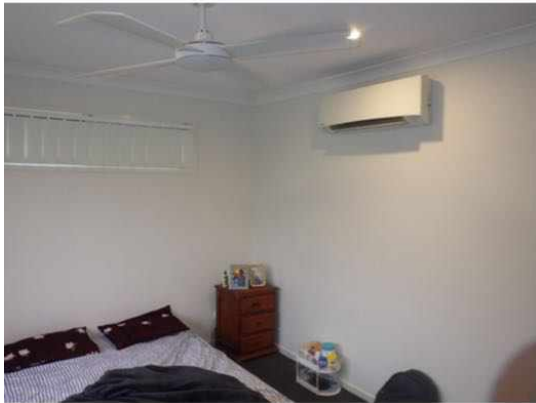
Location: Bedroom - Master > Existing  
Finding: No obvious defect  
Information: No obvious defects found at the time of inspection.

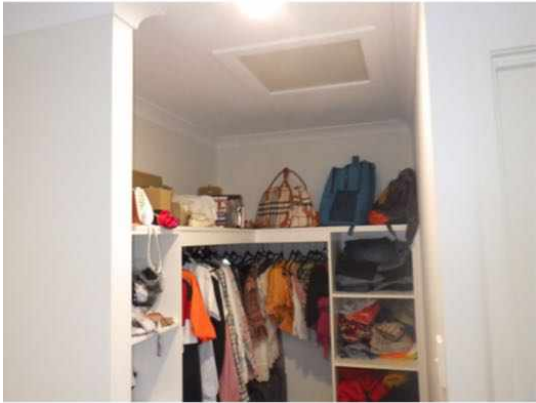
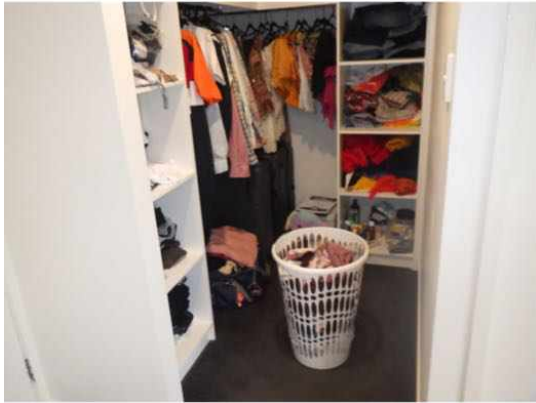
Building: Main Building  
Location: Walk In Robe > Existing  
Finding: No obvious defect  
Information: No obvious defects found at the time of inspection.

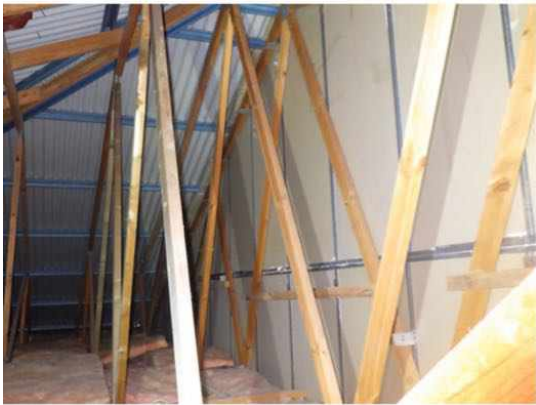
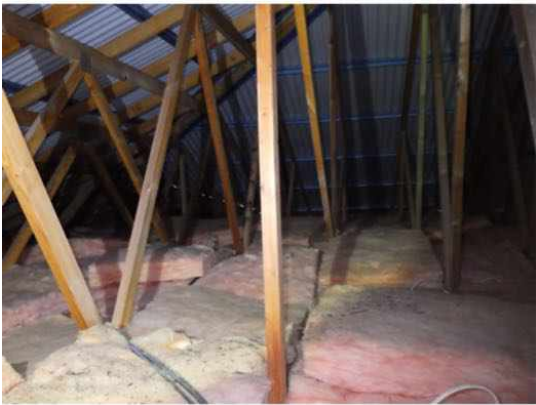
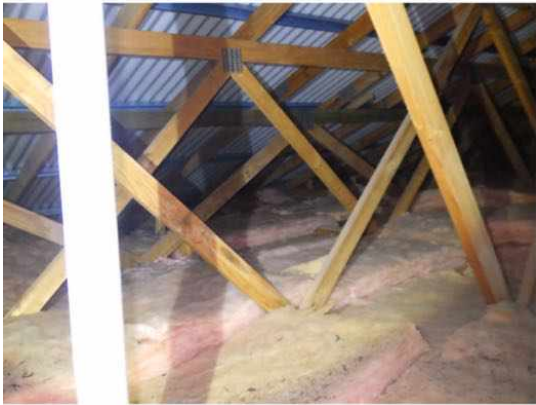
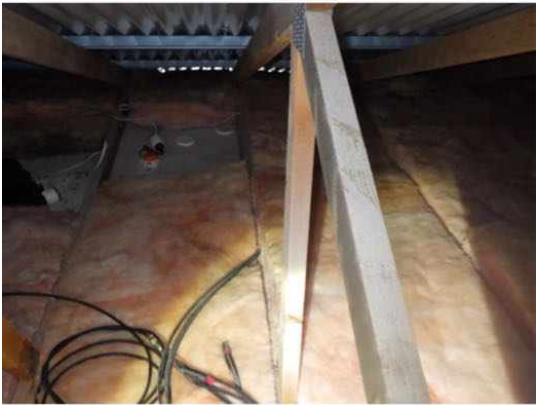
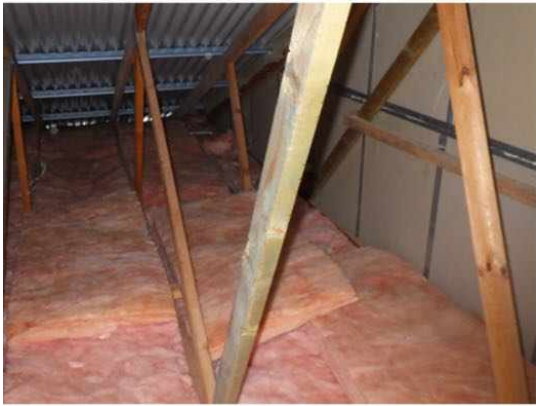
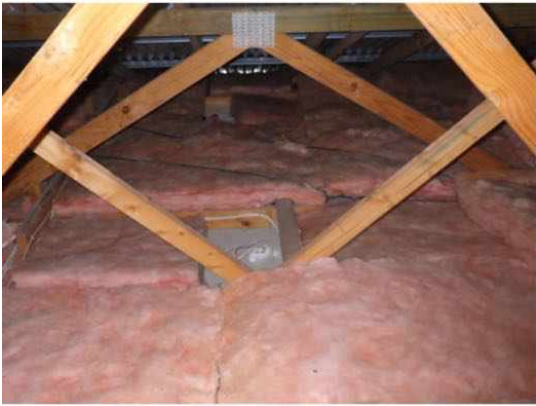
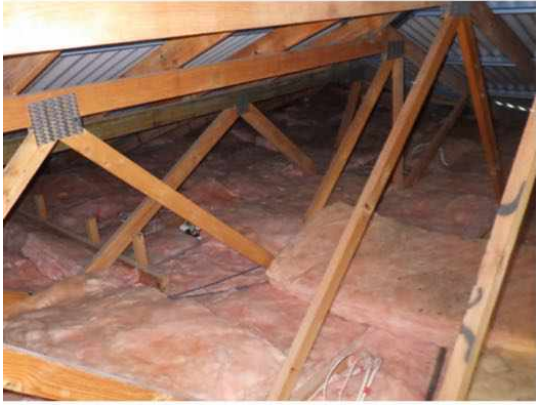
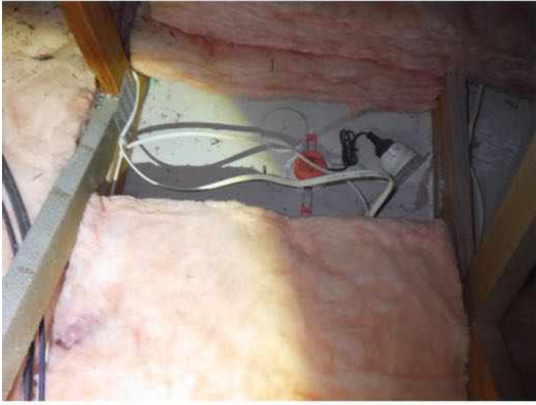
Building: Main Building  
 Location: Attic > Existing  
 Finding: No obvious defect  
 Information: No obvious defects found at the time of inspection.

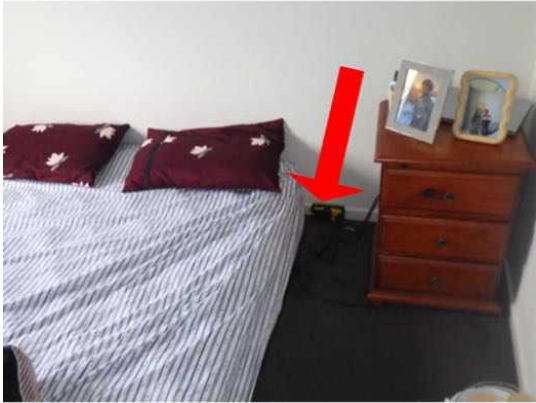
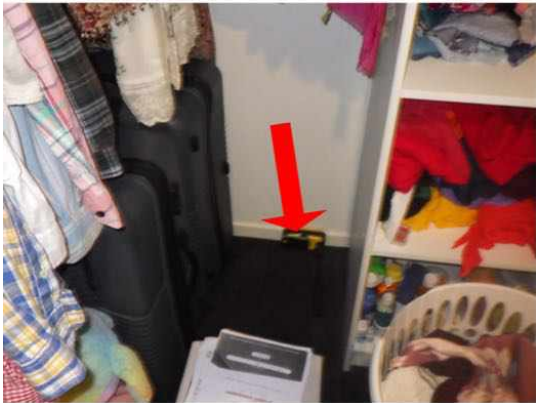
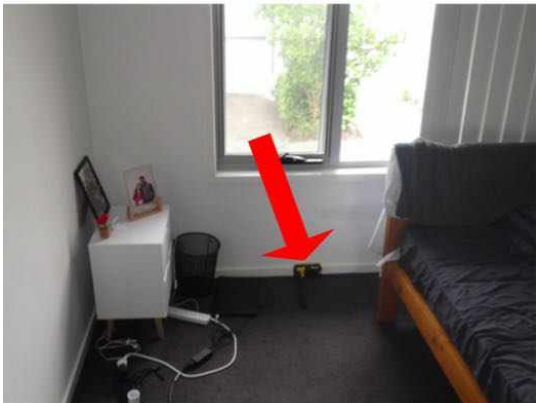
Building: Main Building  
Location: Internal Areas > Existing  
Finding: Termitracker  
Information: The termitracker was positioned randomly to internal wall, timber skirting and window frame areas checking for signs of termite activity.

No activity was recorded at the time of inspection.

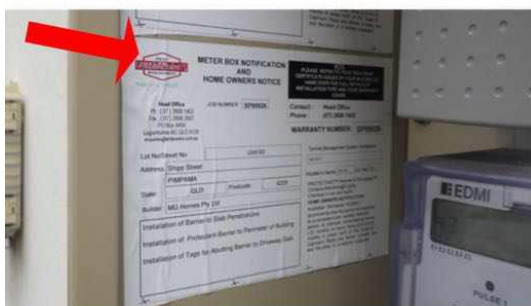
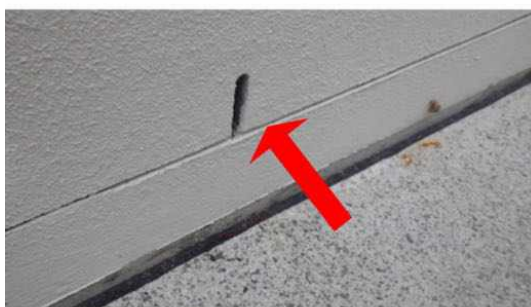
In this instance evidence of a previously installed physical barrier was observed, along with a durable notice inside the electrical meter box.

No evidence of regular or annual inspections was found.

Where a Termite Management System has been identified you should refer to the type of barrier date of installation warranty conditions and any documentation provided by a past owner or possibly the buildings body corporate managers.
