# Building and Timber Pest Inspection Report

Inspection Date: Wed, 21 Jan 2026

Property Address: 4 Wentworth St, Palmers Island NSW 2463,  
Australia

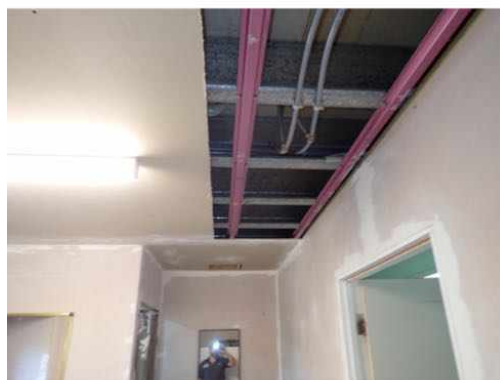
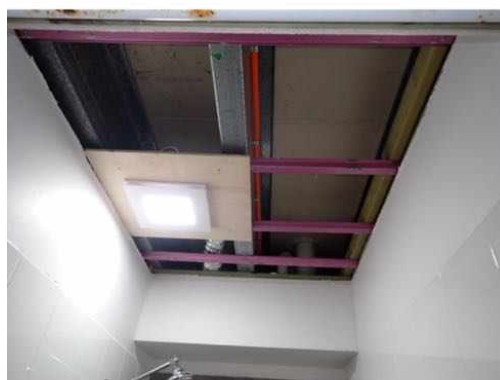
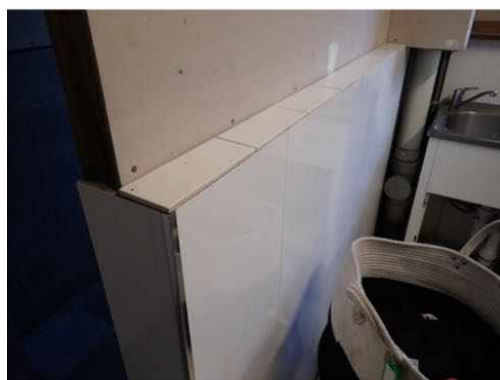
#### Finding 2.01

Building:	Main Building
Location:	Laundry
Finding:	Ground Floor Bathroom/Laundry – Unfinished Works
Information:	The ground floor bathroom/laundry was found to be unfinished at the time of inspection. This includes incomplete fixtures and finishes, which may affect functionality and compliance. It is recommended that a suitably qualified tradesperson complete the remaining works as deemed necessary to bring the area to an acceptable standard.

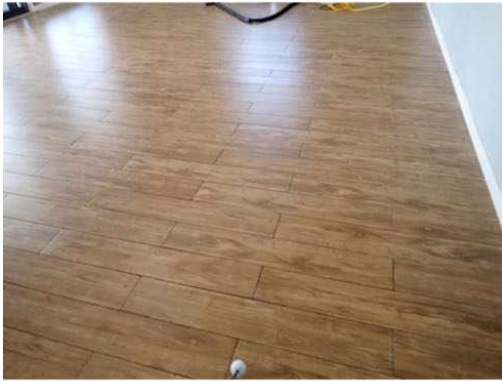
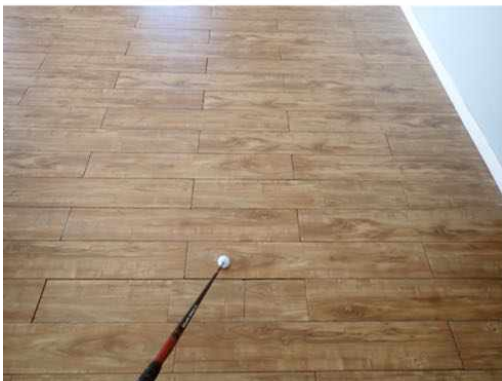
## Finding 2.02

Building:	Main Building
Location:	Top floor tiled area
Finding:	Top Floor – Floor Tiles in Poor Condition
Information:	The floor tiles to the top floor were found to be in poor condition at the time of inspection and require replacement. This may be due to age-related deterioration, poor installation, or issues with the underlying substrate. It is recommended that a suitably qualified tiler remove the tiles, assess the substrate, and carry out repairs or replacement as deemed necessary before re-tiling to ensure a suitable finish.

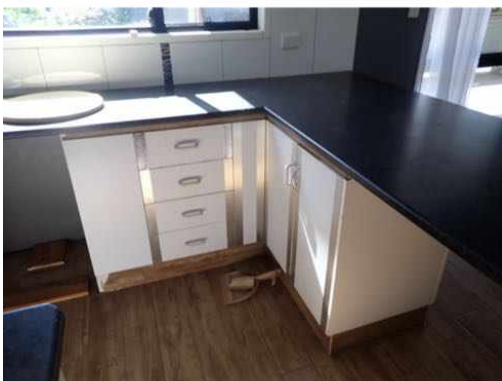
### Finding 2.03

Building:	Main Building
Location:	Kitchen
Finding:	Kitchen – Poor Condition Due to Incomplete Installation and Lack of Maintenance
Information:	The kitchen was found to be in poor condition at the time of inspection due to poor and incomplete installation and a lack of general maintenance, although it was functional. If left unaddressed, the condition may continue to deteriorate over time. It is recommended that a suitably qualified tradesperson carry out repairs, completion works, and general maintenance as deemed necessary to improve the overall condition and longevity of the kitchen.

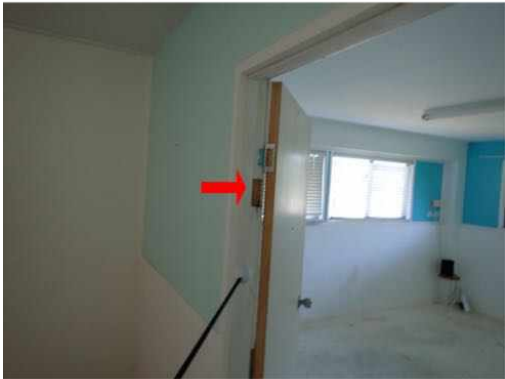
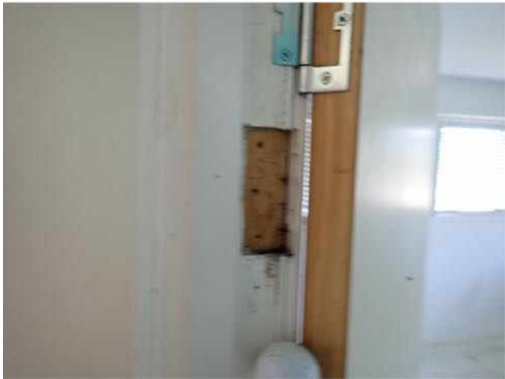
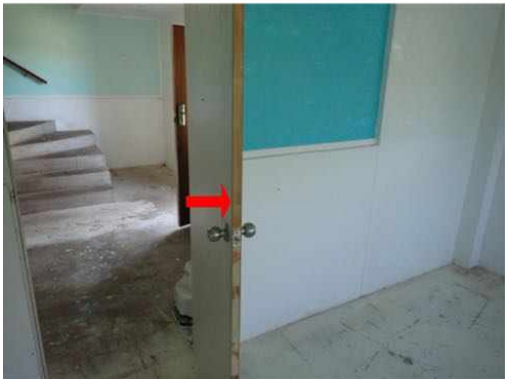
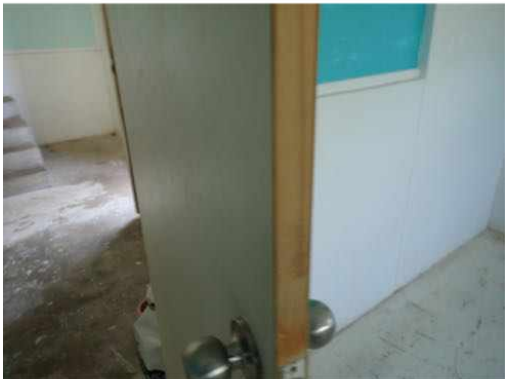
Building: Main Building  
Location: All Areas  
Finding: Internal Doors – Generally in Need of Repair and Maintenance  
Information: The doors throughout the building were found to be generally in need of repair and maintenance at the time of inspection. This may include adjustment, repair of hardware, painting or general servicing due to unfinished works, poor installation and age-related wear and tear. It is recommended that a suitably qualified carpenter or general handyman carry out repairs and maintenance as deemed necessary to restore proper operation and condition.

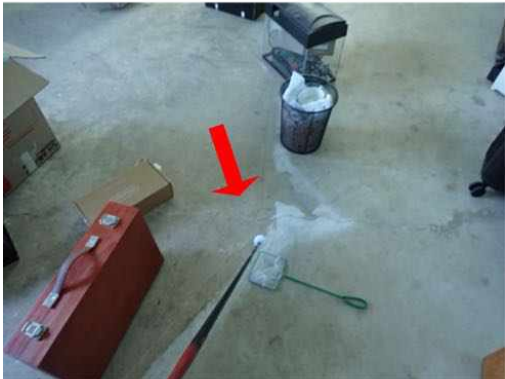
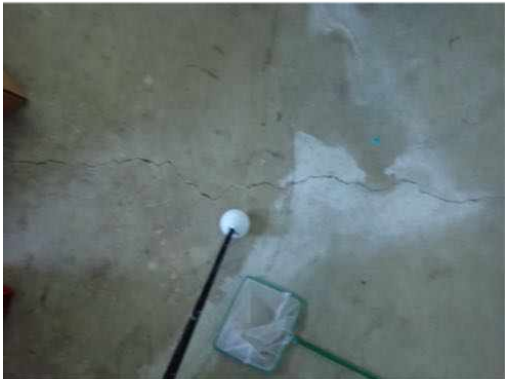
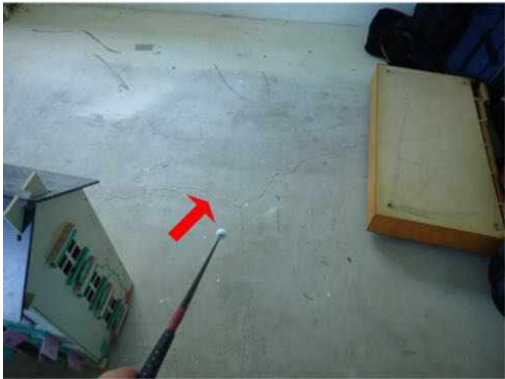
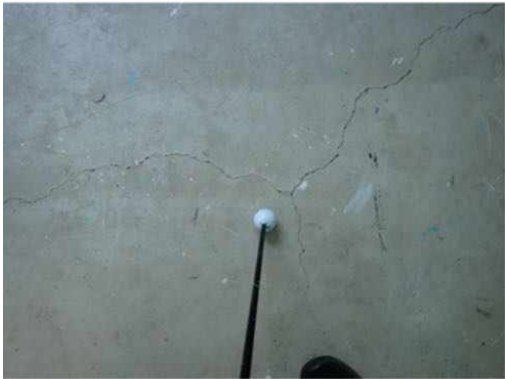
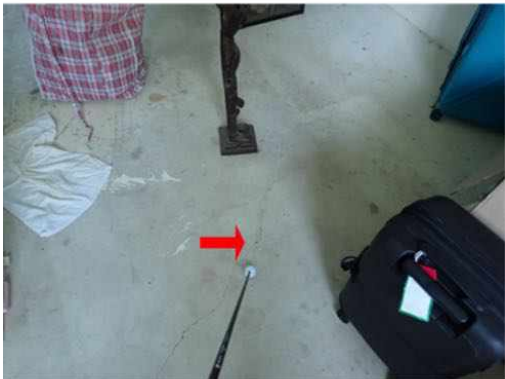
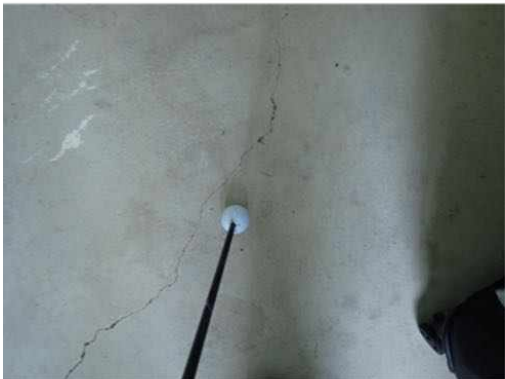
**Finding 3.02**

Building: Main Building  
Location: Ground floor concrete slab  
Finding: Ground Floor Concrete Slab – Several Minor Cracks  
Information: Several minor cracks were identified in the ground floor concrete slab at the time of inspection. These appear consistent with general shrinkage and age-related movement. While not considered structurally significant, it is recommended that the cracks be monitored and repaired as deemed necessary by a suitably qualified tradesperson to help prevent further deterioration.

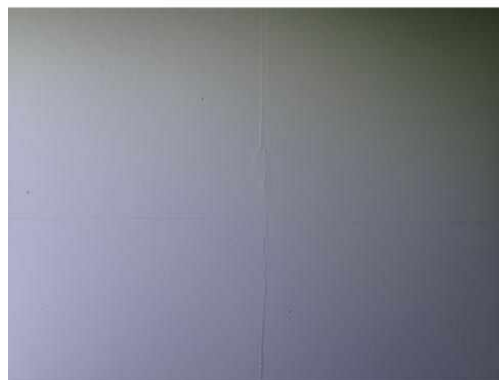
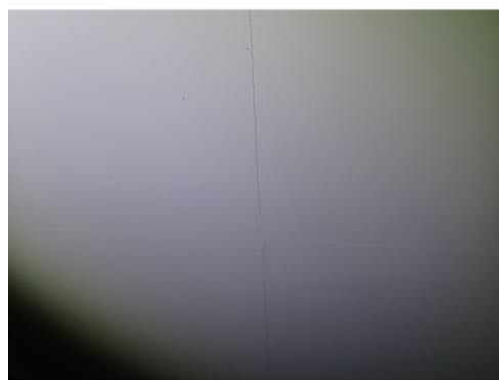
Finding 3.03

Building:	Main Building
Location:	Ground floor concrete slab
Finding:	Ground Floor Ceiling – Minor Cracks to Plaster
Information:	Minor cracks were identified in the ground floor ceiling plaster at the time of inspection. These may be related to poor installation, minor movement, or shrinkage of materials. While not considered structurally significant, it is recommended that the cracks be repaired and monitored as deemed necessary by a suitably qualified tradesperson to maintain the ceiling finish.

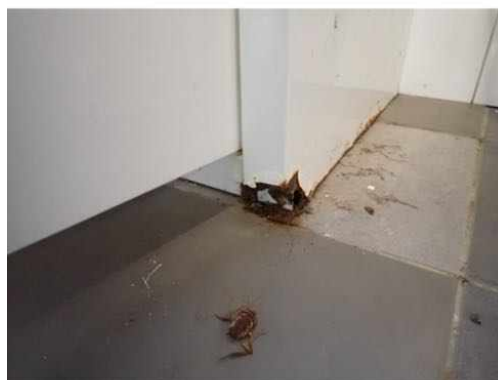
### Finding 3.04

Building:	Main Building
Location:	Laundry
Finding:	Laundry Tub Cabinet – Rust to Bottom Section
Information:	Rust was identified to the bottom of the laundry tub cabinet at the time of inspection. This is likely due to prolonged exposure to moisture. If left unaddressed, the corrosion may continue to deteriorate the cabinet. It is recommended that a suitably qualified tradesperson repair, treat, or replace the affected cabinet as deemed necessary to prevent further deterioration.

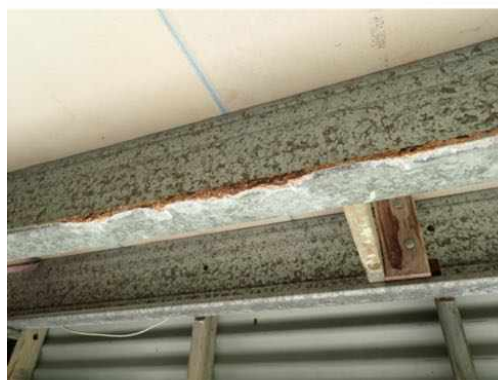
### Finding 3.05

Building:	Main Building
Location:	Carport
Finding:	Carport – Surface Rust to Steel Floor Joist
Information:	Surface rust was identified to a steel floor joist within the carport at the time of inspection. This is consistent with age-related deterioration and exposure to moisture. While the rust appeared to be superficial, ongoing corrosion may occur if left unaddressed. It is recommended that a suitably qualified tradesperson clean, treat, and protect the affected steelwork as deemed necessary to prevent further deterioration.

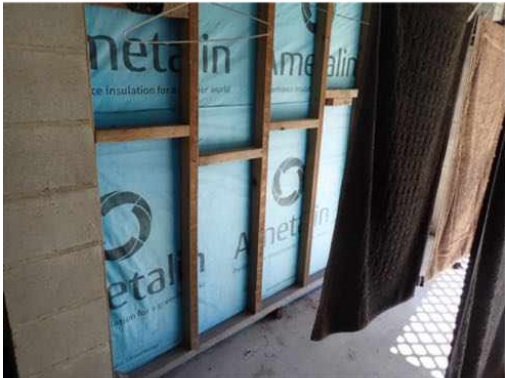
### Finding 3.06

Building:	Main Building
Location:	Carport
Finding:	Carport – Unfinished Works
Information:	Unfinished works were identified to the carport at the time of inspection. This includes incomplete construction of finishing items that may affect functionality and appearance. It is recommended that a suitably qualified tradesperson complete the remaining works as deemed necessary to bring the carport to an acceptable standard.

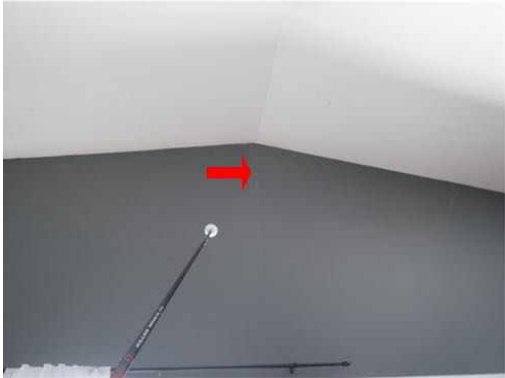
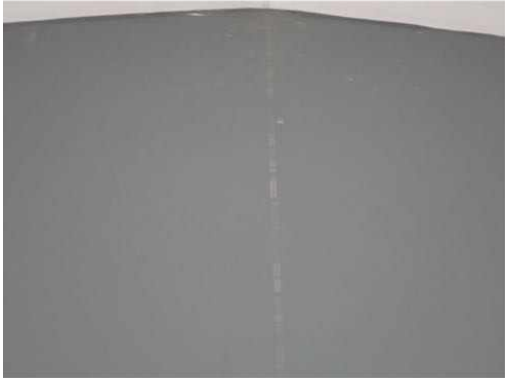
**Finding 3.07**

Building: Main Building  
Location: Living room  
Finding: Living Room – Minor Cracking to Internal Cladding  
Information: Minor cracking was identified to the internal cladding in the living room at the time of inspection. This appears consistent with minor movement and age-related wear. While not considered structurally significant, it is recommended that the affected areas be repaired and monitored as deemed necessary by a suitably qualified tradesperson to maintain the condition of the internal finishes.

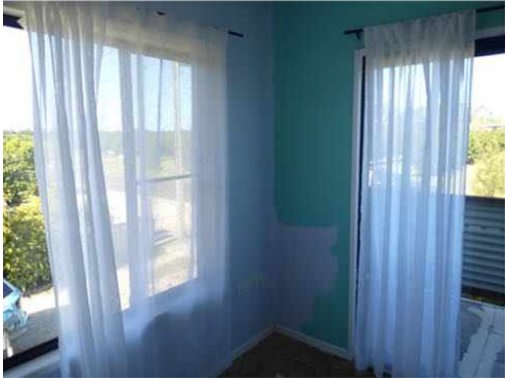
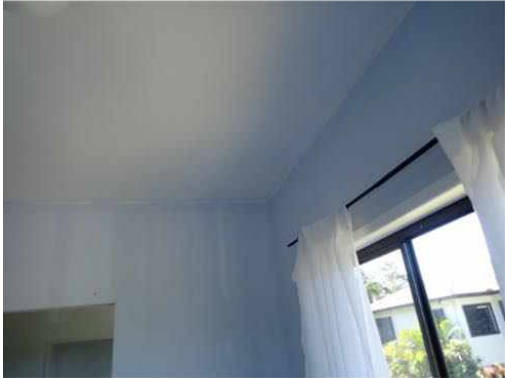
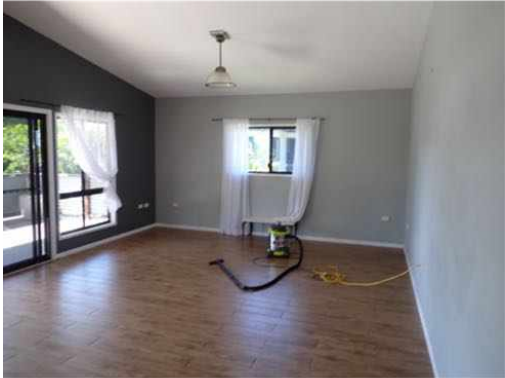
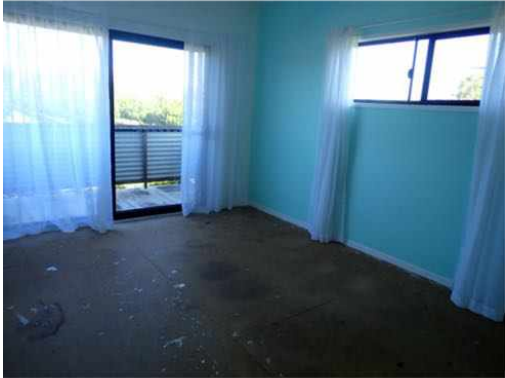
**Finding 3.08**

Building: Main Building  
Location: All areas  
Finding: Internal Paintwork – Poor or Unfinished  
Information: Internal paintwork was found to be poor or unfinished at the time of inspection. This appears to be due to incomplete works or poor workmanship and affects the overall presentation of the internal areas. It is recommended that a suitably qualified painter complete and rectify the paintwork as deemed necessary to achieve an acceptable standard of finish.

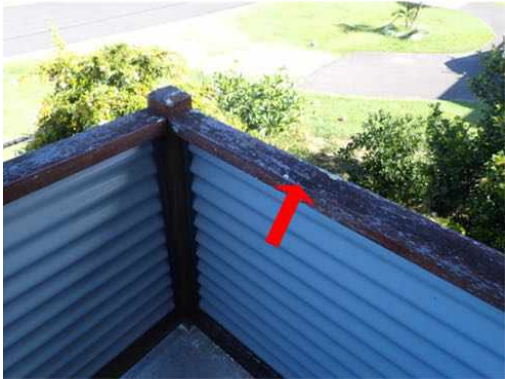
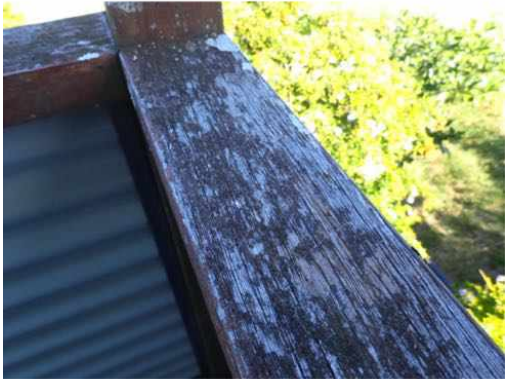
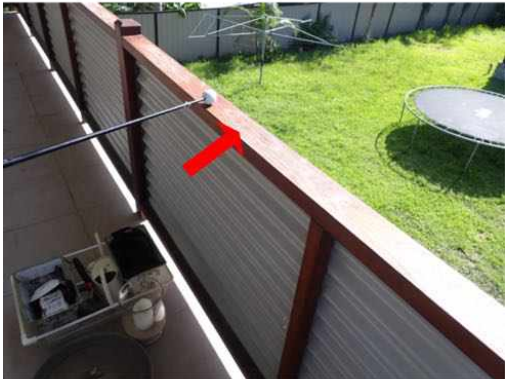
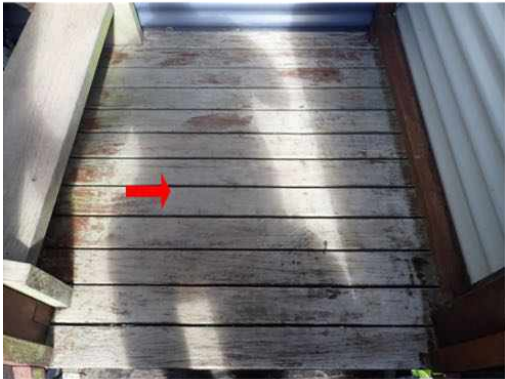
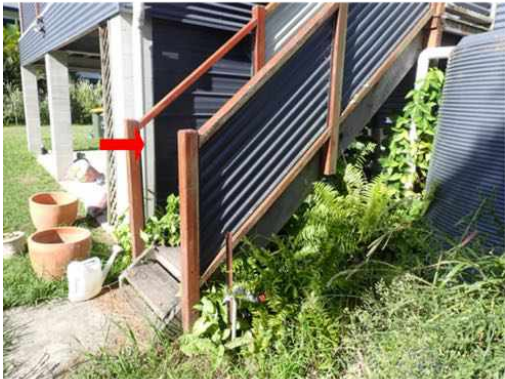
**Finding 3.10**

Building: Main Building  
Location: Balustrades, stair handrails and stairs  
Finding: Balustrades, Stairs and Handrails – Fair Condition, Maintenance Required  
Information: The balustrades, stairs, and stair handrails were found to be in fair condition at the time of inspection, however general maintenance and minor repair works are required. This is consistent with age-related wear and use. It is recommended that a suitably qualified tradesperson carry out maintenance and minor repairs as deemed necessary to maintain safety and serviceability.

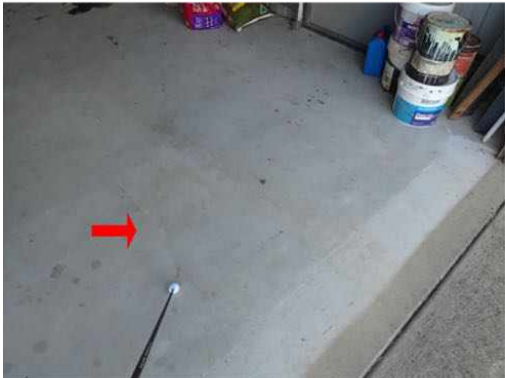
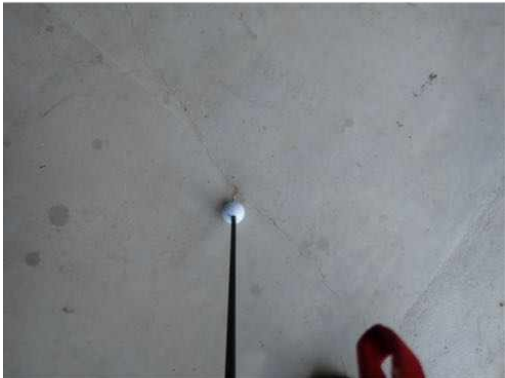
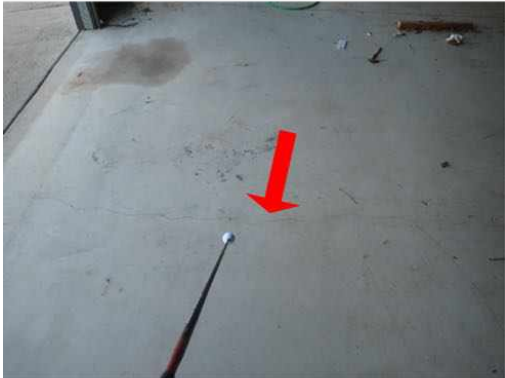
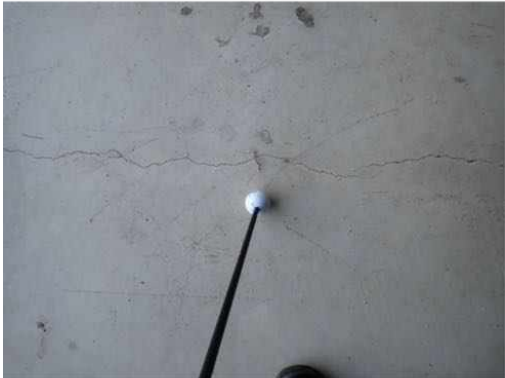
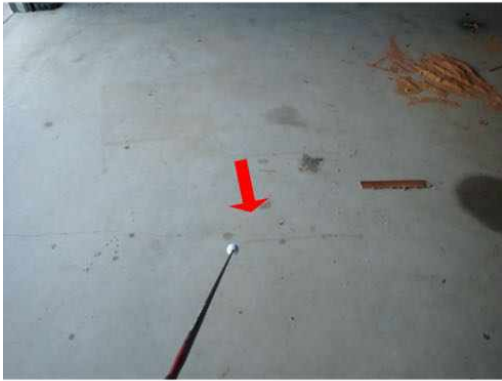
**Finding 3.11**

Building: Main Building  
 Location: Shed  
 Finding: Garage Concrete Slab – Several Minor Cracks  
 Information: Several minor cracks were identified in the garage concrete slab at the time of inspection. These appear consistent with general shrinkage and age-related movement. While not considered structurally significant, it is recommended that the cracks be monitored and repaired as deemed necessary by a suitably qualified tradesperson to help prevent further deterioration.

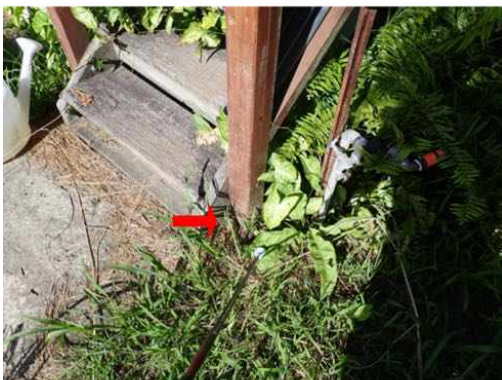
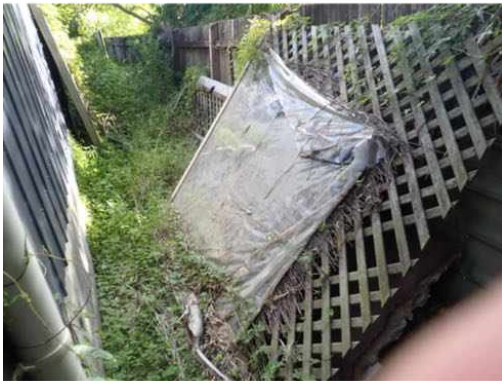
### Finding 6.01

Building:	Main Building
Location:	Rear boundary and rear stairs
Finding:	Timber in Contact with Ground – Conditions Conducive to Termite Attack
Information:	Timber elements were identified in direct contact with the ground at the time of inspection, creating conditions that are conducive to termite attack. This may increase the risk of concealed termite activity and timber damage. It is recommended that a suitably qualified tradesperson rectify the timber-to-ground contact and that a licensed timber pest technician be consulted to provide appropriate termite management measures as deemed necessary.

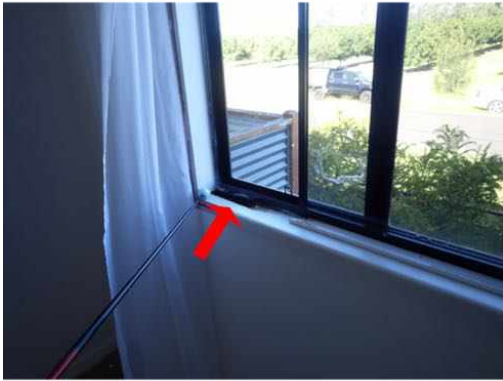
### Finding 7.01

Building:	Main Building
Location:	Bedroom
Finding:	Bedroom Window Frame – Wood Rot Identified
Information:	Wood rot was identified to the bedroom window frame at the time of inspection. This is likely due to prolonged moisture exposure. If left unaddressed, the deterioration may worsen and affect the integrity of the window. It is recommended that a suitably qualified carpenter repair or replace the affected timber and address the source of moisture as deemed necessary.

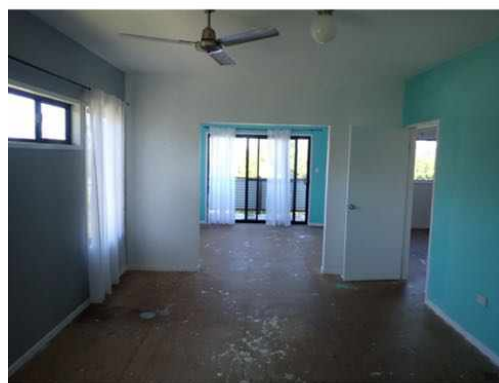
Building:	Main Building
Location:	Bedrooms
Finding:	Bedrooms – Missing Floor Coverings
Information:	Floor coverings were missing in the bedrooms at the time of inspection. This leaves the underlying floor exposed and may affect comfort and durability. It is recommended that a suitably qualified flooring contractor install appropriate floor coverings as deemed necessary to complete the rooms.

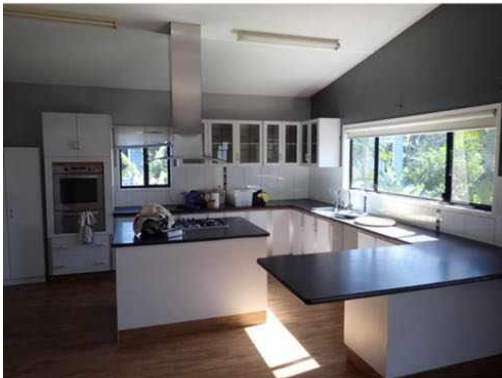
Finding: Additional Photos - Obstructions and Limitations

Information: These photographs are an indication of the obstructions and limitations which impeded full inspection of the area at the time of inspection. These obstructions can hide an array of defects and should be removed to allow full inspection to be carried out. A re-inspection is recommended once the areas are made accessible.
