# Building and Timber Pest Inspection Report

Inspection Date: Mon, 16 Feb 2026

Property Address: 42 Crackenback St, Thurgoona NSW 2640,  
Australia

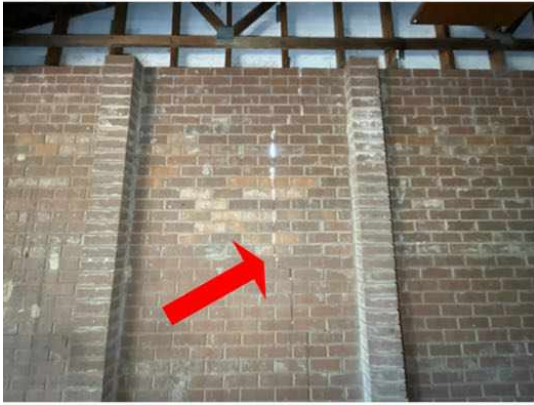
Building: Building 1  
Location: Garage  
Finding: Brickwork - Cracking [Repair required]  
Information: Major cracking was identified to the brickwork in this area. Cracks of this type are likely to have been caused by minor expected movement of building elements, but may also have a structural cause that is more significant.

A crack of this size may be repaired by extensive filling. Additionally, further remedial works to associated building elements, such as eave sheeting or external door frames, is likely to be required.

A qualified bricklayer should be contacted immediately to estimate and perform repair and restoration works. Consultation with a structural engineer may be required where structural instability is found to be the underlying cause of the cracking.

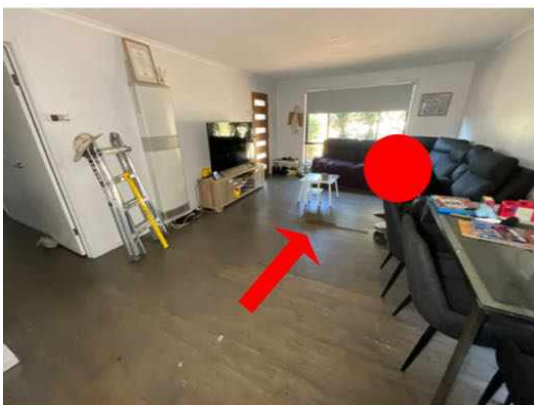
### Finding 3.01

Bouncy floors generally indicate that the floorboards or the subfloor structures are coming loose from the joists that they are installed on. Bouncy flooring may also be the result of gaps between flooring and stumps or joist structures, which require packing.

The client is advised to seek quotations for required repairs from a Registered Builder specialising in re-stumping. The potential resolution may range from packing gaps in subfloor structures through to replacement of subfloors stumps and refixing of flooring.

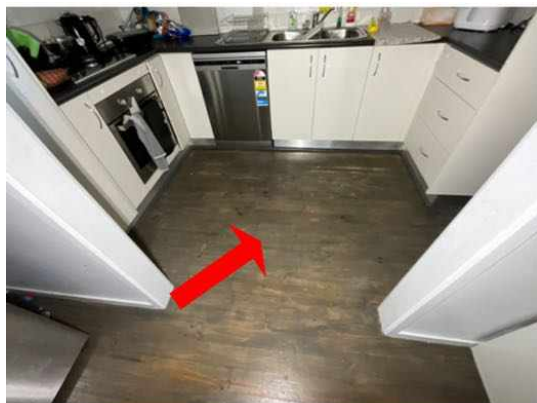
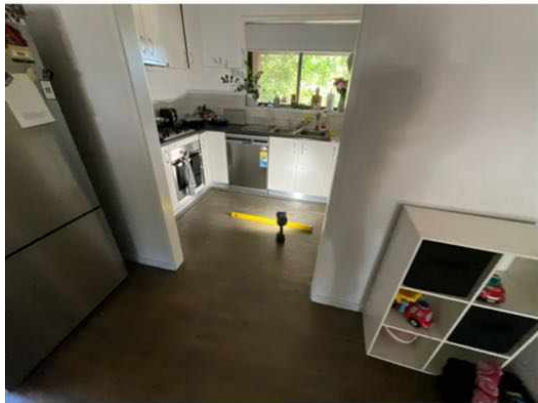
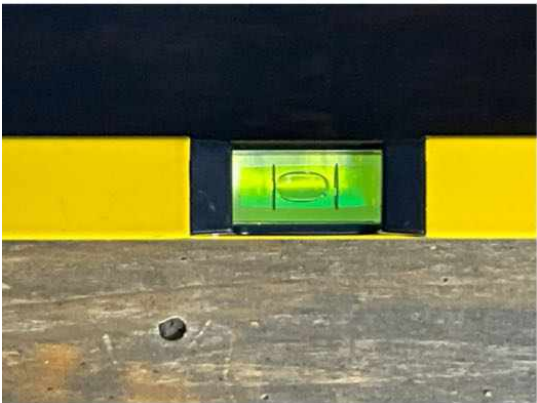
### Finding 3.02

Building:	Building 1
Location:	All Internal Areas
Finding:	Flooring - slightly uneven
Information:	The internal flooring in this area is out of level and uneven. Uneven flooring is likely to indicate minor defects such as expected movement of the foundations of the property, but may also indicate subsidence of the associated subfloor stumps.

It is advised that the flooring be closely monitored to identify any further movement. Where flooring remains relatively unchanged for an extended period of time (i.e. several months), it is likely that this defect has been caused by expected movement of the foundations of the property.

However, where flooring is increasingly uneven, potentially invasive inspection of the subfloor structures and stumps in this area is required. In this case, works to repair are likely to be required, and would be carried out by a registered builder specialising in re-stumping.

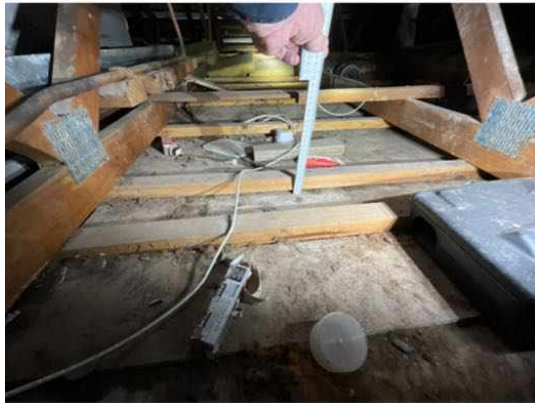
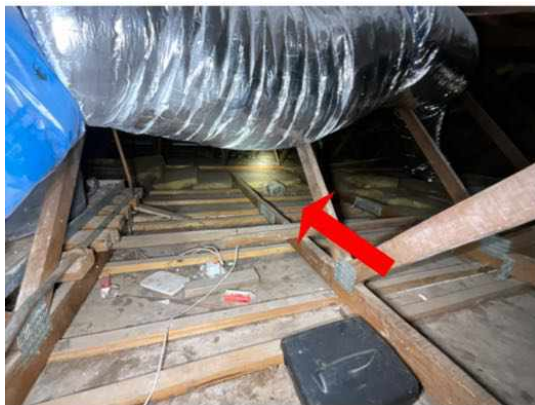
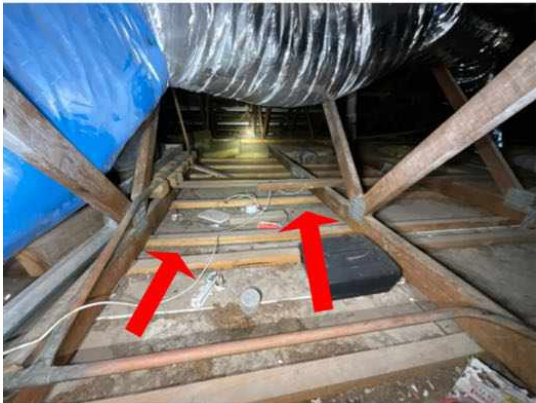
Finding 3.03

Building:	Building 1
Location:	Several interior areas
Finding:	Ceiling - Sagging
Information:	Sections of the ceiling were found to be sagging at the time of inspection. Sagging to the fixed ceiling structure generally indicates that the building materials have swollen, due to contact with water, or that fixings (e.g. nails or glue) have become loose and require reattachment.

Where minor sagging is evident, comparatively minor works, such as re-gluing of ceiling sheets, may be required. Such works may be performed by relevant tradespeople, such as plasterers and painters. Where excessive moisture has caused the roofing structure to swell and sag, the source of the water leak should primarily be identified prior to any remedial works being performed.

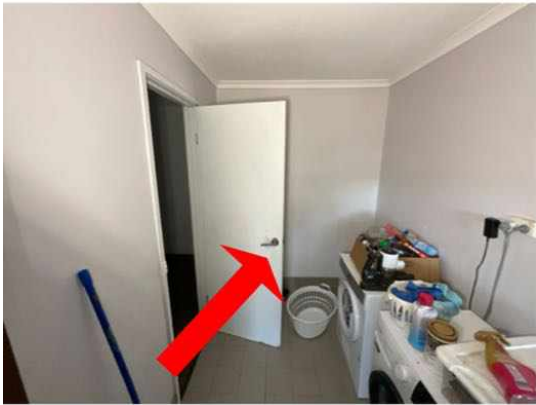
**Finding 3.04**

Building: Building 1  
Location: Laundry, bed 3  
Finding: Door handle- Poor operation  
Information: The door handle/ catch in this area was found to be faulty during the visual inspection. This is most probably because of a lack of maintenance or wear and tear over time.

A general Handy person or lock specialist should be contacted to make needed repairs at the discretion of the owner and restore full function.

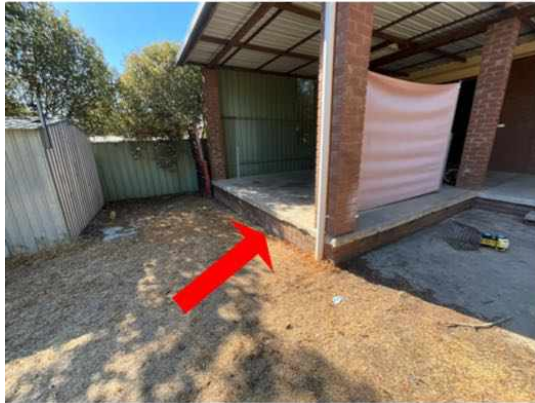
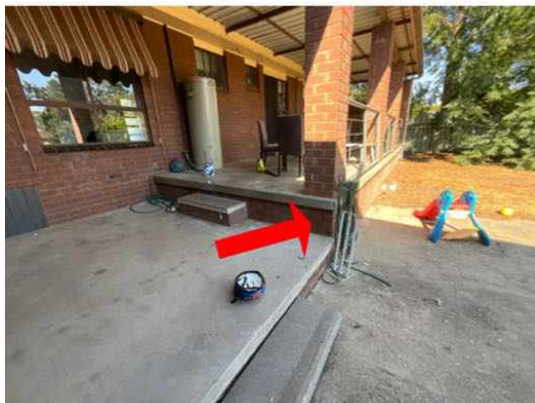
Finding: Brickwork - Cracking noticeable

Information: There were several cracks and or crack repairs evident to external brickwork.

Noticeable cracks are a common occurrence in external brickwork and are a likely result of age expected building movement, general expansion, and/or contraction of building materials in different weather conditions. Noticeable cracks in brickwork may

develop if left unattended, with potential for necessitating major remedial works or replacement of the brickwork.

It is highly advised that a qualified bricklayer be appointed to provide necessary works to cracked brickwork to prevent any further damage. Such works should be conducted as soon as possible.

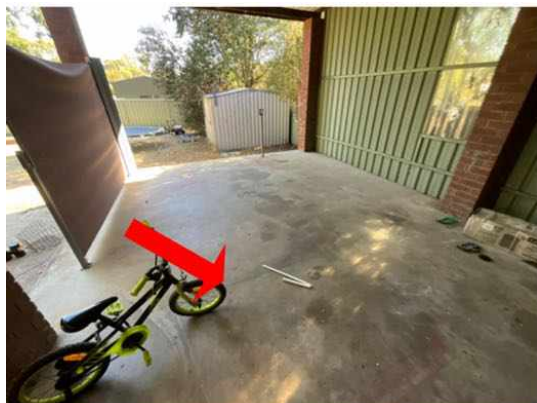
**Building:** Building 1  
**Location:** Carport area  
**Finding:** Cracking - External Concrete Paving Damage Category 1 - Fine (less than 2mm)  
**Information:** Fine cracks were identified in external concrete paving. Although fine cracks are quite noticeable, they are often only considered to be an appearance defect, and usually do not indicate any structural damage. To be considered a Category 1 or fine crack, the crack is found to be less than 2mm in width.

Generally the cause of a hairline crack in existing concrete paving such as driveways and pathways is indicative of the expansion and contraction of the concrete. Such causes are generally due to environmental factors, such as moisture levels, weather conditions, root systems of nearby trees or the soil types on which they are laid.

Fine cracks may also be due to poor original installation of the concrete. Factors such as poor compaction of the sub surface and/or inadequate reinforcing of the slab may create cracking and other secondary defects.

Monitoring of all cracking should be conducted frequently. Always contact a building inspector should cracks widen, lengthen, or become more numerous.

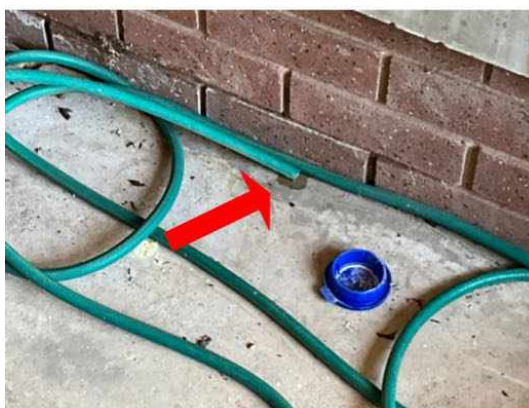
Information: The Hot Water System (HWS) overflow was found to be disconnected from storm water drainage and is creating excessive moisture in the surrounding area.

These damp conditions can lead to secondary defects such as rot, rust or corrosion of associated building elements, the formation of fungal decay, or even the creation of potential slip hazards. When coupled with poor site drainage, pooling of water may also attract termite activity to this area.

It is highly recommended that a licensed plumber be appointed to connect the HWS overflow in order to prevent such an environment from being created. These minor works should be carried out as soon as possible.

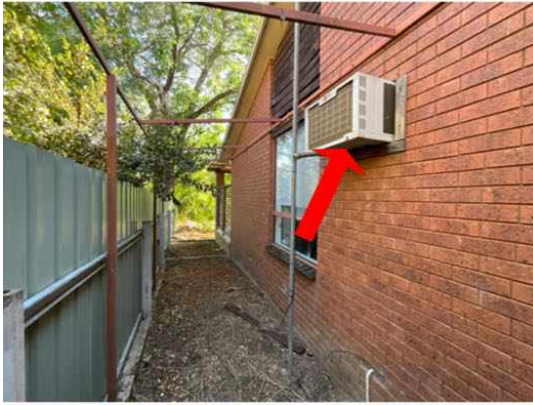
### Finding 6.03

Building: Building 1  
 Location: Yard - Side  
 Finding: Air conditioner - Disconnected overflow  
 Information: The Air Conditioner (A/C) overflow was found to be disconnected from storm water drainage and is creating excessive moisture in the surrounding area.

Such leaking creates an environment which is conducive to an array of defects, including water damage to associated building elements and the attraction of termite or timber pest infestation.

It is highly recommended that a licensed plumber be appointed to connect the A/C overflow in order to prevent such an environment from being created. These minor works should be carried out as soon as possible.

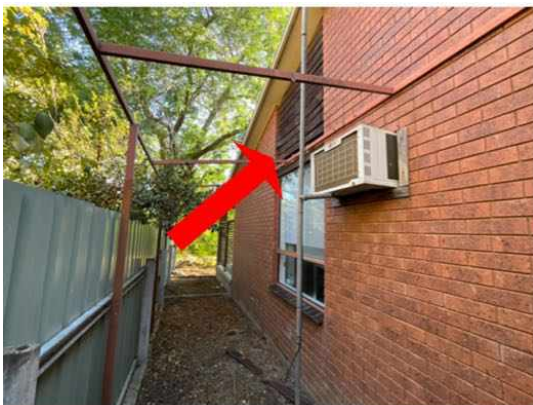
### Finding 6.04

Building: Building 1  
 Location: Yard - Side  
 Finding: Timber - exposed to weather  
 Information: External timbers that are frequently exposed to harsh weather conditions require adequate protection in order to maintain their condition. Where timbers have not been painted or treated adequately, general deterioration is likely to occur at an accelerated rate.

If left unattended, replacement of these timbers is likely to be necessary in the short-term future. Adequate treatment of these timbers is required as soon as possible by a painting contractor or general handyman.

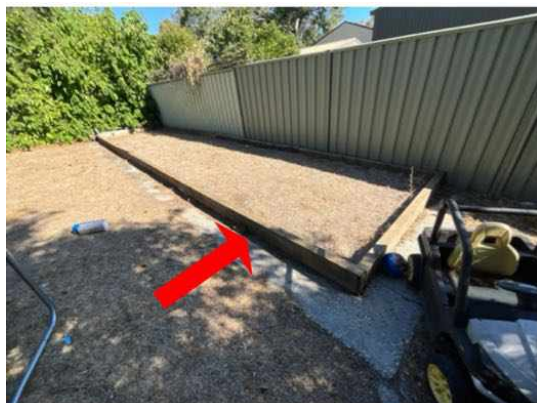
### Finding 6.05

Building: Building 1  
 Location: Yard - Back  
 Finding: Untreated or non-durable timbers in a hazardous environment  
 Information: To reduce the risk of timber pest attack it is essential that timber used in a hazardous environment (e.g. in direct contact with the ground or frequently exposed to damp conditions) is of sufficient durability and/or is adequately preservative treated.

Untreated timbers in direct contact with the ground are likely to develop severe wood rot and/or fungal decay if left unattended creating attraction for subterranean termites to infest the timbers from surrounding areas.

If untreated or non-durable timbers are found to be in a hazardous environment it is highly advised that replacement of these building elements be performed as soon as possible to aid the protection of the property against termite / timber pest attack.

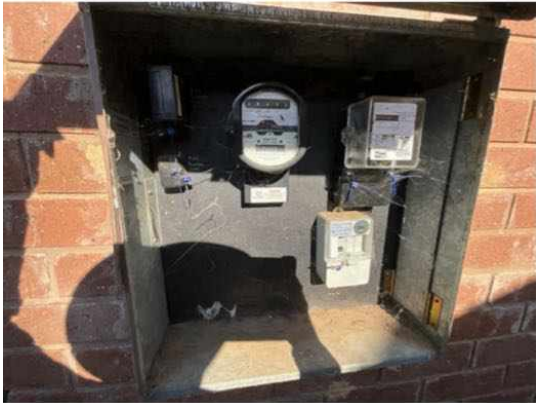
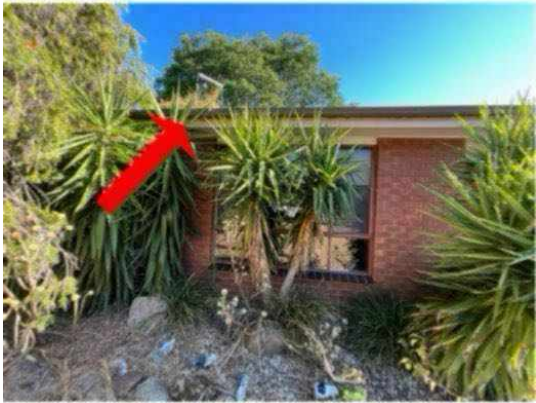
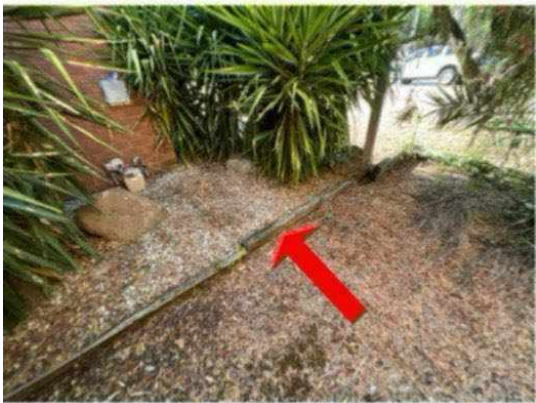
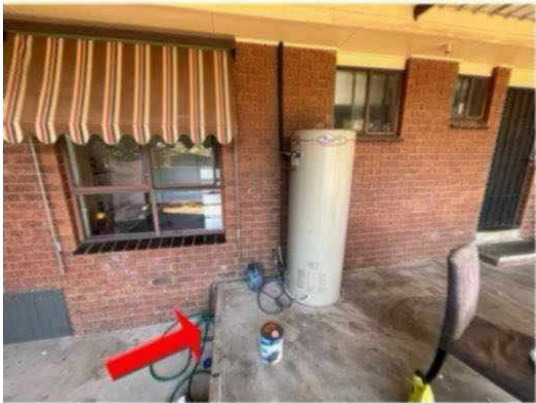
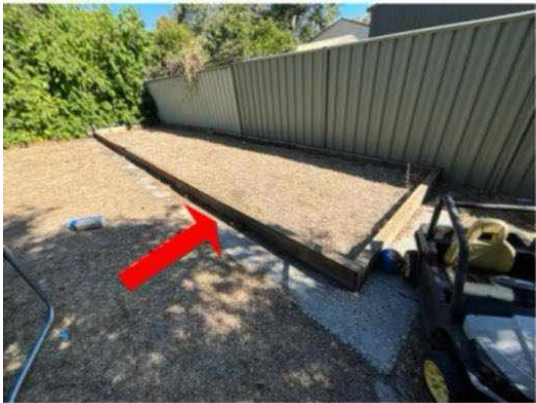
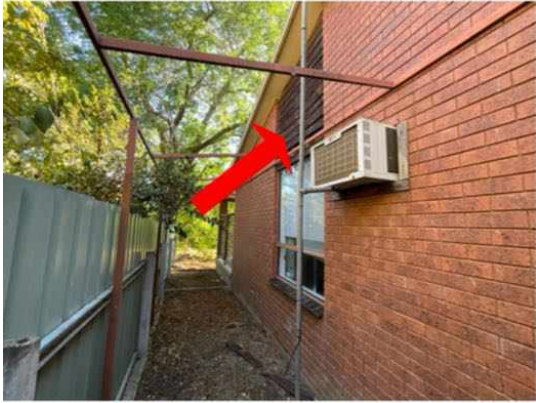
Finding: Termite Management System - no evidence of a chemical installation  
Information: The application of a post-construction chemical termite barrier is highly recommended for all properties, particularly if live termite activity has been found on the site previously. Such barriers are highly effective in preventing termite attack on any timber building elements throughout the property.

A durable notice should be placed in the switchboard unit to indicate current termite barriers. At the time of inspection, it appeared as though no termite management system has been installed, with no evidence to suggest preventative works taking place.

The client may consider gaining further advice from a pest controller as to the costs and procedures involved with this application. It is recommended that obtaining such advice be a short-term priority.

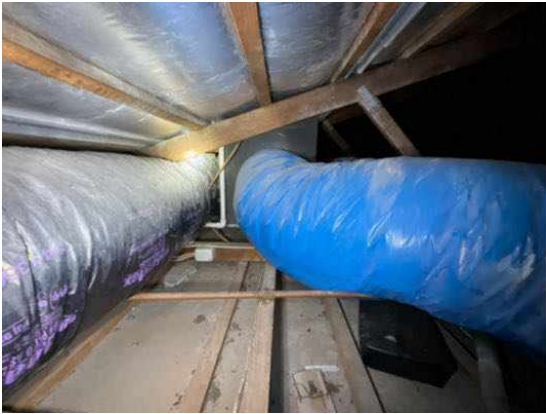
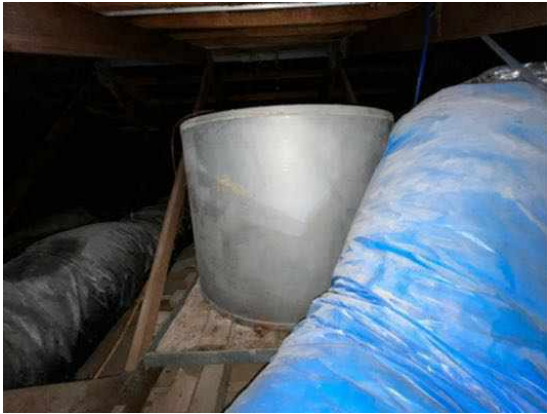
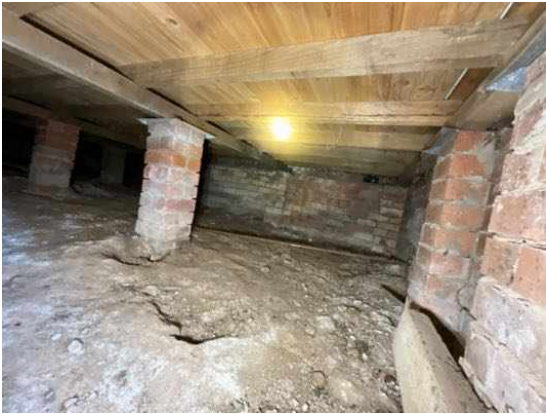
Building: Building 1  
Location: All Areas  
Finding: Additional Photos - Obstructions and Limitations  
Information: These photographs are an indication of the obstructions and limitations which impeded full inspection of the property at the time of inspection. These obstructions can hide an array of defects and should be removed to allow full inspection to be carried out. A re-inspection is recommended once the areas are made accessible.
