Building and Timber Pest Inspection Report

Inspection Date: Wed, 8 Apr 2026

Property Address: 9 Helens Way, Langwarrin VIC 3910,
Australia

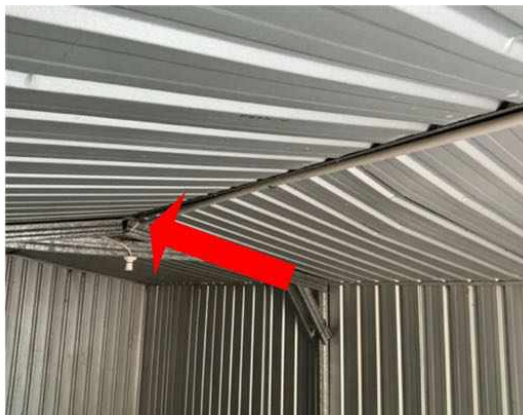
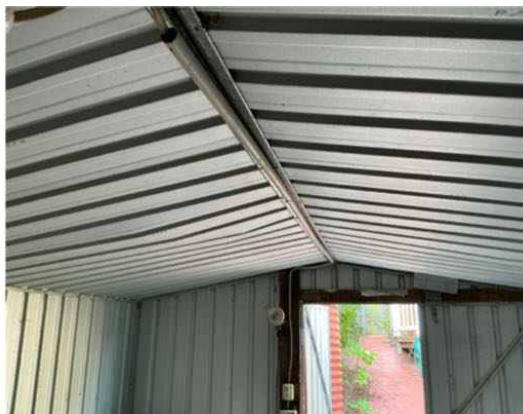
Finding 1.01

Building:	Main Building
Location:	Shed
Finding:	Electrical wires- missing conduit
Information:	The electrical wires to the shed have insufficient or missing conduit. Exposed electrical wiring represents a potential safety hazard for personal contact. Contact a licensed electrician urgently for further inspection investigation and rectification.

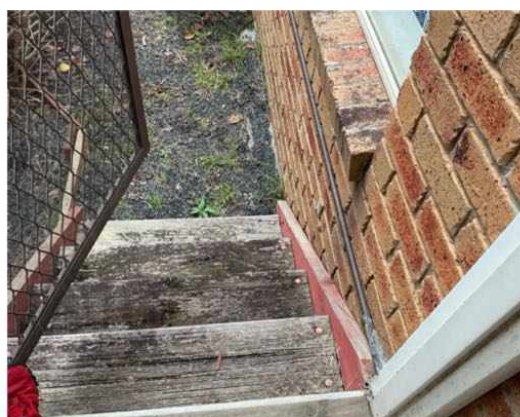
Finding 1.02

Building:	Main Building
Location:	Yard - Back
Finding:	No landing installed
Information:	At the time of the inspection, it was observed that the exit from the garage is fitted with an outward opening door that leads immediately to a set of descending steps. There is no intermediate landing provided between the door threshold and the stairway.

Occupants, exiting the garage may inadvertently step directly onto the stairs without stable footing, increasing the likelihood of trips slips or falls.

It is recommended that a registered builder be engaged as soon as possible to install a compliant landing at the garage exit to provide a safe transition between the doorway and the stairway. Additionally, consideration should be given to door swing direction or the installation.

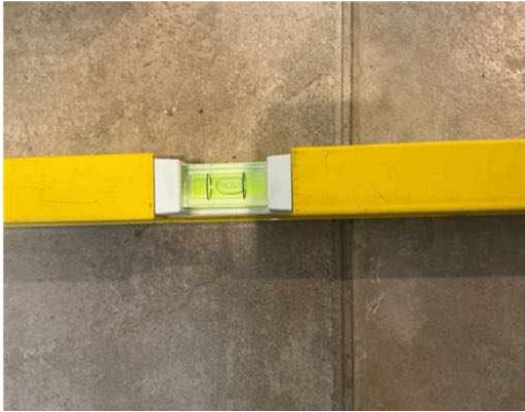
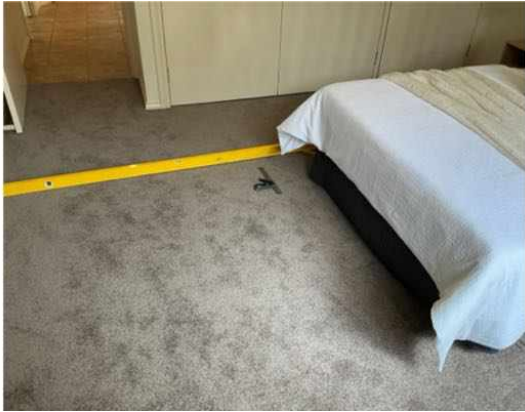
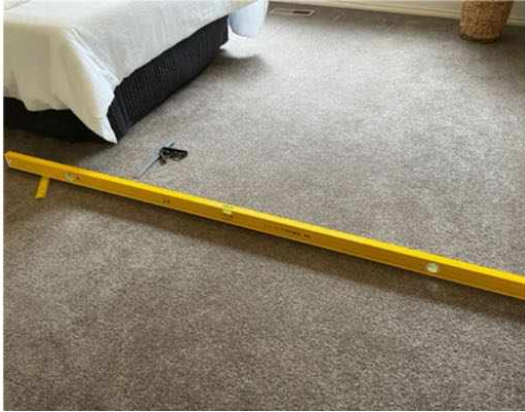
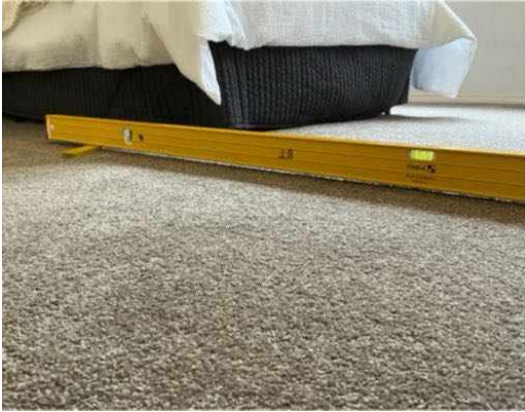
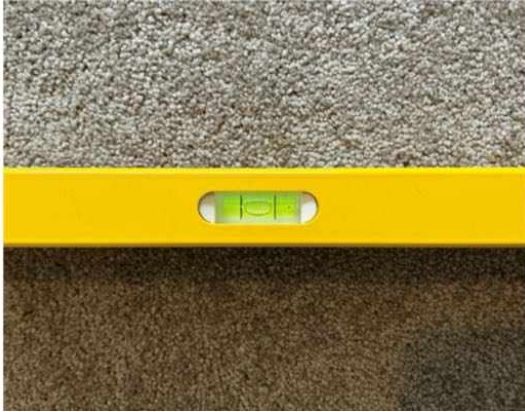
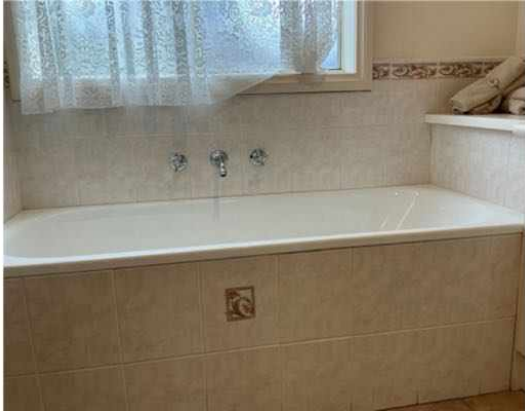
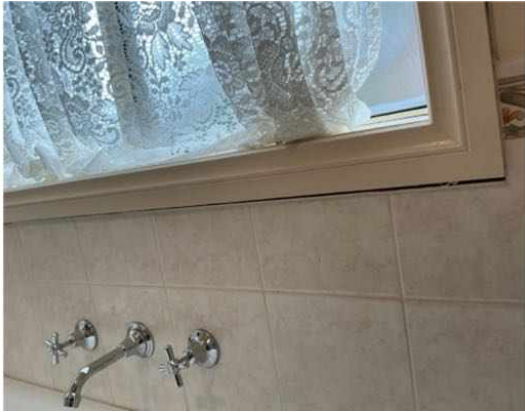
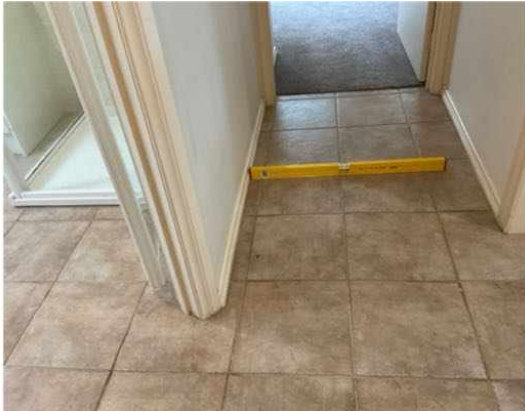
Building: Main Building
Location: Bathroom, bedroom 2 and hallway
Finding: Floors - Uneven/ out of level
Information: The internal flooring to these areas is out of level and uneven. Based on preliminary assessment, it is suspected that this unevenness is primarily due to the movement of the foundations supporting the building. This type of movement could be due to soil subsidence, settlement, or shifts in the foundations/footings.

It is recommended to engage a qualified structural engineer to conduct a thorough examination of the foundational support system to provide appropriate advice and recommendations to reduce the risk of further deterioration as a matter of urgency.

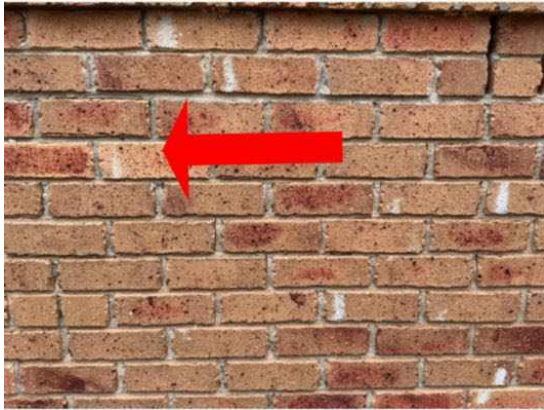
Finding 2.02

Building: Main Building
 Location: Exterior walls - rear
 Finding: Damage to Masonry Walls (Cracks)- Category 2
 Information: It has been observed that damage to the rear masonry walls caused by movement of slabs, footings, or other causes, has occurred. The degree of damage falls within Category 2, described as noticeable cracks which are easily filled. Such cracking may cause doors and/or windows to stick slightly, and are generally less than 5mm in width.

Damage of this category is required to be monitored for a period of 12 months, after which time a crack rated at Category 2 or above is considered a defect requiring rectification, such as minor repairs and repointing. Always contact your building inspector should cracks widen, lengthen, or grow more numerous.

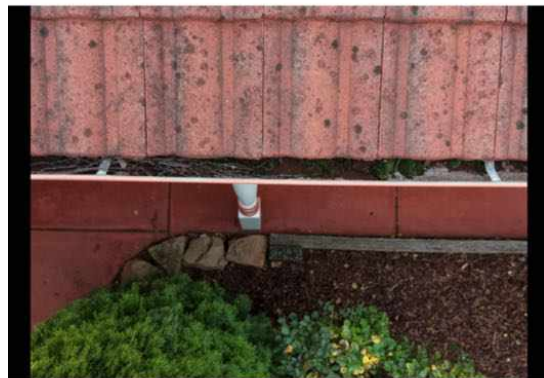
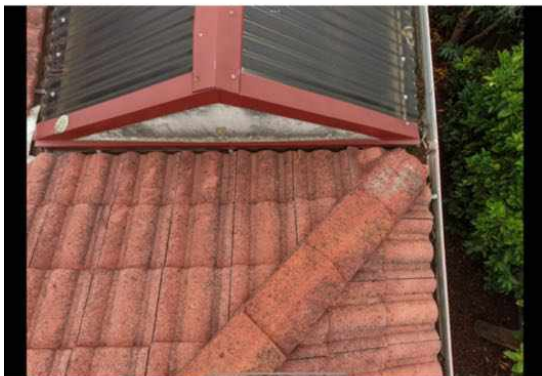
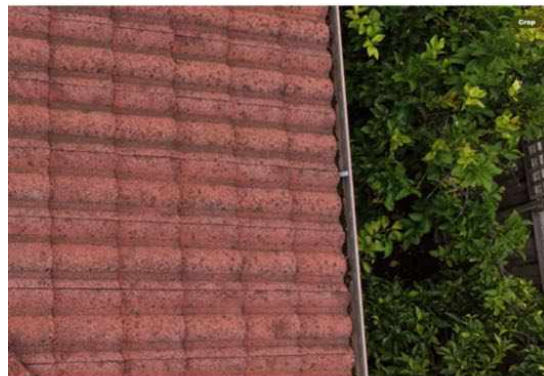
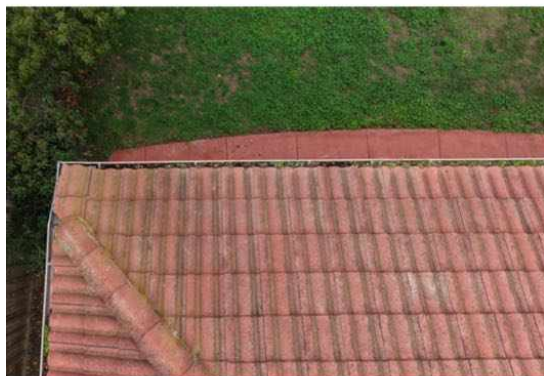
Finding 3.01

Blocked gutters are likely to lead to high levels of moisture in the affected areas. Such moisture will not only cause rust and decay of the associated building materials, but can also provide conditions that are conducive to termite and timber pest activity. Blockages in gutters should therefore be removed immediately to ensure dry conditions are maintained.

Consult a Licensed Plumber for further specific advice on remedial works that may be required. In the interim, it is highly advised that blocked gutters be removed by the homeowner or a general handyperson as a matter of urgency.

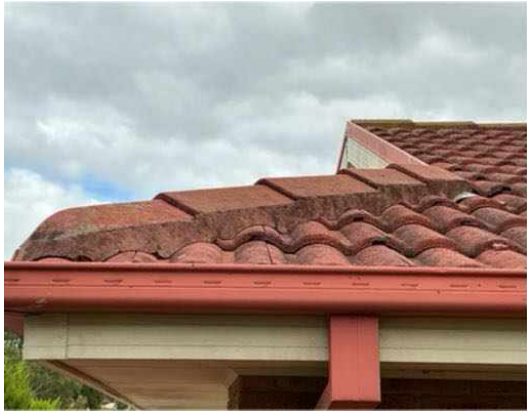
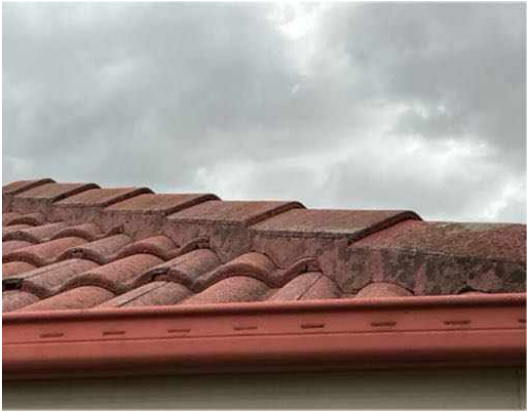
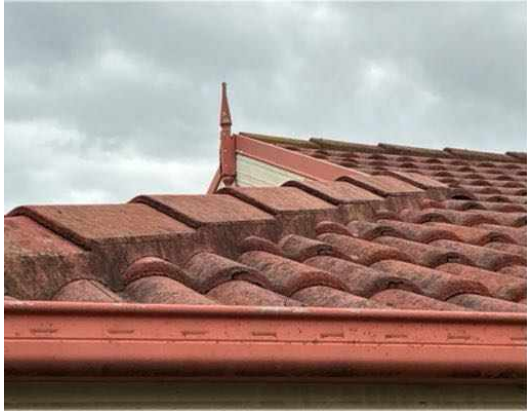
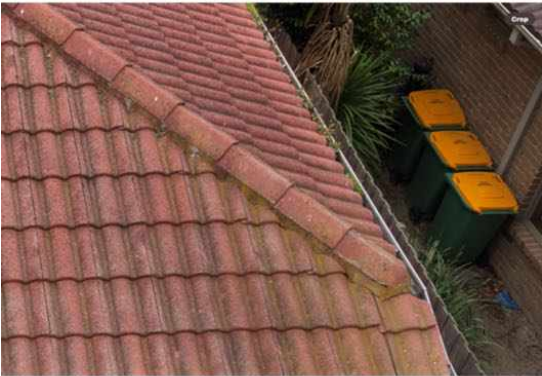
Finding 3.02

Building:	Main Building
Location:	Roof Exterior
Finding:	Roof tile mortar deterioration and cracking
Information:	Cracking and deterioration was observed in the ridge and hip tile mortar bedding. The mortar has separated in several areas, with visible gaps forming between ridge tiles and the underlying bedding. This condition indicates age-related degradation and exposure to the elements, which has caused the mortar to become brittle and lose its bonding integrity.

Compromised mortar may lead to further deterioration, potentially allowing water ingress and structural damage to the roof structure below.

Recommend engaging a qualified roofing contractor to carry out repointing or full re-bedding of affected ridge and hip tiles as necessary. All deteriorated mortar should be removed and replaced with new flexible roof bedding compound in accordance with current Australian Standards (AS 2050).

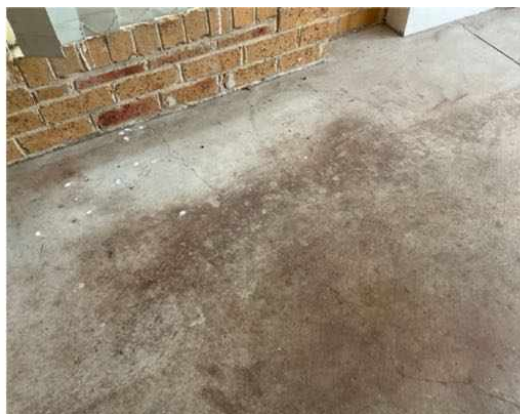
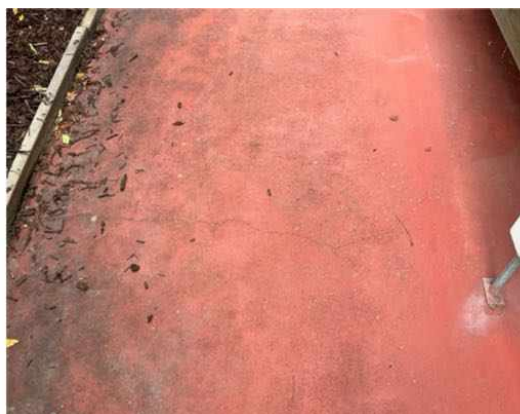
Finding 3.03

Building: Main Building
 Location: Driveway/garage/pathway
 Finding: Driveway/garage/pathway Cracking
 Information: Cracks were identified in the driveway, garage and pathway concrete paving. Although cracks are quite noticeable, they are often only considered to be an appearance defect, and usually do not indicate any structural damage.

Generally the cause of the cracks in existing concrete paving such as driveways and pathways is indicative of the expansion and contraction of the concrete. Such causes are generally due to environmental factors, such as moisture levels, weather conditions, root systems of nearby trees or the soil types on which they are laid.

Cracks may also be due to poor original installation of the concrete. Factors such as poor compaction of the sub surface and/or inadequate reinforcing of the slab may create cracking and other secondary defects.

Monitoring of all cracking should be conducted frequently. Always contact a building inspector should cracks widen, lengthen, or become more numerous.

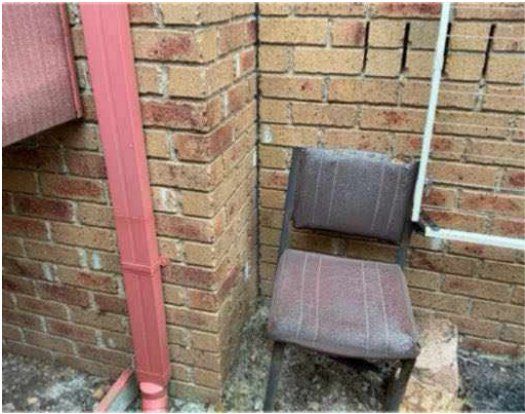
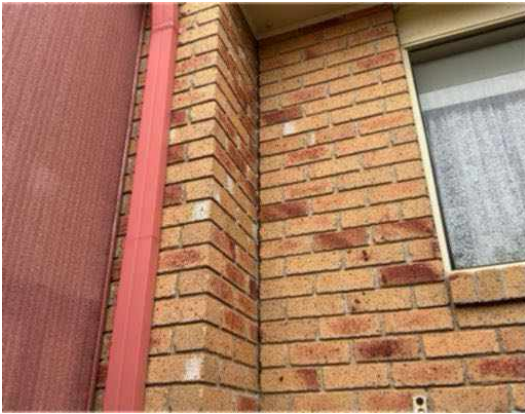
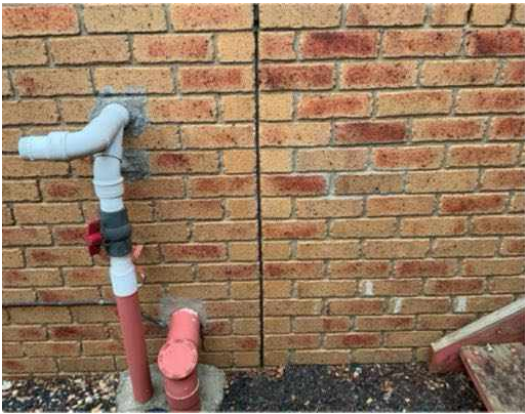
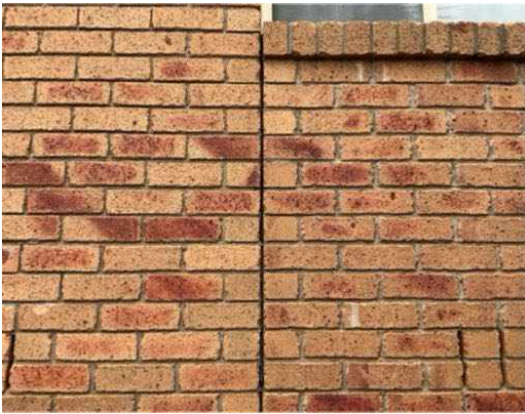
Finding 3.04

Building:	Main Building
Location:	Exterior walls
Finding:	A few gaps to the exterior walls/windows
Information:	A few gaps were noticed to some of the exterior walls/windows to the building. These gaps can let in water, drafts, and pests. Overtime moisture ingress may cause damage to internal walls, mould growth, or structural issues. Gaps also reduce the energy efficiency of the property. Recommend engaging a caulker to seal gaps with an exterior grade flexible sealant that is UV and weather resistant to reduce the risk of pest/water penetration to the building as soon as possible.

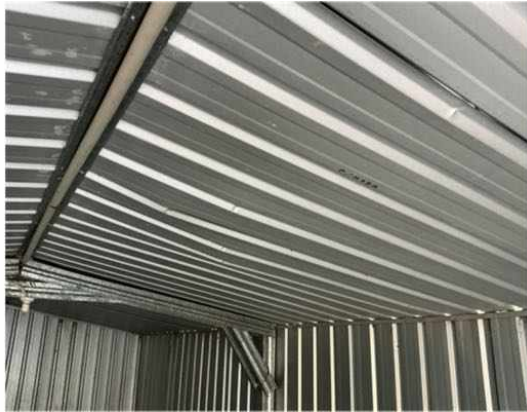
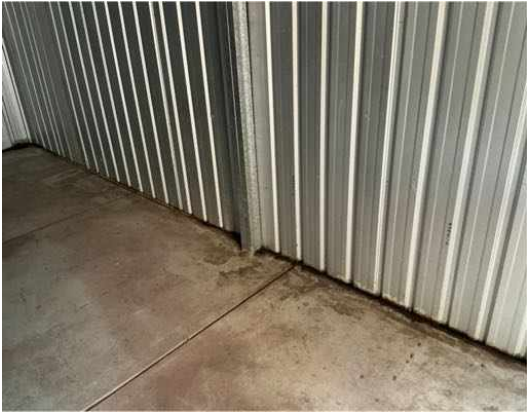
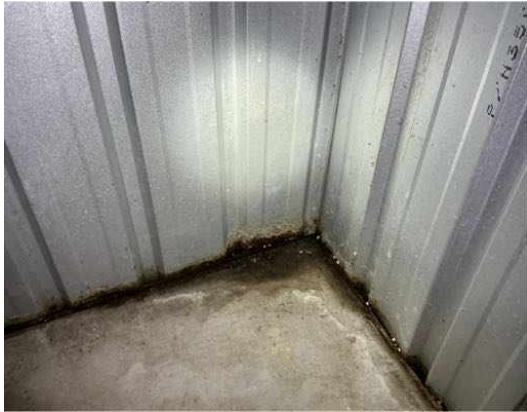
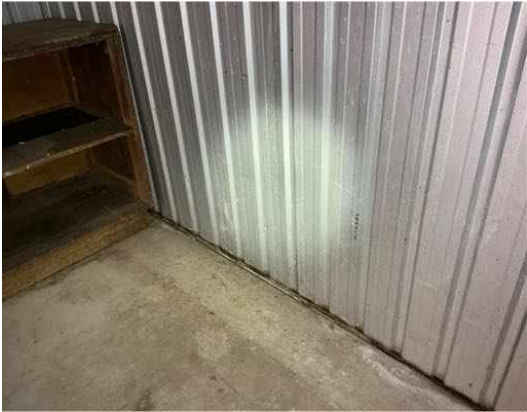
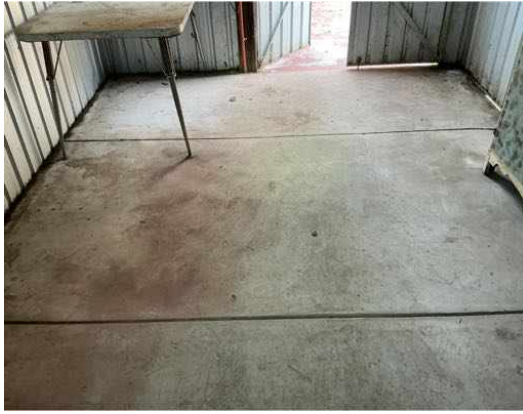
Finding 3.05

Building: Main Building
Location: Yard - Back
Finding: Rust and damage to shed
Information: Rust and damage to parts of the shed. Recommend repair/replacement by a handyman or carpenter to reduce the risk of future deterioration at the owners discretion.

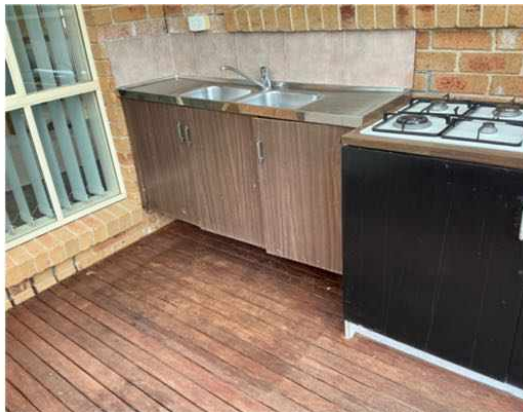
Finding 3.06

Building:	Main Building
Location:	Patio
Finding:	Cabinets need adjustment
Information:	On inspection it was noticed that the patio cabinets do not shut or open correctly and require maintenance or adjustment. Recommend engaging a cabinet maker to adjust/maintain to reduce the risk of further deterioration at the owners discretion.

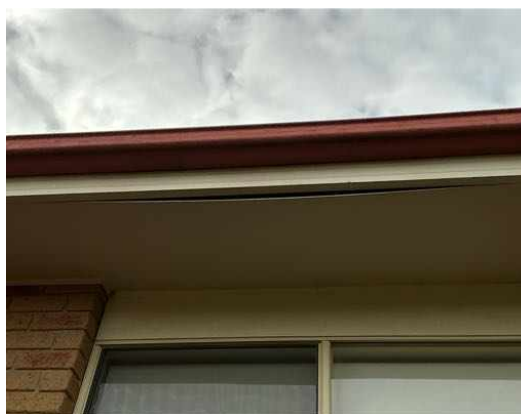
Finding 3.07

Building:	Main Building
Location:	Exterior walls - left side
Finding:	Eaves sagging
Information:	Parts of the left side eaves are sagging. Recommend engaging a carpenter to repair as necessary to reduce the risk of further deterioration as soon as possible.

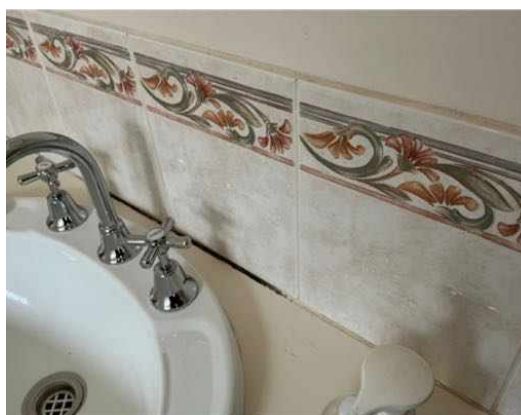
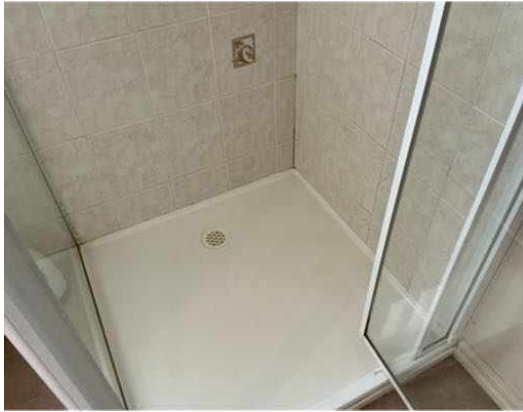
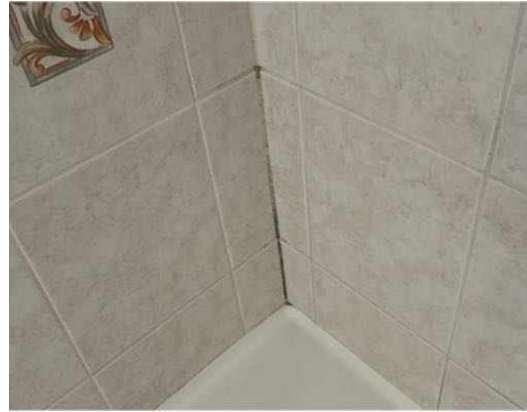
Finding 3.08

Building:	Main Building
Location:	Ensuite - Master
Finding:	Bathroom Sealant and grouting - Missing or damaged
Information:	It was noted on inspection that sealant or grout is degraded to the tiled shower alcove and or other areas of the bathroom.

Different materials and floor areas move at different rates, generally causing cracking to grout or sealant at this point. A flexible sealant is required to allow for expected expansion and contraction, while keeping the joint water tight and protective of all associated building materials.

Flexible and mould resistant materials should be applied to affected areas to prevent any subsequent water damage that is likely to occur. Regular maintenance and replacement of damage or missing or damaged sealant and grout is highly recommended to the wet areas, as this is a regular wear and tear defect. Sealant and grouting in areas that come into regular contact with water should be maintained for the long term care of your property.

A sealant specialist or tiling contractor should be appointed to complete these works as soon as possible

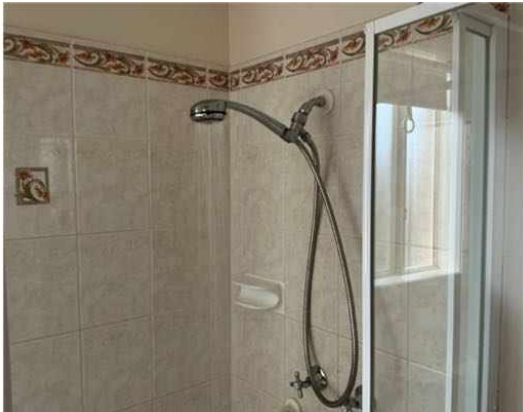
Finding: Ensuite Shower head is dripping/leaking

Information: The shower head to the ensuite bathroom is loose and dripping/leaking. This can

often happen over time with deterioration or if the shower head is loose and needs tightening. Recommend engaging a plumber to repair/replace the shower head to reduce the risk of further deterioration and water leaks as soon as possible.

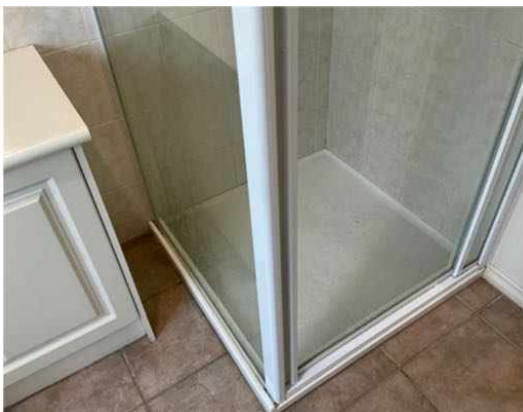
Finding 3.11

Building:	Main Building
Location:	Bathroom
Finding:	Bathroom-Shower screen leaking
Information:	Leaking was evident to the shower screen at the time of inspection. It is suspected that the leaking has occurred as a result of deteriorated or missing caulking to the shower or general ageing of the building elements.

Leaking from the shower where left unattended, is likely to lead to water damage to adjoining flooring and walls. Such damage can lead to water damage and necessitate extensive remedial works being required. Active water leaks may also create an environment that is susceptible to the formation and development of mould.

Appointment of a caulking contractor is required to repair or replace the caulking to the shower area. Such works should be performed as soon as possible to ensure that no further damage occurs.

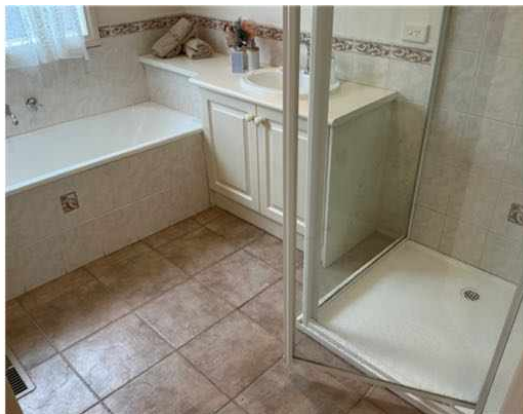
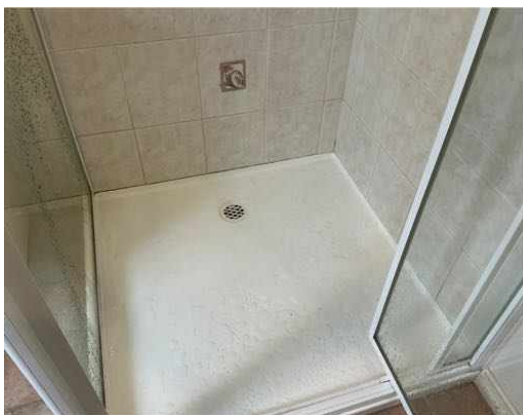
Finding 3.12

Building: Main Building
Location: Bathroom
Finding: Bathroom Sealant and grouting - Missing or damaged
Information: It was noted on inspection that sealant or grout is degraded to the tiled shower alcove and or other areas of the bathroom.

Different materials and floor areas move at different rates, generally causing cracking to grout or sealant at this point. A flexible sealant is required to allow for expected expansion and contraction, while keeping the joint water tight and protective of all associated building materials.

Flexible and mould resistant materials should be applied to affected areas to prevent any subsequent water damage that is likely to occur. Regular maintenance and replacement of damage or missing or damaged sealant and grout is highly recommended to the wet areas, as this is a regular wear and tear defect. Sealant and grouting in areas that come into regular contact with water should be maintained for the long term care of your property.

A sealant specialist or tiling contractor should be appointed to complete these works as soon as possible

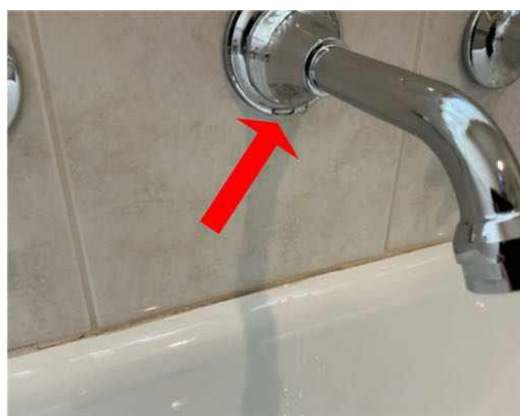
Finding 3.13

Building: Main Building
 Location: Bathroom
 Finding: Spout - Leaking bathroom
 Information: The spout in the bathroom was found to be leaking at the time of inspection. This is a common defect that is consistent with general ageing of the building element. However, it may be indicative of substandard plumbing workmanship if the spout is relatively new.

While this defect only seems minor, if left unmanaged, it is likely to result in the development of rust, water damage and/or extensive water usage.

It is advised that a handyman or licensed plumber be appointed to perform remedial works on the affected tap. Such works should be performed prior to the development of secondary defects to ensure adequate functionality of all associated building elements.

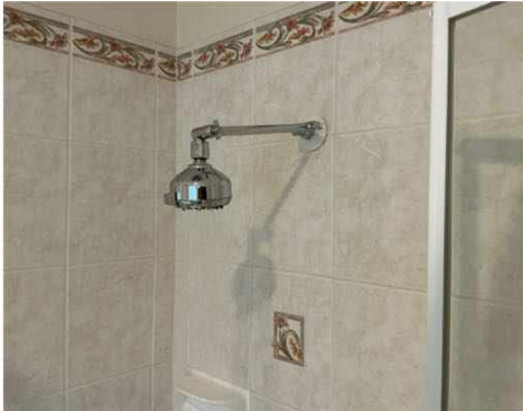
Finding 3.14

Building: Main Building
 Location: Bathroom
 Finding: Shower head is dripping/leaking
 Information: The shower head to the bathroom is loose and dripping/leaking. This can often happen over time with deterioration or if the shower head is loose and needs tightening. Recommend engaging a plumber to repair/replace the shower head to reduce the risk of further deterioration and water leaks as soon as possible.

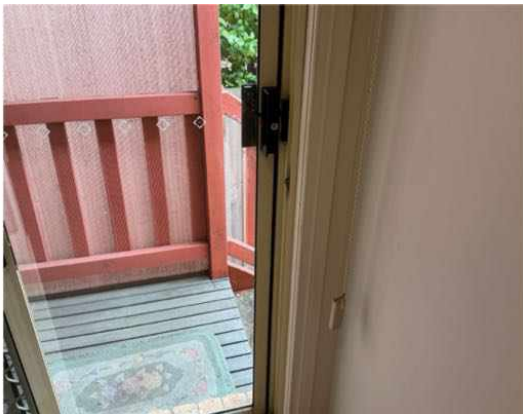
Finding 3.15

Finding: Door - Loose handle laundry

Information: The door handle to the laundry was found to be loose at the time of inspection. Looseness occurs generally when the building materials have aged and decayed, but may be indicative of impact damage (accidental or deliberate).

Repair of the loose door handle is advised to improve the operational state of the associated door.

A qualified carpenter or general handyman should be appointed to repair/replace the door handle at the client's discretion.

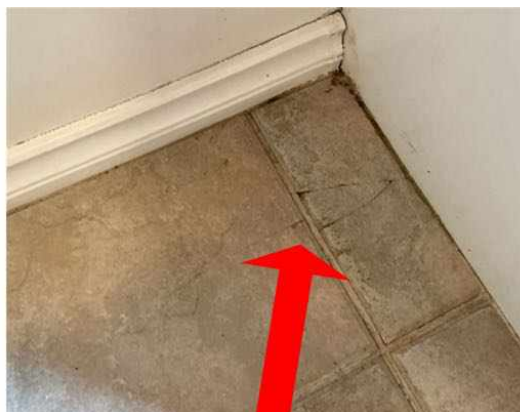
Finding 3.16

Finding: Cracked tiles-laundry

Information: Cracking/damage to the tiles was evident to the laundry at the time of inspection. It is suspected that this cracking has occurred as a result of minor settlement/shrinkage or impact damage.

Cracked tiles to the household detract from the overall appearance of the affected areas however it is unlikely to create or lead to any secondary defects.

While not considered a matter of urgency, replacement of cracked tiles is recommended at the clients discretion. A tiling contractor may be appointed to perform these works. Where cracks become more numerous, contact a licensed building inspector for further investigation.

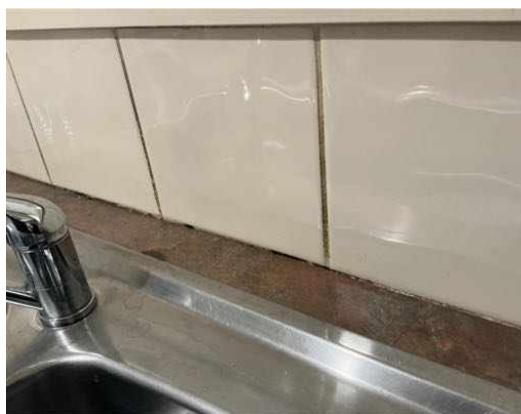
Finding 3.17

Building:	Main Building
Location:	Kitchen
Finding:	Kitchen Sealant and grouting - Missing or damaged
Information:	It was noted on inspection that sealant or grout is degraded to the kitchen splash back and or other areas of the kitchen.

Different materials and floor areas move at different rates, generally causing cracking to grout or sealant at this point. A flexible sealant is required to allow for expected expansion and contraction, while keeping the joint water tight and protective of all associated building materials.

There appears to be excessive mould to the sealant and grout which will likely require scraping out and replacement.

Flexible and mould resistant materials should be applied to affected areas to prevent any subsequent water damage that is likely to occur. Regular maintenance and replacement of damage or missing or damaged sealant and grout is highly recommended to the wet areas, as this is a regular wear and tear defect. Sealant and grouting in areas that come into regular contact with water should be maintained for the long term care of your property.

A sealant specialist or tiling contractor should be appointed to complete these works as soon as possible

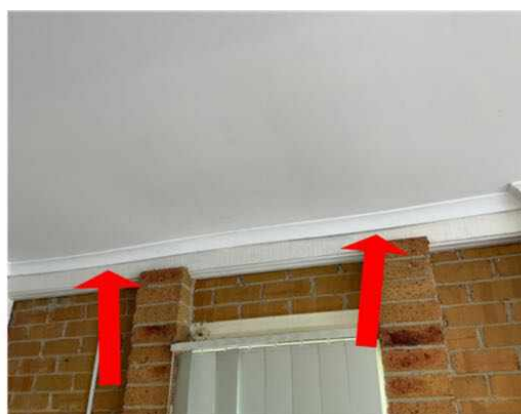
Finding 3.18

Building:	Main Building
Location:	Garage
Finding:	Ceiling - Sagging garage.
Information:	Sections of the garage ceiling were found to be sagging at the time of inspection with a part at risk of collapse. It is recommended to keep this area clear until the ceiling has been repaired for personal safety. Sagging to the fixed ceiling structure generally indicates that the building materials/fixings (e.g. nails or glue) have become loose and require reattachment. This is quite a common defect in garages of this age. It is suspected that internal plaster is used where wet board plasterboard should be used and it gets affected by the moisture and condensation in the air. There is normally no insulation in the garage ceiling allowing the moisture to accelerate the deterioration.

Where sagging is evident repairs such as re-gluing or replacing of ceiling sheets, may be required. Such works may be performed by relevant tradespeople, such as plasterers and painters.

The appropriate action should be taken by the client straight away to ensure that any potential further damage is limited.

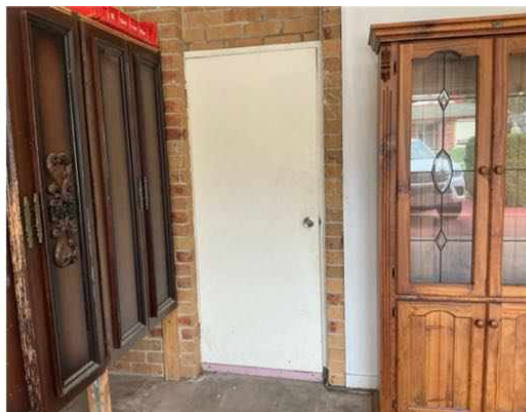
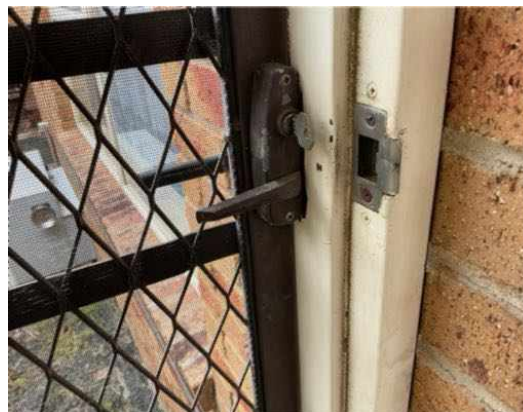
Finding 3.19

Finding: Door handles hitting each other

Information: On inspection of the garage doors it was noted that both of the handles are at the same height and only one of the doors can be shut at a time. Recommend engaging a carpenter to install one of the door handles higher or lower so both doors can be shut at the same time.

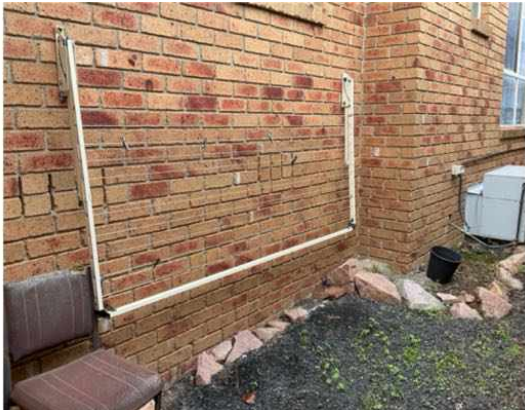
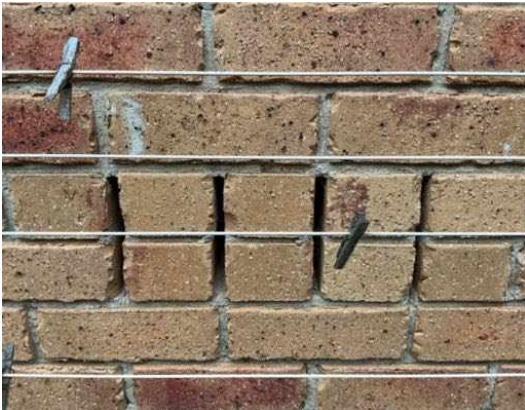
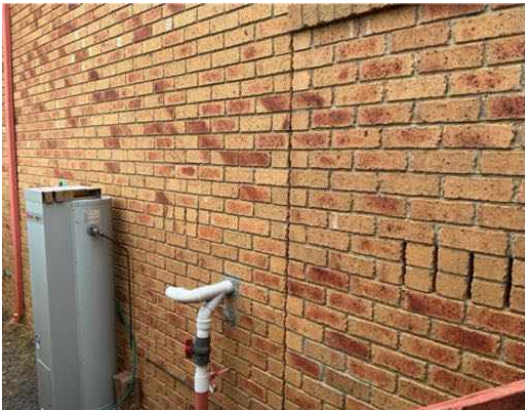
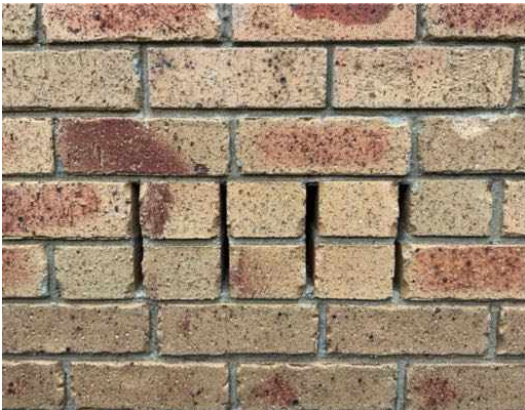
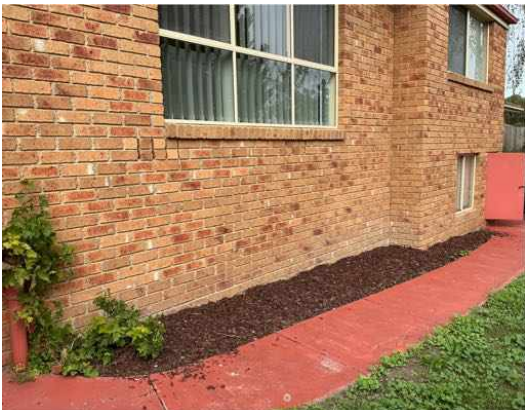
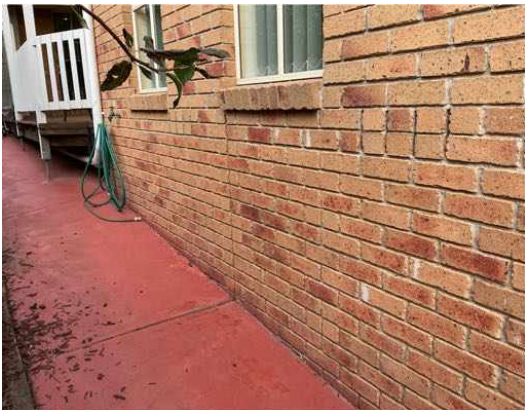
Building:	Main Building
Location:	Subfloor
Finding:	Slots in brickwork for subfloor ventilation
Information:	There is only slots in the brickwork for subfloor ventilation. Recommend engaging a brick layer to install bronze type ventilators to improve subfloor ventilation. Adequate subfloor ventilation aids in preventing excessive moisture wood rot and termite activity by ensuring a dry subfloor environment.

Where ventilation is substandard it is usually caused by factors such as failure to install adequate vents during construction subsequent building works or earth and vegetation covering over vents low subfloor clearance and items or debris in the subfloor restricting airflow.

Subfloor ventilation can be improved in most cases by addressing the causes such as exposing subfloor vents installing additional new vents installing mechanical (forced airflow) ventilation and removing debris from the subfloor.

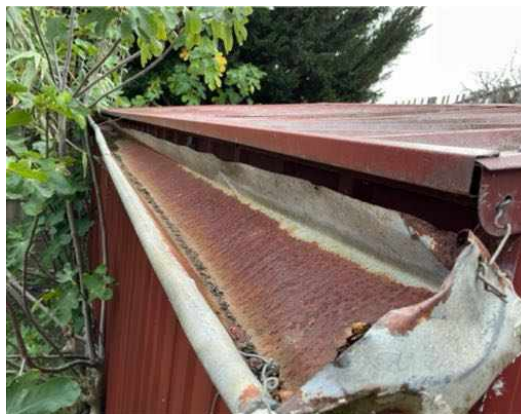
Finding 6.03

Building: Main Building
Location: Shed
Finding: Gutters - Rusted or corroded
Information: The gutters to the shed roof shows evidence of rusting and corrosion, which is likely to have developed as a result of excessive exposure to moisture and or inadequate coatings. This will cause excessive moisture and could attract termites.

As surface rust provides no protection to the underlying iron, the deteriorating condition is likely to worsen if not addressed in the short-term future.

Where possible, the use of galvanized (treated) metals or aluminium coated metals aid in rust prevention, as does regular general maintenance. Rust formation can be controlled with coatings, such as paint, that isolate the iron from the environment.

Rusting and corrosion should be managed by ideally removing or limiting the affected surface from exposure to moisture. A registered builder may be appointed to replace any building elements that have been severely affected by rust or water damage.

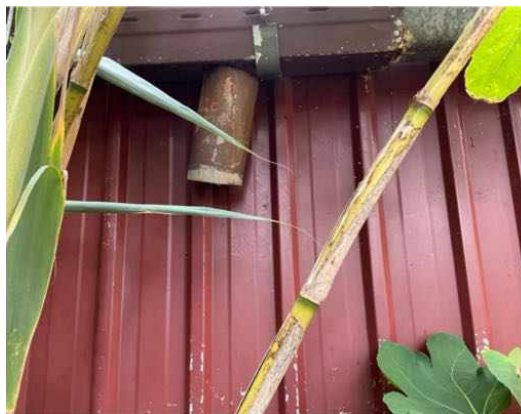
Finding 6.04

Building:	Main Building
Location:	Shed
Finding:	downpipe not connected to stormwater
Information:	The shed down pipe is not connected to stormwater. This disconnection negatively impacts the functional capacity of the plumbing.

Where plumbing doesn't drain adequately, the area at the base perimeter can become excessively damp, potentially creating an environment that is susceptible to rust and corrosion of surrounding building elements, as well as attracting termites and other pests.

It is highly recommended that a plumber be appointed to further inspect the area and to install adequate drainage equipment immediately where necessary.

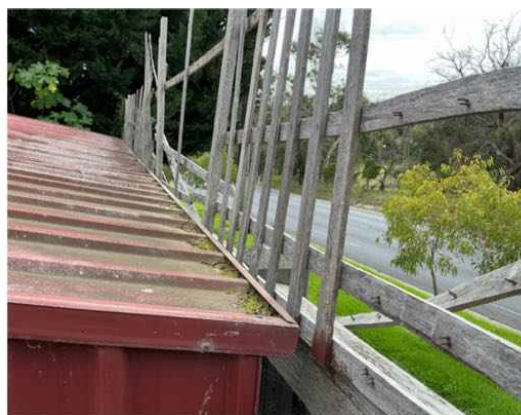
Finding 6.05

Building:	Main Building
Location:	Shed
Finding:	No gutters or down pipes installed
Information:	No gutters or down pipes installed to parts of the shed roof. Where plumbing doesn't drain adequately, the area at the apse perimeter can become excessively damp, potentially creating an environment that is susceptible to rust and corrosion of surrounding building elements as well as attracting termites and other pests. Recommend engaging a plumber to install gutters and down pipes to reduce the risk of footing movement and other moisture related issues as soon as possible.

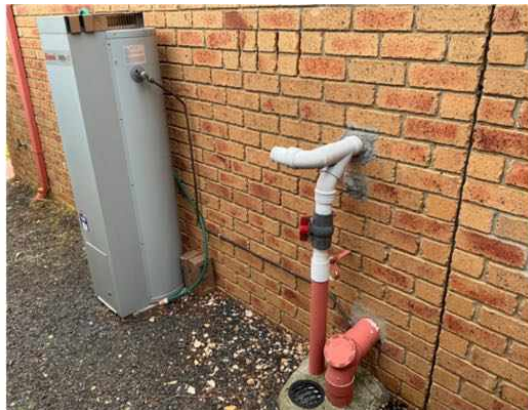
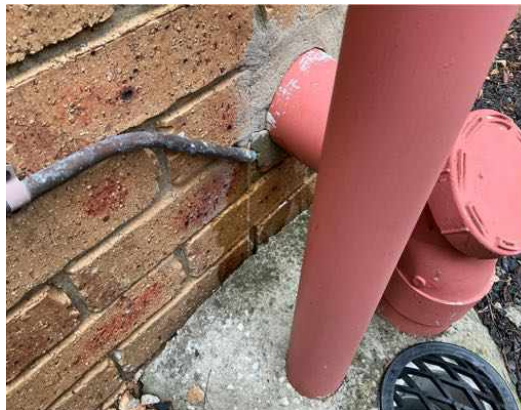
Finding 6.06

Building:	Main Building
Location:	Yard - Back
Finding:	HWS Overflow - Not Connected
Information:	The Hot Water System (HWS) overflow was found to be disconnected from storm water drainage and is creating excessive moisture in the surrounding area.

These damp conditions can lead to secondary defects such as rot, rust or corrosion of associated building elements, the formation of fungal decay, or even the creation of potential slip hazards. When coupled with poor site drainage, pooling of water may

also attract termite activity to this area.

It is highly recommended that a licensed plumber be appointed to connect the HWS overflow in order to prevent such an environment from being created. These minor works should be carried out as soon as possible.

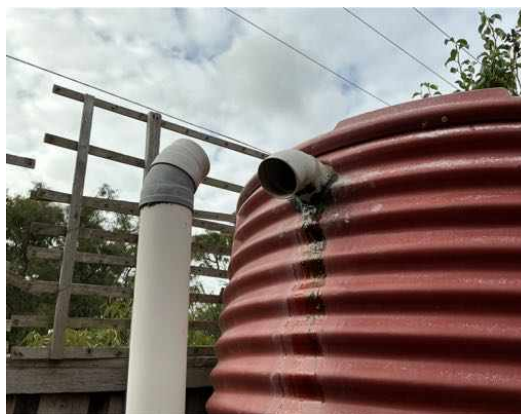
Finding 6.07

Building:	Main Building
Location:	Yard - Back
Finding:	Water tank leaking and leaning
Information:	The water tank is leaning and the downpipe is damaged and will leak water. This disconnection negatively impacts the functional capacity of the plumbing.

Where plumbing doesn't drain adequately, the area at the base perimeter can become excessively damp, potentially creating an environment that is susceptible to rust and corrosion of surrounding building elements, as well as attracting termites and other pests.

It is highly recommended that a plumber be appointed to further inspect the area and to install adequate drainage equipment immediately where necessary.

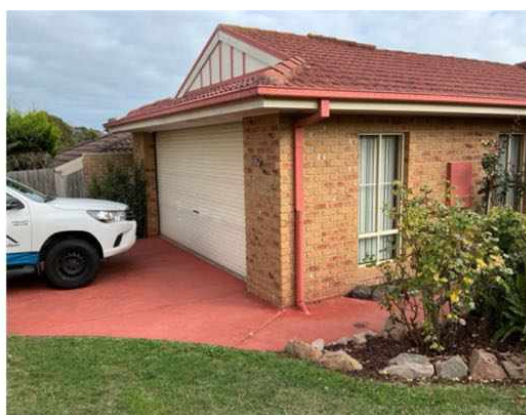
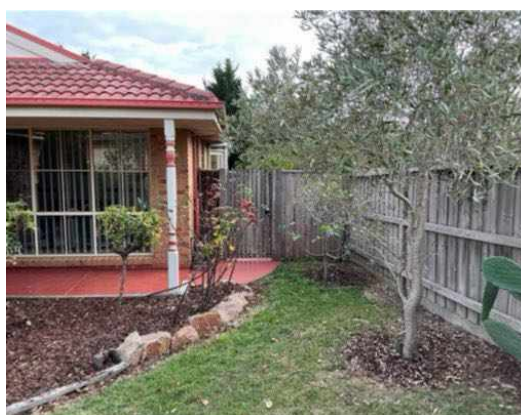
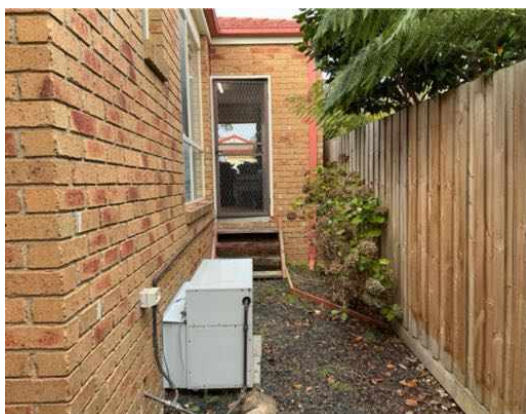
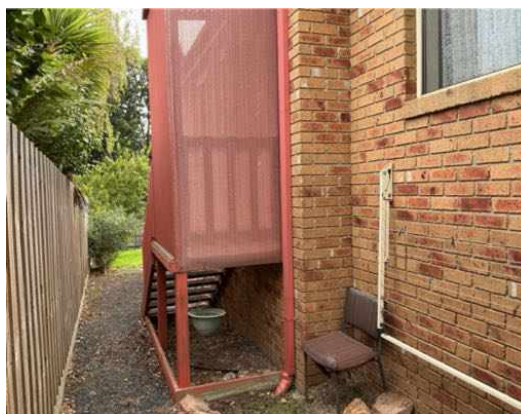
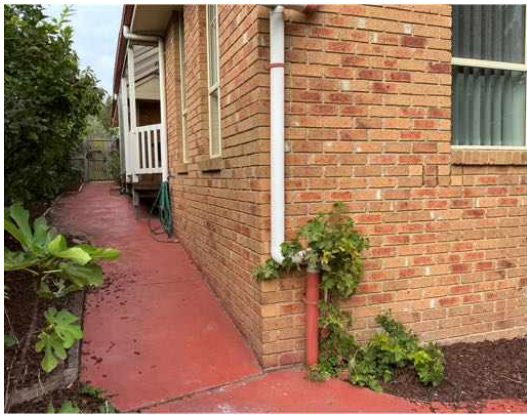
Finding 6.08

Building:	Main Building
Location:	Various parts of the building
Finding:	Bridging attachments to buildings
Information:	Bridging occurs when items against a building provide a concealed entry point for termites into the building or by passing around a termite management system.

Where any part of an attachment to a building is not isolated and is not provided with a clear gap of not less than 25mm from building, bridging occurs. Attachments to buildings such as hot water services, downpipes, verandahs, decks, steps, fences, service conduits and the like provide the opportunity for concealed entry.

Building attachments of this nature need to be frequently inspected for termite activity by a qualified inspector.

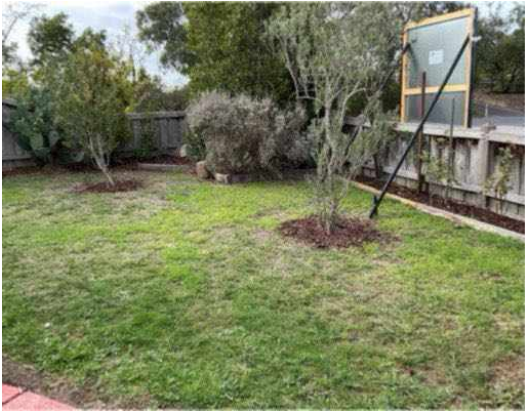
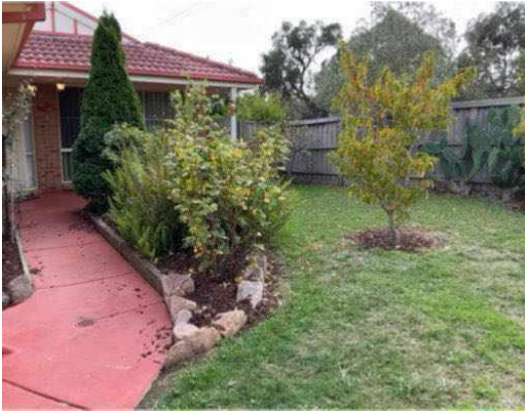
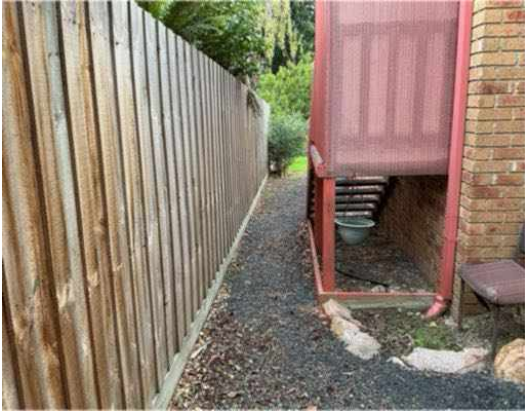
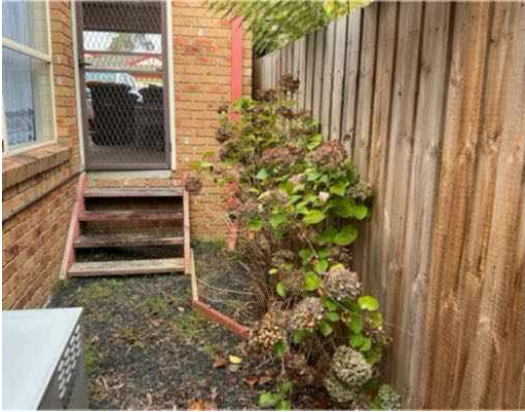
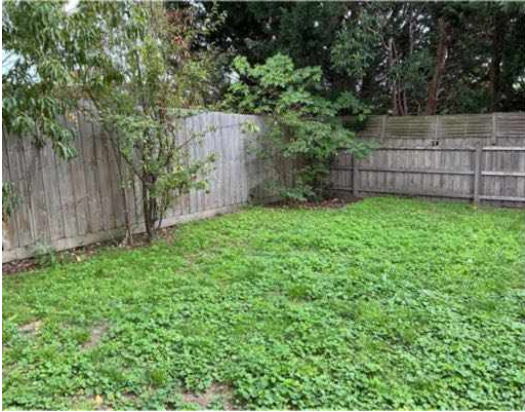
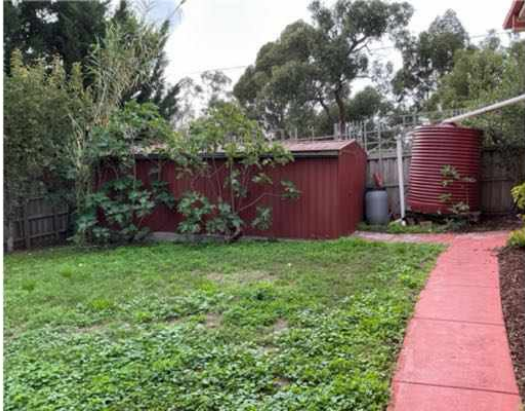
Finding 6.09

Building: Main Building
Location: Various parts of the building
Finding: In ground contact
Information: Any timbers in direct ground contact provide opportunity for concealed termite entry and are likely to be subject to premature rot and decay as the soil retains moisture or damp conditions against the timbers.

Remove untreated timber that is in direct contact with external grounds. Consider replacement with more durable materials i.e. treated timber or non timber elements. Frequent pest inspections are advised to readily identify any termite activity in these areas.

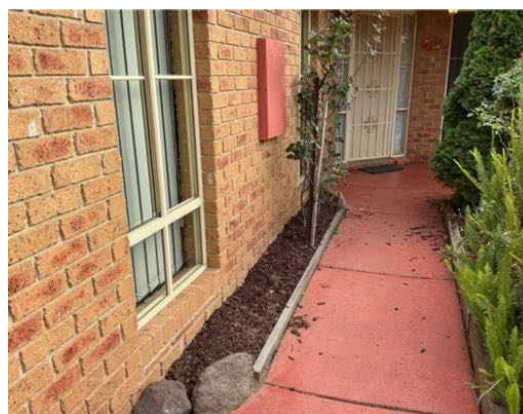
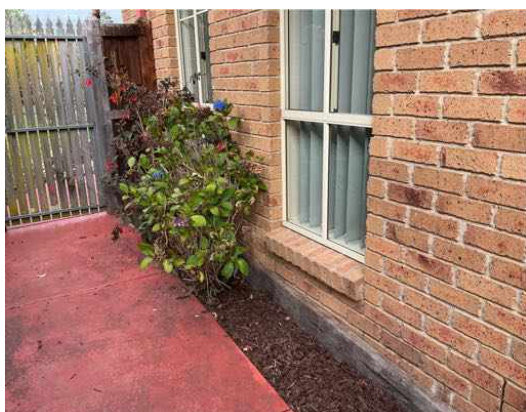
Finding 6.10

Building: Main Building
 Location: Yards
 Finding: Garden Beds Conditions Conducive to Termites
 Information: Garden beds were found to be evident in close proximity to the building. Garden beds immediately adjacent to the perimeter of the building block the visual inspection of these areas, providing a concealed termite entry point.

These garden beds can include untreated timber, and with a combination of moisture from watering hosing can make conditions conducive to termite activity and termite ingress.
