Building and Timber Pest Inspection Report

Inspection Date: Wed, 8 Apr 2026

Property Address: 9 Helens Way, Langwarrin VIC 3910,
Australia

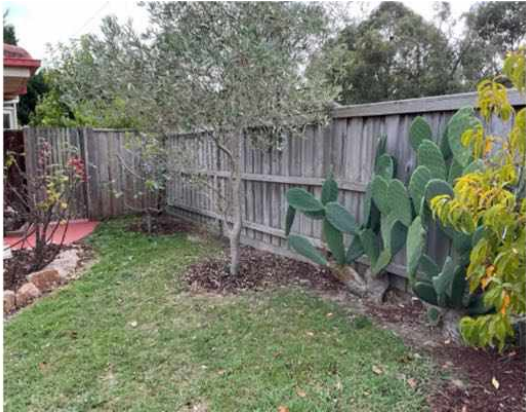
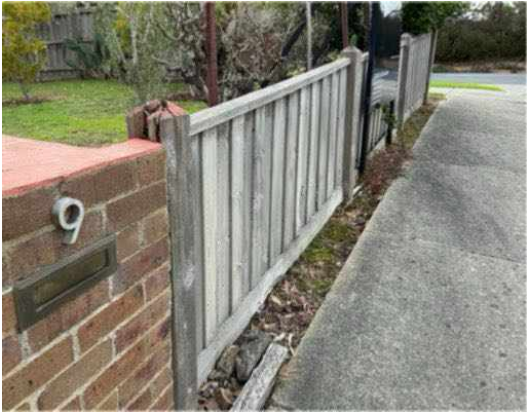
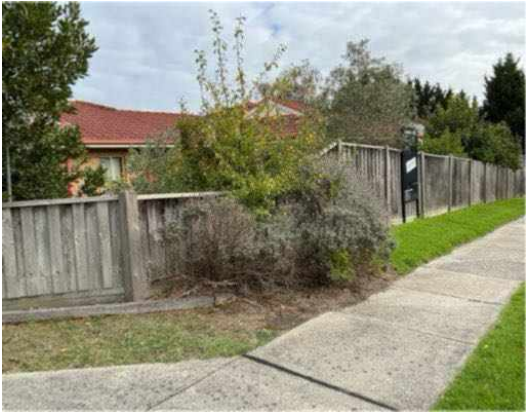
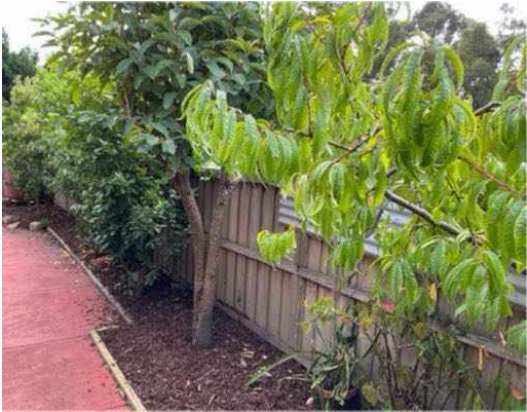
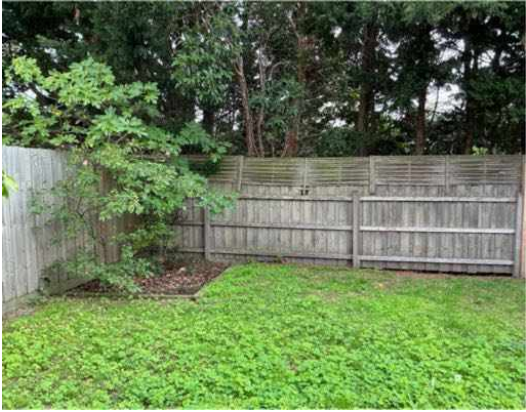
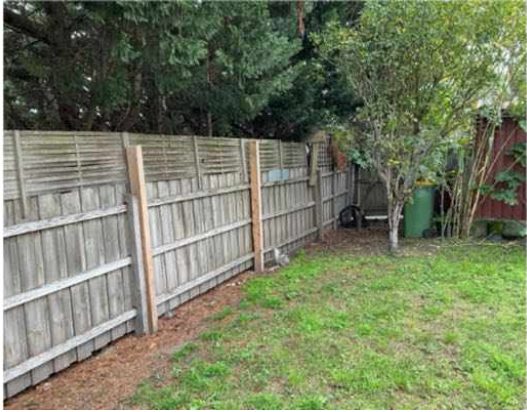
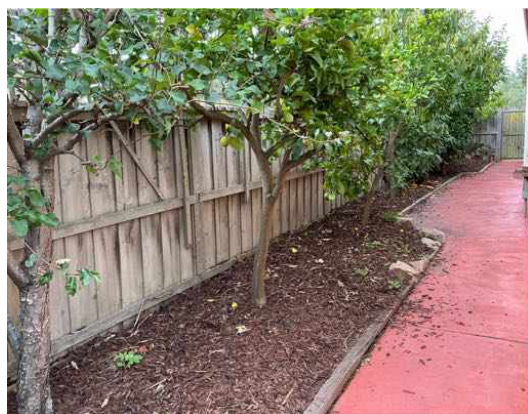
Building: Main Building
 Location: Yards
 Finding: Fencing - wood rot-fungal decay
 Information: It was noted at the time of inspection that sections of the fencing to the property have deteriorated and have fungal decay/wood rot present. Typically fencing deteriorates due to age and or wear, rot and or rust which is generally expected for a structure of this age, due to prolonged exposure to weather conditions. Sometimes inadequate

If left unattended, it is likely that further damage will occur. It is suspected that repair of several elements of the fencing may be required however replacement may be a consideration of the client also.

A licensed fencing contractor should be appointed to provide further advice and perform rectification works as necessary.

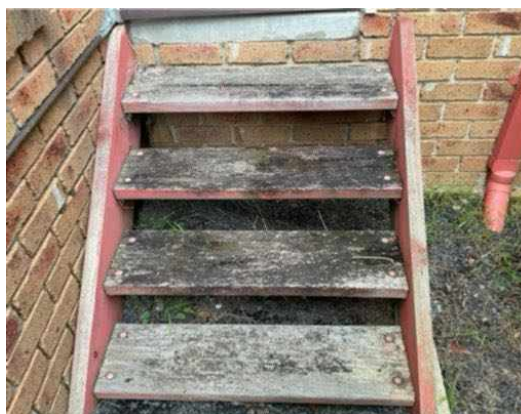
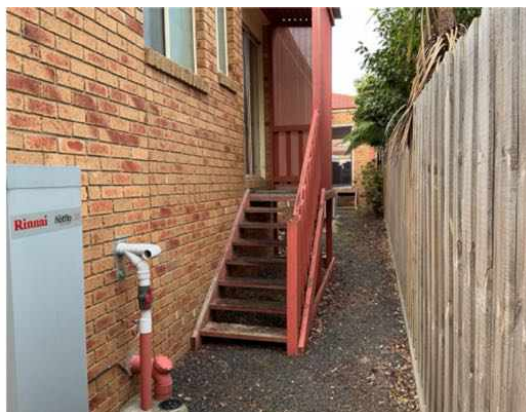
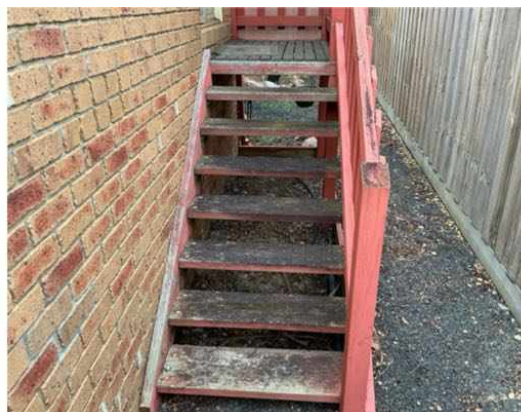
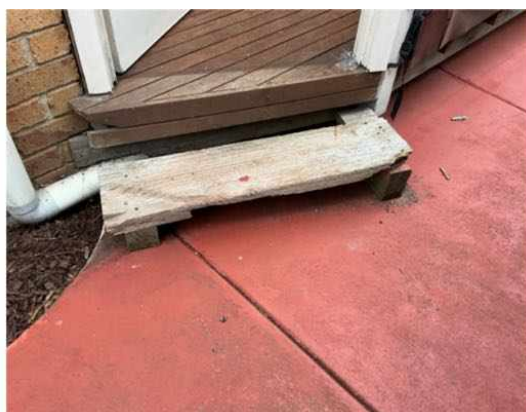
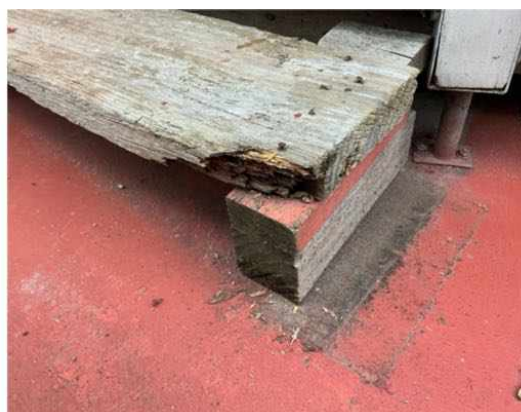
Finding 7.02

Building:	Main Building
Location:	Yard - Back
Finding:	Wood rot rear steps
Information:	The rear steps to building shows evidence of wood rot. Wood rot, also known as Fungal Decay, occurs when timbers and other cellulose building materials are exposed to damp conditions on an ongoing basis. This could be the result of exposure to weathering over a prolonged period of time, or the attraction of excessive moisture from other abutting building materials. Contributing factors also include poor air ventilation in the area.

Wood rot is often associated with general damp problems and is evidenced by a 'musty' smell or mould and mildew occurring on surfaces. If left unmanaged, damp conditions can lead to further health problems and the decay of timbers will continue.

Early intervention and regular maintenance, particularly of exterior timbers, will prolong the useful life of these building elements. Prior to any works being performed, the cause of the moisture that has created the visible wood rot should be identified and addressed in a suitable manner. Replacement of affected timbers may then be a necessary step in protecting surrounding building elements from such deterioration.

A qualified plumber may be appointed to assess the cause of excessive moisture and to provide advice on any remedial works as required. A qualified carpenter or registered builder may also be required to replace affected building materials.

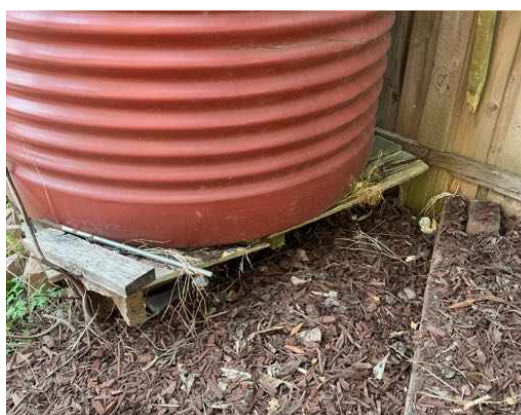
Finding 7.03

Building:	Main Building
Location:	Yard - Back
Finding:	Wood rot to water tank framing
Information:	The water tank framing shows evidence of wood rot. Wood rot, also known as Fungal Decay, occurs when timbers and other cellulose building materials are exposed to damp conditions on an ongoing basis. This could be the result of exposure to weathering over a prolonged period of time, or the attraction of excessive moisture from other abutting building materials. Contributing factors also include poor air ventilation in the area.

Wood rot is often associated with general damp problems and is evidenced by a

'musty' smell or mould and mildew occurring on surfaces. If left unmanaged, damp conditions can lead to further health problems and the decay of timbers will continue.

Early intervention and regular maintenance, particularly of exterior timbers, will prolong the useful life of these building elements. Prior to any works being performed, the cause of the moisture that has created the visible wood rot should be identified and addressed in a suitable manner. Replacement of affected timbers may then be a necessary step in protecting surrounding building elements from such deterioration.

A qualified plumber may be appointed to assess the cause of excessive moisture and to provide advice on any remedial works as required. A qualified carpenter or registered builder may also be required to replace affected building materials.

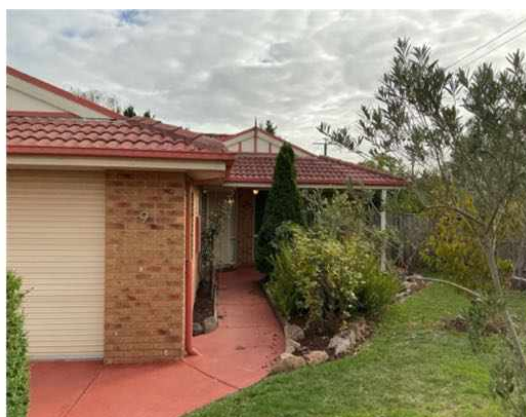
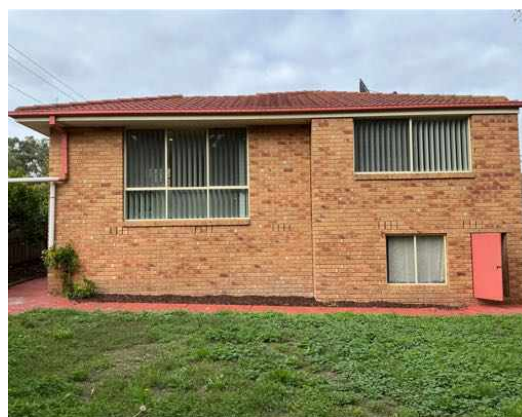
Building: Main Building
Location: All External Areas
Finding: Additional Photos - Obstructions and Limitations
Information: These photographs are an indication of the obstructions and limitations which impeded full inspection of the property at the time of inspection. These obstructions can hide an array of defects and should be removed to allow full inspection to be carried out. A re-inspection is recommended once the areas are made accessible.

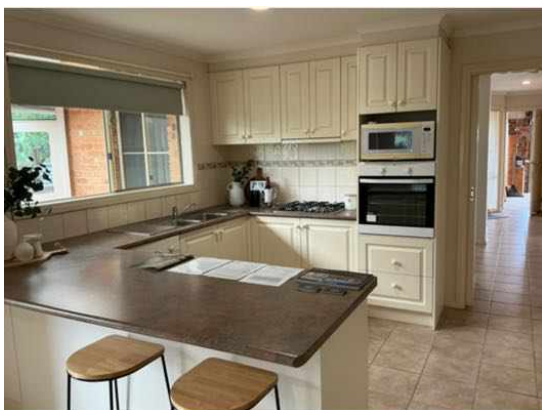
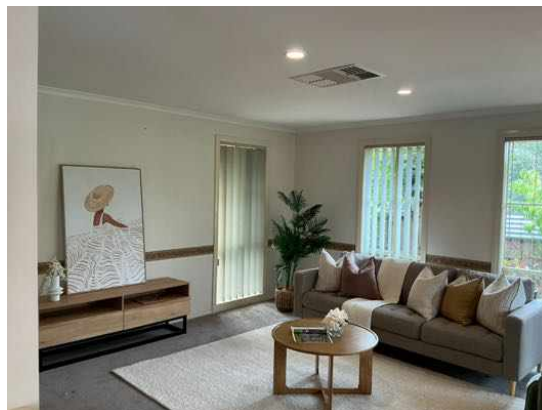
Building: Main Building
Location: All Internal Areas
Finding: Additional Photos - Obstructions and Limitations
Information: These photographs are an indication of the obstructions and limitations which impeded full inspection of the property at the time of inspection. These obstructions can hide an array of defects and should be removed to allow full inspection to be carried out. A re-inspection is recommended once the areas are made accessible.

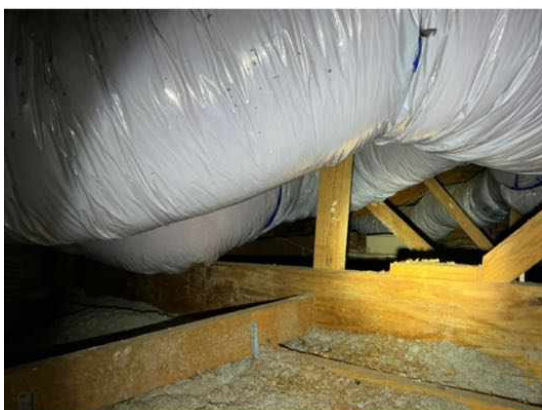
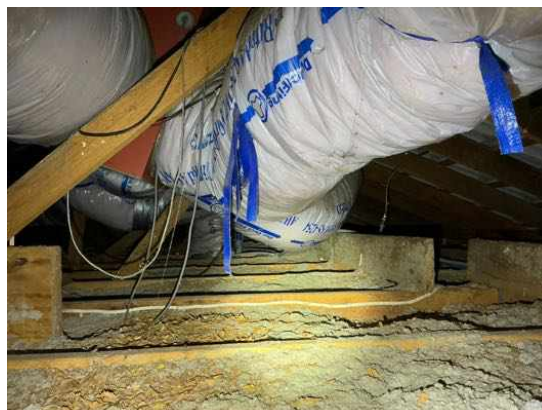
Building: Main Building
 Location: Roof Void
 Finding: Obstructions and Limitations -roof cavity
 Information: These photographs are an indication of the obstructions and limitations which impeded full inspection of the roof cavity at the time of inspection. These obstructions can hide an array of defects and should be removed to allow full inspection to be carried out. A re-inspection is recommended once the areas are made accessible.

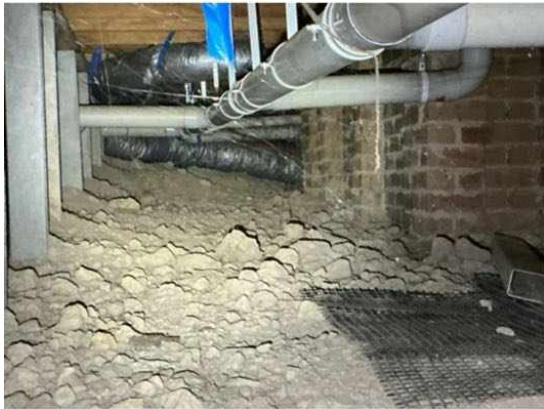
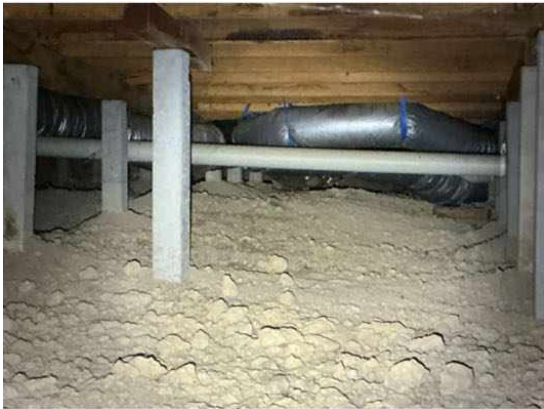
Building: Main Building
 Location: Subfloor
 Finding: Obstructions and Limitations -subfloor
 Information: These photographs are an indication of the obstructions and limitations which impeded full inspection of the subfloor at the time of inspection. These obstructions can hide an array of defects and should be removed to allow full inspection to be carried out. A re-inspection is recommended once the areas are made accessible.

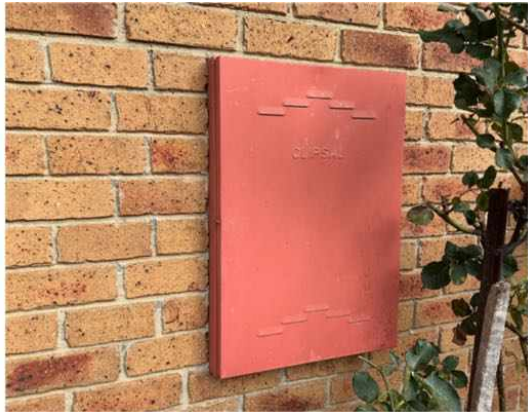
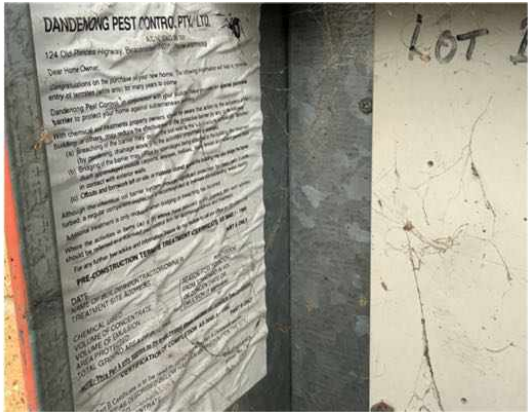
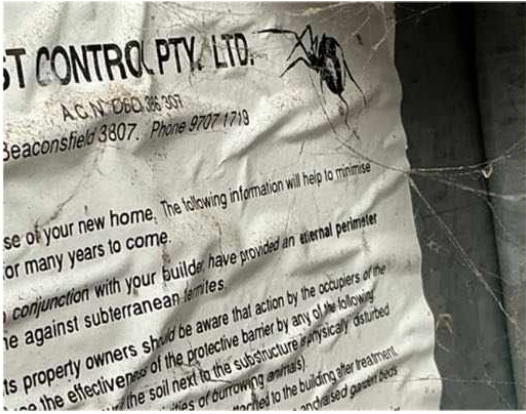
Where a Termite Management System has been identified you should refer to the type of barrier date of installation warranty conditions and any documentation provided by a builder or past owner. Consult the company who installed the barrier to confirm whether the system is still under warranty.

Most chemical termite management systems expire and require replenishment and all physical systems are primarily designed to prevent concealed entry.
