Building and Timber Pest Inspection Report

Inspection Date: Tue, 24 Mar 2026

Property Address: 17 Greendale Road, Wallacia NSW 2745

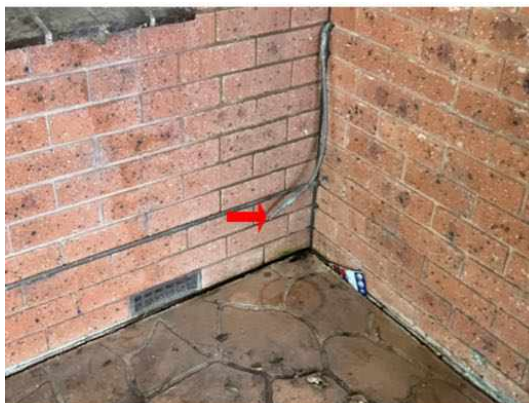
Finding 7.01

Evidence of fungal decay activity and/or damage

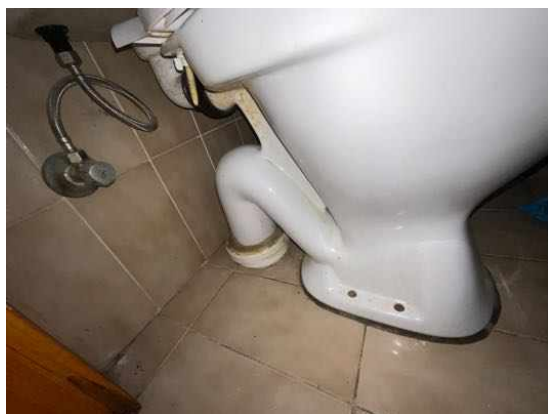
Building: Main Building
 Location: All Areas
 Finding: Water Pressure – Observation Only.
 Information: During the inspection, water pressure appeared to be within a normal operating range based on a basic functional check. However, this observation was made without the use of pressure testing equipment and does not constitute an assessment by a licensed plumber.
