# Building and Timber Pest Inspection Report

Inspection Date: Thu, 9 Apr 2026

Property Address: 60 Fraser Ave, Kellyville NSW 2155,  
Australia

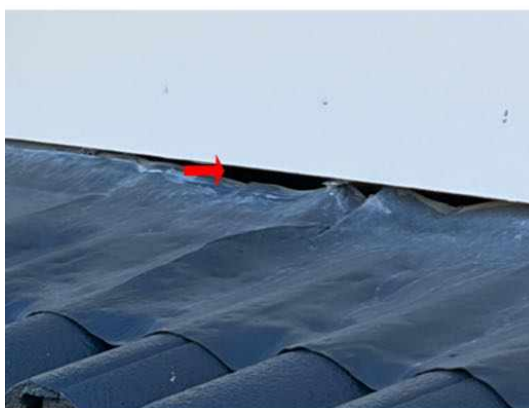
Building:	Main Building
Location:	LHS gable
Finding:	Roof plumbing - Flashing inadequate
Information:	Some sections of the roof are missing or have inadequate roof flashings. Flashings are

Flashings that are not installed adequately or are missing are likely to result in water penetration to the interior of the property, as well as creating excessively damp conditions against the exterior surfaces and around the base perimeter of the building.

Premature ageing and secondary building defects are imminent where roof plumbing is missing or inadequately installed. Additionally, water pooling also creates an environment that is susceptible to termite and pest infestation.

A roofing plumber should be appointed as soon as possible to install relevant roof plumbing materials, ensuring that no further damage is sustained.

- Rectify defective roof flashing to the LHS gable
- Ensure wet area sealant and grouting is in serviceable condition

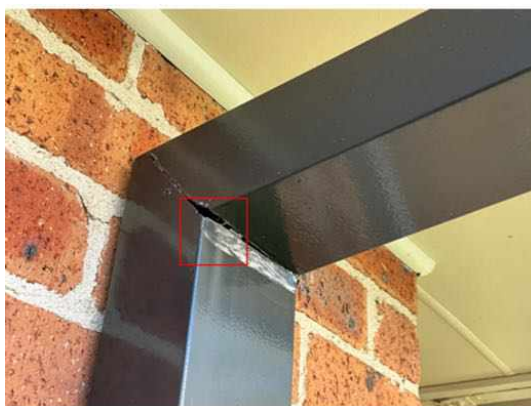
### Finding 3.02

Building:	Main Building
Location:	Multiple areas of roof plumbing
Finding:	Water leak - External
Information:	Water leaks were found to be present to exterior plumbing work. Leaks are generally caused by deterioration of the plumbing elements over time, due to exposure to weather conditions, but may have also been caused by minor impact damage.

Such leaking creates damp conditions in the affected area, causing potential for water pooling and subsequent water damage if left unattended. These conditions may also attract termite attack, particularly if the area is subject to minimal levels of sun throughout daylight hours.

It is highly advised that a licensed plumber be appointed to rectify any water leaks that may be present. Areas of repair and replacement of plumbing fittings and fixtures may be required and, as such, a quotation should be sought.

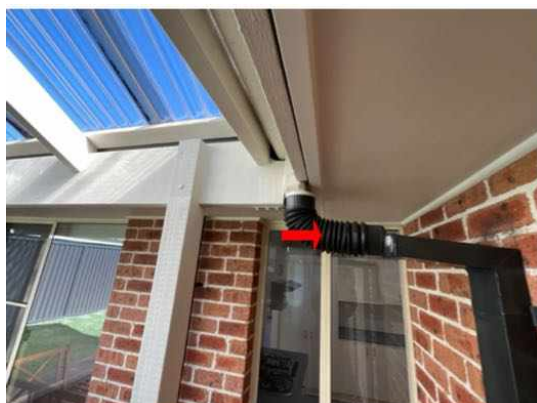
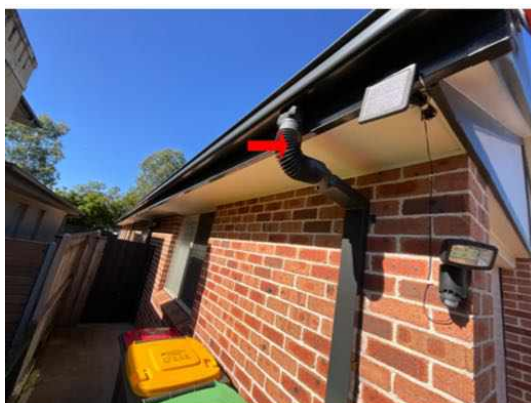
**Finding 3.03**

Building: Main Building  
 Location: Multiple areas  
 Finding: Unconventional handyman work  
 Information: This handyman work appears to have been completed to a substandard level and does not comply with regular building practices. Where handyman work is not completed satisfactorily, accelerated deterioration of the associated building elements is likely to occur and secondary defects to surrounding structures may develop.

It is highly recommended that the substandard work be rectified by professional services. Works to improve this area are likely to increase the safety and the operation of the associated building elements.

The client should exercise care when coming into the immediate vicinity of the substandard works. Rectification works are advised as soon as possible by the appropriate trades.

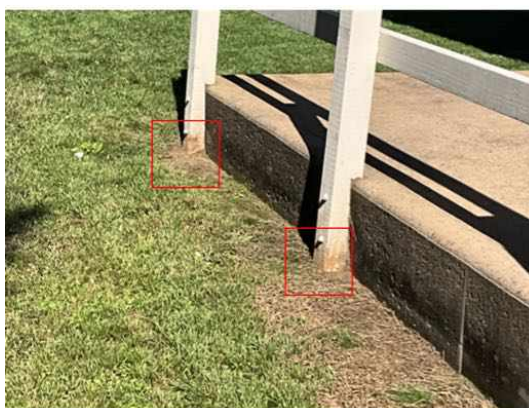
**Finding 3.04**

Building: Main Building  
 Location: Balustrades  
 Finding: Untreated or non-durable timbers in a hazardous environment

Information: To reduce the risk of timber pest attack it is essential that timber used in a hazardous environment (e.g. in direct contact with the ground or frequently exposed to damp conditions) is of sufficient durability and/or is adequately preservative treated.

Untreated timbers in direct contact with the ground are likely to develop severe wood rot and/or fungal decay if left unattended creating attraction for subterranean termites to infest the timbers from surrounding areas.

If untreated or non-durable timbers are found to be in a hazardous environment it is highly advised that replacement of these building elements be performed as soon as possible to aid the protection of the property against termite / timber pest attack.

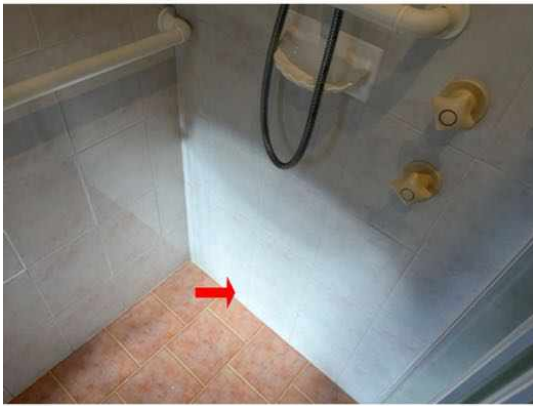
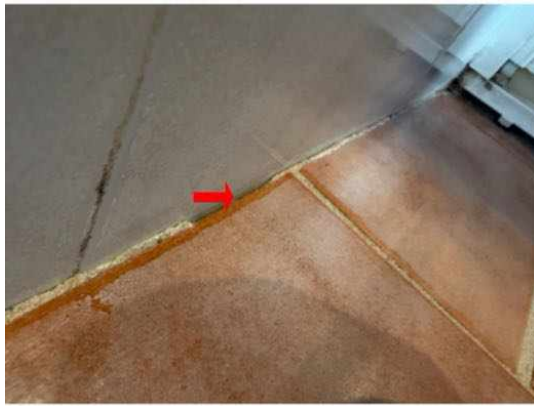
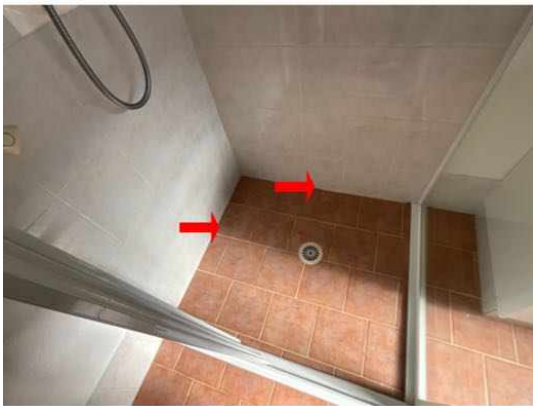
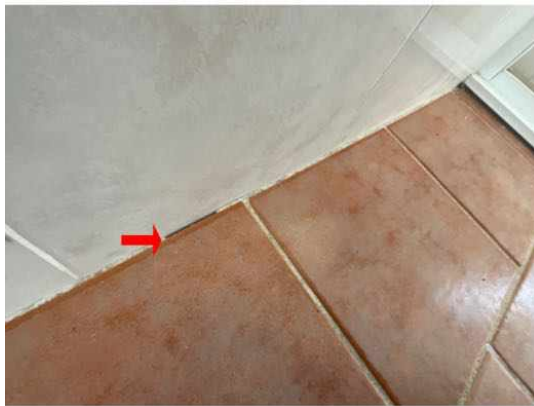
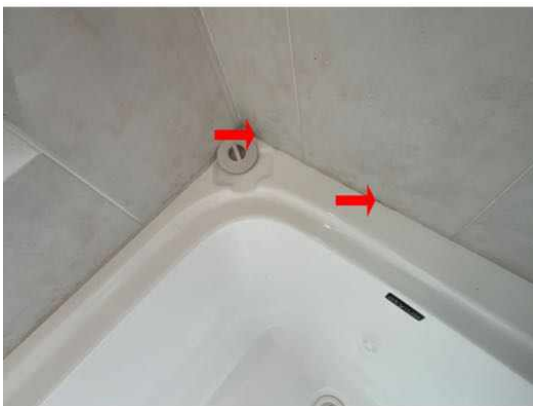
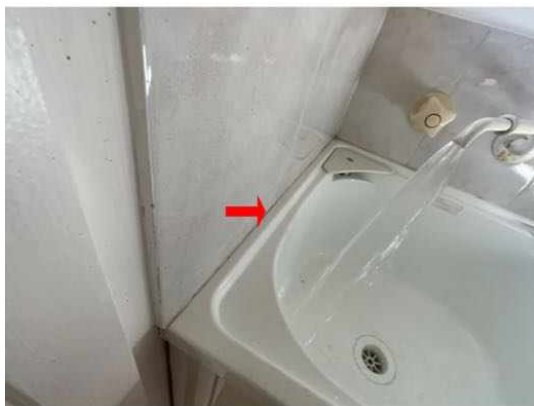
### Finding 3.05

Building: Main Building  
 Location: All wet areas  
 Finding: Sealant and grouting - Missing or damaged  
 Information:

It was noted on inspection that sealant or grout is degraded to this area.

Different materials and floor areas move at different rates, generally causing cracking to grout or sealant at this point. A flexible sealant is required to allow for expected expansion and contraction, while keeping the joint water tight and protective of all associated building materials.

Flexible and mould resistant materials should be applied to affected areas to prevent any subsequent water damage that is likely to occur. Regular maintenance and replacement of damage or missing or damaged sealant and grout is highly recommended to the wet areas, as this is a regular wear and tear defect. Sealant and grouting in areas that come into regular contact with water should be maintained for the long term care of your property.

A sealant specialist should be appointed to complete these works as soon as possible.

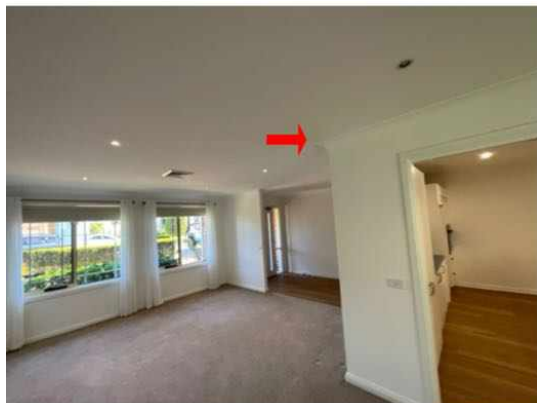
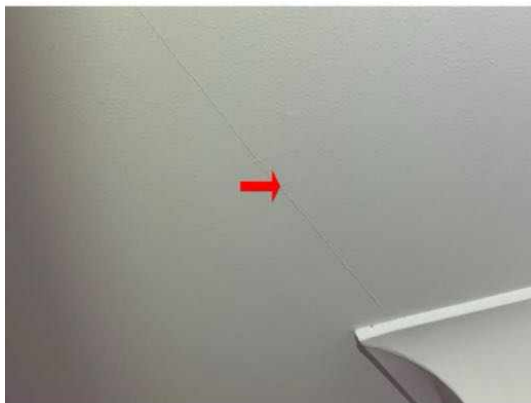
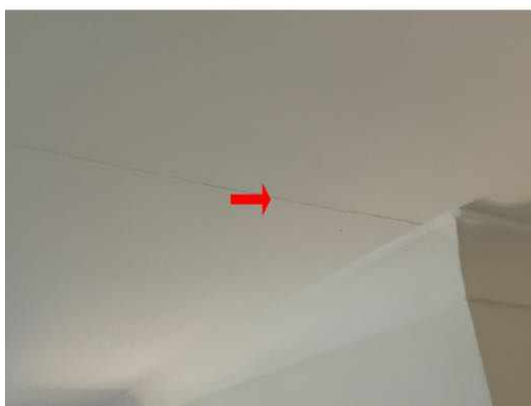
### Finding 3.06

Building:	Main Building
Location:	Multiple areas
Finding:	Cracking - Damage Category 0 - Hairline (less than 1mm)
Information:	Hairline cracks are very minor in nature and generally are only ever an appearance defect. While such cracking may be noticeable in some cases, it is quite common and does not indicate any structural damage.

Cracking of this nature can generally be repaired with minor sanding, filling and/or repainting. Such works should be performed by a qualified painter or a general handyman.

Monitoring of all cracking should be conducted frequently. Always contact a building inspector should cracks widen, lengthen, or become more numerous.

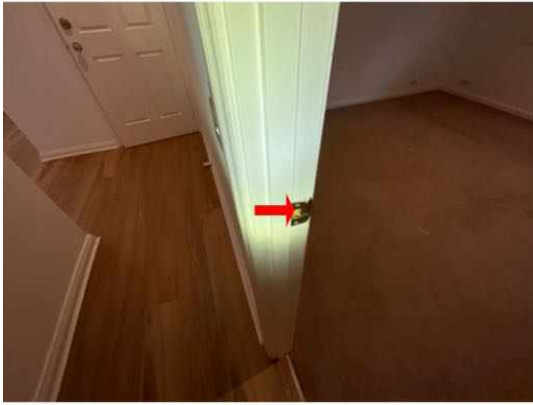
### Finding 3.07

Building:	Main Building
Location:	Multiple areas
Finding:	Door - Striker plate misaligned
Information:	The striker plate to this door appears to have become misaligned and has consequently resulted in the door's operation being compromised.

This is a common defect and is expected in a property of this age, whether being due to substandard installation or general deterioration of the door hardware.

Readjustment of the striker plate is recommended at client discretion. Works such as these can be completed by a general handyman or qualified carpenter.

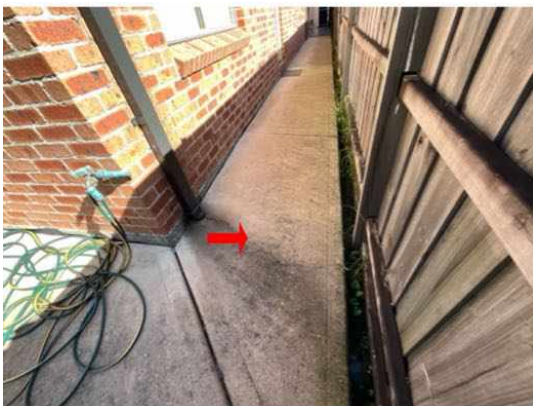
### Finding 3.08

Building:	Main Building
Location:	Backyard
Finding:	Cracking - External Concrete Paving Damage Category 1 - Fine (less than 2mm)
Information:	Fine cracks were identified in external concrete paving. Although fine cracks are quite noticeable, they are often only considered to be an appearance defect, and usually do not indicate any structural damage. To be considered a Category 1 or fine crack, the crack is found to be less than 2mm in width.

Generally the cause of a hairline crack in existing concrete paving such as driveways and pathways is indicative of the expansion and contraction of the concrete. Such causes are generally due to environmental factors, such as moisture levels, weather conditions, root systems of nearby trees or the soil types on which they are laid.

Fine cracks may also be due to poor original installation of the concrete. Factors such as poor compaction of the sub surface and/or inadequate reinforcing of the slab may create cracking and other secondary defects.

Monitoring of all cracking should be conducted frequently. Always contact a building inspector should cracks widen, lengthen, or become more numerous.

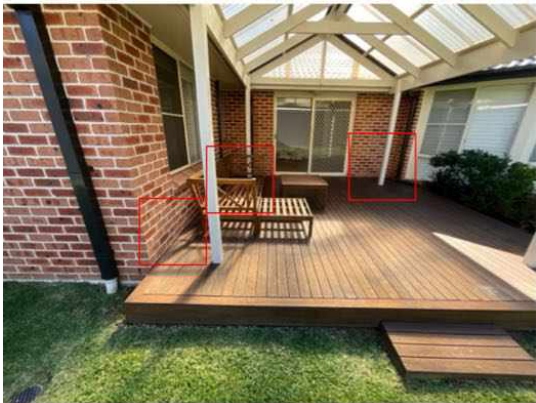
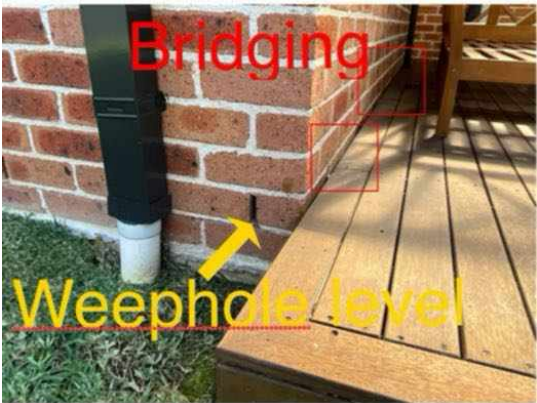
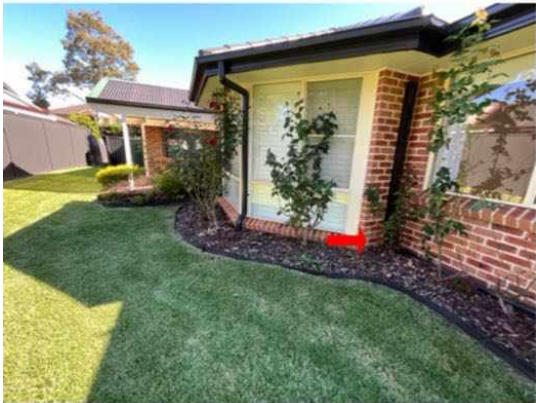
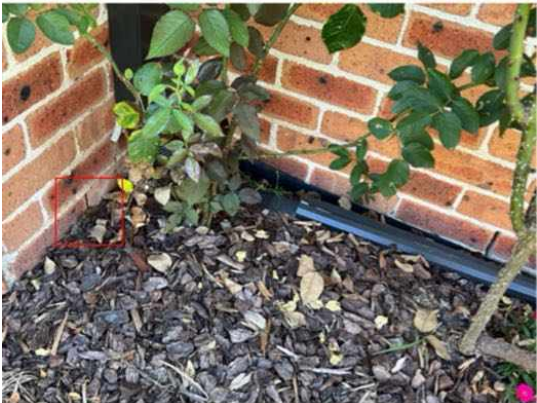
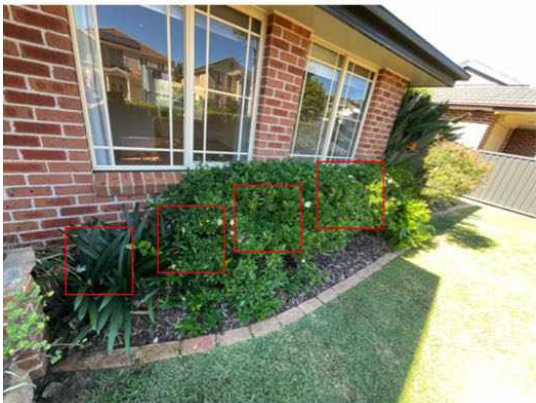
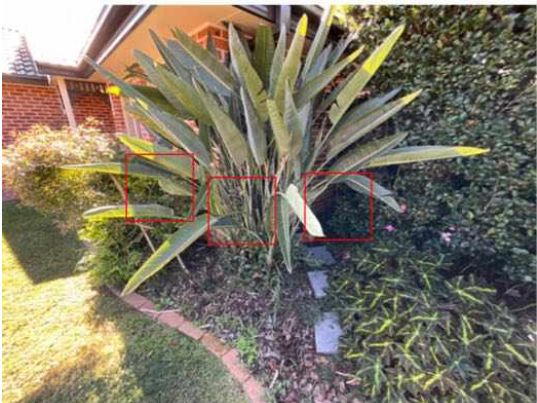
Weep holes in the exterior brickwork of the property are designed to allow condensation that may build up between the brickwork and subsequent timber framework to drain from within the wall hence preventing any deterioration of the timber building elements.

Additionally build-up of moisture is likely to occur if weep holes are covered further attracting termite activity to these areas.

It is highly recommended that weep holes are left exposed in all areas throughout the external property. Therefore if any termite activity leading into weep holes becomes easily detectable during frequent pest inspections. A landscaper must be appointed urgently to lower the garden beds below the weepholes and damp proof course.

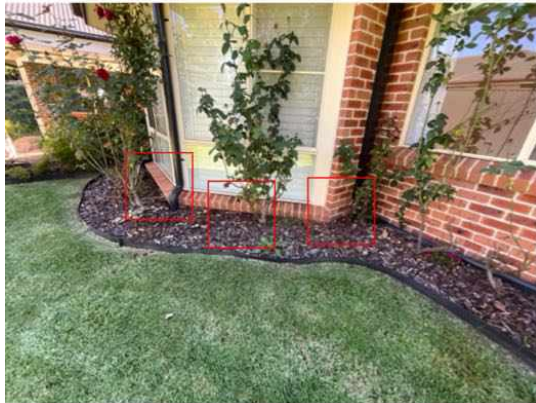
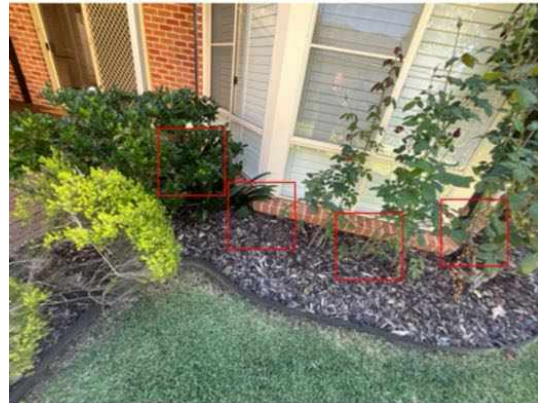
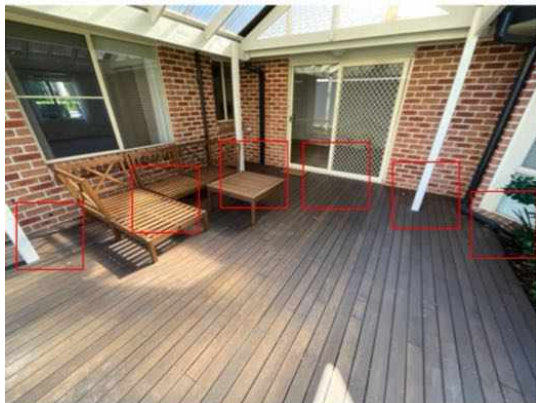
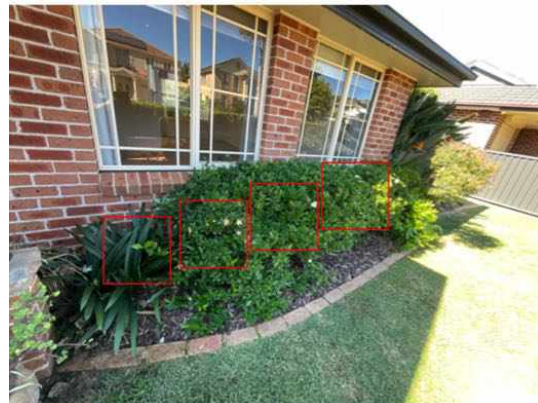
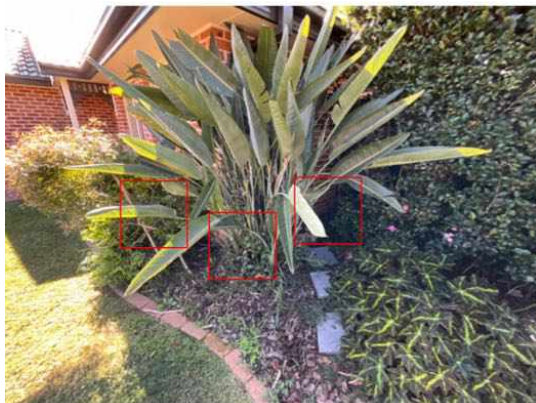
**Finding 6.02**

Building: Main Building  
 Location: Multiple areas  
 Finding: Bridging or breaching of termite barriers - damp course level  
 Information: Bridging is the spanning of a termite barrier or inspection zone so that subterranean termites are provided with passage over or around that barrier.

Damp proof course (DPC) is a barrier of impervious material built into a wall or pier to prevent moisture from moving to any part of the building. Where external ground levels

are built up over this barrier ingress is provided for moisture from the exterior grounds into the base brickwork or other building material and allowed to rise.

Such conditions attract termites into these damp areas which is likely to lead to infestation if left untreated.

While retrospective fitting of DPC is considered to be impractical works are required in order to prevent the extraction of moisture from the external environment into exterior brickwork or wall materials. A landscaper must be appointed urgently to lower the garden beds below the weepholes and damp proof course.

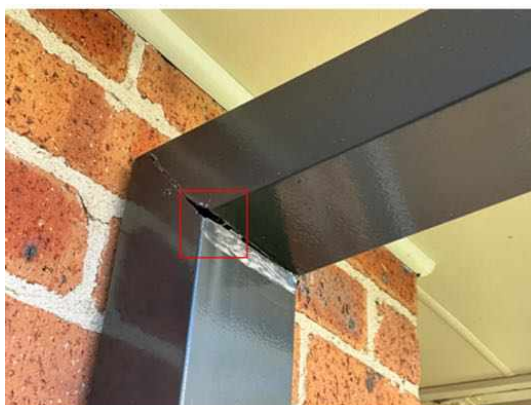
Building:	Main Building
Location:	Multiple areas of roof plumbing
Finding:	Water leak - External
Information:	Water leaks were found to be present to exterior plumbing work. Leaks are generally caused by deterioration of the plumbing elements over time, due to exposure to weather conditions, but may have also been caused by minor impact damage.

Such leaking creates damp conditions in the affected area, causing potential for water pooling and subsequent water damage if left unattended. These conditions may also attract termite attack, particularly if the area is subject to minimal levels of sun throughout daylight hours.

It is highly advised that a licensed plumber be appointed to rectify any water leaks that may be present. Areas of repair and replacement of plumbing fittings and fixtures may be required and, as such, a quotation should be sought.

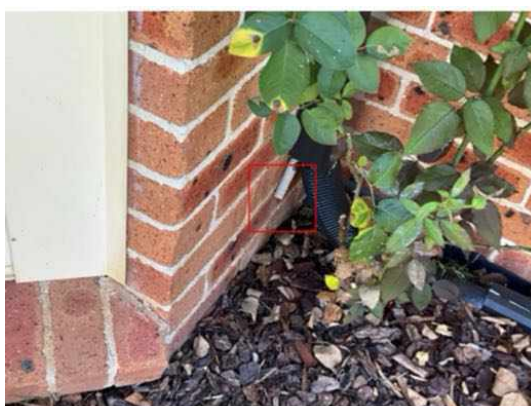
### Finding 6.07

Building: Main Building  
 Location: Multiple areas  
 Finding: Overflow - Not plumbed for drainage  
 Information: The overflow is not plumbed or connected to suitable drainage, which can result in the surrounding area becoming excessively damp.

These damp conditions can lead to secondary defects such as rot, rust or corrosion of associated building elements, the formation of fungal decay, or even the creation of potential slip hazards. When coupled with poor site drainage, pooling of water may also attract termite activity to this area.

It is highly recommended that a licensed plumber be appointed to install adequate drainage to the overflow. These works will ensure that the area remains dry and free of any secondary defects.

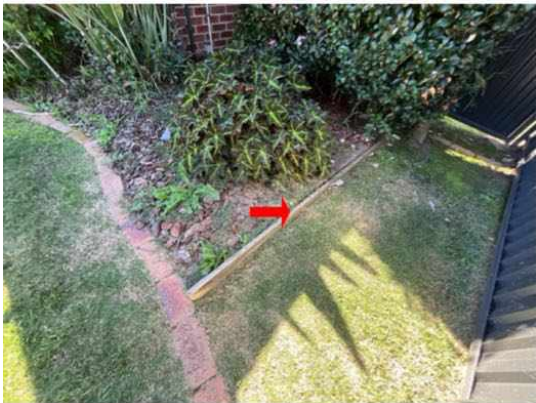
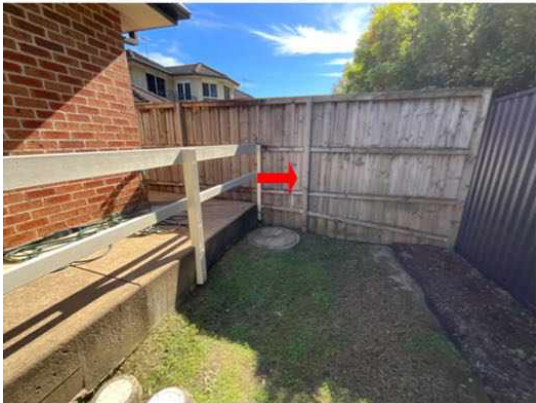
**Finding 6.09**

Building: Main Building  
 Location:  
 Finding: Surrounding bushland - Conductive  
 Information: Home and or building is situated in a high risk area for termite activity, due to close proximity to surrounding bushland.

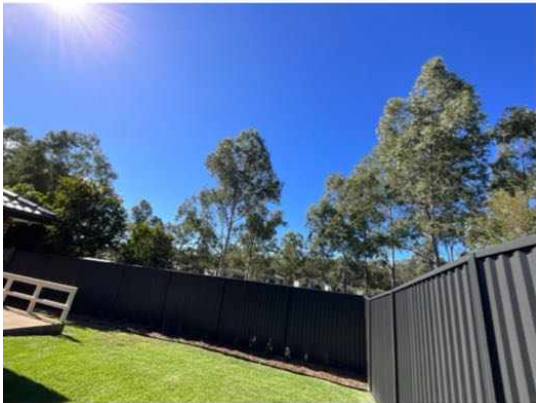
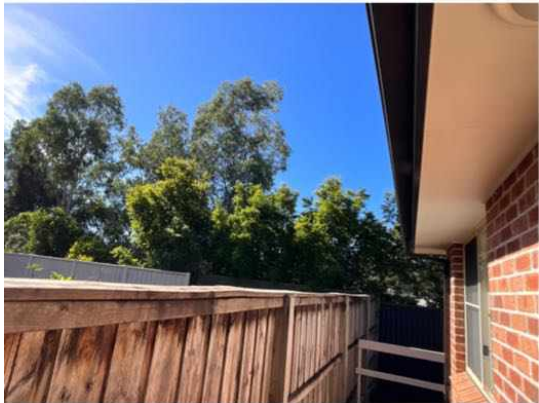
**Finding 6.10**

Building: Main Building  
 Location: Vegetation

Finding: Vegetation - Abutting property  
 Information: Vegetation against external wall may have an invasive root system. If there are weak points in the brick work or concrete slab, it is possible for the roots to gain entry into these areas. Once the roots have gained entry, it is possible for termites to gain concealed entry via these roots. It is recommended to remove the vegetation and root system where possible.

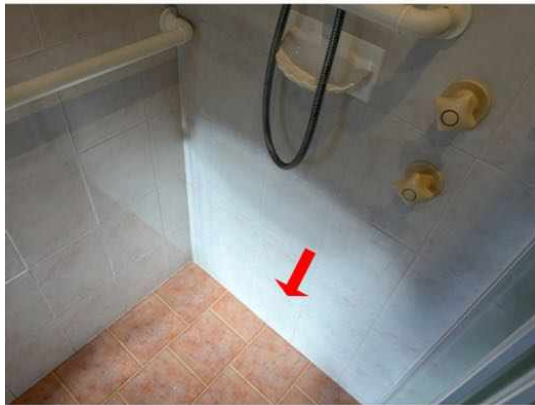
Building:	Main Building
Location:	Ensuite
Finding:	Shower damp - Sealant and grout
Information:	Damp is evident to the lower 400mm of wall to the shower alcove. This defect is quite common, and is suspected to have been caused by moisture permeating or leaching through the grouting and sealant in this area, which shows evidence of deterioration. Leaking pipes within the wall is also a possible cause however this seems unlikely in this instance as there is no moisture build up around the taps or transferring to the other side of the wall. There appears to be no sealant around the tap spindles which may be a small contributing factor.

Damp (or structural damp) refers to the presence of unwanted moisture in the structure of a building, either as the result of intrusion from outside, or condensation from within the structure. In the shower area, internal water leaks, degraded materials or other sources of excessive moisture are generally the cause of damp.

Unmanaged damp in the shower recess is likely to facilitate the formation and development of mould and fungi growth, decaying associated building materials and compromising their structural integrity of associated elements. It is important to address damp conditions, as the World Health Organisation notes that excess moisture leads - on almost all indoor materials - to growth of microbes such as moulds, fungi and bacteria, which subsequently emit spores and other matter into the indoor air. Exposure to these contaminants is associated with a wide range of respiratory and other health-related problems. Damp conditions also create a conducive environment for termite infestation.

Consultation with a bathroom sealant specialist is advised immediately to identify the cause of damp and to perform remedial works as required.

Always ensure that sealant and grout is in good condition to prevent any moisture issues occurring in the future.

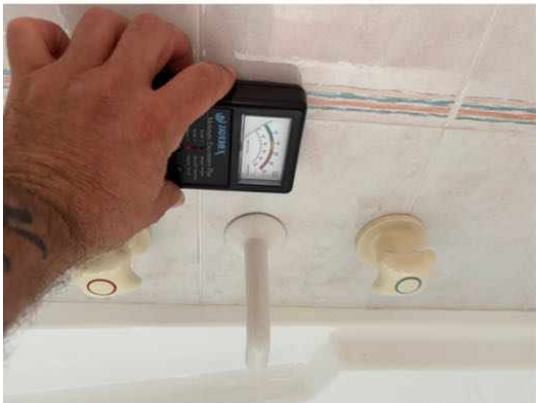
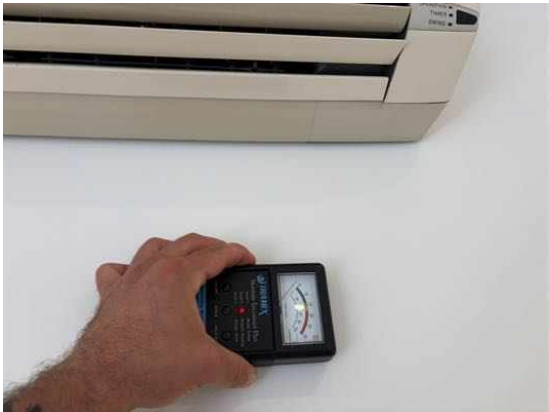
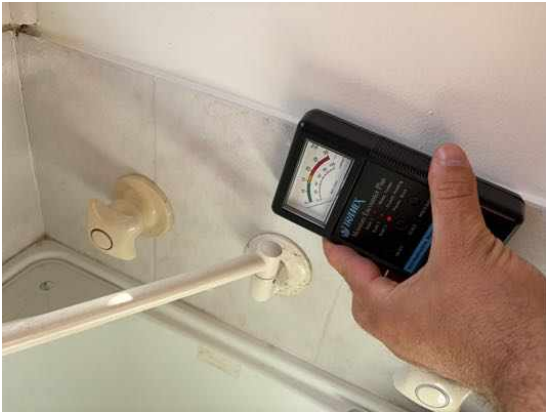
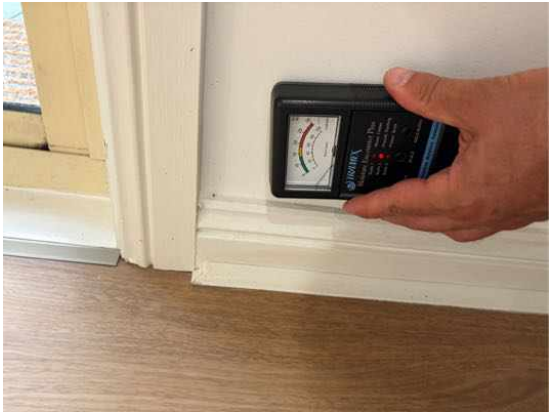
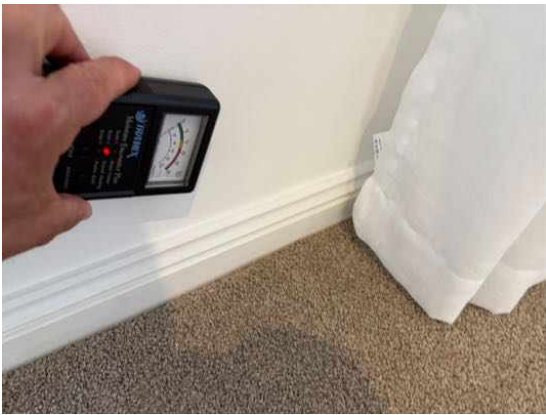
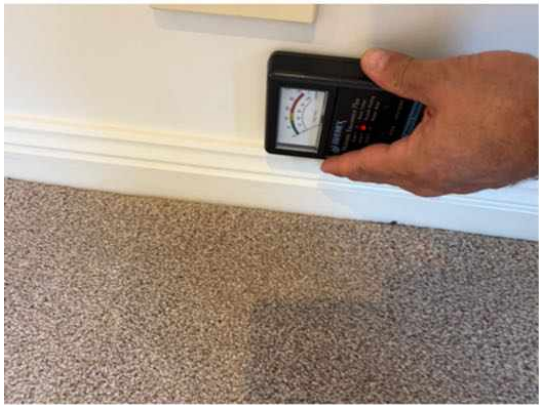
Building: Main Building  
Location: All Areas  
Finding: Moisture metre  
Information: During the inspection the property was checked for moisture using a moisture metre.

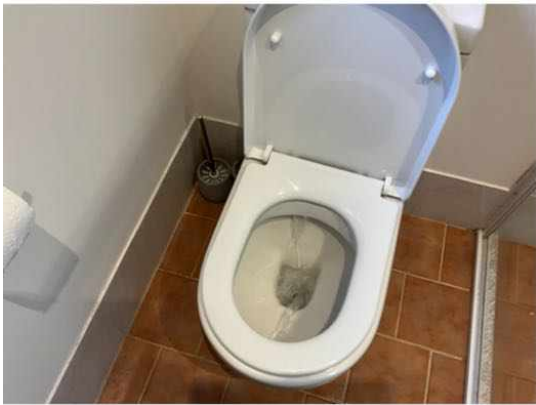
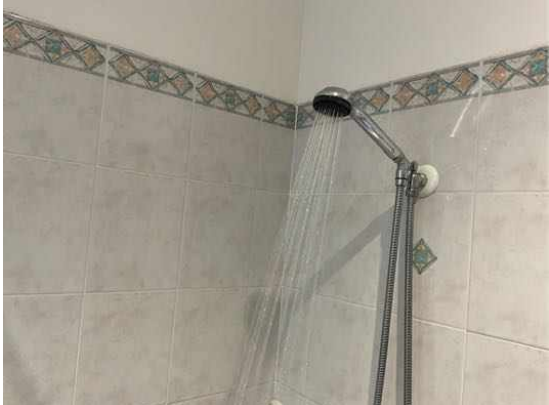
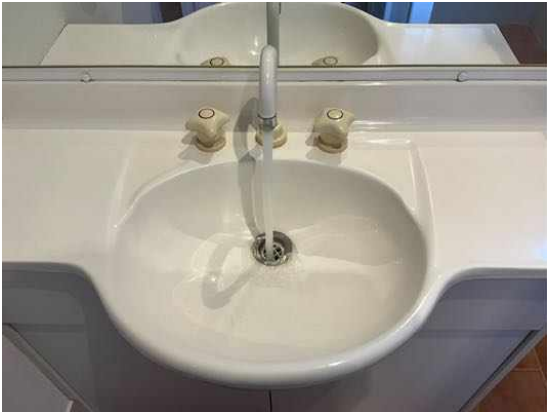
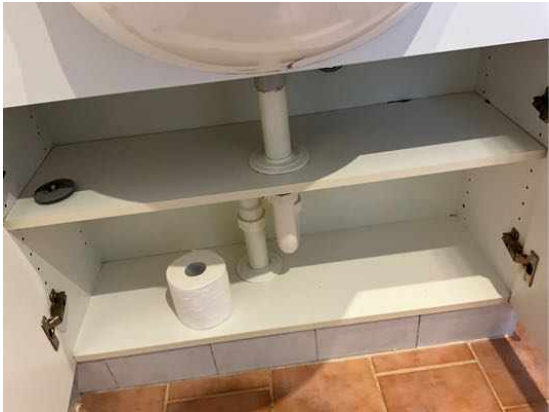
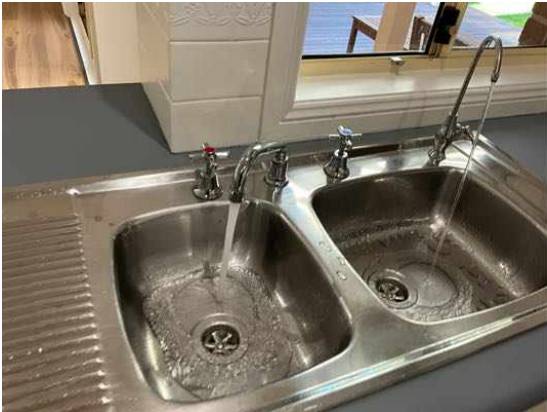
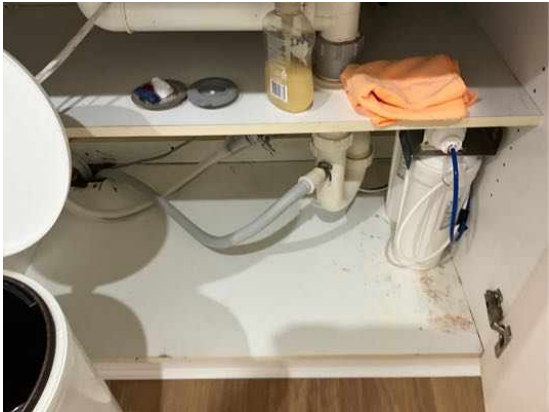
Building: Main Building  
 Location: All Wet Areas  
 Finding: Waterproofing  
 Information:

All taps, mixers and toilets were tested for operation, except for those obstructed. The waterproofing to the shower recess was assessed by checking the walls in and around the shower recess for varying moisture content. There were no significant variations across the tested areas. No sign of recent water damage was evident upon a visual inspection of the surrounding walls, where the visual nature of the inspection was possible.

Consequently, there is no conclusive evidence of any current shower recess leakage other than those which may have already been mentioned earlier in this report. It is reasonable to assume the shower waterproofing is sound. Note that if the shower is not used, or has not been used for some time, moisture readings would not vary significantly and this can lead to erroneous results. It is not possible under the visual inspection criteria (under which a prepurchase inspection is carried out) to categorically determine if there are leaks. If a more accurate assessment is required, a special purpose inspection should be requested. Alternatively, the assumption should be made that the shower may leak.

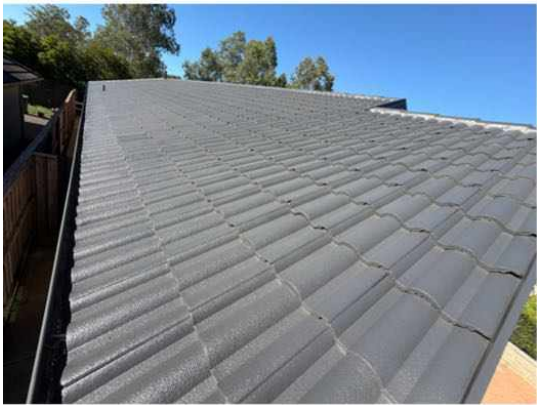
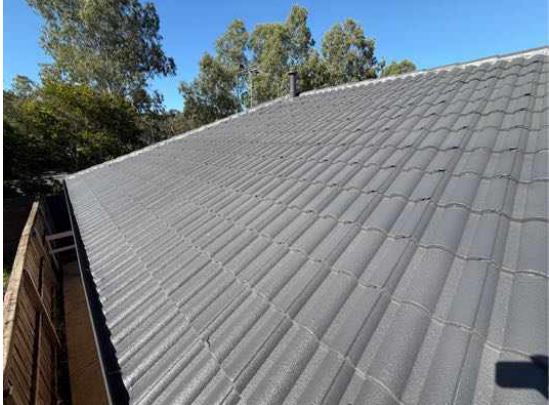
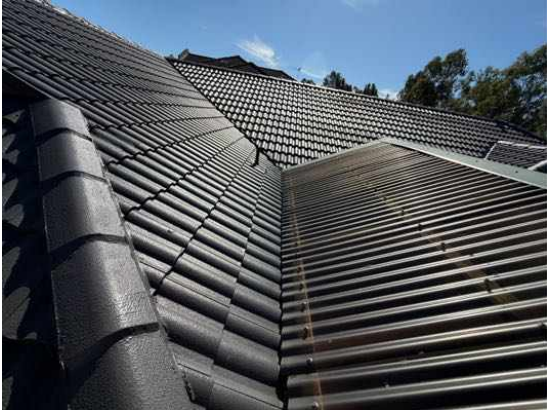
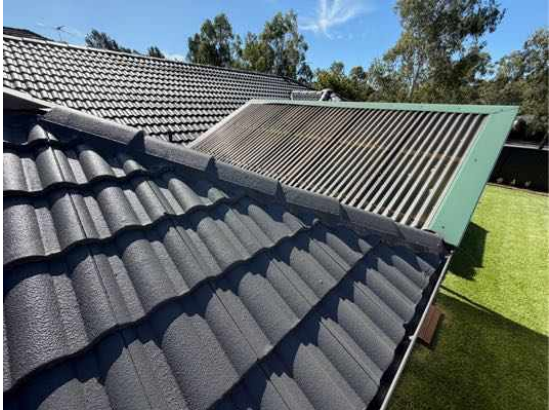
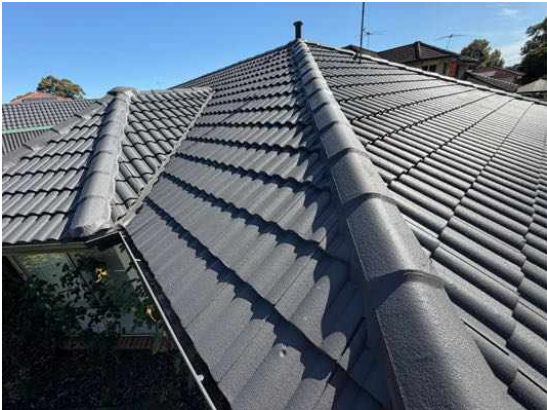
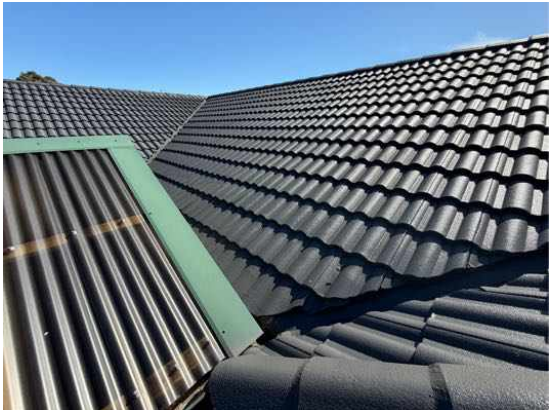
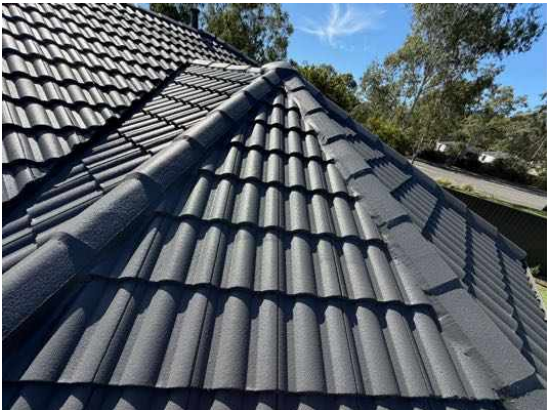
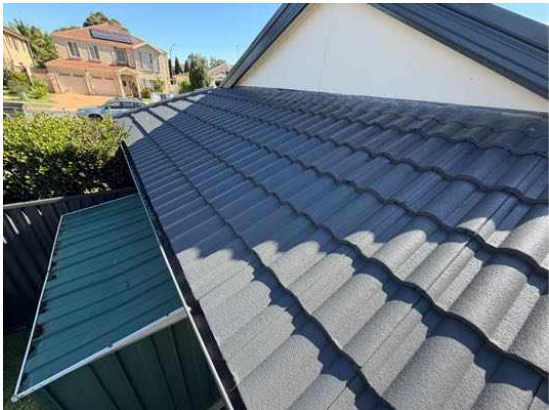
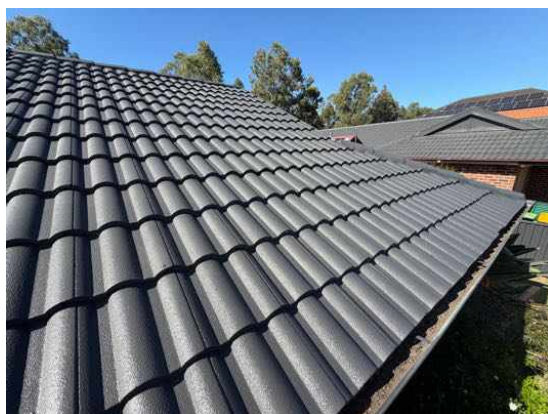
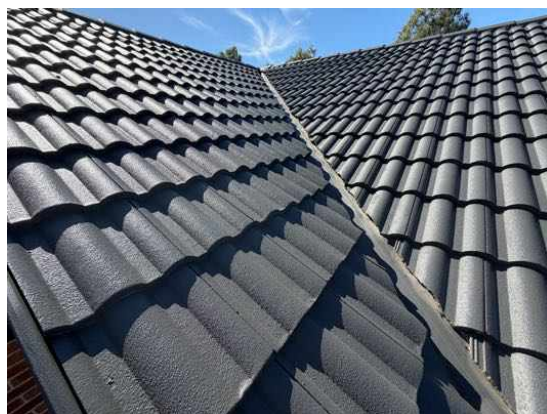
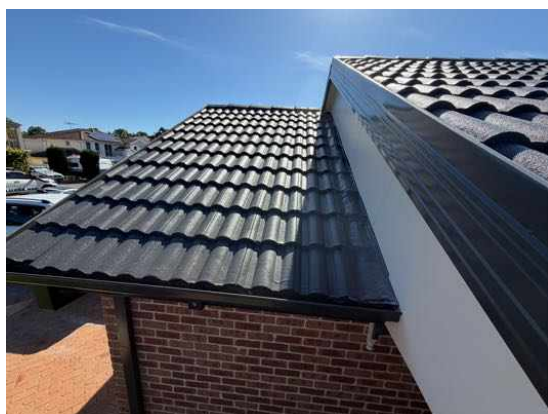
Building: Main Building  
Location: Roof Exterior  
Finding: Additional Photos  
Information:

Additional photos are provided for your general reference.

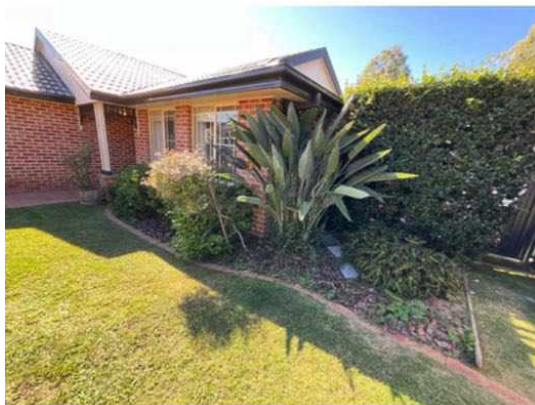
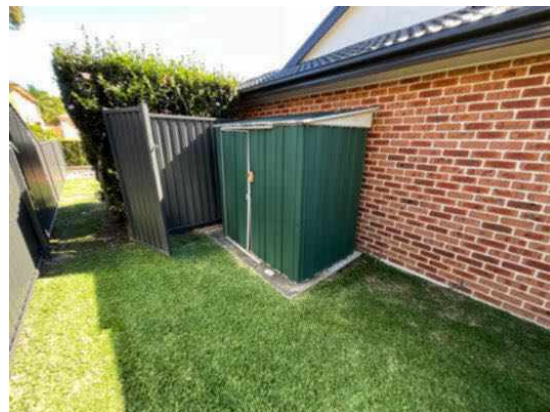
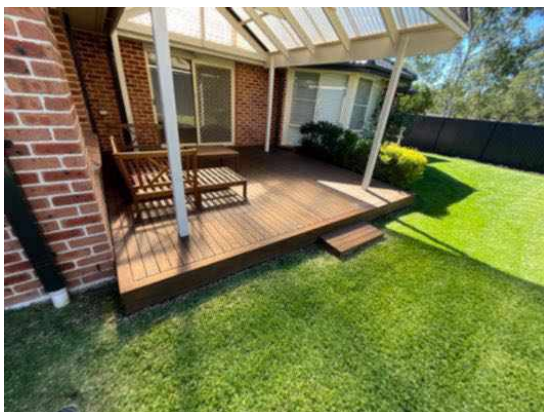
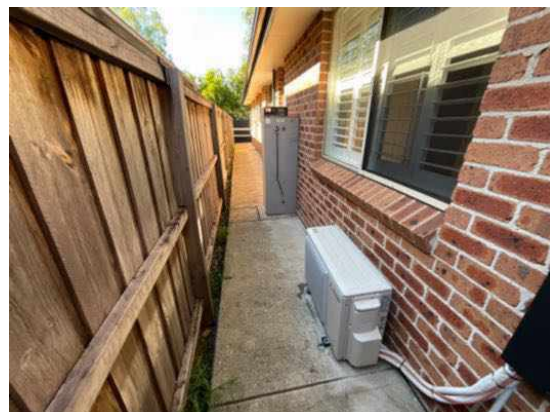
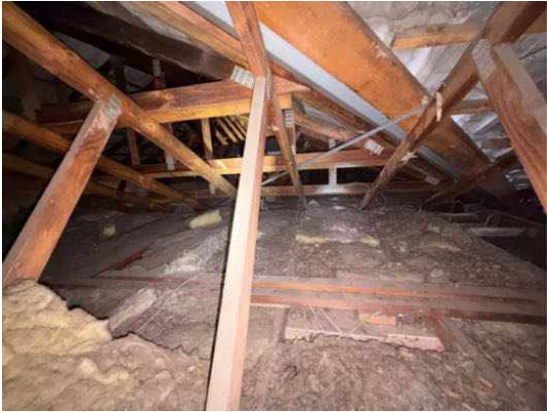
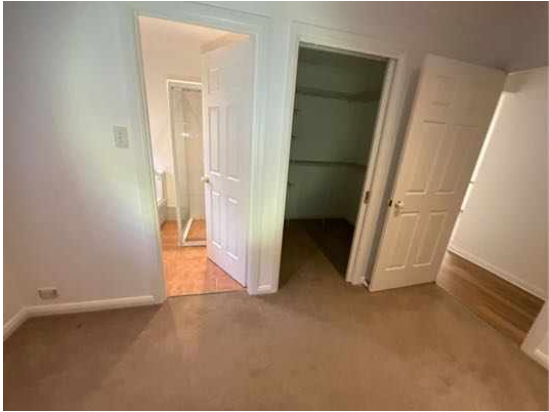
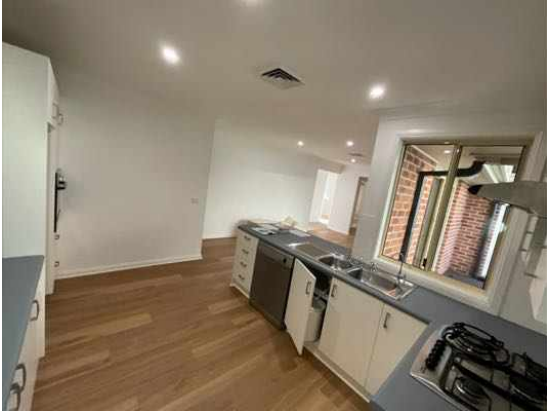
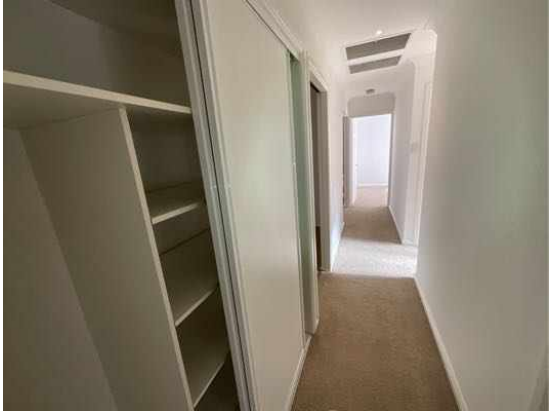
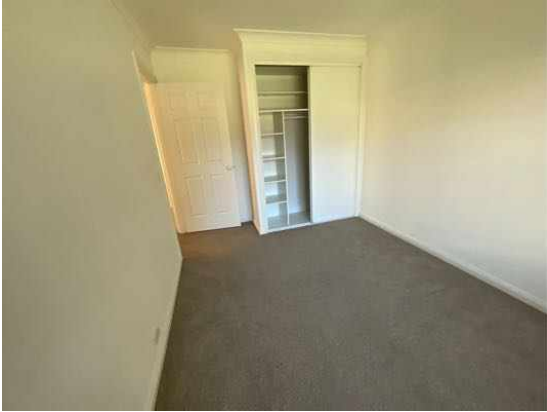
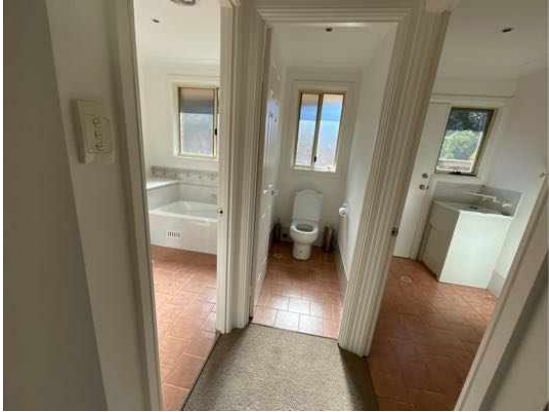
Building: Main Building  
 Location: All Areas  
 Finding: Additional Photos - Obstructions and Limitations  
 Information:

These photographs are an indication of the obstructions and limitations which impeded full inspection of the property at the time of inspection. These obstructions can hide an array of defects and should be removed to allow full inspection to be carried out. A re-inspection is recommended once the areas are made accessible.
