# Building and Timber Pest Inspection Report

Inspection Date: Thu, 26 Mar 2026

Property Address: 30 George Street, Springwood NSW 2777

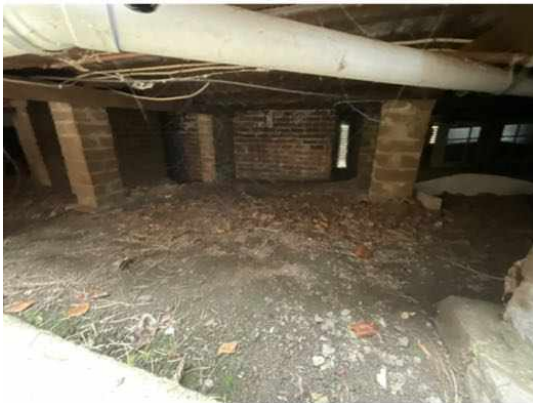
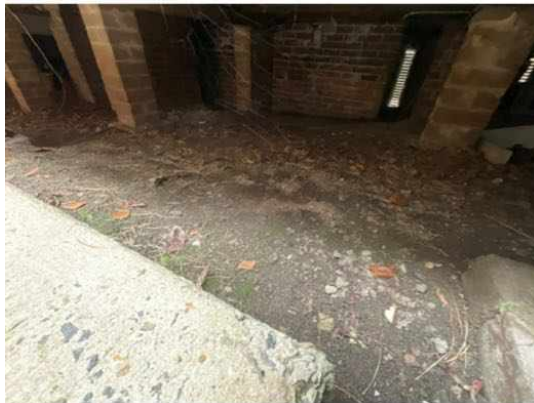
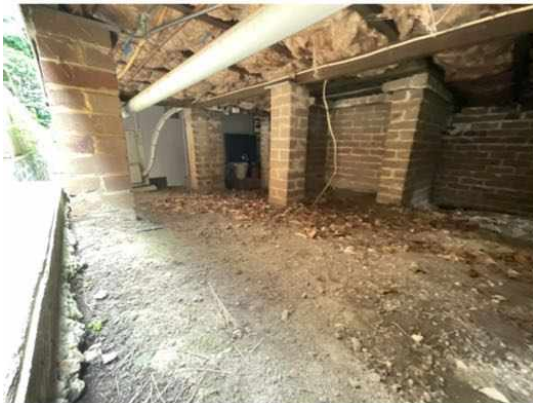
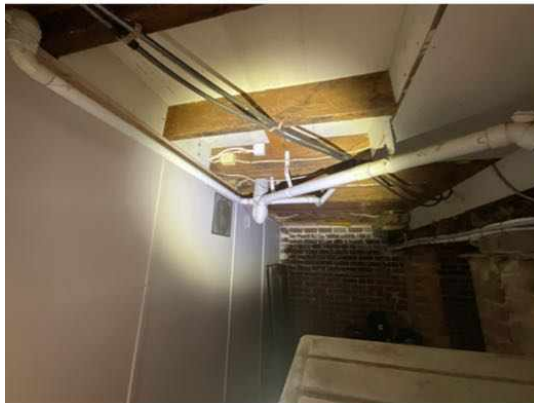
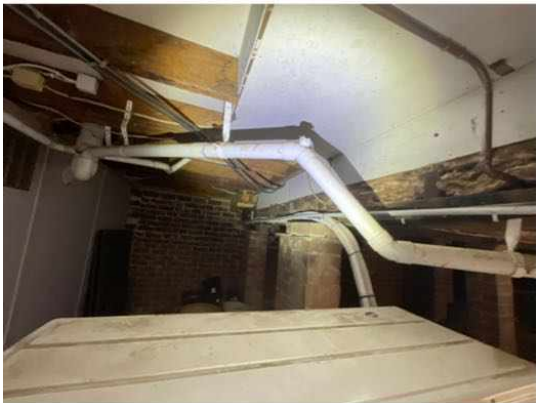
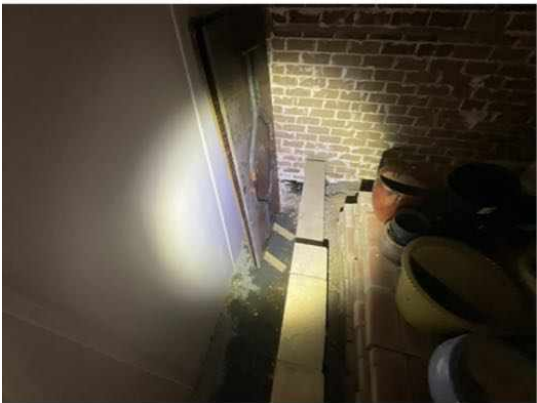
The subfloor space presented in generally serviceable condition at the time of inspection, with no major defects identified in accessible areas. Notwithstanding, due to restricted access and concealed elements, a degree of uncertainty remains, and ongoing monitoring is advised as part of standard property maintenance.

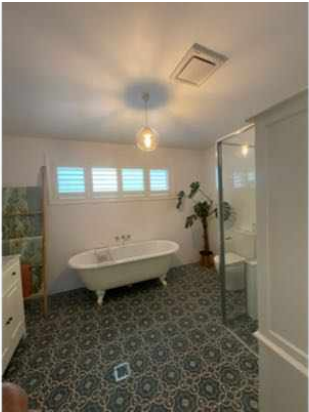
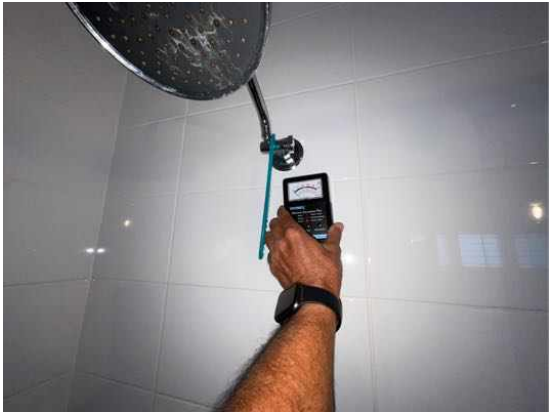
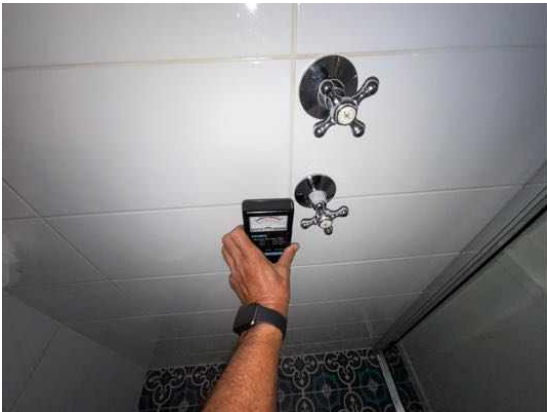
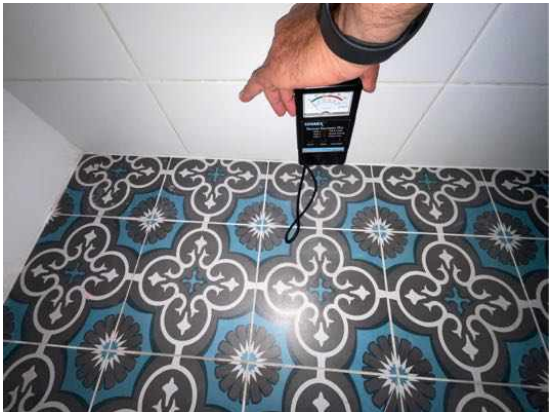
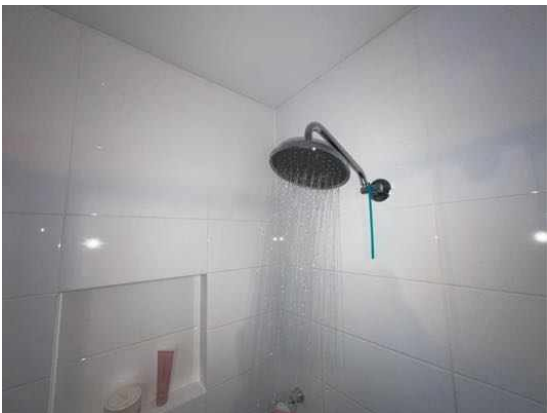
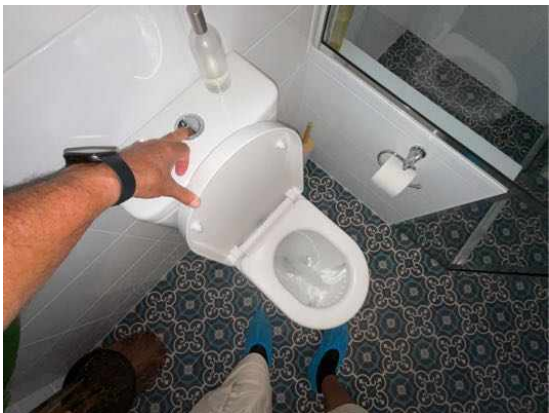
It is not possible under the visual inspection criteria of a standard pre-purchase report to categorically determine if leaks are present. If a more detailed or accurate assessment is required, a special-purpose inspection should be undertaken.

Alternatively, the assumption should be made that leakage may occur, particularly where historical or environmental conditions are conducive. The visual nature of this inspection cannot detect issues concealed behind wall/floor linings or cabinetry, and invasive investigation may be necessary to confirm the true condition of adjacent or hidden structures.

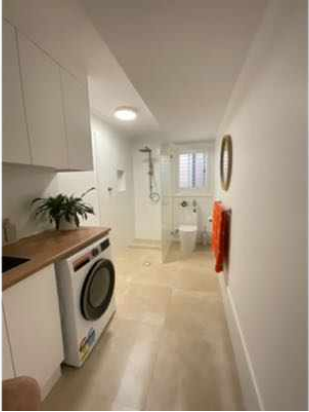
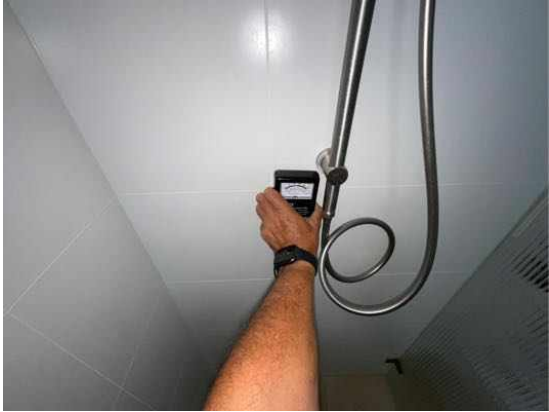
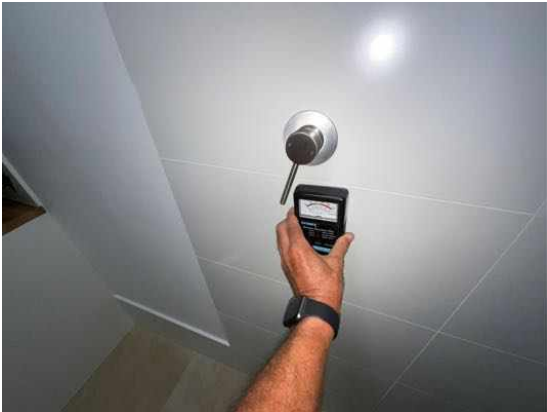
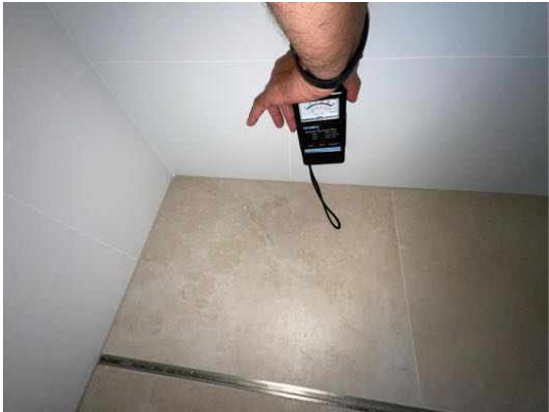
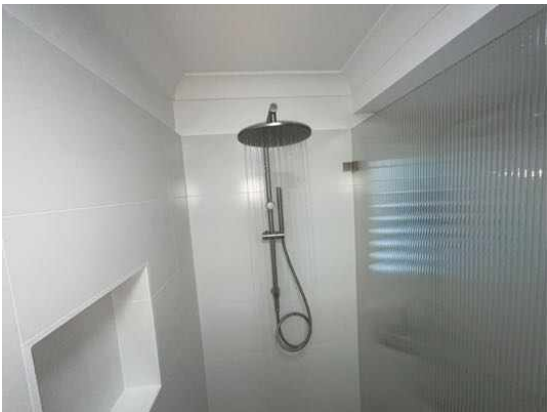
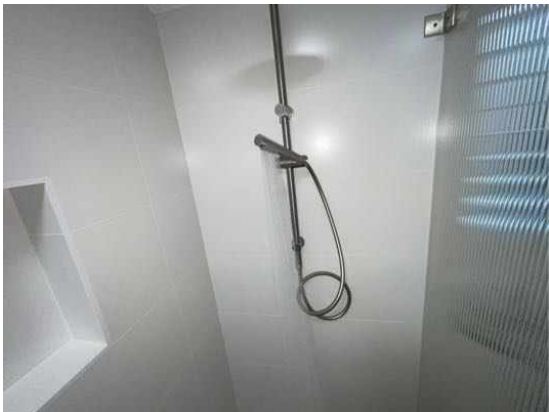
- Alternatively, it should be assumed that the shower may leak until proven otherwise through flood testing and extended monitoring under regular use conditions.
- Wall and floor linings may conceal damage, which will not be visible during a non-invasive inspection.
