Building and Timber Pest Inspection Report

Inspection Date: Wed, 18 Feb 2026

Property Address: 15 Kingsley Grove, Kingswood NSW 2747

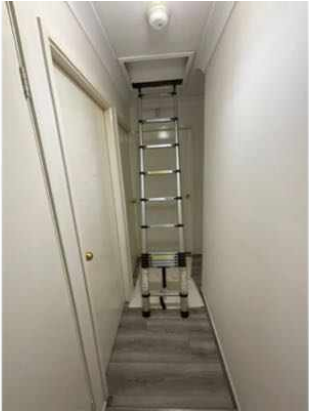
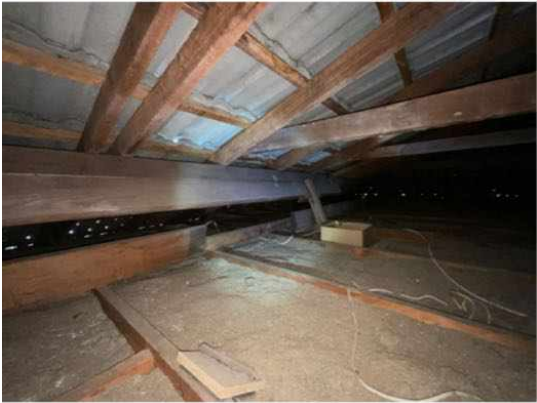
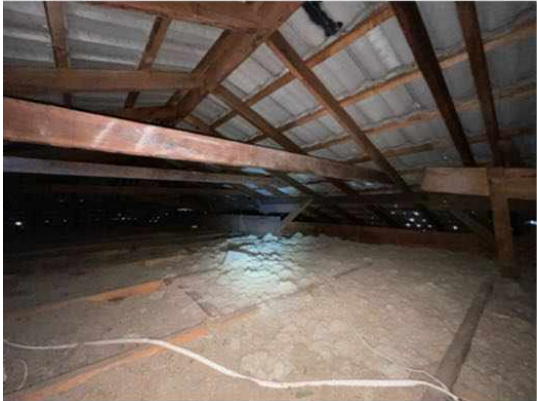
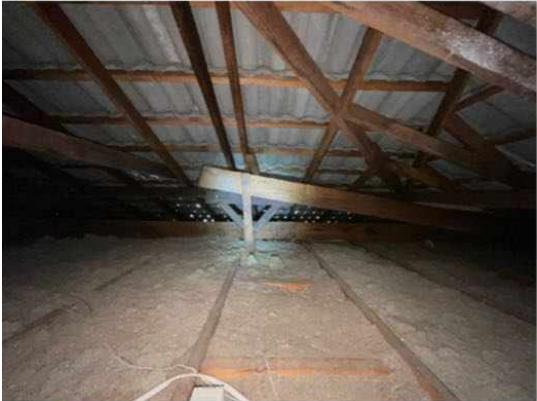
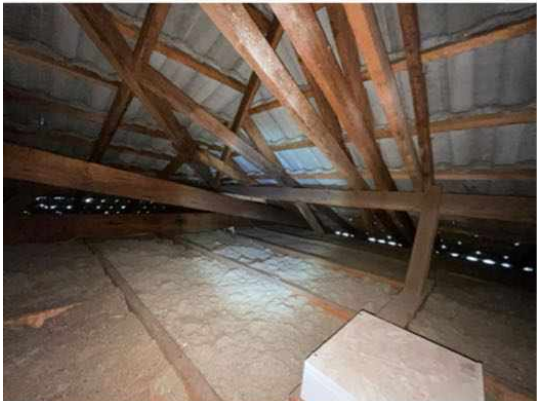
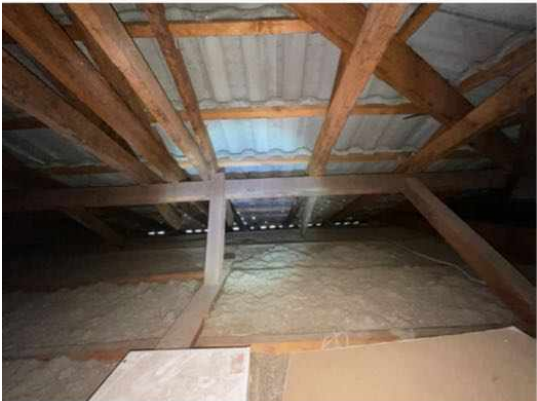
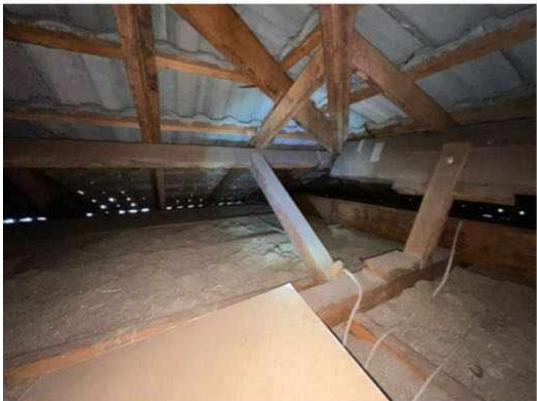
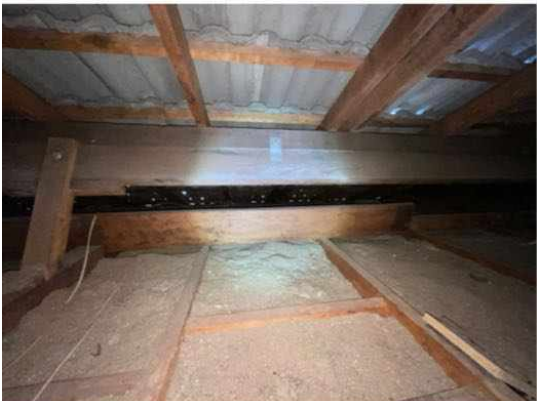
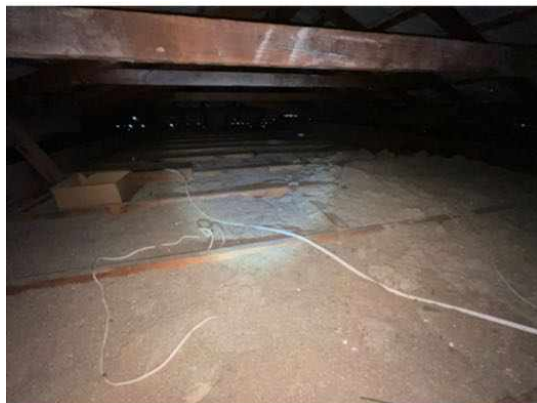
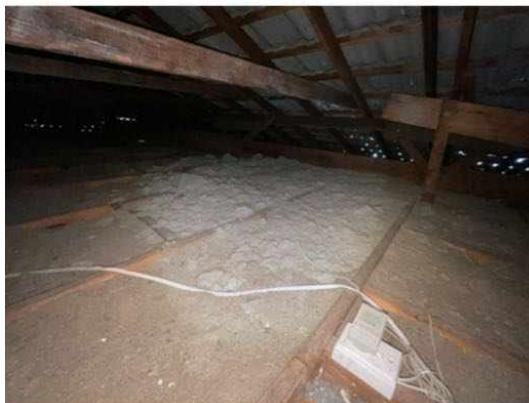
The roof void inspection was limited to safely accessible areas and is inherently restricted due to structural configuration and insulation coverage. No major defects were identified in the visible sections at the time of inspection. Regular monitoring and routine maintenance of the roof covering and associated components is advised to reduce the risk of future water ingress or concealed deterioration.

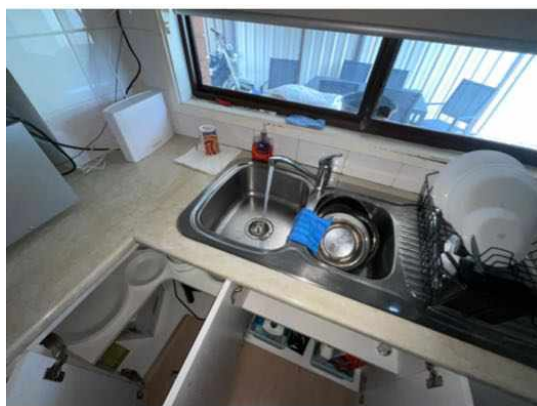
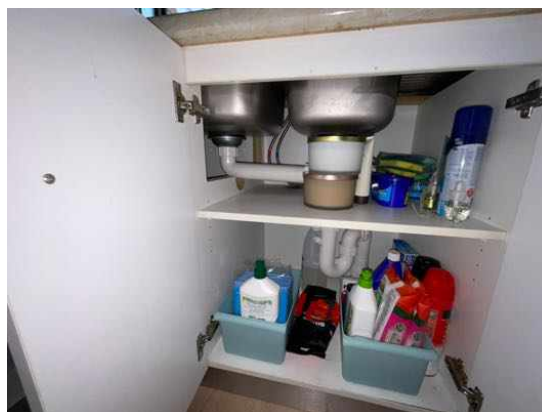
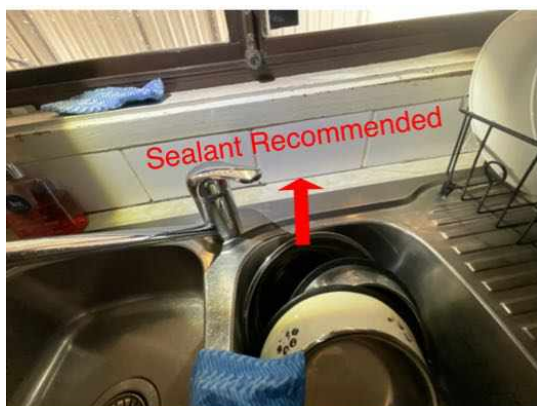
Building: Main Building
 Location: Kitchen
 Finding: Kitchen Sink – Overall Condition & Recommendations.
 Information: Observations:

- Further monitoring and testing are recommended once the tap(s) are in constant use, to identify any drainage issues or signs of slow leaks not evident during the limited inspection.
- For long-term property care, it is advised that sealant and grouting in water-exposed areas be regularly inspected and maintained. A sealant specialist or tiling contractor may be engaged to carry out these works where necessary.
- It is recommended that the stored items beneath the sink be removed to allow for a full re-inspection of the plumbing and cabinetry, ensuring no concealed defects are present.

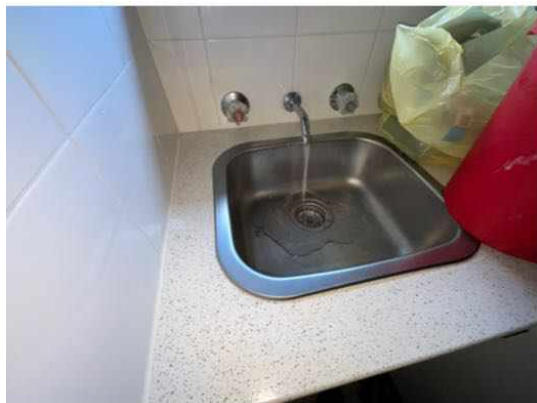
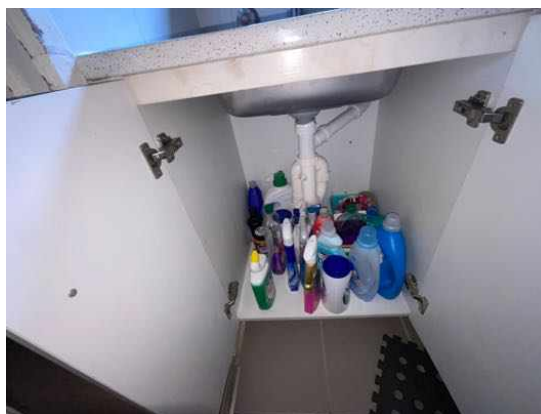
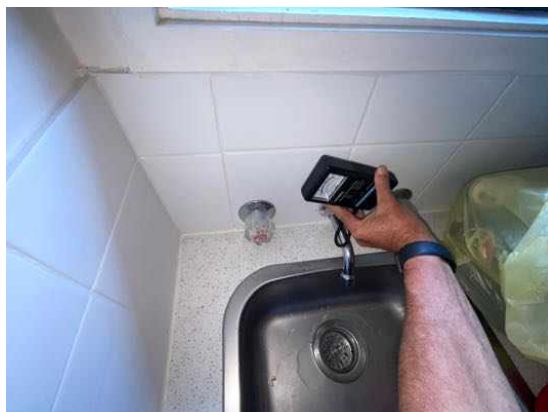
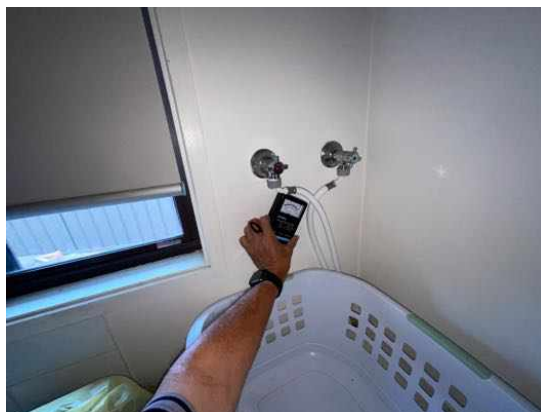
Building: Main Building
 Location: Laundry
 Finding: Laundry - Taps/Plumbing/Drainage.
 Information: Observation: Laundry Tub – Taps, Plumbing, and Cabinetry

- Further monitoring or testing is recommended once the taps are placed into regular use, to ensure no leaks develop over time and that the drainage system continues to perform adequately.
- Sealant and grouting in wet areas should be maintained as part of the long-term care and upkeep of the property.

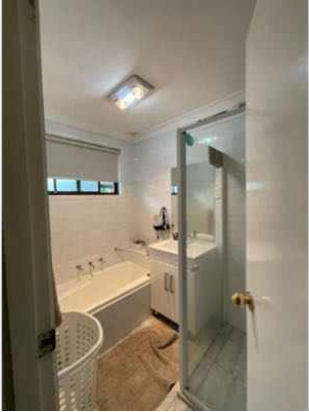
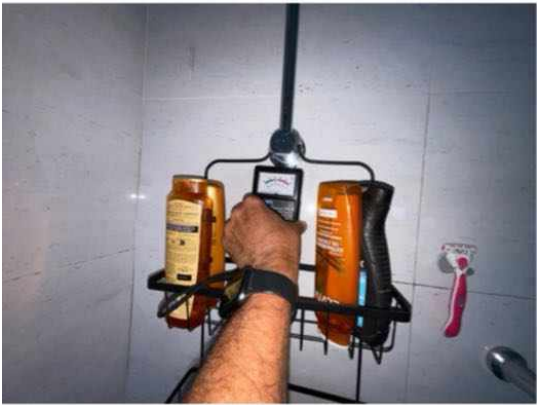
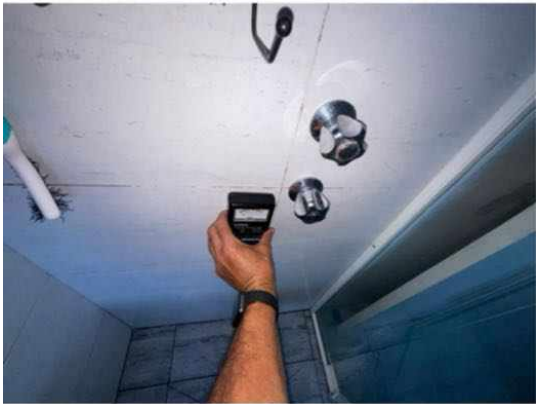
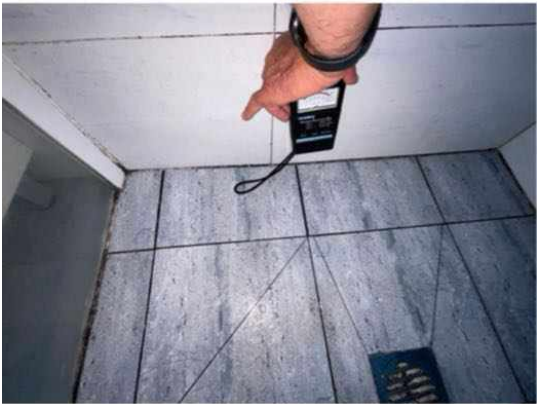
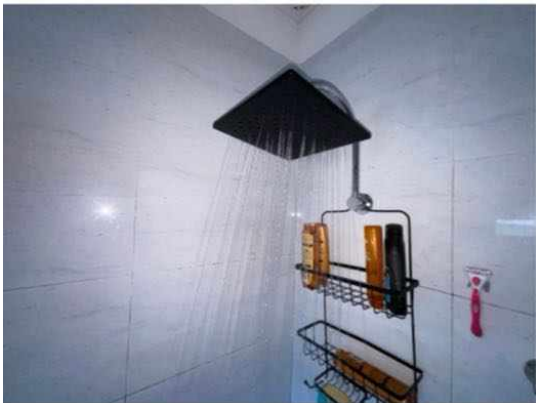
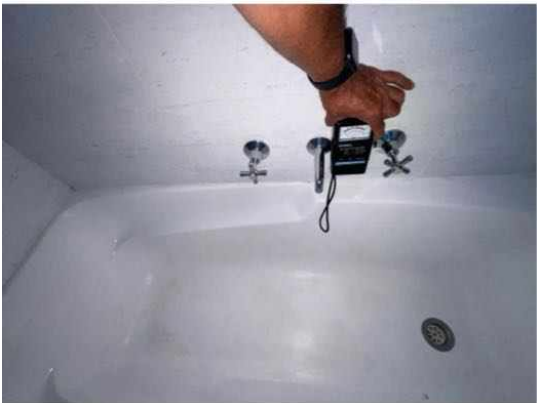
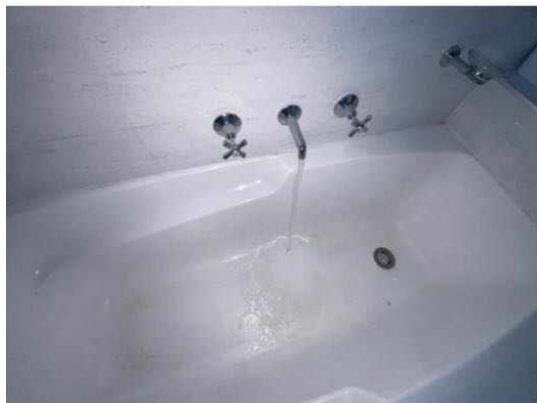
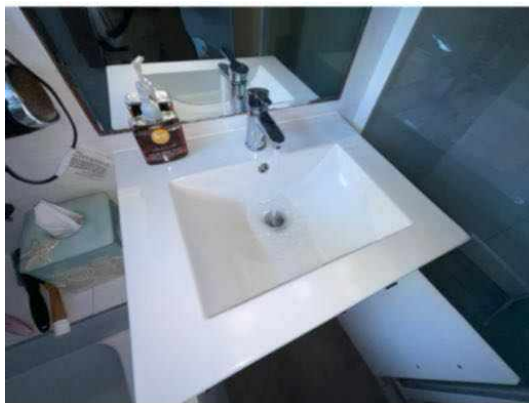
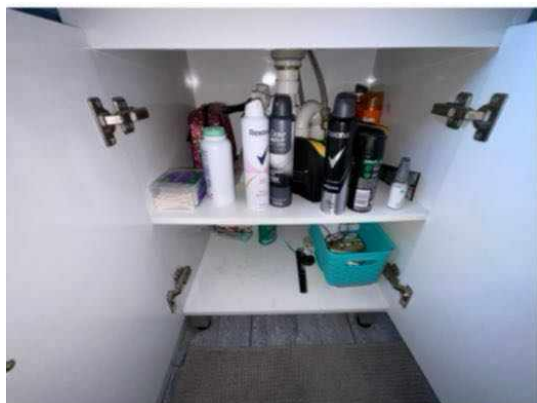
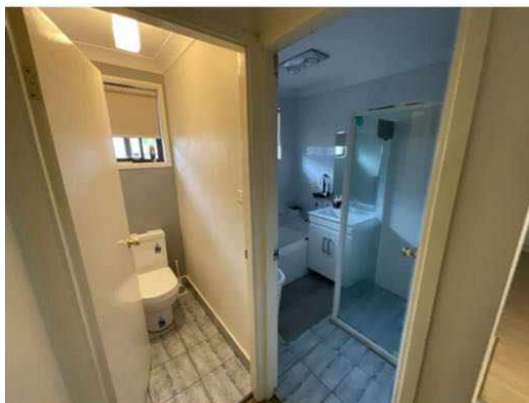
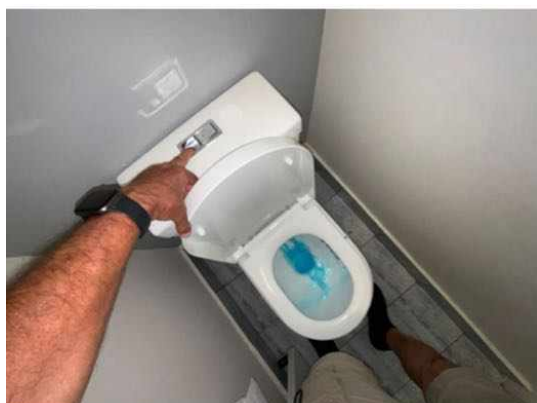
Building: Main Building
 Location: Bathroom
 Finding: Wet Areas - Bathroom(s) - Overall Condition & Recommendations.
 Information: Overall Condition & Recommendations

It is not possible under the visual inspection criteria of a standard pre-purchase report to categorically determine if leaks are present. If a more detailed or accurate assessment is required, a special-purpose inspection should be undertaken.

Alternatively, the assumption should be made that leakage may occur, particularly where historical or environmental conditions are conducive. The visual nature of this inspection cannot detect issues concealed behind wall/floor linings or cabinetry, and invasive investigation may be necessary to confirm the true condition of adjacent or hidden structures.

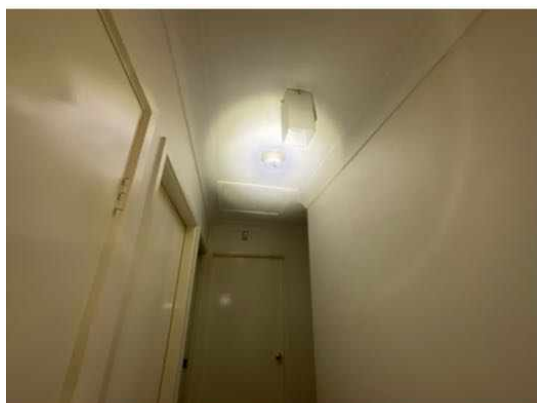
Building: Main Building
Location: All Areas
Finding: Smoke Detectors / Alarms.

Failure to comply with these requirements may pose a serious risk to occupant safety.

- All smoke detectors be tested monthly by the homeowner.
- All systems comply with the requirements of AS 3786 and any applicable state-based legislation.
