Building and Timber Pest Inspection Report

Inspection Date: Fri, 27 Mar 2026

Property Address: 36 Slattery Pl, Pakenham VIC 3810,
Australia

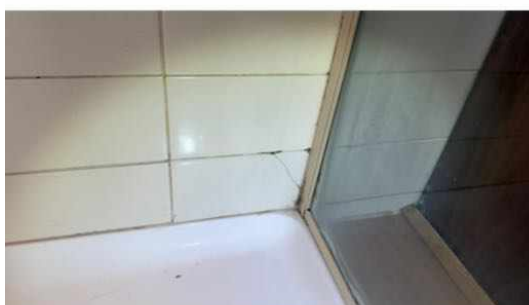
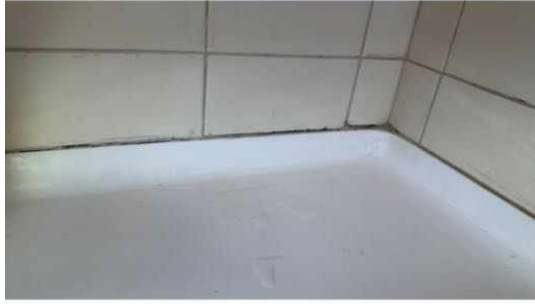
Finding: Shower Waterproofing Failure

Information: Cracked wall tile and deteriorated grout were observed in the shower area during the inspection. Elevated moisture levels were recorded on the adjacent plasterboard wall and to the backside of the shower area, indicating moisture ingress consistent with a likely failure of the waterproofing barrier. These conditions suggest that water is penetrating beyond the tiled surface and affecting surrounding building elements.

Failure of the waterproofing system can lead to concealed damage to structural timbers and wall linings, promote mould growth, and create conditions conducive to timber pest (termite) activity due to persistent dampness. If left unaddressed, this may result in significant deterioration of building components and costly repairs.

It is highly recommended that a licensed plumber and a registered builder be engaged to carry out further investigation and necessary rectification works. An invasive inspection is strongly recommended to determine the full extent of damage, as this assessment is based on a visual, non-invasive inspection and concealed conditions could not be determined.

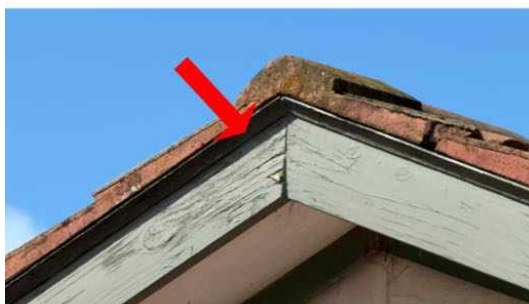
Weathered timber may become susceptible to further decay, including wood rot, if not maintained. Deteriorated roof mortar can lead to loosening of roof tiles and may allow water ingress, particularly during adverse weather conditions.

It is recommended that the affected timber be repaired, treated, sealed, or replaced as required to prevent further deterioration. A licensed roofing contractor should be engaged to repair or re-point the deteriorated roof tile mortar and ensure the roof covering remains secure and weatherproof.

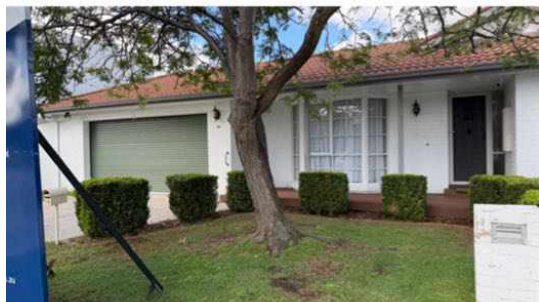
structural distortion.

It is recommended that an arborist or structural engineer be consulted to assess the type, size, and impact potential of the tree. Monitoring of the cracking and ongoing inspection of the area is advised. Depending on the assessment, root management strategies, installation of root barriers, or controlled removal of the tree may be necessary to prevent future structural issues.

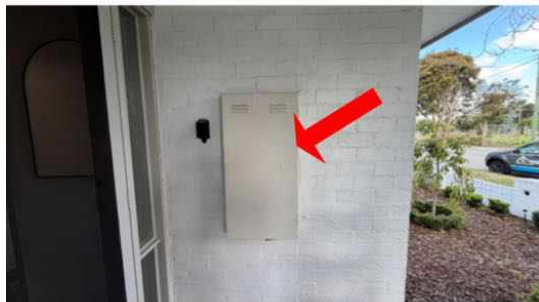
system has been installed, with no evidence to suggest preventative works taking place.

The client may consider gaining further advice from a pest controller as to the costs and procedures involved with this application. It is recommended that obtaining such advice be a short-term priority.

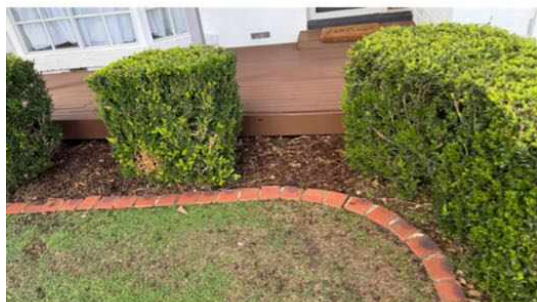
proximity to the soil. Without proper precautions, the moisture in the soil can create an ideal environment for timber decay and other termites to thrive. Regular inspection and treatment can help prevent infestation and protect the decks structural integrity.

An invasive inspection of the area is recommended to determine further actions.

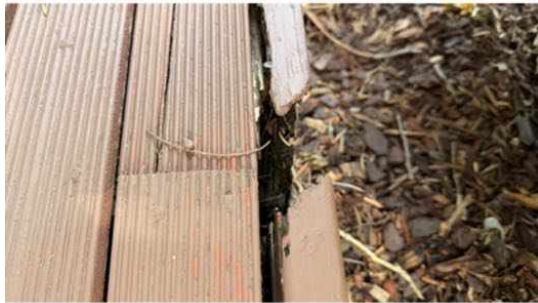
Early intervention and regular maintenance, particularly of exterior timbers, will prolong the useful life of these building elements. Replacement of affected timbers may then be a necessary step in protecting surrounding building elements from such deterioration.

A qualified carpenter or a handy person may also be required to replace affected building materials.

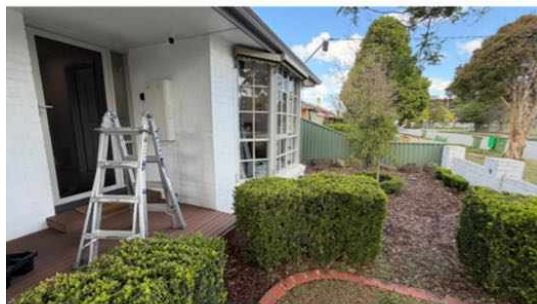
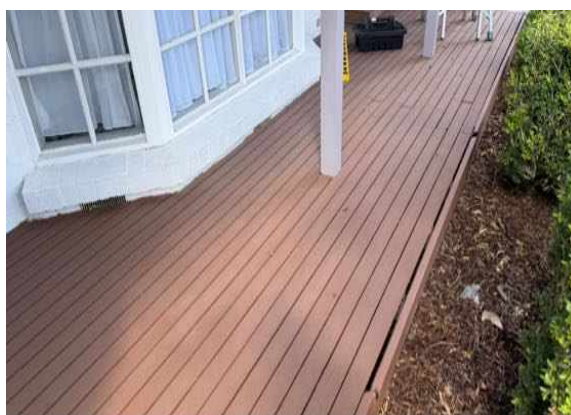
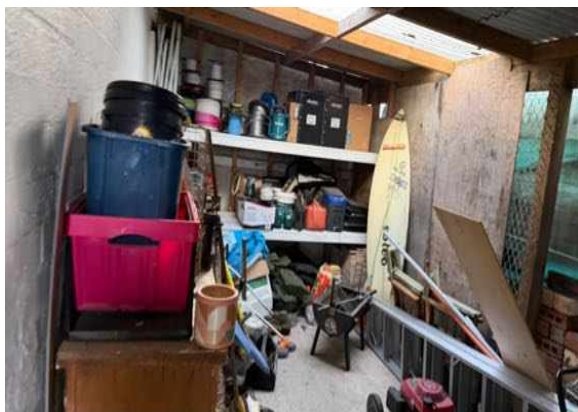
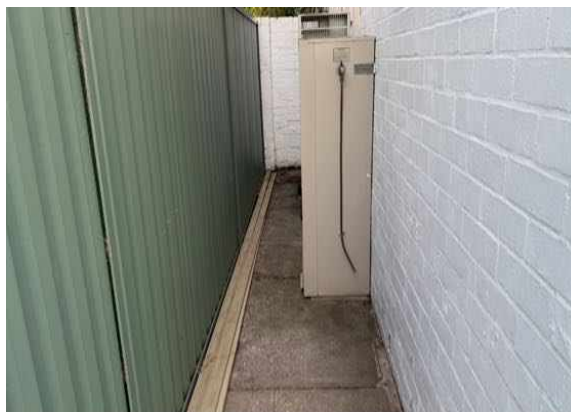
Building: Main Building
 Location: All External Areas
 Finding: Obstructions and Limitations - External areas
 Information: These photographs are an indication of the obstructions and limitations which impeded full inspection of the external areas of the property at the time of inspection. These obstructions can hide an array of defects and should be removed to allow full inspection to be carried out. A re-inspection is recommended once the areas are made accessible.

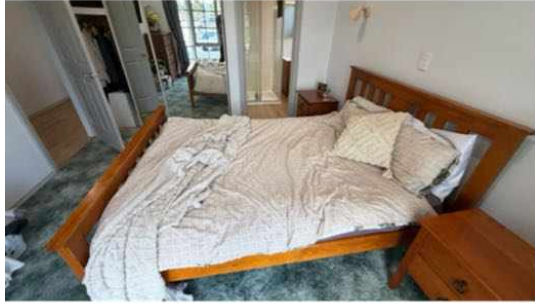
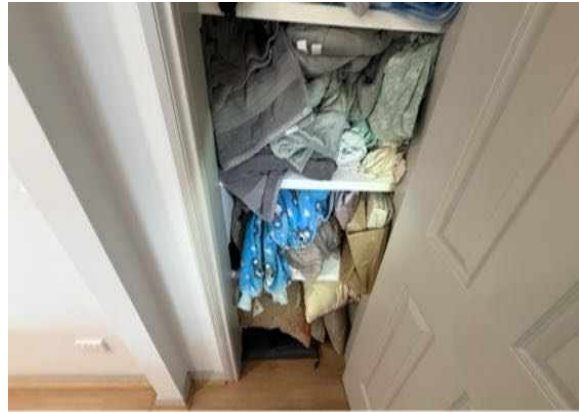
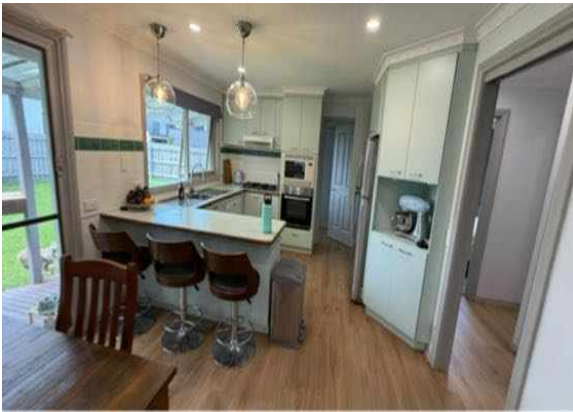
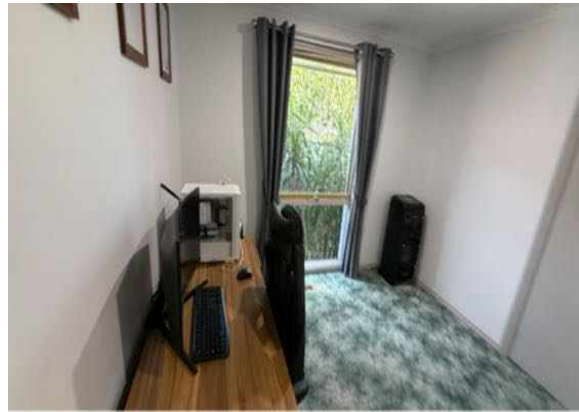
Building: Main Building
 Location: All Internal Areas
 Finding: Obstructions and Limitations - Internal areas
 Information: These photographs are an indication of the obstructions and limitations which impeded full inspection of the internal areas of the property at the time of inspection.

These obstructions can hide an array of defects and should be removed to allow full inspection to be carried out. A re-inspection is recommended once the areas are made accessible.

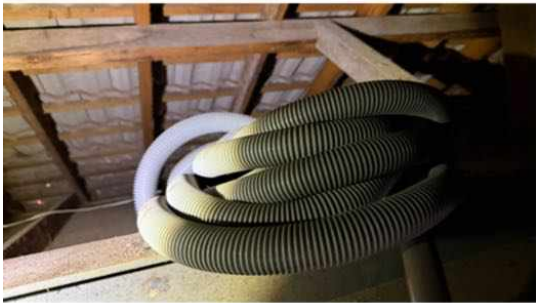
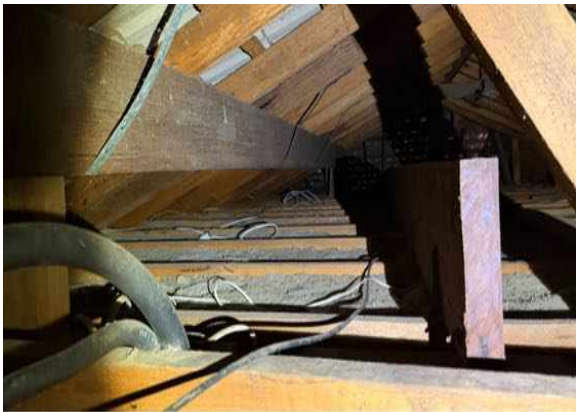
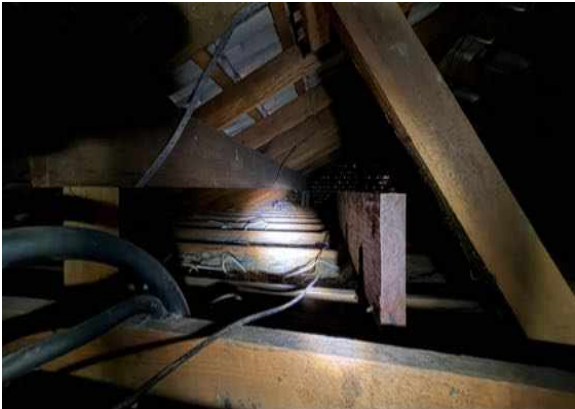
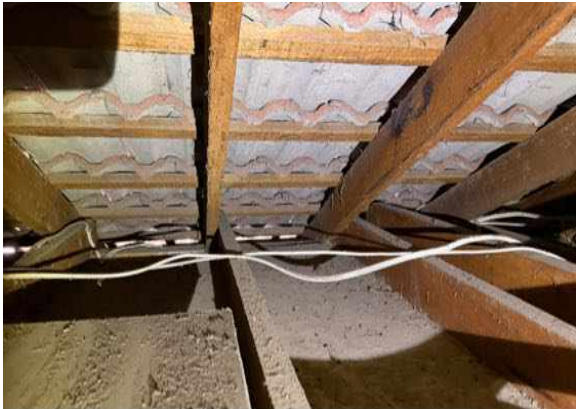
Building:	Main Building
Location:	Roof Void
Finding:	Obstructions and Limitations - Roof Cavity
Information:	These photographs are an indication of the obstructions and limitations which impeded full inspection of the roof cavity of the main building at the time of inspection. These obstructions can hide an array of defects and should be removed to allow full inspection to be carried out. A re-inspection is recommended once the areas are made accessible.

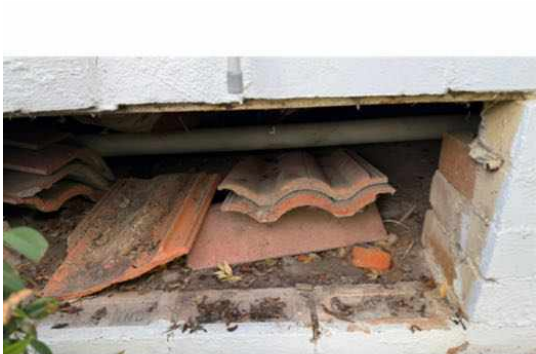
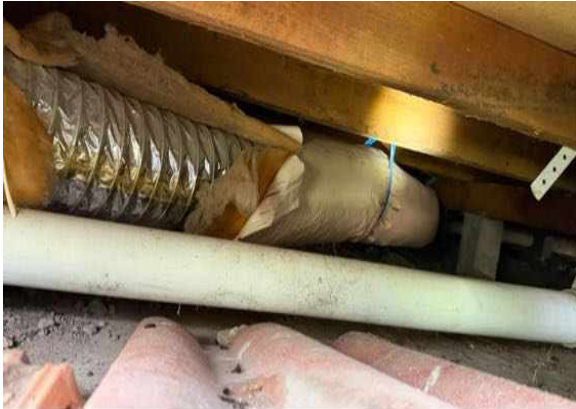
Building: Main Building
 Location: Subfloor
 Finding: Obstructions and Limitations - Subfloor
 Information: These photographs are an indication of the obstructions and limitations which impeded full inspection of the subfloor of the main building at the time of inspection. These obstructions can hide an array of defects and should be removed to allow full inspection to be carried out. A re-inspection is recommended once the areas are made accessible.

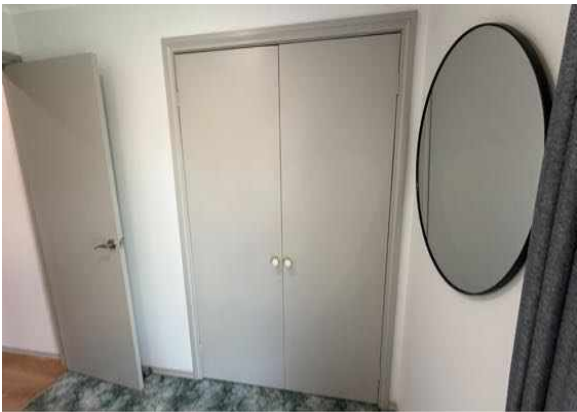
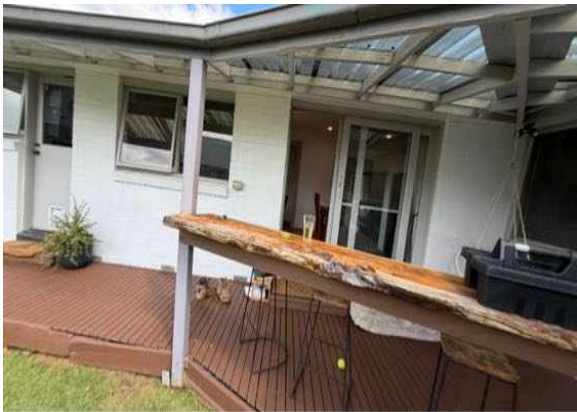
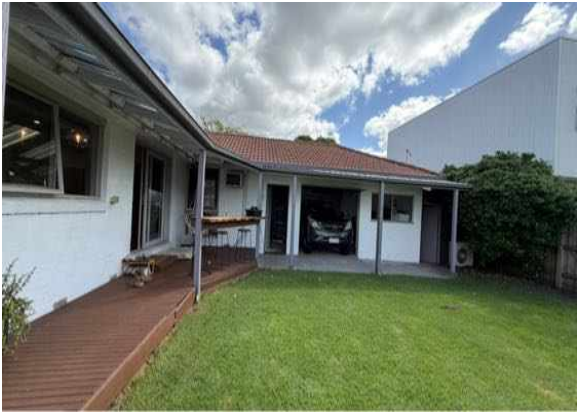
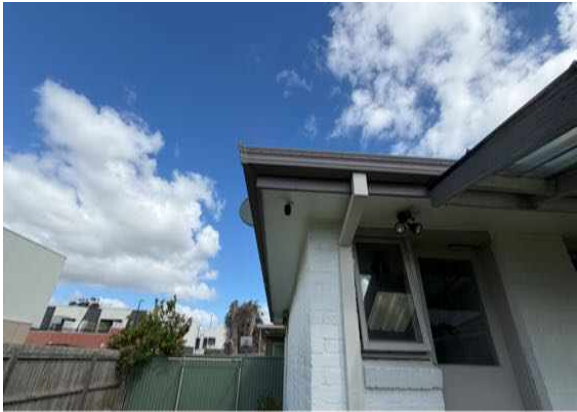
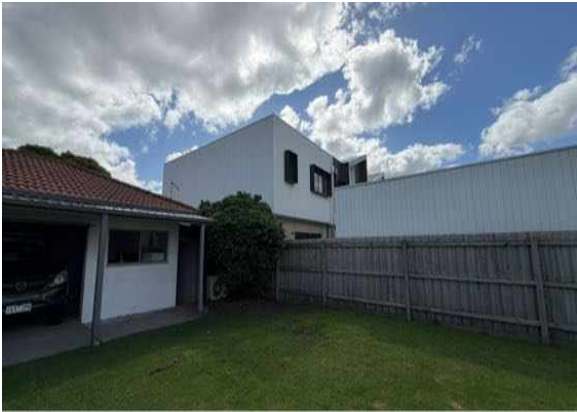
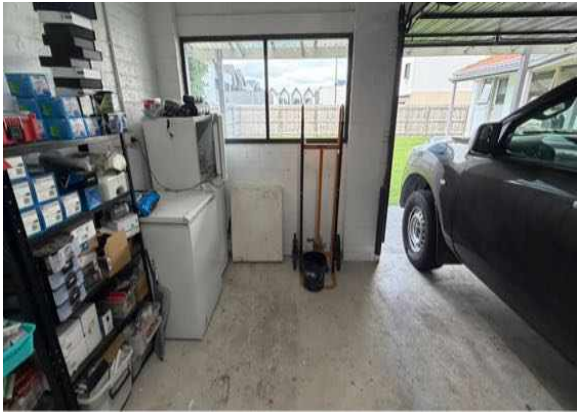
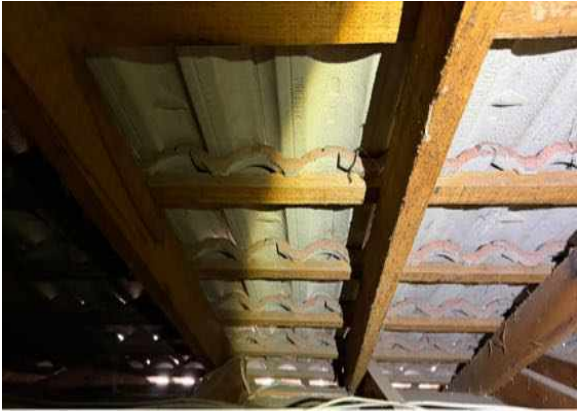
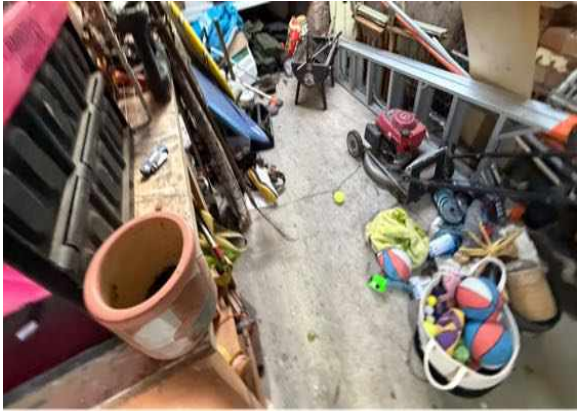
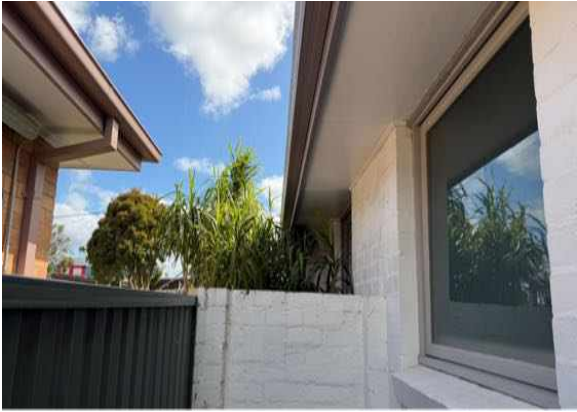
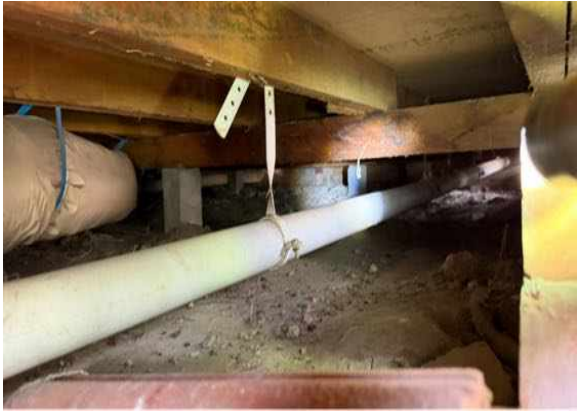
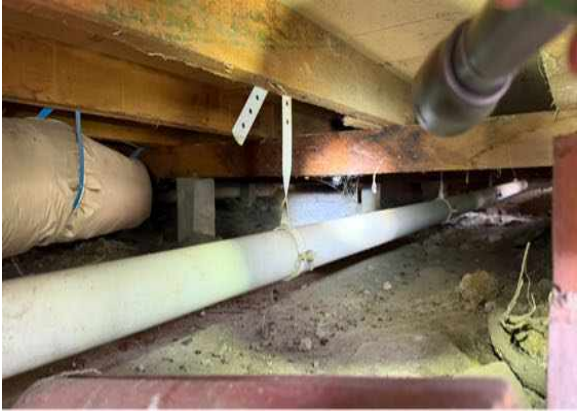
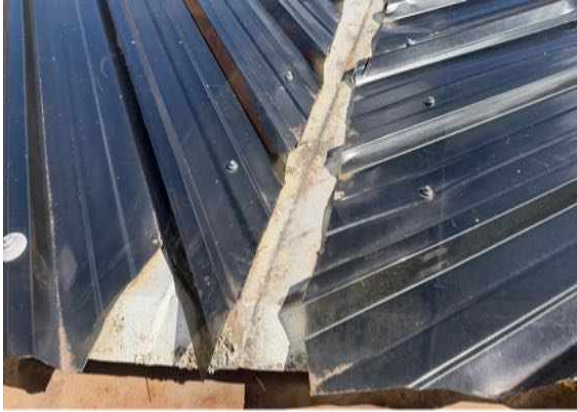
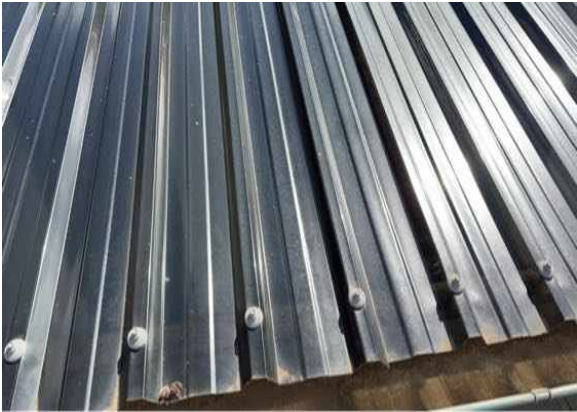
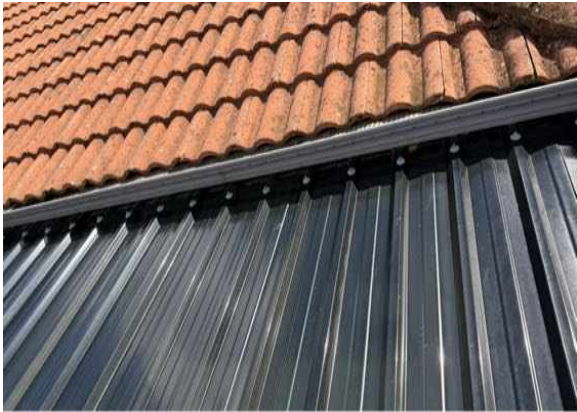
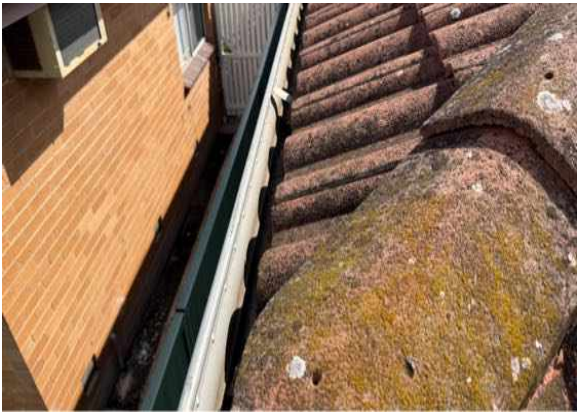
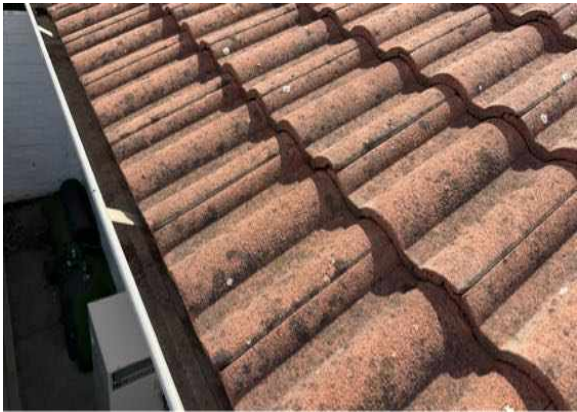
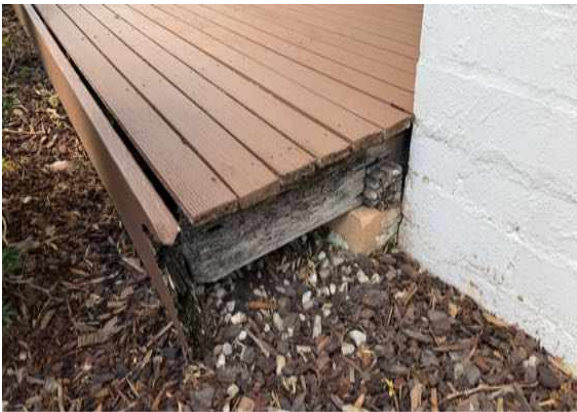
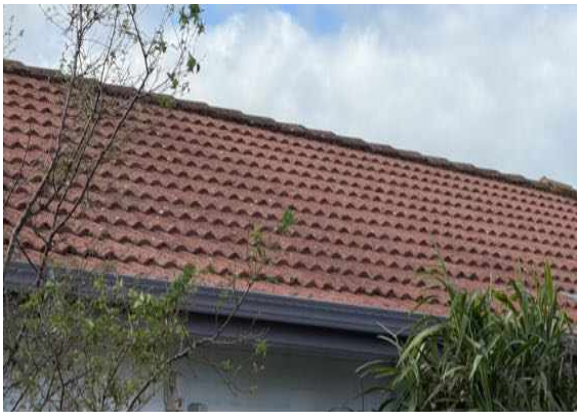
Noted Item

Building: Main Building
Location: All Areas
Finding: Additional Photos for reference
Information: Additional photos have been provided for your reference to enhance your understanding of the property's condition.
